Riva 400, Eroded outfall restoration project  
Anne Arundel County Government  
Department of Public Works  
Watershed, Ecosystem, and Restoration Services

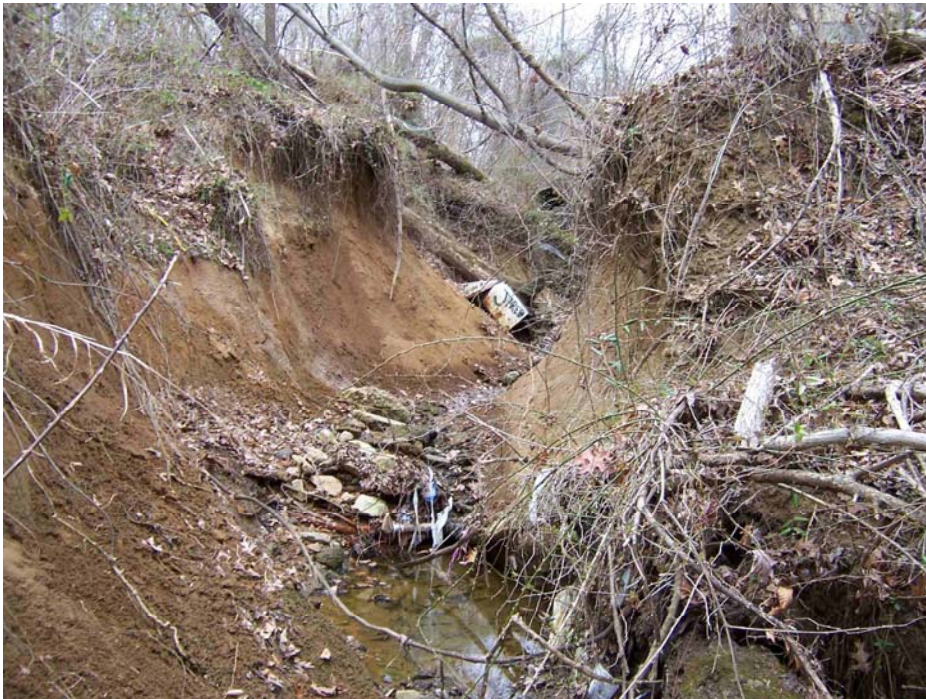
Before Restoration  
Severely degraded perennial gully  
Photo take by KCI during stream assessment  
South River Watershed Study (March 2006)

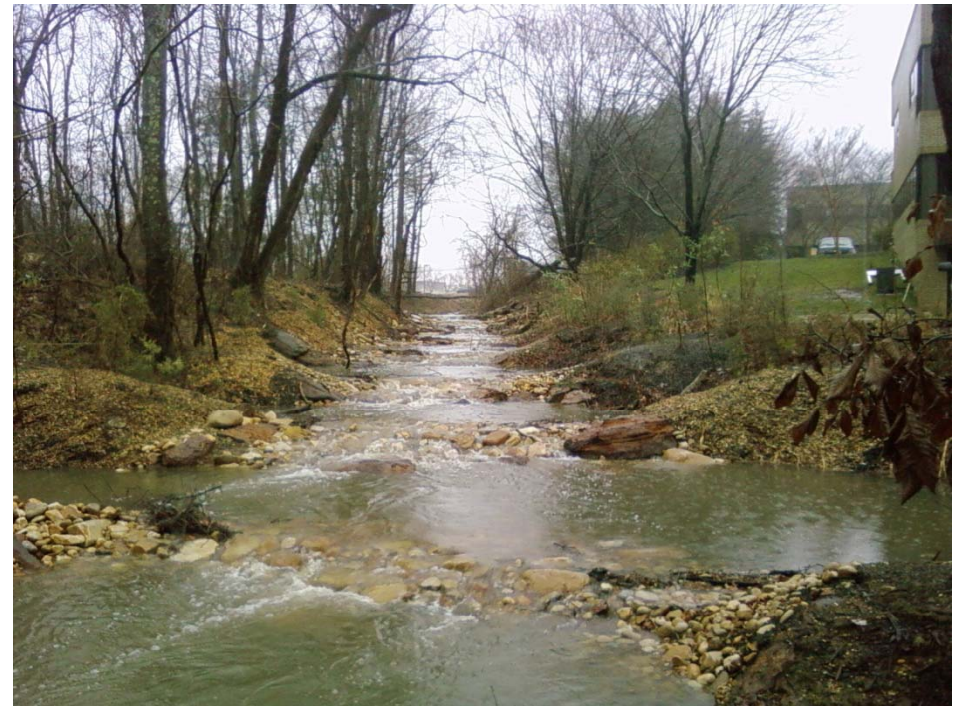
After Restoration  
Step Pool Storm Conveyance System  
During rain event  
Photos taken by: Chris Victoria (March 10/2011)

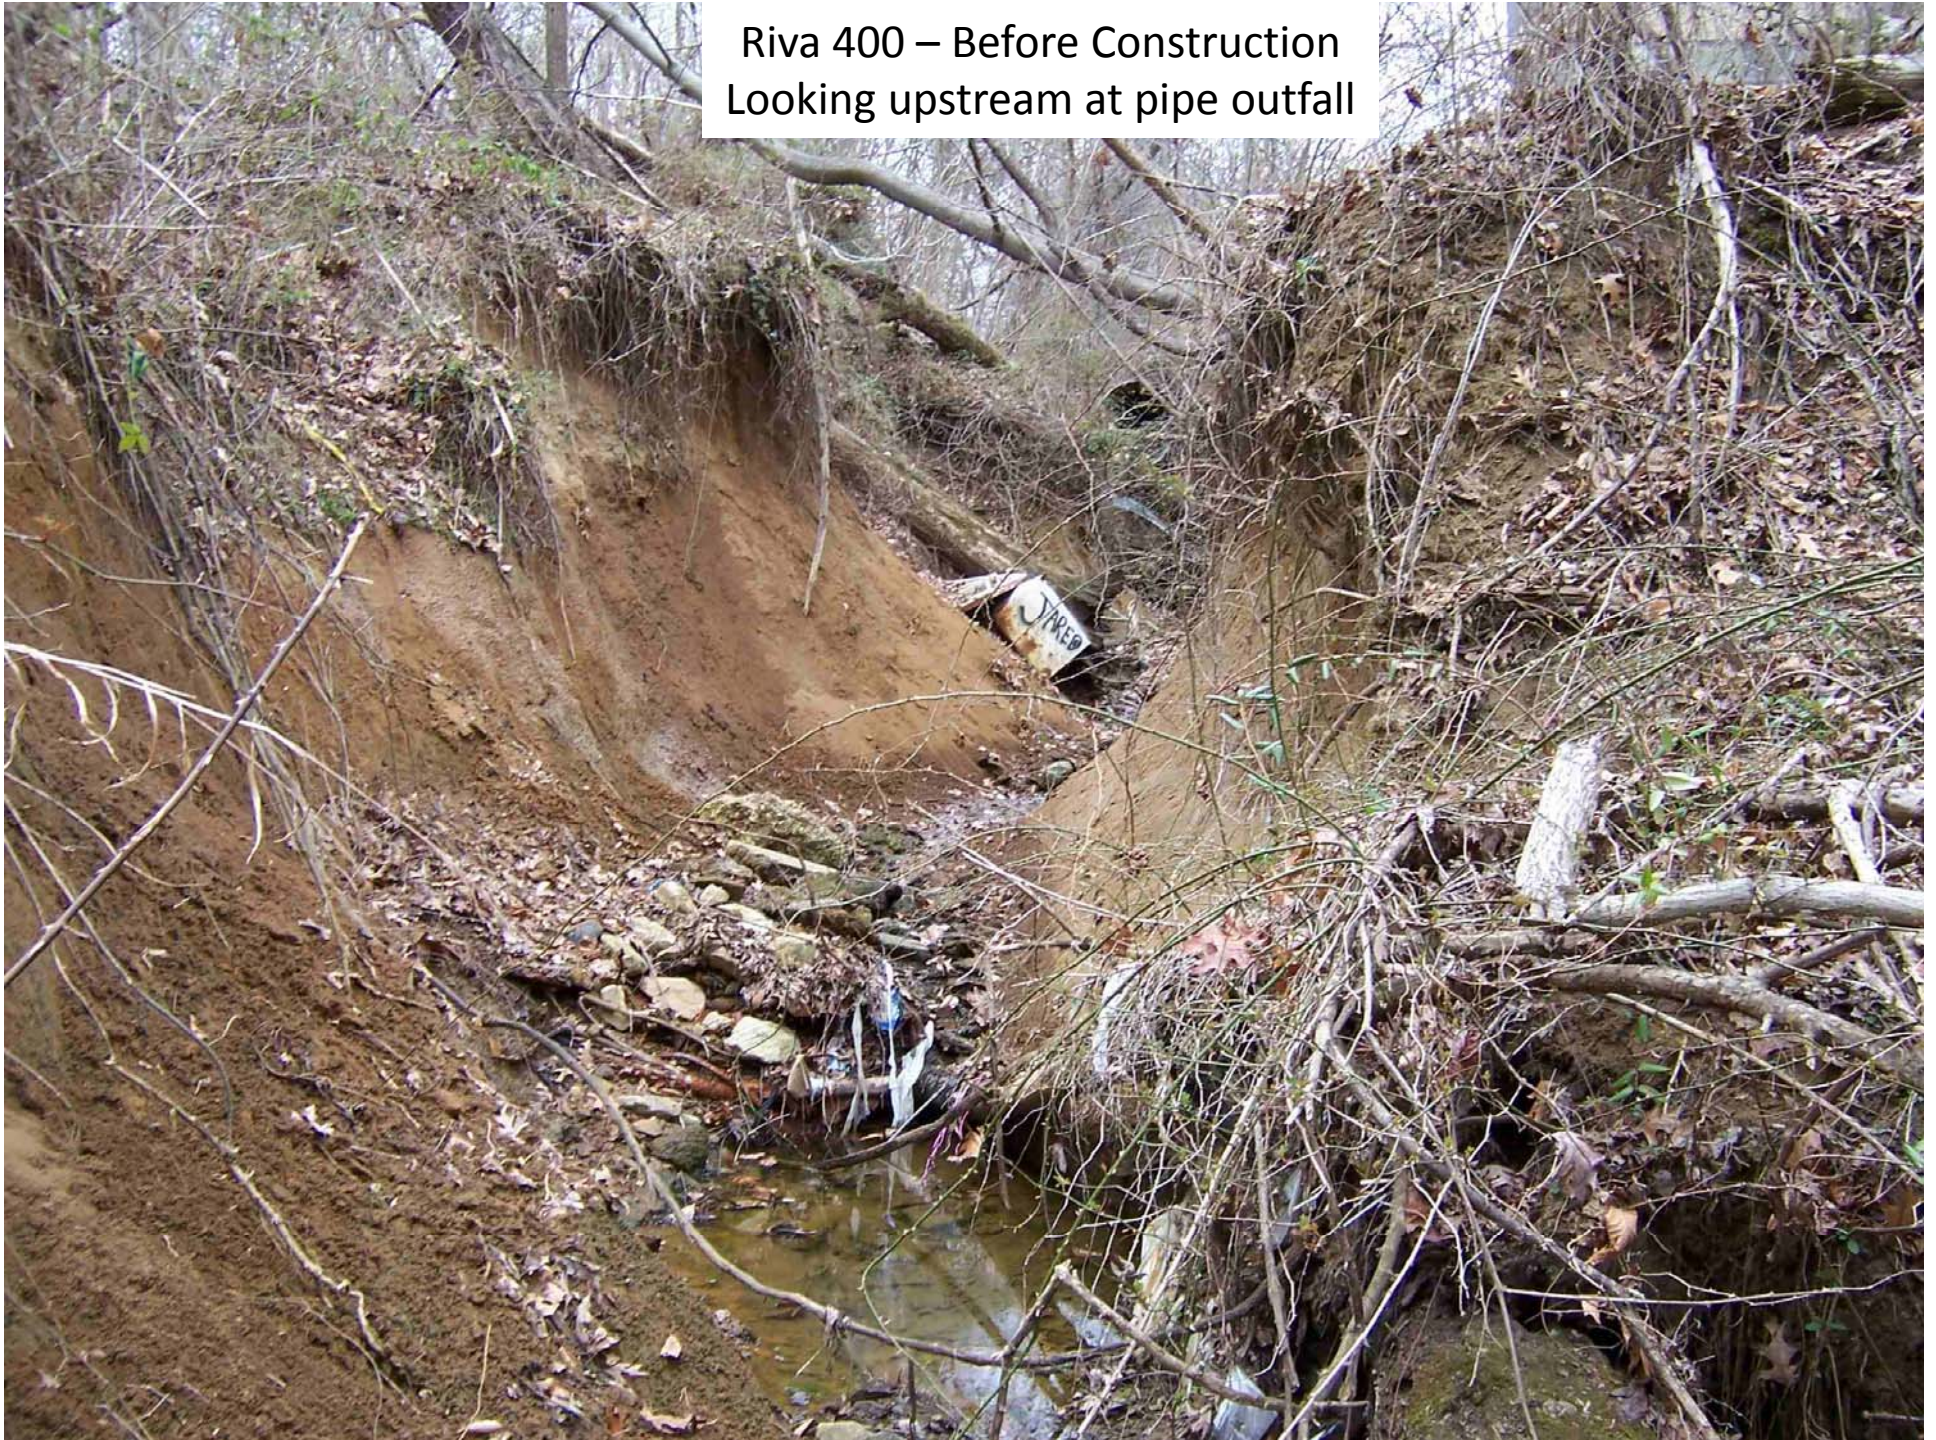
Riva 400 – Before Construction  
Looking upstream at pipe outfall

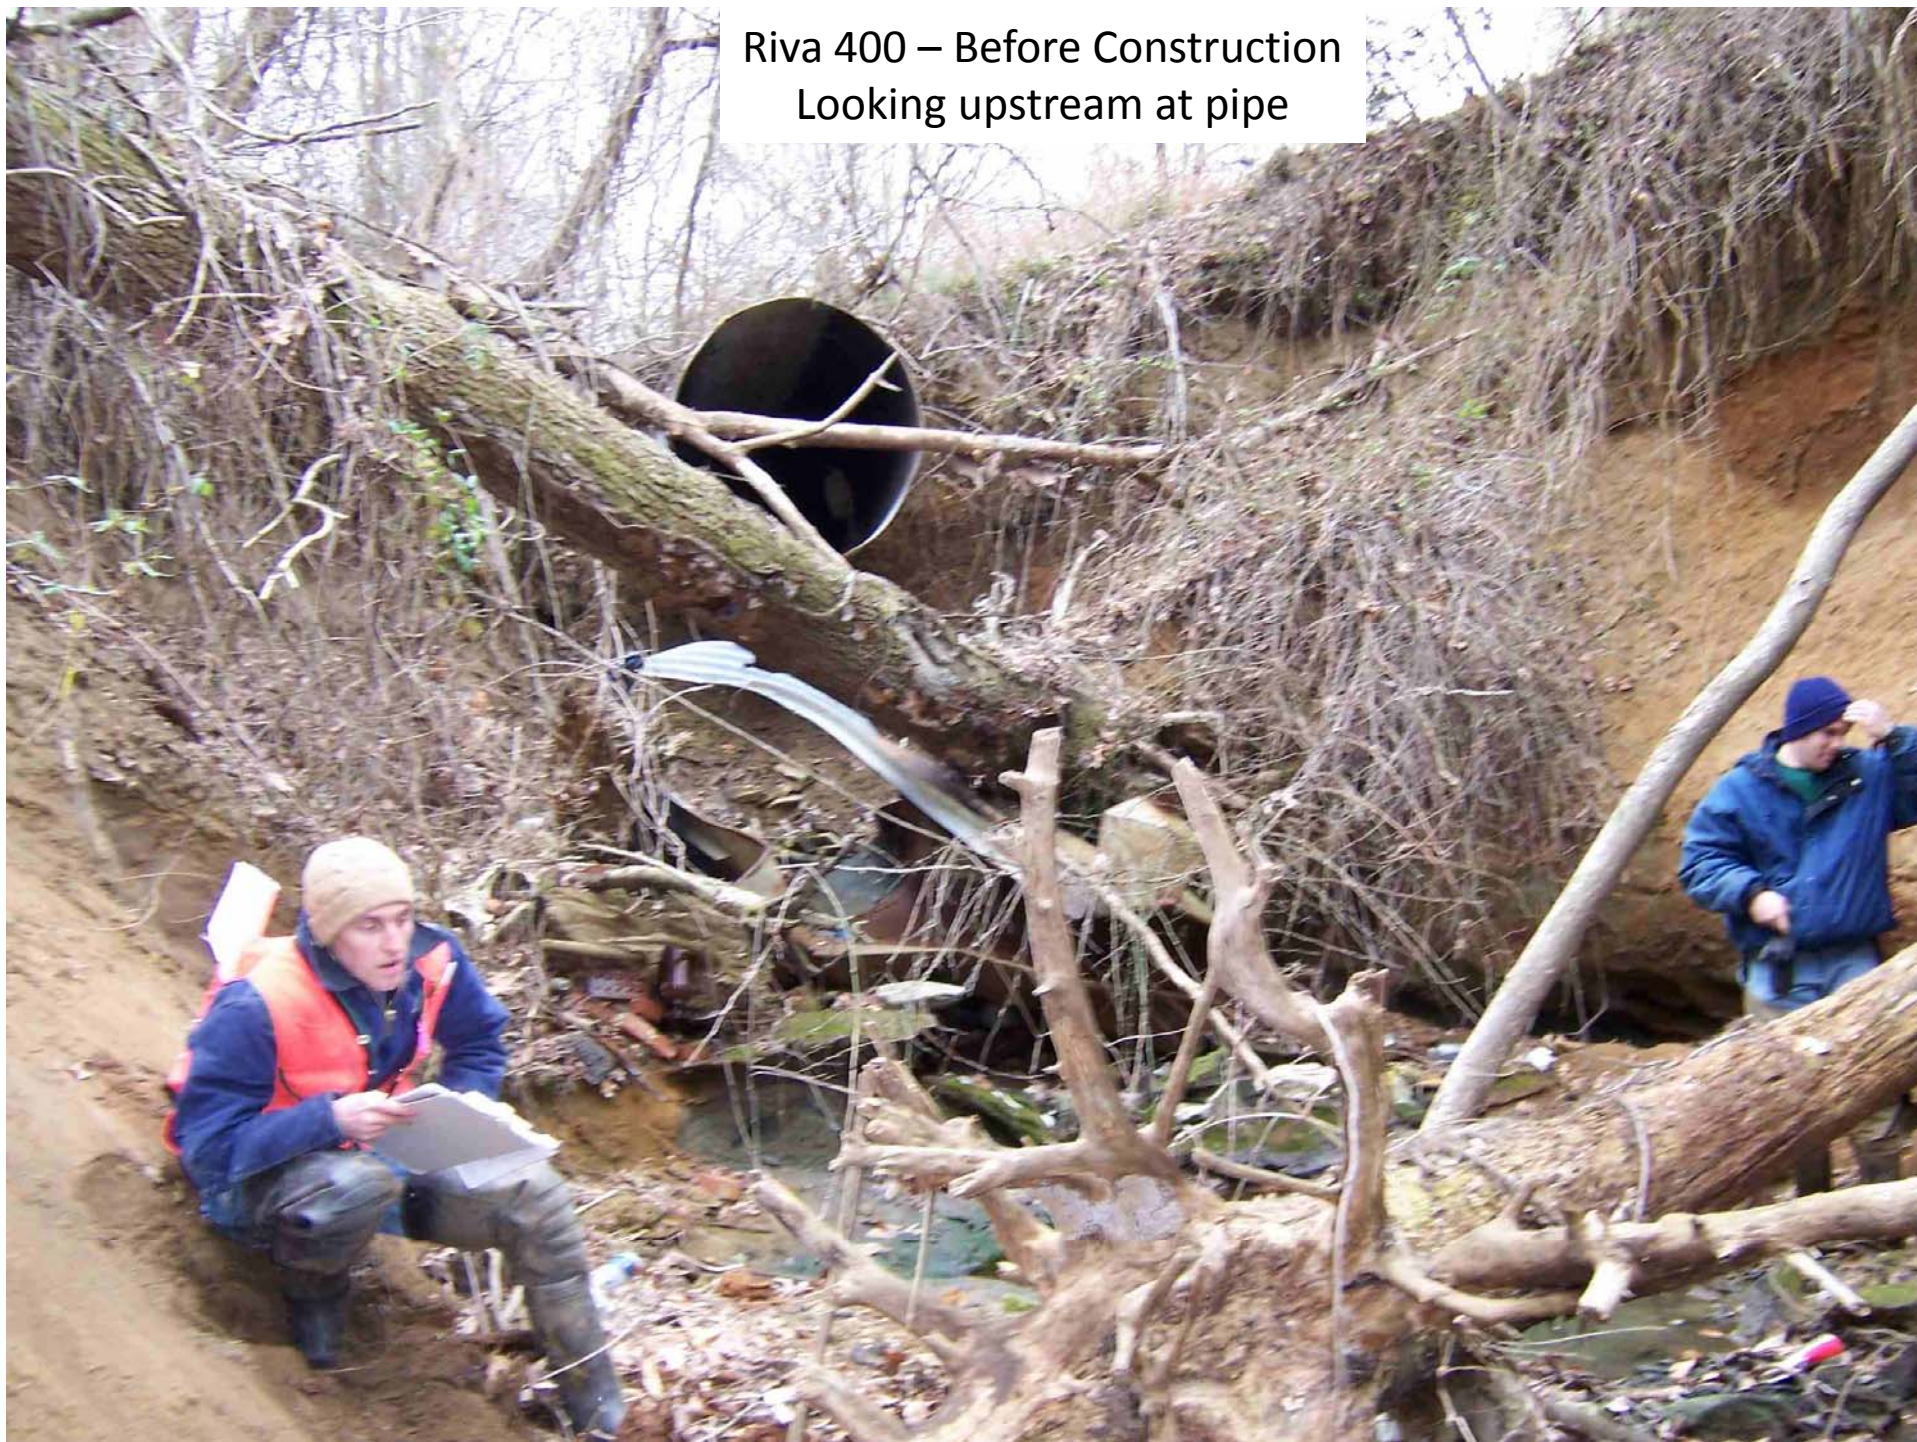
Riva 400 – Before Construction  
Looking upstream at pipe

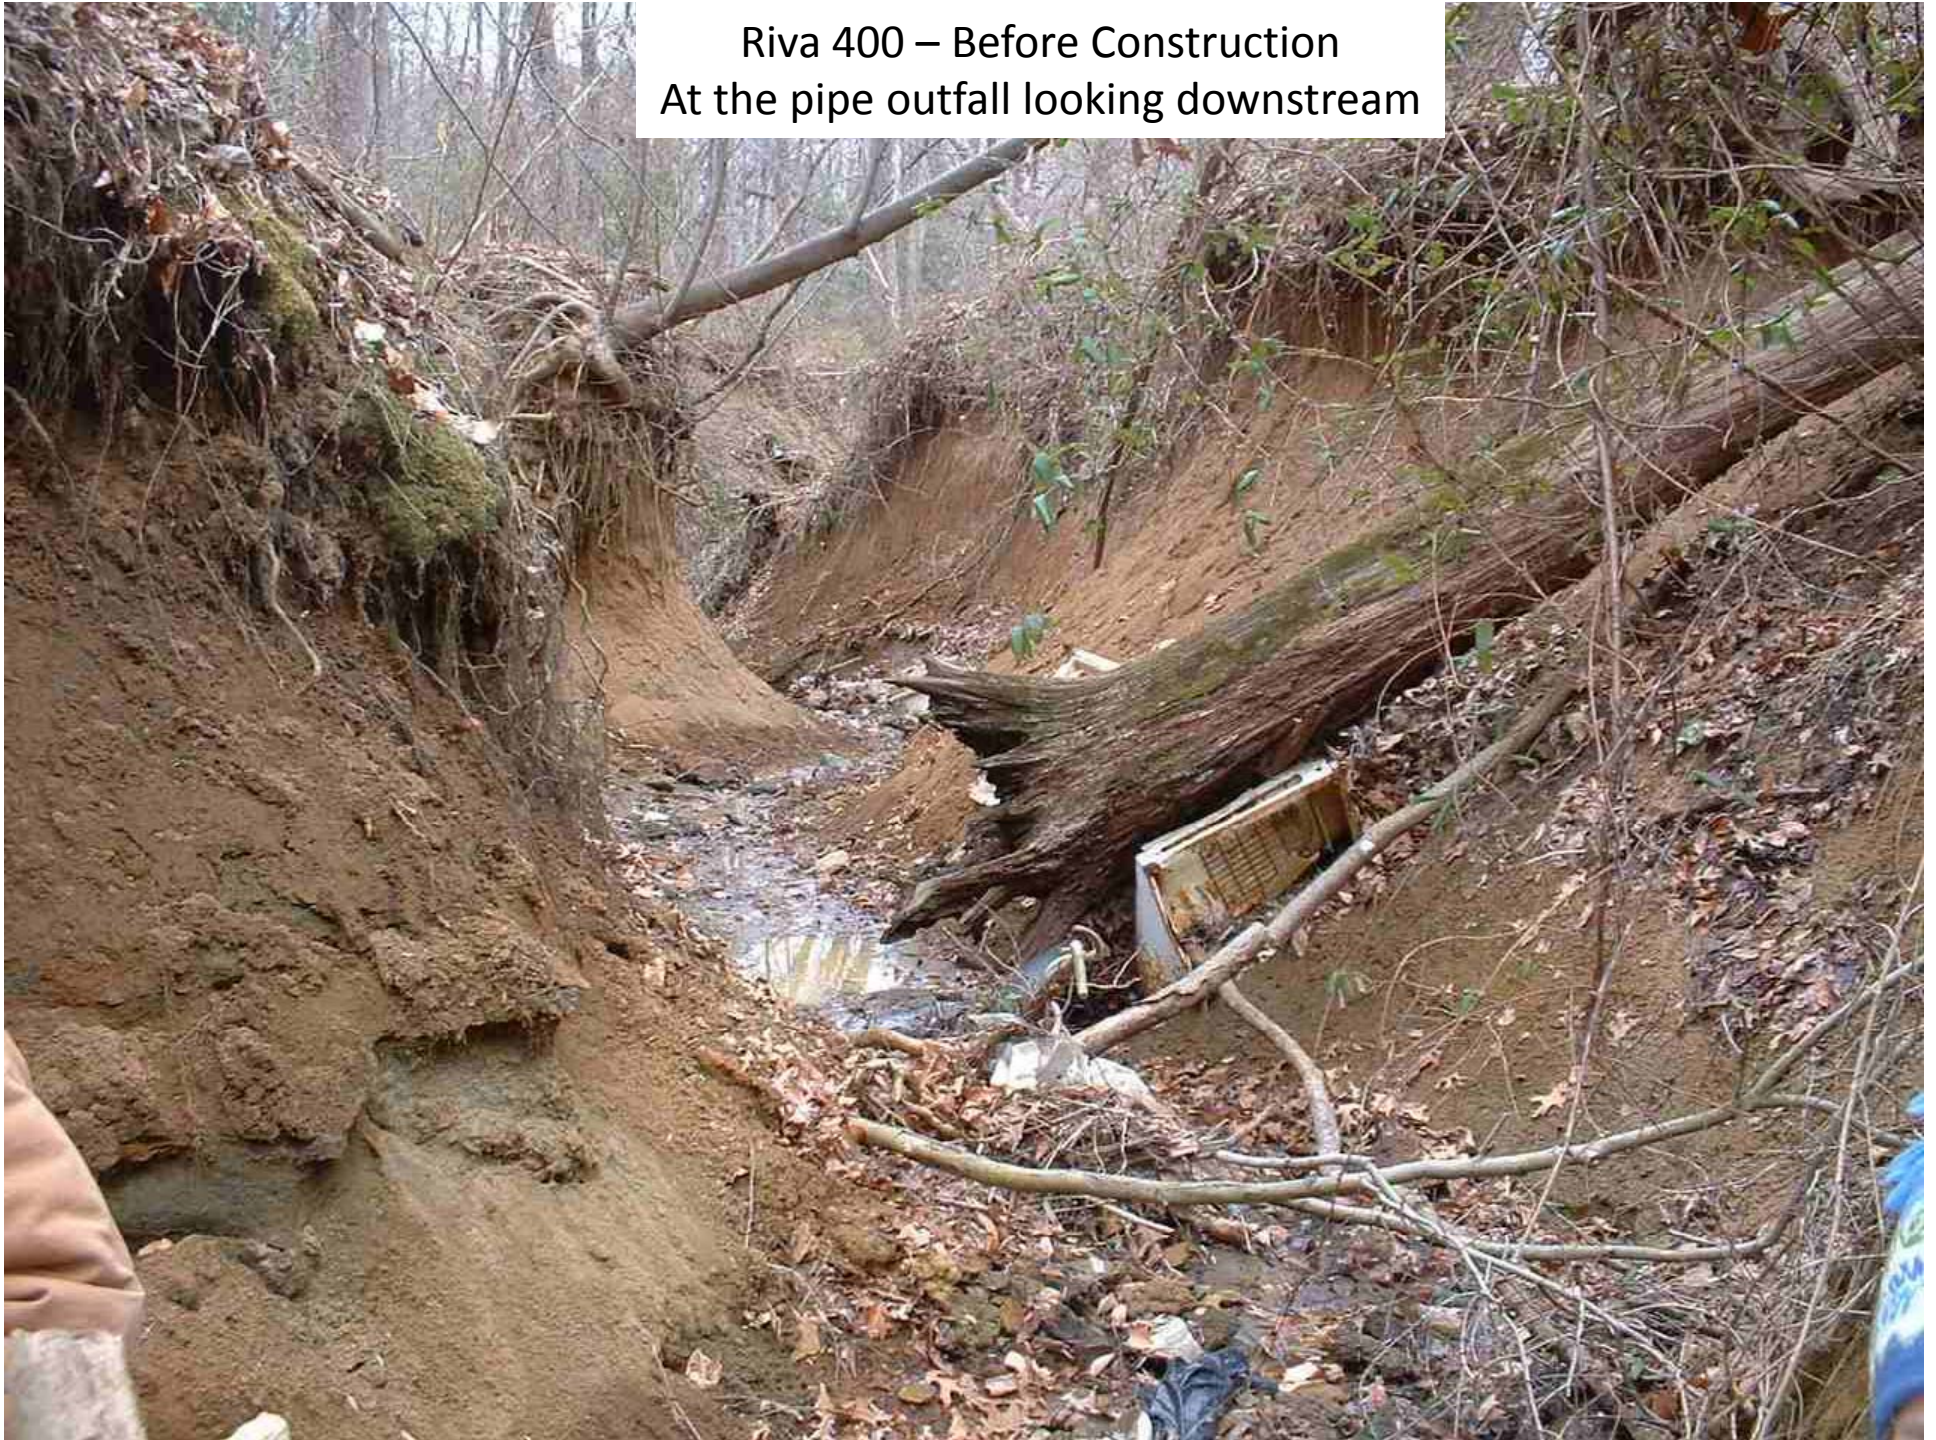
Riva 400 – Before Construction  
At the pipe outfall looking downstream

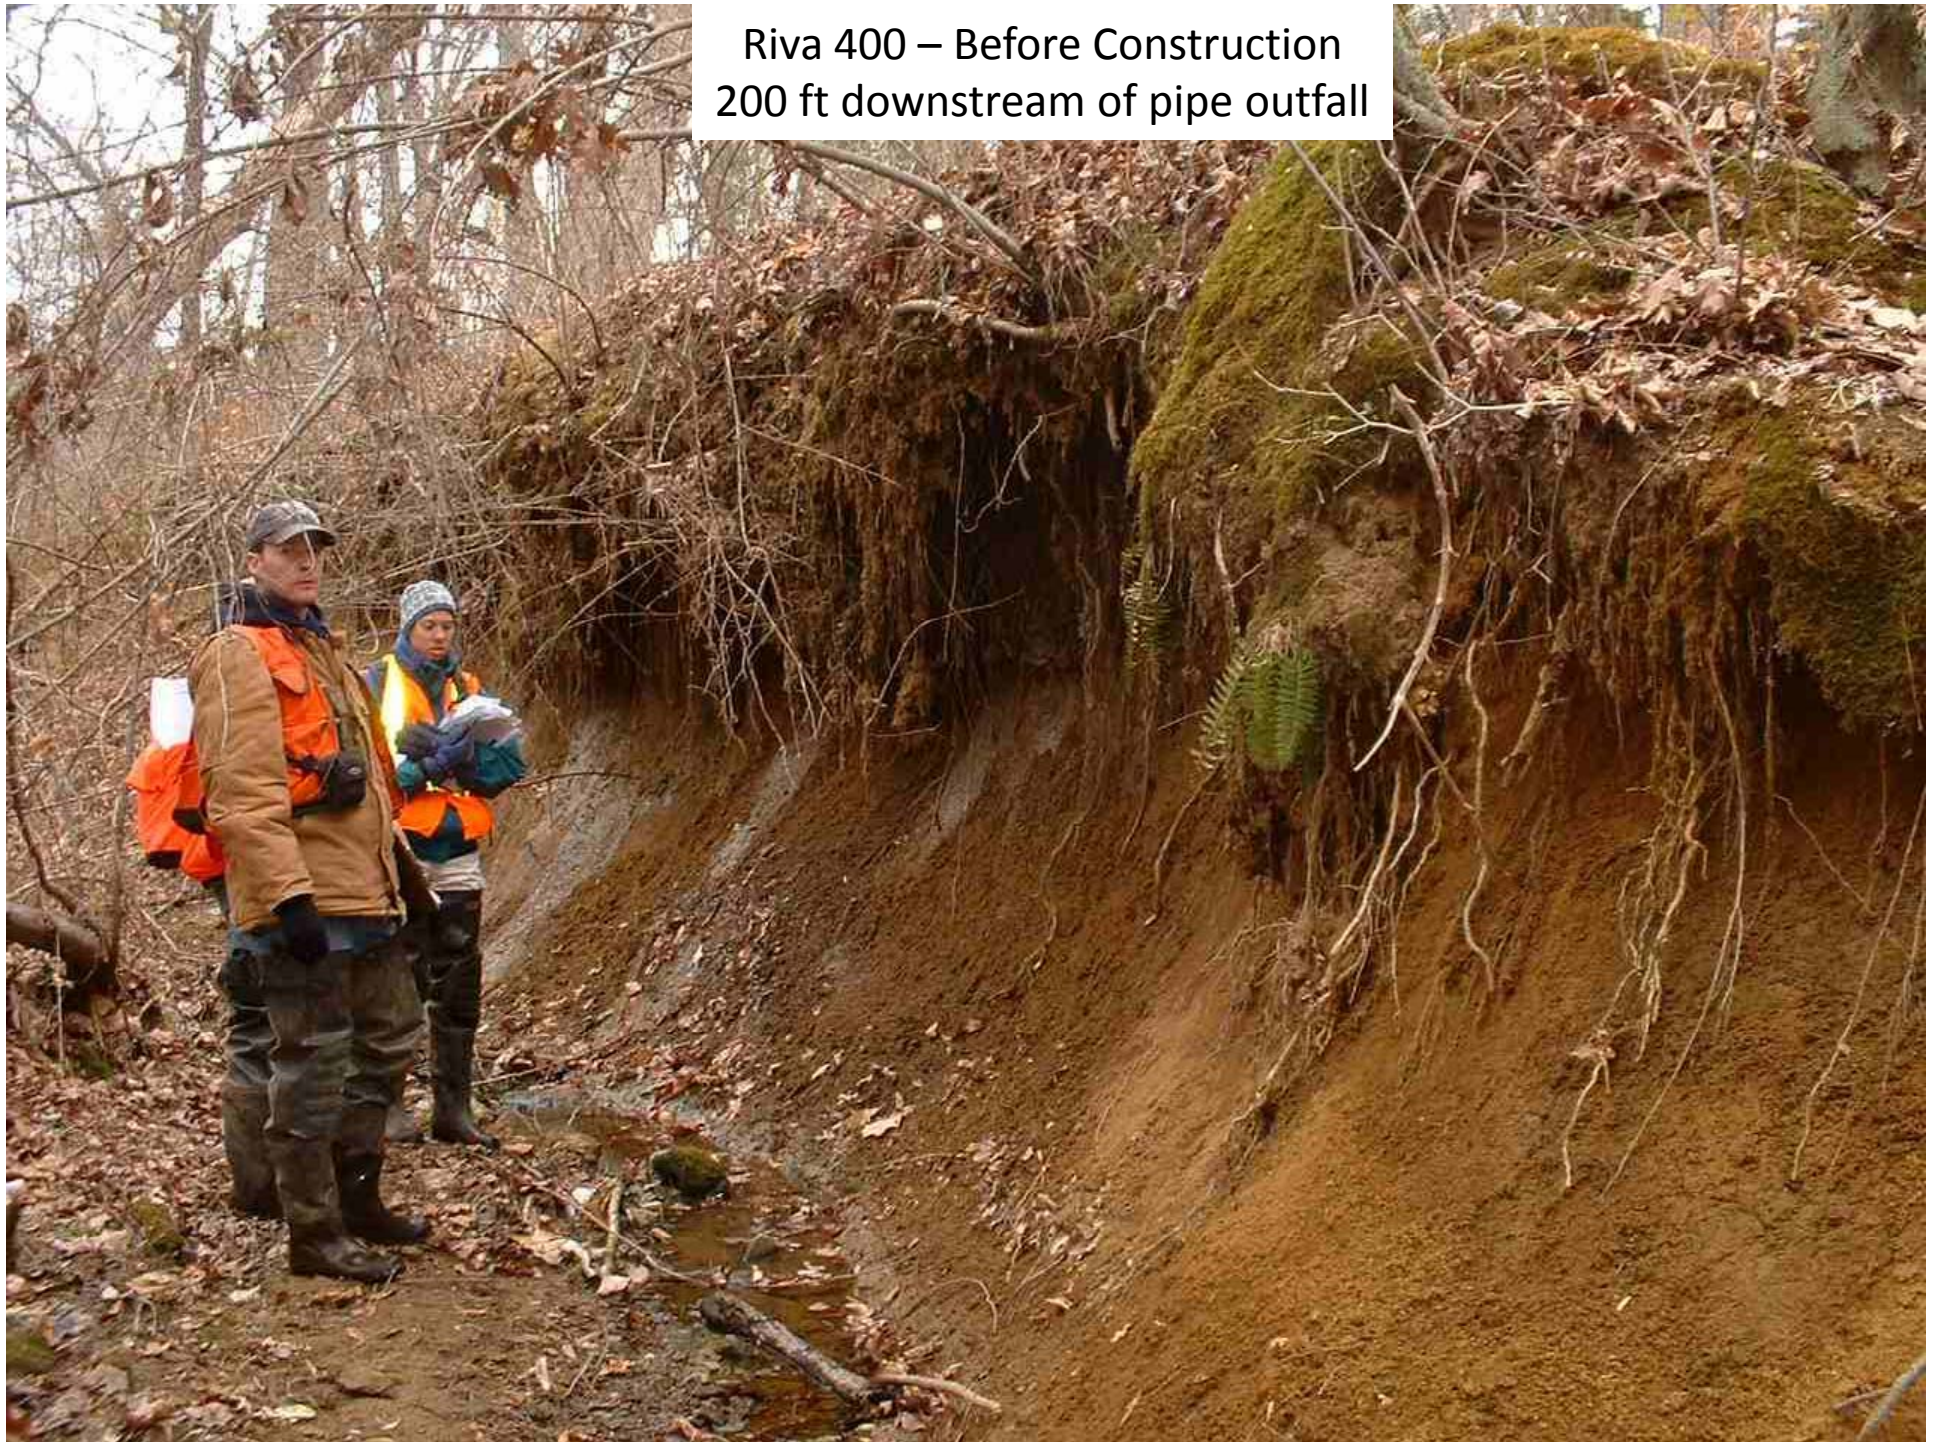
Riva 400 – Before Construction  
200 ft downstream of pipe outfall

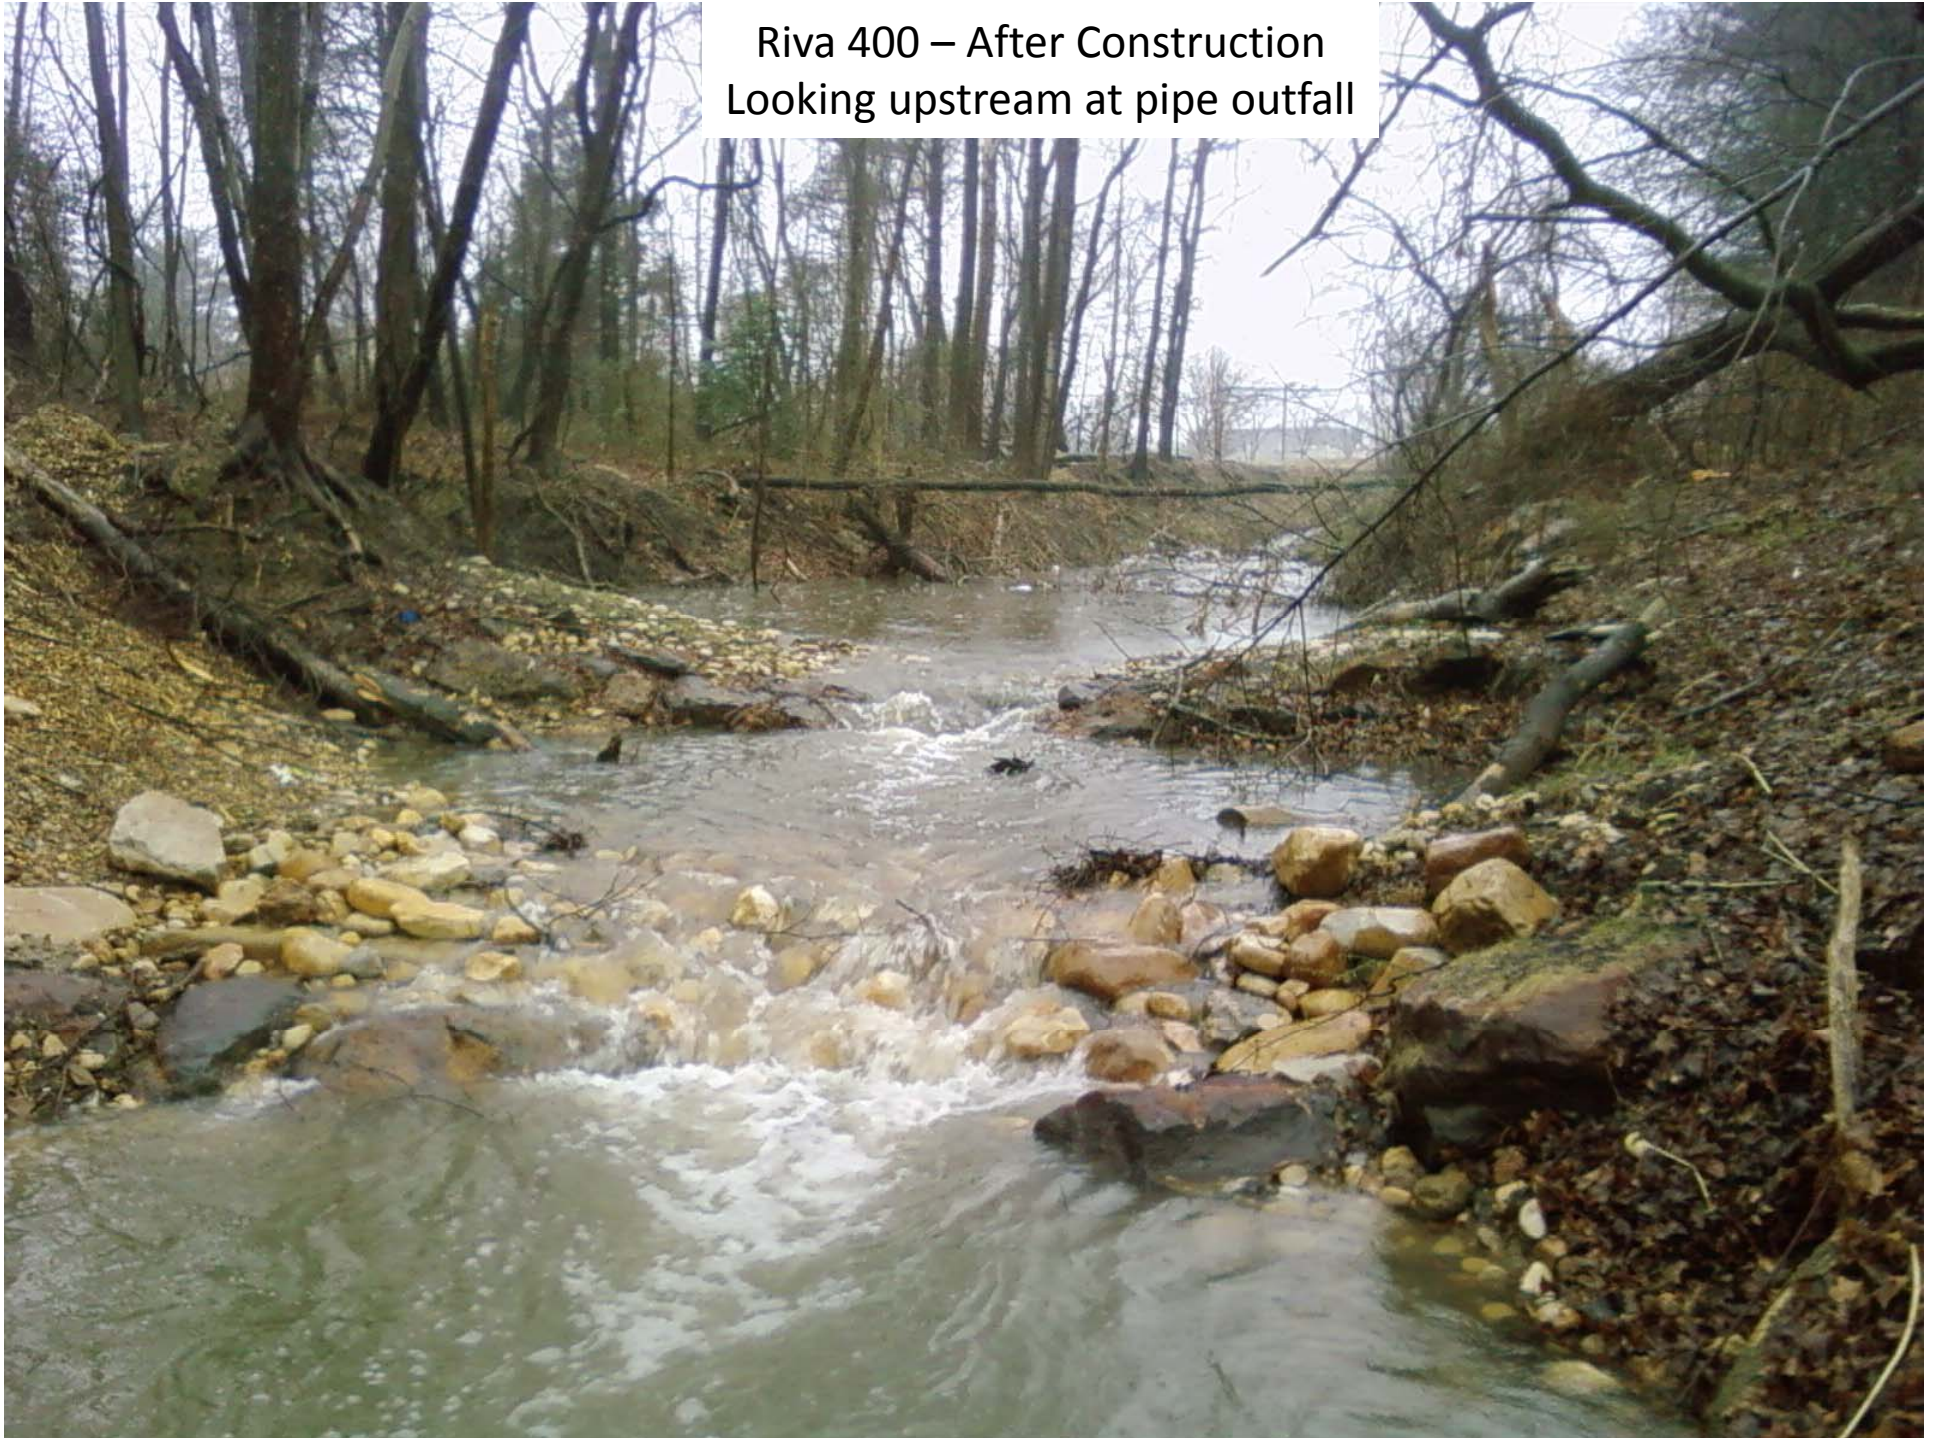
Riva 400 – After Construction  
Looking upstream at pipe outfall

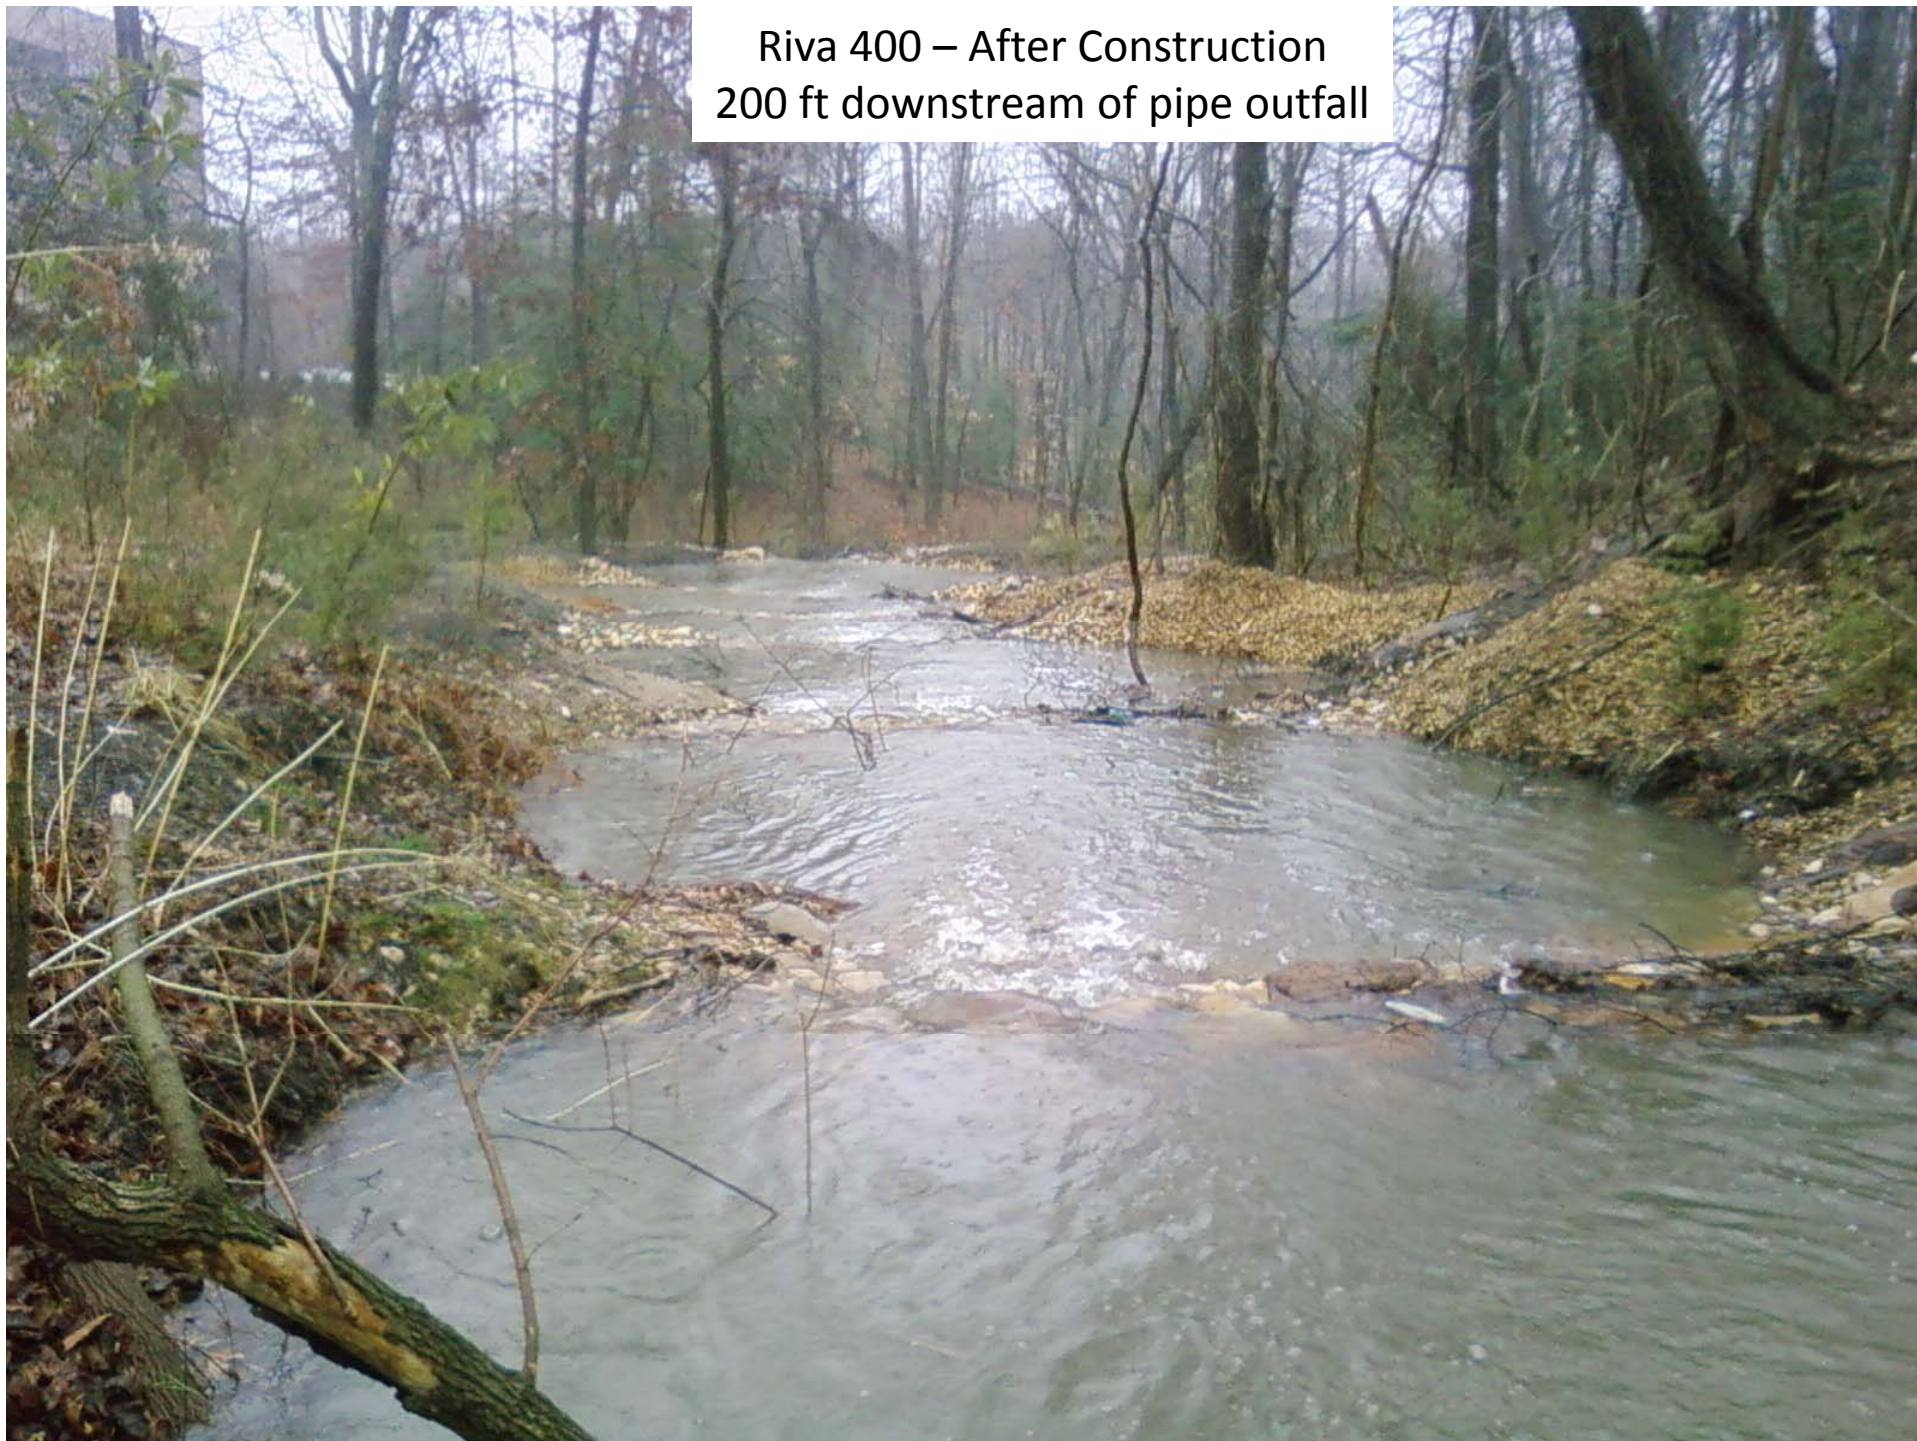
Riva 400 – After Construction  
200 ft downstream of pipe outfall

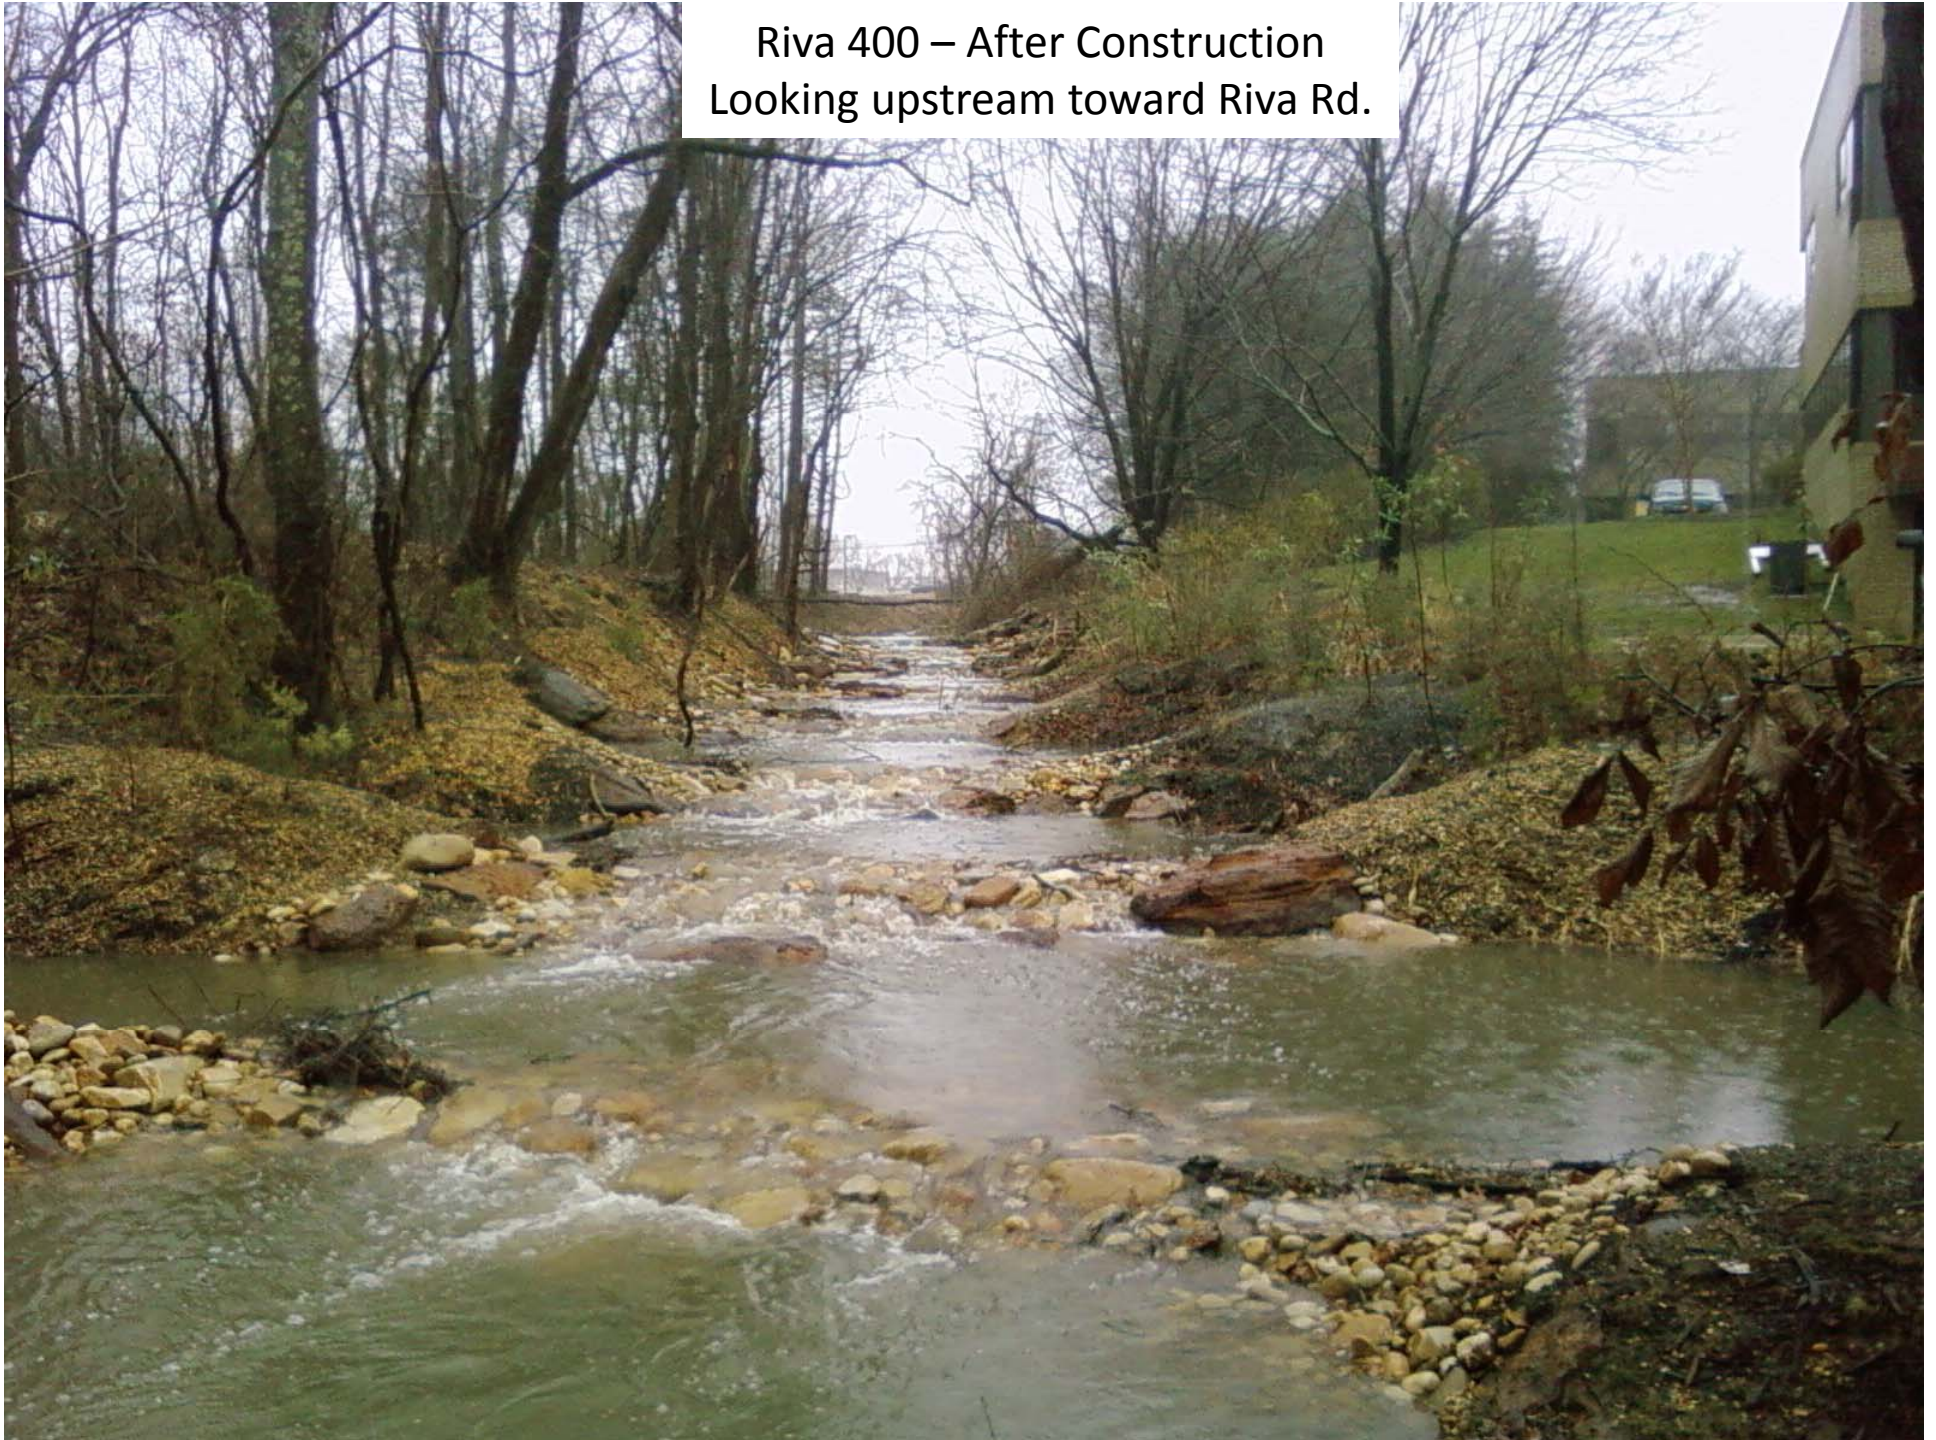
Riva 400 – After Construction  
Looking upstream toward Riva Rd.
