Riva 400, Eroded outfall restoration project  
Anne Arundel County Government  
Department of Public Works  
Watershed, Ecosystem, and Restoration Services

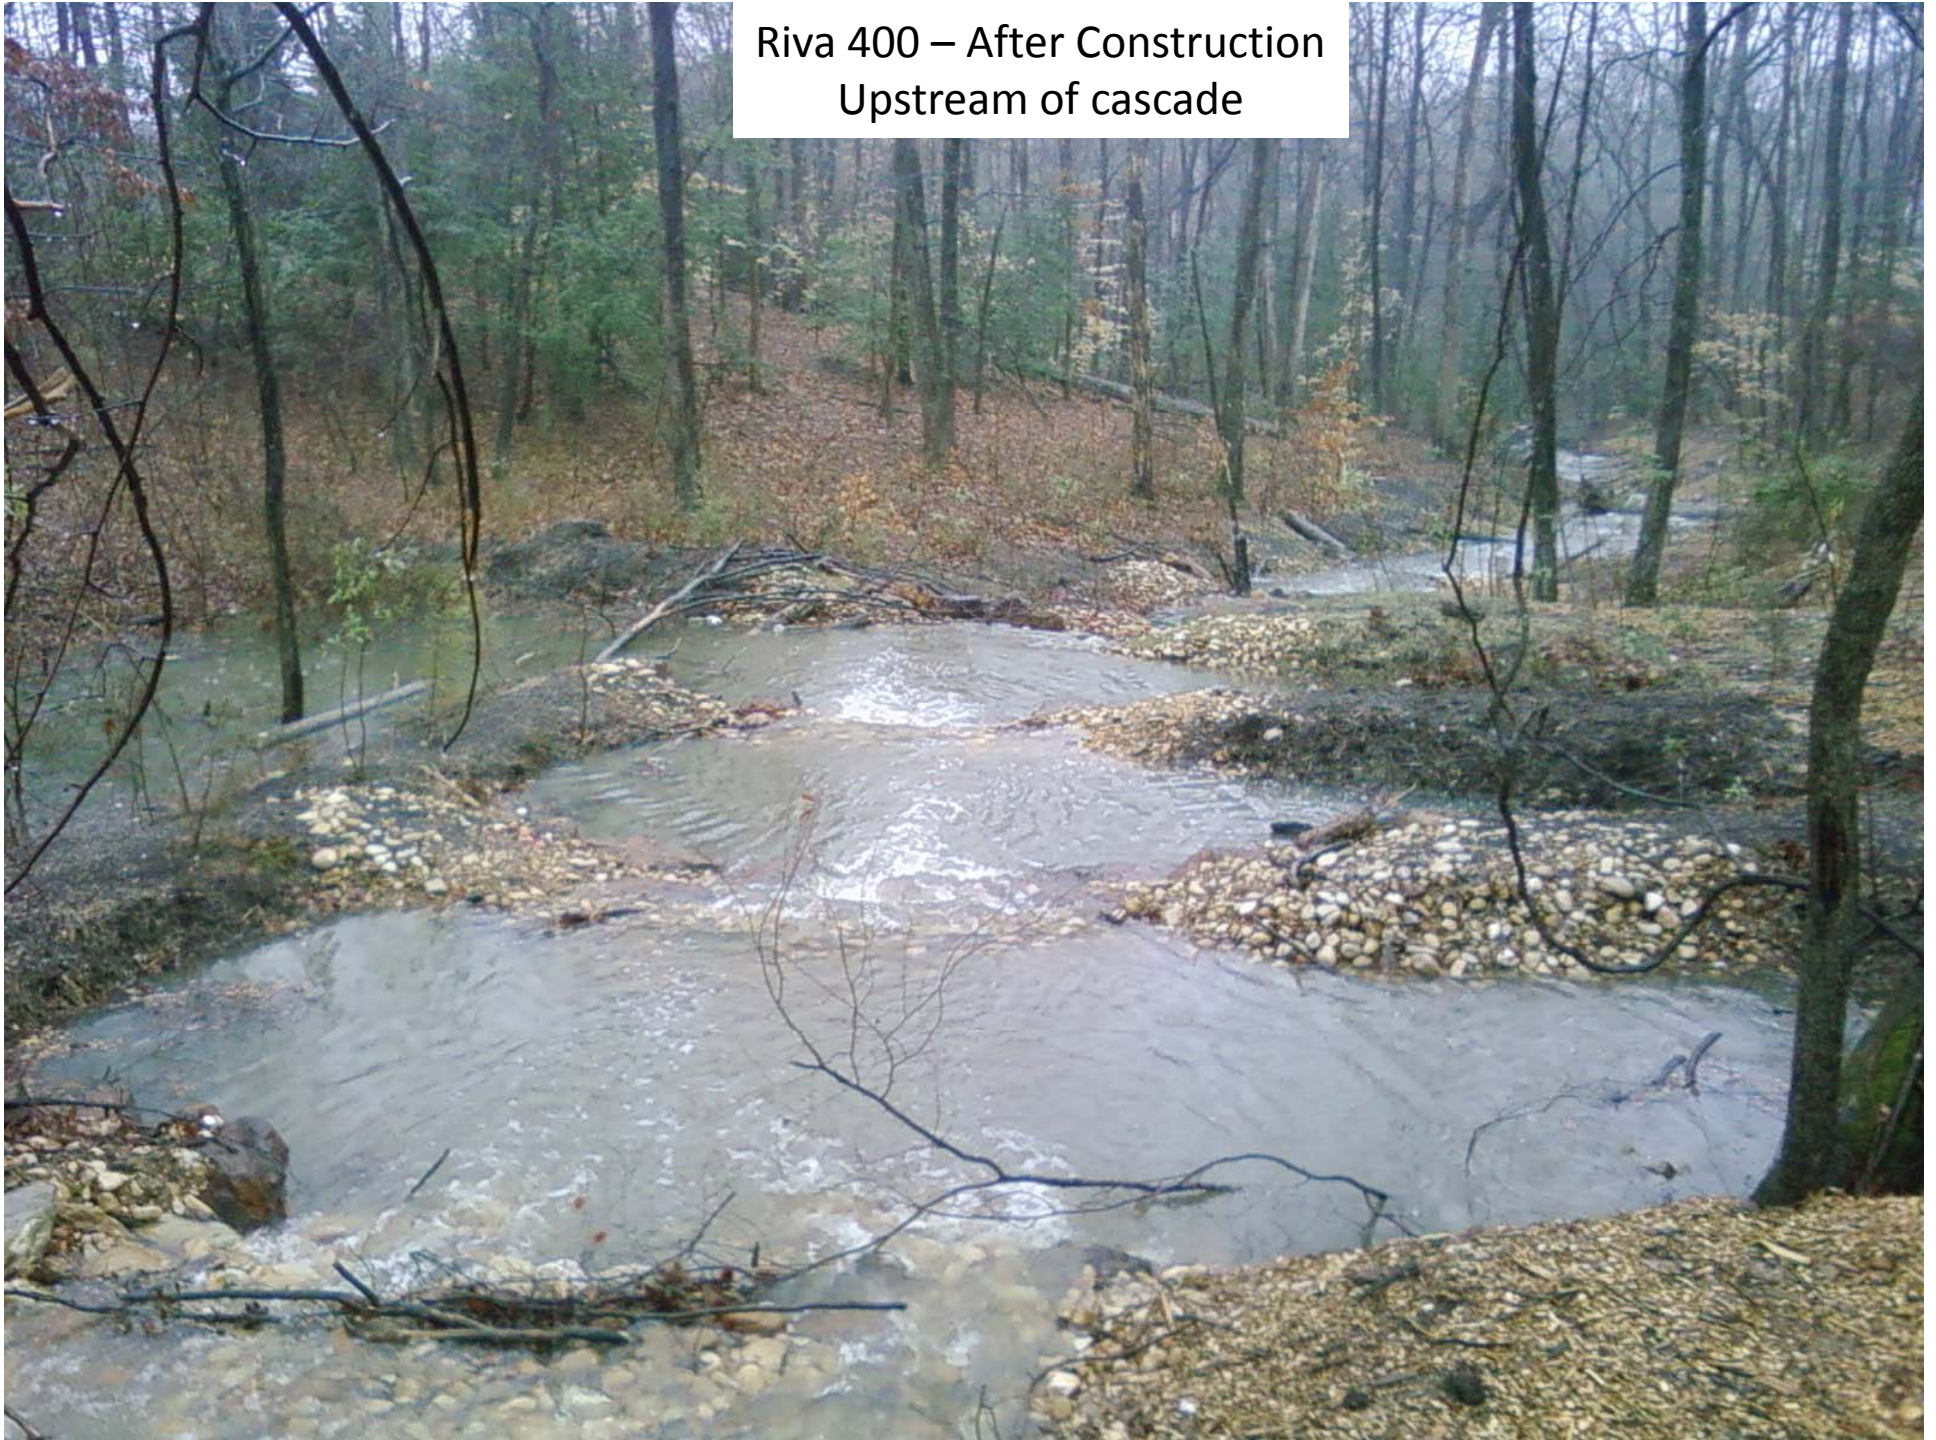
Riva 400 – After Construction  
Upstream of cascade

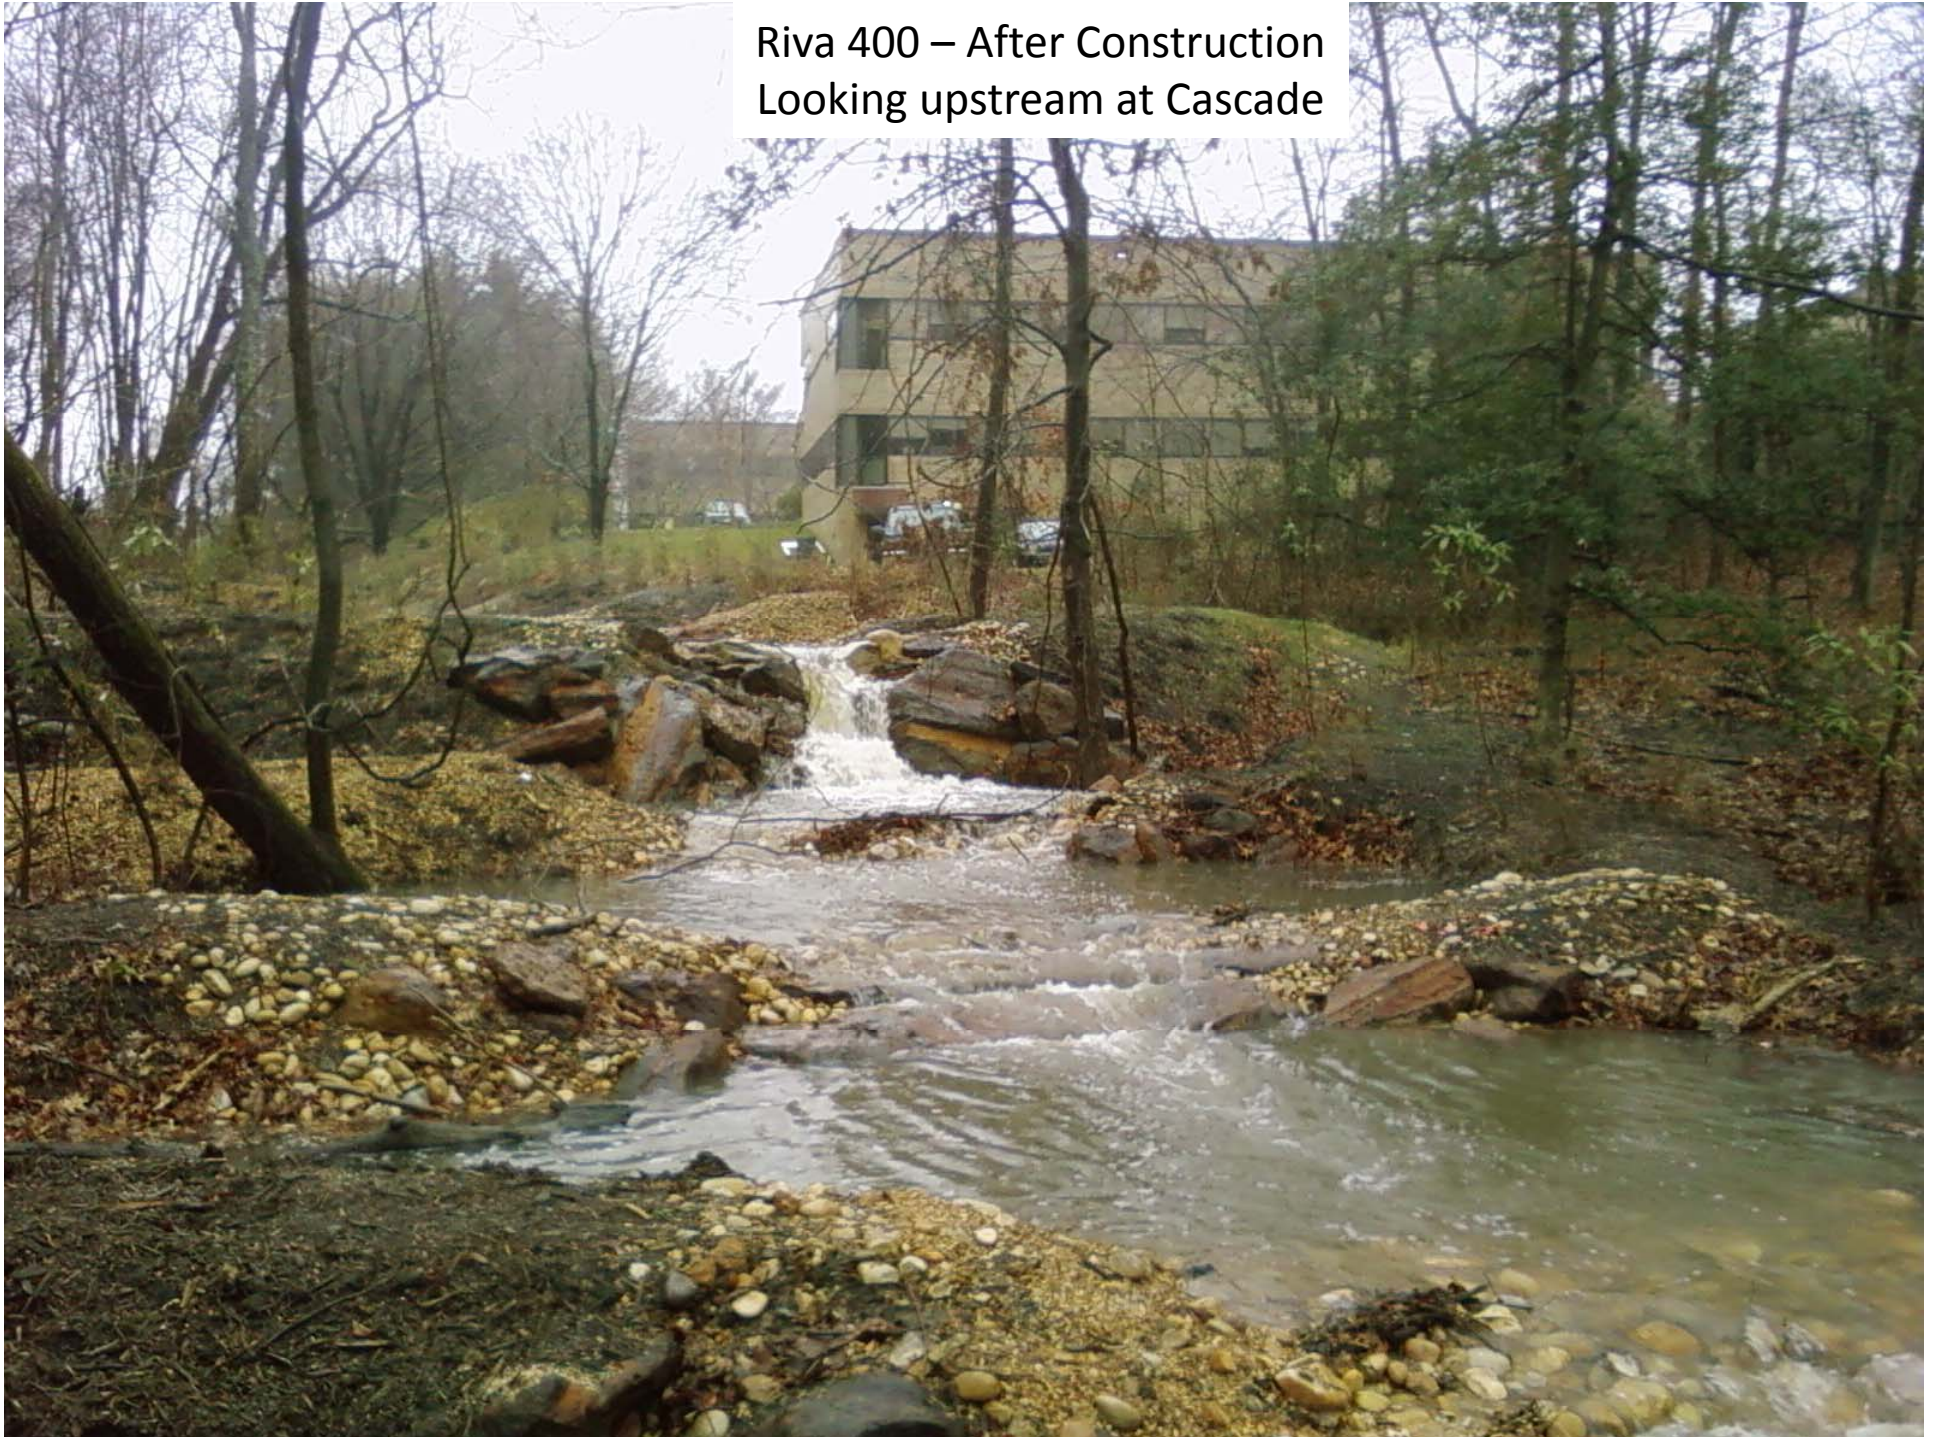
Riva 400 – After Construction  
Looking upstream at Cascade

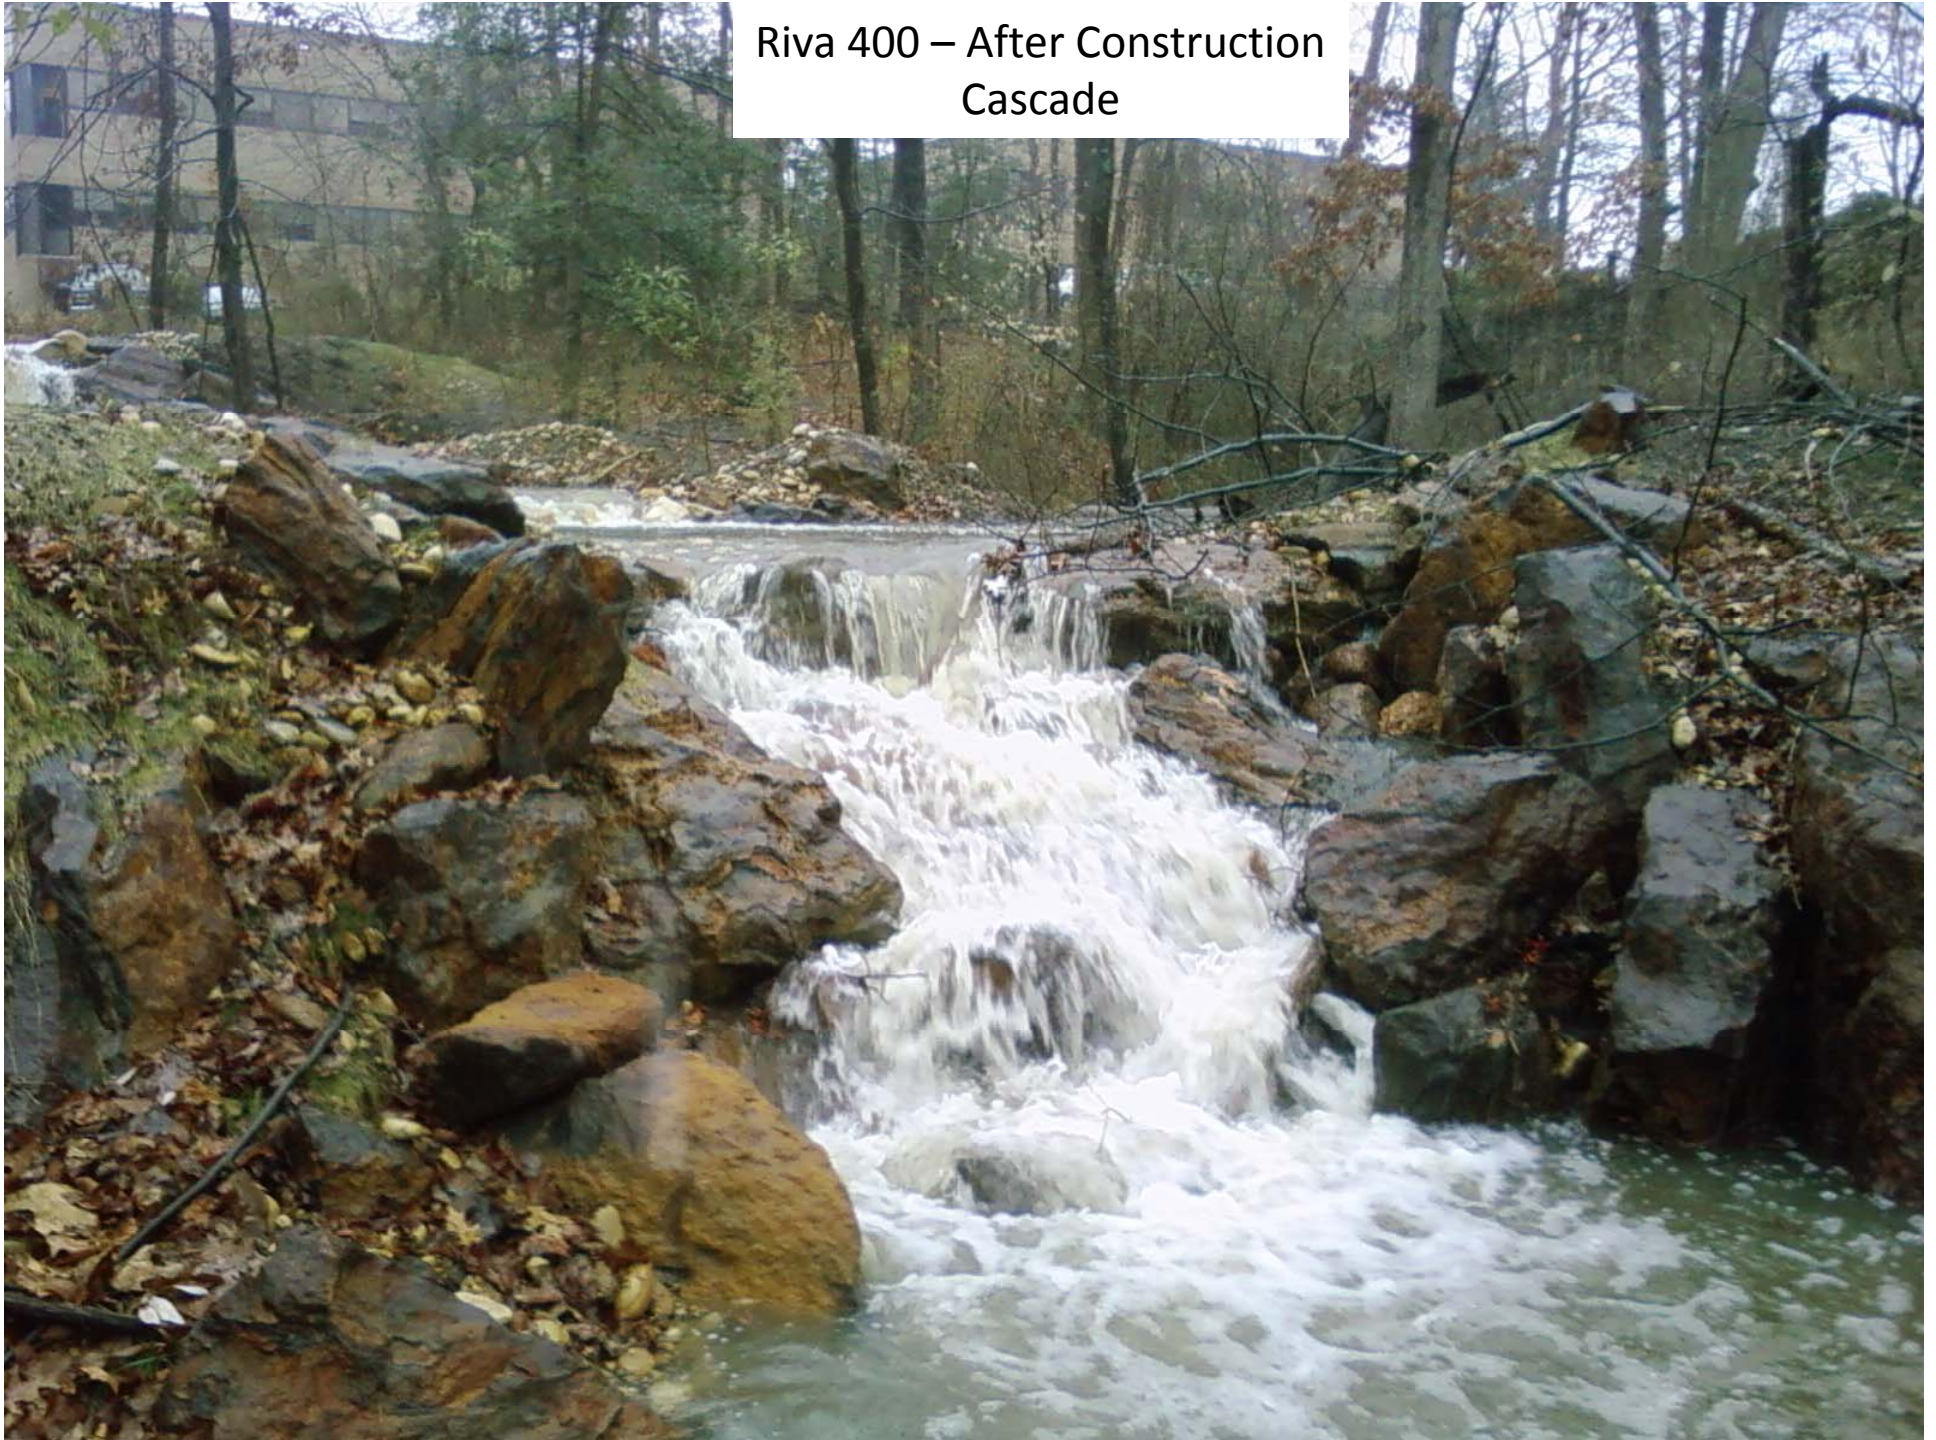
Riva 400 – After Construction  
Cascade

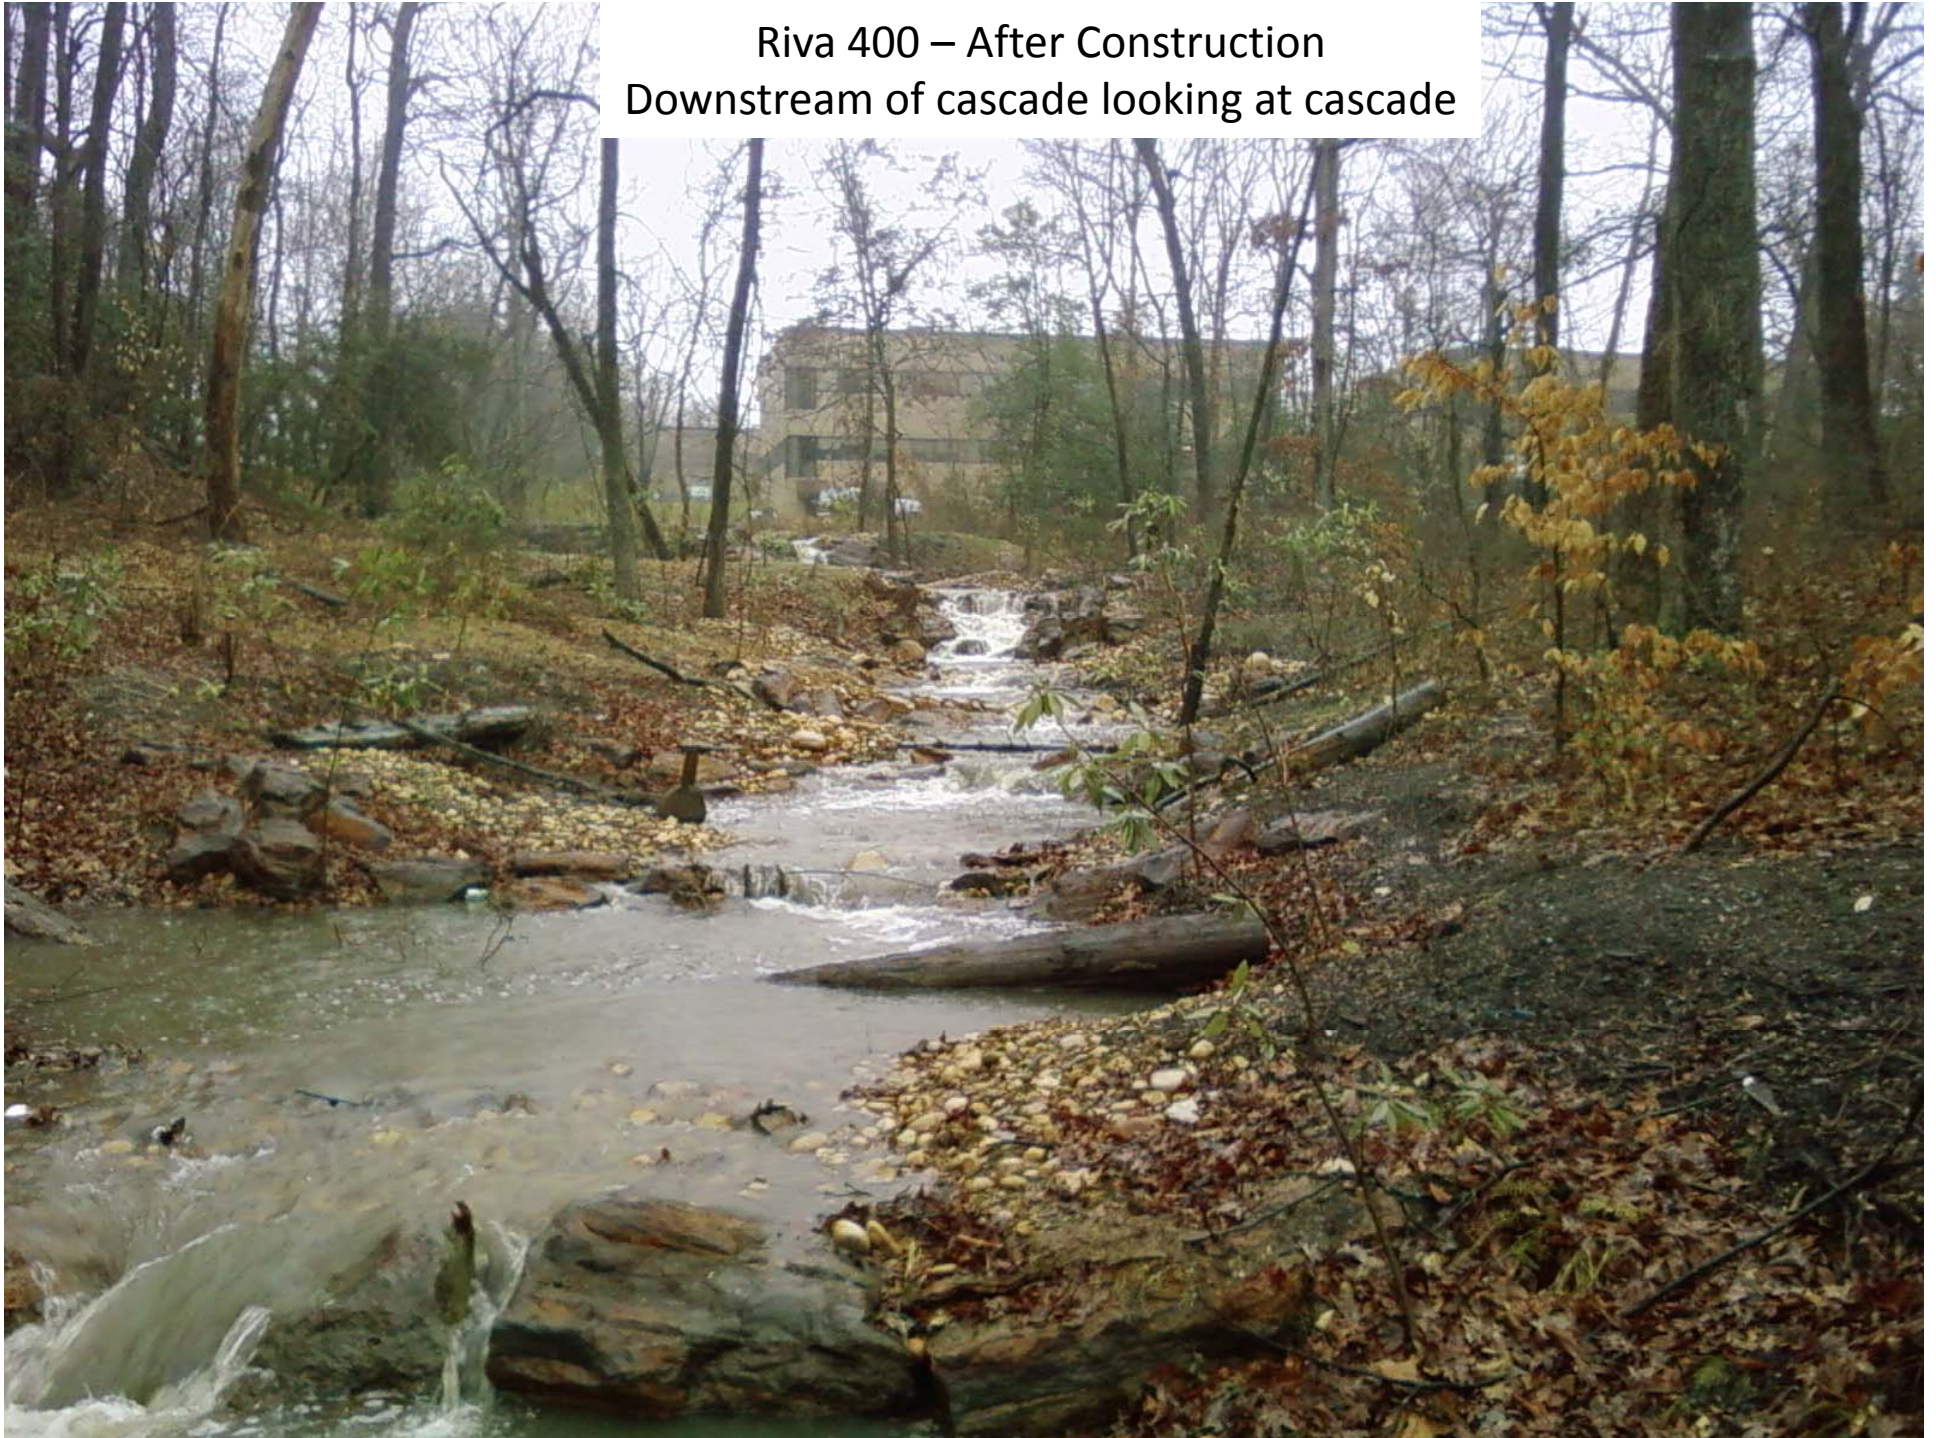
Riva 400 – After Construction  
Downstream of cascade looking at cascade

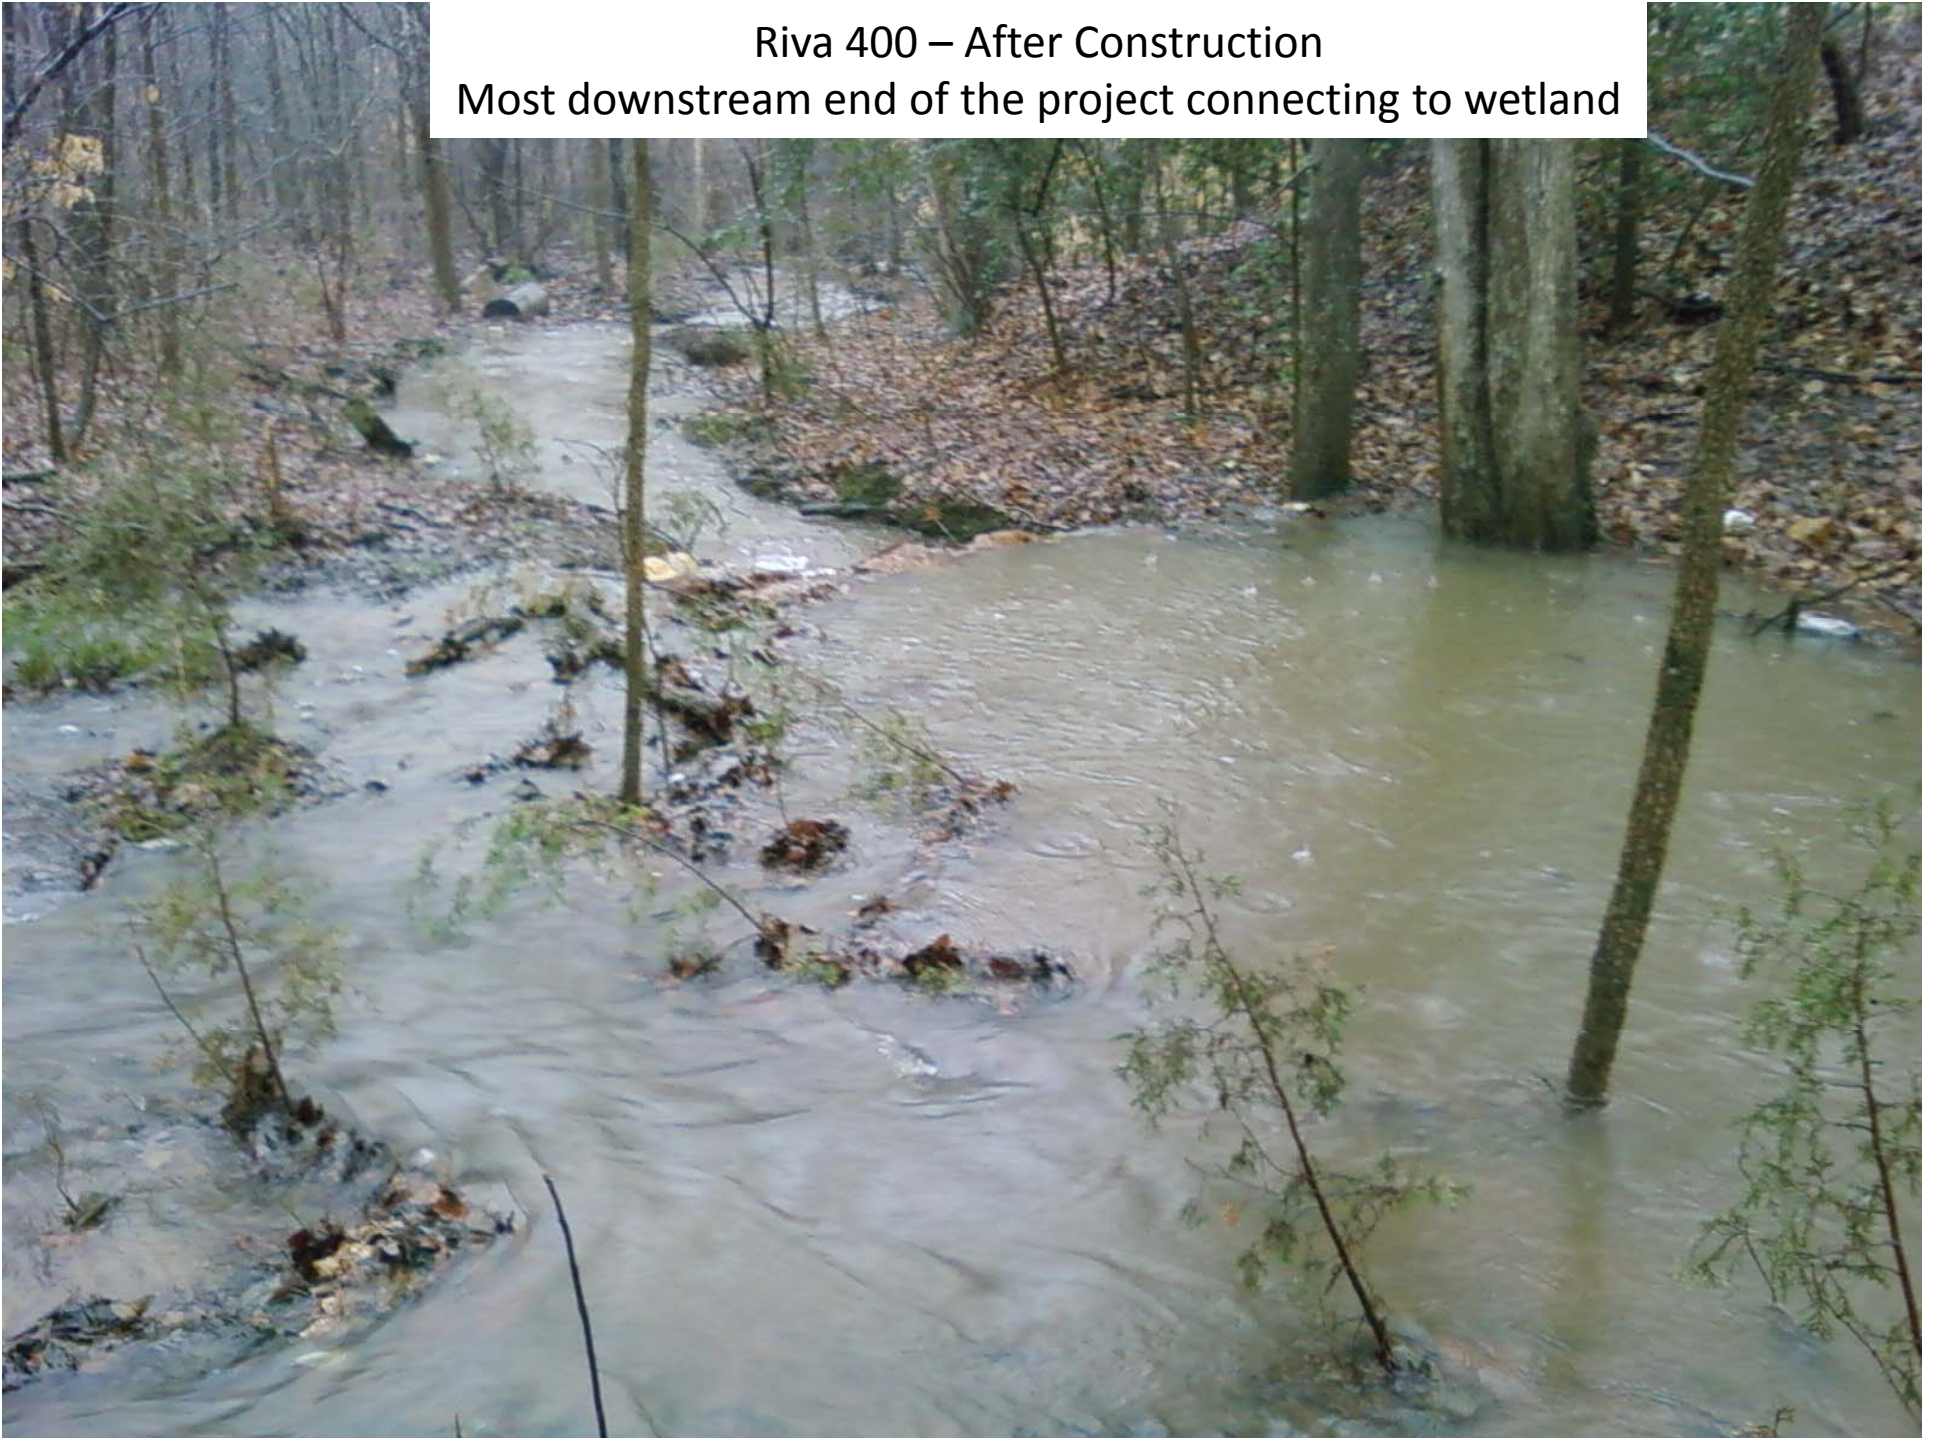
Riva 400 – After Construction  
Most downstream end of the project connecting to wetland
