WEEMS CREEK TRIBUTARIES STREAM SURVEY

REPORT OF FINDINGS

JUNE 30, 1994

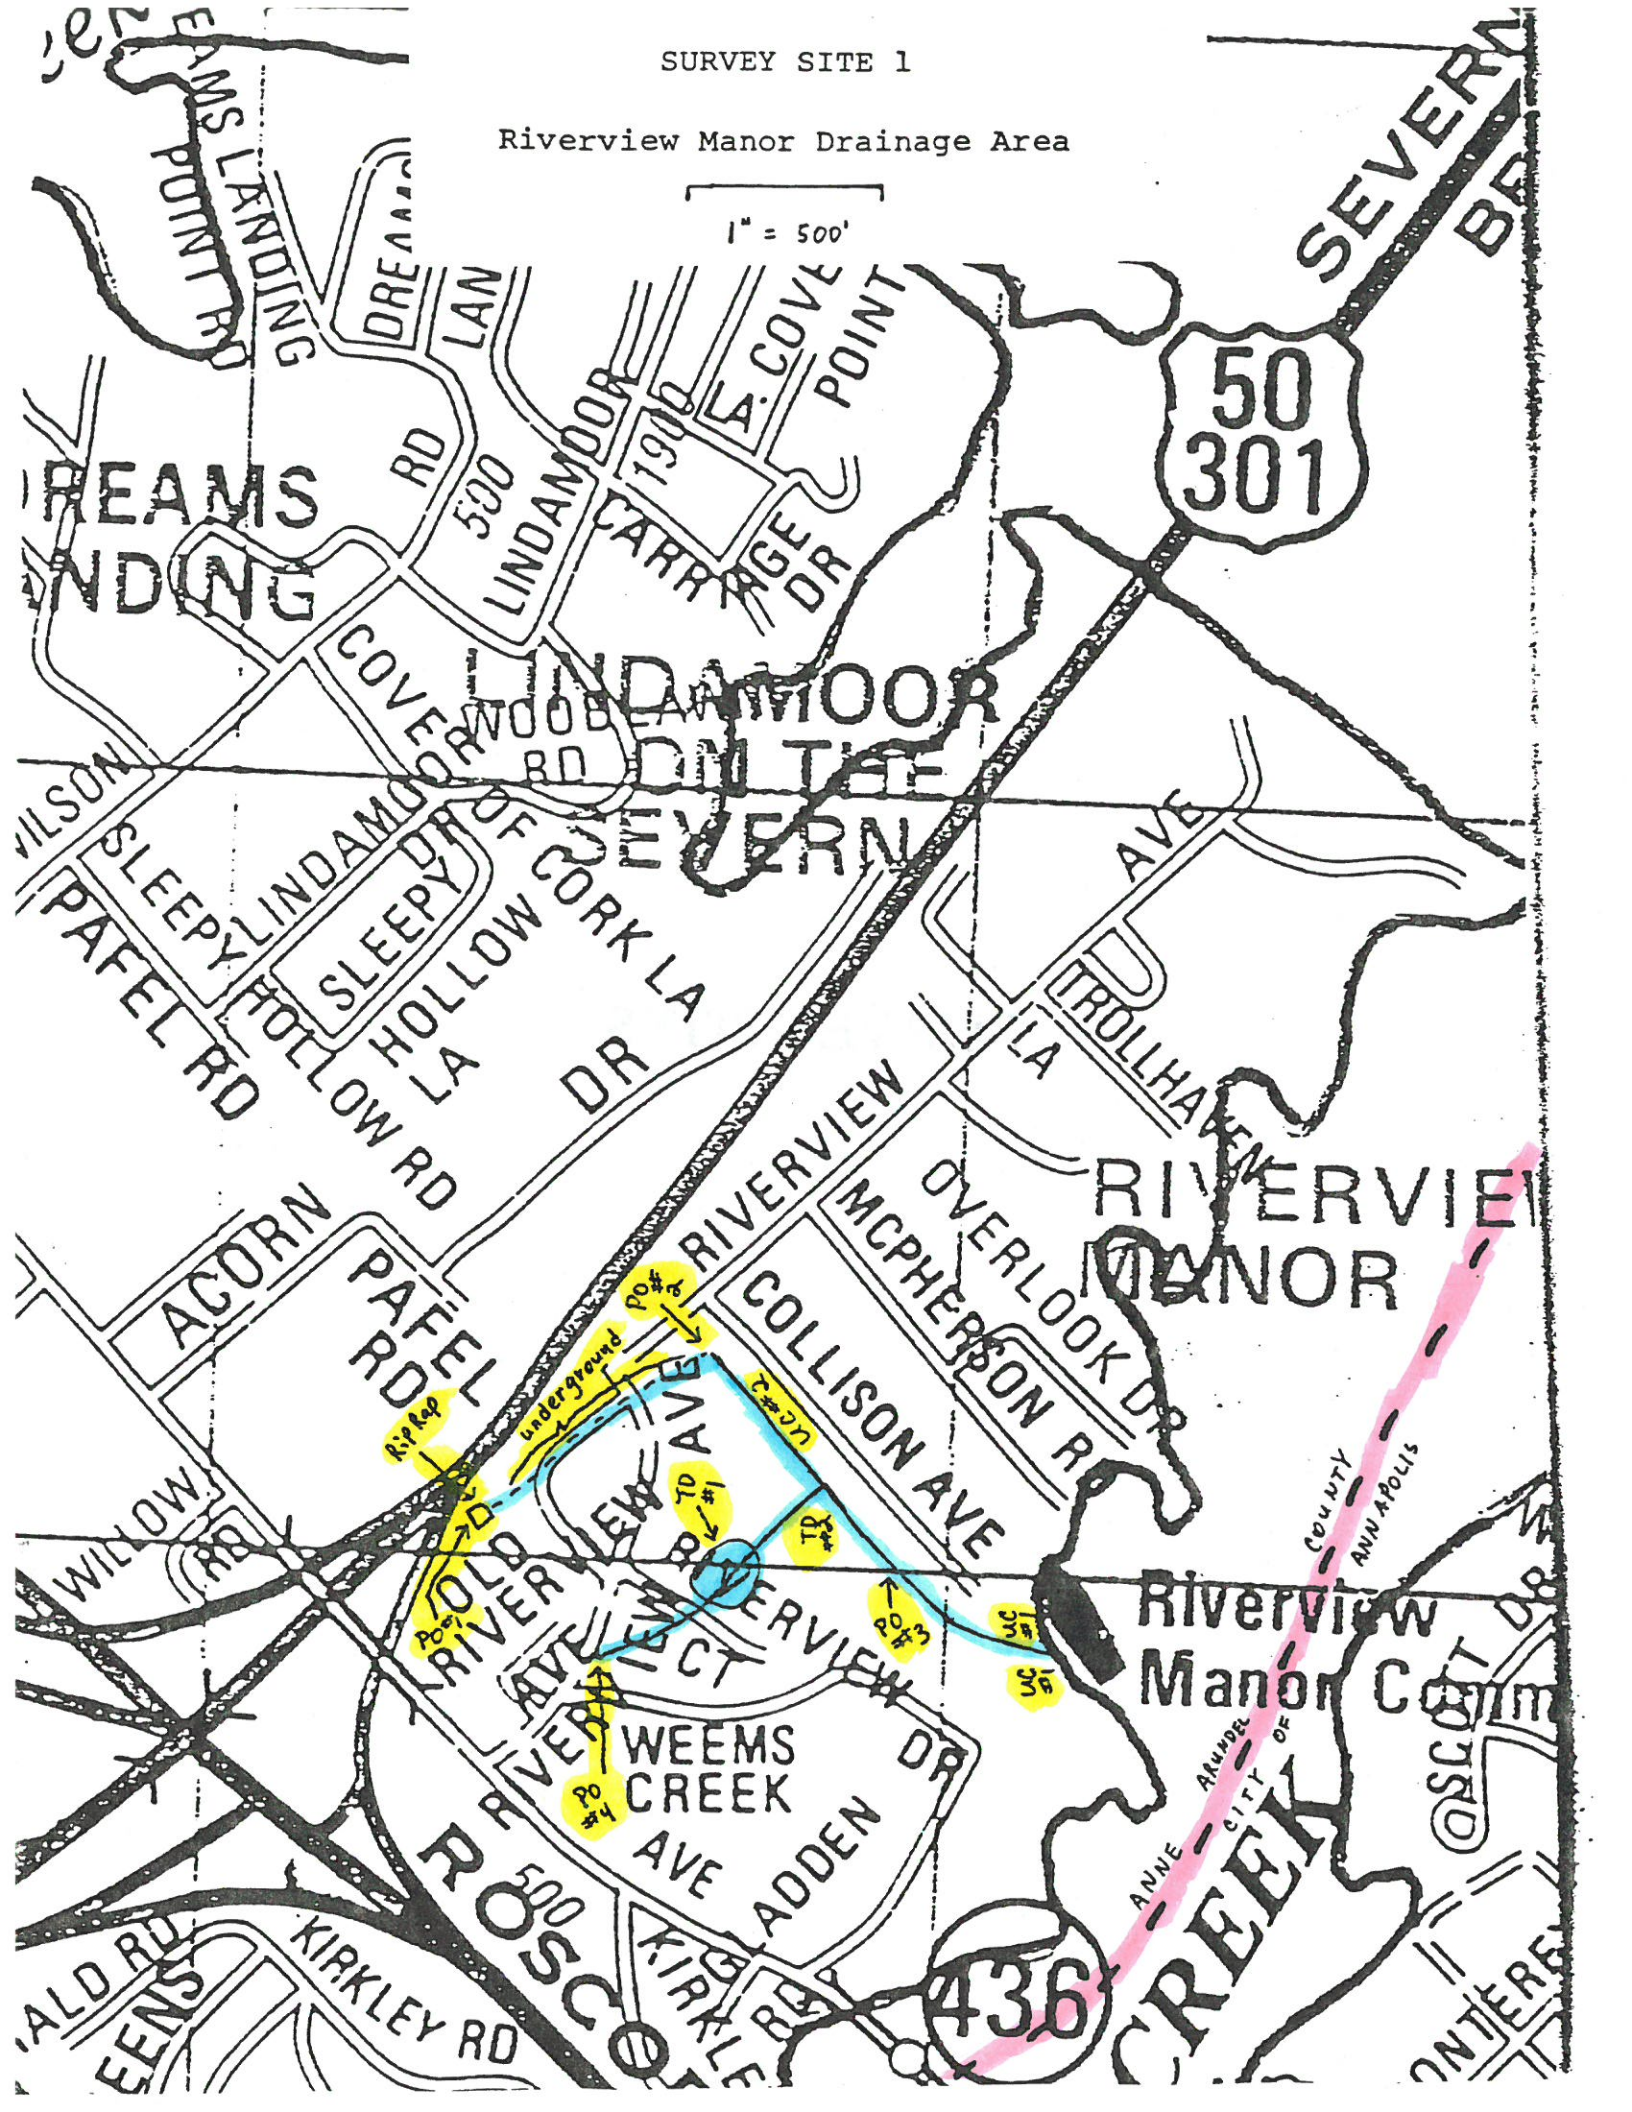
Riverview Manor Drainage Area

Pipe Outfalls: The area which was of most concern to the survey originated at a concrete pipe located under Riverview Avenue, just below the Tavern (PO #4). The volunteers reported that this pipe had created a "newly discovered drainage ditch", which the volunteers had not been aware of previously. The pipe was reported to be two feet in diameter. It opens into a woodland, forming a dry drainage ditch that leads to the main drainage area. While no other unusual conditions were reported in relation to the pipe, this area was reported to be the site of a significant trash dumping area (See TD#1).

The final outfall (PO #3) was reported to be a drainage pipe for house roof and land area. The one foot diameter pipe is made of flexible plastic. Stones were reportedly placed at the outfall for sediment control. The area around the pipe was dry at the time of the survey. No unusual conditions were reported in connection with the pipe.

Unusual Stream Conditions: At the mouth of this survey section, the volunteers described the area as being "brownish" and "oily", with "scum on the surface" (UC #1). No algae was reported, and the volunteers did not notice any signs of aquatic life.

Trash Dumping Areas: Both trash areas were reported along and near the drainage area that stems from PO #4. The largest of the trash sites (TD #1) is found in the middle of

The other trash site (TD #2) was reported further downstream, near the point where the drainage area meets the main survey section. The size of this site was not indicated. Tires and rusty chemical drums were among the items reported at this site.

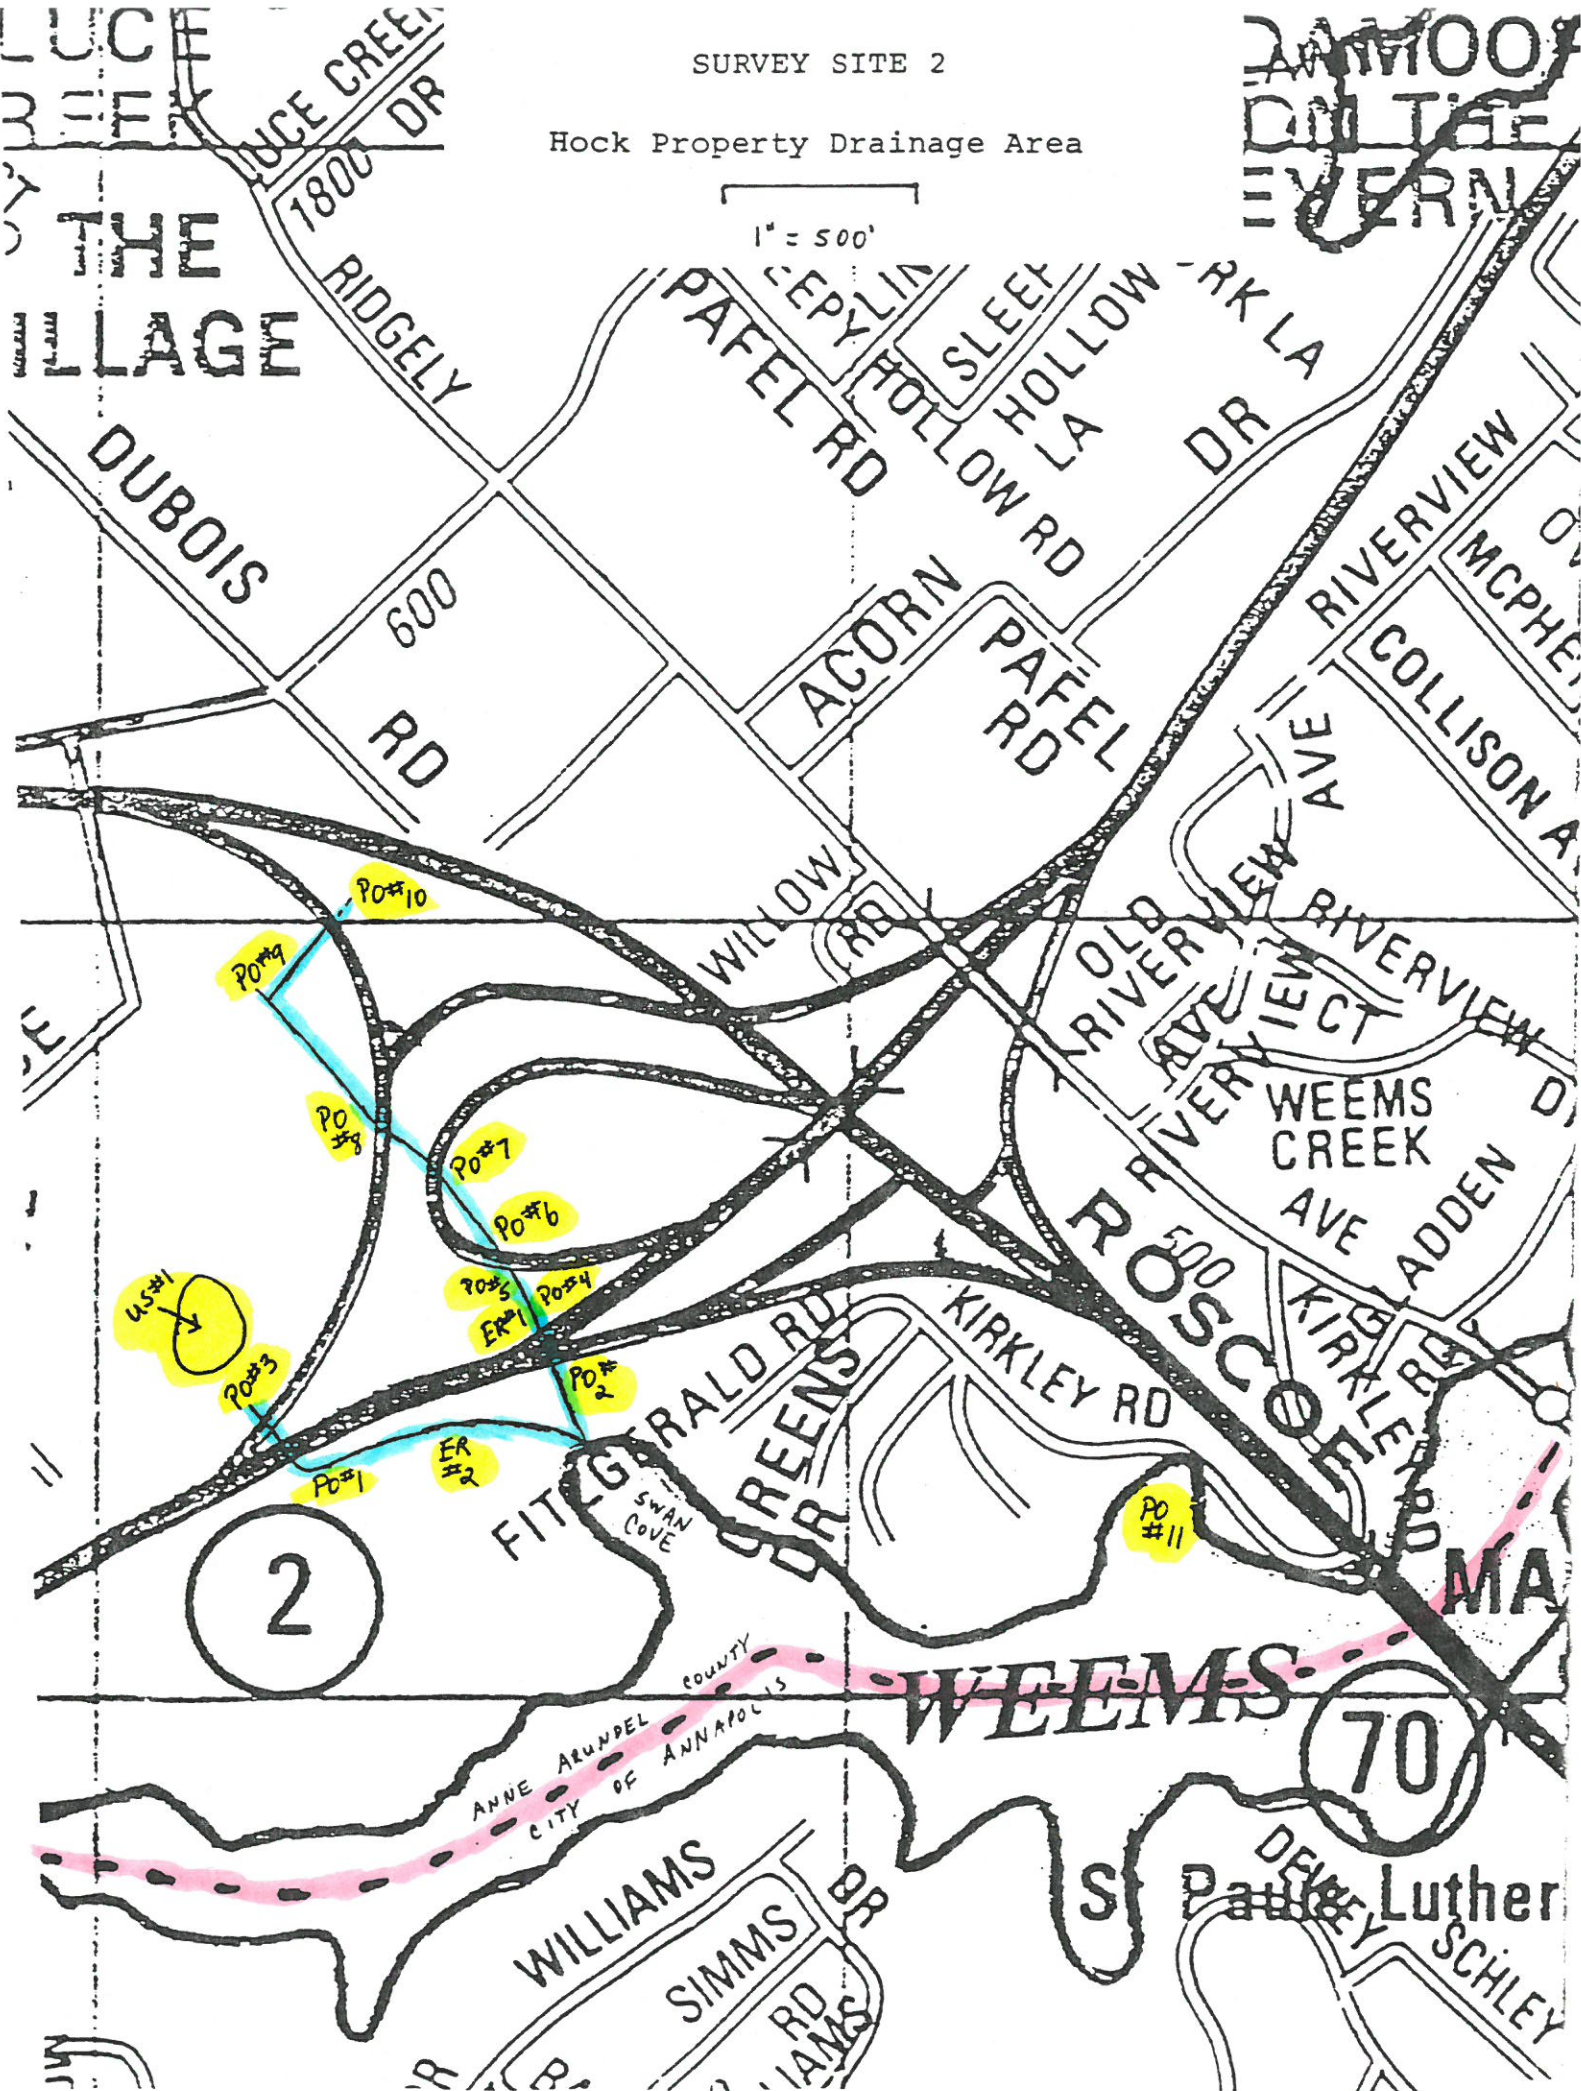
Hock Property Drainage Area

Pipe Outfalls: Virtually all of the pipes reported along this survey section (PO #1 - PO #10) were reported to be part of the highway intersection drainage system. The concrete pipes ranged between three and four feet in diameter. Stream beds above Route 50 are lined with stones, according to the volunteers. Some trash was reported downstream from PO #1. Volunteers also reported another pipe (PO #11) at the head of a cove downstream from the survey site, near Kirkley Road. While details regarding the size and type of pipe were not provided, the volunteers noted that the outfall continues to carry silt into Weems Creek.

Evidence of Erosion: Severe channel erosion was reported along a drainage area below PO #1 (ER #2). Volunteers listed the possible cause of this erosion as runoff from the highway and from US #1. The land directly adjacent to ER #2 was described as being forested.

Survey Site 2 -- ER #1: This area, described as a "sinkhole" next to the highway and a drainage pipe (PO #4) should be examined for possible repair.

Survey Site 2 -- A downed silt barrier in Swan Cove should either be repaired or removed.

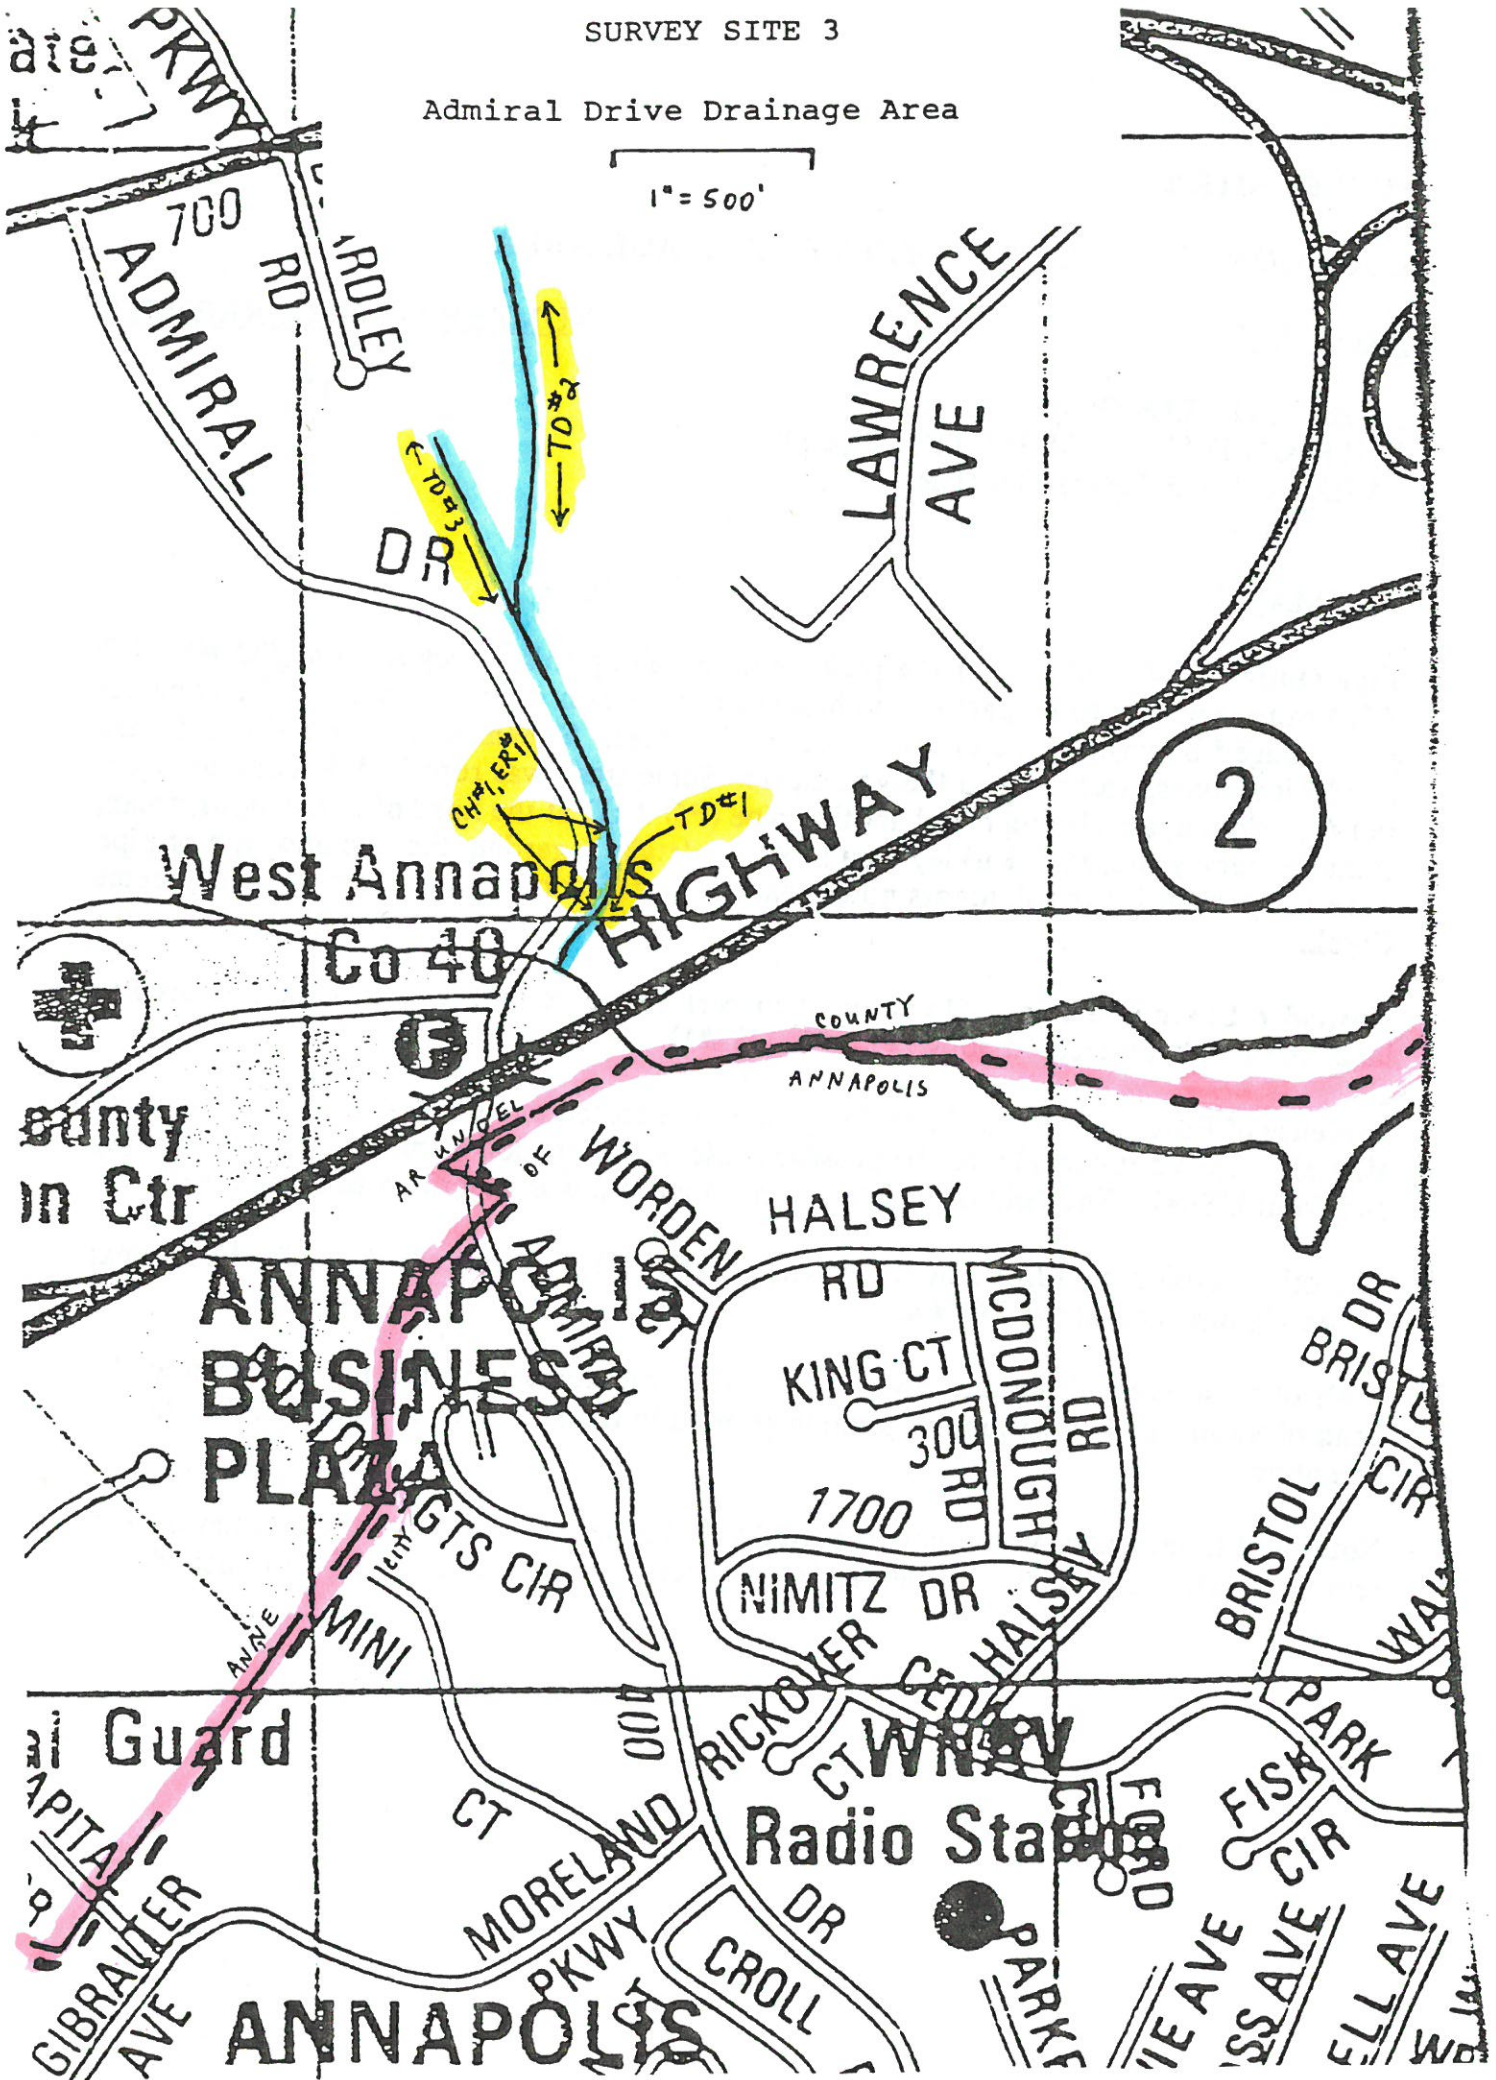
Admiral Drive Drainage Area

Trash Dumping Areas: Several significant trash sites were found, particularly along the upstream portion of this survey site. The largest section (TD #2) was reported as being "along a dry river bed off of Old Admiral Road, along side roads". This area consisted of several trash areas along a stretch of dry creek bed running several hundred yards. The volunteers stated that it was along those areas furthest upstream, where the worst sites were located. In these areas, they reported seeing "paint cans, paint thinner cans, washers, plumbing fixtures, and lots of scrap metal".

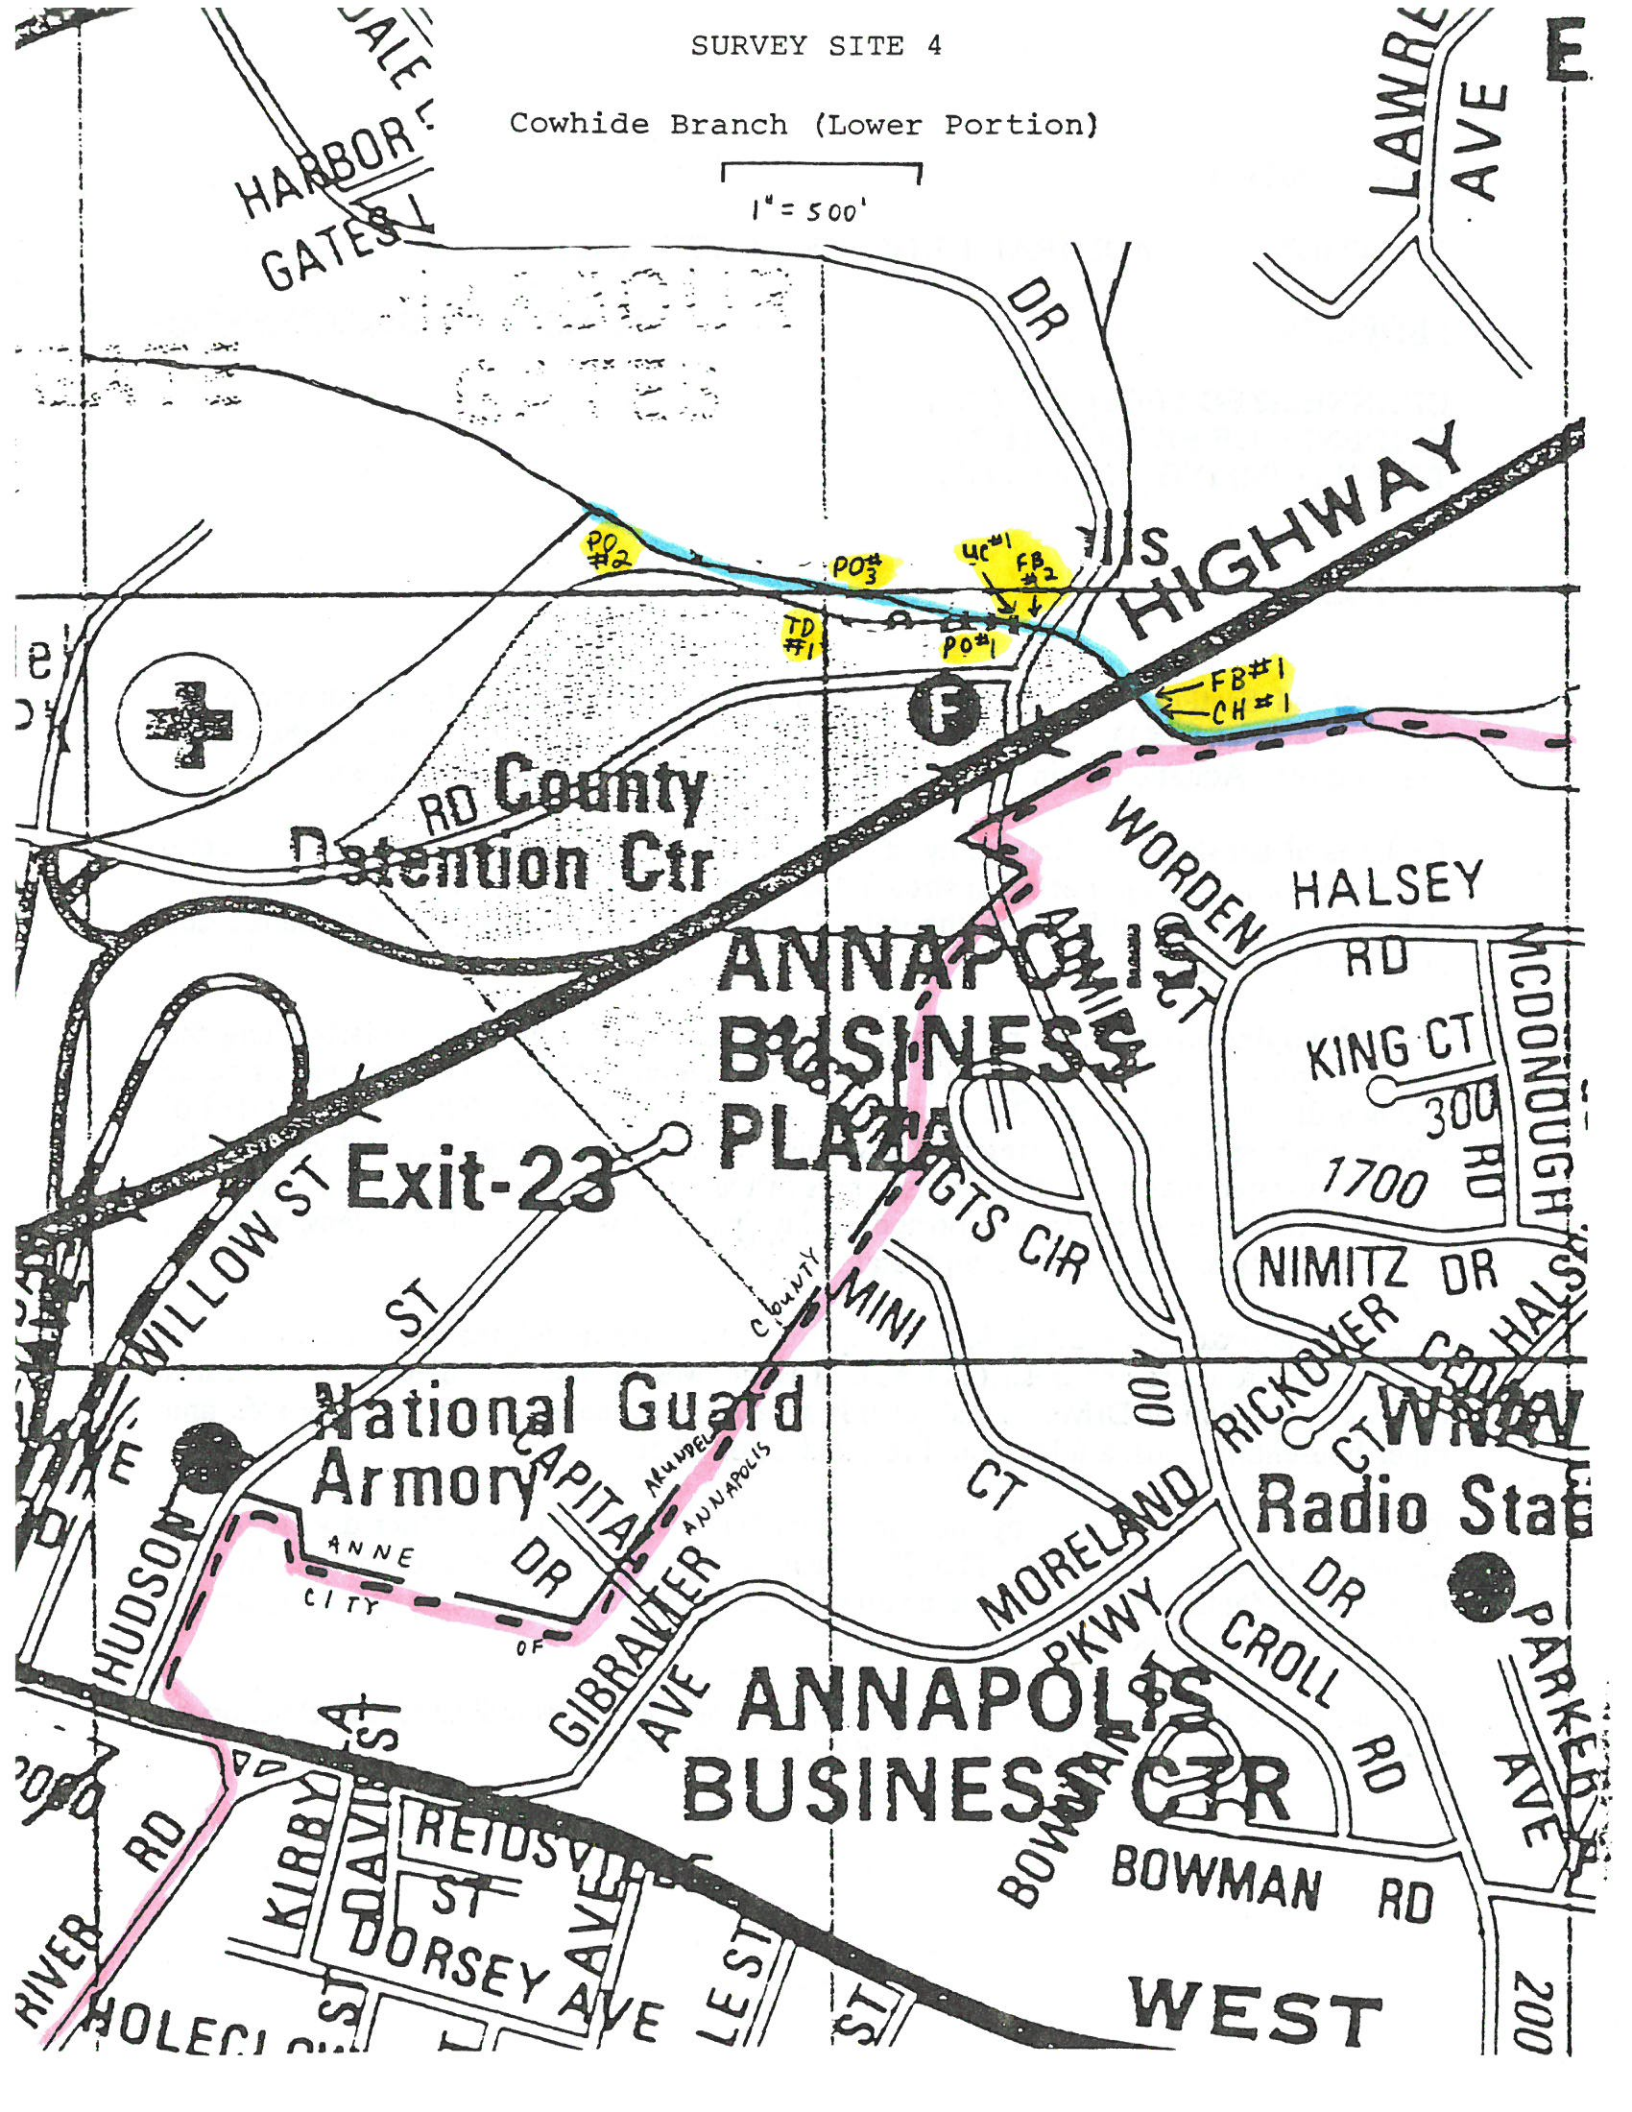
Cowhide Branch (Lower Portion)

Unusual Stream Conditions: The volunteers listed the area surrounding FB #2 as an unusual stream condition (UC #1). The rip-rap dam east of the sewage pumping station has "created a flooding of the existing area, approximately 120 feet wide". While some unspecified aquatic life was reported, the volunteers described the water in the area as being "unclear and turbid". Algae was also reported in this area.

Trash Dumping Areas: The volunteers reported an old dump in a 160 square foot area near the stream and across from the County Detention Center (TD #1). Debris found at this site includes concrete and brick rubble, old tin cans, and cable.

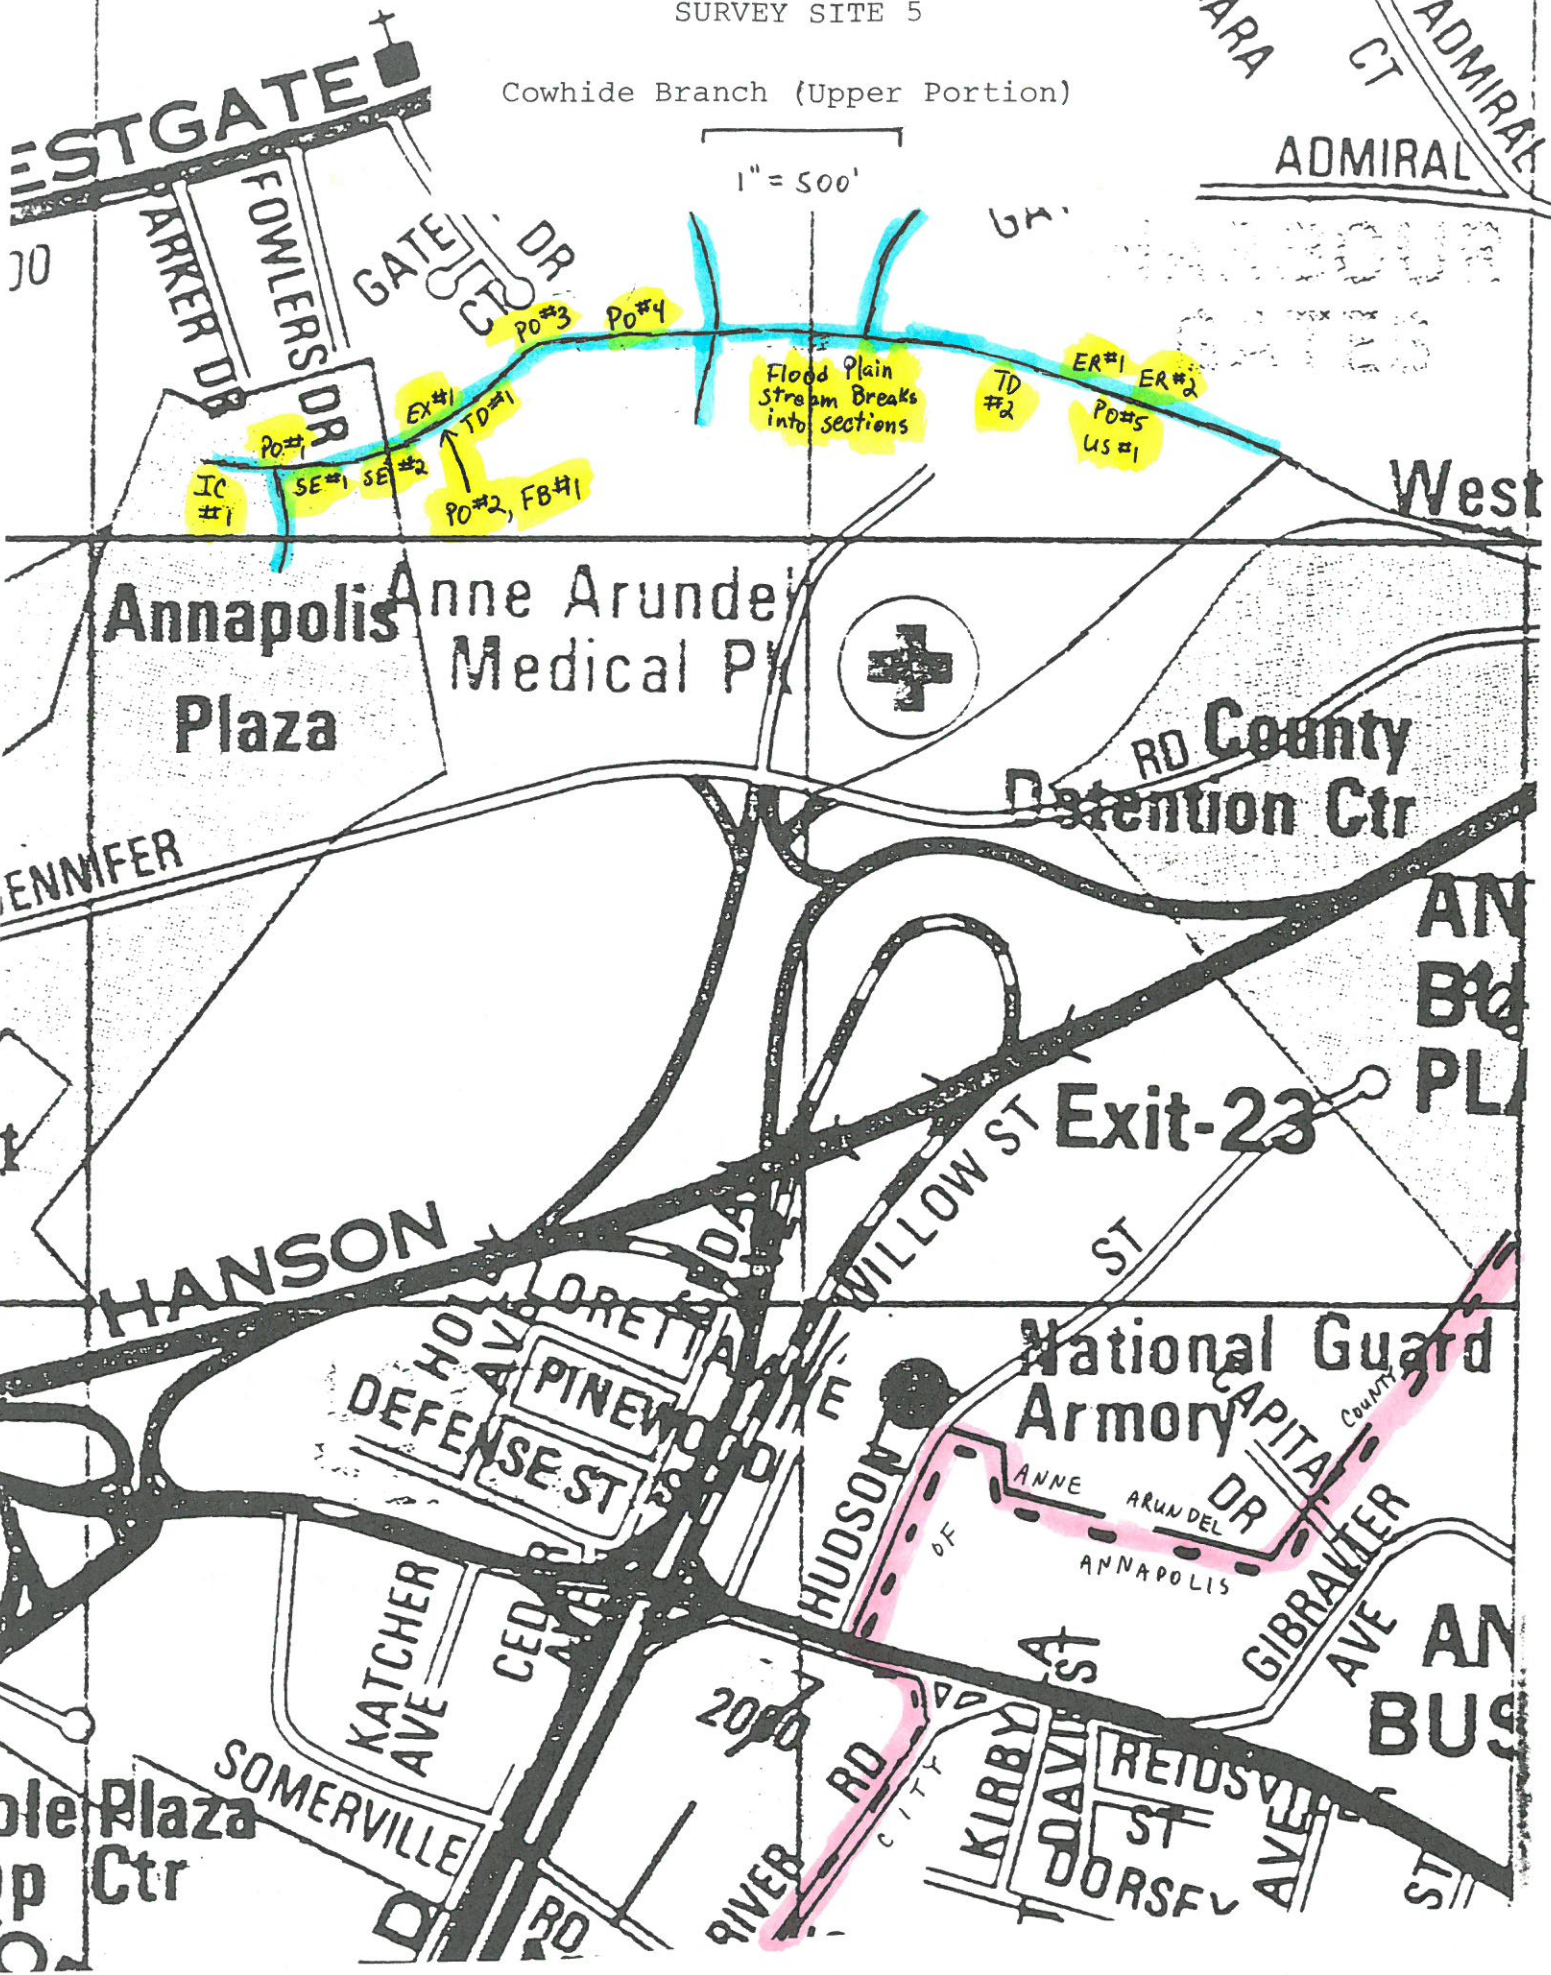
Cowhide Branch (Upper Portion)

The final pipe reported by the volunteers (PO #5) was described as being behind (west of) the Medical Facility. The pipe was further described as being a cement head-drain in a large rip-rap area. Some wood debris was found in the stream at this site.

Evidence of Erosion: The beginning stages of both channel and steep slope erosion were reported by the volunteers behind the Medical Facility (ER #1). Sediment from construction activity was listed as the possible cause of the erosion. The volunteers indicated that "once stabilized, the sediment will stop. The construction site was reported to be approximately 200 feet from the stream channel. An estimated 10% of the five acre site was reported to be exposed soil at the time of the survey.

A short distance downstream, another area of steep slope erosion in its beginning stages (ER #2) was reported. This area was described as being behind the Medical Facility at Jennifer Road. Possible causes for the erosion were listed as "offside flows directed to this area". The volunteers reported runoff from manmade slopes, and said scouring is evident. The site was reported to be 200 - 300 feet from the stream channel. An estimated 5% of the site in this area consisted of bare exposed soil.

Sediment Loading: Extensive sediment loading (SE #1, SE #2) was reported in the upper reaches of the survey site, east of the Mall, below the rip-rap. Along this section, the volunteers reported seeing lots of iron oxide deposits and natural debris along the channel and banks. They also reported seeing sediment deposits in the floodplain. Side bars and center bars of sediment were observed in the stream channel. Past construction was listed as a possible cause of this problem. The volunteers noted that the area was beginning to be stabilized. Further downstream, beyond the Medical Center, the volunteers reported sediment deposition in the floodplain to be not as evident.

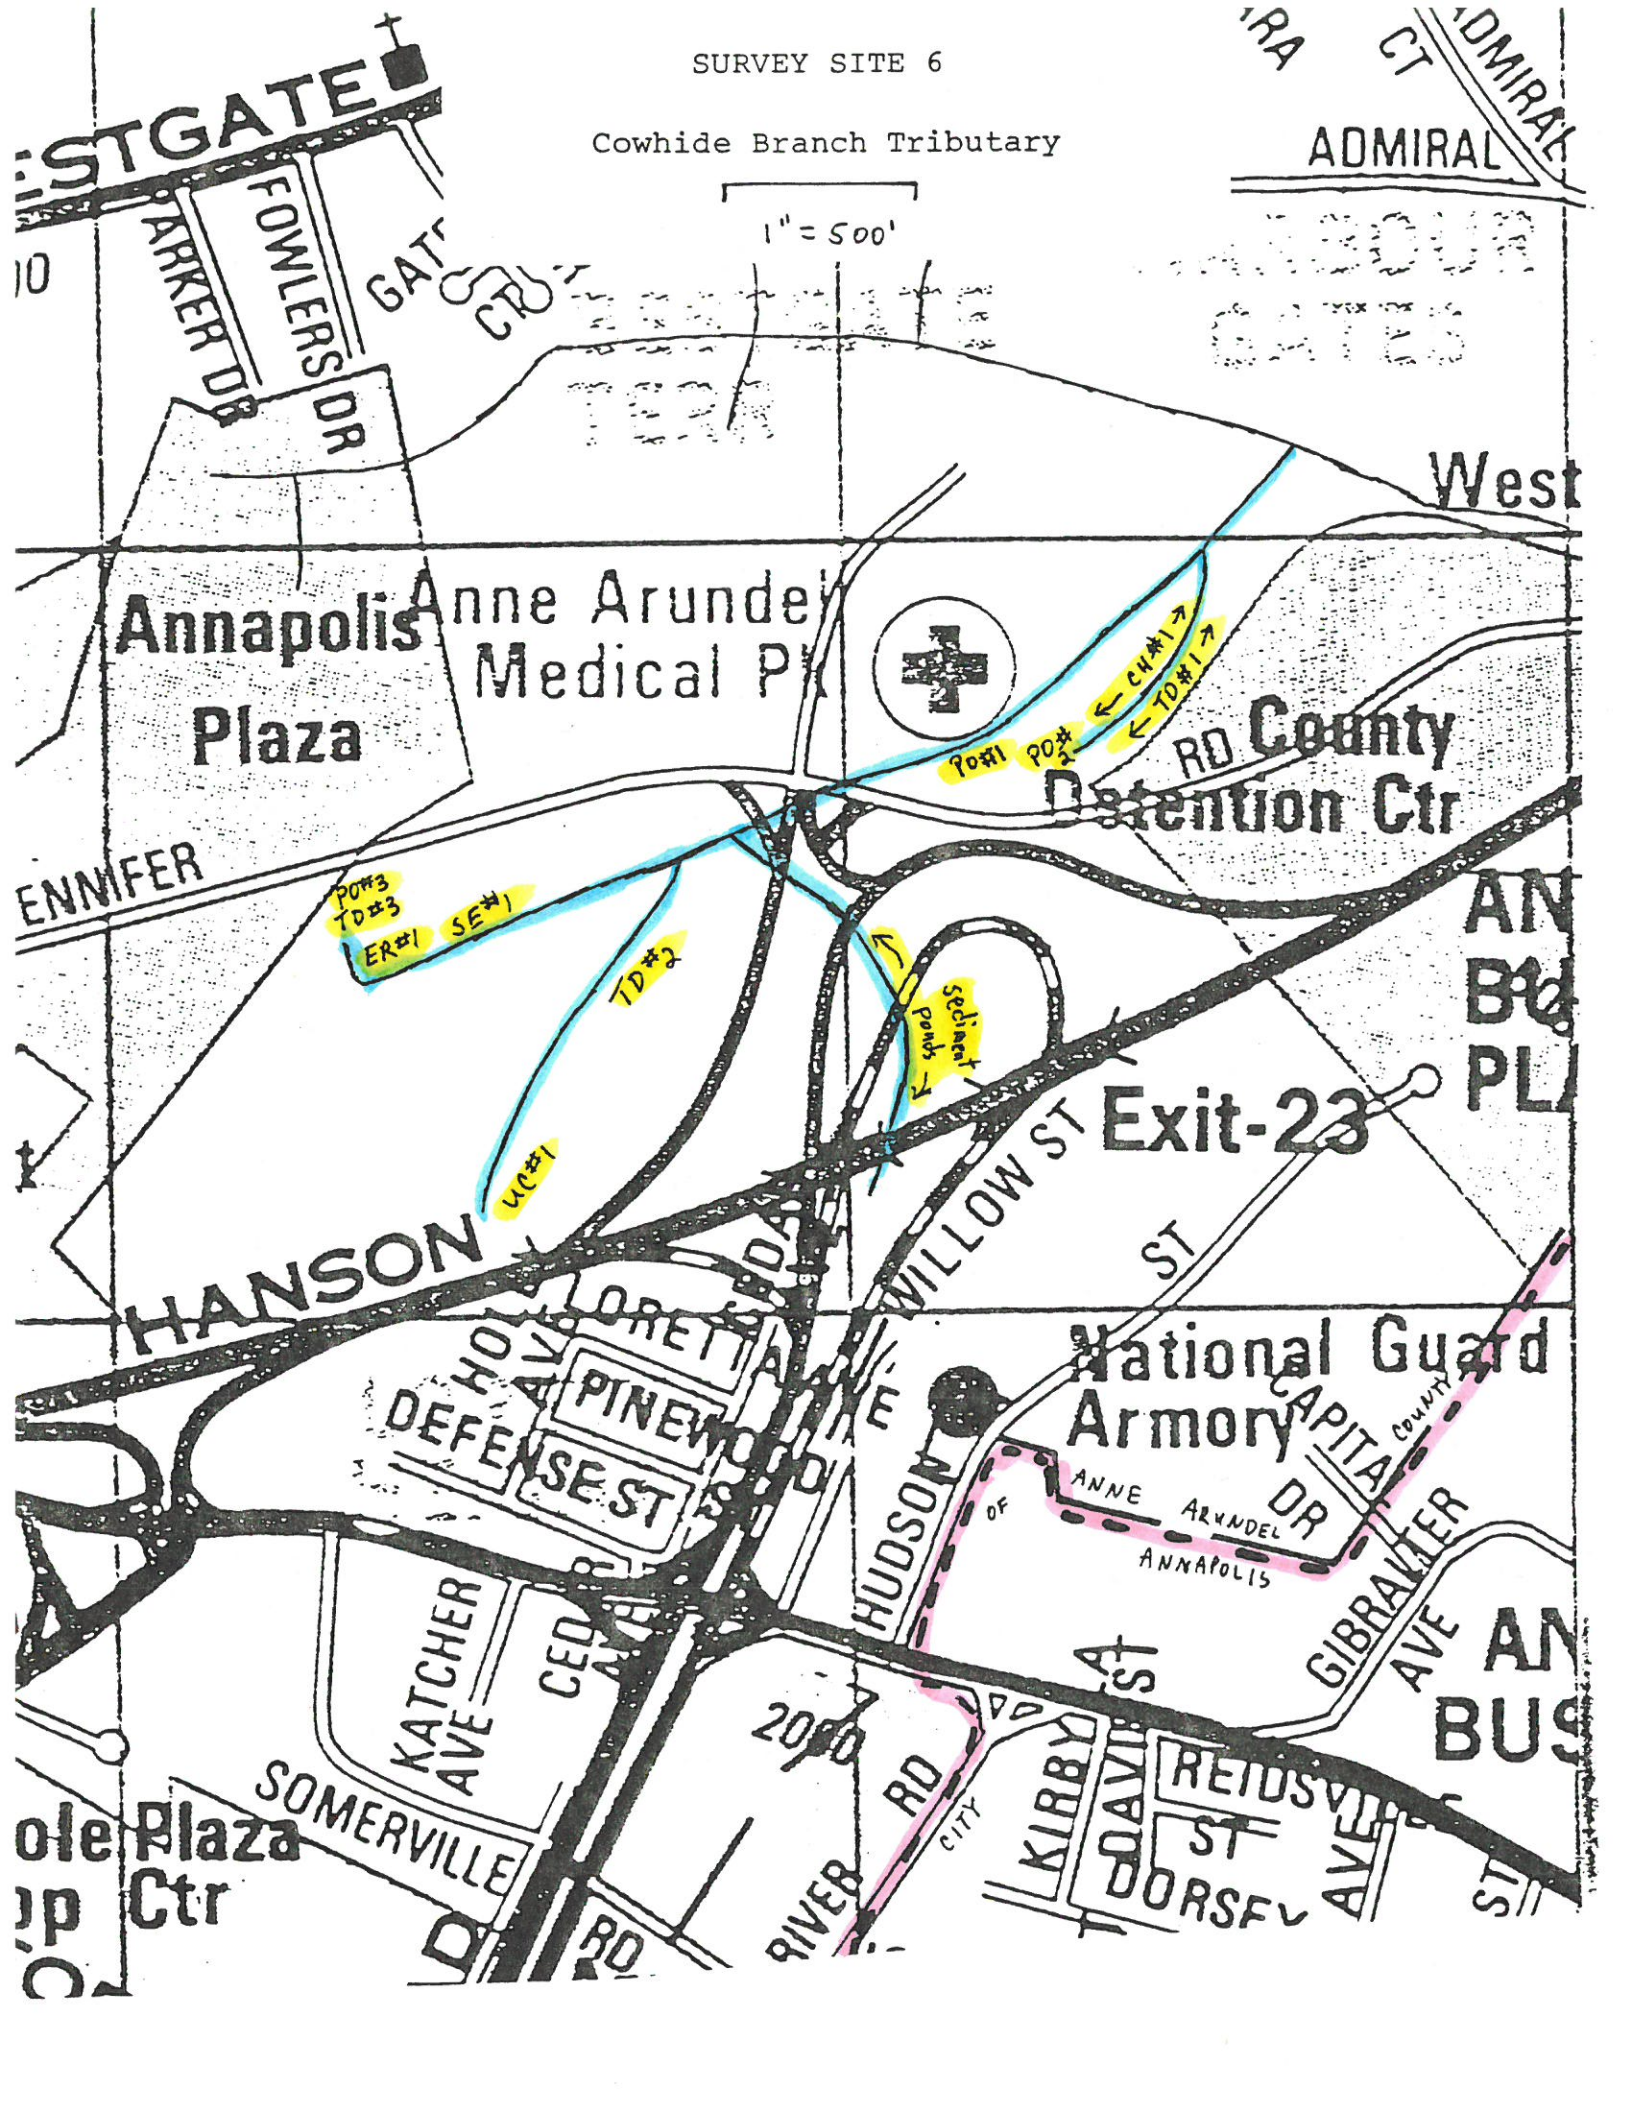
Cowhide Branch Tributary

Unusual Stream Conditions: Near a road culvert which passes under Route 50, volunteers reported heavy seeing heavy blotches of cloudy film in stagnant water (UC #1). No algae was reported. No aquatic life was observed in this area.

Channelized Sections: A concrete channel, running for several hundred feet (CH #1) serves as a drainage point for PO #2, and is not part of the stream channel. A slight bit of downstream sedimentation was observed by the volunteers. No downstream erosion was reported. The channel was dry at the time of the survey.

Anne Arundel County is currently working with an environmental consultant to conduct a stream restoration project along the upper portion of Cowhide Branch (Site 5), in order to control erosion, reduce sediment loading, and create a more natural habitat. If it has not yet been done, other sections of the creek reported to be suffering from severe erosion and sediment loading, should be assessed by the County, the City of Annapolis, and appropriate consultants, for similar restoration work. Along with section 8 (mentioned in recommendation #1) the upper reaches of section 6 should be given high priority for review and assessment.
