WEEMS CREEK TRIBUTARIES STREAM SURVEY

REPORT OF FINDINGS

JUNE 30, 1994

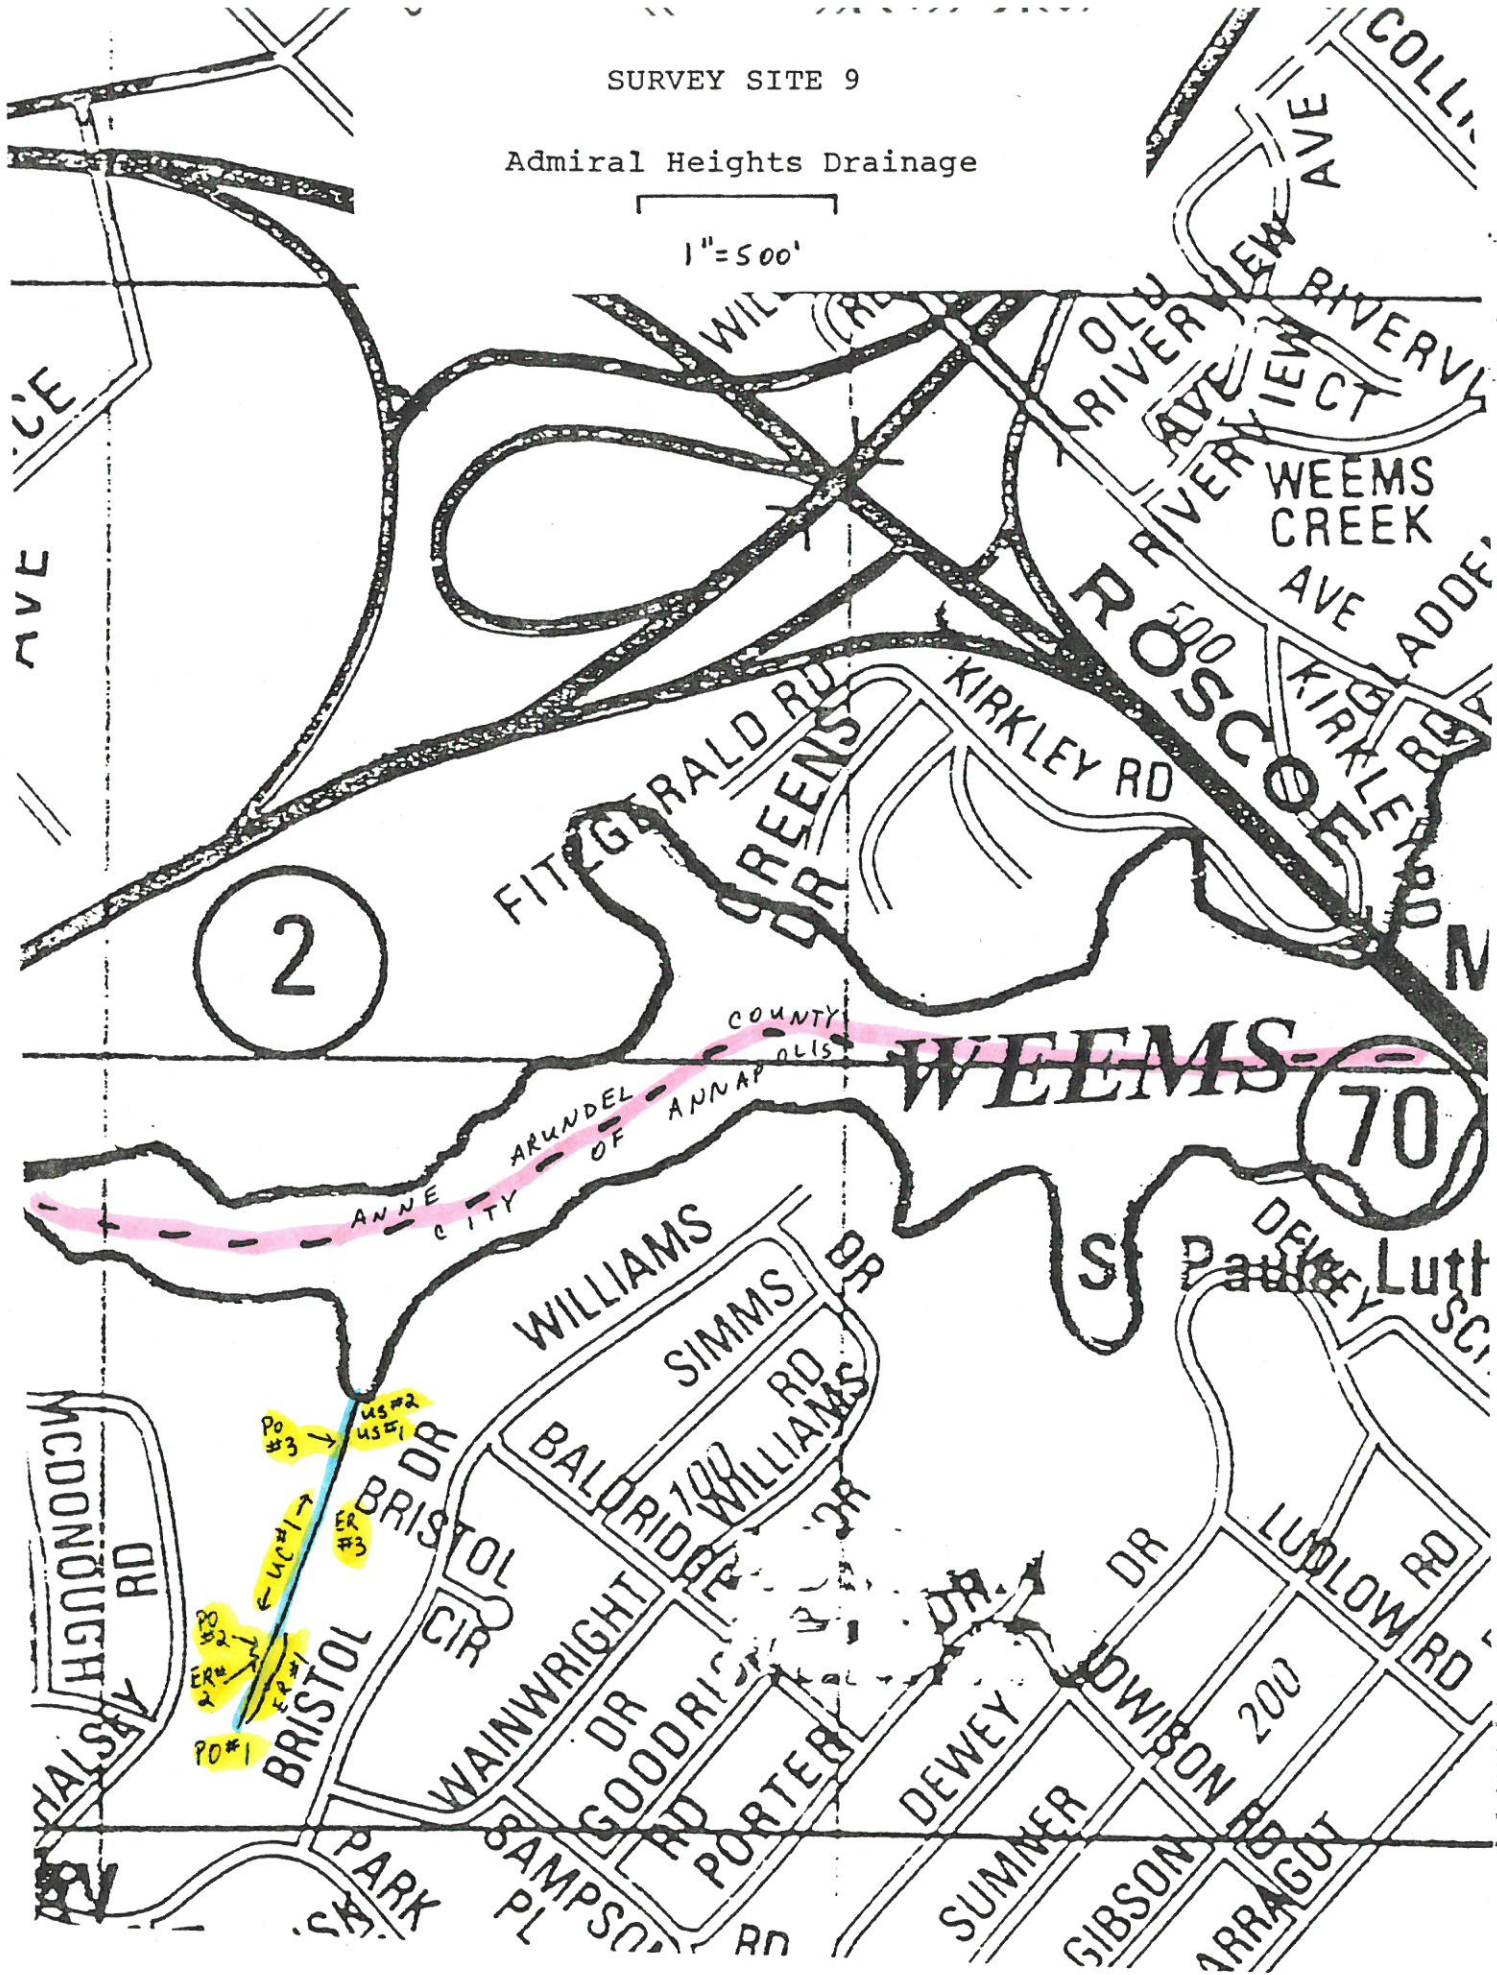
Admiral Heights Drainage

Unusual Stream Conditions: Throughout the survey site, volunteers reported seeing an orange substance which they believed to be "algae or colloidal matter" (UC #1). The volunteers did report seeing signs of aquatic life, and black color on deeply imbedded stones.

Evidence of Erosion: Severe channel erosion was reported immediately below PO #1 (ER #1). This area of erosion continued for 150 feet downstream along the right bank of the stream channel. The volunteers listed a failure of gabions and rip-rap below PO #1, and periods of high stormwater runoff as a possible cause of the erosion.

Further downstream, the volunteers reported another section of severe channel erosion (ER #3). They listed undercutting during periods of high runoff as the possible cause of erosion along this section.

Survey Site 9 -- ER #2: Repairs should be considered for a "pothole", approximately six feet in diameter and five feet deep. This was reported at the point where drainage from PO #2 enters the stream system.

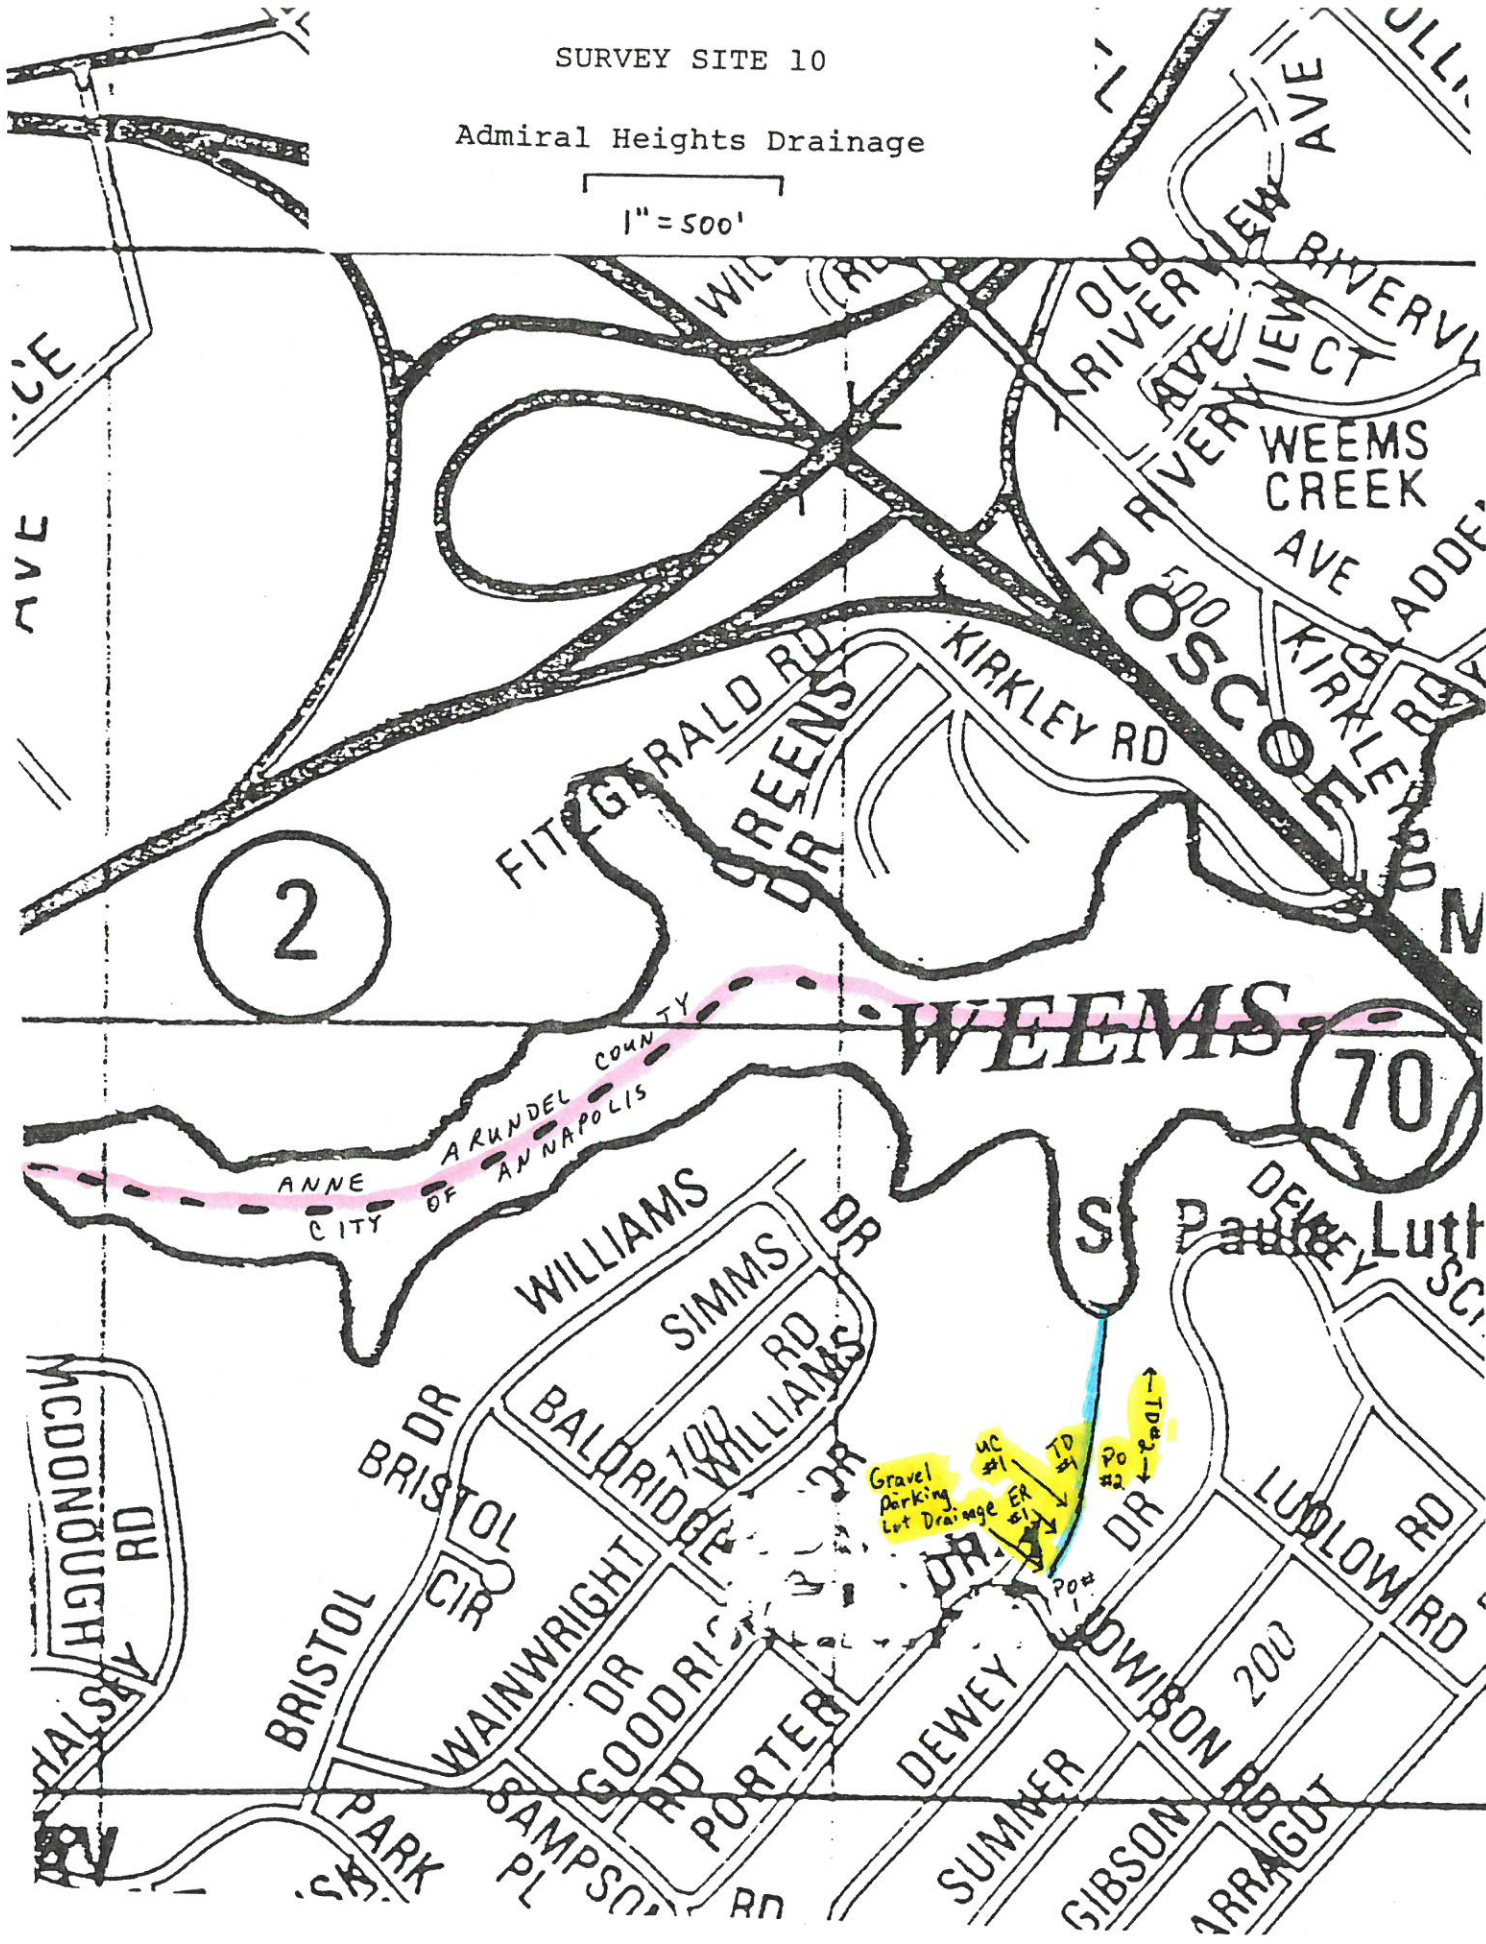
Admiral Heights Drainage

Unusual Stream Conditions: Volunteers reported an increase in the stream gradient approximately 250 feet downstream from Howison Road (UC #1). Construction rubble, including asphalt, had reportedly been dumped in this area.

Evidence of Erosion: Severe channel erosion was reported 200 feet downstream of Howison Road (ER #1). Stormwater runoff and trash were listed as possible causes of the erosion.

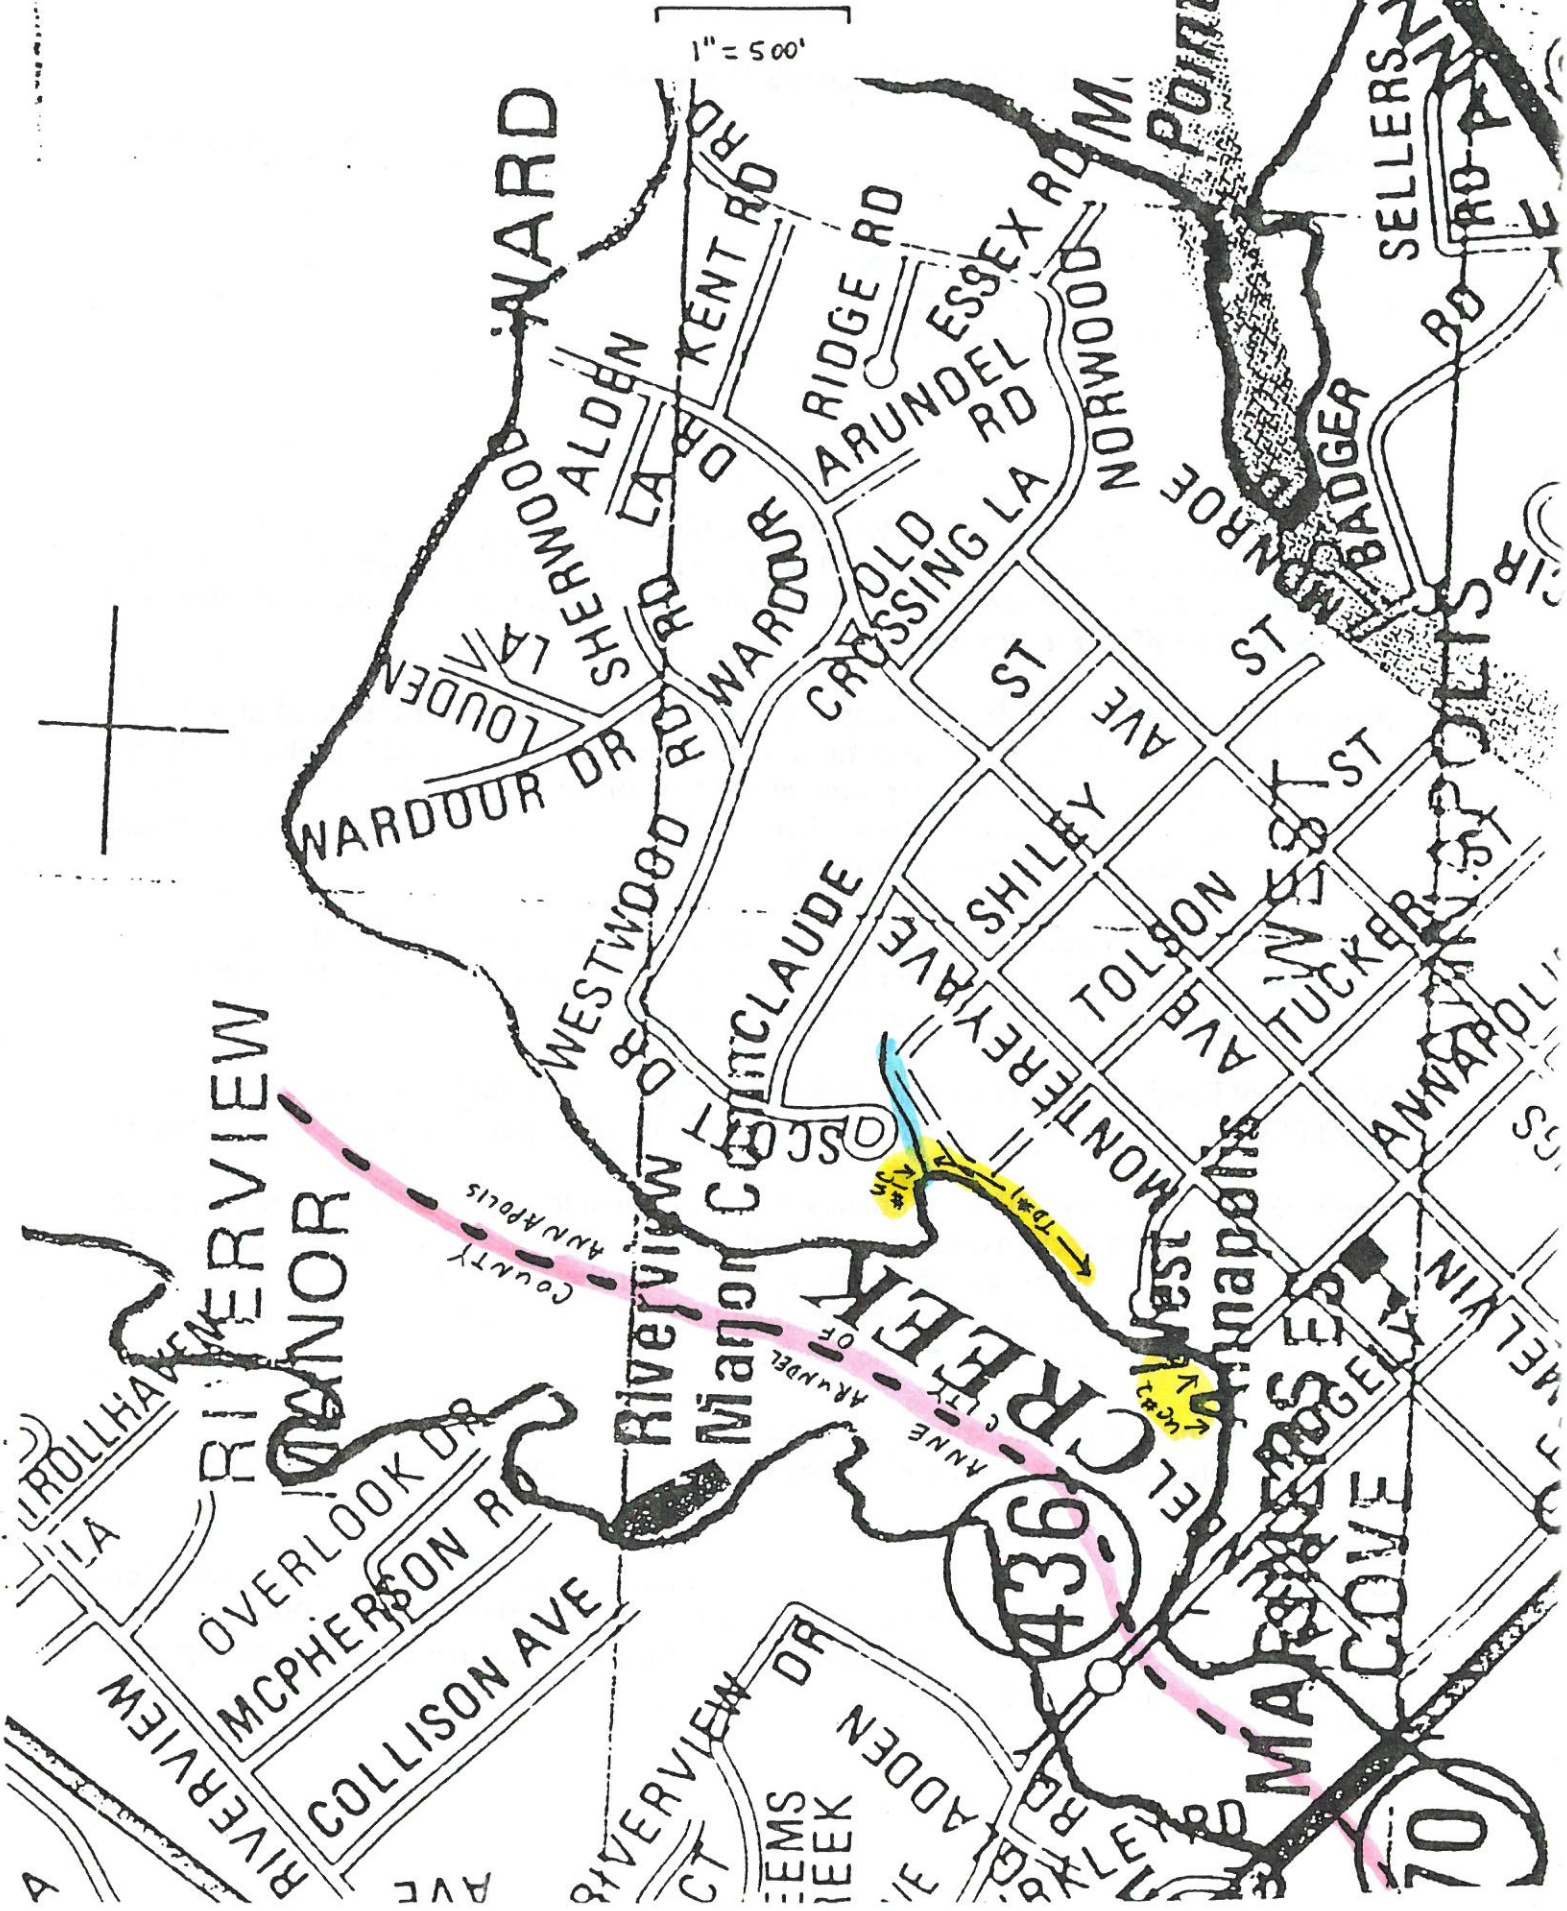
West Annapolis Drainage

Unusual Stream Conditions: Volunteers reported a heavy scum along the lee shore, near the mouth of the drainage area (UC #1). In the area near the end of Annapolis, volunteers reported seeing "lots of oil in the creek" (UC #2).
