MAYO BEACH PARK

4150 Honeysuckle Drive
Edgewater, Maryland 21037

Condition Assessment for Anne Arundel County DEPARTMENT OF RECREATION & PARKS

Contract Number: P582101
Project Number: P582100

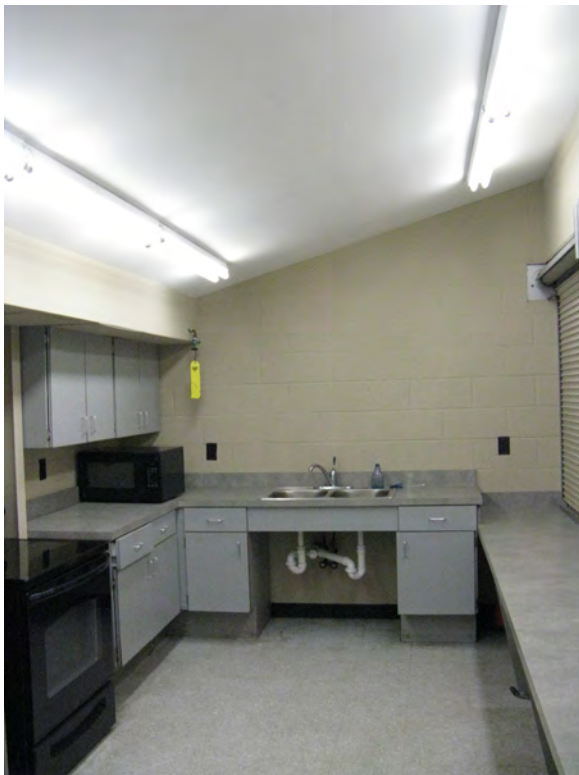
Building 1 - Glass Pavilion appears to be in good working condition and generally functions as anticipated. Later renovations (dates unknown) replaced the sliding doors, windows, bathroom fixtures, and flooring. The kitchen cabinets and countertop are in very poor condition with delaminating surfaces occurring in several locations.

Kitchen cabinets and countertops

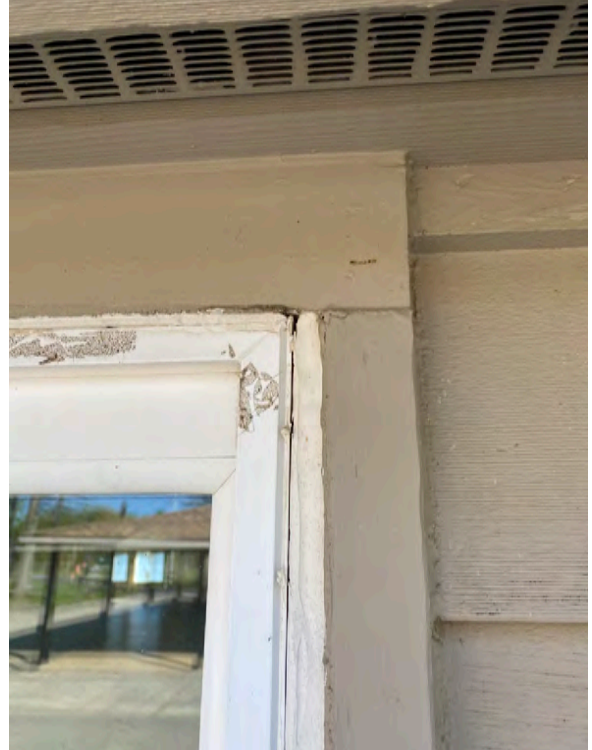
Deteriorated sealant

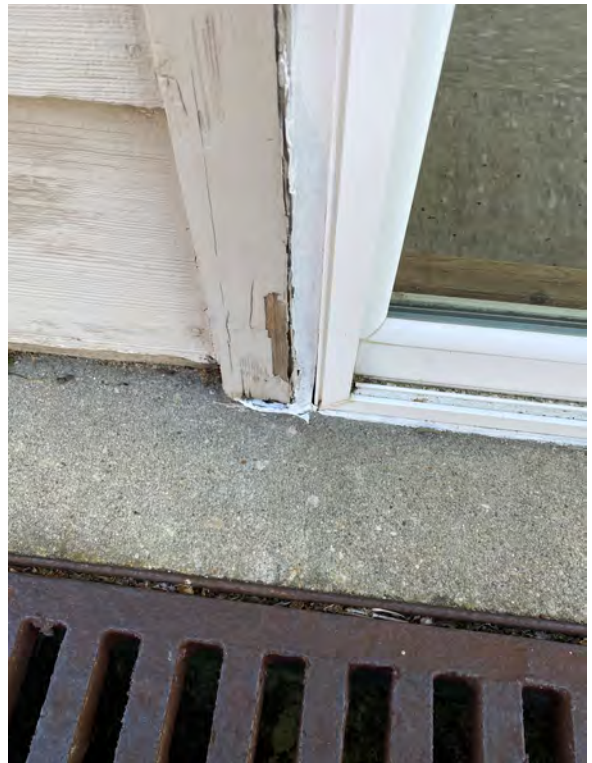
The siding is wood lap siding with 2x wood corner boards. It has received many coats of paint over the years. It is in fair condition with some areas around sliding doors, windows, fascia board, and near ground contact that show rotted or deteriorated conditions.

Deteriorating siding and trim

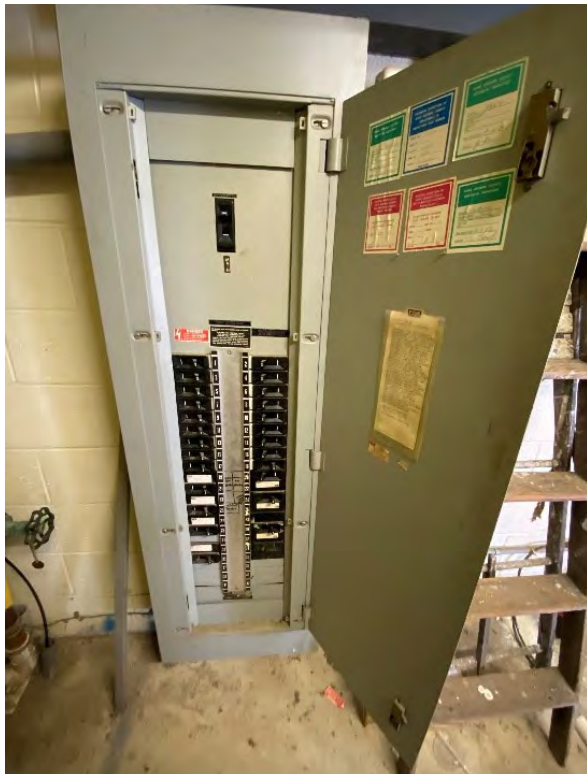
The Glass Pavilion contains a 150-ampere, 1-phase, 3-wire, 120/240V main panelboard in Storage 105. The panelboard is manufactured by Federal Pacific (FPE) and installed in 1980. This main panel is fed from a 200A Service Disconnect which receives power from the Maintenance Building main electrical room. The life expectancy of a typical panelboard is 30-40 years. It is recommended that a replacement for the distribution equipment to be budgeted for in the next 1-3 years.

Main Panelboard

Recommendations - Distribution System			
Item	Description	Condition	Action Required
1.8.1	Main Panelboard	POOR	Over 40 years old. Replace with service entrance rated main breaker panelboard.
1.8.2	Service Disconnect	POOR	Over 40 years old. Remove disconnect when new service entrance rated panelboard is provided.
1.8.3	Building Grounding System	POOR	Replace building grounding system with distribution replacement in next 1-3 years.

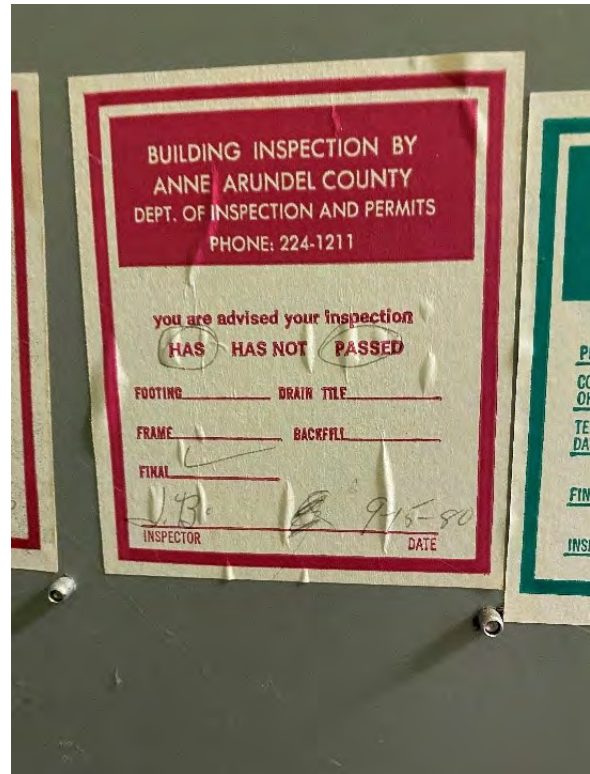
First Complete Inspection

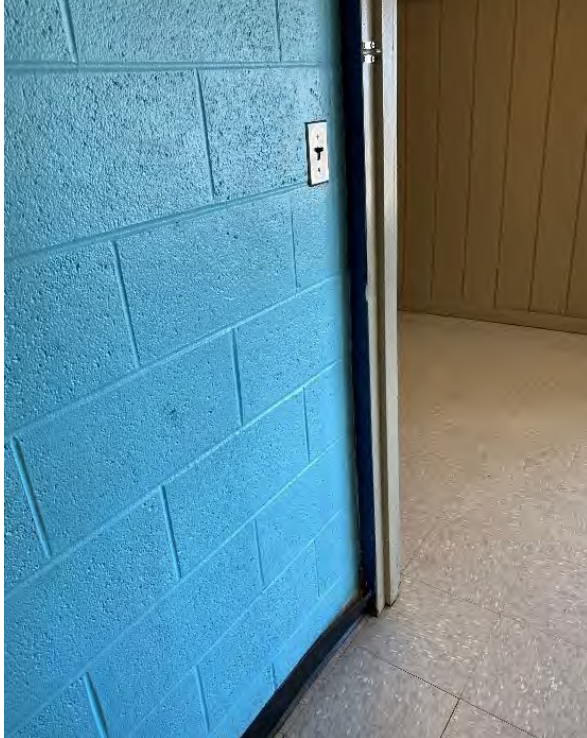
Typical Restroom Switch

Recommendations - Lighting			
Item	Description	Condition	Action Required
1.8.6	Exit Signs	WORK	Repair/replace non-illuminated exit sign.
1.8.7	Restroom Light Switches	WORK	Lower light switches in restrooms to 46" above finished floor to comply with ADA requirements. Refer to ADA report in Appendix A for additional information.
1.8.8	Interior Lighting	WORK	Replace with LED fixtures in future.
1.8.9	Egress Lighting	IMME	Replace existing emergency battery packs with LED. Install new lighting fixture(s) to provide required egress illuminance throughout building.

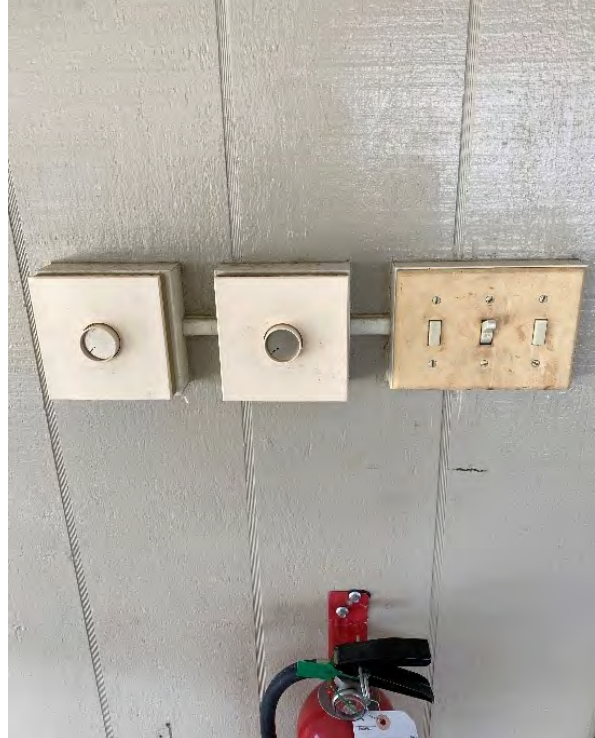
Fluorescent fixtures are installed throughout the building. Fixtures should be replaced with LED in the future. Glass pavilion area has multiple sets of track lighting throughout that are controlled by a bank of dimmer switches near the front entry. The dimmer switches are outdated and should be replaced in the future with the lighting.

Outdated Dimmer Switches

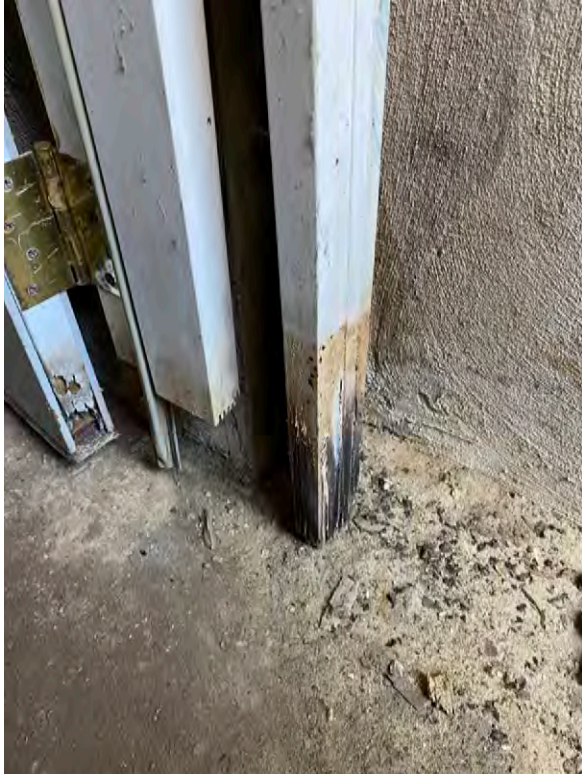
Door & frame damage at 201/B

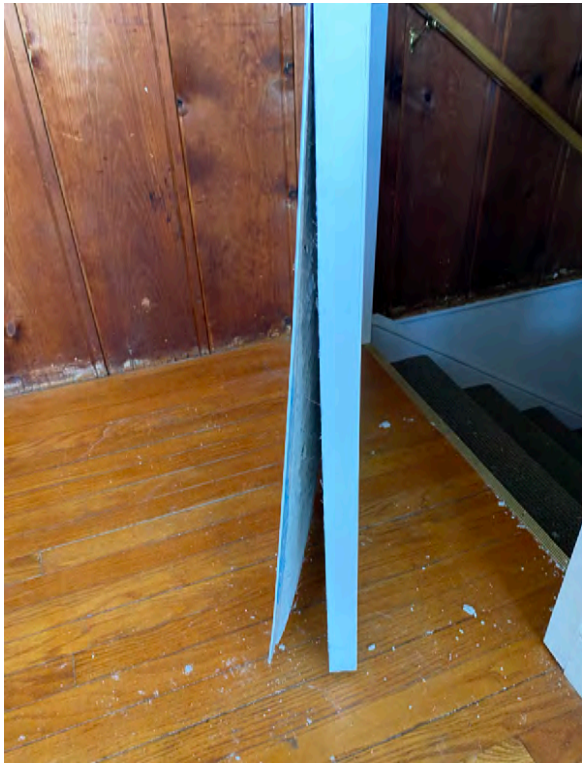
Door damage at 208/E

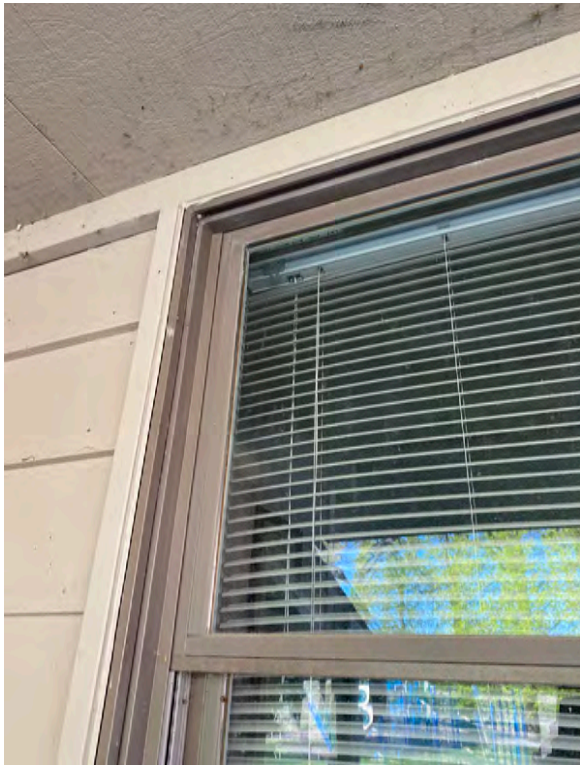
W8 missing screen

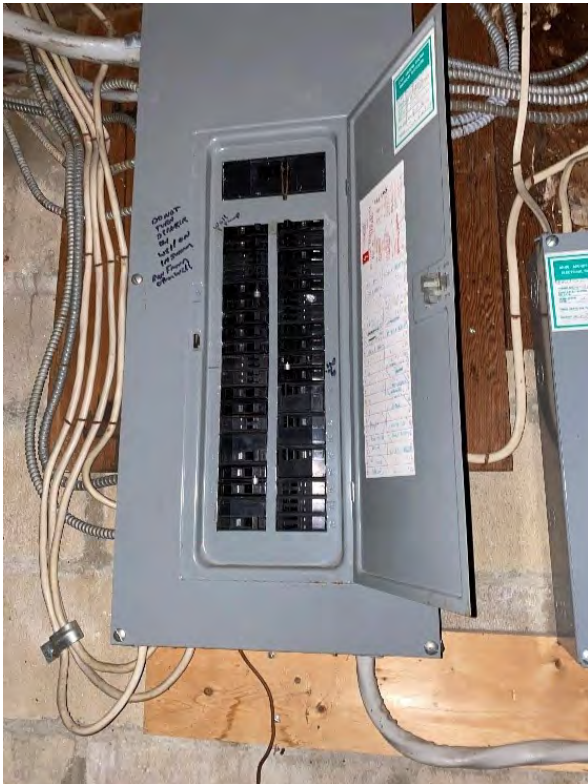
Main Panelboard

The Park Offices contains two 1-phase, 3-wire, 120/240V panelboards in the basement. The panelboards are manufactured by Square D and have inspections dated in 1990. The main panel is fed from the Maintenance Building main electrical room. The electrical capacity for the panels does not appear to be sufficient for the building usage since this building was converted from a residential house to an office/bridal suite. The panelboards should be replaced along with the associated wiring and conduit back to the Maintenance Building main electrical room. It is recommended that a replacement for the distribution equipment to be budgeted for in the next few years to accommodate the current electrical loads in the building.

Recommendations - Distribution System			
Item	Description	Condition	Action Required
2.8.1	Panelboards	WORK	Over 30 years old and undersized for the demand of the building. Replace panelboards in next 1-3 years to accommodate current electrical loads and future washer/dryer.
2.8.2	Building Grounding System	POOR	Replace building grounding system with distribution replacement in next 1-3 years.

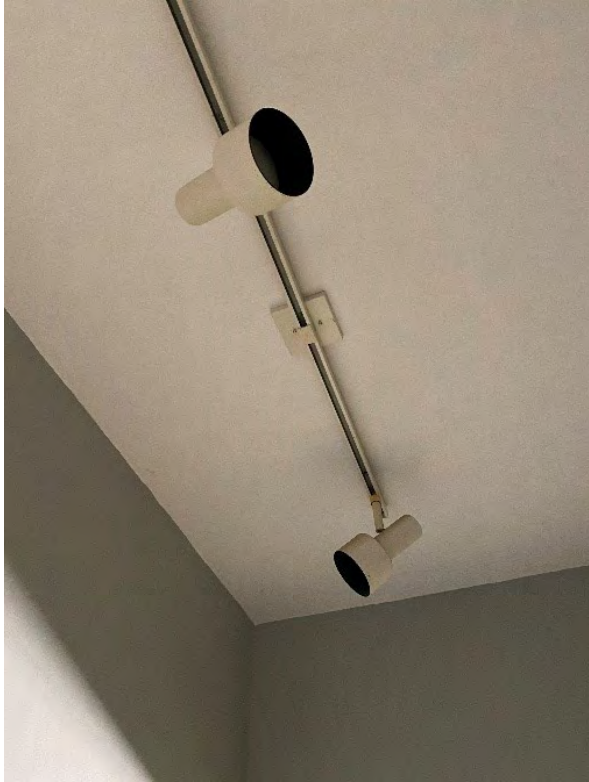
The lighting level in the basement is very low and there were a few lights that were not working. Was unable to turn on many lights on the first floor and it could not be determined whether it was a switching or a lighting issue. First floor did not have any egress lighting or exit signs and should be added immediately. The lights on the 2nd floor were mostly residential or decorative and seemed aged. Recommend replacing all lighting fixtures with LED in next 1-3 years.

1st Floor Non-Working Track Lights

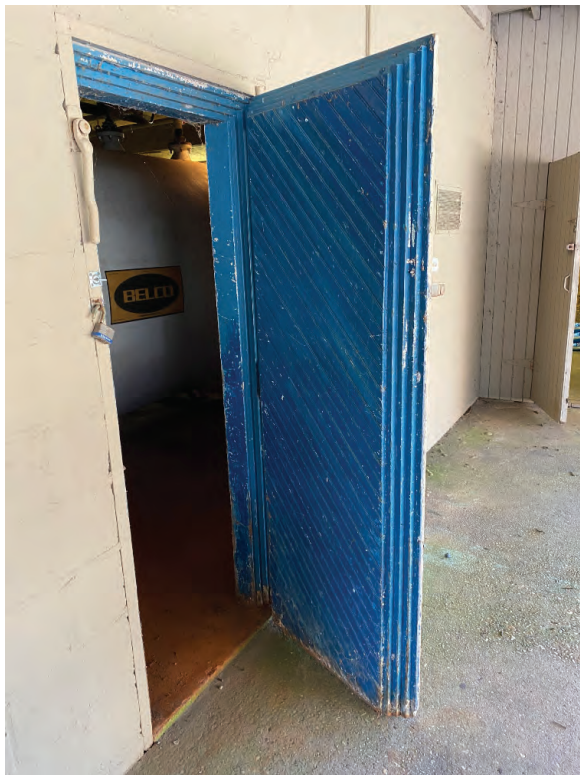
Door 302/A

Recommendations - Door			
Item	Door #	Finish	Condition/Action Required
3.2.1	302/A	POOR	Demo existing door, frame and all hardware and replace with new 18 Gauge Galvannealed Door and 16 Gauge Galvannealed Frame with lever hardware, heavy duty hinges, dead bolt, kick plate and closer. Paint door and frame when installed.
3.2.2	303/A	POOR	This door is a pair of wood fabricated leaves, it lacks many features of a contemporary door, including weatherstripping and insulating value. Demo existing door, frame and all hardware and replace with a pair of new Hollow Metal doors & frame with lever hardware, heavy duty hinges, dead bolt, kick plate and closer. Paint door and frame when installed.
3.2.3	303/B	POOR	Door finish and hardware are very worn and aged. Door jambs and trim are damaged and worn in several places. Door and frame should be replaced in the near term.

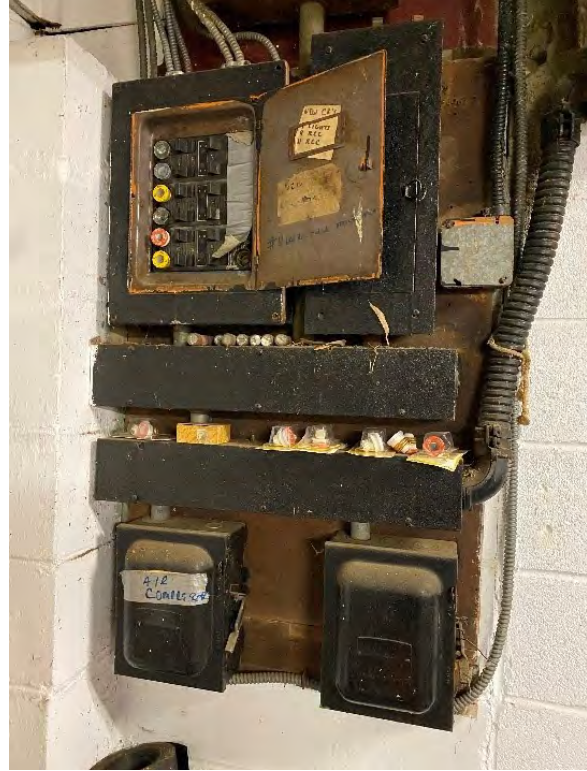
There was also some aged equipment (most likely 50+ years old) in the maintenance room 412 which should be removed or replaced as soon as possible.

Room 412 - Aged Electrical Equipment

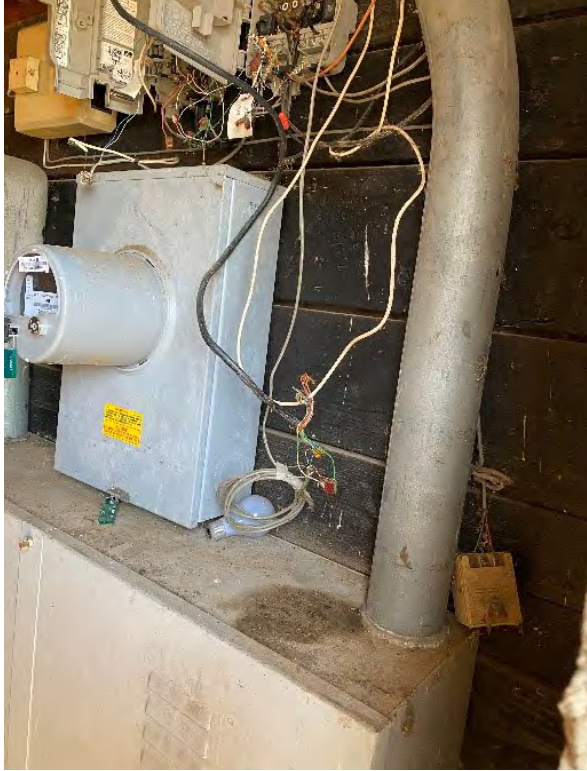
There were many exposed cables discovered throughout the building that are required to be removed per NEC. One of the panelboards in the main electrical room is missing a cover, exposing live parts, and should be provided immediately. Due to the age of the electrical equipment, it is recommended that the grounding system is tested for ground resistance to ensure it complies with NEC. We recommend replacing the grounding system with the main service disconnect in the next 1-3 years. There were two outdoor receptacles that must be provided with GFCI protection immediately. All outdoor receptacles less than 50-amperes must have GFCI protection per NEC 210.8. One of the light switches in the day camp area seemed to be ripped off the wall and should be properly mounted.

Room 411 - Abandoned Cabling

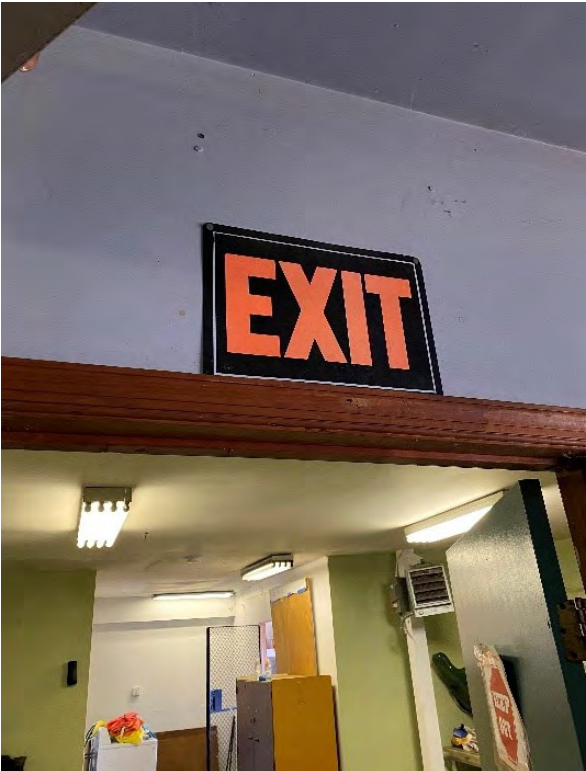
Room 401 - Non-Illuminated Exit Sign

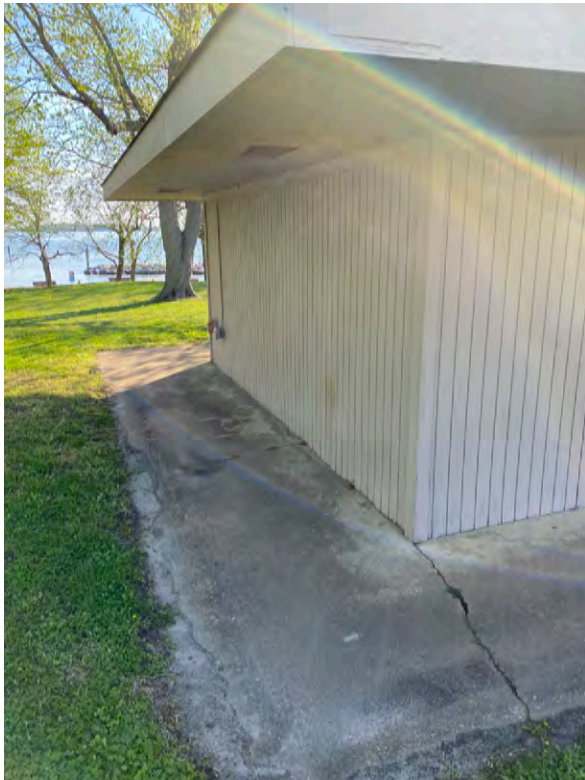
The siding is a replacement vertical T-11 wood panel system with 1x wood corner boards. It has received many coats of paint over the years. It is in fair/poor condition depending upon location. The siding sits directly upon the concrete apron, creating direct contact with the wet grade during rain events. Lower sections of siding is deteriorating from this existing condition.

Concrete Apron and Siding

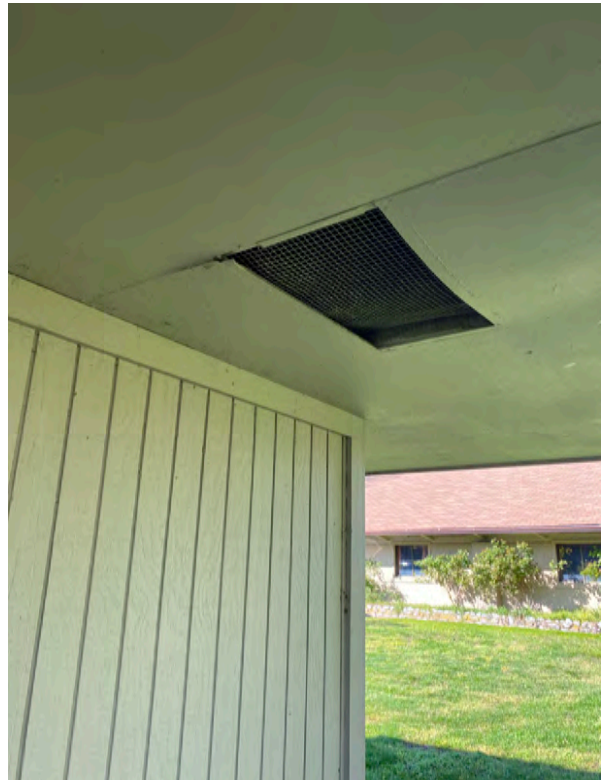
Siding and Roof Vent

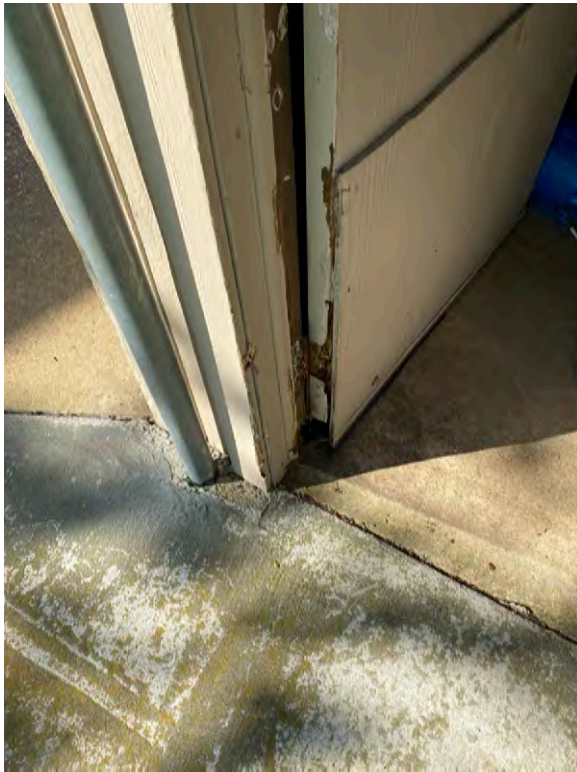
Door 501/A is 3'-0" wide x 6'-8" high patchwork of wood. It has separated from the top hinge and binds against the interior concrete slab when attempting to open it. The door, frame & hardware are deteriorated and in poor condition.

Door 501/A detail

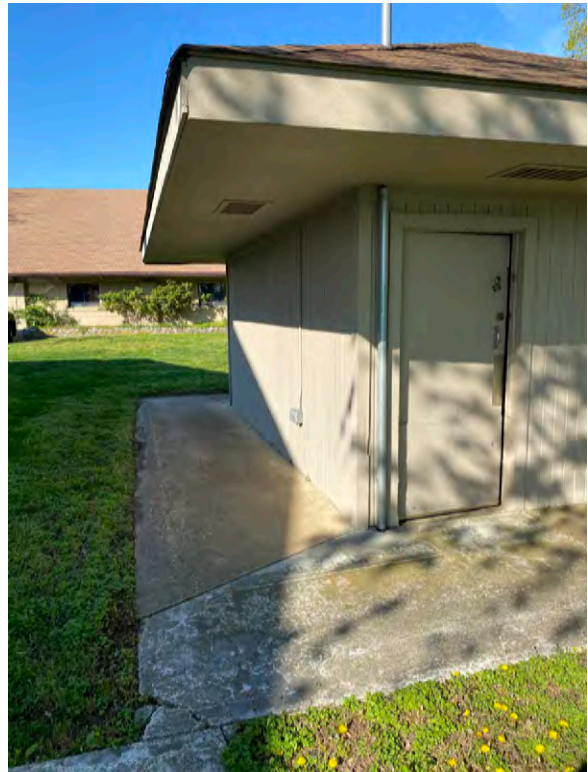
Door 501/A from exterior

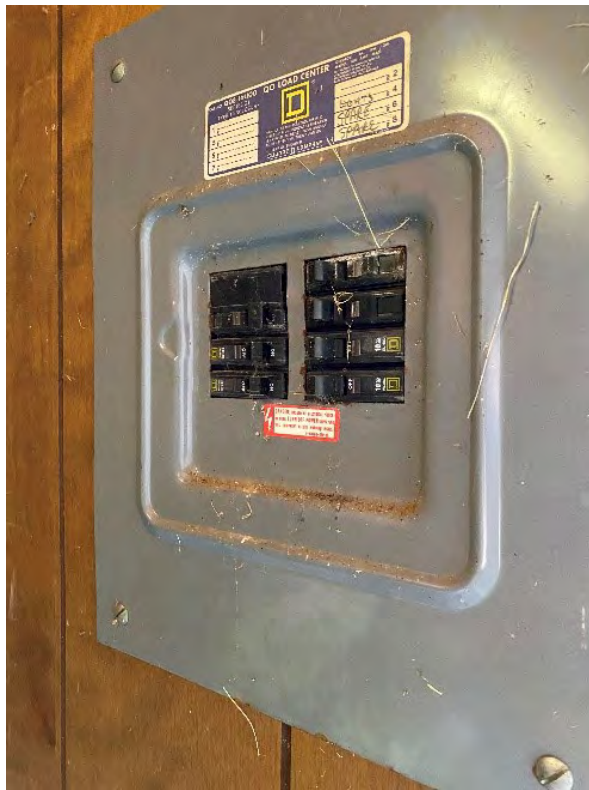
Load Center

This storage building contains a 100-ampere main lug, 1-phase, 3-wire, 120/240V load center. The load center is manufactured by Square D and it could not be determined when it was installed. This load center receives power from the Maintenance Building main electrical room. Working clearance in front of the load center should be maintained per NEC 110.26. The life expectancy of a typical panelboard is 30-40 years. Load center is on the verge of being in poor condition but assuming it is at least 30 years old, like all the other electrical equipment on site, it is recommended that a replacement is budgeted for in the next 1-3 years.

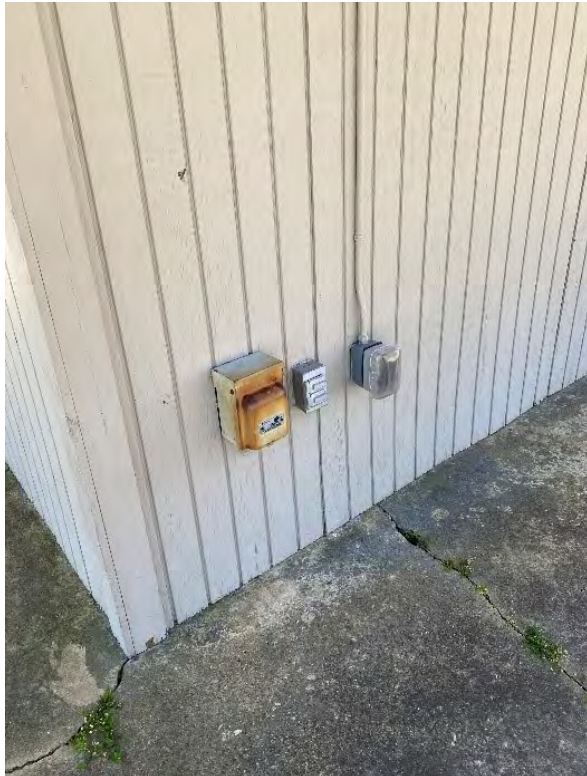
There are multiple outdoor receptacles that do not have GFCI protection or a weatherproof cover. Using a receptacle tester, it was discovered that there is no power coming from these receptacles. If they are not used, they should be removed. There is also an old, rusted disconnect mounted on the exterior wall of the building. This should be replaced if still in use.

Disconnect and Outdoor Receptacles

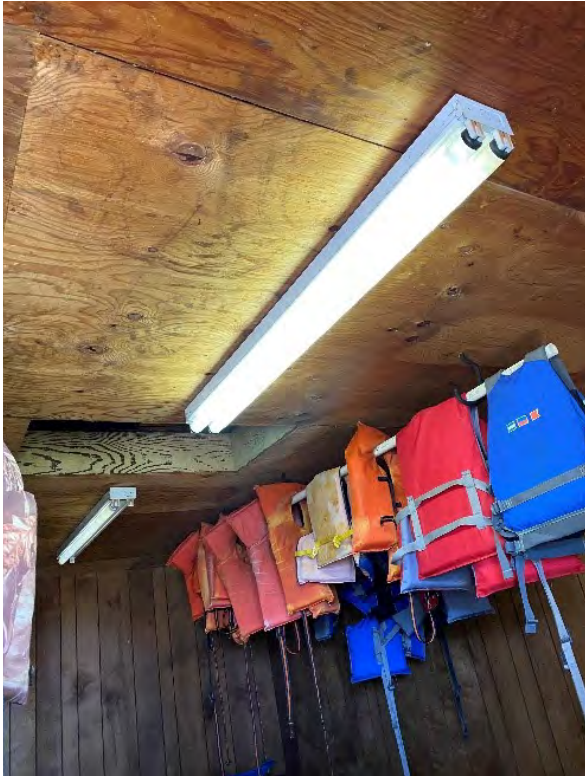
Storage building has two fluorescent lighting fixtures with one of the lighting fixtures is missing a lamp and the other lamp is flickering. Provide new lamps for existing light fixture. Lamps should be replaced for now and fixtures should be replaced with LED in the future.

Interior Lighting

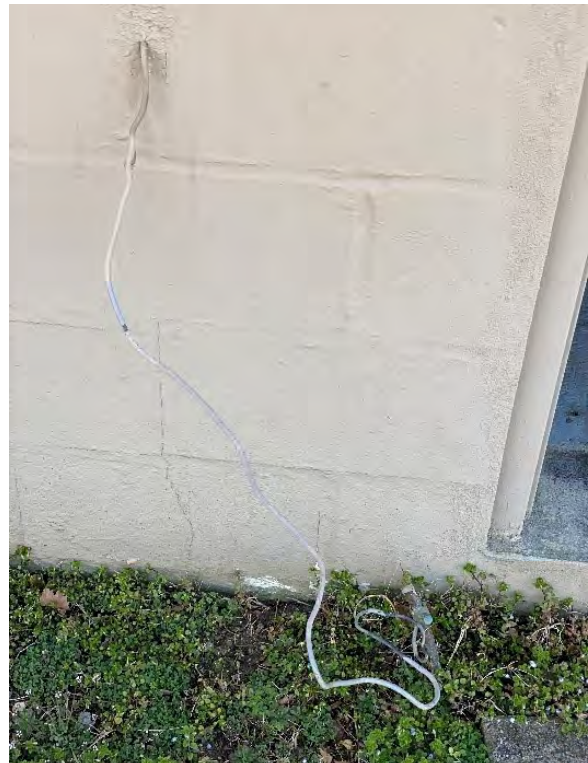
The building grounding system is partially exposed and seems to be in poor condition and should be replaced in the next 1-3 years with the load center. Ground rod(s) should be installed per NEC 250.53.

Building Grounding System

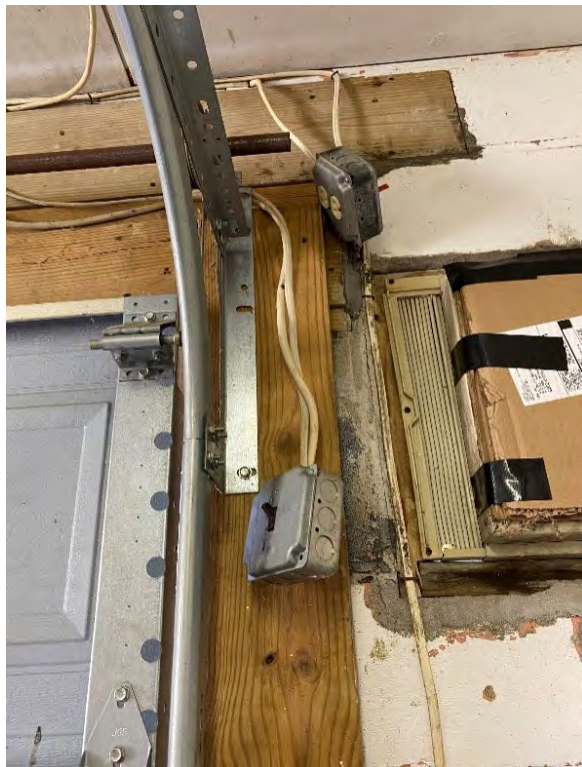
Some lighting control switches and receptacles are hanging by the cabling used to wire them and are not properly secured on the wall. All indoor receptacles in the garage area should be GFCI protected per NEC 210.8. There is an outdoor receptacle that is not GFCI protected or has a weatherproof cover. If this receptacle is abandoned and not in use, it should be removed. Otherwise, provide receptacle with GFCI protection or GFCI circuit breaker for safety. The receptacle and its associated conduit are also not secured to the wall it's mounted on. There is an exterior wall mounted junction box with cut and abandoned wiring inside and no cover. Wiring should be properly terminated and covered. If it is no longer used, it should be removed.

Hanging Receptacle and Switch

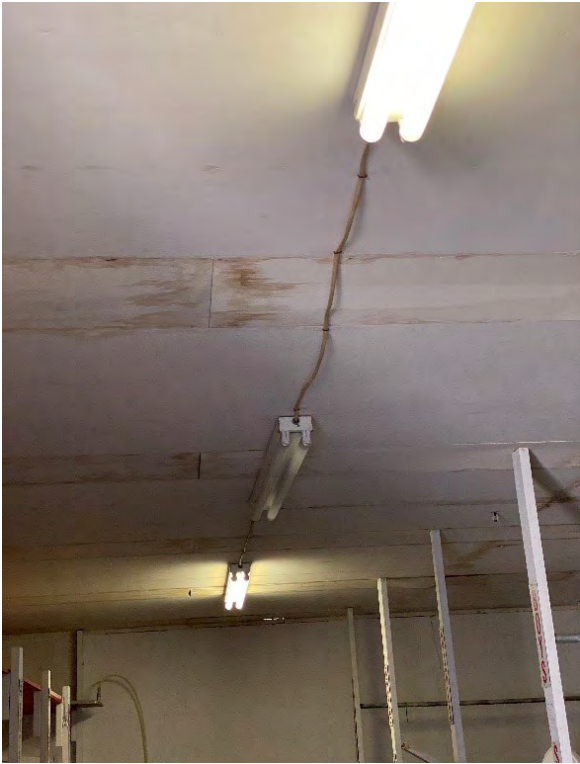
All interior lighting flickers with one of the fixtures not turning on at all. Lighting should be replaced with LED fixtures in next 1-3 years.

Non-working Lighting Fixture

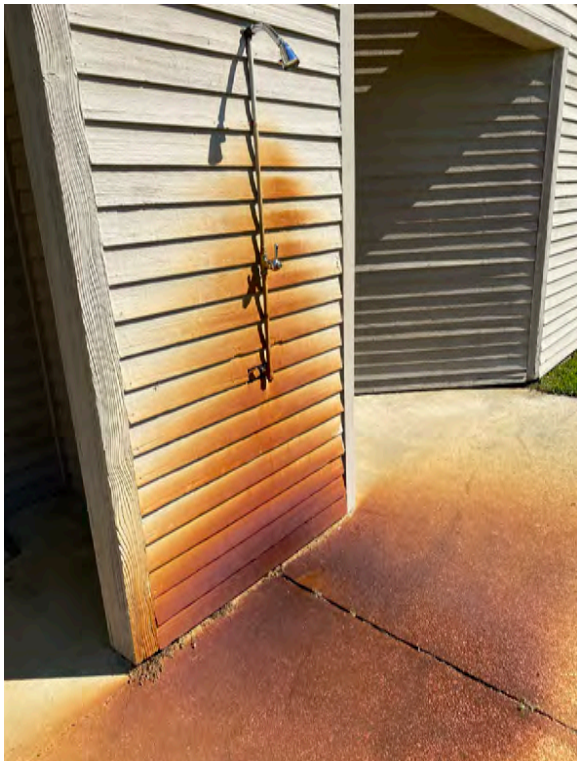
Exterior Shower and View of Rust-stained Patina on Wood Siding

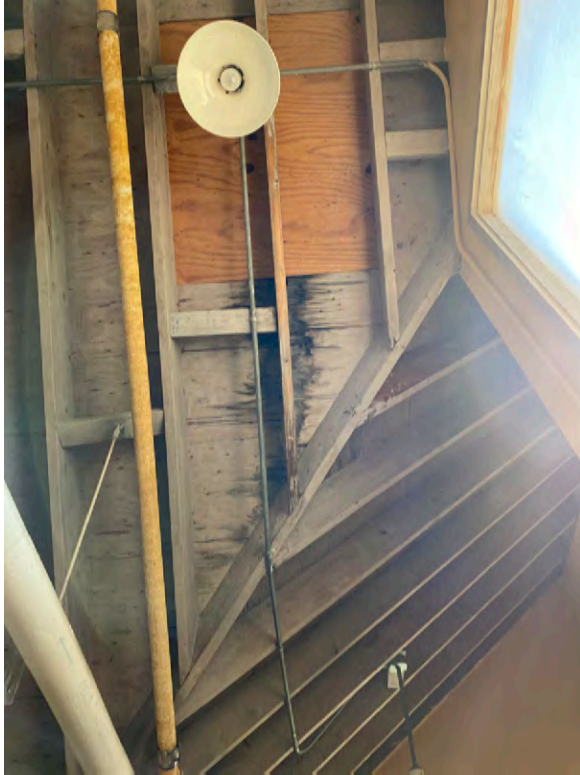
Interior View of Wood Rafters and Leak Stain

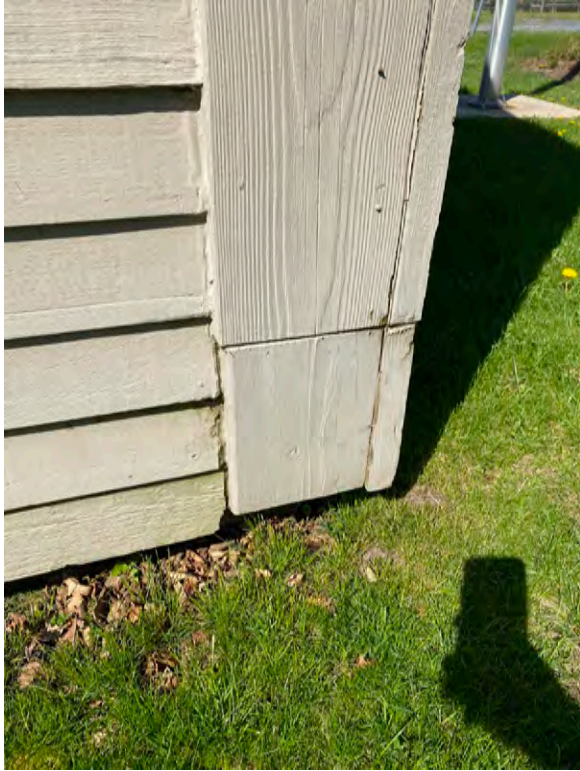
Wood Lap Siding - Prior Repair (Dutchman)

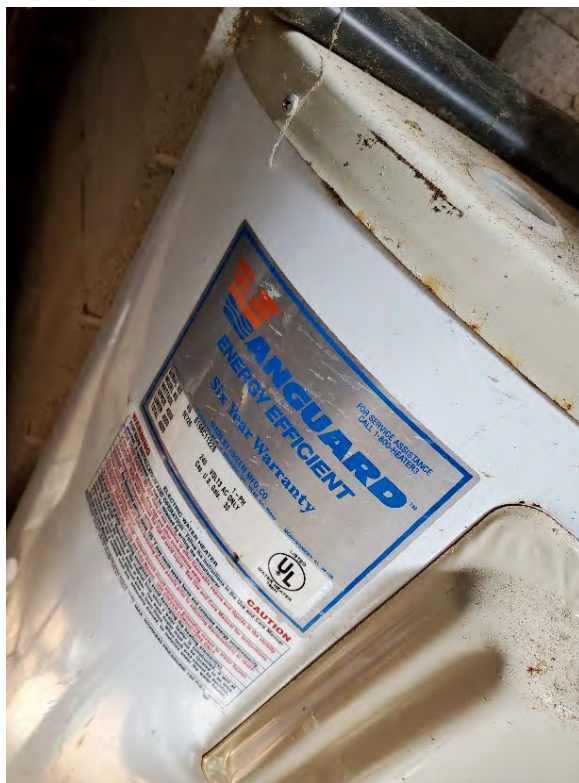
The janitor sink is served a by a 30 gallon 4.5 KW domestic water heater. The water heater is manufactured by Vanguard and is starting to rust.

Domestic Water Heater

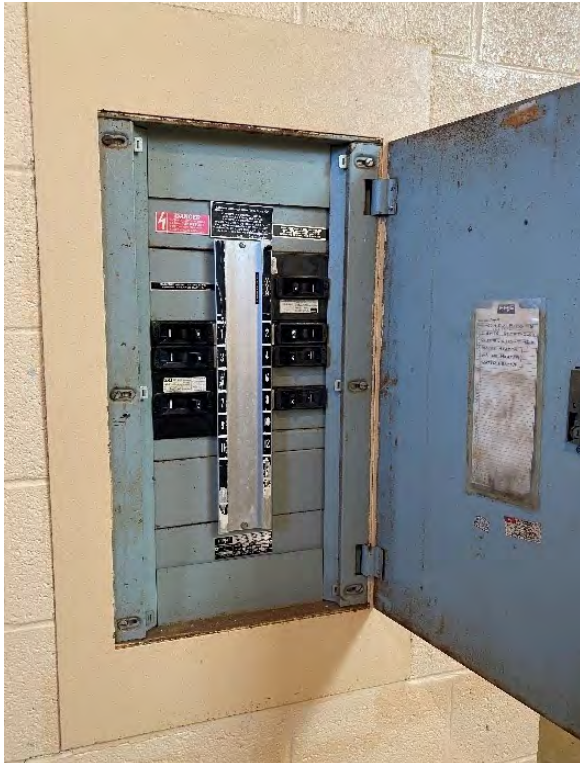
The restroom building contains a 50-ampere main breaker, 1-phase, 3-wire, 120/240V panelboard in the men's restroom. The panelboard is manufactured by Federal Pacific (FPE) and it could not be determined when it was installed. The main panel is fed from a disconnect in the Maintenance Building main electrical room. The latch for the front cover seemed to be broken and it would not close properly. The life expectancy of a typical panelboard is 30-40 years. The panel is in poor condition, and it is recommended that a replacement for the distribution equipment to be budgeted for in the next 1-3 years.

Main Panelboard

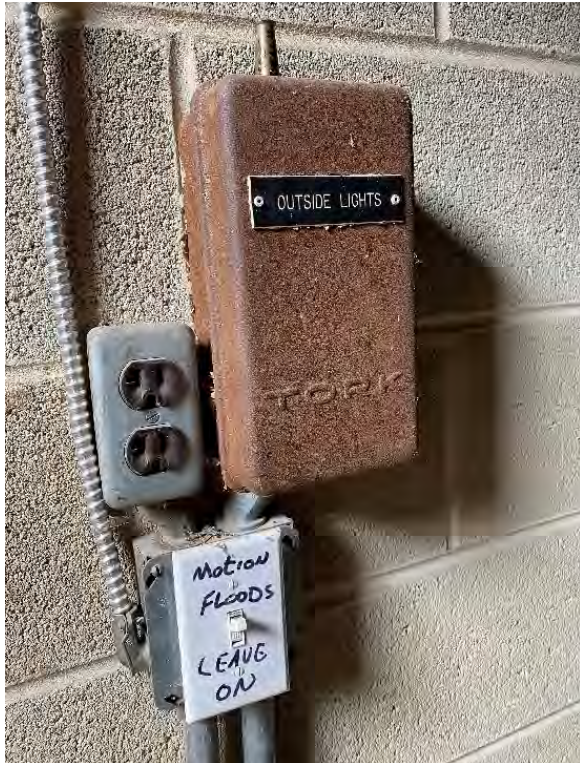
There is an old, rusted time clock for the exterior lighting in the mechanical chase. This should be replaced in the next 1-3 years.

Time Clock / Unprotected Receptacle

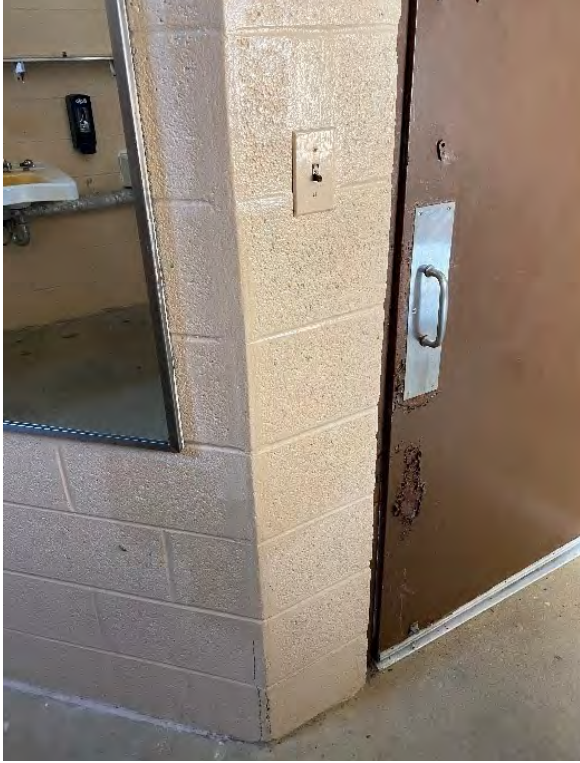
Lighting switches in both restrooms do not comply with ADA mounting height requirements. Interior lighting should be replaced with LED fixtures in the future. Exterior lighting is in poor condition and should be replaced with LED fixtures in next 1-3 years. Exterior lighting would not turn on and it is assumed to be because of the time clock in the mechanical chase.

Restroom Light Switches
