**Anne Arundel County
Department of Public Works**

Peninsula Park Expansion Lake Ogleton Tributary Construction Monitoring Report

April 2025

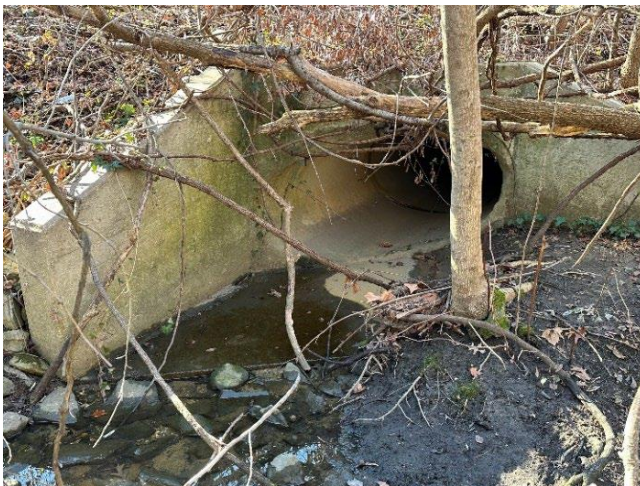
The 60-inch by 38-inch RCCP culvert functions as the primary hydraulic conveyance for stormwater runoff originating from PAL Park (Photo 1). An additional 42-inch reinforced concrete pipe (RCP) provides secondary inflow to the tributary from the Bay Ridge Road drainage area (Photo 2). The primary RCCP outfall is equipped with a cast-in-place concrete headwall, which appeared structurally sound and exhibited no observable signs of distress or deterioration at the time of inspection. Immediately downstream of the culvert there is a one- to two-foot deep head cut, followed by approximately 80 LF of riprap lining (Photo 3). Beyond the limit of the riprap, there is an approximate four-foot-deep head cut that is propagating upstream (Photo 4).

Photo 1 – 60-inch x 38-inch RCCP elliptical outfall

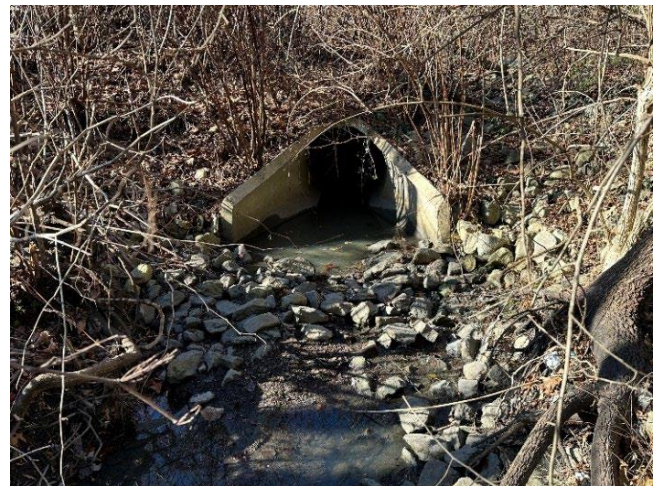
Photo 2 – 42-inch RCP outfall

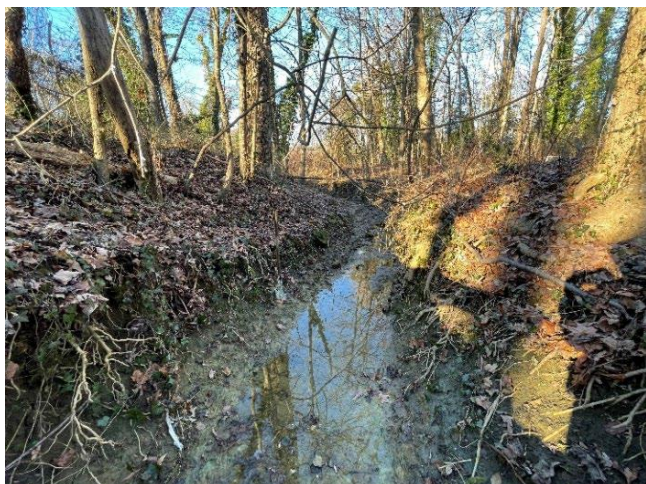
Photo 5 – Reach representative photograph, oriented downstream

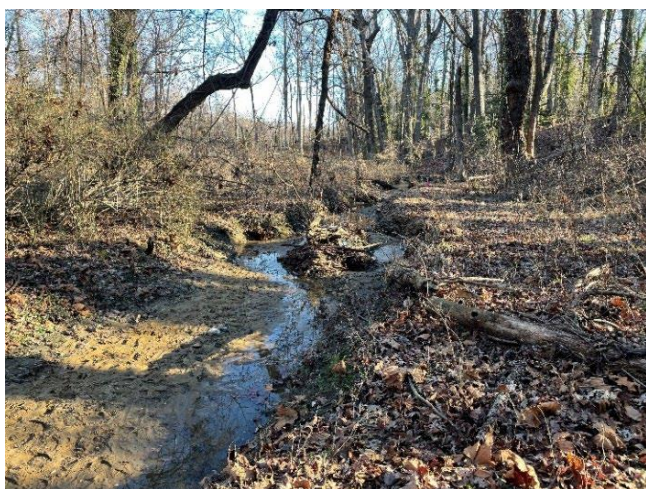
Photo 7 – Reach representative photograph, oriented downstream

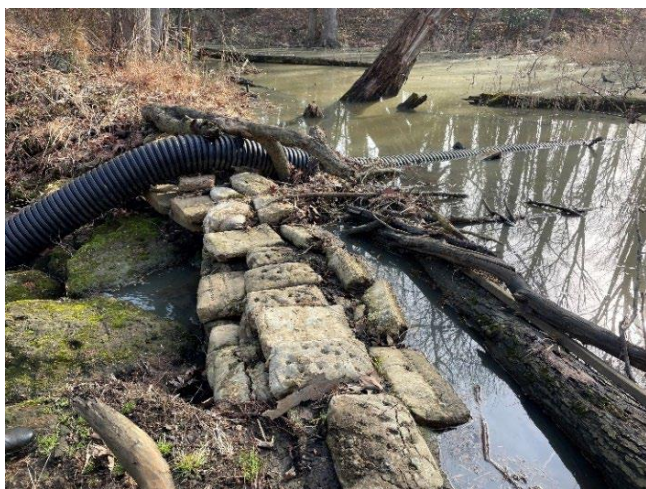
The backwater pool is formed by the upstream-most rock-weir structure of the SPSC system that was installed in 2015. The rock-weir structure is a low-profile grade control feature composed of stacked rock and concrete blocks (Photo 9) (Figure 3, Photo Point 8). The concrete blocks are exhibiting signs of physical deterioration, including surface cracking, which may compromise their structural integrity over time. Continued monitoring is recommended to evaluate the progression of degradation and determine if maintenance or replacement is necessary.

Photo 9 – Rock-weir

Continued monitoring of the riffle-weir structure at the upstream end of the SPSC system is recommended. The SPSC system plays a critical role in attenuating flow energy and reducing sediment transport to Lake Ogleton. The concrete blocks comprising part of the weir show signs of deterioration and may require maintenance or replacement in the future to preserve the system's integrity and effectiveness.

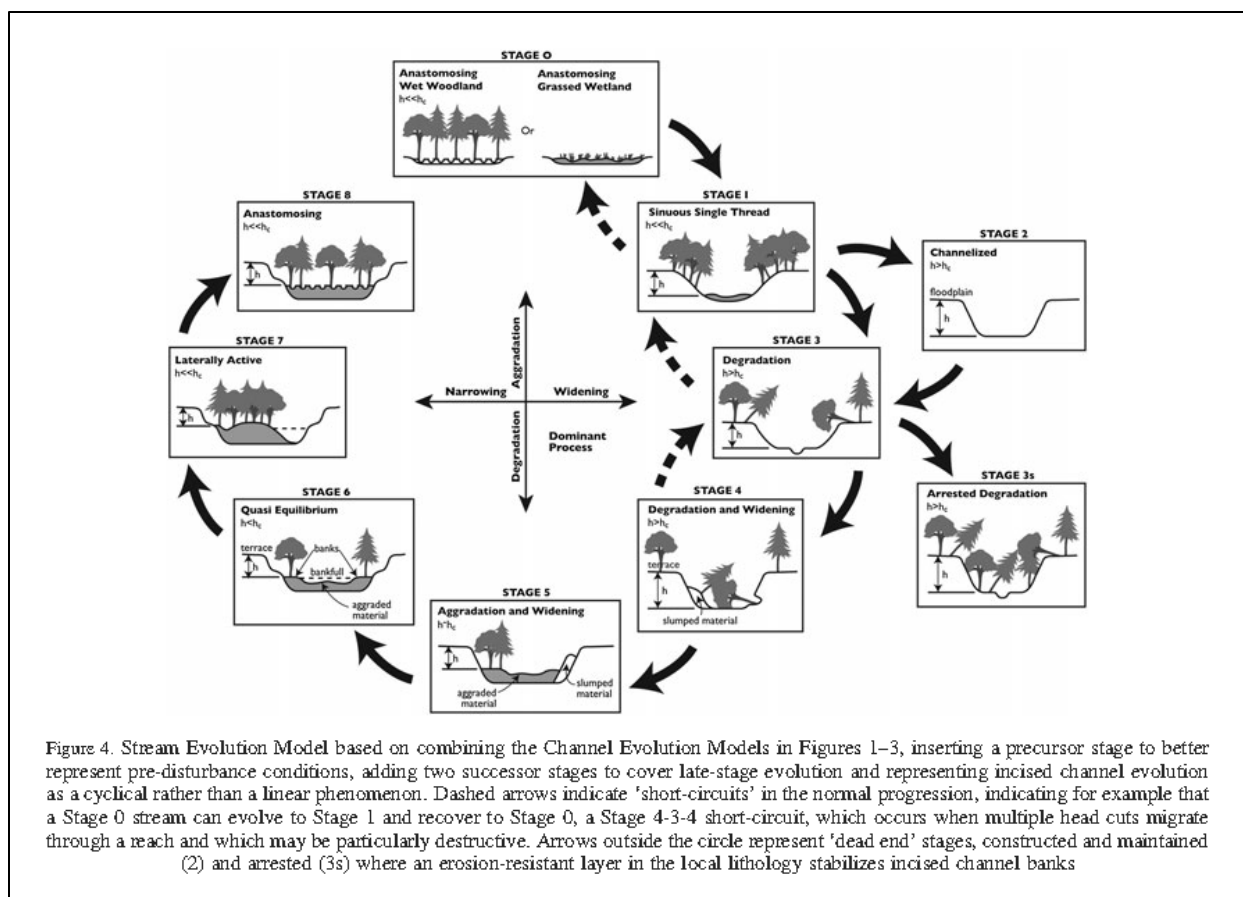
Figure 2 – Stream Evolution Model (Cluer and Thorne, 2014)

Most of the tributary can be considered in Cluer and Thorne 2014 SEM Stage 4 – Degradation and Widening. The reach exhibits active incision, unstable retreating banks, and a lack of floodplain connectivity. At this stage, the channel contains a wide range of flood peaks, while groundwater recharge and hyporheic exchange are largely impaired. Hydraulic diversity is low due to ongoing channel scour, and the system lacks the capacity to retain woody material. Sediment inputs increase significantly as bank retreat destabilizes channel margins. The aquatic plant community is impaired due to continued bed degradation, while riparian vegetation is often lost as the channel widens. In-stream habitat is limited, and habitat complexity is further reduced by bed degradation, resulting in low biodiversity. Water clarity, nutrient cycling, and thermal regulation also continue to be compromised in this stage, leaving the ecosystem highly vulnerable to disturbance.

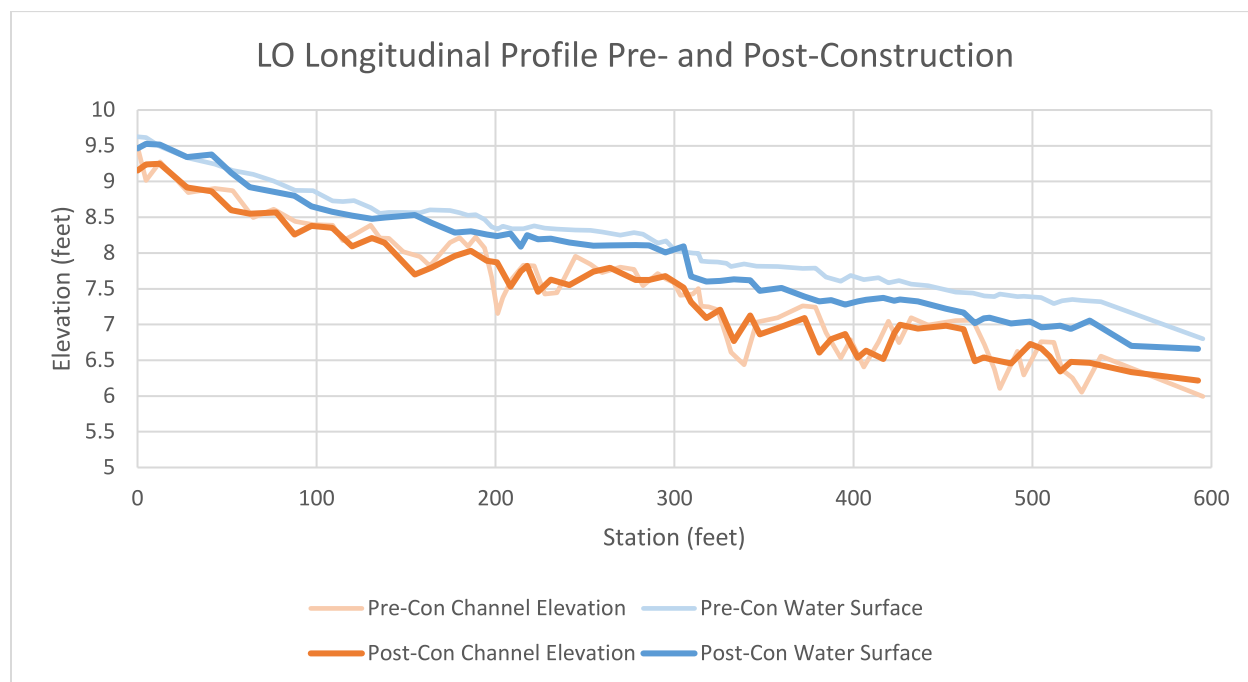
Figure 4-1 – LO Longitudinal Profile Pre- and Post-Construction

Post-construction monitoring data indicates that there was a slight reduction in overall bed slope compared to pre-construction conditions, accompanied by an increase in water surface slope. The change in bed slope is reflective of the ongoing channel degradation at the upstream end that has decreased the bed elevation and sediment deposition at the downstream end that has raised the elevation, resulting in a flatter longitudinal gradient. However, the geomorphic changes may have also increased flow resistance leading to the steeper water surface slope.

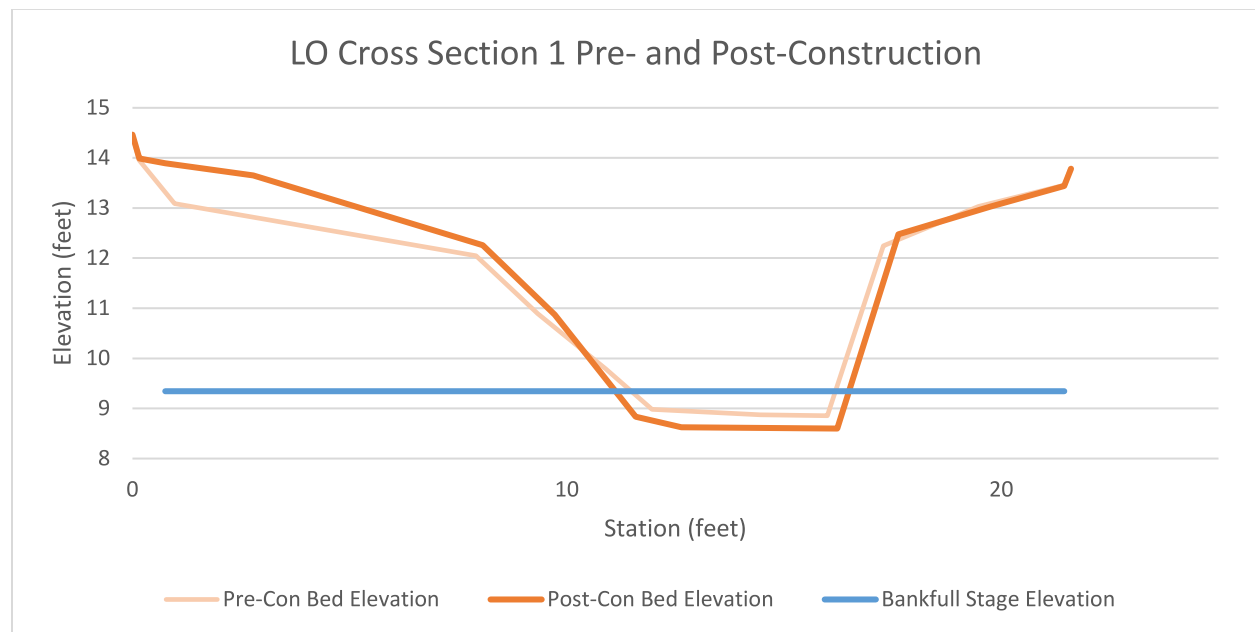
Figure 4-2 – LO Cross Section 1

At LO Cross Section 1, located near the upstream end of the reach, the cross-sectional area and channel depth increased from pre-construction conditions due to lateral retreat of the right bank and bed degradation. The cross-sectional area increased due to a 15% increase in channel width and a 0.2-foot increase in both maximum and mean depth. As a result, the width-to-depth ratio decreased by approximately 28%. The results corroborate the existing conditions assessment (Section 2) that indicated this portion of the channel is actively degrading and widening.

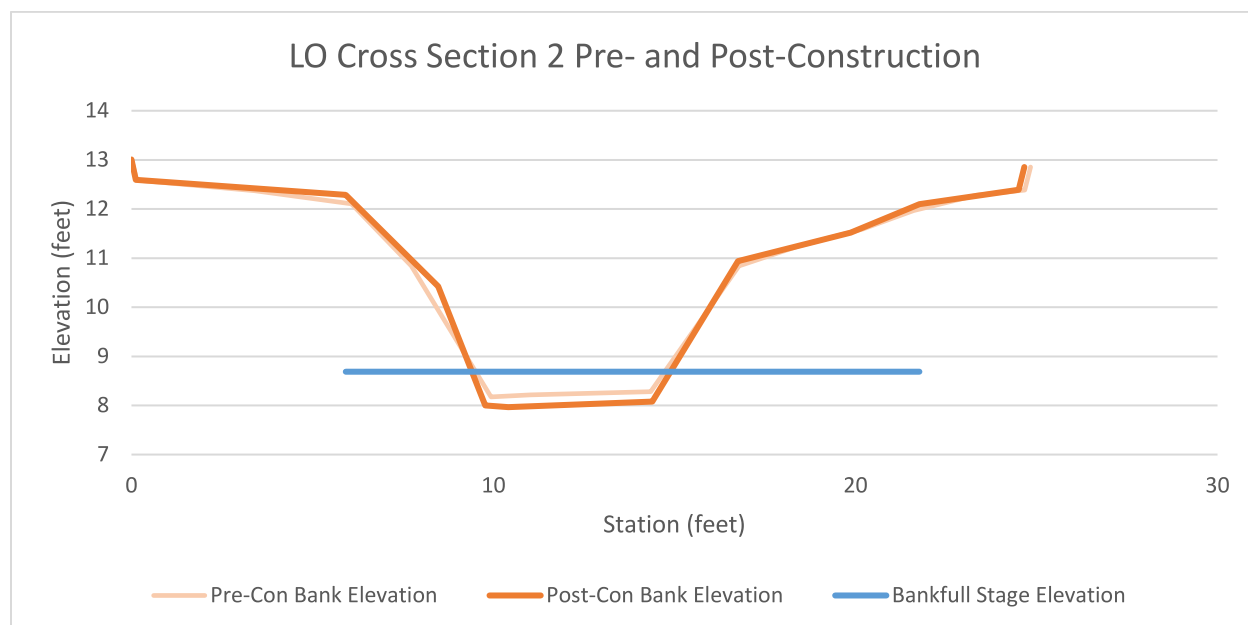
Figure 4-3 – LO Cross Section 2

Similar to LO Cross Section 1, LO Cross Section 2 exhibited an increase in cross-sectional area. Unlike Cross Section 1 where lateral bank retreat contributed significantly to the increase, the observed increase at Cross Section 2 is primarily due to vertical adjustment. Mean and maximum channel depths both increased by 0.2 feet, while channel width increased by only 6%. The deepening resulted in a 29% decrease in the width-to-depth ratio, further supporting evidence of active incision.

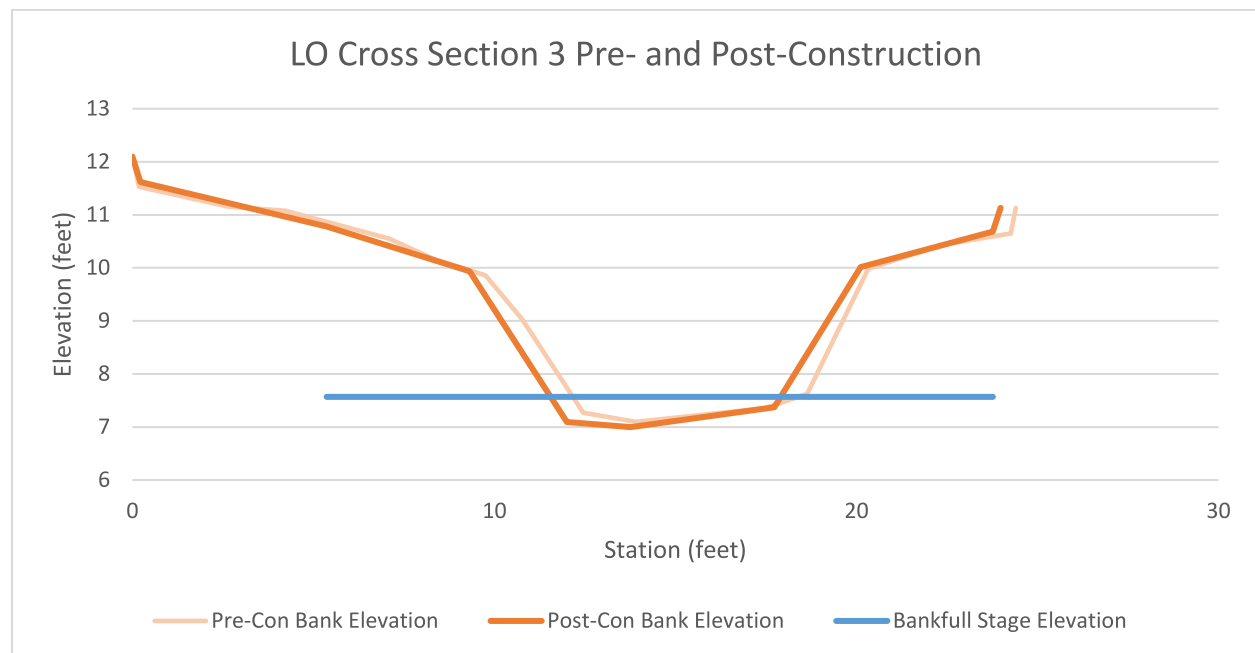
Figure 4-4 – LO Cross Section 3

At LO Cross Section 3 adjustments were observed on both banks, with lateral retreat of the left bank and minor aggradation along the right bank. Overall, the cross-sectional area increased, primarily driven by a 0.1-foot increase in both mean and maximum channel depths since channel width increased by only 3%. As a result, the width-to-depth ratio decreased by approximately 22%, consistent with a channel undergoing progressive vertical adjustment and confined flow conditions.

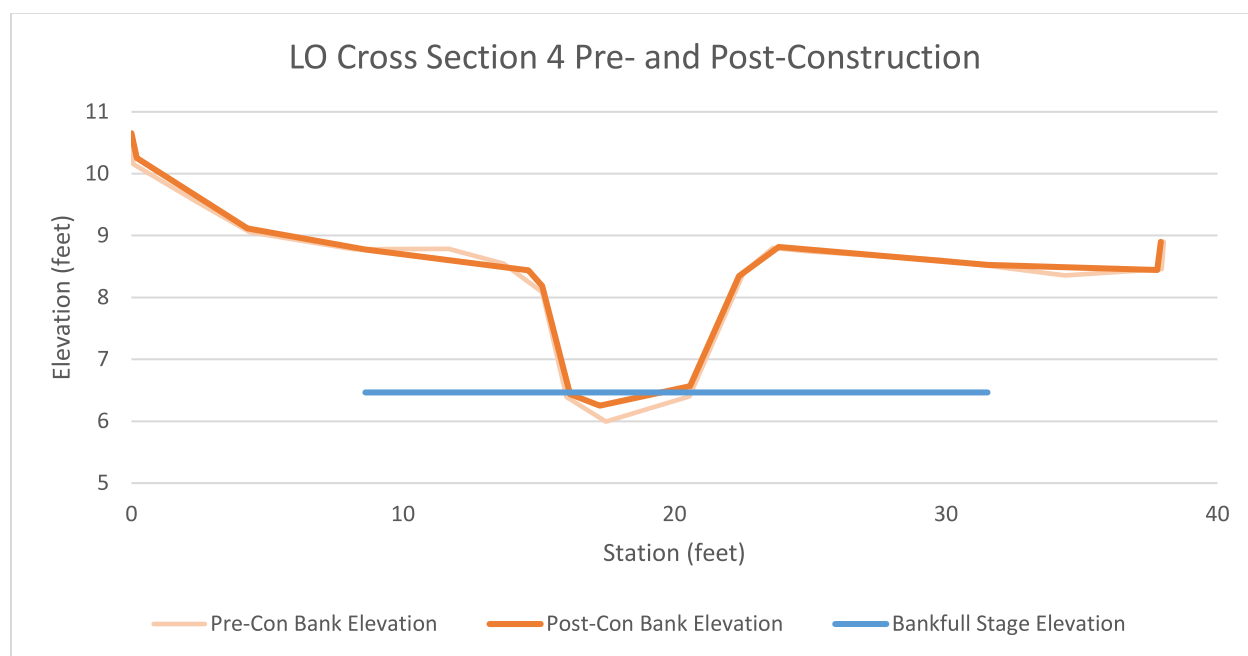
Figure 4-5 – LO Cross Section 4

LO Cross Section 4 is located along a section of the tributary where the valley gradient decreases and floodplain connectivity improves. Post-construction monitoring at this location revealed a reduction in cross-sectional area, primarily driven by a 28% decrease in bankfull channel width and decreases in maximum and mean channel depths of 0.3 feet and 0.2 feet, respectively. The width-to-depth ratio increased by approximately 73%. These morphological changes are consistent with localized deposition, likely resulting from diminished flow energy and reduced sediment transport capacity associated with the lower valley slope and increased floodplain engagement.

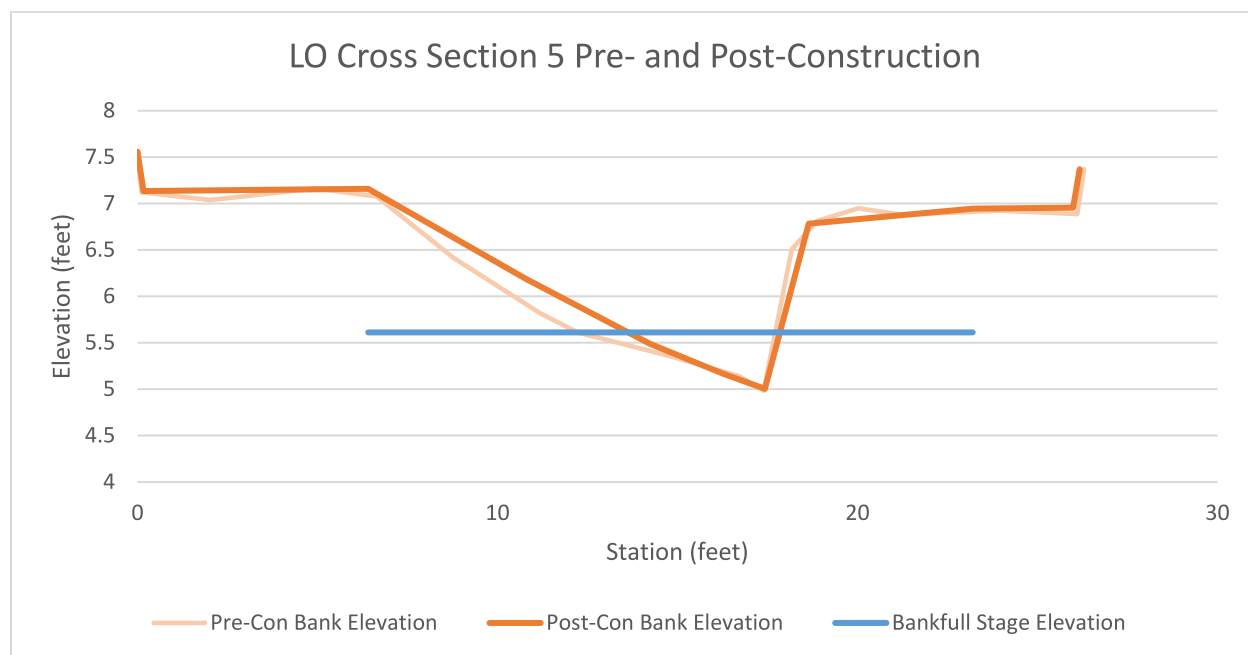
Figure 4-6 – LO Cross Section 5

At LO Cross Section 5, post-construction monitoring indicated a reduction in cross-sectional area. This change was primarily attributed to a 24% decrease in bankfull channel width, resulting from aggradation along the left bank. Both maximum and mean channel depths remained unchanged, indicating that vertical channel dimensions were stable during the monitoring period. Consequently, the width-to-depth ratio decreased by approximately 35%, reflecting a narrowing of the active channel cross-section without evidence of incision.
