Aquatic Biological Assessment of the Watersheds of Anne Arundel County, Maryland: 2005

Prepared by:

Coastal Resources, Inc.
2988 Solomons Island Road
Edgewater, MD 21037

April 2006

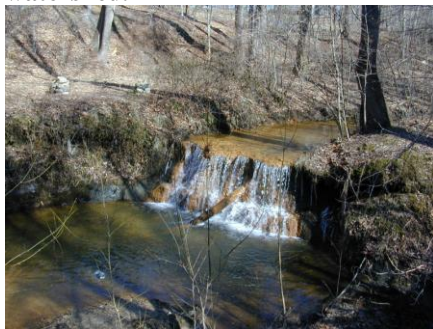
Figure 5. Example of headward erosion in the Patuxent River watershed.
