## Aquatic Biological Assessment of the Watersheds of Anne Arundel County, Maryland: 2006

Tetra Tech, Inc.  
400 Red Brook Blvd., Suite 200  
Owings Mills, MD 21117-5159

Anne Arundel County  
Department of Public Works  
Watershed, Ecosystem, and Restoration Services  
2662 Riva Road  
Annapolis, MD 21401

**November 2008**

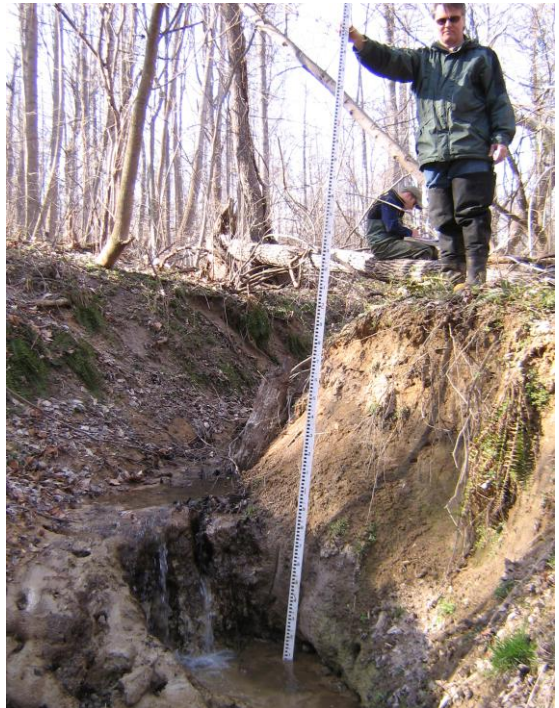
**Figure 22 - Active headcut in Hall Creek sampling unit.**

**Track stream channel evolution and trajectory predictions in subsequent sampling rounds.** Stability assumptions made about particular sites should be validated with repeated measurements and additional assessment work. By verifying these predictions, the County will have a better understanding of how land use changes impact streams over time, which may eventually allow for fine tuning zoning and development regulations toward maximum protection of stream channel stability.
