Targeted Biological Assessment of Streams in Patapsco Tidal and Bodkin Creek Watersheds, Anne Arundel County, Maryland: 2009

Versar, Inc.
9200 Rumsey Road, Suite 100
Columbia, MD 21045

Anne Arundel County
Department of Public Works
Watershed, Ecosystem, and Restoration Services
2662 Riva Road
Annapolis, MD 21401

October 2009

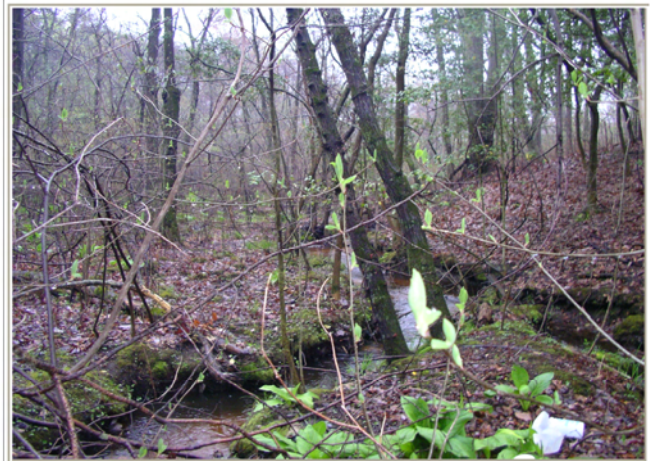
Downstream from Mid-Point

This site is located in the Bodkin Creek watershed in Back Creek. The site is located in the back corner of the last property on the right hand side of Oak Road. Forty-eight percent of the catchment draining to this site is residential, 38% is wooded, and 13.6% is impervious. There is a shaded canopy and the riparian vegetative zone width and the vegetative protection rated as Optimal on both sides of the stream. The substrate at this site is 90% sand with 10% silt. This site rated Partially Degraded for PHI and Supporting for RBP. Its biological condition rated Fair, as no Ephemeroptera nor any scraper taxa were found, thus limiting its BIBI score (BIBI score of 3.29).

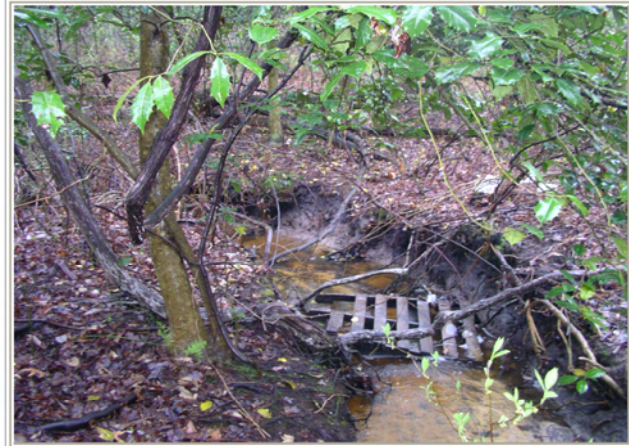
Downstream from Mid-Point

This site is located in the Bodkin Creek watershed in Back Creek. The site is in Poplar Ridge Park, after the last baseball field. In this catchment, the majority of the landuse is residential (54%), but just less than 34% is wooded. There is 15% impervious surface in the surrounding catchment. Poor bank stability was noted along both banks, and high levels of erosion were present in the surrounding watershed, resulting in slightly turbid water clarity in the stream. The field crew observed an ATV course alongside the stream, which may be adding to erosion and bank stability problems. In situ pH measured at this site was 6.30, slightly below the state water quality standard of 6.5. This site rated in the second best category (Partially Degraded) for PHI but in the lower category of Partially Supporting for RBP. The substrate was entirely silt and sand, and epifaunal substrate was marginal, while embeddedness was high. The benthic community at this location included no Ephemeroptera nor any scraper taxa, and only 3 EPT taxa. Benthic conditions rated Poor with a BIBI score of 2.43.

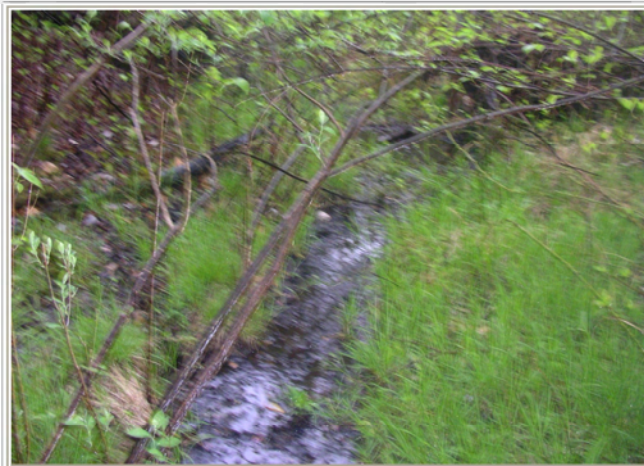
Downstream from Mid-Point

Site BK2-914-T-2009 is located off of Bayside Beach Road, in the Back Creek subwatershed of the Bodkin Creek watershed. Only about 5.6% of the catchment surrounding this site contains impervious surface, with open space dominating the catchment, contributing 61% of catchment area. Residential landuse, along with a very small amount of transportation-related landuse are also present. Despite almost 60% of the macroinvertebrates obtained in the benthic sample being considered intolerant to urban conditions, this site had only one EPT taxa and no scraper taxa present, and only a few climbers. With a BIBI score of 2.43, it rated Poor. Epifaunal substrate and pool substrate were received low ratings, and pool variability was poor with no deep pools present. Field staff noted some trash in and near the site. Streambanks were stable along both sides of the stream and no bank erosion was present. In addition, the riparian buffer was good. Habitat at this site rated Partially Degraded under the PHI (score of 74.9), and Partially Supporting under the RBP (score of 114).

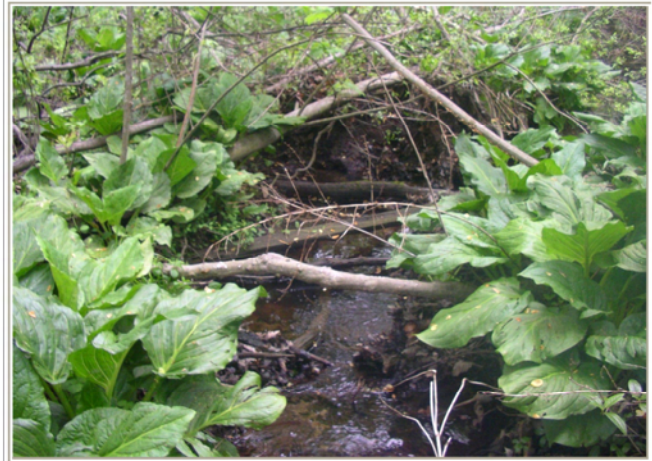
Downstream from Mid-Point

This site is located in the Bodkin Creek watershed in Main Creek. The site is off of Loreen Drive and can be accessed through an empty lot between Joanne Court and Overview Drive. The majority of the landuse near this stream is residential (53%), with almost 40% wooded. This site had Minimally Degraded habitat conditions according to the PHI and Partially Supporting habitat conditions according to the RBP assessment (total score of 124). Epifaunal substrate and available cover rated at the low end of suboptimal here, with substrate comprised entirely of sand and silt. The canopy was partially shaded, and some bank erosion was noted by the field crew. Seventy percent of benthic macroinvertebrates collected at this site were considered intolerant to urban conditions and the biological community rated Fair with a BIBI score of 3.29.

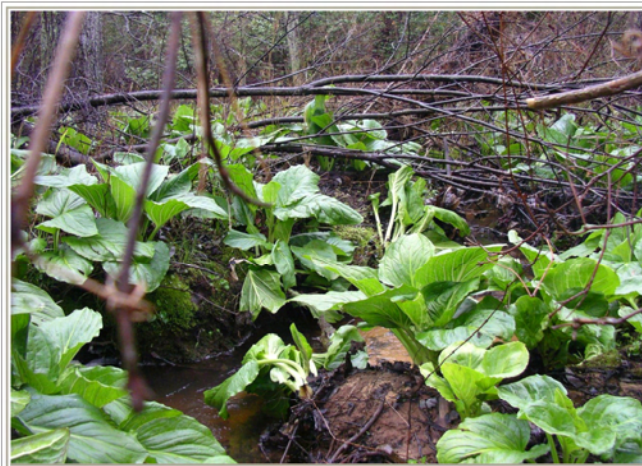
Downstream from Mid-Point

This site is located in the Bodkin Creek watershed in the Main Creek subwatershed. It is off of Old Nike Missile Road near a golf course. Nearby landuse is 40% wooded and 35% residential, with 12% of surfaces considered impervious. The substrate at this site was mainly made up of sand and gravel with some silt. It had a shaded canopy, optimal epifaunal substrate and available cover, and low levels of embeddedness. Despite a Minimally Degraded rating for habitat conditions under the PHI and a Supporting rating under the RBP, this site had a Poor biological community, with a BIBI score of 2.71. The benthic community included no Ephemeroptera nor any scraper taxa, and only two EPT taxa. Bank stability at this site received only a marginal rating.

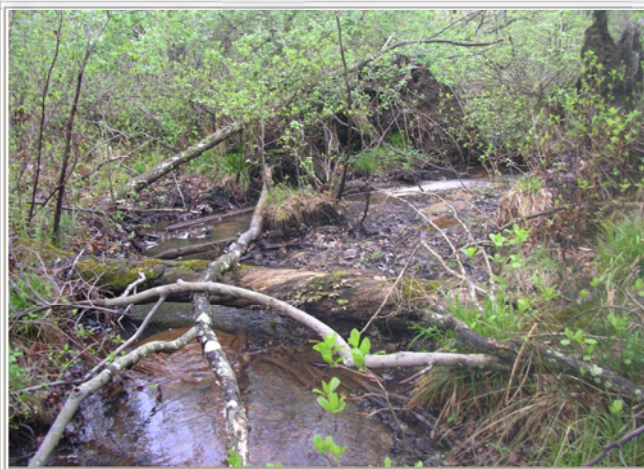
Downstream from Mid-Point

This site is located in the Bodkin Creek watershed in Main Creek. It is off of Ipswich Court behind the middle house on the left side of the cul-de-sac. Landuse near this site is dominated by residential (49%) and wooded areas (32%). This site had a shaded canopy, but its channel flow rated at the low end of suboptimal. With a PHI score of 79.99, this site rated Partially Degraded for habitat and similarly rated Supporting under the RBP (RBP score of 131, 65.5% of Reference). Biological conditions at this site rated Poor, as the BIBI score was 2.43. Neither Ephemeroptera nor any scraper taxa were present in the biological community, thus limiting its score.

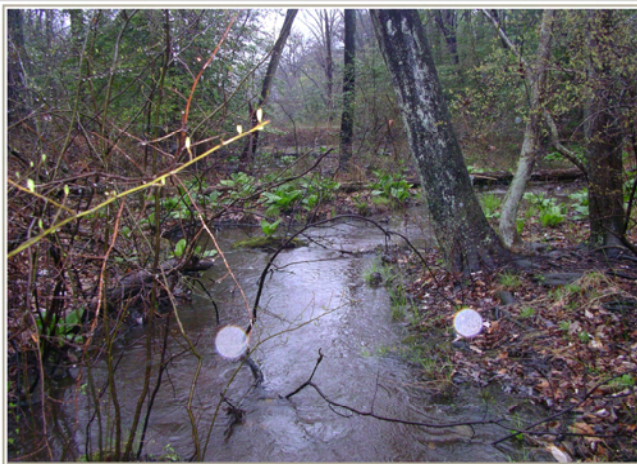
Downstream from Mid-Point

This site is located near Downs Memorial Park in Locust Cove in the Bodkin Creek watershed. The majority of the land use near this site (73%) is wooded area, and 10.9% of the catchment is classified as impervious. The stream substrate is made up mainly of sand with some silt, and the stream canopy is shaded. This site received optimal ratings for bank stability, vegetative protection, and riparian zone width on both sides of the stream, and no bank erosion was noted by the field crew. Total RBP habitat score at this site was 146 (Supporting). Very little trash was present and no buffer breaks were observed. The PHI score was 88.7, the second highest score of all sites sampled during this survey. However, the macroinvertebrate community obtained at this site had no climber, no scraper, and no Ephemeroptera taxa, and only one EPT taxa. Thus, its benthic condition was rated as Very Poor, with a BIBI score of 1.86.

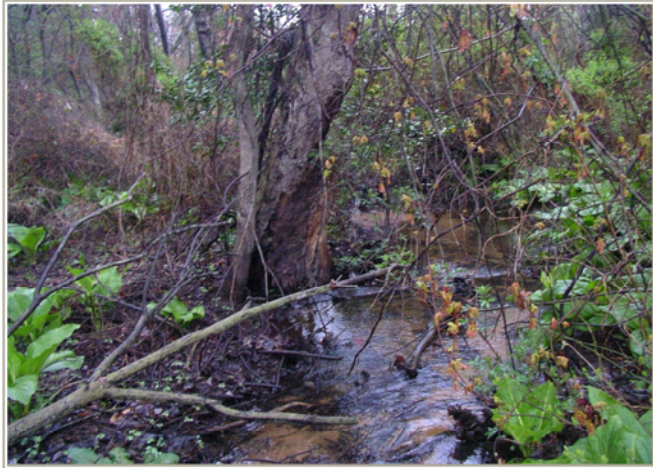
Downstream from Mid-Point

This site is located at the west end of 20th Street in an open area in Stony Creek in the Patapsco Tidal watershed. Landuse near the site is 54% residential, 18.8% wooded, and 15.5% commercial. These landuses result in an impervious surface percentage of 37.4% of total catchment area. Field crew members noted an anaerobic odor present at the site on the day of sampling as well as high levels of trash. Stream substrate contained mostly sand with some silt and some clay present. Embeddedness was high. The canopy was partly shaded, and some emergent and some submerged aquatic vegetation were present. While bank stability, vegetative protection, and riparian vegetative zone width rated well in the RBP habitat assessment, this site received lower scores for epifaunal substrate, sediment deposition, pool substrate, and pool variability. Overall, the total RBP habitat score was 127, Supporting. The total PHI score was 68.1, Partially Degraded. Only 4.6% of the benthic taxa types found at this site were considered intolerant to urban conditions, but the presence of some EPT, some scraper, and some climber taxa resulted in a BIBI score of 2.43, Poor.

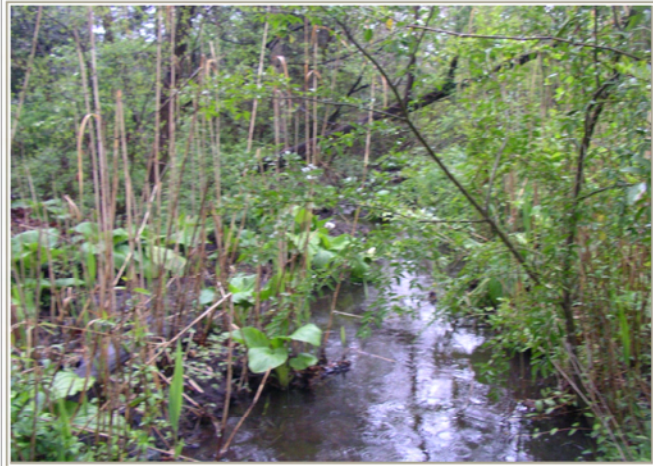
Downstream from Mid-Point

This site is located off of Duvall Highway, south of Grace Avenue. Eighty percent of the landuse near this stream in Stony Creek in the Patapsco Tidal watershed is residential. The catchment has 35.4% impervious surfaces. Epifaunal substrate at this site is lacking in quality, but levels of embeddedness are lower at this site than they are at the majority of other sites sampled in this assessment. The stream is braided, with a partially shaded canopy. Its location only steps from the road could be to blame for the extreme levels of trash observed at the site. A road culvert is present at the site, and narrow riparian vegetative zones with buffer breaks as well as channelization in the form of gabion baskets hamper the habitat quality here. The overall PHI score was 61.7, Degraded. The overall RBP habitat score was 116 (58% comparable to reference conditions), with a narrative rating of Partially Supporting. Despite these rather poor habitat conditions, the benthic community at this site received a BIBI score of 3.57 (Fair), due to the presence of EPT, scraper, and climber taxa.

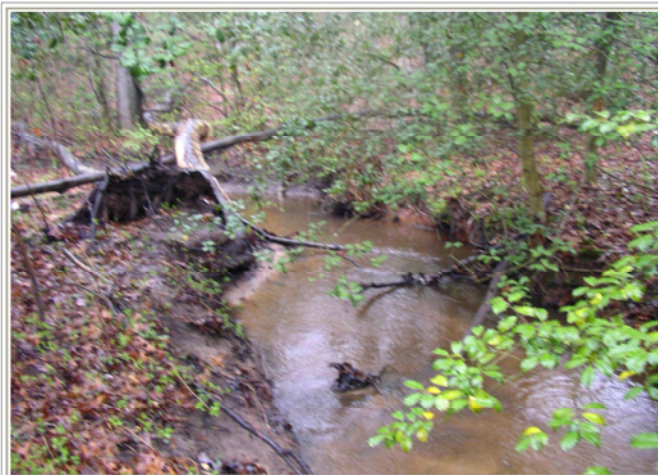
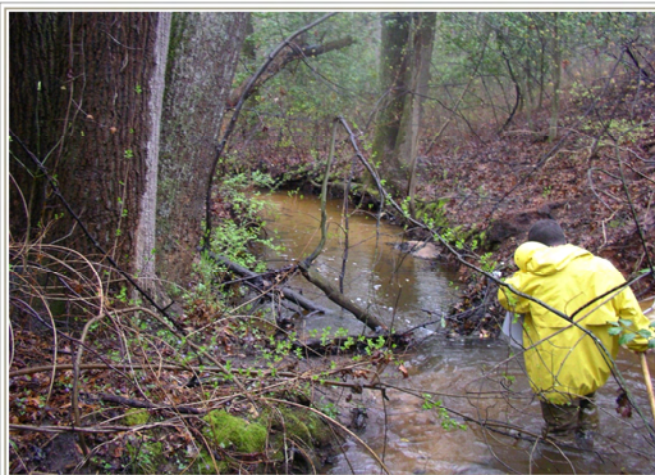
Location = Solley Road, between Jackson Lane and Shady Brook Road

This site is in the Stony Creek subwatershed of the Patapsco Tidal watershed. It is located off of Solley Road between Jackson Lane and Shady Brook Road. The landuse upstream of this site is dominated by residential (53%) and wooded (almost 38%), and 20% of the catchment is considered impervious. Stream banks were moderately unstable to unstable, and erosion was obvious. Stream substrate was made up mainly of sand and gravel with some silt, and moderate levels of deposition were present. The overall PHI score was 65.8 (Degraded), while the overall RBP habitat score was 127 (Supporting). A moderate amount of trash was noted at the site. The benthic community consisted of only one EPT taxa, and no Ephemeroptera. Scrapers and climbers were present in healthy numbers, resulting in a BIBI score of 3.00, Fair.

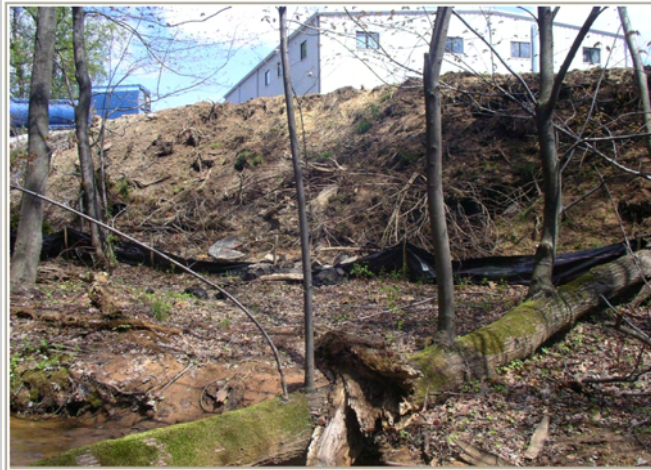
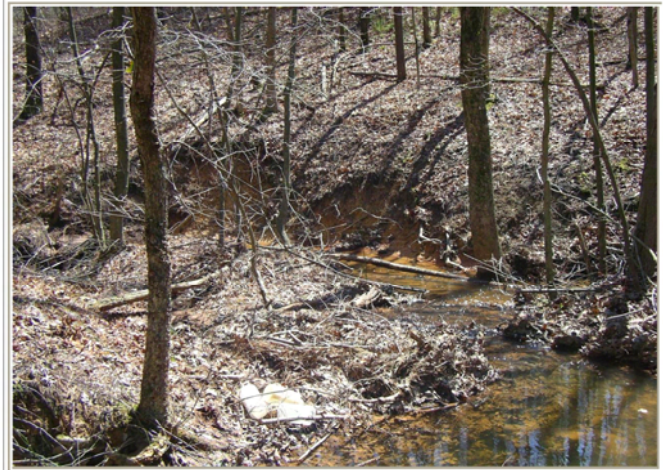
Location = Nabbs Creek Road, below Stony Creek Park

This site is located off of Nabbs Creek Road, south of the bend below Stony Creek Park. It is in Stony Creek, in the Patapsco Tidal watershed. The majority of the landuse upstream of this site is wooded (86.6%), and therefore the catchment has the lowest percentage of impervious surfaces in the study (2.5%). The aesthetic quality of the stream was very good, as very little trash was present. Very few riffles were present in the stream, and those that were present were not of high quality. Thus, substrate for benthos was lacking. Despite all of the wooded area nearby, bank stability and vegetative protection along the banks was marginal, as was sediment deposition in the channel. The stream was not very sinuous, but channelization was not noted. This is not abnormal for coastal plain streams. This site rated Partially Degraded under the PHI (score of 74.2), and Partially Supporting under the RBP habitat assessment (score of 120). Its benthic community received a BIBI rating of Very Poor (score of 1.86). The benthic community did not have a lot of diversity at this site, as only ten types of taxa were collected. However, the community at this site had the highest percentage of benthos intolerant to urban conditions (91%).

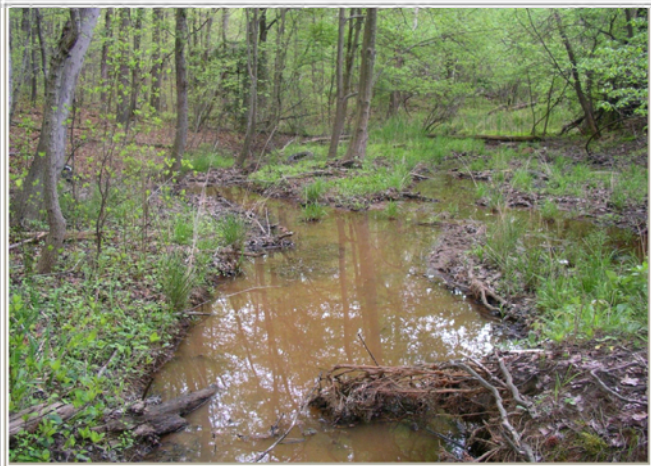
Downstream from Mid-Point

This highly braided site is in Stony Creek in the Patapsco Tidal watershed. The site can be found behind a double-lot property off of Stone Haven Drive. The catchment surrounding this stream is dominated by wooded and residential landuse, in approximately equal amounts (43% and 44%, respectively). Impervious surfaces account for about 15.5% of the catchment area at this site. The field crew noticed an oily sheen in the stream as well as a significant amount of trash. All in situ water quality, except for conductivity were within the normal range. This site had the highest conductivity of all sites sampled and it is likely indicative of a water quality issue. The substrate at this site was about equally composed of sand and silt, and the site received a Marginal rating for epifaunal substrate and available cover. Submerged and emergent aquatic vegetation were present, along with some algae. Bank stability also rated as Marginal, and moderate amounts of erosion were noted in the local watershed. There were large amounts of both instream and dewatered wood present in this stream. Overall, this site received a total RBP habitat score of 107 (Partially Supporting) and a total PHI score of 82.6 (Minimally Degraded). The benthic community rated Poor, with a total BIBI score of 2.14. This score is a result of the lack of any EPT taxa in the stream, as well as a lack of any individuals that are considered intolerant of urban conditions.
