# Herring Bay, Middle Patuxent, and Lower Patuxent Watershed Assessment

## Comprehensive Summary Report

June 2018 | Final Report

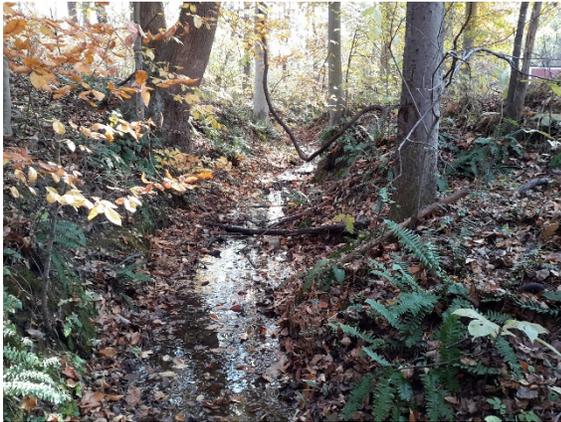
Stream Reach in the Wilson Owen's Branch 2 Subwatershed (MPE) with Minimally Degraded Habitat Condition

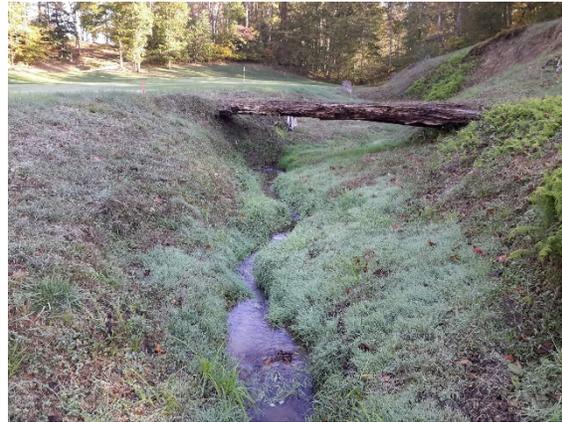
Stream Reach in the Rock Branch 1 Subwatershed (MP2) with Severely Degraded Habitat Condition

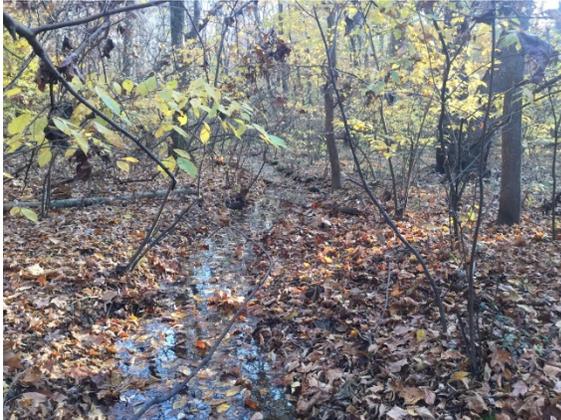
Stream Reach in the Tracy's Creek 2 Subwatershed (HB2) with Minimally Degraded Habitat Condition

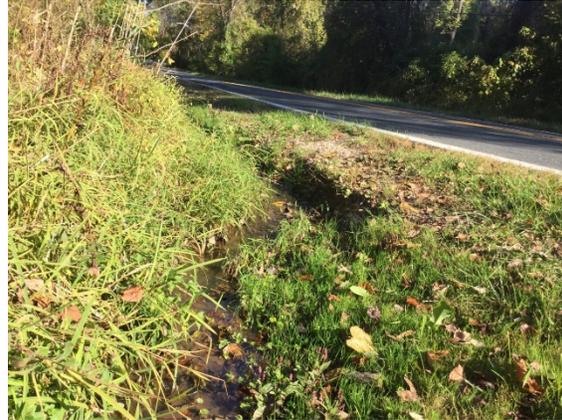
Stream Reach in the Unnamed Tributary 2 Subwatershed (HBQ) with Severely Degraded Habitat Condition

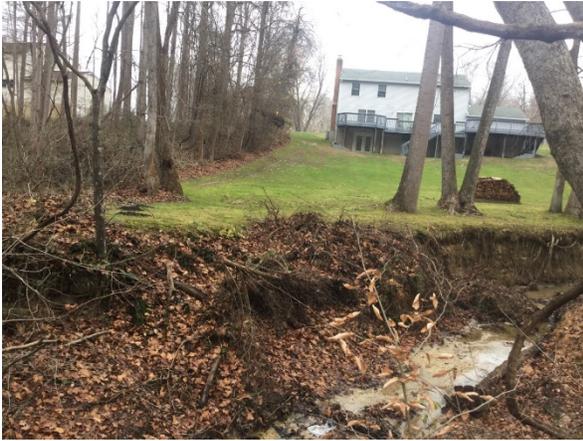
Deficient buffer impacts (residential lawn encroachment), Moderate Impact in the Lyons Creek 8 subwatershed (MPM)

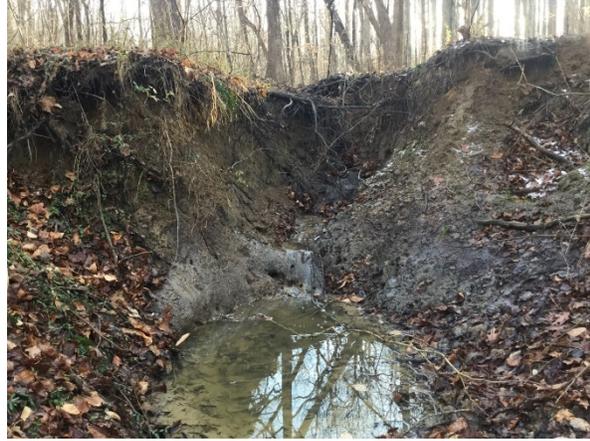
Headcut and bank erosion (7 feet) in Hall Creek 1 subwatershed (MPC)

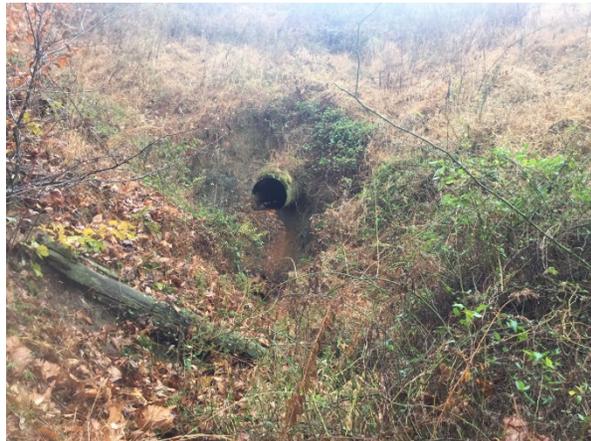
Stream crossing contributing to erosion. Severe Impact in the Tracy's Creek 1 Subwatershed (HB1)

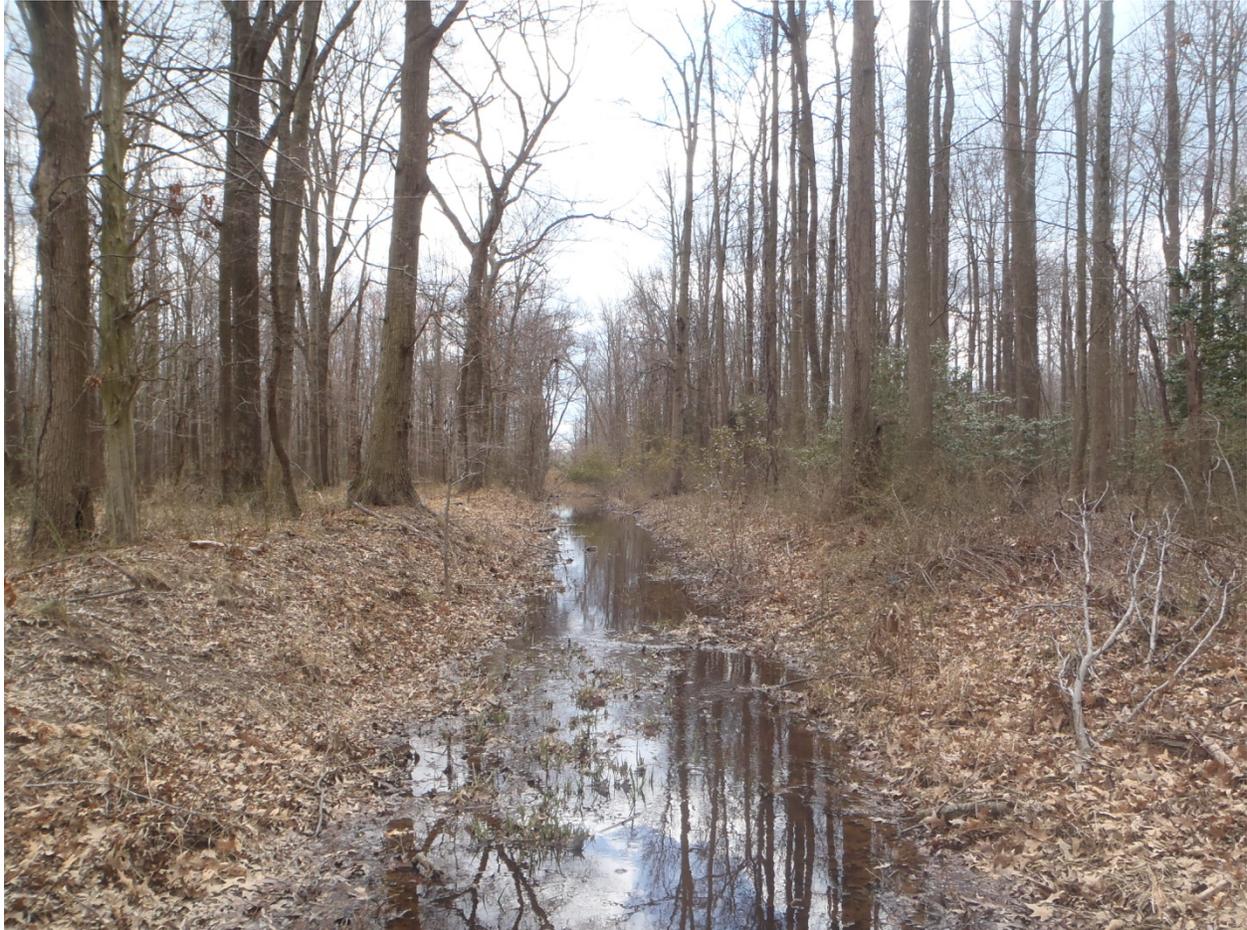
or historic land use. Many of the sites appeared to have been ditched historically or may have been created as a ditch to drain high water tables for agricultural or other land uses and naturalized as more of a stream over time (**Figure 10**). Such sites may be exhibiting residual effects of past disturbances such as agriculture, channelization and deforestation, as much of the County has historically experienced deforestation and extensive alteration of the landscape from agricultural practices.

**Figure 10 – Site HB-09-2013 depicting the lack of physical habitat due to past channelization of the stream.**
