Gambrills/Odenton Public Drinking Water Quality

Department of Public Works

Gambrills/Odenton Public Drinking Water System Quality

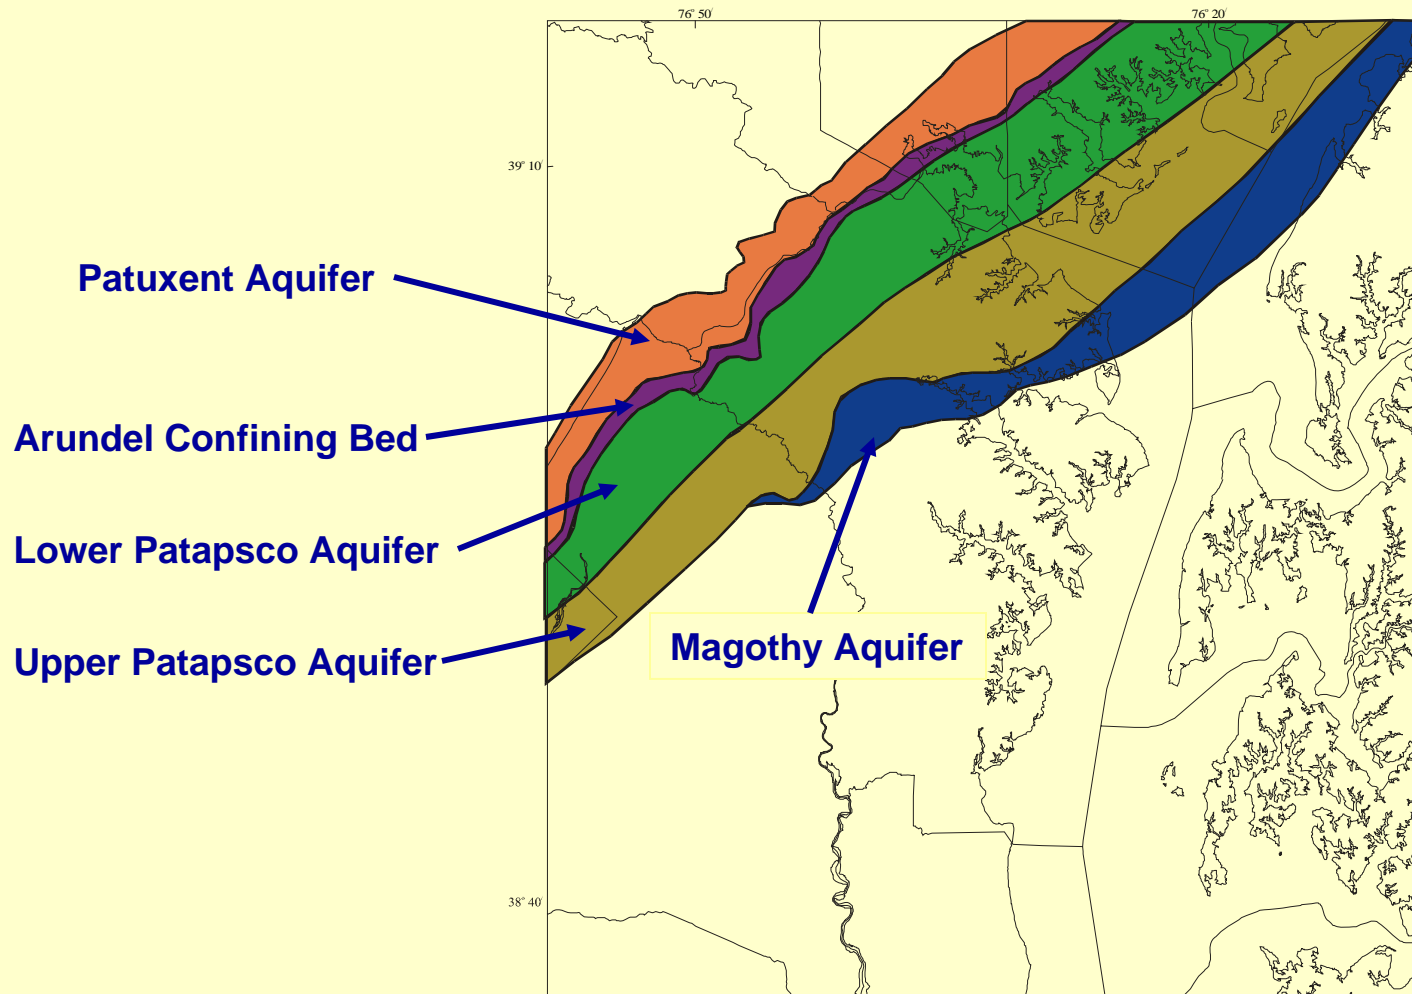
Estimated Outcrop Areas that may Function as Recharge Areas to the Deep Aquifers
