SITE ANALYSIS

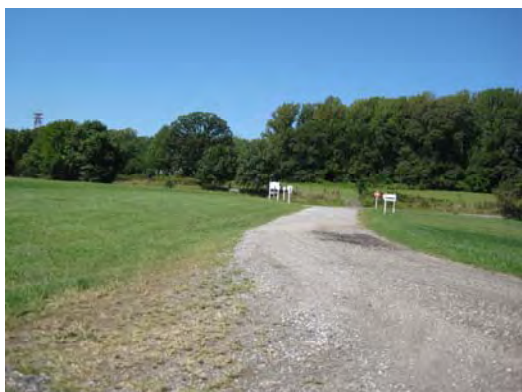
Figure 2a.
The existing egress on
Dairy Farm Road

Currently, access to the Dairy Farm is from Annapolis Road (Maryland Route 175) with egress located on Dairy Farm Road (Figure 2a). Access to the main body of Hammond's Connection is from the Village via a gravel farm lane that parallels Dairy Farm Road (Figure 2b). The farm lane is narrow and may require improvements as well as widening to accommodate the public. To minimize traffic destined for Hammond's Connection from traveling through the Village, an entrance would be provided from Dairy Farm Road. Possible locations could be the existing egress from the Village or a new curb opening opposite Old Dairy Farm Road. The proposed alignment of the South Shore Hike / Bike Trail follows the old WB & A Railroad bed that parallels Maple Road north of the Dairy Farm. The South Shore Trail will connect Annapolis and Odenton with a spur trail into Hammond's Connection.

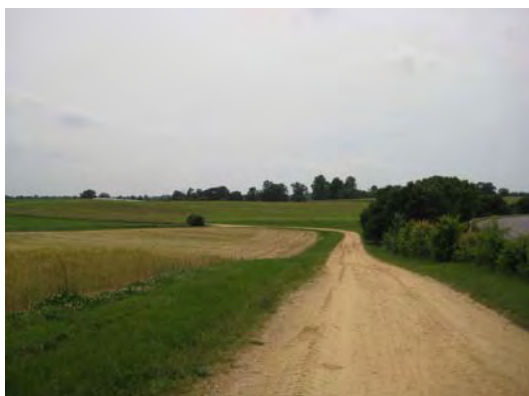
Figure 2b.
The existing gravel lane to
Hammond's Connection

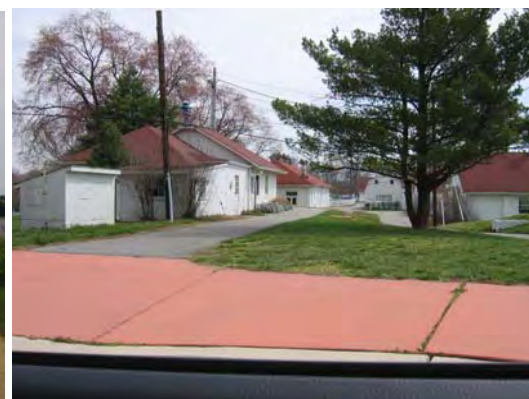
Figure 2c.
The Village

The houses, outbuildings, and all but one of the barns are located at the Village (Figure 2c). A public restroom and picnic pavilion are located at the Village and used during special events and festivals. The 4-H Dairy Club is housed at the Village. The Village is serviced by well water and septic system. Overhead electric lines come on site from Annapolis Road.

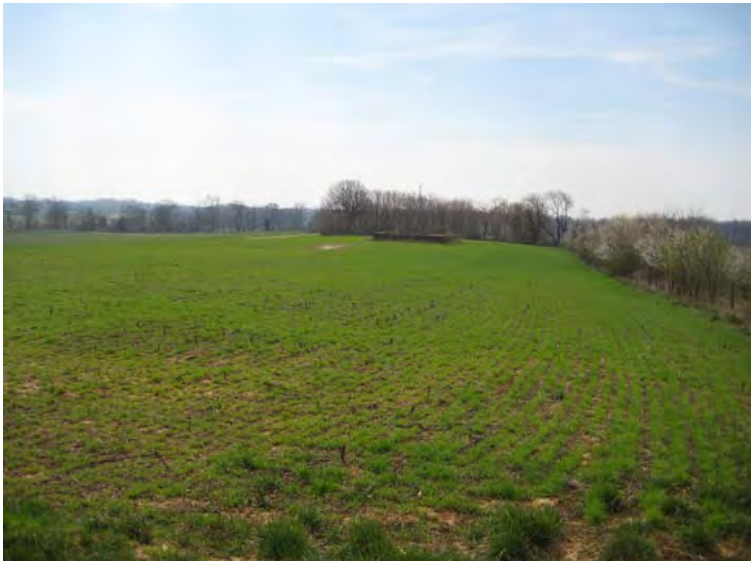
Figure 4a. Looking south along the ridge

From the ridge line described above, a series of relatively flat terraces is separated from one another by slopes of 10 percent to over 15 percent stepping down to Towser's Branch (Figure 4a and 4b). Wooded areas cover some of the steepest slopes. Drainage swales carry surface water from the ridge line to Towser's Branch. Towser's Branch drains from north to south into the Little Patuxent River. A public sewer line parallels the stream within a 30-foot right-of-way on the east and a BGE powerline right-of-way follows along the west side of Towser's Branch. The wetlands along the stream are primarily forested.

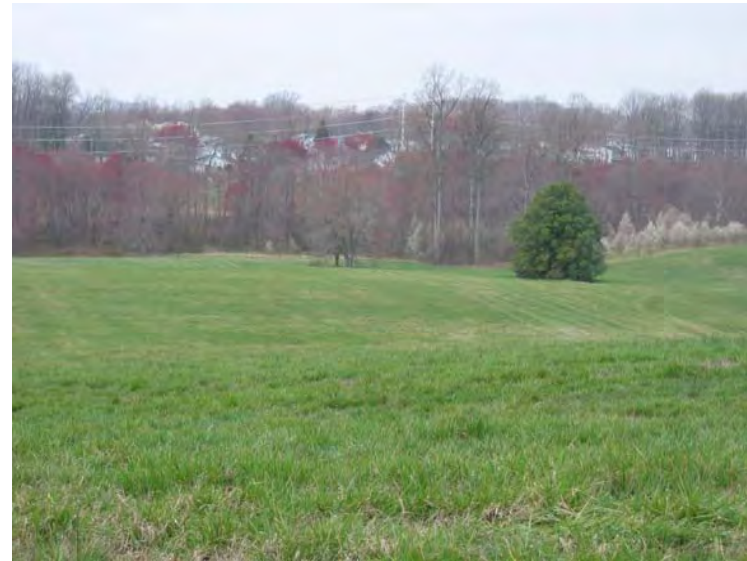
Figure 4b. Looking west from the ridge
