# Targeted Biological Assessments of Streams in the Little Patuxent Watershed, Anne Arundel County, Maryland: 2011

# Targeted Biological Assessment of Streams in the Little Patuxent Watershed, Anne Arundel County, Maryland: 2011

## August 2011 - DRAFT

KCI Technologies, Inc.  
936 Ridgebrook Road  
Sparks, Maryland 21152

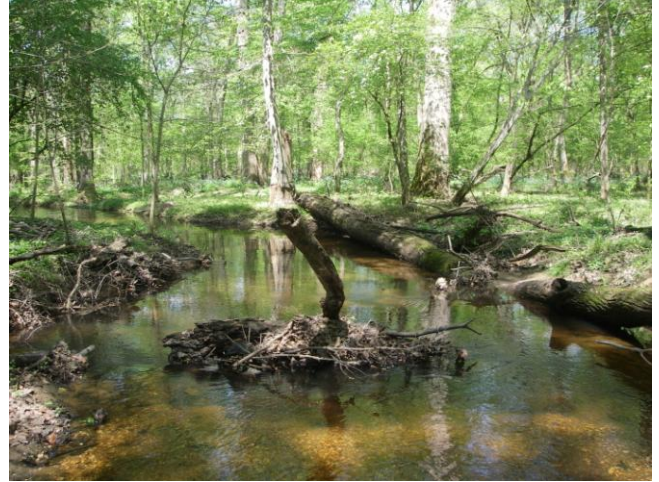
**Downstream View:**

This site is located west of Crain Highway (Rt. 3) approximately 200 meters upstream of the confluence with the Little Patuxent River and is part of the LPA subwatershed. With over 60% as developed land, the drainage area to this site (1,616 acres) contains the entire Crofton Country Club property as well as multiple high density residential communities. This reach was within the floodplain of the Little Patuxent River and as a result was backwatered. Less than 80 organisms were identified in the entire benthic sample, which indicates a poor biological community. Water quality measured below COMAR standards for pH and elevated conductivity, which may impact the biologic community. Because habitat is supporting and biological condition is poor, there may be problems with water quality in this drainage system that cannot be measured through in situ analysis only.

- Biological condition – “Poor”
- Habitat scores “Supporting” and “Partially Degraded”
- This sample only contained 73 organisms, the majority of which were midges (Orthocladius and Tvetenia) and worms (Naididae).
- Measured below COMAR standards for pH and conductivity elevated.
- Adequate habitat with high bank stability. Good riparian width with sub-optimal vegetative protection.

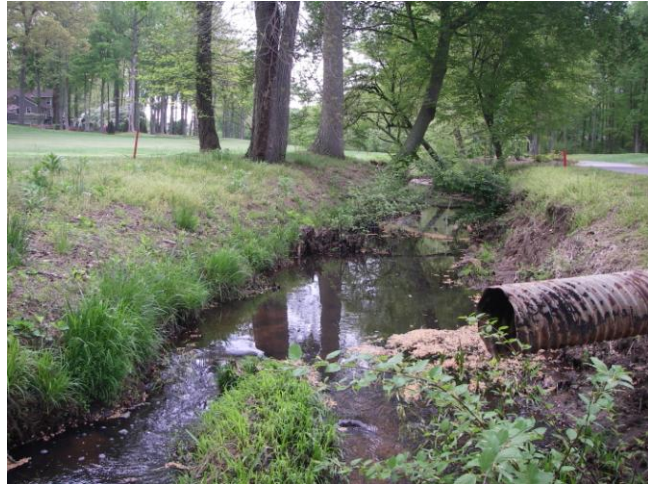
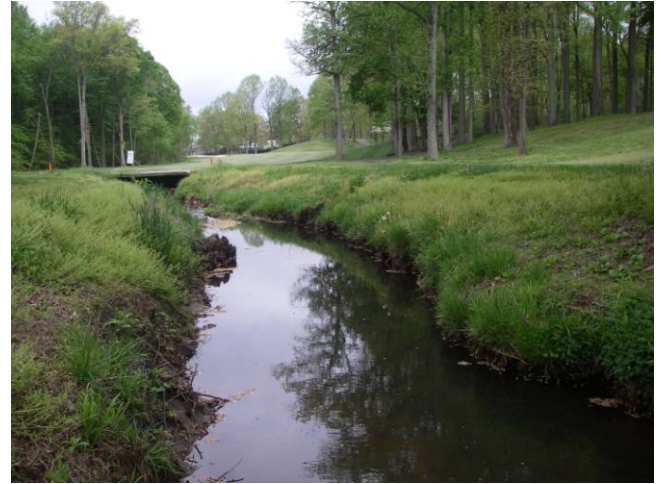
Located east of Crain Highway (State Route 3), this site is part of the LPA subwatershed. With close to 60% as developed land, the drainage area to this site (1,131 acres) contains half of the Crofton Country Club property as well as multiple high density residential communities. This site is located on the Crofton Country Club golf course where a golf cart road runs along the entire right bank of the sampling reach with little to no buffer due to mowed grass and few trees. Low pH and elevated conductivity may be attributed to multiple direct drainage inputs and lack of adequate vegetative protection/buffer. In spite of the partially supporting/severely degraded habitat, high taxa diversity (27 taxa present) including 3 EPT taxa and 2 Ephemeroptera taxa resulted in a biological community that is fair. Since the biological community exceeds the physical habitat potential, nutrient enrichment may be present, especially considering the surrounding golf course land use.

- Biological condition – “Fair”
- Habitat scores “Partially Supporting” and “Severely Degraded”
- Sample dominated by beetles (Stenelmis), midges (Orthocladius), and worms of the Naididae family.
- Measured below COMAR standards for pH and conductivity elevated.
- Bank stability scored high while instream habitat, epibenthic substrate, and woody debris scored low. Poor riparian width with marginal vegetative protection.

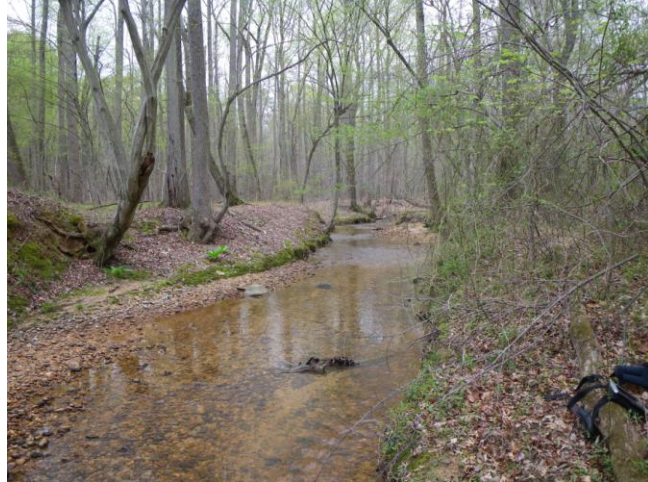
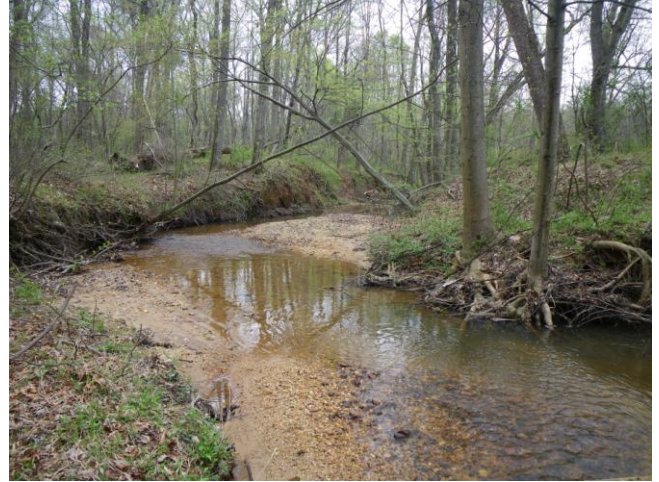
Located off of Welchs Court and Waters Road, behind a mobile home park, this site is part of the LPM subwatershed. Of the 985 acre drainage area to this site, over 75% is forested land with approximately 10% total impervious surface. All measured water quality parameters were within COMAR standards. The abundance of good quality cobble and large gravel riffles, good velocity and depth diversity, and overall supporting physical habitat quality resulted in a fair biological community with high taxa diversity (33) and numerous EPT taxa (6) and scraper taxa (4).

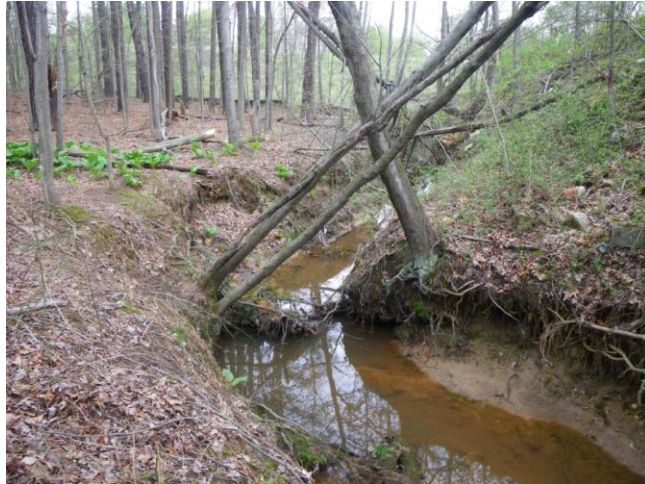
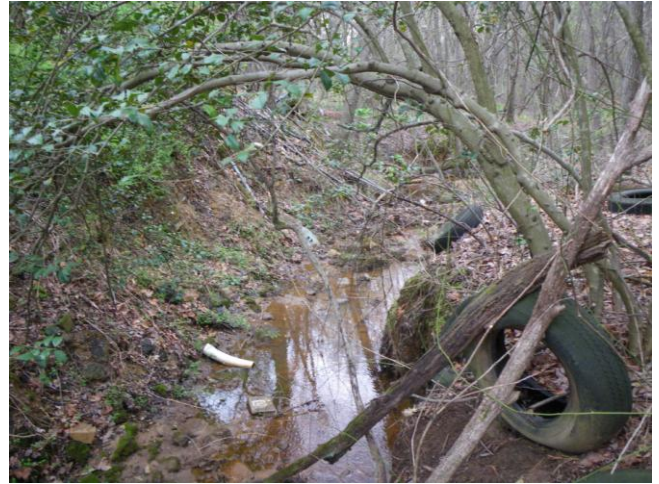
Located off of Fort Meade Road (Rt. 198), this site is part of the LPM subwatershed. This sampling reach runs adjacent to a parking lot with excessive dumping on the left bank and into the channel. The site is also located immediately downstream of culvert and rip-rap stabilization. As a result, the site has very poor habitat and the channel is deeply incised with areas of severe bank erosion and undercutting. Of the 176 acre drainage area to this site, close to half consists of developed land, 28% of which is commercial property including the Arundel Gateway Business Park as well as portions of Baltimore-Washington Parkway and Rt. 198. The remaining 46% of the drainage area is forested land. Water quality measurements indicated elevated conductivity, which may be attributed to the high percentage of impervious surface (31%) within the drainage area. The lack of EPT, intolerant, or scraper taxa in this sample are indicators of a very poor biological community.

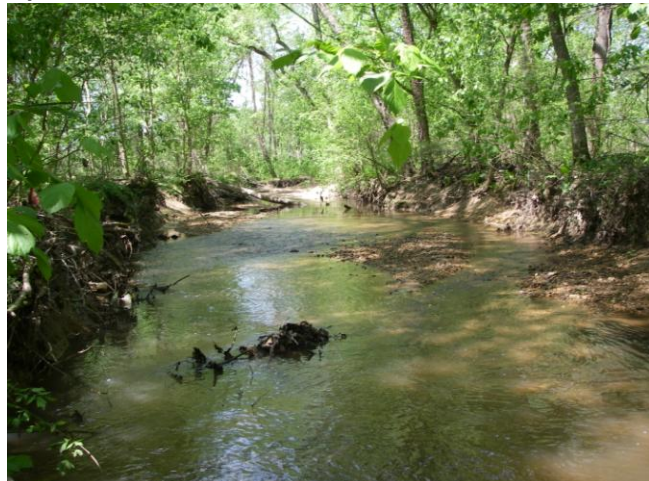
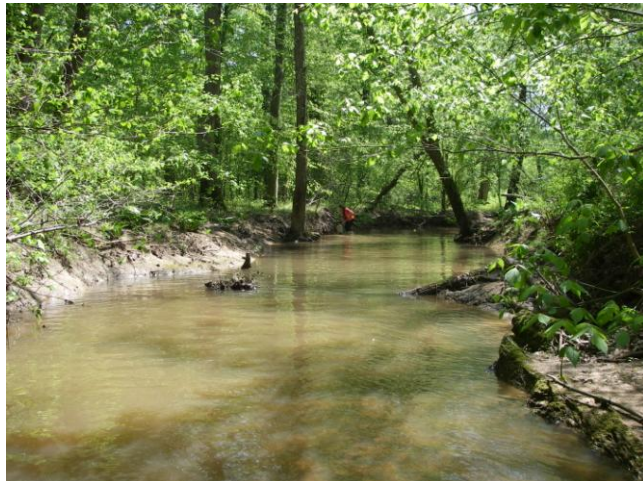
Located on the Towsers Branch mainstem approximately 150 meters upstream of the confluence with the Little Patuxent River and downstream of the crossing at Capitol Raceway Road, this site is part of the LPD subwatershed. Of the 4,248 acre drainage area, over half is developed land with 31% as high density residential. Approximately one-fourth of the drainage area is impervious, which may attribute to the elevated conductivity values measured at the site. This site also fell below COMAR standards for pH; however, this may be due to wetland drainage upstream. The channel is overwidened with actively eroding silt/clay banks indicating an unstable stream. The partially supporting habitat limits the benthic community, resulting in a poor biological rating. No EPT taxa were present in the benthic sample with only 2% intolerant urban taxa.

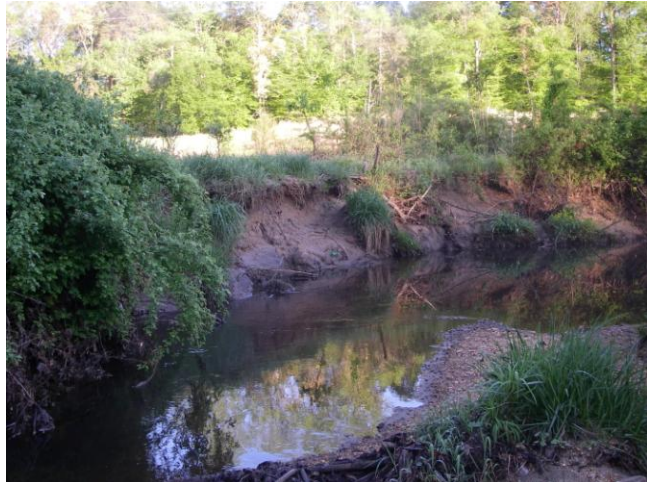
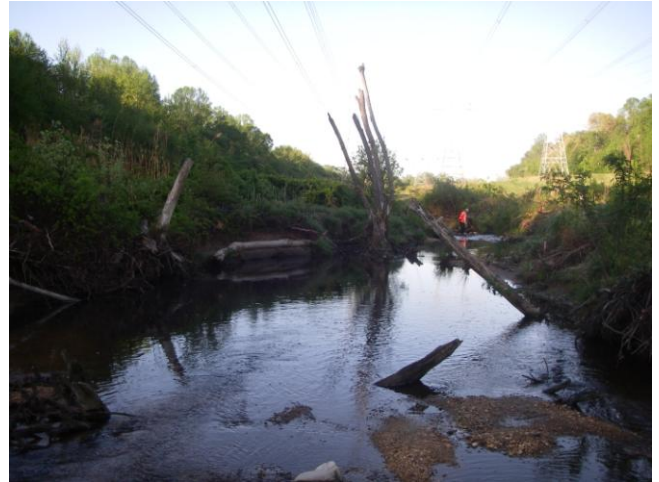
This site is located on Towsers Branch mainstem immediately downstream of the crossing at Evergreen Road off of Crain Highway and is part of the LPD subwatershed. Abundant woody debris with some riffle habitat and very deep pools are present throughout the stream. Of the 3,431 acre drainage area to this site, half consists of developed land with the remaining 21% as forested, 20% as agriculture, and 10% as open space. Several holding ponds from the adjacent quarry operation appear to drain into the stream just upstream of the sampling reach. A powerline corridor runs the entire length of the left bank of the site which results in poor vegetative protection and riparian buffer. The channel is also incised with actively eroded stream banks indicating an unstable stream type. Insufficient physical habitat and potential water quality impairment, including low pH and elevated conductivity, likely contribute to a poor biological community. Only 4% of the benthic sample consisted of intolerant urban taxa with only one EPT taxa present.

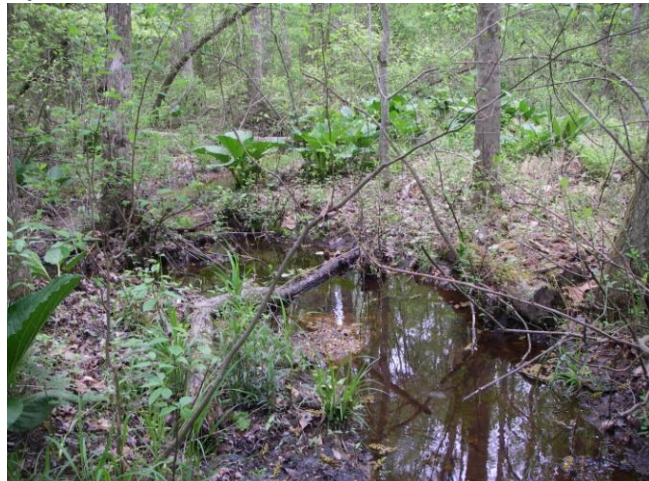
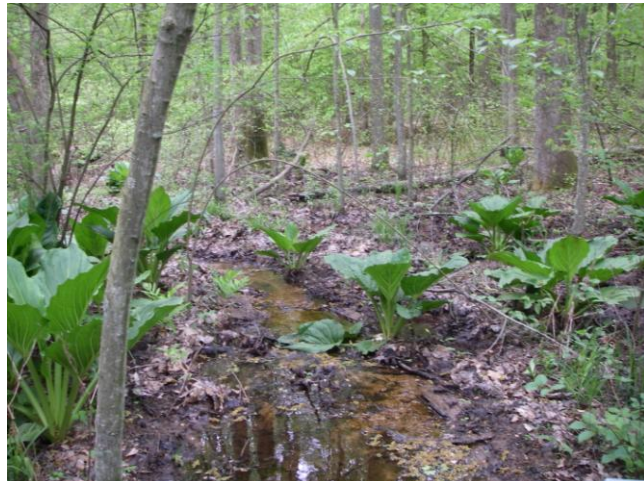
Located behind houses along Meyers Station Road, this site is part of the LP1 subwatershed and drains to the Little Patuxent River. The drainage area to this site (105 acres) is largely forested land (87%) with only 1.5% impervious surface. This site is on a small channel that runs through a wetland and has full floodplain access on both banks. Riffle habitat and woody debris support high scores for physical habitat; however, the lack of Ephemeroptera and scraper taxa in the subsample resulted in a poor biological score. Because habitat is supporting and biological condition is poor, there may be problems with water quality in this drainage area that cannot be measured through in situ analysis only. Measured pH values fell below COMAR standards, but this is likely to be influenced by the surrounding wetland system that drains to the site.

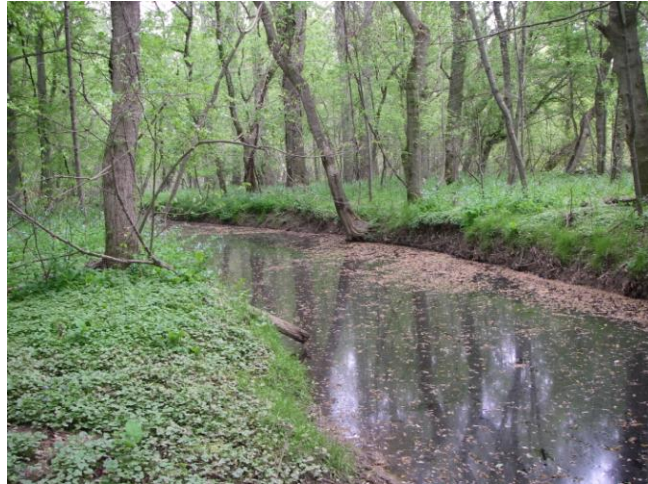
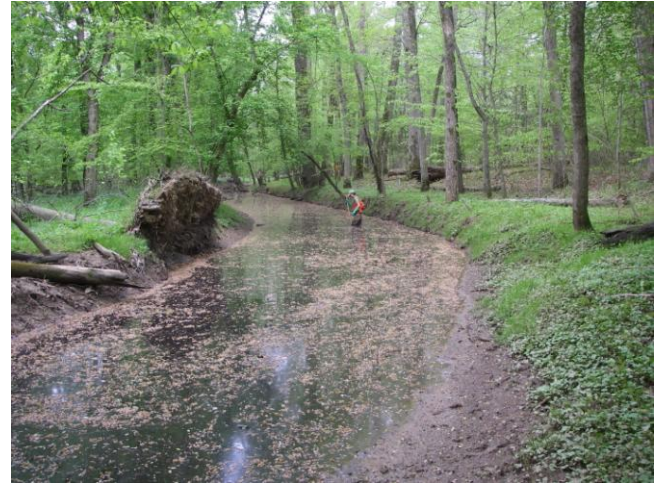
Located on the Little Patuxent River floodplain between Grays Ford Road and Crain Highway (State Route 3), this site is part of the LP1 subwatershed. Because this site is located approximately 100 meters upstream of the confluence with the Little Patuxent River, the sampling reach was backwatered pool habitat with little observable flow. Low dissolved oxygen levels measured at this site are largely attributed to the stream being backwatered with little mixing occurring in the water column. Few woody debris and fibrous roots along the banks provided only minimal stable habitat for the benthic community. In spite of the partially supporting habitat, 21 taxa were present in the benthic sample with one Ephemeroptera taxa and one scraper taxa present. Of the 169 acre drainage area, 46% is forested land and 30% is developed land with only 1.7% impervious surface. However, it should be noted that the one large developed parcel (classified as industrial land use), appears to never have been fully developed and is more characteristic of open land, hence the low imperviousness in this drainage area.

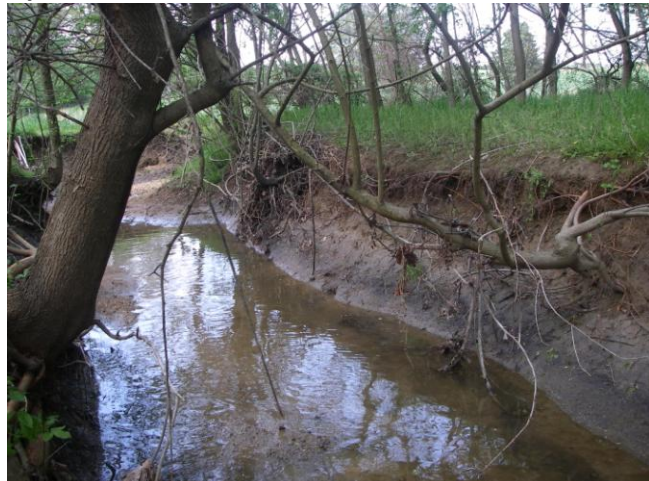
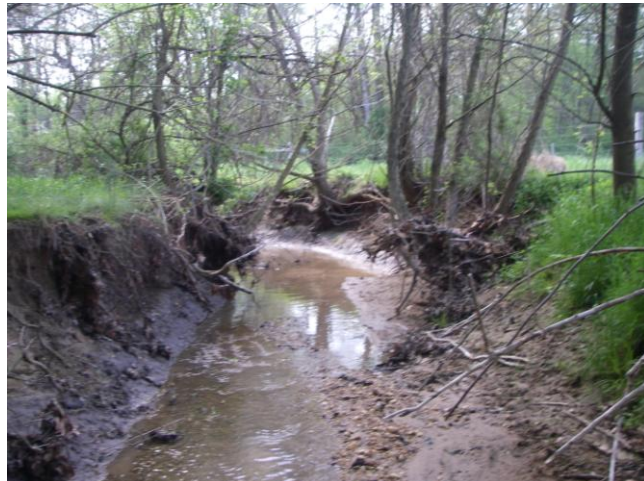
Located at the end of Springhill Court, this site is part of the LPC subwatershed and drains to Towsers Branch. Of the 1,001 acre drainage area to the site, over half consists of agricultural land-- the majority of which is the US Naval Academy Dairy Farm, with developed land accounting for 23% of the drainage area. This channel is deeply incised with a severely eroded stream banks, indicating an unstable stream reach. Poor quality riffles and an overall lack of stable substrate resulted in non-supporting physical habitat. No EPT or scraper taxa were present in the benthic sample and only 1% of the sample consisted of intolerant urban taxa. Measured pH values fell below COMAR standards, but this may be due to naturally occurring acidic conditions.

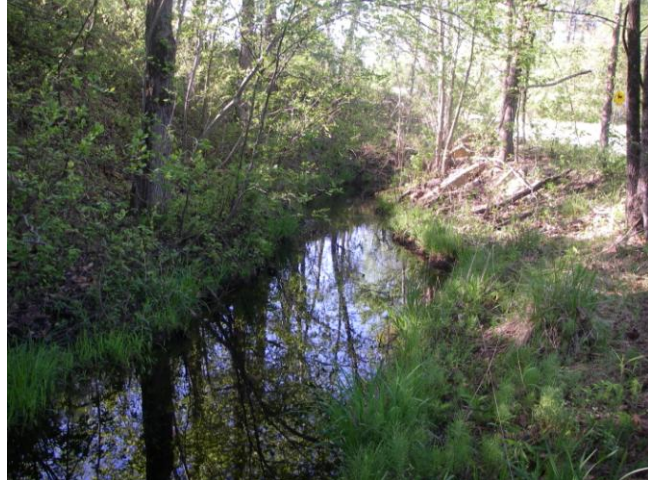
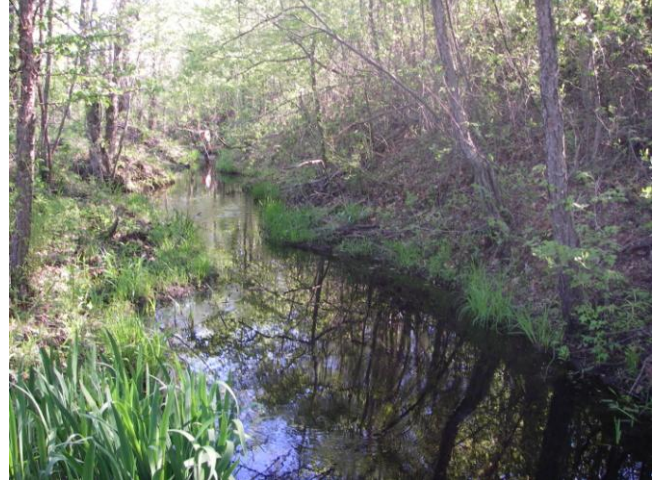
Located immediately downstream of Patuxent Road, this site is part of the LP2 subwatershed. This site drains a large wetland system upstream of the road crossing and into a large wetland downstream, and as a result the site was slightly backwatered. Low dissolved oxygen and pH values measured at this site are largely attributed to the wetland drainage and subsequent backwatering with little mixing occurring in the water column. Forested land accounts for 73% of the drainage area to this site with developed land accounting for 17%. Of the 366 acre drainage area, only 1.8% is impervious. However, a complete lack of EPT, Ephemeroptera, and scraper taxa resulted in a poor biological community.

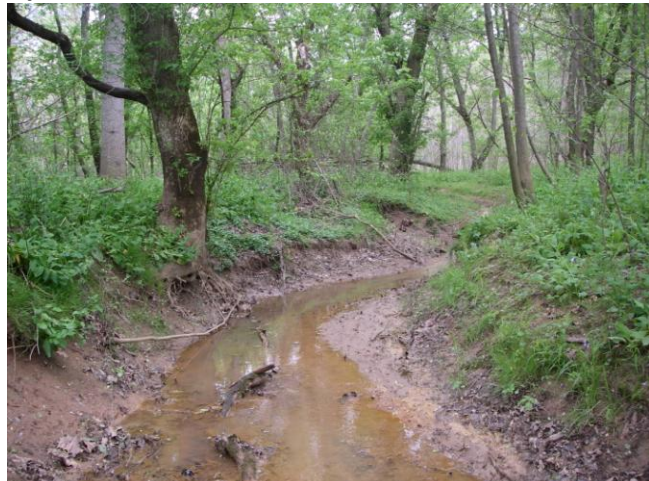
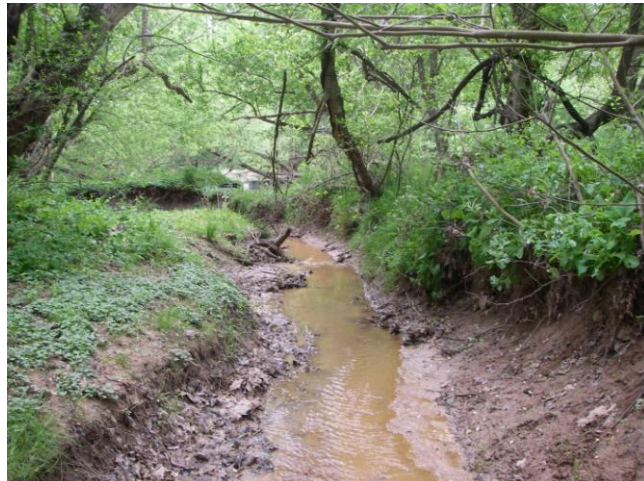
Located approximately 0.4 miles northeast of the intersection of Patuxent Road and Bragers Road, this site is part of the LP2 subwatershed. This site is located approximately 50 meters upstream of the confluence with the Little Patuxent River, and consequently the downstream end of the reach was backwatered. Poor quality riffles in a silt/clay substrate and minimal woody debris provide inadequate epifaunal substrate, resulting in a poor biological community. Because the sampling reach is located on the active floodplain of the Little Patuxent River, the local physical habitat is being influenced by backwatering and fine sediment deposition. Of the 277 acre drainage area to the site, only 6% is impervious surface. Half of the drainage area consists of forested land with the remaining 39% as open and 11% as developed land; however, it should be noted that the majority of the land classified as open is an active quarry operation.

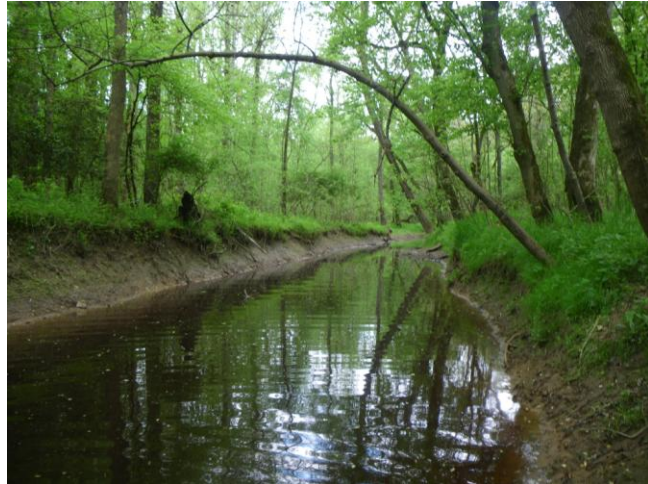
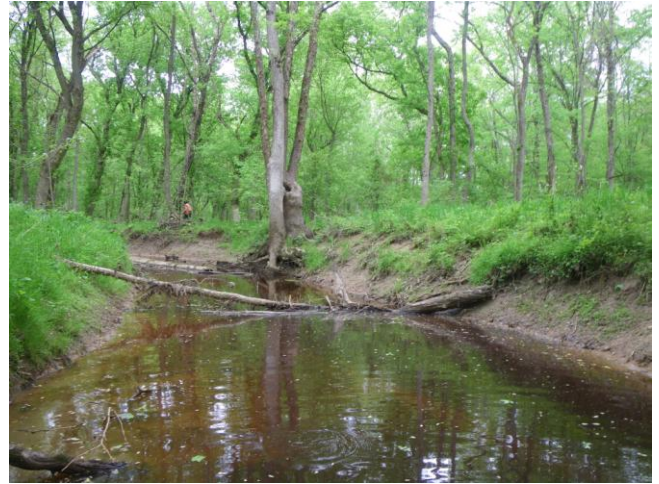
This site is located approximately 200 meters northeast of Patuxent Road and is part of the LP3 subwatershed. The drainage area to this site (798 acres) is largely forested land (85%) with only 3% impervious surface. However, because the stream is located approximately 200 meters upstream of the confluence with the Little Patuxent River, this site was predominantly backwatered with virtually no visible flow. Low dissolved oxygen levels measured at this site are largely attributed to the stream being backwatered with little mixing occurring in the water column. Poor physical habitat consisted of mostly deep pools with anaerobic silt/muck bottom, insufficient for supporting a robust biological community. Measured pH values fell below COMAR standards, which is likely due to wetland drainage as evidenced by the tannic color of the water.

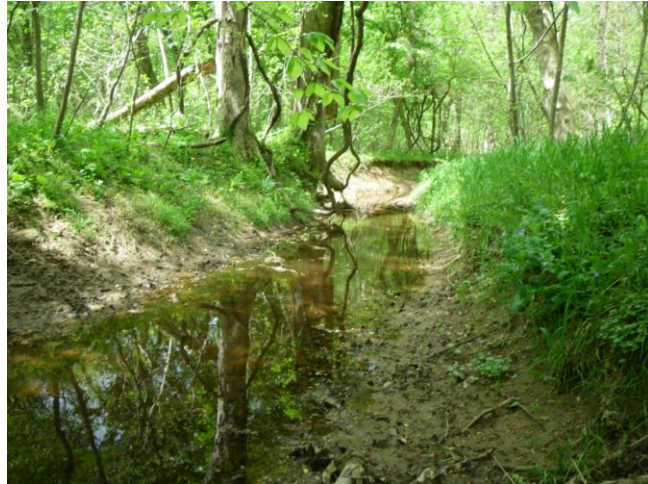
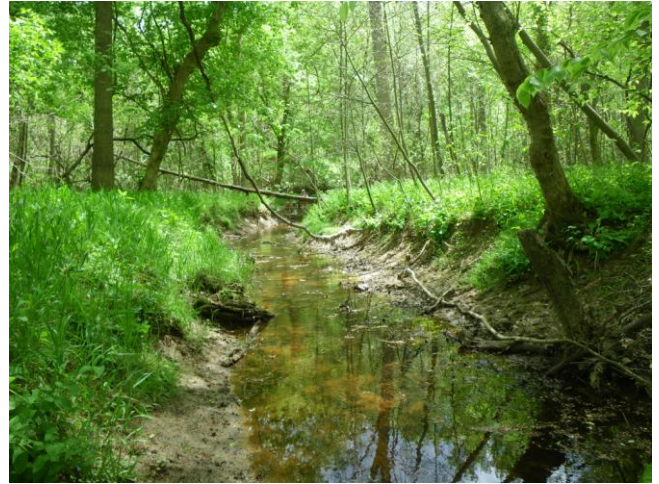
Located approximately 300 meters east of Patuxent Road, this site is part of the LP3 subwatershed. The drainage area to this site (385 acres) is predominantly forested land (83%), which includes property on the Patuxent Research Refuge. Located on the floodplain of the Little Patuxent River, this site drains an extensive wetland area. With very little flow, the site is an entrenched channel with a silt/sand bottom and an abundance of detrital material. Although the site received a partially supporting habitat score, epifaunal substrate was only marginal, resulting in a poor biological community which contained only one EPT taxa, lacked Ephemeroptera taxa, and consisted of just 6% intolerant taxa in the benthic sample. All measured water quality parameters fell within COMAR standards. Impacts from historical land use (deforestation, channelization, etc.) may continue to limit the stream's ability to support a healthy biota.

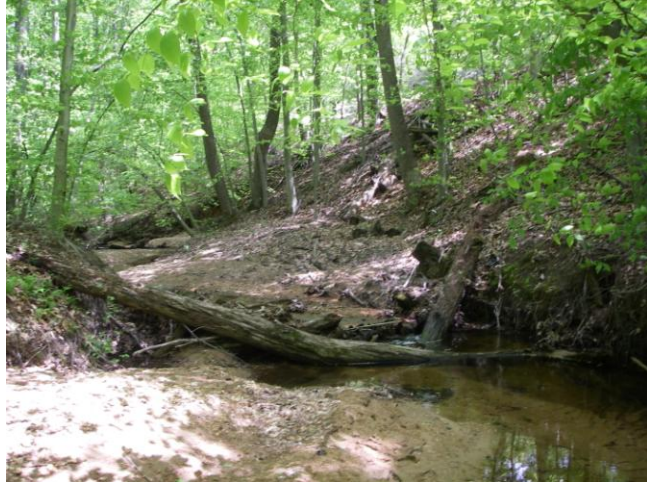
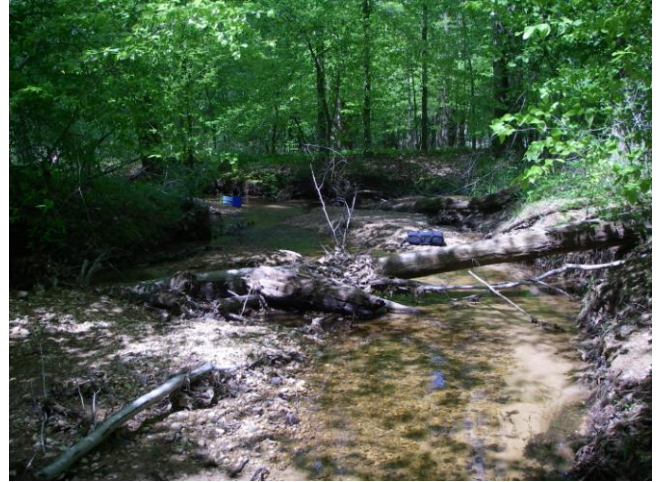
Located just off of a hike and bike trail near Strawberry Lake Way, this site is part of the LPL subwatershed. Of the 798 acre drainage area to this site, 30% consists of impervious surface and largely drains high density residential communities (68%). Conductivity values were elevated, likely due to the high imperviousness in the drainage area. Numerous good quality riffles and woody debris/rootwads support a fair biological community with high taxa diversity. Multiple sand and gravel bars throughout the stream indicate a system that is overwidened and actively aggrading.

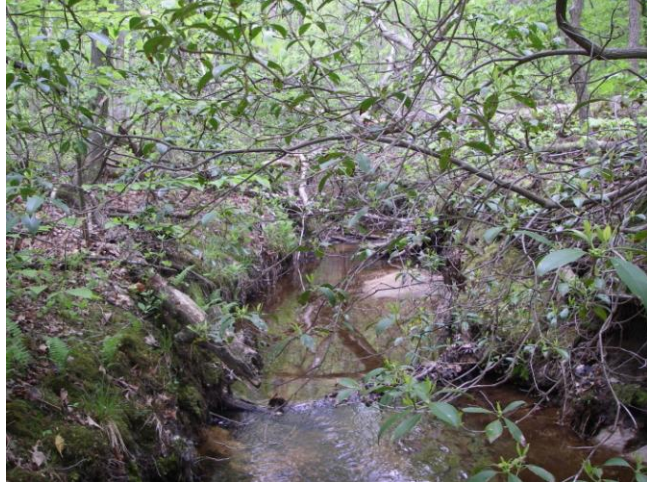
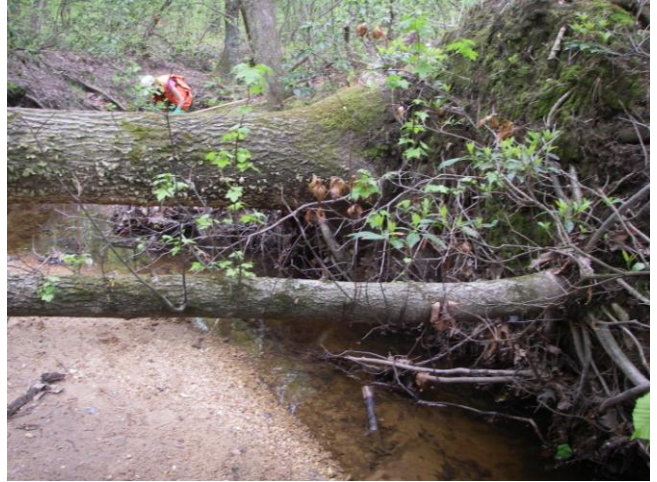
Located behind a retention pond to the east of Streamview Drive, this site is part of the LPL subwatershed. Of the 241 acre drainage area to this site, 27% consists impervious surface and largely drains high density residential communities (64%). Low pH and elevated conductivity values measured at this site may be attributed to an outfall from the retention pond that flows directly into the sampling reach. A mix of riffle and woody debris habitat is only partially supporting of a healthy biological community. Only 2% of the benthic sample accounted for taxa intolerant to urban stressors, and the overall benthic community was rated poor.

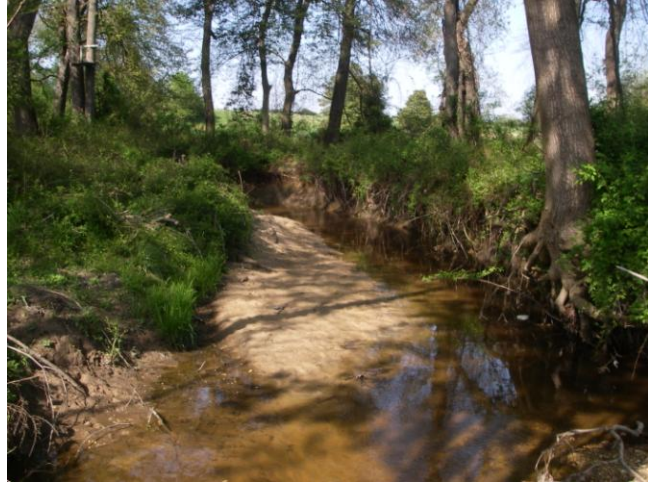
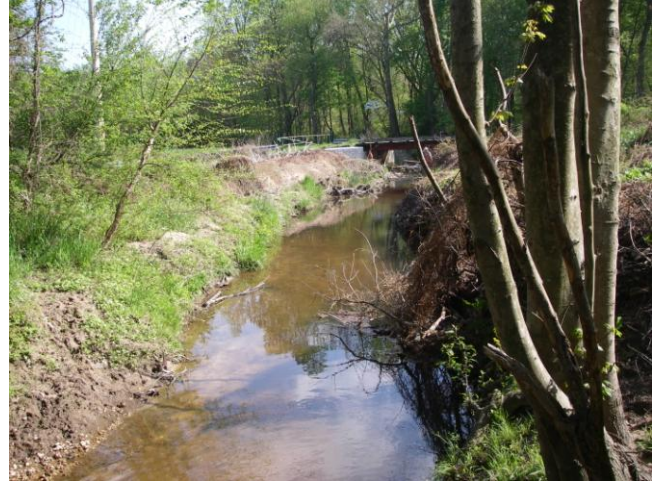
Located east of a powerline corridor that runs behind Springhill Court, this site is part of the LPB subwatershed. Of the 1,330 acre drainage area to this site, 64% consists of developed land and 20% as forested land. Impervious surface accounts for 24% of the drainage area. The channel is incised with severe bank erosion indicating an unstable stream type, likely resulting from the high imperviousness upstream. The riparian buffer width was limited due to the powerline corridor along the left bank and pasture along the right bank (US Naval Academy Dairy Farm). Water quality measured below COMAR standards for pH, which is likely due to wetland drainage upstream. Because habitat is supporting and biological condition is poor, there may be problems with water quality in this drainage system that cannot be measured through in situ analysis only. However, the unstable stream type may also be impacting the biota.

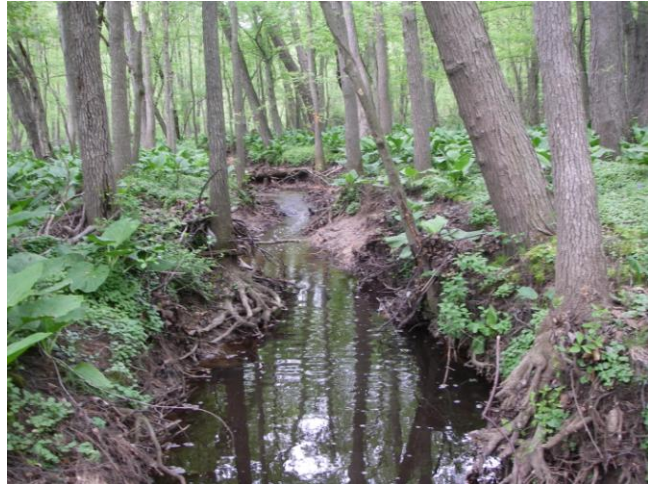
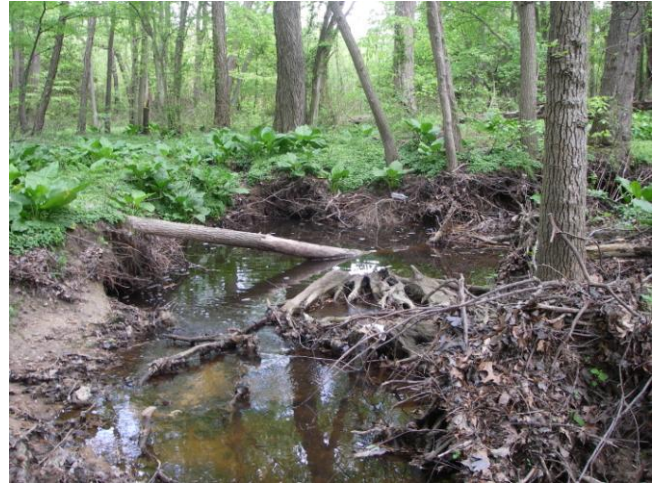
Located behind the end of Autumn Valley Lane and Four Season Drive, this site is part of the LPB subwatershed and drains to Towsers Branch. A quarter of the drainage area to this site is impervious surface as the dominant land cover is developed (68%), followed by forested land (25%). This site has a limited forested riparian buffer due to the powerline corridor along the left bank and pasture along the right bank (US Naval Academy Dairy Farm). Wetlands surround and drain to this reach, which may contribute to the low pH measurements. A mix of riffle and woody debris habitat support a poor biological community that had high taxa diversity yet a lack of both Ephemeroptera and intolerant taxa. The downstream end of the reach is deeply incised; however, armoring around a utility line has prevented the headcut from moving upstream but also backwatered the stream for a good portion of the sampling reach.

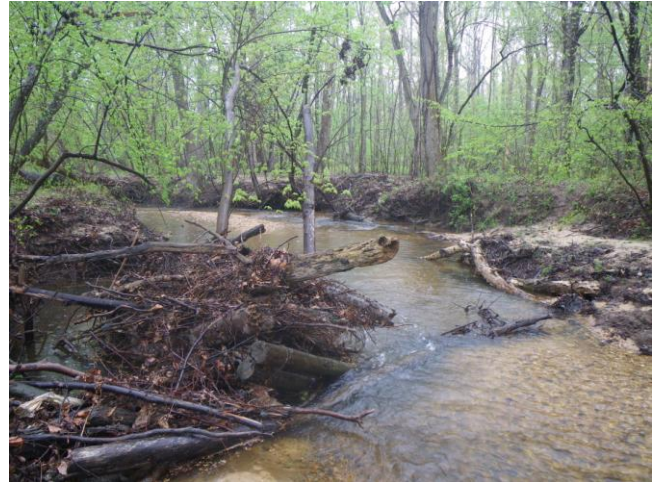
Downstream View:

This site is located on the Rogue Harbor Branch mainstem approximately 150 meters upstream of the confluence with the Little Patuxent River, just west of Piney Orchard Parkway, in the LPF subwatershed. The drainage area to this site (5,388 acres) drains a large section of Fort Meade Military Reservation and part of the Patuxent Research Refuge. The predominant land cover is split between developed and forested land (38% for each) with a large portion of open space (21%), resulting in 19.7% imperviousness. There is an good mix of stable habitat including an abundance of roots and woody debris as well as gravel riffles. Heavy bar formation in the channel indicates some overwidening, but stream banks are mostly stable. Ten EPT taxa, including 3 Ephemeroptera, and 6 scraper taxa were present in the benthic sample; however, only 6% of the sample consisted of taxa intolerant to urban stressors. Elevated levels of conductivity may be a result of the developed land cover upstream and may affect the quantity of intolerant taxa.

- Biological condition – “Good”
- Habitat scores “Comparable to Reference” and “Partially Degraded”
- Sample dominated by midges (including Polypedilum and Rheotanytarsus) and beetles (Stenelmis).
- Water quality values within COMAR standards but conductivity elevated.
- Instream habitat, epibenthic substrate, and bank stability received sub-optimal scores. Low scores for remoteness and woody debris. Good riparian width and vegetative protection.

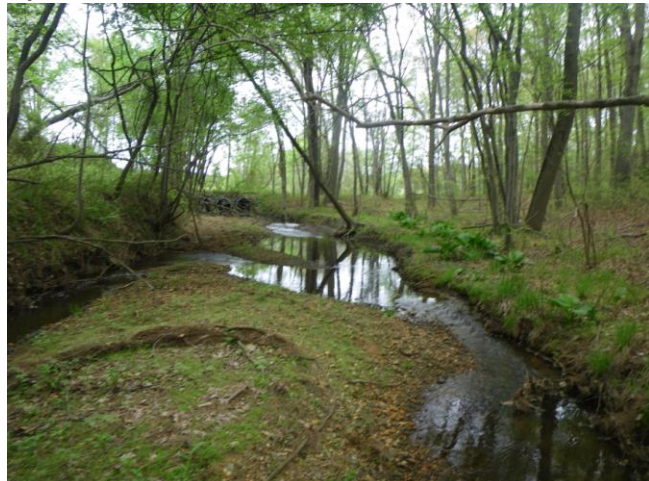
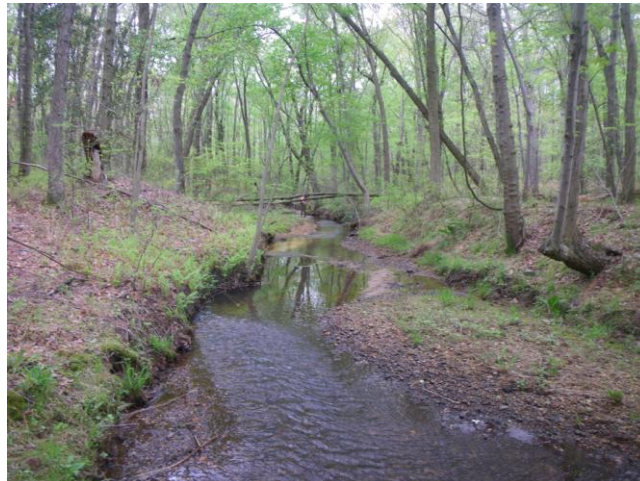
Upstream View:

Located in the Patuxent Research Refuge off of Wildlife Loop Road and immediately downstream of a culvert adjacent to a firing range, this site is on a tributary to Rouge Harbor and is part of the LPF subwatershed. The drainage area to this site (773 acres) drains a section of Fort Meade Military Reservation and part of the Patuxent Research Refuge. The predominant land cover is developed (43%), which may explain the elevated conductivity levels, followed closely by forested land (38%). Numerous riffles, while only moderate quality, as well as rootwads support a good biological community. The benthic sample for this site had high taxa diversity (31 taxa) and was dominated by an intolerant mayfly, *Caenis* (T.V. = 2.1), resulting in a high percentage of Ephemeroptera (24%) and percentage of taxa intolerant to urban stressors (33%).

- Biological condition – “Good”
- Habitat scores “Supporting” and “Partially Degraded”
- Sample dominated by *Caenis*(Ephemeroptera) and beetles (*Stenelmis*).
- Water quality values within COMAR standards but conductivity elevated.
- Bank stability scored high. Sub-optimal habitat diversity. Low scores for remoteness and woody debris. Good vegetative protection.

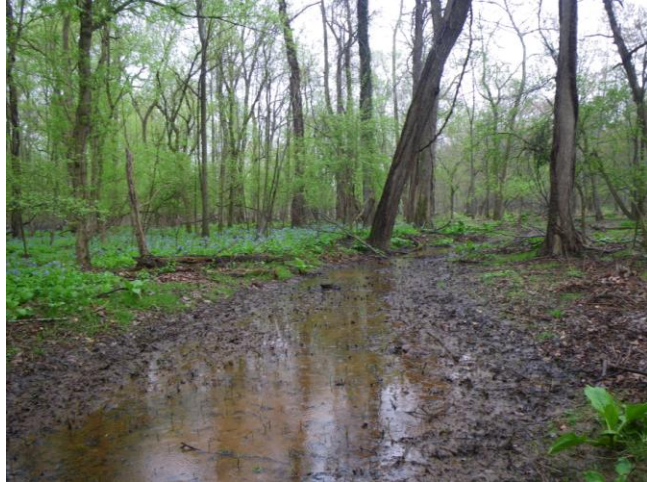
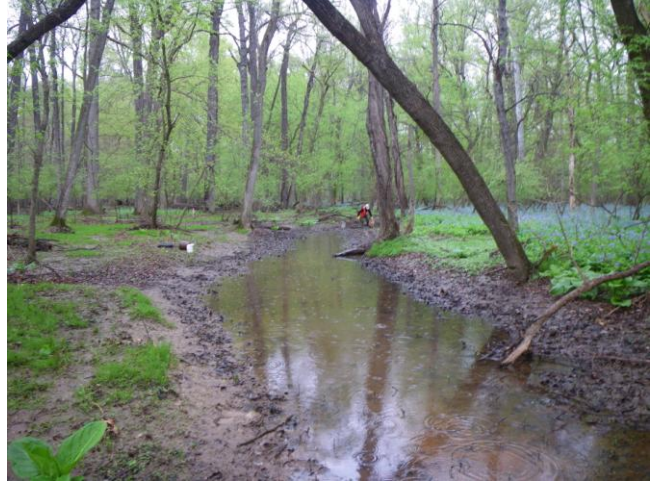
Upstream View:

Located on the property of the District of Columbia Children's Center and approximately 475 meters east of the end of Forest Haven Avenue, this site is part of the LP5 subwatershed. Of the 118 acre drainage area, 62% is forested with the remaining 27% as developed and 12% as open space, resulting in 13.5% imperviousness. Located approximately 150 meters upstream of the confluence at the Little Patuxent River, the stream drains an extensive wetland network and has very little visible flow. The channel consists of all muck and detritus bottom substrate with very little stable benthic substrate. Some small emergent vegetation is present but mostly young plants. An excellent riparian buffer contributes to a partially supporting habitat. Elevated conductivity levels may be a result of the developed land cover upstream.

- Biological condition – “Poor”
- Habitat scores “Partially Supporting” and “Partially Degraded”
- Bivalves (Musculium), isopods (Caecidotea), and worms (Tubificidae) dominated the sample.
- Water quality values within COMAR standards but conductivity elevated.
- Poor habitat diversity but banks are stable. Good riparian width and vegetative protection.

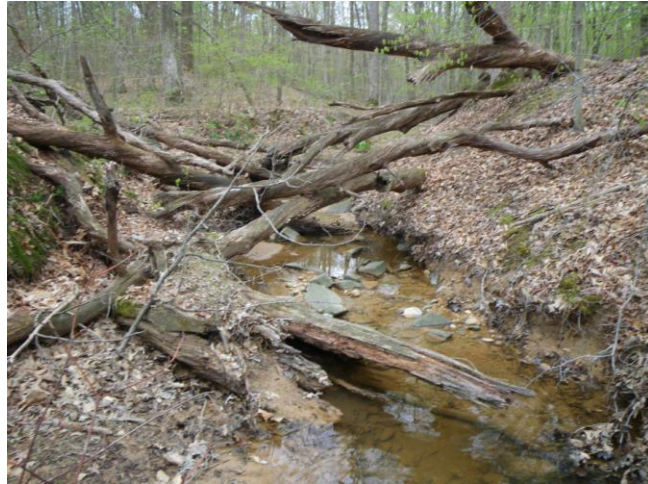
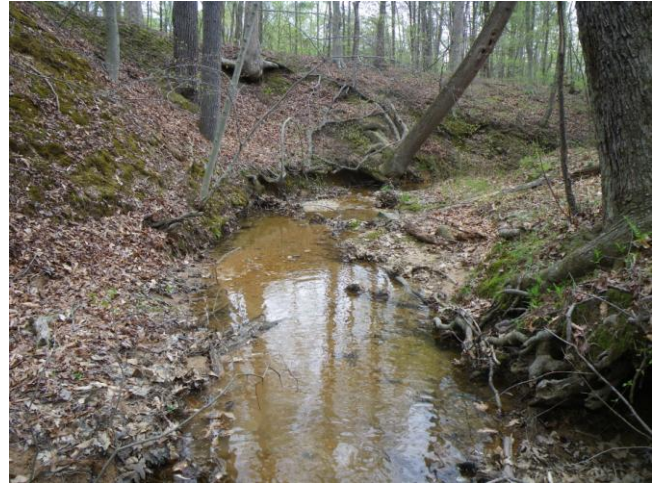
Upstream View:

Located within the Patuxent Research Refuge approximately 100 meters upstream of Bald Eagle Drive near the visitor center, this site is on an unnamed tributary to the Little Patuxent River and is part of the LPO subwatershed. The 146 acre drainage area to this site is predominantly forested land (95%) with only 5% accounting for developed land. Only 1.7% of the drainage area is impervious surface. Even though there is an adequate mix of riffles and woody debris/rootwad habitat, there is a poor biological community due to few EPT taxa and the complete lack of Ephemeroptera taxa and scraper taxa in the benthic sample. Measured pH values fell below COMAR standards; however, the lack of anthropogenic disturbance suggests that it is due to naturally acidic conditions in this drainage area. Evidence of incision, overwidening, and active bank erosion indicate that the channel has not yet reach a stable form, which could also explain why the benthic community is not meeting expectations.

- Biological condition – “Poor”
- Habitat scores “Supporting” and “Minimally Degraded”
- Black flies (Simulium and Stegopterna) dominated the sample.
- Measured below COMAR standards for pH.
- Most habitat variables received sub-optimal scores. Scored high for woody debris. Good riparian width with sub-optimal vegetative protection.

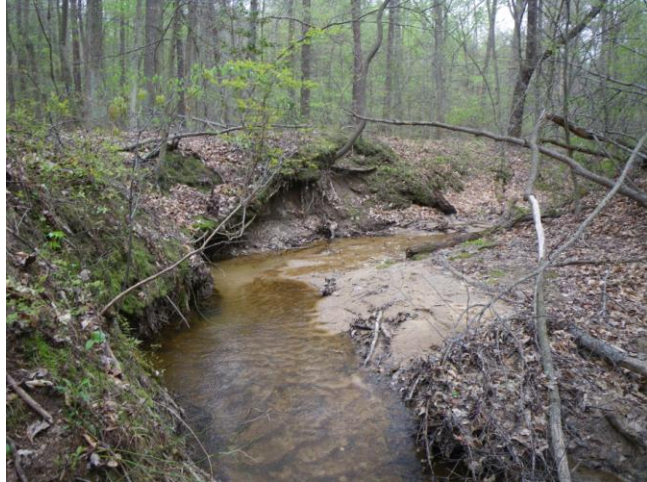
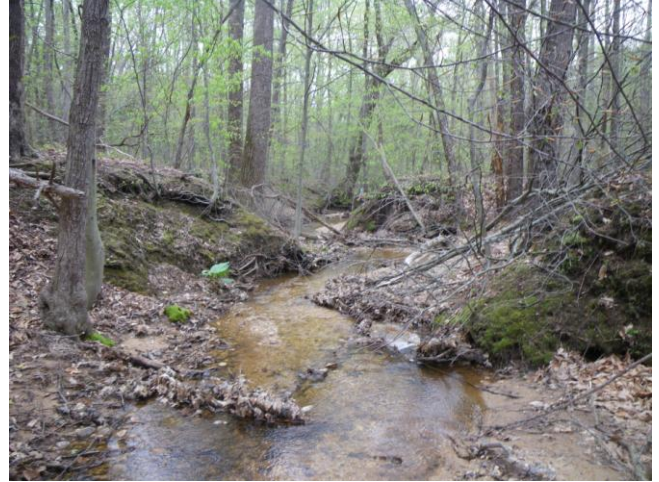
Upstream View:

This site is located within the Patuxent Research Refuge approximately 0.4 miles west of the visitor center on an unnamed tributary that drains to the Little Patuxent River in the LPO subwatershed. The 208 acre drainage area to this site is predominantly forested land (86%) with 13% accounting for open space. Only 0.6% of the drainage area is impervious surface. This site has an optimal mix of stable habitat types with numerous riffles and rootwads providing adequate habitat for a healthy and diverse benthic community. High taxa diversity (35 taxa) including 8 EPT taxa, 2 Ephemeroptera taxa, and 6 scraper taxa were present in this sample. Moderate bar formation and some minor bank erosion is present, but the stream appears to be evolving to a more stable stream type from a previously disturbed and incised state. Measured pH values fell below COMAR standards; however, the lack of anthropogenic disturbance suggests that it is due to naturally acidic conditions in this drainage area.

- Biological condition – “Good”
- Habitat scores “Comparable to Reference” and “Minimally Degraded”
- Various midges and the Trichoptera genus, Diplectrona, dominated the sample.
- Measured below COMAR standards for pH.
- Most habitat variables received sub-optimal to optimal scores. Scored very high for woody debris. Good riparian width and vegetative protection.

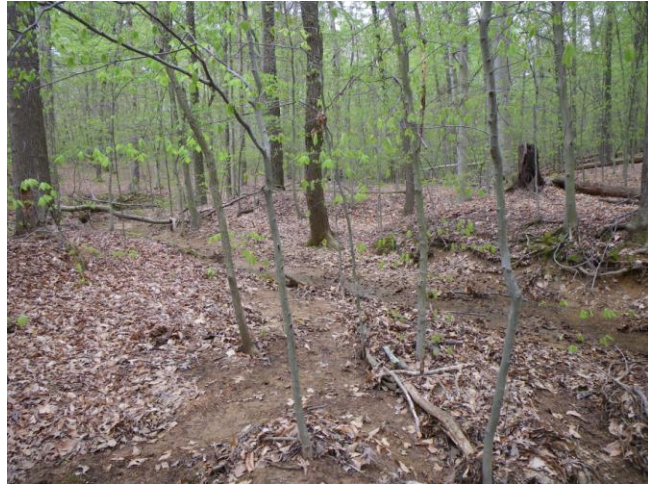
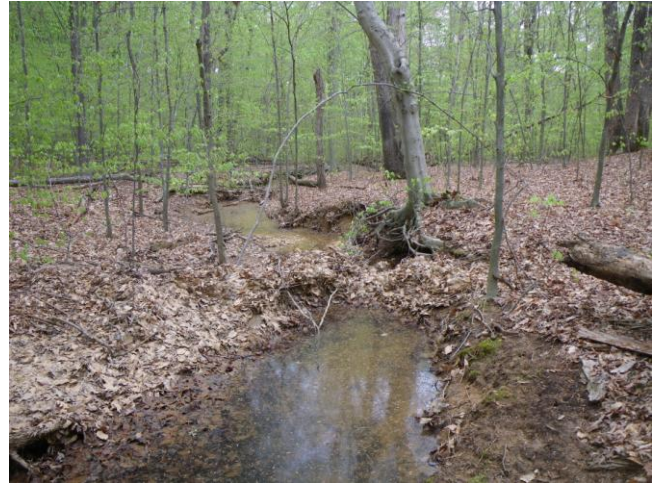
Upstream View:

Located within the Patuxent Research Refuge just off of Switchboard Road, this site is on an unnamed tributary that drains to the Little Patuxent River and is part of the LPO subwatershed. The 101 acre drainage area to this site consists largely of forested land (94%) with only 5% accounting for developed land, only 1.4% which of is impervious surface. This reach consisted of a series of stagnant, backwatered pools caused by leaf/woody debris jams throughout the reach and exhibited virtually no visible flow. While there were only a few poor quality riffles present, instream woody debris and leaf packs provided habitat to the benthic community. A high percentage of intolerants (50%) and climbers (8%) in the sample led to a fair biological condition rating. Low dissolved oxygen levels measured at this site are largely attributed to the stream being backwatered with little mixing occurring in the water column and the abundance of detrital decomposition. Measured pH values fell below COMAR standards; however, the lack of anthropogenic disturbance suggests that it is due to naturally acidic conditions in this drainage area. Furthermore, the lack of flow and small drainage area suggest that this reach may be intermittent in nature.

- Biological condition – “Fair”
- Habitat scores “Partially Supporting” and “Partially Degraded”
- Isopods (Caecidotea), worms (Lumbricina and Enchytraeidae), and midges dominated the sample.
- Measured below COMAR standards for pH and dissolved oxygen.
- Marginal habitat diversity and banks are moderately stable. Good riparian width with sub-optimal vegetative protection.

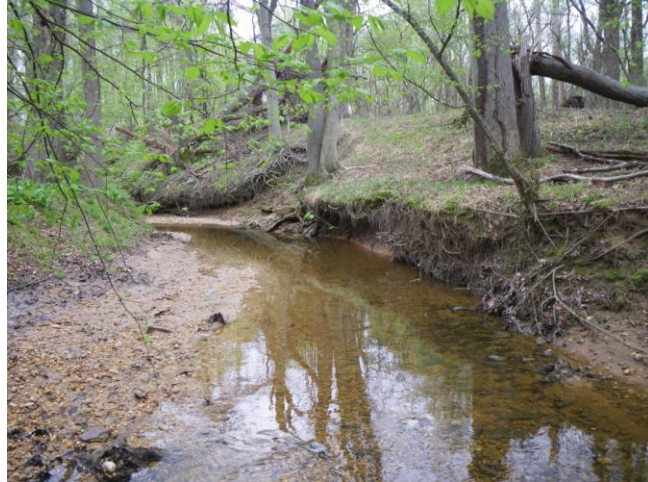
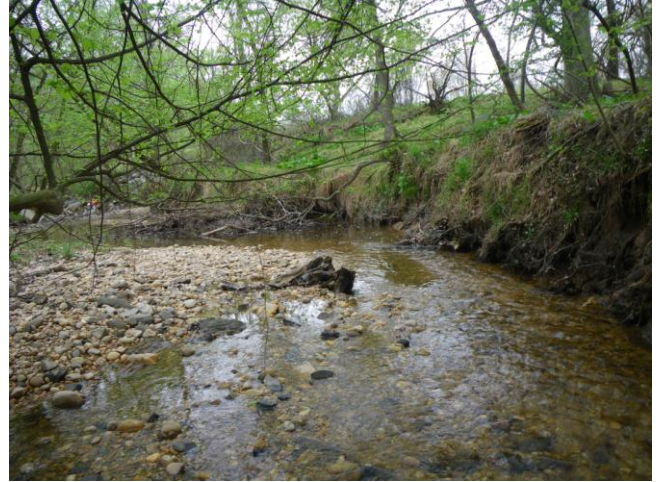
Upstream View:

Located south of Oak Hill Drive on a tributary to the Little Patuxent River, this site is part of the LP5 subwatershed. Over half of the 407 acre drainage area is developed land (56%) and includes part of the Fort Meade Military Reservation. The channel is incised and overwidened with some heavily eroded banks and extensive bar formation. Gravel dominated riffles of moderate quality provide limited habitat for a very poor biological community. Only 11 taxa were present in the benthic sample which completely lacked EPT, Ephemeroptera, scraper, and intolerant taxa. Because habitat is partially supporting and biological condition is very poor, there are likely water quality issues, such as elevated conductivity, impacting the biological community.

- Biological condition – “Very Poor”
- Habitat scores “Partially Supporting” and “Partially Degraded”
- Orthocladius (midge) dominated the sample.
- Water quality values within COMAR standards but conductivity elevated.
- Most habitat variables received sub-optimal scores. Moderately unstable banks. Refuse present in moderate amounts.

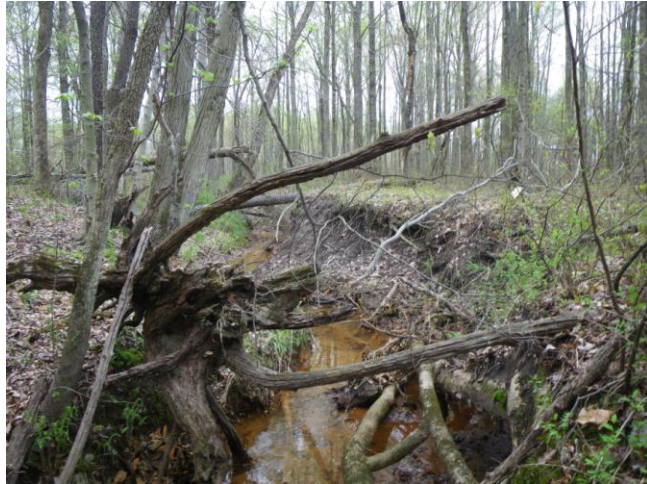
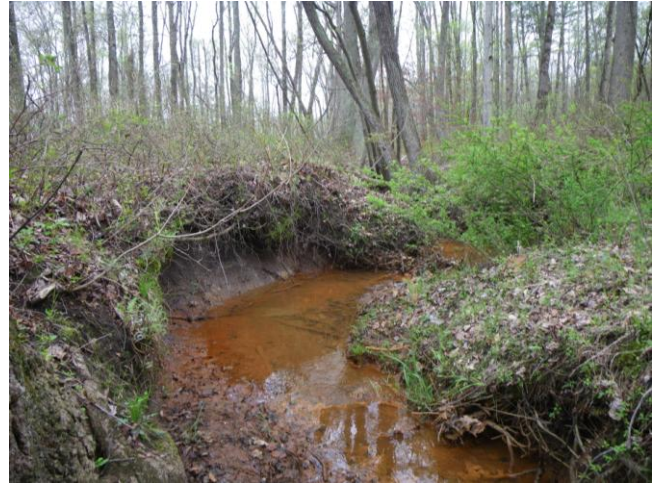
Upstream View:

This site is located between Patuxent Freeway (Rt. 32) and General Aviation Drive, this site is on an unnamed tributary to the Little Patuxent River and is part of the LPN subwatershed. Close to half of the 124 acre drainage area to this site is developed land (49%), which includes part of the Fort Meade Military Reservation. Forested and open space account for the remaining 32% and 20% of the drainage area, respectively. Over a third of the drainage area (37%) is impervious surface, which includes several large parking lots and a large stretch of Rt. 32. This site is located on an incised channel with little observed flow. The stream appears to have been historically channelized but is creating meanders and increasing sinuosity, which is leading to actively eroding and undercutting banks. Less than 80 organisms were identified in the entire benthic sample, which indicates a poor biological community likely resulting from the degraded habitat conditions. Elevated levels of conductivity, possibly due to the high imperviousness in the drainage area, may also be impacting biota.

- Biological condition – “Poor”
- Habitat scores “Partially Supporting” and “Partially Degraded”
- This sample only contained 64 organisms, the majority of which were midges (Diplocladius) and bivalves (Musculium and Pisidiidae).
- Water quality values within COMAR standards but conductivity elevated.
- Instream habitat and epibenthic substrate received marginal scores. Moderately unstable banks. Good riparian width with sub-optimal vegetative protection.
