# Targeted Biological Assessments of Streams in the Little Patuxent Watershed, Anne Arundel County, Maryland: 2011

# Targeted Biological Assessment of Streams in the Little Patuxent Watershed, Anne Arundel County, Maryland: 2011

## August 2011 - DRAFT

KCI Technologies, Inc.  
936 Ridgebrook Road  
Sparks, Maryland 21152

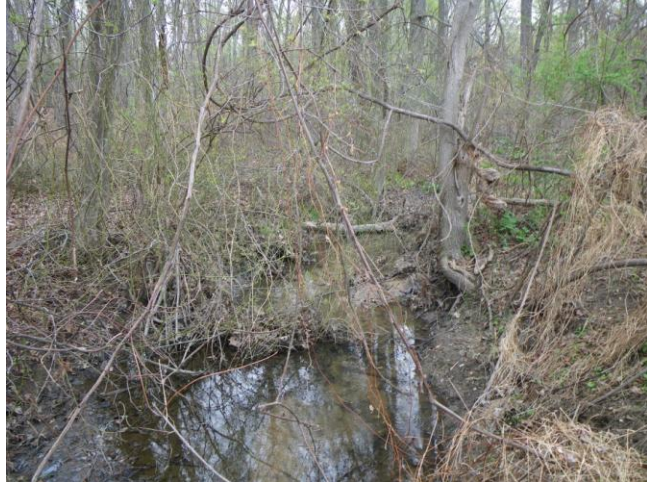
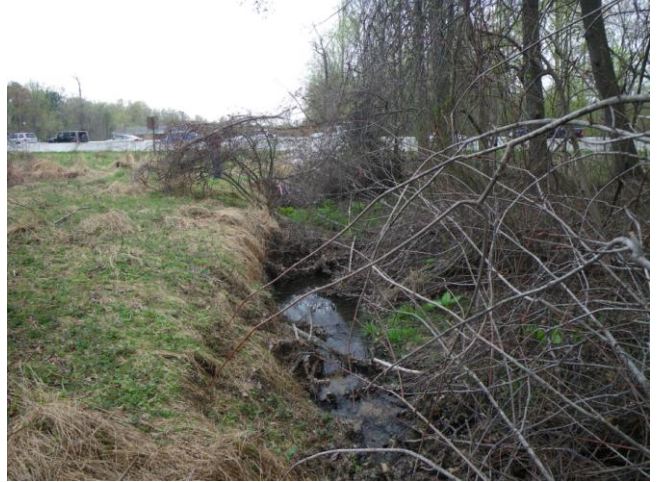
Upstream View:

Located near the intersection of O'Brien Road and Mapes Road immediately downstream of the Fort Meade Golf Course, this site is on an unnamed tributary and is part of the LPN subwatershed. Of the 123 acre drainage area to this site, open space accounts for 41%, developed land accounts for 36%, and forested land accounts for the remaining 24%. Close to one-quarter of the drainage area (22%) is impervious surface. Half of the drainage area to this site drains the Fort Meade Golf Course while the other half drains developed parcels on the Fort Meade Military Reservation. Riparian vegetation along the left bank is mostly cleared due to a utility corridor. Because habitat is supporting and biological condition is poor, there may be problems with water quality in this drainage area that cannot be measured through in situ analysis only. Measured pH values fell below COMAR standards, but it is unclear whether it is due to naturally acidic conditions or anthropogenic disturbance.

- Biological condition – “Poor”
- Habitat scores “Supporting” and “Partially Degraded”
- Midges, black flies (Simulium), and worms (Naididae and Tubificidae) dominated the sample.
- Measured below COMAR standards for pH.
- Poor remoteness score and marginal habitat diversity.

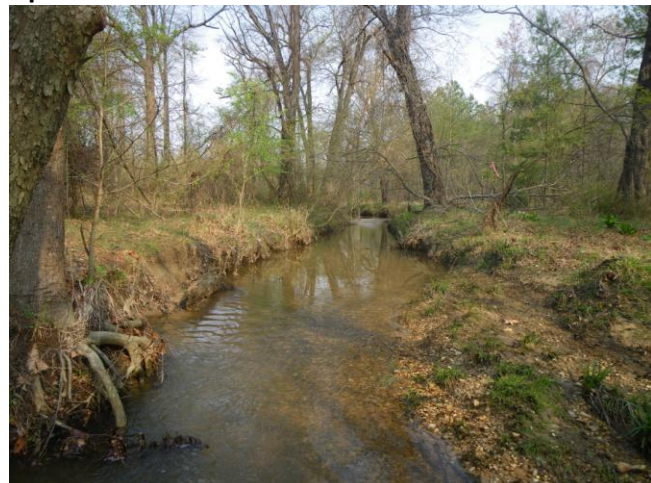
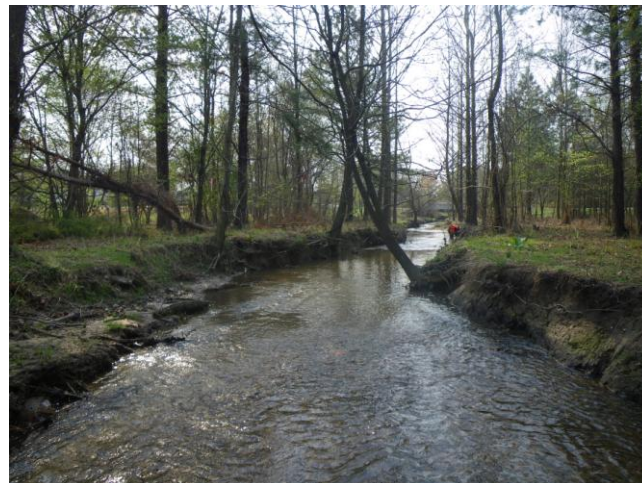
**Upstream View:**

Located near the intersection of Rock Avenue and Leonard Wood Avenue, this site drains a large section of Fort Meade Military Reservation to Rogue Harbor and is part of the LPE subwatershed. An abundance of rootwads and gravel riffles provide stable habitat for a fair biological habitat. There are some areas of active erosion, but the banks are mostly stable. Forty percent of the 1,905 acre drainage area to this site is developed land, with 32% as forested and 25% as open space. One fifth of the drainage area is impervious surface, which may explain the elevated conductivity measured at this site.

- Biological condition – “Fair”
- Habitat scores “Supporting” and “Partially Degraded”
- Sample dominated by midges (Orthocladius, Polypedilum, and Tanytarsus) and black flies (Stenelmis).
- Water quality values within COMAR standards but conductivity elevated.
- Remoteness scored poorly with sub-optimal scores for most of the remaining habitat variables. Good riparian width with sub-optimal vegetative protection.

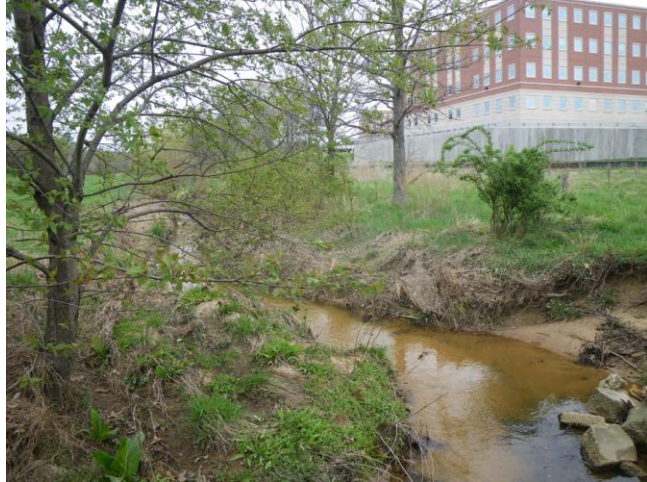
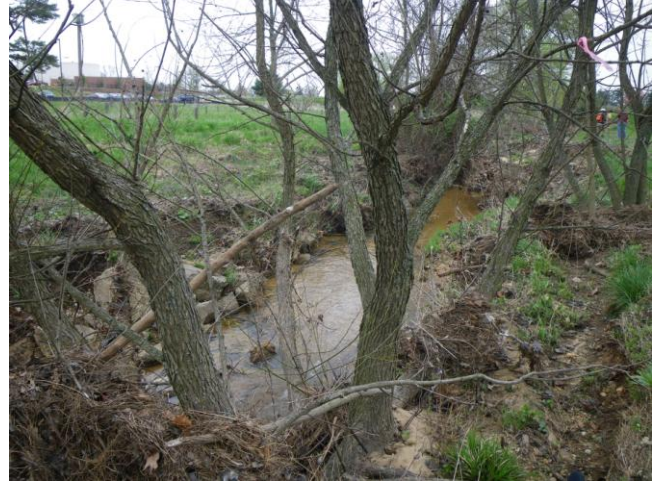
Upstream View:

Located on the Fort Meade Golf Course directly off of Kenyon Loop, this site drains a large section of Fort Meade Military Reservation to Rogue Harbor and is part of the LPE subwatershed. The riparian buffer is severely lacking due to the golf course and active bank erosion is present throughout the site. Numerous pipe outfalls were observed along the right bank, which likely contributed to the elevated conductivity measured at this site. A relatively high taxa diversity (22 taxa), number of scraper taxa, and a high percentage of climbers present in the benthic sample resulted in a fair biological condition rating. Forty percent of the 1,381 acre drainage area to this site is developed land, with 39% as forested and 17% as open space, resulting in 18% impervious cover.

- Biological condition – “Fair”
- Habitat scores “Partially Supporting” and “Severely Degraded”
- Orthocladius (midge) dominated the sample.
- Water quality values within COMAR standards but conductivity elevated.
- Very low woody debris, percent shading, and remoteness scores. Marginal habitat diversity, riparian width, and vegetative protection.

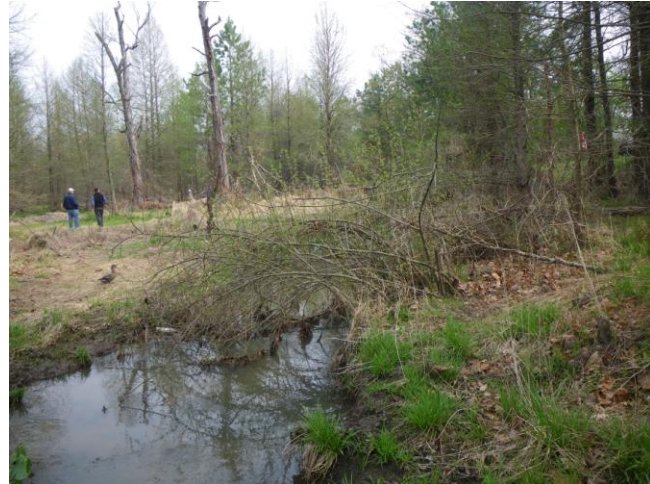
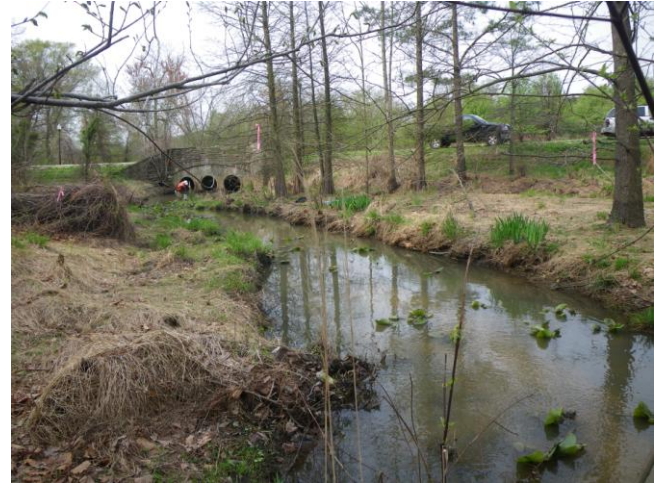
**Upstream View:**

This site is located immediately upstream of Redwood Road and drains to Rogue Harbor in the LPG subwatershed. The entire drainage area of this site (1,082 acres) is within the Fort Meade Military Reservation and consists of 42% developed land, 38% open space, and 19% forested land. Nearly one-quarter of the drainage area (24%) is impervious surface. Elevated levels of conductivity may be a result of the developed land cover upstream. This site is backwatered due to a debris jam at the culvert which is located at the downstream portion of the site. A wet retention pond is located 230 meters upstream from the site and may be altering flow. Despite the poor physical habitat quality, a fair biological community attributed to high taxa diversity (26 taxa), number of scraper taxa, and a high percentage of climbers (46%) present in the benthic sample, as well as the presence of *Caenis*, an intolerant mayfly.

- Biological condition – “Fair”
- Habitat scores “Partially Supporting” and “Severely Degraded”
- Polypedilum (midge) dominated the sample.
- Water quality values within COMAR standards but conductivity elevated.
- Very low woody debris, percent shading, and remoteness scores. Marginal habitat diversity.

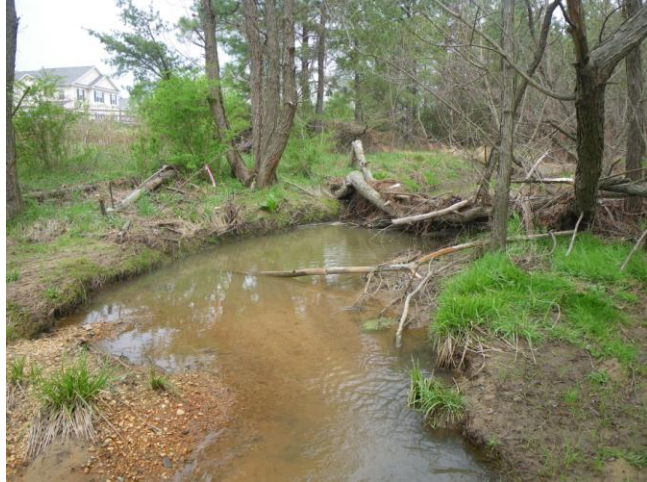
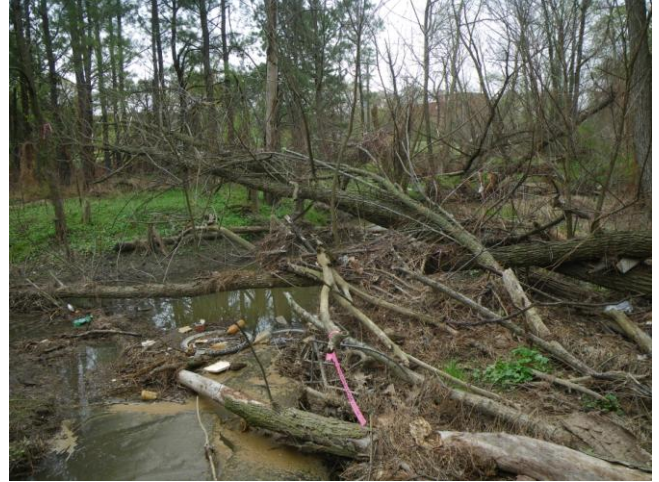
**Upstream View:**

Located immediately upstream of Llewellyn Avenue, this site drains to Rogue Harbor and is part of the LPG subwatershed. The entire drainage area of this site (790 acres) is within the Fort Meade Military Reservation and consists largely of developed and open space (39% for both) with 23% as forested land. Impervious surface accounts for 22% of the drainage area. This site is backwatered a good distance due to a culvert just downstream of the sampling reach and possible beaver activity. Because habitat is supporting and biological condition is poor, there may be problems with water quality in this drainage system that cannot be measured through in situ analysis only. The depressed biological community may be a result of the backwatered condition in the sampling reach.

- Biological condition – *“Poor”*
- Habitat scores *“Supporting”* and *“Degraded”*
- Midges (Orthocladius, Polypedilum, and Tanytarsus) dominated the sample.
- Water quality values within COMAR standards but conductivity elevated.
- Bank stability scored high but habitat diversity received marginal scores. Very poor remoteness score.

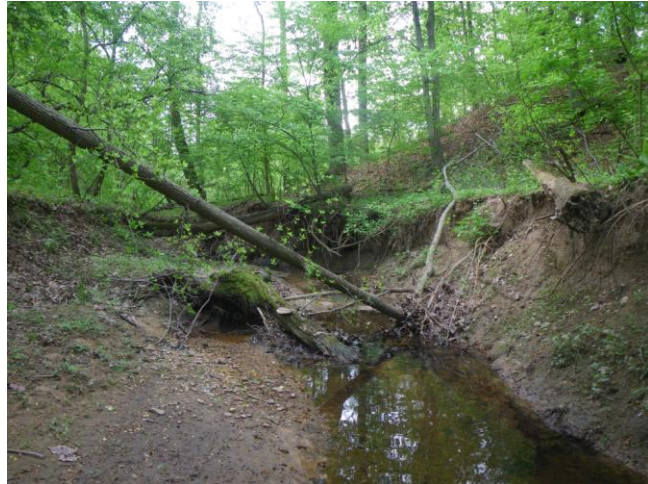
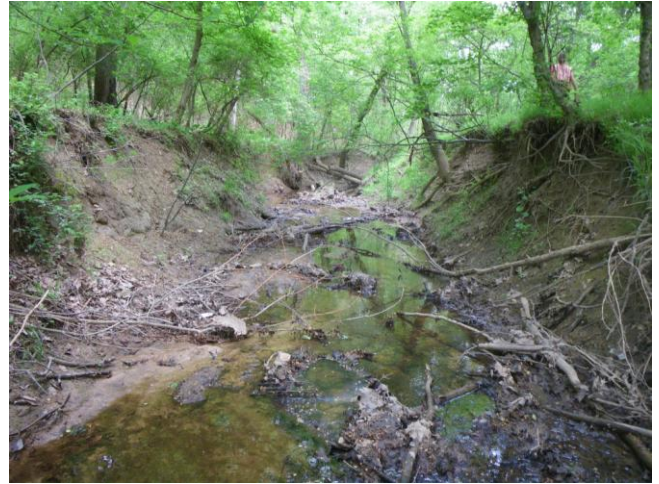
Upstream View:

This site is located approximately 150 meters downstream of Russett Green West and approximately 100 meters upstream of the confluence with the Little Patuxent River in the LP6 subwatershed. Of the 413 acre drainage area, 78% is developed land, the majority of which is high density residential. The remaining 21% of the drainage area is forested land. Nearly one-half of the drainage area (47%) is impervious surface. The site is deeply incised and overwidened with severe erosion on both banks and heavy sediment deposition, likely due to the altered flow regime. Woody debris is abundant but primarily dewatered due to low flow in the channel. Riffle habitat is also present but poor quality. A complete lack of EPT, Ephemeroptera, and taxa intolerant to urban stressors characterize a very poor biological community. Elevated conductivity levels are likely the result of a highly-developed, highly-impervious drainage area, and are potentially indicative of water quality impairment.

- Biological condition – *“Very Poor”*
- Habitat scores *“Non Supporting”* and *“Partially Degraded”*
- Sample dominated by midges (Chironomus, Cricotopus, and Orthocladius) and worms of the Tubificidae family.
- Water quality values within COMAR standards but conductivity elevated.
- Refuse present in moderate amounts. Poor bank stability with marginal habitat diversity. Good riparian width but poor vegetative protection.

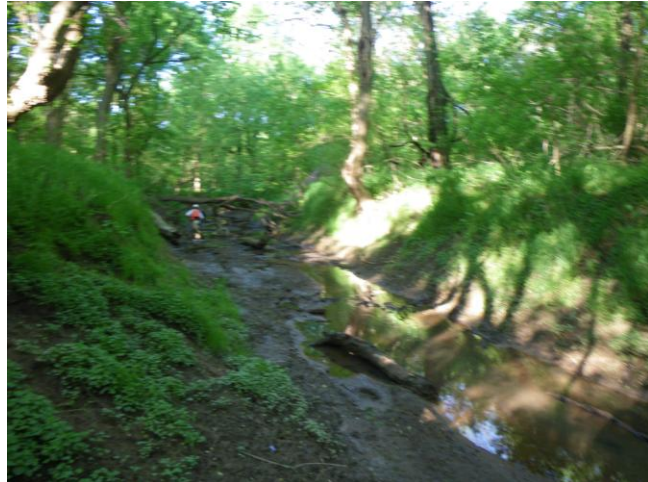
Upstream View:

- Biological condition – *“Very Poor”*
- Habitat scores *“Partially Supporting”* and *“Partially Degraded”*
- Caecidotea (isopod) and Chironomus (midge) dominated the sample.
- Measured below COMAR standards for dissolved oxygen.
- Poor instream habitat with marginal epibenthic substrate. Banks are stable with abundant woody debris. Good riparian width with sub-optimal vegetative protection.

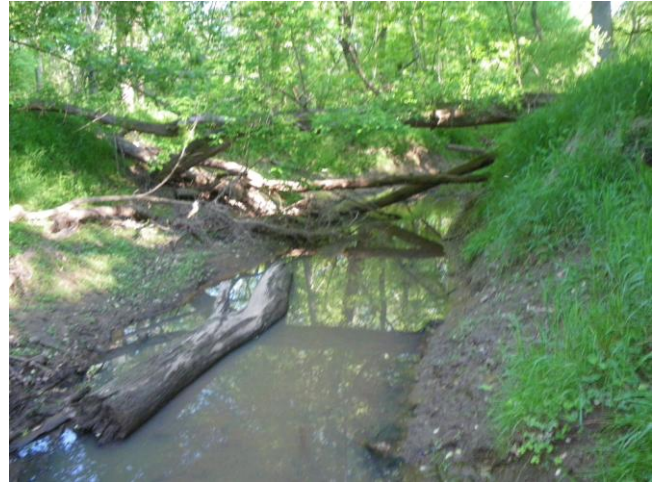
Downstream View:

Located approximately 100 meters upstream of the confluence with the Little Patuxent River, this site is northwest of the Marsh Crossing Drive and Big Pool Road intersection and adjacent to the Oxbow Natural Area in the LP6 subwatershed. Of the 375 acre drainage area to this site, the majority of the land cover is forested (75%) with the remaining 17% and 9% consisting of open space and developed land, respectively. Only 2% of the drainage area is impervious surface. In spite of the heavily forested drainage area, the channel is incised and overwidened with very little flow and a very poor biological community. It appears that the channel has either been historically channelized or is a relic of the abandoned oxbow channel. The benthic sample completely lacked EPT, Ephemeroptera, scraper, and climber taxa; however, half of the taxa were intolerant to urban stressors.

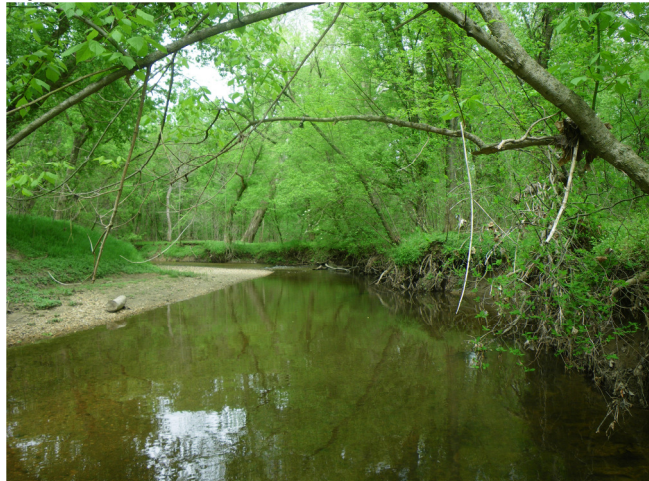
Upstream View:

This site is located on the mainstem of Dorsey Run, approximately 100 meters upstream of the confluence with the Little Patuxent River, just off of the eastbound Route 32 ramp to southbound Baltimore-Washington Parkway (Rt. 295) in the LPI subwatershed. Of the 8,054 acre drainage area to this site, 1,704 acres drains from Howard County. Over one-half of the total drainage area is developed land (56%) with 32% as forested and 11% as open space. More than one-quarter of the drainage area is impervious surface (27%). This site is located on a large, wide channel with a good mix of velocity/depth and stable habitat for benthos; however, large bar formation and active bank erosion is evident, suggesting an unstable stream reach. Gravel riffles of moderate quality and abundant woody debris support a good biological community. The benthic sample for this site had high taxa diversity (31 taxa), 7 EPT, 2 Ephemeroptera, and 7 scraper taxa; but, only 6% of the sample consisted of taxa intolerant to urban stressors. Elevated levels of conductivity, likely resulting from the heavily developed land cover upstream, may be influencing the quantity of intolerant taxa.

- Biological condition – “Good”
- Habitat scores “Supporting” and “Degraded”
- Snails (Amnicola) and bivalves (Musculium) dominated the sample.
- Water quality values within COMAR standards but conductivity elevated.
- Percent shading, remoteness, and woody debris received low scores. Moderately unstable banks with sub-optimal habitat diversity. Good riparian width.

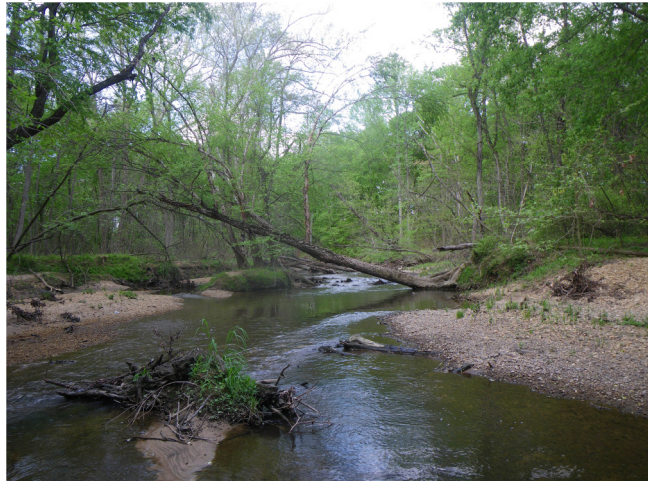
**Upstream View:**

Located on the Dorsey Run mainstem, just prior of the exit at eastbound Route 32 to southbound Baltimore-Washington Parkway (Rt. 295), this site is part of the LPI subwatershed. Of the 7,562 acre drainage area to this site, 1,704 acres drains from Howard County. Over half of the total drainage area is developed land (58%) with 31% as forested and 10% as open space. More than one-quarter of the drainage area is impervious surface (28%). This site is located on a deep, wide channel with extensive bar formation and heavy bank erosion on the outer meanders, likely due to altered flow regimes caused by high imperviousness. Several very deep pools were observed throughout this site. An abundance of woody debris and rootwads provides adequate habitat for a fair biological community. Elevated levels of conductivity may be a result of the developed land cover upstream and may be influencing the quantity of intolerant taxa--only 5% of the benthic sample consisted of taxa intolerant to urban stressors.

- Biological condition – *“Fair”*
- Habitat scores *“Supporting”* and *“Partially Degraded”*
- Worms (Naididae) and midges dominated the sample.
- Water quality values within COMAR standards but conductivity elevated.
- Most habitat variables received sub-optimal scores. Good riparian width with suboptimal vegetative protection.

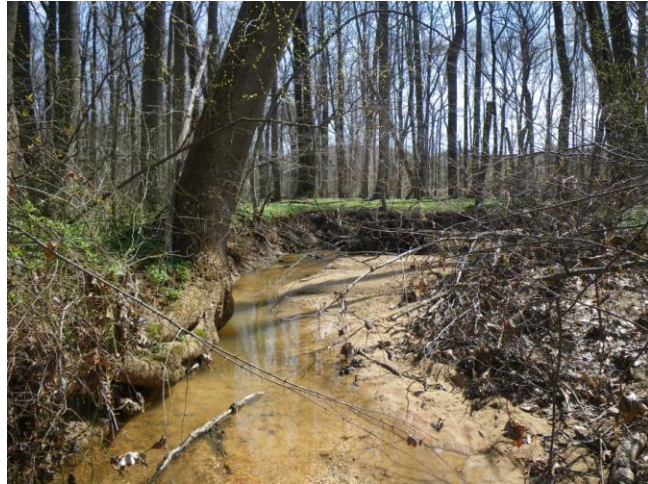
Upstream View:

Located approximately 100 meters upstream from the confluence with Dorsey Run, just off of the exit of Guilford Road to National Business Parkway, this site is part of the LPJ subwatershed. Over half of the 873 acre drainage area to this site is forested land with 26% as developed land with 12% as impervious surface. The stream channel is overwidened and incised with multiple bars throughout, likely due to altered flow regimes caused by development upstream. Both banks are actively eroding. An abundance of woody debris and rootwads, but poor quality riffle habitat, supports a fair biological community. Elevated levels of conductivity may be a result of the developed land cover upstream and may be influencing the quantity of intolerant taxa--only 6% of the benthic sample consisted of taxa intolerant to urban stressors.

- Biological condition – “Fair”
- Habitat scores “Supporting” and “Partially Degraded”
- Midges (Hydrobaenus, Orthocladius, and Parametriocnemus) dominated the sample.
- Water quality values within COMAR standards but conductivity elevated.
- Most habitat variables received sub-optimal scores. Moderately unstable banks. Good riparian width with sub-optimal vegetative protection.

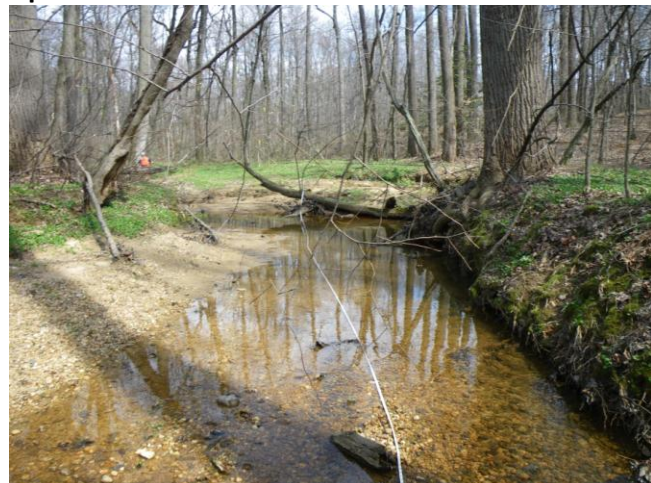
Upstream View:

Located behind the National Business Park located off of the Baltimore Washington Parkway, this site is part of the LPJ subwatershed and drains to Dorsey Run. Of the 535 acre drainage area to this site, over half of the area is forested land (61%) with 24% as developed and 14% as open space. Eleven percent of the drainage area is impervious surface. A trail runs approximately 2 meters from the left bank and multiple bars were observed throughout the site. Good woody debris and rootwad habitat along with some gravel riffles support a fair biological community. Elevated levels of conductivity may be a result of the developed land cover upstream and may be influencing the quantity of intolerant taxa--only 5% of the benthic sample consisted of taxa intolerant to urban stressors.

- Biological condition – “Fair”
- Habitat scores “Supporting” and “Minimally Degraded”
- Sample dominated by Parametrioicnemus (midge).
- Water quality values within COMAR standards but conductivity elevated.
- Most habitat variables received sub-optimal scores. Good riparian width with suboptimal vegetative protection.

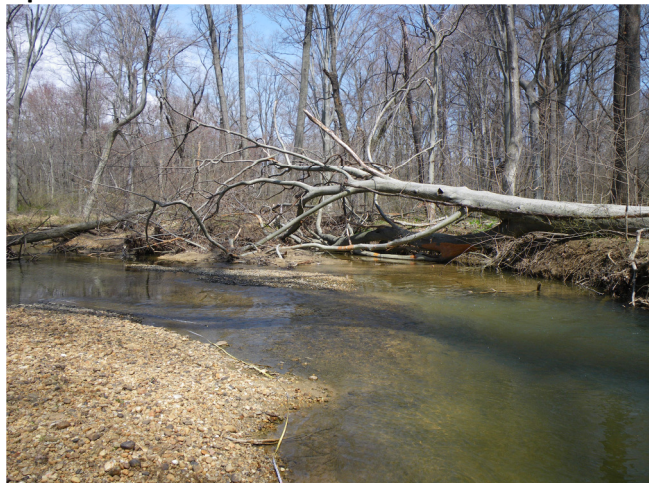
Upstream View:

Located on the Dorsey Run mainstem, just off of the exit of Guilford Road to National Business Parkway, this site is part of the LPH subwatershed. Of the 6,321 acre drainage area to this site, 1,704 acres drains from Howard County. Over half of the total drainage area is developed land (64%) with 26% as forested and 10% as open space. Almost one-third of the drainage area is impervious surface (30%). This channel is overwidened with large mid-channel and point bars, likely due to altered flow regimes caused by high imperviousness. Several deep pools with cover provide good habitat for fish. A good mix of gravel riffles, rootwads, and wood provide diverse habitat for benthic macroinvertebrates. However, the biological community was poor due to the complete lack of Ephemeroptera taxa and taxa intolerant to urban stressors. Elevated levels of conductivity may be a result of the highly-developed land cover upstream and are likely influencing the quantity of intolerant taxa. Because habitat is supporting and biological condition is poor, there may be additional water quality impairments, other than elevated conductivity, in this drainage area that cannot be measured through in situ analysis only.

- Biological condition – *“Poor”*
- Habitat scores *“Supporting”* and *“Partially Degraded”*
- Orthocladius (midge) dominated the sample.
- Water quality values within COMAR standards but conductivity elevated.
- Most habitat variables received sub-optimal scores. Refuse present in moderate amounts. Good riparian width with sub-optimal vegetative protection.

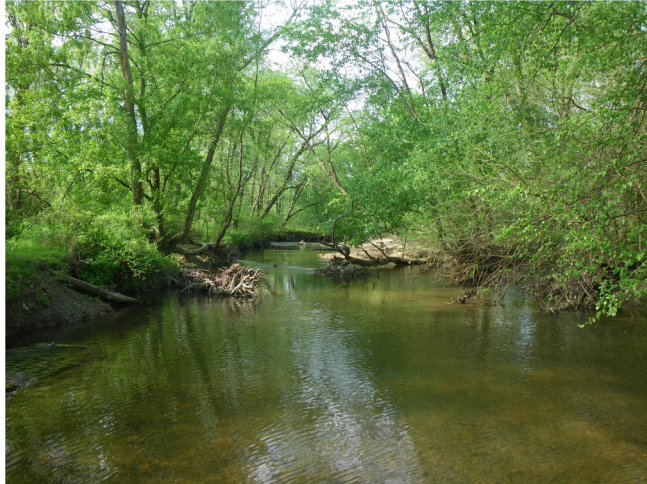
Upstream View:

Located on the mainstem of Dorsey Run just off of Brock Bridge Road, this site is part of the LPH subwatershed. Of the 5,994 acre drainage area to this site, 1,632 acres drains from Howard County. Over half of the total drainage area is developed land (63%) with 26% as forested and 10% as open space. Nearly one-third of the drainage area is impervious surface (30%). This site is a large, overwidened channel with many mid-channel and point bars, likely due to altered flow regimes caused by high imperviousness. There is a good mix of velocity/depth and an abundance of large woody debris in deep pools provides good habitat for fish. The presence of moderate quality gravel riffles provides some stable habitat for a poor biological community. Elevated conductivity levels may be a result of the highly-developed land cover upstream, much of which is industrial/commercial development, and may be influencing the quantity of intolerant taxa--only 5% of the benthic sample consisted of taxa intolerant to urban stressors. Because habitat is supporting and biological condition is poor, there may be problems with water quality in this drainage system, as indicated by the elevated conductivity readings, which are impacting the biota.

- Biological condition – *“Poor”*
- Habitat scores *“Supporting”* and *“Partially Degraded”*
- Worms of the Naididae family dominated the sample.
- Water quality values within COMAR standards but conductivity elevated.
- Most habitat variables received sub-optimal scores. Good riparian width with suboptimal vegetative protection.

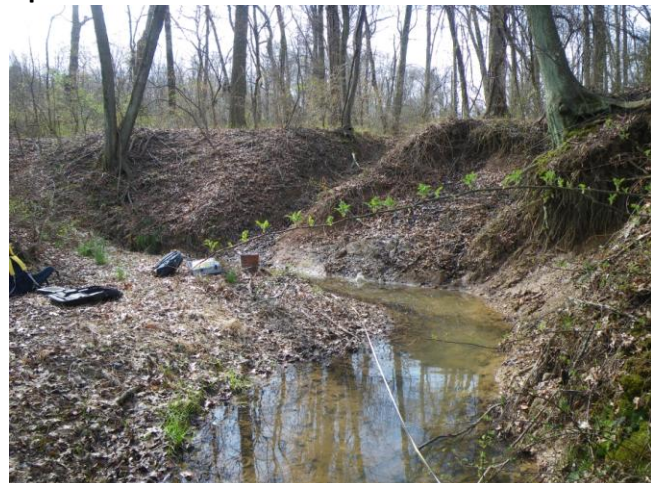
Upstream View:

Located just off of Race Road between Citrus Avenue and Sellner Road, this site is part of the LPK subwatershed. This site is deeply incised most likely due to a road culvert located just upstream. A 2 foot drop below the culvert is causing a severe fish blockage. The reach is overwidened leading to mid-channel bars and areas of active bank erosion, indicating an unstable stream type. Shallow, poor quality riffles provide inadequate habitat leading to a very poor biological community with low taxa diversity. There was a complete lack of Ephemeroptera taxa and climber taxa in the benthic sample; however over half of the sample (59%) consisted of taxa intolerant to urban stressors. The small drainage area to this site (89 acres) is largely forested land (79%) with 17% as developed land. Only 9% of the drainage area is impervious surface. Conductivity levels were elevated considerably, possibly due to highway runoff from Baltimore-Washington Parkway (Rt. 295) and Jessup Road (Rt. 175) or from the corrugated metal culvert pipe immediately upstream of the sampling reach.

- Biological condition – *“Very Poor”*
- Habitat scores *“Non Supporting”* and *“Degraded”*
- Midges (Hydrobaenus) and black flies (Stegopterna) dominated the sample.
- Water quality values within COMAR standards but conductivity elevated.
- Moderately unstable banks, poor instream habitat, and marginal epibenthic substrate. Refuse present in moderate amounts.

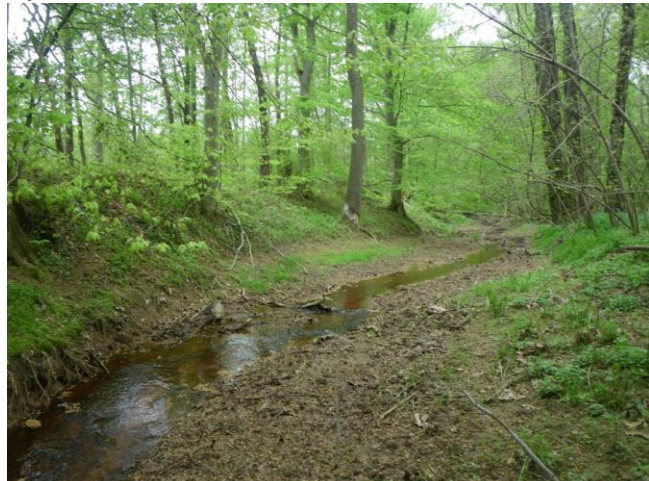
Upstream View:

Located in the Patuxent Research Refuge just west of Wildlife Loop Road, this site is part of the LP4 subwatershed. The majority of the 596 acre drainage area to this site is forested land (94%) with 6% as open space. Less than 1% of the entire drainage area is impervious surface (0.2%). This site is a low gradient stream on the floodplain of the Little Patuxent River with reduced flow due to debris jams just upstream. With an entirely silt/sand bottom, there is very little stable habitat and an abundance of fine particulate organic matter. A complete lack of EPT, Ephemeroptera, and scraper taxa resulted in a very poor biological community. Although habitat is partially supporting, instream habitat and epifaunal substrate were rated in the poor categories, limiting the streams ability to support a diverse biological community. Furthermore, the acidic pH values (below COMAR standards), which appear to be naturally influenced by the surrounding wetland system draining to the site, may further limit the biological potential of this stream.

- Biological condition – “Very Poor”
- Habitat scores “Partially Supporting” and “Partially Degraded”
- Amphipods (Crangonyx) and bivalves (Musculium) dominated the sample.
- Measured below COMAR standards for pH.
- Poor habitat diversity but banks are stable. Very little woody debris present. Good riparian width with sub-optimal vegetative protection.
