Little Patuxent Watershed Assessment

Comprehensive Summary Report

June 2016

Prepared by:
Anne Arundel County
Department of Public Works
Bureau of Engineering
Watershed Protection and
Restoration Program (WPRP)

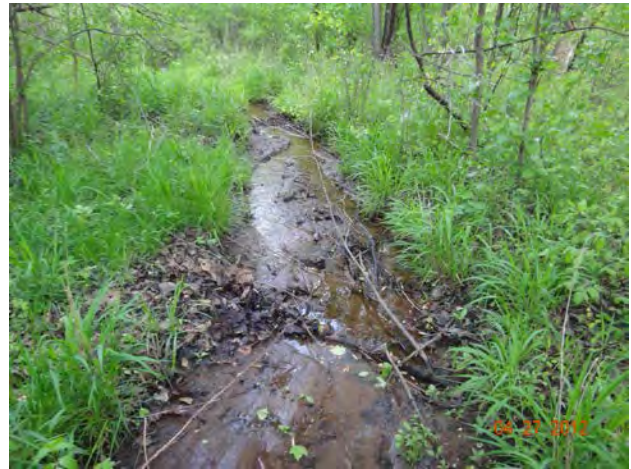
Figure 2-1 - Examples of Assessed Stream Reaches

Stream Reach in the Crofton Golf Subwatershed (LPG) with Minimally Degraded Habitat Condition

Physical habitat condition is a widely used measure of the overall health of a stream and its ability to support aquatic life. Healthy physical habitat for aquatic organisms is typically comprised of stable channels and substrates, diverse flow characteristics, and abundant cover and food sources. Natural streams are typically in a state of dynamic equilibrium. However, this equilibrium can be disrupted. Habitat parameters common in healthy streams begin to deteriorate when increased urban and agricultural stressors are introduced. Examples of assessed stream reaches are depicted in Figure 2-1.

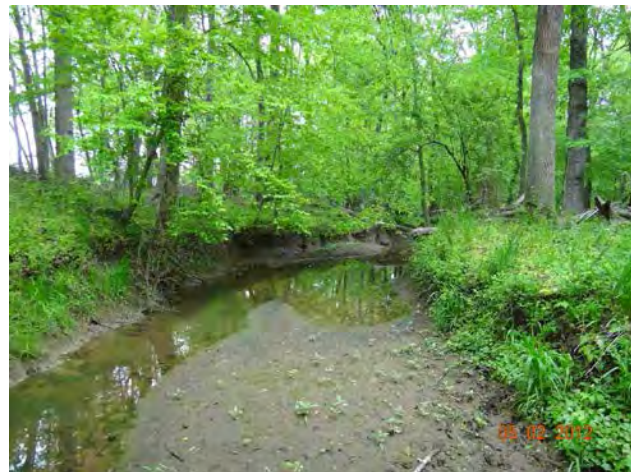
Stream Reach in the Dorsey Run 3 Subwatershed (LP2) with Partially Degraded Habitat Condition

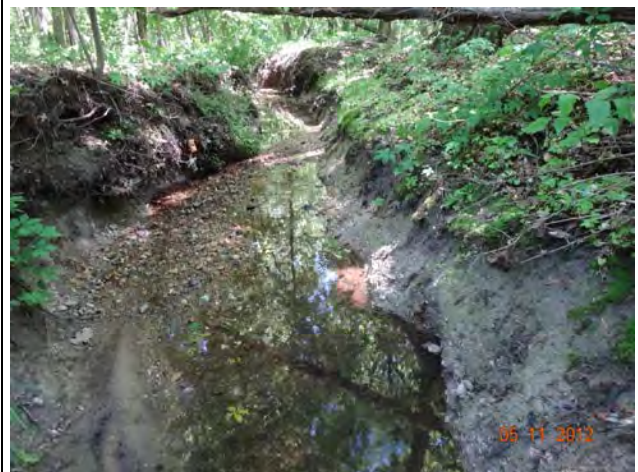
Stream Reach in Towsers Branch 1 Subwatershed (LP3) with Degraded Habitat Condition

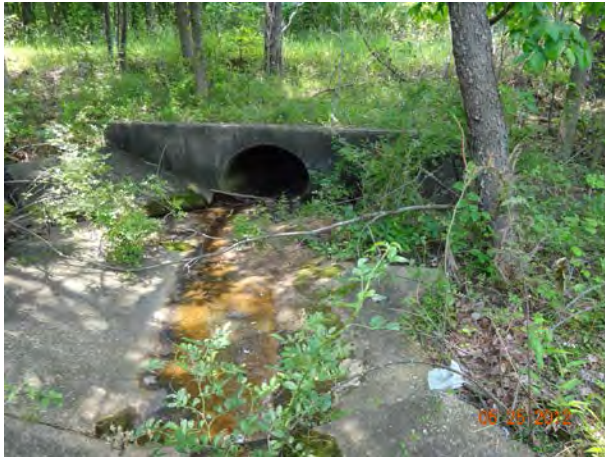
Crossing in the Oak Hill Subwatershed (LPA) with Moderate Impact Score

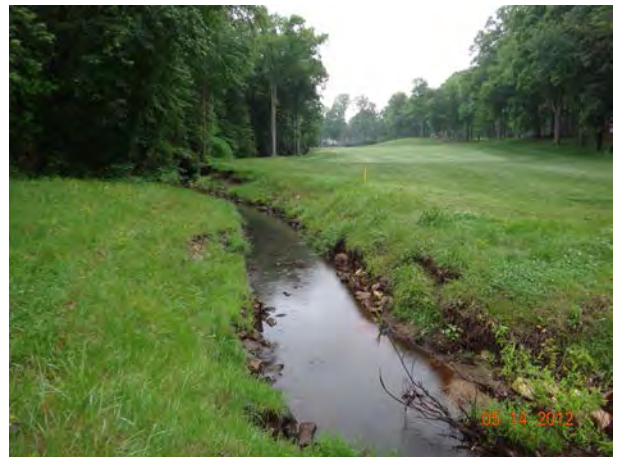
Deficient Buffer in the Crofton Golf Subwatershed (LPG) with Moderate Impact Score

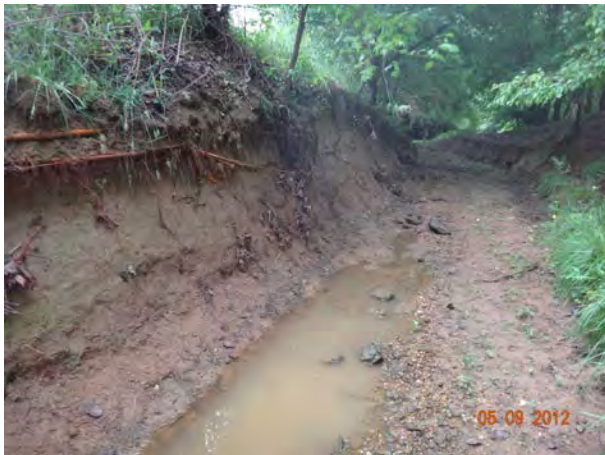
Bank Erosion in the Towsers Branch 2 Subwatershed (LP6) with Moderate Impact Score

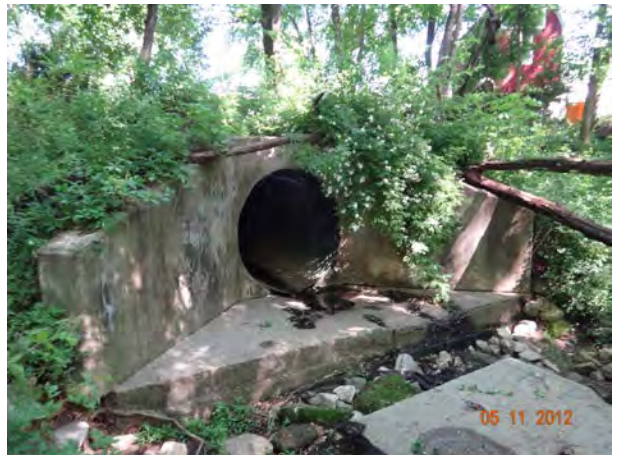
Outfall in the Towsers Branch 1 Subwatershed (LP3) with Moderate Impact Score

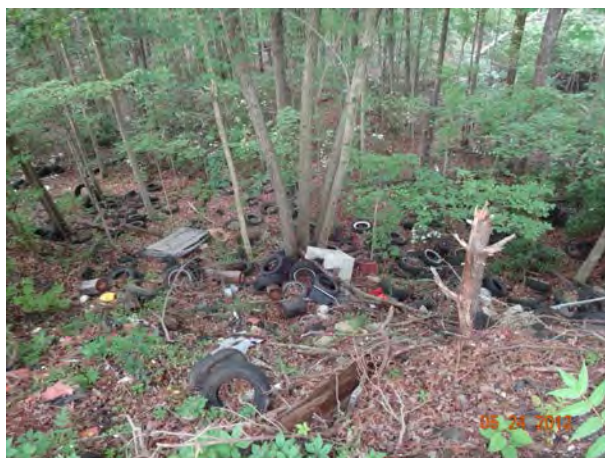
Washdown from Dumpsite in the Oak Hill Subwatershed (LPA)

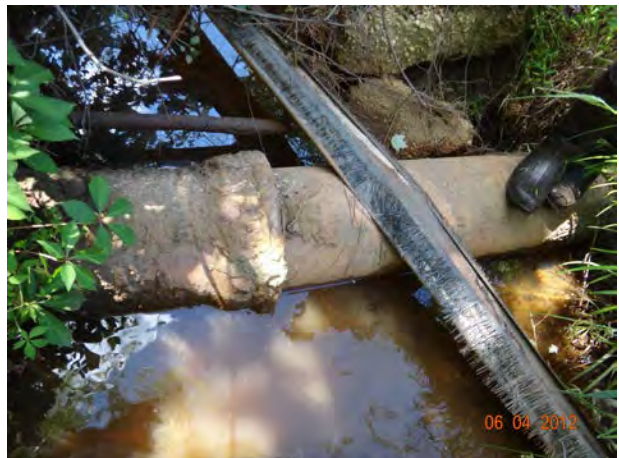
Exposed Utility in the Little Patuxent 2 Subwatershed (LP0) with Moderate Impact Score

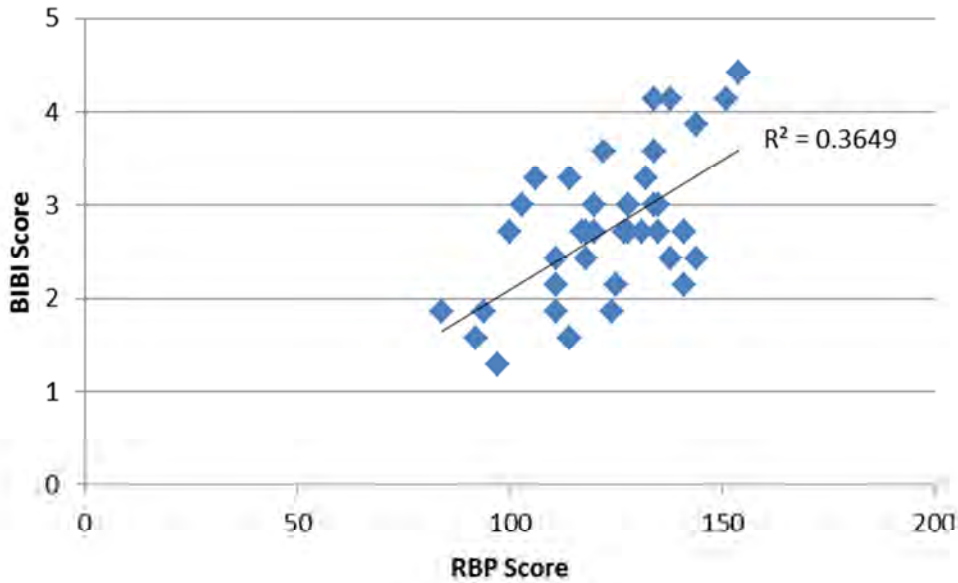
Figure 10 – Relationship between RBP habitat assessment score and BIBI score for 40 targeted sites in the Little Patuxent watershed.

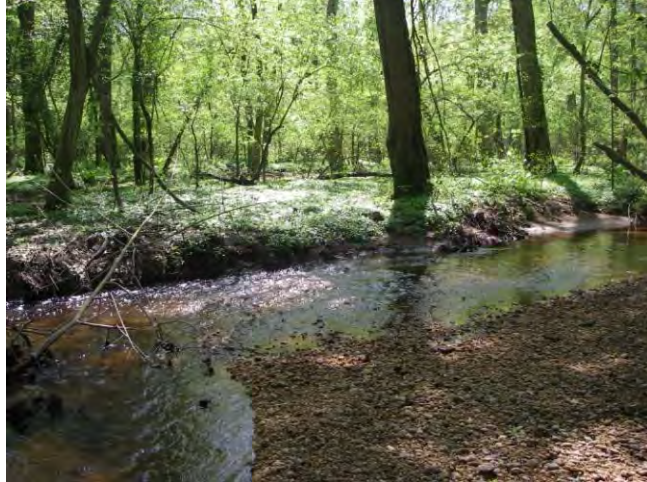
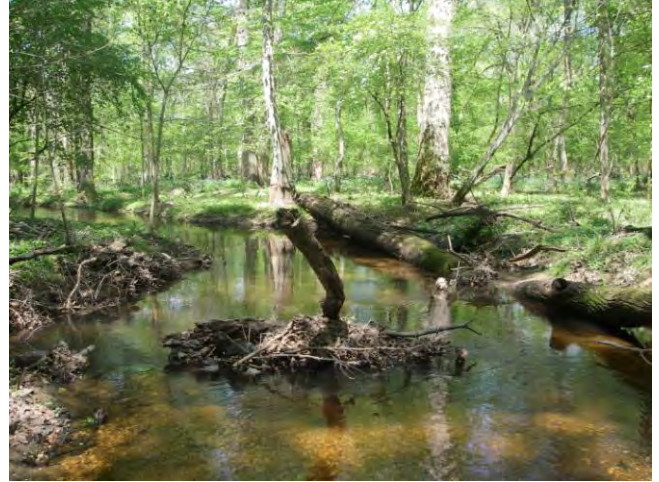
Upstream View:

This site is located west of Crain Highway (Rt. 3) approximately 200 meters upstream of the confluence with the Little Patuxent River and is part of the LPA subwatershed. With over 60% as developed land, the drainage area to this site (1,616 acres) contains the entire Crofton Country Club property as well as multiple high density residential communities. This reach was within the floodplain of the Little Patuxent River and as a result was backwatered. Less than 80 organisms were identified in the entire benthic sample, which indicates a poor biological community. Water quality measured below COMAR standards for pH and elevated conductivity, which may impact the biologic community. Because habitat is supporting and biological condition is poor, there may be problems with water quality in this drainage system that cannot be measured through in situ analysis only.

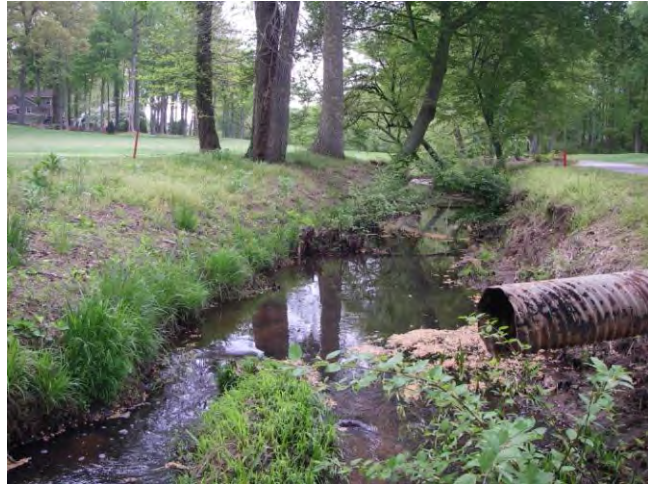
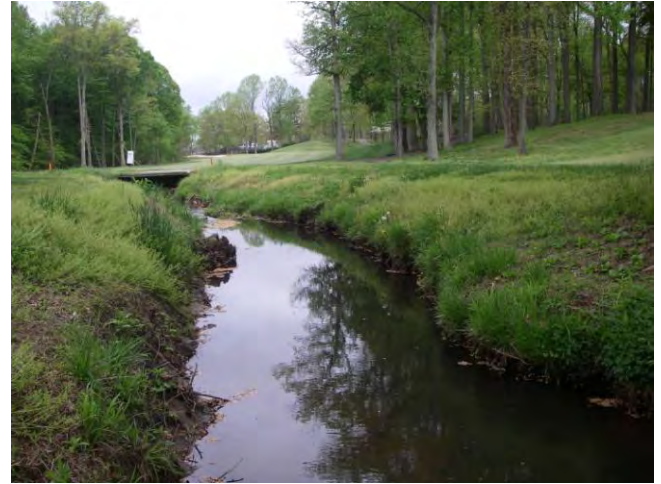
Upstream View:

Located east of Crain Highway (State Route 3), this site is part of the LPA subwatershed. With close to 60% as developed land, the drainage area to this site (1,131 acres) contains half of the Crofton Country Club property as well as multiple high density residential communities. This site is located on the Crofton Country Club golf course where a golf cart road runs along the entire right bank of the sampling reach with little to no buffer due to mowed grass and few trees. Low pH and elevated conductivity may be attributed to multiple direct drainage inputs and lack of adequate vegetative protection/buffer. In spite of the partially supporting/severely degraded habitat, high taxa diversity (27 taxa present) including 3 EPT taxa and 2 Ephemeroptera taxa resulted in a biological community that is fair. Since the biological community exceeds the physical habitat potential, nutrient enrichment may be present, especially considering the surrounding golf course land use.

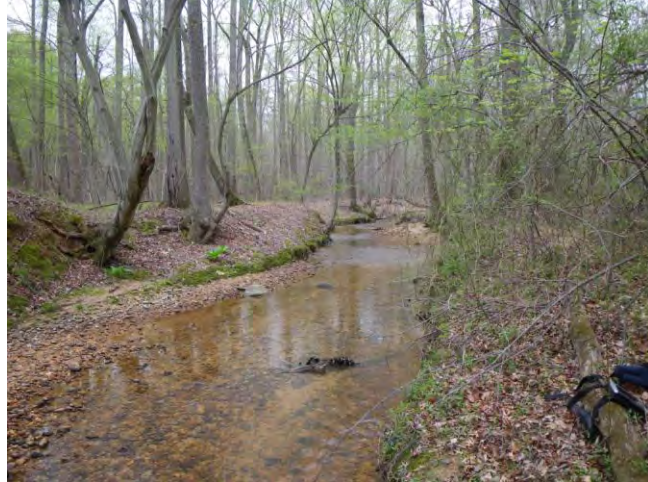
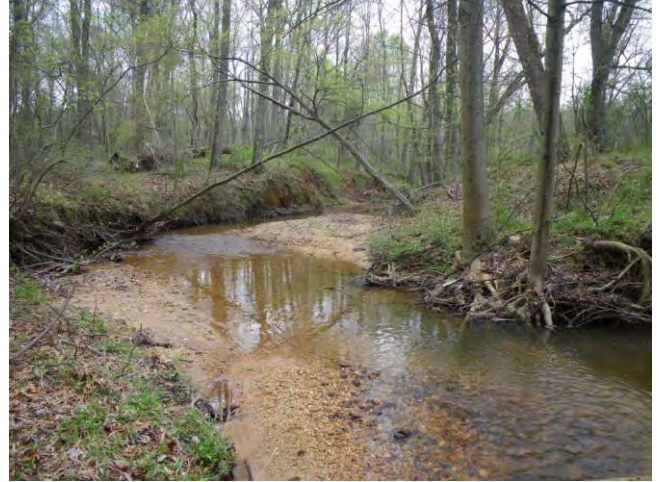
Upstream View:

Located off of Welchs Court and Waters Road, behind a mobile home park, this site is part of the LPM subwatershed. Of the 985 acre drainage area to this site, over 75% is forested land with approximately 10% total impervious surface. All measured water quality parameters were within COMAR standards. The abundance of good quality cobble and large gravel riffles, good velocity and depth diversity, and overall supporting physical habitat quality resulted in a fair biological community with high taxa diversity (33) and numerous EPT taxa (6) and scraper taxa (4).

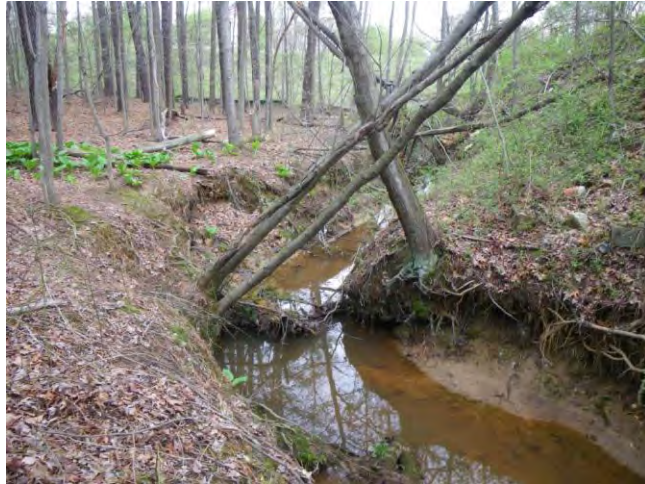
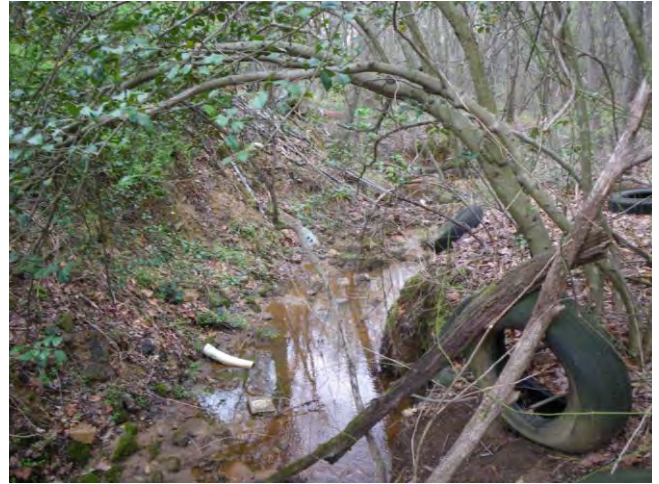
Upstream View:

Located off of Fort Meade Road (Rt. 198), this site is part of the LPM subwatershed. This sampling reach runs adjacent to a parking lot with excessive dumping on the left bank and into the channel. The site is also located immediately downstream of culvert and rip-rap stabilization. As a result, the site has very poor habitat and the channel is deeply incised with areas of severe bank erosion and undercutting. Of the 176 acre drainage area to this site, close to half consists of developed land, 28% of which is commercial property including the Arundel Gateway Business Park as well as portions of Baltimore-Washington Parkway and Rt. 198. The remaining 46% of the drainage area is forested land. Water quality measurements indicated elevated conductivity, which may be attributed to the high percentage of impervious surface (31%) within the drainage area. The lack of EPT, intolerant, or scraper taxa in this sample are indicators of a very poor biological community.

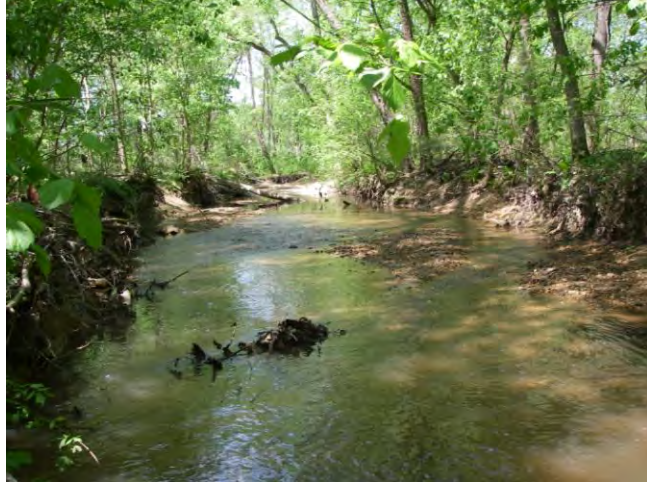
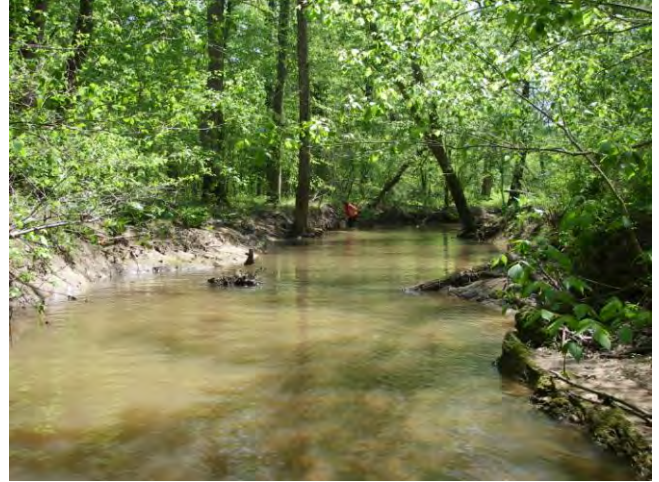
Upstream View:

Located on the Towsers Branch mainstem approximately 150 meters upstream of the confluence with the Little Patuxent River and downstream of the crossing at Capitol Raceway Road, this site is part of the LPD subwatershed. Of the 4,248 acre drainage area, over half is developed land with 31% as high density residential. Approximately one-fourth of the drainage area is impervious, which may attribute to the elevated conductivity values measured at the site. This site also fell below COMAR standards for pH; however, this may be due to wetland drainage upstream. The channel is overwidened with actively eroding silt/clay banks indicating an unstable stream. The partially supporting habitat limits the benthic community, resulting in a poor biological rating. No EPT taxa were present in the benthic sample with only 2% intolerant urban taxa.

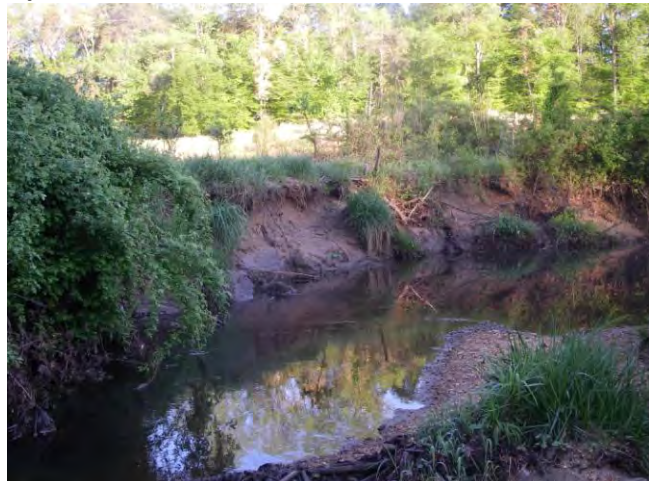
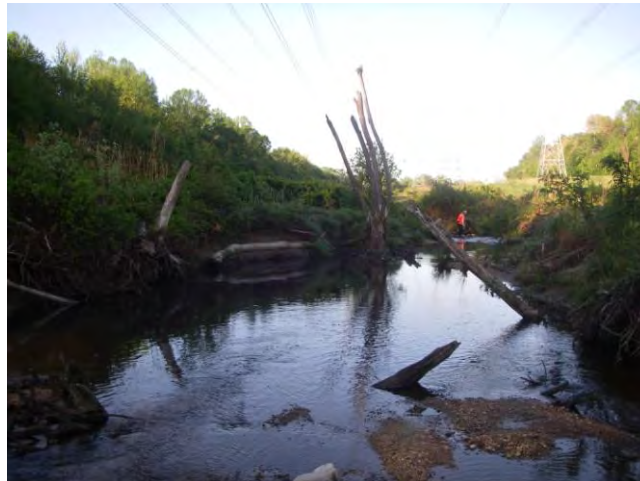
Upstream View:

This site is located on Towsers Branch mainstem immediately downstream of the crossing at Evergreen Road off of Crain Highway and is part of the LPD subwatershed. Abundant woody debris with some riffle habitat and very deep pools are present throughout the stream. Of the 3,431 acre drainage area to this site, half consists of developed land with the remaining 21% as forested, 20% as agriculture, and 10% as open space. Several holding ponds from the adjacent quarry operation appear to drain into the stream just upstream of the sampling reach. A powerline corridor runs the entire length of the left bank of the site which results in poor vegetative protection and riparian buffer. The channel is also incised with actively eroded stream banks indicating an unstable stream type. Insufficient physical habitat and potential water quality impairment, including low pH and elevated conductivity, likely contribute to a poor biological community. Only 4% of the benthic sample consisted of intolerant urban taxa with only one EPT taxa present.

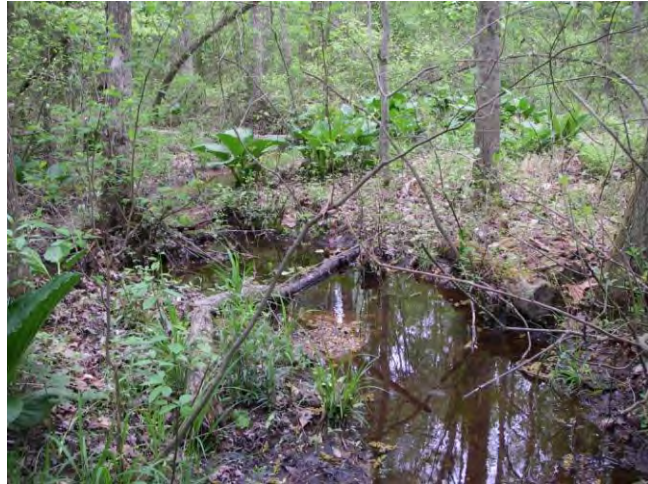
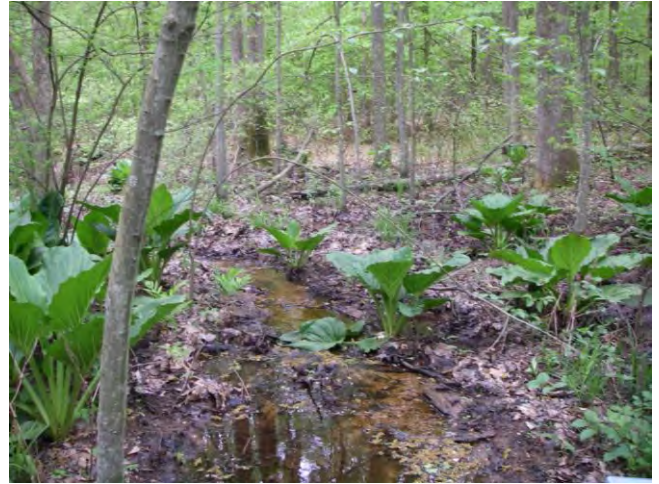
Upstream View:

Located behind houses along Meyers Station Road, this site is part of the LP1 subwatershed and drains to the Little Patuxent River. The drainage area to this site (105 acres) is largely forested land (87%) with only 1.5% impervious surface. This site is on a small channel that runs through a wetland and has full floodplain access on both banks. Riffle habitat and woody debris support high scores for physical habitat; however, the lack of Ephemeroptera and scraper taxa in the subsample resulted in a poor biological score. Because habitat is supporting and biological condition is poor, there may be problems with water quality in this drainage area that cannot be measured through in situ analysis only. Measured pH values fell below COMAR standards, but this is likely to be influenced by the surrounding wetland system that drains to the site.

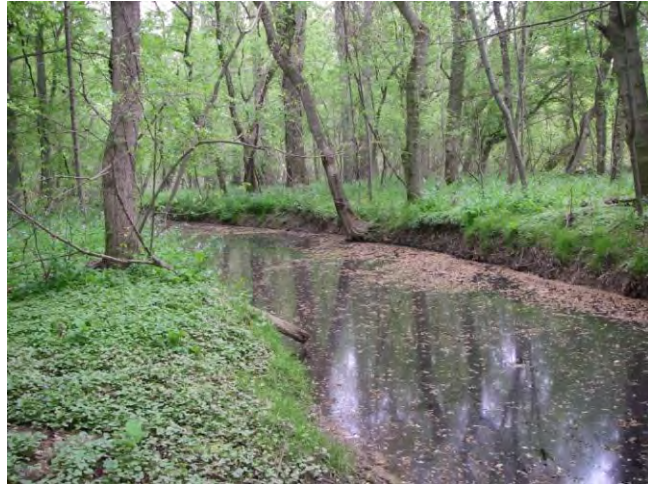
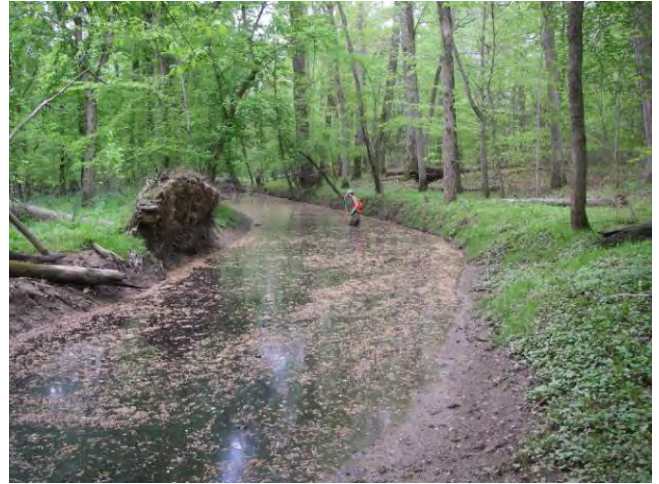
Upstream View:

Located on the Little Patuxent River floodplain between Grays Ford Road and Crain Highway (State Route 3), this site is part of the LP1 subwatershed. Because this site is located approximately 100 meters upstream of the confluence with the Little Patuxent River, the sampling reach was backwatered pool habitat with little observable flow. Low dissolved oxygen levels measured at this site are largely attributed to the stream being backwatered with little mixing occurring in the water column. Few woody debris and fibrous roots along the banks provided only minimal stable habitat for the benthic community. In spite of the partially supporting habitat, 21 taxa were present in the benthic sample with one Ephemeroptera taxa and one scraper taxa present. Of the 169 acre drainage area, 46% is forested land and 30% is developed land with only 1.7% impervious surface. However, it should be noted that the one large developed parcel (classified as industrial land use), appears to never have been fully developed and is more characteristic of open land, hence the low imperviousness in this drainage area.

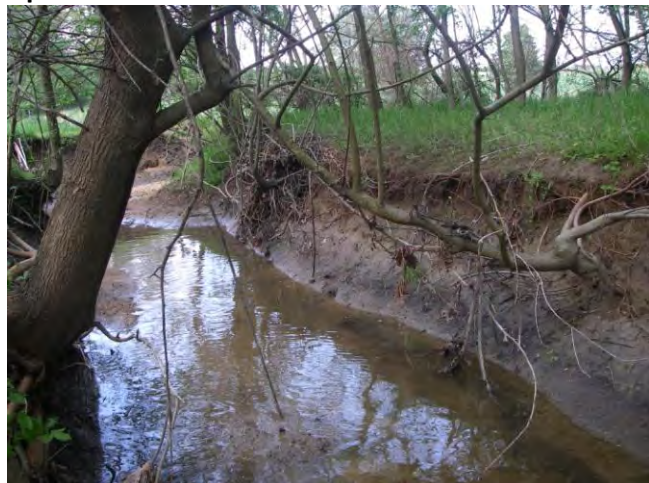
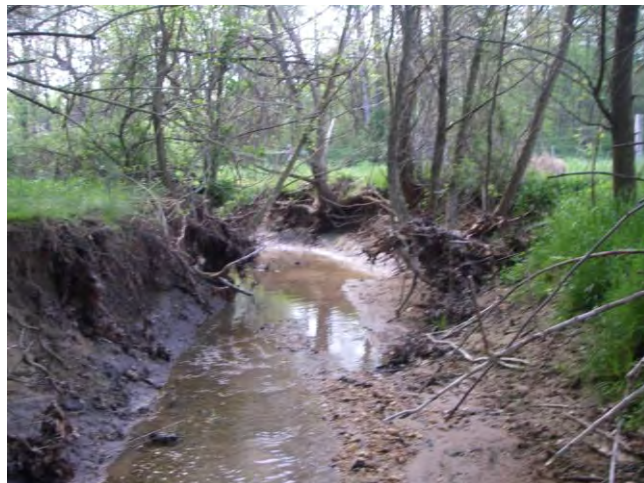
Upstream View:

Located at the end of Springhill Court, this site is part of the LPC subwatershed and drains to Towsers Branch. Of the 1,001 acre drainage area to the site, over half consists of agricultural land-- the majority of which is the US Naval Academy Dairy Farm, with developed land accounting for 23% of the drainage area. This channel is deeply incised with a severely eroded stream banks, indicating an unstable stream reach. Poor quality riffles and an overall lack of stable substrate resulted in non-supporting physical habitat. No EPT or scraper taxa were present in the benthic sample and only 1% of the sample consisted of intolerant urban taxa. Measured pH values fell below COMAR standards, but this may be due to naturally occurring acidic conditions.

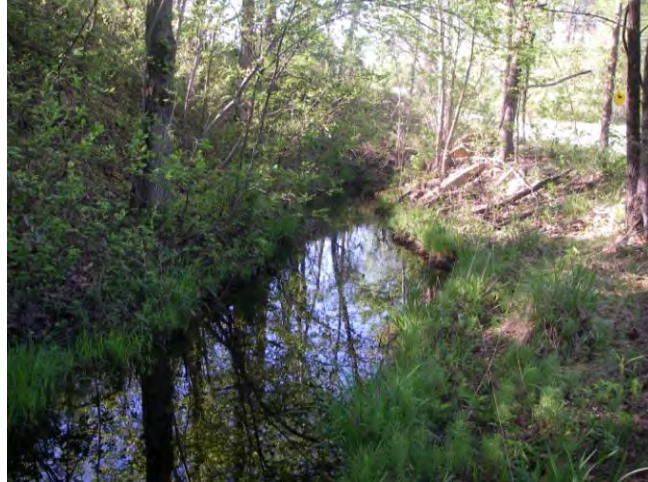
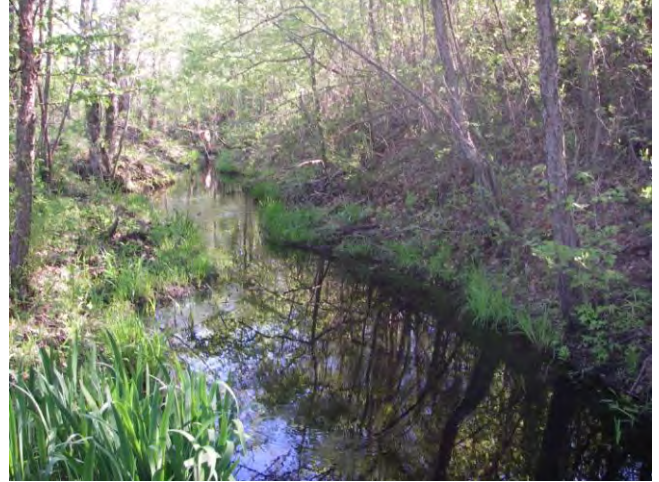
Upstream View:

Located immediately downstream of Patuxent Road, this site is part of the LP2 subwatershed. This site drains a large wetland system upstream of the road crossing and into a large wetland downstream, and as a result the site was slightly backwatered. Low dissolved oxygen and pH values measured at this site are largely attributed to the wetland drainage and subsequent backwatering with little mixing occurring in the water column. Forested land accounts for 73% of the drainage area to this site with developed land accounting for 17%. Of the 366 acre drainage area, only 1.8% is impervious. However, a complete lack of EPT, Ephemeroptera, and scraper taxa resulted in a poor biological community.

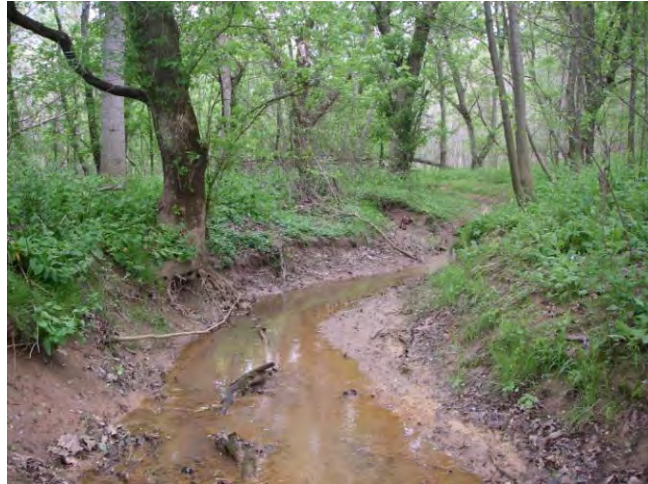
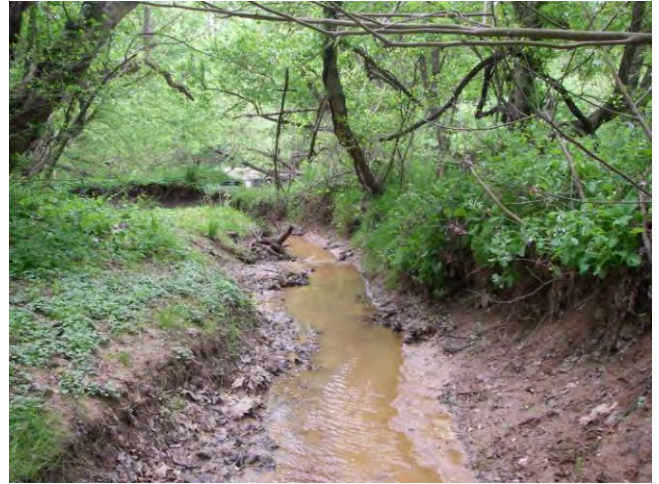
Upstream View:

Located approximately 0.4 miles northeast of the intersection of Patuxent Road and Bragers Road, this site is part of the LP2 subwatershed. This site is located approximately 50 meters upstream of the confluence with the Little Patuxent River, and consequently the downstream end of the reach was backwatered. Poor quality riffles in a silt/clay substrate and minimal woody debris provide inadequate epifaunal substrate, resulting in a poor biological community. Because the sampling reach is located on the active floodplain of the Little Patuxent River, the local physical habitat is being influenced by backwatering and fine sediment deposition. Of the 277 acre drainage area to the site, only 6% is impervious surface. Half of the drainage area consists of forested land with the remaining 39% as open and 11% as developed land; however, it should be noted that the majority of the land classified as open is an active quarry operation.

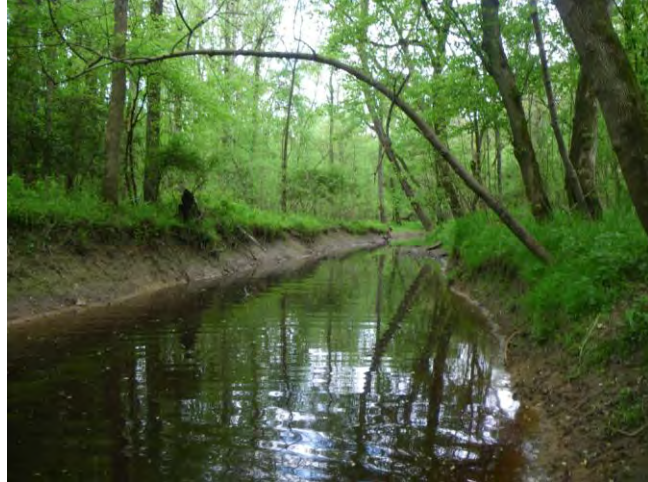
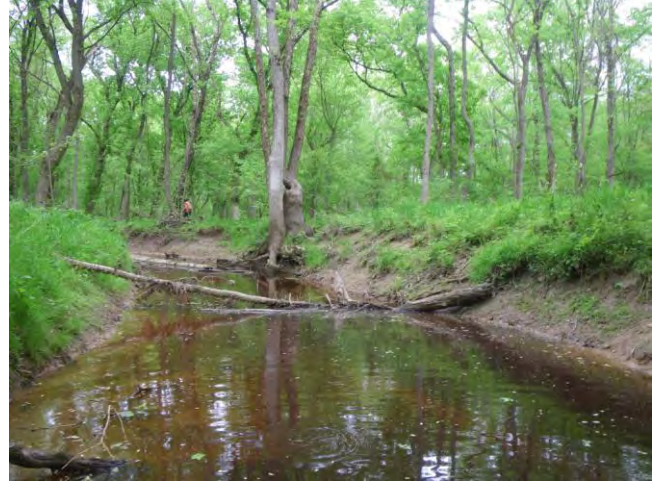
This site is located approximately 200 meters northeast of Patuxent Road and is part of the LP3 subwatershed. The drainage area to this site (798 acres) is largely forested land (85%) with only 3% impervious surface. However, because the stream is located approximately 200 meters upstream of the confluence with the Little Patuxent River, this site was predominantly backwatered with virtually no visible flow. Low dissolved oxygen levels measured at this site are largely attributed to the stream being backwatered with little mixing occurring in the water column. Poor physical habitat consisted of mostly deep pools with anaerobic silt/muck bottom, insufficient for supporting a robust biological community. Measured pH values fell below COMAR standards, which is likely due to wetland drainage as evidenced by the tannic color of the water.

- Biological condition – *“Poor”*
- Habitat scores *“Non Supporting”* and *“Degraded”*
- Sample dominated by midges (*Serromyia* and *Chironomus*) and worms (*Tubificidae*).
- Measured below COMAR standards for pH and dissolved oxygen.
- Marginal habitat diversity but good riparian vegetation. Banks are moderately unstable. Good riparian width but marginal vegetative protection on the left bank.

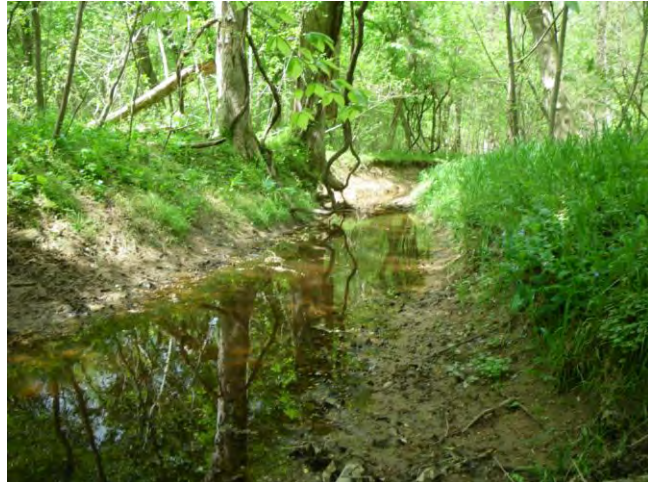
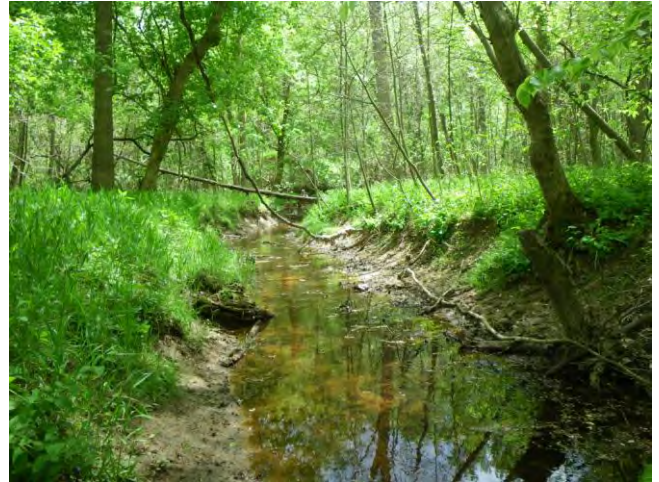
Located approximately 300 meters east of Patuxent Road, this site is part of the LP3 subwatershed. The drainage area to this site (385 acres) is predominantly forested land (83%), which includes property on the Patuxent Research Refuge. Located on the floodplain of the Little Patuxent River, this site drains an extensive wetland area. With very little flow, the site is an entrenched channel with a silt/sand bottom and an abundance of detrital material. Although the site received a partially supporting habitat score, epifaunal substrate was only marginal, resulting in a poor biological community which contained only one EPT taxa, lacked Ephemeroptera taxa, and consisted of just 6% intolerant taxa in the benthic sample. All measured water quality parameters fell within COMAR standards. Impacts from historical land use (deforestation, channelization, etc.) may continue to limit the stream's ability to support a healthy biota.

- Biological condition – “Very Poor”
- Habitat scores “Partially Supporting” and “Partially Degraded”
- Amphipods (Crangonyx) and midges dominated the sample.
- Water quality values within COMAR standards.
- Moderately stable banks with marginal habitat diversity. Good riparian width with sub-optimal vegetative protection.

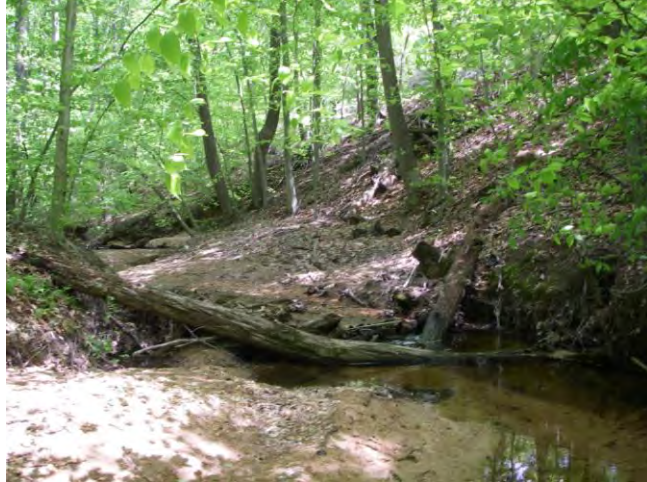
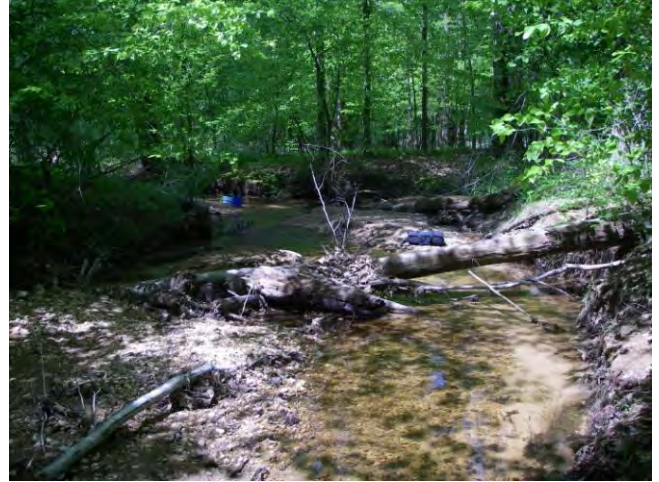
Located just off of a hike and bike trail near Strawberry Lake Way, this site is part of the LPL subwatershed. Of the 798 acre drainage area to this site, 30% consists of impervious surface and largely drains high density residential communities (68%). Conductivity values were elevated, likely due to the high imperviousness in the drainage area. Numerous good quality riffles and woody debris/rootwads support a fair biological community with high taxa diversity. Multiple sand and gravel bars throughout the stream indicate a system that is overwidened and actively aggrading.

- Biological condition – “Fair”
- Habitat scores “Supporting” and “Minimally Degraded”
- Worms (Naididae), midges (Orthocladius) and black flies (Simulium) dominated the sample.
- Water quality values within COMAR standards but conductivity elevated.
- Scored high for instream habitat, epibenthic substrate, and woody debris.

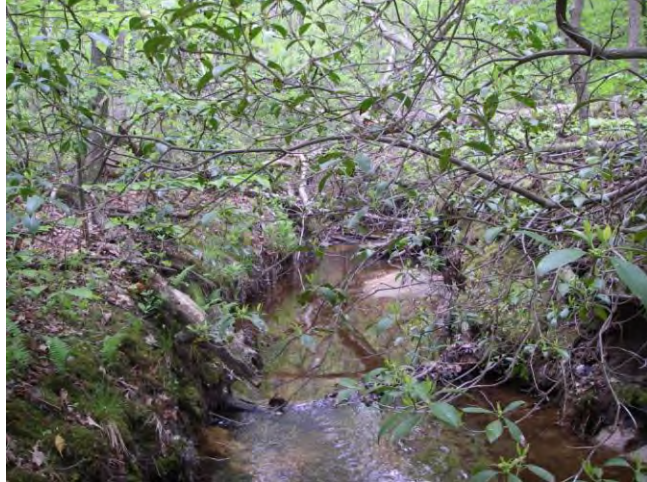
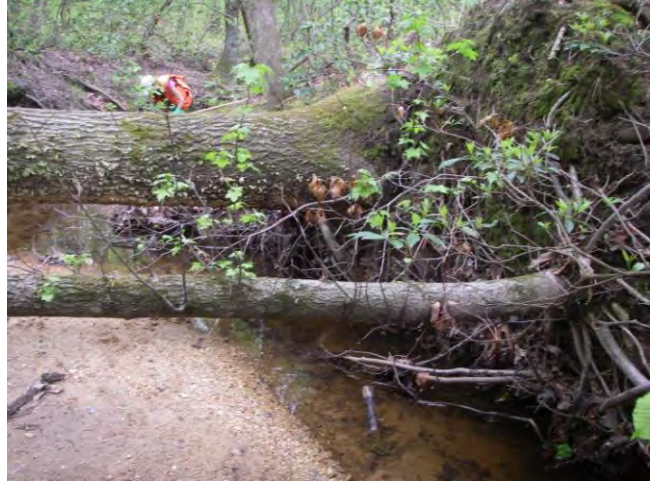
Located behind a retention pond to the east of Streamview Drive, this site is part of the LPL subwatershed. Of the 241 acre drainage area to this site, 27% consists impervious surface and largely drains high density residential communities (64%). Low pH and elevated conductivity values measured at this site may be attributed to an outfall from the retention pond that flows directly into the sampling reach. A mix of riffle and woody debris habitat is only partially supporting of a healthy biological community. Only 2% of the benthic sample accounted for taxa intolerant to urban stressors, and the overall benthic community was rated poor.

- Biological condition – “Poor”
- Habitat scores “Partially Supporting” and “Partially Degraded”
- Worms of the Naididae family and various midges dominated the sample.
- Measured below COMAR standards for pH and conductivity elevated.
- Most habitat variables received sub-optimal scores. Good riparian width with sub-optimal vegetative protection.

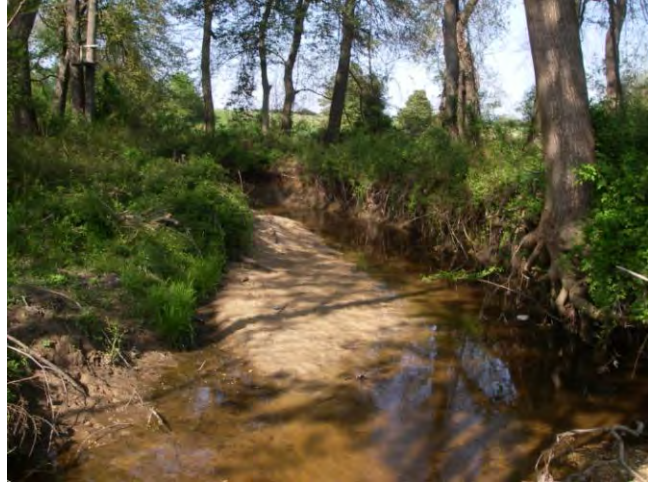
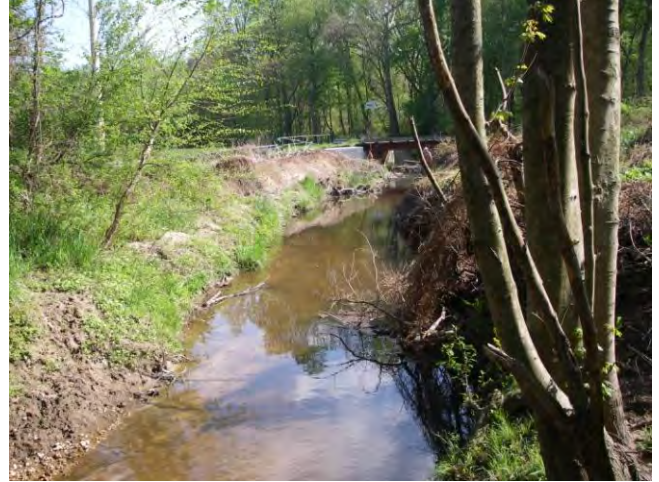
Located east of a powerline corridor that runs behind Springhill Court, this site is part of the LPB subwatershed. Of the 1,330 acre drainage area to this site, 64% consists of developed land and 20% as forested land. Impervious surface accounts for 24% of the drainage area. The channel is incised with severe bank erosion indicating an unstable stream type, likely resulting from the high imperviousness upstream. The riparian buffer width was limited due to the powerline corridor along the left bank and pasture along the right bank (US Naval Academy Dairy Farm). Water quality measured below COMAR standards for pH, which is likely due to wetland drainage upstream. Because habitat is supporting and biological condition is poor, there may be problems with water quality in this drainage system that cannot be measured through in situ analysis only. However, the unstable stream type may also be impacting the biota.

- Biological condition – “Poor”
- Habitat scores “Supporting” and “Partially Degraded”
- Sample dominated by midges (Orthocladius, Polypedilum, and Tvetenia).
- Measured below COMAR standards for pH.
- Marginal bank stability. Instream habitat and epibenthic substrate received sub-optimal scores. Refuse present in moderate amounts.

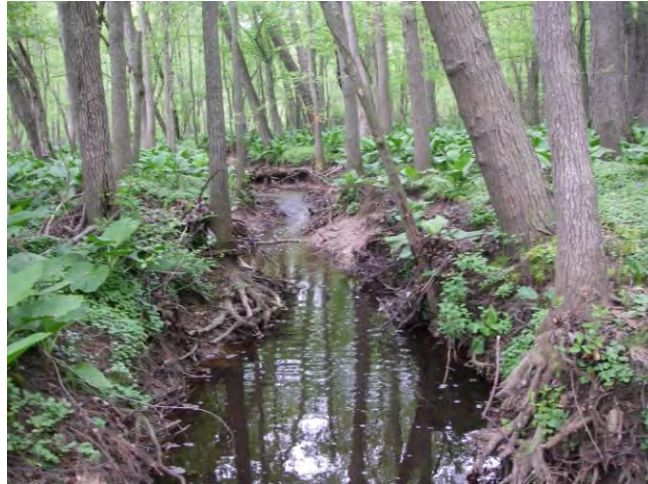
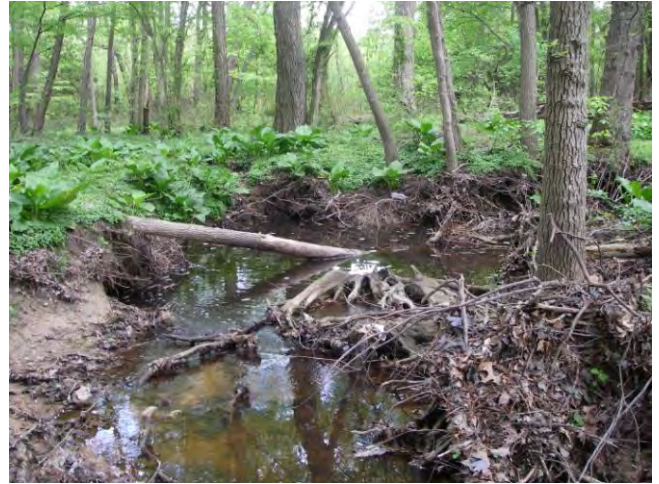
Located behind the end of Autumn Valley Lane and Four Season Drive, this site is part of the LPB subwatershed and drains to Towsers Branch. A quarter of the drainage area to this site is impervious surface as the dominant land cover is developed (68%), followed by forested land (25%). This site has a limited forested riparian buffer due to the powerline corridor along the left bank and pasture along the right bank (US Naval Academy Dairy Farm). Wetlands surround and drain to this reach, which may contribute to the low pH measurements. A mix of riffle and woody debris habitat support a poor biological community that had high taxa diversity yet a lack of both Ephemeroptera and intolerant taxa. The downstream end of the reach is deeply incised; however, armoring around a utility line has prevented the headcut from moving upstream but also backwatered the stream for a good portion of the sampling reach.

- Biological condition – “Poor”
- Habitat scores “Partially Supporting” and “Partially Degraded”
- Sample dominated by midges (Diplocladius and Orthocladius), worms (Naididae), and beetles (Ancyronyx).
- Measured below COMAR standards for pH.
- Sub-optimal habitat diversity. Moderately unstable banks. Good riparian width but poor vegetative protection.

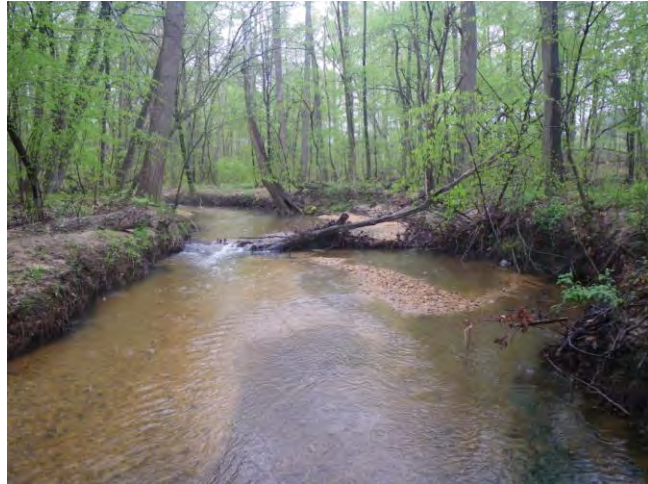
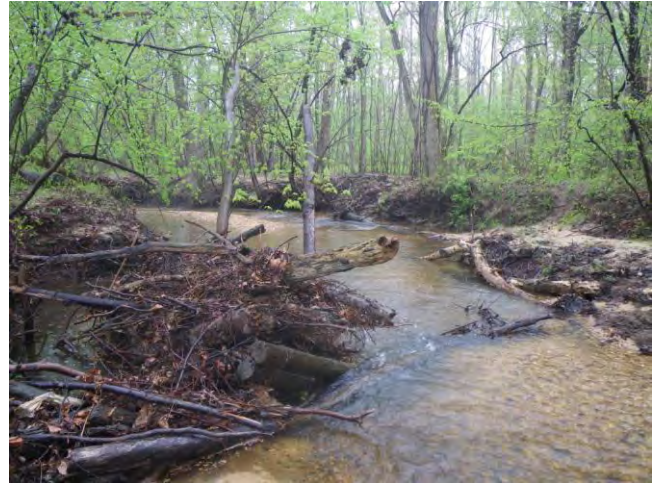
This site is located on the Rogue Harbor Branch mainstem approximately 150 meters upstream of the confluence with the Little Patuxent River, just west of Piney Orchard Parkway, in the LPF subwatershed. The drainage area to this site (5,388 acres) drains a large section of Fort Meade Military Reservation and part of the Patuxent Research Refuge. The predominant land cover is split between developed and forested land (38% for each) with a large portion of open space (21%), resulting in 19.7% imperviousness. There is an good mix of stable habitat including an abundance of roots and woody debris as well as gravel riffles. Heavy bar formation in the channel indicates some overwidening, but stream banks are mostly stable. Ten EPT taxa, including 3 Ephemeroptera, and 6 scraper taxa were present in the benthic sample; however, only 6% of the sample consisted of taxa intolerant to urban stressors. Elevated levels of conductivity may be a result of the developed land cover upstream and may affect the quantity of intolerant taxa.

- Biological condition – “Good”
- Habitat scores “Comparable to Reference” and “Partially Degraded”
- Sample dominated by midges (including Polypedilum and Rheotanytarsus) and beetles (Stenelmis).
- Water quality values within COMAR standards but conductivity elevated.
- Instream habitat, epibenthic substrate, and bank stability received sub-optimal scores. Low scores for remoteness and woody debris. Good riparian width and vegetative protection.

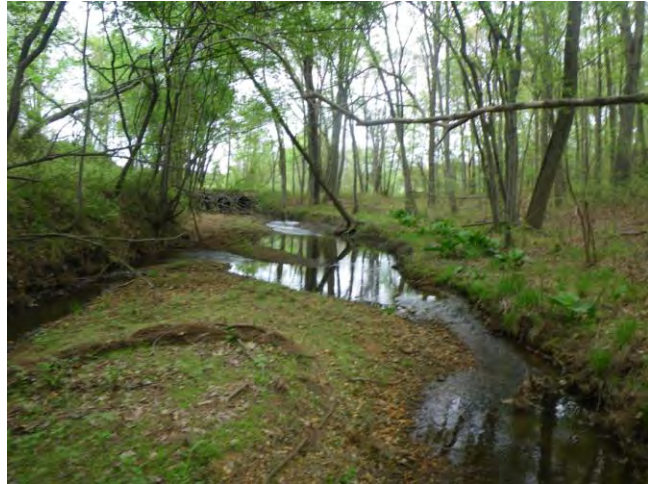
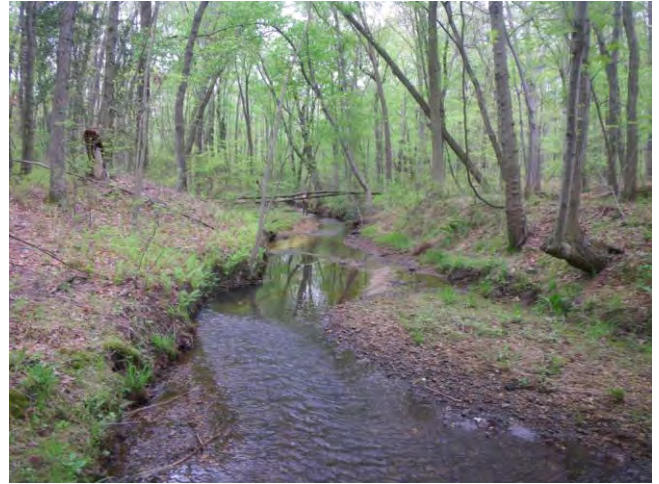
Located in the Patuxent Research Refuge off of Wildlife Loop Road and immediately downstream of a culvert adjacent to a firing range, this site is on a tributary to Rouge Harbor and is part of the LPF subwatershed. The drainage area to this site (773 acres) drains a section of Fort Meade Military Reservation and part of the Patuxent Research Refuge. The predominant land cover is developed (43%), which may explain the elevated conductivity levels, followed closely by forested land (38%). Numerous riffles, while only moderate quality, as well as rootwads support a good biological community. The benthic sample for this site had high taxa diversity (31 taxa) and was dominated by an intolerant mayfly, *Caenis* (T.V. = 2.1), resulting in a high percentage of Ephemeroptera (24%) and percentage of taxa intolerant to urban stressors (33%).

- Biological condition – “Good”
- Habitat scores “Supporting” and “Partially Degraded”
- Sample dominated by *Caenis*(Ephemeroptera) and beetles (*Stenelmis*).
- Water quality values within COMAR standards but conductivity elevated.
- Bank stability scored high. Sub-optimal habitat diversity. Low scores for remoteness and woody debris. Good vegetative protection.

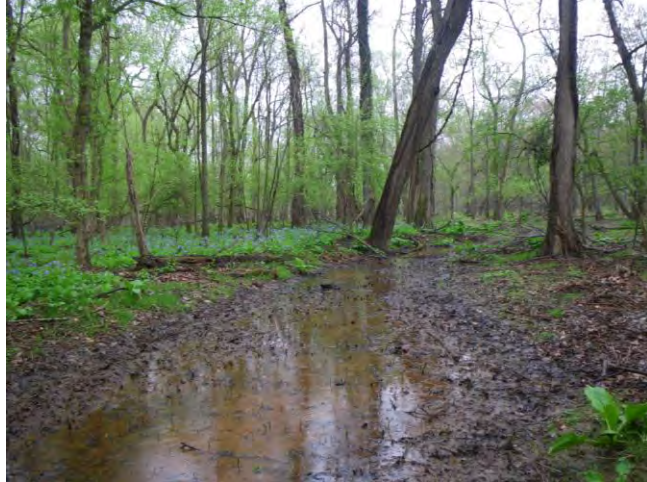
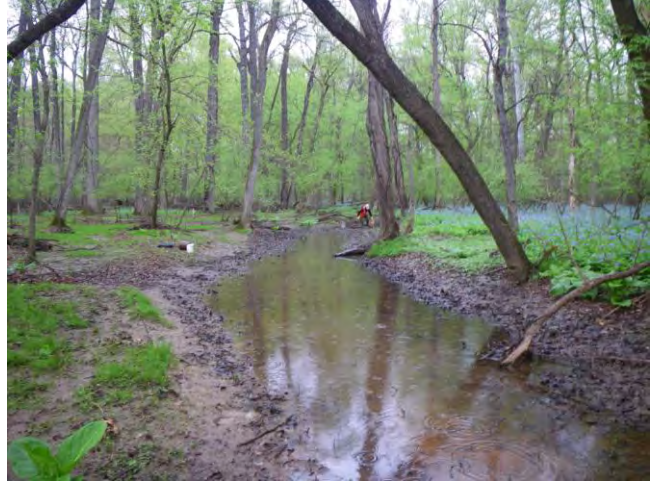
Located on the property of the District of Columbia Children's Center and approximately 475 meters east of the end of Forest Haven Avenue, this site is part of the LP5 subwatershed. Of the 118 acre drainage area, 62% is forested with the remaining 27% as developed and 12% as open space, resulting in 13.5% imperviousness. Located approximately 150 meters upstream of the confluence at the Little Patuxent River, the stream drains an extensive wetland network and has very little visible flow. The channel consists of all muck and detritus bottom substrate with very little stable benthic substrate. Some small emergent vegetation is present but mostly young plants. An excellent riparian buffer contributes to a partially supporting habitat. Elevated conductivity levels may be a result of the developed land cover upstream.

- Biological condition – “Poor”
- Habitat scores “Partially Supporting” and “Partially Degraded”
- Bivalves (Musculium), isopods (Caecidotea), and worms (Tubificidae) dominated the sample.
- Water quality values within COMAR standards but conductivity elevated.
- Poor habitat diversity but banks are stable. Good riparian width and vegetative protection.
