Little Patuxent Watershed Assessment

Comprehensive Summary Report

June 2016

Prepared by:
Anne Arundel County
Department of Public Works
Bureau of Engineering
Watershed Protection and
Restoration Program (WPRP)

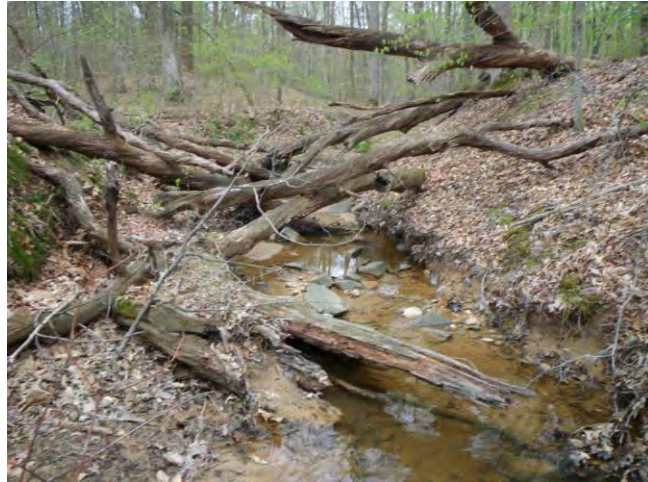
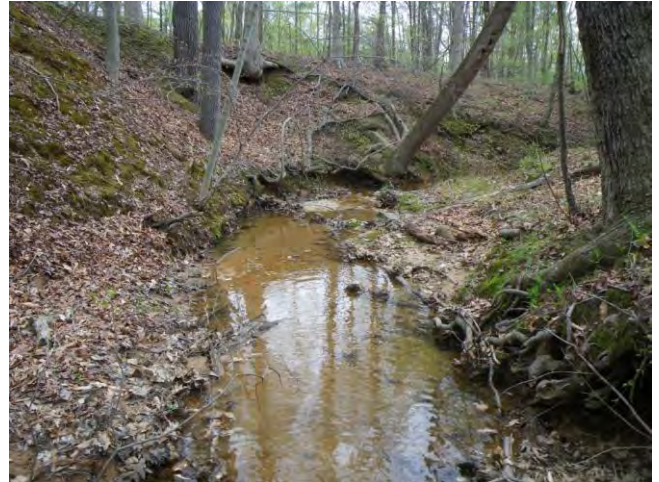
Located within the Patuxent Research Refuge approximately 100 meters upstream of Bald Eagle Drive near the visitor center, this site is on an unnamed tributary to the Little Patuxent River and is part of the LPO subwatershed. The 146 acre drainage area to this site is predominantly forested land (95%) with only 5% accounting for developed land. Only 1.7% of the drainage area is impervious surface. Even though there is an adequate mix of riffles and woody debris/rootwad habitat, there is a poor biological community due to few EPT taxa and the complete lack of Ephemeroptera taxa and scraper taxa in the benthic sample. Measured pH values fell below COMAR standards; however, the lack of anthropogenic disturbance suggests that it is due to naturally acidic conditions in this drainage area. Evidence of incision, overwidening, and active bank erosion indicate that the channel has not yet reach a stable form, which could also explain why the benthic community is not meeting expectations.

- Biological condition – *“Poor”*
- Habitat scores *“Supporting”* and *“Minimally Degraded”*
- Black flies (Simulium and Stegopterna) dominated the sample.
- Measured below COMAR standards for pH.
- Most habitat variables received sub-optimal scores. Scored high for woody debris. Good riparian width with sub-optimal vegetative protection.

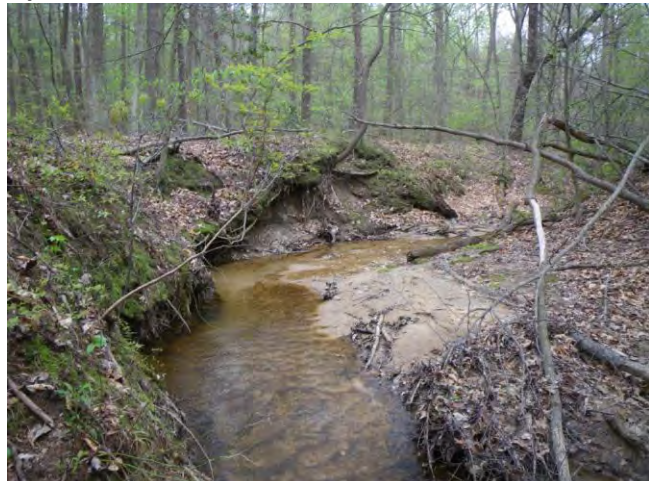
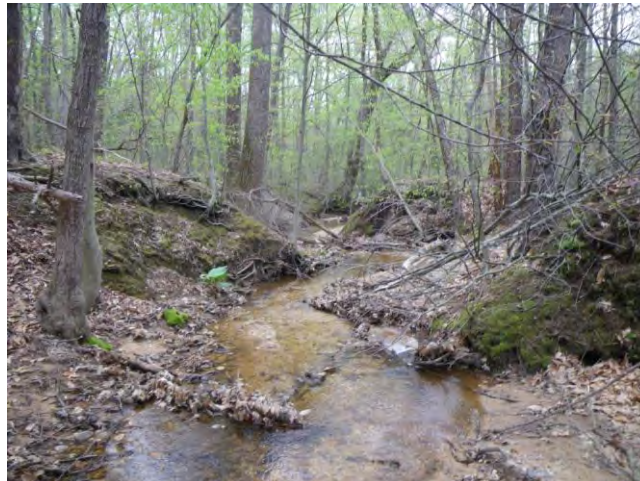
This site is located within the Patuxent Research Refuge approximately 0.4 miles west of the visitor center on an unnamed tributary that drains to the Little Patuxent River in the LPO subwatershed. The 208 acre drainage area to this site is predominantly forested land (86%) with 13% accounting for open space. Only 0.6% of the drainage area is impervious surface. This site has an optimal mix of stable habitat types with numerous riffles and rootwads providing adequate habitat for a healthy and diverse benthic community. High taxa diversity (35 taxa) including 8 EPT taxa, 2 Ephemeroptera taxa, and 6 scraper taxa were present in this sample. Moderate bar formation and some minor bank erosion is present, but the stream appears to be evolving to a more stable stream type from a previously disturbed and incised state. Measured pH values fell below COMAR standards; however, the lack of anthropogenic disturbance suggests that it is due to naturally acidic conditions in this drainage area.

- Biological condition – “Good”
- Habitat scores “Comparable to Reference” and “Minimally Degraded”
- Various midges and the Trichoptera genus, Diplectrona, dominated the sample.
- Measured below COMAR standards for pH.
- Most habitat variables received sub-optimal to optimal scores. Scored very high for woody debris. Good riparian width and vegetative protection.

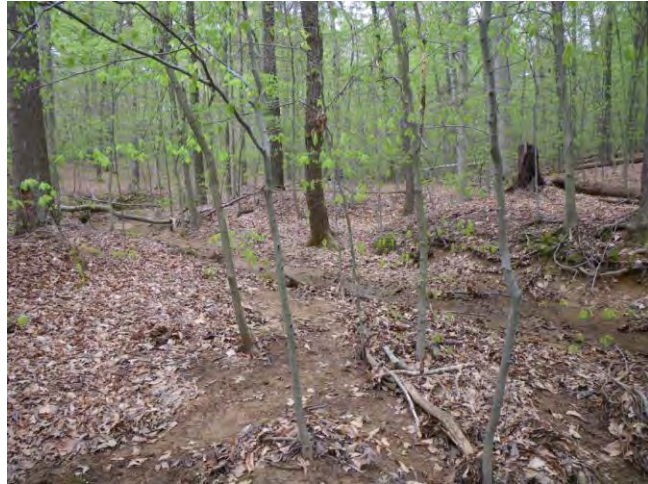
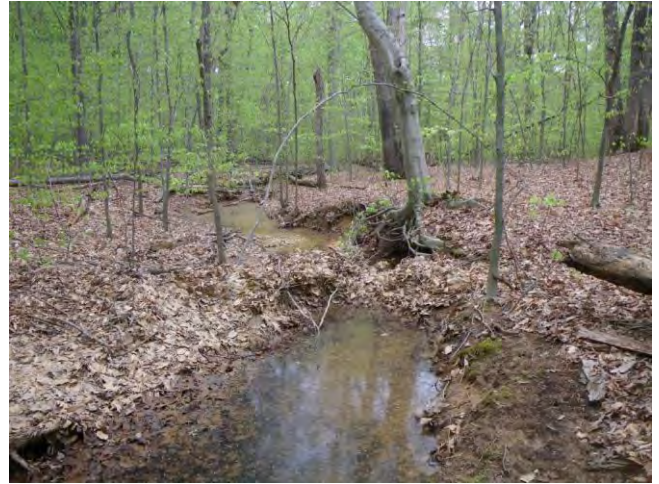
Located within the Patuxent Research Refuge just off of Switchboard Road, this site is on an unnamed tributary that drains to the Little Patuxent River and is part of the LPO subwatershed. The 101 acre drainage area to this site consists largely of forested land (94%) with only 5% accounting for developed land, only 1.4% which of is impervious surface. This reach consisted of a series of stagnant, backwatered pools caused by leaf/woody debris jams throughout the reach and exhibited virtually no visible flow. While there were only a few poor quality riffles present, instream woody debris and leaf packs provided habitat to the benthic community. A high percentage of intolerants (50%) and climbers (8%) in the sample led to a fair biological condition rating. Low dissolved oxygen levels measured at this site are largely attributed to the stream being backwatered with little mixing occurring in the water column and the abundance of detrital decomposition. Measured pH values fell below COMAR standards; however, the lack of anthropogenic disturbance suggests that it is due to naturally acidic conditions in this drainage area. Furthermore, the lack of flow and small drainage area suggest that this reach may be intermittent in nature.

- Biological condition – “Fair”
- Habitat scores “Partially Supporting” and “Partially Degraded”
- Isopods (Caecidotea), worms (Lumbricina and Enchytraeidae), and midges dominated the sample.
- Measured below COMAR standards for pH and dissolved oxygen.
- Marginal habitat diversity and banks are moderately stable. Good riparian width with sub-optimal vegetative protection.

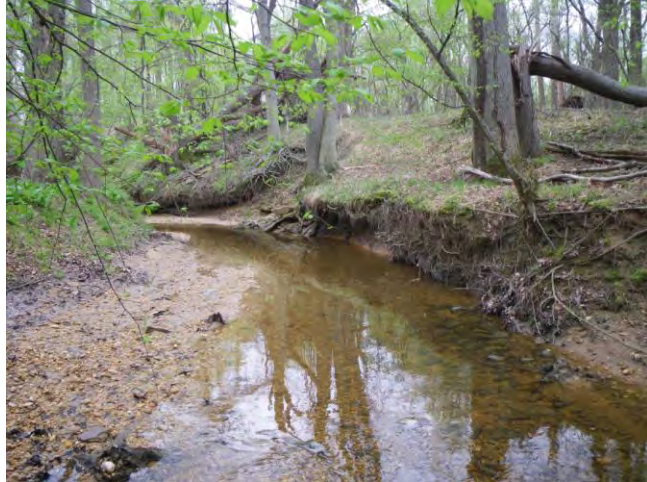
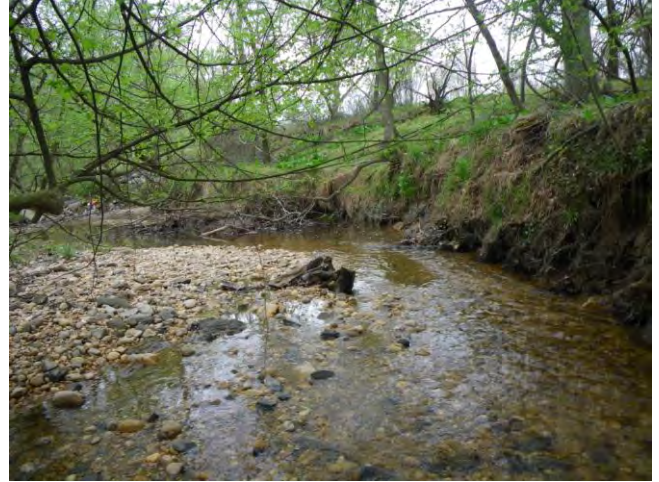
Located south of Oak Hill Drive on a tributary to the Little Patuxent River, this site is part of the LP5 subwatershed. Over half of the 407 acre drainage area is developed land (56%) and includes part of the Fort Meade Military Reservation. The channel is incised and overwidened with some heavily eroded banks and extensive bar formation. Gravel dominated riffles of moderate quality provide limited habitat for a very poor biological community. Only 11 taxa were present in the benthic sample which completely lacked EPT, Ephemeroptera, scraper, and intolerant taxa. Because habitat is partially supporting and biological condition is very poor, there are likely water quality issues, such as elevated conductivity, impacting the biological community.

- Biological condition – “Very Poor”
- Habitat scores “Partially Supporting” and “Partially Degraded”
- Orthocladius (midge) dominated the sample.
- Water quality values within COMAR standards but conductivity elevated.
- Most habitat variables received sub-optimal scores. Moderately unstable banks. Refuse present in moderate amounts.

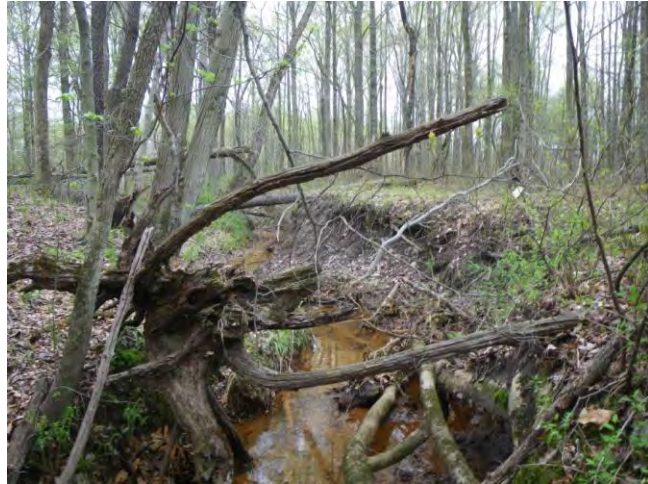
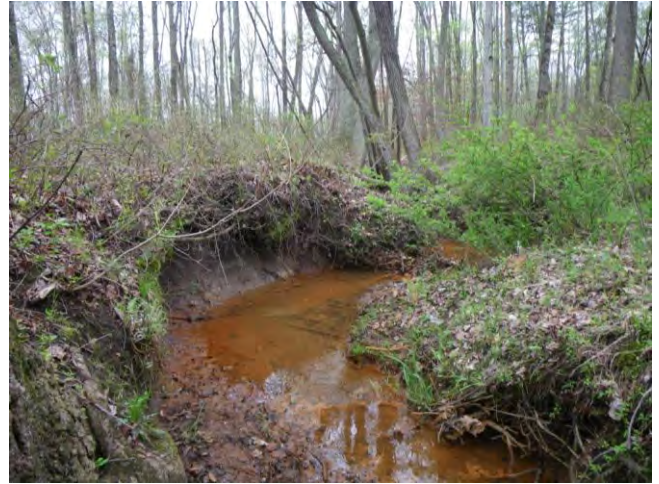
This site is located between Patuxent Freeway (Rt. 32) and General Aviation Drive, this site is on an unnamed tributary to the Little Patuxent River and is part of the LPN subwatershed. Close to half of the 124 acre drainage area to this site is developed land (49%), which includes part of the Fort Meade Military Reservation. Forested and open space account for the remaining 32% and 20% of the drainage area, respectively. Over a third of the drainage area (37%) is impervious surface, which includes several large parking lots and a large stretch of Rt. 32. This site is located on an incised channel with little observed flow. The stream appears to have been historically channelized but is creating meanders and increasing sinuosity, which is leading to actively eroding and undercutting banks. Less than 80 organisms were identified in the entire benthic sample, which indicates a poor biological community likely resulting from the degraded habitat conditions. Elevated levels of conductivity, possibly due to the high imperviousness in the drainage area, may also be impacting biota.

- Biological condition – “Poor”
- Habitat scores “Partially Supporting” and “Partially Degraded”
- This sample only contained 64 organisms, the majority of which were midges (Diplocladius) and bivalves (Musculium and Pisidiidae).
- Water quality values within COMAR standards but conductivity elevated.
- Instream habitat and epibenthic substrate received marginal scores. Moderately unstable banks. Good riparian width with sub-optimal vegetative protection.

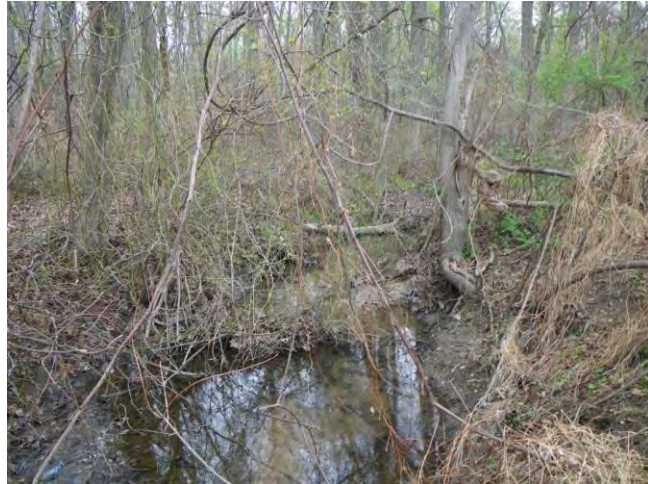
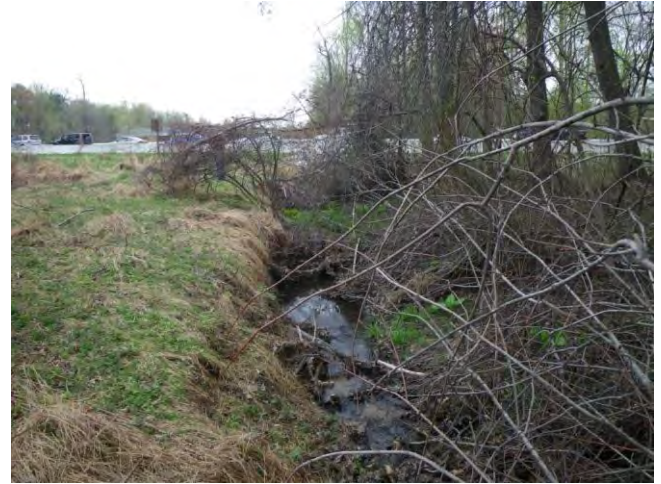
Located near the intersection of O'Brien Road and Mapes Road immediately downstream of the Fort Meade Golf Course, this site is on an unnamed tributary and is part of the LPN subwatershed. Of the 123 acre drainage area to this site, open space accounts for 41%, developed land accounts for 36%, and forested land accounts for the remaining 24%. Close to one-quarter of the drainage area (22%) is impervious surface. Half of the drainage area to this site drains the Fort Meade Golf Course while the other half drains developed parcels on the Fort Meade Military Reservation. Riparian vegetation along the left bank is mostly cleared due to a utility corridor. Because habitat is supporting and biological condition is poor, there may be problems with water quality in this drainage area that cannot be measured through in situ analysis only. Measured pH values fell below COMAR standards, but it is unclear whether it is due to naturally acidic conditions or anthropogenic disturbance.

- Biological condition – “Poor”
- Habitat scores “Supporting” and “Partially Degraded”
- Midge, black flies (Simulium), and worms (Naididae and Tubificidae) dominated the sample.
- Measured below COMAR standards for pH.
- Poor remoteness score and marginal habitat diversity.

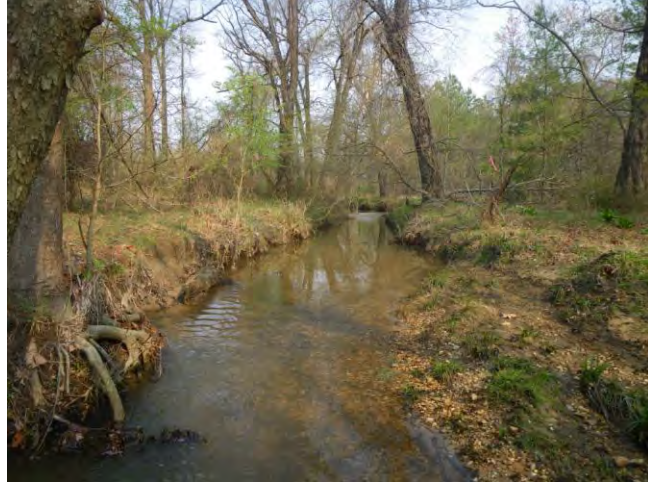
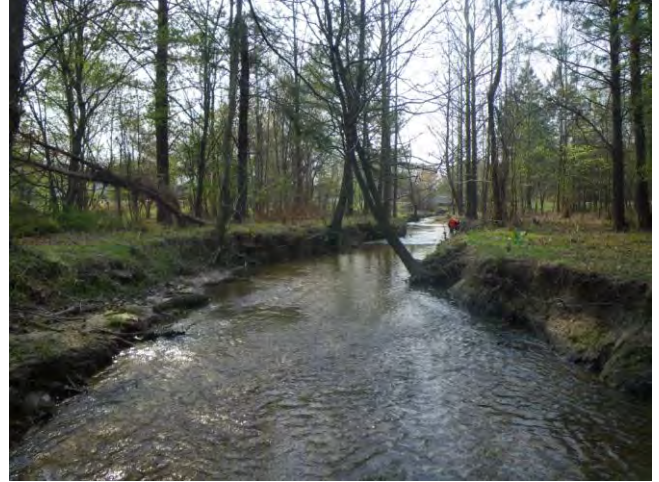
Located near the intersection of Rock Avenue and Leonard Wood Avenue, this site drains a large section of Fort Meade Military Reservation to Rogue Harbor and is part of the LPE subwatershed. An abundance of rootwads and gravel riffles provide stable habitat for a fair biological habitat. There are some areas of active erosion, but the banks are mostly stable. Forty percent of the 1,905 acre drainage area to this site is developed land, with 32% as forested and 25% as open space. One fifth of the drainage area is impervious surface, which may explain the elevated conductivity measured at this site.

- Biological condition – “Fair”
- Habitat scores “Supporting” and “Partially Degraded”
- Sample dominated by midges (Orthocladius, Polypedilum, and Tanytarsus) and black flies (Stenelmis).
- Water quality values within COMAR standards but conductivity elevated.
- Remoteness scored poorly with sub-optimal scores for most of the remaining habitat variables. Good riparian width with sub-optimal vegetative protection.

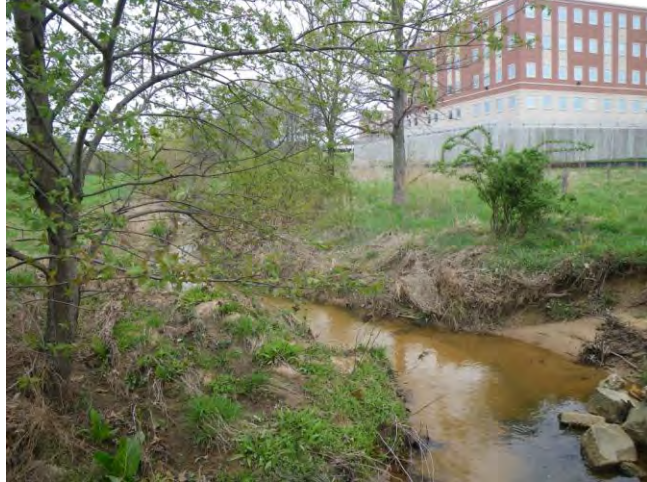
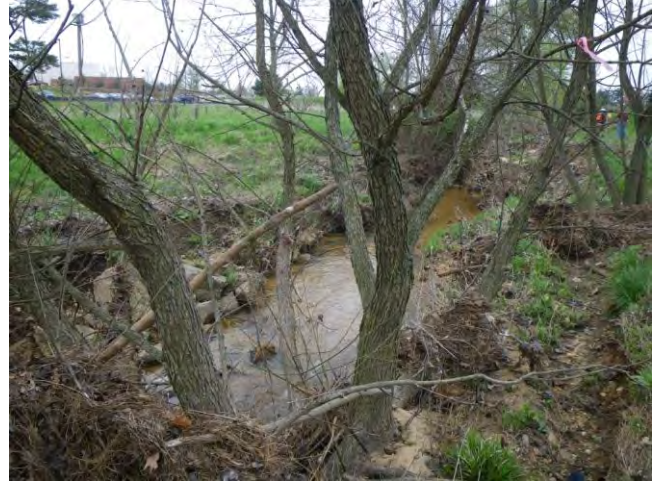
Located on the Fort Meade Golf Course directly off of Kenyon Loop, this site drains a large section of Fort Meade Military Reservation to Rogue Harbor and is part of the LPE subwatershed. The riparian buffer is severely lacking due to the golf course and active bank erosion is present throughout the site. Numerous pipe outfalls were observed along the right bank, which likely contributed to the elevated conductivity measured at this site. A relatively high taxa diversity (22 taxa), number of scraper taxa, and a high percentage of climbers present in the benthic sample resulted in a fair biological condition rating. Forty percent of the 1,381 acre drainage area to this site is developed land, with 39% as forested and 17% as open space, resulting in 18% impervious cover.

- Biological condition – “Fair”
- Habitat scores “Partially Supporting” and “Severely Degraded”
- Orthocladius (midge) dominated the sample.
- Water quality values within COMAR standards but conductivity elevated.
- Very low woody debris, percent shading, and remoteness scores. Marginal habitat diversity, riparian width, and vegetative protection.

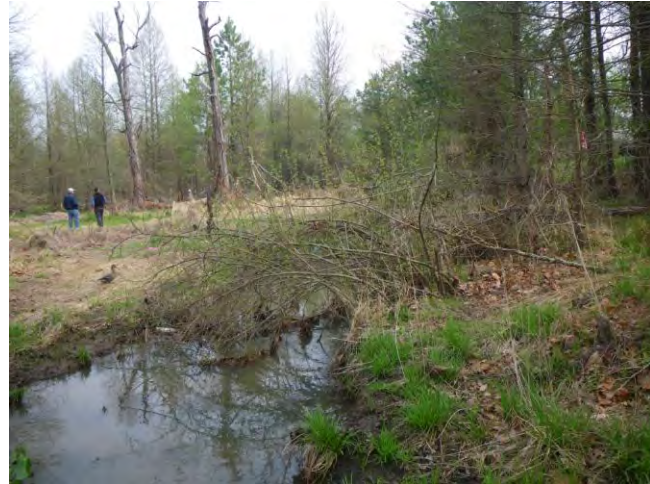
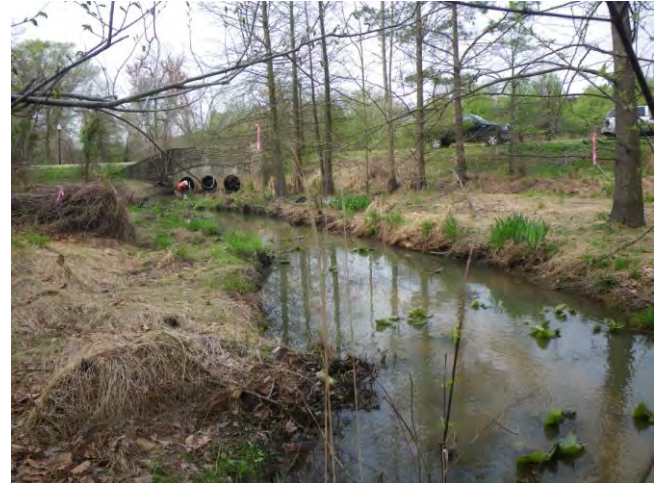
This site is located immediately upstream of Redwood Road and drains to Rogue Harbor in the LPG subwatershed. The entire drainage area of this site (1,082 acres) is within the Fort Meade Military Reservation and consists of 42% developed land, 38% open space, and 19% forested land. Nearly one-quarter of the drainage area (24%) is impervious surface. Elevated levels of conductivity may be a result of the developed land cover upstream. This site is backwatered due to a debris jam at the culvert which is located at the downstream portion of the site. A wet retention pond is located 230 meters upstream from the site and may be altering flow. Despite the poor physical habitat quality, a fair biological community attributed to high taxa diversity (26 taxa), number of scraper taxa, and a high percentage of climbers (46%) present in the benthic sample, as well as the presence of *Caenis*, an intolerant mayfly.

- Biological condition – “Fair”
- Habitat scores “Partially Supporting” and “Severely Degraded”
- Polypedilum (midge) dominated the sample.
- Water quality values within COMAR standards but conductivity elevated.
- Very low woody debris, percent shading, and remoteness scores. Marginal habitat diversity.

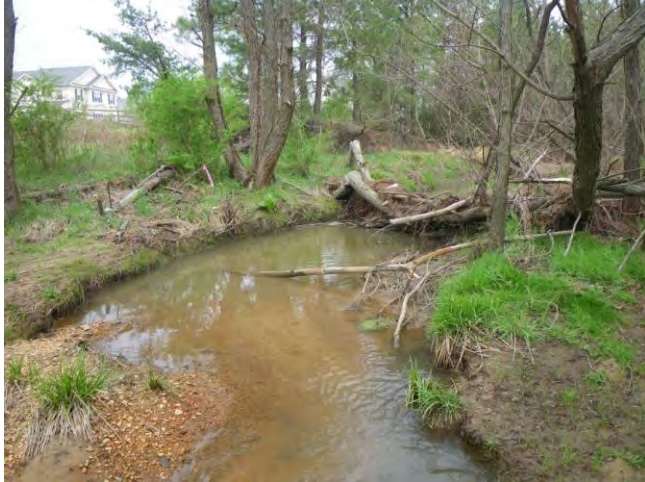
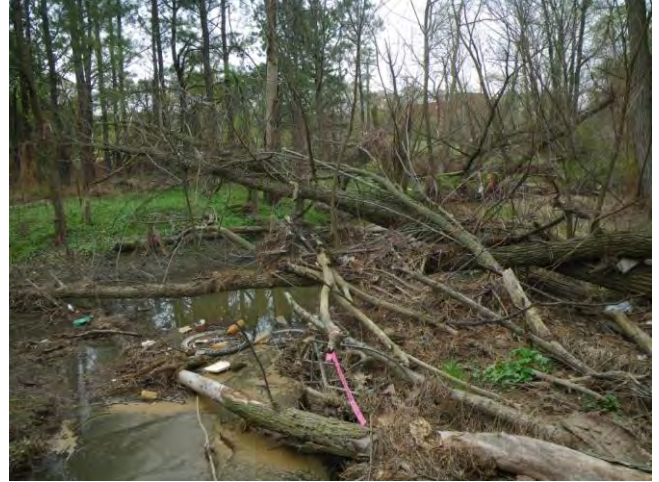
Located immediately upstream of Llewellyn Avenue, this site drains to Rogue Harbor and is part of the LPG subwatershed. The entire drainage area of this site (790 acres) is within the Fort Meade Military Reservation and consists largely of developed and open space (39% for both) with 23% as forested land. Impervious surface accounts for 22% of the drainage area. This site is backwatered a good distance due to a culvert just downstream of the sampling reach and possible beaver activity. Because habitat is supporting and biological condition is poor, there may be problems with water quality in this drainage system that cannot be measured through in situ analysis only. The depressed biological community may be a result of the backwatered condition in the sampling reach.

- Biological condition – *“Poor”*
- Habitat scores *“Supporting”* and *“Degraded”*
- Midges (Orthocladius, Polypedilum, and Tanytarsus) dominated the sample.
- Water quality values within COMAR standards but conductivity elevated.
- Bank stability scored high but habitat diversity received marginal scores. Very poor remoteness score.

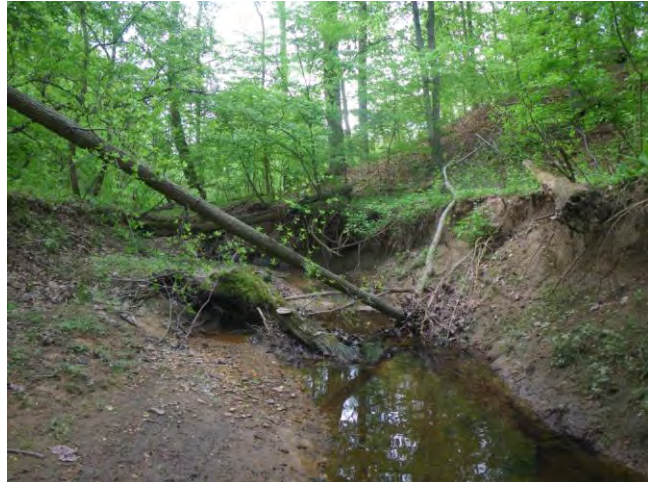
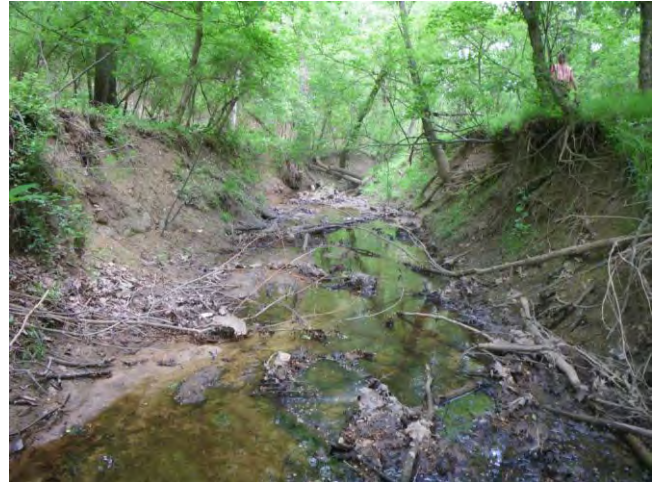
This site is located approximately 150 meters downstream of Russett Green West and approximately 100 meters upstream of the confluence with the Little Patuxent River in the LP6 subwatershed. Of the 413 acre drainage area, 78% is developed land, the majority of which is high density residential. The remaining 21% of the drainage area is forested land. Nearly one-half of the drainage area (47%) is impervious surface. The site is deeply incised and overwidened with severe erosion on both banks and heavy sediment deposition, likely due to the altered flow regime. Woody debris is abundant but primarily dewatered due to low flow in the channel. Riffle habitat is also present but poor quality. A complete lack of EPT, Ephemeroptera, and taxa intolerant to urban stressors characterize a very poor biological community. Elevated conductivity levels are likely the result of a highly-developed, highly-impervious drainage area, and are potentially indicative of water quality impairment.

- Biological condition – *“Very Poor”*
- Habitat scores *“Non Supporting”* and *“Partially Degraded”*
- Sample dominated by midges (Chironomus, Cricotopus, and Orthocladius) and worms of the Tubificidae family.
- Water quality values within COMAR standards but conductivity elevated.
- Refuse present in moderate amounts. Poor bank stability with marginal habitat diversity. Good riparian width but poor vegetative protection.

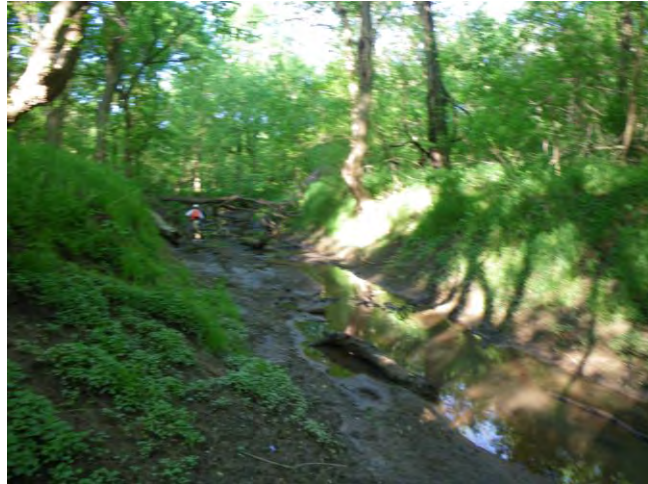
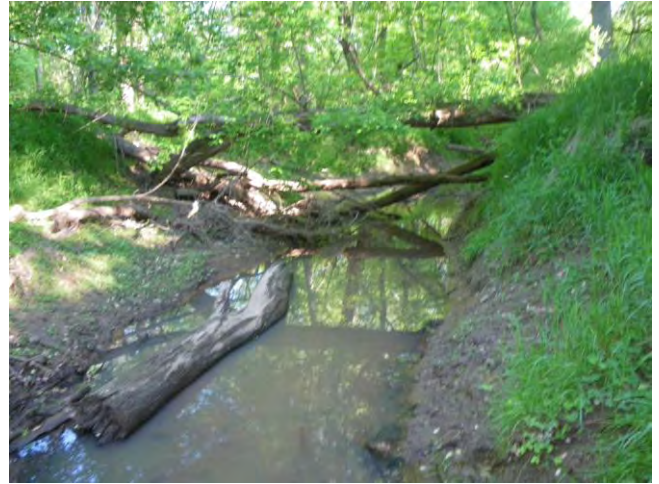
Located approximately 100 meters upstream of the confluence with the Little Patuxent River, this site is northwest of the Marsh Crossing Drive and Big Pool Road intersection and adjacent to the Oxbow Natural Area in the LP6 subwatershed. Of the 375 acre drainage area to this site, the majority of the land cover is forested (75%) with the remaining 17% and 9% consisting of open space and developed land, respectively. Only 2% of the drainage area is impervious surface. In spite of the heavily forested drainage area, the channel is incised and overwidened with very little flow and a very poor biological community. It appears that the channel has either been historically channelized or is a relic of the abandoned oxbow channel. The benthic sample completely lacked EPT, Ephemeroptera, scraper, and climber taxa; however, half of the taxa were intolerant to urban stressors.

- Biological condition – *“Very Poor”*
- Habitat scores *“Partially Supporting”* and *“Partially Degraded”*
- Caecidotea (isopod) and Chironomus (midge) dominated the sample.
- Measured below COMAR standards for dissolved oxygen.
- Poor instream habitat with marginal epibenthic substrate. Banks are stable with abundant woody debris. Good riparian width with sub-optimal vegetative protection.

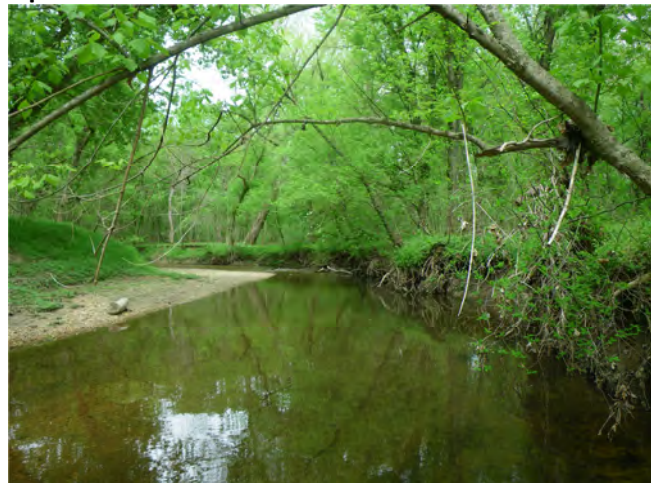
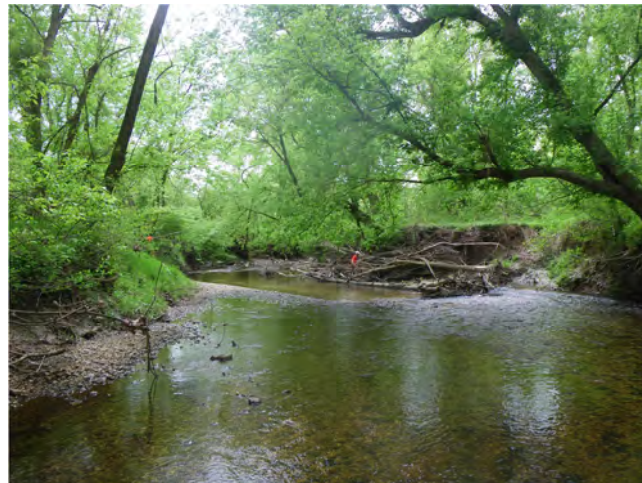
This site is located on the mainstem of Dorsey Run, approximately 100 meters upstream of the confluence with the Little Patuxent River, just off of the eastbound Route 32 ramp to southbound Baltimore-Washington Parkway (Rt. 295) in the LPI subwatershed. Of the 8,054 acre drainage area to this site, 1,704 acres drains from Howard County. Over one-half of the total drainage area is developed land (56%) with 32% as forested and 11% as open space. More than one-quarter of the drainage area is impervious surface (27%). This site is located on a large, wide channel with a good mix of velocity/depth and stable habitat for benthos; however, large bar formation and active bank erosion is evident, suggesting an unstable stream reach. Gravel riffles of moderate quality and abundant woody debris support a good biological community. The benthic sample for this site had high taxa diversity (31 taxa), 7 EPT, 2 Ephemeroptera, and 7 scraper taxa; but, only 6% of the sample consisted of taxa intolerant to urban stressors. Elevated levels of conductivity, likely resulting from the heavily developed land cover upstream, may be influencing the quantity of intolerant taxa.

- Biological condition – “Good”
- Habitat scores “Supporting” and “Degraded”
- Snails (Amnicola) and bivalves (Musculium) dominated the sample.
- Water quality values within COMAR standards but conductivity elevated.
- Percent shading, remoteness, and woody debris received low scores. Moderately unstable banks with sub-optimal habitat diversity. Good riparian width.

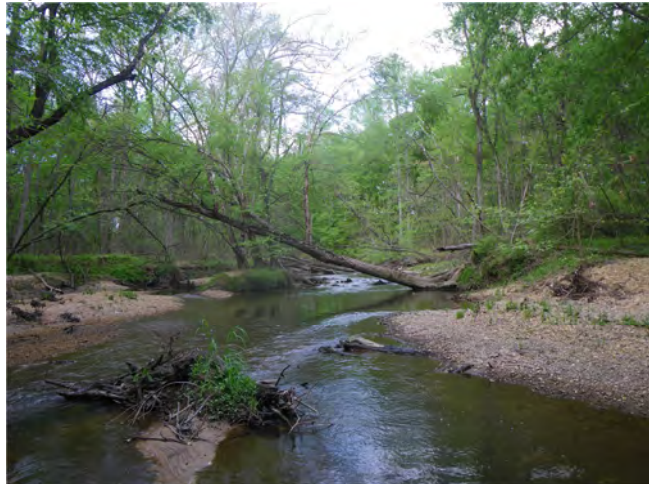
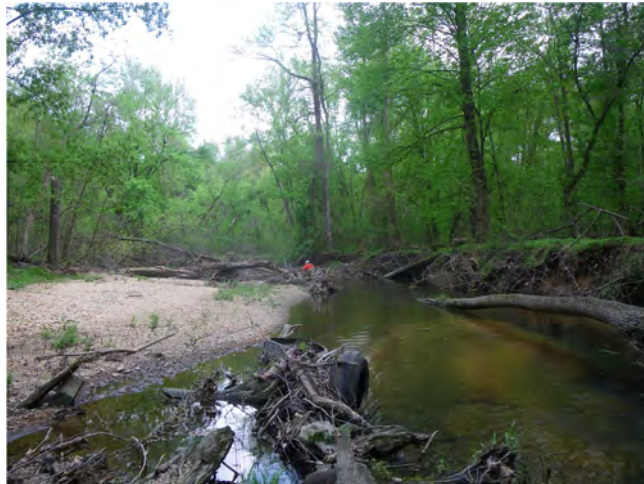
Located on the Dorsey Run mainstem, just prior of the exit at eastbound Route 32 to southbound Baltimore-Washington Parkway (Rt. 295), this site is part of the LPI subwatershed. Of the 7,562 acre drainage area to this site, 1,704 acres drains from Howard County. Over half of the total drainage area is developed land (58%) with 31% as forested and 10% as open space. More than one-quarter of the drainage area is impervious surface (28%). This site is located on a deep, wide channel with extensive bar formation and heavy bank erosion on the outer meanders, likely due to altered flow regimes caused by high imperviousness. Several very deep pools were observed throughout this site. An abundance of woody debris and rootwads provides adequate habitat for a fair biological community. Elevated levels of conductivity may be a result of the developed land cover upstream and may be influencing the quantity of intolerant taxa--only 5% of the benthic sample consisted of taxa intolerant to urban stressors.

- Biological condition – *“Fair”*
- Habitat scores *“Supporting”* and *“Partially Degraded”*
- Worms (Naididae) and midges dominated the sample.
- Water quality values within COMAR standards but conductivity elevated.
- Most habitat variables received sub-optimal scores. Good riparian width with suboptimal vegetative protection.

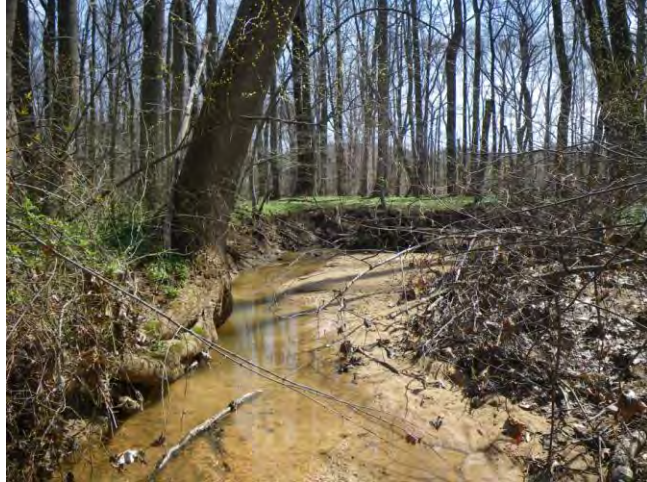
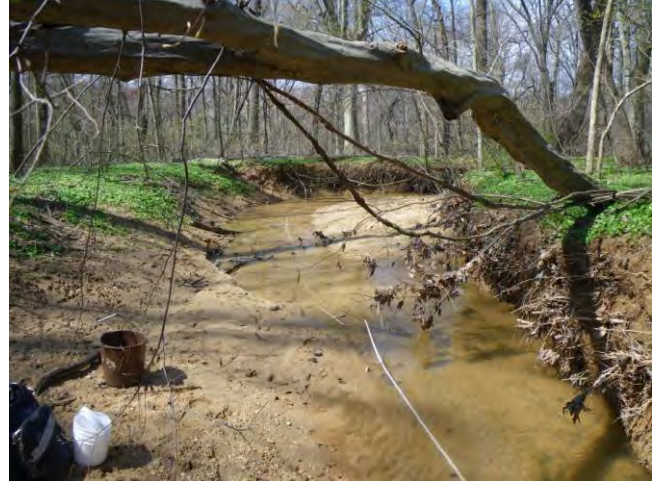
Located approximately 100 meters upstream from the confluence with Dorsey Run, just off of the exit of Guilford Road to National Business Parkway, this site is part of the LPJ subwatershed. Over half of the 873 acre drainage area to this site is forested land with 26% as developed land with 12% as impervious surface. The stream channel is overwidened and incised with multiple bars throughout, likely due to altered flow regimes caused by development upstream. Both banks are actively eroding. An abundance of woody debris and rootwads, but poor quality riffle habitat, supports a fair biological community. Elevated levels of conductivity may be a result of the developed land cover upstream and may be influencing the quantity of intolerant taxa--only 6% of the benthic sample consisted of taxa intolerant to urban stressors.

- Biological condition – “Fair”
- Habitat scores “Supporting” and “Partially Degraded”
- Midges (Hydrobaenus, Orthocladius, and Parametriocnemus) dominated the sample.
- Water quality values within COMAR standards but conductivity elevated.
- Most habitat variables received sub-optimal scores. Moderately unstable banks. Good riparian width with sub-optimal vegetative protection.

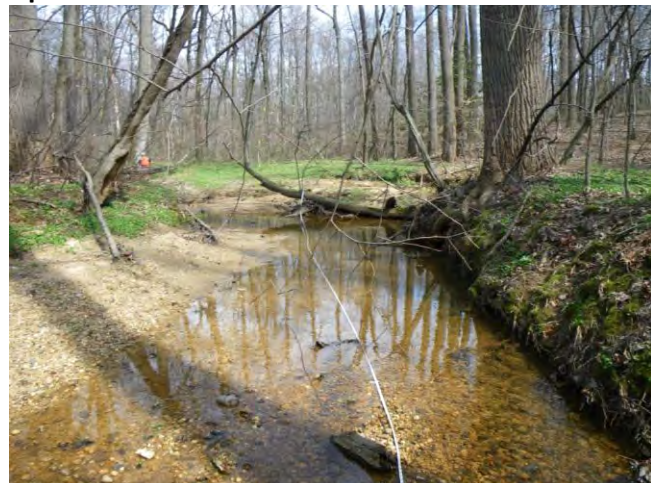
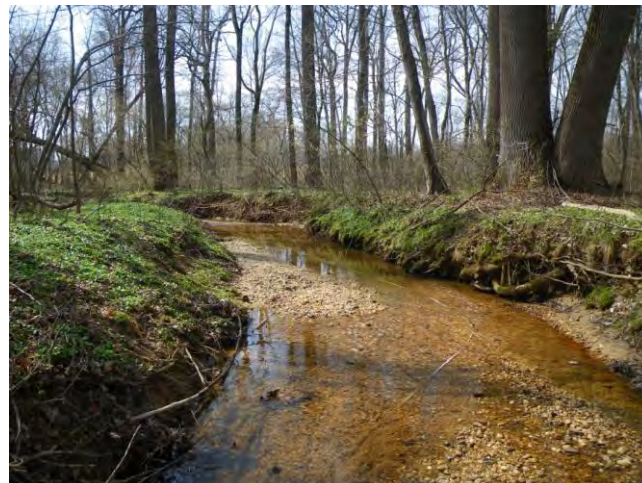
Located behind the National Business Park located off of the Baltimore Washington Parkway, this site is part of the LPJ subwatershed and drains to Dorsey Run. Of the 535 acre drainage area to this site, over half of the area is forested land (61%) with 24% as developed and 14% as open space. Eleven percent of the drainage area is impervious surface. A trail runs approximately 2 meters from the left bank and multiple bars were observed throughout the site. Good woody debris and rootwad habitat along with some gravel riffles support a fair biological community. Elevated levels of conductivity may be a result of the developed land cover upstream and may be influencing the quantity of intolerant taxa--only 5% of the benthic sample consisted of taxa intolerant to urban stressors.

- Biological condition – *“Fair”*
- Habitat scores *“Supporting”* and *“Minimally Degraded”*
- Sample dominated by Parametrioicnemus (midge).
- Water quality values within COMAR standards but conductivity elevated.
- Most habitat variables received sub-optimal scores. Good riparian width with suboptimal vegetative protection.

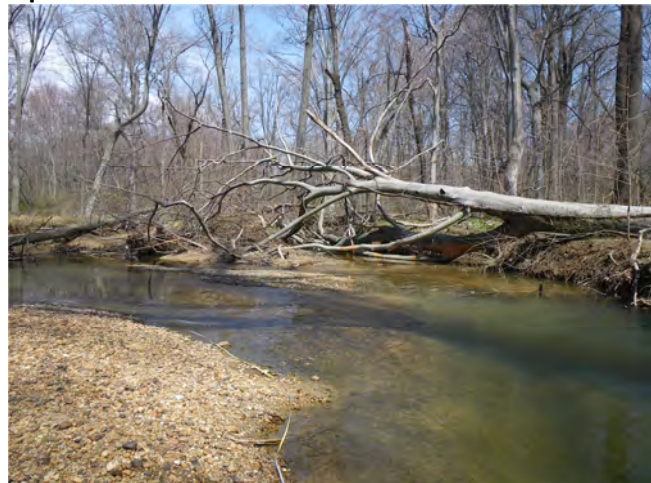
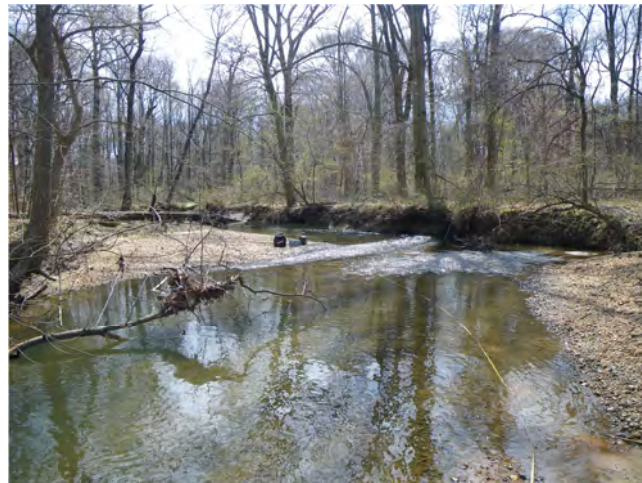
Located on the Dorsey Run mainstem, just off of the exit of Guilford Road to National Business Parkway, this site is part of the LPH subwatershed. Of the 6,321 acre drainage area to this site, 1,704 acres drains from Howard County. Over half of the total drainage area is developed land (64%) with 26% as forested and 10% as open space. Almost one-third of the drainage area is impervious surface (30%). This channel is overwidened with large mid-channel and point bars, likely due to altered flow regimes caused by high imperviousness. Several deep pools with cover provide good habitat for fish. A good mix of gravel riffles, rootwads, and wood provide diverse habitat for benthic macroinvertebrates. However, the biological community was poor due to the complete lack of Ephemeroptera taxa and taxa intolerant to urban stressors. Elevated levels of conductivity may be a result of the highly-developed land cover upstream and are likely influencing the quantity of intolerant taxa. Because habitat is supporting and biological condition is poor, there may be additional water quality impairments, other than elevated conductivity, in this drainage area that cannot be measured through in situ analysis only.

- Biological condition – *“Poor”*
- Habitat scores *“Supporting”* and *“Partially Degraded”*
- Orthocladius (midge) dominated the sample.
- Water quality values within COMAR standards but conductivity elevated.
- Most habitat variables received sub-optimal scores. Refuse present in moderate amounts. Good riparian width with sub-optimal vegetative protection.

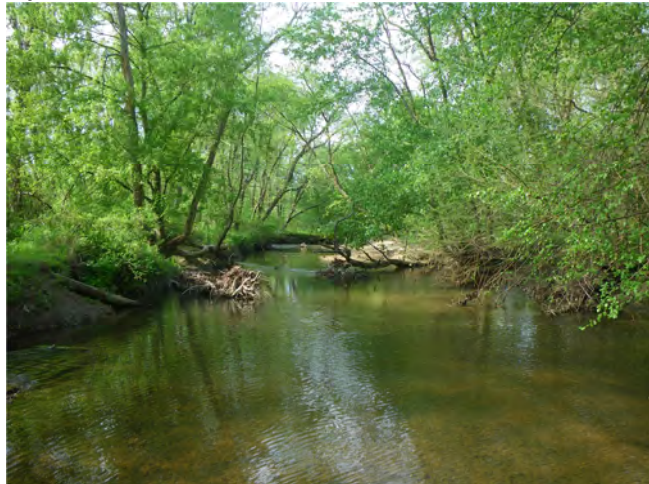
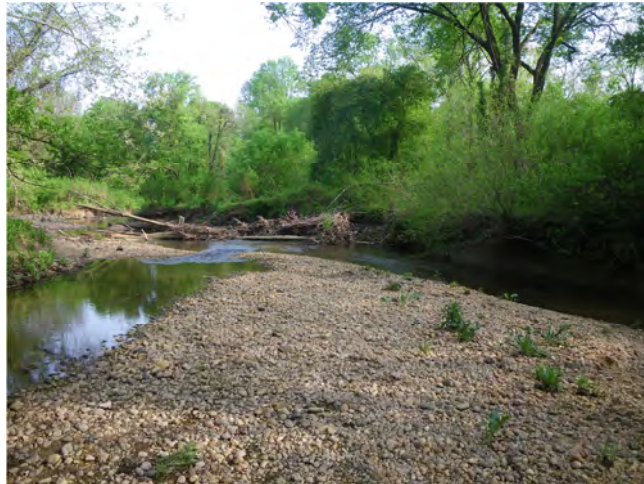
Located on the mainstem of Dorsey Run just off of Brock Bridge Road, this site is part of the LPH subwatershed. Of the 5,994 acre drainage area to this site, 1,632 acres drains from Howard County. Over half of the total drainage area is developed land (63%) with 26% as forested and 10% as open space. Nearly one-third of the drainage area is impervious surface (30%). This site is a large, overwidened channel with many mid-channel and point bars, likely due to altered flow regimes caused by high imperviousness. There is a good mix of velocity/depth and an abundance of large woody debris in deep pools provides good habitat for fish. The presence of moderate quality gravel riffles provides some stable habitat for a poor biological community. Elevated conductivity levels may be a result of the highly-developed land cover upstream, much of which is industrial/commercial development, and may be influencing the quantity of intolerant taxa--only 5% of the benthic sample consisted of taxa intolerant to urban stressors. Because habitat is supporting and biological condition is poor, there may be problems with water quality in this drainage system, as indicated by the elevated conductivity readings, which are impacting the biota.

- Biological condition – “Poor”
- Habitat scores “Supporting” and “Partially Degraded”
- Worms of the Naididae family dominated the sample.
- Water quality values within COMAR standards but conductivity elevated.
- Most habitat variables received sub-optimal scores. Good riparian width with suboptimal vegetative protection.

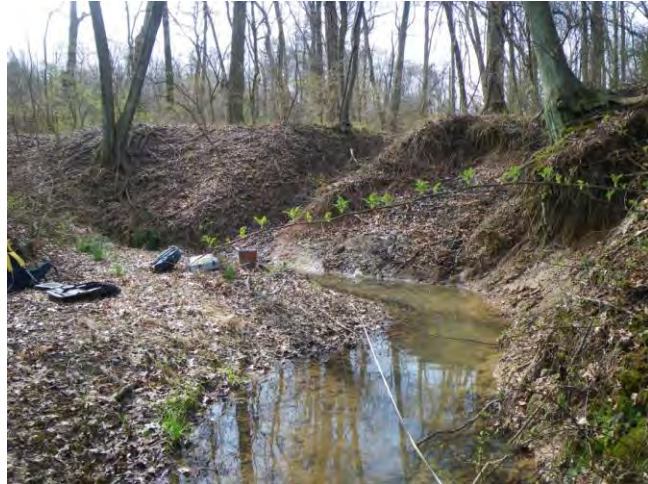
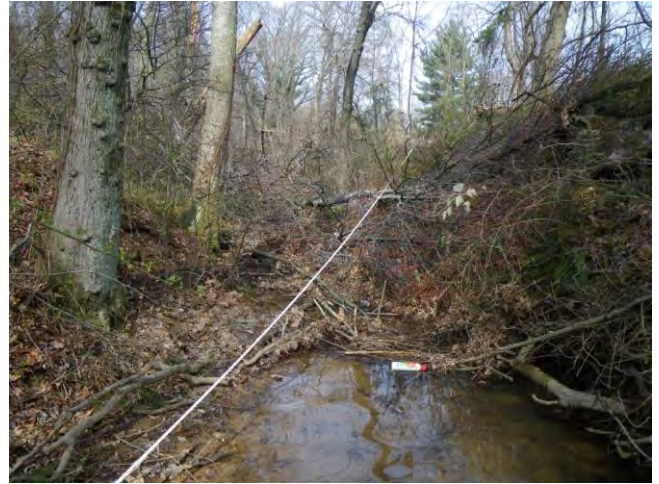
Located just off of Race Road between Citrus Avenue and Sellner Road, this site is part of the LPK subwatershed. This site is deeply incised most likely due to a road culvert located just upstream. A 2 foot drop below the culvert is causing a severe fish blockage. The reach is overwidened leading to mid-channel bars and areas of active bank erosion, indicating an unstable stream type. Shallow, poor quality riffles provide inadequate habitat leading to a very poor biological community with low taxa diversity. There was a complete lack of Ephemeroptera taxa and climber taxa in the benthic sample; however over half of the sample (59%) consisted of taxa intolerant to urban stressors. The small drainage area to this site (89 acres) is largely forested land (79%) with 17% as developed land. Only 9% of the drainage area is impervious surface. Conductivity levels were elevated considerably, possibly due to highway runoff from Baltimore-Washington Parkway (Rt. 295) and Jessup Road (Rt. 175) or from the corrugated metal culvert pipe immediately upstream of the sampling reach.

- Biological condition – *“Very Poor”*
- Habitat scores *“Non Supporting”* and *“Degraded”*
- Midges (Hydrobaenus) and black flies (Stegopterna) dominated the sample.
- Water quality values within COMAR standards but conductivity elevated.
- Moderately unstable banks, poor instream habitat, and marginal epibenthic substrate. Refuse present in moderate amounts.

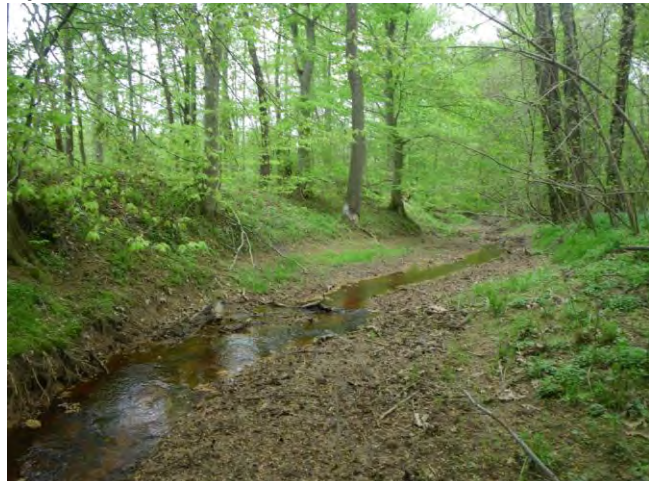
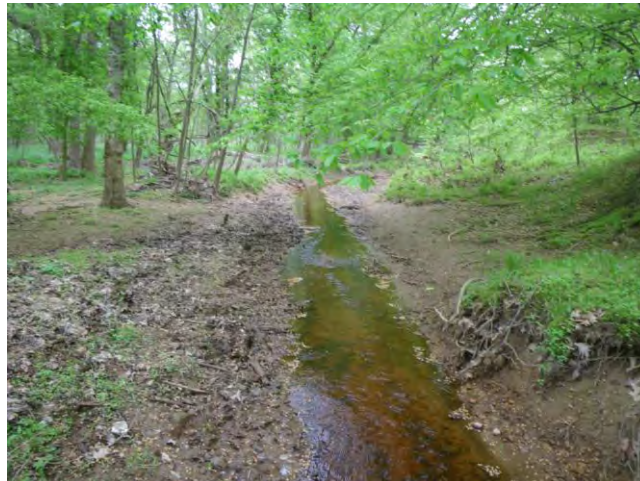
Located in the Patuxent Research Refuge just west of Wildlife Loop Road, this site is part of the LP4 subwatershed. The majority of the 596 acre drainage area to this site is forested land (94%) with 6% as open space. Less than 1% of the entire drainage area is impervious surface (0.2%). This site is a low gradient stream on the floodplain of the Little Patuxent River with reduced flow due to debris jams just upstream. With an entirely silt/sand bottom, there is very little stable habitat and an abundance of fine particulate organic matter. A complete lack of EPT, Ephemeroptera, and scraper taxa resulted in a very poor biological community. Although habitat is partially supporting, instream habitat and epifaunal substrate were rated in the poor categories, limiting the streams ability to support a diverse biological community. Furthermore, the acidic pH values (below COMAR standards), which appear to be naturally influenced by the surrounding wetland system draining to the site, may further limit the biological potential of this stream.

- Biological condition – “Very Poor”
- Habitat scores “Partially Supporting” and “Partially Degraded”
- Amphipods (Crangonyx) and bivalves (Musculium) dominated the sample.
- Measured below COMAR standards for pH.
- Poor habitat diversity but banks are stable. Very little woody debris present. Good riparian width with sub-optimal vegetative protection.

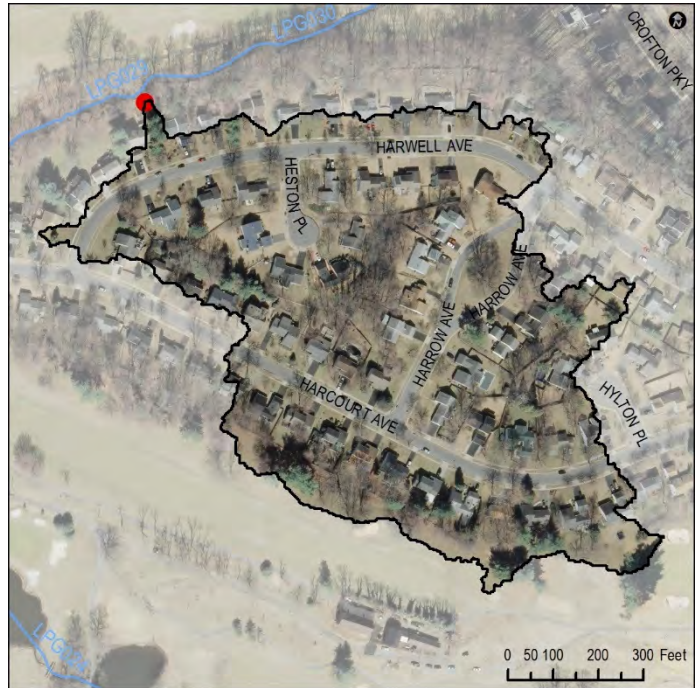
Figure 2 - Aerial Photo of Drainage Area

The Crofton neighborhood served by Harcourt and Harwell Avenues is a low/medium density residential area consisting of single-family houses. It is served by 13 catch basins (GIS-verified), 11 of which are street inlets. The stormwater outfall is to a stream on the northwest edge of the neighborhood, on the site of the Crofton Country Club. All houses in the community have driveways and garages in addition to on-street parking. There are tree lawns between the streets and sidewalks. The street areas along the curbs, the tree lawns, and the sidewalks are the prime retrofit opportunities for stormwater treatment to the MEP. Also, the single-family homes in the community all have roof area sufficient to justify rain harvesting systems for each home. The purpose of this concept plan is to incorporate ESD to the MEP.

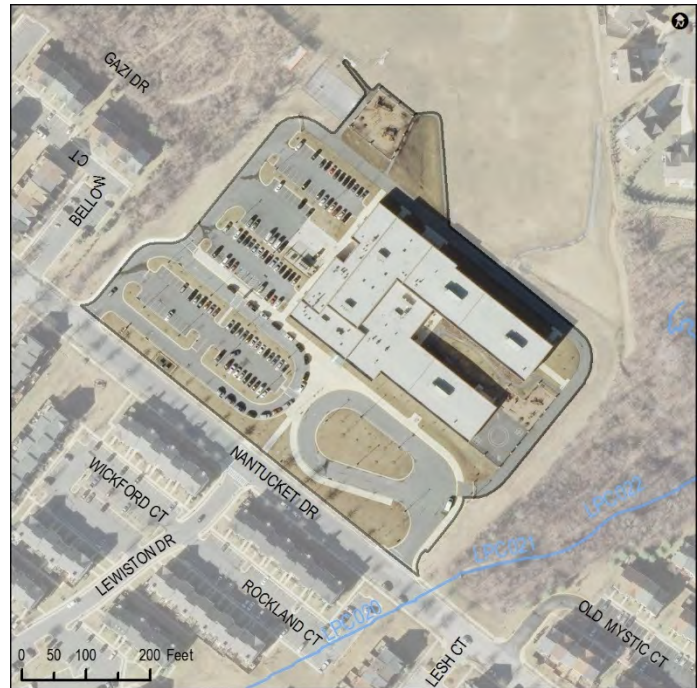
Figure 2 Aerial Photo of Drainage Area

Nantucket Elementary School is owned and maintained by Anne Arundel County Public Schools. The 7 acre school site (total parcel is 15 acres) consists of parking lots, sidewalks, a single building, courtyard areas, and multiple recreation areas (Figure 2). Currently, a stormwater collection system with 12 catch basins conveys water to the County’s collection system along Nantucket Drive. A small portion of the impervious area flows to the east of the school building. The parking lot and building roof areas are the prime opportunities for retrofits of stormwater management to the MEP. Construction plans were made available by the County for an addition to school which occurred in 2014/2015 (AACPS 2014). The plans showed utilities, topography, and other
