# Magothy River Watershed Assessment

Comprehensive Study Summary Report

May 2010

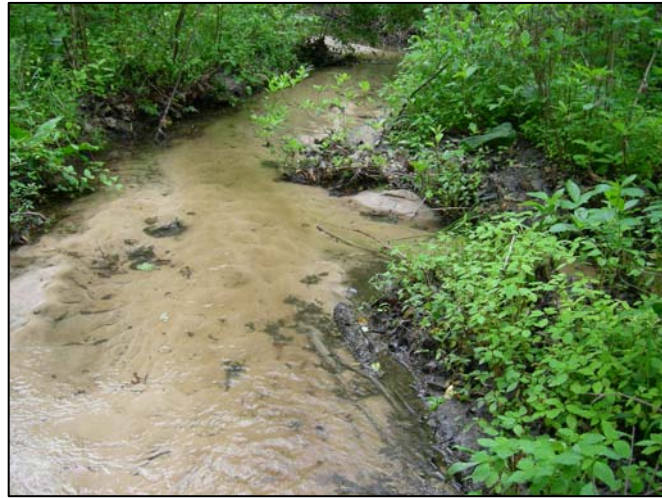
Figure 2.1 – Examples of Assessed Stream Reaches

Stream Reach in the Bailys Branch Subwatershed (MR1) with Minimally Degraded Habitat Condition

Degraded” condition. Approximately 62% of perennial stream miles in the Magothy River Watershed were rated as “Partially Degraded.” “Minimally Degraded” streams comprised roughly 28% of the perennial streams, followed by “Degraded” and “Severely Degraded” streams at 6.8% and 2.6%, respectively. The Magothy Branch and Cypress Creek subwatersheds had the highest number (three) of stream reaches that are either “Degraded” or “Severely Degraded.” The Deep Creek and Bailys Branch subwatersheds had the highest percentage of perennial stream miles that were considered “Minimally Degraded” with 84% and 72%, respectively. A summary of MPHI condition categories by stream mile and number of reaches is provided in Table 2.2. A map of the MPHI conditions throughout the watershed is presented as Map 2.2. Examples of assessed stream reaches are depicted in Figure 2.1.

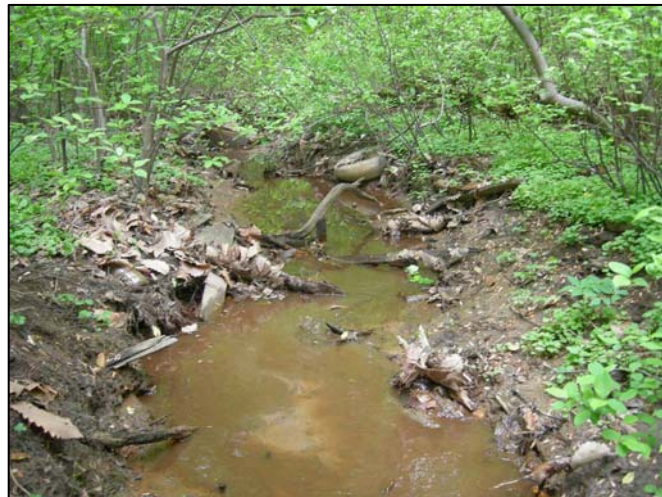
Stream Reach in the Cypress Creek Subwatershed (MGC) with Severely Degraded Habitat Condition

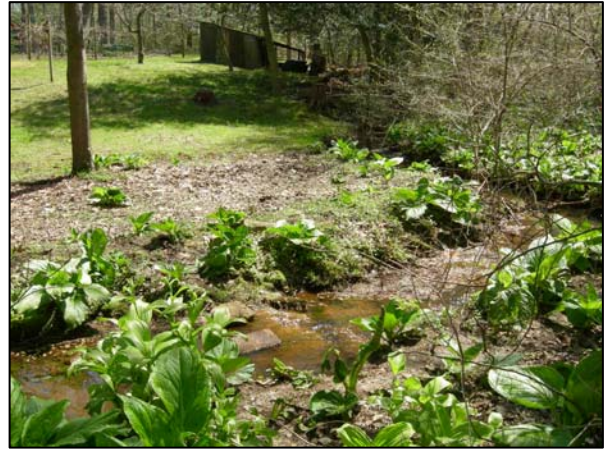
Figure 2.2 – Examples of Environmental and Infrastructure Features

Deficient Buffer (Residential Lawn Encroachment) with Moderate Impact in the Little Magothy River Subwatershed (MGV)

A summary of the impacts for each infrastructure or environmental feature is presented in Table 2.3. The distribution of these features throughout the watershed is presented in Map 2.3. Stream crossings, which typically include culverted segments of stream, accounted for the largest number of inventory features and the highest cumulative impact score. Riparian buffer impacts and pipe and ditch impacts were the next most common inventory features identified in the Magothy River Watershed. Riparian buffer impacts were most often associated with encroachment from residential lawns. Pipes and drainage ditches that contribute flow and erosive forces to the Magothy River Watershed streams were most often associated with stormwater outfalls. The relative abundance of these three infrastructure features (*i.e.*, stream crossings, deficient buffers, and pipes and ditches) is consistent with a more urbanized watershed like the Magothy River. The remaining features (*i.e.*, dumpsites, eroded areas, obstructions, utilities, and head cuts) were encountered less frequently, but certainly contributed locally to areas of stream degradation throughout the watershed. Examples of environmental and infrastructure features encountered in the Magothy River Watershed are depicted in Figure 2.2.

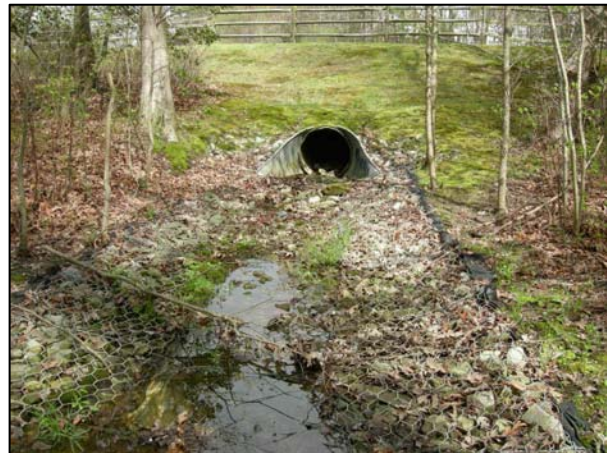
Pipe and Ditch Contributing Flow with Moderate Impact in the Forked Creek Subwatershed (MGL)

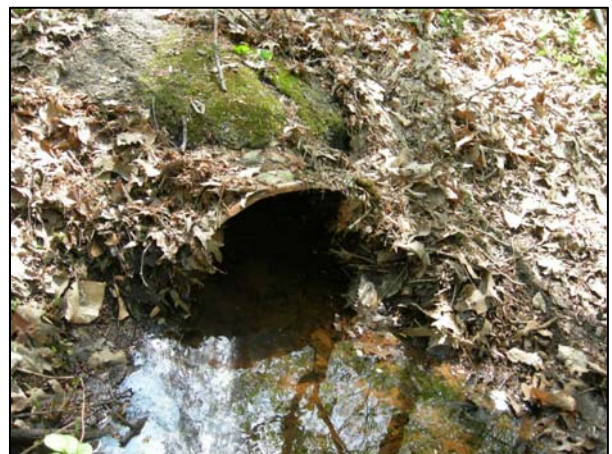
Stream Crossing with Moderate Impact in the Deep Creek Subwatershed (MGT)

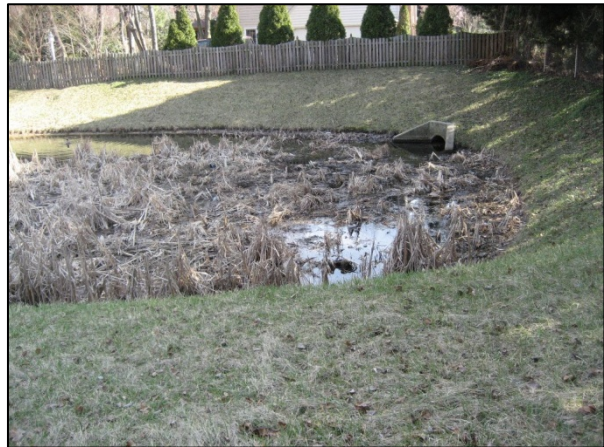
Figure 2.4 – Examples of Poorly Performing BMPs

Poorly Performing Infiltration Basin near Dunkeld Court in the Cypress Creek Subwatershed (MGC)

To function as designed, BMPs need to be properly maintained. Some of the older BMPs in the County are no longer functioning or effective for a variety of reasons. Some are failing due to a lack of maintenance. Others are failing due to inadequate original design or changes in development intensity within a drainage area that exceeds the original design capacity of the BMP. Many of the failed or failing BMPs in the Magothy River Watershed consist of overwhelmed infiltration systems or detention ponds that have become clogged. Other BMPs, such as dry ponds were designed primarily for water quantity management and as such offer very little water quality benefit. Examples of poorly performing BMPs are presented in Figure 2.4.

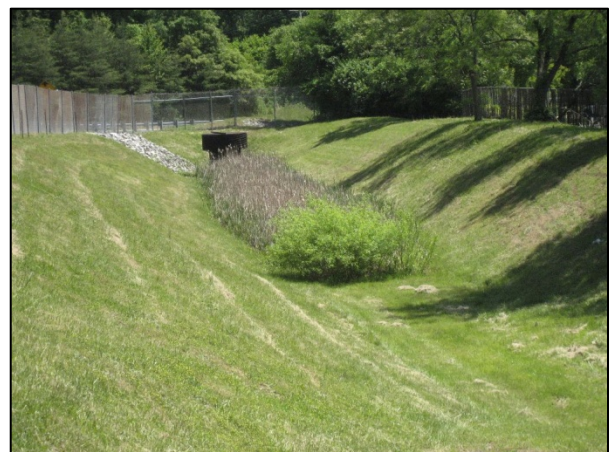
Poorly Performing Extended Detention Pond near Leelyn Drive in the Cypress Creek Subwatershed (MGC)

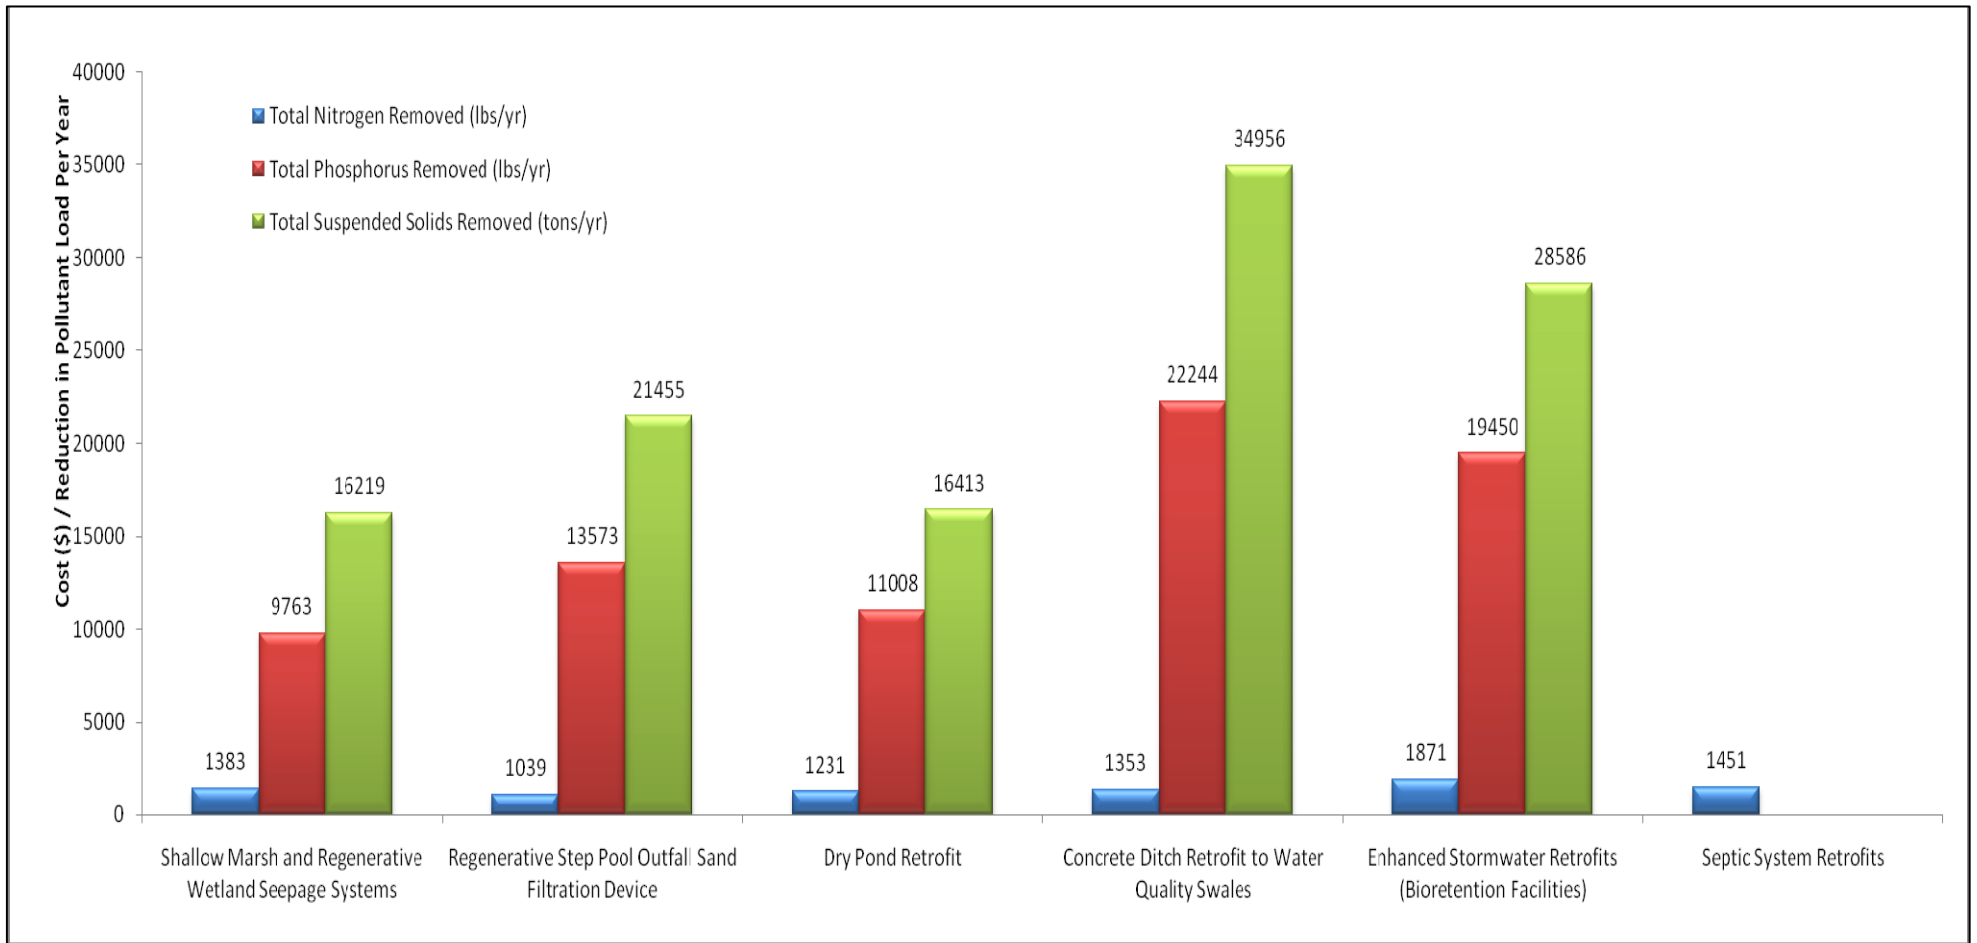
Figure 5.5 – Cost/Benefit Ratio of Retrofit and Restoration Scenarios for Pollutant Removal

The results of the cost/benefit calculations are presented in both tabular and graphical format. Figure 5.5 compares the modeled cost effectiveness across the entire watershed of different scenarios that correspond to different retrofit and restoration types. Figures 5.6 through 5.8 compare the total removal and the cost-effectiveness for total phosphorus (TP), total nitrogen (TN), and total suspended solids (TSS) in the priority subwatersheds. Table 5.7 summarizes the calculated unit costs for removal of these pollutants assuming all retrofit and restoration projects are implemented.

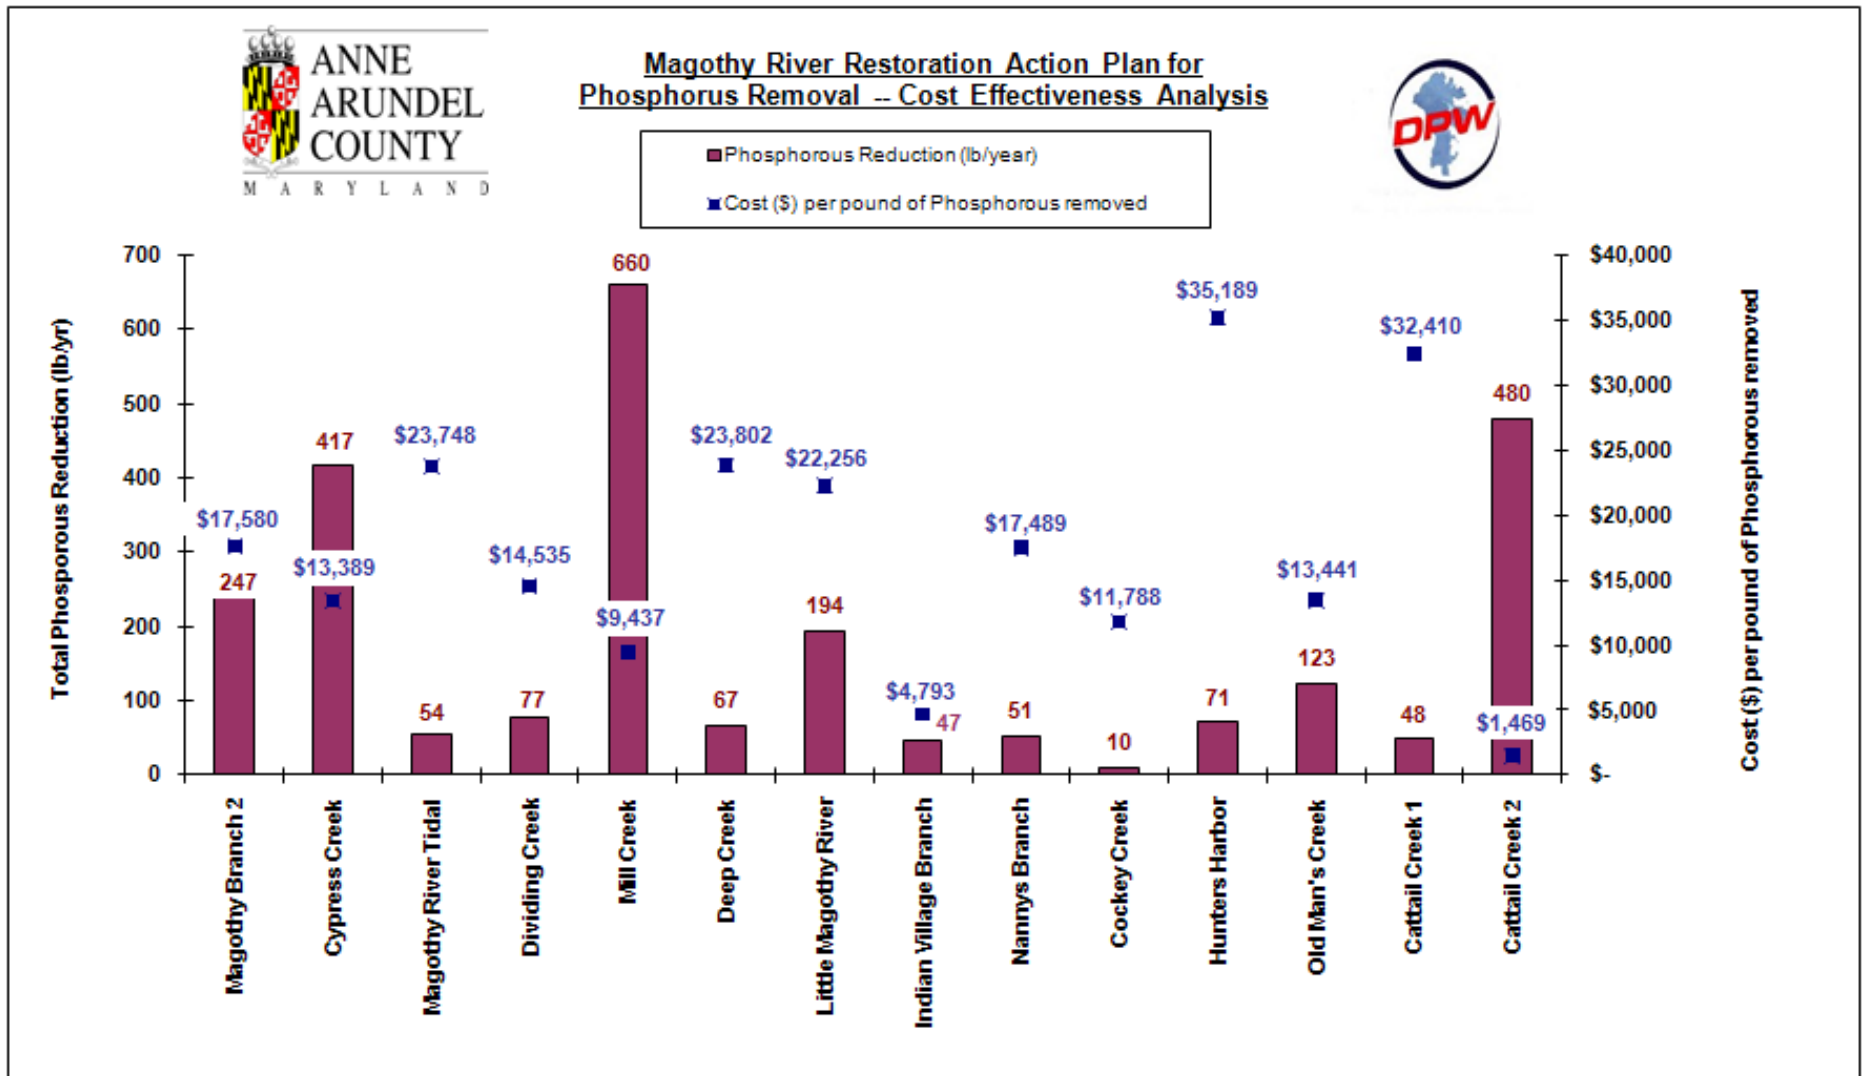
Figure 5.6 – Cost Effectiveness Analysis by Subwatershed of Total Phosphorus Removal

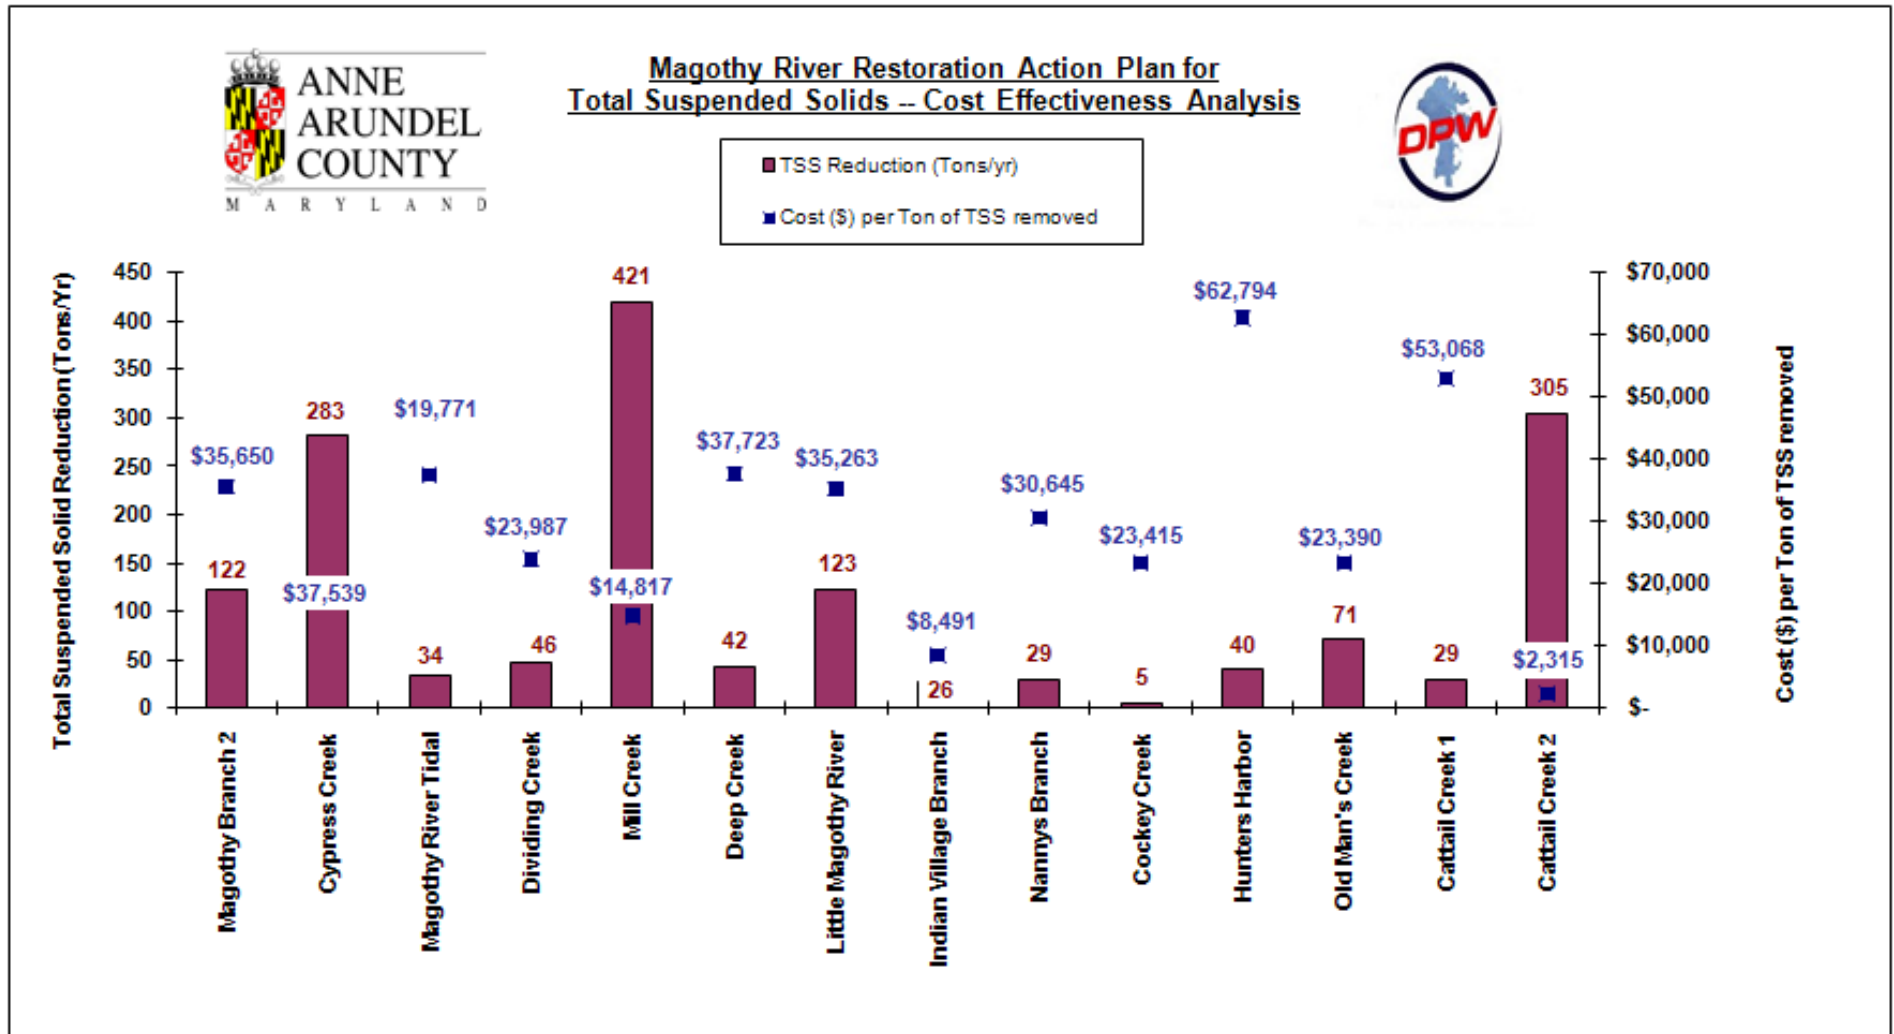
Figure 5.8 – Cost Effectiveness Analysis by Subwatershed of Total Suspended Solids Removal
