## APPENDIX A – FLOODING POTENTIAL TECHNICAL MEMORANDUM

## TECHNICAL MEMORANDUM

**SUBJECT:** Patapsco Non-Tidal Watershed Assessment - 01090525  
Crossing Modeling Site Selection and Field Survey

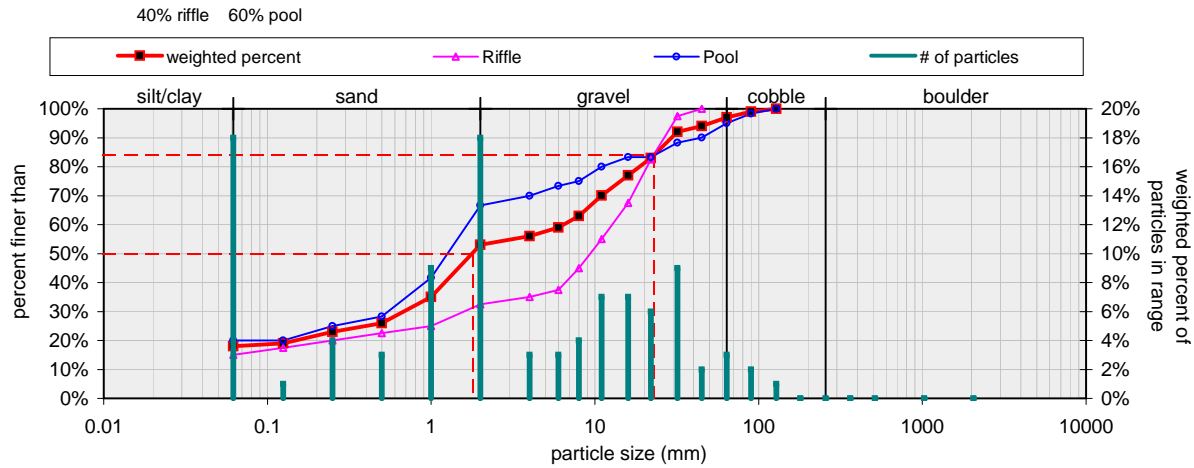
**Weighted pebble count by bed features ---**

Size (mm)		Size Distribution		Type	
D16	0.062	mean	1.2	silt/clay	18%
D35	1	dispersion	20.9	sand	35%
D50	1.8	skewness	-0.1	gravel	44%
D65	8.8			cobble	3%
D84	23			boulder	0%
D95	51			bedrock	0%

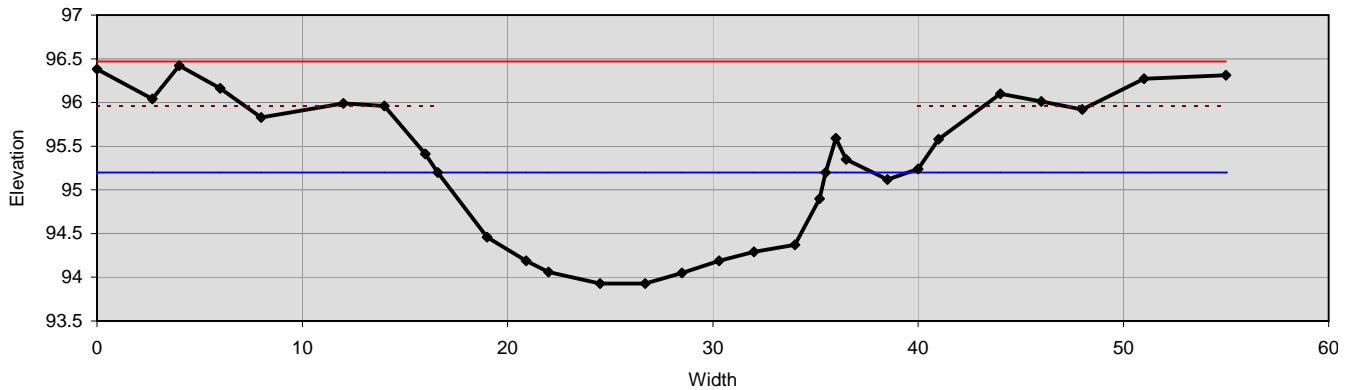
**Cross-section**

Bankfull Dimensions	
17.8	x-section area (ft.sq.)
20.6	width (ft)
0.9	mean depth (ft)
1.3	max depth (ft)
21.0	wetted perimeter (ft)
0.8	hydraulic radius (ft)
23.8	width-depth ratio

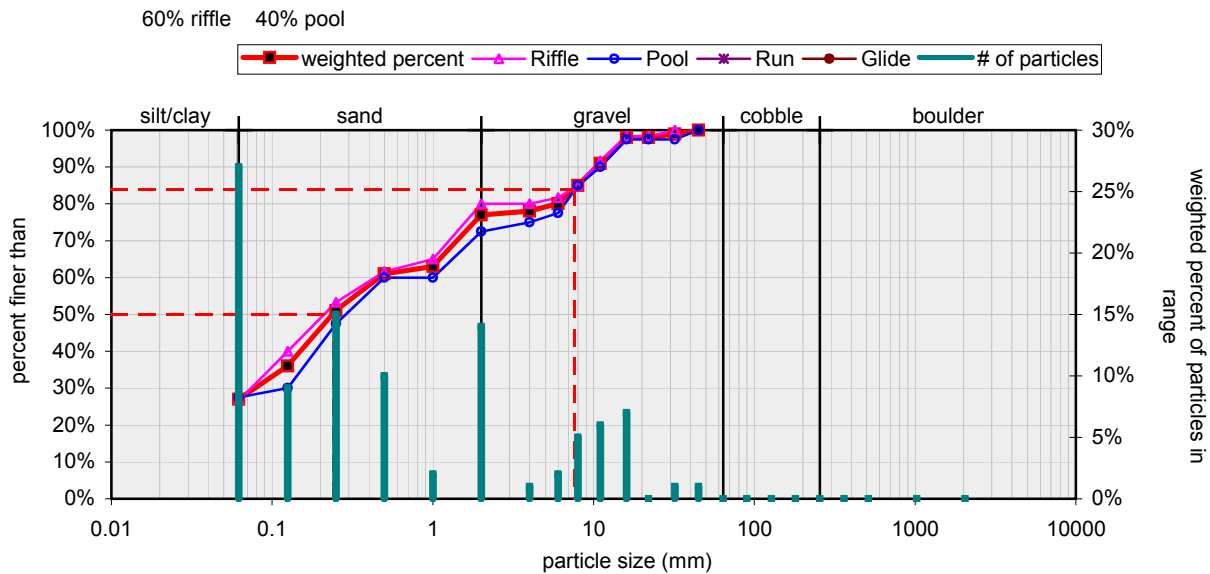
**Weighted pebble count by bed features ---**

Size (mm)		Size Distribution		Type	
D16	0.062	mean	0.7	silt/clay	27%
D35	0.12	dispersion	17.8	sand	50%
D50	0.24	skewness	0.3	gravel	23%
D65	1.1			cobble	0%
D84	7.6			boulder	0%
D95	14			bedrock	0%

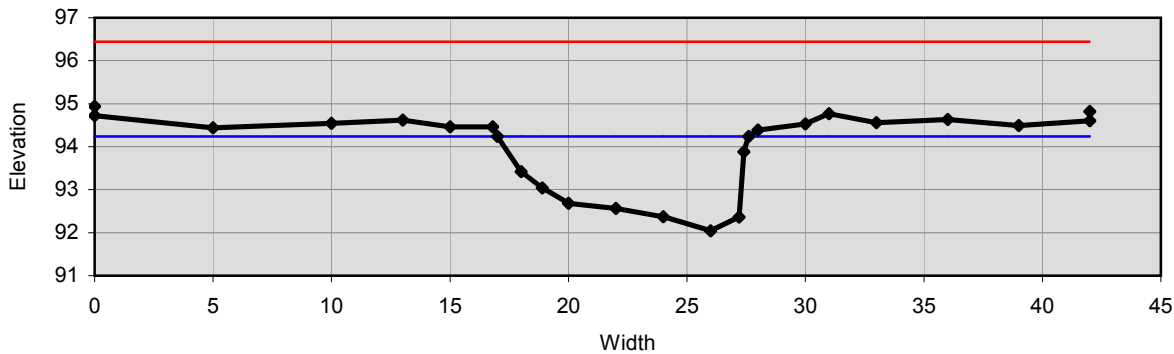
**Cross Section**

Bankfull Dimensions	
16.4	x-section area (ft.sq.)
10.6	width (ft)
1.5	mean depth (ft)
2.2	max depth (ft)
12.7	wetted perimeter (ft)
1.3	hydraulic radius (ft)
6.8	width-depth ratio

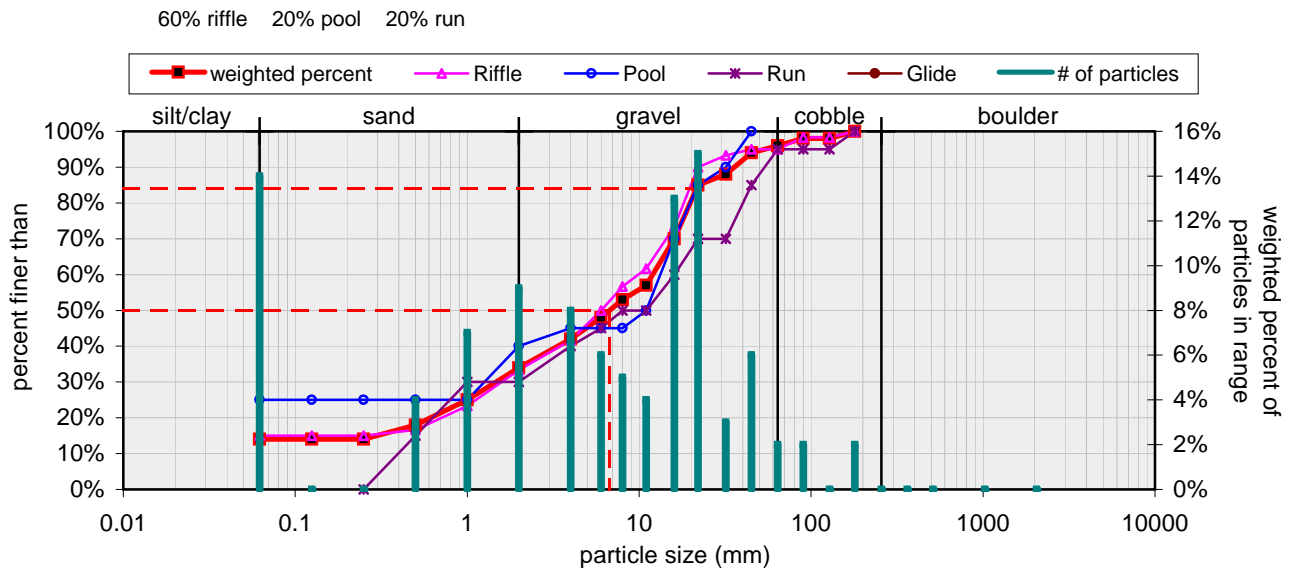
**Weighted pebble count by bed features ---**

Size (mm)	Size Distribution	Type
D16 0.35	mean 2.8	silt/clay 14%
D35 2.2	dispersion 11.2	sand 20%
D50 6.7	skewness -0.3	gravel 62%
D65 14		cobble 4%
D84 22		boulder 0%
D95 54		bedrock 0%

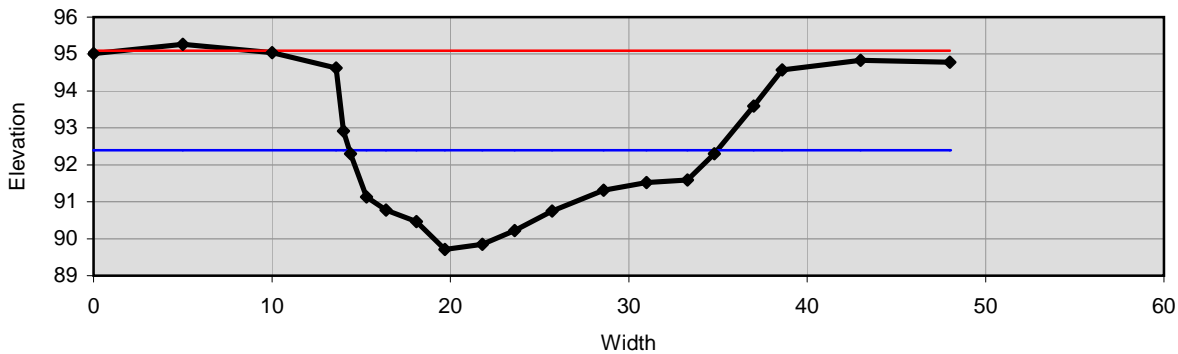
**Cross Section**

Bankfull Dimensions	
31.7	x-section area (ft.sq.)
20.6	width (ft)
1.5	mean depth (ft)
2.7	max depth (ft)
21.9	wetted perimeter (ft)
1.4	hydraulic radius (ft)
13.4	width-depth ratio

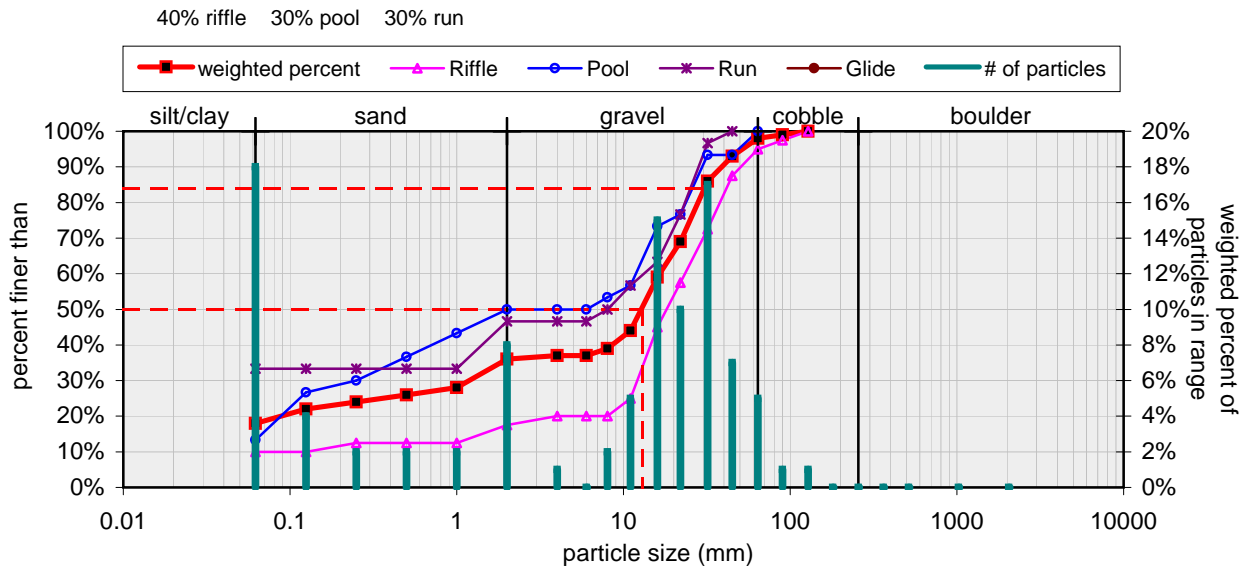
**Weighted pebble count by bed features ---**

Size (mm)		Size Distribution		Type	
D16	0.062	mean	1.4	silt/clay	18%
D35	1.8	dispersion	106.0	sand	18%
D50	13	skewness	-0.6	gravel	62%
D65	19			cobble	2%
D84	31			boulder	0%
D95	52			bedrock	0%

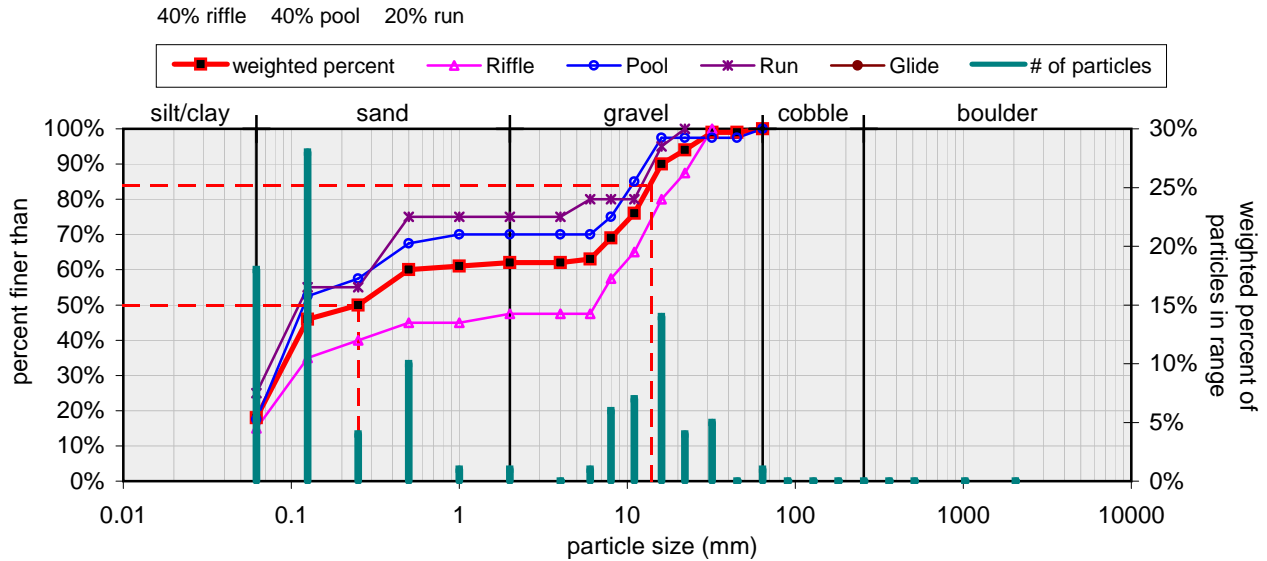
**Weighted pebble count by bed features ---**

Size (mm)	Size Distribution	Type
D16 0.062	mean 0.9	silt/clay 18%
D35 0.095	dispersion 30.0	sand 44%
D50 0.25	skewness 0.4	gravel 38%
D65 6.6		cobble 0%
D84 14		boulder 0%
D95 24		bedrock 0%

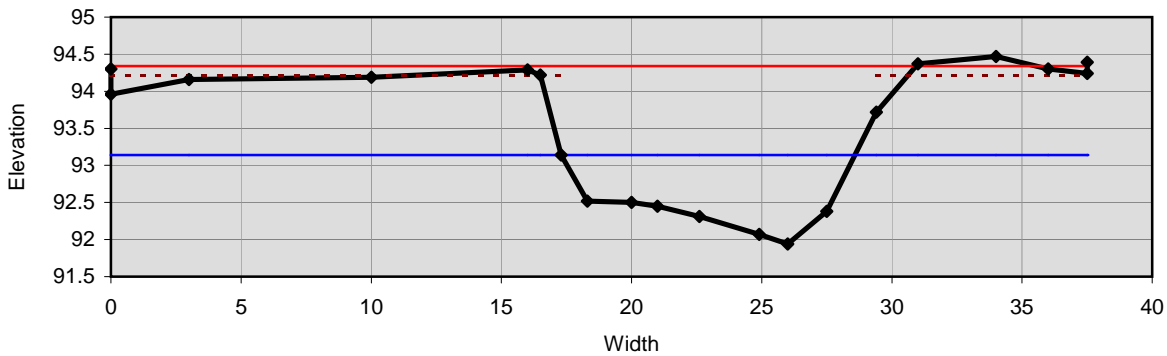
**Cross Section**

Bankfull Dimensions	
8.6	x-section area (ft.sq.)
11.3	width (ft)
0.8	mean depth (ft)
1.2	max depth (ft)
11.8	wetted perimeter (ft)
0.7	hydraulic radius (ft)
14.8	width-depth ratio

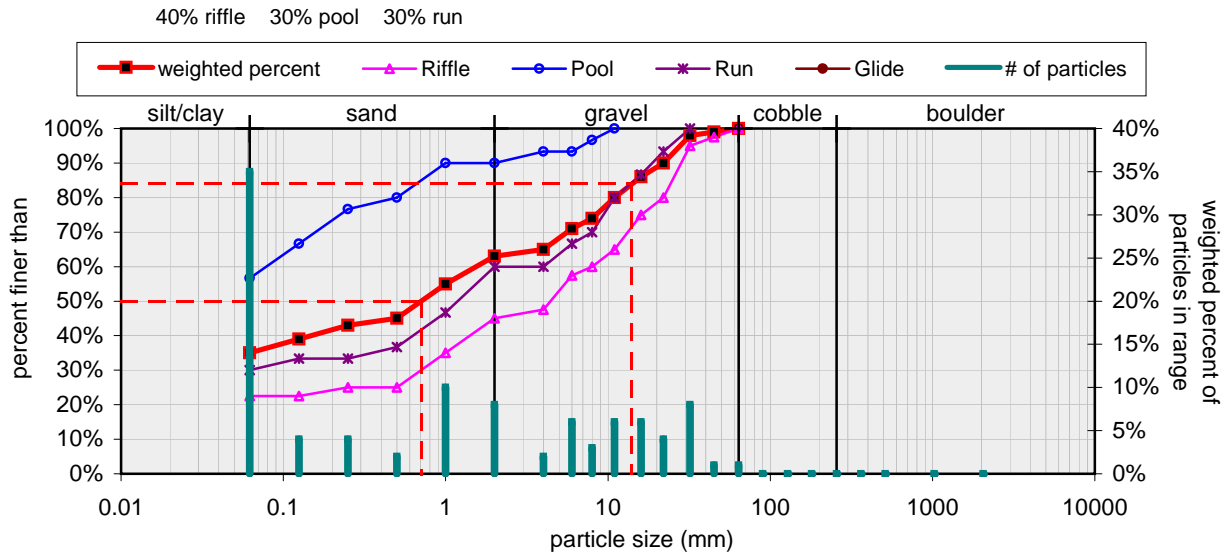
**Weighted pebble count by bed features ---**

Size (mm)	Size Distribution	Type
D16 0.062	mean 0.9	silt/clay 35%
D35 0.062	dispersion 15.6	sand 28%
D50 0.71	skewness 0.1	gravel 37%
D65 4		cobble 0%
D84 14		boulder 0%
D95 28		bedrock 0%

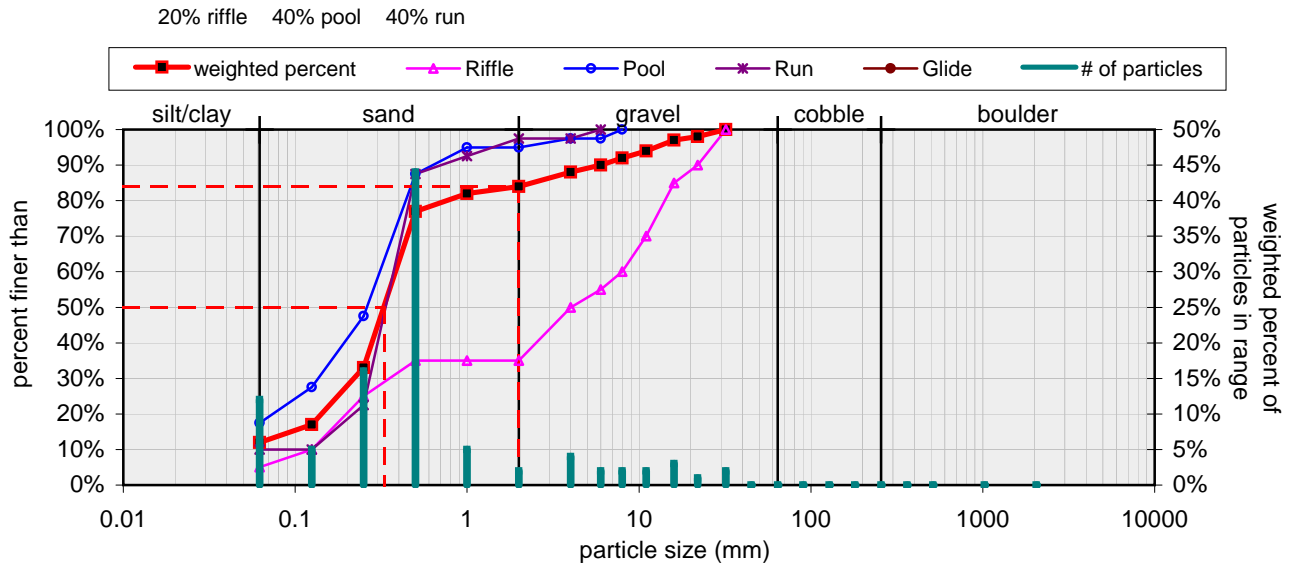
**Weighted pebble count by bed features ---**

Size (mm)		Size Distribution		Type	
D16	0.11	mean	0.5	silt/clay	12%
D35	0.26	dispersion	4.5	sand	72%
D50	0.33	skewness	0.1	gravel	16%
D65	0.41			cobble	0%
D84	2			boulder	0%
D95	12			bedrock	0%

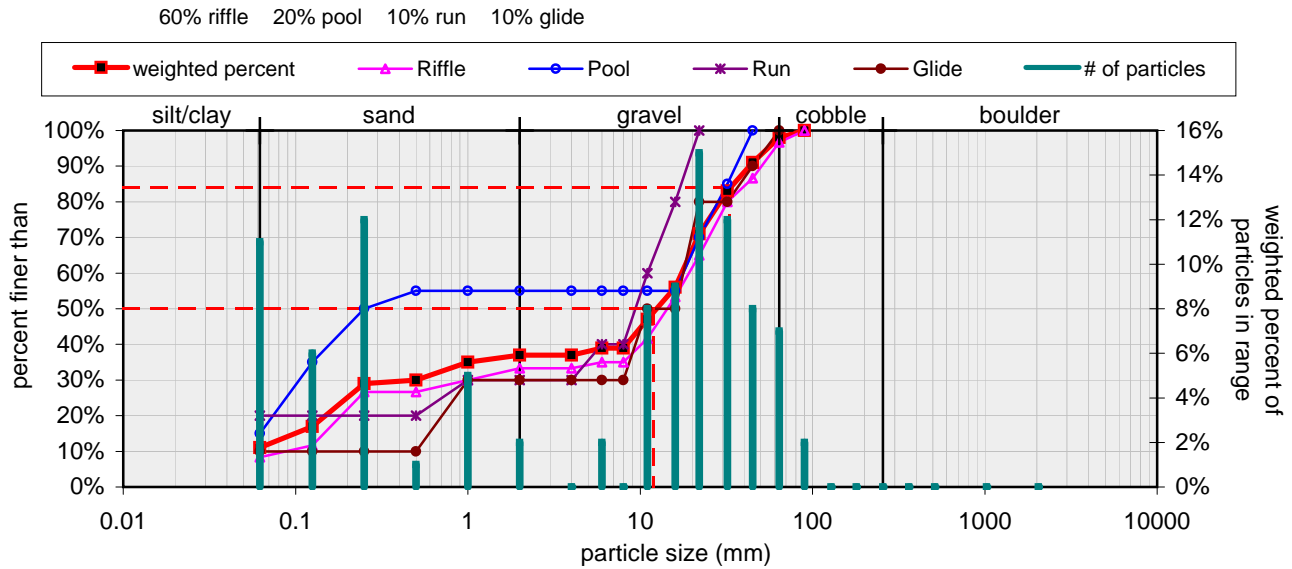
**Weighted pebble count by bed features ---**

Size (mm)		Size Distribution		Type	
D16	0.11	mean	1.9	silt/clay	11%
D35	1	dispersion	55.9	sand	26%
D50	12	skewness	-0.5	gravel	61%
D65	19			cobble	2%
D84	33			boulder	0%
D95	55			bedrock	0%

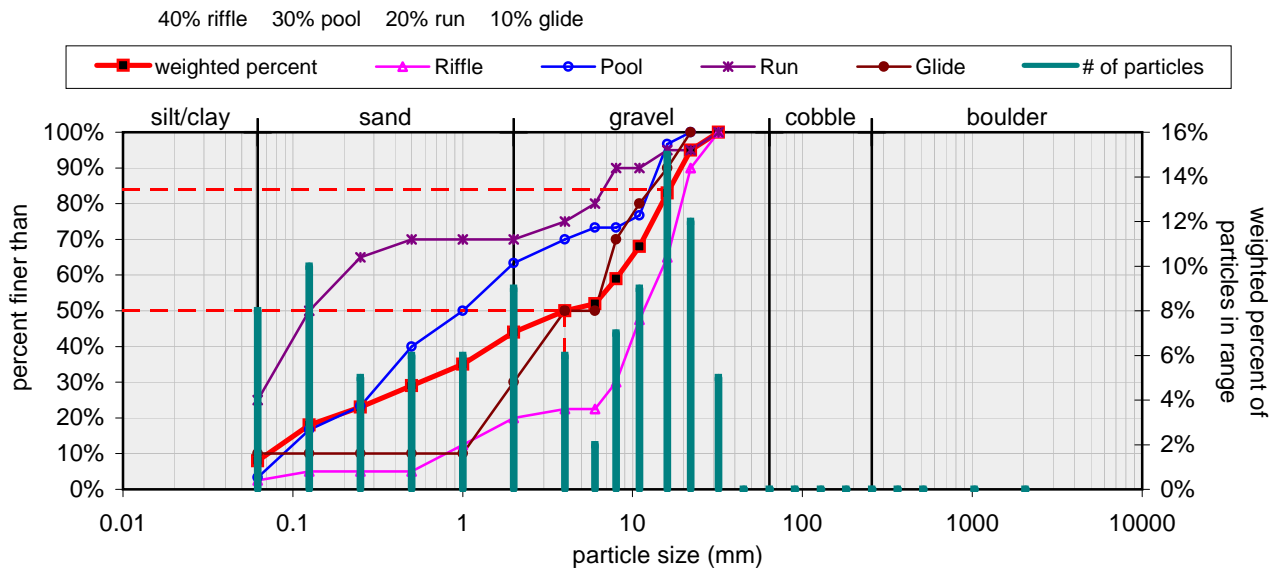
**Weighted pebble count by bed features ---**

Size (mm)		Size Distribution		Type	
D16	0.11	mean	1.3	silt/clay	8%
D35	1	dispersion	20.2	sand	36%
D50	4	skewness	-0.3	gravel	56%
D65	9.9			cobble	0%
D84	16			boulder	0%
D95	22			bedrock	0%

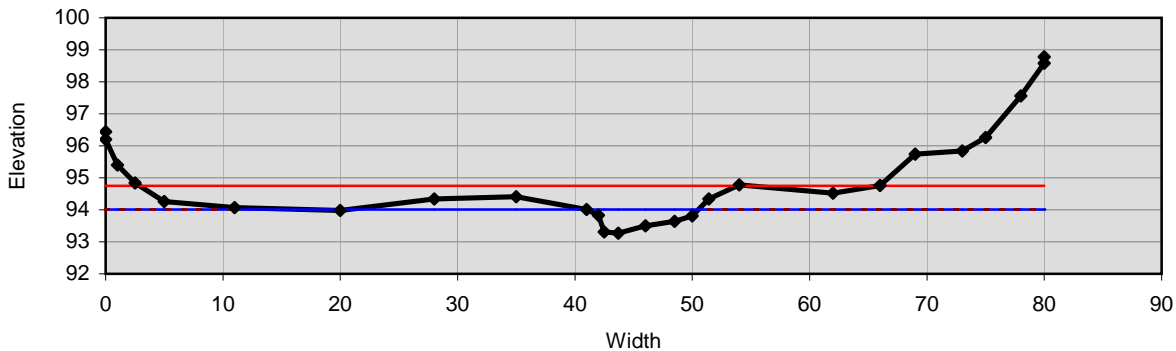
**Cross Section**

Bankfull Dimensions	
4.2	x-section area (ft.sq.)
13.2	width (ft)
0.3	mean depth (ft)
0.7	max depth (ft)
13.5	wetted perimeter (ft)
0.3	hydraulic radius (ft)
41.0	width-depth ratio

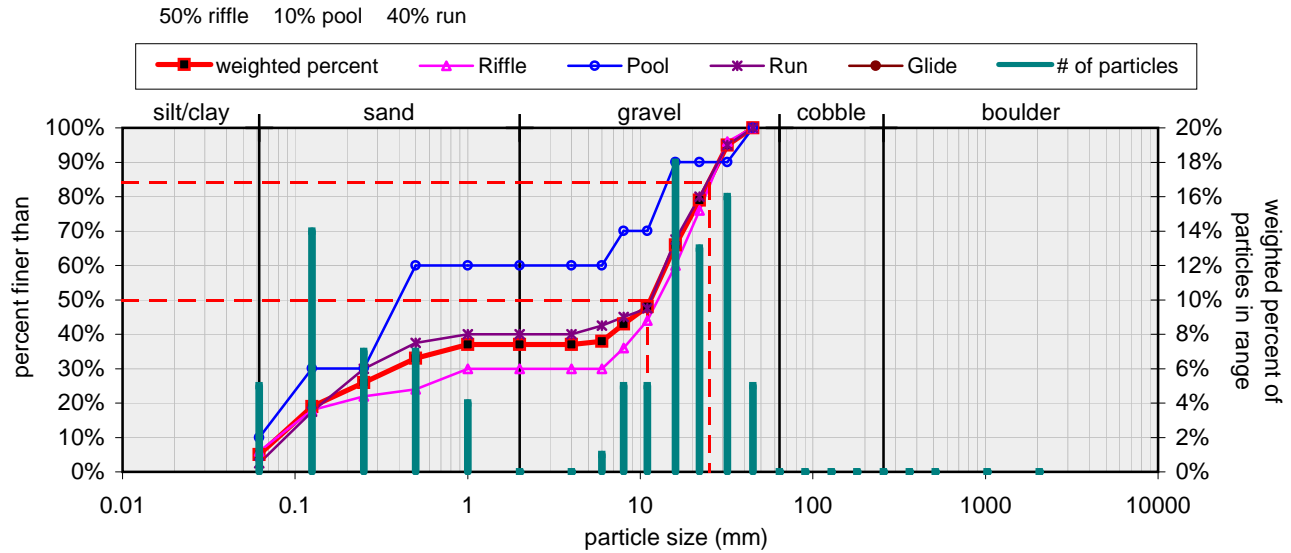
**Weighted pebble count by bed features ---**

Size (mm)	Size Distribution	Type
D16 0.11	mean 1.7	silt/clay 5%
D35 0.71	dispersion 51.1	sand 32%
D50 11	skewness -0.5	gravel 63%
D65 16		cobble 0%
D84 25		boulder 0%
D95 32		bedrock 0%

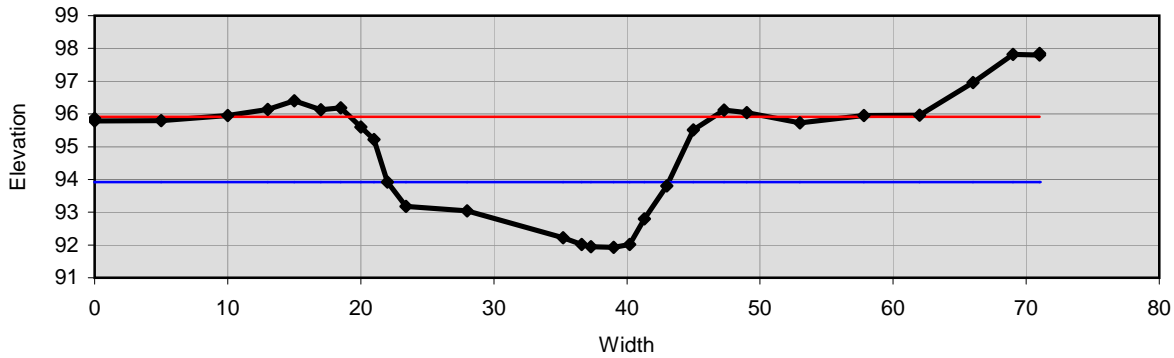
**Cross Section**

Bankfull Dimensions	
25.8	x-section area (ft.sq.)
21.1	width (ft)
1.2	mean depth (ft)
2.0	max depth (ft)
22.0	wetted perimeter (ft)
1.2	hydraulic radius (ft)
17.3	width-depth ratio

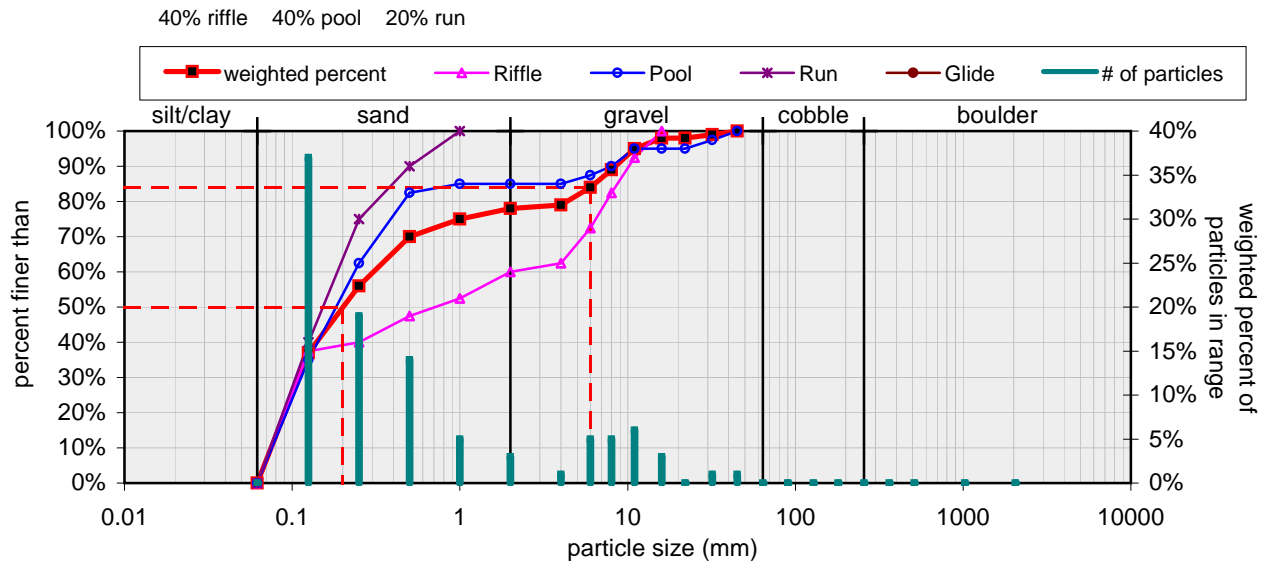
**Weighted pebble count by bed features ---**

Size (mm)		Size Distribution		Type	
D16	0.084	mean	0.7	silt/clay	0%
D35	0.12	dispersion	16.2	sand	78%
D50	0.2	skewness	0.4	gravel	22%
D65	0.39			cobble	0%
D84	6			boulder	0%
D95	11			bedrock	0%

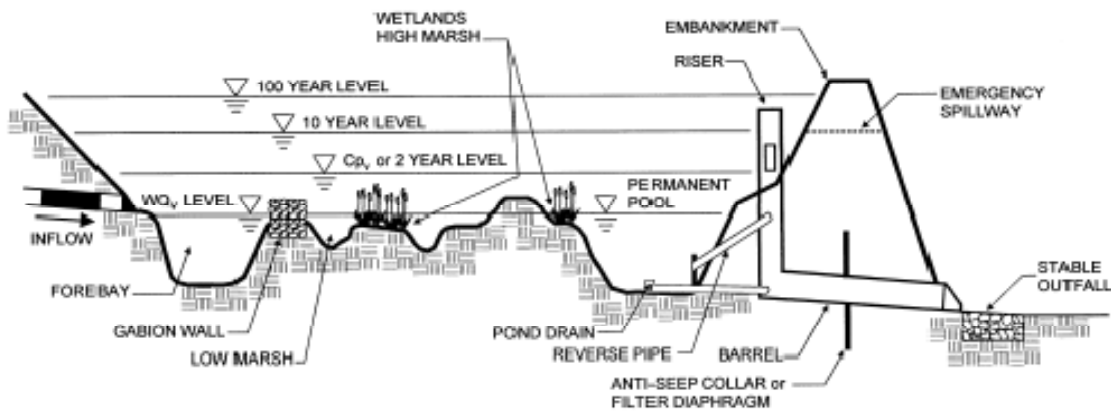
FIGURE 4: TYPICAL SHALLOW WETLAND, CROSS SECTION PROFILE (FROM MARYLAND STORMWATER DESIGN MANUAL, MDE 2009)

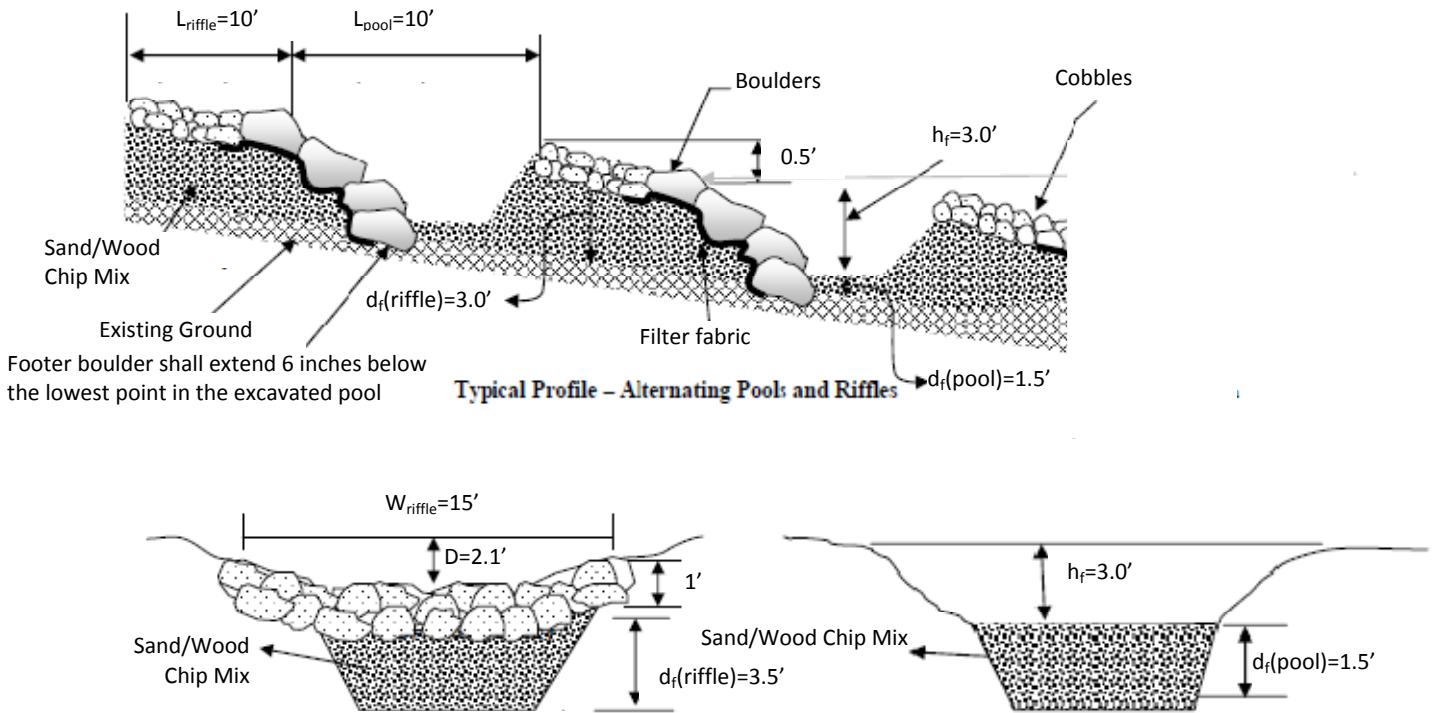
FIGURE 2: TYPICAL DETAILS

Riffle Weir Cross Section Through Cobble

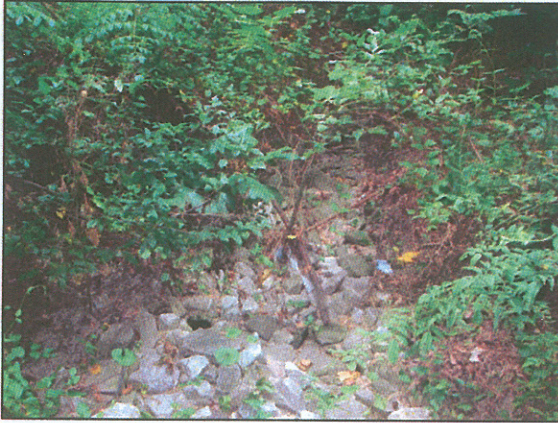
PHOTO 1: UPSTREAM SECTION OF EXISTING RIP RAP CHANNEL

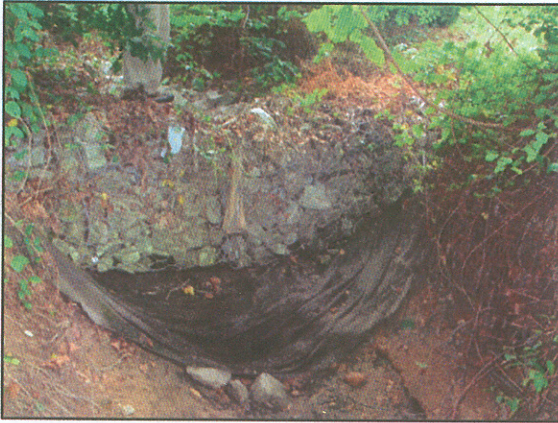
PHOTO 1: FAILING GABION BASKET FACING UPSTREAM

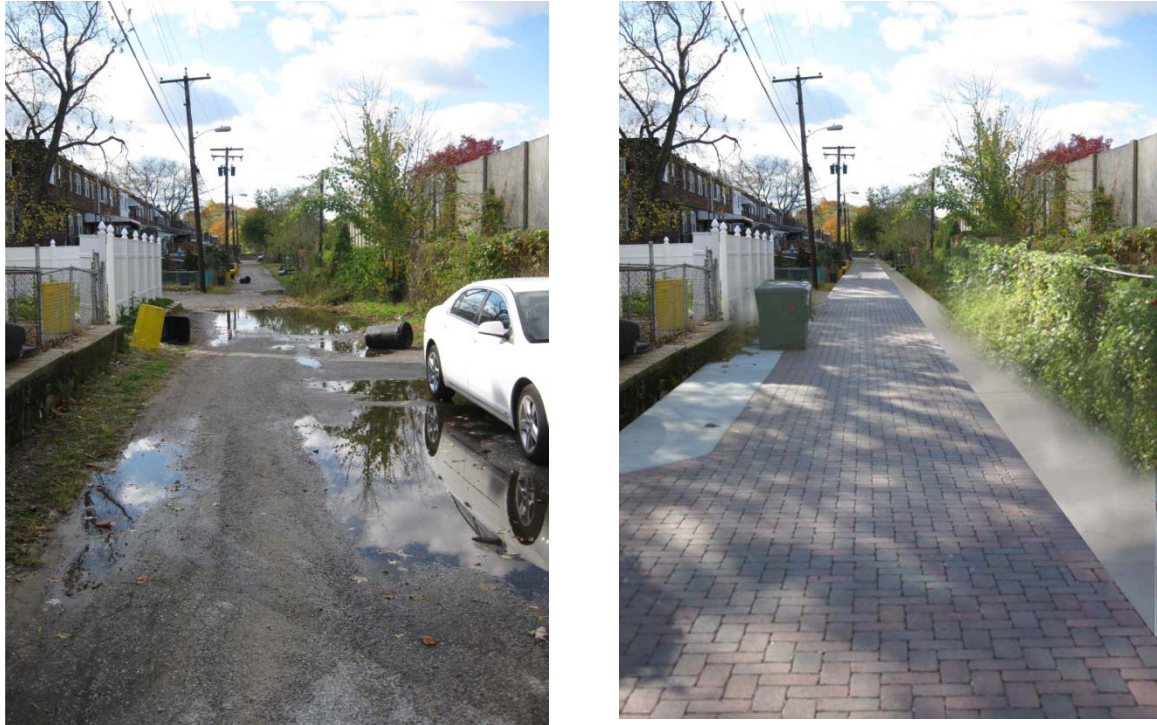
**FIGURE 5: RENDERINGS OF PRE AND POST CONSTRUCTION GREEN ALLEY EXAMPLE**

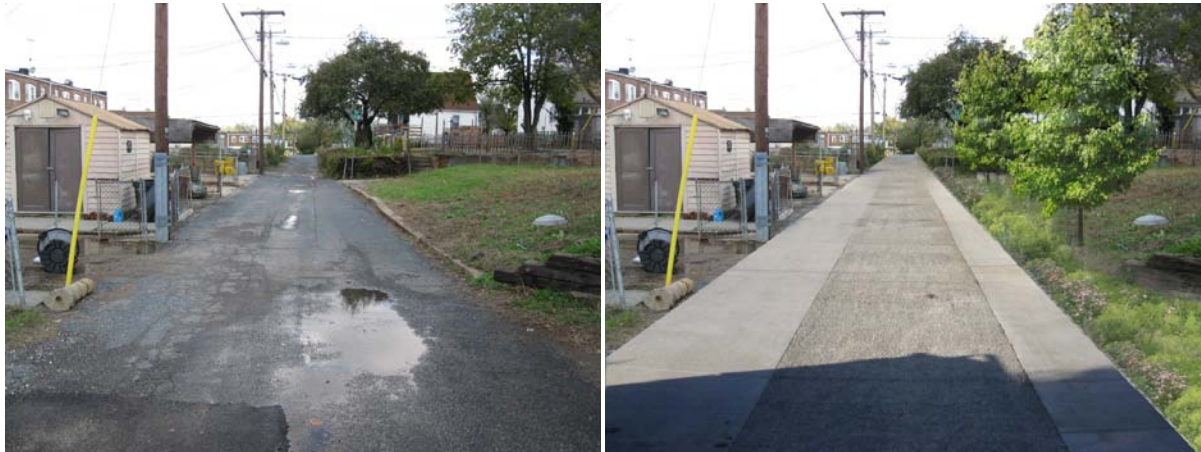
**FIGURE 6: RENDERINGS OF PRE AND POST CONSTRUCTION GREEN ALLEY EXAMPLE (LOWER END OF ALLEY 3)**

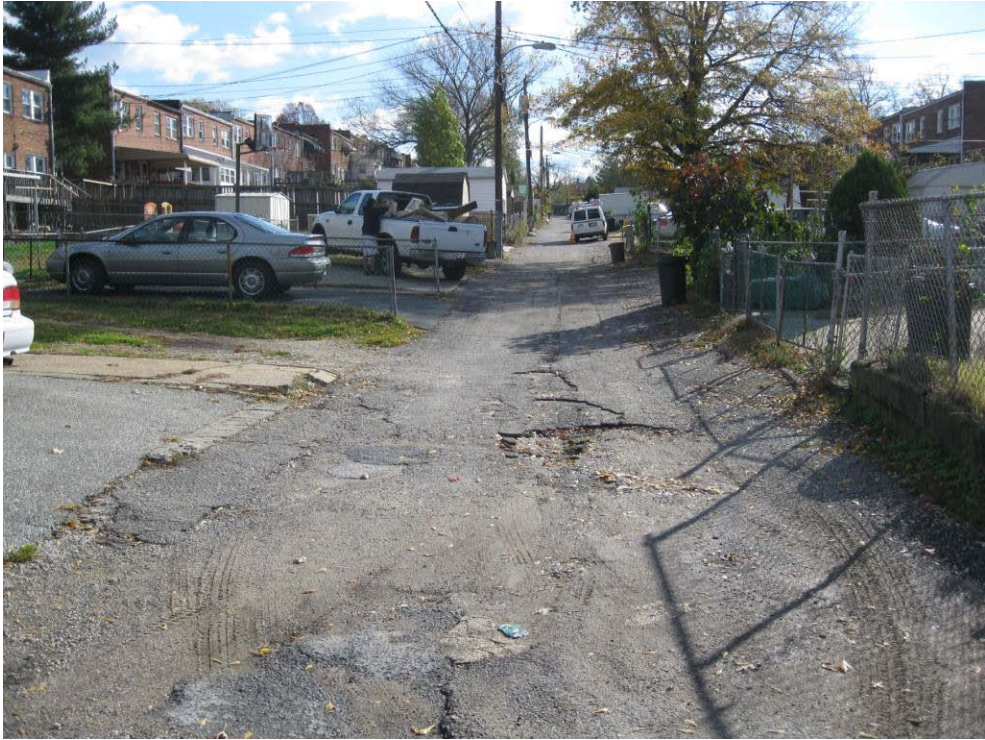
**PHOTO 1: EXISTING ALLEY WAY (NOTE THE POOR PAVEMENT CONDITION)**

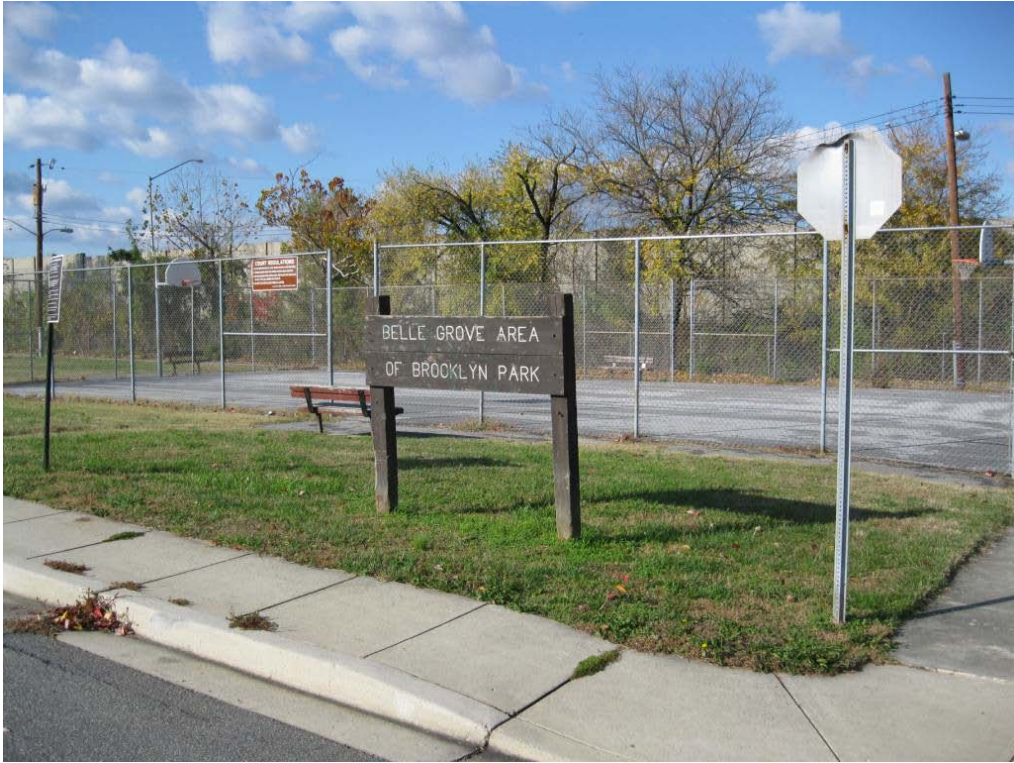
**PHOTO 2: EXISTING BASKETBALL COURT FOR PROPOSED POROUS PAVEMENT PROJECT**

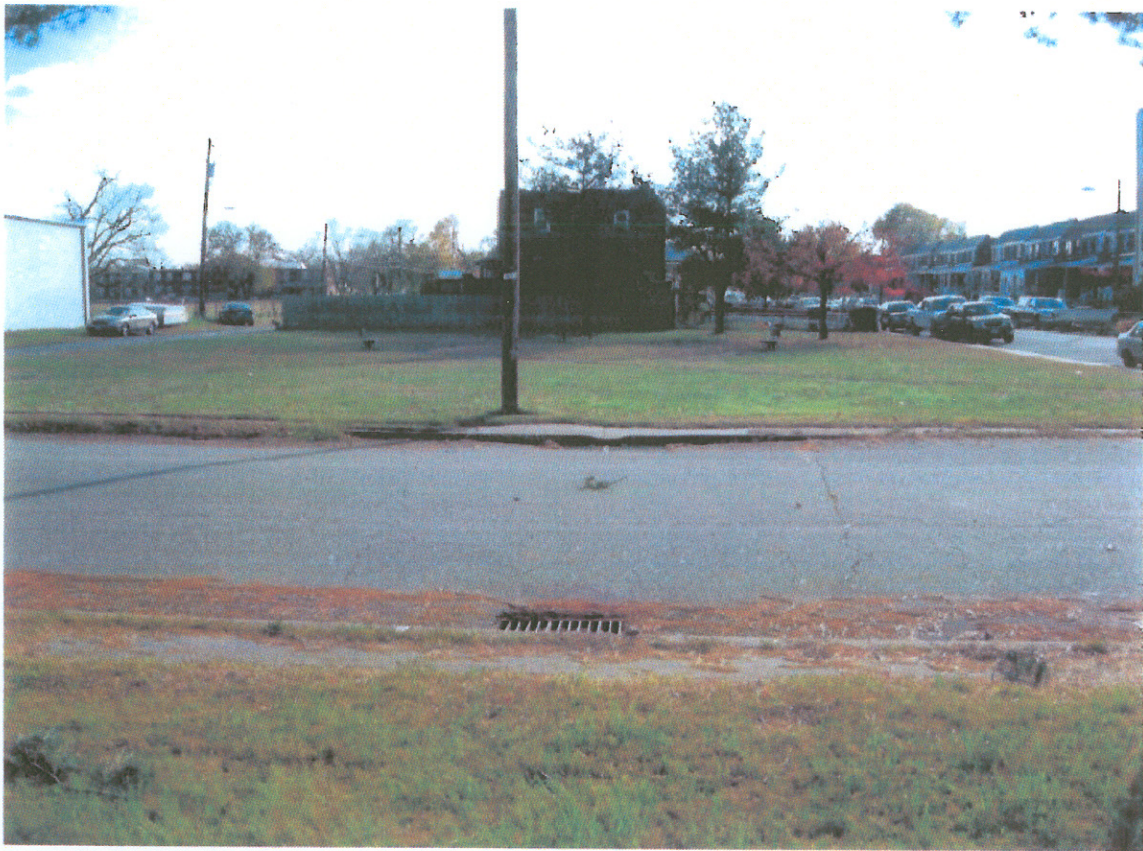
PHOTO 3: EXISTING SITE FOR POTENTIAL BIORETENTION/ RAIN GARDEN

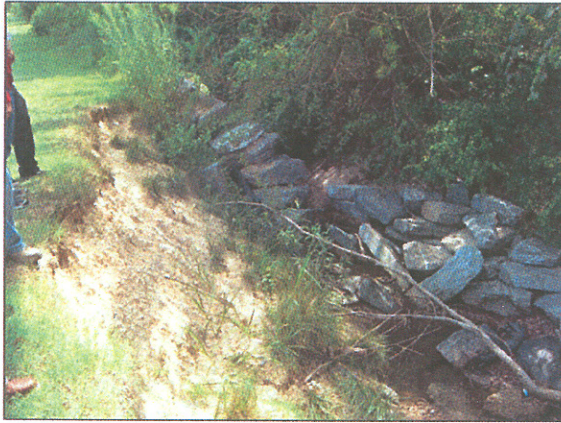
PHOTO 1: VIEW OF FAILING IMBRICATED WALL

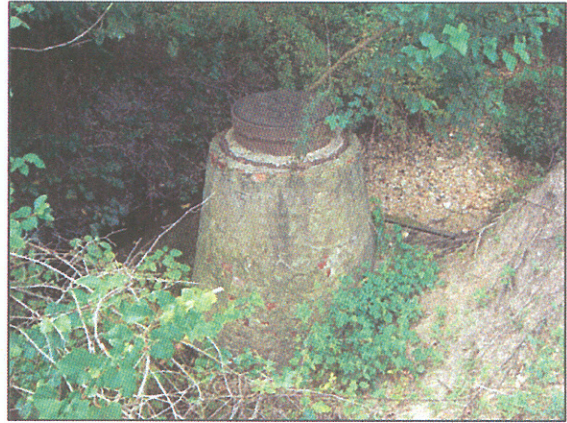
PHOTO 2: VIEW OF EXPOSED SANITARY SEWER STANDPIPE
