Patapsco Non-Tidal Watershed Assessment

Comprehensive Summary Report

August 2011 FINAL

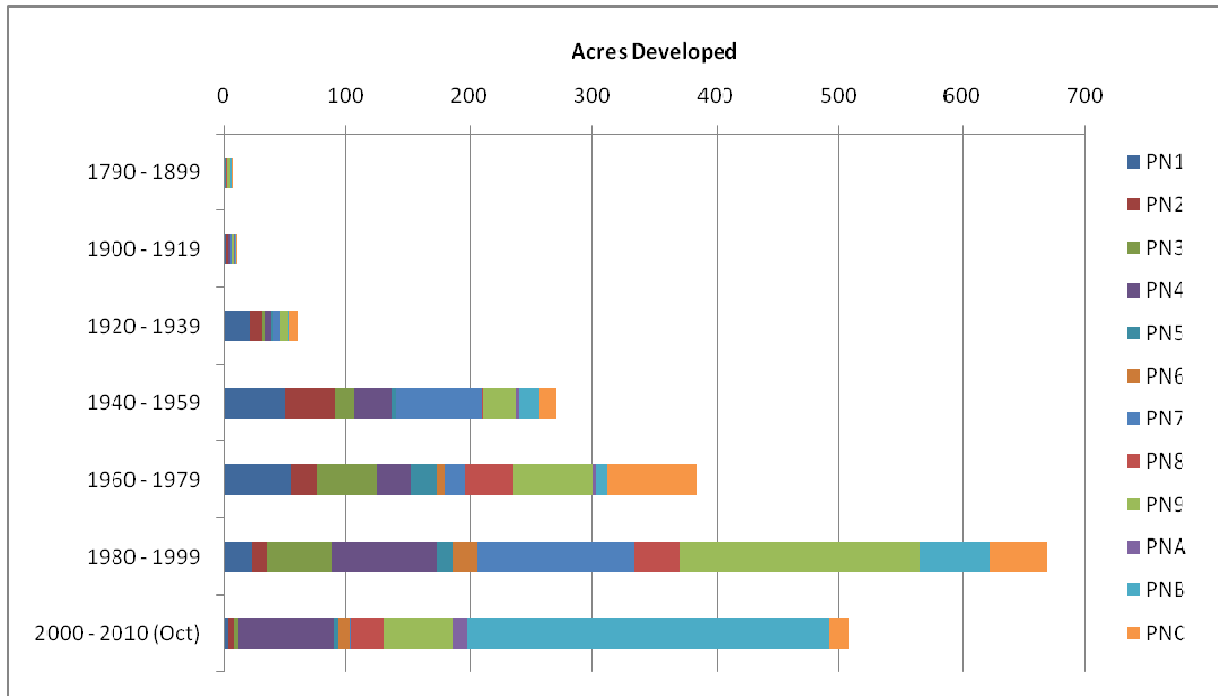
FIGURE 1-1: ACRES DEVELOPED THROUGH TIME BY SUBWATERSHED

The Patapsco Non-Tidal watershed has been developed over the course of several centuries. Data from the County on development age was provided for impervious surfaces, excluding most roads (owned by SHA) and BWI Airport. Therefore, development age data presented in this section is largely reflective of development that has occurred on property that is under the jurisdiction of the County. The earliest documented development occurred in the late 1700's and has continued to increase, exponentially so, through the present. Figure 1-1 demonstrates the total number of impervious acres developed in each subwatershed between 1790 and October 2010. The chart shows that development peaked between 1980 and 1999 before stormwater management regulations for water quality were put in place in 1999. However, a significant amount of development has continued to occur throughout the last decade after water quality regulations were developed. The majority of the development in the last decade has occurred in Piney Run (PNB), an area along the Baltimore-Washington Parkway. A map of development age is shown as Map 1.11.

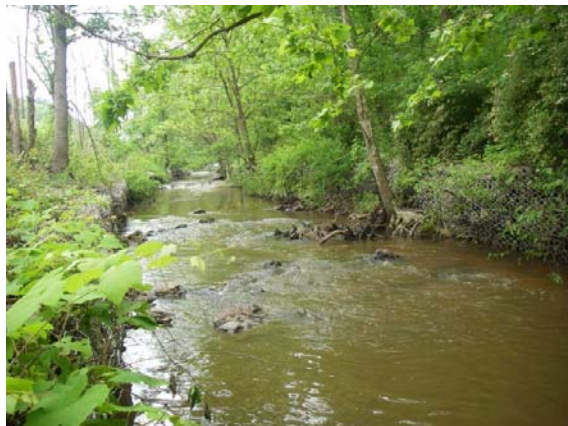
FIGURE 2-1: EXAMPLES OF ASSESSED STREAM REACHES

Stream Reach in the Stoney Run 1 Subwatershed (PN6) with Minimally Degraded Habitat Condition

Physical habitat condition is a good measure of the overall health of a stream and its ability to support aquatic life. Healthy physical habitat for aquatic organisms is typically comprised of stable channels and substrates, diverse flow characteristics, and abundant cover and food sources. Natural streams are typically in a state of dynamic equilibrium. However, this equilibrium can be disrupted and habitat parameters common in healthy streams begin to deteriorate when increased urban and agricultural stressors are introduced. Examples of stream reaches in the Patapsco Non-tidal Watershed are shown in Figure 2-1.

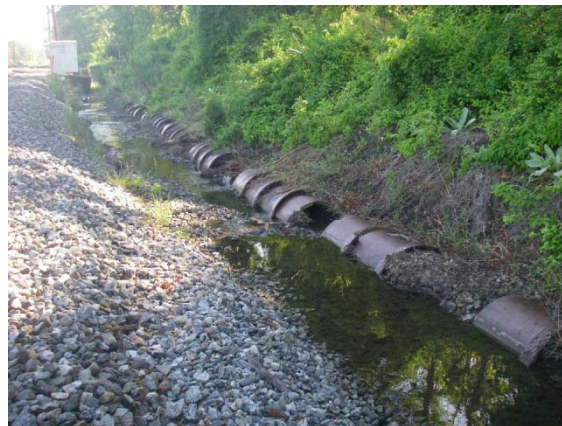
Stream Reach in the Deep Run 1 Subwatershed (PNC) with Severely Degraded Habitat Condition

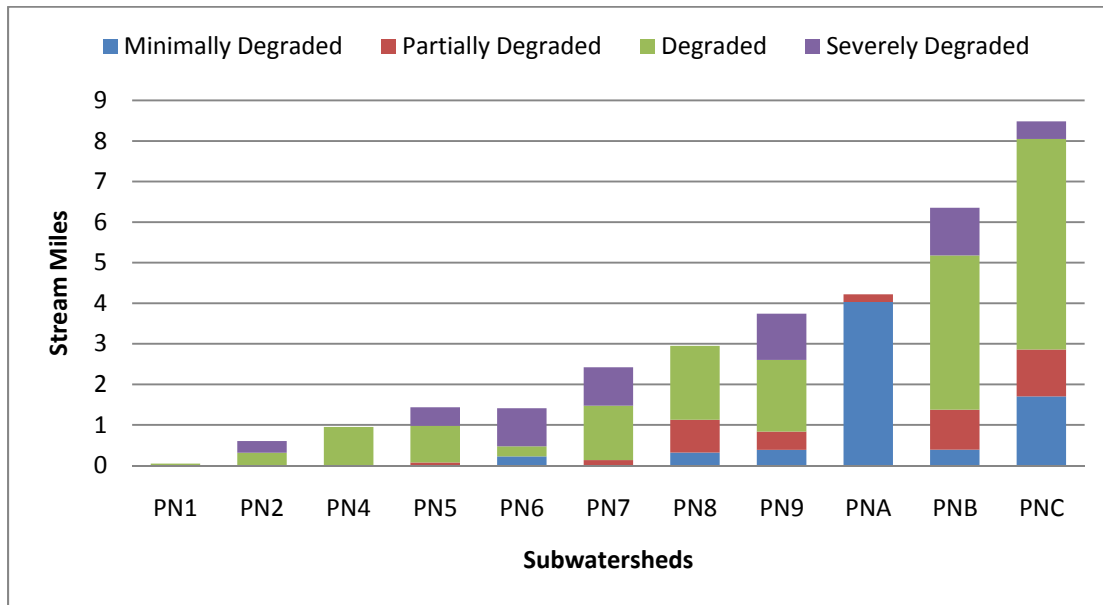
FIGURE 2-2: MPHI RESULTS PER SUBWATERSHED

Based on the calculated MPHI score, each stream reach is assigned a condition category of “Minimally Degraded,” “Partially Degraded,” “Degraded,” or “Severely Degraded.” The average stream weighted MPHI score for the Patapsco Non-Tidal Watershed is 70.15 which correspond to a “Partially Degraded” condition. Approximately 50.2% of perennial stream miles in the Patapsco Non-Tidal Watershed were rated as “Partially Degraded.” “Severely Degraded” streams comprised roughly of 21.6% of the perennial streams, followed by “Degraded” and “Minimally Degraded” streams at 11.6% and 16.5%, respectively. Deep Run had the highest number of “Severely Degraded” and “Degraded” reaches. Stoney Run 3 subwatershed had the highest percentage of perennial stream miles that were considered “Minimally Degraded” with 40%. A summary of MPHI condition categories by stream mile and number of reaches is provided in Table 2-3. A map of the MPHI conditions throughout the watershed is presented as Map 2.2. Examples of assessed stream reaches are depicted in Figure 2-2.

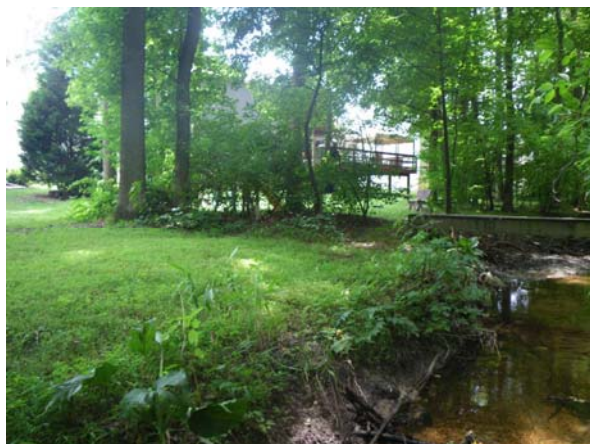
FIGURE 2-3: EXAMPLES OF ENVIRONMENTAL AND INFRASTRUCTURE FEATURES

Deficient buffer impacts (residential lawn encroachment), Moderate Impact in the Stoney Run 4 subwatershed (PN9)

Being aware of and knowledgeable about infrastructure and other environmental features observed along streams is very important for assessment of current conditions. For this reason, fieldwork included an inventory of infrastructure and significant environmental features that compiled within each perennial reach and associated riparian area. These include obstructions to stream flow and organism passage, utilities, channel erosion, dumpsites, head cuts, and outfall pipes and drainage ditches. Depending on the inventory feature type, the associated impact was scored in the field as “Minor,” “Moderate,” “Severe,” or “Extreme” based on its potential impact on the integrity or health of the stream reach. These impacts were translated to a 0-10 point scale depending on the feature type according to the County’s protocol. In addition to the impact scores, other quantitative and qualitative data, such as dimension, relative location, composition, and restoration potential, were collected for each feature. Examples of three types of impacts are shown in Figure 2-3.

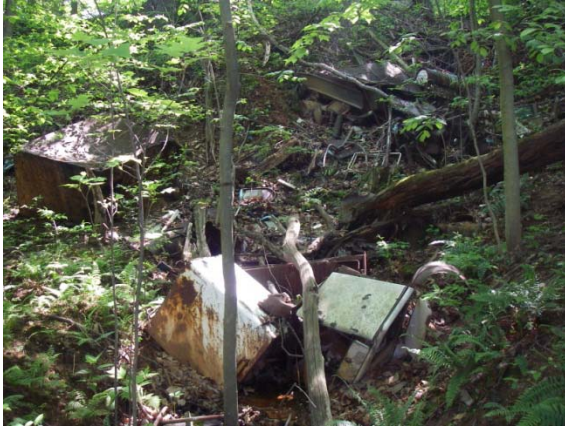
Dumpsite impacts in the Patapsco mainstem (PN5) subwatershed with a Moderate Impact

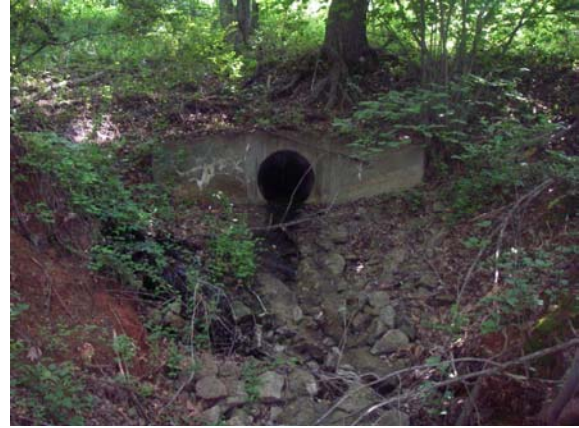
Pipe and ditch impacts contributing to erosion. Moderate Impact in the Stoney Run 1 Subwatershed (PN6)

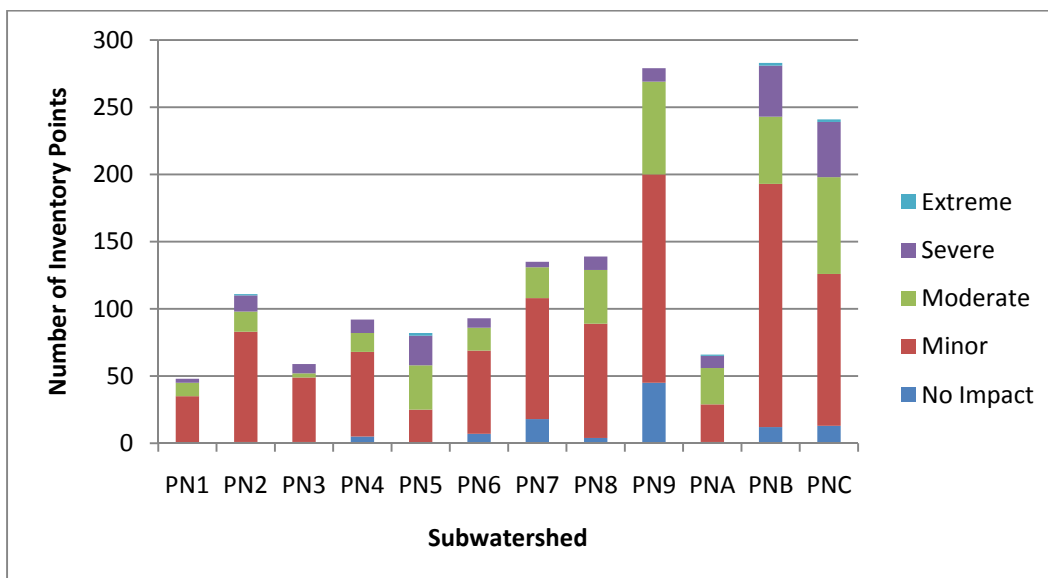
FIGURE 2-4: SEVERITY OF INVENTORY POINTS PER SUBWATERSHED

PNB is the largest subwatershed in terms of watershed area and stream length; therefore it is not surprising that it was found to have the most inventory points (283), although most are in the minor impact category. PN9 and PNC, also large subwatersheds, follow with 279 and 241 respectively. Table 2-5 below presents the number of inventory points per stream mile for each subwatershed, which represents the density of inventory points. PN2, PN8 and PN6 have the highest densities. The ‘score’ as developed in Table 2-5 is the sum product of the number of inventory points and the impact score received by those points summarized by subwatershed. The score normalized by stream length indicates that PNC and PN5 have the greatest level of impact followed by PN8 and PN2.

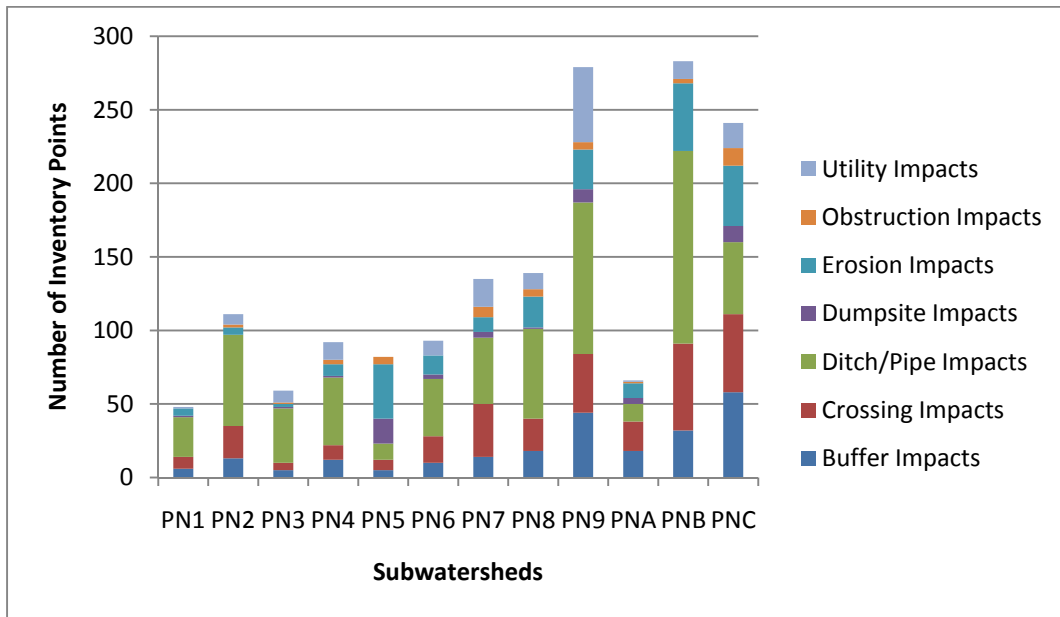
FIGURE 2-5: INVENTORY POINTS PER SUBWATERSHED

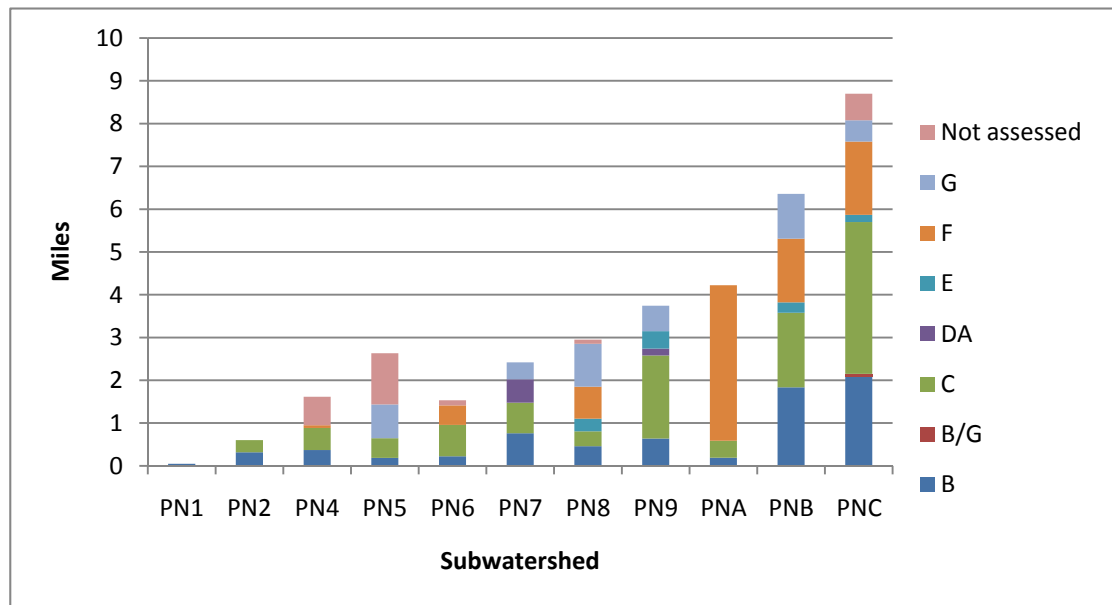
FIGURE 2-7: MILES OF ROSGEN STREAM TYPE CLASSIFICATION PER SUBWATERSHED

The distribution of Rosgen Level I classifications across the watershed is depicted in Map 2.5 and summarized in Table 2-8 and Figure 2-7. As shown, approximately 31% of the reaches (11 miles) were classified as Type “C” channels, which are typically characterized as having a well developed floodplain, relatively sinuous with a channel slope of 2% or less.

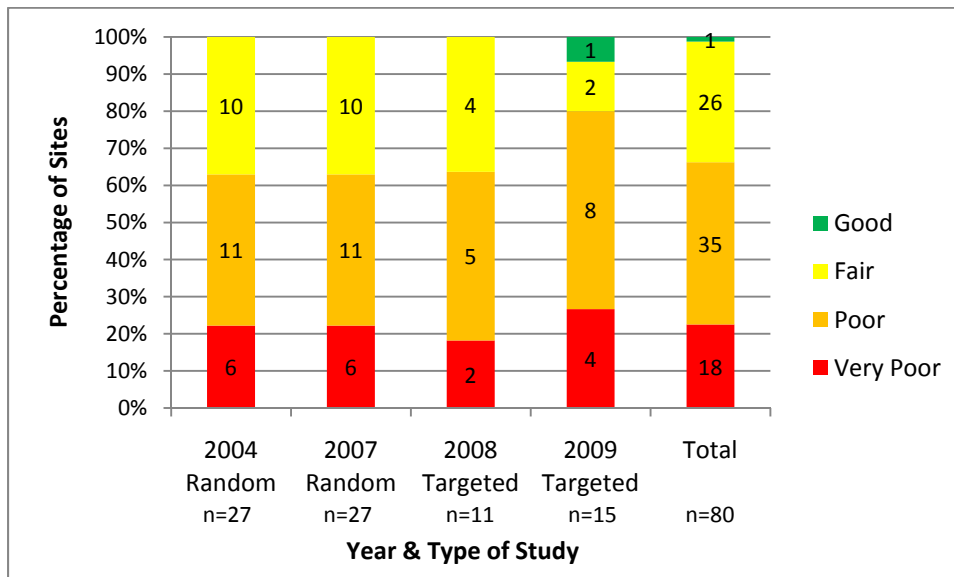
FIGURE 2-8: BIOASSESSMENT RATINGS BY YEAR AND STUDY

Figure 2-8 provides the percentages of each rating category for each of the sampling years. There is a good deal of consistency over time in the proportion of sites in each of the categories. Additionally, the percentages described above for the entire dataset follow closely the pattern displayed by each year.

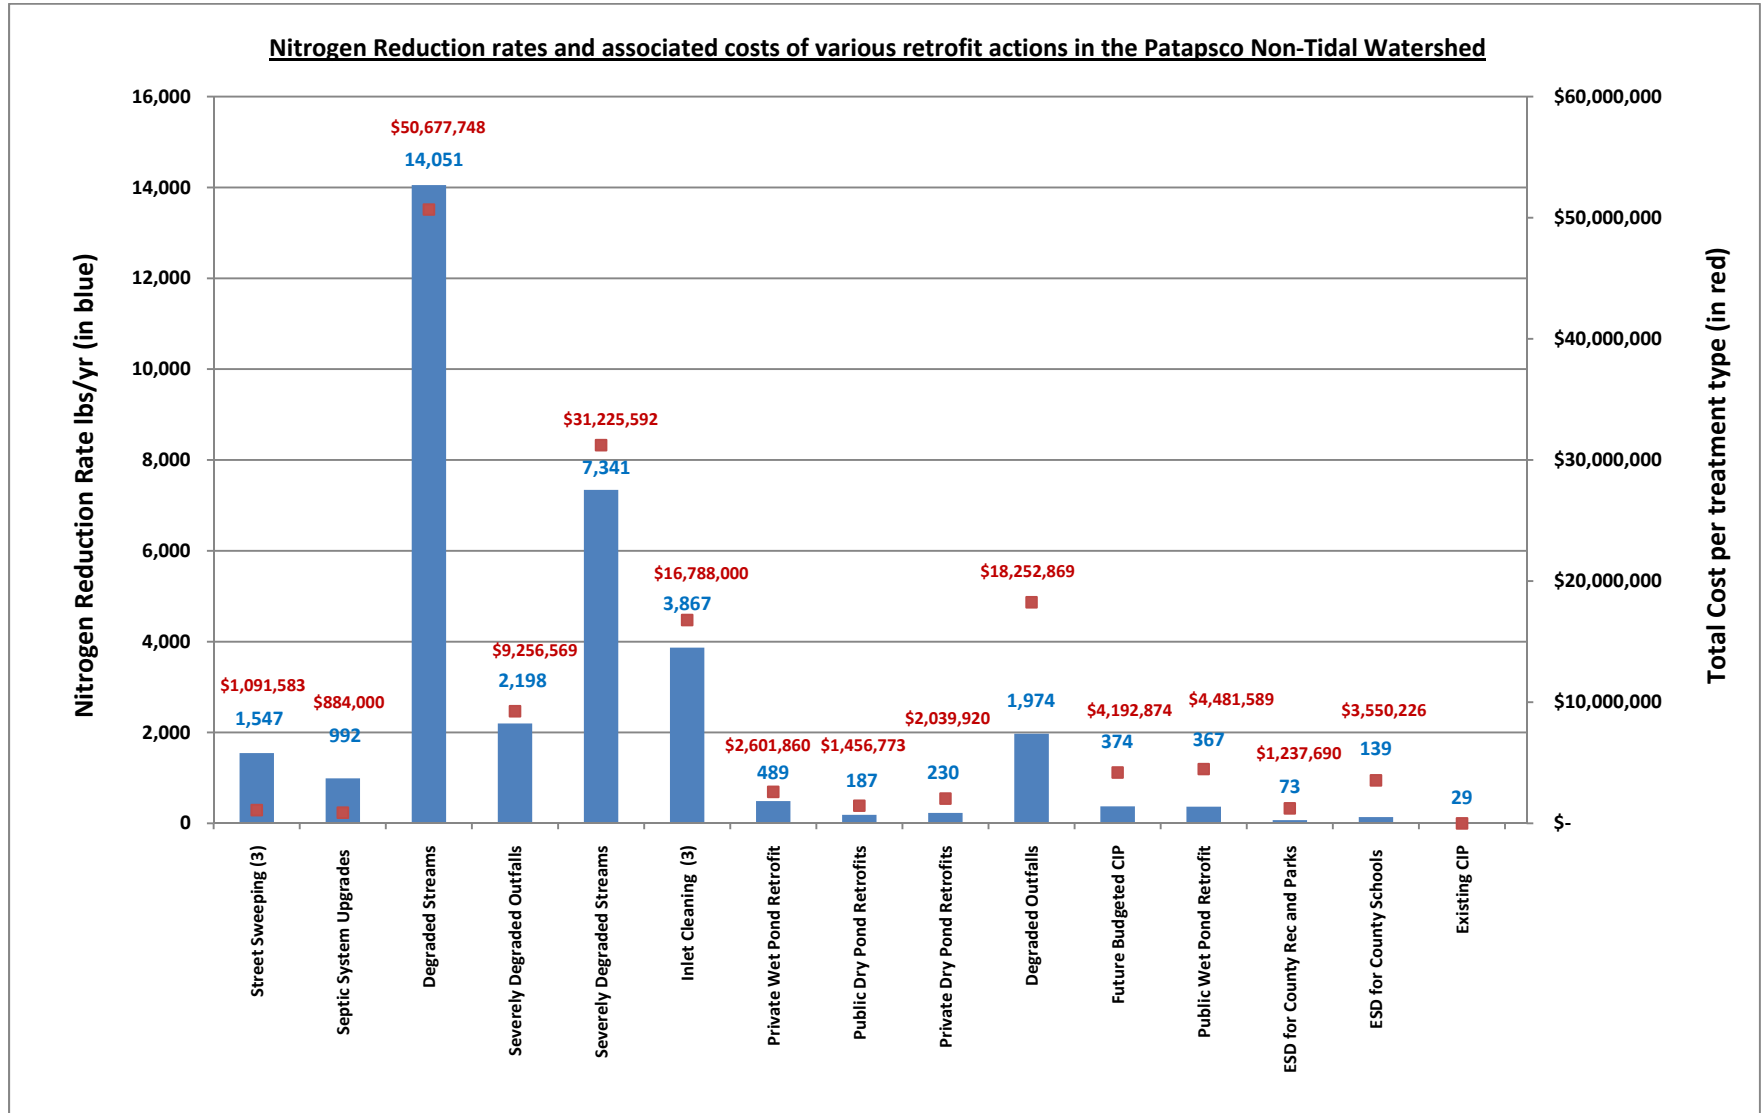
FIGURE 5-1: NITROGEN REDUCTION COSTS PER TREATMENT TYPE

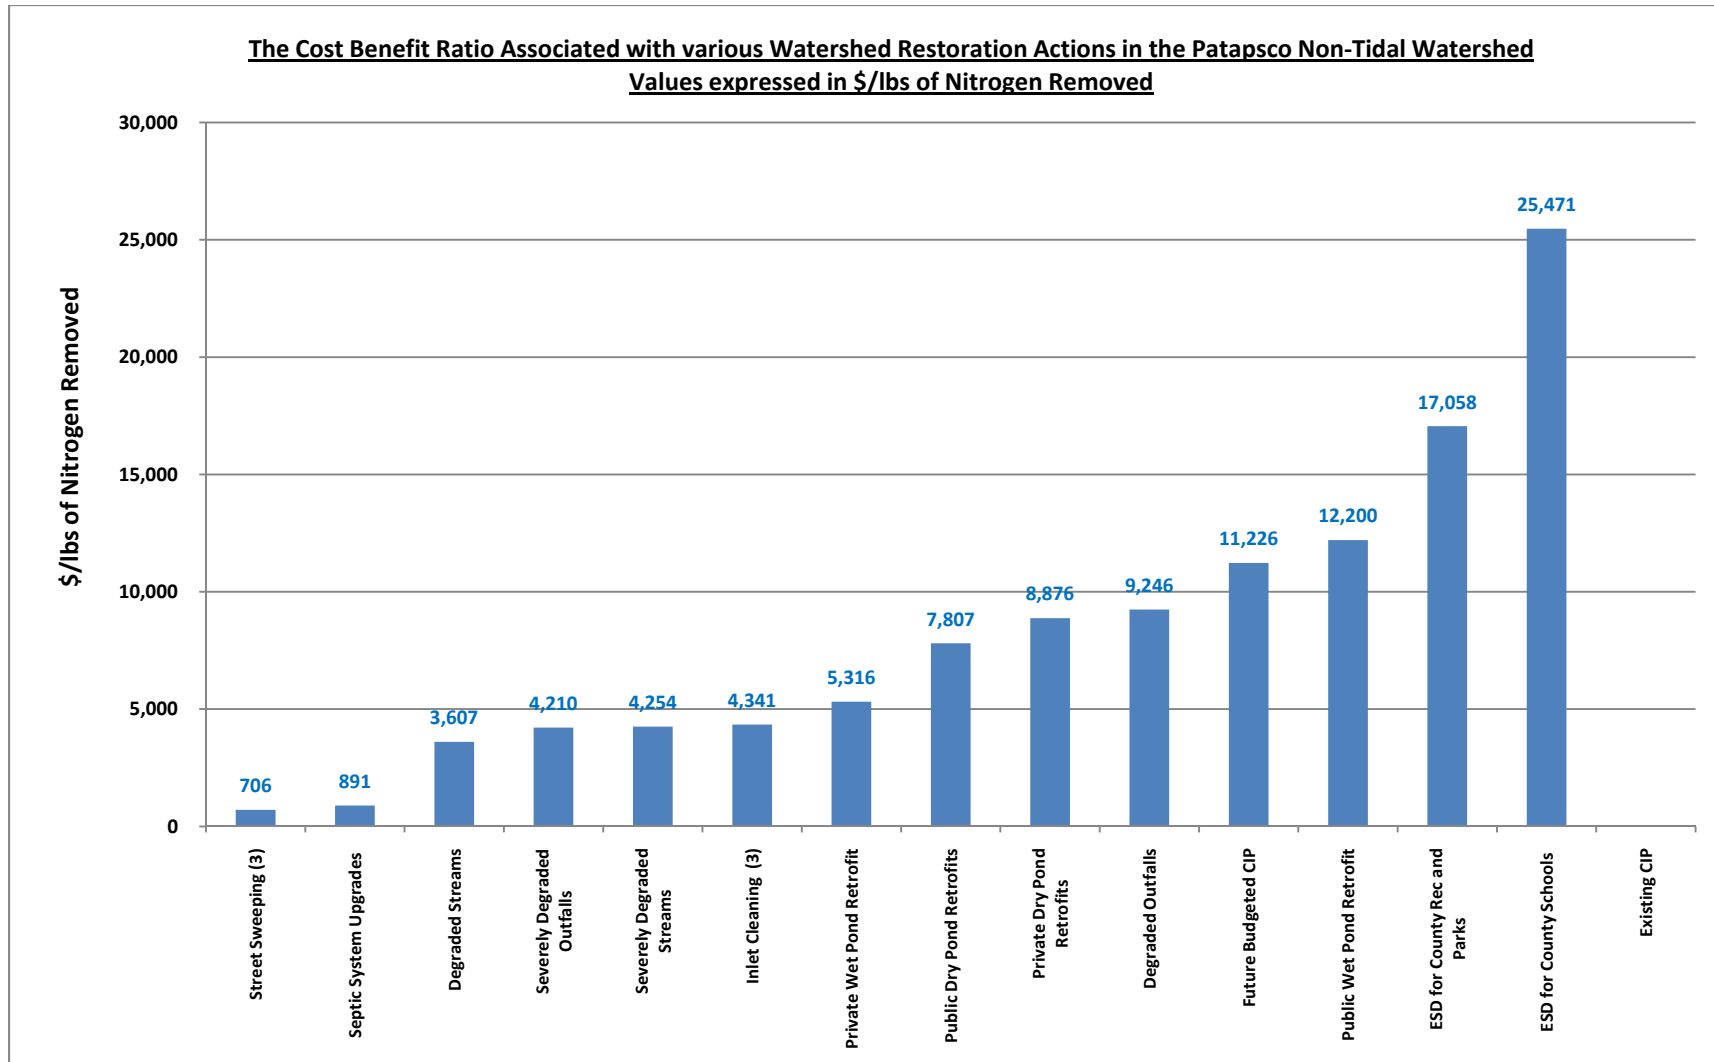
FIGURE 5-2: COST BENEFIT RATIO SUMMARY
