# **SITE SELECTION OF STREAM CROSSINGS TO BE ANALYZED FOR FLOOD OVERTOPPING**

## **TECHNICAL MEMORANDUM**

### **Subtask 2.1.5 Patapsco Tidal and Bodkin Creek Watershed Study**

**Targeted Biological Assessment of Streams in Patapsco Tidal and Bodkin  
Creek Watersheds, Anne Arundel County, Maryland: 2009**

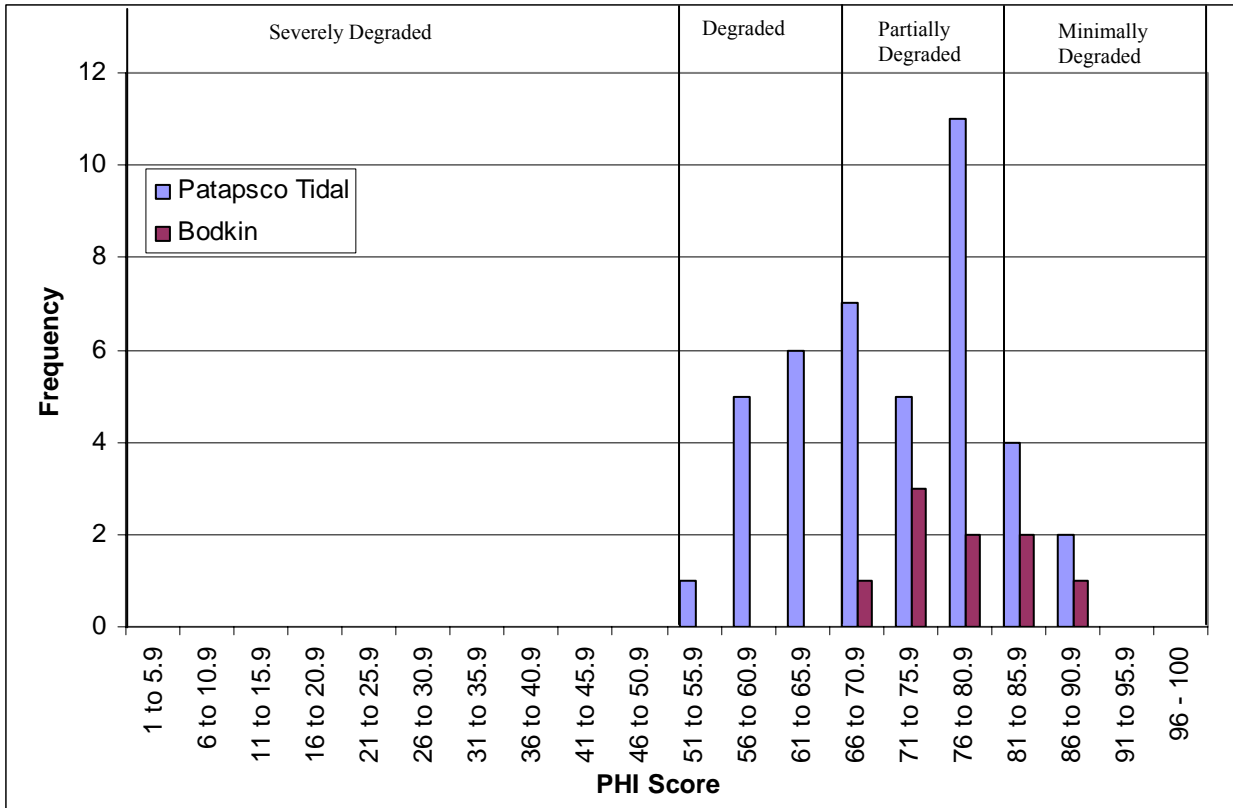
Figure 4-1. Distribution of PHI scores for 50 targeted sites sampled in Patapsco Tidal (41 sites) and Bodkin Creek (9 sites) watersheds, Anne Arundel County, MD, 2009

Few sites received top ratings. The best conditions rated as Minimally Degraded by PHI (9 sites) were generally found in smaller streams and were more common in Bodkin Creek (Figures 3-4 and 4-1). While fewer sites were sampled in Bodkin Creek, the overall distribution of PHI scores in Bodkin Creek fell in the higher categories of Partially Degraded and Minimally Degraded, with no sites rating Degraded (Figure 4-1). Two of the three sites rated as Comparable to Reference by RBP score were found along mainstem creeks.

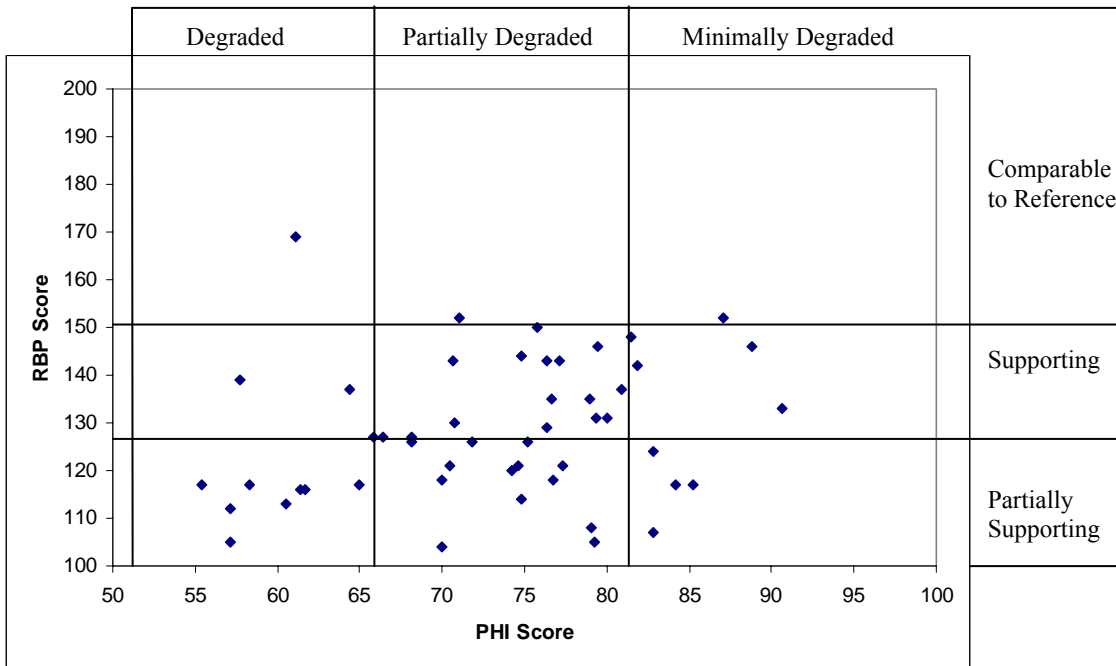
Figure 4-2. Comparison of PHI and RBP Habitat Assessment scores for 50 targeted sites sampled in Patapsco Tidal and Bodkin Creek watersheds, Anne Arundel County, Maryland, 2009.

Scores for RBP and PHI were not necessarily consistent with one another, because the two indicators incorporate different parameters associated with stream habitat (Figure 4-2). At 27 of the 50 sites (54%), sites received a comparable rating between the PHI and RBP habitat assessments (for example, when a site rated in the highest category of Minimally Degraded by the PHI were also rated Comparable to Reference by the RBP). However, almost half of the time (46% of sites) the ratings between the two assessment procedures differed in their relative assessment by category. For instance, site PT7-932-T-2009 received the best RBP

narrative rating (Comparable to Reference) but was rated in the third of four categories (Degraded) by the PHI. The differences between ratings did not appear to follow any particular pattern, i.e., the PHI narrative rating was not always lower than the RBP narrative rating as the above example indicated. At four sites, the PHI narrative rating was the best possible rating of Minimally Degraded, while the RBP narrative rating was only Partially Supporting.

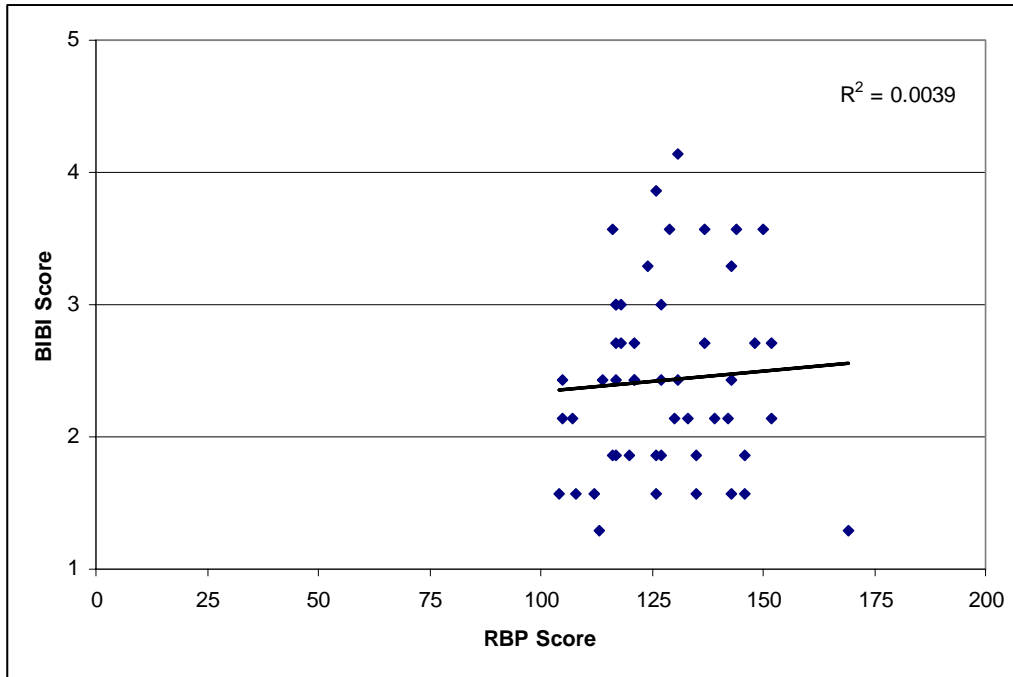
Figure 4-4. Relationship of RBP habitat assessment score to BIBI score for 50 targeted sites sampled in Patapsco Tidal and Bodkin Creek watersheds, Anne Arundel County, Maryland, 2009. Regression coefficient is also presented.

Neither the RBP Habitat Assessment score nor the PHI exhibited a strong relationship to BIBI scores (Figures 4-4 and 4-5, Tables 4-1 and 4-2). The lack of correlation between BIBI scores and the habitat indicators (either RBP or PHI) suggest that other factors such as water quality or flow regime may be having a greater effect on benthic macroinvertebrates. Tables 4-1 and 4-2 show a pattern suggesting water quality impairment depressing biological integrity, regardless of habitat method used. In particular, some sites (shown in bold in Tables 4-1 and

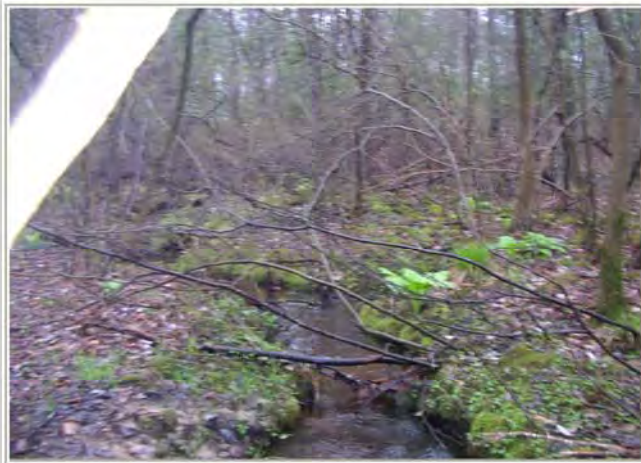
Upstream from Mid-Point

**Results** Biological Condition : Fair  
 Habitat Rating : RBP : Supporting MPHI : Partially Degraded

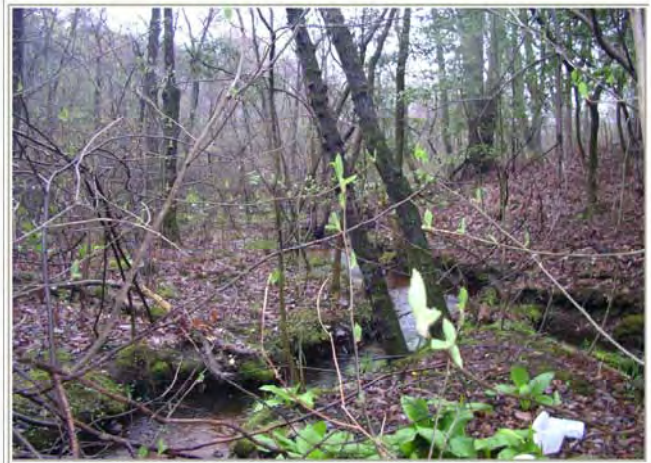
Downstream from Mid-Point

This site is located in the Bodkin Creek watershed in Back Creek. The site is located in the back corner of the last property on the right hand side of Oak Road. Forty-eight percent of the catchment draining to this site is residential, 38% is wooded, and 13.6% is impervious. There is a shaded canopy and the riparian vegetative zone width and the vegetative protection rated as Optimal on both sides of the stream. The substrate at this site is 90% sand with 10% silt. This site rated Partially Degraded for PHI and Supporting for RBP. Its biological condition rated Fair, as no Ephemeroptera nor any scraper taxa were found, thus limiting its BIBI score (BIBI score of 3.29).

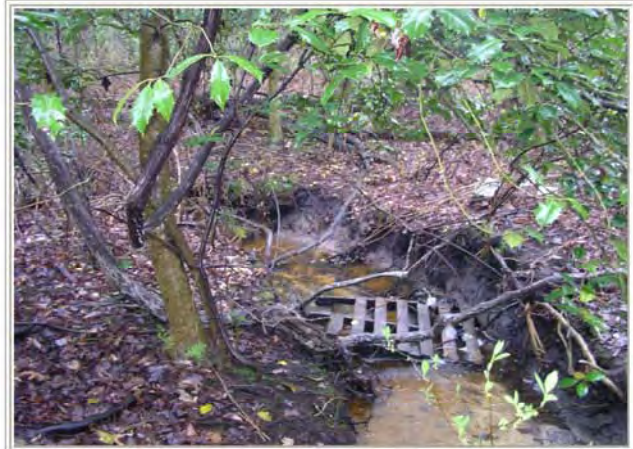
Downstream from Mid-Point

This site is located in the Bodkin Creek watershed in Back Creek. The site is in Poplar Ridge Park, after the last baseball field. In this catchment, the majority of the landuse is residential (54%), but just less than 34% is wooded. There is 15% impervious surface in the surrounding catchment. Poor bank stability was noted along both banks, and high levels of erosion were present in the surrounding watershed, resulting in slightly turbid water clarity in the stream. The field crew observed an ATV course alongside the stream, which may be adding to erosion and bank stability problems. In situ pH measured at this site was 6.30, slightly below the state water quality standard of 6.5. This site rated in the second best category (Partially Degraded) for PHI but in the lower category of Partially Supporting for RBP. The substrate was entirely silt and sand, and epifaunal substrate was marginal, while embeddedness was high. The benthic community at this location included no Ephemeroptera nor any scraper taxa, and only 3 EPT taxa. Benthic conditions rated Poor with a BIBI score of 2.43.

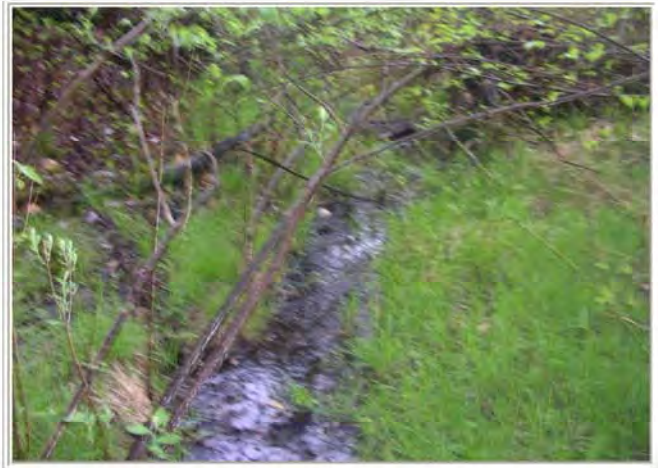
Downstream from Mid-Point

Site BK2-914-T-2009 is located off of Bayside Beach Road, in the Back Creek subwatershed of the Bodkin Creek watershed. Only about 5.6% of the catchment surrounding this site contains impervious surface, with open space dominating the catchment, contributing 61% of catchment area. Residential landuse, along with a very small amount of transportation-related landuse are also present. Despite almost 60% of the macroinvertebrates obtained in the benthic sample being considered intolerant to urban conditions, this site had only one EPT taxa and no scraper taxa present, and only a few climbers. With a BIBI score of 2.43, it rated Poor. Epifaunal substrate and pool substrate were received low ratings, and pool variability was poor with no deep pools present. Field staff noted some trash in and near the site. Streambanks were stable along both sides of the stream and no bank erosion was present. In addition, the riparian buffer was good. Habitat at this site rated Partially Degraded under the PHI (score of 74.9), and Partially Supporting under the RBP (score of 114).

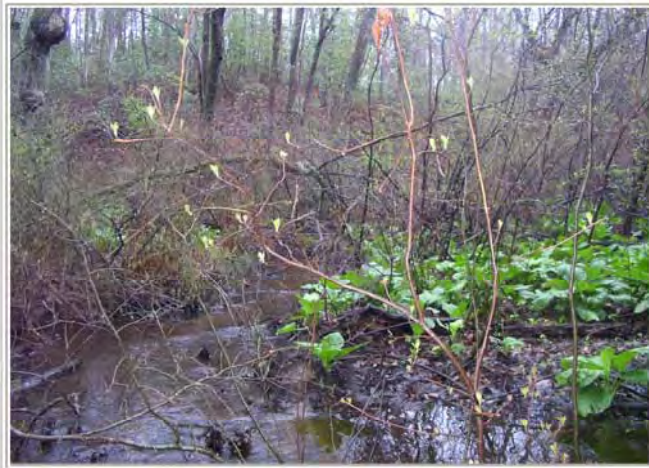
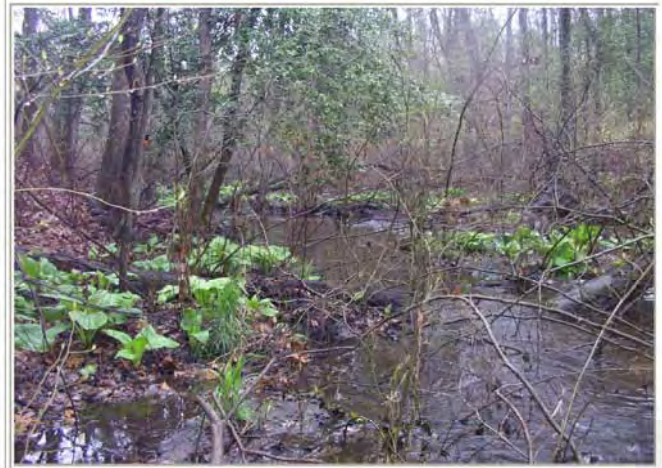
Location = Loreen Drive at Silver Run Drive

This site is located at Loreen Drive at Silver Run Drive in the Bodkin Creek watershed in the Main Creek subwatershed. The area surrounding the stream was very marshy and organic deposits and skunk cabbage were present in large quantities. Streambanks were mainly stable and vegetative protection and riparian widths were good. Fifty-nine percent of the catchment draining to this site has residential landuse, while 33% is wooded. Impervious surfaces make up 17.4% of the catchment acreage. In situ pH was 6.33 at this site, notable since it was slightly below the state water quality standard of 6.5. This site had Partially Degraded habitat conditions according to the PHI and rated Supporting under the RBP. This site tied with two other sites in having the largest number of benthic taxa collected during sampling – 42. Benthic metric scores were high for this large number of taxa as well as for a healthy number of scraper taxa. The biological condition at this site was Fair with a BIBI score of 3.57.

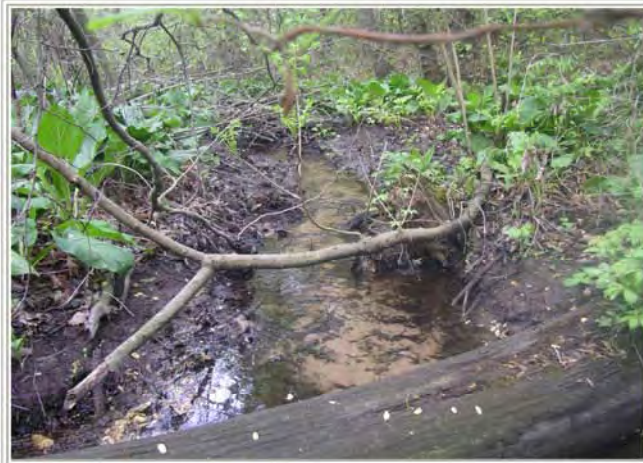
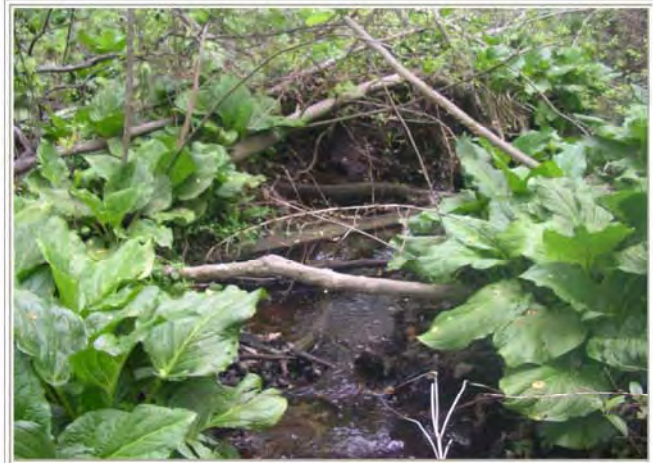
Location = Loreen Drive, between Joanne Court and Overview Drive

This site is located in the Bodkin Creek watershed in Main Creek. The site is off of Loreen Drive and can be accessed through an empty lot between Joanne Court and Overview Drive. The majority of the land use near this stream is residential (53%), with almost 40% wooded. This site had Minimally Degraded habitat conditions according to the PHI and Partially Supporting habitat conditions according to the RBP assessment (total score of 124). Epifaunal substrate and available cover rated at the low end of suboptimal here, with substrate comprised entirely of sand and silt. The canopy was partially shaded, and some bank erosion was noted by the field crew. Seventy percent of benthic macroinvertebrates collected at this site were considered intolerant to urban conditions and the biological community rated Fair with a BIBI score of 3.29.

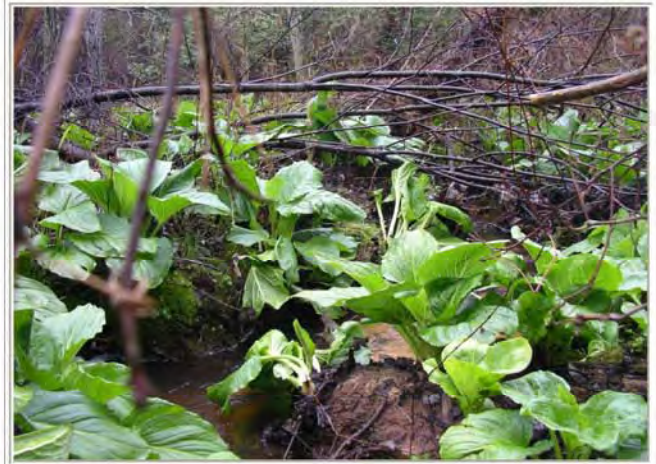
Downstream from Mid-Point

This site is located in the Bodkin Creek watershed in the Main Creek subwatershed. It is off of Old Nike Missile Road near a golf course. Nearby landuse is 40% wooded and 35% residential, with 12% of surfaces considered impervious. The substrate at this site was mainly made up of sand and gravel with some silt. It had a shaded canopy, optimal epifaunal substrate and available cover, and low levels of embeddedness. Despite a Minimally Degraded rating for habitat conditions under the PHI and a Supporting rating under the RBP, this site had a Poor biological community, with a BIBI score of 2.71. The benthic community included no Ephemeroptera nor any scraper taxa, and only two EPT taxa. Bank stability at this site received only a marginal rating.

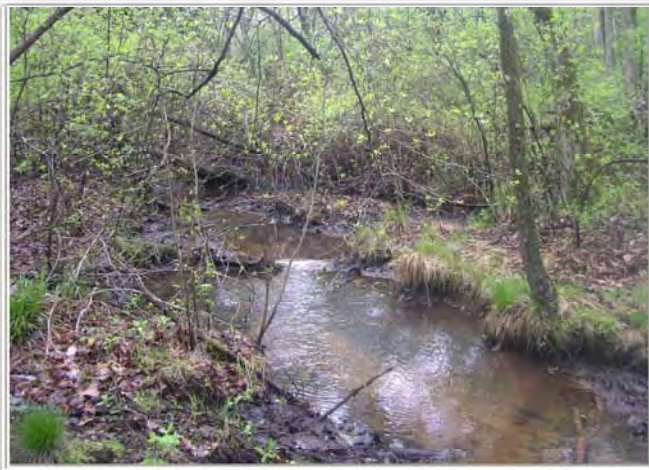
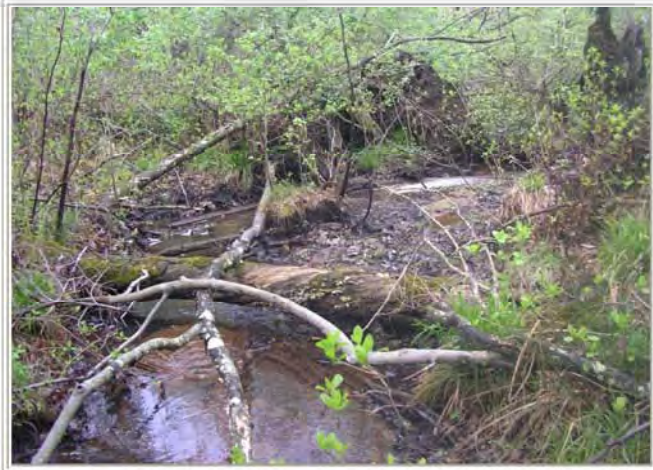
Watershed = Bodkin Creek  
 Subwatershed = Main Creek  
 Location = Ipswich Court

This site is located in the Bodkin Creek watershed in Main Creek. It is off of Ipswich Court behind the middle house on the left side of the cul-de-sac. Landuse near this site is dominated by residential (49%) and wooded areas (32%). This site had a shaded canopy, but its channel flow rated at the low end of suboptimal. With a PHI score of 79.99, this site rated Partially Degraded for habitat and similarly rated Supporting under the RBP (RBP score of 131, 65.5% of Reference). Biological conditions at this site rated Poor, as the BIBI score was 2.43. Neither Ephemeroptera nor any scraper taxa were present in the biological community, thus limiting its score.

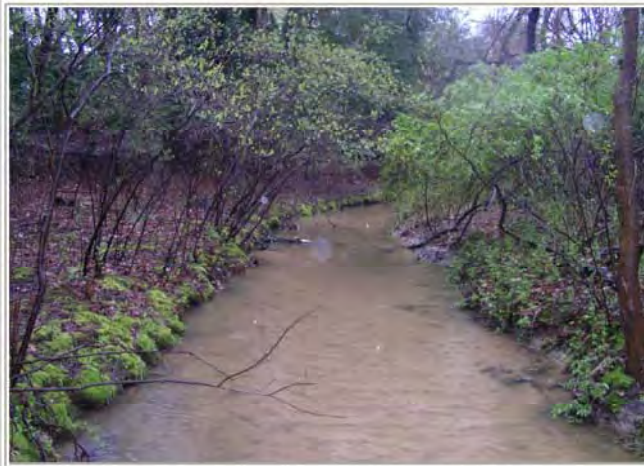
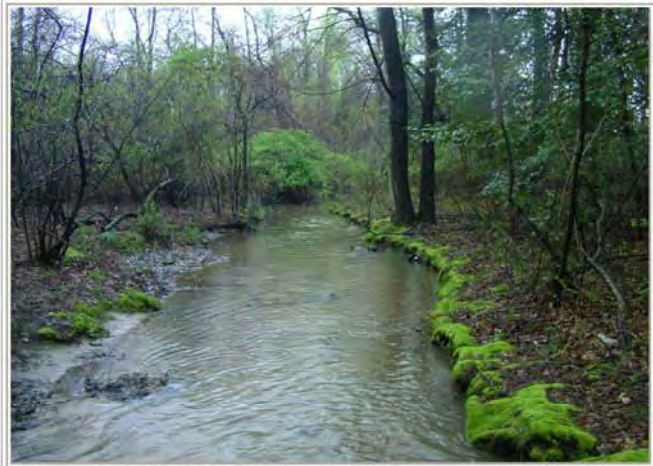
Location = Ventner Drive at Bodkin Elementary School

This site is in Wharf Creek in the Bodkin Creek watershed. The site is located at Bodkin Elementary School at Ventner Drive. Landuse near this site was 41% commercial, 24% wooded, and 23% open space. Impervious surfaces made up 28.3% of the catchment. Moderate levels of trash were present at the time of sampling. Stream substrate was completely sand, and embeddedness was high. Consequently, epifaunal substrate and available cover received a marginal rating. In situ pH was measured as 6.35, slightly below the state water quality standard of 6.5. Habitat rating scores were moderate, resulting in a PHI rating of Partially Degraded and an RBP habitat rating of Supporting. However, the benthic community is Very Poor, with a BIBI score of 1.86. The benthic community consisted of only 1 EPT taxa and only 8% of the macroinvertebrates obtained in the sample are considered intolerant to urban conditions.

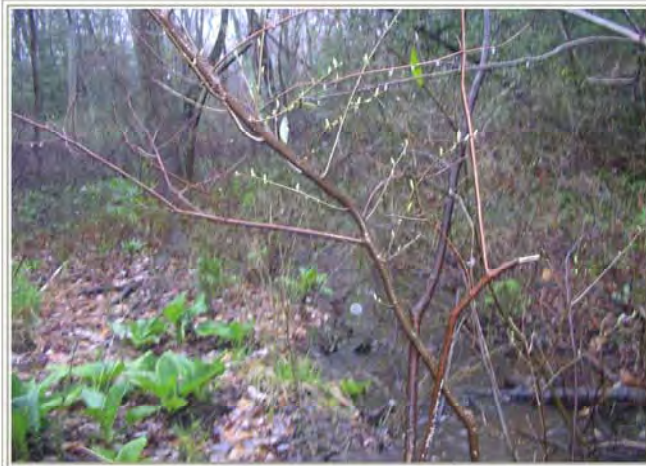
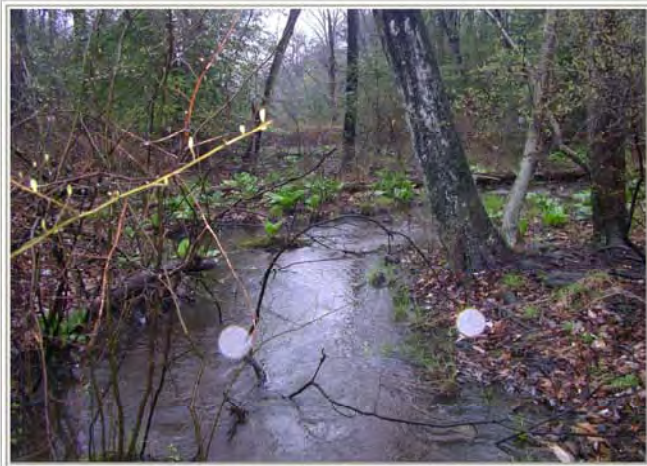
Watershed = Bodkin Creek  
 Subwatershed = Locust Cove  
 Location = Downs Memorial Park

This site is located near Downs Memorial Park in Locust Cove in the Bodkin Creek watershed. The majority of the landuse near this site (73%) is wooded area, and 10.9% of the catchment is classified as impervious. The stream substrate is made up mainly of sand with some silt, and the stream canopy is shaded. This site received optimal ratings for bank stability, vegetative protection, and riparian zone width on both sides of the stream, and no bank erosion was noted by the field crew. Total RBP habitat score at this site was 146 (Supporting). Very little trash was present and no buffer breaks were observed. The PHI score was 88.7, the second highest score of all sites sampled during this survey. However, the macroinvertebrate community obtained at this site had no climber, no scraper, and no Ephemeroptera taxa, and only one EPT taxa. Thus, its benthic condition was rated as Very Poor, with a BIBI score of 1.86.

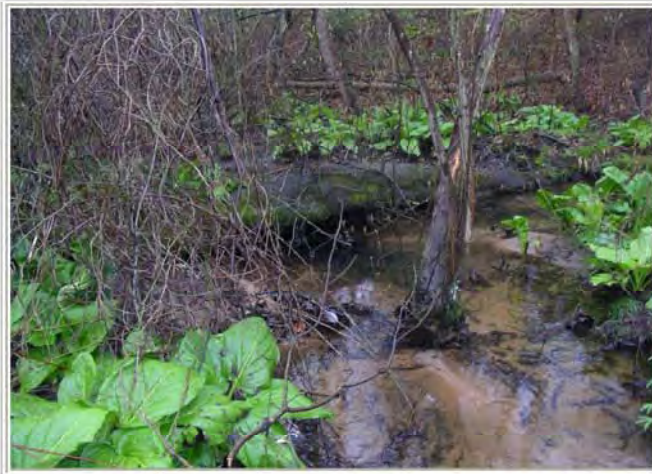
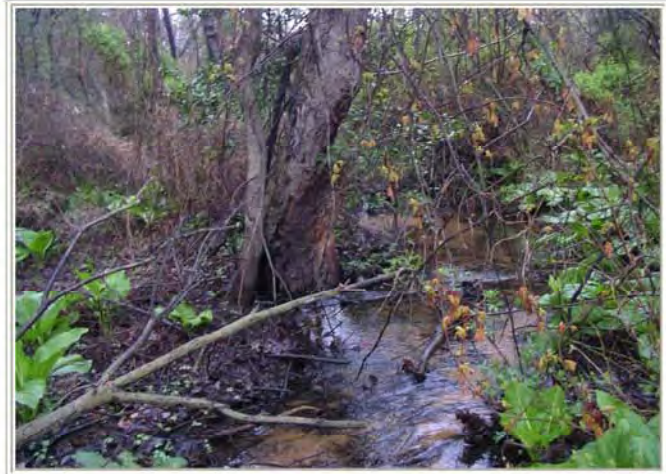
Watershed = Patapsco Tidal  
 Subwatershed = Stony Creek  
 Location = West end of 20th Street

This site is located at the west end of 20th Street in an open area in Stony Creek in the Patapsco Tidal watershed. Landuse near the site is 54% residential, 18.8% wooded, and 15.5% commercial. These landuses result in an impervious surface percentage of 37.4% of total catchment area. Field crew members noted an anaerobic odor present at the site on the day of sampling as well as high levels of trash. Stream substrate contained mostly sand with some silt and some clay present. Embeddedness was high. The canopy was partly shaded, and some emergent and some submerged aquatic vegetation were present. While bank stability, vegetative protection, and riparian vegetative zone width rated well in the RBP habitat assessment, this site received lower scores for epifaunal substrate, sediment deposition, pool substrate, and pool variability. Overall, the total RBP habitat score was 127, Supporting. The total PHI score was 68.1, Partially Degraded. Only 4.6% of the benthic taxa types found at this site were considered intolerant to urban conditions, but the presence of some EPT, some scraper, and some climber taxa resulted in a BIBI score of 2.43, Poor.

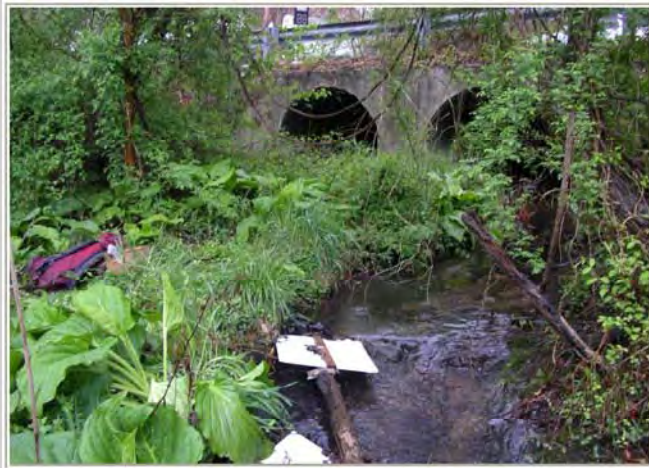
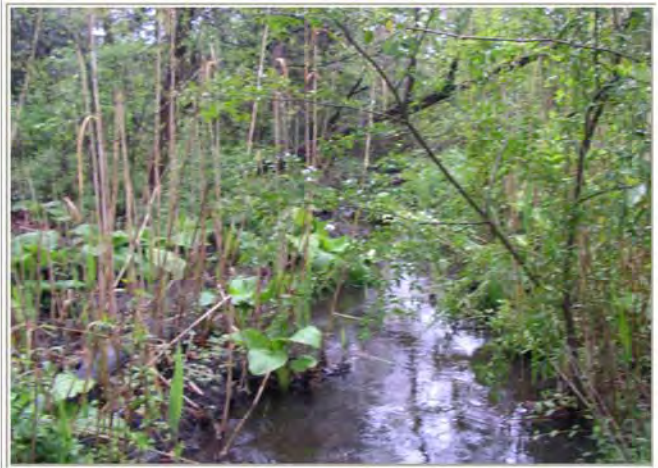
Watershed = Patapsco Tidal  
 Subwatershed = Stony Creek  
 Location = Duvall Highway, south of Grace Avenue

This site is located off of Duvall Highway, south of Grace Avenue. Eighty percent of the landuse near this stream in Stony Creek in the Patapsco Tidal watershed is residential. The catchment has 35.4% impervious surfaces. Epifaunal substrate at this site is lacking in quality, but levels of embeddedness are lower at this site than they are at the majority of other sites sampled in this assessment. The stream is braided, with a partially shaded canopy. Its location only steps from the road could be to blame for the extreme levels of trash observed at the site. A road culvert is present at the site, and narrow riparian vegetative zones with buffer breaks as well as channelization in the form of gabion baskets hamper the habitat quality here. The overall PHI score was 61.7, Degraded. The overall RBP habitat score was 116 (58% comparable to reference conditions), with a narrative rating of Partially Supporting. Despite these rather poor habitat conditions, the benthic community at this site received a BIBI score of 3.57 (Fair), due to the presence of EPT, scraper, and climber taxa.

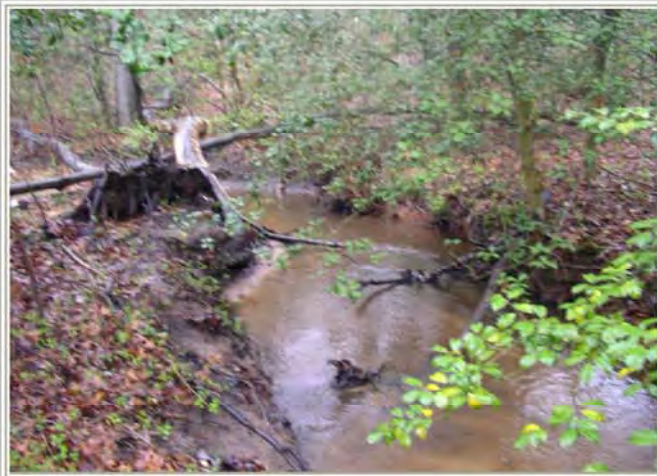
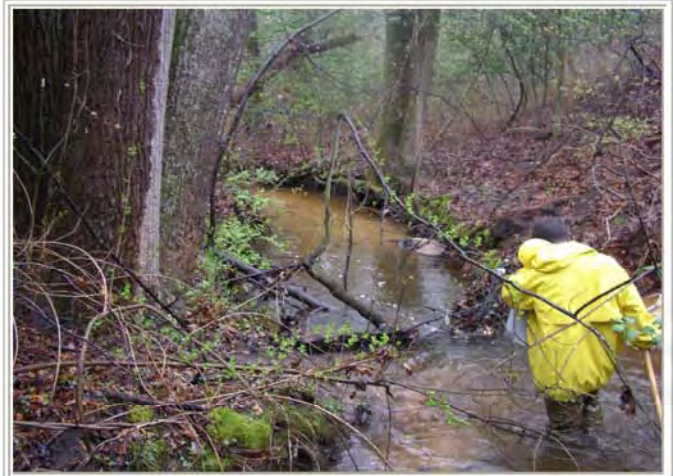
Location = Solley Road, between Jackson Lane and Shady Brook Road

This site is in the Stony Creek subwatershed of the Patapsco Tidal watershed. It is located off of Solley Road between Jackson Lane and Shady Brook Road. The landuse upstream of this site is dominated by residential (53%) and wooded (almost 38%), and 20% of the catchment is considered impervious. Stream banks were moderately unstable to unstable, and erosion was obvious. Stream substrate was made up mainly of sand and gravel with some silt, and moderate levels of deposition were present. The overall PHI score was 65.8 (Degraded), while the overall RBP habitat score was 127 (Supporting). A moderate amount of trash was noted at the site. The benthic community consisted of only one EPT taxa, and no Ephemeroptera. Scrapers and climbers were present in healthy numbers, resulting in a BIBI score of 3.00, Fair.

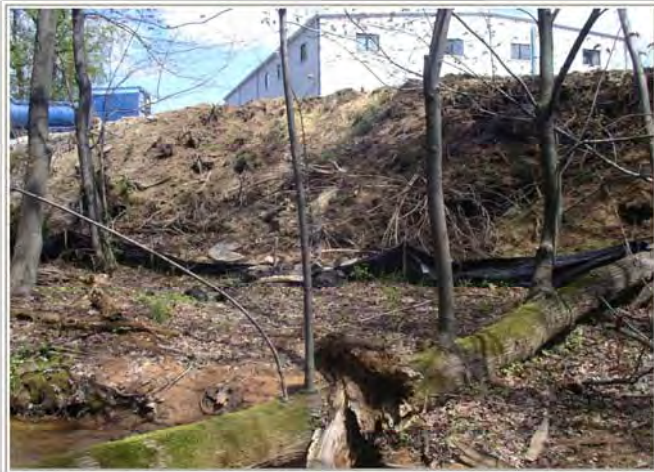
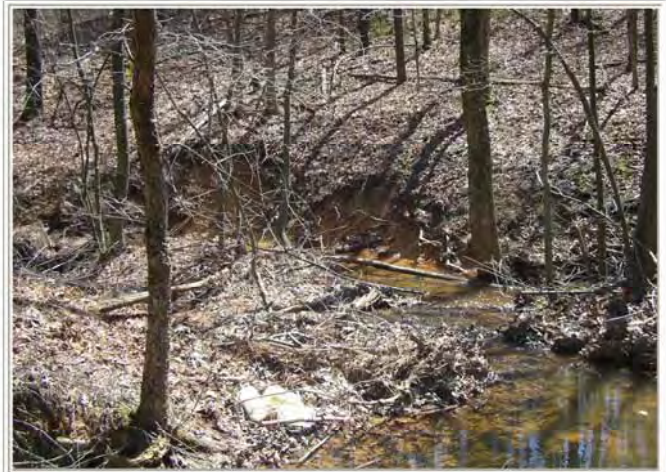
Location = Nabbs Creek Road, below Stony Creek Park

This site is located off of Nabbs Creek Road, south of the bend below Stony Creek Park. It is in Stony Creek, in the Patapsco Tidal watershed. The majority of the landuse upstream of this site is wooded (86.6%), and therefore the catchment has the lowest percentage of impervious surfaces in the study (2.5%). The aesthetic quality of the stream was very good, as very little trash was present. Very few riffles were present in the stream, and those that were present were not of high quality. Thus, substrate for benthos was lacking. Despite all of the wooded area nearby, bank stability and vegetative protection along the banks was marginal, as was sediment deposition in the channel. The stream was not very sinuous, but channelization was not noted. This is not abnormal for coastal plain streams. This site rated Partially Degraded under the PHI (score of 74.2), and Partially Supporting under the RBP habitat assessment (score of 120). Its benthic community received a BIBI rating of Very Poor (score of 1.86). The benthic community did not have a lot of diversity at this site, as only ten types of taxa were collected. However, the community at this site had the highest percentage of benthos intolerant to urban conditions (91%).

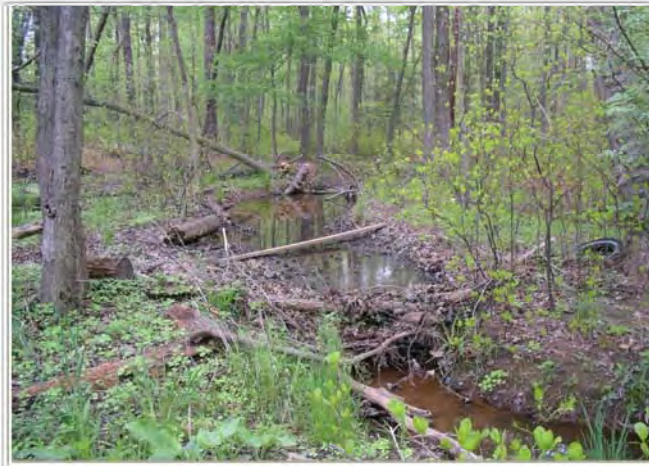
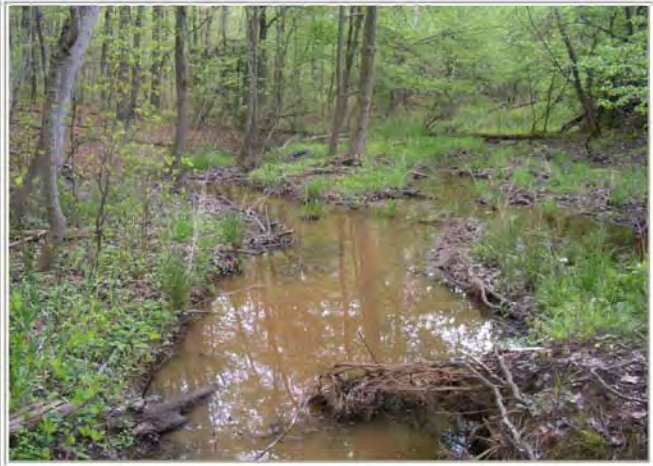
Watershed = Patapsco Tidal  
 Subwatershed = Stony Creek  
 Location = Stone Haven Drive

This highly braided site is in Stony Creek in the Patapsco Tidal watershed. The site can be found behind a double-lot property off of Stone Haven Drive. The catchment surrounding this stream is dominated by wooded and residential landuse, in approximately equal amounts (43% and 44%, respectively). Impervious surfaces account for about 15.5% of the catchment area at this site. The field crew noticed an oily sheen in the stream as well as a significant amount of trash. All in situ water quality, except for conductivity were within the normal range. This site had the highest conductivity of all sites sampled and it is likely indicative of a water quality issue. The substrate at this site was about equally composed of sand and silt, and the site received a Marginal rating for epifaunal substrate and available cover. Submerged and emergent aquatic vegetation were present, along with some algae. Bank stability also rated as Marginal, and moderate amounts of erosion were noted in the local watershed. There were large amounts of both instream and dewatered wood present in this stream. Overall, this site received a total RBP habitat score of 107 (Partially Supporting) and a total PHI score of 82.6 (Minimally Degraded). The benthic community rated Poor, with a total BIBI score of 2.14. This score is a result of the lack of any EPT taxa in the stream, as well as a lack of any individuals that are considered intolerant of urban conditions.

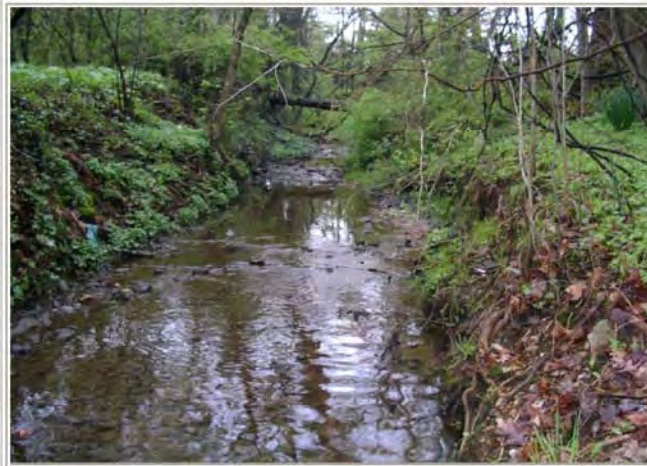
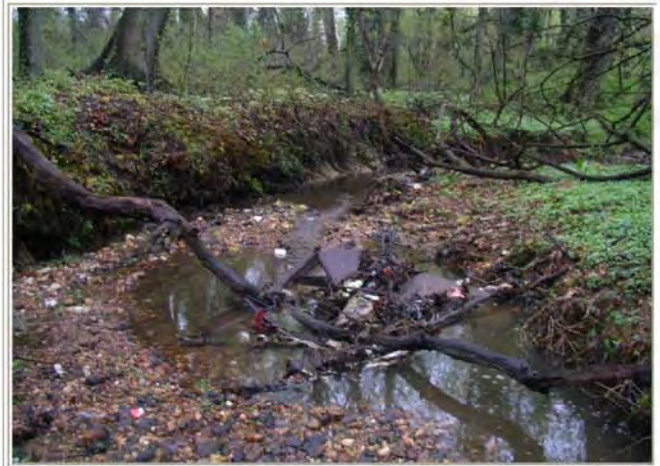
Location = Cedar Hill Cemetary, off of Cedar Hill Lane

This site is located in Cabin Branch Creek 2, in the Patapsco Tidal watershed. The stream site is southeast of the central loop of Cedar Hill Cemetery off of Cedar Hill Lane. Landuse upstream of this site is dominated by residential (57%) and open space (30%), with fairly high levels of impervious surfaces (42% of all surfaces). Embeddedness was low at this site, and epifaunal substrate rated as Suboptimal. The stream was fairly straight, and composed mainly of runs with a few riffles. Its substrate was made up of similar amounts of cobble, gravel, sand, and silt. RBP habitat rated Supporting (73% comparable to reference, total score of 146), while the PHI score was 79.4, or Partially Degraded. Benthos at this site rated Very Poor, with a BIBI score of 1.57. No Ephemeroptera or scraper taxa were present at this site, and none of the macroinvertebrates obtained in the benthic sample were considered intolerant of urban conditions.

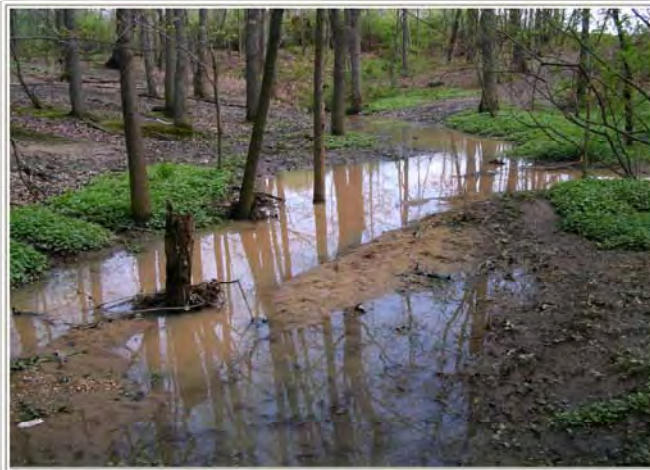
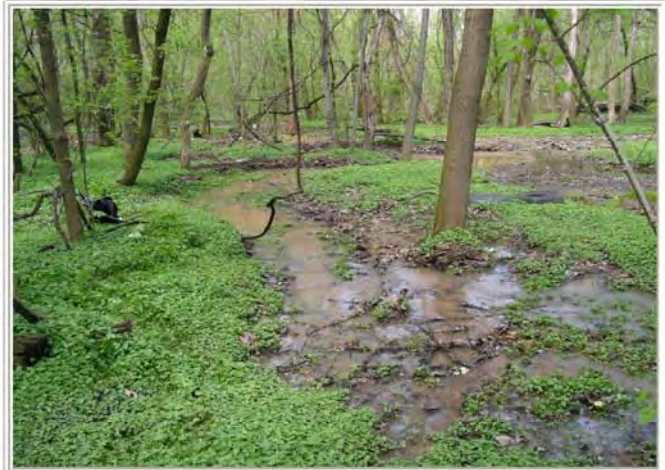
Location = West of undeveloped portion of Arundel Boulevard

This braided stream site is located to the west of the undeveloped portion of Arundel Boulevard. It is in Cabin Branch Creek 2, part of the Patapsco Tidal watershed. Landuse above this site is 52% residential, with some open space (22%) and wooded areas (19%). While bank erosion at this site was very minimal, the stream is highly embedded and substrate for benthos is marginal. The benthic community at this site rated Poor, with a BIBI score of 2.71. Scrapers and climbers were found in healthy numbers at this site, but no EPT taxa were present in the benthic sample, nor were there many macroinvertebrates intolerant of degraded urban condition. ATV tracks near the site indicate activity that may be contributing to less than optimal habitat conditions. The stream rated Partially Degraded under the PHI (total score of 74.7), and Partially Supporting under the RBP habitat with a total score of 121 (60.5% comparable to reference). Channel substrate was dominated by sand with some silt, and in situ water quality parameters were within the normal range.

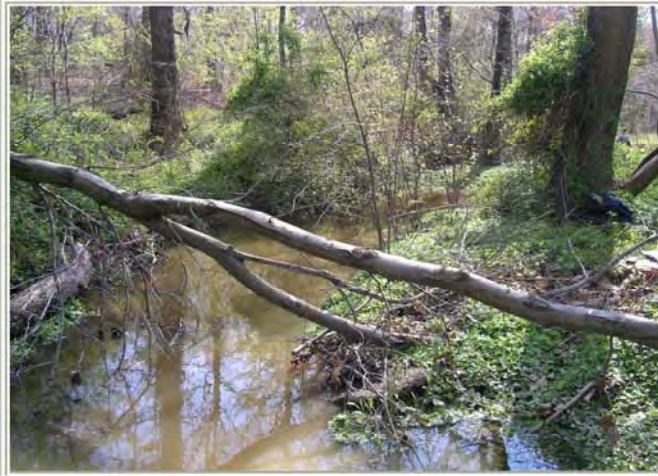
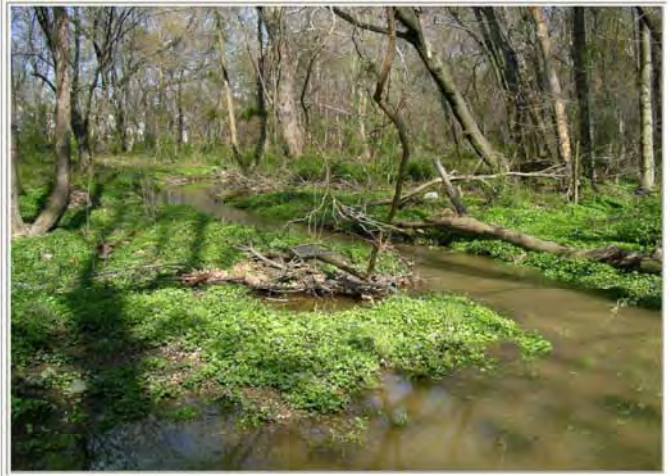
Watershed = Patapsco Tidal  
 Subwatershed = Cabin Branch  
 Location = Meadow Road

This Cabin Branch Creek site in the Patapsco Tidal watershed is located at the southeast corner of Meadow Road. A variety of landuses exist in the catchment surrounding this site, but the most prevalent landuse is residential (approximately 41%). Along with the residential landuse, commercial, industrial, transportation, and utility landuses contribute to the 43% impervious surfaces in this catchment. Open space (16.6%) and wooded landuses (11.3%) are also present. In situ pH measured at this site was 6.13, slightly below the state water quality minimum standard of 6.50. Other water quality parameters were within normal ranges. Very little trash was present at the site. Embeddedness was very high, while bank erosion was minimal. Under the PHI, this site received a score of 66.4 (Partially Degraded). Total RBP habitat score was 127 (Supporting). Despite a fairly moderate habitat, as evaluated under both the PHI and RBP assessments, the benthic community at this site is in Very Poor condition according to the BIBI (BIBI score of 1.86). Only 8 kinds of taxa were found at this site, and no EPT nor pollution-intolerant taxa were found.

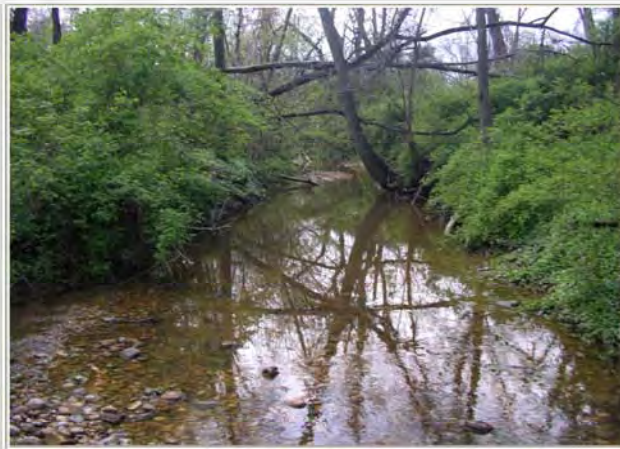
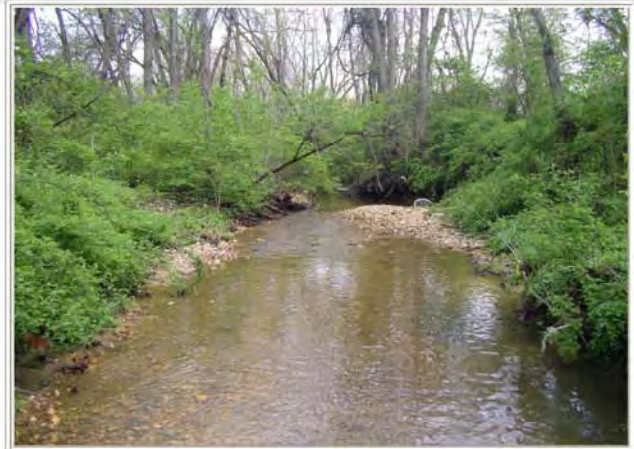
Watershed = Patapsco Tidal  
 Subwatershed = Cabin Branch  
 Location = Behind Beltway Crossing Shopping Center

Located in the west corner of the Beltway Crossing Shopping Center, this Cabin Branch Creek site is part of the Patapsco Tidal watershed. There are a wide variety of landuses in the surrounding catchment, including residential (46%), wooded areas (18.5%), and smaller percentages of open space, transportation, commercial, industrial, airport, utility, and water landuses. Thirty-eight percent of the catchment is impervious. All water quality parameters measured at this site fell within normal ranges. Moderate amounts of bank erosion were noted by field staff at this site, with the right bank having the poorest bank stability. A moderate amount of trash was present at the time of sampling. Both epifaunal substrate and pool substrate received optimal ratings. Channel substrate was dominated by gravel (60%) with some cobble and sand (20% of each). The total RBP habitat assessment score at this site was 152. Comparable to Reference, while the PHI rated the site as Partially Degraded, with a score of 71. None of the benthic macroinvertebrates obtained through benthic sampling at this site were considered intolerant to urban conditions, and only 1 EPT taxon was present in the sample. Thus, even with some good substrate for biota, high quality macroinvertebrates are not occupying this site. The overall BIBI score was 2.14, a rating of Poor.

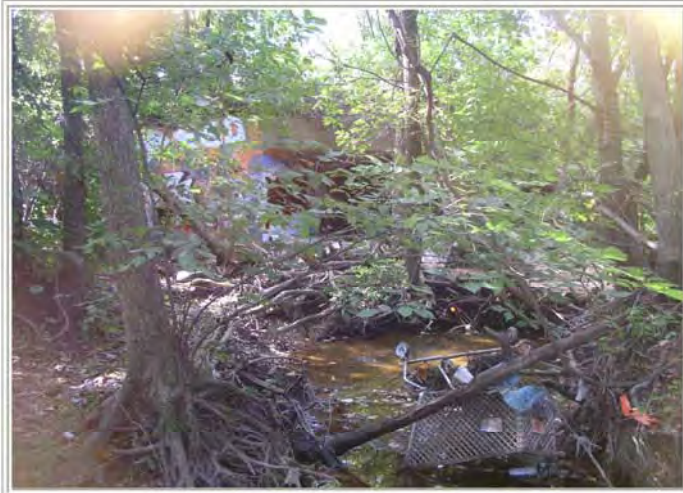
Upstream from Mid-Point

This is a replicate sample for site PT3-947-T-2009. Please note that the photos were taken during a return visit in August 2009. At that time, both the original and duplicate stream reaches were dry. Photos attached do not indicate the condition of stream at the time of benthic sampling.

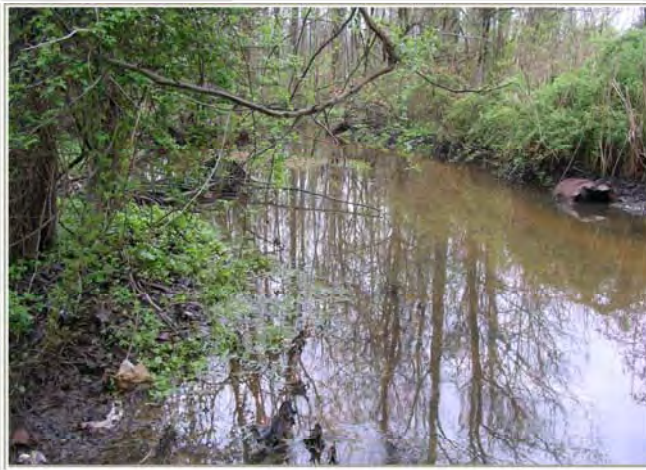
Upstream from Mid-Point

This braided Cabin Branch Creek site in the Patapsco Tidal watershed can be accessed from the left side of a trail that crosses Snow Hill Lane, and then cutting southeast into the woods. The dominant landuses in the catchment surrounding this site are residential (41%) and wooded (24%), but many other types of landuse are present, including open space, transportation, commercial, industrial, airport, utility, and water landuses. Just over one-third of the catchment area is impervious surface. The field crew noted a large amount of trash present at the time of sampling. Both epifaunal substrate and pool substrate variability received marginal ratings, and sediment deposition was poor. Silt and sand dominated the channel substrate (95% of channel substrate materials when combined). Overall, the total RBP habitat score was 105 (Partially Supporting), one of the lowest scores of all sites in this study. The PHI also rated the stream poorly, with an overall score of 57.1 (Degraded), the second lowest PHI score of all sites in the study. The benthic macroinvertebrate community at the site rated Poor, with a BIBI score of 2.43. Despite a wide variety of taxa obtained through sampling (n=28), no EPT taxa were present, and only six percent of the benthos obtained were considered intolerant to urban conditions.

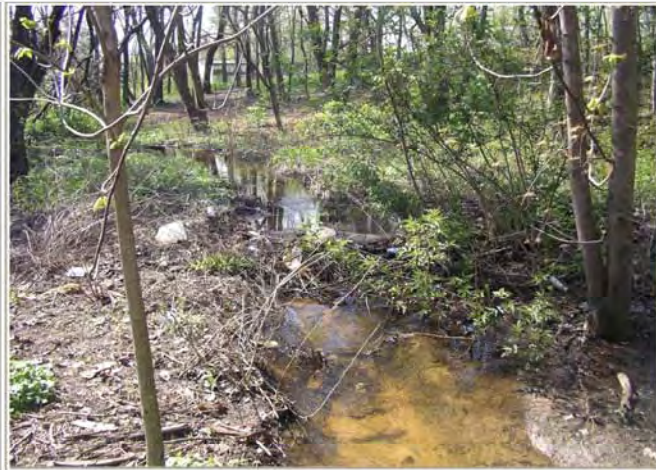
Upstream from Mid-Point

Just off of Furnace Branch Road, near the north corner of the school parking lot is site PT5-929-T-2009. This is in Furnace Creek in the Patapsco Tidal watershed. The most prevalent landuse in the catchment of this site is residential (63%), with 13% commercial landuse the next most prevalent. These landuses contribute to the 41% imperviousness of the catchment. In situ water quality parameters measured at this site were within acceptable ranges. Significant amounts of trash were noted by the field crew at the time of sampling. The site was approximately 75% embedded, and instream habitat conditions, including epifaunal substrate and pool substrate, were poor to marginal, with very little pool variability and a great amount of sediment deposition. The total RBP score at this site was the lowest of all scores in the study (104, Partially Supporting, 52% Comparable to Reference). The PHI did not rate this site as harshly (PHI = 70.0, Partially Degraded), but did note poor epifaunal substrate, and a lack of instream habitat, including only one piece of instream wood. These poor habitat conditions contribute to the Very Poor benthic community present in this stream (BIBI = 1.57). No EPT taxa were present, and no taxa were considered to be intolerant of urban conditions.

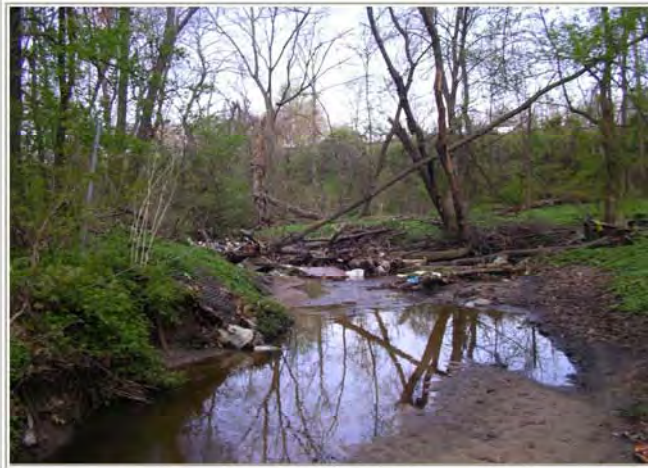
Upstream from Mid-Point

This site, located in Furnace Creek in the Patapsco Tidal watershed, has more than 50% impervious catchment area. With 62% residential and 21% commercial landuse, this high percentage of impervious surface is not unusual. This site is just east of the Glen Haven Memorial Gardens. The field crew found in situ water quality parameters to be within acceptable ranges. A minor buffer break (ATV path) was present along the left bank of the stream. Some bank erosion was noted at this site, and approximately 75% of the substrate was embedded. Epifaunal substrate and instream habitat were poor to marginal, and large amounts of trash were found at the site. The PHI rated this site as Degraded, with a score of 60.5, while the RBP habitat assessment was 113, Partially Supporting. A low community diversity was found through benthic sampling (nine taxa), and only one EPT taxon was found. In addition, no benthos considered intolerant to urban conditions were present in the benthic sample. Overall, the BIBI rated this site as Very Poor, with a score of 1.29, the lowest score of all sites sampled in this survey.

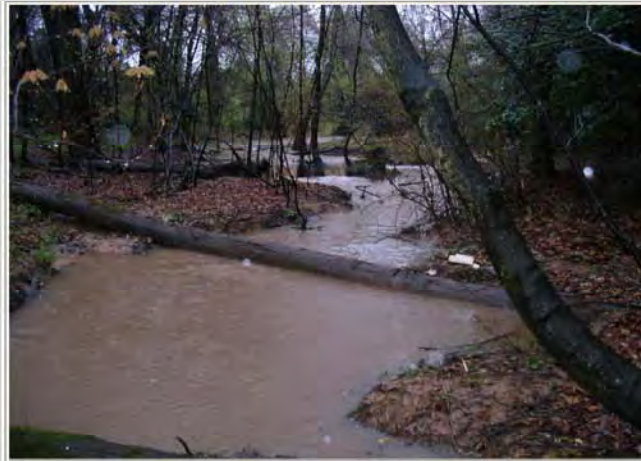
Upstream from Mid-Point

This Curtis Creek site is off of Fort Smallwood Road, north of Pillman Road and behind Jet Blast Companies. It is part of the Patapsco Tidal watershed. Wooded areas dominate the landuse of the catchment (57%) with 15% residential and 14% industrial landuses also present. Impervious surfaces account for 23.7% of the catchment area. Sediment fences adjacent to the site were failing at the time of sampling. Channel substrate was composed primarily of sand (80%) with some silt (20%), and most of the sampling reach was long sandy run. Substrate was 100% embedded and the canopy was only 25% shaded. All water quality parameters were within acceptable ranges. The RBP rated this site as Supporting, with a total score of 130. Under the PHI, this site rated Partially Degraded, with a total score of 70.7. No EPT taxa were present in the benthic sample obtained at this site and only 8% of the macroinvertebrates obtained were considered intolerant to urban conditions. Overall, the BIBI rated this site as Poor, with a score of 2.14. Water level was somewhat elevated at time of sampling (it was raining during sampling and had rained within the 24 hours prior to sampling), but site was sampled that day due to limited sampling window.
