# **SITE SELECTION OF STREAM CROSSINGS TO BE ANALYZED FOR FLOOD OVERTOPPING**

## **TECHNICAL MEMORANDUM**

### **Subtask 2.1.5 Patapsco Tidal and Bodkin Creek Watershed Study**

**Targeted Biological Assessment of Streams in Patapsco Tidal and Bodkin  
Creek Watersheds, Anne Arundel County, Maryland: 2009**

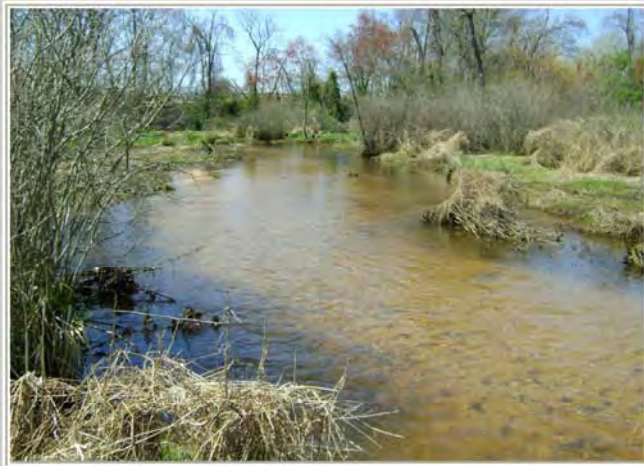
Upstream from Mid-Point

A wide variety of landuses are present in the catchment surrounding this site, which is located in Sawmill Creek 1 in the Patapsco Tidal watershed. The site can be accessed at the intersection of Virginia Avenue and Maple Lane. No one landuse is particularly dominant, but wooded areas, open space, and residential landuse all contribute between 22 and 27%. Airport land is nearly 10% of the catchment area, and smaller amounts of transportation and industrial lands are present as well. Just under 30% of the catchment is made up of impervious surface. All in situ water quality parameters fell within acceptable limits according to Maryland water quality standards. Streambanks at this site were not eroded, and instream habitat was good. Channel substrate was a mix of sand and silt, and 85% of the reach length was made up of runs, with the remaining 15% riffles. This site received the highest RBP habitat assessment score of all sites included in the study (169, Comparable to Reference). However, under the PHI, this site was rated Degraded with a score of 61.1. One factor negatively affecting the PHI was the paltry 5% canopy shading present at the site. The benthic community at this site was not very diverse (only 9 kinds of taxa were found in the benthic sample), and no EPT nor scraper taxa were included in the sample. In addition none of the benthic macroinvertebrates were considered intolerant of urban conditions. Thus, the BIBI rating for this site was Very Poor, with a score of 1.29.

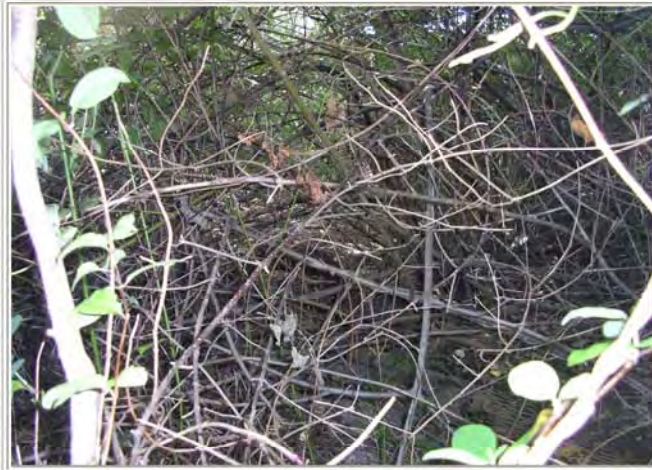
Upstream from Mid-Point

This site is located in Sawmill Creek 1 in the Patapsco Tidal watershed. It is on the south side of Longwood Avenue, between Hopkins and Idlewood Streets. Thirty-two percent of the landuse surrounding this site is related to the BWI airport, and 51% of the catchment acreage is impervious. In situ water quality parameters were all within acceptable ranges. Despite its close proximity to the BWI airport, the benthic macroinvertebrate community at this site scored in the Fair range, with a BIBI of 3.00. Twenty-two different taxa were found, including three EPT taxa and two scrapers. However, only 2% of the sample consisted of macroinvertebrates considered intolerant of urban conditions. According to the landowner, the county had done dredging work there approximately ten years ago and installed chainlink fence and chicken wire throughout the site. An old metal fence is embedded into the streambed along almost the entire length of reach, which made benthic sampling somewhat difficult. Streambanks along both sides of the stream had minimal levels of erosion and only 25% of the canopy was shaded. Epifaunal substrate and pool substrate variability were rated in the lower end of Suboptimal, and sediment deposition was marginal. Along the left bank of the stream, the riparian zone was rated Poor. The total RBP score was 117 (Partially Supporting) while the PHI rating was Degraded (score of 64.9).

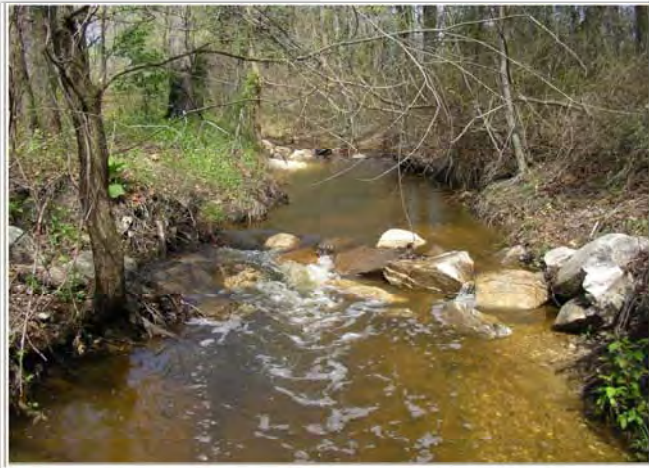
Upstream from Mid-Point

Near the BWI Airport, this site is located on the east side of Aviation Boulevard where the stream crosses the road. It is in Sawmill Creek 1, in the Patapsco Tidal watershed. Fifty percent of the landuse surrounding this site is related to the BWI airport, and 52% of the catchment acreage is impervious. The close proximity of this site to BWI Airport likely influences the quality of the benthic macroinvertebrate community and the habitat at this site. The benthic community received a BIBI score of 1.86 (Very Poor), as the sample lacked any EPT or scraper taxa and no taxa were considered intolerant to urban conditions. While the water had a distinct reddish/orangish color, all water quality parameters measured by the field crew were within acceptable limits according to state water quality standards. Field crew members noted a moderate amount of trash present at the site. Streambanks had some erosion along both sides of the stream, and bank stability was rated marginal along the left bank. Epifaunal substrate and instream habitat were in the optimal to suboptimal range. Embeddedness was 45% and the canopy was 85% shaded. The total RBP score was 135 (Supporting) while the PHI rating was Partially Degraded (score of 76.7).

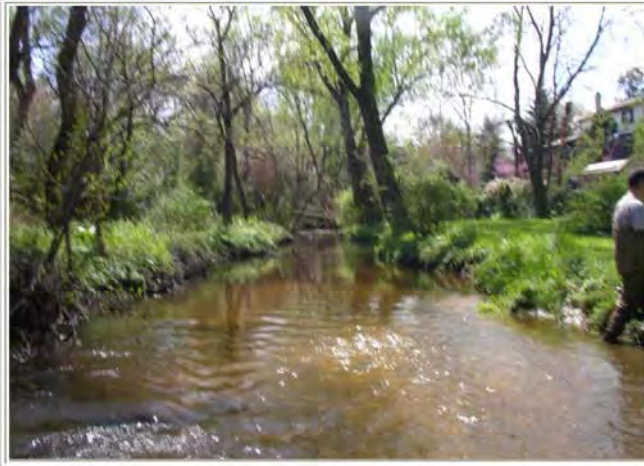
Upstream from Mid-Point

This site is located behind the GMC Trucks property off of Crain Highway. It is in Sawmill Creek 1 in the Patapsco Tidal watershed. Residential landuse makes up the greatest percentage of landuse in the catchment at 31%, while wooded and open space landuse account for 24 and 19%, respectively. Impervious surface makes up 32.3% of the catchment area. Epifaunal substrate and instream habitat were rated in the suboptimal range at this site, and embeddedness was 50%. The field crew noted a moderate amount of trash nearby, and the left bank lacked adequate vegetative protection along with a narrow riparian vegetative zone. Moderate levels of erosion were noted in the local watershed. Overall, the site received a narrative rating of Partially Degraded under the PHI (score of 70.6) and rated Supporting under the RBP (score of 143, 71.5 % comparable to reference). While a good diversity of taxa were found through benthic macroinvertebrate sampling (n=26), no EPT taxa were present in the sample and only 7.5% of the macroinvertebrates were considered intolerant of urban conditions. A healthy number of scrapers were present, along with some climbers, resulting in a Poor classification by the BIBI (score of 2.43). Some SAV was present.

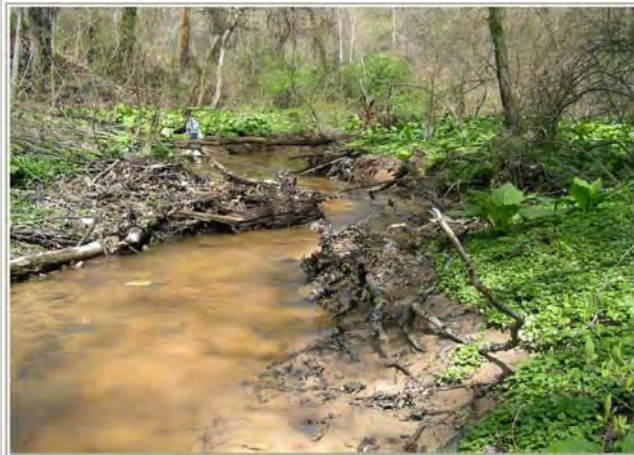
Upstream from Mid-Point

Residential landuse is the most prevalent landuse in the catchment of site PT8-923-T-2009, accounting for 58% of the catchment area. This site is located in Marley Creek 1, in the Patapsco Tidal watershed. Other landuses present include wooded (24%), commercial (7%), and transportation-related (6%). This site is located on the south side of Marley Neck Boulevard, just north of Mercet Drive. Channel substrate consisted of 80% sand and 20% silt, and the stream was 100% embedded. The field crew noted moderate to heavy amounts of trash and some bank erosion. This site had suboptimal epifaunal substrate, while instream habitat, pool substrate, and pool variability rated marginal. Impervious surfaces account for just under 31% of the catchment area. The total RBP Habitat score was 135 (Supporting), while the PHI score of 78.9 rated the site as Partially Degraded. The benthic community at the site showed signs of degradation, with an overall BIBI score of 1.57 (Very Poor). Benthic macroinvertebrate sampling targeted rootwads and woody debris, which accounted for about half of the benthic habitat present at the site. No sensitive EPT taxa were obtained in the benthic sample, nor were there any scrapers. In addition, less than 5% of the macroinvertebrates present in the benthic sample were considered intolerant of urban conditions.

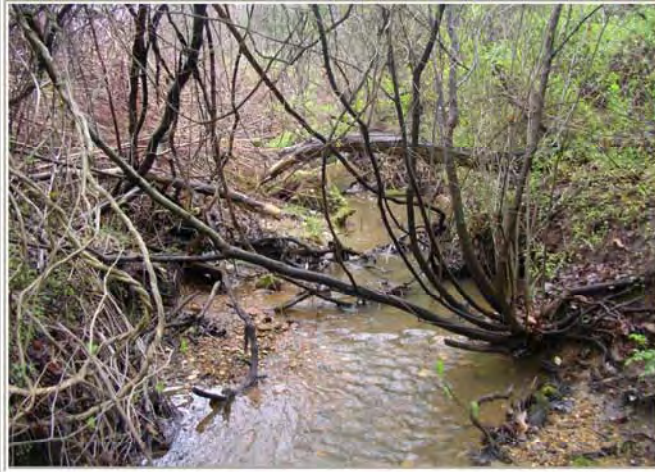
Upstream from Mid-Point

This site in Marley Creek 1 in the Patapsco Tidal watershed had one of the lowest amounts of impervious surface in its catchment of all sites included in this study (4.6%). Much of the landuse surrounding this site is wooded (73%) or open space (16%), and only small amounts of utility (6%), water (2%), and transportation landuses (1.7%) are present. The site is located off of Marley Neck Road, north of a train and automobile junkyard. This junkyard is located just outside the 50-meter riparian area along the right bank of the stream. The proximity of the site just next to the road, along with the nearness of the junkyard resulted in the lowest ratings possible for remoteness and aesthetics (trash). Despite the low amounts of impervious surface, this site is plagued by terrible bank erosion. The field crew rated the entire 75-meter stretch as having extreme bank erosion along the left bank and moderate bank erosion along the right bank. Overall habitat scores were low at this site, with the RBP habitat assessing the site as Partially Supporting (score of 117), and the PHI rating the site as Degraded (score of 55.4, the lowest PHI score in the study). The benthic community also rated as Very Poor, with a BIBI score of 1.86. Community diversity was lacking, as only 7 taxa were present in the benthic sample.

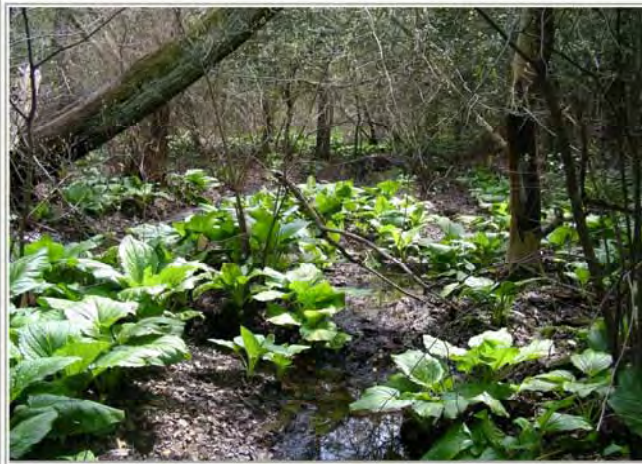
Upstream from Mid-Point

This Marley Creek 1 site in the Patapsco Tidal watershed is located on a farm off of Marley Neck Road at Tanyard Cove Road. This stream had stable banks with very little erosion present. No trash was observed at the site by field staff. Much of the length of the stream sampled consisted of long sandy run, with few riffles or pools. Epifaunal substrate and pool substrate were both rated toward the lower end of suboptimal, with most of the channel substrate composed of sand (80%) and some silt (20%). Overall, this site rated as Supporting under the RBP (score of 150, 75% comparable to reference), and as Partially Degraded under the PHI (score of 75.8). The benthic community present at this site received one of the higher BIBI scores of all sites included in this study (BIBI = 3.57, Fair), and had a high amount of diversity (35 taxa present, including 5 EPT taxa). In situ pH levels at this site were 6.33, slightly below the minimum state water quality standard of 6.5.

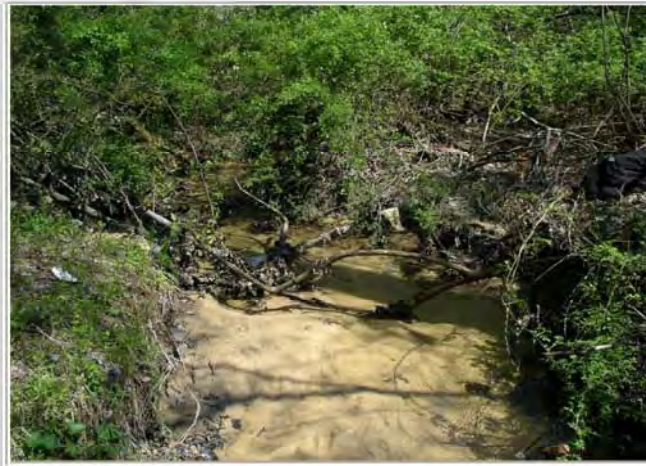
Upstream from Mid-Point

This site in the Rock Creek subwatershed of the Patapsco Tidal watershed is surrounded by residential landuse in 64% of its catchment. Wooded landuse accounts for 20% of the catchment, and some commercial (8%) and some transportation-related landuse (4%) is also present. Approximately 30% of the catchment draining to this site is impervious surface. This site is located near the intersection of Tower Bridge Drive and Robin Air Court. A sewage line runs along the stream on the right bank and serves as a severe break in the buffer. Sewage odors were strong and field staff thought that sewage could possibly be draining into the stream. In situ pH was 6.24, slightly below the minimum state water quality standard of 6.5. The biological community at this site rated Poor under the BIBI, with a total score of 2.14. Only one pollution-sensitive EPT taxa was present in the benthic sample, and only one scraper taxa. Seventy-five percent of the benthic macroinvertebrates found at this site were considered tolerant of urban conditions. Severe bank erosion was present along some stretches of both streambanks. Epifaunal substrate rated Marginal, and channel substrate consisted mainly of sand (90%) with some silt, and was almost completely embedded. Deposition was severe with sand 30 to 50 cm deep in some places. These less than ideal habitat conditions resulted in a Partially Degraded rating under the PHI and a Partially Supporting rating under the RBP.

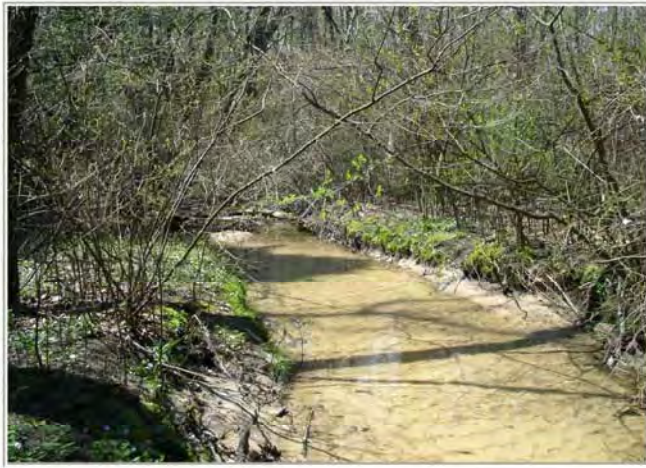
Upstream from Mid-Point

This site is located along the east side of Edwin Raynor Boulevard, north of Countryside Drive. It is in the Rock Creek subwatershed of the Patapsco Tidal watershed. Eighty-three percent of the landuse surrounding this site is residential with some open space present (9.8%). Impervious surface accounts for just under 40% of the catchment area. From the benthic macroinvertebrate sample obtained here, biological community diversity was high, with 24 different taxa present, including three EPT taxa. No scrapers were present, however, and the overall BIBI score was 2.43, Poor. Severe bank erosion affected some stretches of both streambanks, and large amounts of litter were noted by field staff. A large amount of sand was present at this site, both in the form of channel substrate and deposition that affected channel flow status and filled pools. In general, habitat conditions were somewhat degraded, as reflected by a PHI rating of Partially Degraded (score of 77.3) and a RBP rating of Partially Supporting (score of 121). A slightly low pH level was detected at this site, with in situ pH at 6.31, just below the state's minimum water quality standard of 6.5.

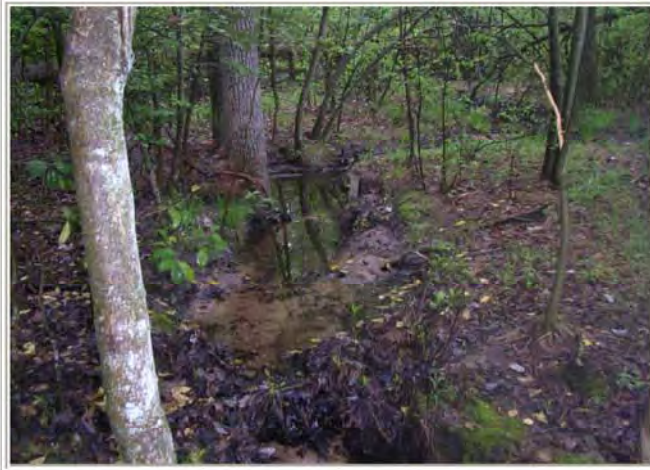
Upstream from Mid-Point

Wooded landuse is dominant around site PTB-918-T-2009, contributing to 60% of the catchment area. Some residential (23%) and some open space (12%) landuses are also present, and overall imperviousness levels are only about 9%. This site is located in Tar Cove Park, north of Compass Point Golf Course. This is part of the Rock Creek subwatershed of the Patapsco Tidal watershed. Overall, the benthic macroinvertebrate community at this site indicates a stream in Poor condition, with a BIBI score of 2.14. The site scored well for the percent of the benthic sample considered intolerant of urban conditions (67%), but moderate community diversity and few EPT and no scraper taxa, as well as few climbers contributed to the Poor rating. Habitat at this site rated Minimally Degraded under the PHI with the highest total PHI score of all sites included in this study (90.6). Bank stability was good with no erosion present and a healthy riparian buffer width. Only small amounts of trash were noted. Epifaunal substrate and pool substrate were in the suboptimal to marginal ranges, and the overall RBP habitat score was 133, Supporting.

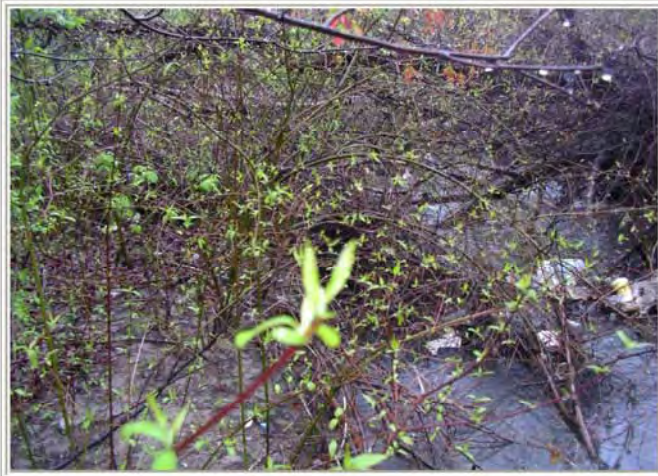
Upstream from Mid-Point

The catchment surrounding this site had the greatest percentage of impervious surface (65%) of any site in this study. More than half of the landuse here is commercial, with another 32% residential, and 6.7% transportation-related. Only 6.8% of the surrounding landuse is wooded. This site is part of the Back Creek subwatershed in the Patapsco Tidal watershed. It is located off of Chesapeake Center Drive at the Centre at Glen Burnie shopping center, and it was littered with large amounts of trash when the field crew visited. In addition, in situ pH values at this site were 8.68, a bit above the state's maximum water quality standard of 8.5. The benthic community at this site scored among the lowest of all sites included in this survey (BIBI score of 1.57, Very Poor), which was not surprising, given the prevalence of impervious cover and the site's proximity to a large retail area. There were very few macroinvertebrates living in this stream, and only 4 taxa were present in the benthic sample, none of which were EPT taxa nor any taxa considered intolerant of urban conditions. Some bank erosion affected portions of both banks, and the riparian buffer zone width rated at the low end of suboptimal. Instream habitat, epifaunal substrate, and pool substrate showed signs of degradation, and the site rated as Partially Degraded under the PHI with a score of 68.1. Under the RBP, this site rated Supporting with a total score of 126.

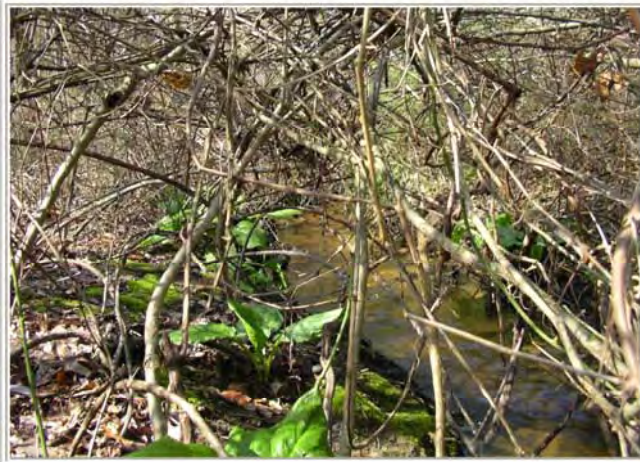
Upstream from Mid-Point

This Friendship Park site is part of the Sawmill Creek 2 subwatershed in the Patapsco Tidal watershed. Industrial landuse contributes to 31% of the catchment area, followed by wooded and open space, which each account for approximately 25%. The overall catchment impervious percentage is 38%. Benthic macroinvertebrates sampled at this site indicate a fairly healthy stream, with an overall BIBI score of 3.57 (Fair). There was good community diversity, with moderate amounts of EPT taxa present, but overall very few macroinvertebrates considered intolerant of urban conditions. A minimal amount of bank erosion was present along both streambanks, while moderate amounts of sediment deposition affected substrate. Instream wood was completely absent and only one piece of dewatered wood was present in the reach. Habitat was rated Partially Degraded (76.3) under the PHI and Supporting (129) under the RBP.

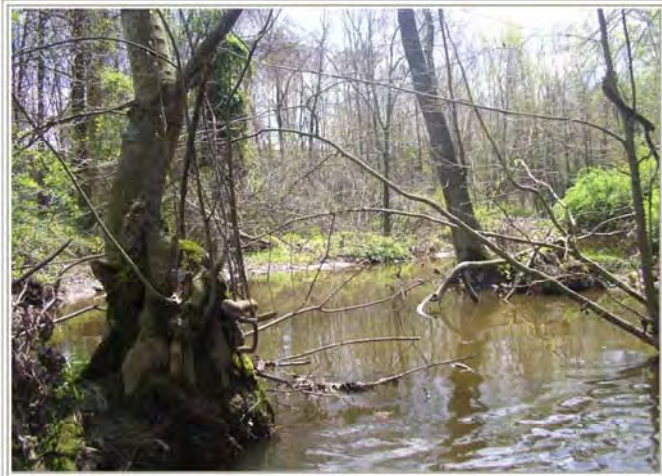
Upstream from Mid-Point

This site can be accessed from the Marley Station Mall, in the northwest corner of the parking lot. It is part of the Marley Creek 3 subwatershed in the Patapsco Tidal watershed. Most of the landuse in the surrounding area is residential (55%) and wooded (18%), and the shopping center and other commercial areas contribute to about 11% of the catchment area. This results in 36% impervious surface in the surrounding catchment. Benthic community diversity was somewhat diminished at this site, and no macroinvertebrates considered intolerant to urban conditions and no scraper taxa were obtained through benthic sampling. The site received a BIBI score of 2.14 (Poor). Field crew members noted large amounts of trash present at the time of sampling. Channel substrate was dominated by silt (60%) with some sand and gravel, and sediment deposition rated Marginal. Thus epifaunal substrate, pool substrate, and instream habitat conditions were all less than ideal. Habitat overall was rated Degraded under the PHI (57.7) and Supporting under the RBP habitat assessment procedure (score of 139).

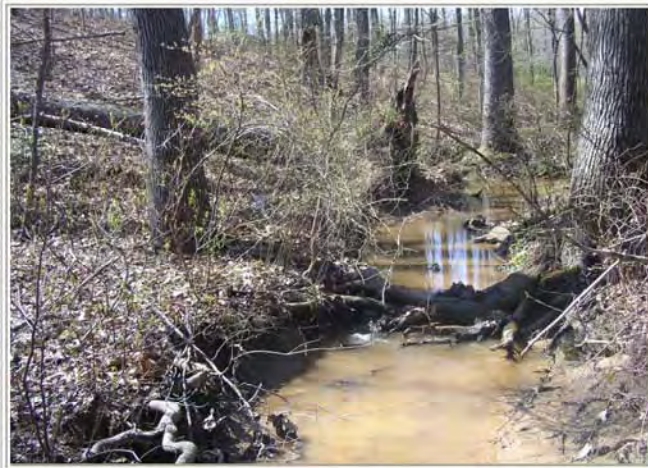
Upstream from Mid-Point

At this site, wooded and open space landuses are most prevalent in the surrounding catchment (37% and 30%, respectively), followed by 25% industrial landuse. Resultant imperviousness is 18%. Part of the Nabbs Creek subwatershed of the Patapsco Tidal watershed, this site is located near the southwest corner of Arbor Wood Place. The benthic community sampled at this site had a poor community diversity (n=10 taxa), and low numbers of EPT and scraper taxa, with few climbers. Thus, it rated Very Poor according to the BIBI (score of 1.57). The PHI rated the habitat as Degraded (score of 57.2), while the RBP rated the habitat as Partially Supporting (score of 112). Moderate amounts of bank erosion were affecting the stability of both banks, and significant levels of deposition were present throughout the stream, resulting in poor substrate conditions. Emergent grasses, some SAV, and some algae were present in the stream, and only 30% of the canopy was shaded.

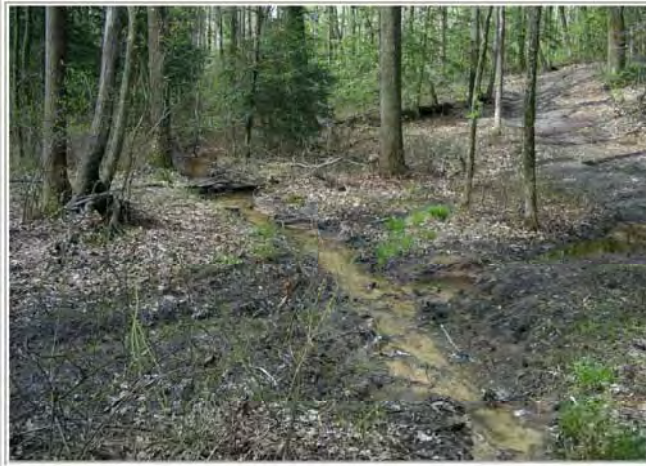
Upstream from Mid-Point

The catchment surrounding this site is made up of residential and wooded landuse (70% and 30% respectively). Approximately 12% of the catchment area is impervious. It is part of the Hines Bog Pond subwatershed in the Patapsco Tidal watershed, and is located off of Fox Hollow Run. During spring sampling, large numbers of juvenile spring peepers were present at this site. The macroinvertebrates in the benthic sample revealed a Very Poor stream, with low community diversity, only 1 EPT taxa, and no scraper taxa (BIBI score of 1.57). Habitat assessments were not quite as harsh, with the RBP rating the stream as Partially Supporting, and the PHI rating the stream as Partially Degraded. Severe bank erosion affected portions of both banks, and the riparian buffer zone along both banks was very narrow. A dirt road served as a severe buffer break along both sides of the stream. Field staff noted moderate amounts of trash present, and deep pools were lacking.
