# URBAN BEST MANAGEMENT PRACTICES TECHNICAL MEMORANDUM

## Subtask 2.2 Patapsco Tidal and Bodkin Creek Watershed Study

**June 2011**

## **APPENDIX D**

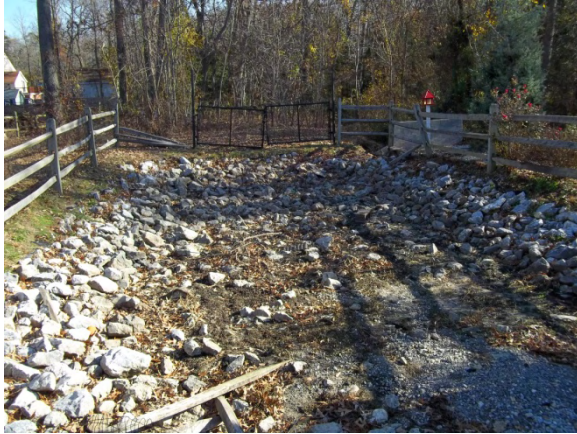
Photo 1 – Existing infiltration BMP at end of 209<sup>th</sup> Street in dry condition (looking downstream)

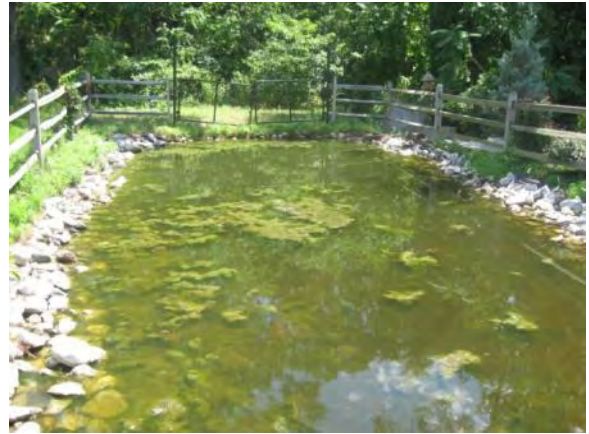
Photo 2 – Existing infiltration BMP at end of 209<sup>th</sup> Street filled with water and algae (looking downstream)

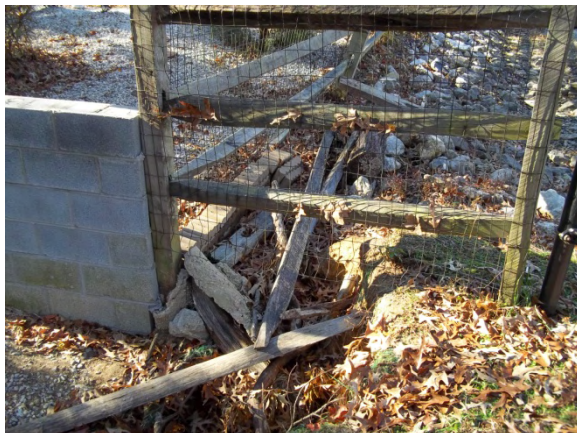
Photo 3 – Inadvertent spillway for existing infiltration BMP

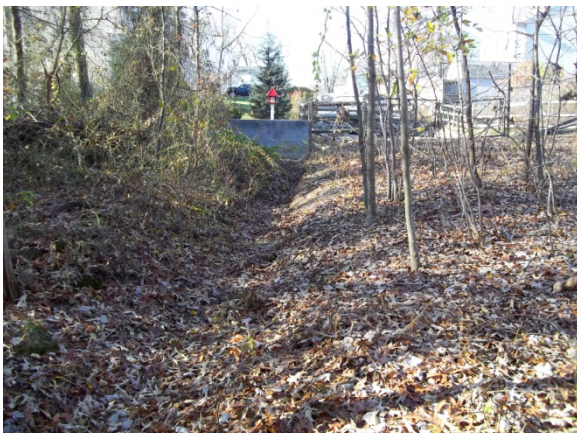
Photo 5 – Opportunistic channel draining infiltration BMP (looking upstream toward BMP)

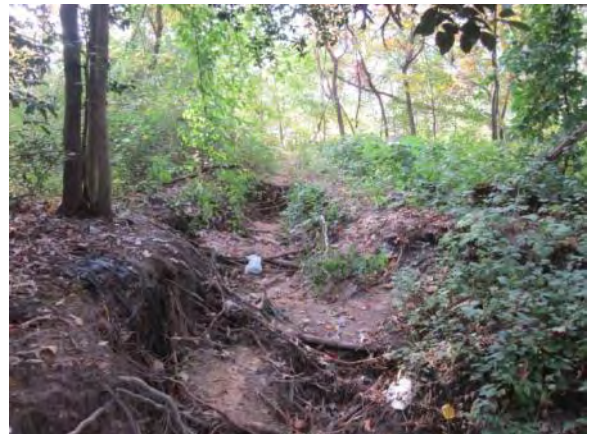
Photo 6 – Opportunistic channel showing significant erosion (looking downstream)

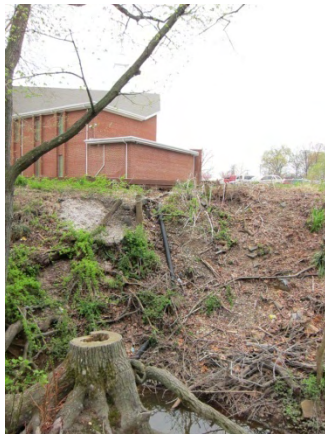
Photo 3 – Stream bank erosion threatening the church parking lot

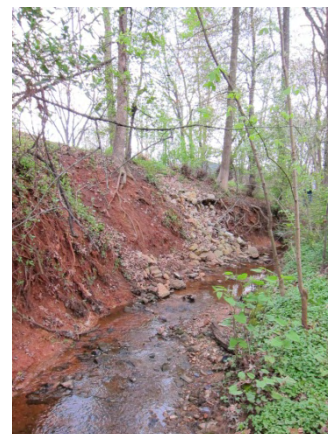
Photo 4 – Stream bank erosion prevalent throughout the Phase 1 restoration area

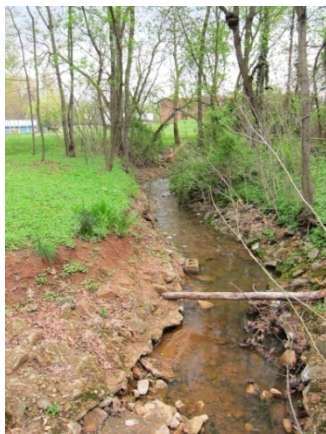
Photo 5 – Cement armoring currently along downstream portion of Reach 2

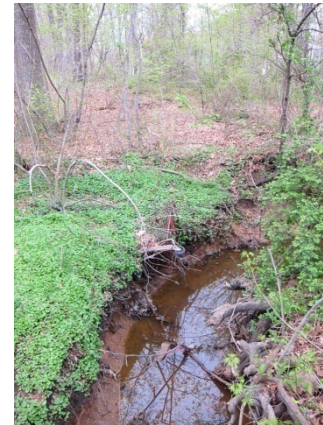
Photo 10 – Stream bank erosion prevalent throughout the restoration area

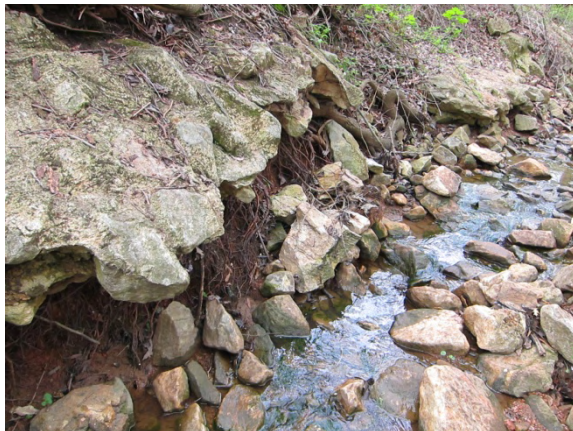
Photo 11 – Cement armoring currently along downstream portion Phase Two.

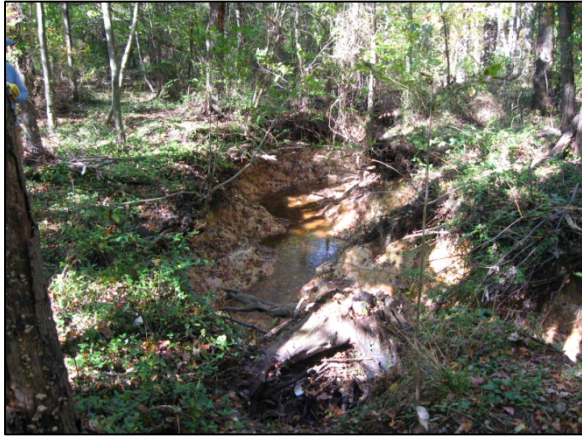
Photo 1 – Deeply Incised Segment Downstream of Headcut

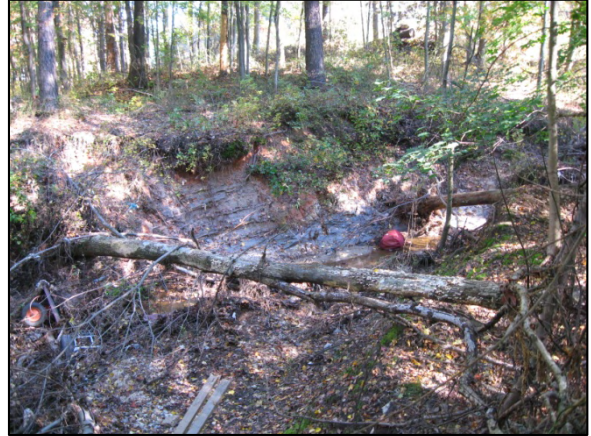
Photo 2 – Severe Bank Erosion in Upstream Portion of Reach

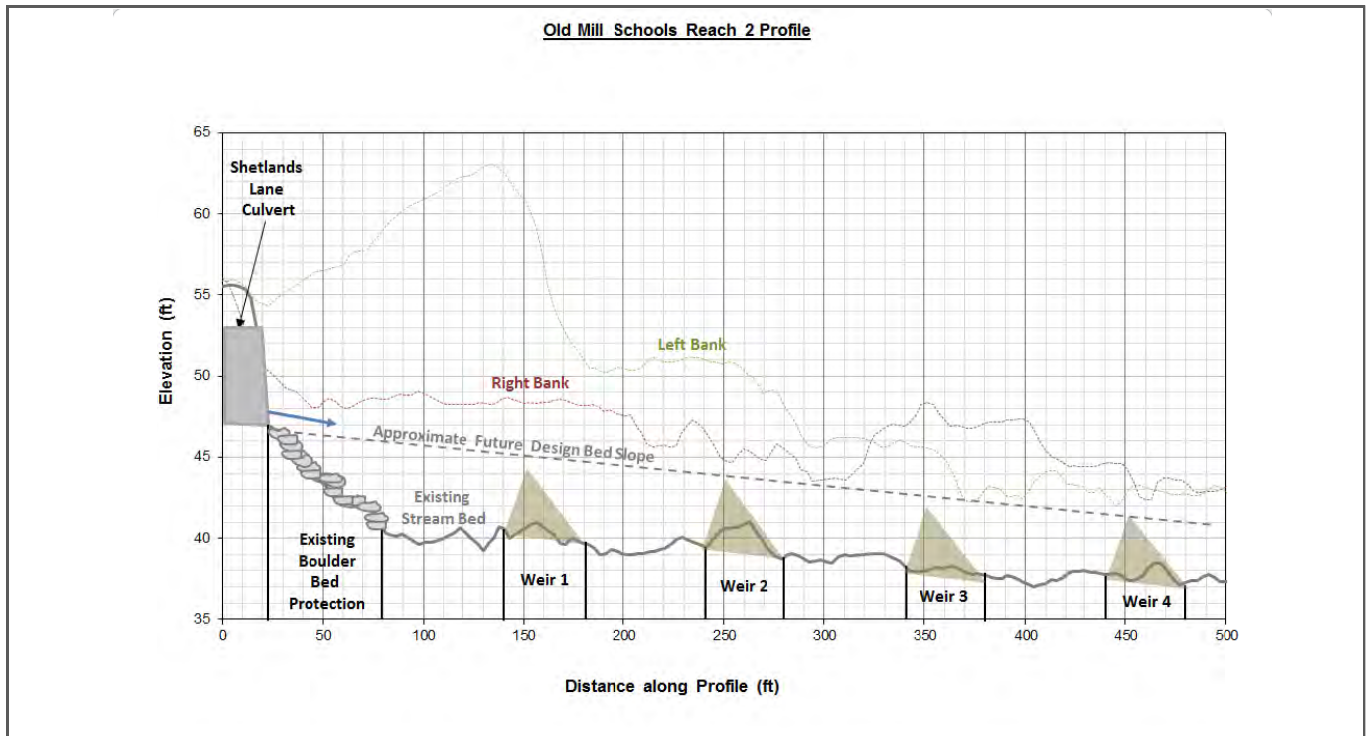
Figure 4 – Profile Views of Reach 2 Restoration

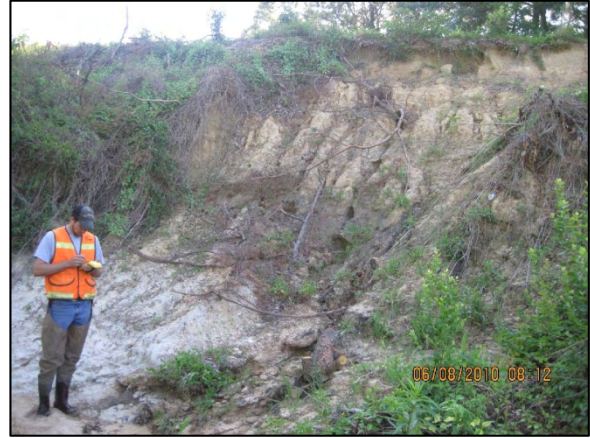
Photo 8 – Extreme Bank Erosion Downstream of Culvert

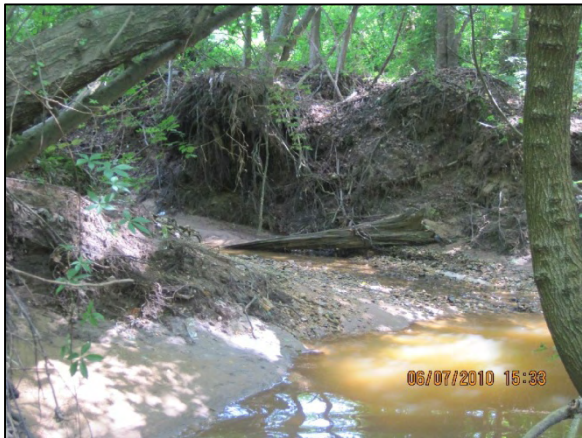
Photo 9 – Severe Bank Erosion

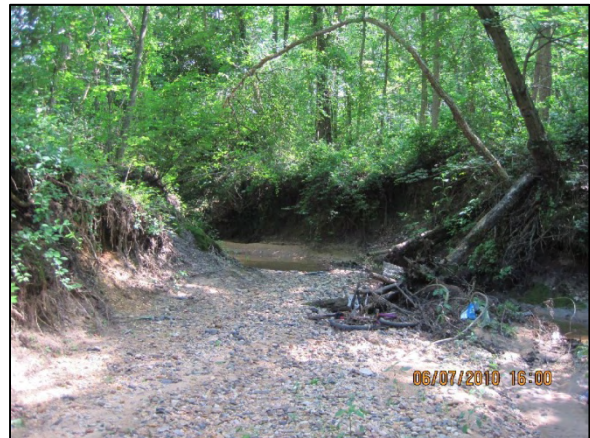
Photo 10 – Continued Severe Bank Erosion at Downstream End of Reach
