SEVERN RIVER

Watershed Management Master Plan

Current Conditions Report

December 2002

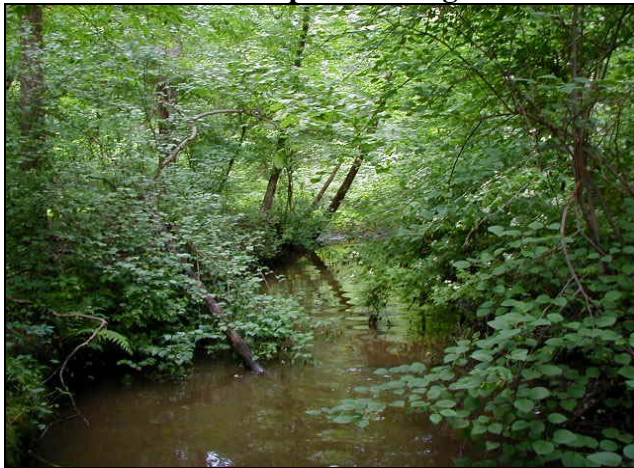
Optimal Range

Poor - Less than 10% stable habitat. Lack of habitat is obvious

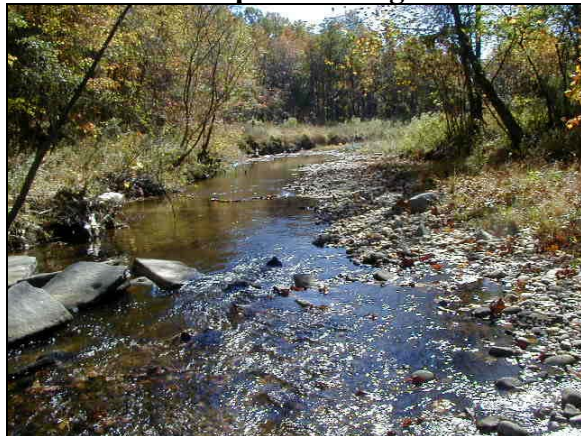
Optimal Range

Rated based on the amount and variety of hard, stable substrates usable by benthic macroinvertebrates. Because they inhibit colonization, flocculent materials or fine sediments surrounding otherwise good substrates are assigned low scores. Scores are also reduced when substrates are less stable.

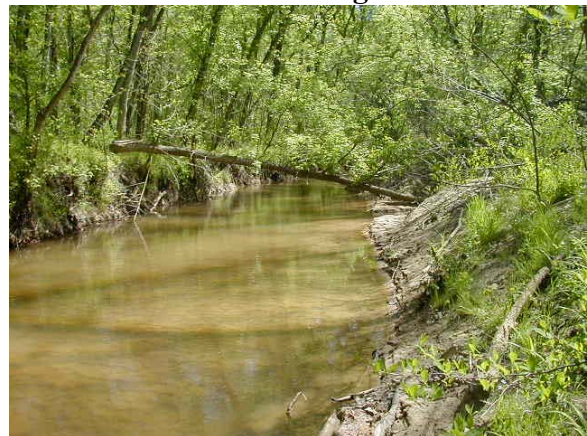
Poor Range

Poor - Stable substrate lacking; or particles are over 75% surrounded by fine sediment or flocculent material

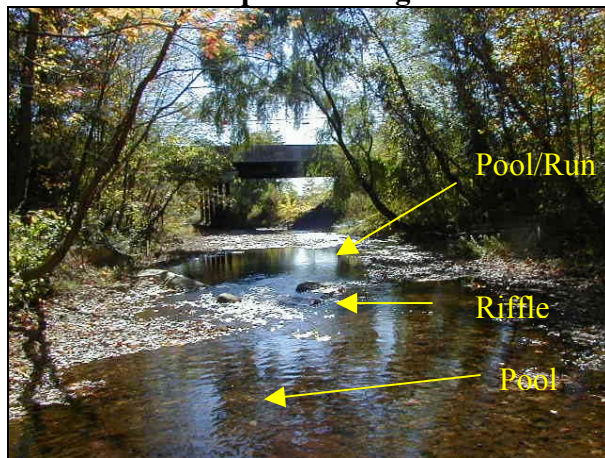
Optimal Range

Rated based on the variety of velocity/depth regimes present at a site (slow-shallow, slow-deep, fast-shallow, and fast deep). As with embeddedness, this metric may result in lower scores in low-gradient streams but will provide statewide information on the physical habitat found in Maryland streams.

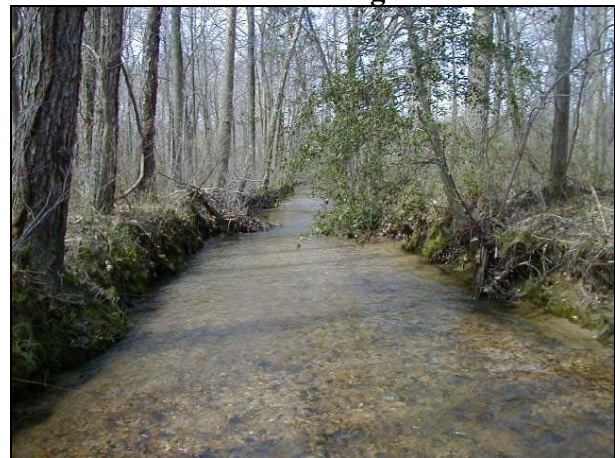
Poor Range

Poor - Dominated by 1 velocity/depth category (usually pools)

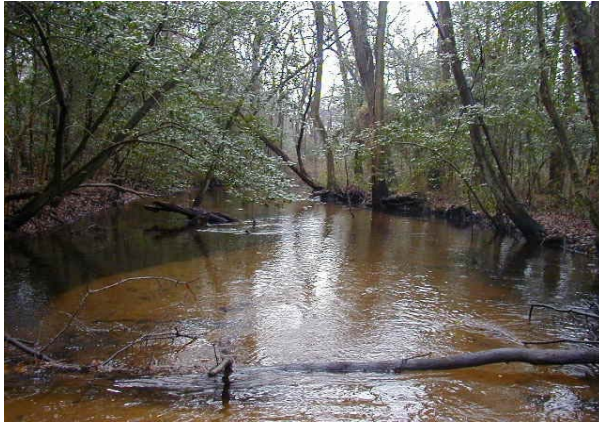
Optimal Range

Rated based on the variety and spatial complexity of slow- or still-water habitat within the sample segment. It should be noted that even in high-gradient segments, functionally important slow-water habitat may exist in the form of larger eddies. Within a category, higher scores are assigned to segments, which have undercut banks, woody debris or other types of cover for fish.

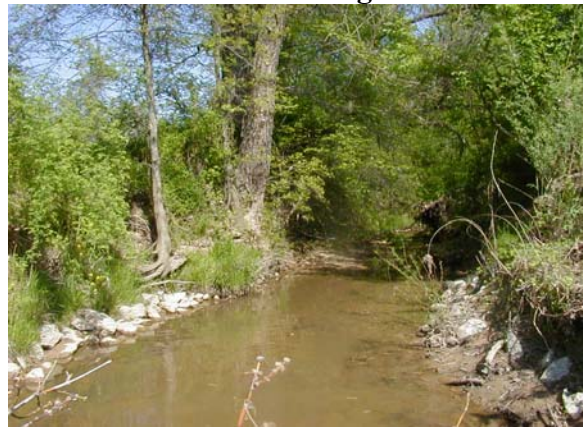
Poor Range

Poor - Max depth <0.2m in pool/glide/eddy habitat; or absent completely

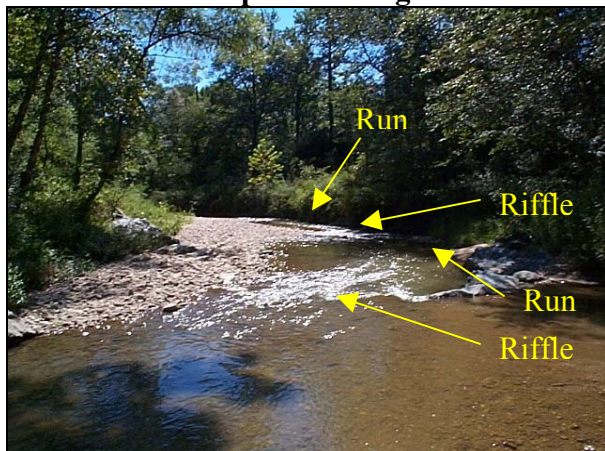
Optimal Range

Rated based on the depth, complexity, and functional importance of riffle/run habitat in the segment, with the highest scores assigned to segments dominated by deeper riffle/run areas, stable substrates, and a variety of current velocities.

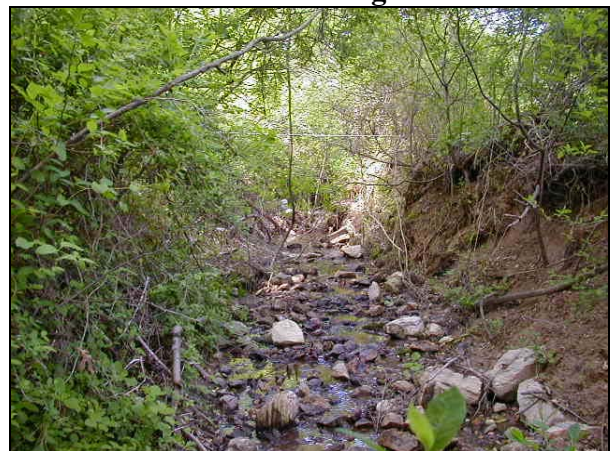
Poor Range

Poor - Riffle/run depth <1cm; or riffle/run substrates concreted

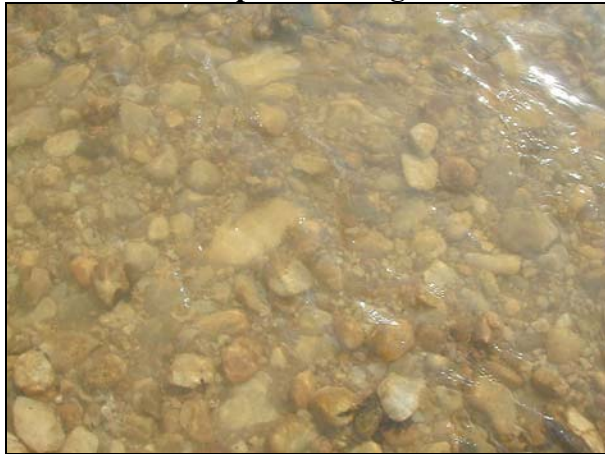
Optimal Range

Rated as percentage based on the fraction of surface area of larger particles that is surrounded by fine sediments on the stream bottom. In low gradient streams with substantial natural deposition, the correlation between embeddedness and fishability or ecological health may be weak or non-existent, but this metric is rated in all streams to provide similar information from all sites statewide.

Percentage that gravel, cobble, and boulder particles are surrounded by fine sediment or flocculent material

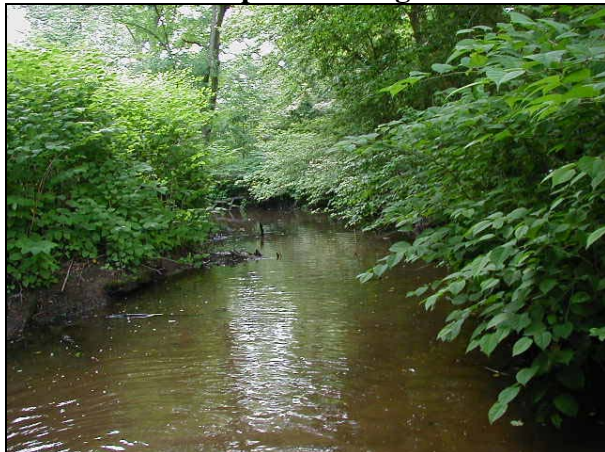
Optimal Range

Rated based on estimates of the degree and duration of shading at a site during summer, including any effects of shading caused by landforms. If assessment carried out during leaf off, consider shading that would be present during leaf on.

Percentage of segment that is shaded (duration is considered in scoring), 0% = fully exposed to sunlight all day in summer; 100% = fully and densely shaded all day in summer

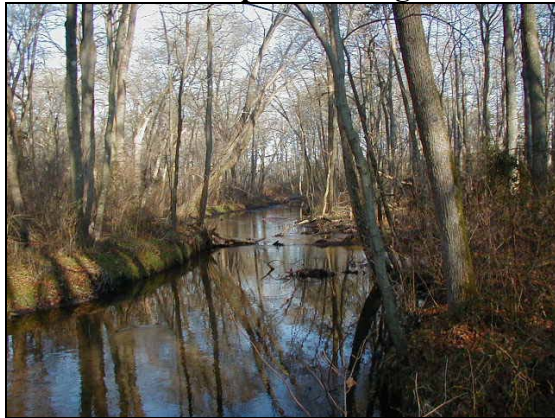
Optimal Range

The scoring of this metric is based on the amount of human refuse in the stream and along the banks of the sample segment.

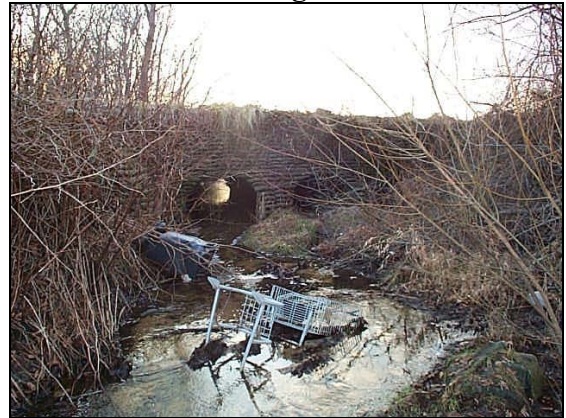
Poor Range

Poor - Refuse abundant and unsightly

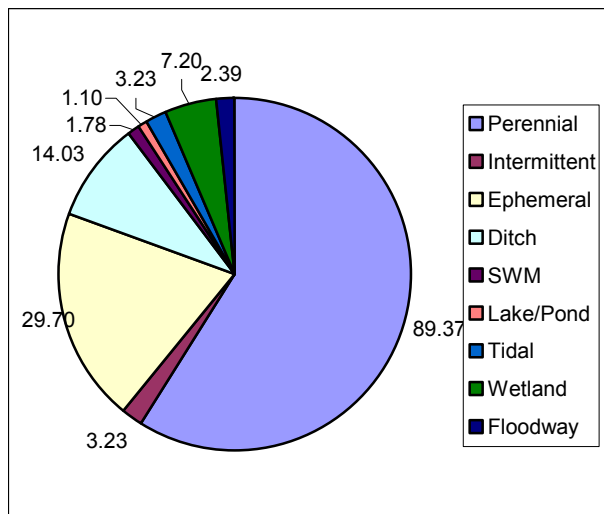
Perennial streams are most abundant with 89.37 miles making up 58.8% of the total for the entire Watershed. Ephemeral streams comprise 19.5% of the channels with the remaining types making up the final 21%.

Figure 3.1 Stream Miles per Type

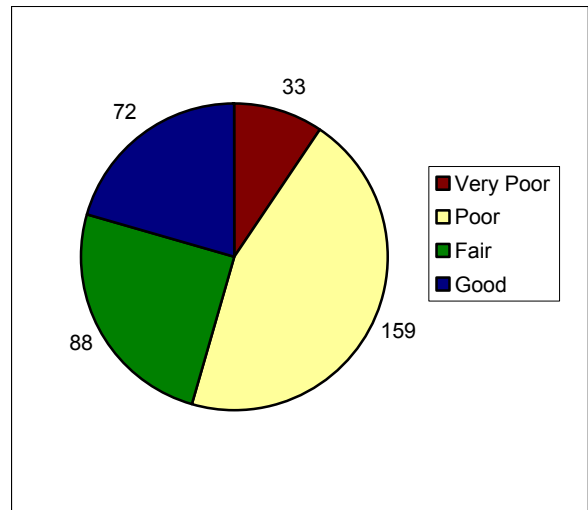
Figure 3.6 Number of Habitat Assessment Reaches per MPHI Category

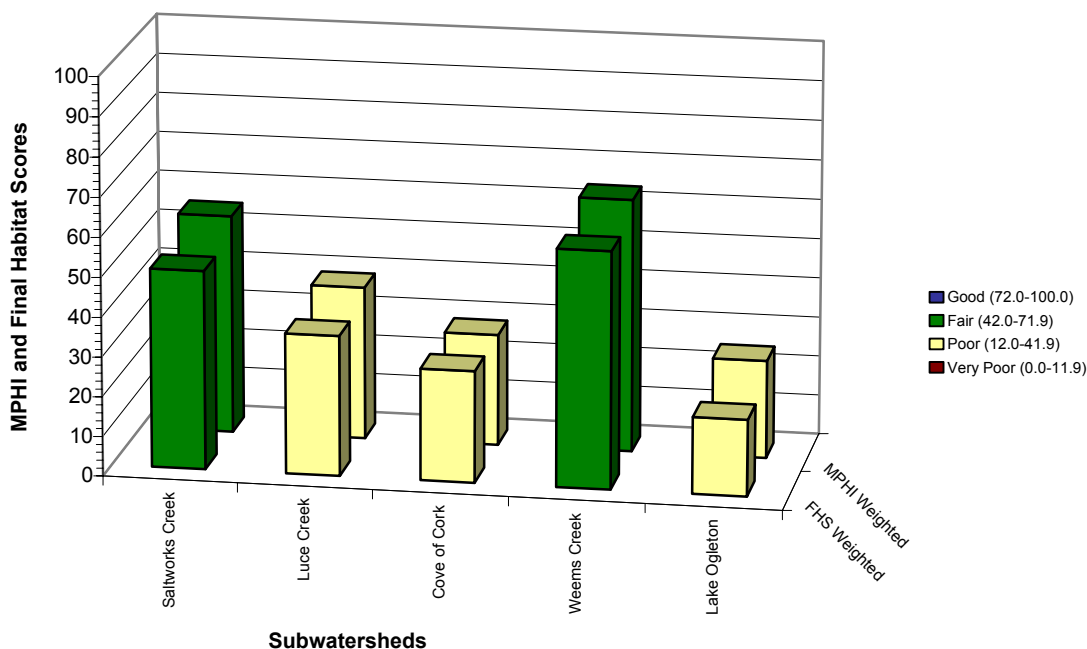
Five of the eight subwatersheds in this area have perennial streams with habitat assessments conducted. The overall stream length weighted subwatershed Maryland Physical Habitat Index (MPHI) and Final Habitat Scores (FHS) are presented in Figure 4.4 to highlight the difference between the MPHI and the FHS. The average difference between the MPHI and FHS for the lower south shore was 3.6, with Lake Ogleton and Saltworks Creek having the biggest influences from infrastructure and environmental features. Cove of Cork and had very little influence from infrastructure and environmental features at the subwatershed level.

Figure 4.4 Stream length Weighted Subwatershed Scores (MPHI Scores are displayed in the back row)
