Upper Patuxent River Watershed Overall Summary Recommendation Report

Prepared for:
Anne Arundel County
Department of Public Works

September 2008

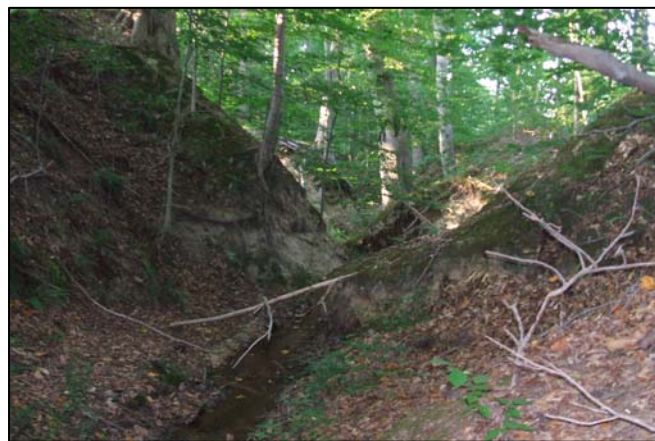
Within the surveyed profile along the mainstem, 20 headcuts were observed, ranging in height from 0.25 to 12 feet. The sinuosity of the reach is 1.12. Over the surveyed reach length of 900 feet the overall drop of the stream is nearly 47 feet resulting in an average gradient of 5.2% with bank heights averaging over 15 feet. A local slope of 2.7% was utilized for the determination of the discharge, because it hydraulically controls discharge in this steep setting. The discharge based upon the Cowan methodology was estimated to be 18.7 cubic feet per second (cfs). This result is

Typical View of the Impaired Reach

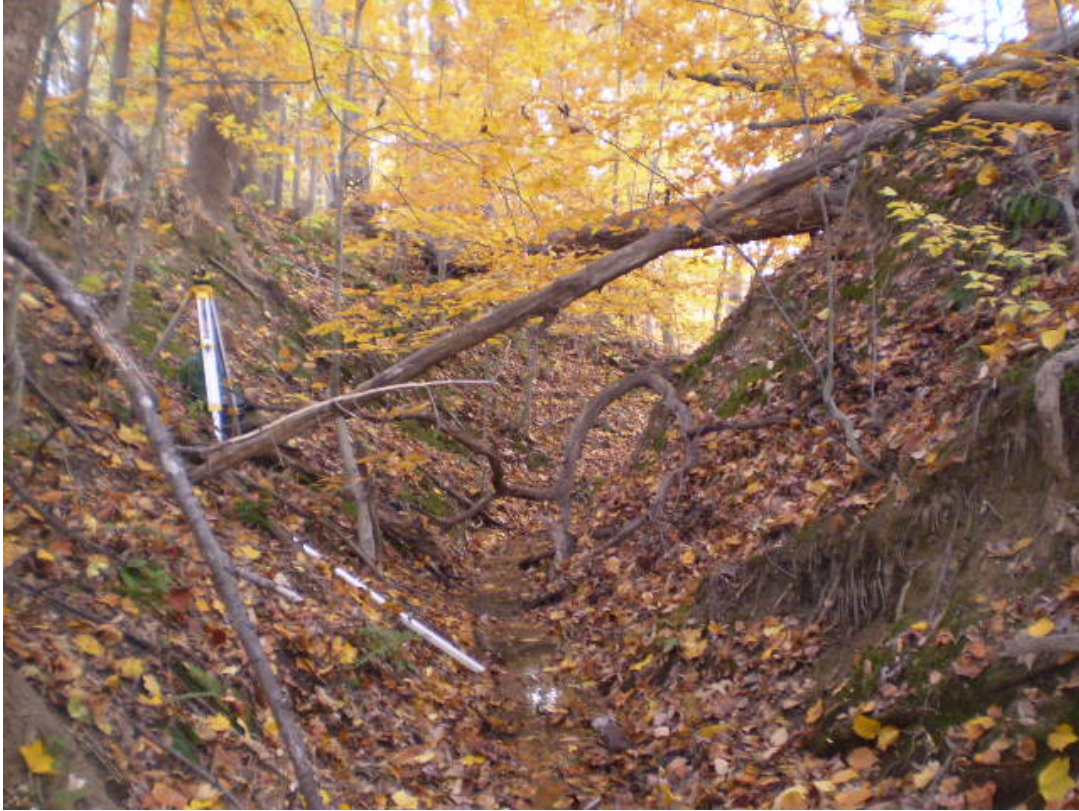
Photo 1. Impaired Reach. View of riffle cross section looking upstream

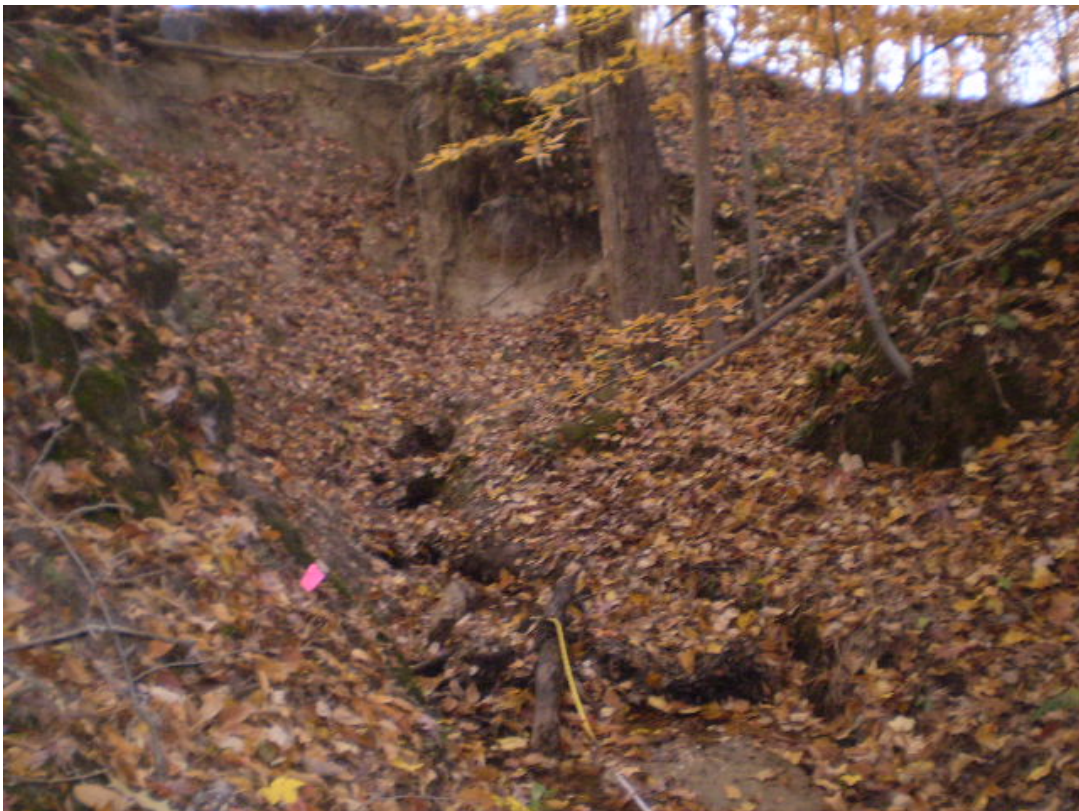
Photo 2. Impaired Reach. View of bank erosion looking upstream

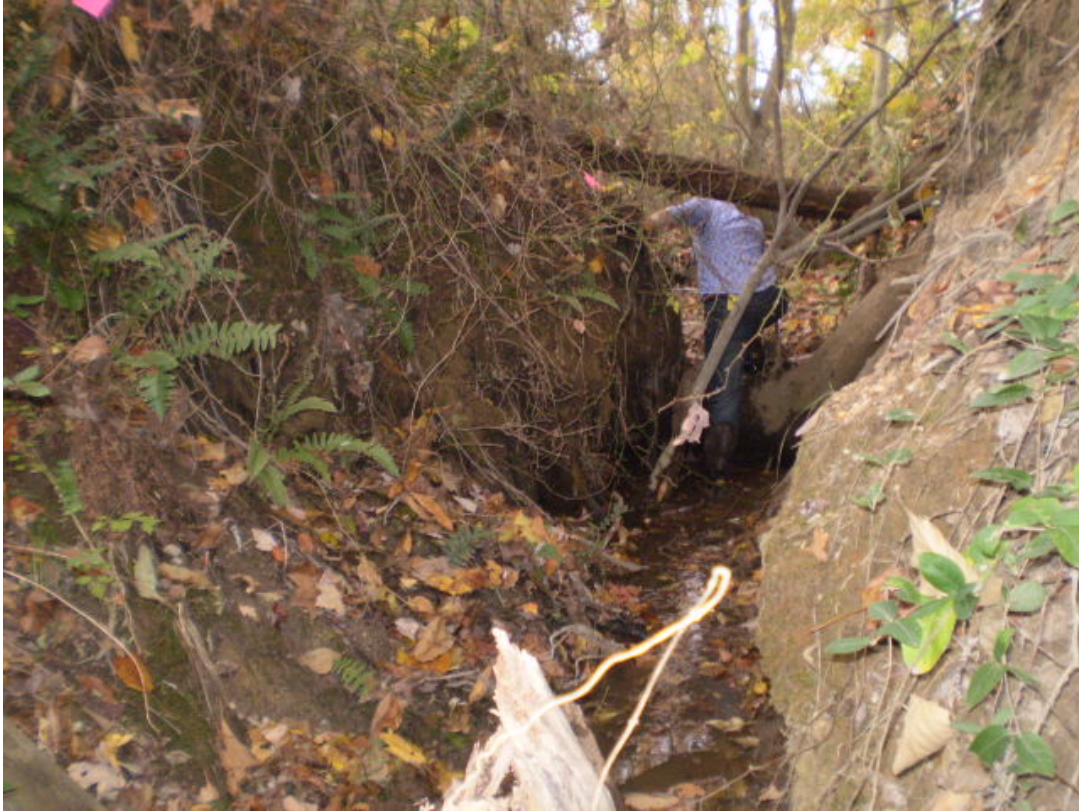
Photo 3. Impaired Reach. View of small headcut looking upstream

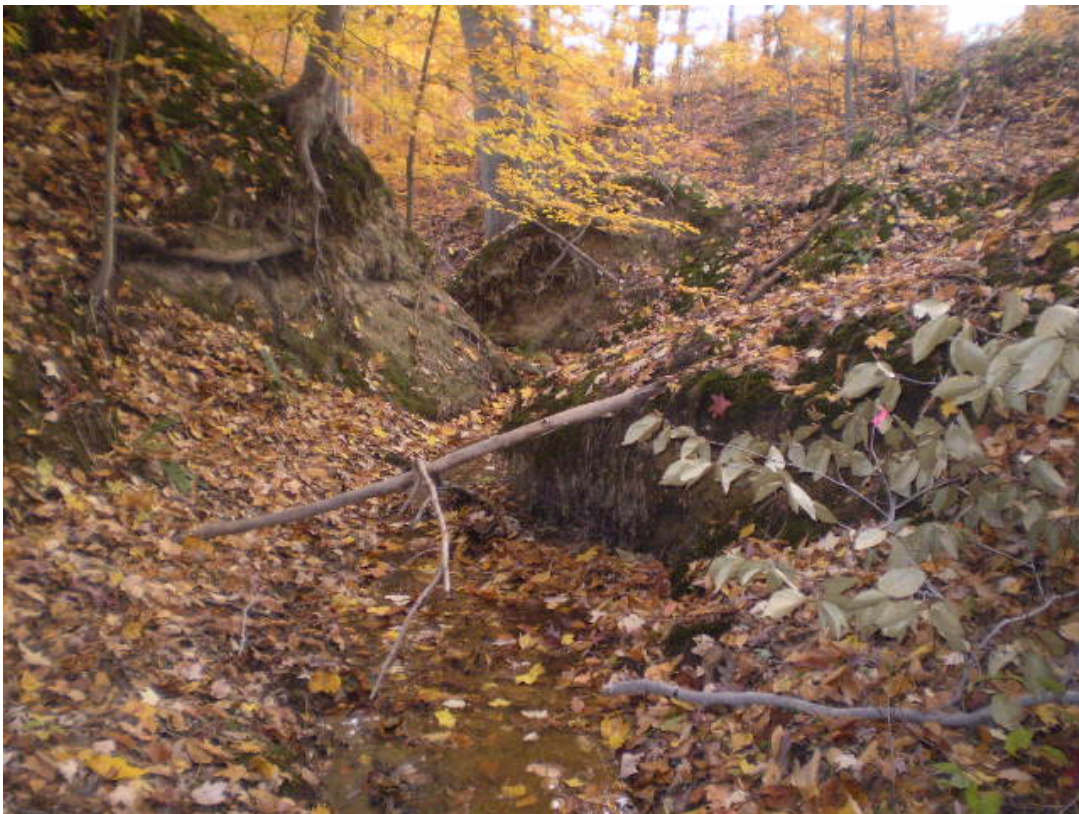
Photo 4. Impaired Reach. View of erosion looking upstream

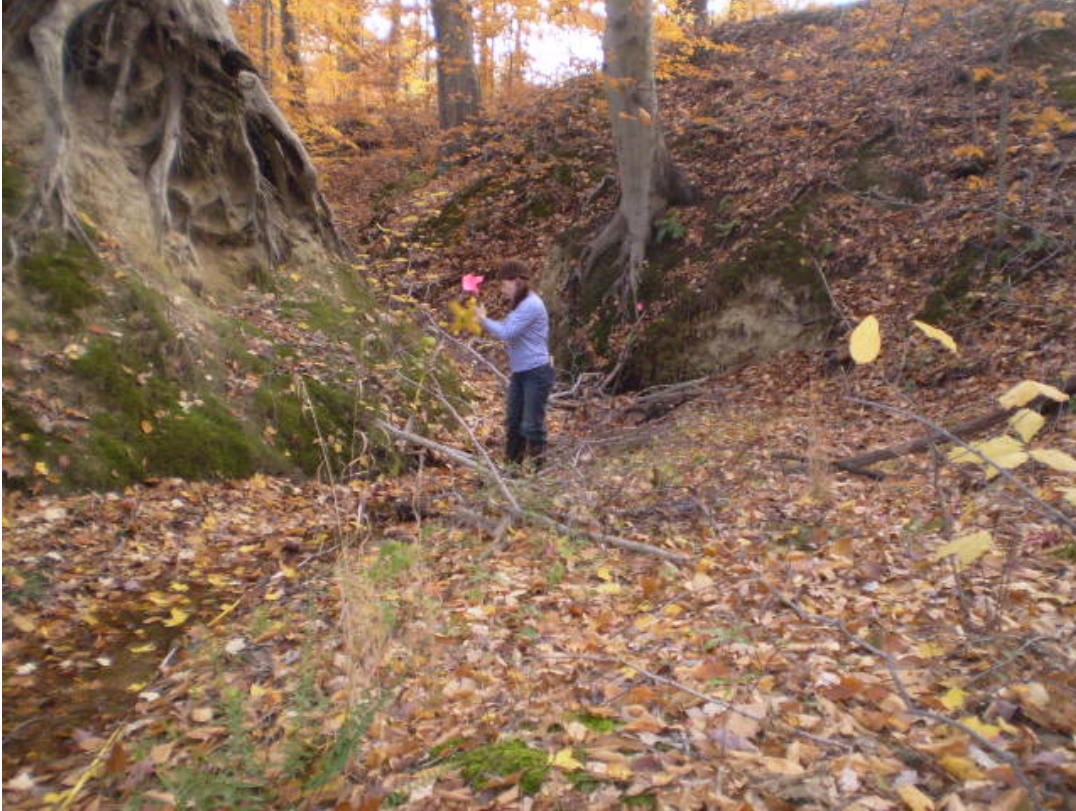
Photo 5. Impaired Reach. View showing incision looking upstream

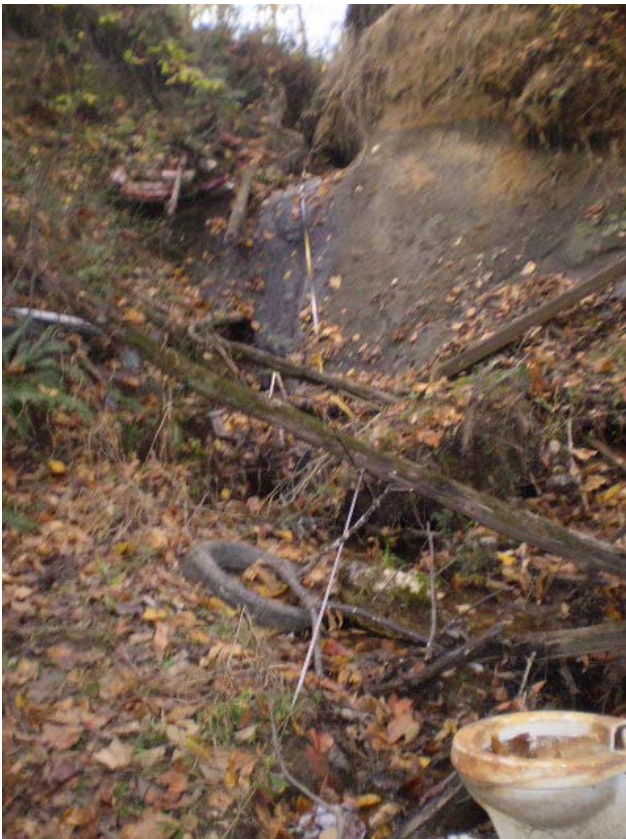
Photo 6. Impaired Reach. View large headcut and debris looking upstream

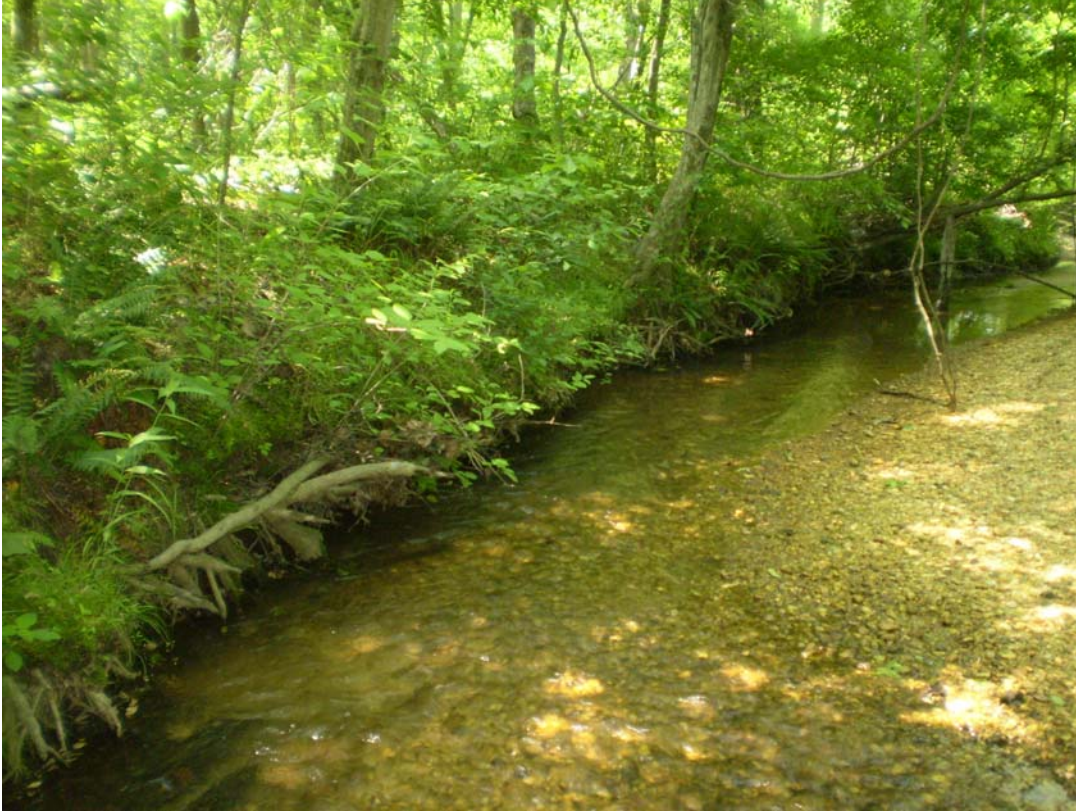
Photo 7. Reference Reach. View of woody banks showing rooting depth looking upstream

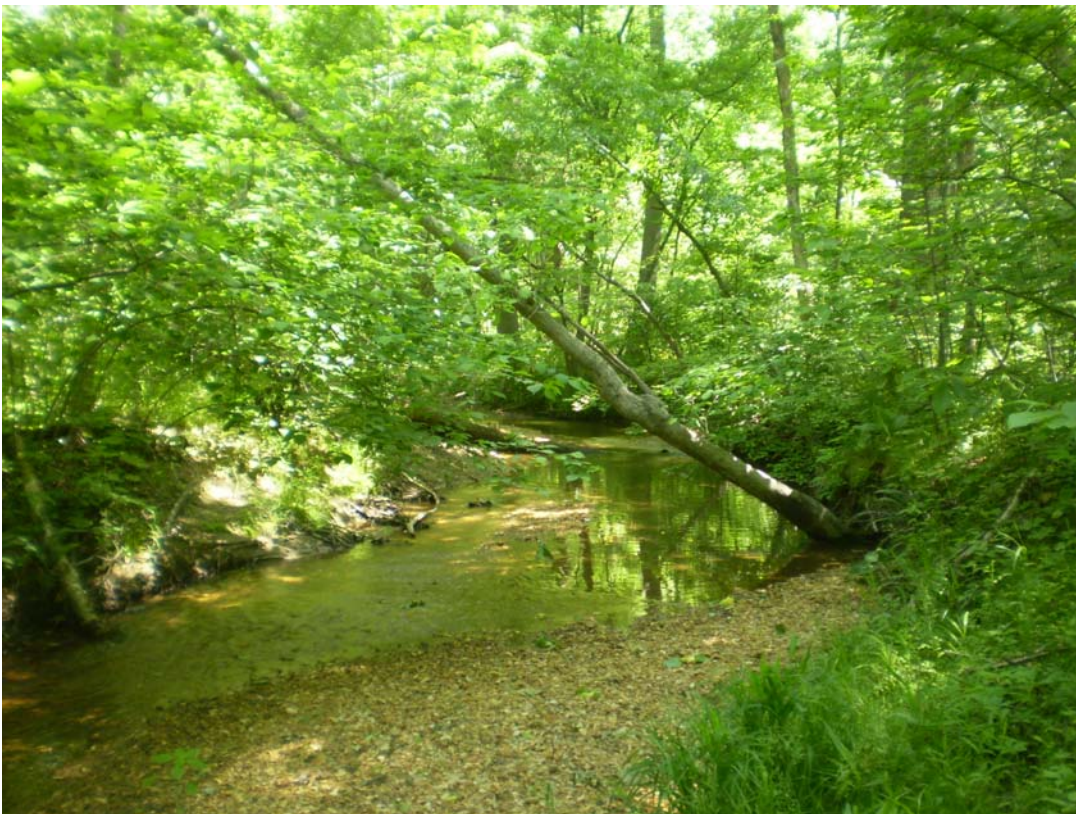
Photo 8. Reference Reach. View of point bars and low bank heights looking upstream

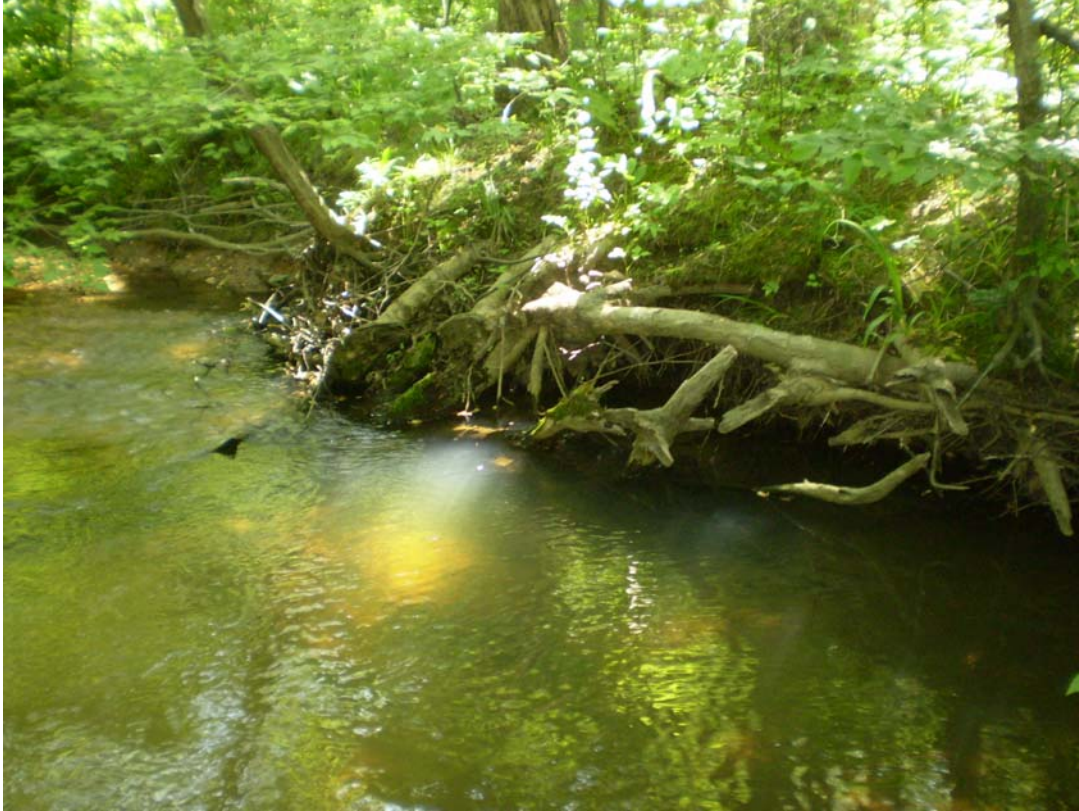
Photo 9. Reference Reach. View of woody habitat looking downstream

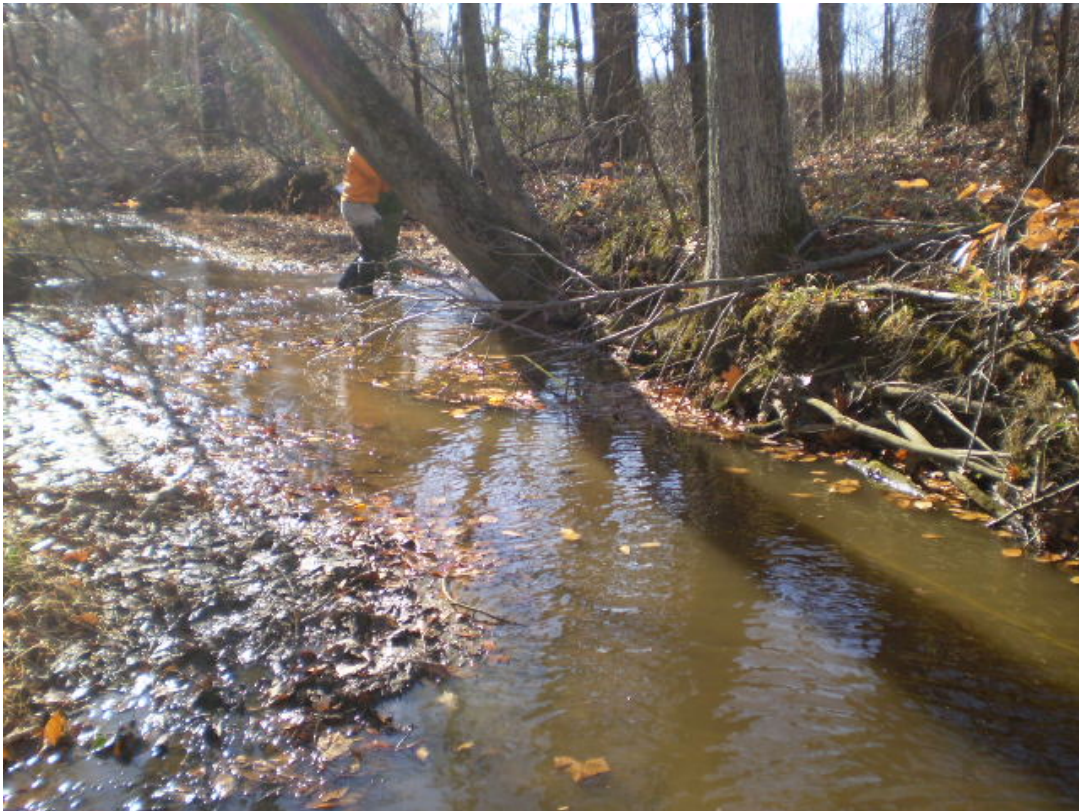
Photo 10. Reference Reach. View of trees growing at water surface looking downstream

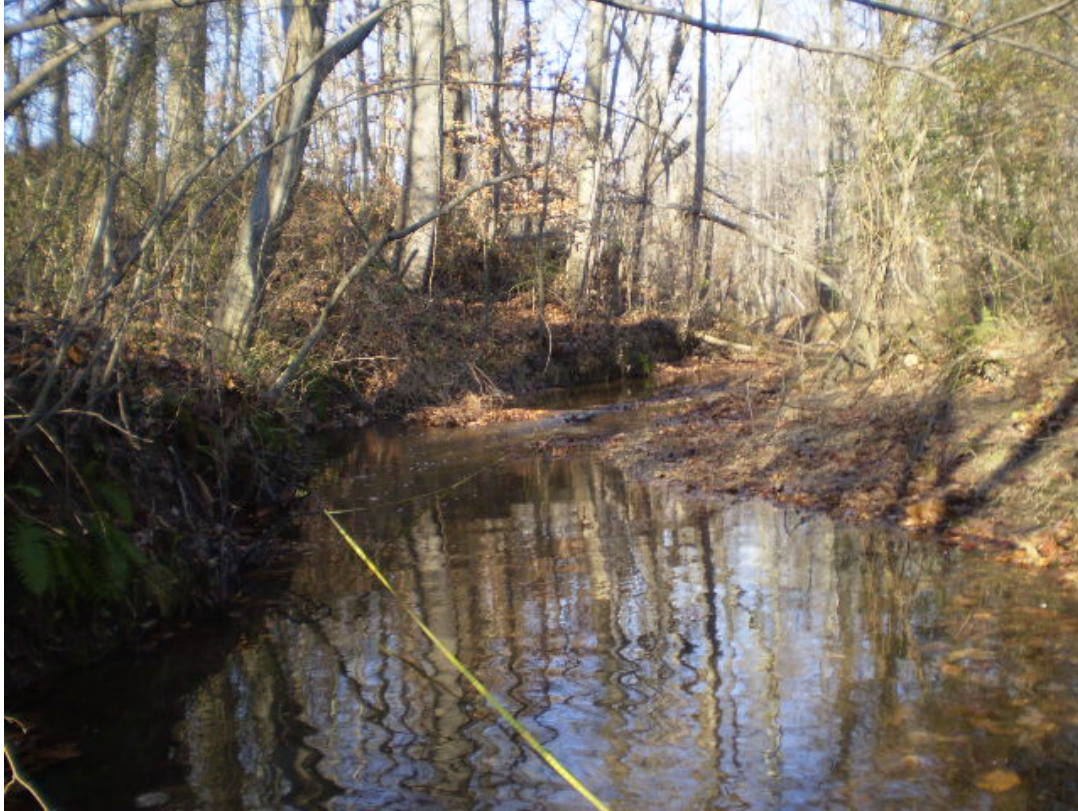
Photo 11. Reference Reach. View of riffle/pool sequence looking upstream

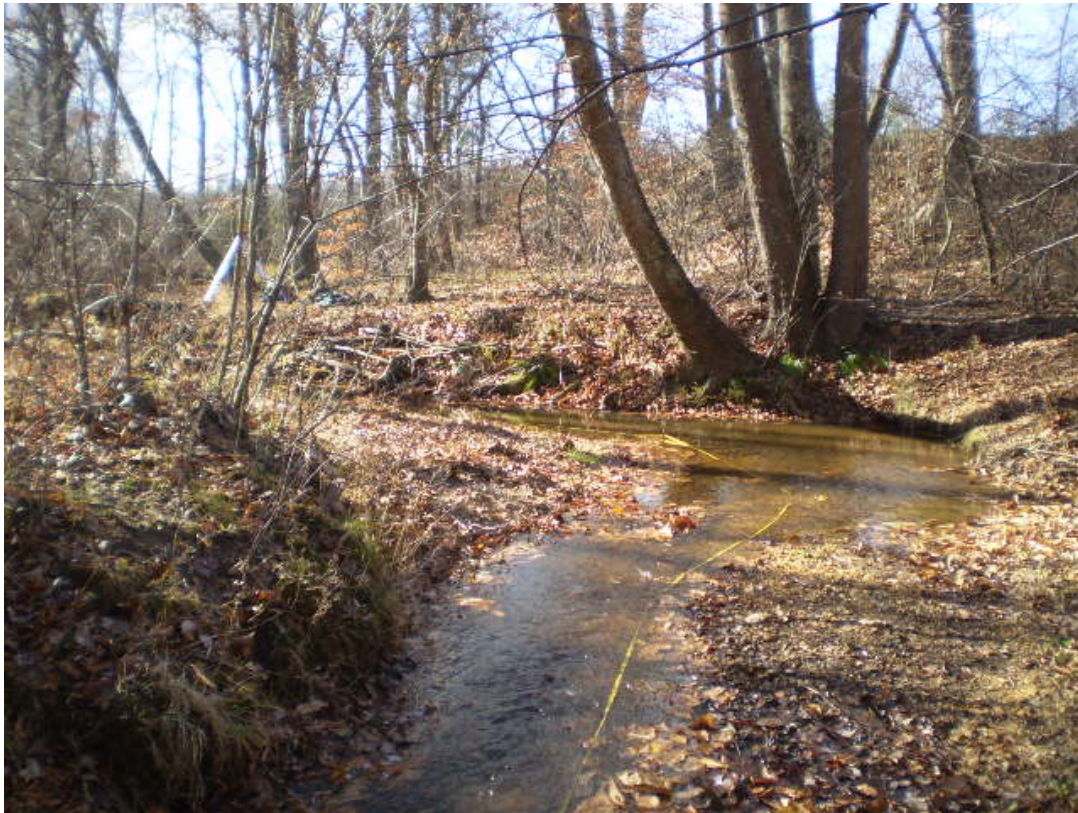
Photo 12. Reference Reach. View of trees and roots protecting banks looking upstream

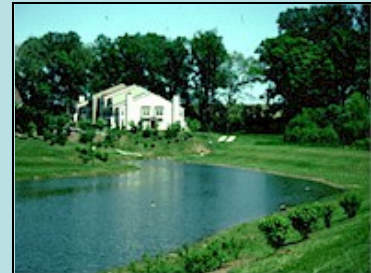
Stormwater detention ponds are wet structures that are often used to capture stormwater runoff in residential areas.

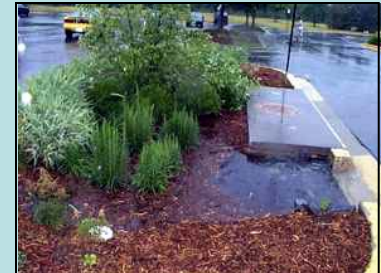
Infiltration practices capture stormwater and allow it to seep into the soil. This rain garden helps capture and filter runoff from a parking lot

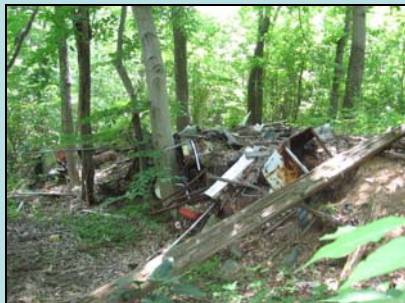
Dumpsite with moderate impact score located near town of Laurel

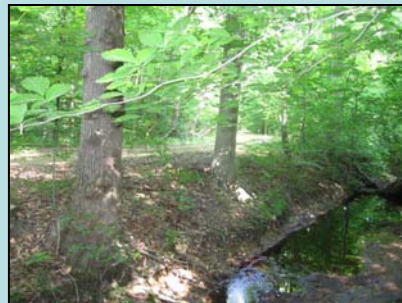
Deficient buffer with moderate impact score located in Patuxent Research Refuge

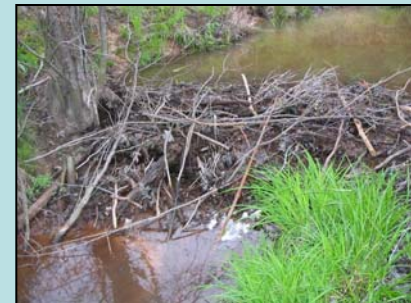
Obstruction with severe impact score located in Patuxent Research Refuge

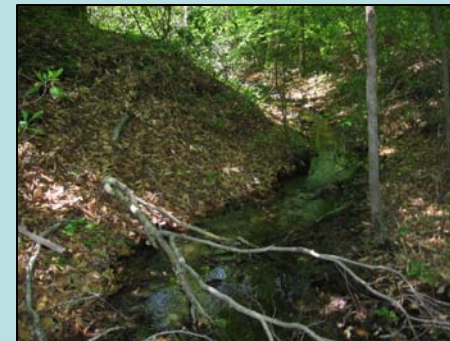
Minimally degraded stream reach in the northern section of the Upper Patuxent River Watershed

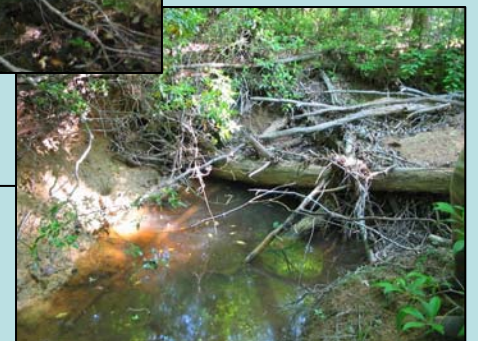
Partially degraded stream reach in the northern section of the Upper Patuxent River Watershed

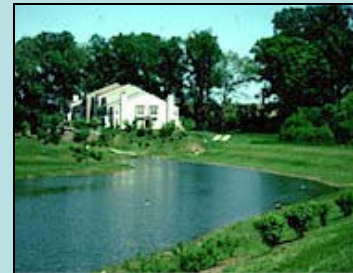
Stormwater detention ponds are wet structures that are often used to capture stormwater runoff in residential areas.

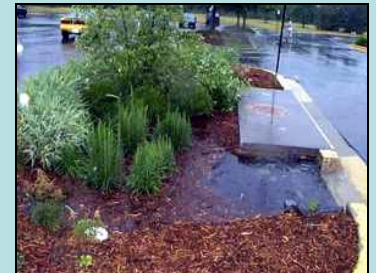
Infiltration practices capture stormwater and allow it to seep into the soil. This rain garden helps capture and filter runoff from a parking lot.

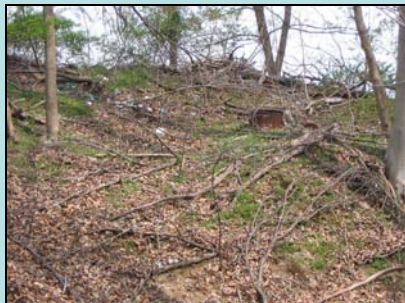
Dumpsite
with severe
impact
score
located
south of
Harwood
Rd.

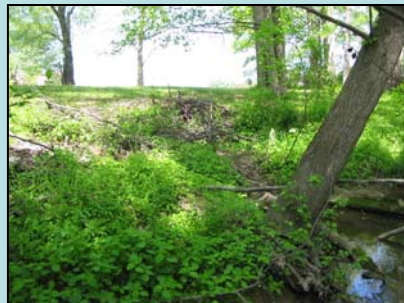
**Deficient
buffer** with
moderate
impact
score
located
near
Double
Gate Rd.

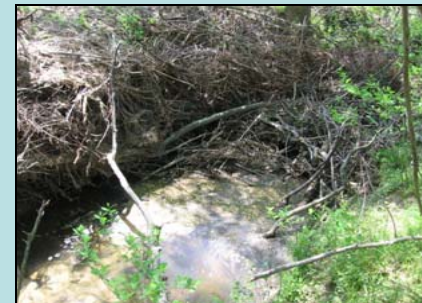
Obstruction
with
moderate
impact score
located near
Foxhall Dr.

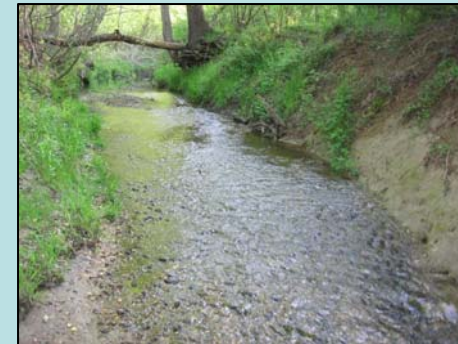
Minimally degraded stream reach in the southern section Upper Patuxent River Watershed

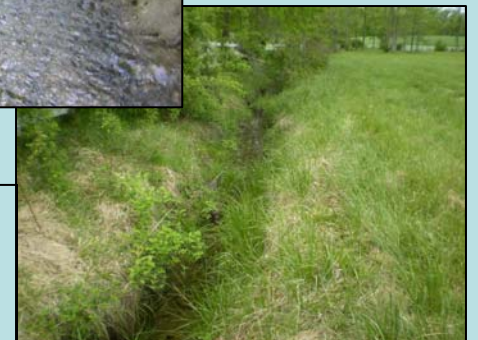
Severely degraded stream reach in the southern section Upper Patuxent River Watershed
