# Targeted Biological Assessment of Streams in the West River and Rhode River Watersheds, Anne Arundel County, Maryland: 2012

## August 2012 - Final Report

KCI Technologies, Inc.  
936 Ridgebrook Road  
Sparks, Maryland 21152

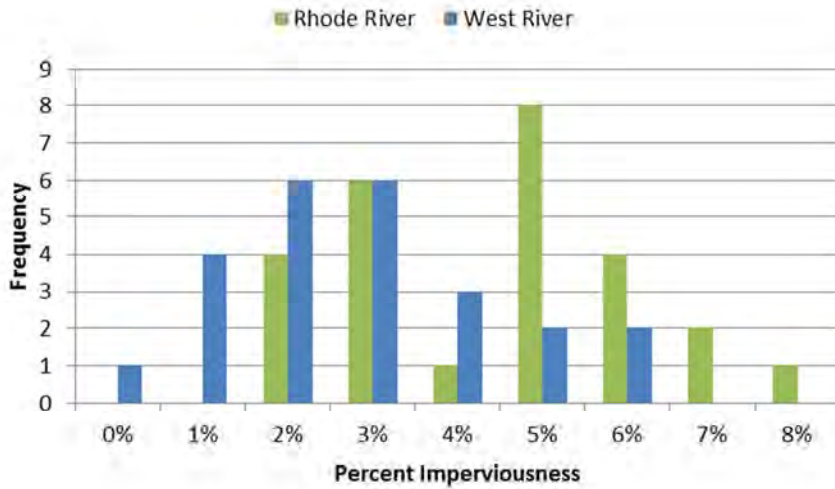
Overall, imperviousness was low throughout both watersheds with the average imperviousness for the sites in West and Rhode at 2.6 percent and 4.0 percent, respectively. Imperviousness in West River ranged from a low of 0.0 percent at WEST-55, a headwater stream south of Cumberstone Road, to a high of 5.8 percent at WEST-53. Imperviousness in Rhode River ranged from a low of 1.0 percent at RHOD-11 to a high of 7.8 percent at RHOD-33 (Figure 3).

Figure 3 - Histogram showing the distribution of percent imperviousness for 26 targeted sites in the Rhode River watershed and 24 targeted sites in the West River watershed.

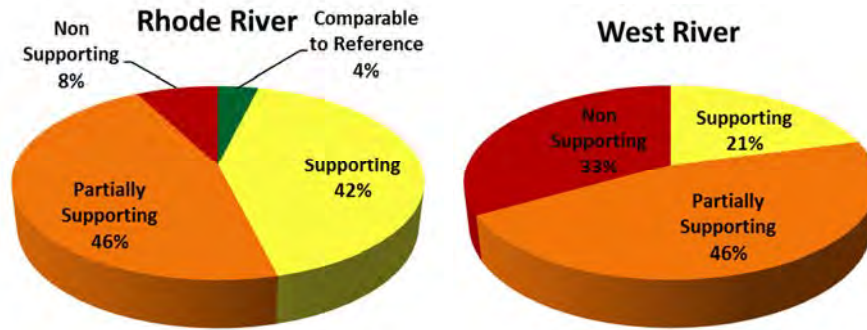
The lowest PHI score for Rhode River of 56.61 was recorded at RHOD-40 while the highest score, 92.57 was recorded at RHOD-14. The majority of sites were rated as ‘Partially Degraded’ (19 sites) with five sites rated as ‘Minimally Degraded’ and two sites as ‘Degraded’ (Figure 6). Similar to Rhode River sites, the majority of West River sites were rated as ‘Partially Degraded’ (18 sites) with three sites rated as ‘Degraded’ (Figure 6). There were two sites in the watershed that received the highest classification of ‘Minimally Degraded’, and one site receiving the lowest classification of ‘Severely Degraded.’

Figure 5 - RBP scores for 26 targeted sites in the Rhode River watershed and 24 targeted sites in the West River watershed

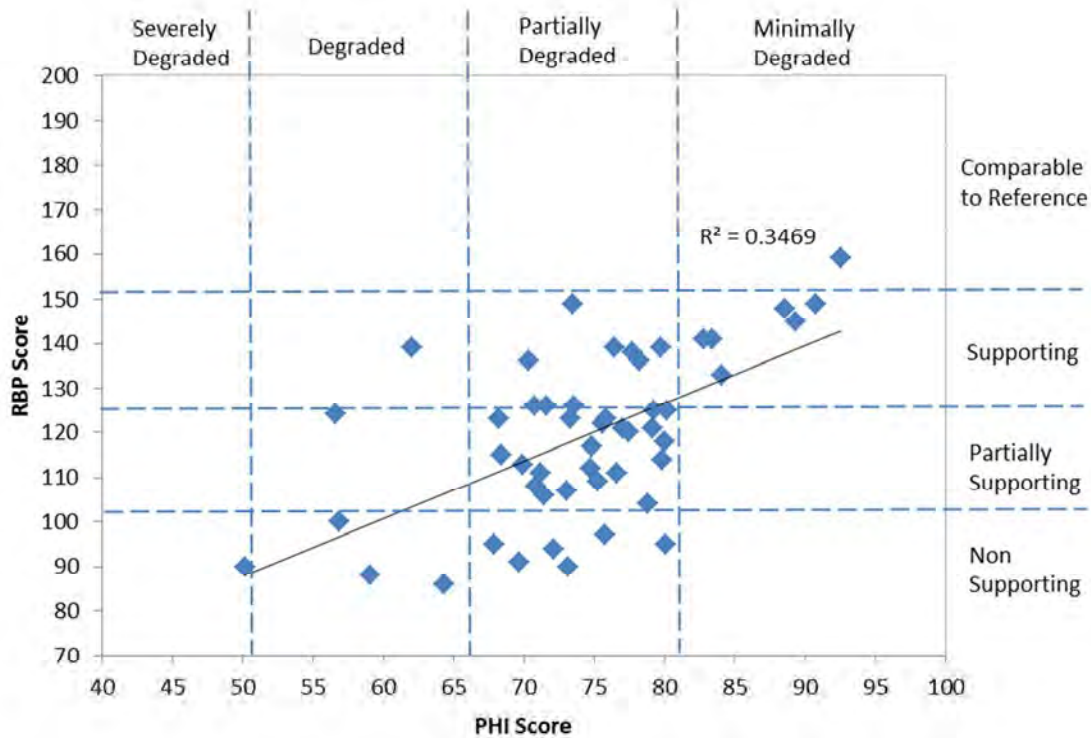
Supporting' (RBP) and one site (in West River) was rated in the most impaired 'Severely Degraded' category for the PHI. Habitat scores for the RBP and PHI assessments were significantly correlated to one another ( $p < 0.0001$ ) with only a moderate goodness of fit ( $R^2 = 0.3469$ ), and often the corresponding narrative categories did not match with respect to the overall level of degradation (Figure 11). For example, six sites were rated as 'Partially Degraded' by the PHI but rated as 'Non Supporting' by the RBP, which is a difference by two assessment categories. These differences are largely due to dissimilarities in scoring parameters between the two indices. For instance, PHI uses remoteness and shading as two of the five metrics used to calculate the habitat score while RBP uses riparian conditions (i.e. vegetative protection and riparian width) as four of the 13 metrics.

Figure 11 – Comparison of RBP and PHI habitat assessment scores for 50 targeted sites in the West and Rhode Rivers watersheds.

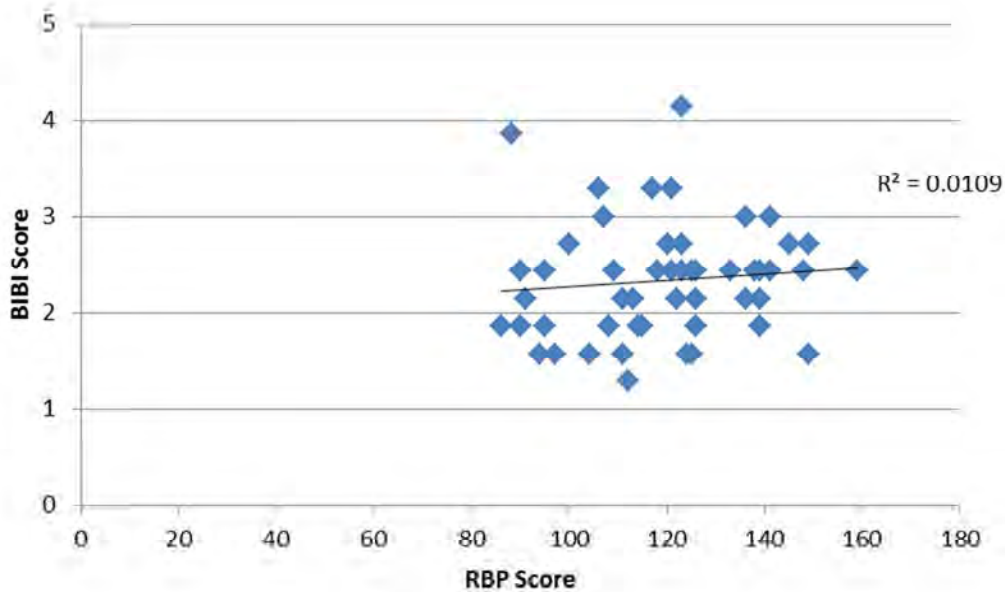
BIBI scores were not significantly correlated with either RBP scores ( $p = 0.233$ ; Figure 12) or PHI scores ( $p = 0.405$ ; Figure 13), suggesting that these indices are not adequate predictors of biological conditions in the West and Rhode Rivers watersheds. Nonetheless, it is likely that physical habitat conditions are limiting the potential of biological communities in numerous subwatersheds, especially at sites where the biological conditions match degraded physical habitat conditions. Furthermore, significant correlations were found between individual physical habitat parameters and the BIBI score. Two RBP physical habitat variables, Epifaunal Substrate/Available Cover ( $p = 0.006$ ) and Channel Alteration ( $p = 0.007$ ), as well as two PHI variables, Epibenthic Substrate ( $p = 0.003$ ) and Instream Habitat ( $p = 0.011$ ), were significantly positively correlated with the BIBI score (Appendix E). As epifaunal substrate and available cover improves to include substrate favorable for epifaunal colonization (i.e., mix of snags, submerged logs, cobble or other stable habitat) the BIBI score generally increases (Figure 14). While overall RBP and PHI scores were not significantly correlated with BIBI scores, these physical habitat parameters were determined to be better predictors of biological conditions than combined habitat indices.

Figure 12 – Correlation between RBP habitat assessment score and BIBI score for 50 targeted sites in the West and Rhode Rivers watersheds.

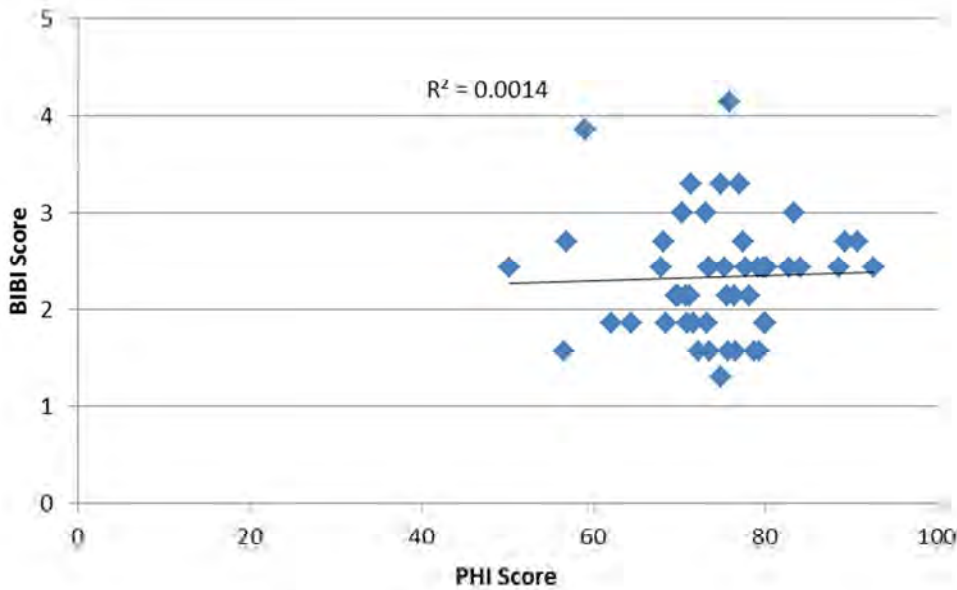
**Figure 13 – Correlation between PHI habitat assessment score and BIBI score for 50 targeted sites in the West and Rhode Rivers watersheds.**

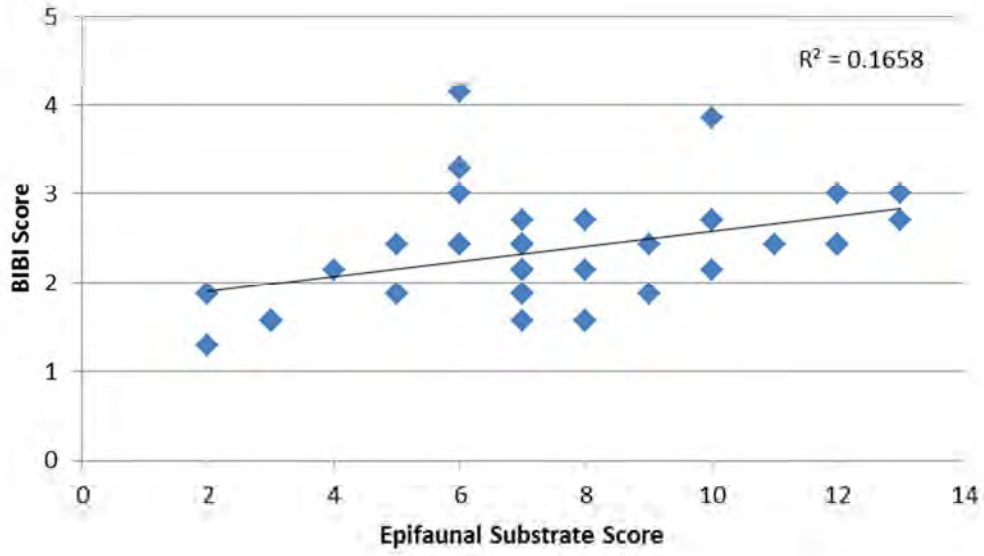
Drainage area was also significantly correlated with RBP habitat scores and several RBP and PHI metrics including channel flow status ( $p < 0.0001$ ), pool variability ( $p < 0.0001$ ), instream habitat ( $p < 0.0001$ ), and epibenthic substrate ( $p = 0.001$ ). Given that the instream habitat and epibenthic substrate metrics correlated very well with BIBI scores and individual metrics, we see a connection between drainage area, habitat adequacy and biological community. It is likely that instream physical habitat becomes more diverse and heterogeneous in larger stream systems, which provides an increased potential for full colonization by benthic macroinvertebrate communities.

Figure 14 - Correlation of Epifaunal Substrate Score with BIBI Score for 50 targeted sites in the West and Rhode Rivers watersheds.

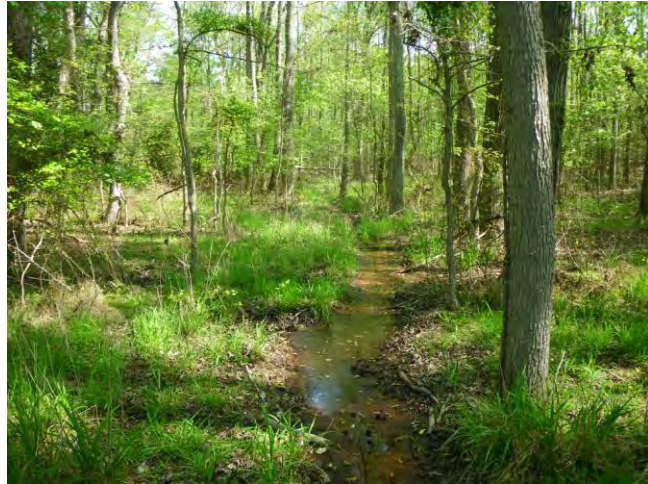
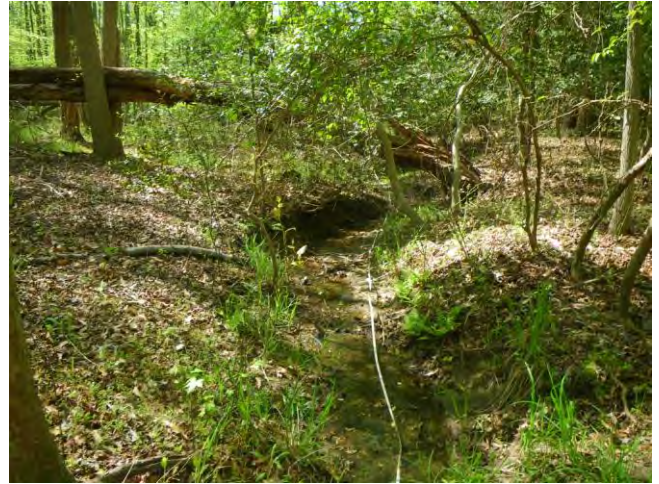
This site is located south of Triton Beach Road and upstream of Deep Pond in Beverly Beach, which is part of the RRB subwatershed. With the smallest drainage area of all sites sampled in Rhode River (24 acres) this stream had only standing water in shallow pools with no visible flow. Forested land accounted for 93% of the area draining to the site with only 4% imperviousness. The stream is also tannic due to heavy leaf litter which has accumulated in this highly forested drainage area. Although over half of macroinvertebrates in the benthic sample were intolerant to urban stresses, the biological condition remains poor. This site measured below COMAR standards for pH and dissolved oxygen with elevated conductivity, which may impact the biologic community. Low flow conditions observed at this site may be affecting water quality and the biological condition.

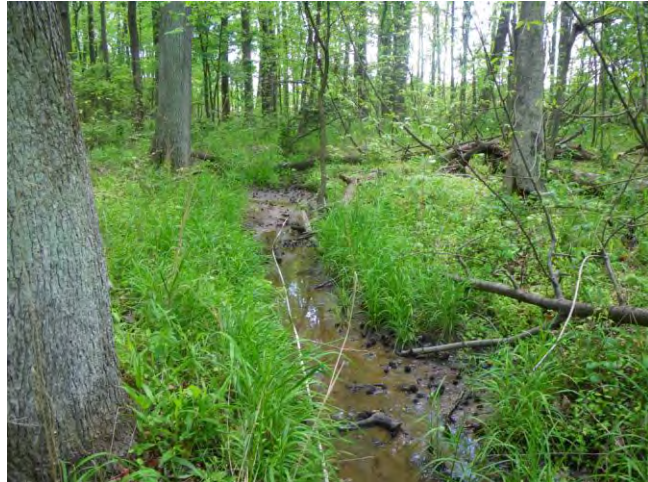
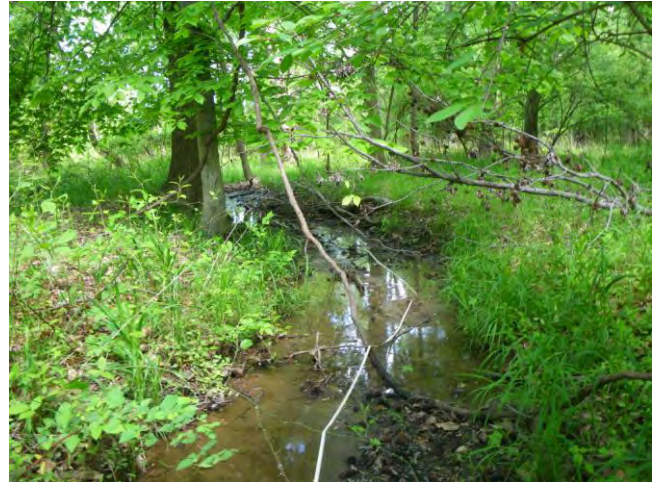
This site is located on Smithsonian Environmental Research Center (SERC) property and is located in the subwatershed RRE which drains to Boathouse Creek. Over half of the 42 acre drainage area consists of pasture (56%) with approximately one-third as forested land (35%) with only 3% imperviousness. Very little flow was observed at this site and water quality measured below COMAR standards for pH. In spite of the partially supporting/partially degraded habitat and high percentage of taxa intolerant to urban stressors (39%), a low taxa count (8 taxa) with no Ephemeroptera, scraper, or climber taxa resulted in a biological community that is very poor. Low flow conditions observed at this site may be affecting water quality and the biological condition.

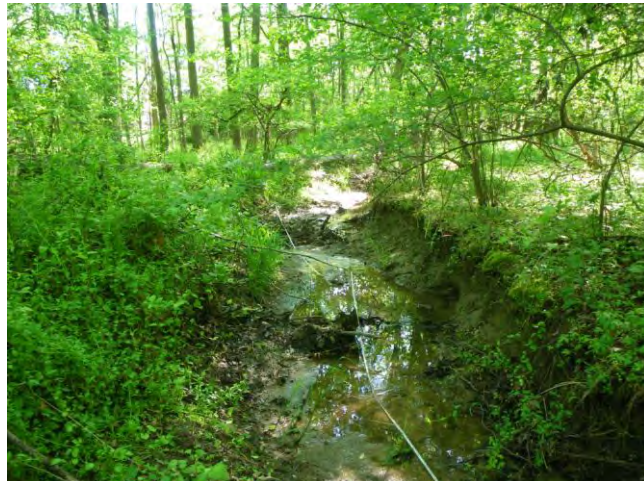
Located between Dock Road and Contees Wharf Road, this site is in the Forrest Branch (RR0) subwatershed. Two-thirds of the 42 acre drainage area consists of forested land (65%) with just 4% impervious surface. Macroinvertebrates intolerant to urban stressors accounted for over two-thirds of the sample; however, only 12 taxa were present including only two EPT, one scraper, and no Ephemeroptera. Very little flow was observed at this site resulting in minimal habitat available for benthos and a poor biological community. Water quality also measured below COMAR standards for pH.

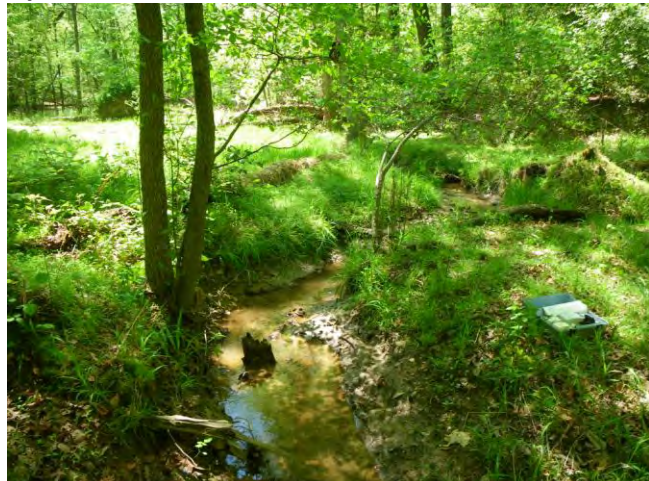
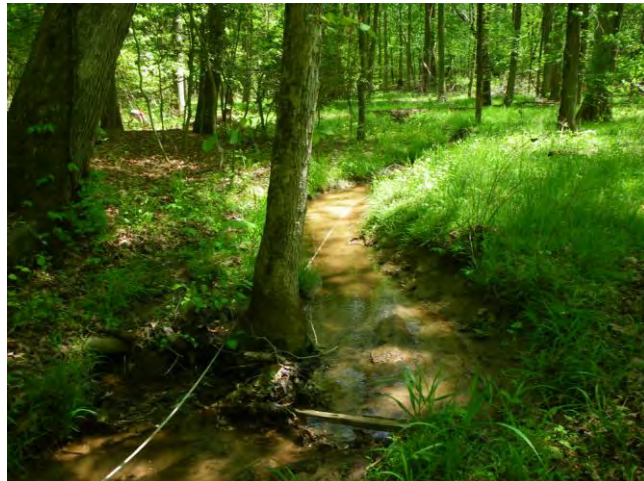
Upstream View:

This site is located on Sellman Creek, which is part of the RR2 subwatershed and on Smithsonian Environmental Research Center (SERC) property. Of the 97 acre drainage area, 59% consists of forested land and 35% pasture. Only 1% of the drainage area is impervious surface. Approximately half of the benthic sample consisted of individuals intolerant to urban stressors (49%); however, a lack of EPT taxa and Ephemeroptera taxa as well as low occurrences of scraper and climber taxa resulted in a poor biological community. Water quality measured below COMAR standards for pH, which may be a result of the bald cypress wetland located upstream of the site.

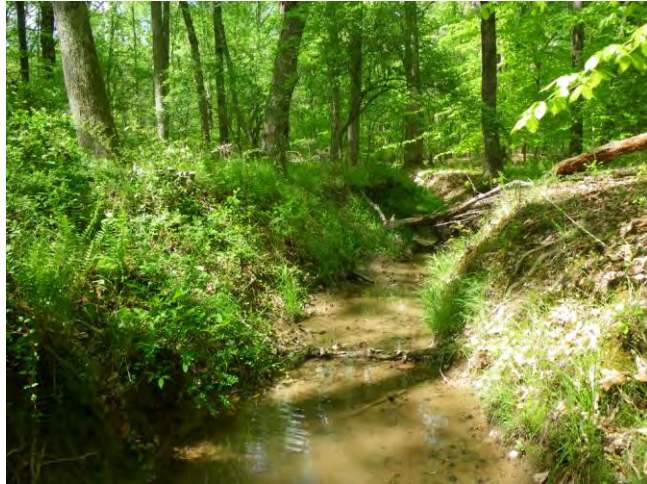
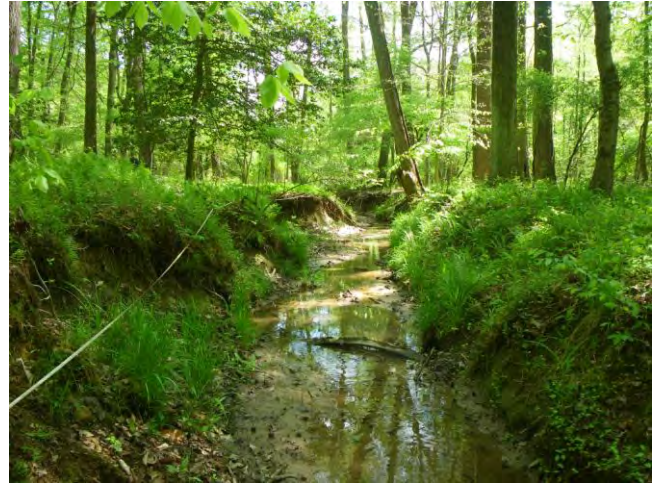
This site is located in the Sellman Creek (RR2) watershed and is on Smithsonian Environmental Research Center (SERC) property. The dominant land cover of the 9 acre drainage area consists of forested land (79%) with only 1% imperviousness. However, the incised channel had little flow and severely undercutting banks with little benthic habitat. As a result, the biological community was very poor and dominated by tolerant midges with no EPT or Ephemeroptera taxa present. Water quality measured below COMAR standards for pH. Low flow conditions observed at this site may be affecting water quality and the biological condition.

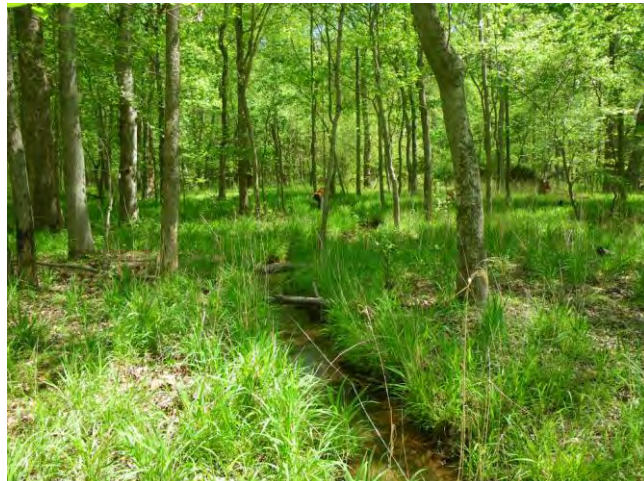
This site is located to the east of Muddy Creek Road and Contees Wharf Road on Alexander Branch, which is part of the RR2 (Sellman Creek) watershed. Located on Smithsonian Environmental Research Center (SERC) property, two-thirds of the 153 acre drainage area consists of forested land (67%) with 21% of land as row crops. Only 1% of the drainage area is impervious surface. This stream runs through wetland and has stable, well vegetated banks with roots providing stable benthic habitat. Water quality measured below COMAR standards for pH, which may be attributed to wetland conditions. Although approximately one-third of the benthic sample consisted of individuals intolerant to urban stressors (32%), few EPT taxa and no Ephemeroptera or scraper taxa attributed to a poor biological community.

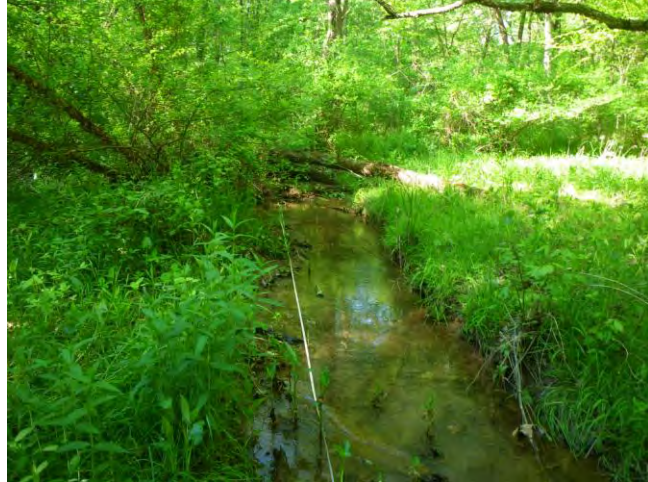
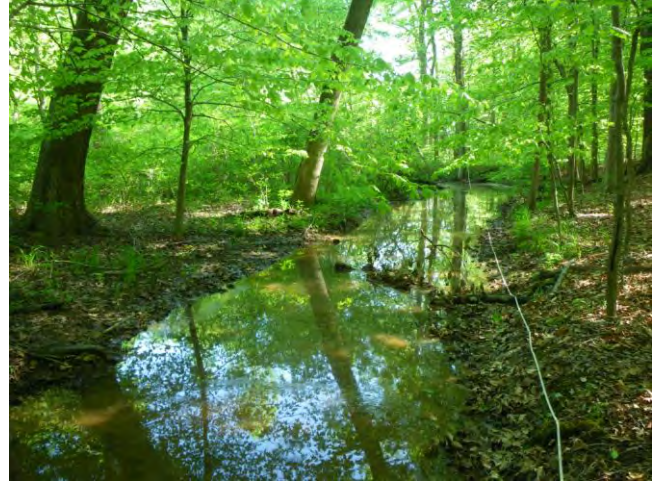
Located east of Muddy Creek Road, this site is located on All Hardwood Branch, which is part of the Many Fork Branch (RR3) watershed and drains directly into Muddy Creek. The stream runs through an old mill pond valley that turned into a wetland and is partially backwatered due to a large woody debris jam and beaver dam. Eighty percent of the benthic sample consisted of individuals intolerant to urban stressors; however, low taxa diversity with no Ephemeroptera or scraper taxa present resulted in a poor biological score. Over half of the 373 acre drainage area consists of forested land (57%) while one-fourth of the area is row crops (25%). Only 3% of the drainage area is impervious surface. Water quality measured below COMAR standards for pH.

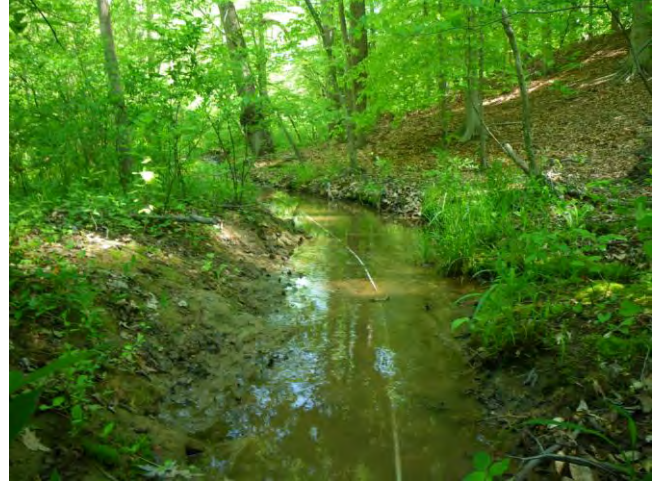
This site is located on All Hardwood Branch, which is part of the Many Fork Branch (RR3) watershed. Located on Smithsonian Environmental Research Center (SERC) property, the 174 acre drainage area to this site is largely forested land (57%) or row crops (34%) with minimal imperviousness (2%). This stream runs through wetland and has multiple threads just upstream of the sampling site. Wetland conditions may be contributing to a depressed pH, which measured below COMAR standards. Although over half of the benthic sample consisted of individuals intolerant to urban stressors, the lack of Ephemeroptera and scraper taxa resulted in a biological community with a poor score.

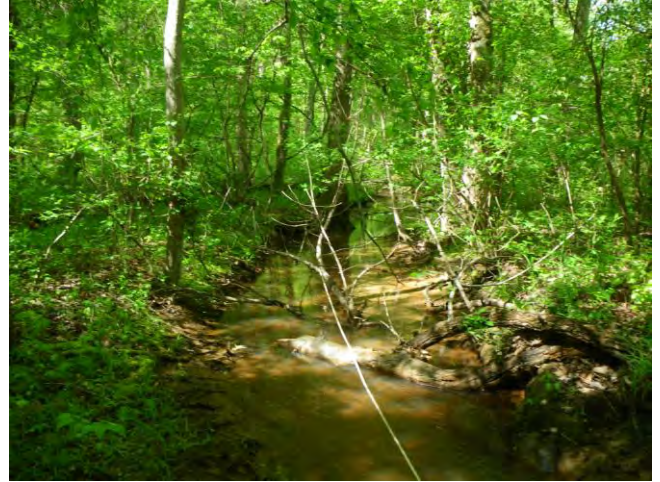
This site is located on North Fork Muddy Creek, which is part of the RR8 watershed (North Fork Muddy Creek). Two-thirds of the 604 acre drainage area is forested (66%) with 14% as 2-acre residential. Only 5% of the drainage area to this site consists of impervious surface. The stream is adjacent to and draining wetlands with an abundance of large woody debris and root habitat for benthos. Although taxa diversity (23 taxa) and percent climbers (9%) received high scores, a lack of Ephemeroptera and scraper taxa contributed to a biological community with an overall poor score. Water quality measured below COMAR standards for pH.

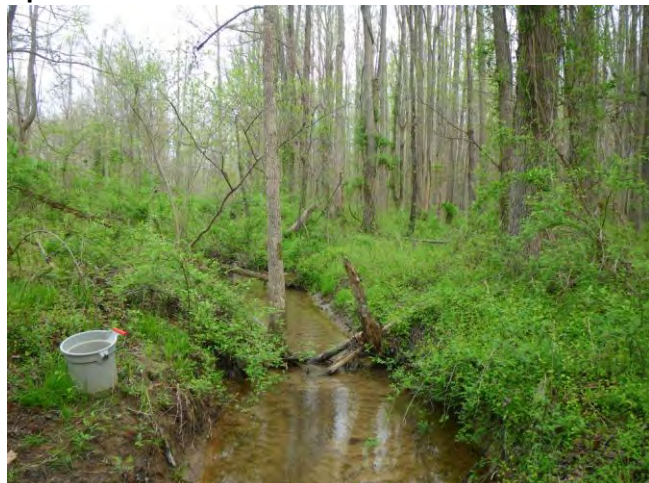
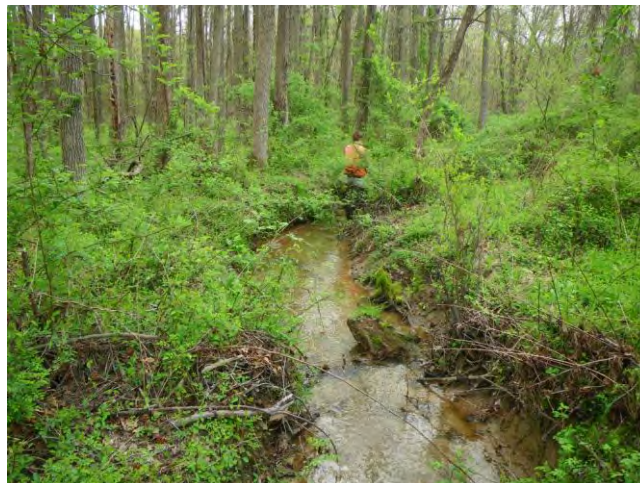
Upstream View:

This site is located approximately 150 meters upstream of Muddy Creek Road on North Fork Muddy Creek, which is part of the RR8 watershed (North Fork Muddy Creek). Of the 279 acres draining to the site, 43% is forested while 27% is 2-acre residential. Impervious surface accounts for 6% of the drainage area. Although the percentage of benthic individuals intolerant to urban stressors (42%) and percent climbers (18%) both received high scores, a complete lack of Ephemeroptera and scraper taxa contributed to an overall poor score for the biological community.

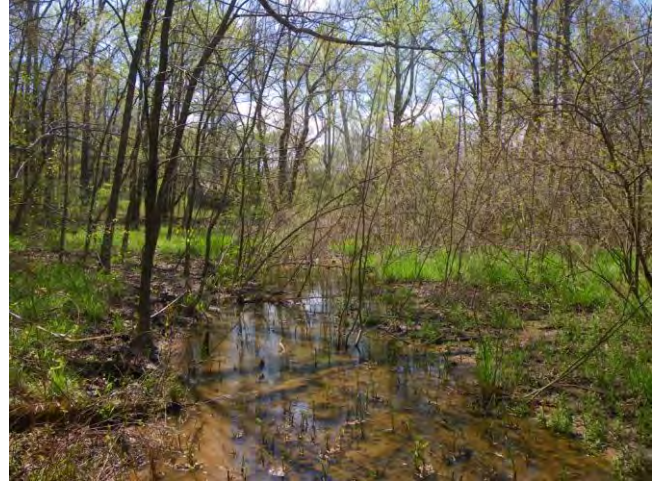
This site is located between Collins Road and Old Muddy Creek Road on Bluejay Branch, which is part of the North Fork Muddy Creek watershed (RR8). Approximately half of the 479 acre drainage area is forested (53%) with 27% consisting of 2-acre residential land use. Only 5% of the drainage area is impervious surface. This shallow, slow flowing stream runs through vegetated wetland with an abundance of attached algae throughout. All in situ water quality measurements were within COMAR standards. Poor taxa diversity (11 taxa) with no EPT or Ephemeroptera taxa and very few individuals intolerant to urban stressors contributed to a very poor biological community. A lack of habitat complexity for benthos was observed at this site.

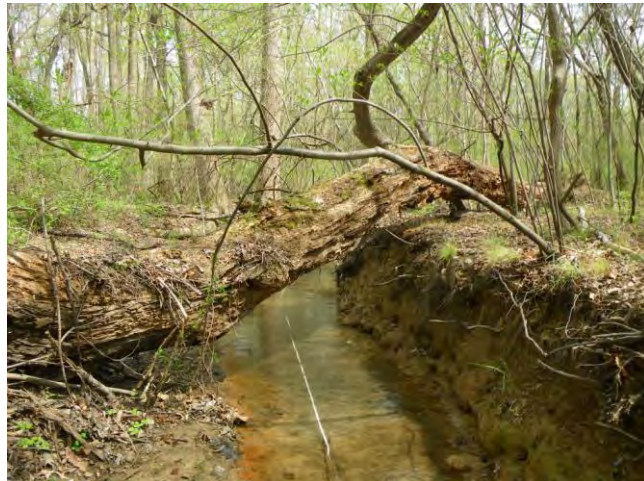
This site is located north of Fiddlers Hill Road and to the west of Muddy Creek Road on Bluejay Branch, which is part of the North Fork Muddy Creek watershed (RR8). One-third of the 289 acre drainage area consists of forested land (35%) with another one-third consisting of 2-acre residential land use (38%). Imperviousness accounts for only 6% of the drainage area. This shallow, sandy bottom channel has minimal bed feature diversity with mostly run features. Woody debris and some roots provide the only stable habitat for benthos. This site received a very poor biological condition score due to poor taxa diversity (10 taxa) with no EPT, Ephemeroptera, scraper, or taxa intolerant to urban stressors.

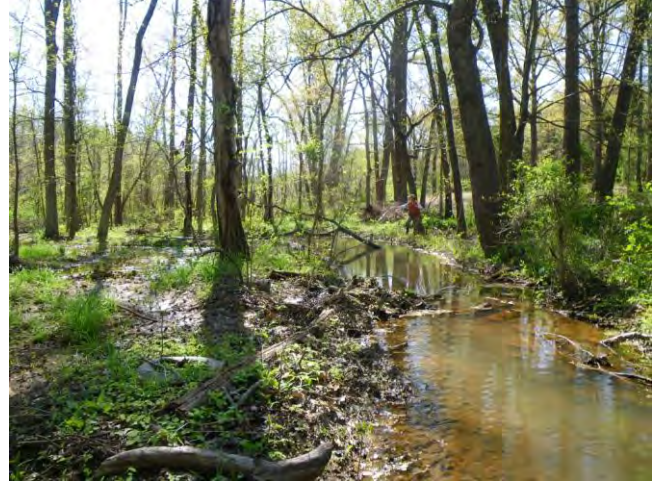
This site is located approximately 150 meters downstream of Old Muddy Creek Road and Collins Road on Williamson Branch, which is part of the North Fork Muddy Branch (RR8) watershed. An earthen berm impoundment near the site's midpoint is creating backwatering conditions in the upstream portion of the reach. The stream has formed new channels around the impoundment and onto the floodplain. Water quality measured within COMAR standards; however, abundant algae was observed. The drainage area to this site (661 acres) is largely forested (61%) with 19% as 2-acre residential land use. Imperviousness accounts for only 5% of the drainage area. Over half of the benthic sample consisted of climber taxa (58%); however, low taxa diversity (15 taxa) with few EPT taxa and no Ephemeroptera or scraper taxa contributed to an overall pool biological community.

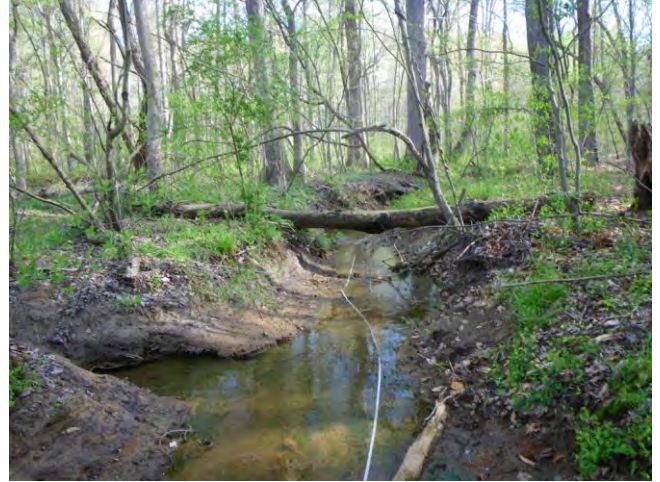
This site is located east of Solomons Island Road on the headwater portion of Williamson Branch, which is part of the Williamson Branch (RR7) watershed. The drainage area to this site (289 acres) is largely forested (63%) with little impervious surface (6%). The stream drains a wetland valley with multiple overflow channels. A horse trail and footbridge are located just upstream of the site. Even though half of the benthic sample consisted of individuals intolerant to urban stressors, the complete lack of EPT, Ephemeroptera, and scraper taxa contributed to a very poor benthic community rating. Water quality measured below COMAR standards for pH with elevated levels of conductivity.

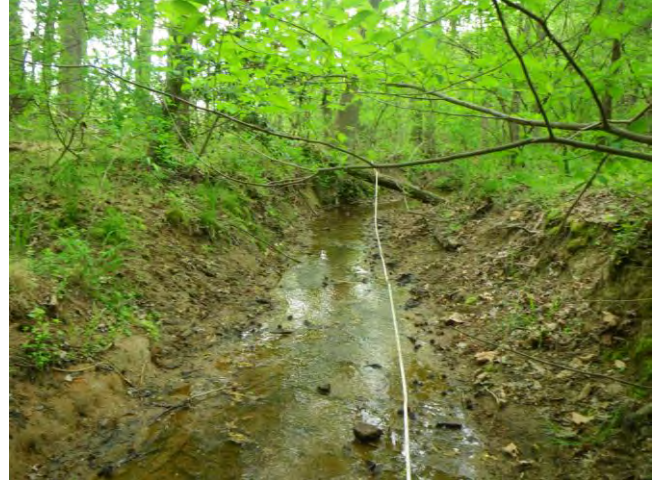
This site is located on Jessica Brook, a part of the Williamson Branch watershed (RR7) , approximately 150 meters upstream of the confluence with Williamson Branch. Of the 129 acre drainage area, 47% is forested while 30% is 2-acre residential. Impervious surface accounts for only 6% of the drainage area. The channel appears to have been straightened in the past and there is erosion along both banks. Although over half of the benthic sample consisted of individuals intolerant to urban stressors and 22% climbers, suboptimal taxa diversity, only one EPT taxa and no Ephemeroptera or scraper taxa contributed to an overall poor biological community. Water quality measured below COMAR standards for pH. Impacts from historical land use (e.g. channelization) may continue to limit the stream's ability to support a healthy biota.

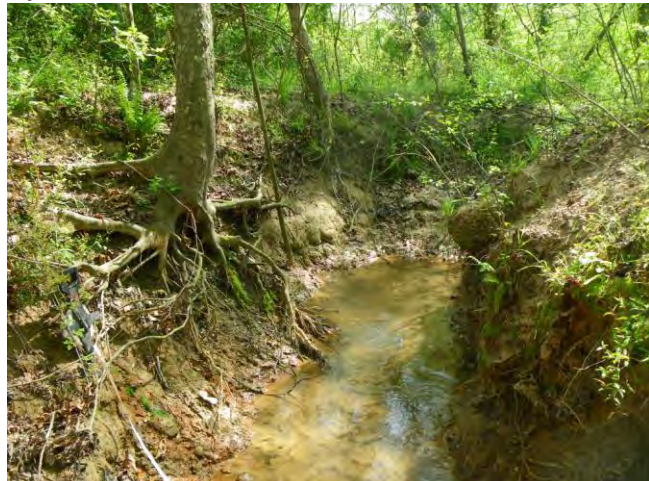
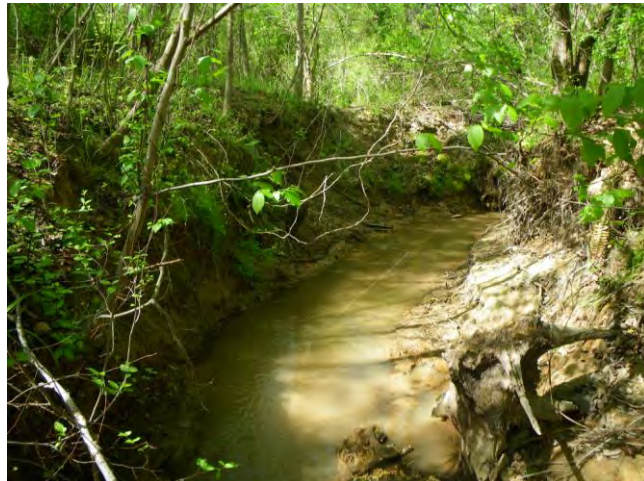
Upstream View:

This site is located on an unnamed tributary that runs between Three Rivers Road and Chews Chapel Road and is 230 meters upstream of the confluence with Muddy Creek. A part of the South Fork Muddy Creek II watershed (RR5), the drainage area to this site (454 acres) is largely forested (65%) with little impervious surface (3%). This reach is just downstream of a beaver dam and is deeply incised with some areas of severely eroded and undercut banks. Heavy sediment deposition and little diversity of bed features along with some large woody debris and roots provide partially supporting habitat for the biological community. Over half of the benthic sample consisted of climbers; however, suboptimal taxa diversity including only one EPT taxa, few intolerant taxa, and no Ephemeroptera or scraper taxa contributed to a very poor biological condition score.

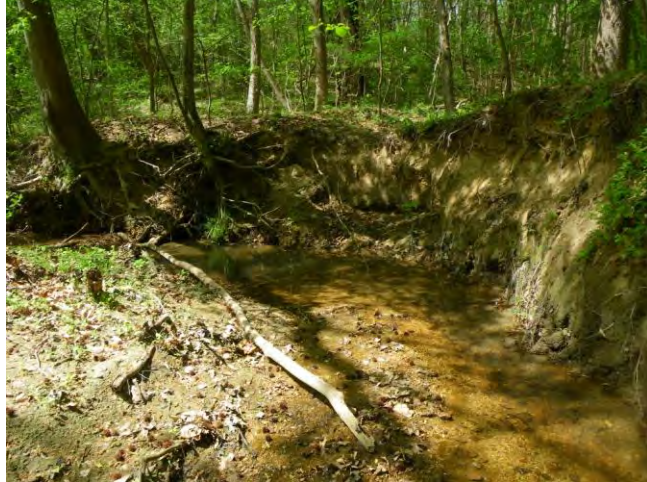
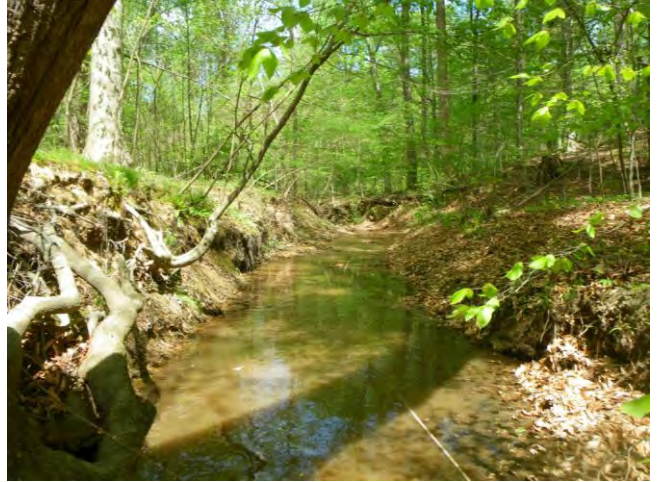
This site is located along the headwater portion of Muddy Creek, which is part of the South Fork Muddy Creek II watershed (RR5). Of the 481 acre drainage area, approximately half is forested land (53%) and one-fourth (25%) is 2-acre residential land use with only 6% impervious surface. The channel has good sinuosity; however, it is also incised with banks severely eroded along the outer meanders. A good mix of habitats and velocities provides a supporting habitat to a fair benthic community. Close to half of the benthic sample consisted of climber taxa; in addition, two scraper taxa and three EPT taxa were also present in the sample. Water quality values were within COMAR standards but conductivity was elevated.

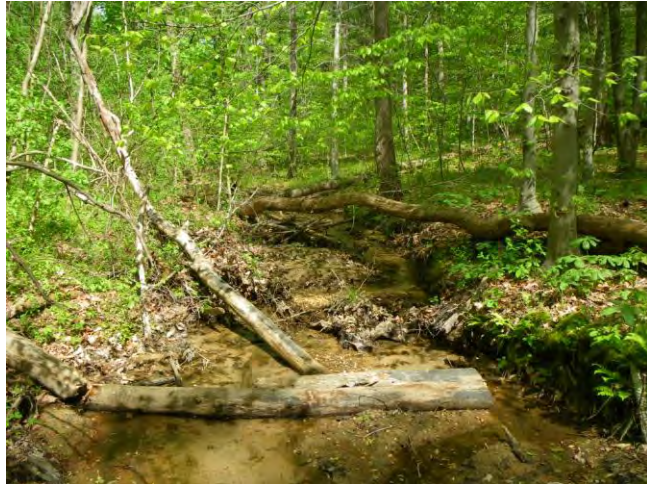
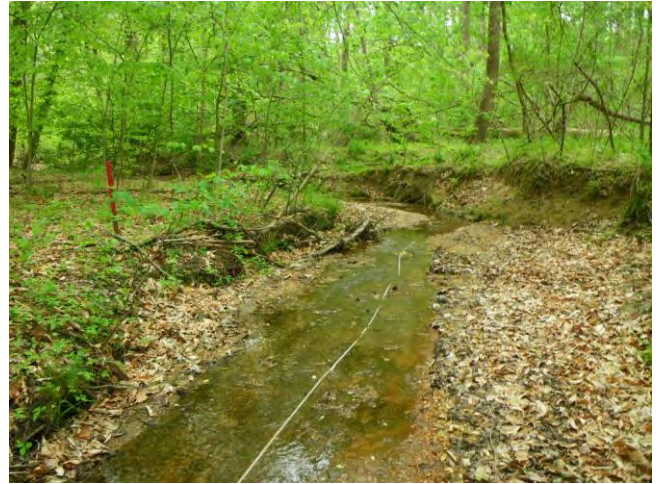
Upstream View:

Located on an unnamed tributary to Muddy Creek, this site is part of the South Fork Muddy Creek II watershed (RR5). Large point bars were observed in this shallow channel which suggests heavy sedimentation. Partially supporting habitat, consisting mainly of riffles and runs with few pools, is available to the biological community. The benthic sample for this site had high taxa diversity (24 taxa) and a high percentage of climbers (32%); however, low scores for EPT taxa, Ephemeroptera, and scraper taxa resulted in a poor biological community. Of the 112 acre drainage area, 57% is forested with 33% as 2-acre residential land use. Impervious surface accounts for 8% of the drainage area, which is the highest percentage of imperviousness for all sites sampled in Rhode River.

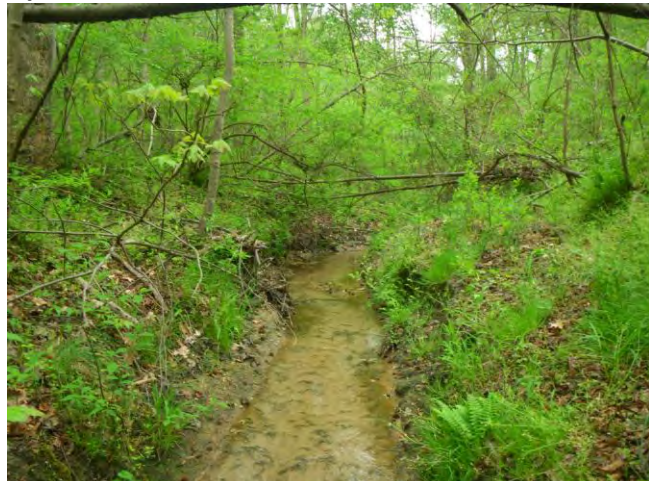
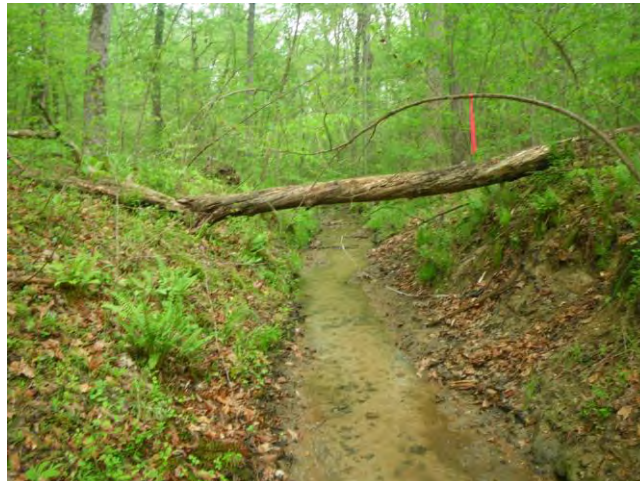
Upstream View:

Located behind Fibich Lane on an unnamed tributary to Muddy Creek, this site is part of the South Fork Muddy Creek II watershed (RR5). This channel is incised with a shallow, sandy bottom and little bed feature diversity. Minimal woody debris and leaf packs provide partially supporting habitat for benthos. Although over one third of the benthic sample consisted of individuals intolerant to urban stressors (36%) low taxa diversity with few EPT taxa and no Ephemeroptera or scraper taxa contributed to a poor biological community. The majority of the 145 acre drainage area is forested (68%) with minimal impervious surface (4%). Water quality values were within COMAR standards but conductivity was elevated.

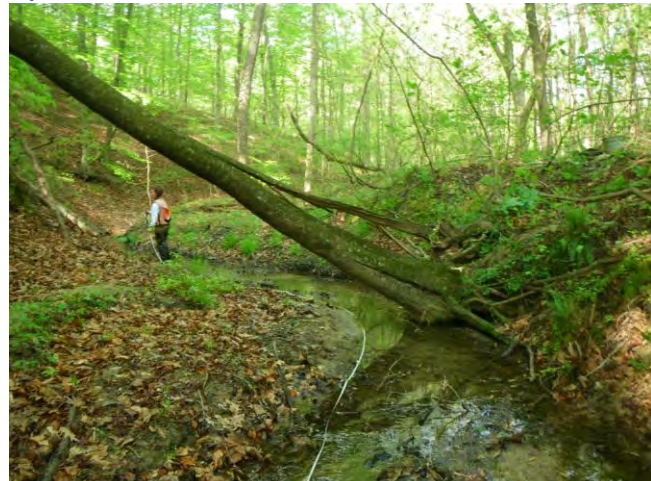
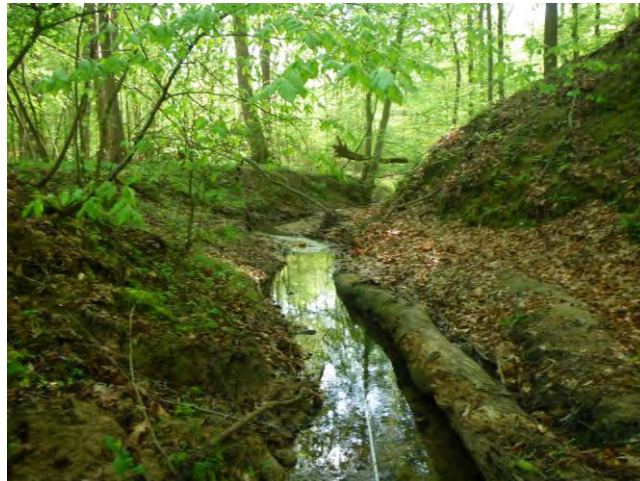
Upstream View:

Southeast of Three Rivers Road, this site is located on an unnamed tributary to Muddy Creek, which is part of the South Fork Muddy Creek II watershed (RR5). This is a shallow stream with mostly riffle/run features but lacks deep pools. A good mix of shallow gravel riffles with large woody debris, rootwads, and leaf packs provides supporting habitat for benthos. The absence of Ephemeroptera and scraper taxa contributes to a poor biological score. Of the 110 acre drainage area, 64% is forested with 21% developed land. Impervious surface accounts for only 4% of the drainage area.

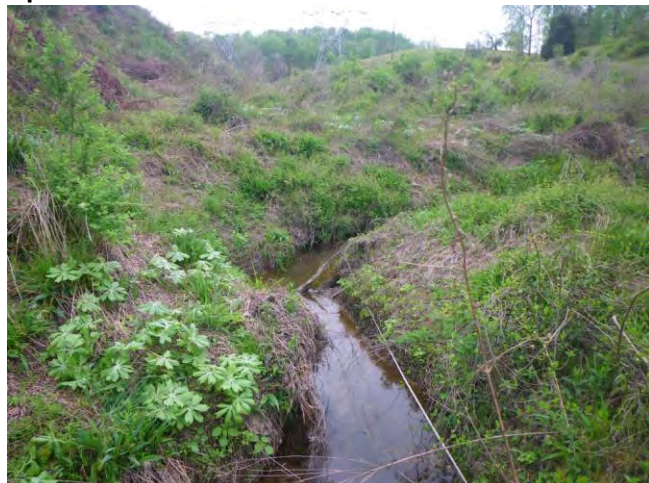
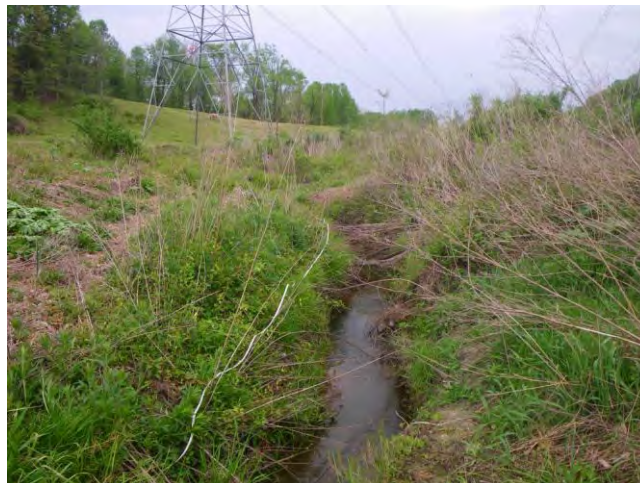
**Upstream View:**

This site is located on the mainstem of Muddy Creek and is part of the South Fork Muddy Creek II watershed (RR5). Of the 238 acre drainage area, 53% is forested with 21% as 2-acre residential and 17% as agriculture. Seven percent of the drainage area is impervious surface. This channel runs through a powerline corridor with no canopy cover and is adjacent to pasture. Although this stream exhibits good sinuosity, little flow/depth variation and extensive attached algae provides degraded habitat to a very poor biological community. The benthic sample for this site had poor taxa diversity (12 taxa) with very few intolerant individuals (2%) and no EPT, Ephemeroptera, or scraper taxa. Water quality values were within COMAR standards but conductivity was elevated.

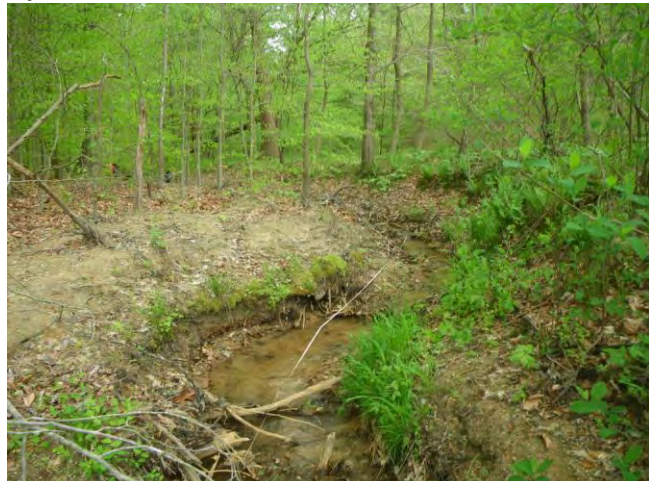
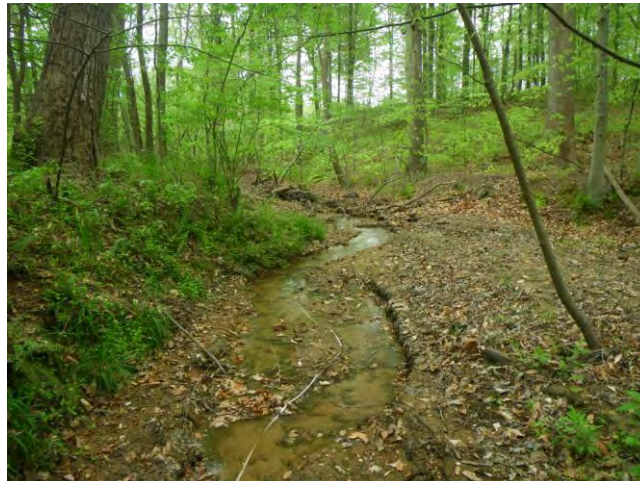
**Upstream View:**

Northwest of Three Rivers Road, this site is located on an unnamed tributary to Muddy Creek and is part of the South Fork Muddy Creek II watershed (RR5). This channel is shallow with a sandy bottom and little flow/depth diversity, likely due to heavy sedimentation and lacks habitat complexity with wood and leaf packs providing most of the benthic substrate. Although 32% of the benthic sample consisted of individuals intolerant to urban stressors, marginal taxa diversity (14 taxa) with few EPT taxa and no Ephemeroptera or scraper taxa resulted in an overall poor biologic score. Of the 114 acre drainage area, 59% is forested with 34% as 2-acre residential land use. Only 4% of the drainage area is impervious.

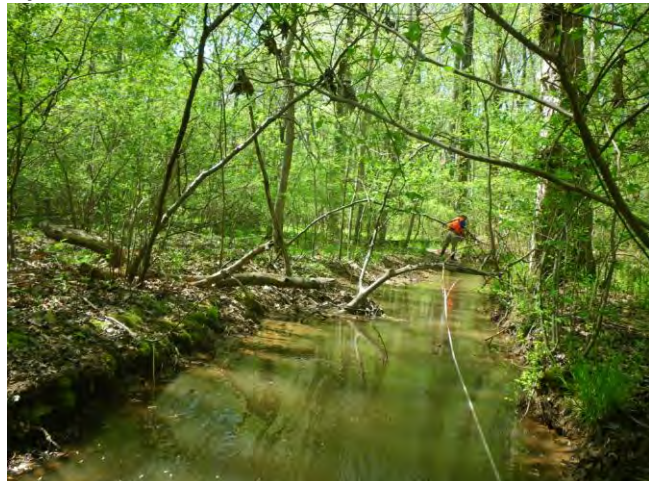
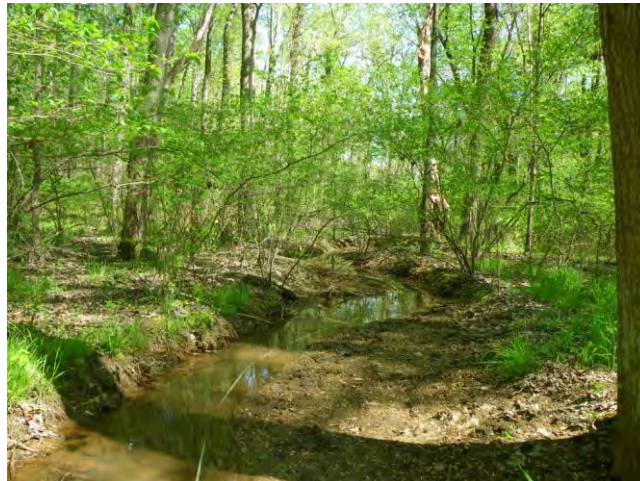
Upstream View:

This site is located on Mill Swamp Branch, which is part of the South Fork Muddy Creek I watershed (RR9). Of the 233 acre drainage area, 46% is agriculture, 27% forested, and 21% developed. Only 4% of the drainage area consists of impervious surface. This is a slow moving, sediment filled stream with a debris jam causing some backwatering. Woody debris and roots along the bank provide the majority of benthic habitat. Over half of the benthic sample consisted of climber taxa (55%) and intolerant individuals accounted for 20% of the sample. In addition, the inclusion of three scraper taxa and three Ephemeroptera taxa resulted in a fair biological score. Water quality measured below COMAR standards for pH and dissolved oxygen, which may be a result of poor flow conditions.

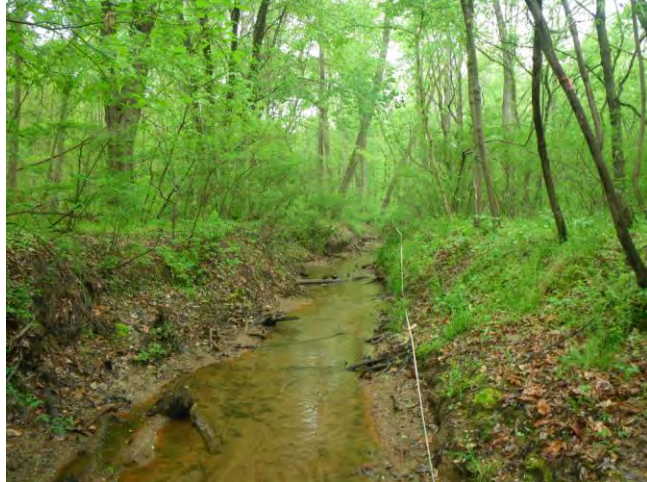
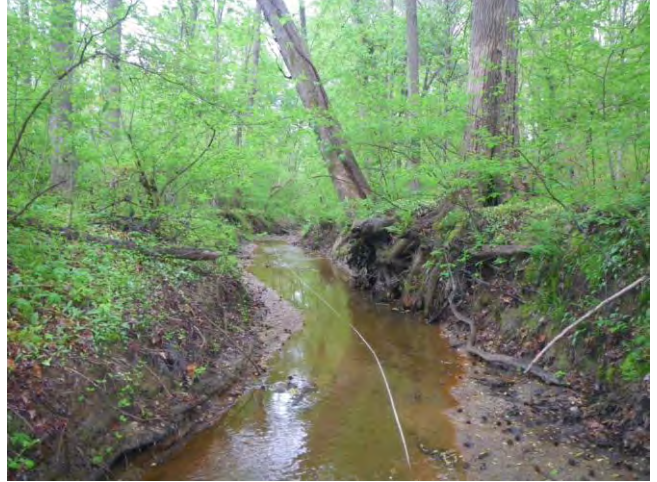
Located on Big Hob Run, this site is part of the South Fork Muddy Creek I watershed (RR9). Over half of the 444 acre drainage area is forested (53%) with 21% consisting of agricultural land. Impervious surface accounts for only 2% of the drainage area. This channel is incised and overwidened with a shallow, sandy bottom that lacks bed feature complexity. Some large woody debris and gravel riffles provide partially supporting habitat for the benthic community. The benthic sample scored high for climber taxa because Polypedilum (a tolerant midge) dominated the benthic sample. However, few EPT and intolerant taxa in addition to no Ephemeroptera or scraper taxa resulted in a very poor biological score.

- Biological condition – *“Very Poor”*
- Habitat scores *“Partially Supporting”* and *“Partially Degraded”*
- Polypedilum (midge) dominated the sample.
- Water quality values within COMAR standards.
- Incised, overwidened channel with shallow sandy bottom and lack of bed feature complexity. Some woody debris and gravel riffles provide benthic habitat. Banks are moderately stable with suboptimal vegetative protection. Good riparian width.
