# Targeted Biological Assessment of Streams in the West River and Rhode River Watersheds, Anne Arundel County, Maryland: 2012

## August 2012 - Final Report

KCI Technologies, Inc.  
936 Ridgebrook Road  
Sparks, Maryland 21152

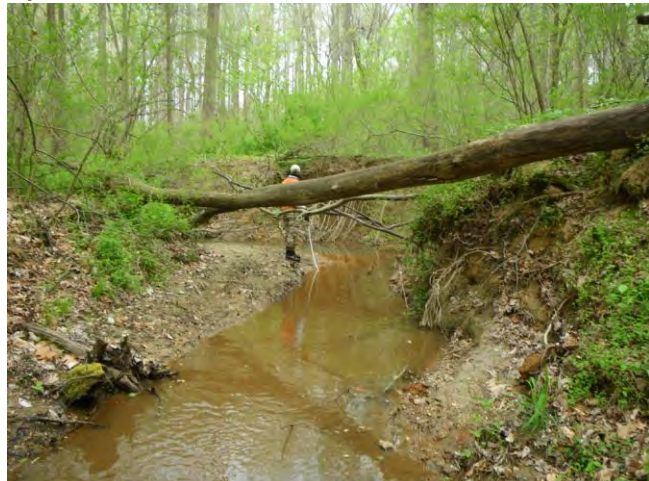
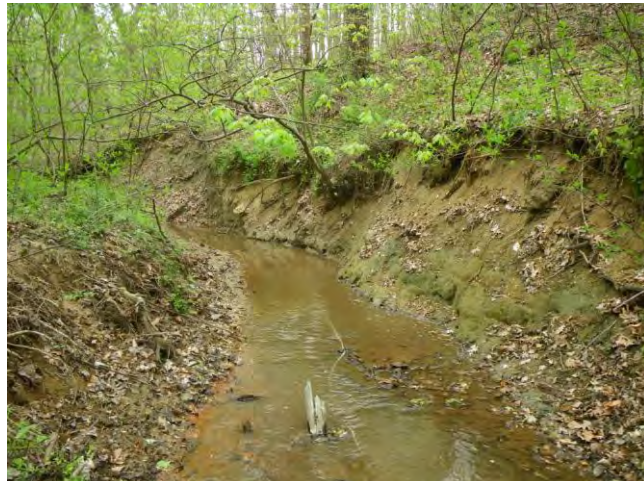
Located on Big Hob Run, this site is part of the South Fork Muddy Creek I watershed (RR9). The dominant land cover of the 323 acre drainage area consists of forested land (53%) with the remaining land cover consisting of 17% as agriculture and 30% split equally between developed land and open space. Impervious surface accounts for only 3% of the drainage area. This channel is deeply incised with heavily eroded banks. Numerous gravel riffles provide stable habitat for a poor benthic community consisting of poor taxa diversity (12 taxa) with few EPT, Ephemeroptera, and intolerant taxa. Water quality measured below COMAR standards for pH.

- Biological condition – “Poor”
- Habitat scores “Partially Supporting” and “Partially Degraded”
- Polypedilum (midge) dominated the sample.
- Measured below COMAR standards for pH.
- Deeply incised channel with heavily eroded banks and poor vegetative protection. Numerous gravel riffles provide stable habitat, but woody debris lacking. Good riparian width.

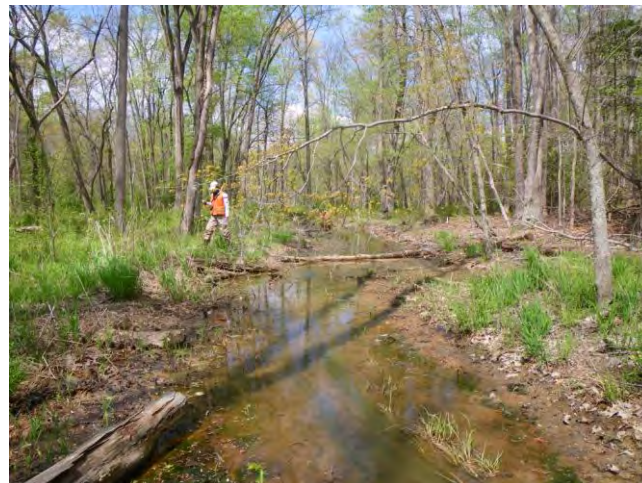
Downstream View:

Located 200 meters downstream of the confluence of South Fork Muddy Creek and Rainy Day Branch, this site is part of the South Fork Muddy Creek I watershed (RR9). This site is located on Smithsonian Environmental Research Center (SERC) property and is immediately downstream of a beaver dam, draining a large wetland. Emergent vegetation and attached algae is present in the channel with some large woody debris providing stable benthic habitat. Poor taxa diversity (13 taxa) with no EPT, Ephemeroptera, or scraper taxa contributed to a very poor biologic community score. Water quality measured below COMAR standards for pH, which may be an effect of wetland conditions upstream. The dominant land cover of the 442 acre drainage area consists of forested land (64%) with minimal impervious surface (3%).

- Biological condition – “Very Poor”
- Habitat scores “Supporting” and “Partially Degraded”
- Isopods (Caecidotea) and midges (Orthocladius, Cricotopus, and Chironomus) dominated the sample.
- Measured below COMAR standards for pH.
- Immediately downstream of beaver dam, draining large wetland. Some woody debris providing stable benthic substrate. Banks are stable with good riparian width and vegetative protection.

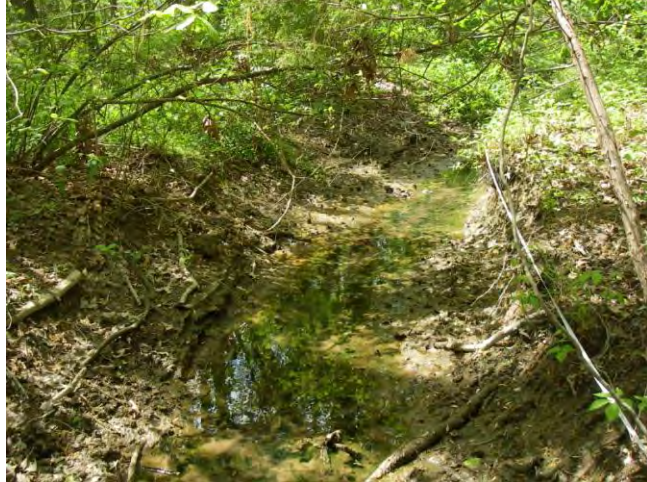
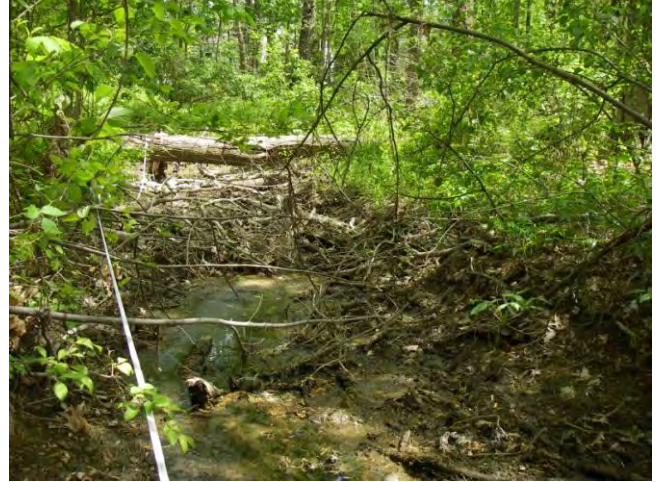
Located 300 meters downstream of Muddy Creek Road, this site is part of the Gales Creek watershed (WR3). Minimal flow was observed at this site as well as poor stable habitat for benthics consisting of woody debris and poor rootwads. Water quality measured below COMAR standards for pH. Although three scraper taxa were identified in the benthic sample, few climber and intolerant taxa and a complete lack of EPT and Ephemeroptera taxa contributed to a poor biological community score. Half of the 264 acre drainage area consisted of agricultural land (50%) with 25% as developed. Impervious surface accounted for only 3% of the drainage area.

- Biological condition – “Poor”
- Habitat scores “Non Supporting” and “Partially Degraded”
- Midges (Orthocladius), isopods (Caecidotea), and amphipods (Crangonyx) dominated the sample.
- Measured below COMAR standards for pH.
- Minimal flow with poor stable habitat in form of woody debris and poor rootwads. Moderately unstable banks with marginal vegetative protection. Good riparian width.

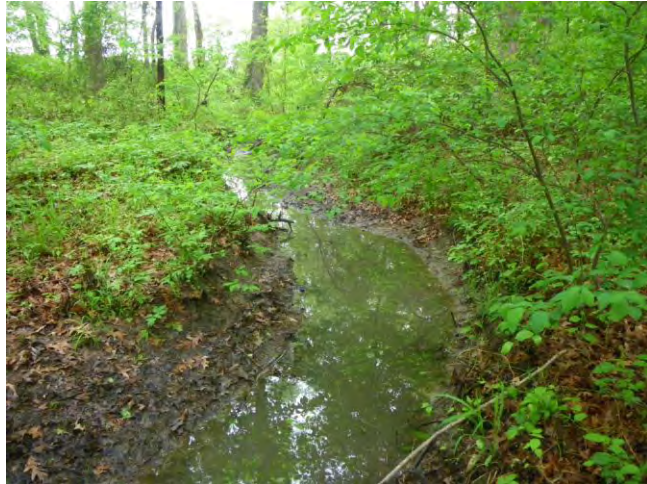
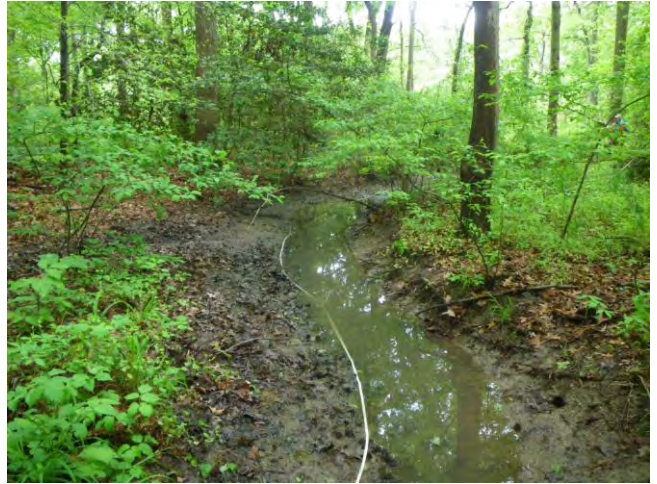
Located 250 meters west of Plantation Boulevard, this site is part of the Gales Creek watershed (WR3). Likely an ephemeral or intermittent channel, virtually no flow was observed at this site with water mostly present as standing pools. Some submerged vegetation provides habitat, but benthic habitat is severely lacking. Only 6 taxa were identified in the benthic sample, which was largely dominated by the tolerant midge, Chironomus. Because of the poor taxa diversity in addition to the complete lack of EPT, Ephemeroptera, scraper, and climber taxa this site received a very poor biological community score. Forested land accounted for 76% of the 40 acre drainage area with little impervious surface (2%). Water quality measured below COMAR standards for pH and dissolved oxygen. In addition, conductivity values were elevated. Depressed water quality measurements at this site may be an effect of low flow conditions.

- Biological condition – *“Very Poor”*
- Habitat scores *“Partially Supporting”* and *“Partially Degraded”*
- Chironomus (midge) dominated the sample.
- Measured below COMAR standards for pH and dissolved oxygen. Conductivity also elevated.
- Likely ephemeral or intermittent channel with virtually no flow and water present mostly as standing pools. Banks are stable with good riparian width and vegetative protection.

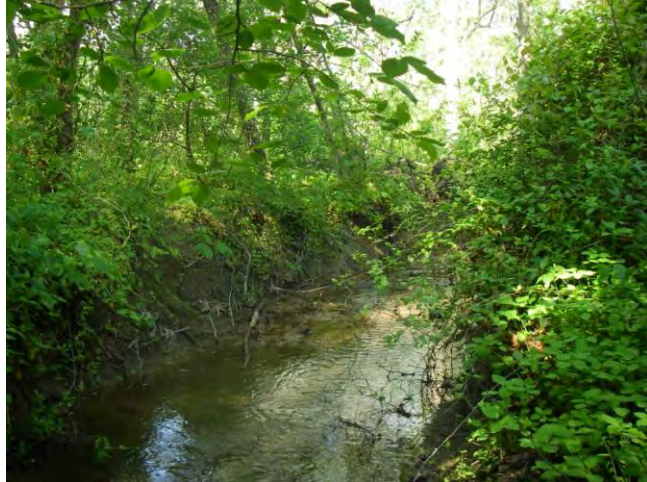
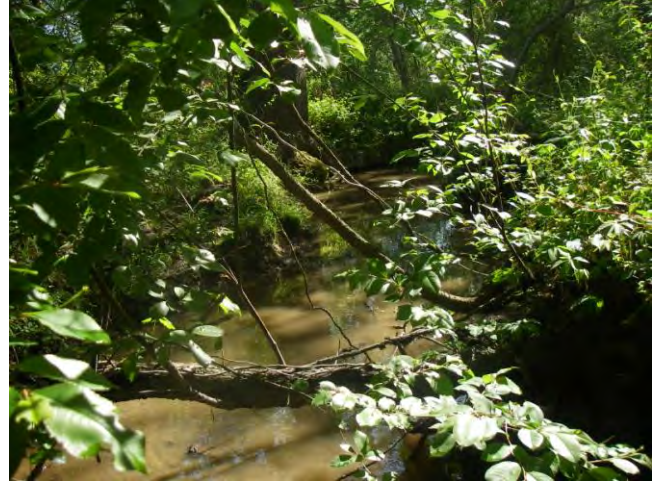
This site is located 120 meters downstream of Muddy Creek Road and is part of the Johns Creek watershed (WR1). Some riffles and woody debris provide habitat for a poor biologic community consisting of few EPT, Ephemeroptera, and scraper taxa. Water quality measured below COMAR standards for pH. Of the 486 acre drainage area, 45% is forested and 33% is row crops. Only 2% of the drainage area consists of impervious surface.

- Biological condition – “Poor”
- Habitat scores “Partially Supporting” and “Partially Degraded”
- Polypedilum (midge) and Synurella (amphipod) dominated the sample.
- Measured below COMAR standards for pH.
- Some riffles and good woody debris. Poor riparian because of adjacent mowed lawns with minimal buffer, although roots are helping eroded banks.

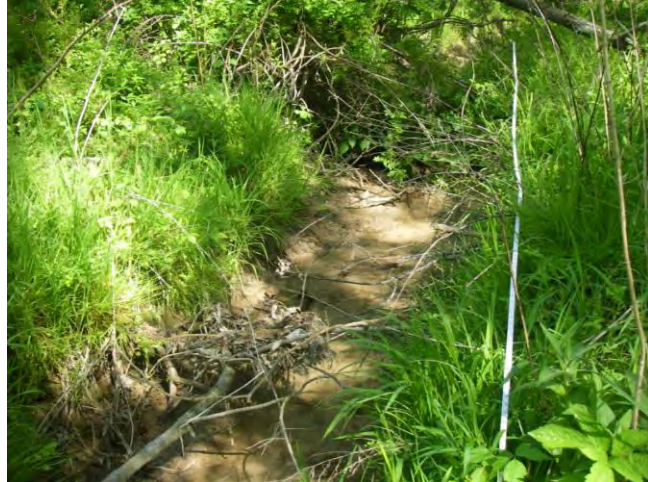
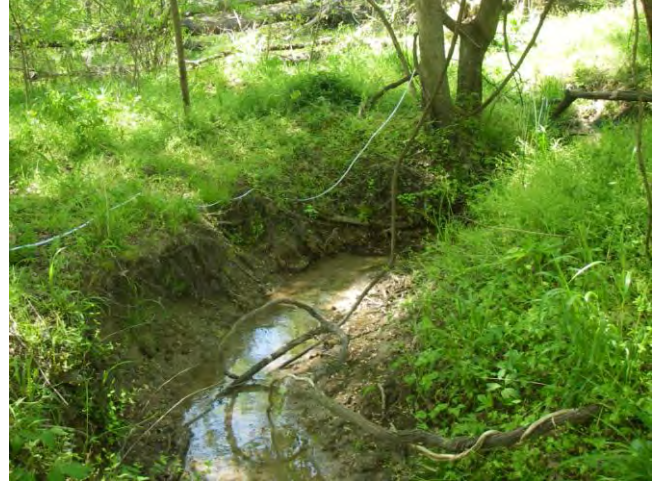
This site is located in the Johns Creek watershed (WR1) and runs parallel to Muddy Creek Road. The channel is adjacent to row crops and may have been straightened in the past. Poor habitat for benthos, consisting of minimal woody debris and rootwads was observed at the site. Although over half of the benthic sample consisted of individuals intolerant to urban stressors (56%), poor taxa diversity (12 taxa) with few EPT and climber taxa and no Ephemeroptera or scraper taxa resulted in an overall biological score of very poor. Water quality measured below COMAR standards for pH, which may be attributed to low flow conditions. Over two-thirds of the 136 acre drainage area consists of row crops (65%) with 18% as 2-acre residential land use. Imperviousness accounts for 3% of the drainage area.

- Biological condition – “Very Poor”
- Habitat scores “Non Supporting” and “Degraded”
- Amphipods (*Synurella*) dominated the sample.
- Measured below COMAR standards for pH.
- Low flow, silty bottomed stream with poor habitat and poor velocity/depth diversity. Moderately unstable banks with marginal vegetative protection. Good riparian width.

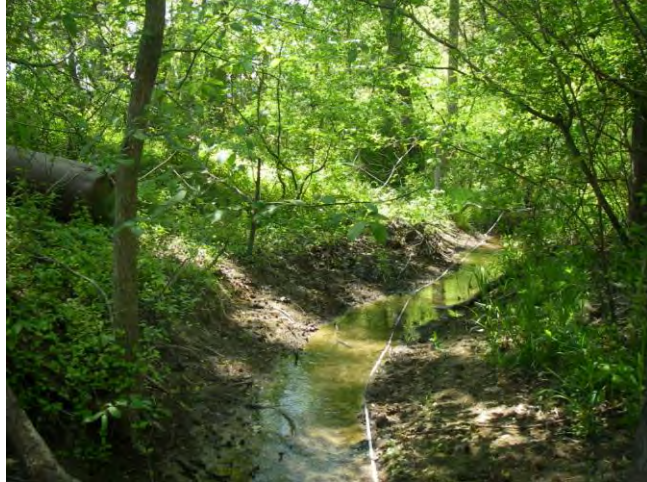
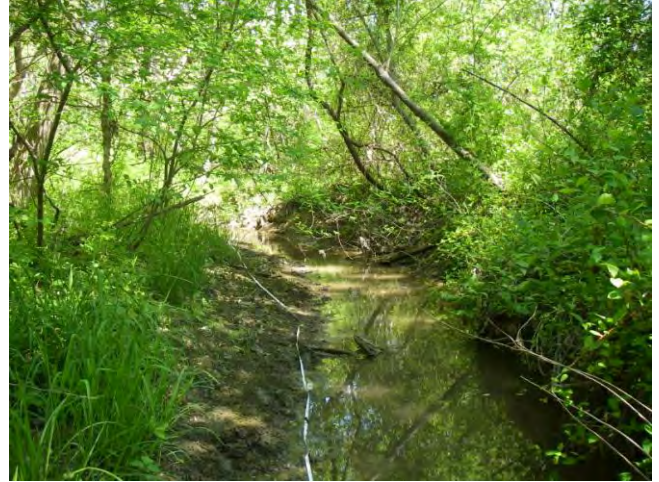
This site is located 80 meters west of Old Sudley Road and is part of the Johns Creek watershed (WR1). The channel is behind an old crop field with horse trails evident, although they do not appear to be severely affecting the site. Of the 234 acre drainage area, 65% is forested with little impervious surface (2%). Of the 20 taxa identified in the benthic sample, 2 were EPT taxa and 30% consisted of climber taxa. However, few intolerant taxa in addition to a complete lack of Ephemeroptera and scraper taxa contributed to an overall poor biological community score. Water quality measured below COMAR standards for pH.

- Biological condition – “Poor”
- Habitat scores “Partially Supporting” and “Partially Degraded”
- Midges (Polypedilum, Orthocladius, Parametricnemus, Odontomes, and Rheocricotopus) dominated the sample.
- Measured below COMAR standards for pH.
- Debris jam at 0 meters blocking some flow and creating some stagnant areas. Marginal habitat for benthos. Moderately stable banks with suboptimal vegetative protection.

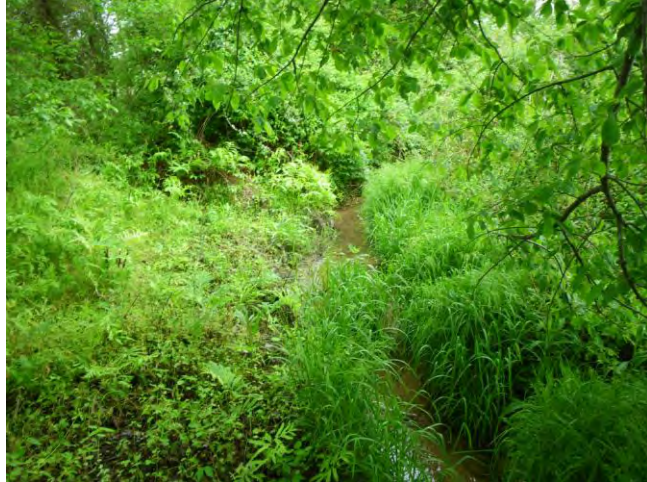
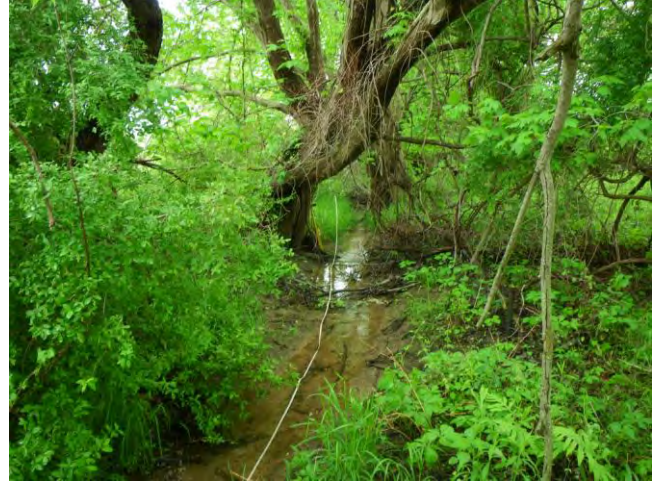
This site is located in the Johns Creek watershed (WR1) and runs parallel to Muddy Creek Road and is adjacent to cropland with limited riparian buffer. The channel consists of mostly run/glide features with little benthic habitat and no pools. Individuals intolerant to urban stressors accounted for over half of the benthic sample (57%) with 14% of the sample consisting of climber taxa. However, marginal taxa diversity (16 taxa) with few EPT and scraper taxa and no Ephemeroptera contributed to an overall fair biologic score. Of the 82 acre drainage area, 57% is row crops with 30% as 2-acre residential. Three percent of the drainage area is impervious surface. Water quality measured below COMAR standards for pH.

- Biological condition – “Fair”
- Habitat scores “Partially Supporting” and “Partially Degraded”
- Amphipods (*Synurella*) and bivalves (*Pisidium*) dominated the sample.
- Measured below COMAR standards for pH.
- Shallow channel with little benthic habitat and poor velocity/depth diversity. Limited riparian buffer between crop fields. Banks are stable but with suboptimal vegetative protection.

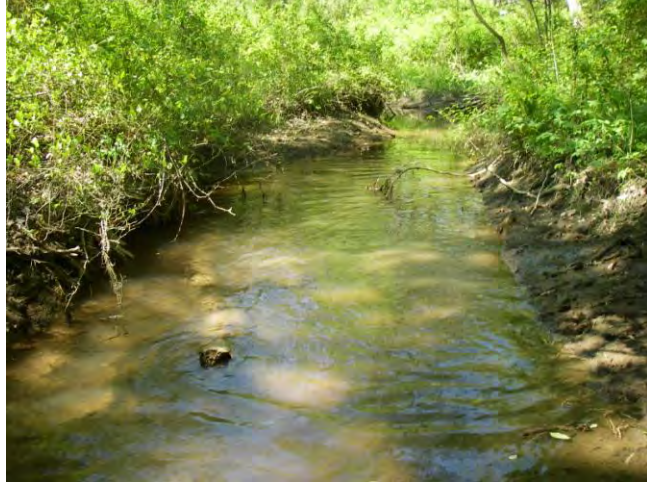
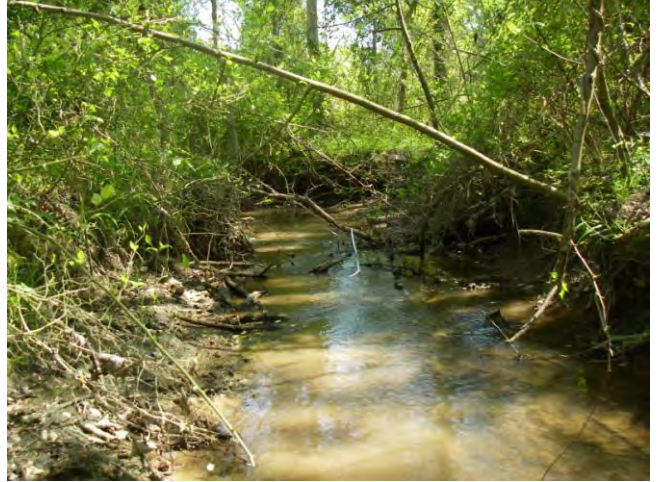
This site is located on the mainstem of Smith Creek and is part of the Smith Creek I watershed (WRB). The site is 300 meters upstream of the tidal portion of Smith Creek with lots of woody debris and good velocity diversity. Forested land is the dominant land cover of the 865 acre drainage area (70%) with minimal impervious surface (2%). Of the 20 taxa identified in the benthic sample, 22% were climber taxa, 2 were EPT taxa, and 2 were scraper taxa resulting in an overall fair biological score. Water quality measured below COMAR standards for pH.

- Biological condition – “Fair”
- Habitat scores “Supporting” and “Partially Degraded”
- Amphipods (Gammarus) and midges (Polypedilum) dominated the sample.
- Measured below COMAR standards for pH.
- Lots of woody debris and good velocity diversity. Suboptimal habitat diversity. Moderately unstable banks with suboptimal vegetative protection. Riparian width is also suboptimal.

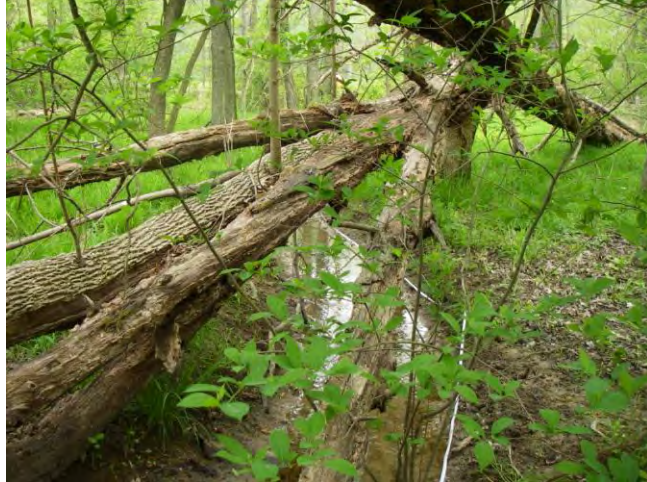
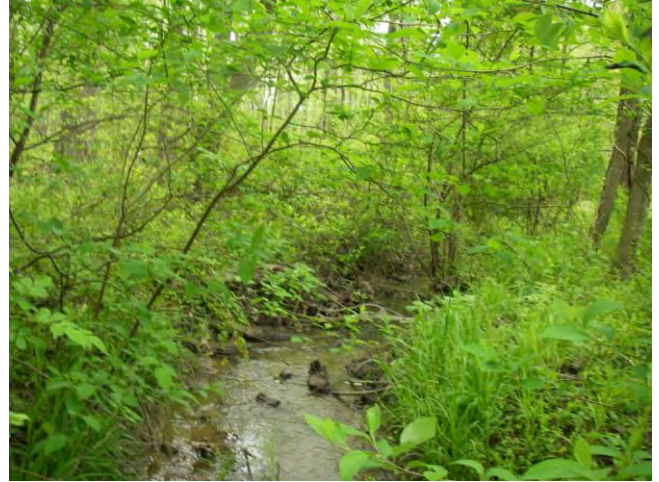
This site is 250 meters south of Westbury Farm Lane and 250 meters west of Muddy Creek Road and is located on an unnamed tributary to Smith Creek, which is part of the Smith Creek I watershed (WRB). The channel has shallow water depth but has good sinuosity and a good mix of velocities. Woody debris, rootwads, and vegetation provide stable habitat for the benthic community. Although 47% of the benthic sample consisted of climbers and intolerant organisms accounted for 44% of the sample, poor taxa diversity (12 taxa) with few EPT taxa and no Ephemeroptera or scraper taxa resulted in a poor biologic score. Over half of the 195 acre drainage area is forested (53%) with pasture land cover accounting for 20%. Two percent of the drainage area is impervious surface. Water quality measured below COMAR standards for pH.

- Biological condition – “Poor”
- Habitat scores “Supporting” and “Minimally Degraded”
- Polypedilum (midge) and Synurella (amphipod) dominated the sample.
- Measured below COMAR standards for pH.
- Good sinuosity and good mix of habitat in form of woody debris/rootwads and vegetation. Good mix of velocity but only shallow depth. Banks are stable with good riparian width and vegetative protection.

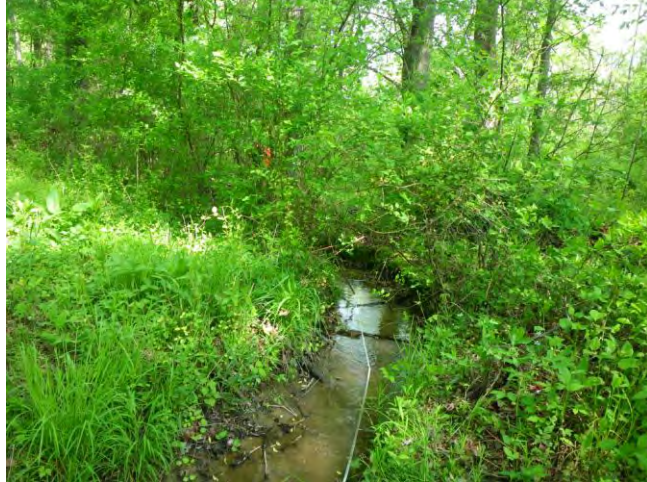
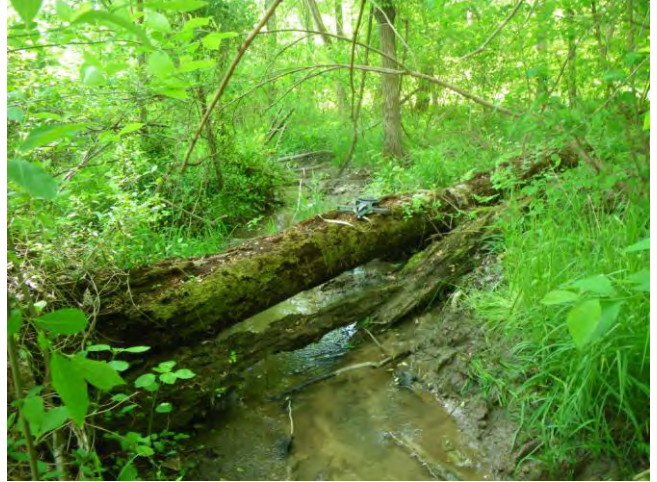
This site is adjacent to Westbury Farm Lane and is located on an unnamed tributary to Smith Creek, which is part of the Smith Creek I watershed (WRB). Of the 113 acre drainage area, 64% of land cover is forested and 25% is agriculture with only 2% imperviousness. Very good rootwads are keeping banks stable with woody debris accounting for the majority of stable benthic habitat. Although 60% of the benthic sample consisted of intolerant organisms and 29% climbers, poor taxa diversity (10 taxa), few EPT taxa and a lack of Ephemeroptera and scraper taxa resulted in an overall poor biological score. Water quality measured below COMAR standards for pH.

- Biological condition – “Poor”
- Habitat scores “Supporting” and “Minimally Degraded”
- Synurella (amphipod) and Polypedilum (midge) dominated the sample.
- Measured below COMAR standards for pH.
- Suboptimal riparian width because of powerline easement parallel to stream along left bank. Very good rootwads keeping banks stable and a lot of woody debris for bethos.

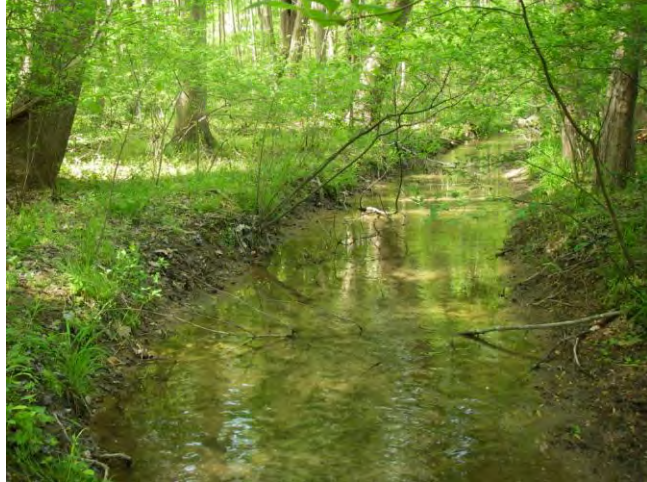
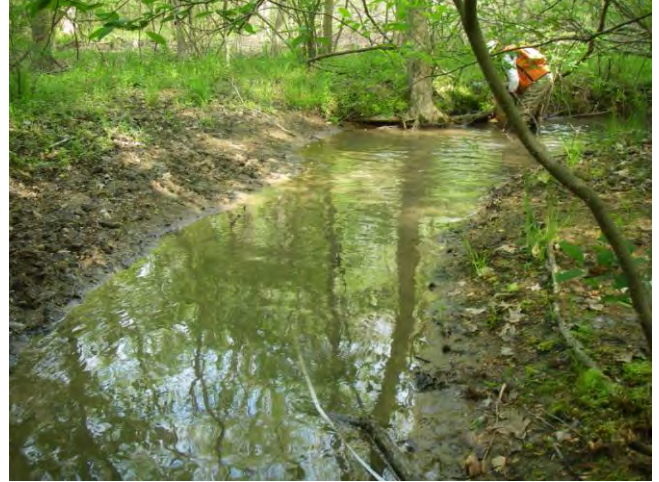
This site is located on the mainstem of Smith Creek and is part of the Smith Creek I watershed (WRB). Mostly slow, shallow flow was observed at this site with the lower half of the site slightly backwatered due to the wetland complex downstream. Poor benthic habitat consisting of mainly woody debris supports a poor benthic community consisting of few EPT taxa and Ephemeroptera or scraper taxa. The majority of the 572 acre drainage area is forested (82%) with minimal imperviousness (1%). Water quality measured below COMAR standards for pH, which may be the effects of wetland conditions.

- Biological condition – “Poor”
- Habitat scores “Supporting” and “Partially Degraded”
- Midges (Polypedilum) and worms (Tubificidae) dominated the sample.
- Measured below COMAR standards for pH.
- Mostly slow shallow flow with poor habitat consisting of woody debris. Banks are stable with good riparian width.

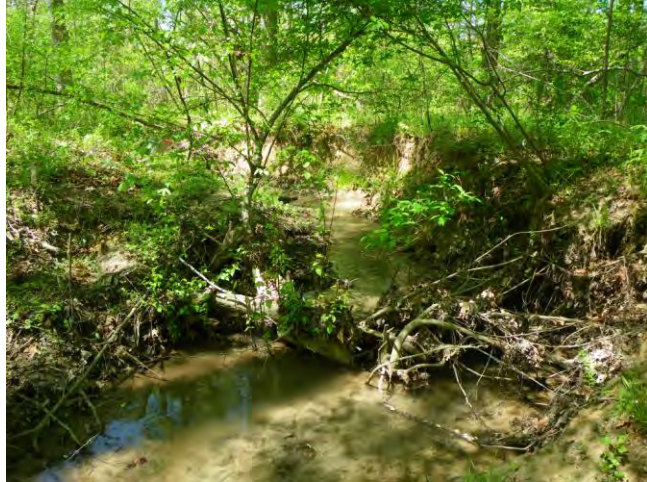
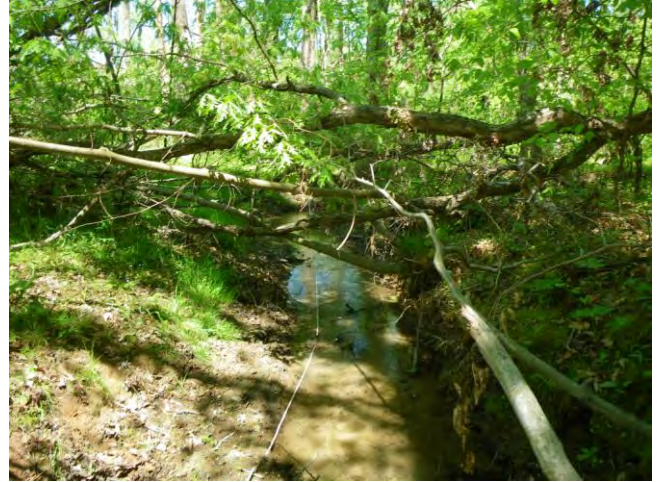
This site is located on the mainstem of Smith Creek and is part of the Smith Creek II watershed (WRC). This channel is incised with shallow water depth and mostly run/glide features. Despite lacking habitat diversity, this benthic sample received a good overall rating. Of the 20 taxa identified in the benthic sample, 2 were scraper taxa and 4 were EPT taxa, 2 of which were Ephemeroptera taxa. The majority of the 349 acre drainage area is forested (83%) with minimal imperviousness (1%).

- Biological condition – “Good”
- Habitat scores “Partially Supporting” and “Partially Degraded”
- Amphipods (*Synurella*), worms (*Tubificidae*), and midges (*Polypedilum*) dominated the sample.
- Water quality values within COMAR standards.
- Shallow, incised channel with excellent sinuosity. Raw eroded banks on outer meanders with habitat diversity lacking. Good riparian width.

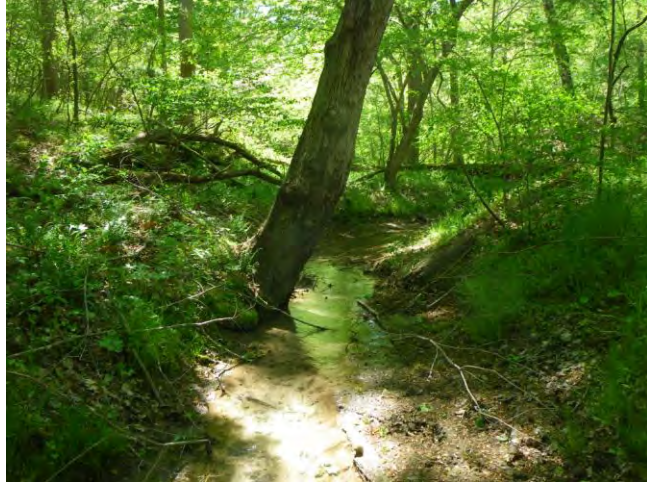
**Upstream View:**

- Biological condition – “Fair”
- Habitat scores “Partially Supporting” and “Partially Degraded”
- Bivalves (Pisidium), amphipods (Synurella), and midges (Polypedilum) dominated the sample.
- Water quality values within COMAR standards.
- Shallow, incised channel with good sinuosity. Poor velocity/depth diversity with habitat diversity also lacking. Good riparian width.

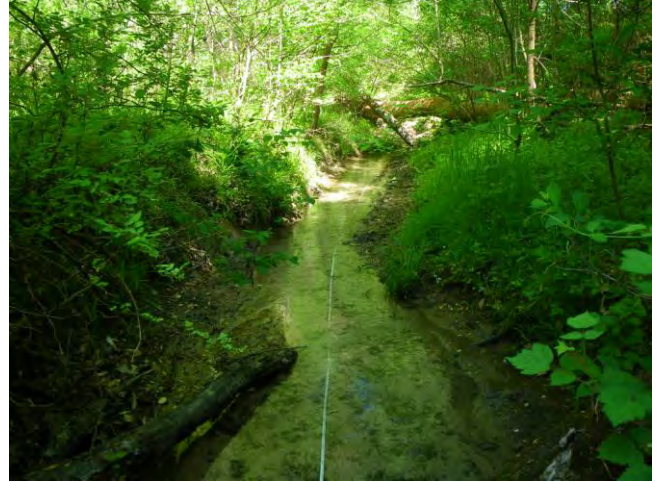
**Downstream View:**

This site is located on the mainstem of Smith Creek and is part of the Smith Creek II watershed (WRC). The channel is incised with poor velocity/depth diversity and nearly all run/riffle features. Of the 20 taxa identified in the benthic sample, 21% were climber taxa and 27% were intolerant taxa. Four EPT taxa were identified in the sample, including one Ephemeroptera, resulting in a fair biological community score. The majority of the 336 acre drainage area is forested (84%) with minimal imperviousness (1%).

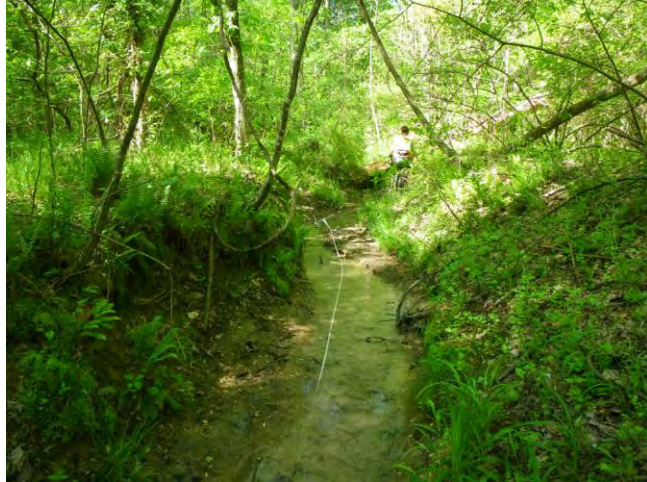
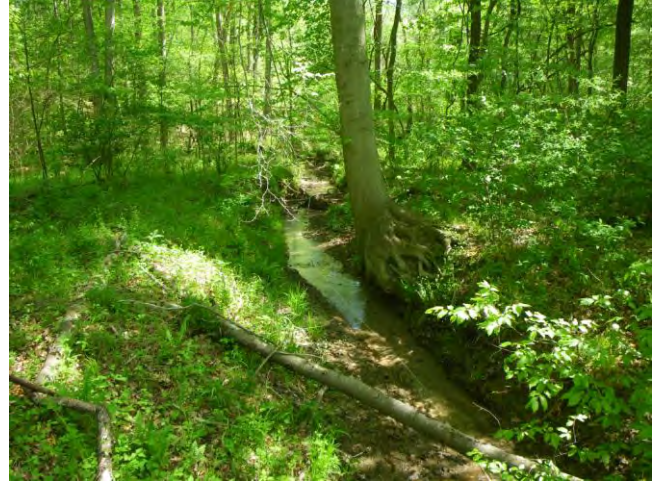
This site is located on the mainstem of Smith Creek and is part of the Smith Creek II watershed (WRC). The channel is incised with mostly run/riffle features and lacking habitat diversity. Although over half of the benthic sample consisted of intolerant taxa (62%), poor taxa diversity (13 taxa) in addition to few EPT taxa and no Ephemeroptera or scraper taxa contributed to a poor biological score. The majority of the 145 acre drainage area is forested (87%) with minimal imperviousness (2%).

- Biological condition – “Poor”
- Habitat scores “Partially Supporting” and “Partially Degraded”
- Amphipods (*Synurella*) dominated the sample.
- Water quality values within COMAR standards.
- Shallow, incised channel with banks mostly healed over and stabilized. Habitat diversity lacking. Good riparian width.

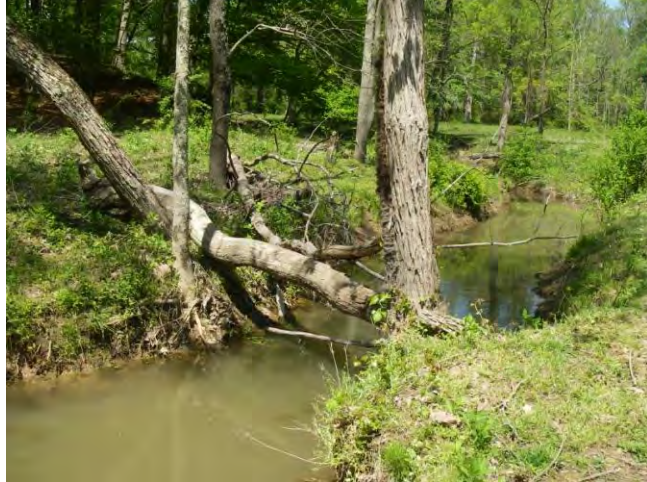
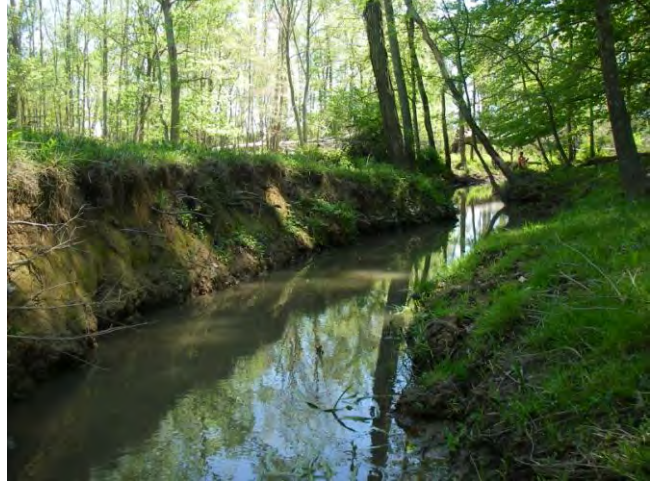
Located in the Lerch Creek I watershed (WR5), this site is in the middle of a cow pasture located behind the Citgo gas station at the intersection of Galesville Road and Muddy Creek Road. Of the 1,641 acre drainage area, which is the largest drainage area of sites sampled in West River, 48% is forested, 28% is agricultural land, and 20% is developed. Three percent of the drainage area consists of impervious surface. Good rootwads and instream vegetation provide stable habitat for benthos. Climber taxa accounted for 71% of the benthic sample; however, the complete lack of EPT and Ephemeroptera taxa resulted in a poor score for the biological community. Water quality measured below COMAR standards for pH.

- Biological condition – *“Poor”*
- Habitat scores *“Non Supporting”* and *“Degraded”*
- Polypedilum (midge) dominated the sample.
- Measured below COMAR standards for pH.
- Poor riparian width on right bank because of pasture. Bank slumping because of multiple cattle crossings. Marginal habitat for benthos consisting of rootwads and instream vegetation.

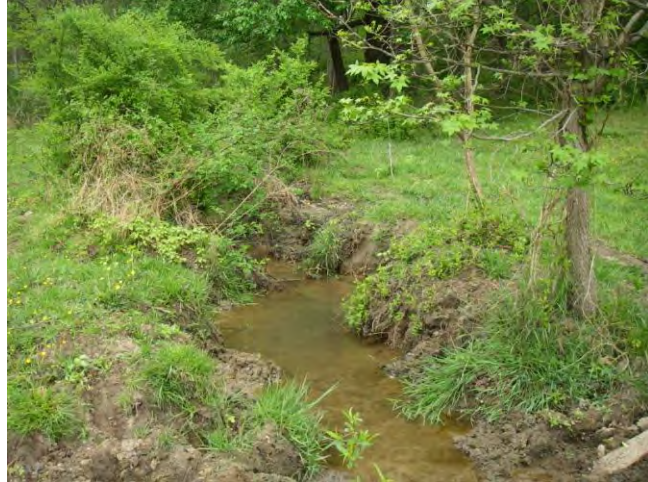
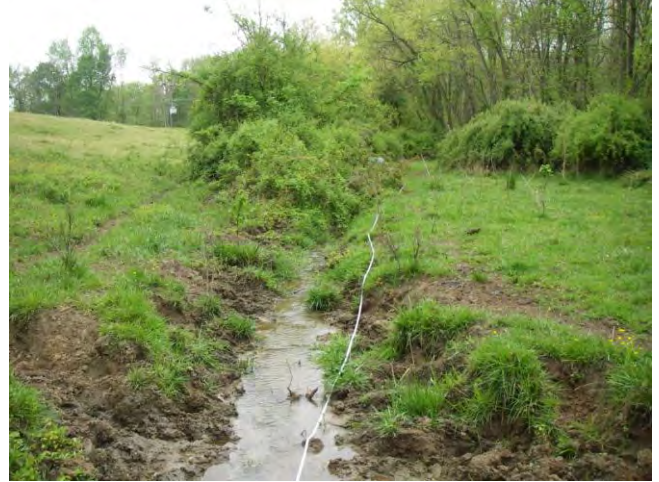
Located 300 meters northwest of the intersection of Galesville Road and Muddy Creek Road, this site is a part of the Lerch Creek I watershed (WR5). Of the 182 acre drainage area, 35% is row crops, 30% is forested, and 28% is developed. Impervious surface accounts for 5% of the drainage area. The site is located in the middle of a cow pasture with minimal riparian zone width, if any. Of the 21 taxa identified in the benthic sample, 30% were climbers; however, only one scraper taxa was identified and no EPT taxa were present resulting in a poor biological score. Water quality measured below COMAR standards for pH.

- Biological condition – “Poor”
- Habitat scores “Non Supporting” and “Severely Degraded”
- Midges (Polypedilum), black flies (Simulium), and isopods (Caecidotea) dominated the sample.
- Measured below COMAR standards for pH.
- Reach is in the middle of a cow pasture resulting in a marginal riparian zone and poor habitat quality for benthos. Banks are moderately unstable with poor vegetative protection.

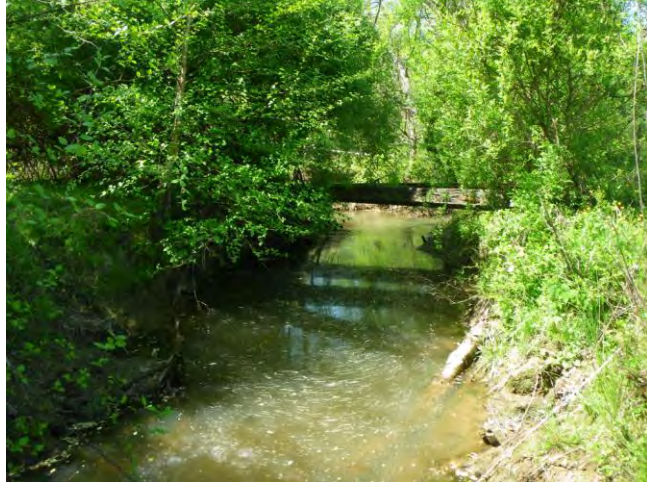
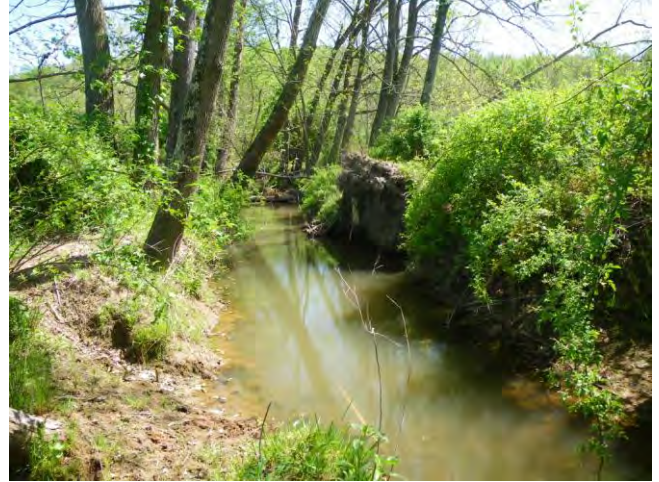
This site is part of the Lerch Creek II watershed (WR6) and is located 300 meters downstream of Owensville Road. Half of the 1,358 acre drainage area is forested (51%) with 26% as agricultural land and 19% developed. Impervious surface accounts for 3% of the drainage area. The channel runs through pasture with little riparian vegetation and few mature trees. The benthic sample received a fair score due to good taxa diversity (24 taxa) and the presence of four EPT taxa, one of which was a sensitive Ephemeroptera taxa, as well as two scraper taxa.

- Biological condition – “Fair”
- Habitat scores “Non Supporting” and “Degraded”
- Chironomus (midge) dominated the sample.
- Water quality values within COMAR standards.
- Stream runs through pasture with minimal riparian width. Marginal habitat complexity for benthos. Cattle access stream and banks are somewhat trampled resulting in a poor bank stability score.

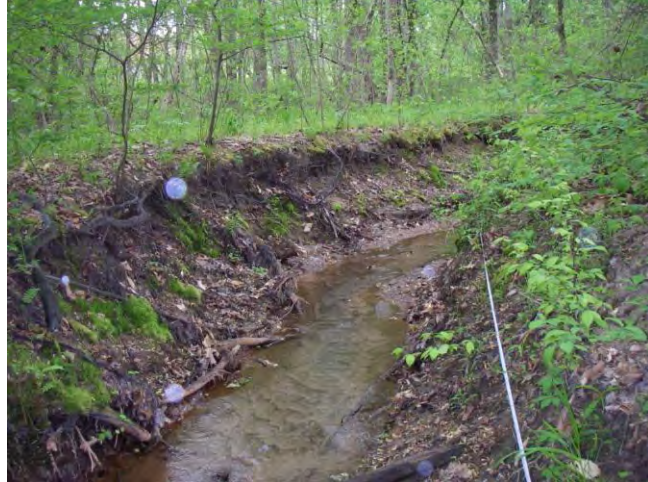
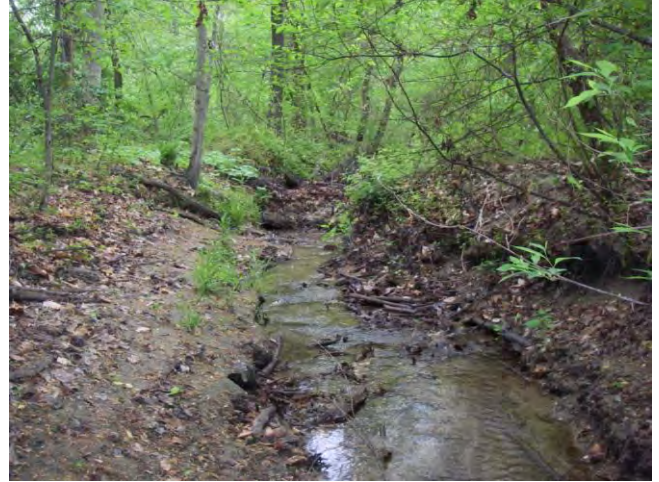
This site is located behind Owensbrooke Court and is part of the Lerch Creek II watershed (WR6). The channel runs parallel to Charlesgift Court and Rousby Run with woody debris providing stable habitat for benthos. Although over half of the benthic sample consisted of climber taxa (64%), poor taxa diversity (11 taxa) and a complete lack of Ephemeroptera or scraper taxa in the sample resulted in an overall poor biological community. Of the 213 acre drainage area, 35% is developed (mainly 2-acre residential), 34% is forested, and 24% consists of row crops. Imperviousness accounts for 5% of the drainage area. Water quality measured below COMAR standards for pH.

- Biological condition – “Poor”
- Habitat scores “Partially Supporting” and “Partially Degraded”
- Polypedilum (midge) dominated the sample.
- Measured below COMAR standards for pH.
- Raw banks with woody debris as marginal habitat for benthos. Moderately unstable banks with marginal vegetative protection. Suboptimal riparian width.

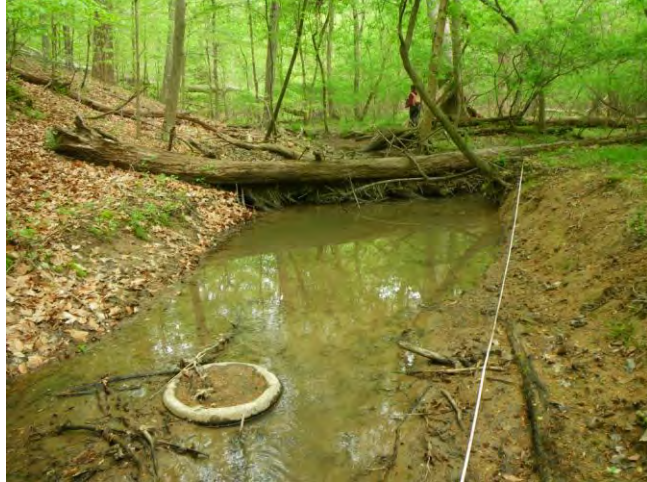
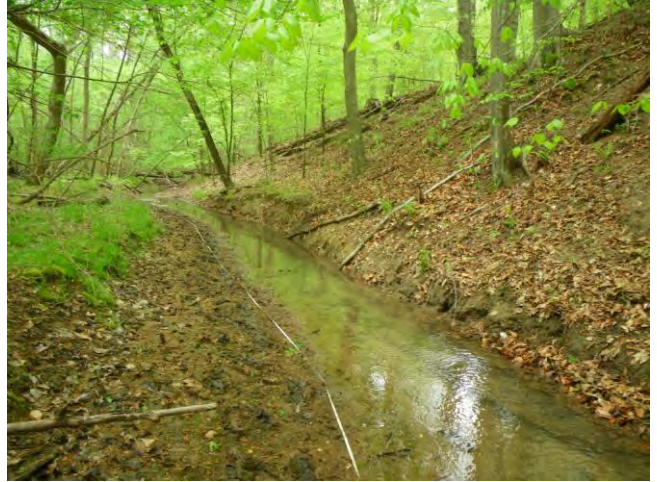
Located 350 meters south of Owensville Road, this site is a part of the Lerch Creek II watershed (WR6). Habitat complexity is lacking in this shallow stream with heavy siltation. Anaerobic decomposition was also observed in pools and stagnant areas. Water quality measured below COMAR standards for pH. Intolerant organisms accounted for over half of the benthic sample (62%). Of the 18 taxa identified in the sample, one scraper taxa was present as well as two EPT taxa, including one Ephemeroptera, resulting in an overall score of fair for the biological community. Of the 458 acre drainage area, forested land is the dominant land use (64%) with 30% split equally between agriculture and developed land. Two percent of the drainage area is impervious surface.

- Biological condition – “Fair”
- Habitat scores “Partially Supporting” and “Partially Degraded”
- Amphipods (Synurella), isopods (Caecidotea), and worms (Tubificidae) dominated the sample.
- Measured below COMAR standards for pH.
- Shallow stream with heavy siltation. Habitat complexity lacking. Moderately stable banks with suboptimal vegetative protection. Good riparian width.

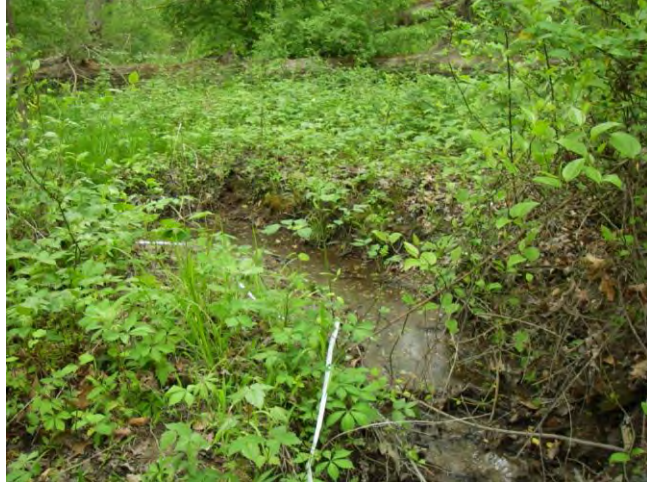
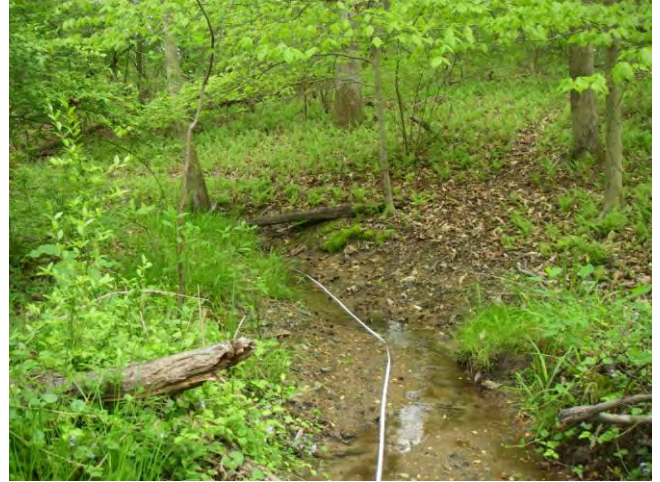
Located in the Tenthouse Creek watershed (WR7), this site is on a small tributary 230 meters north of Galesville Road and 130 meters upstream of tidal conditions. Very low water level was observed at this site with minimal stable habitat for benthos. The majority of the benthic sample consisted of taxa intolerant to urban stressors; however, poor taxa diversity (12 taxa) with only one EPT taxa and no Ephemeroptera, scraper, or climber taxa contributed to an overall biological score of very poor. The majority of the 47 acre drainage area is forested (61%) with minimal impervious surface (1%). Water quality measured below COMAR standards for pH.

- Biological condition – “*Very Poor*”
- Habitat scores “*Partially Supporting*” and “*Partially Degraded*”
- Caecidotea (isopod) dominated the sample.
- Measured below COMAR standards for pH.
- Very low water level, minimal stable habitat in woody debris for benthos. Banks are stable with suboptimal vegetative protection. Good riparian width.

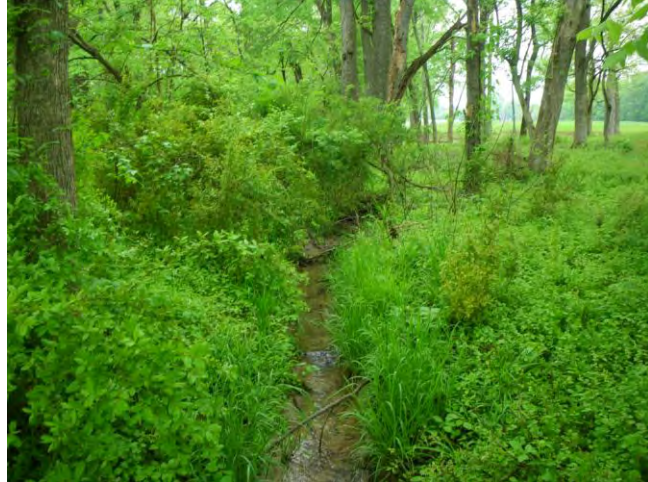
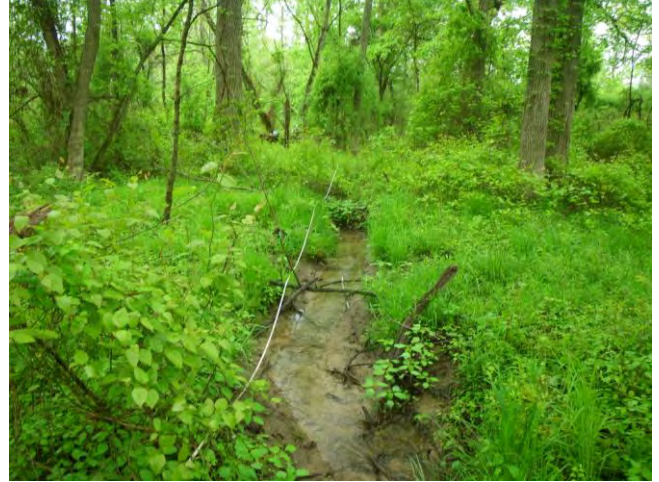
Located in the Tenthouse Creek watershed (WR7), this site is 150 meters upstream of the tidal portion of Cox Creek. This channel is shallow and runs through a narrow wetland. Woody debris and roots provide the only habitat for benthos. Over half of the benthic sample consisted of taxa intolerant to urban stressors (67%); however, a complete lack of Ephemeroptera and scraper taxa contributed to an overall poor biological community score. Of the 67 acre drainage area, 35% is agricultural land, 33% is developed , and 32% is forested. Impervious surface accounts for 5% of the drainage area. Water quality measured below COMAR standards for pH.

- Biological condition – “Poor”
- Habitat scores “Partially Supporting” and “Partially Degraded”
- Amphipods (Synurella) and isopods (Caecidotea) dominated the sample.
- Measured below COMAR standards for pH.
- Shallow intermittent stream with woody debris/rootwads providing only marginal benthic habitat. Banks are stable with good riparian width and vegetative protection.

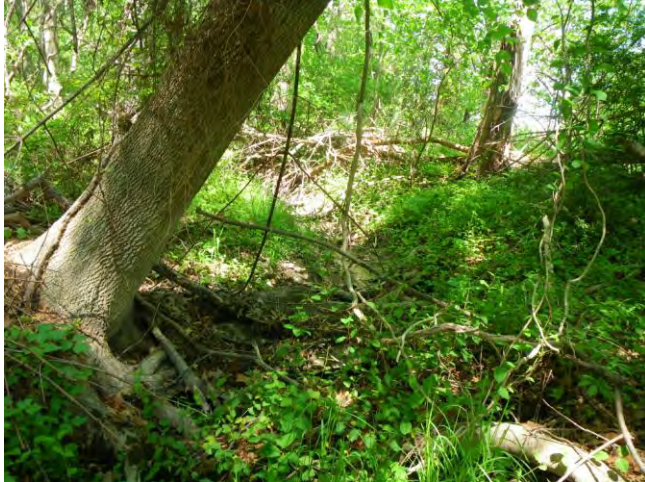
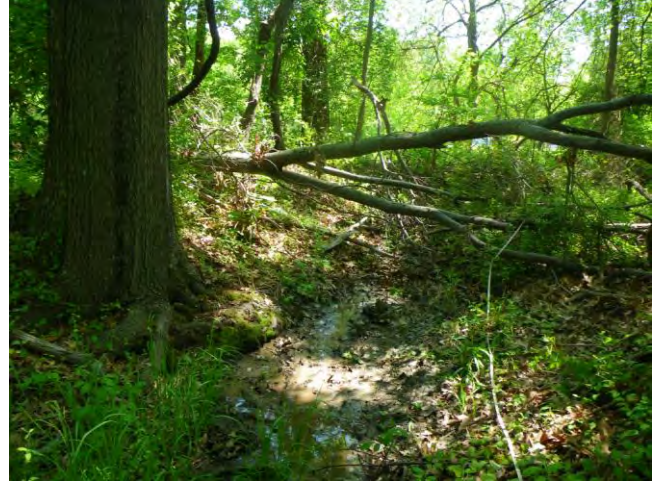
Located in the Tenthouse Creek watershed (WR7), this site is 300 meters downstream of Bayfields Road and 130 meters upstream of the tidal portion of Cox Creek. Of the 20 acre drainage area, 38% is developed, 37% is agriculture (row crops), and 25% is forested. Four percent of the drainage area is impervious surface. Water quality measured below COMAR standards for pH. Poor taxa diversity (12 taxa) with few EPT and climber taxa and no Ephemeroptera or scraper taxa resulted in a very poor biological score.

- Biological condition – “Very Poor”
- Habitat scores “Non Supporting” and “Partially Degraded”
- Worms (Tubificidae) and isopods (Caecidotea) dominated the sample.
- Measured below COMAR standards for pH.
- Little buffer due to residential property on right bank and cropland on left bank. Very little flow with very poor habitat. Multiple rootwads throughout. Refuse present in moderate amounts.

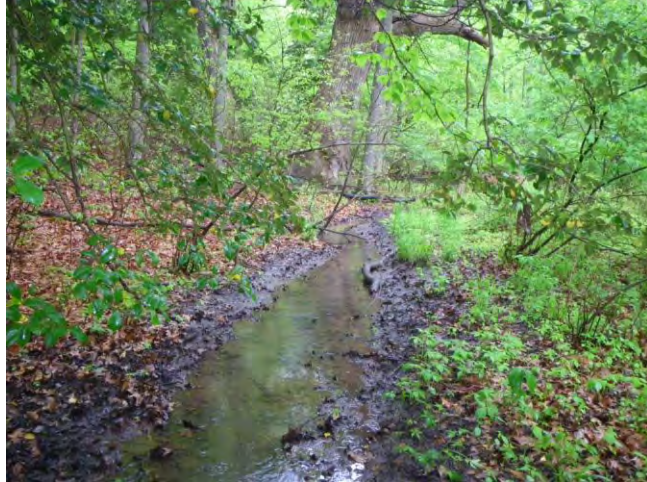
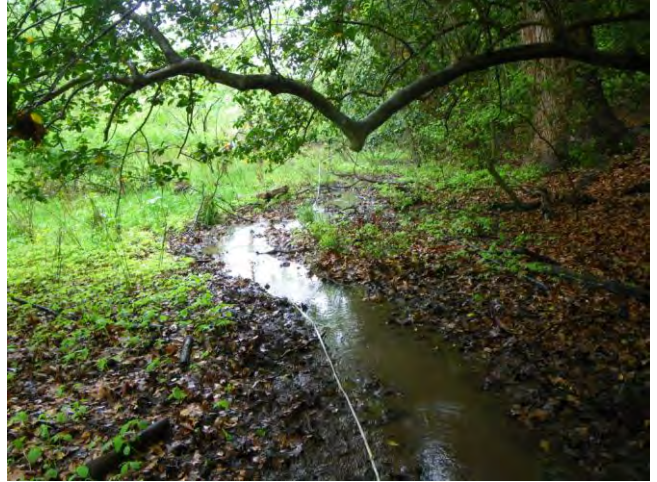
Located in the Popham Creek watershed (WR4), this site is behind Annandale Road and 200 meters upstream of the tidal portion of Popham Creek. The majority of the 66 acre drainage area is forested (72%) with minimal impervious surface (2%). The stream runs through a broad wetland valley with an abundance of fine particulate organic matter, leaves, and some woody debris. Taxa intolerant to urban stressors accounted for 78% of the benthic sample. However, few EPT and climber taxa as well as a complete lack of Ephemeroptera and scraper taxa contributed to an overall score of poor for the biological community. Water quality measured below COMAR standards for pH, which may be an effect of wetland conditions.

- Biological condition – *“Poor”*
- Habitat scores *“Supporting”* and *“Partially Degraded”*
- Amphipods (*Synurella*) and isopods (*Caecidotea*) dominated the sample.
- Measured below COMAR standards for pH.
- Abundance of leaves and some woody debris providing marginal habitat for benthos. Banks are stable with good riparian width and vegetative protection.
