# Targeted Biological Assessment of Streams in the West River and Rhode River Watersheds, Anne Arundel County, Maryland: 2012

## August 2012 - Final Report

KCI Technologies, Inc.  
936 Ridgebrook Road  
Sparks, Maryland 21152

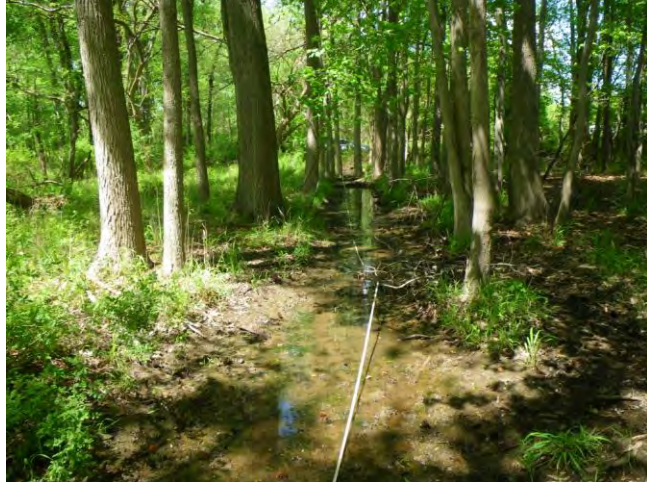
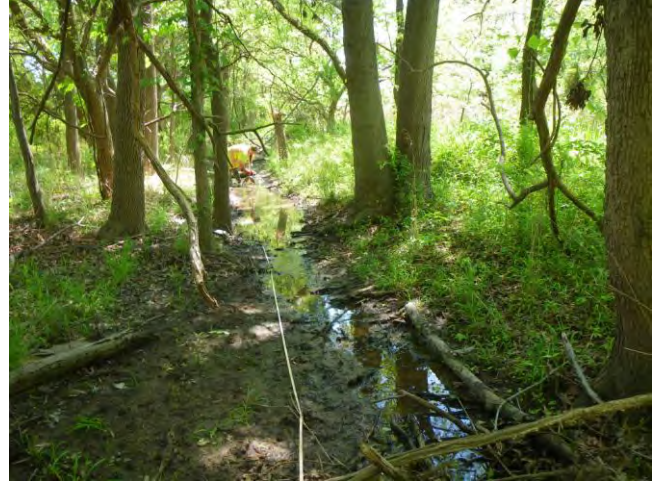
This site is located approximately 200 meters upstream of the tidal portion of Cheston Creek, which is part of the Cheston Creek watershed (WR2). Located on Smithsonian Environmental Research Center (SERC) property, 40% of the 48 acre drainage area is forested with 36% as agricultural land. Six percent of the drainage area is impervious surface. Although water quality values were within COMAR standards, conductivity values were elevated. This stream was shallow with virtually no flow and poor habitat for benthos. Taxa intolerant to urban stressors accounted for 69% of the benthic sample; however, poor taxa diversity (10 taxa) and a complete lack of EPT, Ephemeroptera, scraper, and climber taxa resulted in a very poor score for the biological community.

- Biological condition – “Very Poor”
- Habitat scores “Non Supporting” and “Partially Degraded”
- Caecidotea (isopod) dominated the sample.
- Water quality values within COMAR standards but conductivity elevated.
- Shallow stream with virtually no flow, likely ephemeral or intermittent. Poor habitat, but numerous rootwads provide bank protection and limited habitat for benthos. Good riparian.

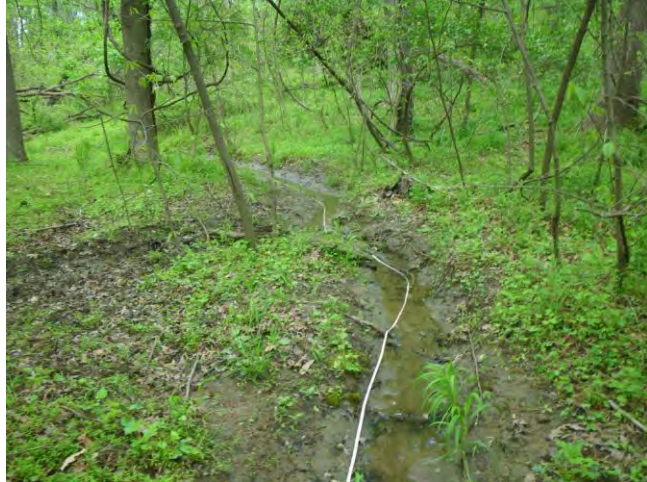
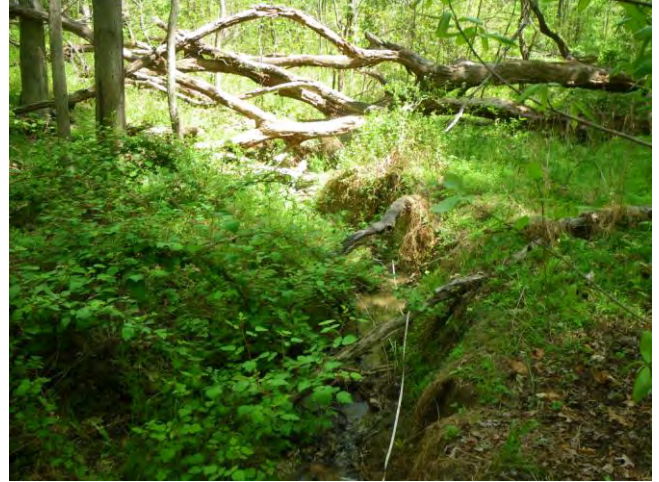
This site is located on Smithsonian Environmental Research Center (SERC) property and is 150 meters upstream of the tidal portions of Scaffold Creek, which is part of the Cheston Creek watershed (WR2). At 18 acres, this site has the smallest drainage area of sites sampled in West River and is 56% forested and 44% agricultural land with no impervious surface. This stream was shallow with minimal habitat complexity and virtually no flow. Water quality measured below COMAR standards for pH. Although 41% of the benthic sample consisted of taxa intolerant to urban stressors, poor taxa diversity (8 taxa) with one climber taxa and no EPT, Ephemeroptera, or scraper taxa resulted in a biological community that is very poor.

- Biological condition – *“Very Poor”*
- Habitat scores *“Non Supporting”* and *“Partially Degraded”*
- Chironomus (midge) and Caecidotea (isopod) dominated the sample.
- Measured below COMAR standards for pH.
- Shallow channel with minimal habitat complexity. Upstream half of reach deeply incised with raw eroding banks. Virtually no observable flow, likely ephemeral or intermittent. Good riparian width.
