Harness Creek Gully Repair P584605

30% Schematic Design Report

Anne Arundel County,
Maryland

KCI Technologies, Inc.
May 2022
KCI Project Number 171804667.16

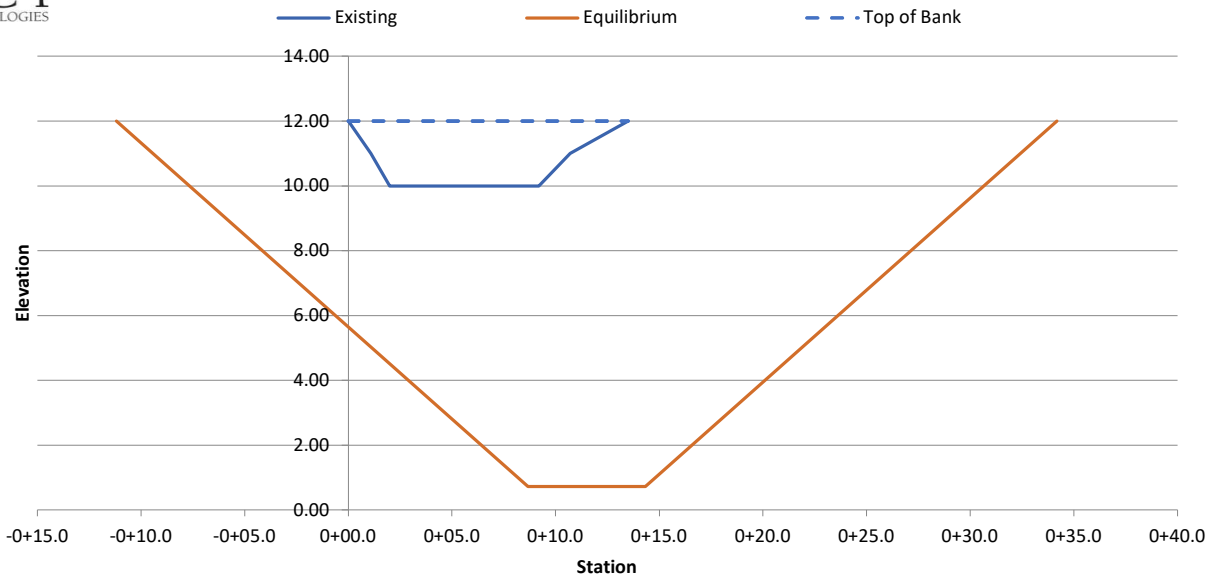
Cross Section 1

BKFL/TOB ELEV=	WIDTH (FT)	MEAN DEPTH (FT)	CROSS SECTION AREA (SQ FT)	WIDTH-DEPTH RATIO	DISCHARGE (cfs)
12					
EXISTING	13.5	1.5	20.0	9.1	89.2
EQUILIBRIUM	45.4	6.3	287.7	7.2	181.2

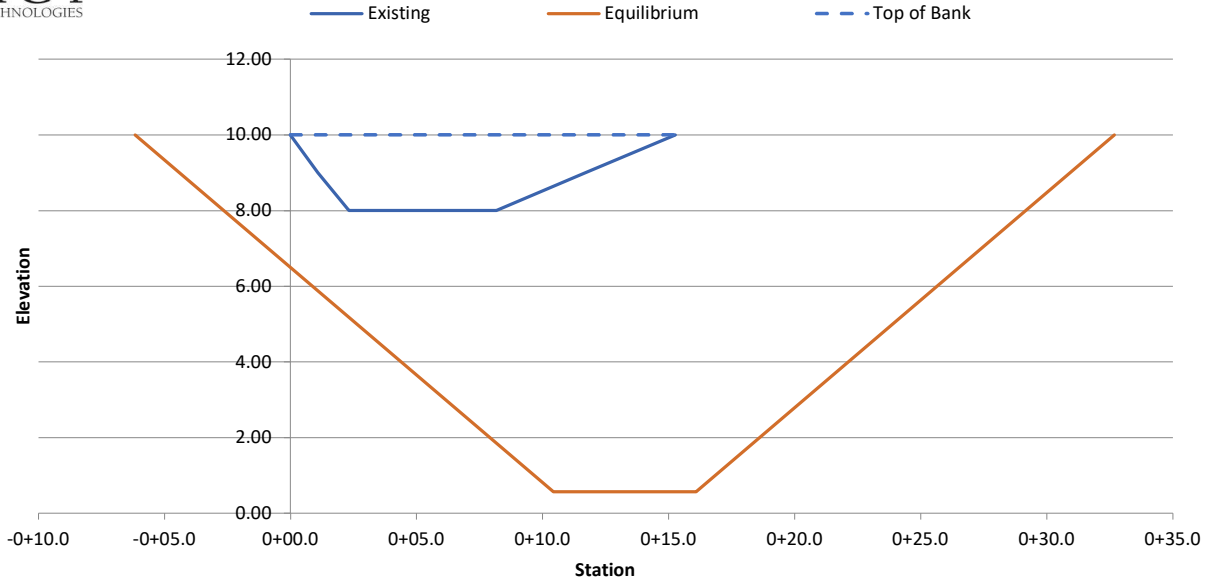
Cross Section 3

BKFL/TOB ELEV= 10	WIDTH (FT)	MEAN DEPTH (FT)	CROSS SECTION AREA (SQ FT)	WIDTH-DEPTH RATIO	DISCHARGE (cfs)
EXISTING	15.3	1.4	21.2	11.0	60.7
EQUILIBRIUM	38.8	5.4	209.8	7.2	153.1
