SHIPLEY'S CHOICE DAM REHABILITATION PROJECT PROJECT UPDATE

1. Official Project Name. Shipley's Choice Dam Rehabilitation Project: The project will be referred to as the Shipley's Dam Project in this document.

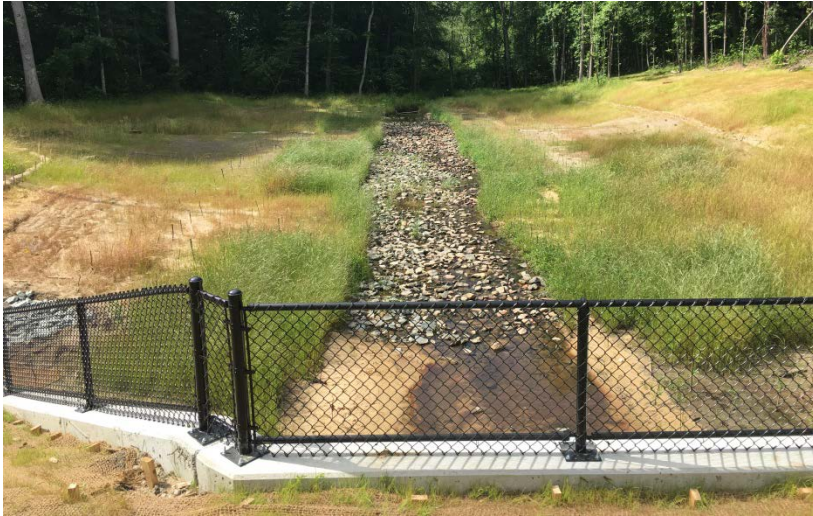
Photo 1 – View upstream from W Benfield Road and new box culvert

a. The Phase 1 work at West Benfield Road was completed. Final tasks included grading and paving the road, installing stone ditches, plantings along the stream, and seeding. The road was reopened to traffic on June 19th.

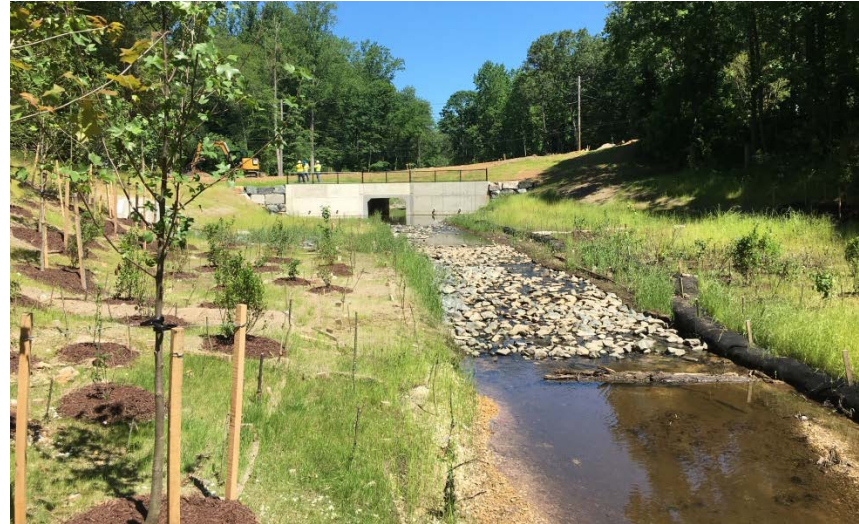
Photo 2 – Plantings downstream from the new culvert

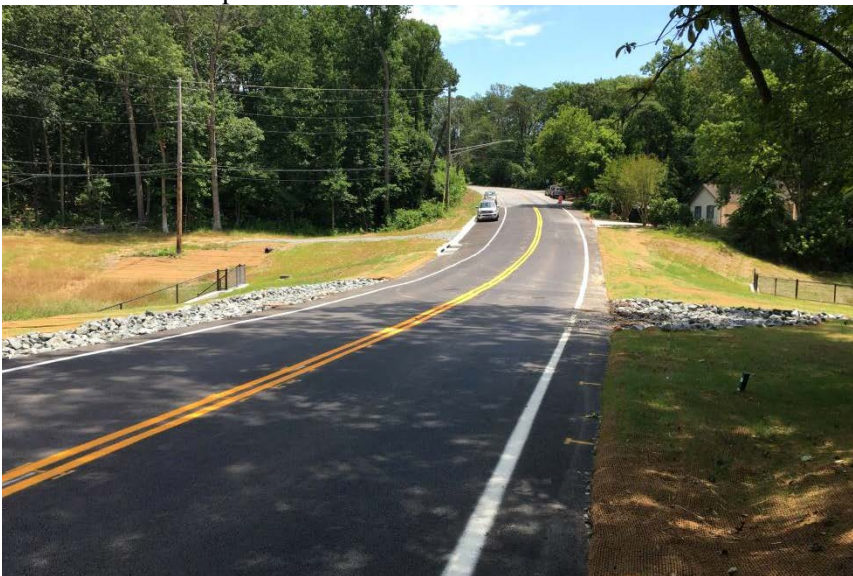
Photo 3 – View eastbound along the reopened W Benfield Road

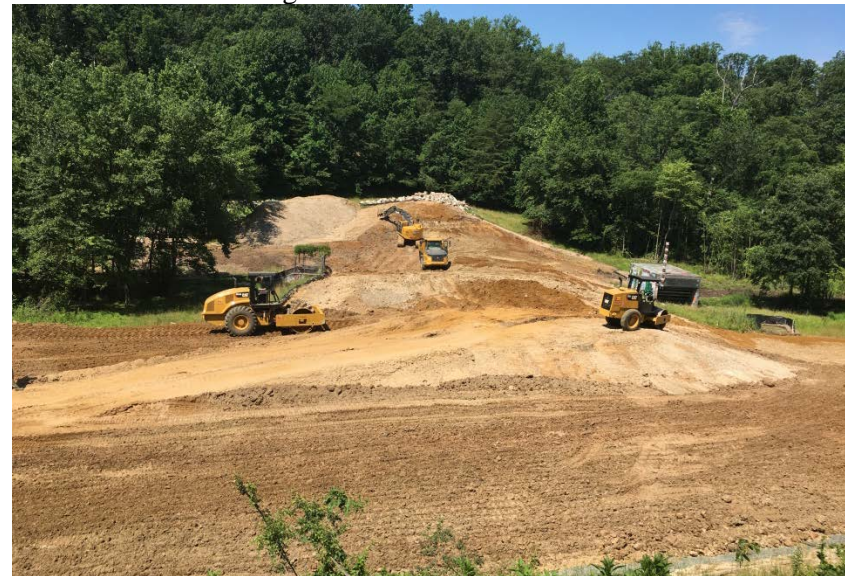
Photo 4 – Dam excavation and fill placement

b. Work continues on Phase 2 construction at the dam site. After installing numerous trench drains to collect hillside seepage, Paydirt began excavating the dam embankment with the top 8 feet removed without incident. Below that, Paydirt encountered wet clay material in the dam, which was expected given the seepage issues the dam has experienced for years. However, this has slowed progress as the material must be dried before it can be placed and compacted on the hillside. The wettest material is being hauled offsite.
