URBAN BEST MANAGEMENT PRACTICES TECHNICAL MEMORANDUM

Subtask 2.2 Patapsco Tidal and Bodkin Creek Watershed Study

July 2011

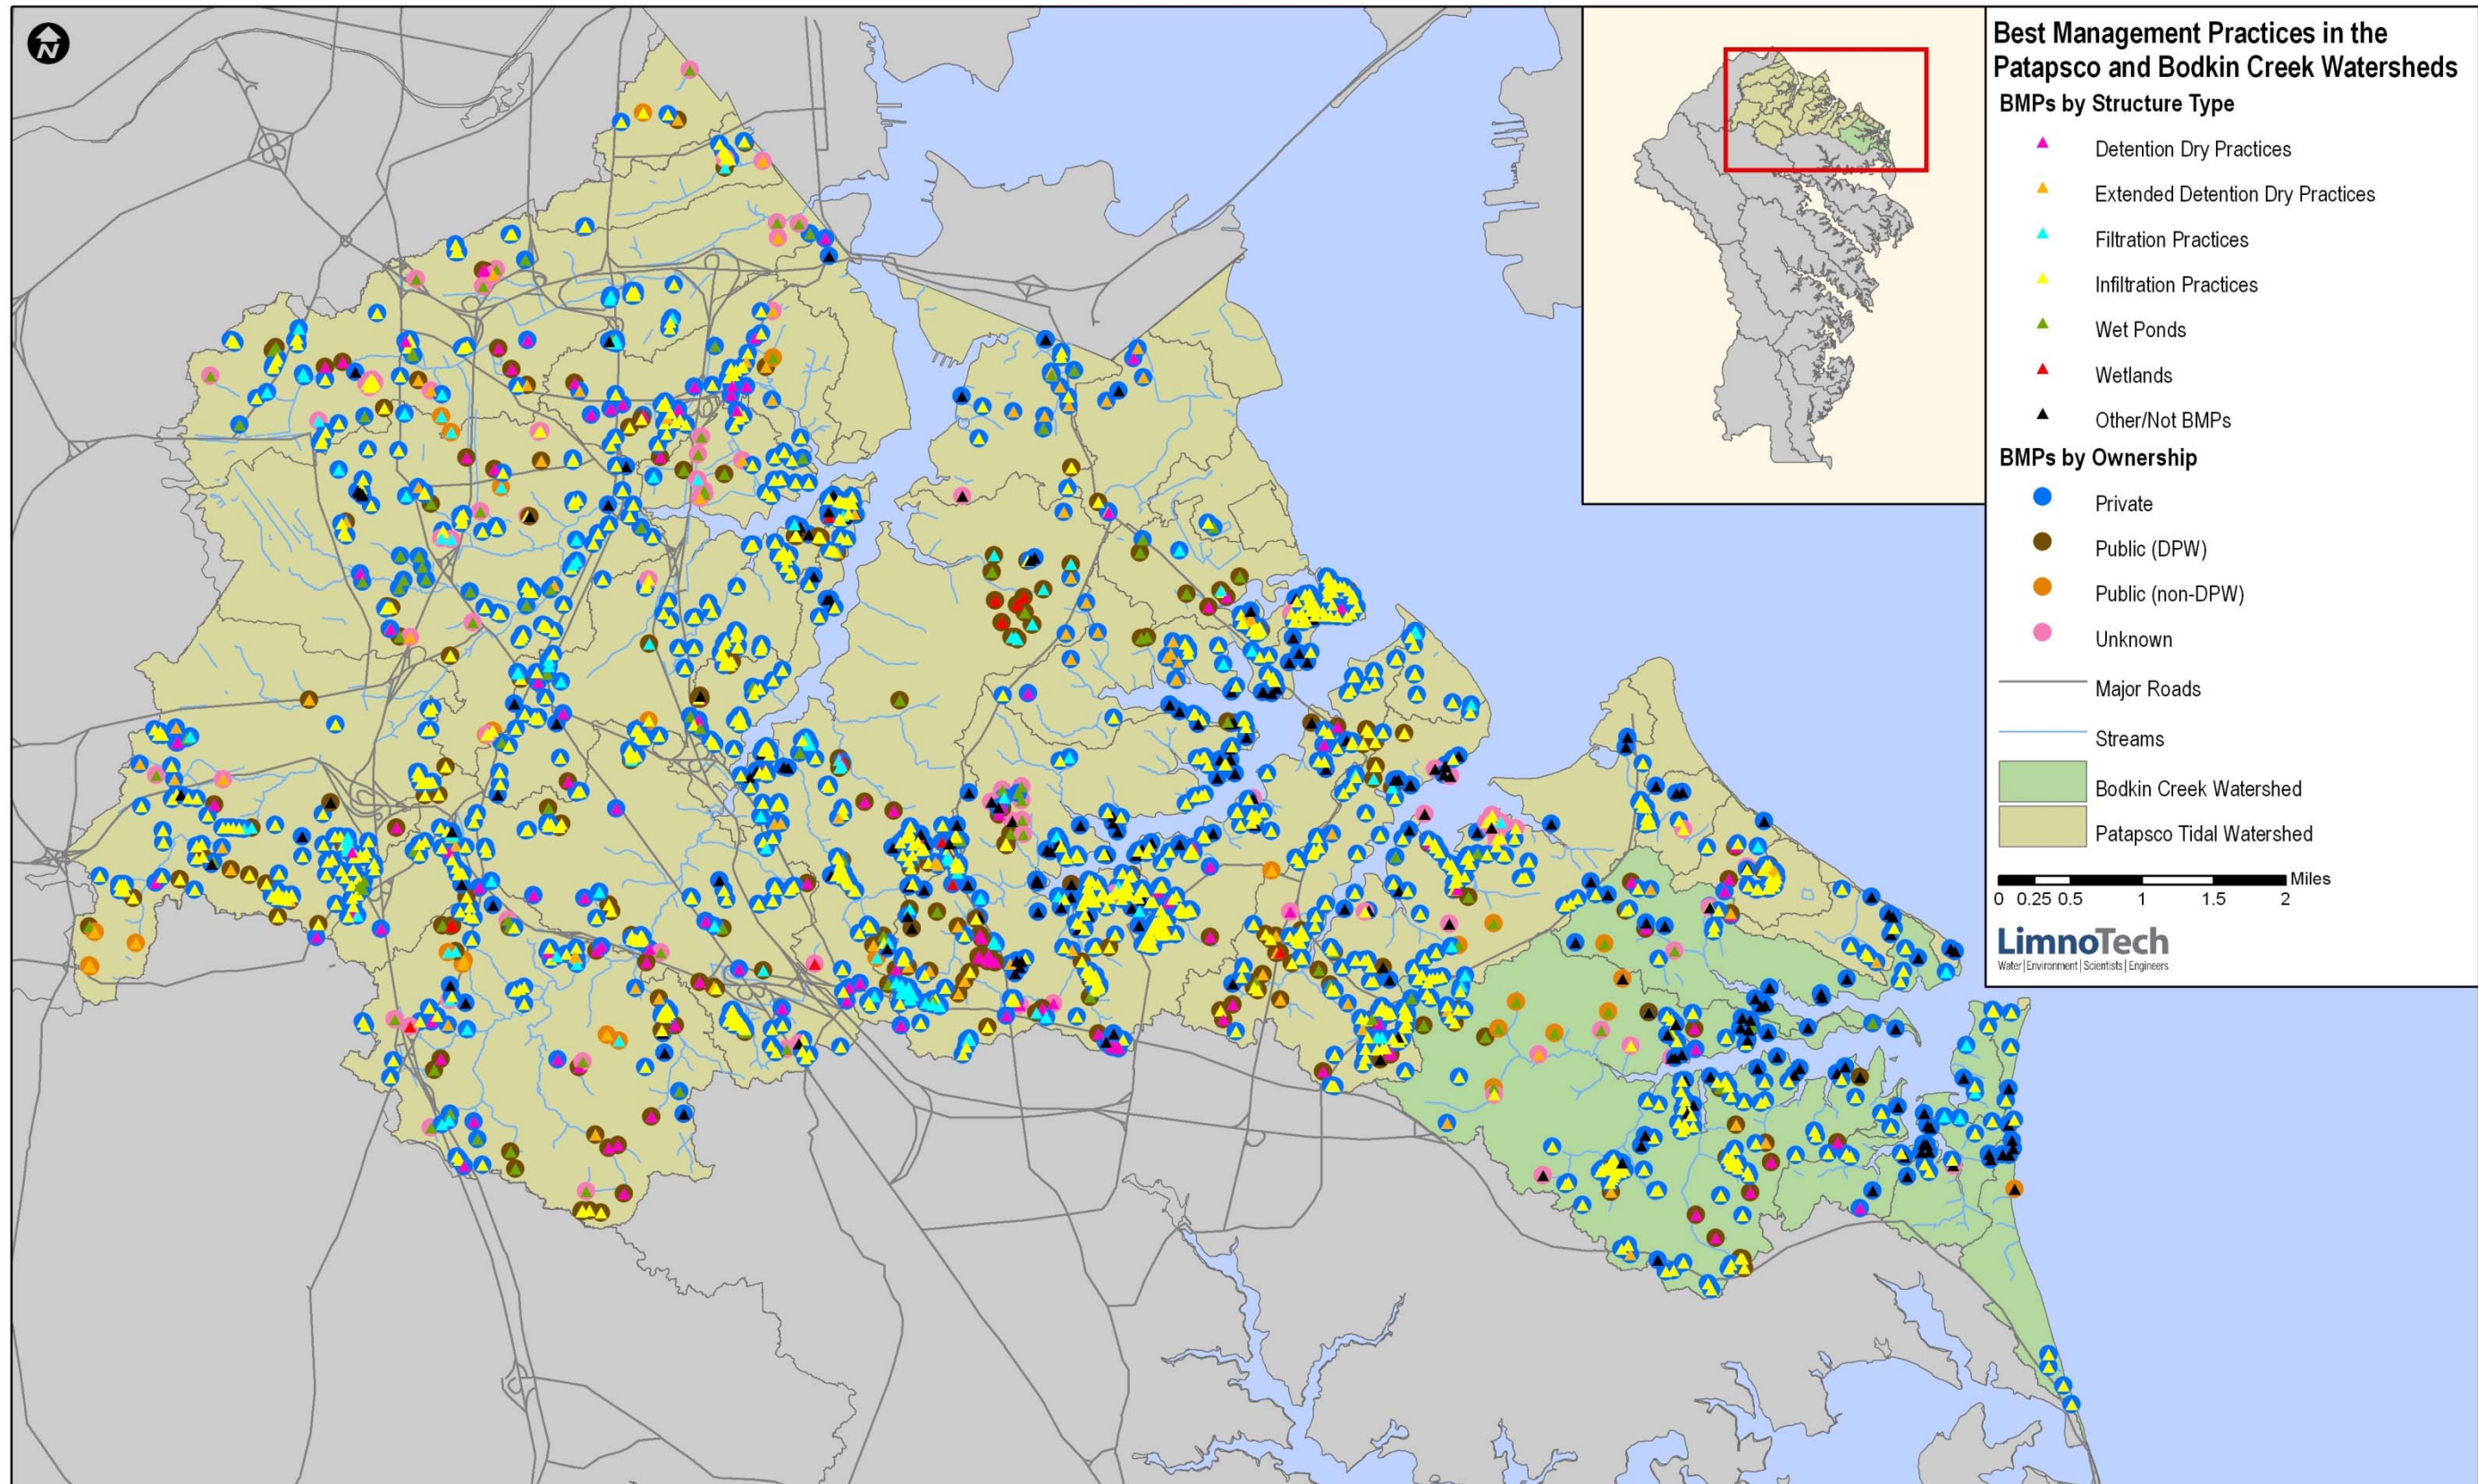
Figure 1. BMPs in the Patapsco Tidal and Bodkin Creek Watersheds

Table 9 is a detailed analysis of all 1,578 BMPs identified and located in this study. The 2,082 researched BMPs are also represented in Figure 1. The BMPs are shown by structure type and ownership.
