Aquatic Biological Assessment of the Watersheds of Anne Arundel County, Maryland: 2004

Anne Arundel County, Maryland
Department of Public Works
Watershed and Ecosystems Services Group
2664 Riva Road
Annapolis, MD 21401

November 2007

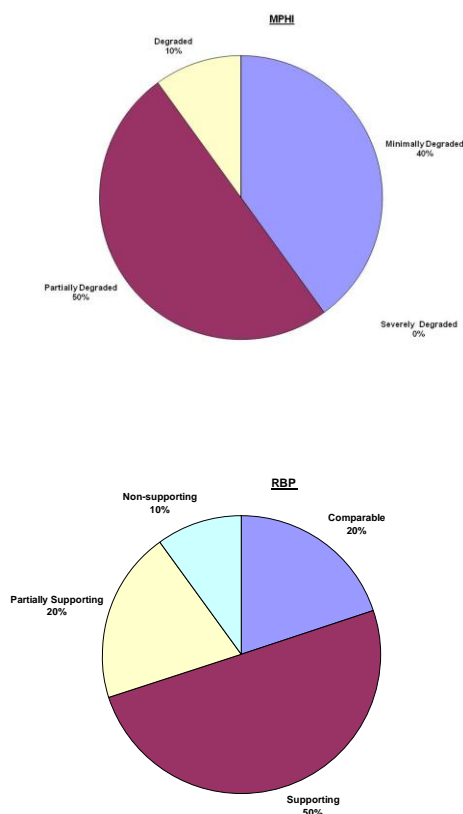
Figure 5 – Severn Run Habitat Scores

The MBSS PHI rated 40 % of the streams within the Severn Run sampling unit as “Minimally Degraded”, 40 % of streams were rated as “Partially Degraded”, and 20 % were rated “Degraded” (**Figure 5**). The average PHI score was 76.4 ± 7.4 , or “Partially Degraded” overall. The RBP habitat assessment rated 20% of streams as “Comparable” to the reference condition, 50% as “Supporting,” 20% as “Partially Supporting” and 10 % were rated as “Non-Supporting.” The average EPA RBP score was 136.3 ± 22.0 , or “Supporting” overall.

However, while habitat was judged to be supporting in the unit, some problems were identified. Throughout the unit, moderately high levels of sediment deposition were observed, meaning that fine sediments were found to have filled some pools and impacted about 20 to 50% of the total length of the reaches assessed.

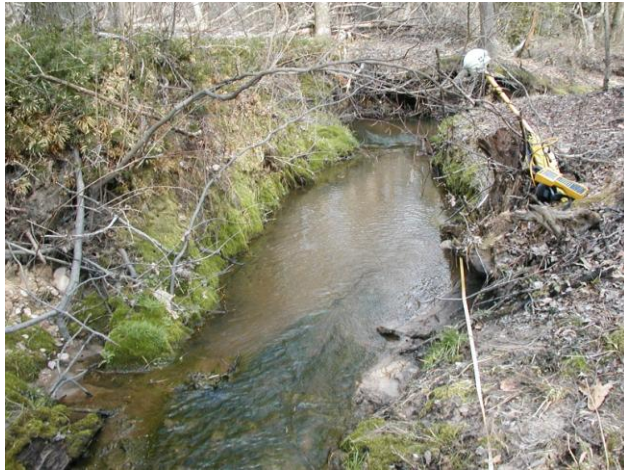
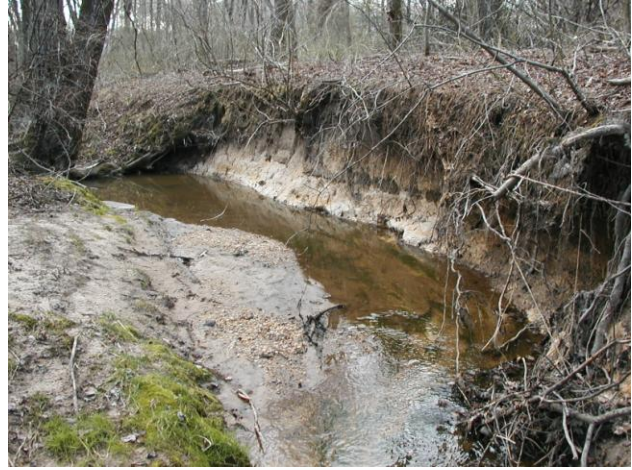
- Biological condition: “Poor”
- Habitat scores:
 - RBP: “Partially Supporting”
 - MPHI: “Partially Degraded”

- Habitat quality results were mixed for this site, but trending toward more than expected impairment based on the biological community observed.
- Habitat impairments observed include poor pool quality, low levels of epifaunal substrate, and high impact from sediment deposition. Additional assessments necessary to determine appropriate remedies for these impairments.
- Investigate potential for additional stormwater management on the extensive developed lands in this watershed.

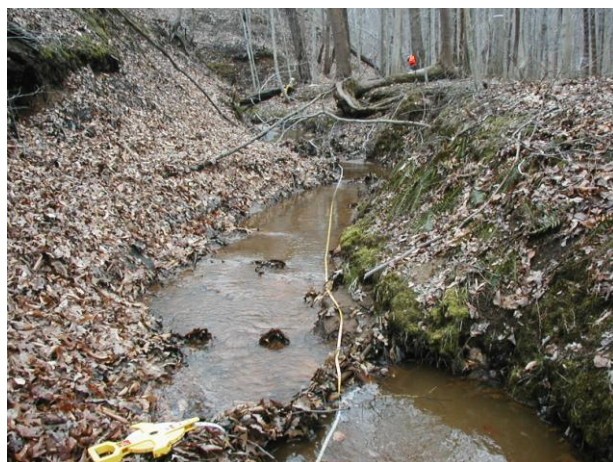
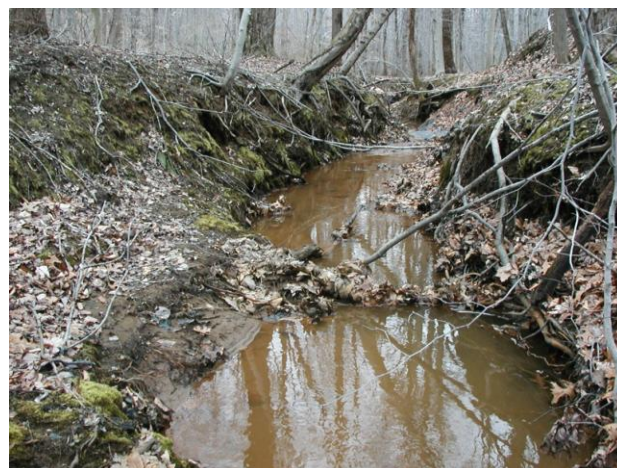
- Biological condition: “Fair”
- Habitat scores:
 - RBP: “Partially Supporting
 - MPHI: Minimally Degraded”

- Biological conditions showed mixed results in relation to habitat quality observed.
- Bank stability, lack of vegetative bank protection, low levels of epifaunal substrate, and moderate sediment loads in-channel were identified as top habitat impairments. Additional investigations necessary to determine need and feasibility of any possible corrective actions.
- Investigate feasibility of stormwater best management practices installation / retrofits for residential and commercial land uses in upstream drainage area.

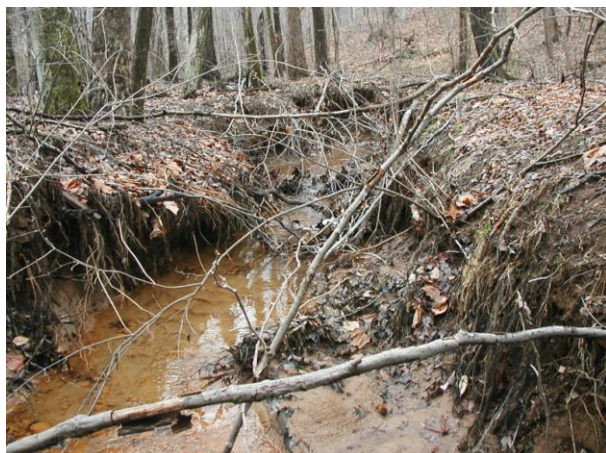
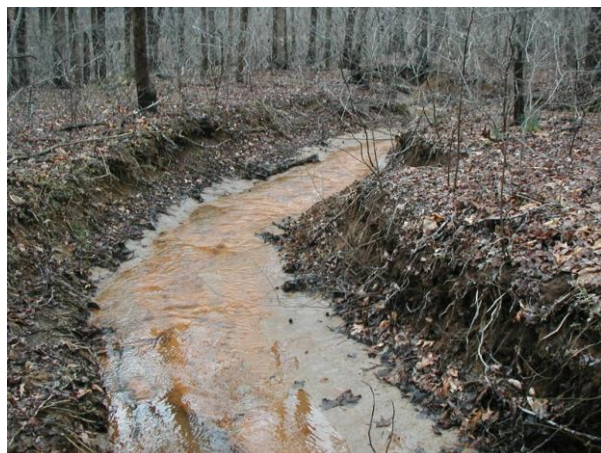
- Biological condition: "Fair"
- Habitat scores:
 - RBP: "Partially Supporting"
 - MPHI: "Degraded"

- Biological community enhanced relative to habitat quality observed.
- Bank stability, lack of vegetative bank protection, low levels of epifaunal substrate, and moderate sediment loads in-channel were identified as top habitat impairments. Additional investigations necessary to determine need and feasibility of any possible corrective actions.
- Investigate feasibility of stormwater best management practices installation / retrofits for residential land uses in upstream drainage area.

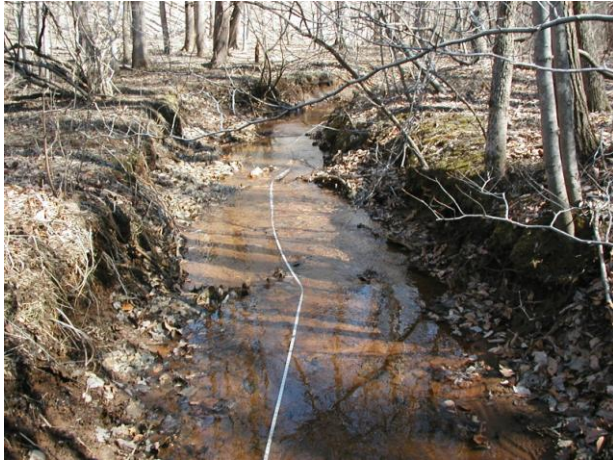
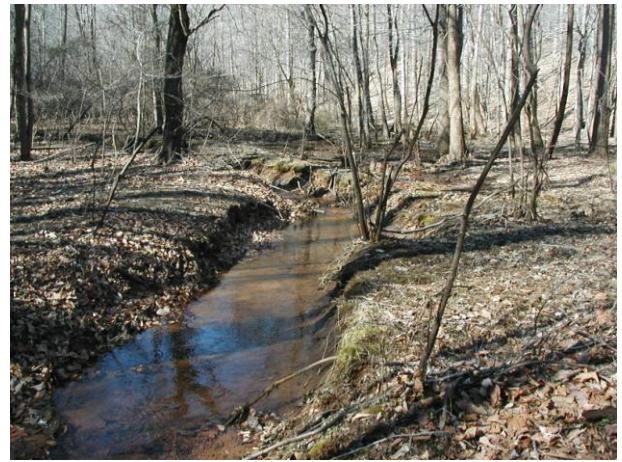
- Biological condition: “Good”
- Habitat scores:
 - RBP: “Supporting”
 - MPHI: “Partially Degraded”

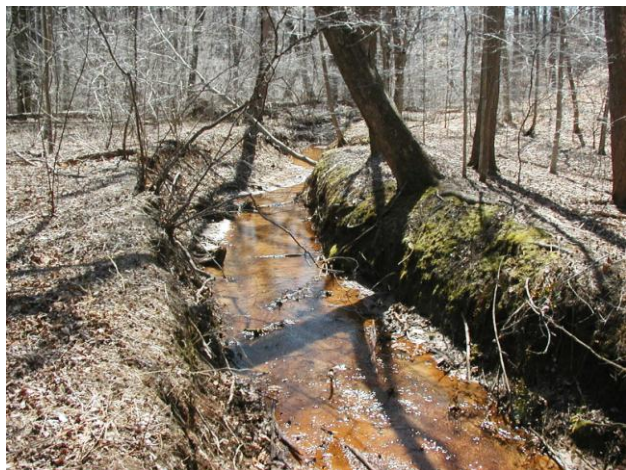
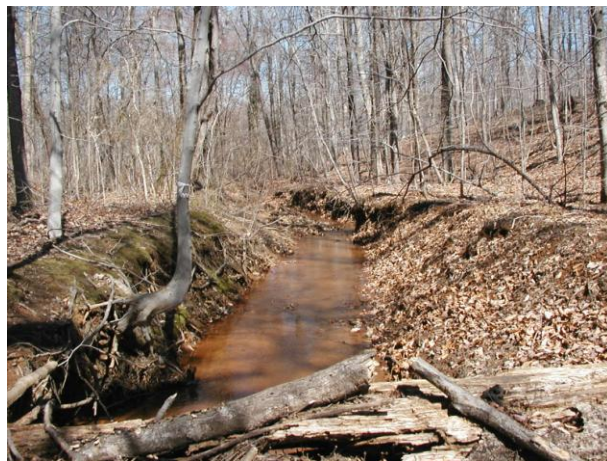
- Biological condition: “Good”
- Habitat scores:
 - RBP: “Partially Supporting”
 - MPHI: “Partially Degraded”

- Biological community is significantly enhanced in relation to observed habitat quality.
- Low levels of imperviousness should be preserved to ensure survival of high quality biological community. Management efforts should focus on watershed preservation activities.
- Bank stability, excessive sediment deposition, and low amounts of suitable substrate were the main habitat impairments observed in this reach. Additional assessment work is necessary to determine the what, if any, restoration should occur within this reach.

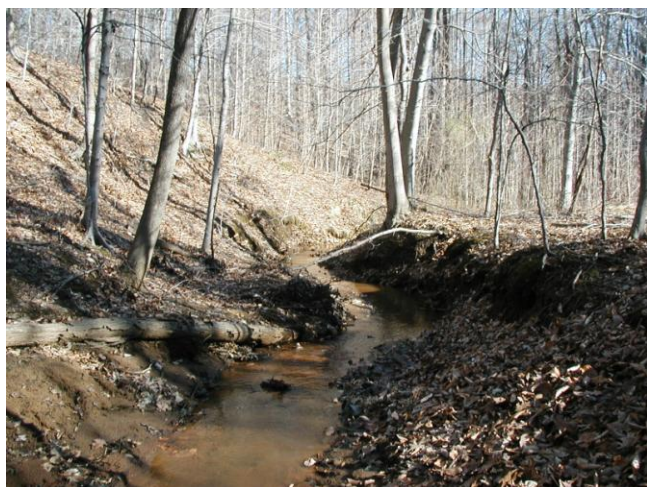
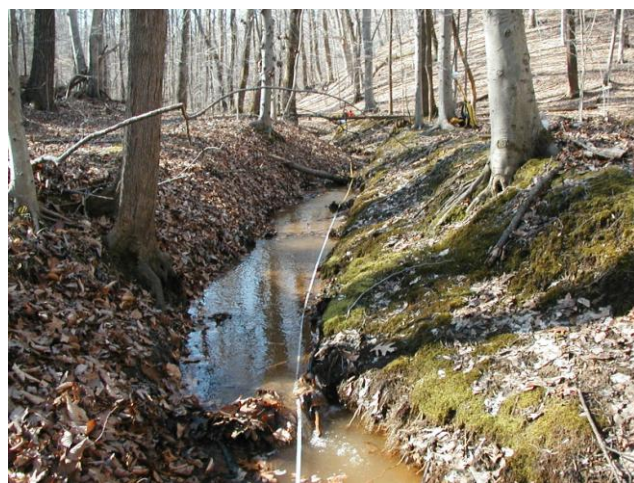
- Biological condition: “Fair”
- Habitat scores:
 - RBP: “Partially Supporting”
 - MPHI: “Minimally Degraded”

- Biological conditions in relation to observed habitat quality are mixed.
- Pool substrate, excessive sediment deposition, and a deficiency in epifaunal substrate were the primary habitat limitations identified in the habitat assessments. Additional assessments are necessary to determine feasibility and necessity of any restoration activities.
- Opportunities to implement stormwater management retrofits should be realized as possible in the extensive residential areas upstream of the sampling reach.

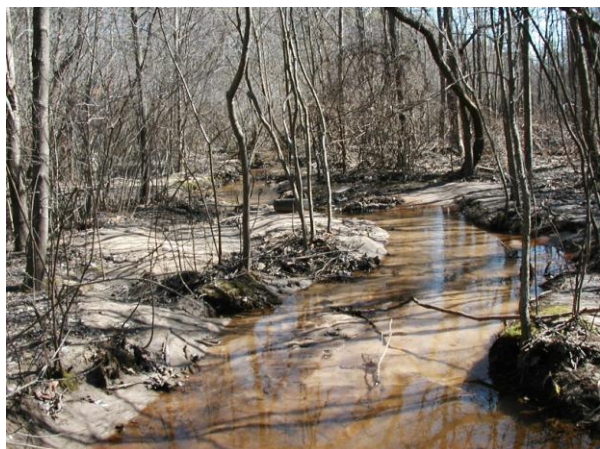
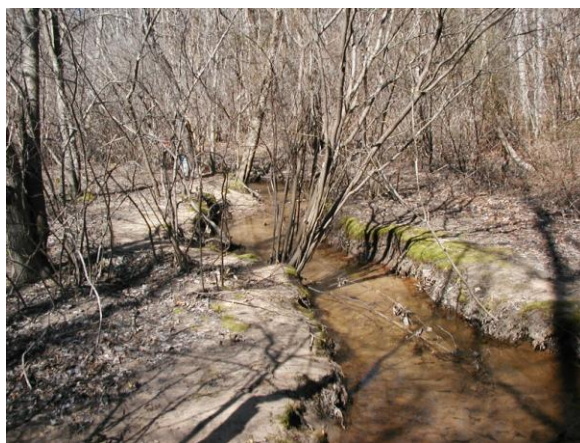
- Biological condition: “Poor”
- Habitat scores:
 - RBP: “Comparable”
 - MPHI: “Minimally Degraded”

- Biological conditions are much more impaired than predicted from available habitat conditions, a likely indication of severe water quality impairment.
- Investigate retrofit opportunities for stormwater management within the extensive residential and commercial / industrial land uses comprising nearly 60% of the upstream drainage area to this reach.
- Inspection of photos from this site shows high levels of fine sediment deposition in the adjacent floodplain, possibly indicating an overload of sediment to this system that could depress the biological community. Additional investigations are necessary to confirm this observation.

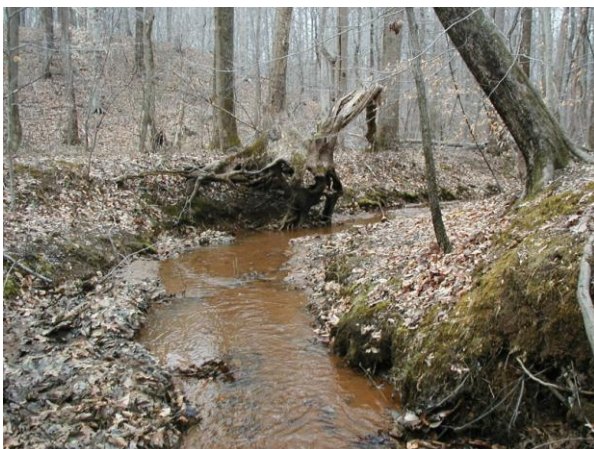
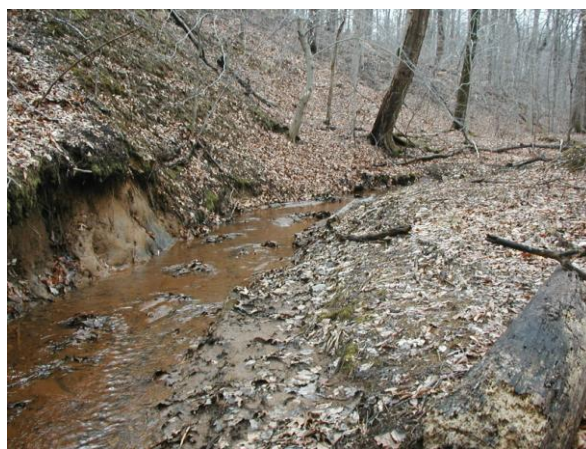
- Biological condition: “Fair”
- Habitat scores:
 - RBP: “Comparable”
 - MPHI: “Minimally Degraded”

- Biological community is more impaired than expected for available habitat, indicative of a water quality impact from upstream land uses.
- Minor habitat impairments observed include low levels of sinuosity, somewhat low levels of epifaunal substrate, and poor pool habitat variability.
- Investigate retrofit opportunities for stormwater management in the extensive residential land uses upstream of sample site in order to improve water quality.

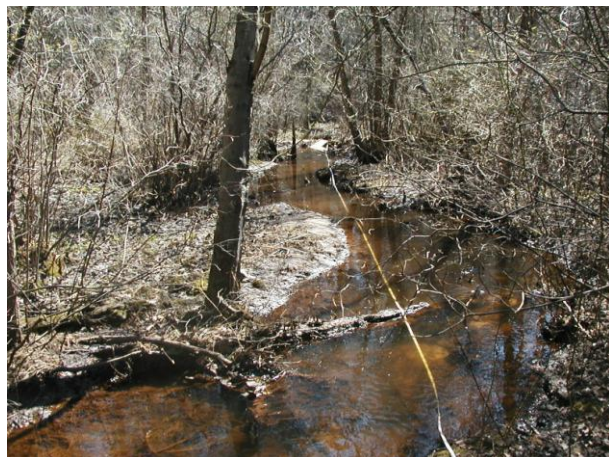
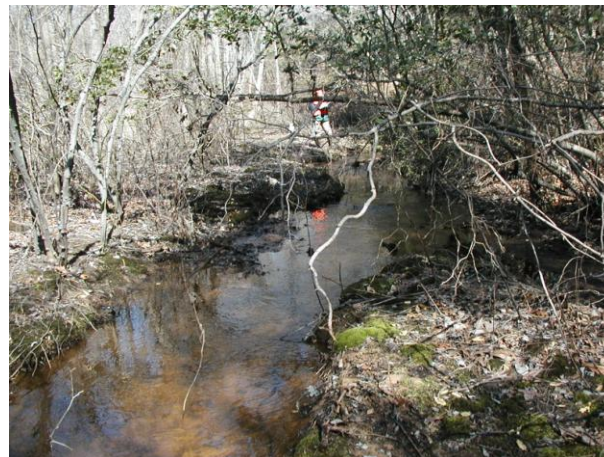
- Biological condition: “Poor”
- Habitat scores:
 - RBP: “Comparable”
 - MPHI: “Minimally Degraded”

- Biological conditions are greatly impaired in the context of measured habitat quality, indicating water quality impairment associated with upstream runoff to this stream reach exist.
- Determine feasibility of stormwater management retrofit / installation in extensive residential land uses in upstream contributing drainage area.

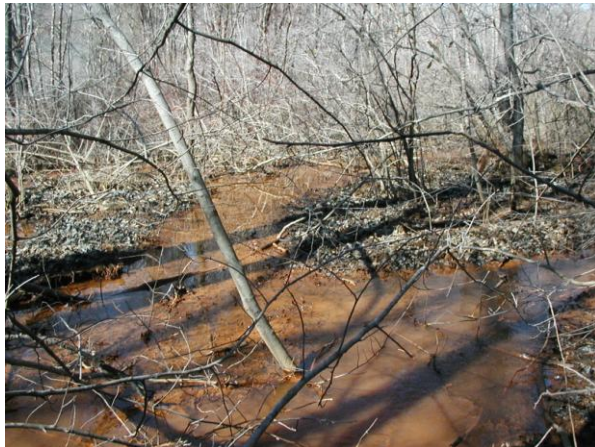
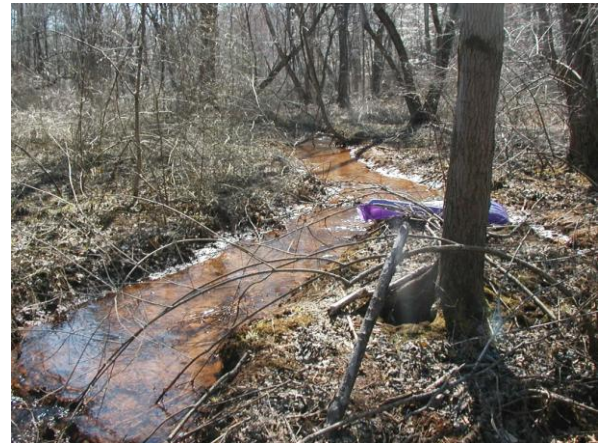
- Biological condition: "Poor"
- Habitat scores:
 - RBP: "Comparable"
 - MPHI: "Partially Degraded"

- Biological community degraded in comparison to available habitat, indicative of water chemistry impairments associated with runoff from developed areas upstream.
- Poor distribution of pool depths and moderately low levels of epifaunal substrate were major habitat impairments observed in this stream reach.
- Additional investigations necessary to determine possible types and sources of water quality impairments that might be present in this stream reach.

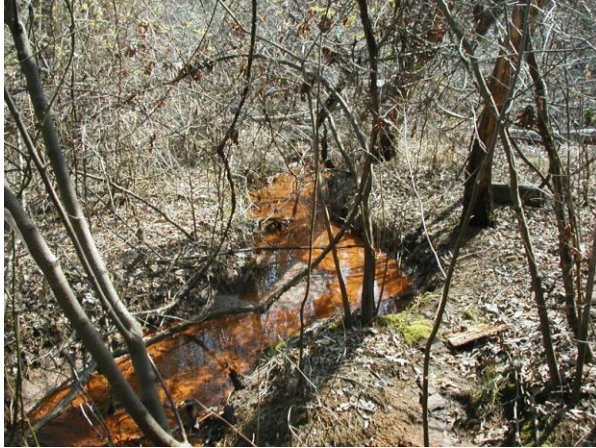
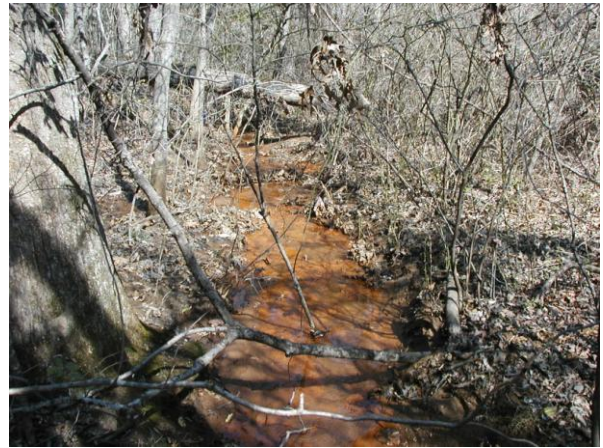
- Biological condition: “Very Poor”
- Habitat scores:
 - RBP: “Partially Supporting”
 - MPHI: “Partially Degraded”

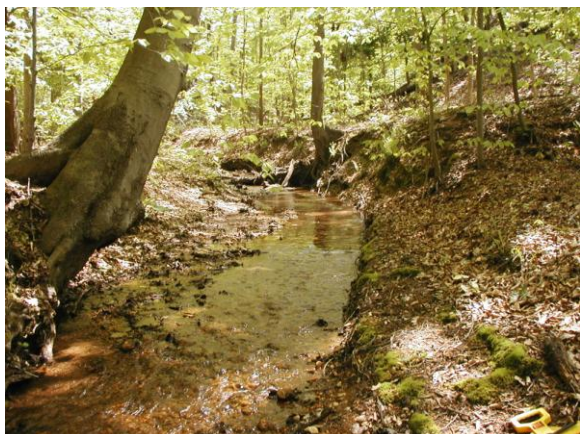
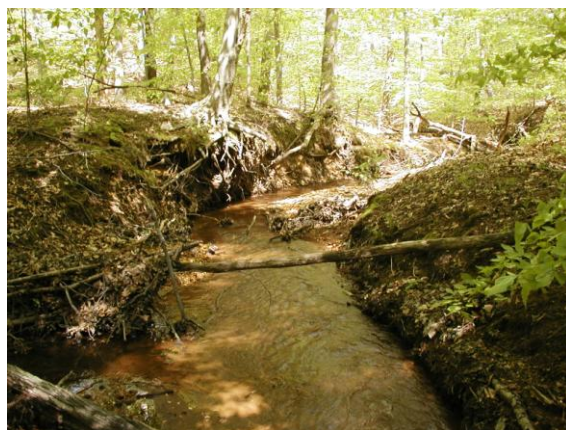
- Biological condition: “Fair”
- Habitat scores:
 - RBP: “Supporting”
 - MPHI: “Partially Degraded”

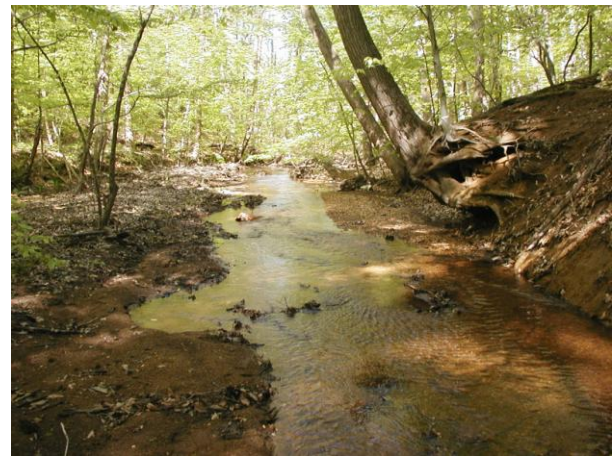
Upstream

- Biological condition: “Fair”
- Habitat scores:
 - RBP: “Supporting”
 - MPHI: “Partially Degraded”

- Biological conditions enhanced relative to the observed level of habitat quality.
- Watershed enhancements should include best management practice installation, as appropriate, on the agricultural and develop lands within the upstream drainage area.
- Moderate bank instability, poor pool habitat, low levels of woody material and other epifaunal substrate, and overwide channel conditions were the primary habitat impairments observed. Additional assessments are necessary to determine the need, feasibility of corrective actions.

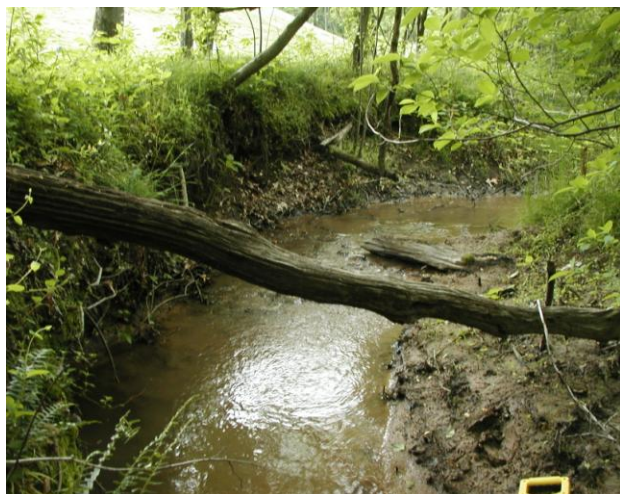
Upstream

- Biological condition: “Poor”
- Habitat scores:
 - RBP: “Partially Supporting”
 - MPH: “Partially Degraded”

- Habitat assessment results were mixed for this site, but biological community observed is trending toward more than expected impairment based on the observed habitat quality.
- High levels of bank instability observed. Perform geomorphic assessment work to determine cause of bank instability, develop appropriate restoration plan, if necessary.
- Mixed agricultural and urban land uses should be evaluated for potential BMP implementation.

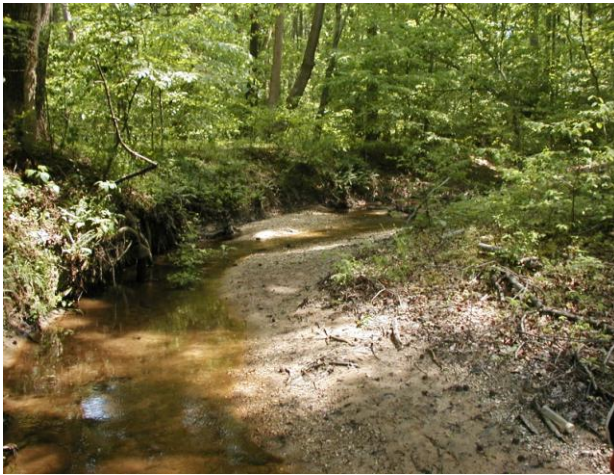
Upstream

- Biological condition: “Fair”
- Habitat scores:
 - RBP: “Supporting”
 - MPHI: “Minimally Degraded”

- Habitat assessment results were mixed for this site, but biological community observed is trending toward more than expected impairment based on the observed habitat quality.
- Additional assessments necessary to determine feasibility of stormwater best management practices retrofits on residential land uses.
- Habitat impairments include excessive channel width, resulting in poor baseflow habitat, and poor pool quality associated with excessive sediment inputs. Additional assessments are recommended to determine feasibility, correctability of observed impacts.

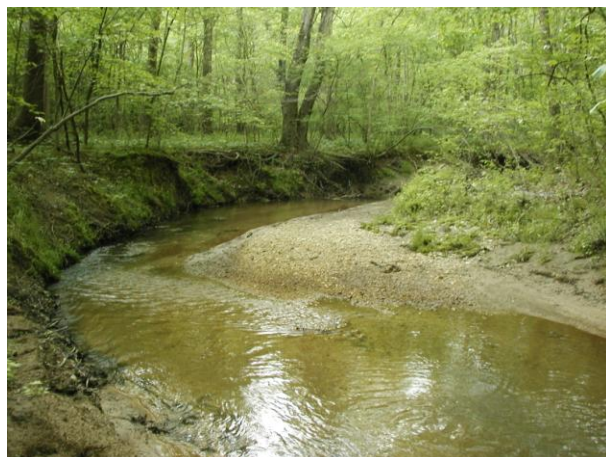
Downstream

- Biological condition: “Good”
- Habitat scores:
 - RBP: “Comparable”
 - MPHI: “Minimally Degraded”

- Biological conditions are as expected for observed level of habitat quality.
- Protect current watershed conditions to maintain high quality riparian area system.
- Determine need for best management practices installation on upstream agricultural lands.
- Only minor streambank erosion observed here. Determine need for correction with additional assessments.

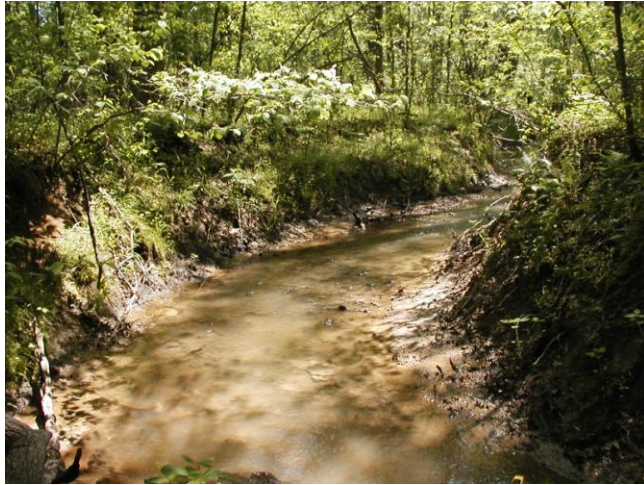
Upstream

- Biological condition: “Poor”
- Habitat scores:
 - RBP: “Supporting”
 - MPHI: “Minimally Degraded”

- Biological community is of lower quality expected for observed habitat conditions.
- Perform assessment to determine if a water quality impairment depressing biological community exists.
- Habitat scores show depressed levels of necessary habitat for macroinvertebrates. Determine if epifaunal substrate could be enhanced in this reach.
- Determine the feasibility of best management practice implementation on upstream agricultural lands, as necessary.

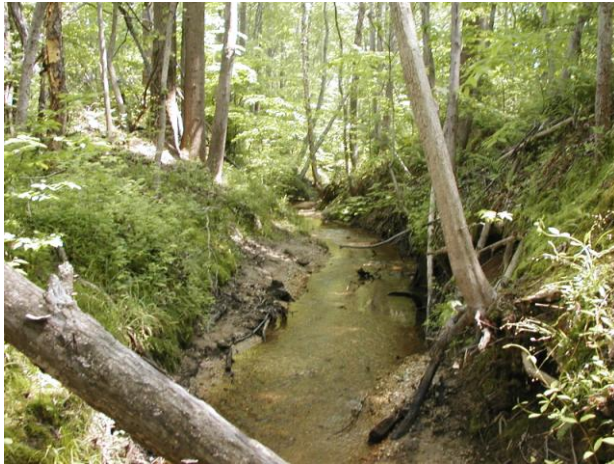
Upstream

- Biological condition: “Fair”
- Habitat scores:
 - RBP: “Supporting”
 - MPHI: “Minimally Degraded”

- Habitat assessment results were mixed for this site, but biological community observed is trending toward more than expected impairment based on the observed habitat quality.
- Some impairment noted in right bank riparian area. Pool quality was judged marginal. Additional investigation is necessary to determine need for any restoration.
- Determine necessity and feasibility of best management practice installation on residential land uses.

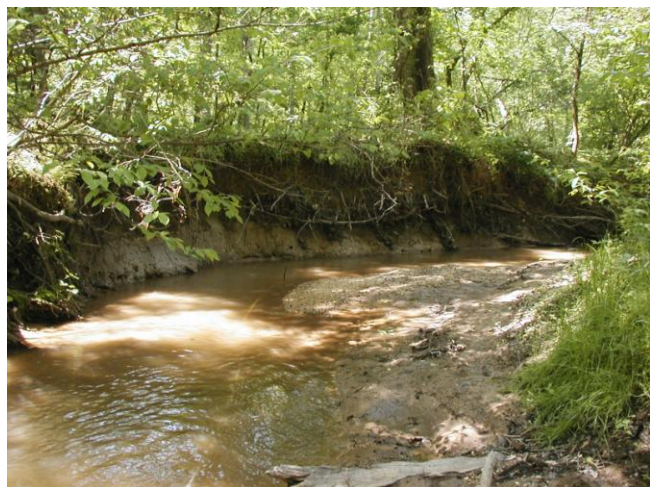
Upstream

- Biological condition: “Fair”
- Habitat scores:
 - RBP: “Comparable”
 - MPHI: “Minimally Degraded”

- Biological conditions are slightly impaired in comparison to observed habitat conditions.
- Consider possible water quality assessment to determine if site water chemistry is depressing biological community.
- Some moderate bank erosion observed. Additional investigation needed to determine if restoration required.
- Determine the feasibility of best management practice implementation on upstream agricultural lands.
