# Aquatic Biological Assessment of the Watersheds of Anne Arundel County, Maryland: 2011

# **Aquatic Biological Assessment of the Watersheds of Anne Arundel County, Maryland: 2011 Round Two - Year Three**

## **February 2012**

**KCI Technologies, Inc.  
936 Ridgebrook Road  
Sparks, Maryland 21152**

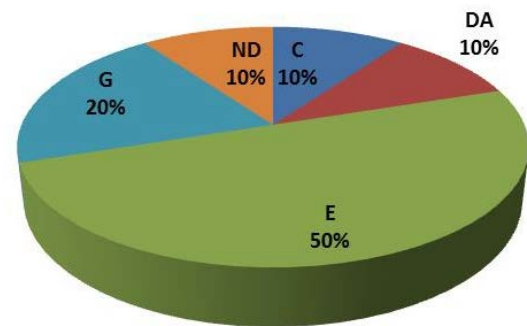
**Figure 15 - Rosgen stream types observed in Severn Run (n=10)**

Site-specific geomorphic assessment results can be found in Appendix A. Stream type E was observed in half of the sites in the Severn Run sampling unit (Figure 15). Twenty percent of sites were entrenched G type streams. Less-entrenched, and generally more stable, C type streams and the anastomosed DA type streams each accounted for ten percent of the sites. The stream type of one site, R2-09-08, could not be determined due to substantial ditching and straightening of the channel.

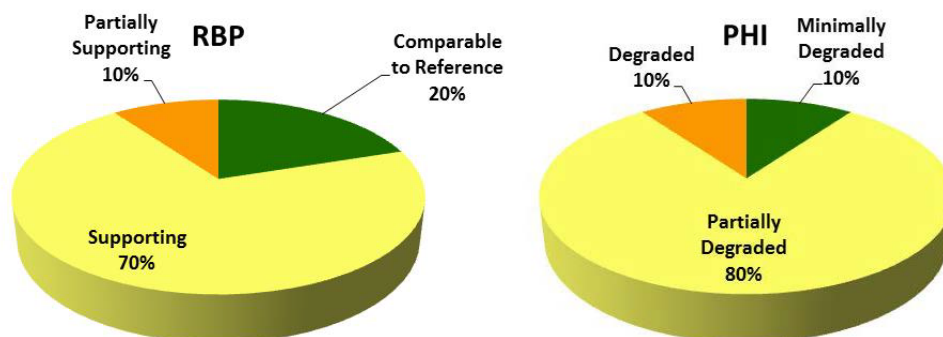
Figure 16 – Upper Magothy Habitat Scores (n=10)

The majority of sites in Upper Magothy were rated 'Supporting' (70 percent) with two sites (20 percent) rated as 'Comparable to Reference' and only one site (10 percent) rated as 'Partially Supporting' by the EPA RBP method (Figure 16). With an average RBP score of  $141.6 \pm 14.1$  and a narrative rating of 'Supporting,' this sampling unit received the highest average RBP score. Individual site scores ranged from 114 ('Partially Supporting') to 167 ('Comparable to Reference'). Similar to the RBP scores, the majority of sites were rated 'Partially Degraded' (80 percent) with the remaining 20 percent split equally between 'Minimally Degraded' and 'Degraded.' The average PHI rating was 'Partially Degraded' with a score of  $73.0 \pm 5.9$ , with individual site scores ranging from 65.9 ('Degraded') to 84.8 ('Minimally Degraded'). The majority of reaches received suboptimal scores for instream physical habitat as well as high scores for bank stability, vegetative protection, and riparian zone width.

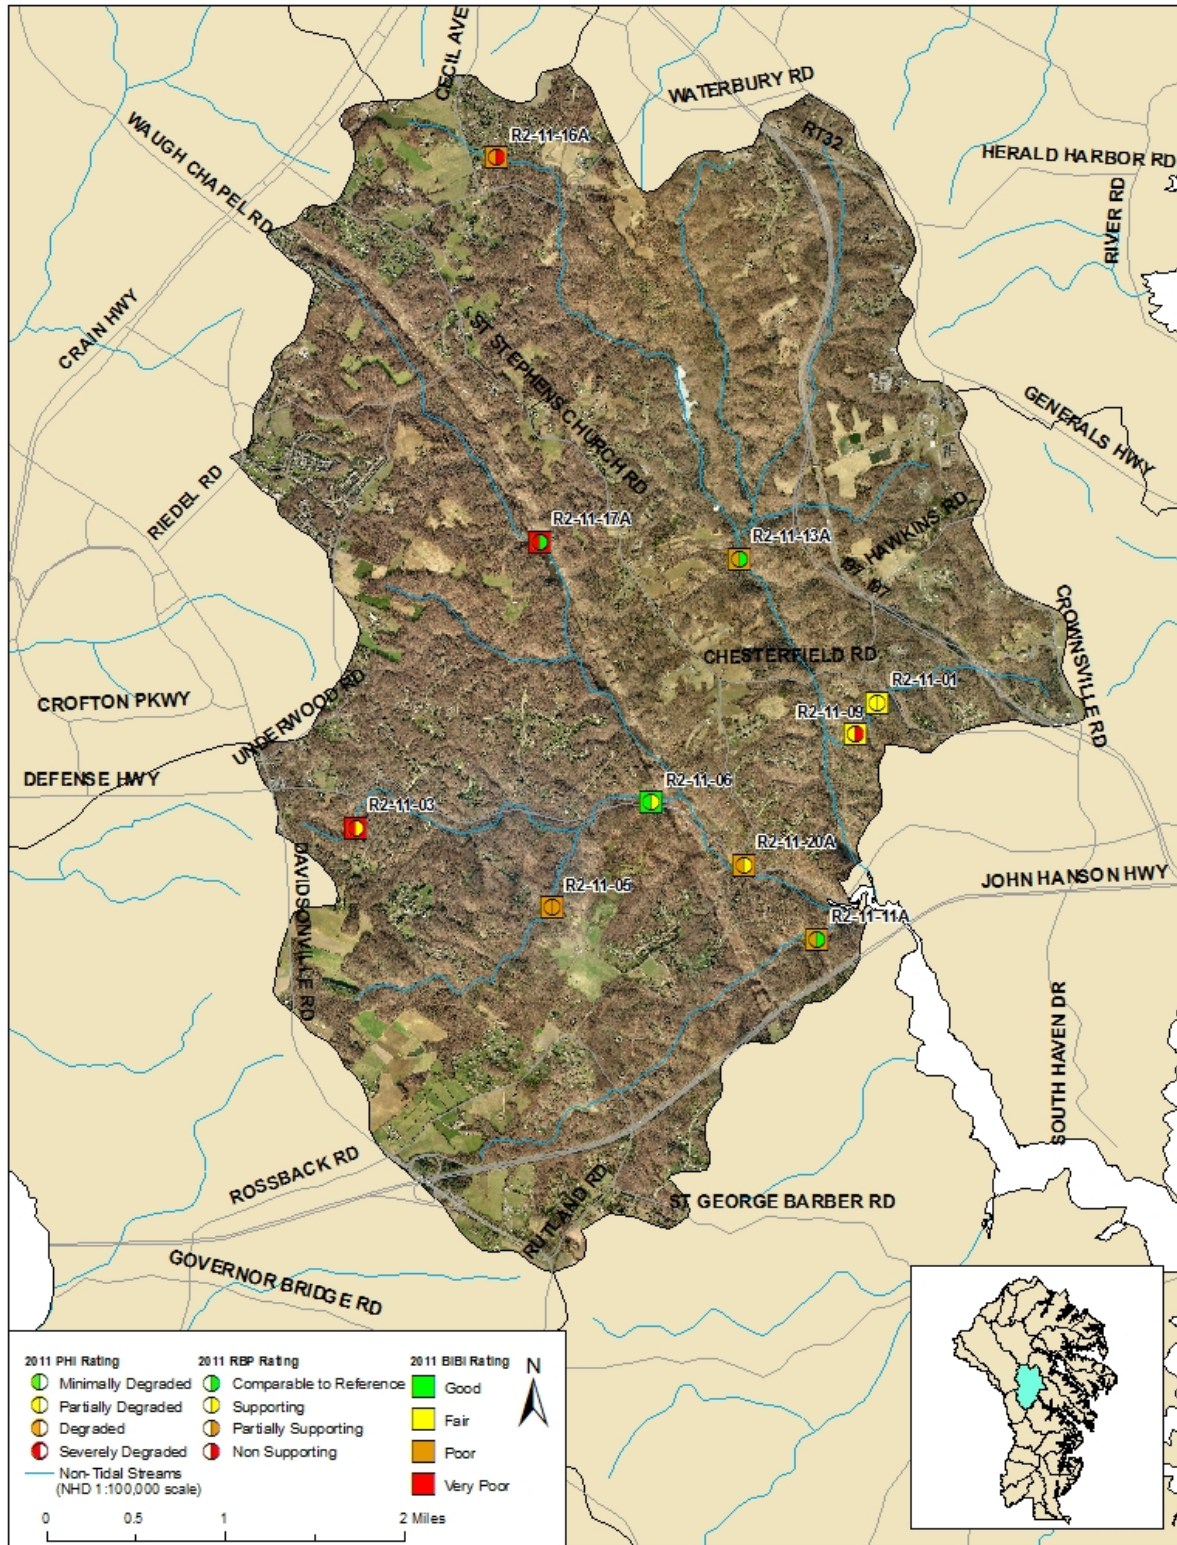
Figure 21 – Upper North River Sampling Sites

The Upper North River sampling unit is located in the central part of the County between Crofton and Crownsville (Figure 1) and has a drainage area of 12,795 acres. The ten sampling sites (seven 1<sup>st</sup> order, two 2<sup>nd</sup> order, and one 3<sup>rd</sup> order) have drainage areas ranging from 156 to 5,666 acres (Figure 21). Land use in the Upper North River sampling unit is primarily comprised of forested land (62 percent) followed by developed land (25 percent) and agriculture (9 percent). Nine sampling sites have forest as a dominant land use, with just one site located on Bacon Ridge Branch (R2-11-16A) dominated by developed land. Impervious surfaces comprise of 7.4 percent of the Upper North sampling unit with individual sites ranging from 5.1 to 13.6 percent imperviousness. However, two major transportation corridors, Interstate I-97 and John Hanson Highway (MD Routes 50/301), cross through the watershed.

Site R2-11-17A, located in the headwaters of North River within a wetland complex and adjacent to a powerline right-of-way corridor (Figure 21), received the lowest BIBI score of 1.57 with a 'Very Poor' rating. Fourteen taxa were present in this sample, which was predominantly comprised of midges including *Psectrocladius* (TV=6.6) and *Zalustschia* (TV=6.6) that accounted for 37 and 29 percent of the sample, respectively. This sample consisted of few climbers and no EPT, Ephemeroptera, or scraper taxa. Located on Bell Branch and adjacent to Defense Highway (Route 450), site R2-11-06 received the highest BIBI score of all sites sampled in 2011 (4.43), resulting in a 'Good' biological condition rating. Of the 29 taxa identified in this sample, seven were EPT including two Ephemeroptera taxa. This site also scored high for scraper taxa (total of 4) and percent climbers (24 percent).

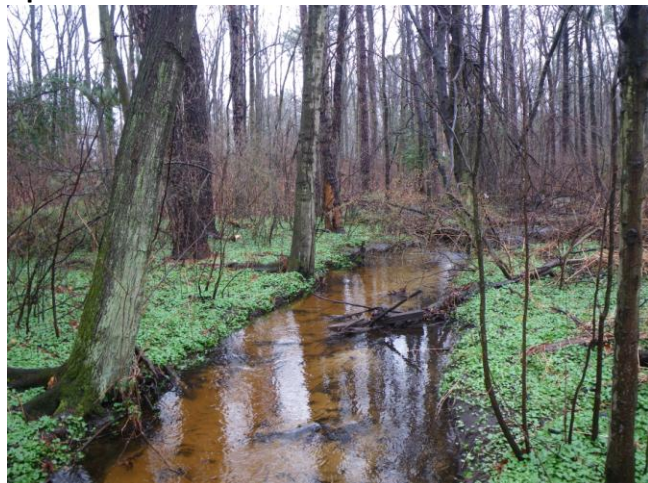
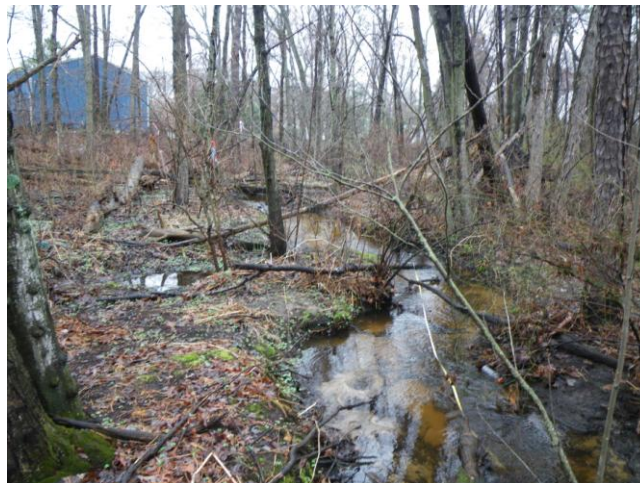
## Upper Magothy Sampling Unit

- Biological condition – “Fair”
- Habitat scores “Supporting” and “Partially Degraded”
- Midges, including Parametrioctenemus and Tanytarsus, dominated the sample. Scored high for number of taxa, EPT, scraper taxa, and percent climbers.
- Water quality values within COMAR standards.
- Sub-optimal epibenthic substrate and instream habitat. Wood/rootwads and undercut banks also provide stable habitat. Refuse present in moderate amounts.

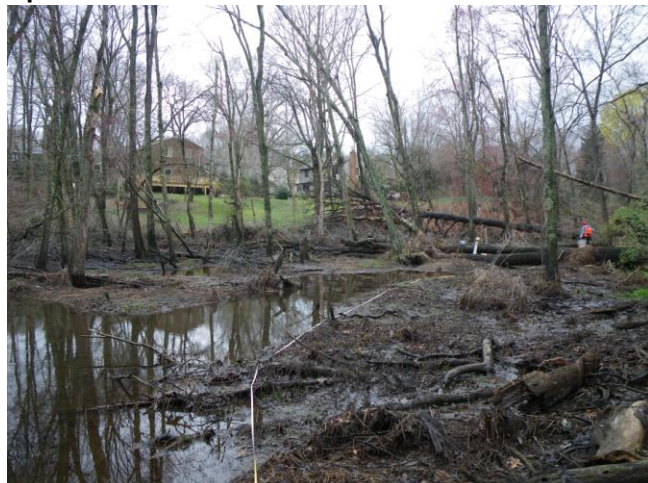
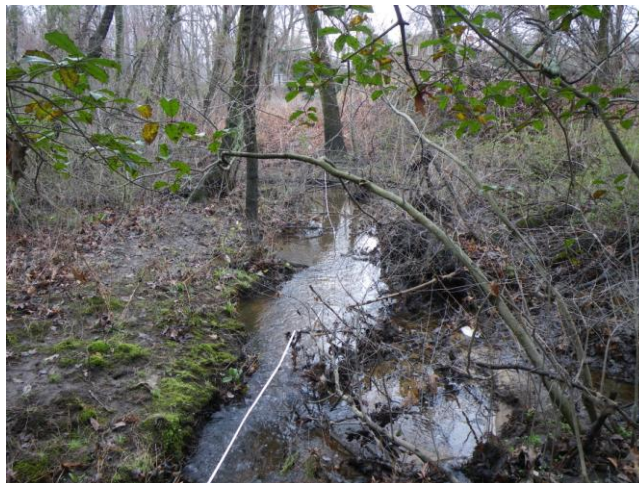
## Upper Magothy Sampling Unit

- Biological condition – “Fair”
- Habitat scores “Supporting” and “Degraded”
- Isopods (tolerant Caecidotea), midges (Rheotanytarsus), and bivalves (Musculium) dominated the sample. Scored high for number of taxa, scraper taxa, and percent climbers.
- Water quality values within COMAR standards.
- Marginal habitat diversity with refuse present in moderate amounts. Stable, well-vegetated banks and good riparian width.

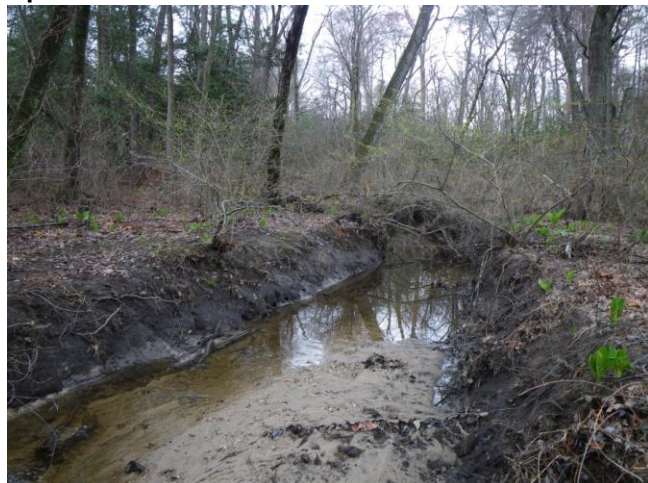
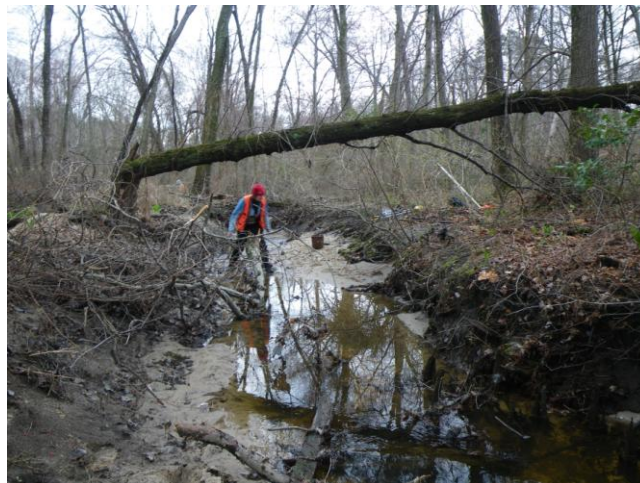
## Upper Magothy Sampling Unit

- Biological condition – “Fair”
- Habitat scores “Partially Supporting” and “Partially Degraded”
- Midge, including Parametrioctenemus, dominated the sample. Scored high for number of taxa, scraper taxa, and percent climbers.
- Water quality values within COMAR standards.
- Marginal instream habitat and epibenthic substrate with abundant woody debris. Heavily eroded banks with little vegetative protection. Good riparian width.

- Buffer enhancement.
- Determine causes of instability observed in this reach and evaluate potential for stabilization.
- Investigate potential water quality impacts from residential land uses.

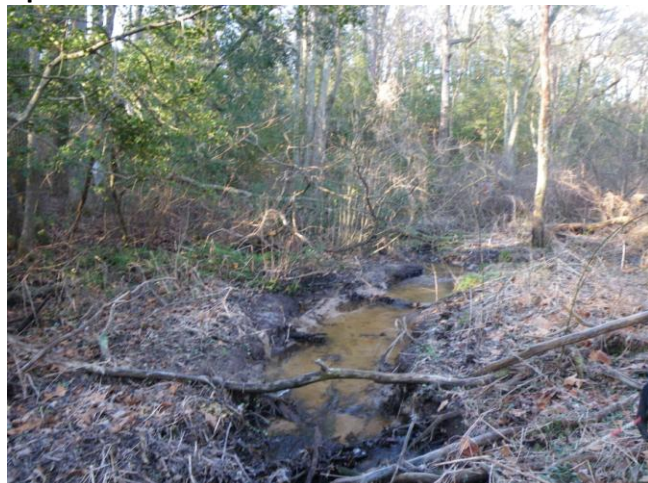
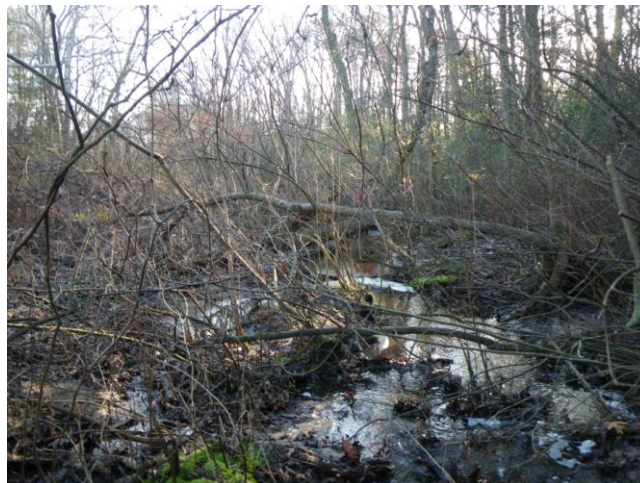
## Upper Magothy Sampling Unit

- Biological condition – “Fair”
- Habitat scores “Supporting” and “Partially Degraded”
- Midges, including Parametrioctenemus and Corynoneura, and caddisflies (Diplectrona) dominated the sample. Scored high for number of taxa and EPT.
- Water quality values within COMAR standards but conductivity elevated.
- Woody debris and rootwads providing some stable habitat. Refuse present in moderate amounts. Stable, well-vegetated banks with good riparian width on the left bank; however, poor riparian width on the right bank.

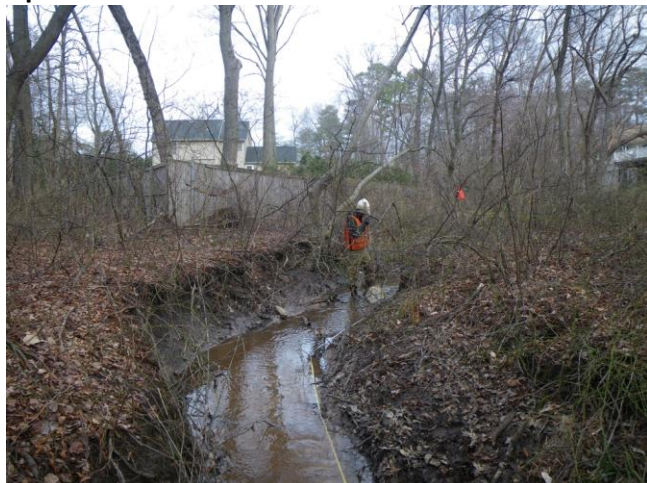
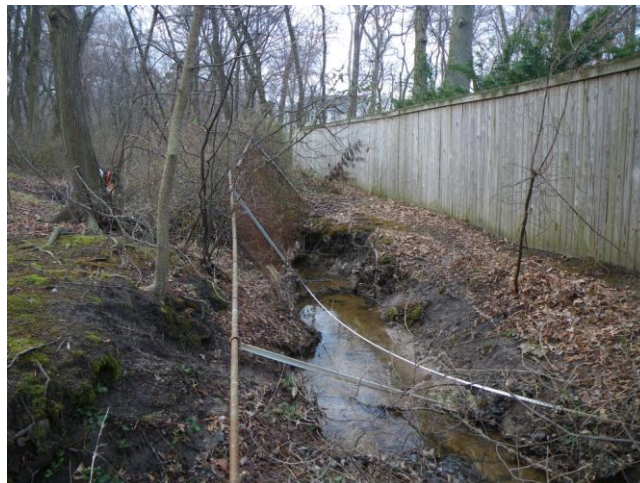
- Biological condition – “Fair”
- Habitat scores “Non Supporting” and “Severely Degraded”
- Midges (Polypedilum), caddisflies (Cheumatopsyche), and bivalves (Physa) dominated the sample. Scored high for number of taxa, scraper taxa, and percent climbers.
- Measured below COMAR standards for pH.
- Poor habitat diversity and refuse present in moderate amounts. Incised channel with heavily undercut banks. Minimal vegetative protection and poor riparian width.

- Buffer enhancement.
- Determine causes of instability observed in this reach and evaluate potential for stabilization.
- Consider trash cleanup for this reach.
- Investigate potential water quality impacts from residential land uses.

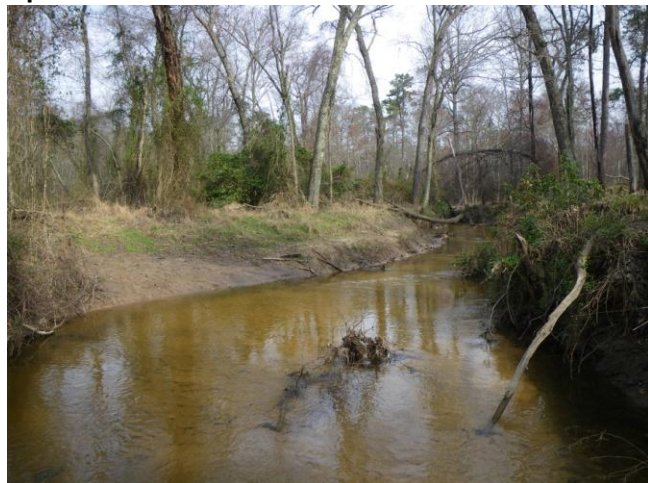
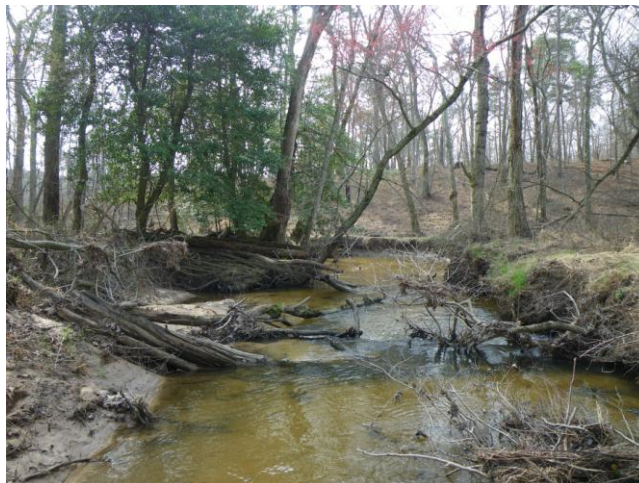
- Biological condition – “Fair”
- Habitat scores “Comparable to Reference” and “Partially Degraded”
- Cheumatopsyche (caddisfly) dominated the sample. Scored high in most metric categories.
- Water quality values within COMAR standards but conductivity elevated.
- Sub-optimal instream habitat and epibenthic substrate. Abundant woody debris providing additional stable habitat. Banks are moderately stable with good riparian width.

- Maintain the protection of the riparian areas.
- Determine causes of instability observed in this reach and evaluate potential for stabilization.
- Because habitat is comparable to reference and biological condition is fair, look for problems with water quality and correct, if possible.

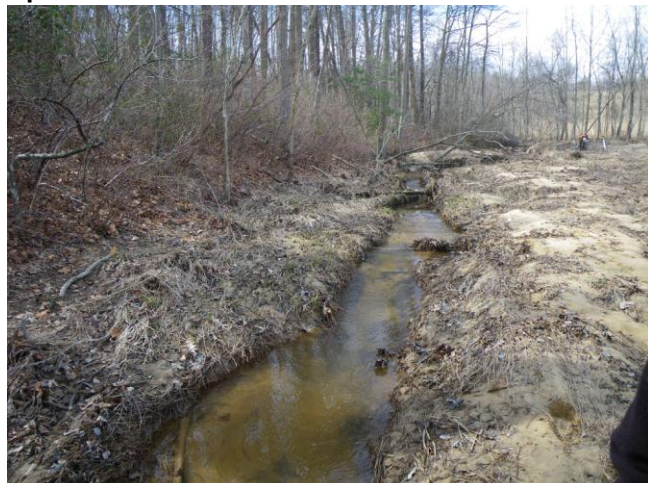
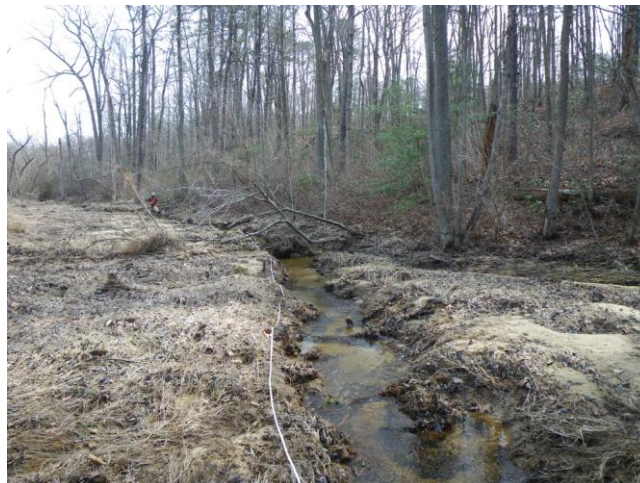
## Severn Run Sampling Unit

- Biological condition – “Fair”
- Habitat scores “Supporting” and “Degraded”
- Sample contained 38 taxa, including Haploperla (tolerant stonefly) and various midges. Scored high in most metric categories.
- Measured below COMAR standards for pH.
- Marginal to sub-optimal habitat diversity with woody debris providing most of the stable habitat. Moderately stable banks with good riparian width.

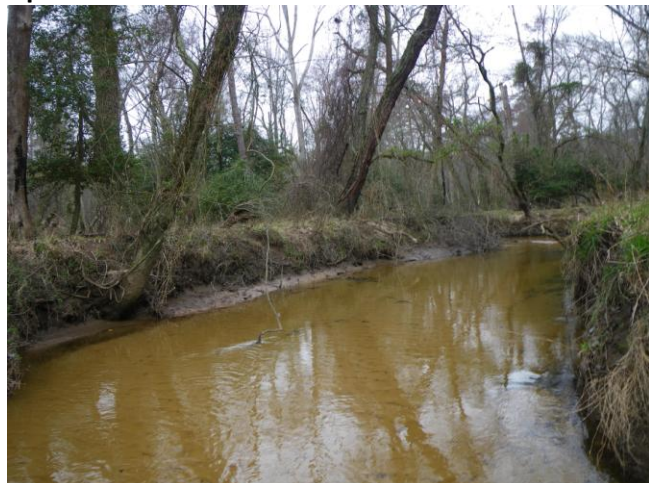
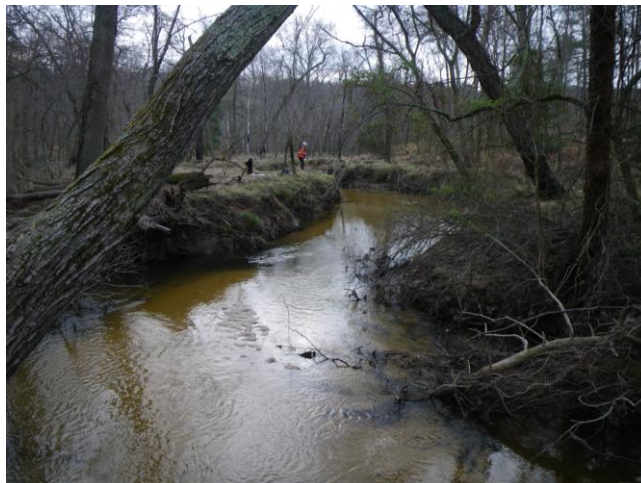
## Severn Run Sampling Unit

- Biological condition – “Fair”
- Habitat scores “Supporting” and “Partially Degraded”
- Midges (Orthocladus and Rheotanytarsus) and caddisflies (Cheumatopsyche) dominated the sample. Scored high in most metric categories.
- Water quality values within COMAR standards but conductivity elevated.
- Sub-optimal habitat diversity with abundant woody debris. Good mix of velocity and depth. Moderately unstable banks but with good riparian width.

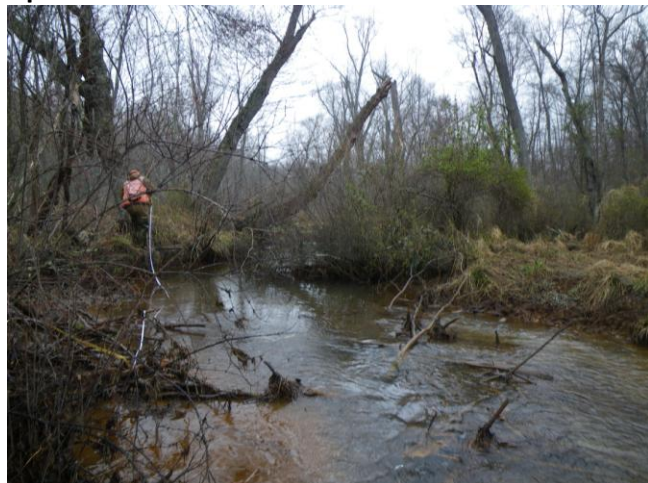
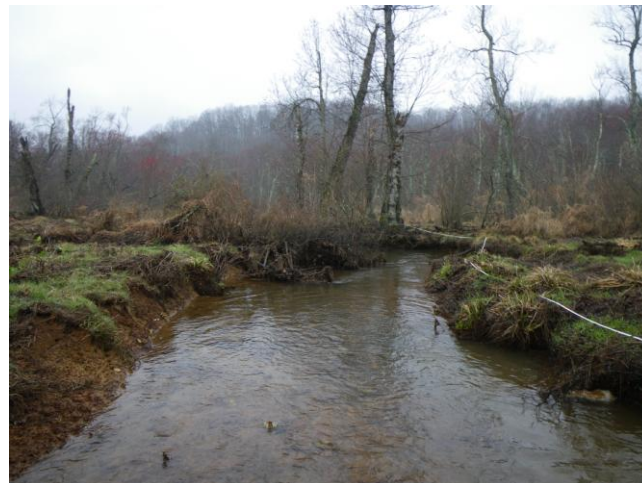
## Upper North River Sampling Unit

Upstream View:

Downstream View:

- Biological condition – “Poor”
- Habitat scores “Comparable to Reference” and “Partially Degraded”
- Black flies (Simulium) dominated the sample. Scored high for scraper taxa because of the presence of one snail (Physa).
- Water quality values within COMAR standards.
- Abundance of woody debris/rootwads and submerged vegetation provide a good mix of stable habitat. Moderately stable, well-vegetated banks with good riparian width.
- Bimodal distribution of substrate (sand/clay).

- Maintain the protection of the riparian areas.
- Because habitat is comparable to reference and biological condition is poor, look for problems with water quality and correct, if possible.

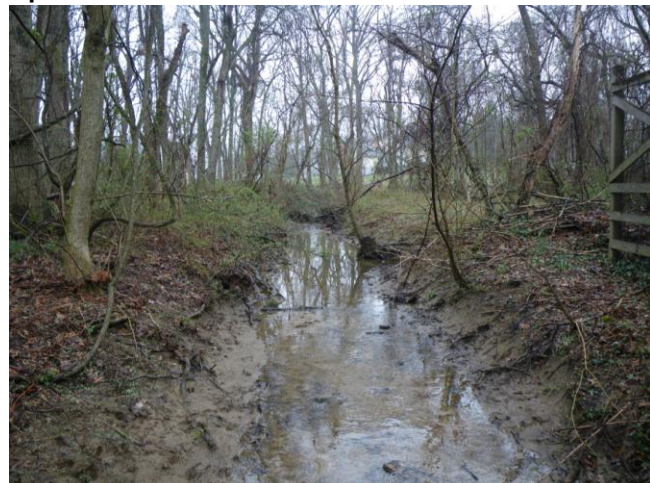
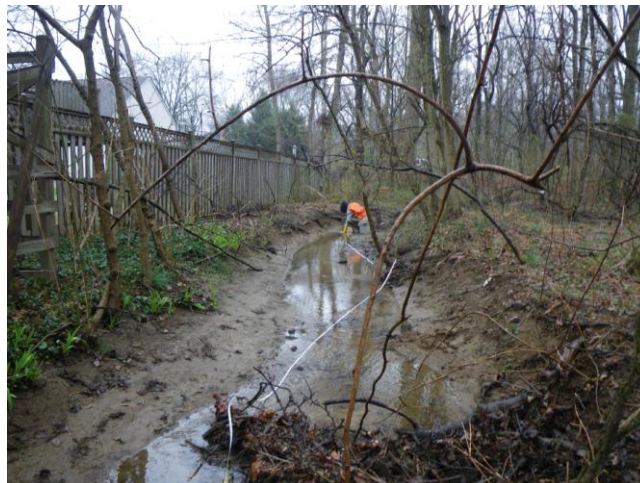
## Upper North River Sampling Unit

### Upstream View:

### Downstream View:

- Biological condition – “Poor”
- Habitat scores “Non Supporting” and “Degraded”
- Parametriocnemus (midge), Tubificidae (worm), and Simulium (black fly) dominated the sample. Scored high for number of taxa, scraper taxa, and percent climbers; but, received low scores for remaining metrics.
- Water quality values within COMAR standards but conductivity elevated.
- Poor habitat diversity with minimal woody debris. Poor vegetative protection and riparian width along the right bank of the channel.
- Bimodal distribution of substrate (sand/clay).

- Buffer enhancement.
- Determine causes of instability observed in this reach and evaluate potential for stabilization.

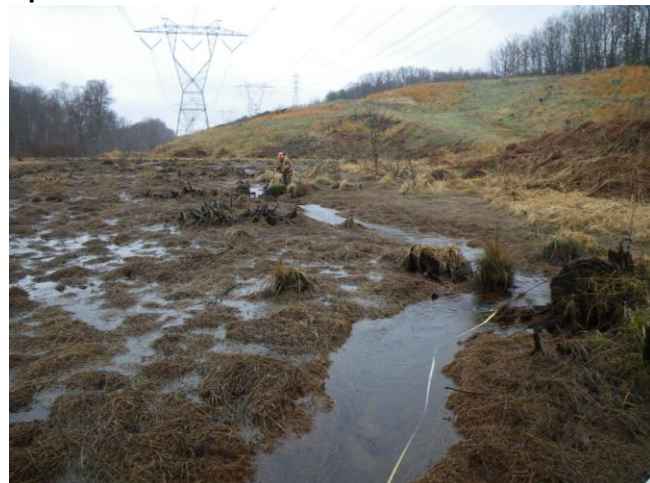
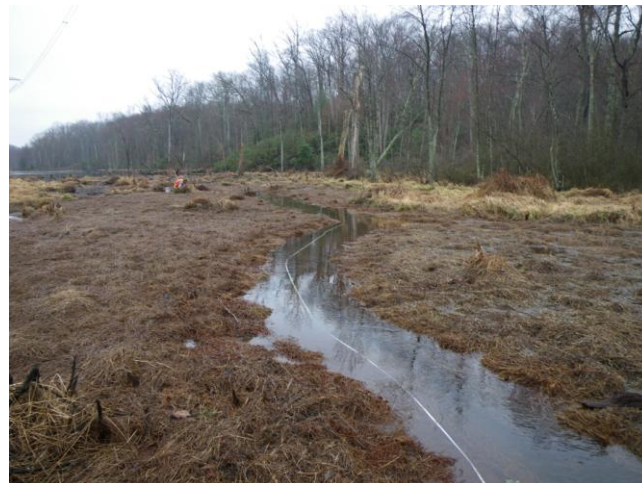
## Upper North River Sampling Unit

Upstream View:

Downstream View:

- Biological condition – “Very Poor”
- Habitat scores “Comparable to Reference” and “Partially Degraded”
- Midge, Zalutschia and Psectrocladius, dominated the sample.
- Measured below COMAR standards for pH.
- Sub-optimal habitat diversity but little woody debris. Stable, well-vegetated banks and good riparian width.

- Maintain the protection of the riparian areas.
- Because habitat is comparable to reference and biological condition is very poor, look for problems with water quality and correct, if possible.

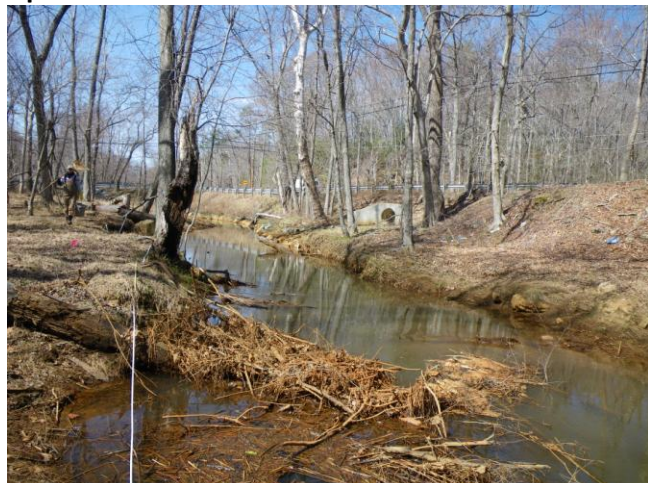
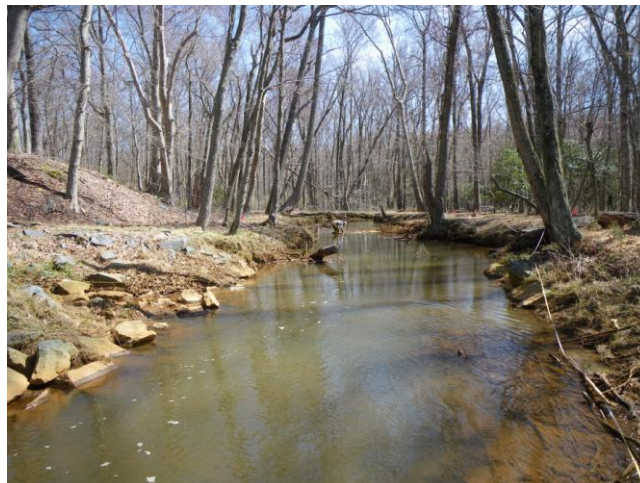
## Upper North River Sampling Unit

### Upstream View:

### Downstream View:

- Biological condition – “Poor”
- Habitat scores “Supporting” and “Degraded”
- Dicrotendipes, Paratanytarsus, and Polypedilum (midges) dominated the sample. Scored high for percent climbers because of the presence of Polypedilum.
- Measured below COMAR standards for pH.
- Sub-optimal habitat diversity. Defense High runs adjacent to the right bank with little buffer between the road and stream. Stable banks with large boulder reinforcement along the majority of the right bank.
- Stream type not determined due to influence of large culvert and bank stabilization, as well as highway grading on the channel dimensions.

- Buffer enhancement.
- Because habitat is supporting and biological condition is poor, look for problems with water quality and correct, if possible.

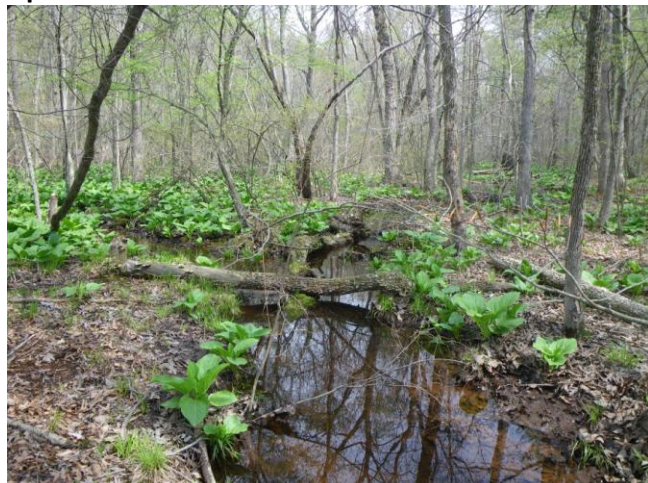
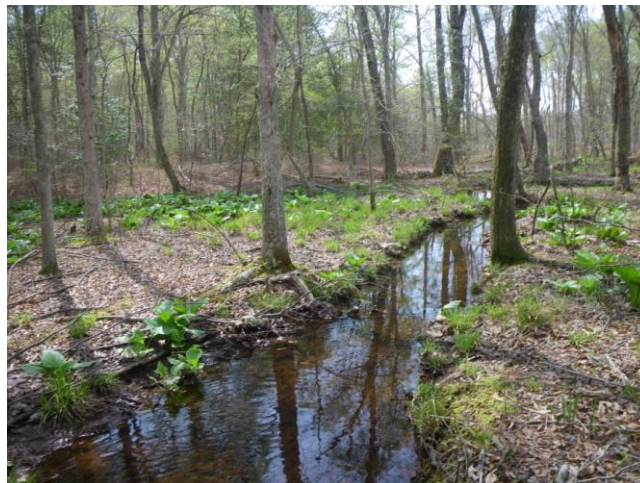
## Upper Patuxent Sampling Unit

### Upstream View:

### Downstream View:

- Biological condition – “Poor”
- Habitat scores “Comparable to Reference” and “Minimally Degraded”
- Caecidotea (intolerant isopod) and Psectrocladius (midge) dominated the sample. Scored high for intolerant percent.
- Measured below COMAR standards for pH.
- Sub-optimal instream habitat and epibenthic substrate. Very stable banks with excellent vegetative protection and riparian width.
- Bimodal distribution of substrate (sand/clay).

- Maintain the protection of the riparian areas.
- Because habitat is comparable to reference and biological condition is poor, look for problems with water quality and correct, if possible.

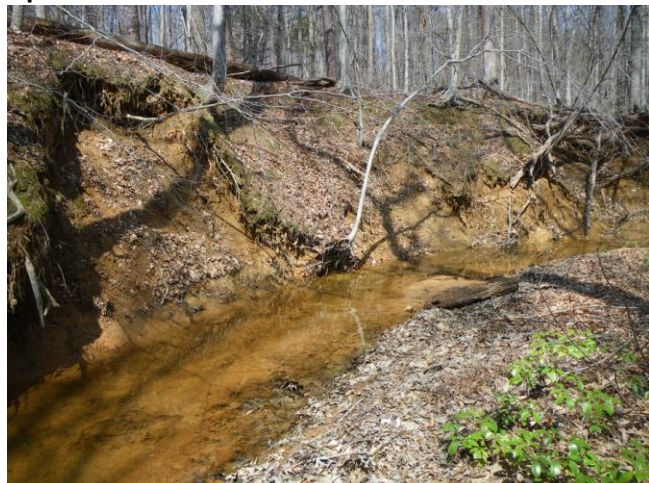
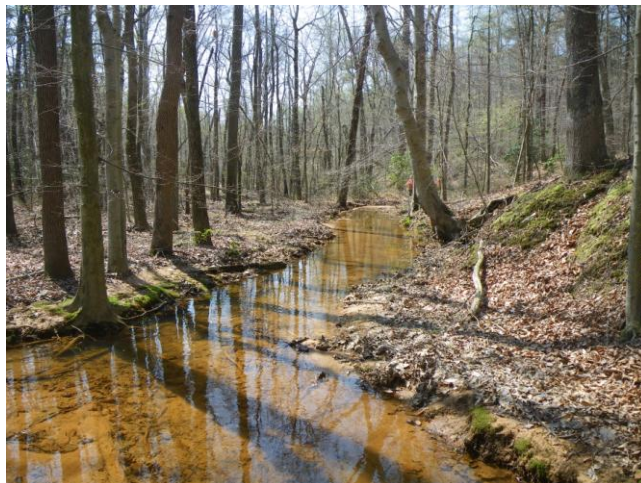
## Upper Patuxent Sampling Unit

Upstream View:

Downstream View:

- Biological condition – “Poor”
- Habitat scores “Comparable to Reference” and “Minimally Degraded”
- Leuctra (intolerant stonefly) and Stegopterna (intolerant black fly) dominated the sample. Scored high for intolerant percent.
- Measured below COMAR standards for pH.
- A very sinuous reach with sub-optimal instream habitat and epibenthic substrate. Stable, well-vegetated banks and good riparian width.
- Bimodal distribution of substrate (sand/gravel).

- Maintain the protection of the riparian areas.
- Because habitat is comparable to reference and biological condition is poor, look for problems with water quality and correct, if possible.
