## **Biological condition summary of targeted sites within the Galloway Creek watershed**

Anne Arundel County, Maryland  
Department of Public Works  
Bureau of Engineering  
Watershed, Ecosystem, and Restoration Services Division  
Annapolis, Maryland

**July 2011**

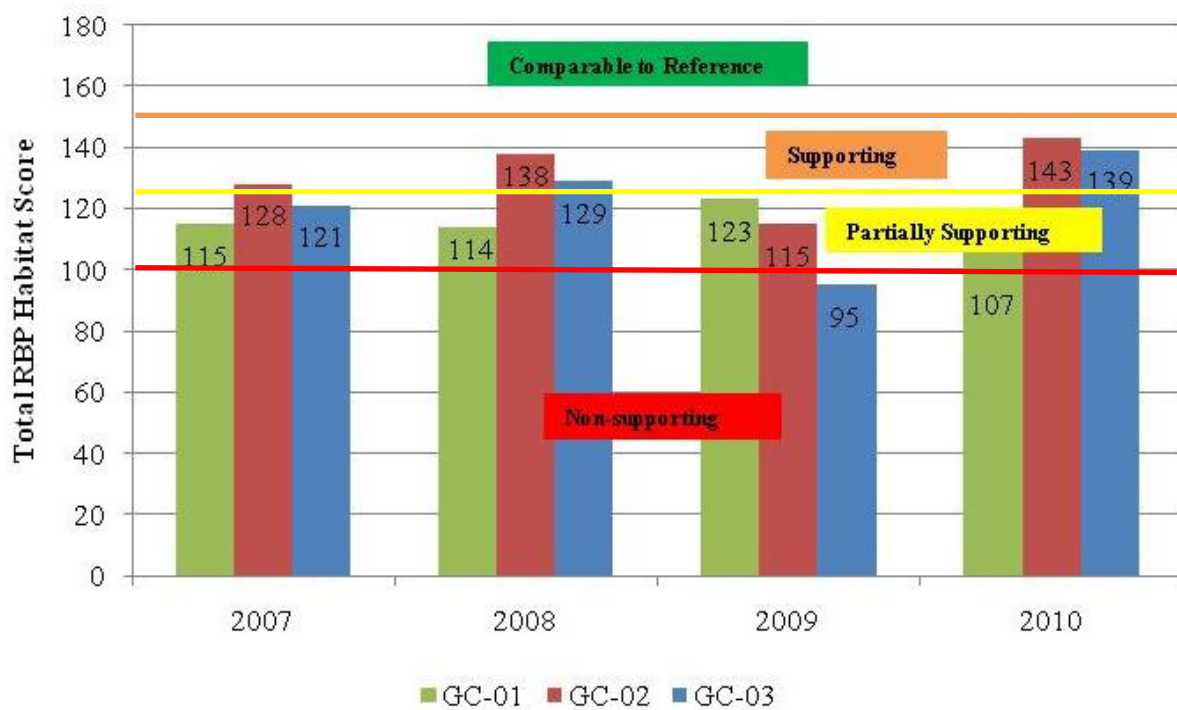
Figure 2. Summary of A) Biological and B) Habitat conditions observed at the Galloway Creek targeted sites.

**III. Result.** Conditions within Galloway Creek are summarized in Table 6 and Figure 2. Detailed summaries of the data discussed below are found in Appendix A.

For GC-02, the average BIBI score was 2.36, with an identical range of scores as found at GC-01 (3.00 to 1.86). The average BIBI score was lowest at this station. Conversely, average habitat conditions assessed by RBP rated this station as having the highest quality habitat of the three sites, with Supporting quality three of four years and averaging Supporting over the assessed years.

Site GC-03 had the highest average BIBI score observed during this assessment with an average score of 3.57, placing this station solidly in the Fair category. Scores ranged from 4.14 (Good) to 2.43 (Poor) observed in 2010, the first time a score lower than Fair was measured at this station. RBP habitat condition averaged as Partially Supporting (115). Scores ranged from Supporting (139) to Non-supporting (95), but only one year of four was evaluated as Non-supporting.

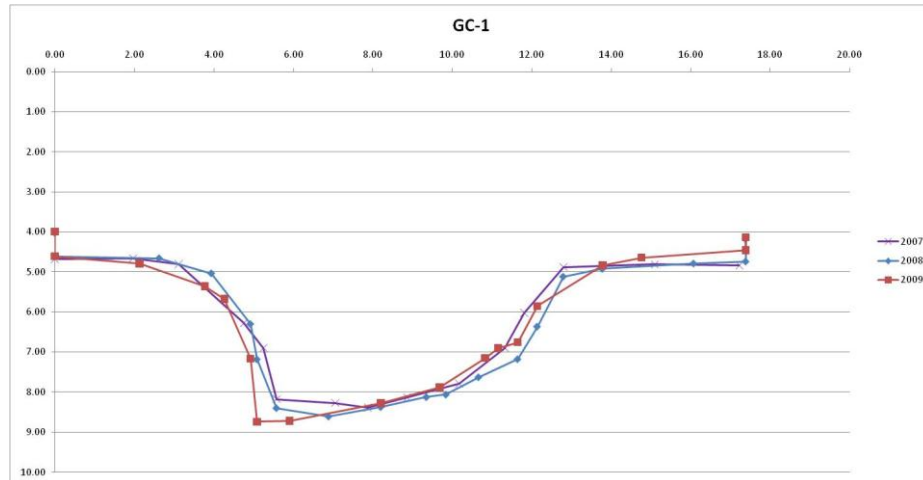
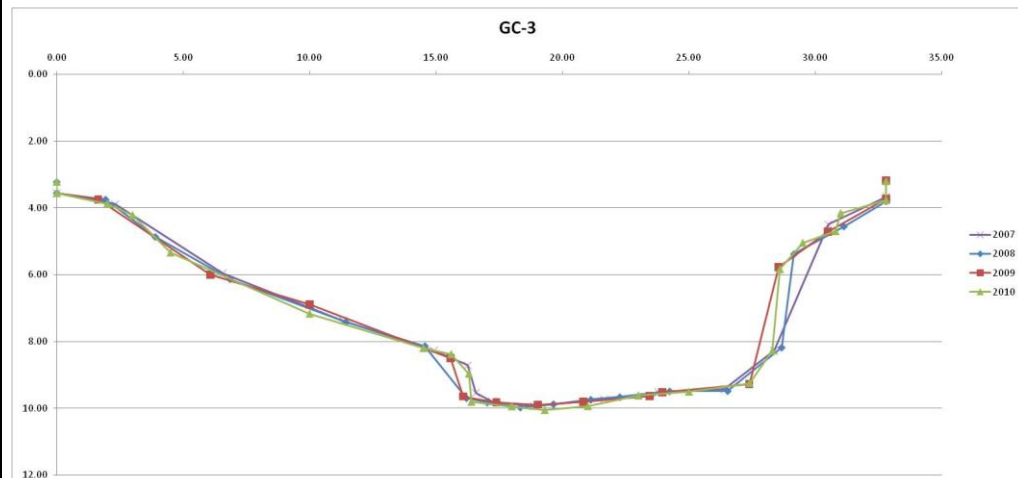
Figure 3. Comparisons of cross section measurements at the three monitoring stations along with their associated stream types. No 2010 data available for GC-01. The zero point for all measurements is located on the left bank facing downstream.

Geomorphic conditions at the three stations were fairly consistent across the sample period. As illustrated in Figure 3, the G type was observed consistently at site GC-02, the B type was found in all years at GC-03, and the E stream type was observed at GC-01. At GC-01, no classification work was performed in 2010 due to the change in site location.

The E5 channel has been consistently observed at site GC-01. This site has a broad, flat, wetland-dominated floodplain area. Banks are low and moderately well vegetated and flood flows easily access the floodplain. Woody debris is present in moderate amounts. Beaver activity has been frequently observed by the field crews over the years. E type channels are considered stable types, maintaining pattern, cross sectional dimensions, and stream slope as long as hydrologic and land use characteristics remain stable. The E type is a possible endpoint of the evolutionary sequence illustrated in Figure 4 (Simon and Hupp 1986). Some enlargement of the bankfull channel area, however, has been observed between 2007 and 2009, increasing from around 12 ft<sup>2</sup> to about 16 ft<sup>2</sup>, a boost of approximately 30%. It is possible that some of this change is due to measurement error along the cross section. Slope, median streambed particle size, and sinuosity did not change in a meaningful way from year to year.

At GC-02, the G stream type was observed during all assessments. Typical of the G type, the reach at this location has dropped below the original floodplain elevation and begun the process of reestablishing itself at a lower elevation (Figure 4). Bank instability on the right bank was observed by field crews, including a small undercut not well mapped in the cross section plots in Figure 3. Additionally, the bankfull channel cross section appears to have contracted compared to the 2007 baseline value, moving from 8.8 ft<sup>2</sup> to 6.9 ft<sup>2</sup>, a decrease of approximately 20%. What cannot be ruled out, however, is that the presumed change in cross sectional area may be the result of measurement error associated in the profiling of the undercut right bank. It should be noted that the bed on the left side of the channel shows clear evidence of downcutting over time. Evaluating the possible bank and bed stability conditions together, this reach is likely in a moderate phase of channel evolution, possibly in late Stage III, consistent with a Rosgen G type channel, an unstable type that eventually adjusts itself to a quasi-equilibrium state (Rosgen 1996). The relatively high levels of imperviousness are the likely drivers of this adjustment as the channel resizes itself to manage increased flows associated with urbanization (Paul and Meyer 2001). Little change from year to year was observed in slope, median stream bed particle size, or sinuosity.

In summary, the stream types observed at each station have changed little since 2007, but as illustrated in Figure 3, channel cross sections have possibly adjusted during this time. Two of three stations (GC-01, GC-03) are characterized by Rosgen types considered stable endpoints and are visually similar in appearance to stable configurations detailed in the Channel Evolution Model (CEM) developed by Simon and Hupp (1986). GC-02 appears to be experiencing more on-going instability, is classified as an unstable Rosgen type, and appears to be undergoing degradation as described by the CEM, particularly compared to the other two reaches.
