**Assessment of the biological health of streams on the Patuxent Research
Refuge within Anne Arundel County: Results from Round 2 of the
Anne Arundel County Biological Monitoring Program**

December 2018

Anne Arundel County, Maryland
Department of Public Works
Bureau of Engineering
Watershed Protection and Restoration Program
Ecological Assessment and Evaluation Group

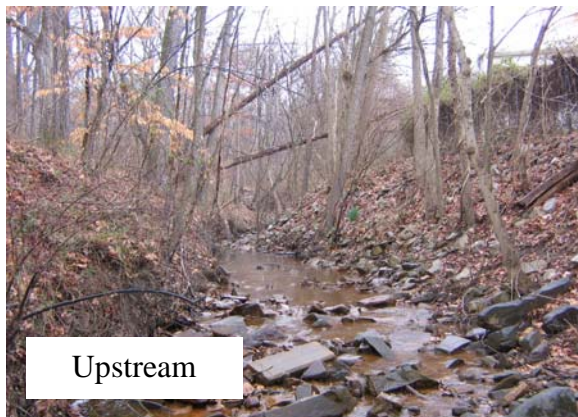
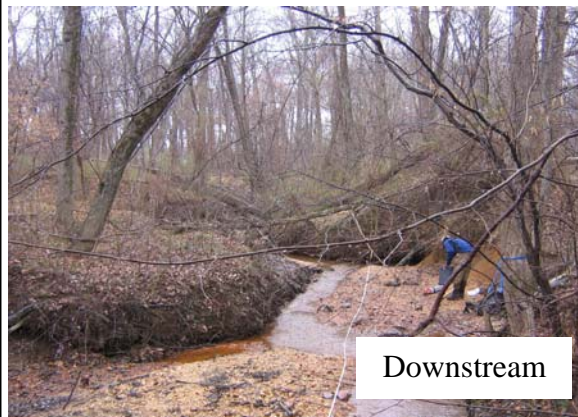
- Biological condition – "Fair"
- Habitat scores "Not Supporting" and "Partially Degraded"
- Habitat assessment results indicate poor and fair conditions at this site, which is in agreement with the diverse biological assemblage.
- Bank, channel, pool, and sediment conditions are mostly marginal.
- Conductivity is high.
- Sample dominated by midges (Parametriocnemus, Orthocladius/Cricotopus) and caddisflies (Chimarra)
- Stream type was not identified because it has been highly modified.

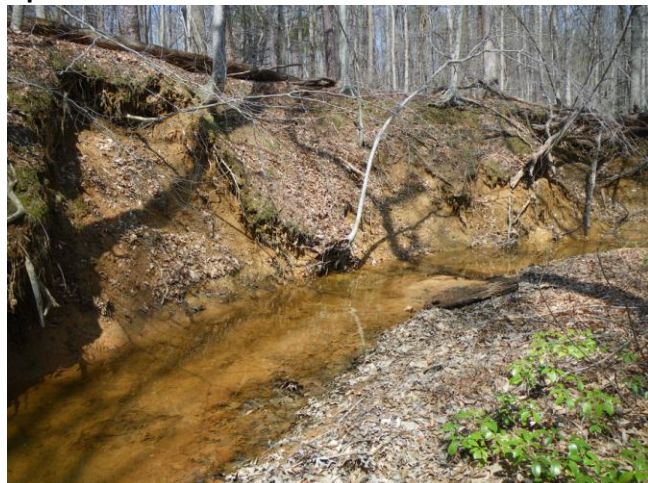
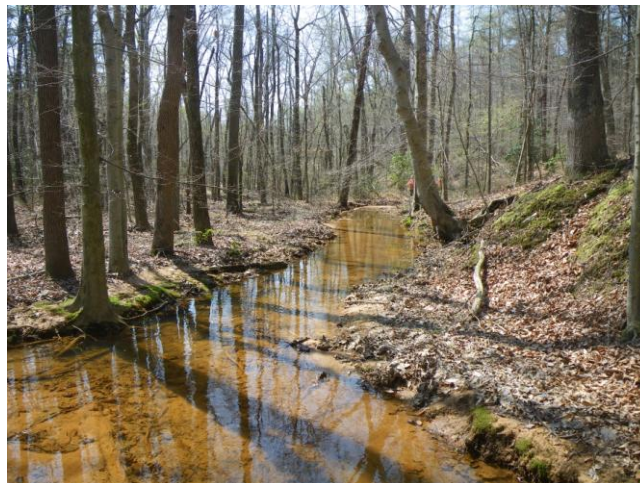
R2-16-03

- Biological condition – “Poor”
- Habitat scores “Comparable to Reference” and “Minimally Degraded”
- Leuctra (intolerant stonefly) and Stegopterna (intolerant black fly) dominated the sample. Scored high for intolerant percent.
- Measured below COMAR standards for pH.
- A very sinuous reach with sub-optimal instream habitat and epibenthic substrate. Stable, well-vegetated banks and good riparian width.
- Bimodal distribution of substrate (sand/gravel).

- Maintain the protection of the riparian areas.
- Because habitat is comparable to reference and biological condition is poor, look for problems with water quality and correct, if possible.

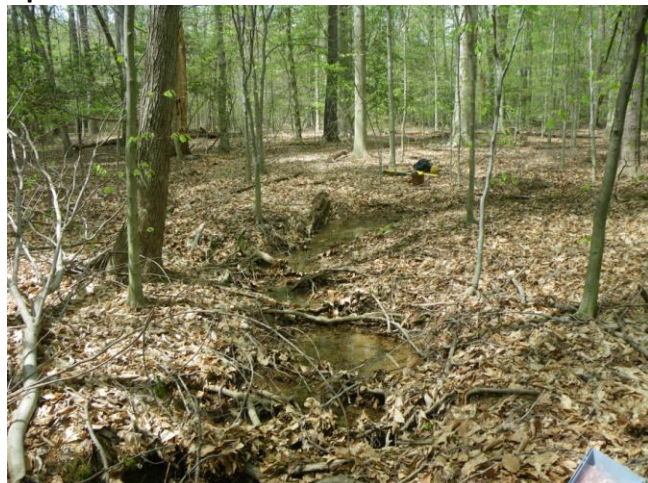
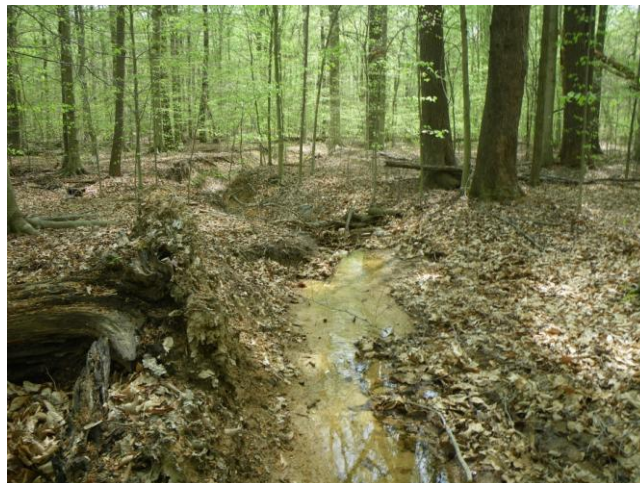
R2-16-04

- Biological condition – “Poor”
- Habitat scores “Non Supporting” and “Partially Degraded”
- Midges dominated the sample including Tvetenia and Orthocladiinae.
- Measured below COMAR standards for pH.
- Poor instream habitat and epibenthic substrate with woody debris and leaf packs providing habitat for benthos. Moderately unstable bank with a severe headcut in the middle portion of the reach. Good riparian width.
- Stream transitioning from C to F due to a severe headcut and scour pool in middle portion of the reach.

- Maintain the protection of the riparian areas.
- Determine causes of instability observed in this reach and evaluate potential for stabilization.

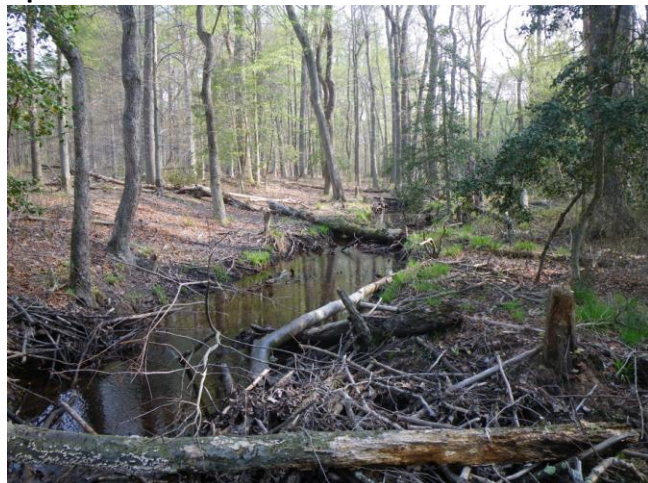
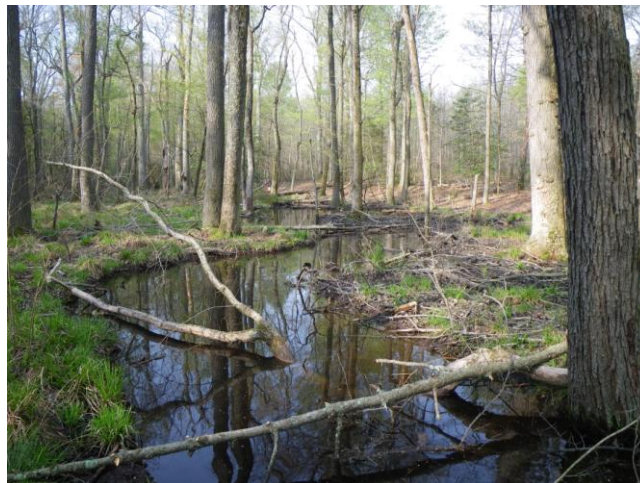
R2-16-05

- Biological condition – “Very Poor”
- Habitat scores “Comparable to Reference” and “Minimally Degraded”
- The black fly, Simulium, and midges, Psectrocladius and Polypedilum, dominated the sample. Scored high for percent climbers because of the presence of Polypedilum.
- Measured below COMAR standards for pH.
- Sub-optimal habitat diversity with an abundance of woody debris. Poor velocity/depth diversity due to multiple beaver dams impacting the reach. Stable, well-vegetated banks and good riparian width.

- Maintain the protection of the riparian areas.
- Because habitat is comparable to reference and biological condition is very poor, look for problems with water quality and correct, if possible.

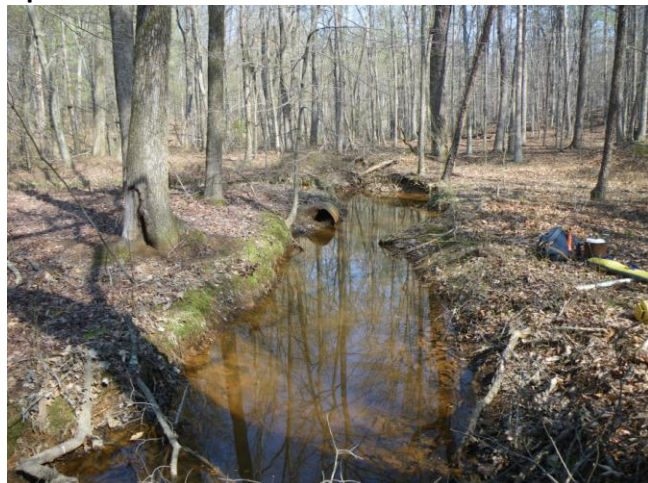
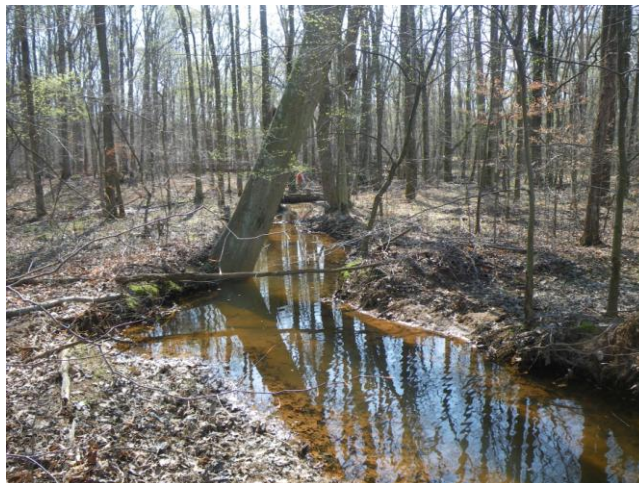
R2-16-06

- Biological condition – “Poor”
- Habitat scores “Supporting” and “Minimally Degraded”
- Black flies (Simulium and Stegopterna) dominated the sample. Scored high for intolerant percent.
- Measured below COMAR standards for pH.
- Sub-optimal habitat diversity. Stable, well-vegetated banks and good riparian width.

- Maintain the protection of the riparian areas.
- Because habitat is supporting and biological condition is poor, look for problems with water quality and correct, if possible.

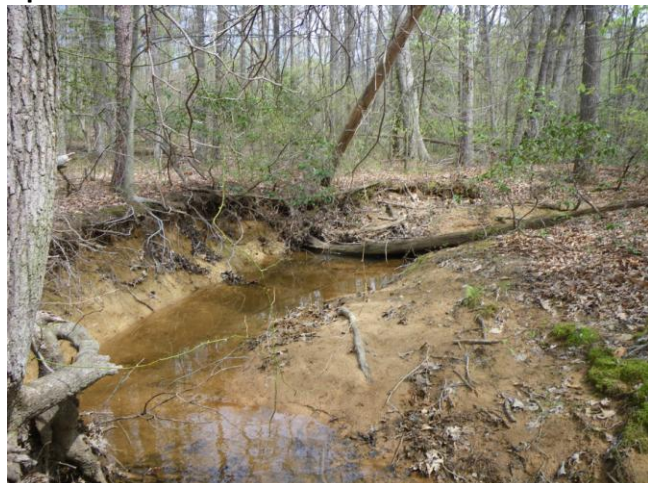
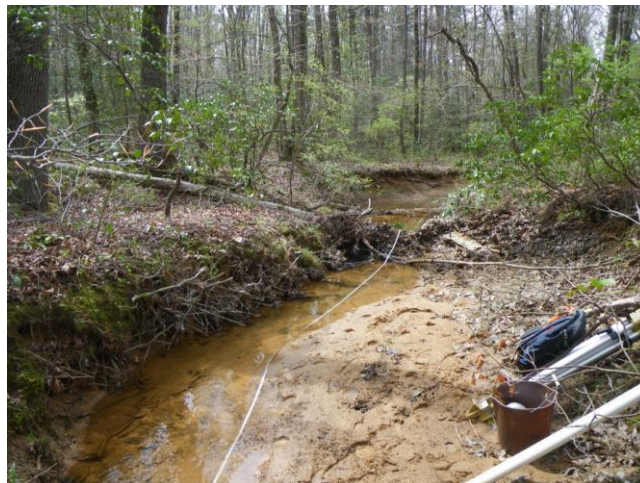
R2-16-08

- Biological condition – “Fair”
- Habitat scores “Supporting” and “Minimally Degraded”
- Simulium (black fly) and Psectrocladius (midge) dominated the sample. Scored high for percent climbers because of the presence of Polypedilum (midge).
- Measured below COMAR standards for pH.
- Most habitat parameters received sub-optimal scores. Incised reach with areas of active bank erosion; however, banks are well vegetated with good riparian width.
- Bimodal distribution of substrate (gravel/sand).

- Maintain the protection of the riparian areas.
- Determine causes of instability observed in this reach and evaluate potential for stabilization.

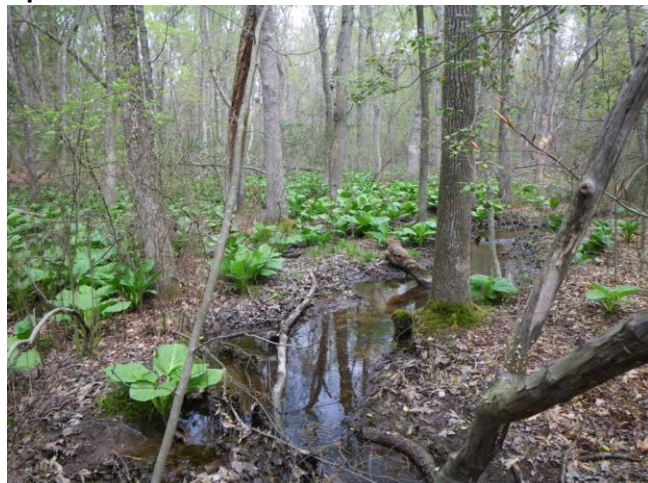
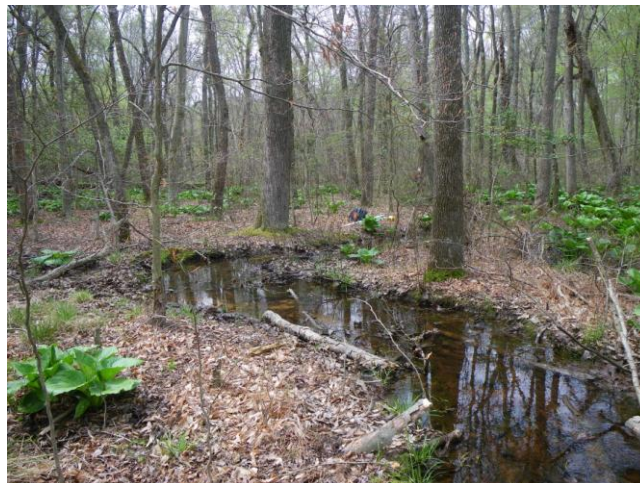
R2-16-09

- Biological condition – “*Very Poor*”
- Habitat scores “*Comparable to Reference*” and “*Minimally Degraded*”
- Psectrocladius (midge) and Caecidotea (intolerant isopod) dominated the sample. Scored high for intolerant percent.
- Measured below COMAR standards for pH.
- Sub-optimal instream habitat and epibenthic substrate with abundant rootwads/woody debris providing stable habitat. Very stable banks with excellent vegetative protection and riparian width.

- Maintain the protection of the riparian areas.
- Because habitat is comparable to reference and biological condition is very poor, look for problems with water quality and correct, if possible.

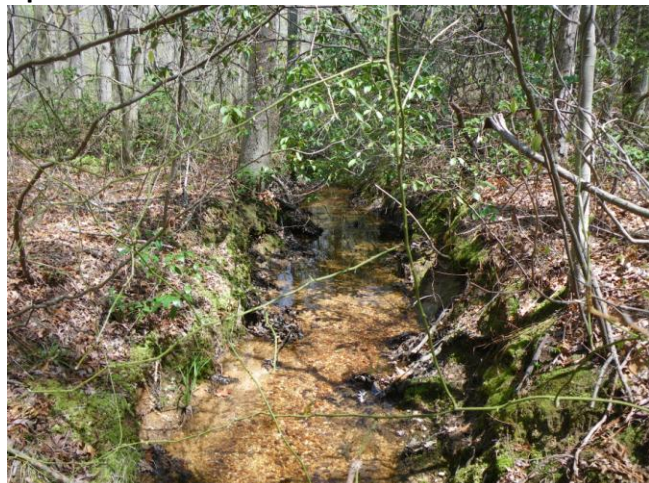
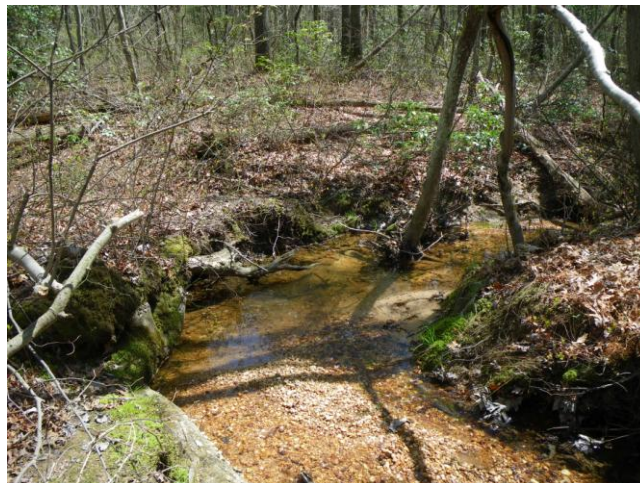
R2-16-11A

- Biological condition – “Very Poor”
- Habitat scores “Supporting” and “Minimally Degraded”
- Stegopterna (intolerant black fly) and Leuctra (intolerant isopod) dominated the sample. Scored high for intolerant percent.
- Measured below COMAR standards for pH.
- Marginal to sub-optimal habitat diversity with moderately stable banks. Good vegetative protection and excellent riparian width.
- Bimodal distribution of substrate (gravel/sand).

- Maintain the protection of the riparian areas.
- Because habitat is supporting and biological condition is very poor, look for problems with water quality and correct, if possible.

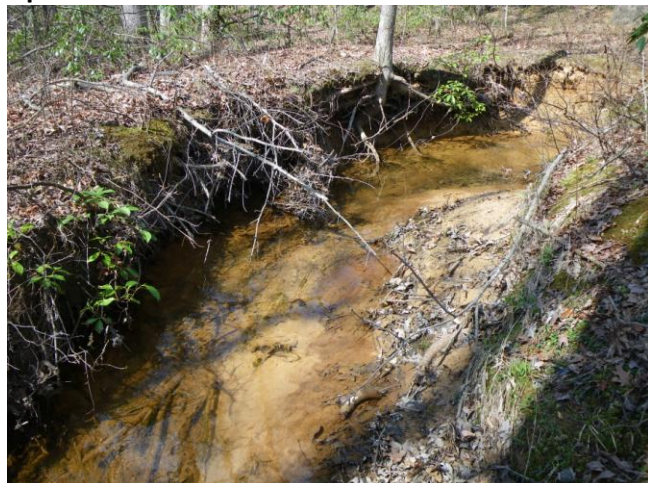
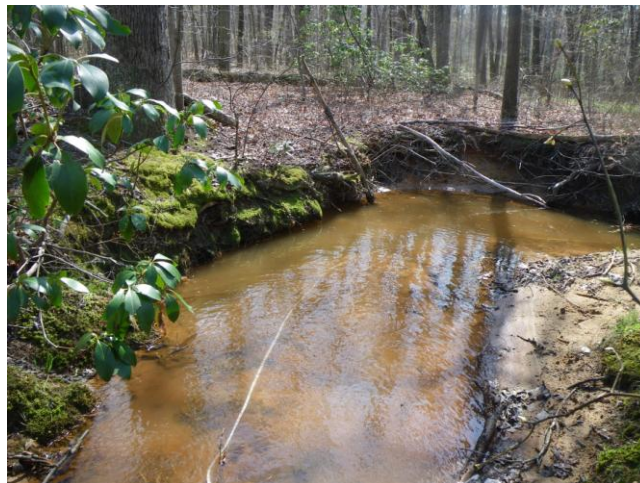
R2-16-12A

- Biological condition – “Poor”
- Habitat scores “Partially Supporting” and “Partially Degraded”
- Stegopterna and Simulium (black flies) and Leuctra (intolerant stonefly) dominated the sample. Scored high for EPT taxa and intolerant percent.
- Measured below COMAR standards for pH.
- Most habitat parameters received marginal to sub-optimal scores. Over widened channel with moderately unstable banks.
- Bimodal distribution of substrate (sand/gravel).
