# Aquatic Biological Assessment of the Watersheds of Anne Arundel County, Maryland: Round Two 2009 - 2013

Anne Arundel County, Maryland  
Department of Public Works  
Watershed, Ecosystem, and Restoration Services

KCI Technologies, Inc.  
936 Ridgebrook Road  
Sparks, Maryland 21152

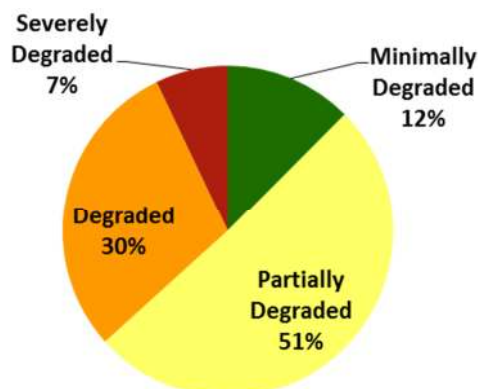
**Figure 16. Countywide PHI Physical Habitat Conditions (2009-2013; n=240)**

Countywide results indicate that 12% of the streams in Anne Arundel County had “Minimally Degraded” habitat, 51% had “Partially Degraded” habitat, and 37% had “Degraded” or “Severely Degraded” habitat (Figure 16).
