## **APPENDIX A – TECHNICAL MEMORANDA**

# **SITE SELECTION OF STREAM CROSSINGS TO BE ANALYZED FOR FLOOD OVERTOPPING**

## **TECHNICAL MEMORANDUM**

### **Subtask 2.1.6 Magothy River Watershed Study**

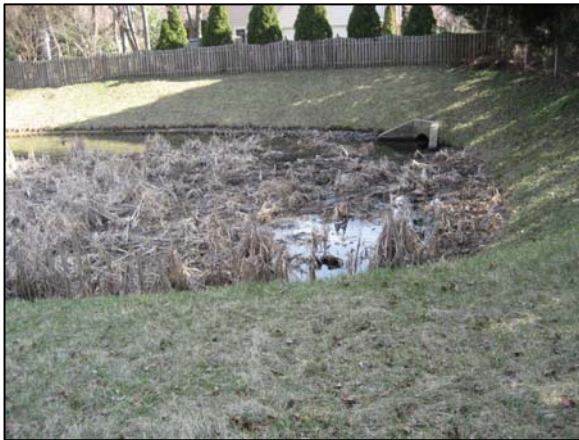
Photo 1 - Existing Infiltration Basin

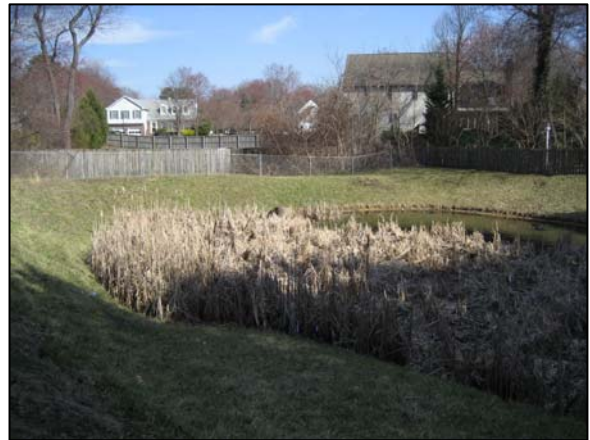
Photo 2 - Existing Infiltration Basin

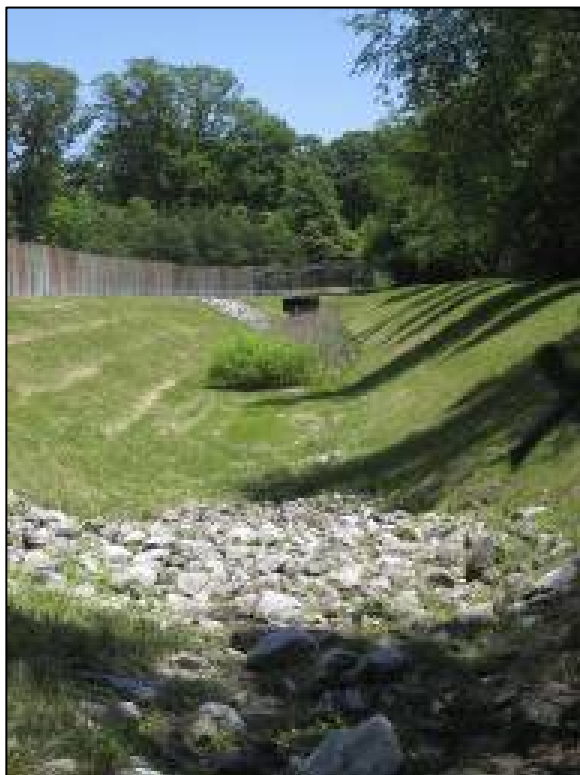
Photo 1 – Ditch looking down gradient

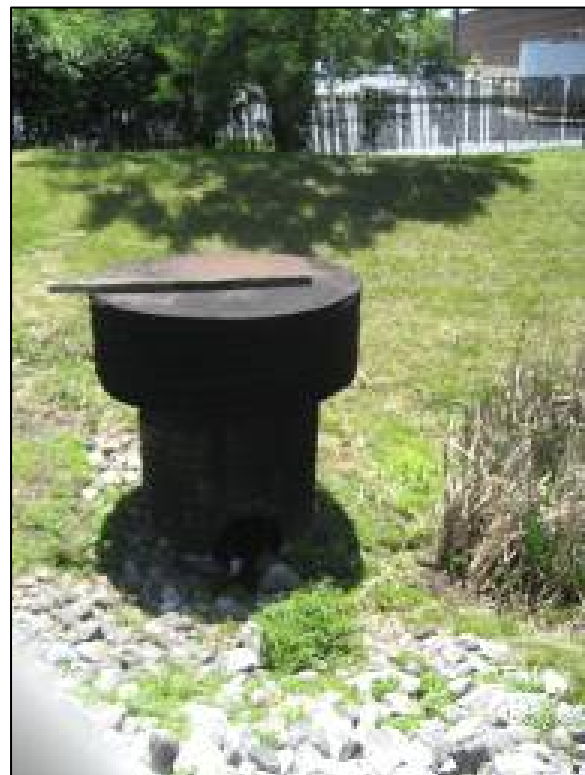
Photo 2 –Riser with bypass

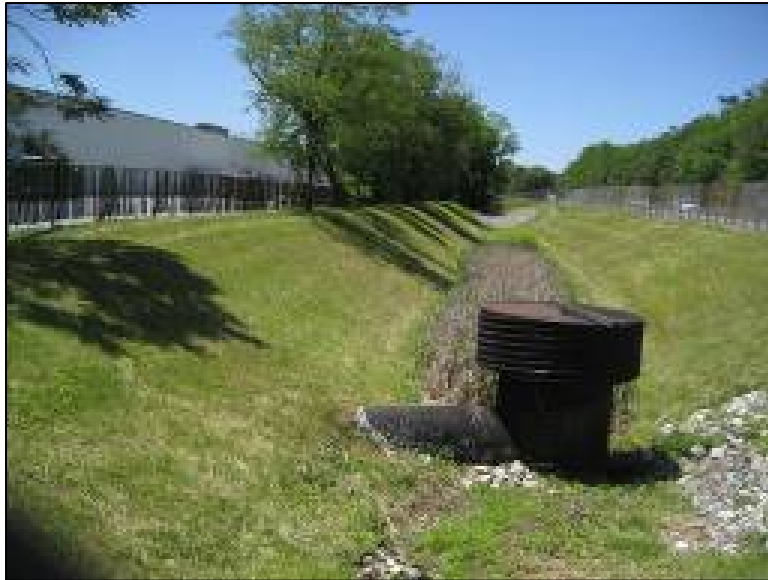
Photo 3 – Ditch and riser looking up gradient
