Patapsco Tidal and Bodkin Creek Watershed Assessment

Comprehensive Summary Report

August 2012

Anne Arundel County
Department of Public Works
Bureau of Engineering
Watershed Ecosystem and
Restoration Services Division
Watershed Assessment and
Planning Program

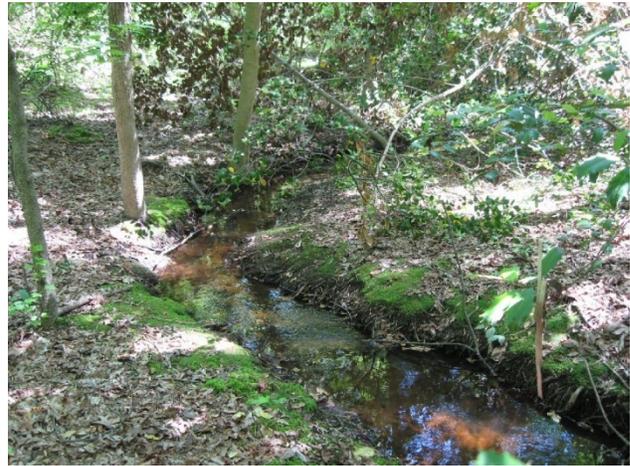
Stream Reach in the Hines Bog Pond Subwatershed (PTM) with Minimally Degraded Habitat Condition

Physical habitat condition is a widely used measure of the overall health of a stream and its ability to support aquatic life. Healthy physical habitat for aquatic organisms is typically comprised of stable channels and substrates, diverse flow characteristics, and abundant cover and food sources. Natural streams are typically in a state of dynamic equilibrium. However, this equilibrium can be disrupted. Habitat parameters common in healthy streams begin to deteriorate when increased urban and agricultural stressors are introduced. Examples of assessed stream reaches are depicted in Figure 2.1.

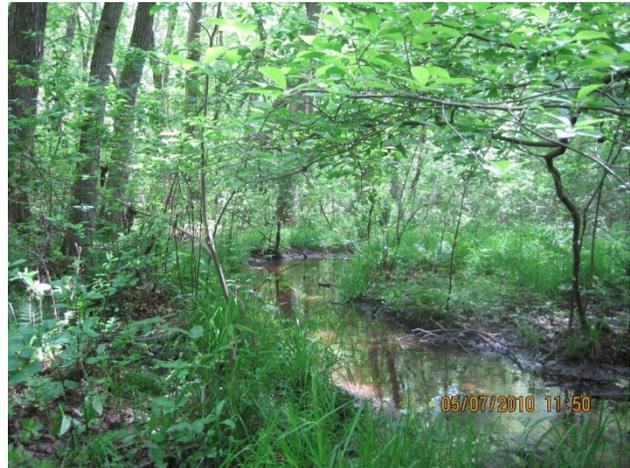
Stream Reach in the Main Creek Subwatershed (BK3) with Minimally Degraded Habitat Condition

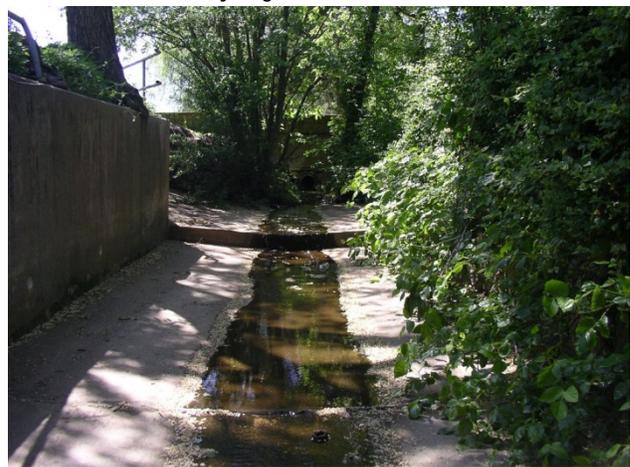
Concrete-lined Stream Reach in the Cabin Branch 2 Subwatershed (PT2)

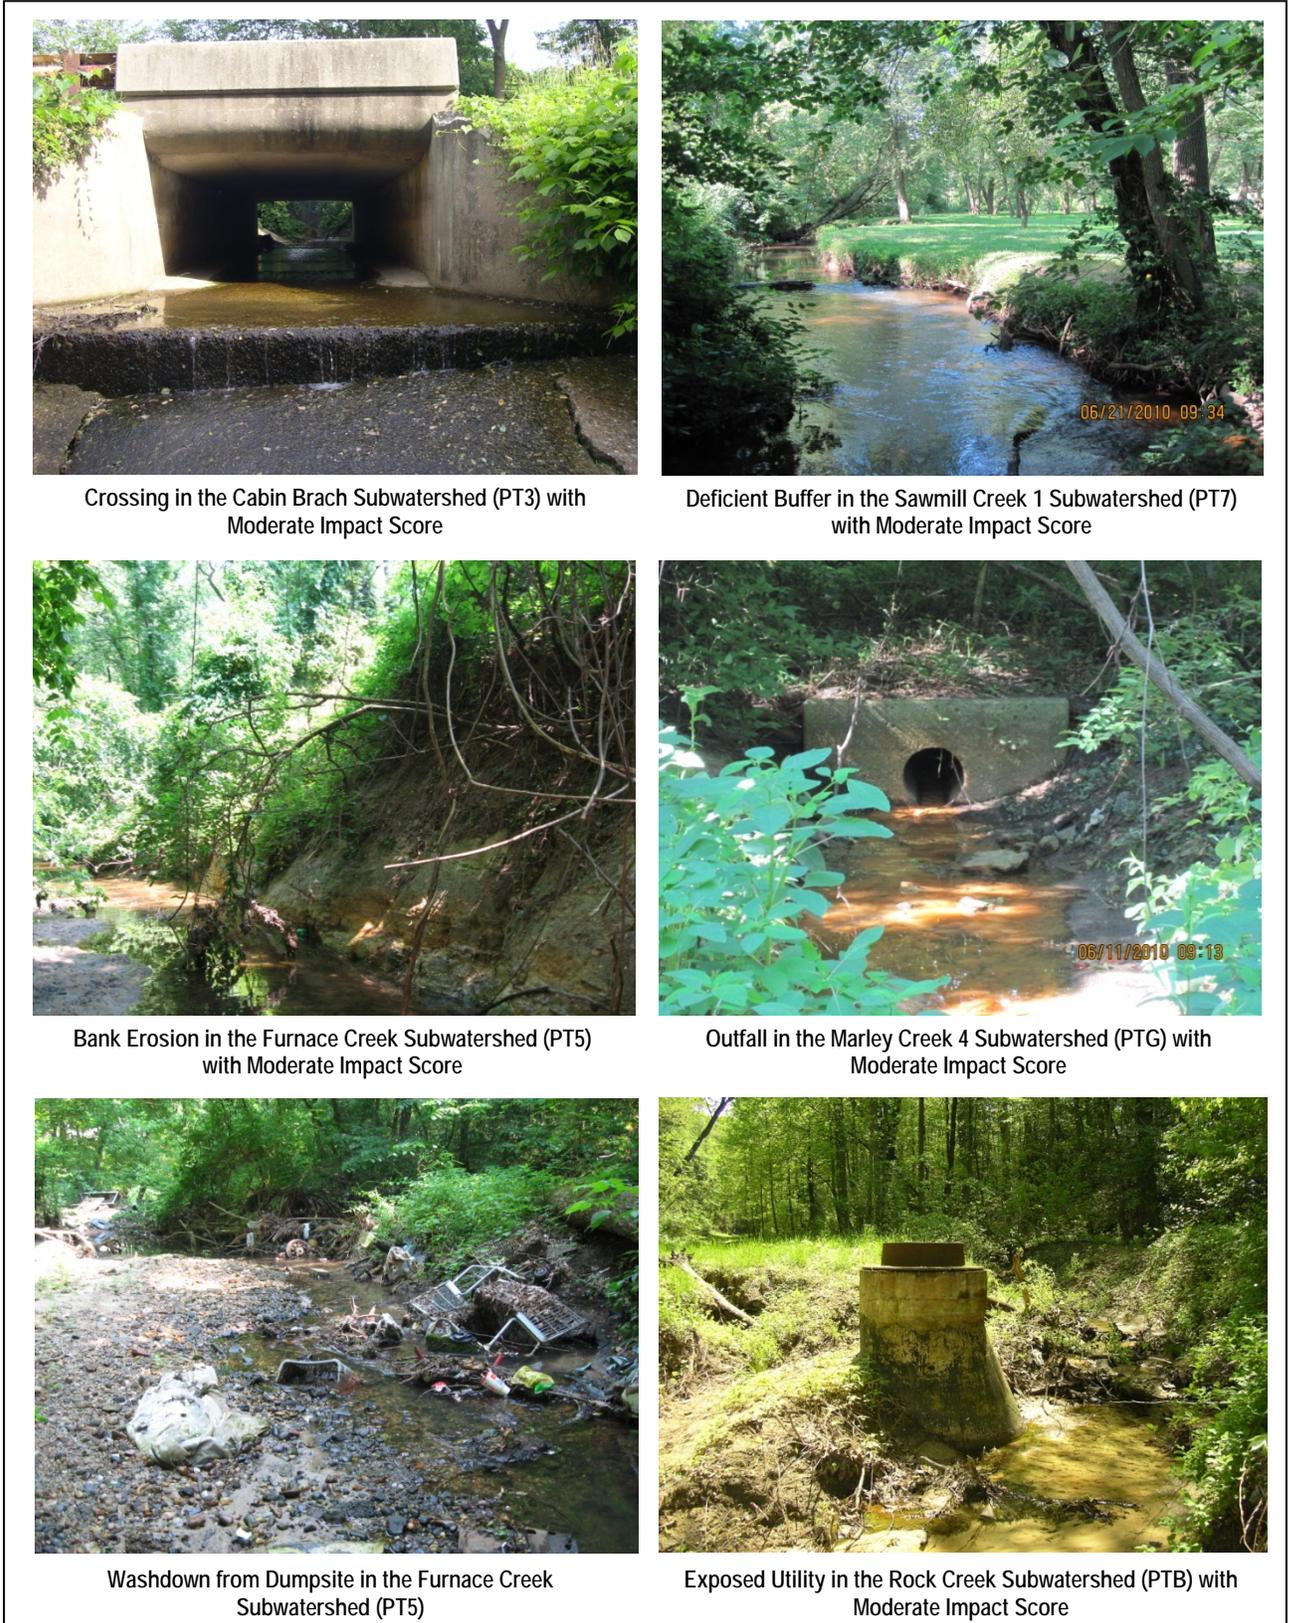
Figure 2.2 – Examples of Environmental and Infrastructure Features

- Channel **obstructions** can include natural features like fallen trees as well as man-made features like concrete dams or riprap. These obstructions can partially or completely obscure water flow, which can cause flooding and localized erosion and can impede the passage of fish.

- **Utilities** can include sanitary sewers, storm sewers, water lines, gas lines, and electrical transmission lines (buried or overhead). Impacts from utilities are the most severe when they intersect the stream channel where they can alter stream hydraulics and cause localized erosion.

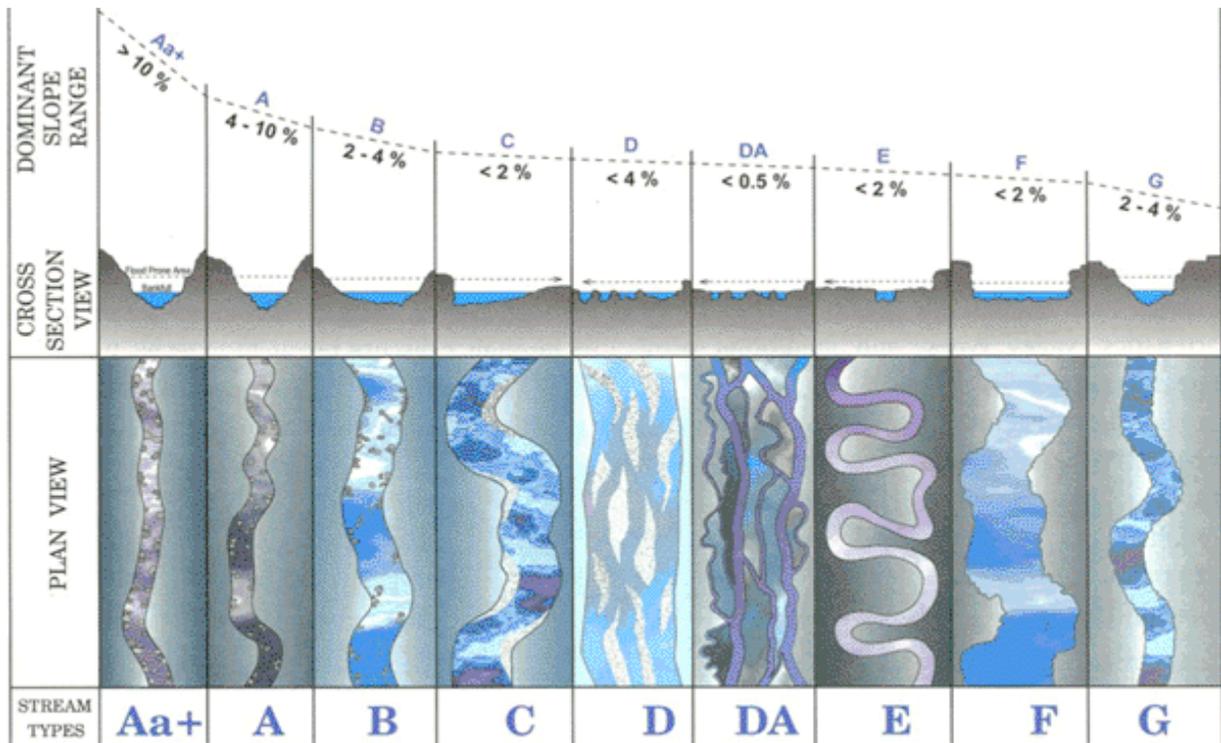
Figure 2.3 – Representation of Rosgen Level I Classifications of Major Stream Types

An assessment of channel geomorphology is useful to better understand the stability of a stream and its associated behaviors. The Rosgen classification system is one such assessment method. It provides measurable benchmarks for determining stream stability and for comparing the stream with similar streams in an undisturbed state regardless of their location. The Rosgen classification system has four levels. The Level I classification is a geomorphic characterization that groups streams as Types A through G based on aspects of channel geometry, including water surface slope, entrenchment, width/depth ratio, and sinuosity. A simplification of the longitudinal, cross-sectional, and plan views of the major stream types under the Rosgen Level I classification scheme is presented in Figure 2.3.

The County utilizes Rosgen Level I geomorphic classifications in its watershed modeling and analysis as indicators of stream stability and channel entrenchment. In the Patapsco Tidal and Bodkin Creek Watersheds, field data were collected to support the Rosgen Level I geomorphic classification of each single-threaded reach, regardless of perenniality. This is a change from previous watershed studies where only perennial channels were assessed.

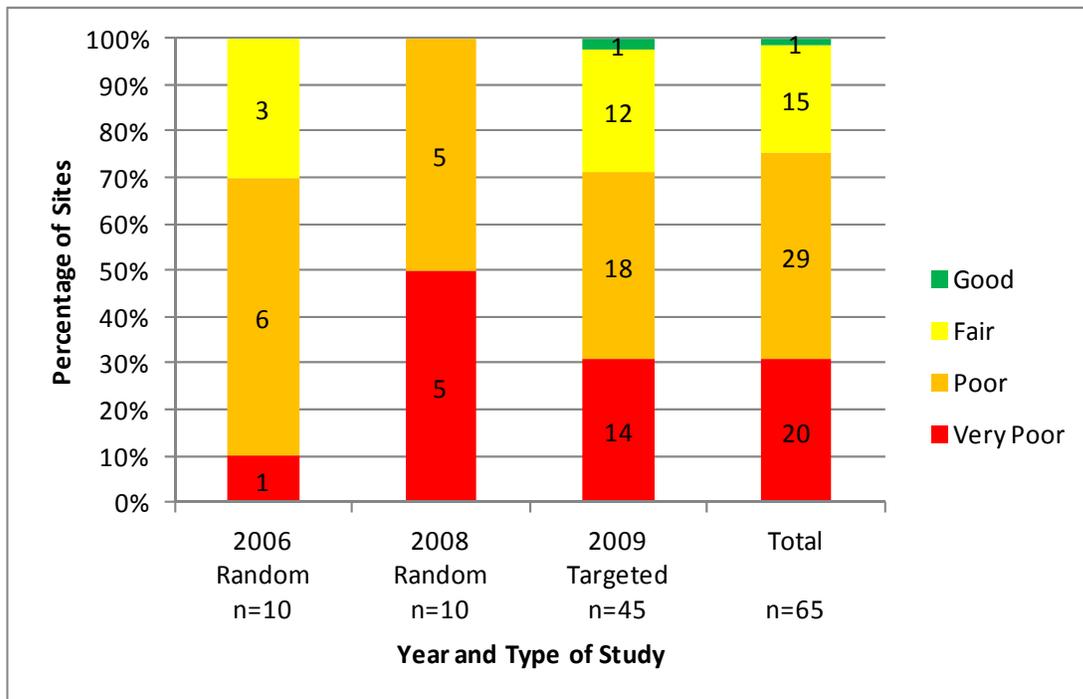
Figure 2.4 – Bioassessment Ratings in the Patapsco Tidal Watershed by Year and Study

Overall, BIBI results indicated that benthic macroinvertebrate communities have been degraded to a great degree in many areas across the Patapsco Tidal and Bodkin Creek watersheds. The overwhelming majority of sites sampled in both watersheds were rated either “Poor” or “Very Poor” (Figures 2.4 and 2.5). There is a good deal of consistency over time in the proportion of sites in each of the categories. The percentages described above for the entire datasets follow fairly closely the patterns displayed by each year in each watershed. Poor to Very Poor scores were not restricted to a certain portion of the watersheds, but were observed in many subwatersheds throughout Patapsco Tidal and Bodkin Creek. Many of the targeted sites sampled in 2009 were characterized by low Percent Ephemeroptera, Number of Ephemeroptera Taxa, Number of EPT Taxa, and Percent Intolerant Urban (Roth et al., 2009). Other data examined in the 2009 report suggested that water quality degradation, in addition to habitat condition, was likely affecting stream biological integrity. The results of the targeted sampling in 2009 are consistent with the prior random assessments performed in both the Bodkin Creek (Stribling et al., 2008) and Patapsco Tidal (Victoria et al., 2010) watersheds.

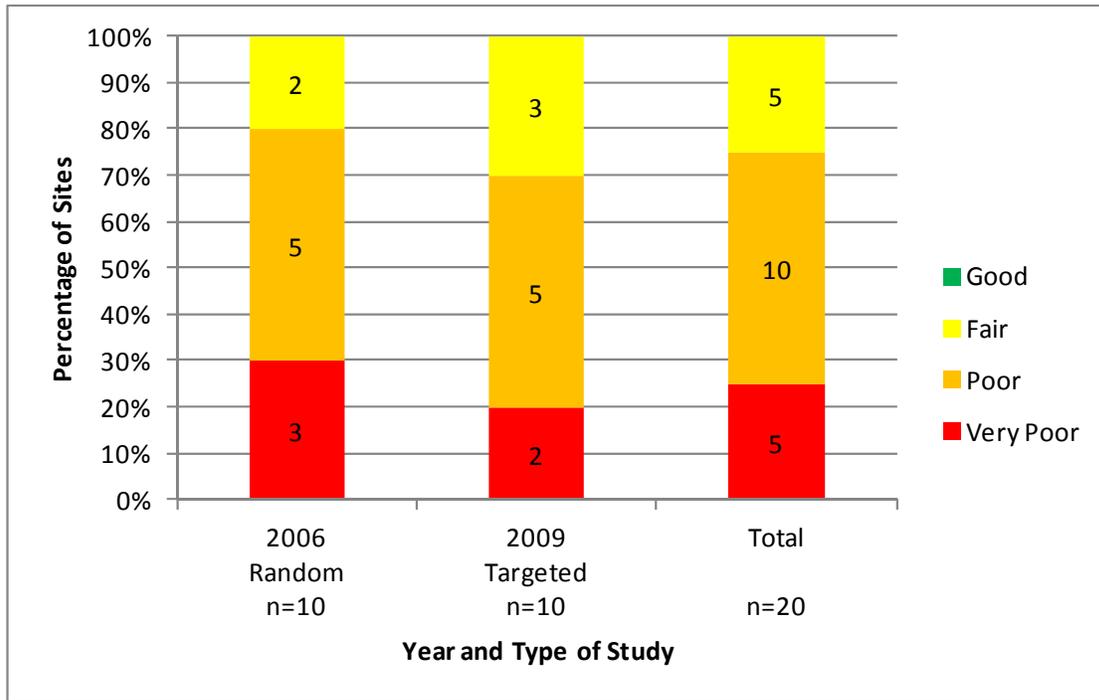
Figure 2.5 – Bioassessment Ratings in the Bodkin Creek Watershed by Year and Study

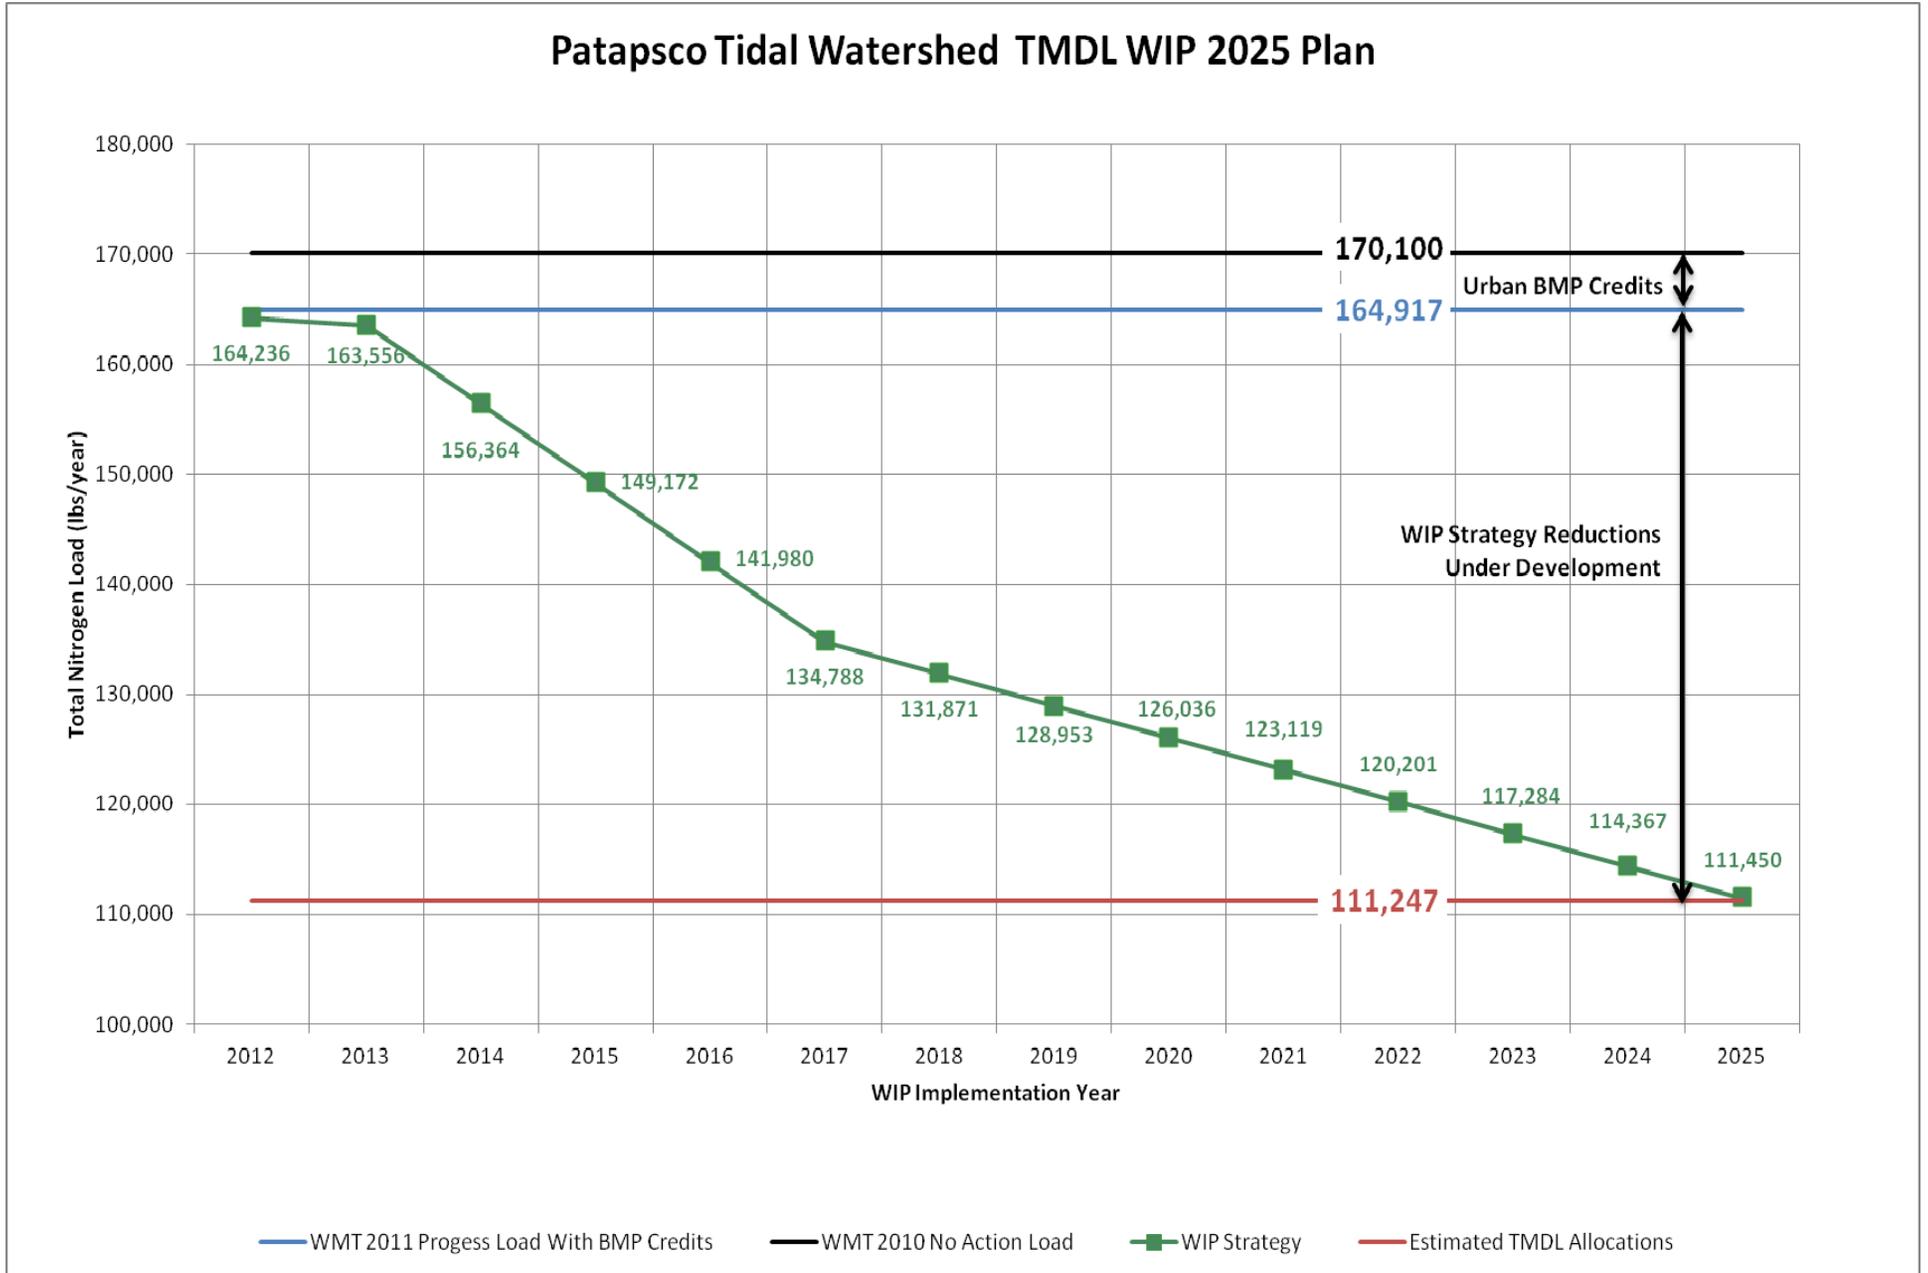
Figure 5.1 – Annual Progress of WIP Strategy towards Meeting Total Nitrogen Load Allocations – Patapsco Tidal Watershed

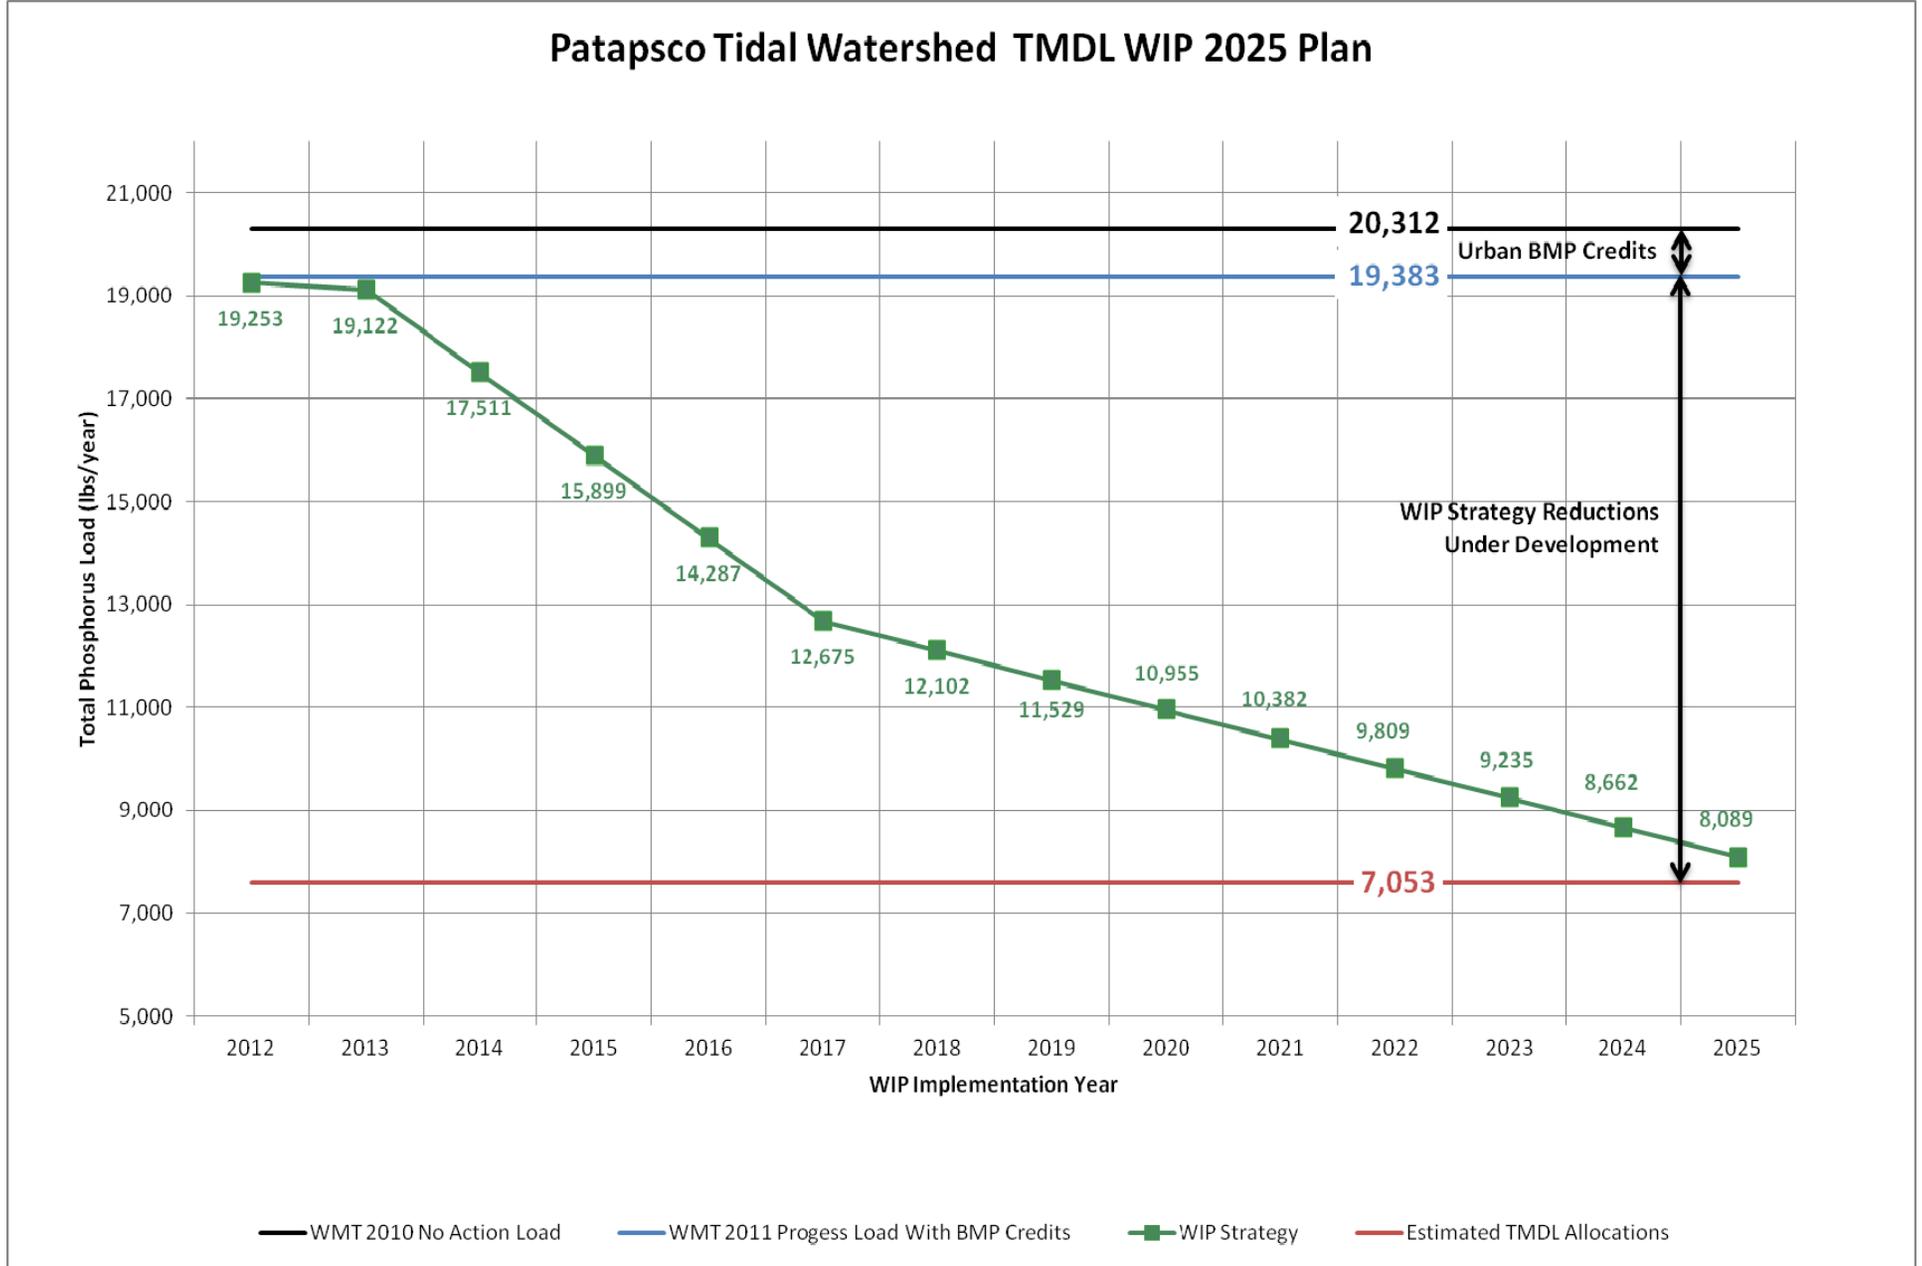
Figure 5.2 – Annual Progress of WIP Strategy towards Meeting Total Phosphorus Load Allocations – Patapsco Tidal Watershed

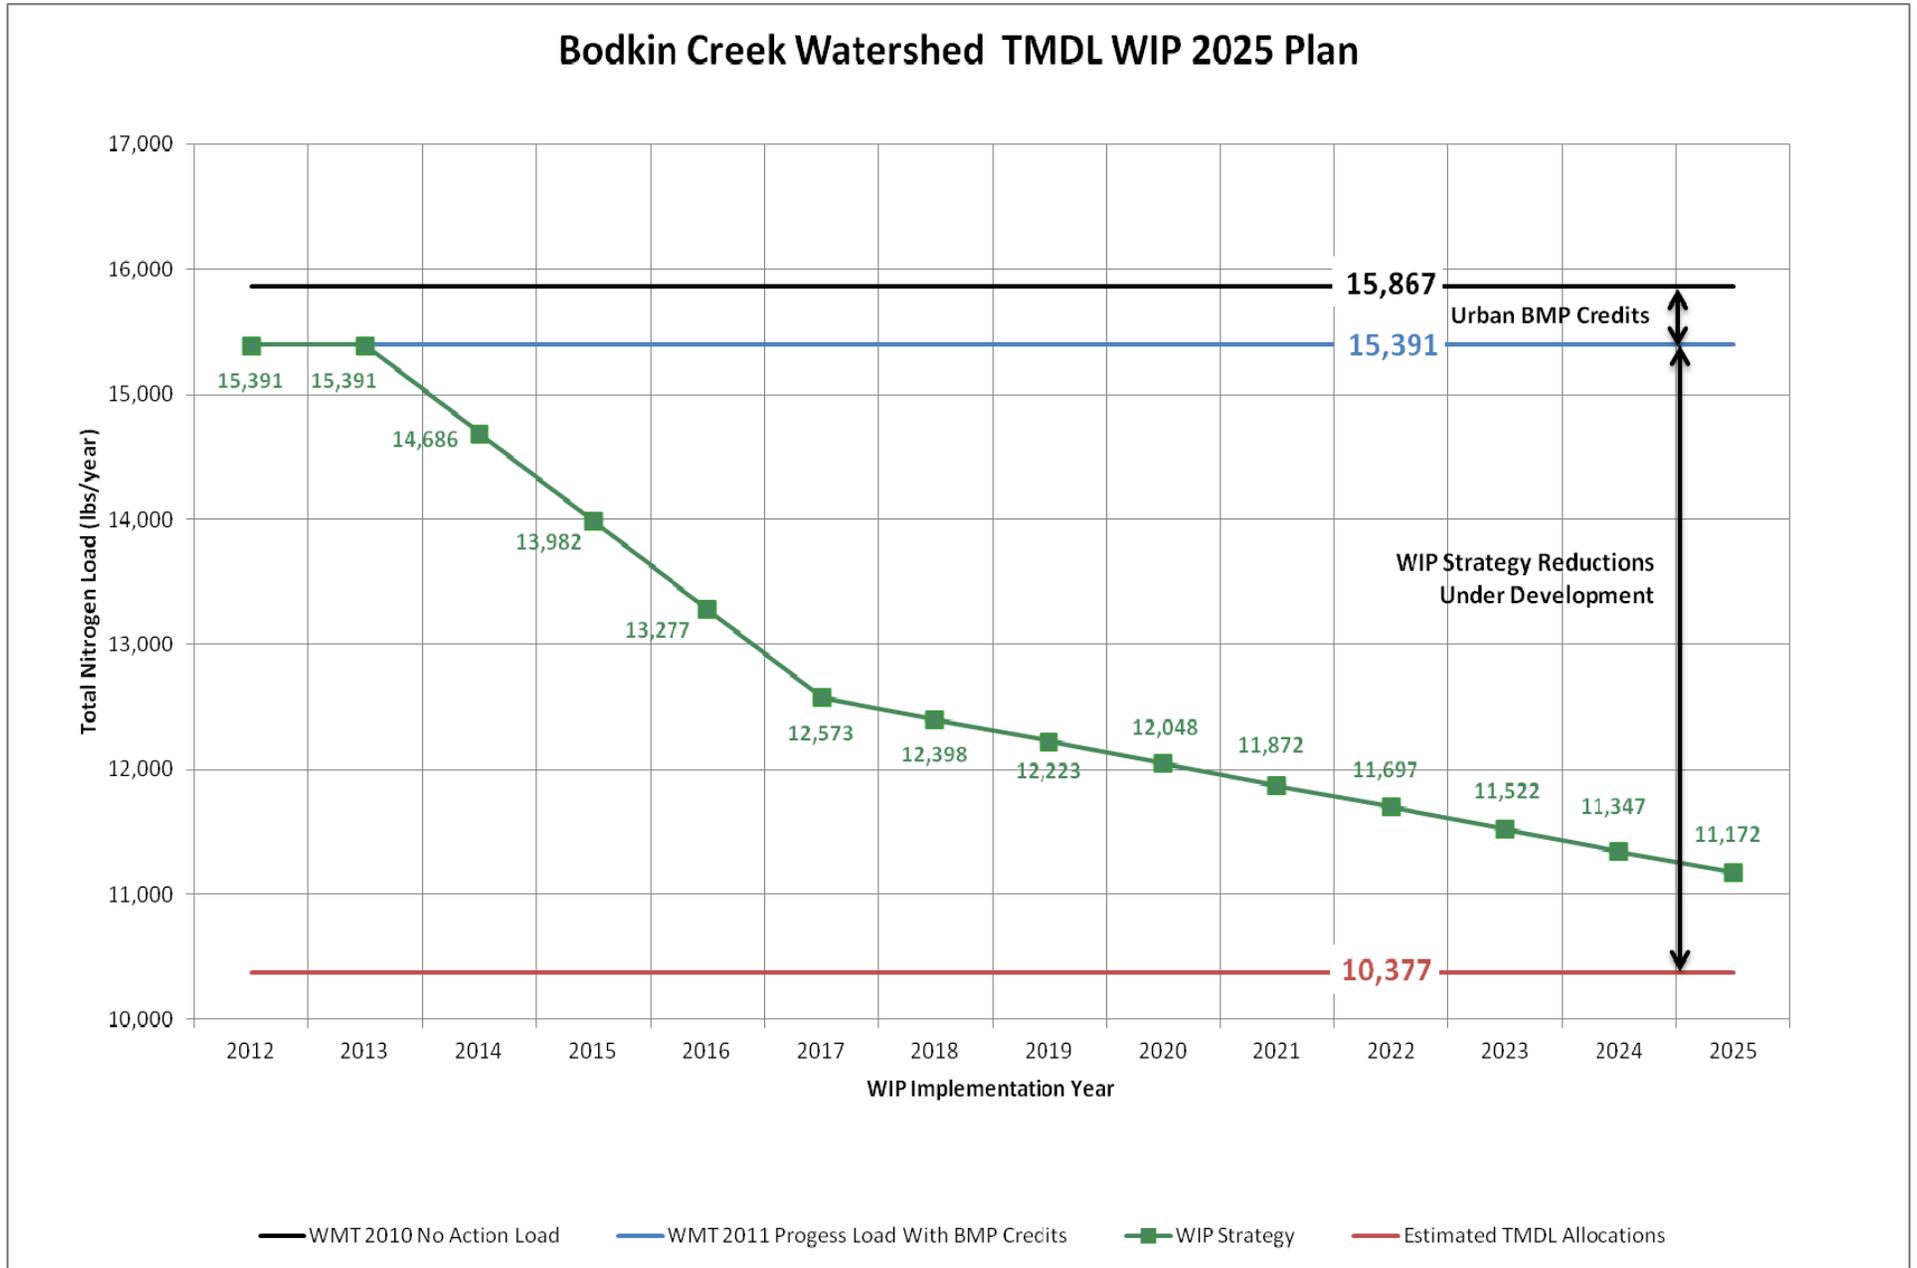
Figure 5.3 – Annual Progress of WIP Strategy towards Meeting Total Nitrogen Load Allocations – Bodkin Creek Watershed

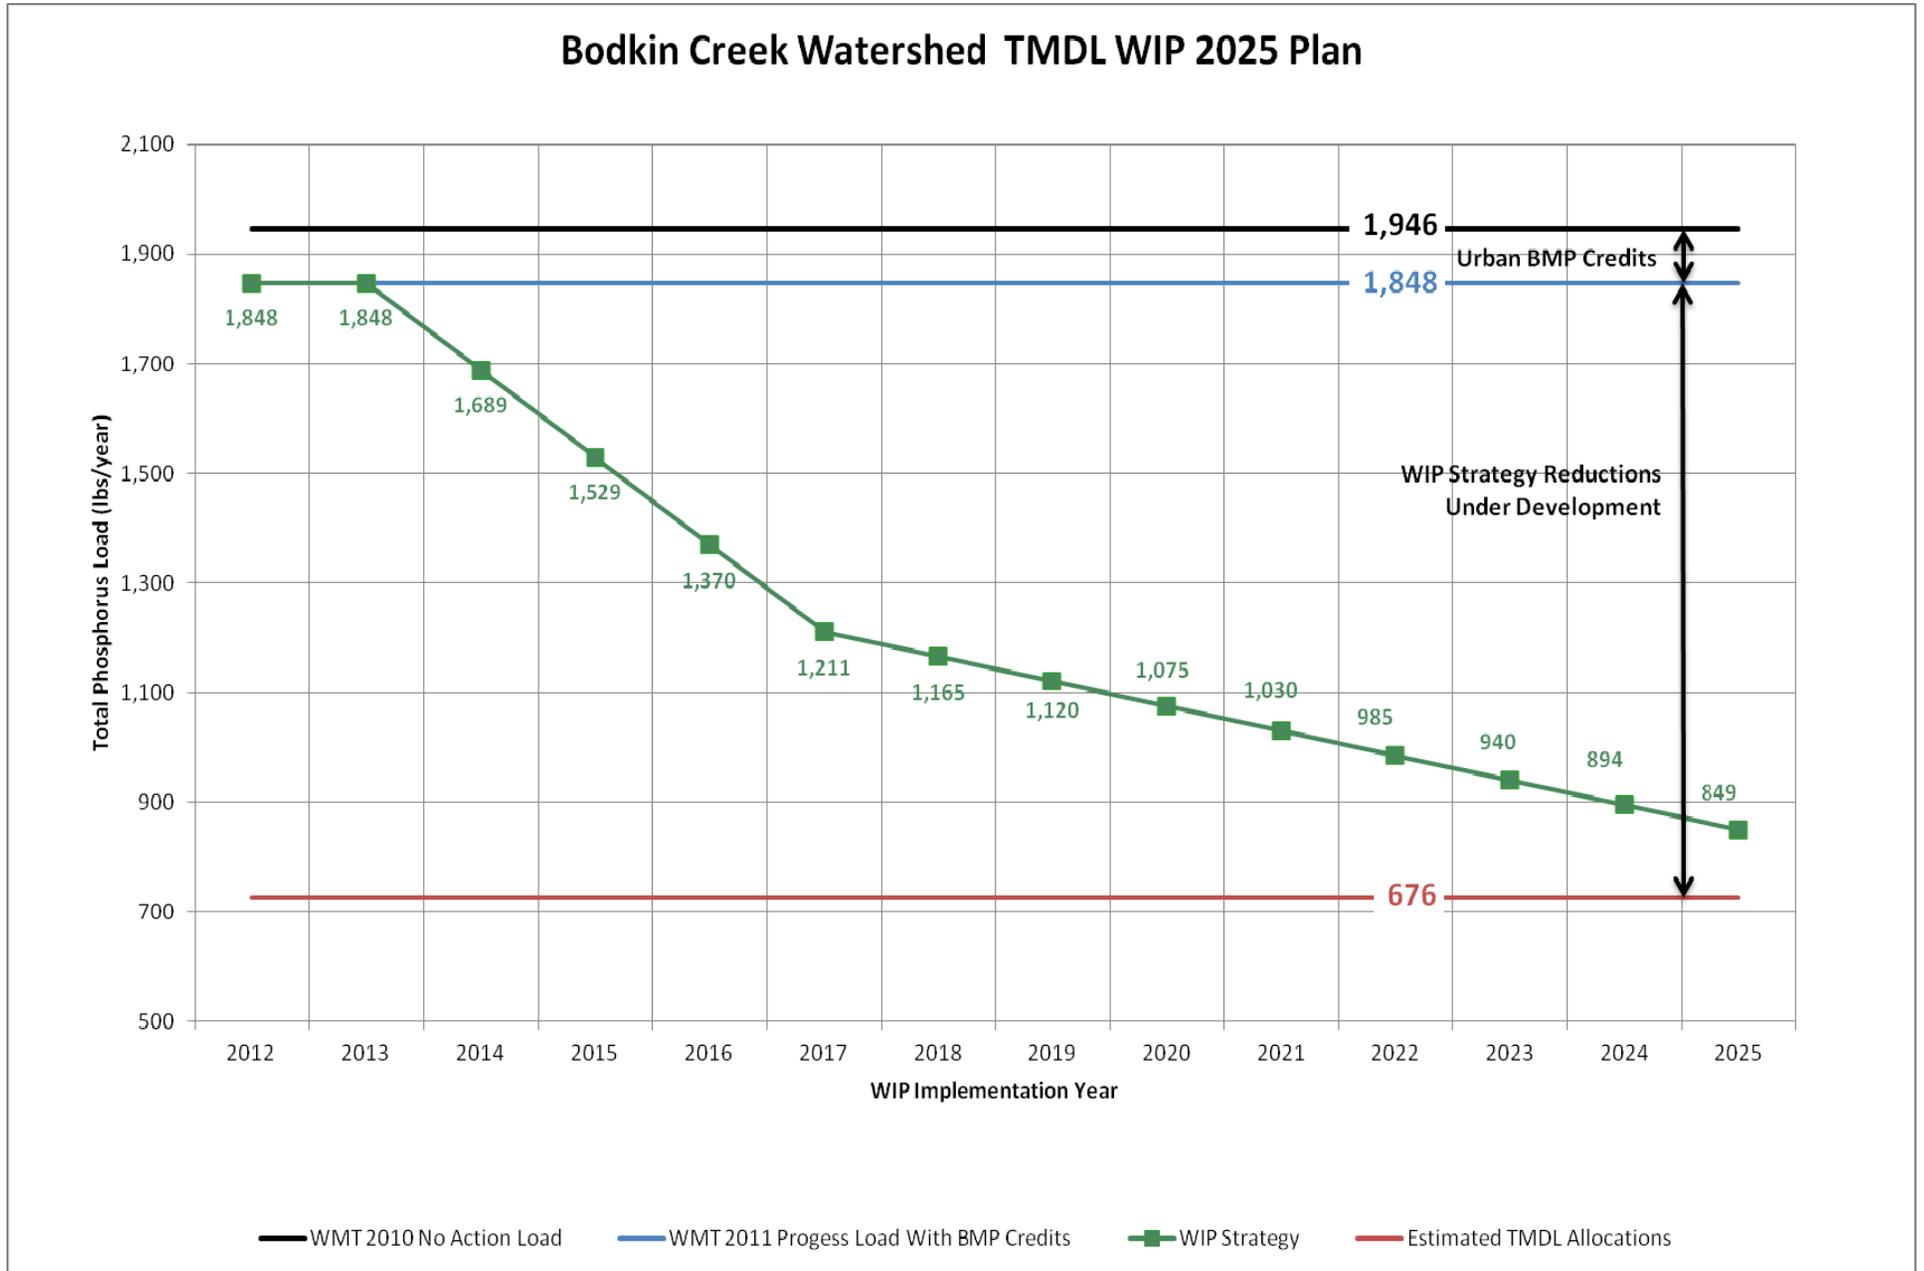
Figure 5.4 – Annual Progress of WIP Strategy towards Meeting Total Phosphorus Load Allocations – Bodkin Creek Watershed
