2010 Annual Report for  
Anne Arundel County  
Storm Water National Pollutant  
Discharge Elimination System

Permit Number MD0068306

June 2011

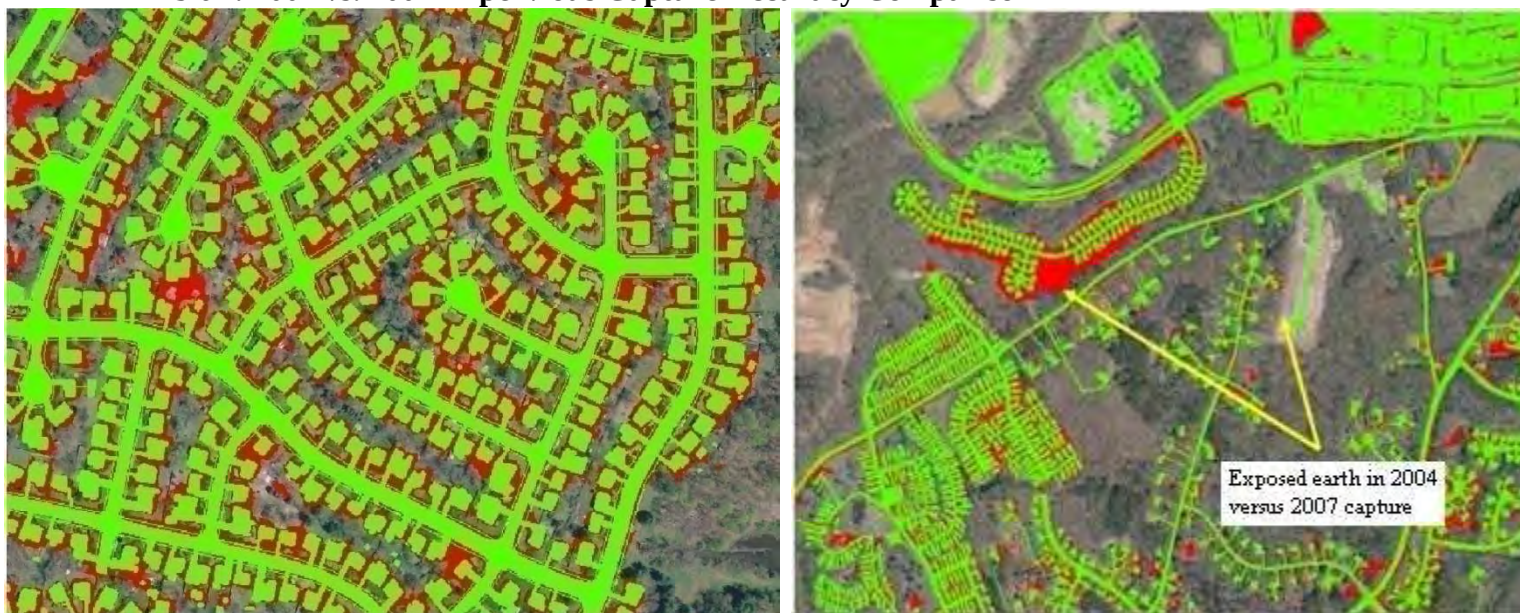
## Exhibit 2: 2004 vs. 2007 Impervious Capture Accuracy Comparison

Red – 2004 Impervious Surface Dataset

Green – 2007 Impervious Surface Dataset

**Exhibit 2** demonstrates the enhancements of this updated dataset. Direct comparisons between the 2004 and 2007/2008 information are therefore problematic due to the different levels of accuracy. Detail documenting the difference between the 2004 and 2007/2008 datasets was included in the 2008 report. The 2009 report included a breakdown of land cover for each of the County's twelve watersheds, based on the 2007/2008 mapping.

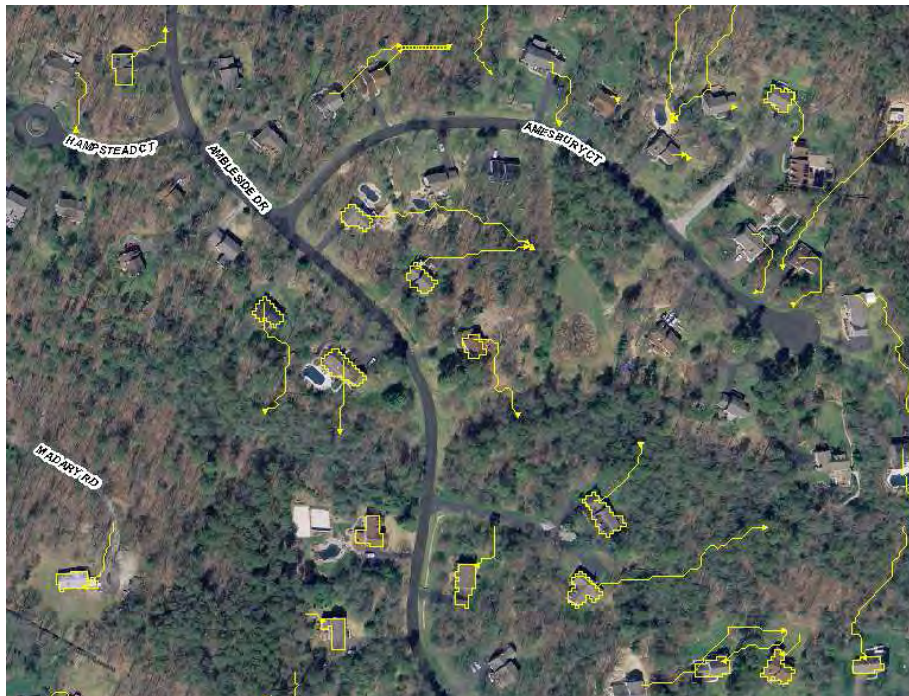
**Exhibit 3: Disconnected Rooftops and Their Pervious Flow Path**

calculated using similar methodology for the entire County. These disconnected rooftop and non-rooftop areas are believed to be treated fully by the environmental site design procedures and thus were subtracted from the County's total uncontrolled impervious surface. **Exhibit 3** depicts select areas in the Magothy River watershed that qualify for rooftop disconnection credit. The disconnected rooftop areas and the extent of pervious flow paths are highlighted in yellow.

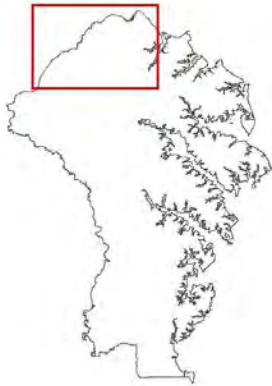
Exhibit 8: Patapsco Non-Tidal Subwatershed Summary Pollutant Loads Based on Existing Conditions

Date: November 8, 2010  
File: J:\Shared\NPDES\Watershed Management Programs\WMP\Share\Watershed Studies\Patapsco River Non-Tidal Study\Study Reports\Map\Map 3.2 Summary Pollutant Loads Based on Existing Conditions.mxd  
Map Product: Watershed Assessment and Planning Program  
Copyright: 2010
