## Aquatic Biological Assessment of the Watersheds of Anne Arundel County, Maryland: 2007

**Prepared by:**

Tetra Tech, Inc.  
400 Red Brook Blvd., Suite 200  
Owings Mills, MD 21117-5159

**November 2008**

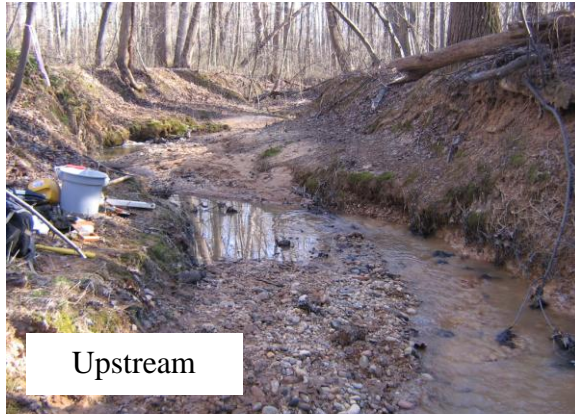
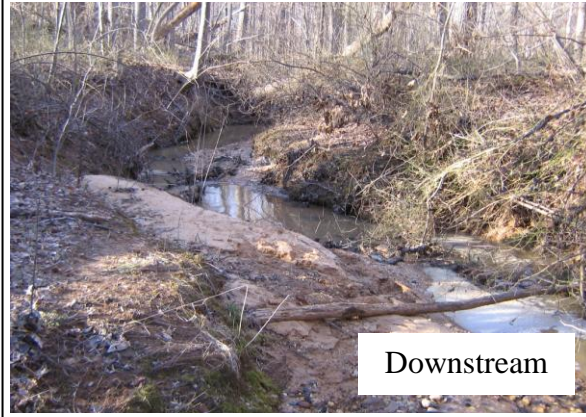
Upstream

Downstream

**Location/Site Access:** Located at 7789 Rotherman Drive 120m south  
**Latitude/Longitude:** 39.14969/-76.74251

Drainage Area (mi <sup>2</sup> )	0.44	Cross Sectional Area (ft <sup>2</sup> )	15.9
Bankfull Width (ft)	9.6	Water Surface Slope (ft/ft)	1.1
Mean Bankfull Depth (ft)	1.7	Sinuosity	1.0
Floodprone Width (ft)	15.7	D50 (mm)	0.19
Entrenchment Ratio	1.6	Adjustments?	↑ Sin, ↓ ER
Width to Depth Ratio	5.8	<b>Rosgen Stream Type</b>	<b>G5c</b>

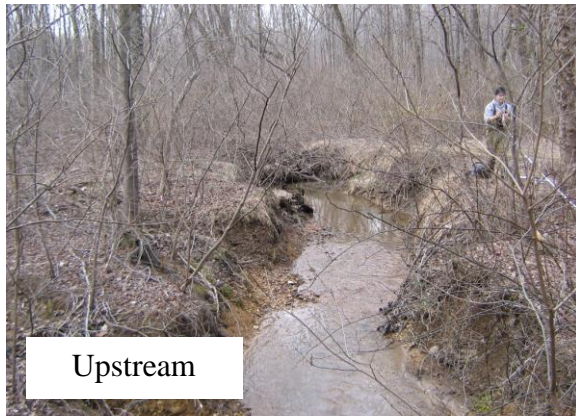
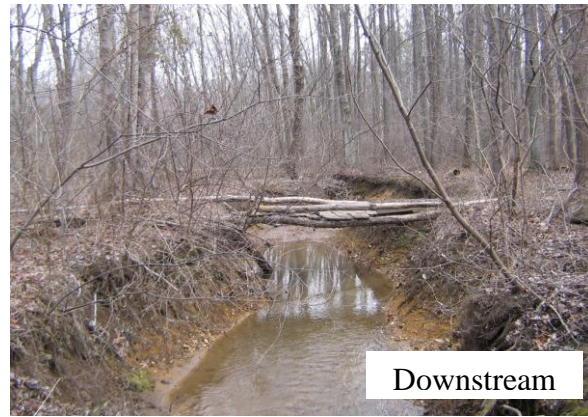
Upstream

Downstream

**Location/Site Access:** Located at Forest Rd.  
**Latitude/Longitude:** 39.16676/-76.75985

Drainage Area (mi <sup>2</sup> )	0.88	Cross Sectional Area (ft <sup>2</sup> )	6.2
Bankfull Width (ft)	7.5	Water Surface Slope (ft/ft)	0.94
Mean Bankfull Depth (ft)	0.8	Sinuosity	1.1
Floodprone Width (ft)	10.2	D50 (mm)	0.19
Entrenchment Ratio	1.4	Adjustments?	↑ Sin
Width to Depth Ratio	9.2	<b>Rosgen Stream Type</b>	<b>G5c</b>

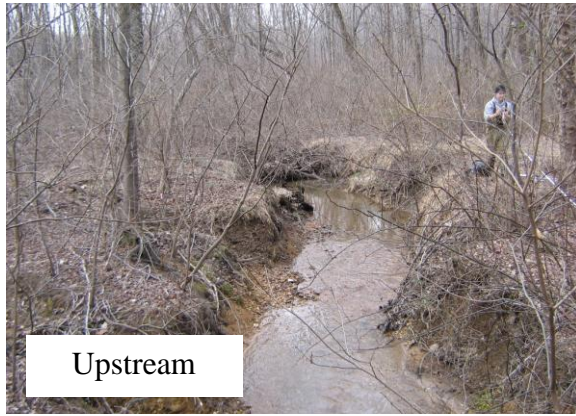
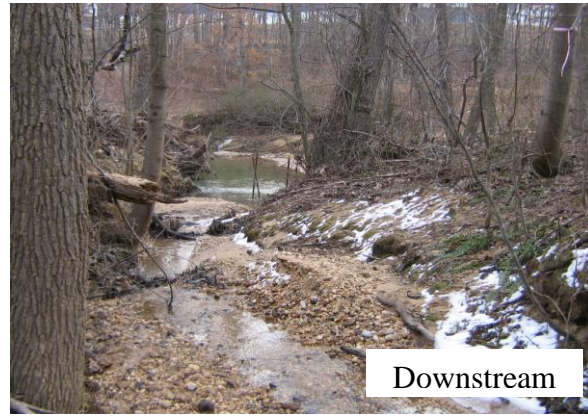
Upstream

Downstream

**Location/Site Access:** Located at Dorsey Rd. Crossing 500m east  
 Latitude/Longitude: 39.17465/-76.72089

Drainage Area (mi <sup>2</sup> )	0.22	Cross Sectional Area (ft <sup>2</sup> )	6.5
Bankfull Width (ft)	6.5	Water Surface Slope (ft/ft)	1.8
Mean Bankfull Depth (ft)	1.0	Sinuosity	1.1*
Floodprone Width (ft)	23.9	D50 (mm)	1
Entrenchment Ratio	3.7	Adjustments?	↑ Sin
Width to Depth Ratio	6.5	<b>Rosgen Stream Type</b>	<b>E5</b>

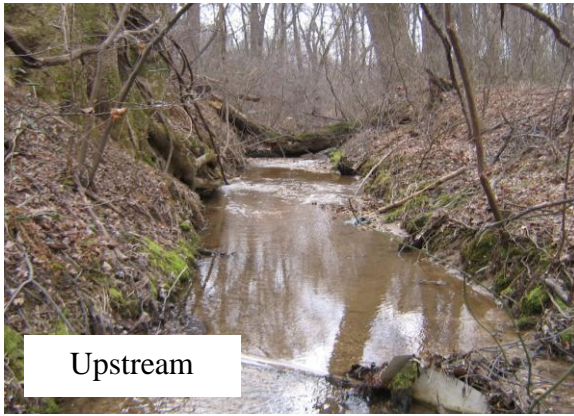
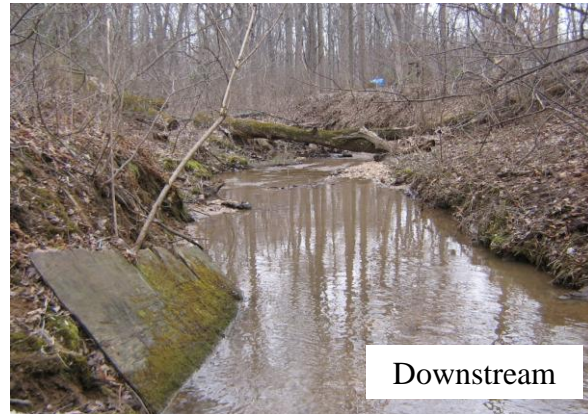
Upstream

Downstream

**Location/Site Access:** Located at Forest Ave. crossing, 120ft. D.S.  
Latitude/Longitude: 39.16201/-76.75938

Drainage Area (mi <sup>2</sup> )	0.40	Cross Sectional Area (ft <sup>2</sup> )	9.5
Bankfull Width (ft)	9.7	Water Surface Slope (ft/ft)	0.85
Mean Bankfull Depth (ft)	1.0	Sinuosity	1.0*
Floodprone Width (ft)	14.4	D50 (mm)	0.5
Entrenchment Ratio	1.5	Adjustments?	↑ Sin, ↑ W/D
Width to Depth Ratio	9.9	<b>Rosgen Stream Type</b>	<b>B5c</b>

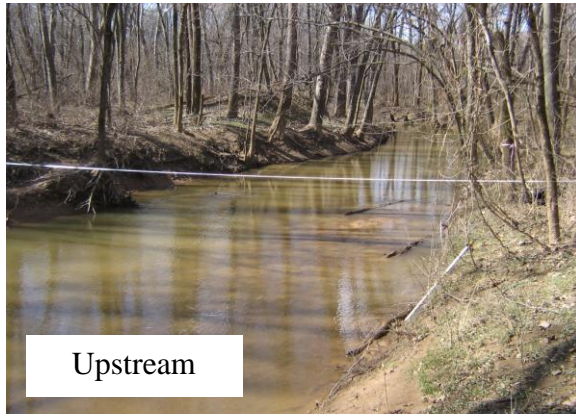
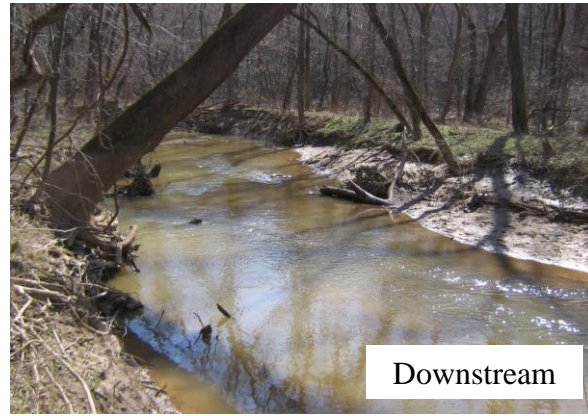
Upstream

Downstream

**Location/Site Access:** Located at 200m DS from Race Rd.  
Latitude/Longitude: 39.21243/-76.70044

Drainage Area (mi <sup>2</sup> )	20.0	Cross Sectional Area (ft <sup>2</sup> )	126.1
Bankfull Width (ft)	39.9	Water Surface Slope (ft/ft)	0.086
Mean Bankfull Depth (ft)	3.2	Sinuosity	1.2
Floodprone Width (ft)	361*	D50 (mm)	0.27
Entrenchment Ratio	9*	Adjustments?	↑ Sin
Width to Depth Ratio	12.7	<b>Rosgen Stream Type</b>	<b>C5</b>

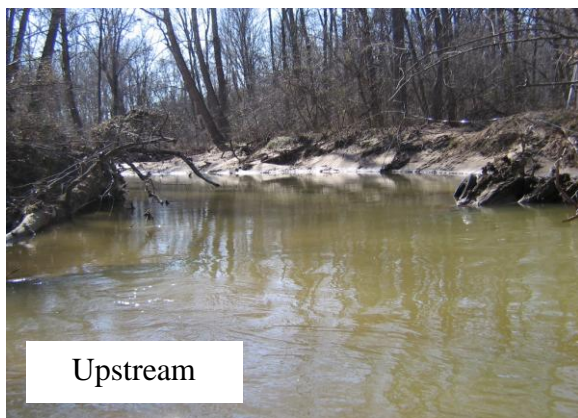
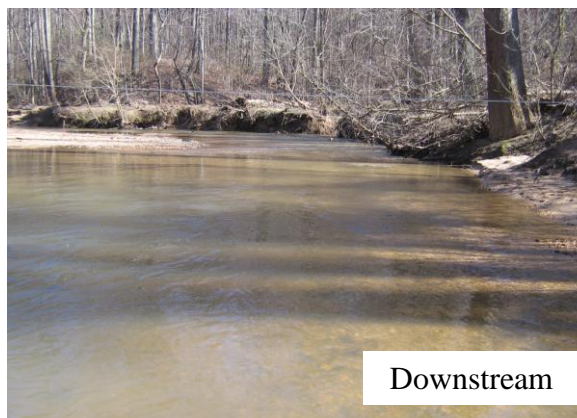
Upstream

Downstream

**Location/Site Access:** Located at 130m S of Race Rd.

Drainage Area (mi <sup>2</sup> )	19.5	Cross Sectional Area (ft <sup>2</sup> )	228.8
Bankfull Width (ft)	56.1	Water Surface Slope (ft/ft)	0.17
Mean Bankfull Depth (ft)	4.1	Sinuosity	1.1*
Floodprone Width (ft)	750*	D50 (mm)	0.45
Entrenchment Ratio	13.4*	Adjustments?	↑ Sin
Width to Depth Ratio	13.8	<b>Rosgen Stream Type</b>	<b>C5</b>

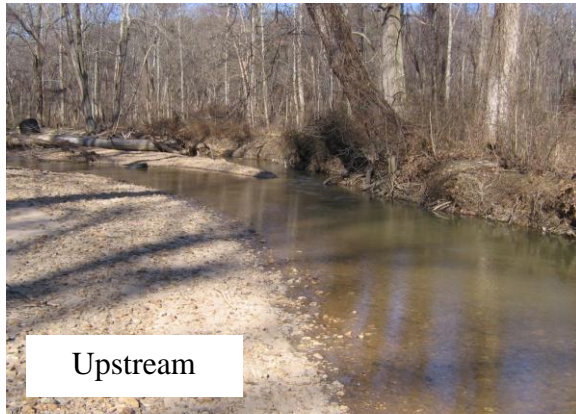
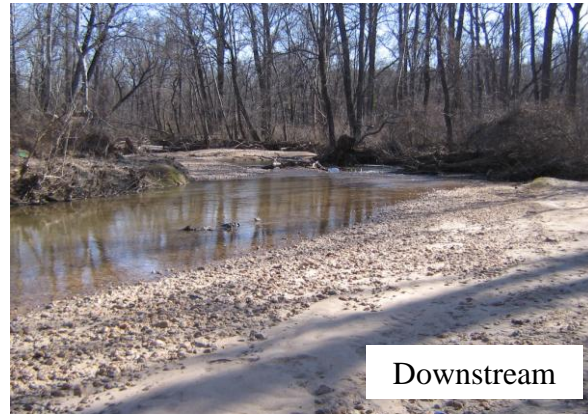
Upstream

Downstream

**Location/Site Access:** Located at 100m from Race rd. (south)  
 Latitude/Longitude: 39.19177/-76.71631

Drainage Area (mi <sup>2</sup> )	19.5	Cross Sectional Area (ft <sup>2</sup> )	150.2
Bankfull Width (ft)	60.8	Water Surface Slope (ft/ft)	0.51
Mean Bankfull Depth (ft)	2.5	Sinuosity	1.2
Floodprone Width (ft)	876*	D50 (mm)	14
Entrenchment Ratio	14.4*	Adjustments?	None
Width to Depth Ratio	24.6	<b>Rosgen Stream Type</b>	<b>C4</b>

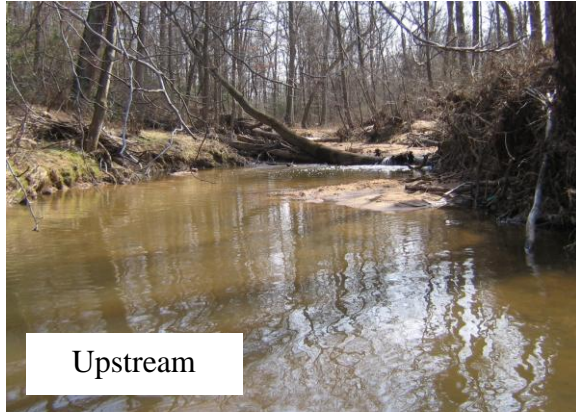
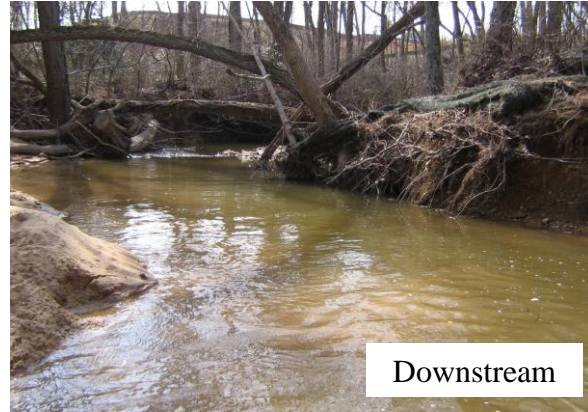
Upstream

Downstream

**Location/Site Access:** Located at Park in back lot of Oceaneering, on airport 100way Rd.  
Latitude/Longitude: 39.17089/-76.72085

Drainage Area (mi <sup>2</sup> )	3.24	Cross Sectional Area (ft <sup>2</sup> )	30.3
Bankfull Width (ft)	20.1	Water Surface Slope (ft/ft)	0.91
Mean Bankfull Depth (ft)	1.5	Sinuosity	1.2
Floodprone Width (ft)	26.2	D50 (mm)	4
Entrenchment Ratio	1.3	Adjustments?	None
Width to Depth Ratio	13.4	<b>Rosgen Stream Type</b>	<b>F4</b>

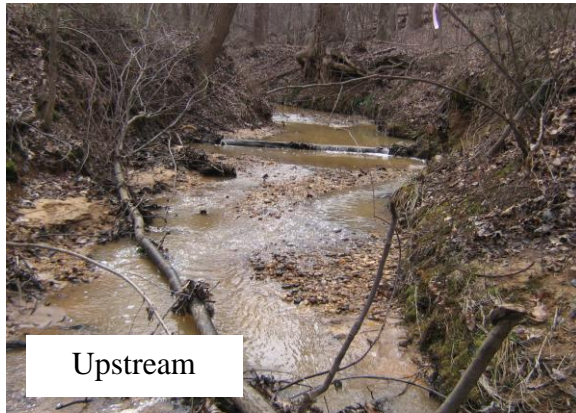
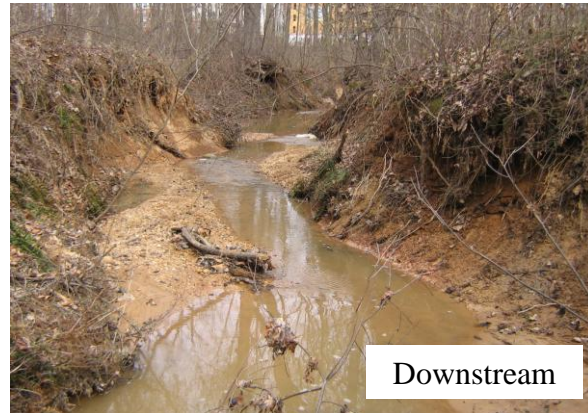
Upstream

Downstream

**Location/Site Access:** Located at Milestone parkway development SE  
 Latitude/Longitude: 39.15106/-76.74563

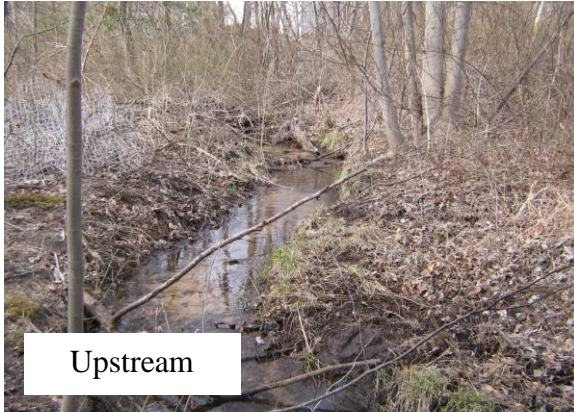
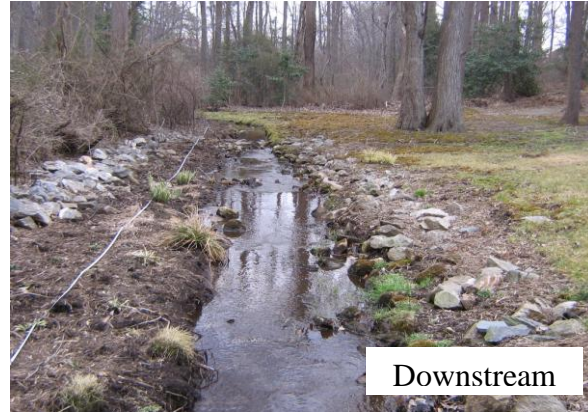
Upstream

Downstream

**Location/Site Access:** Located at Cedar Dr. crossing, 100m U.S.  
 Latitude/Longitude: 39.14103/-76.71756

Drainage Area (mi <sup>2</sup> )	0.09	Cross Sectional Area (ft <sup>2</sup> )	5.5
Bankfull Width (ft)	6.7	Water Surface Slope (ft/ft)	0.88
Mean Bankfull Depth (ft)	0.8	Sinuosity	1.0
Floodprone Width (ft)	59.7	D50 (mm)	0.18
Entrenchment Ratio	8.9	Adjustments?	↑Sin
Width to Depth Ratio	8.2	<b>Rosgen Stream Type</b>	<b>E5</b>

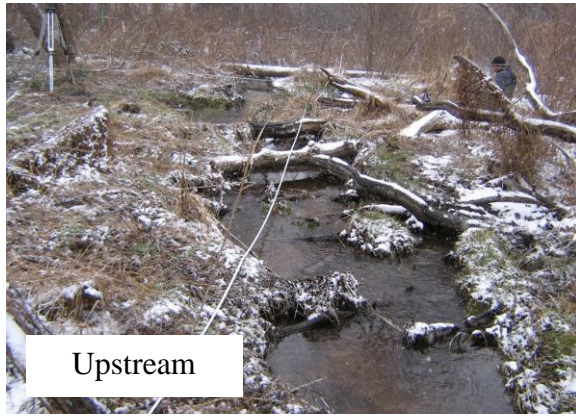
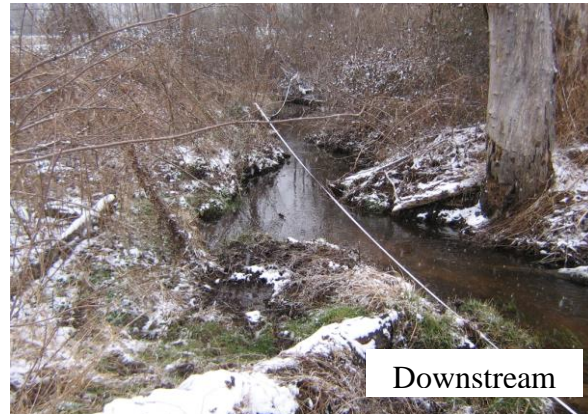
Upstream

Downstream

**Location/Site Access:** Located at end of Macedonia Drive (south end) 530 ft. SW  
 Latitude/Longitude: 39.13982/-76.7093

Drainage Area (mi <sup>2</sup> )	0.48	Cross Sectional Area (ft <sup>2</sup> )	4.8
Bankfull Width (ft)	9.6	Water Surface Slope (ft/ft)	0.67
Mean Bankfull Depth (ft)	0.5	Sinuosity	1.2*
Floodprone Width (ft)	105*	D50 (mm)	0.32
Entrenchment Ratio	10.9*	Adjustments?	↑Sin
Width to Depth Ratio	19.3	<b>Rosgen Stream Type</b>	<b>C5</b>

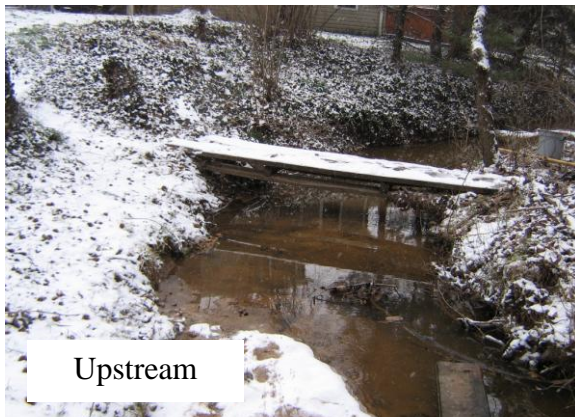
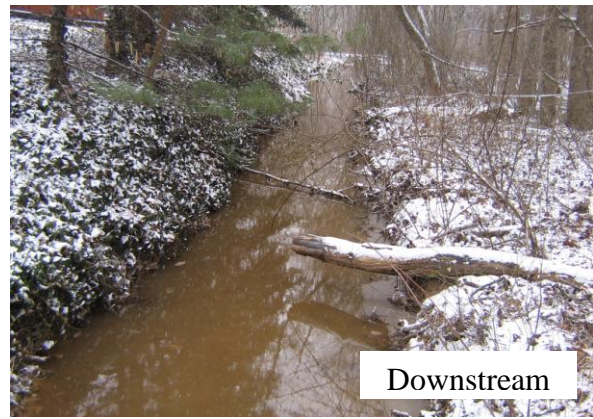
Upstream

Downstream

**Location/Site Access:** Located at Farm Pond Ct.  
 Latitude/Longitude: 39.15509/-76.70765

Drainage Area (mi <sup>2</sup> )	0.32	Cross Sectional Area (ft <sup>2</sup> )	11.8
Bankfull Width (ft)	7.6	Water Surface Slope (ft/ft)	0.1
Mean Bankfull Depth (ft)	1.5	Sinuosity	1.1*
Floodprone Width (ft)	72	D50 (mm)	0.35
Entrenchment Ratio	9.5	Adjustments?	↑Sin
Width to Depth Ratio	4.9	<b>Rosgen Stream Type</b>	<b>E5</b>

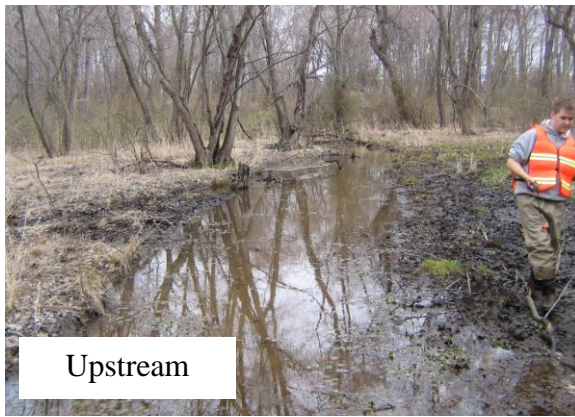
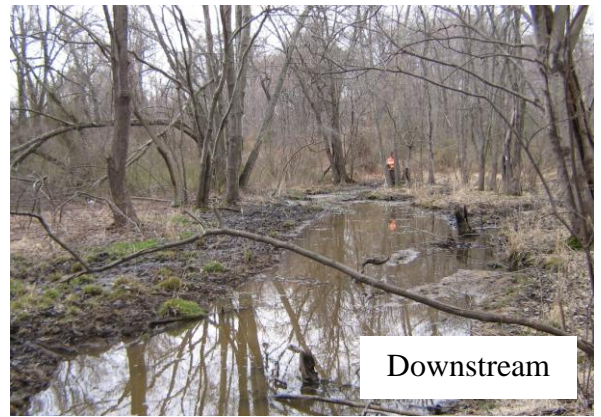
Upstream

Downstream

**Location/Site Access:** Located at BWI airport  
**Latitude/Longitude:** 39.16058/-76.68603

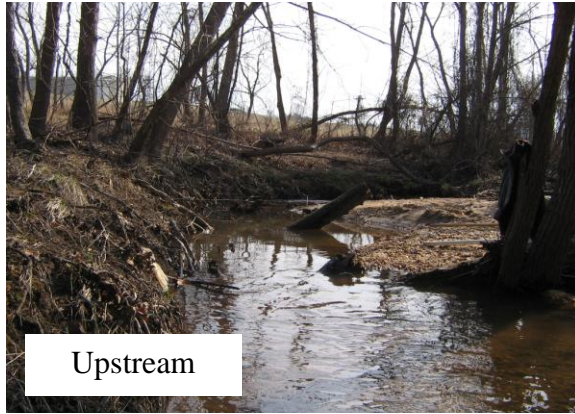
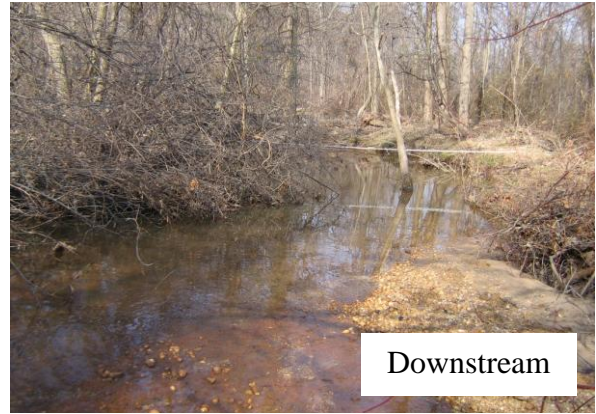
Upstream

Downstream

**Location/Site Access:** Located at Northrop Grunman parking lot off of Rt. 170  
**Latitude/Longitude:** 39.18985/-76.68848

Drainage Area (mi <sup>2</sup> )	1.53	Cross Sectional Area (ft <sup>2</sup> )	37.1
Bankfull Width (ft)	20.8	Water Surface Slope (ft/ft)	0.86
Mean Bankfull Depth (ft)	1.8	Sinuosity	1.4
Floodprone Width (ft)	98*	D50 (mm)	1.0
Entrenchment Ratio	4.7*	Adjustments?	↑Sin
Width to Depth Ratio	11.7	<b>Rosgen Stream Type</b>	<b>E5</b>

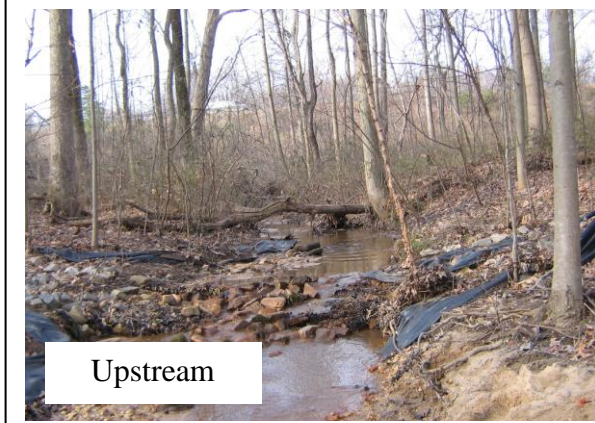
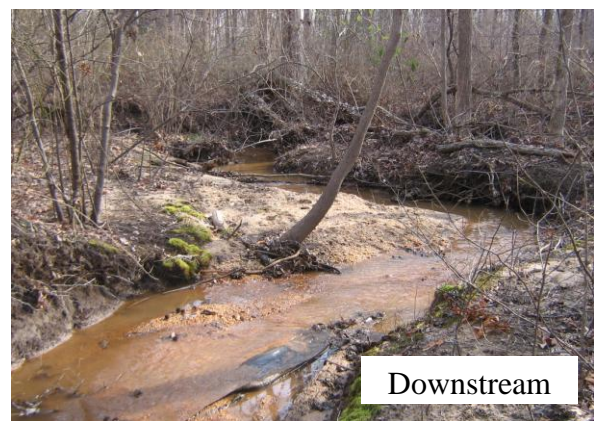
**Location/Site Access:** Located at Terrain Court. 400ft. S.  
**Latitude/Longitude:** 39.15459/-76.70966

Drainage Area (mi <sup>2</sup> )	0.24	Cross Sectional Area (ft <sup>2</sup> )	7.3
Bankfull Width (ft)	13.9	Water Surface Slope (ft/ft)	1.1
Mean Bankfull Depth (ft)	0.5	Sinuosity	1.4
Floodprone Width (ft)	18.7	D50 (mm)	0.3
Entrenchment Ratio	1.3	Adjustments?	None
Width to Depth Ratio	26.7	<b>Rosgen Stream Type</b>	<b>F5</b>

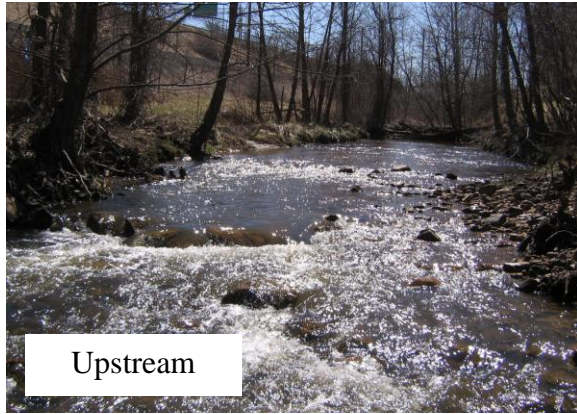
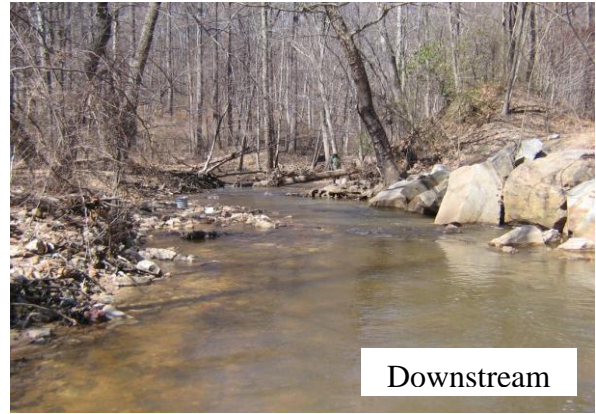
**Location/Site Access:** Located at Ridge Rd., park at closed road park entrance  
**Latitude/Longitude:** 39.20741/-76.69706

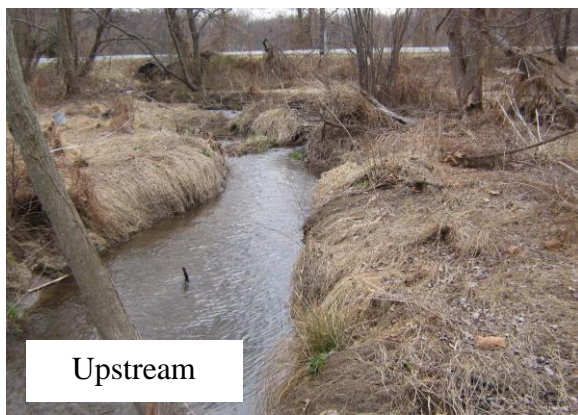
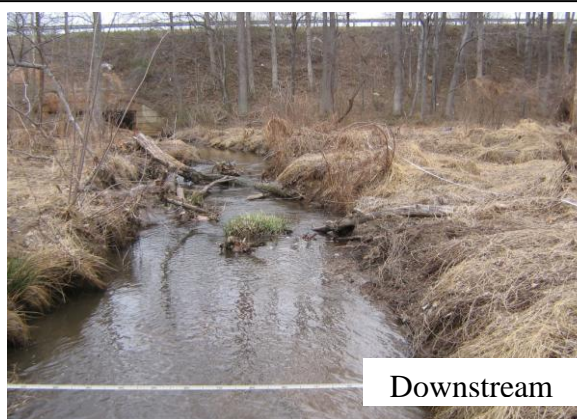
Upstream

- Biological condition – "Poor"
- Habitat scores "Non Supporting" and "Severely Degraded"
- Adequate substrate/available cover, moderately unstable banks, no pools, evidence of channelization, minimally impacted riparian zone
- Assemblage is dominated by beetles and midges. The most abundant species are *Stenelmis* and *Orthocladius/Cricotopus*.
- Stream type was not evaluated
- Biological community is in better condition than expected for measured level of habitat quality.

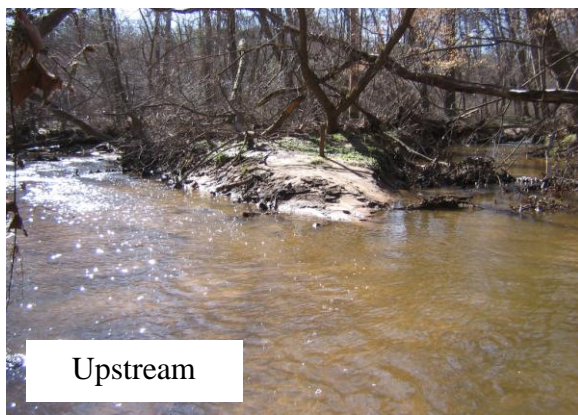
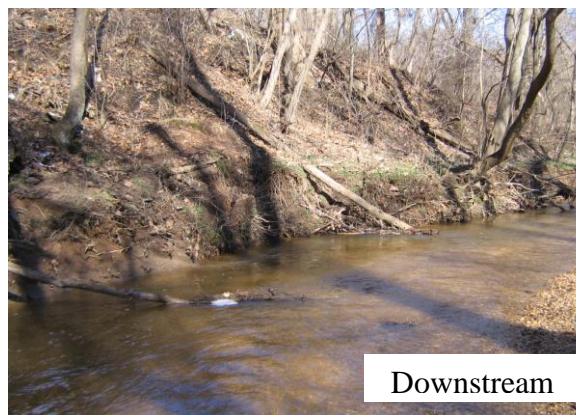
Upstream

- Biological condition – "Poor"
- Habitat scores "Partially Supporting" and "Degraded"
- Adequate substrate/available cover, moderately unstable banks, fairly straight channel, optimal riparian zone
- Assemblage dominated by midges. The most abundant taxon, *Hydrobaenus*, comprises 46% of the sample.
- Stream type was identified as an C5, slope was 0.47 percent, and the median channel substrate was coarse to medium sand
- Typically, C channels are stable. However, the marginal habitat ratings related to bank conditions may indicate that this reach is transitioning to an unstable form
- Biological community is appropriate for observed habitat quality.

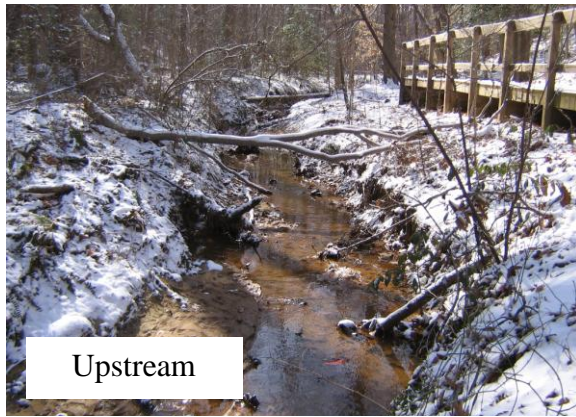
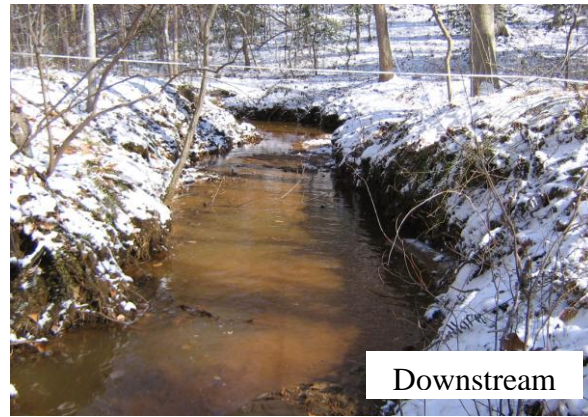
Upstream

- Biological condition – "Fair"
- Habitat scores "Non Supporting" and "Partially Degraded"
- Marginal substrate/available cover, moderately unstable banks, evidence of channelization, minimally impacted riparian zone
- Assemblage is dominated by worms (46%) and midges (36%). The most abundant taxon is Tubificinae.
- Stream type was identified as an E5, slope was 0.20 percent, and the median channel substrate was fine sand
- Habitat assessment results were mixed for this site, but biological community observed is trending toward less than expected impairment based on the observed habitat quality.

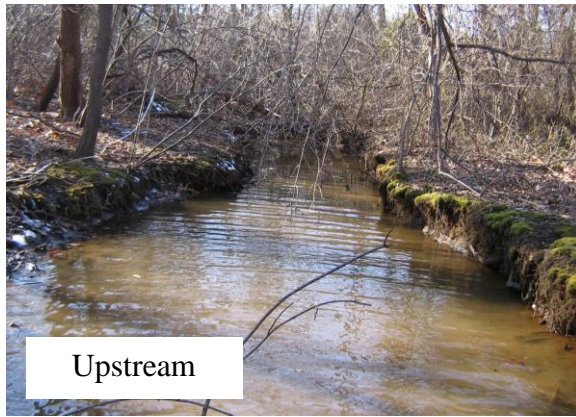
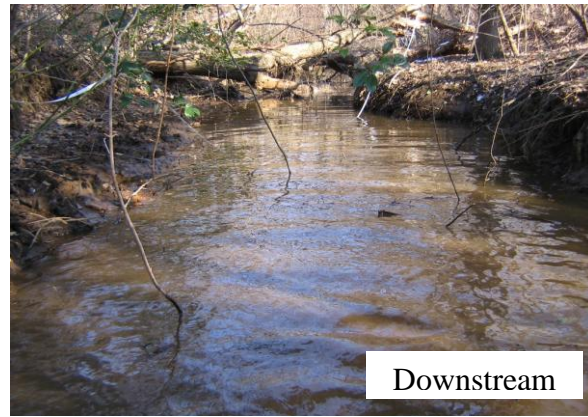
Upstream

- Biological condition – "Very Poor"
- Habitat scores "Non Supporting" and "Degraded"
- Adequate substrate/available cover, moderately unstable banks, evidence of channelization, marginal riparian zone
- The most abundant taxon, Sphaeriidae (Mollusca), comprises 31% of the sample. The other taxa are mostly worms, midges and amphipods.
- Stream type was identified as an E5, slope was 0.136 percent, and the median channel substrate was fine sand
- Habitat assessment results were mixed for this site, but biological community observed is trending toward more than expected impairment based on the observed habitat quality.

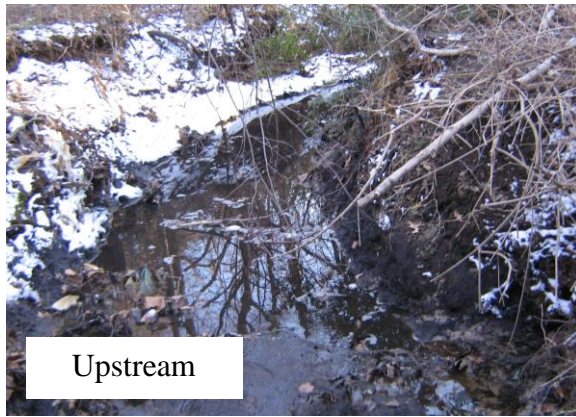
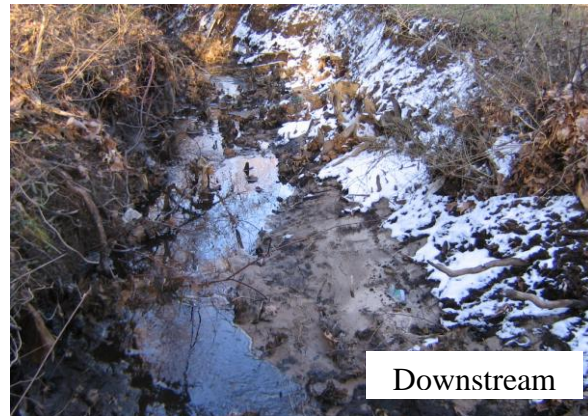
Upstream

- Biological condition – "Very Poor"
- Habitat scores "Non Supporting" and "Degraded"
- Marginal substrate/available cover, moderately unstable banks, optimal riparian zone
- Assemblage is dominated by worms. One taxon, Tubificinae, comprises 60% of the sample. No EPT taxa.
- Specific conductance relatively high.
- Stream type was identified as an G5c, slope was 1.02 percent, and the median channel substrate was fine sand
- Habitat assessment results were mixed for this site, but biological community observed is trending toward more than expected impairment based on the observed habitat quality.

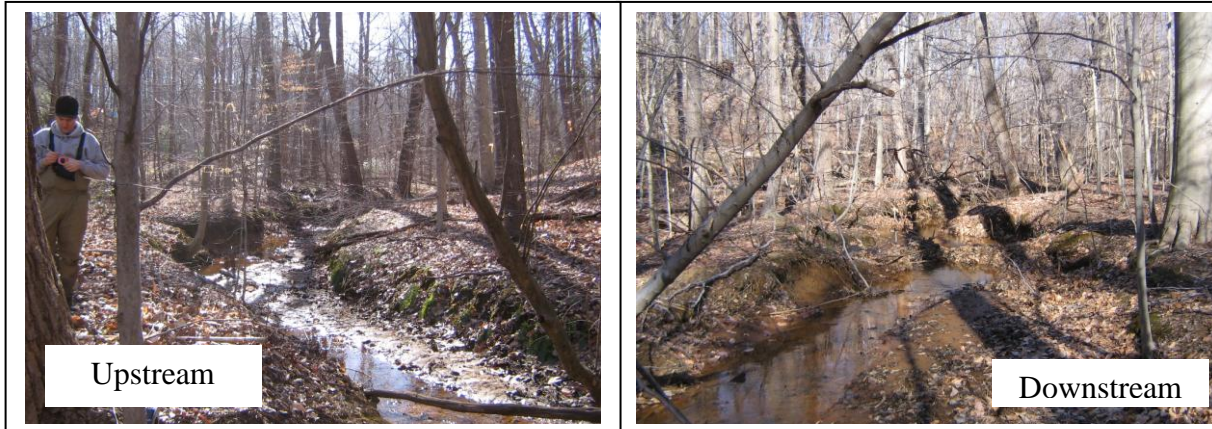
- Biological condition – "Poor"
- Habitat scores "Non Supporting" and "Partially Degraded"
- Marginal substrate/available cover, moderately unstable banks, moderate sediment deposition, minimally impacted riparian zone
- 15 midge taxa comprise 67% of the assemblage. The most abundant taxa are *Polypedilum* and *Diplocladius*.
- Stream type was identified as an G5c, slope was 0.62 percent, and the median channel substrate was fine to medium sand
- Habitat conditions are mixed for this site, with one assessment method indicating impairment and one indicating some kind of enrichment.

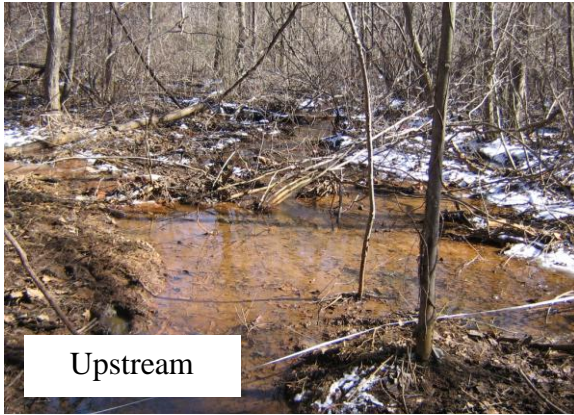
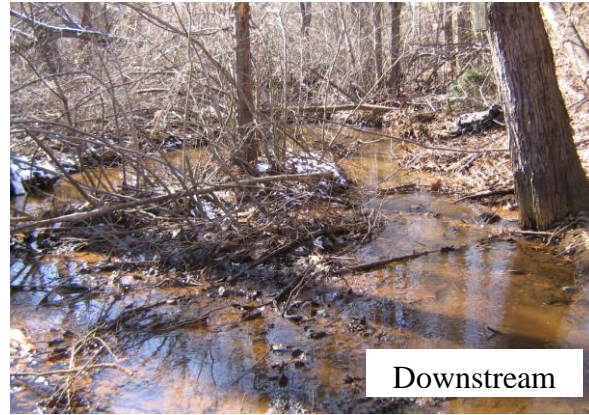
Upstream

- Biological condition – "Poor"
- Habitat scores "Non Supporting" and "Degraded"
- Marginal substrate/available cover, moderately unstable banks, heavy sediment deposition, marginal riparian zone (right bank)
- Assemblage dominated by mollusks (49%) and midges (32%). The most abundant taxa are *Physa* and *Thienemannimyia*.
- Stream type was identified as an C5, slope was 0.59 percent, and the median channel substrate was fine to medium sand
- Habitat conditions are mixed for this site, with one assessment method indicating impairment and one indicating some kind of enrichment.

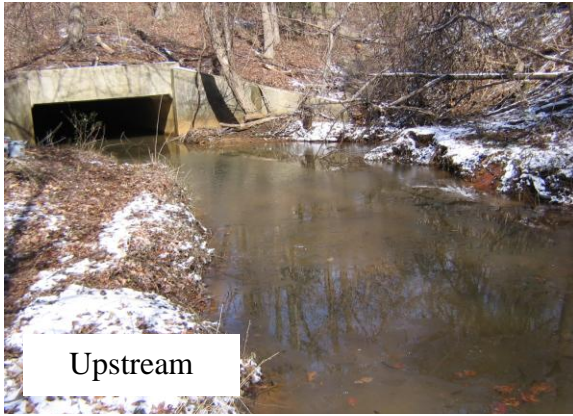
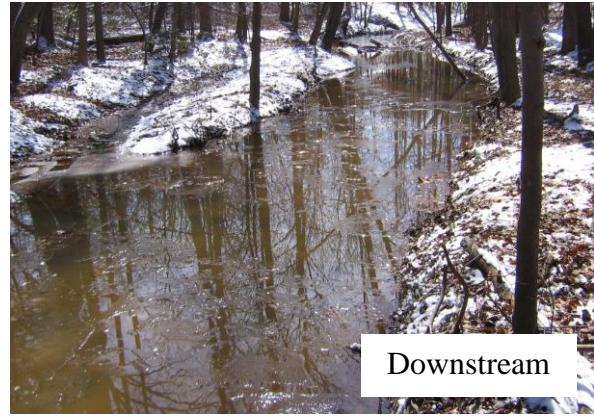
Upstream

- Biological condition – "Poor"
- Habitat scores "Non Supporting" and "Severely Degraded"
- Poor substrate conditions, obvious channelization, heavy sediment deposition, marginal riparian zone (left bank)
- Assemblage dominated by worms (47%). *Nais* and *Tubificinae* are the most abundant taxa. Many of the other organisms are midges (18%) and Mollusks (9%).
- Stream type was identified as an E5, slope was 0.013 percent, and the median channel substrate was silt
- While impaired, biological community is in better condition than expected for measured level of habitat quality.

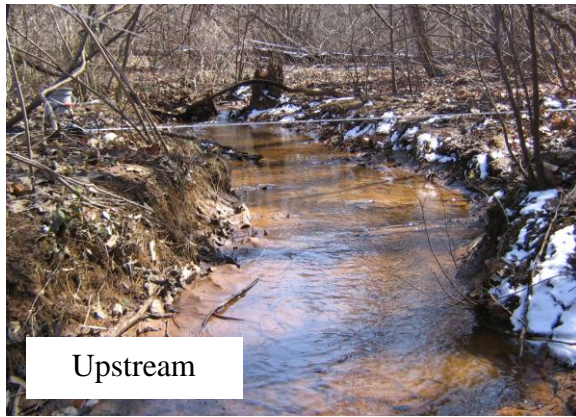
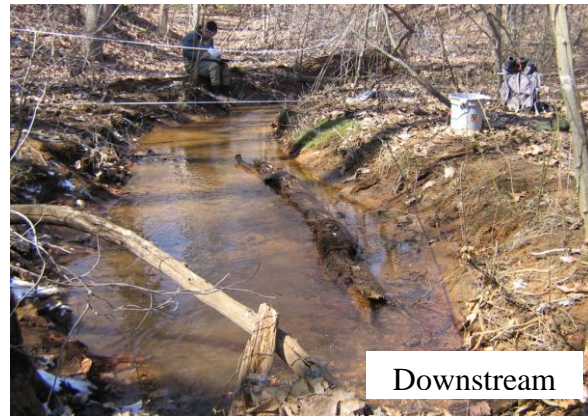
Upstream

- Biological condition – "Very Poor"
- Habitat scores "Partially Supporting" and "Degraded"
- Marginal bank and substrate habitat features
- Sample dominated by midges (*Parametriocnemus*)
- Stream type was identified as an E5, slope was 0.59 percent, and the median channel substrate was medium sand
- Biological community is in worse condition than would be expected for available habitat quality.

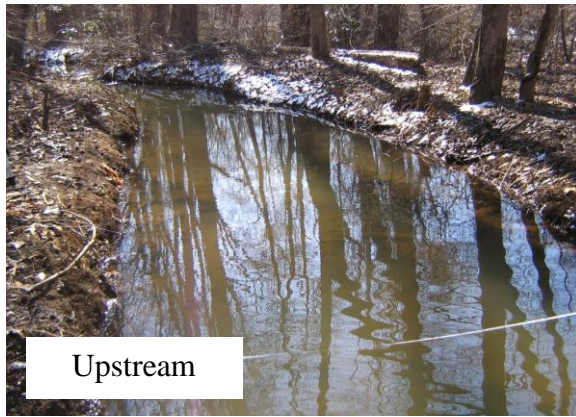
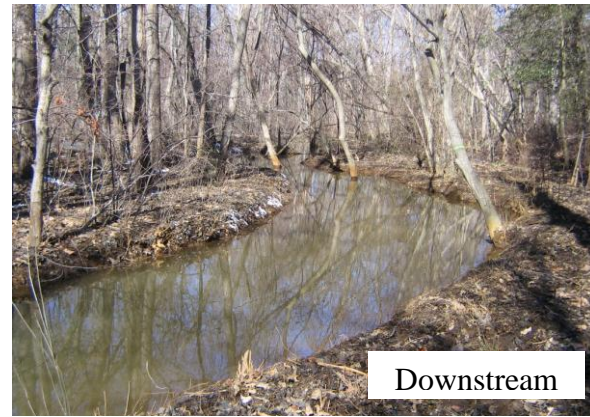
- Biological condition – "Poor"
- Habitat scores "Partially Supporting" and "Degraded"
- Marginal substrate/available cover, straight channel, limited instream woody debris, marginal riparian zone (right bank)
- Assemblage dominated by worms (53%) and mollusks (34%). The most abundant taxa are Tubificinae and *Pisidium*.
- pH relatively high
- Stream type was identified as an E5, slope was 0.04 percent, and the median channel substrate was medium sand
- Biological community is appropriate for observed habitat quality.

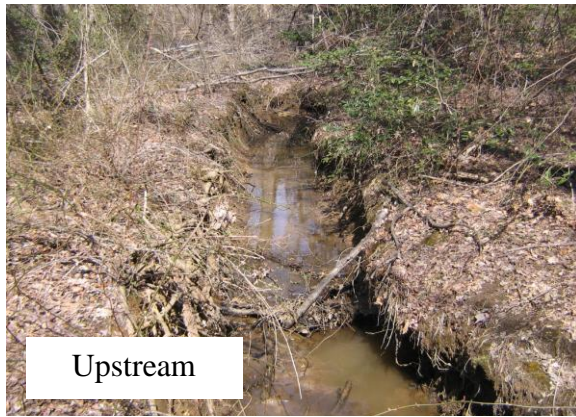
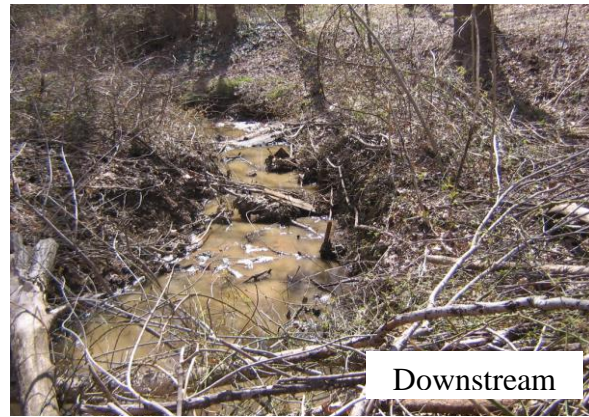
Upstream

- Biological condition – "Poor"
- Habitat scores "Partially Supporting" and "Degraded"
- Marginal substrate/available cover , moderately unstable banks, minimally impacted riparian zone
- Assemblage dominated by midges (67%). The most abundant taxa are *Parametriocnemus* and *Polypedilum*.
- Stream type was identified as an E5, slope was 0.55 percent, and the median channel substrate was fine sand
- Typically, E channels are stable. However, the marginal habitat ratings related to bank and substrate features may indicate that this reach is transitioning to an unstable form
- Biological community is appropriate for observed habitat quality.

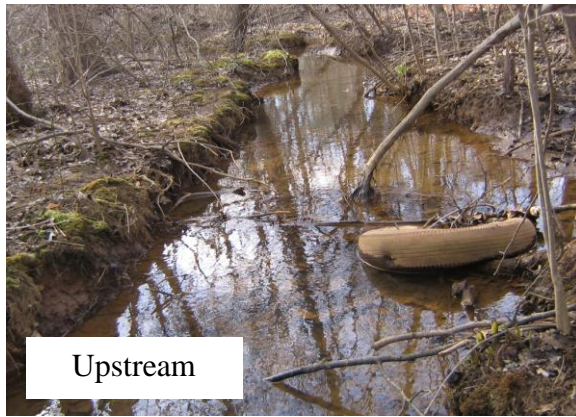
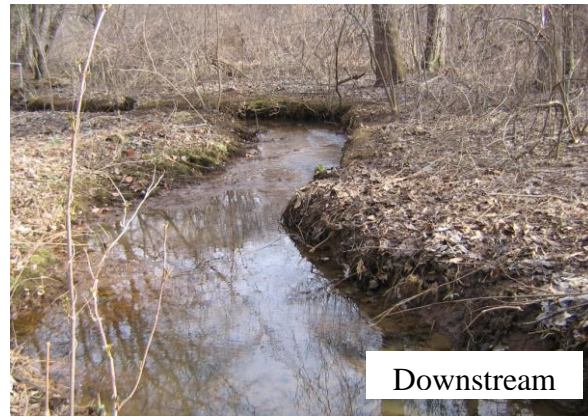
Upstream

- Biological condition – "Poor"
- Habitat scores "Partially Supporting" and "Degraded"
- Adequate substrate/available cover, moderate sediment deposition, marginal riparian zone (left bank)
- Good taxa richness. The most abundant organisms are worms (27%), isopods (15%), amphipods (14%) and midges (15%).
- Stream type was identified as an E5, slope was 0.21 percent, and the median channel substrate was fine sand
- Typically, E channels are stable. This reach could become unstable with any additional disturbance in the riparian area
- Biological community is appropriate for observed habitat quality.

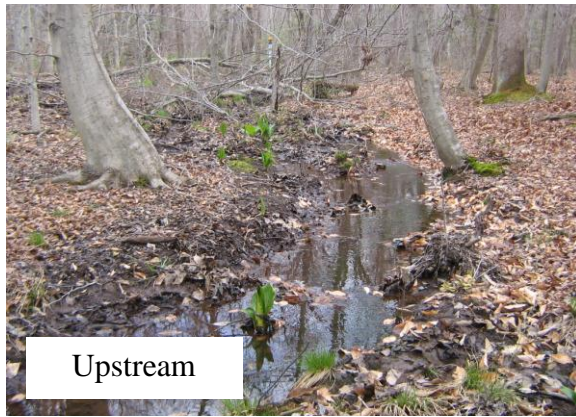
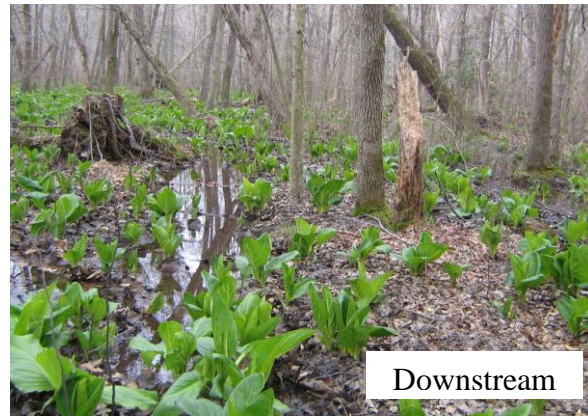
Upstream

- Biological condition – "Poor"
- Habitat scores "Partially Supporting" and "Partially Degraded"
- Adequate substrate/available cover, moderately unstable banks, straight channel, optimal riparian zone
- Assemblage dominated by midges (40%) and isopods (31%). *Caecidotea*, an isopod, is the most abundant organism.
- Stream type was identified as an E5, slope was 0.69 percent, and the median channel substrate was fine to medium sand
- Habitat assessment results were mixed for this site, but biological community observed is trending toward more than expected impairment based on the observed habitat quality.

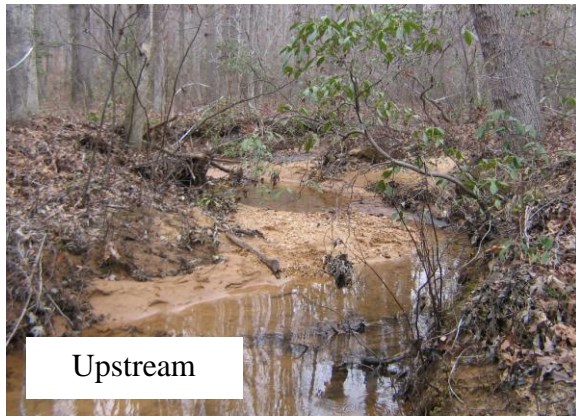
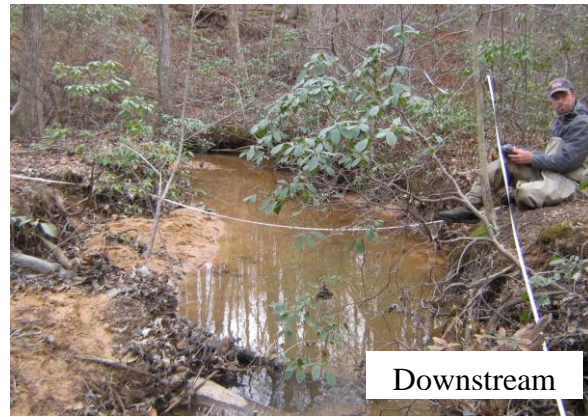
Upstream

- Biological condition – "Poor"
- Habitat scores "Partially Supporting" and "Partially Degraded"
- Adequate substrate/available cover, moderately unstable banks, optimal riparian zone
- One species of black fly (*Stegopterna*) comprises 50% of the assemblage. Midges and worms make up 39%. No EPT taxa.
- Stream type was identified as an E5, slope was 0.47 percent, and the median channel substrate was medium sand
- Habitat assessment results were mixed for this site, but biological community observed is trending toward more than expected impairment based on the observed habitat quality.

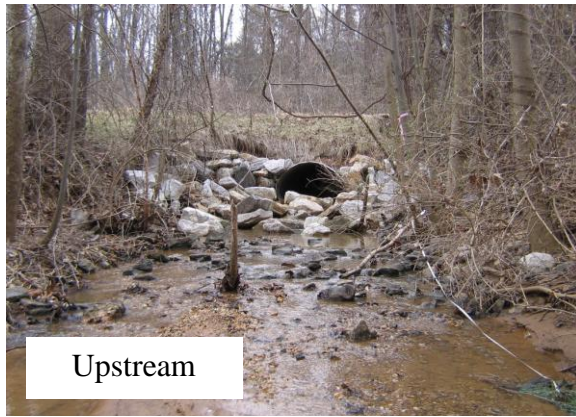
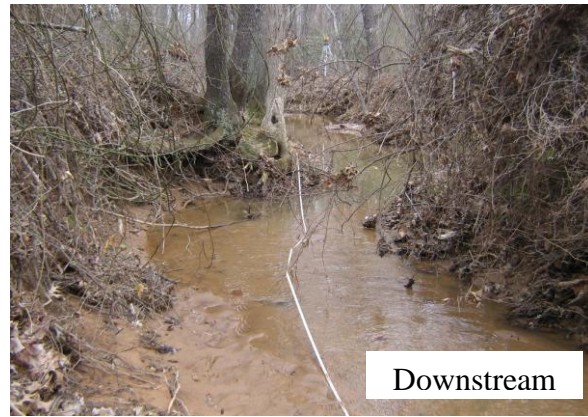
Upstream

- Biological condition – "Very Poor"
- Habitat scores "Non Supporting" and "Severely Degraded"
- Marginal substrate/available cover, obvious channel alteration, marginal riparian zone
- Assemblage dominated by midges (75%). The most abundant taxa are *Zavreliomyia* and *Hydrobaenus*.
- Stream type was not evaluated.
- Biological community is appropriate for observed habitat quality.

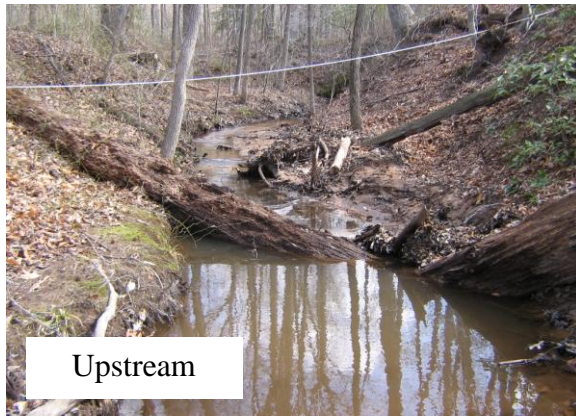
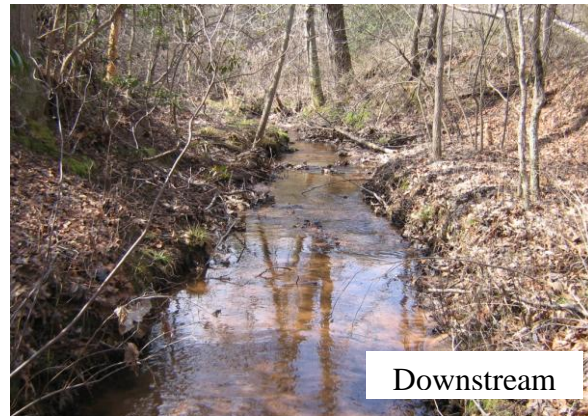
Upstream

- Biological condition – "Poor"
- Habitat scores "Partially Supporting" and "Partially Degraded"
- Adequate substrate/available cover, evidence of channelization, minimally impacted riparian zone
- Midgees are the most abundant organisms, comprising 45% of the assemblage, followed by black flies (23%). Four EPT taxa were also found.
- Stream type was identified as an B5c, slope was 0.42 percent, and the median channel substrate was medium sand.
- Habitat assessment results were mixed for this site, but biological community observed is trending toward more than expected impairment based on the observed habitat quality.

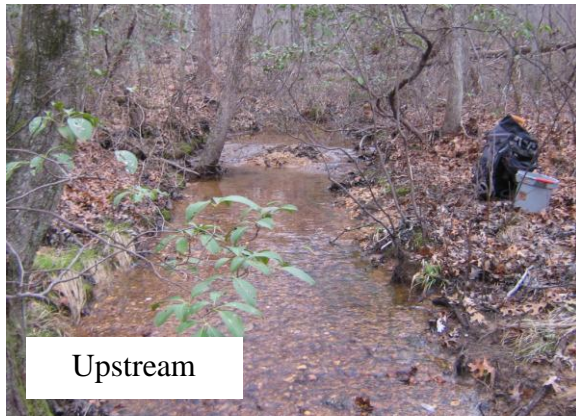
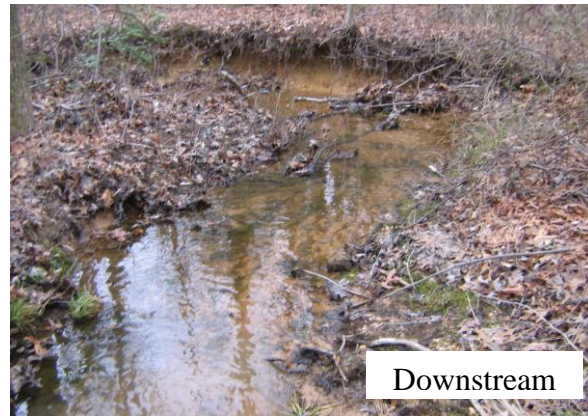
Upstream

- Biological condition – "Poor"
- Habitat scores "Supporting" and "Minimally Degraded"
- Adequate substrate/available cover, moderately unstable (left) bank, optimal riparian zone
- Black flies (*Stegopterna*) comprise 42% of the assemblage. Most of the other organisms are midges, stoneflies and worms.
- pH is relatively low
- Stream type was identified as an E4, slope was 1.4 percent, and the median channel substrate was medium gravel
- Biological community is in worse condition than would be expected for available habitat quality.

#### **Recommendations:**

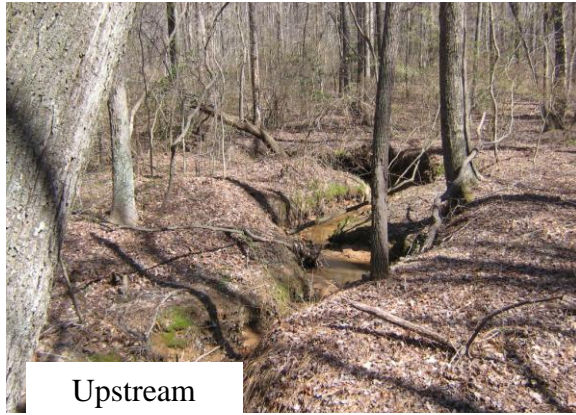
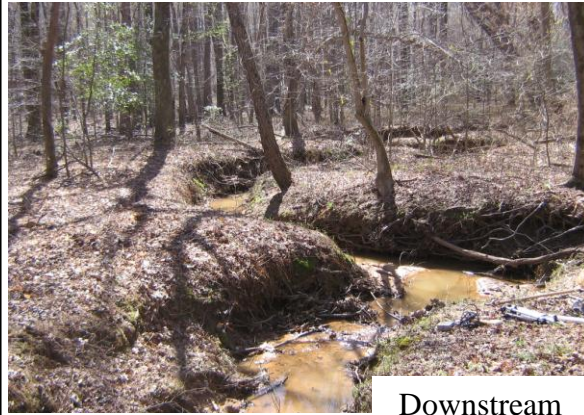
Upstream

- Biological condition – "Poor"
- Habitat scores "Partially Supporting" and "Minimally Degraded"
- Adequate substrate/available cover, moderately unstable banks, optimal riparian zone
- Good taxa richness. Assemblage is dominated by midges (49%). The most abundant taxon is *Parametriocnemus*.
- Difficult classification. Stream type was identified as an G4c, but has E type characteristics. Slope was 1.7 percent, and the median channel substrate was medium sand
- Habitat assessment results were mixed for this site, but biological community observed is trending toward more than expected impairment based on the observed habitat quality.

#### **Recommendations:**

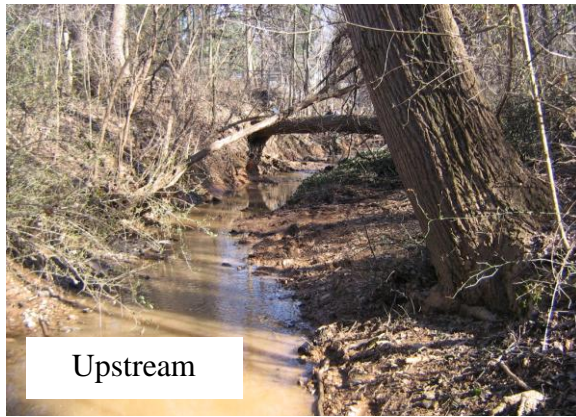
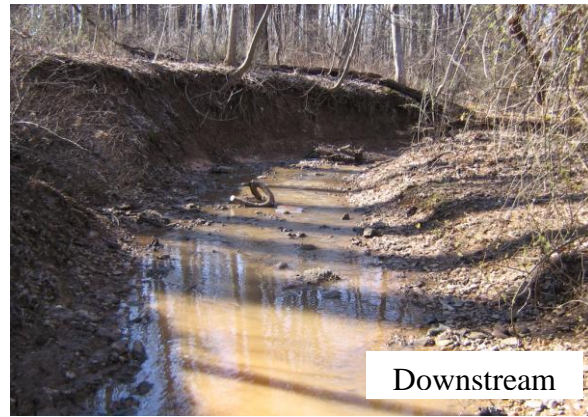
Upstream

- Biological condition – "Very Poor"
- Habitat scores "Non Supporting" and "Degraded"
- Marginal substrate/available cover, moderately unstable banks, limited pool habitat, marginal riparian zone (right bank)
- Poor taxa richness. One species, *Hydrobaenus* (a midge), comprises 77% of the assemblage.
- Stream type was identified as an B5c, slope was 0.83 percent, and the median channel substrate was fine to medium sand
- Habitat assessment results were mixed for this site, but biological community observed is trending toward more than expected impairment based on the observed habitat quality.

#### **Recommendations:**

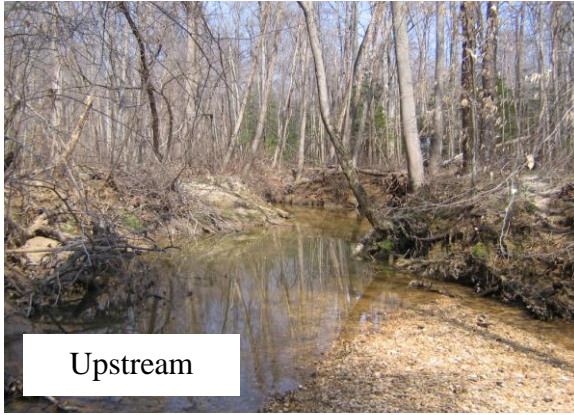
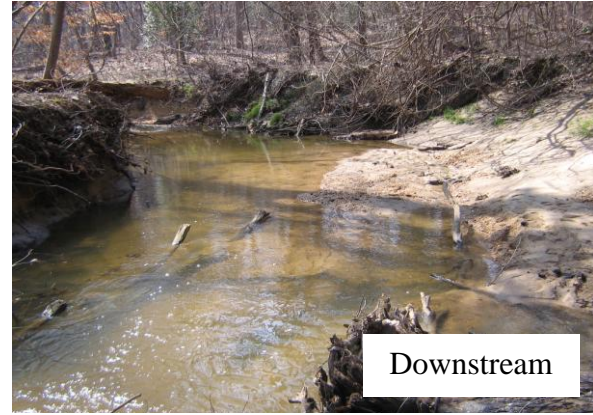
Upstream

- Biological condition – "Fair"
- Habitat scores "Partially Supporting" and "Degraded"
- Marginal substrate/available cover, moderately unstable banks, minimally impacted riparian zone
- Good taxa richness. 12 midge taxa comprise 52% of the assemblage. 5 EPT taxa. *Hydrobaenus* is the most abundant taxon.
- pH is relatively high
- Stream type was identified as an G5c, slope was 0.56 percent, and the median channel substrate was medium sand
- Biological community is in better condition than expected for measured level of habitat quality..

### **Recommendations:**
