## Aquatic Biological Assessment of the Watersheds of Anne Arundel County, Maryland: 2007

**Prepared by:**

Tetra Tech, Inc.  
400 Red Brook Blvd., Suite 200  
Owings Mills, MD 21117-5159

**November 2008**

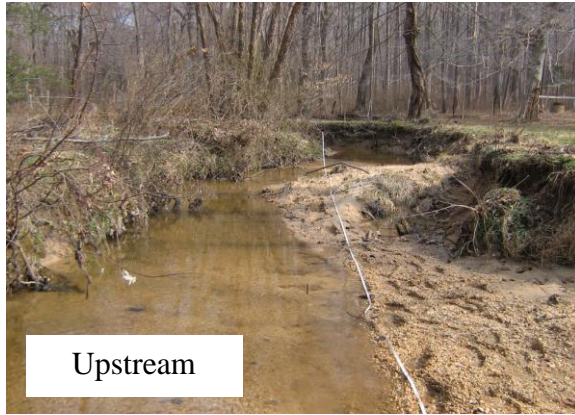
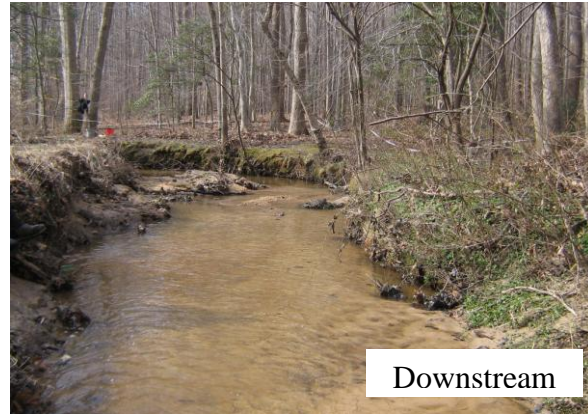
Upstream

- Biological condition – "Very Poor"
- Habitat scores "Partially Supporting" and "Degraded"
- Adequate substrate/available cover, poor (left) bank stability, moderate sediment deposition, poor riparian zone (left bank)
- Assemblage dominated by worms (42%) and midges (50%). The most abundant taxa are *Hydrobaenus* and *Nais*.
- pH is relatively high
- Stream type was identified as an F5, slope was 0.23 percent, and the median channel substrate was fine sand
- Biological community is in worse condition than would be expected for available habitat quality.

### **Recommendations:**

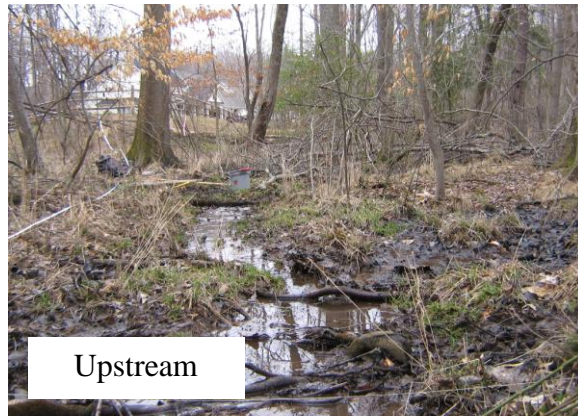
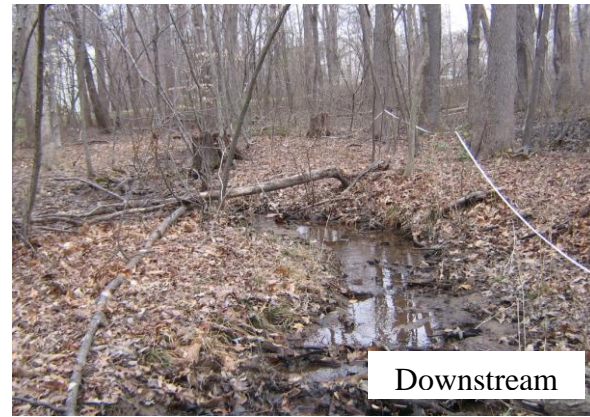
- Biological condition – "Poor"
- Habitat scores "Partially Supporting" and "Partially Degraded"
- Marginal substrate/available cover, limited pool habitat, minimally impacted riparian zone
- Half of the assemblage is comprised of isopods (*Caecidotea*) and mollusks (*Pisidium*). Most of the other organisms are midges, worms and amphipods.
- Stream type was identified as an C5, slope was 1.2 percent, and the median channel substrate was fine sand
- Habitat assessment results were mixed for this site, but biological community observed is trending toward more than expected impairment based on the observed habitat quality.

#### **Recommendations:**

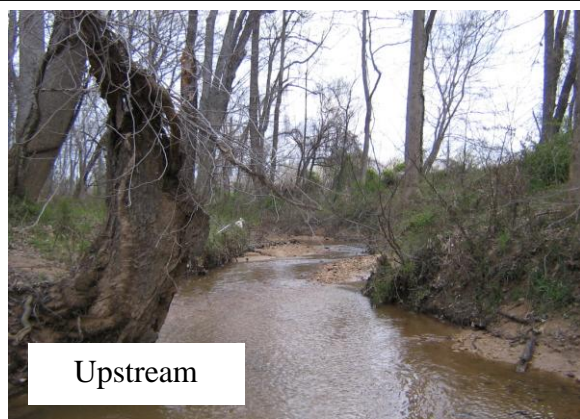
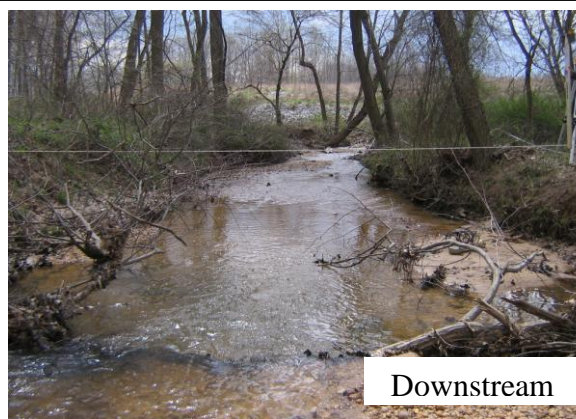
- Biological condition – "Poor"
- Habitat scores "Non Supporting" and "Degraded"
- Adequate substrate/available cover, moderately unstable (right) bank, straight channel, no pools, minimally impacted riparian zone
- Assemblage dominated by midges (79%). *Pseudorthocladius* and *Hydrobaenus* are the most abundant taxa.
- Stream type was identified as an B4c, slope was 0.82 percent, and the median channel substrate was medium gravel
- Habitat assessment results were mixed for this site, but biological community observed is trending toward less than expected impairment based on the observed habitat quality.

#### **Recommendations:**

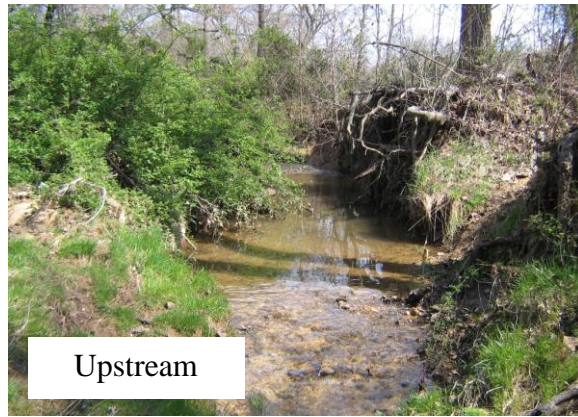
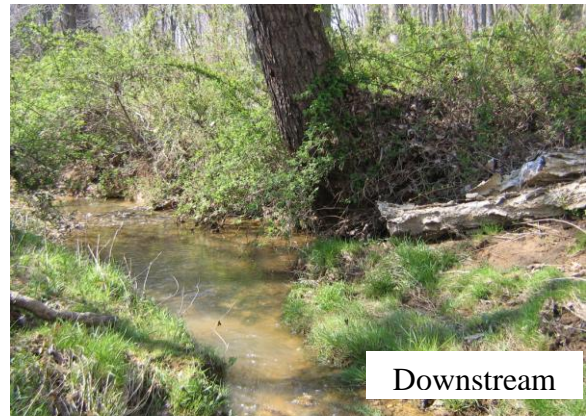
Upstream

- Biological condition – "Very Poor"
- Habitat scores "Partially Supporting" and "Degraded"
- Adequate substrate/available cover, moderately unstable (left) bank, fairly straight channel, poor (left) riparian zone
- Assemblage dominated by midges. One taxon, *Hydrobaenus*, makes up 52% of the sample.
- Difficult classification disturbed reach. Stream type was identified as an B5c, slope was 0.21 percent, and the median channel substrate was fine sand
- Biological community is in worse condition than would be expected for available habitat quality.

#### **Recommendations:**

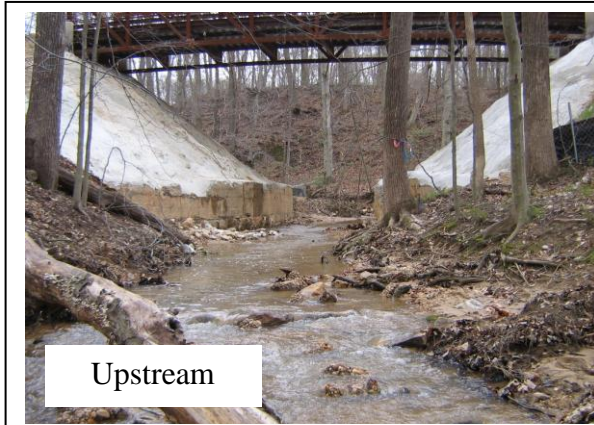
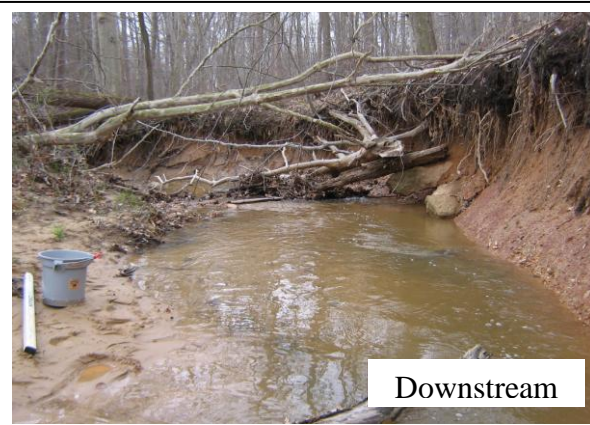
Upstream

- Biological condition – "Poor"
- Habitat scores "Partially Supporting" and "Degraded"
- Adequate substrate/available cover, moderately unstable (right) bank, obvious channel alteration, marginal riparian zone
- Assemblage dominated by midges (56%) and worms (35%). *Nais* and *Hydrobaenus* are the most abundant taxa.
- Stream type was identified as an F5, slope was 1.85 percent, and the median channel substrate was coarse sand
- Typically, F channels are not stable. This channel is not stable and the riparian zone is disturbed – making recovery to a stable channel form difficult
- Biological community is appropriate for observed habitat quality.

#### **Recommendations:**

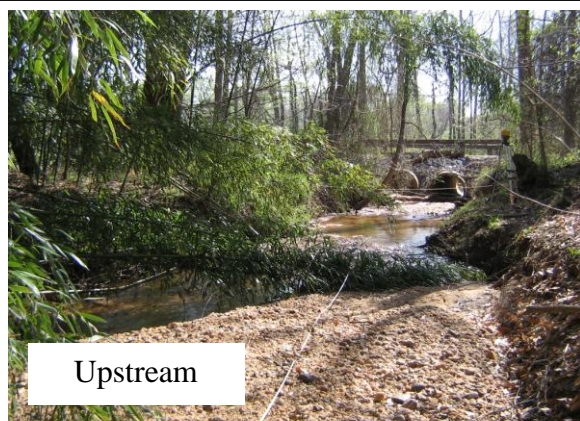
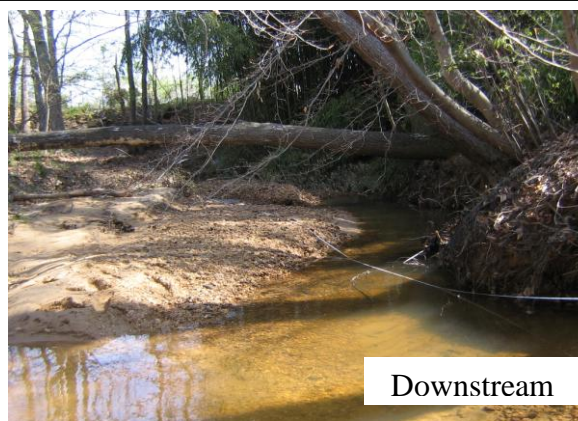
Upstream

- Biological condition – "Fair"
- Habitat scores "Partially Supporting" and "Partially Degraded"
- Adequate substrate/available cover, moderately unstable banks, marginal riparian zone (left bank)
- Good taxa richness. Midges comprise 56% of the sample. *Hydrobaenus* is the most abundant taxon. 6 EPT taxa.
- Stream type was identified as an F4, slope was 0.98 percent, and the median channel substrate was medium gravel
- Habitat assessment results were mixed for this site, but biological community observed is trending toward less than expected impairment based on the observed habitat quality.

**Recommendations:**
