# Aquatic Biological Assessment of the Watersheds of Anne Arundel County, Maryland: 2019

# **Aquatic Biological Assessment of the Watersheds of Anne Arundel County, Maryland: 2019 Round Three—Year Three**

**December 2019**

**KCI Technologies, Inc.  
936 Ridgebrook Road  
Sparks, Maryland 21152**

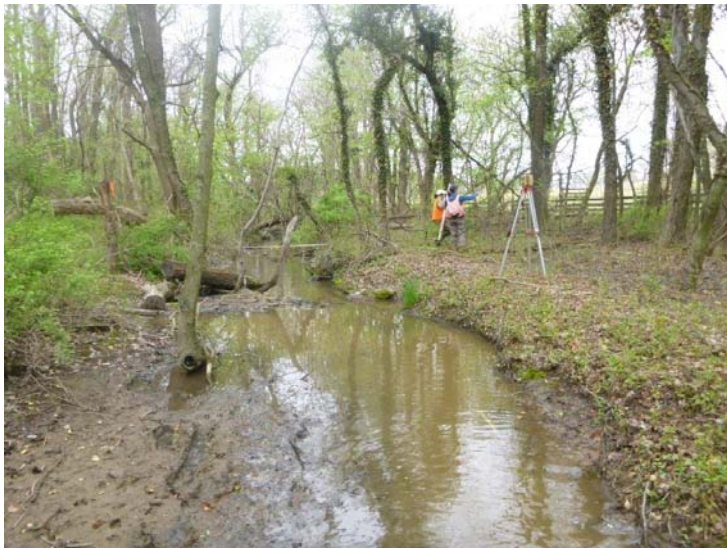
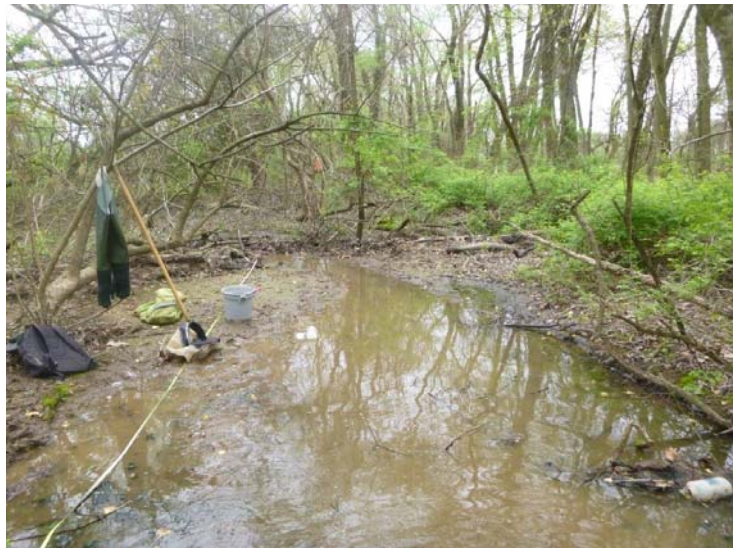
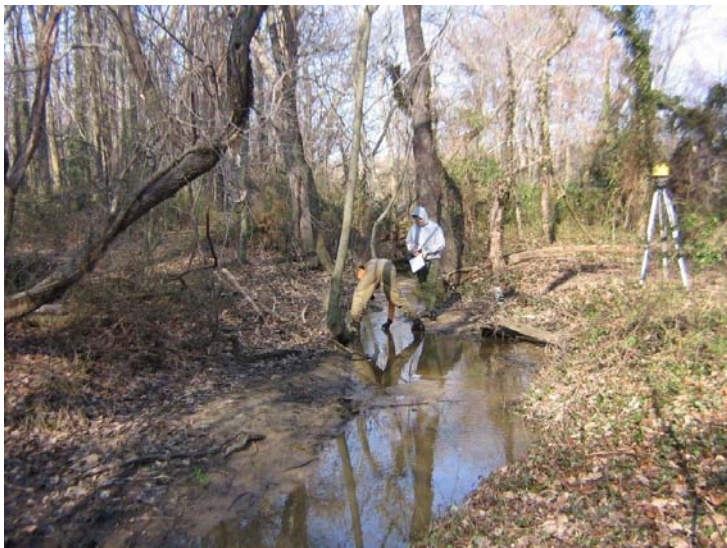
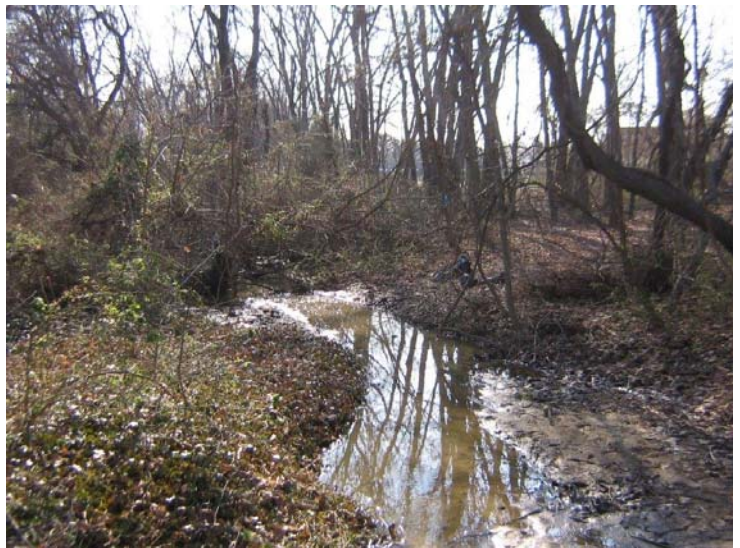
Upstream View - 2019

Downstream View - 2019

Upstream View - 2008

Downstream View - 2008

2019 Data	2008 Data
Benthic Macroinvertebrate Community	Poor	Very Poor
Fish Community	Poor	Not sampled prior to 2017
RBP Habitat Condition	Partially Supporting	Partially Supporting
MPHI Habitat Condition	Partially Degraded	Partially Degraded
Water Quality Conditions	High conductivity; Elevated nutrients	High conductivity

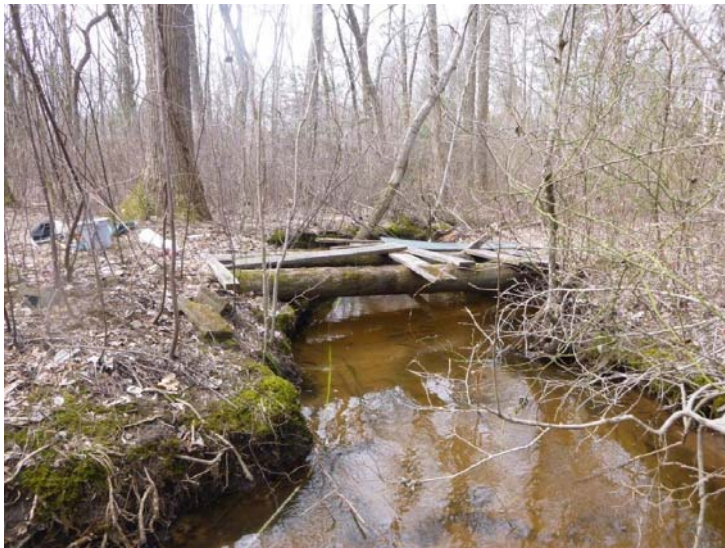
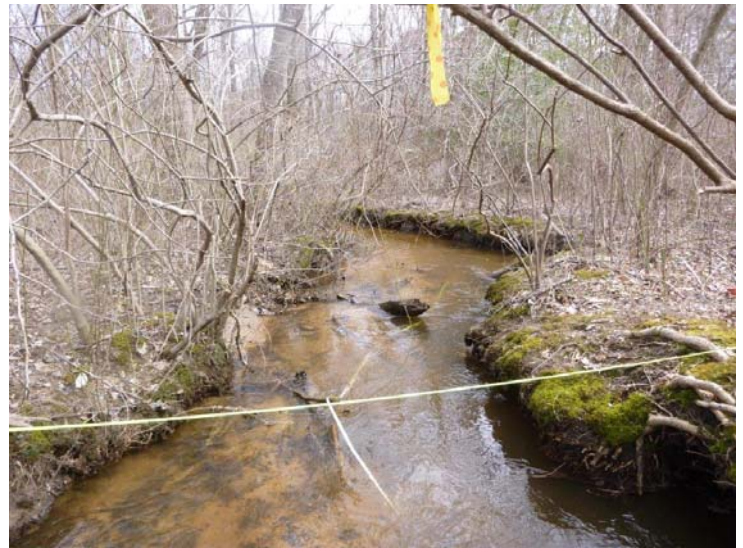
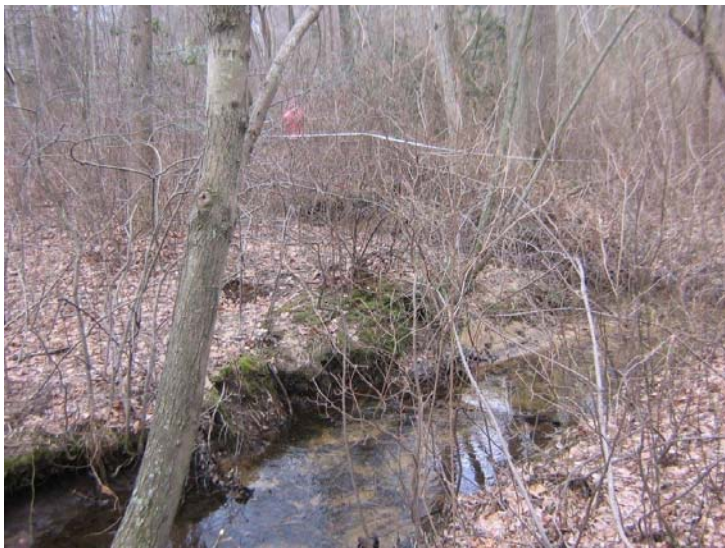
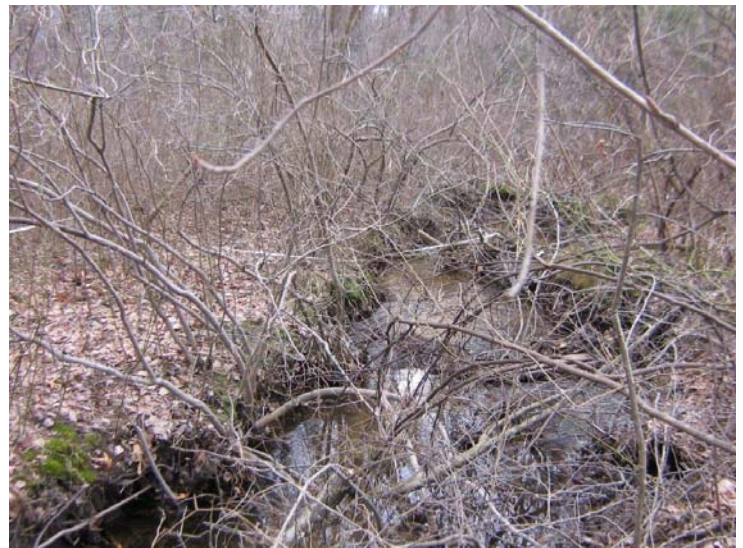
Upstream View - 2019

Downstream View - 2019

Upstream View - 2008

Downstream View - 2008

<u>2019 Data</u>	<u>2008 Data</u>
Benthic Macroinvertebrate Community	Fair	Poor
Fish Community	Good	Not sampled prior to 2017
RBP Habitat Condition	Supporting	Supporting
MPHI Habitat Condition	Minimally Degraded	Partially Degraded
Water Quality Conditions	High conductivity; Elevated nitrogen	High conductivity

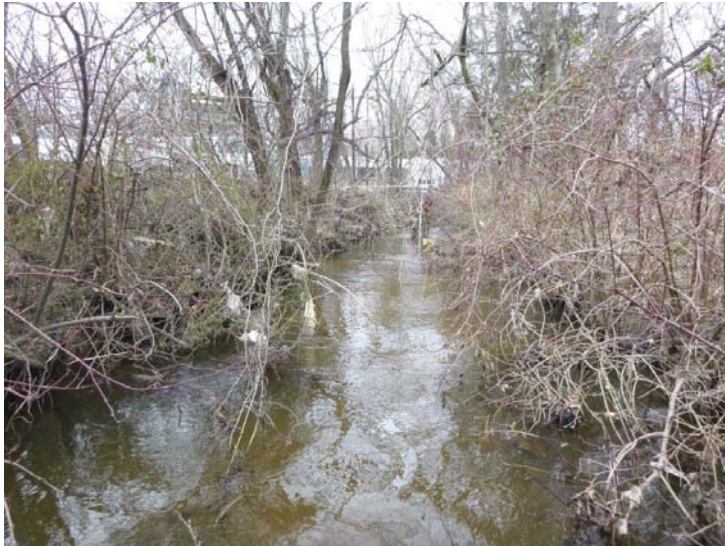
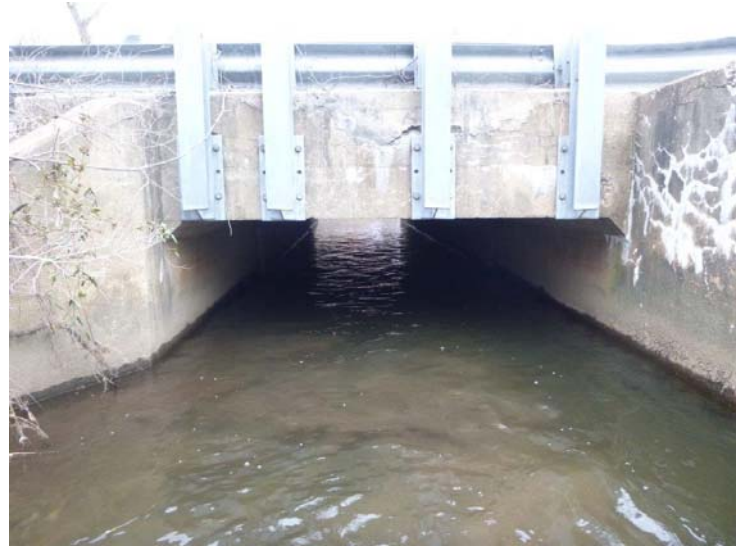
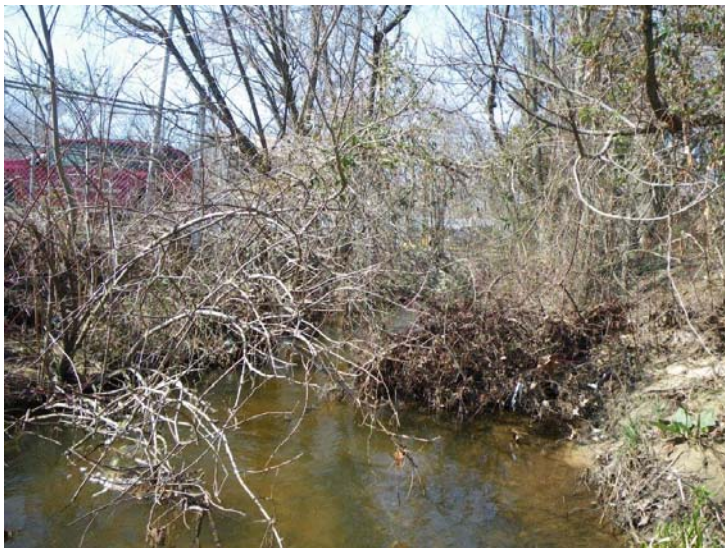
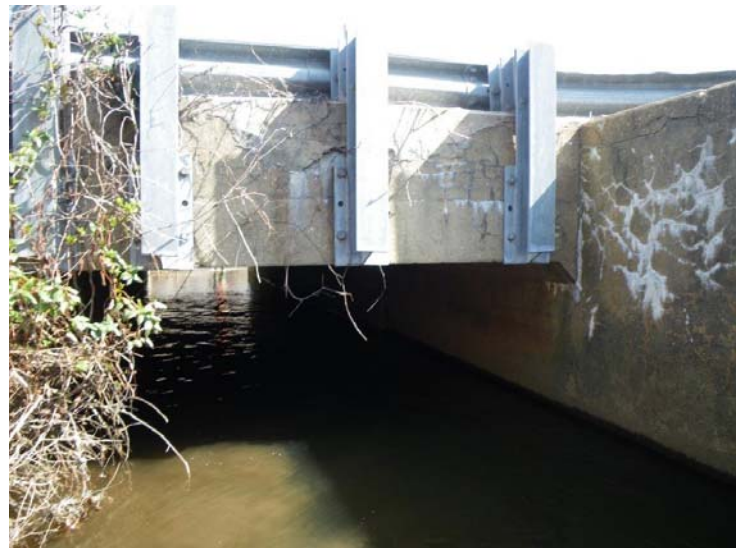
Upstream View - 2019

Downstream View - 2019

Upstream View - 2010

Downstream View - 2010

<u>2019 Data</u>	<u>2010 Data</u>
Benthic Macroinvertebrate Community	Fair	Poor
Fish Community	Good	Not sampled prior to 2017
RBP Habitat Condition	Partially Supporting	Partially Supporting
MPHI Habitat Condition	Degraded	Degraded
Water Quality Conditions	High conductivity; Elevated nitrogen	High conductivity

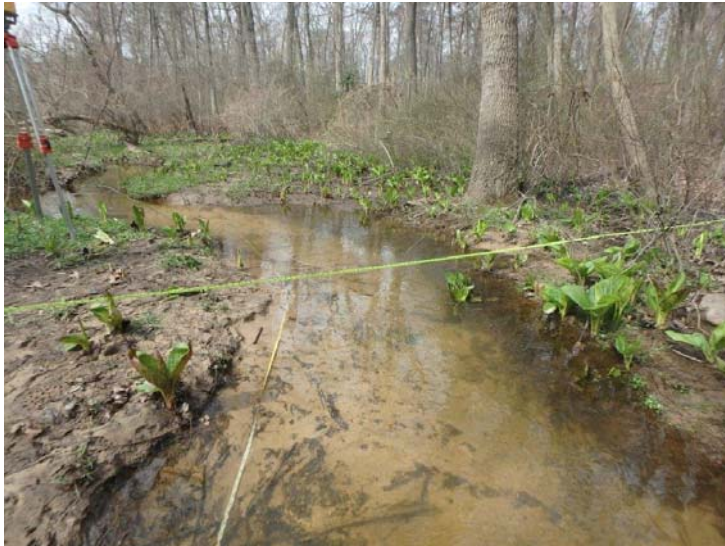
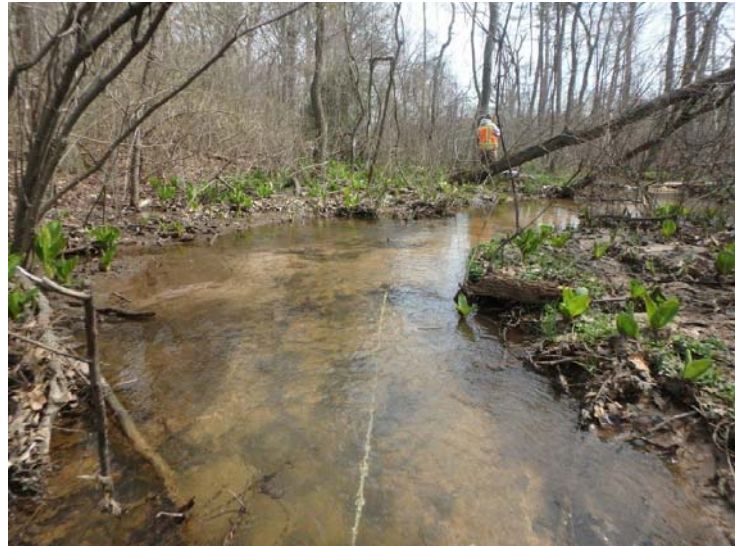
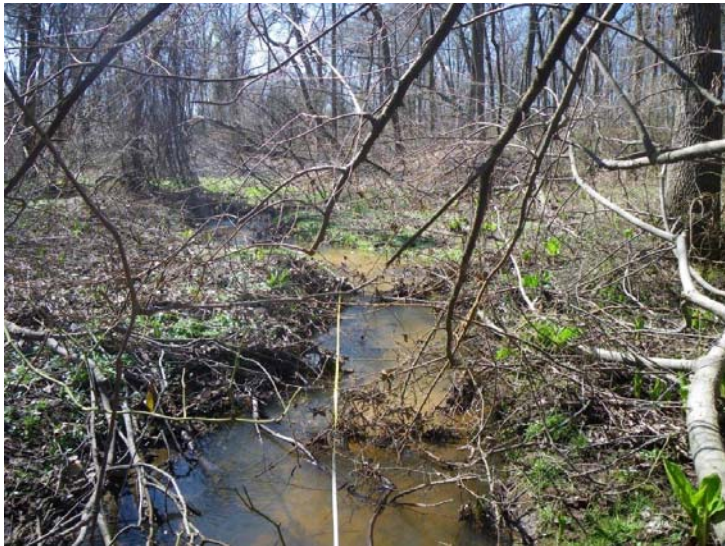
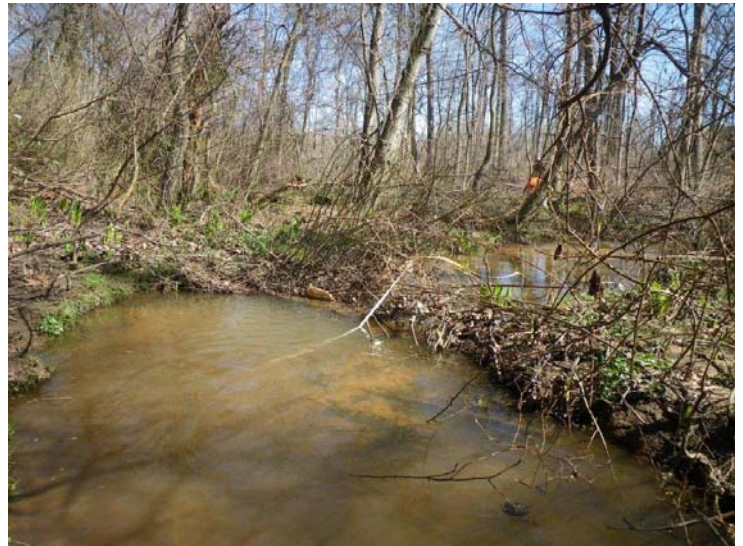
Upstream View - 2019

Downstream View - 2019

Upstream View - 2010

Downstream View - 2010

<u>2019 Data</u>	<u>2010 Data</u>
Benthic Macroinvertebrate Community	Poor	Poor
Fish Community	Good	Not sampled prior to 2017
RBP Habitat Condition	Supporting	Supporting
MPHI Habitat Condition	Partially Degraded	Partially Degraded
Water Quality Conditions	Elevated nitrogen; High conductivity	High conductivity

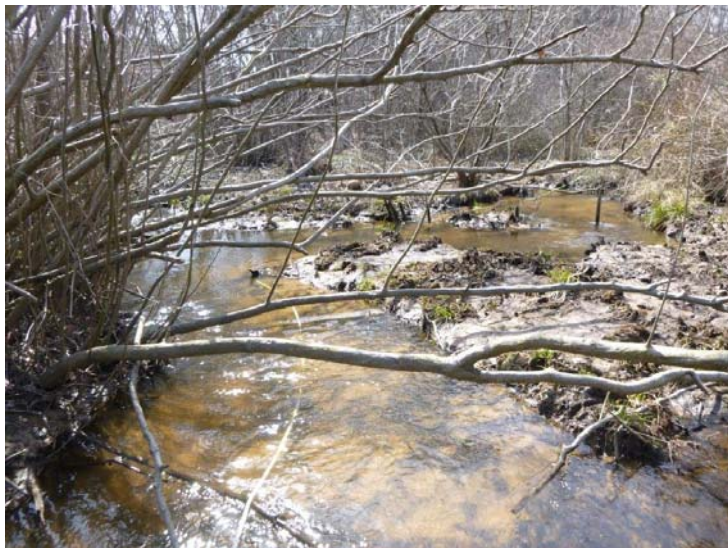
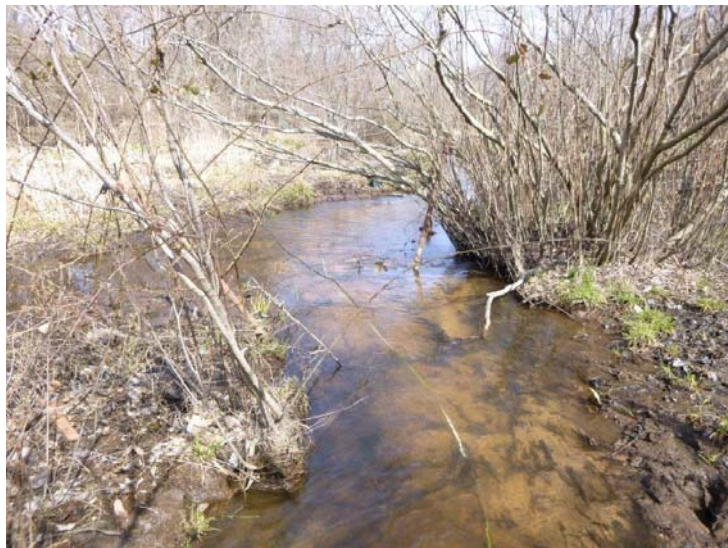
## Upstream View

## Downstream View

Benthic Macroinvertebrate Community	Fair
Fish Community	Qualitative
RBP Habitat Condition	Supporting
MPHI Habitat Condition	Partially Degraded
Water Quality Conditions	Elevated nitrogen

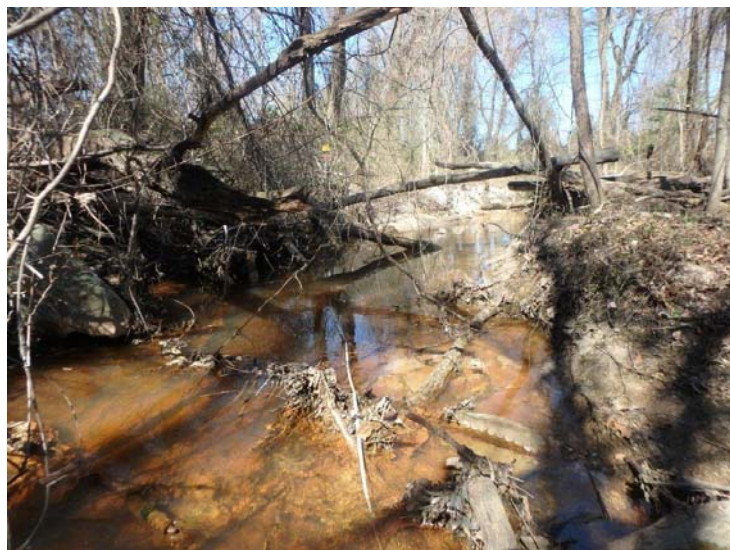
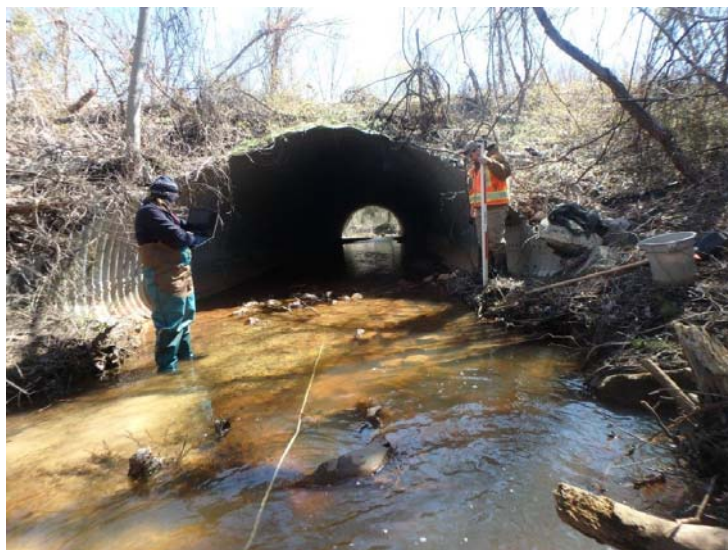
## Upstream View

## Downstream View

Benthic Macroinvertebrate Community	Very Poor
Fish Community	Very Poor
RBP Habitat Condition	Non-Supporting
MPHI Habitat Condition	Degraded
Water Quality Conditions	High conductivity; Elevated nutrients

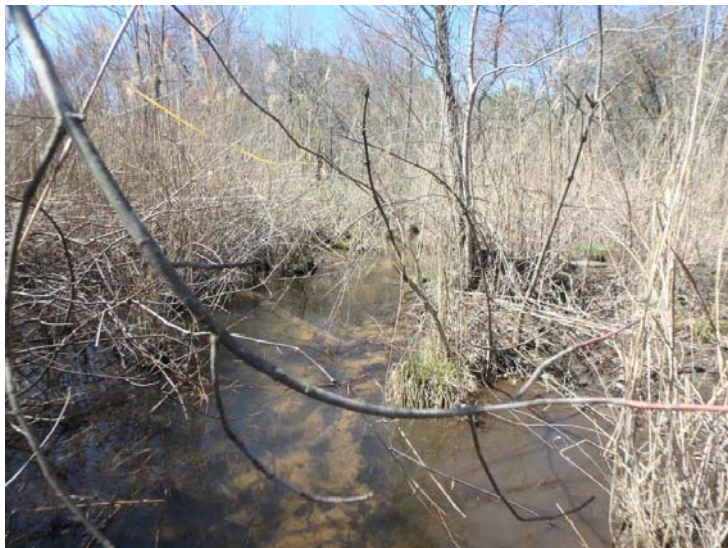
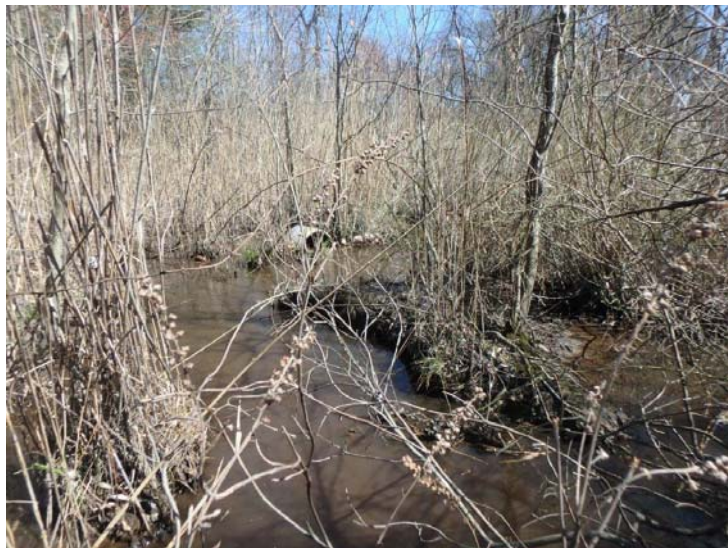
## Upstream View

## Downstream View

Benthic Macroinvertebrate Community	Good
Fish Community	Qualitative
RBP Habitat Condition	Supporting
MPHI Habitat Condition	Partially Degraded
Water Quality Conditions	Elevated nitrogen

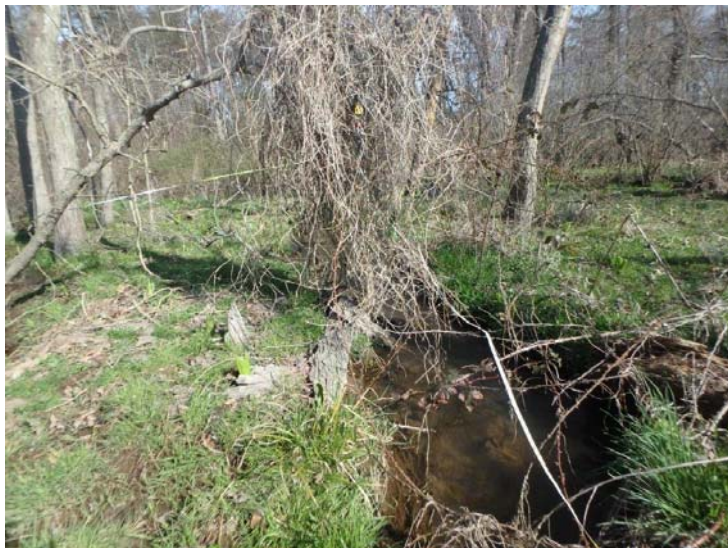
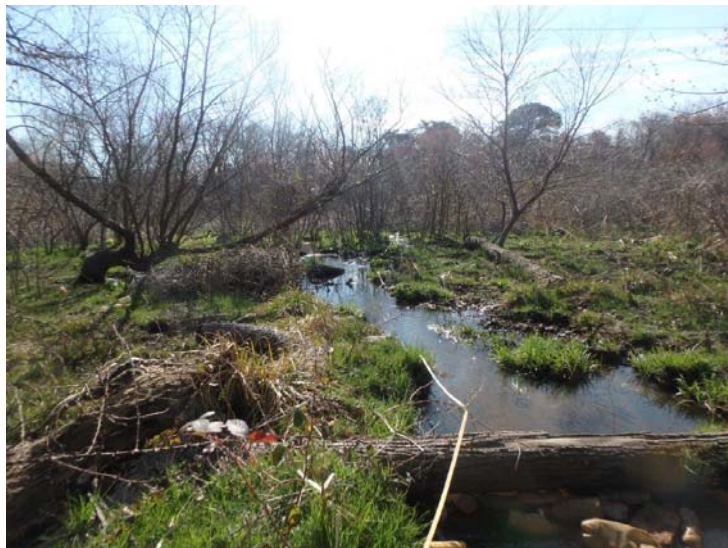
## Upstream View

## Downstream View

Benthic Macroinvertebrate Community	Very Poor
Fish Community	Fair
RBP Habitat Condition	Supporting
MPHI Habitat Condition	Minimally Degraded
Water Quality Conditions	High conductivity; Elevated nitrogen

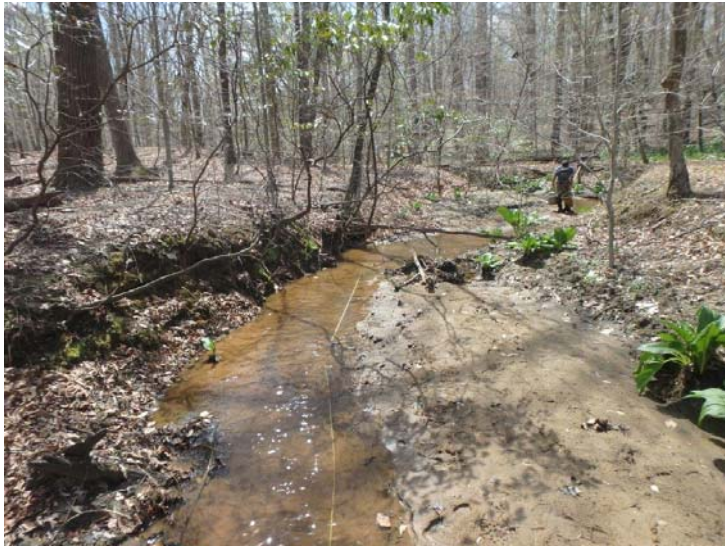
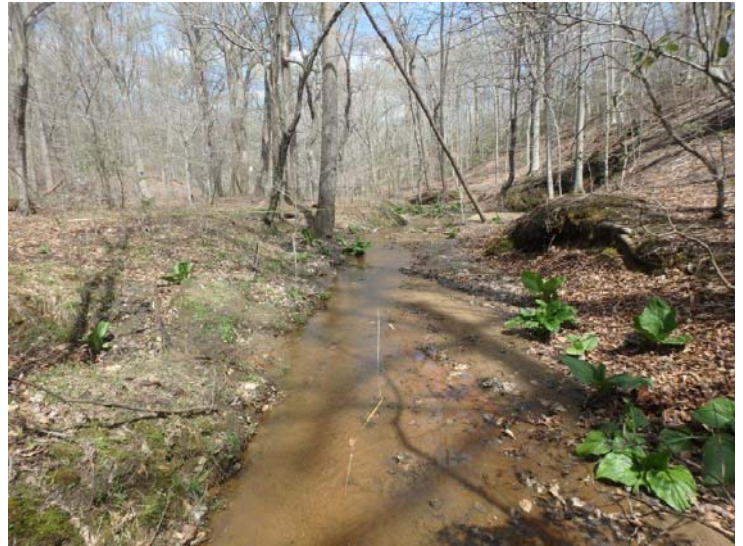
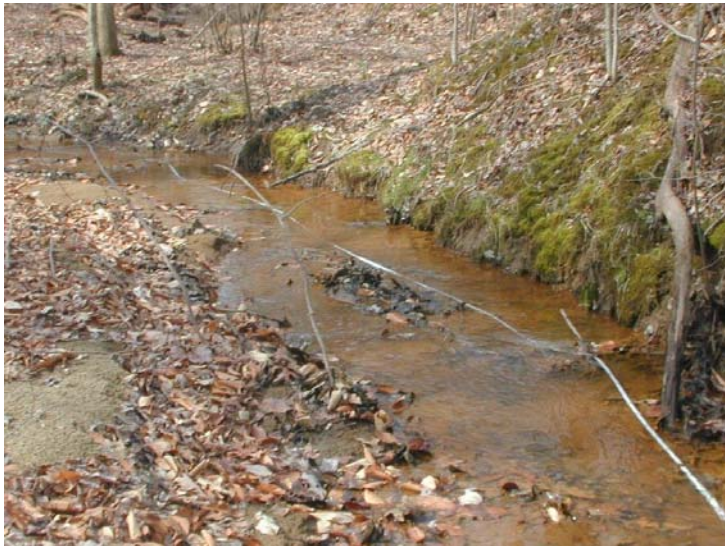
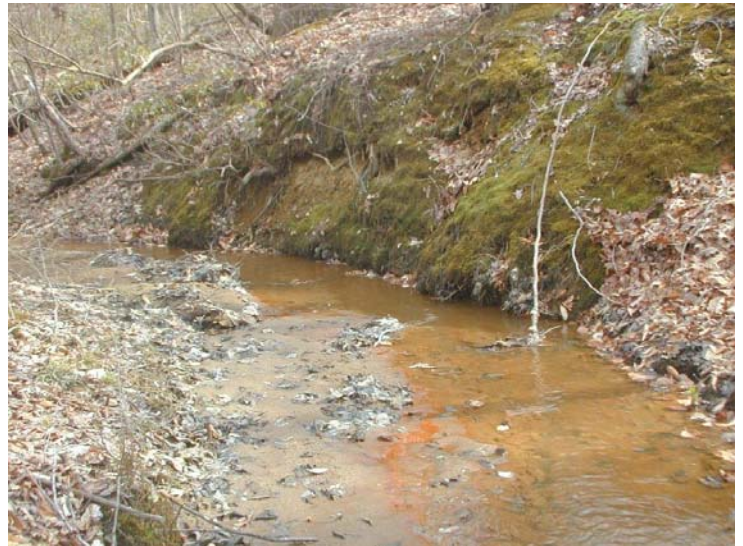
Upstream View - 2019

Downstream View - 2019

Upstream View - 2005

Downstream View - 2005

2019 Data	2005 Data
Benthic Macroinvertebrate Community	Very Poor	Fair
Fish Community	Poor	Not sampled prior to 2017
RBP Habitat Condition	Partially Supporting	Partially Supporting
MPHI Habitat Condition	Partially Degraded	Partially Degraded
Water Quality Conditions	Within acceptable ranges	Within acceptable range

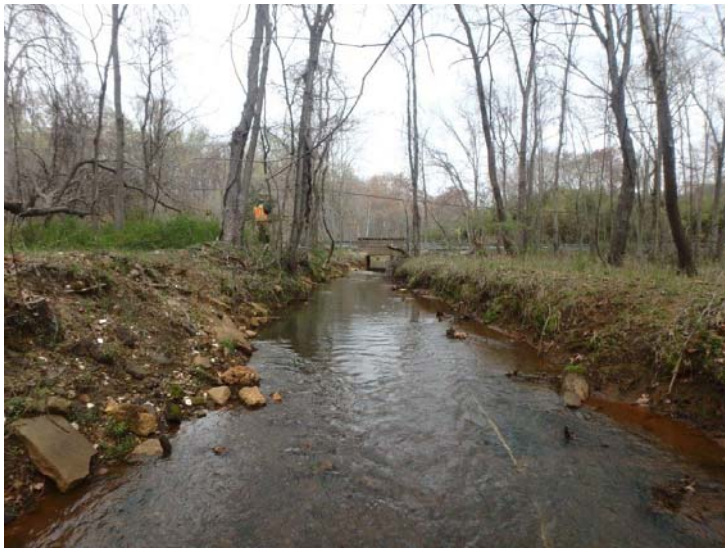
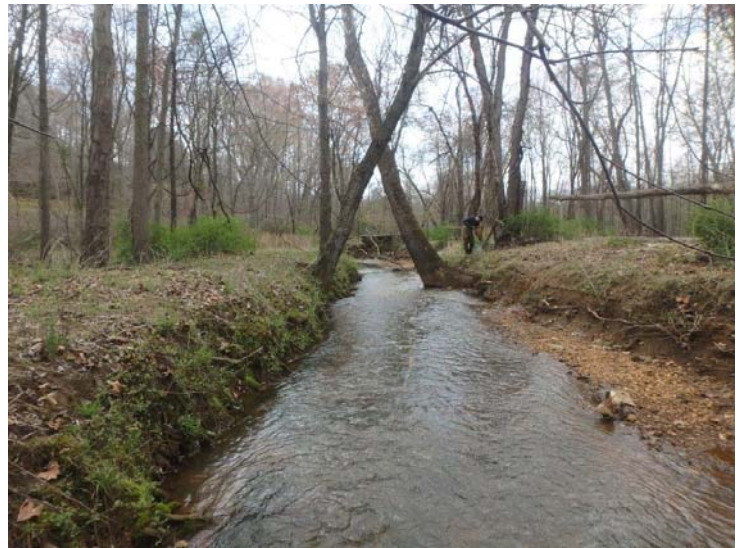
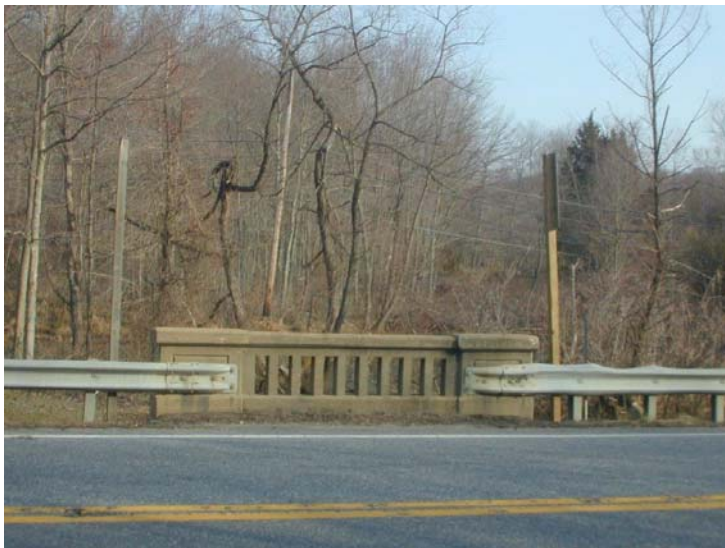
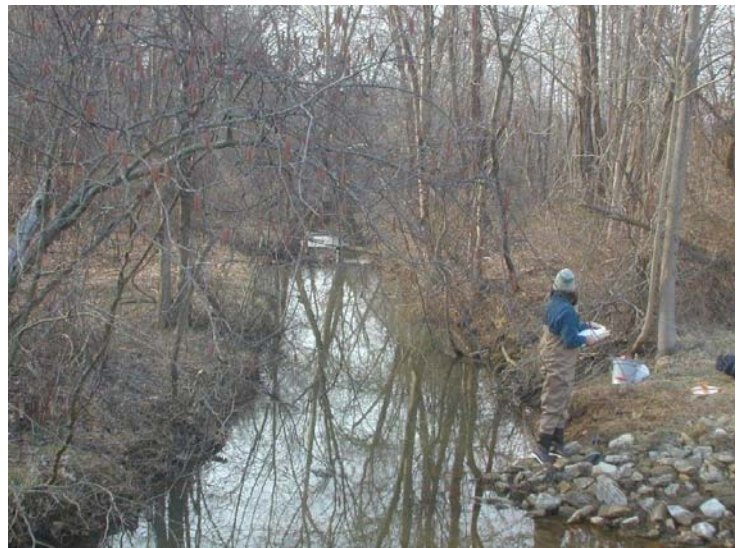
Upstream View - 2019

Downstream View - 2019

Upstream View - 2005

Downstream View - 2005

2019 Data	2005 Data
Benthic Macroinvertebrate Community	Poor	Poor
Fish Community	Fair	Not sampled prior to 2017
RBP Habitat Condition	Supporting	Supporting
MPHI Habitat Condition	Degraded	Degraded
Water Quality Conditions	Elevated nutrients	Within acceptable range

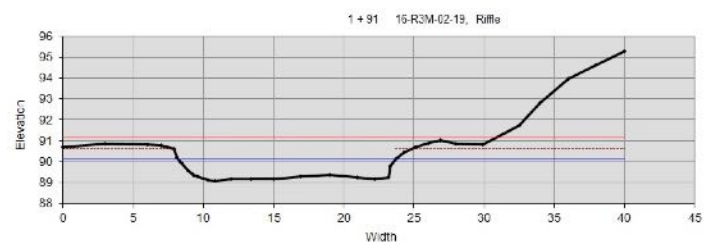
### Cross-sectional Survey

**Rosgen Stream Type C4**

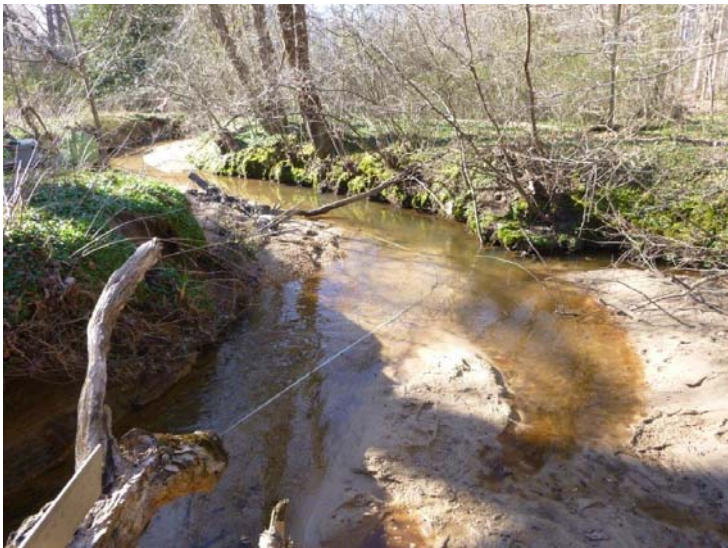
Downstream View - 2019

2019 Data	2007 Data
Benthic Macroinvertebrate Community	Very Poor	Very Poor
Fish Community	Fair	Not sampled prior to 2017
RBP Habitat Condition	Partially Supporting	Partially Supporting
MPHI Habitat Condition	Partially Degraded	Severely Degraded
Water Quality Conditions	Elevated nitrogen	Within acceptable range

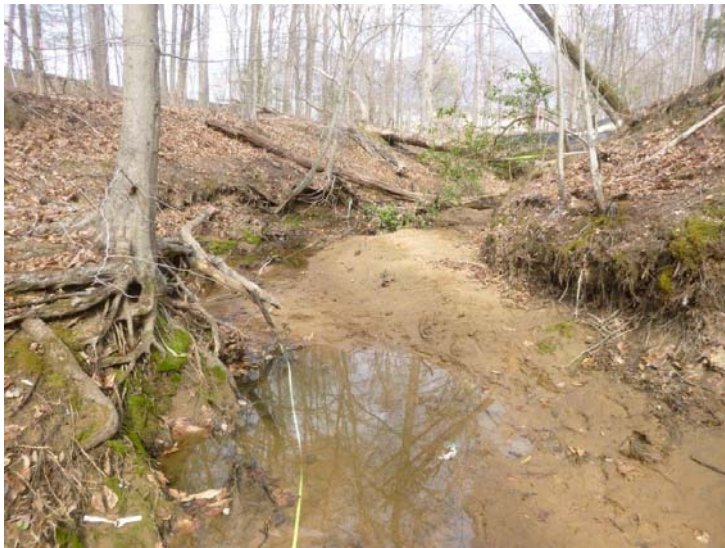
Upstream View - 2019

<u>2019 Data</u>	<u>2007 Data</u>
Benthic Macroinvertebrate Community	Very Poor	Very Poor
Fish Community	Poor	Not sampled prior to 2017
RBP Habitat Condition	Partially Supporting	Partially Supporting
MPHI Habitat Condition	Degraded	Partially Degraded
Water Quality Conditions	High conductivity; Elevated nitrogen	High conductivity

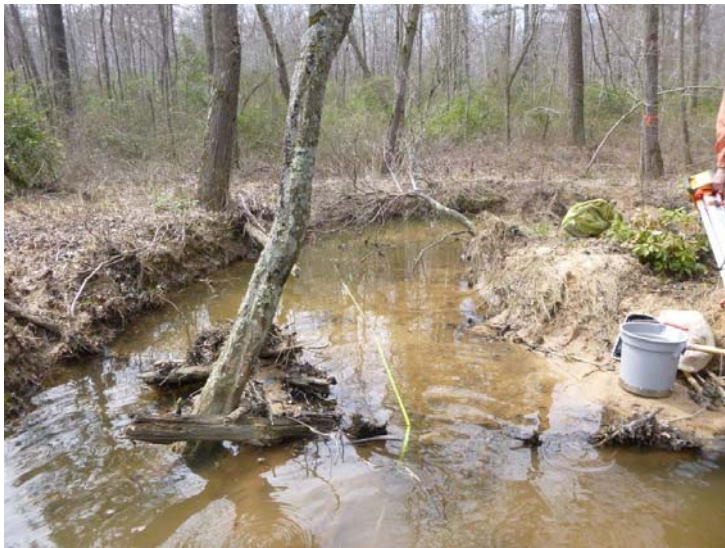
Upstream View - 2019

<u>2019 Data</u>	<u>2009 Data</u>
Benthic Macroinvertebrate Community	Poor	Poor
Fish Community	Fair	Not sampled prior to 2017
RBP Habitat Condition	Supporting	Supporting
MPHI Habitat Condition	Partially Degraded	Partially Degraded
Water Quality Conditions	High conductivity	High conductivity

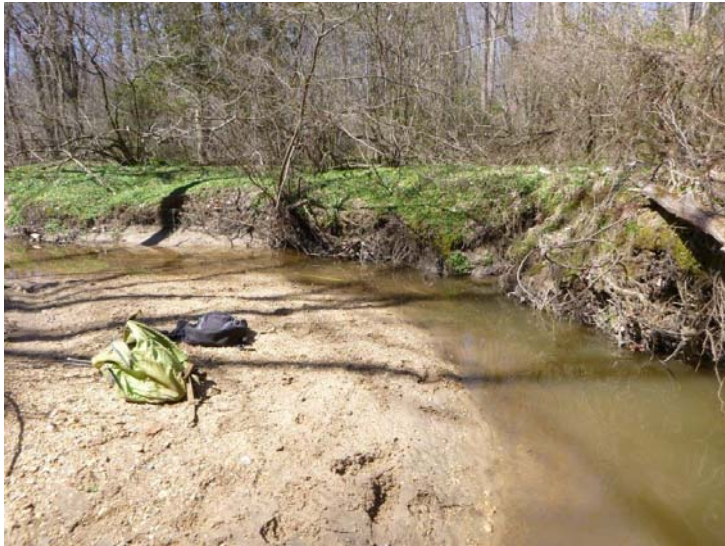
Upstream View - 2019

<u>2019 Data</u>	<u>2009 Data</u>
Benthic Macroinvertebrate Community	Very Poor	Poor
Fish Community	Fair	Not sampled prior to 2017
RBP Habitat Condition	Partially Supporting	Partially supporting
MPHI Habitat Condition	Partially Degraded	Degraded
Water Quality Conditions	Elevated nitrogen	High conductivity

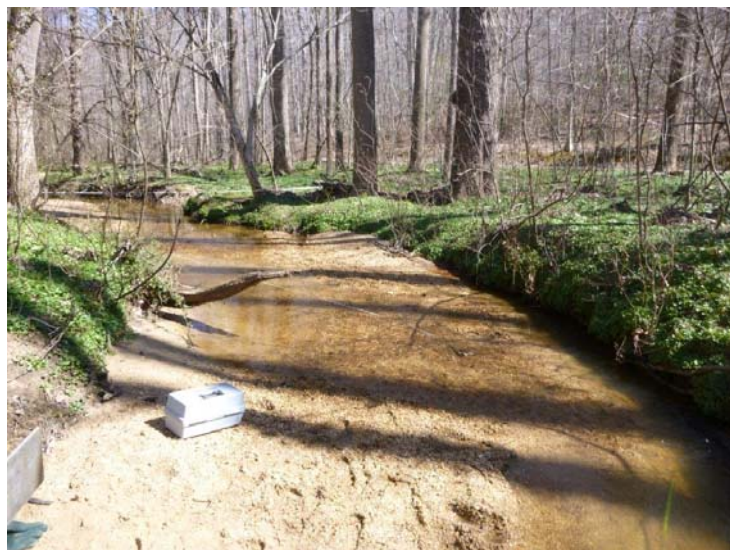
## Upstream View

Benthic Macroinvertebrate Community	Very Poor
Fish Community	Good
RBP Habitat Condition	Partially Supporting
MPHI Habitat Condition	Minimally Degraded
Water Quality Conditions	Elevated nitrogen

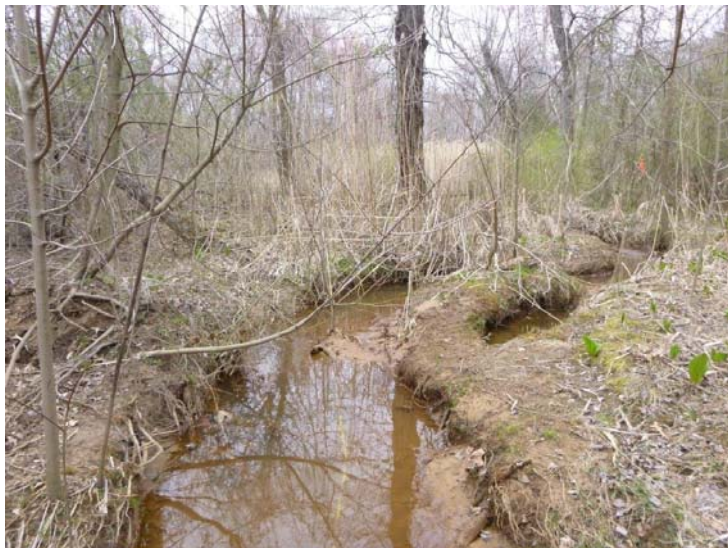
## Upstream View

Benthic Macroinvertebrate Community	Poor
Fish Community	Poor
RBP Habitat Condition	Supporting
MPHI Habitat Condition	Severely Degraded
Water Quality Conditions	High conductivity; Elevated nutrients

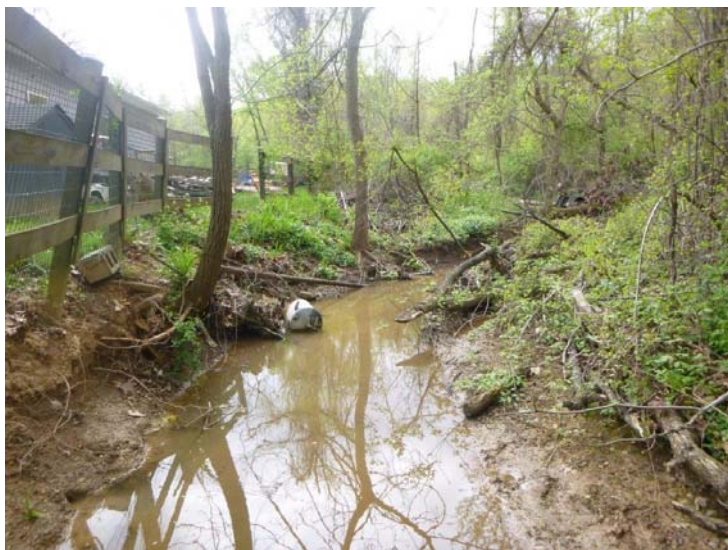
## Upstream View

Benthic Macroinvertebrate Community	Poor
Fish Community	Very Poor
RBP Habitat Condition	Non-Supporting
MPHI Habitat Condition	Degraded
Water Quality Conditions	High conductivity; Elevated nutrients

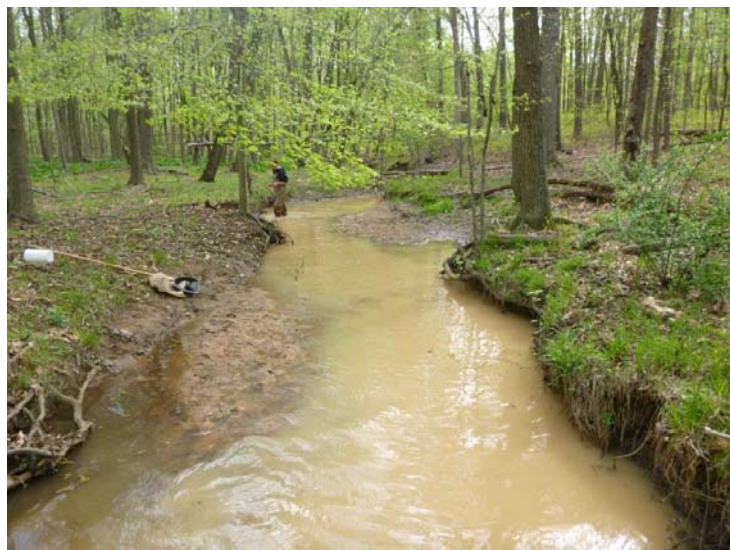
## Upstream View

Benthic Macroinvertebrate Community	Poor
Fish Community	Poor
RBP Habitat Condition	Partially Supporting
MPHI Habitat Condition	Partially Degraded
Water Quality Conditions	High conductivity; High lead; High copper; Elevated nutrients; High turbidity

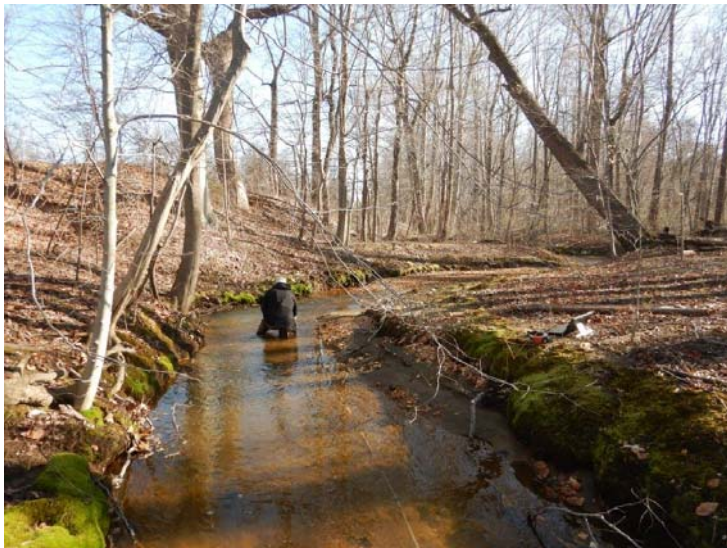
Upstream View - 2019

Benthic Macroinvertebrate Community	Fair
Fish Community	Fair
RBP Habitat Condition	Supporting
MPHI Habitat Condition	Partially Degraded
Water Quality Conditions	Elevated nutrients

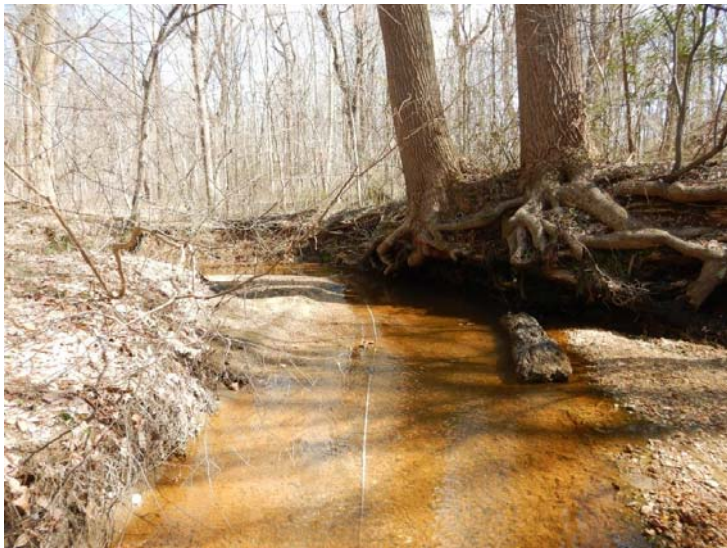
Upstream View - 2019

2019 Data	2004 Data
Benthic Macroinvertebrate Community	Very Poor	Fair
Fish Community	Poor	Not sampled prior to 2017
RBP Habitat Condition	Supporting	Supporting
MPHI Habitat Condition	Partially Degraded	Minimally Degraded
Water Quality Conditions	Elevated nutrients	Within acceptable range

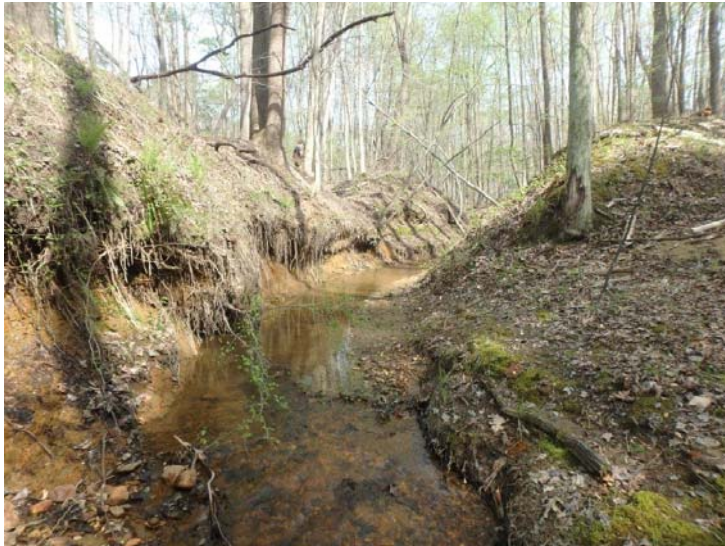
Upstream View - 2019

2019 Data	2010 Data
Benthic Macroinvertebrate Community	Poor	Good
Fish Community	Very Poor	Not sampled prior to 2017
RBP Habitat Condition	Partially Supporting	Supporting
MPHI Habitat Condition	Partially Degraded	Minimally Degraded
Water Quality Conditions	Low pH; Elevated phosphorus	Within acceptable range

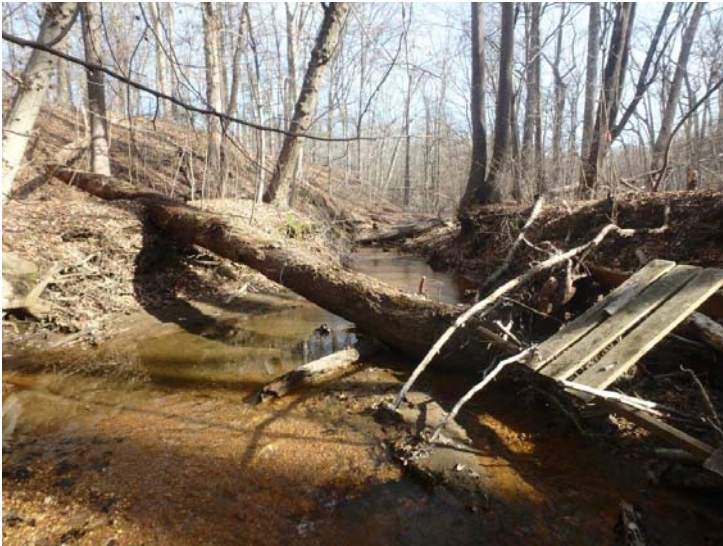
Upstream View - 2019

<u>2019 Data</u>	<u>2010 Data</u>
Benthic Macroinvertebrate Community	Fair	Fair
Fish Community	Fair	Not sampled prior to 2017
RBP Habitat Condition	Partially Supporting	Partially Supporting
MPHI Habitat Condition	Degraded	Partially Degraded
Water Quality Conditions	Within acceptable ranges	Within acceptable range

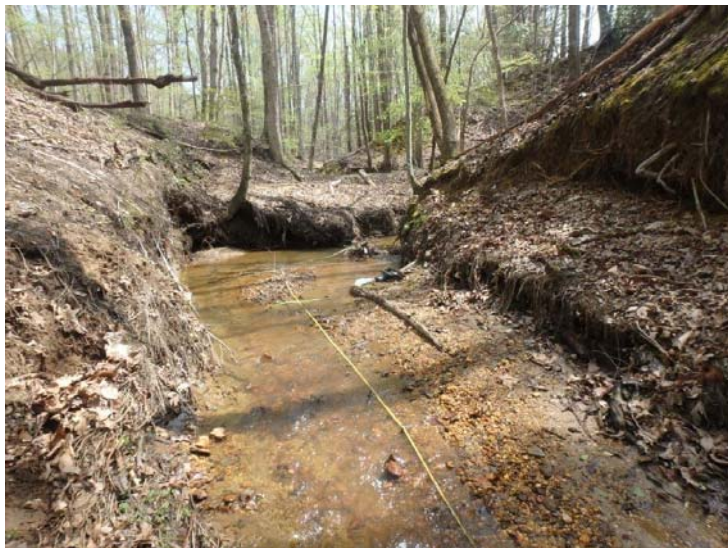
## Upstream View

Benthic Macroinvertebrate Community	Poor
Fish Community	Poor
RBP Habitat Condition	Partially Supporting
MPHI Habitat Condition	Degraded
Water Quality Conditions	Low pH

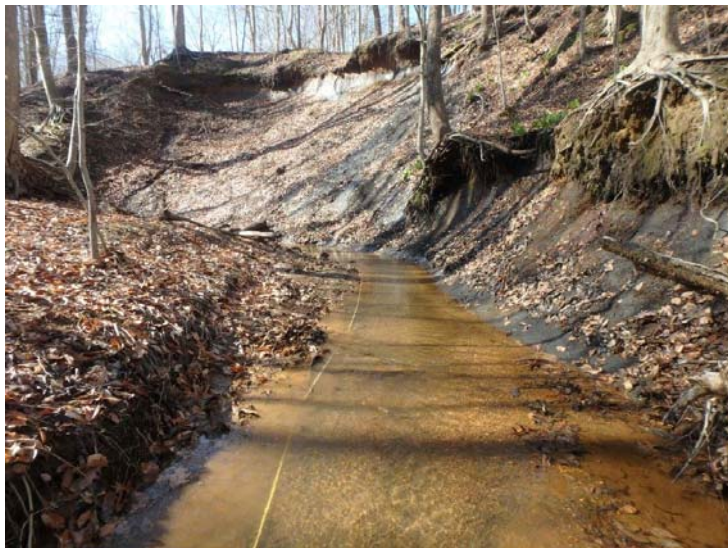
## Upstream View

Benthic Macroinvertebrate Community	Poor
Fish Community	Poor
RBP Habitat Condition	Partially Supporting
MPHI Habitat Condition	Degraded
Water Quality Conditions	Elevated nitrogen

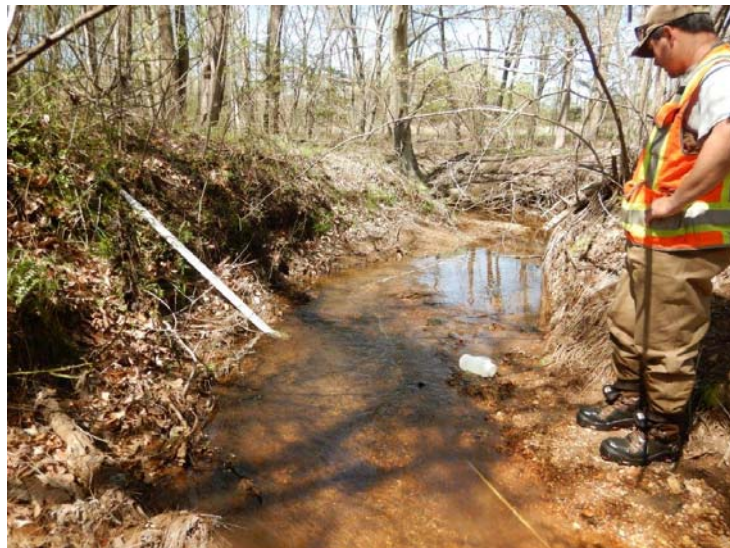
## Upstream View

Benthic Macroinvertebrate Community	Good
Fish Community	Fair
RBP Habitat Condition	Partially Supporting
MPHI Habitat Condition	Partially Degraded
Water Quality Conditions	Low pH; Elevated phosphorus

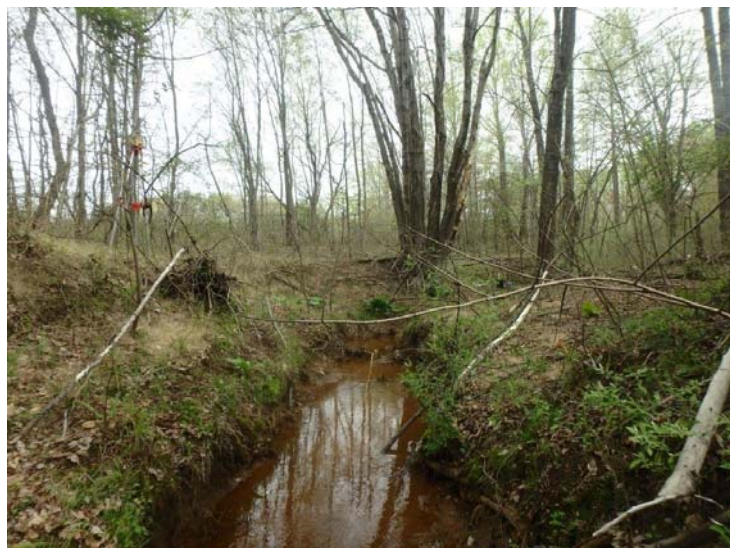
## Upstream View

Benthic Macroinvertebrate Community	Poor
Fish Community	Fair
RBP Habitat Condition	Partially Supporting
MPHI Habitat Condition	Partially Degraded
Water Quality Conditions	Low pH
