Odor Control Summer Monitoring Data

Annapolis Water Reclamation Facility
Odor Control Evaluations

December 10, 2024

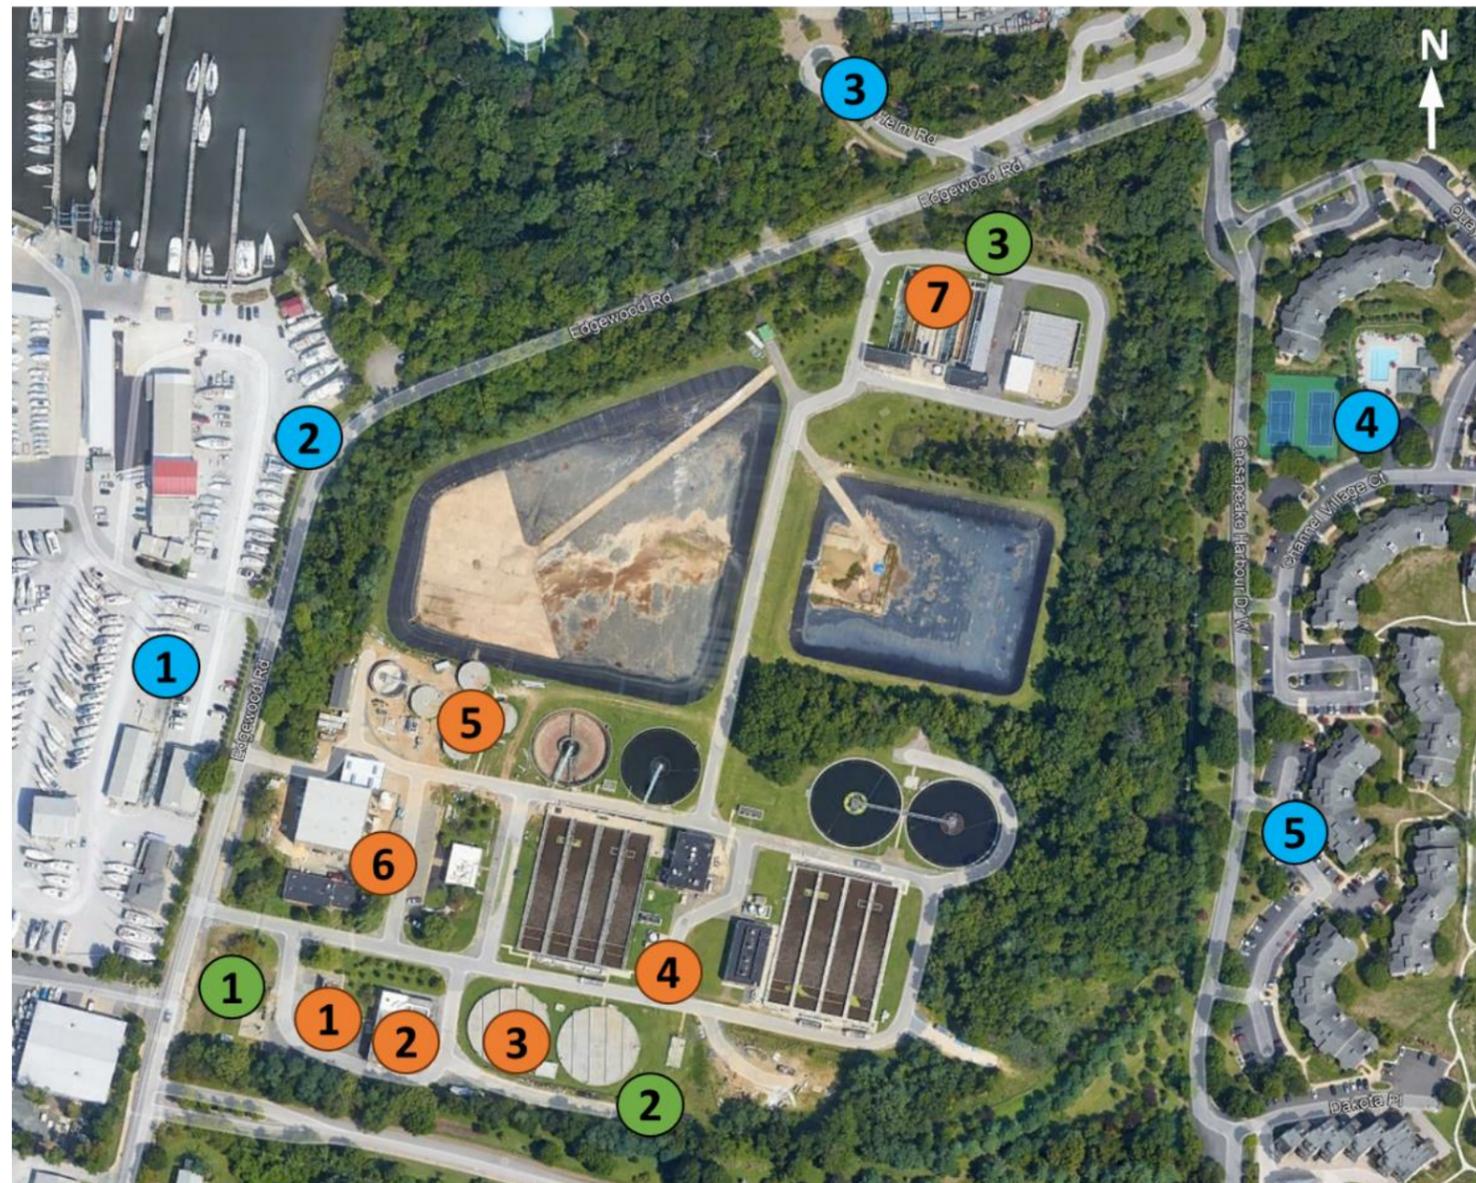
Figure 2-1: Summer Monitoring Locations

The summer monitoring included continuous hydrogen sulfide (H₂S) and temperature monitoring at a total of fifteen (15) locations over a six-week period, from July 1, 2024, to August 13, 2024. Seven (7) AcruLog™ hydrogen sulfide (H₂S) part-per-million (PPM) data loggers were used to monitor odors at the source of emissions within the WRF, while eight AcruLog™ (8) part-per-billion (PPB) monitors were used to monitor odor levels after the impacts of dispersion. The monitored locations are shown in Figure 2-1, orange circles denote interior source locations, green circles indicate fence line locations, and blue circles indicate neighborhood locations. Further details on winter and summer monitoring locations can be found in Odor Monitoring Plan provided in Appendix A.

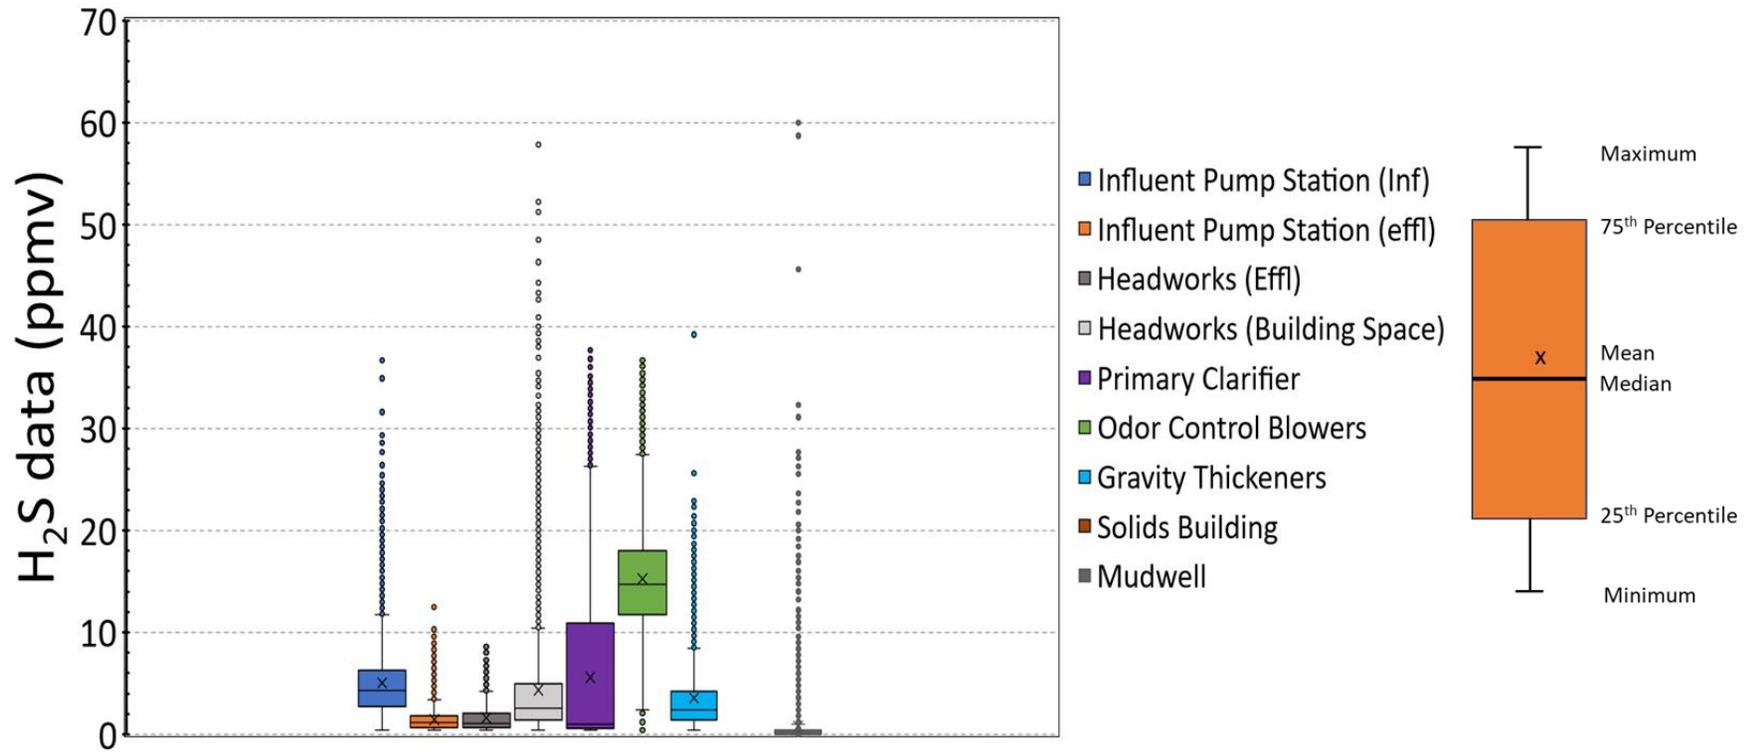
Figure 3-1: Box-And-Whisker Plots Showing the Change in Measurable H₂S Concentration Distribution for the Locations Within the WRF (July 1 to August 13).

In general, summer H₂S levels at all locations were relatively high compared to the winter data, consistent with the reasoning that warmer temperatures increase biological activity, promote the volatilization of odorous compounds, and create anaerobic conditions, leading to higher H₂S production and release.

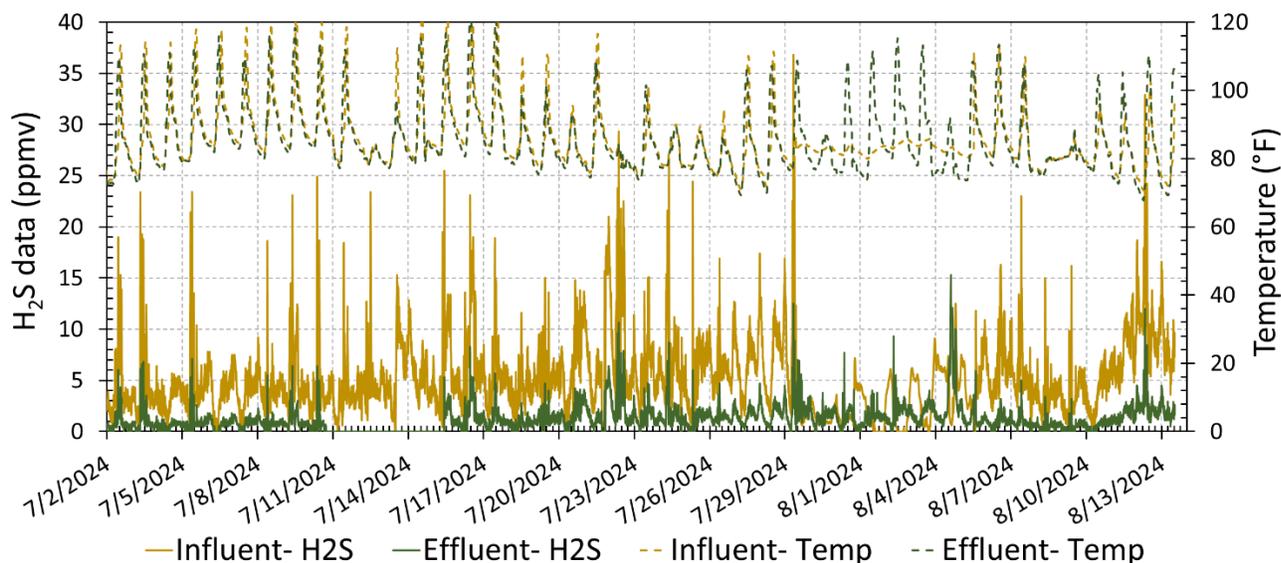
Figure 3-2: Results of Continuous Monitoring at Influent Pump Station (7/1/2024-8/13/2024)

The H₂S readings at the influent pump station are not excessive and can be effectively treated with appropriate odor control technologies (evaluated in separate TM). Although the existing biofilter is currently used for treating these odors, the effluent data shown in Figure 3-2 indicate that the existing treatment system is not effective in addressing the odorous air from the influent pump station.

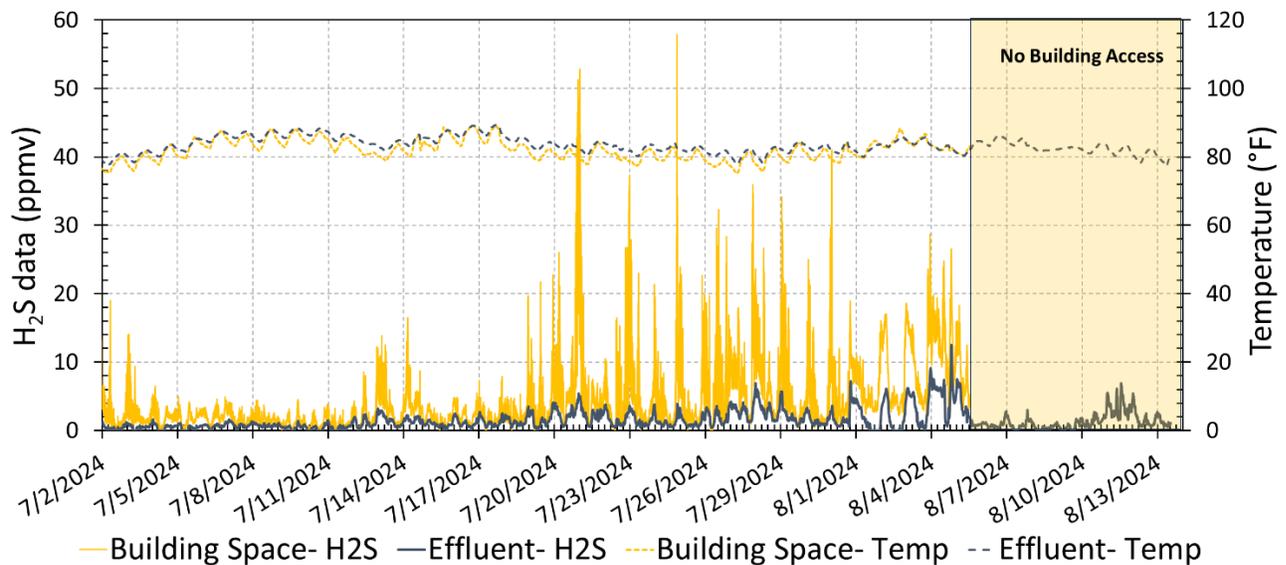
Figure 3-3: Results of Continuous Monitoring at Screen and Grit Building (7/1/2024-8/13/2024)

During the winter sampling, H₂S levels at the Headworks effluent peaked at 19.9 ppmv, with an overall average of 2.1 ppmv for the monitoring period. These results show that winter odorous air readings were higher than the summer readings, despite the low flow rate issue during the winter sampling, which was mitigated during the summer by using a pump to feed air into the bucket setup.

The H₂S readings at the screen and grit building are significant. As these are not being treated, it is likely that these emissions are contributing to offsite odors. Treatment recommendations are provided in a separate TM.

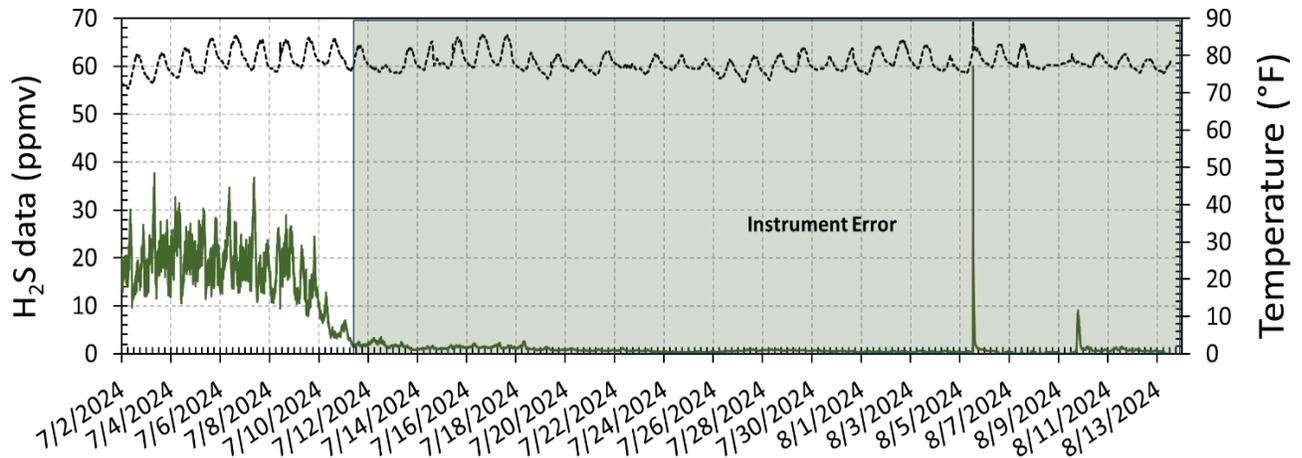
Figure 3-4: Results of Continuous Monitoring at Primary Clarifier Launderers (7/1/2024-8/13/2024)

To monitor odorous air formed in the primary clarifiers, a PPM logger was placed in one of the primary clarifier launders— near the existing takeoff (PC1). This space is enclosed to effectively capture the odors and is not accessible to personnel. The H₂S concentration and ambient air temperature measured for the six-week period, spanning from July 1 to August 13, are shown in Figure 3-4. The presented data shows the continuous generation of H₂S in the primary clarifier launders. It was noticed that the logger was getting too close to the water level, and the splashing water was interfering with the data logging. As a result, the measured H₂S concentrations were lower after a few weeks of sampling (7/12 – 8/13).

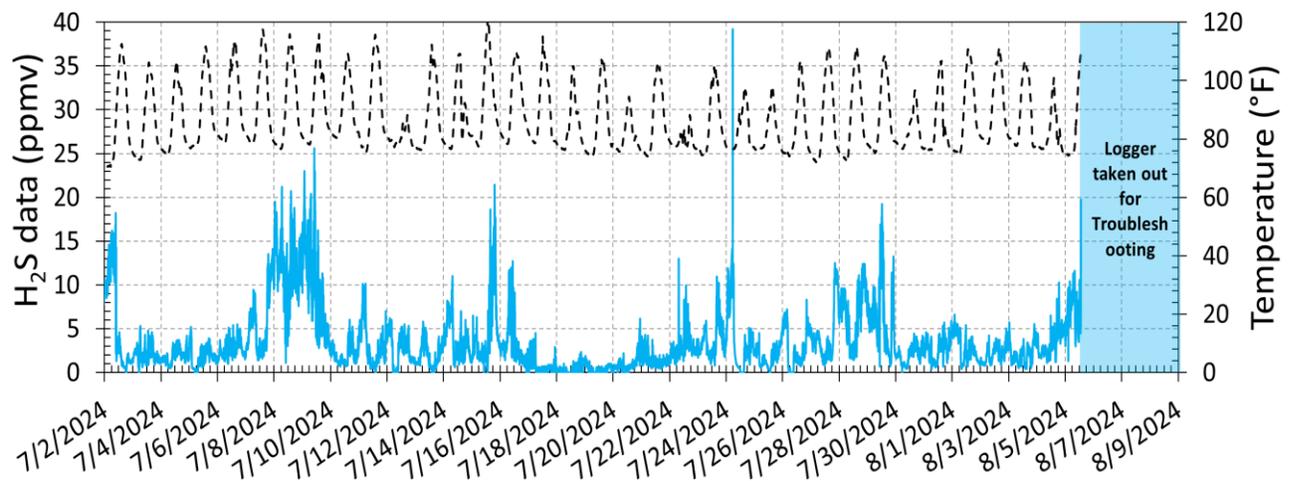
Figure 3-5: Results of Continuous Monitoring at Gravity Sludge Thickeners (7/1/2024-8/13/2024)

During this monitoring period, one H₂S PPM monitor was installed beneath the covers of GST. This space is enclosed to effectively capture the odors and is not accessible to personnel. The H₂S concentrations and ambient air temperature measured for the six-week period, spanning from July 1 to August 13, are shown in Figure 3-5. The presented data shows the continuous generation of H₂S in the GST. Overall, the recorded H₂S detection frequency and magnitude at the GST were also relatively high, at 95% and 0.4 to 39.5 ppmv, respectively.

The measured concentrations are significantly higher than those observed during the winter months (0.4 – 4.2 ppmv), which is expected with the effects of higher summer temperatures. Odors from this location are directed to the existing aeration blowers (see Section 3.1.5 below).

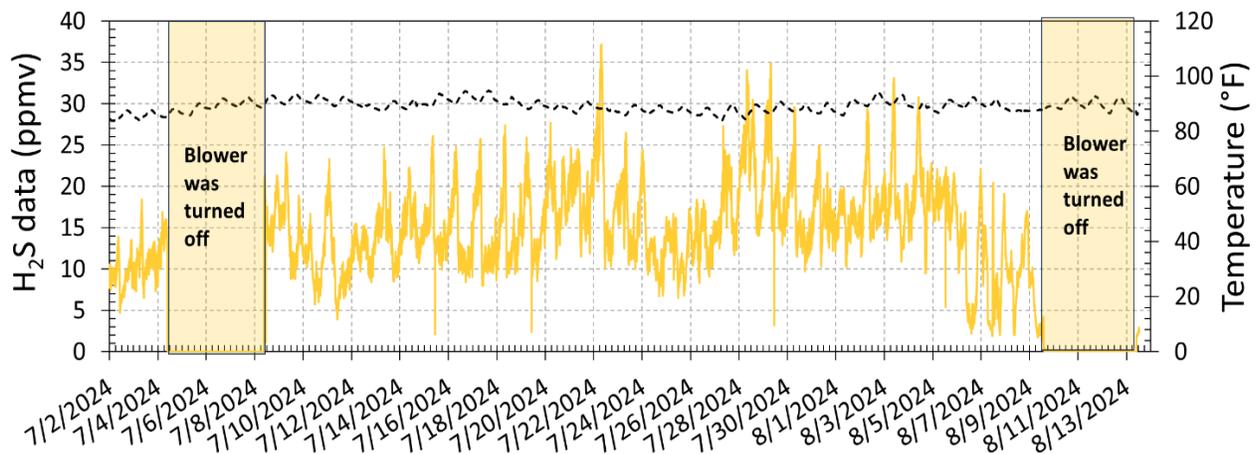
Figure 3-6: Results of Continuous Monitoring at Odor Control Blowers (7/1/2024-8/13/2024)

The measurable H₂S concentration was as high as 39.2 ppmv at times, with a detection frequency of 95%. These values are consistent with the combined odor measurements from the primary clarifiers and GSTs. However, during the winter months, H₂S levels measured at the blowers were significantly lower, ranging from 0.4 to 9.3 ppm. Despite this, the levels were still consistent with the combined odor measurements from the primary clarifiers and GSTs observed during winter monitoring.

While the current treatment scheme for the primary clarifiers and GSTs is effective, the County is undertaking a project to replace the aeration blowers with new blowers that are incompatible with the levels of H₂S expected from this odorous air stream. Therefore, a new odor control system will be required. Evaluation of odor technologies for these odorous air stream is discussed in a separate TM.

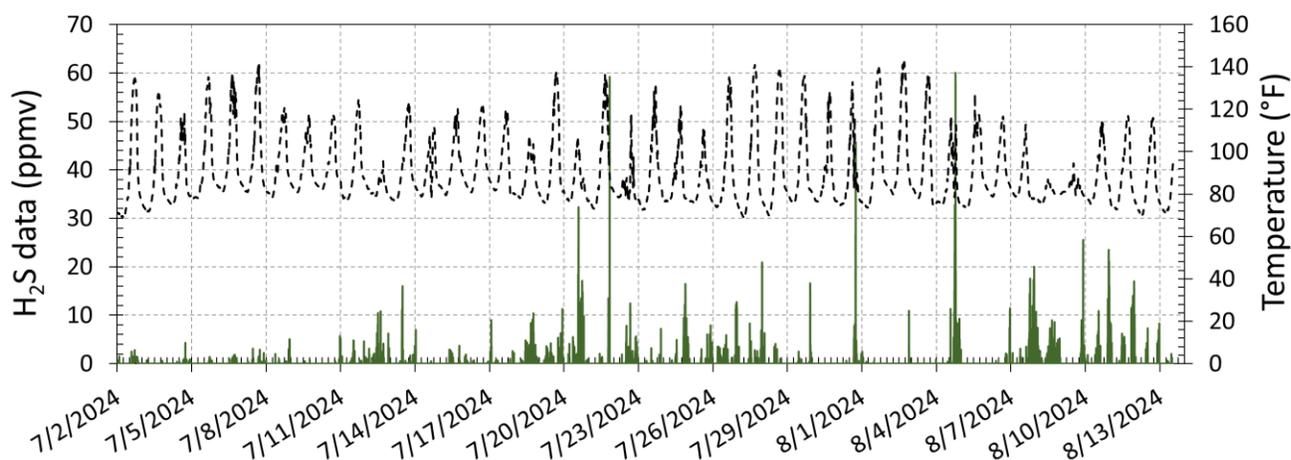
Figure 3-7: Results of Continuous Monitoring at Mudwell (7/1/2024- 8/13/2024)

The logger deployed at the mudwell recorded H₂S levels ranging from 0.4 to 60.0 ppmv and a detection frequency of 43%. The buildup of solids within the mudwell is likely contributing to decay and odors. Additionally, the data suggests that detection events may be linked to operational activities, such as active backwash events, which could be causing the release of H₂S from the mudwell. The County is actively flushing the tank and working on permanent covers and automatic flushing systems to help mitigate these odors.

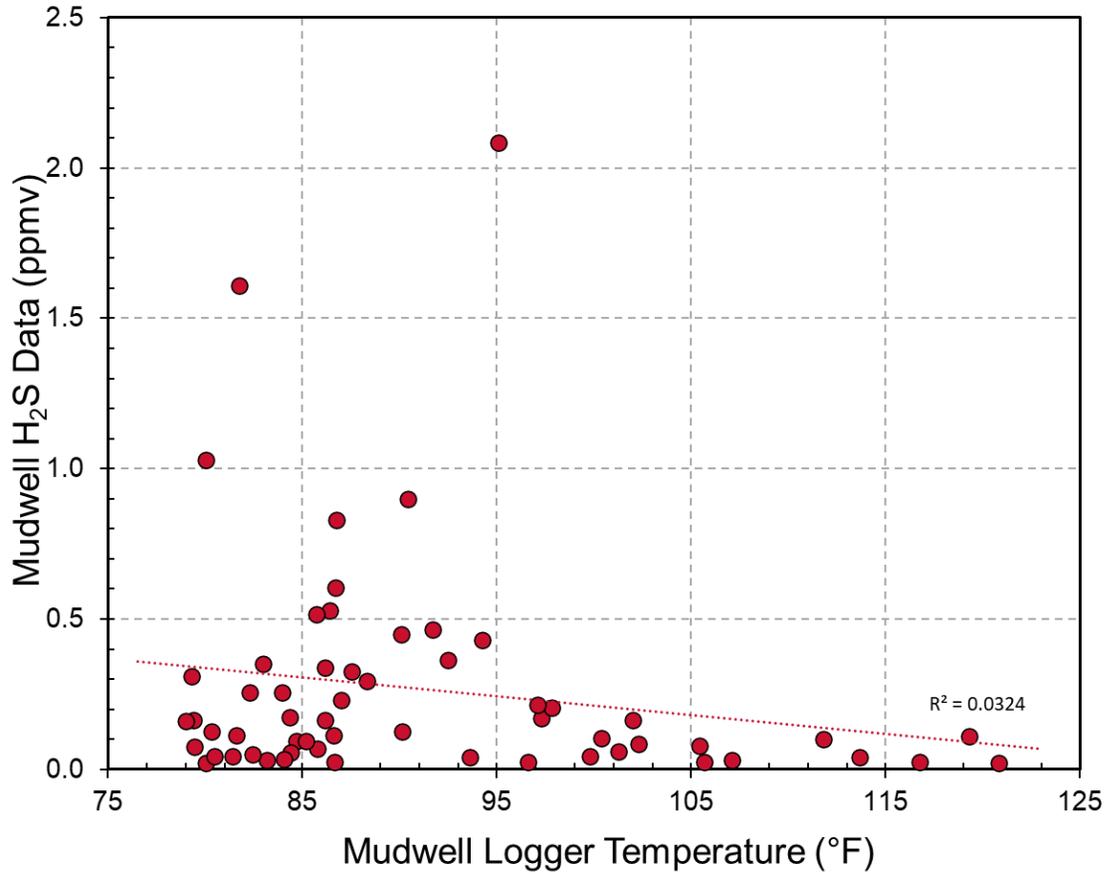
Figure 3-8 Hourly Time-Averaged Mudwell H₂S Data Plotted against Ambient Temperature Data Recorded by the Logger

The logger was located outside. Temperatures were measured in excess of 140 °F, which was likely caused by exposure to direct sunlight. This could impact overall accuracy. The peaks in the detected H₂S values seem to align with the ambient temperature peaks recorded by the logger, so a correlation plot was developed to verify this relationship. However, as seen in Figure 3-8, the hourly time-averaged H₂S emissions plotted against the hourly time-averaged temperature data did not show any clear correlation, indicating that odor emission at the mudwell is not temperature dependent.

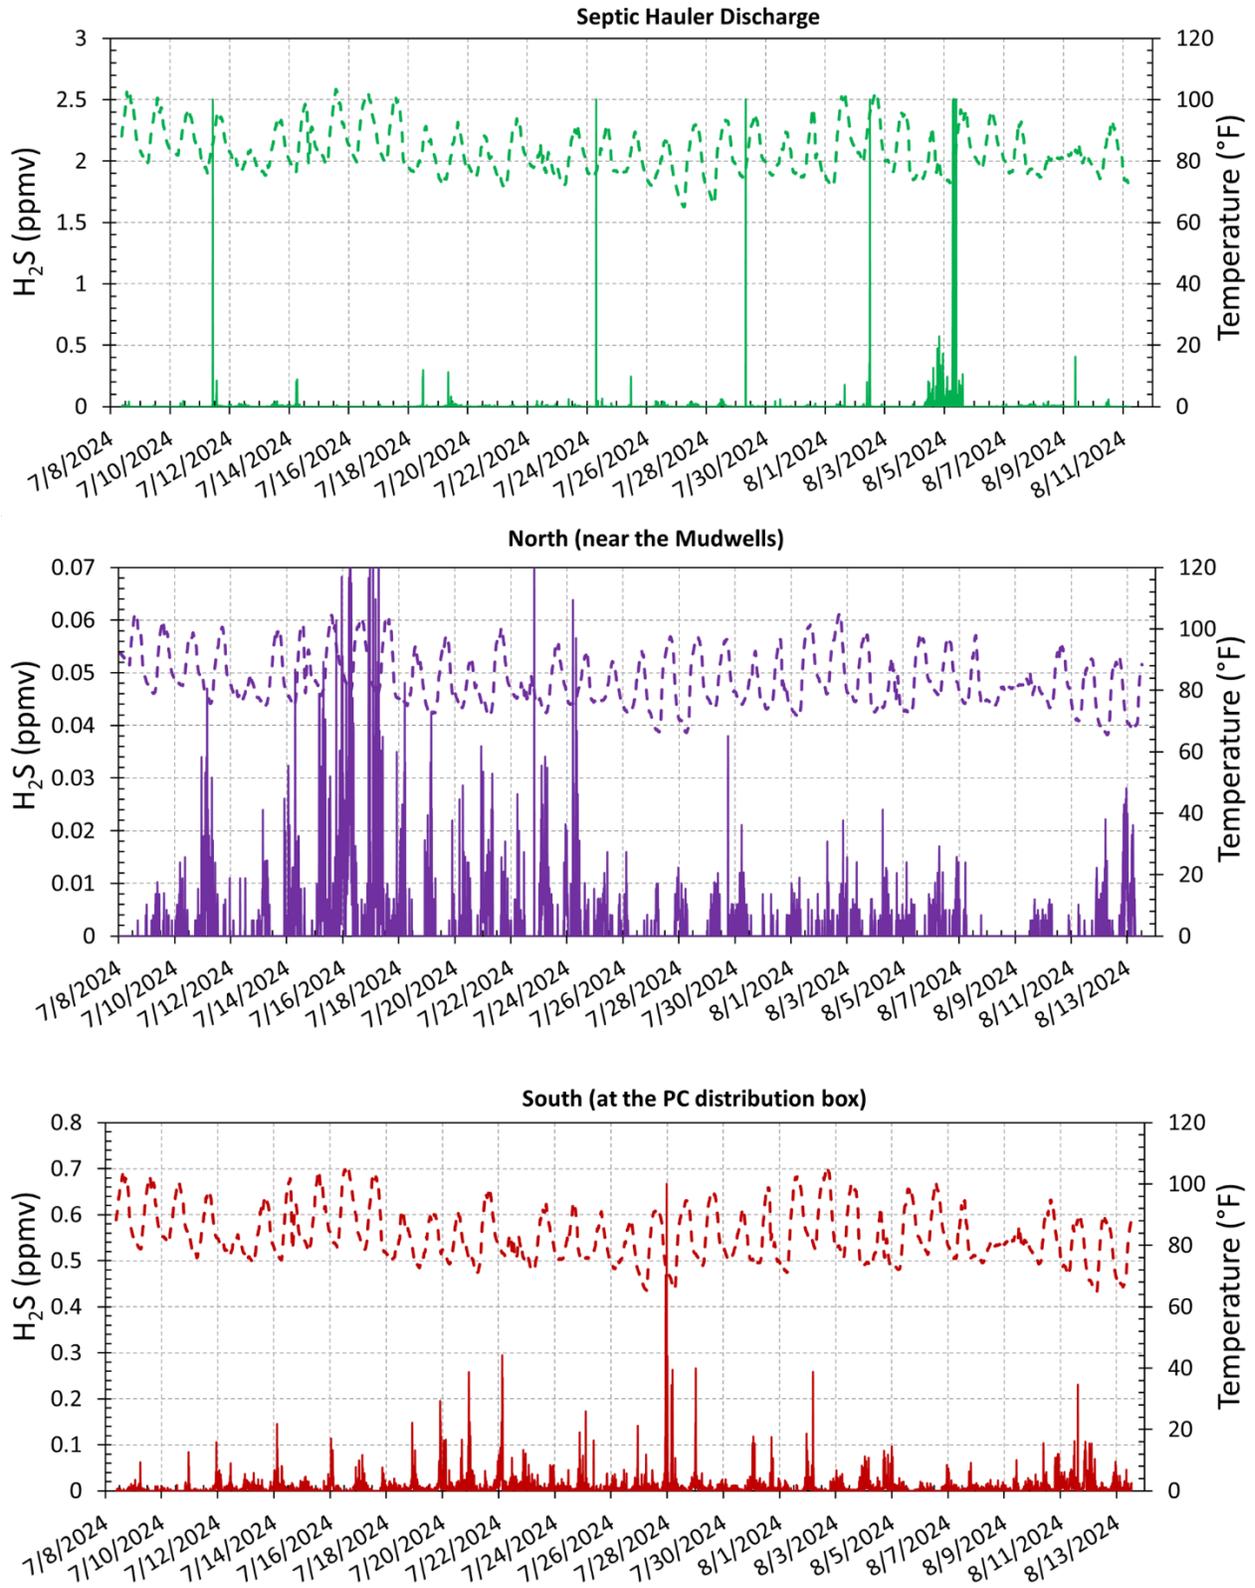
Figure 3-9: Results of Continuous Monitoring at the Fenceline (7/8/2024- 8/13/2024).

As shown in Figure 3-9, a total of three PPB loggers were installed to monitor the fenceline: one to the west (at the septage hauler discharge), one to the south (near the primary clarifier distribution box), and one to the north (near the denitrification filters) of the WRF. Figure 3-9 presents the H₂S concentrations and ambient air temperatures measured by the three fenceline PPB loggers deployed over the six-week monitoring periods. Note that the PPB data has been converted to PPM for easier comparison with all other data presented above.

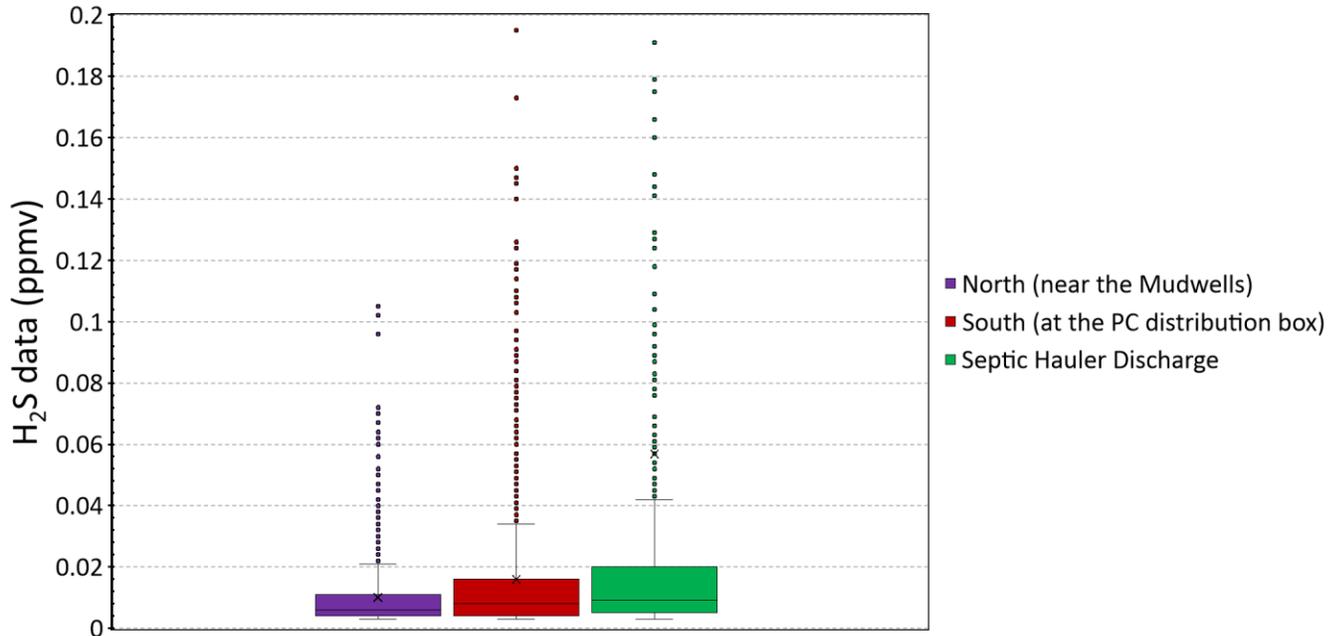
Figure 3-10: Box-And-Whisker Plots Showing the Change in Measurable H₂S Concentration Distribution for the Fenceline Locations (July 8 to August 13).

The changes in the measurable H₂S concentration distribution over the monitoring period for the fenceline locations are illustrated in Figure 3-10. Additionally, the measured range of H₂S concentrations, as well as the percent of detection events, are presented in Table 3-2.

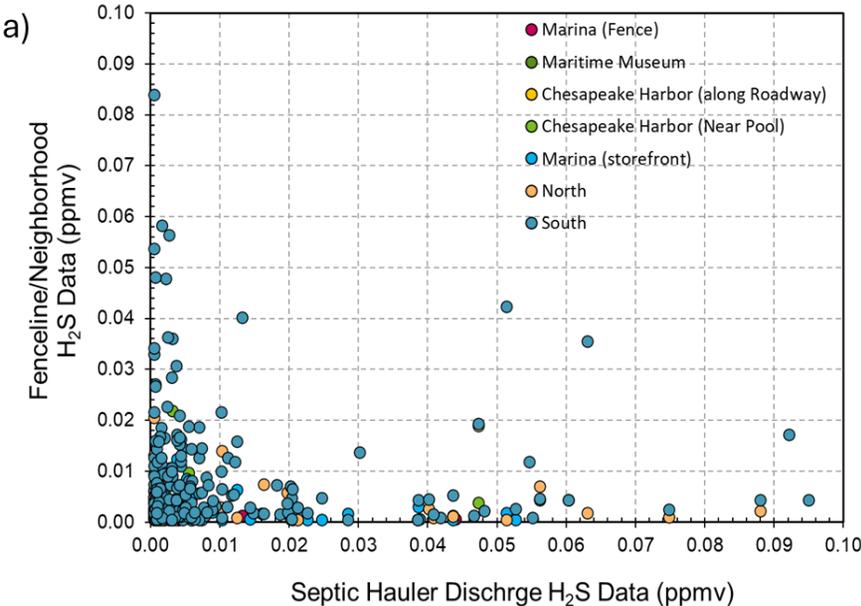
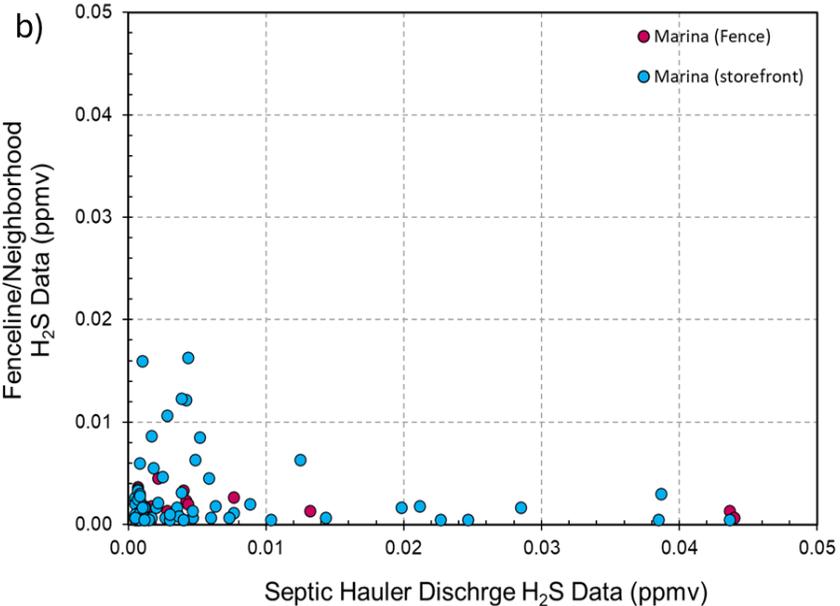
Figure 3-13: Hourly Time-Averaged Concentrations: a) Fenceline and Neighborhood Data Plotted against Septic Hauler Discharge Data; b) Marina Data Plotted against Septic Hauler Discharge Data

Figure 3-13 shows the correlation plot for the septic hauler discharge data with the other PPB loggers’ data.

No direct correlation was observed between the odor emissions from the Septic Hauler Discharge and any of the fenceline or neighborhood locations during this round of odor monitoring.

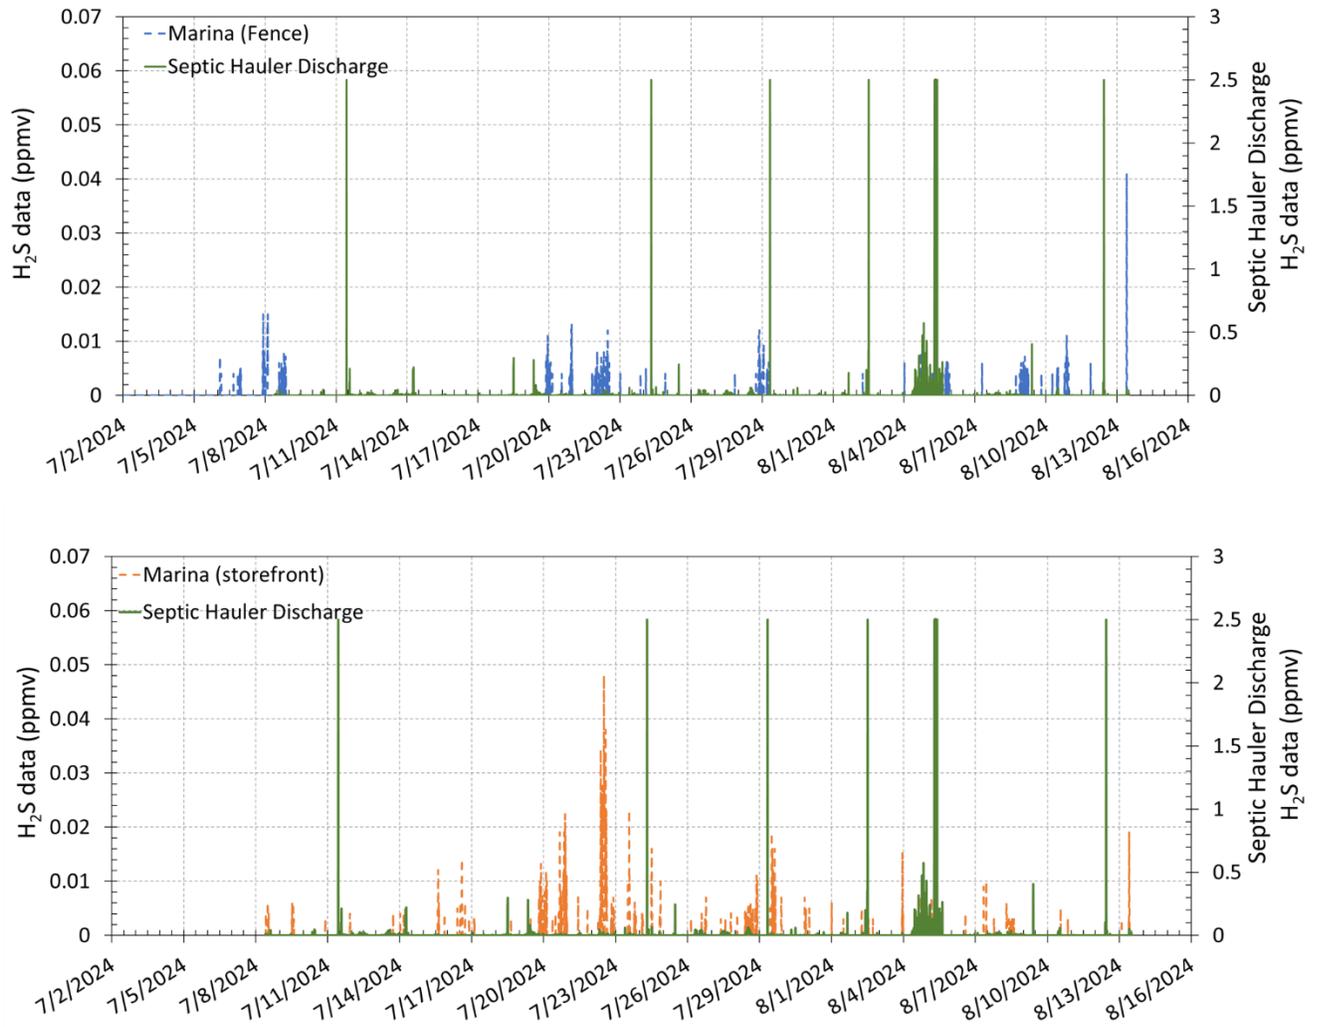
Figure 3-14: Continuous Monitoring data from Septic Hauler Discharge Plotted against the Data measured at the Marina

As the Septic Hauler Discharge is closest to the marina, a comparison was made between the Septic Hauler Discharge H₂S and the monitors at the marina, as shown in Figure 3-14 below.

As with above, no direct correlation is evident. There are times when concentrations are observed at the marina but not at the Septic Hauler Discharge location.

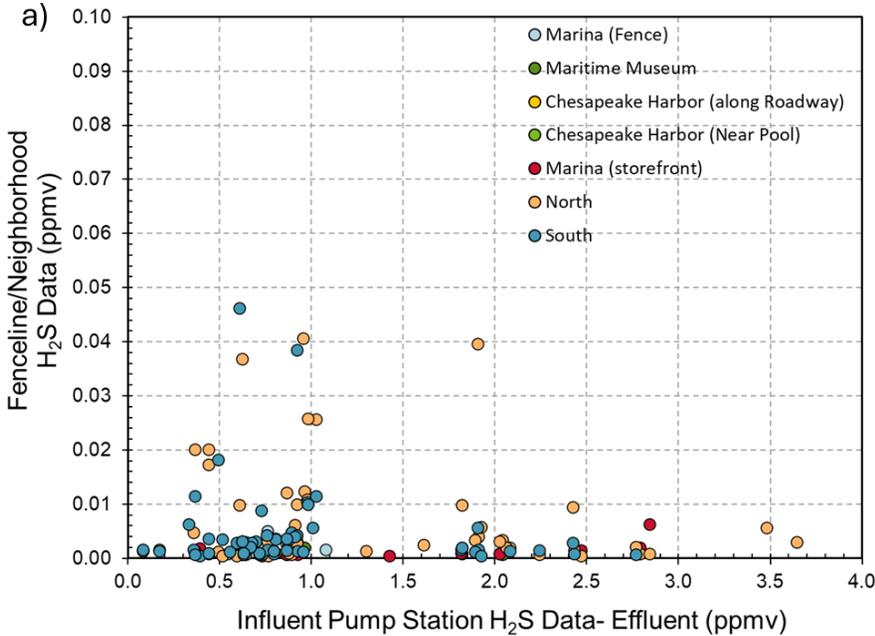
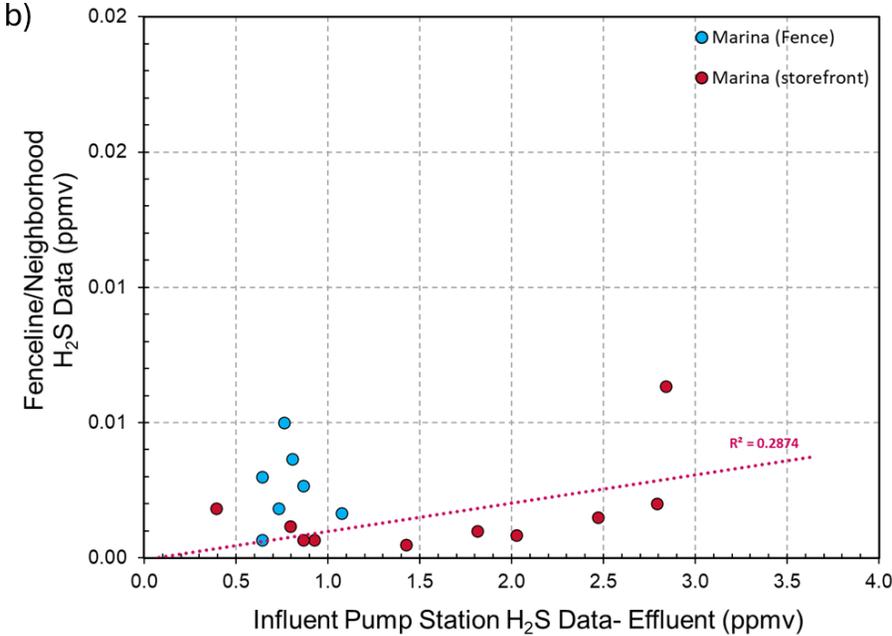
Figure 3-15: Hourly Time-Averaged Concentrations: a) Fenceline and Neighborhood Data Plotted against Influent Pump Station Effluent Data; b) Marina Data Plotted against Influent Pump Station Effluent Data

Figure 3-15 shows the correlation plot for the influent pump station effluent data with the other PPB loggers' data. No strong correlation was observed between the odor emissions from the IPS effluent and any of the fenceline or neighborhood locations during this round of odor monitoring, except for the data collected at the marina storefront. The odor data from the marina storefront closely correlated with the influent pump station effluent data.

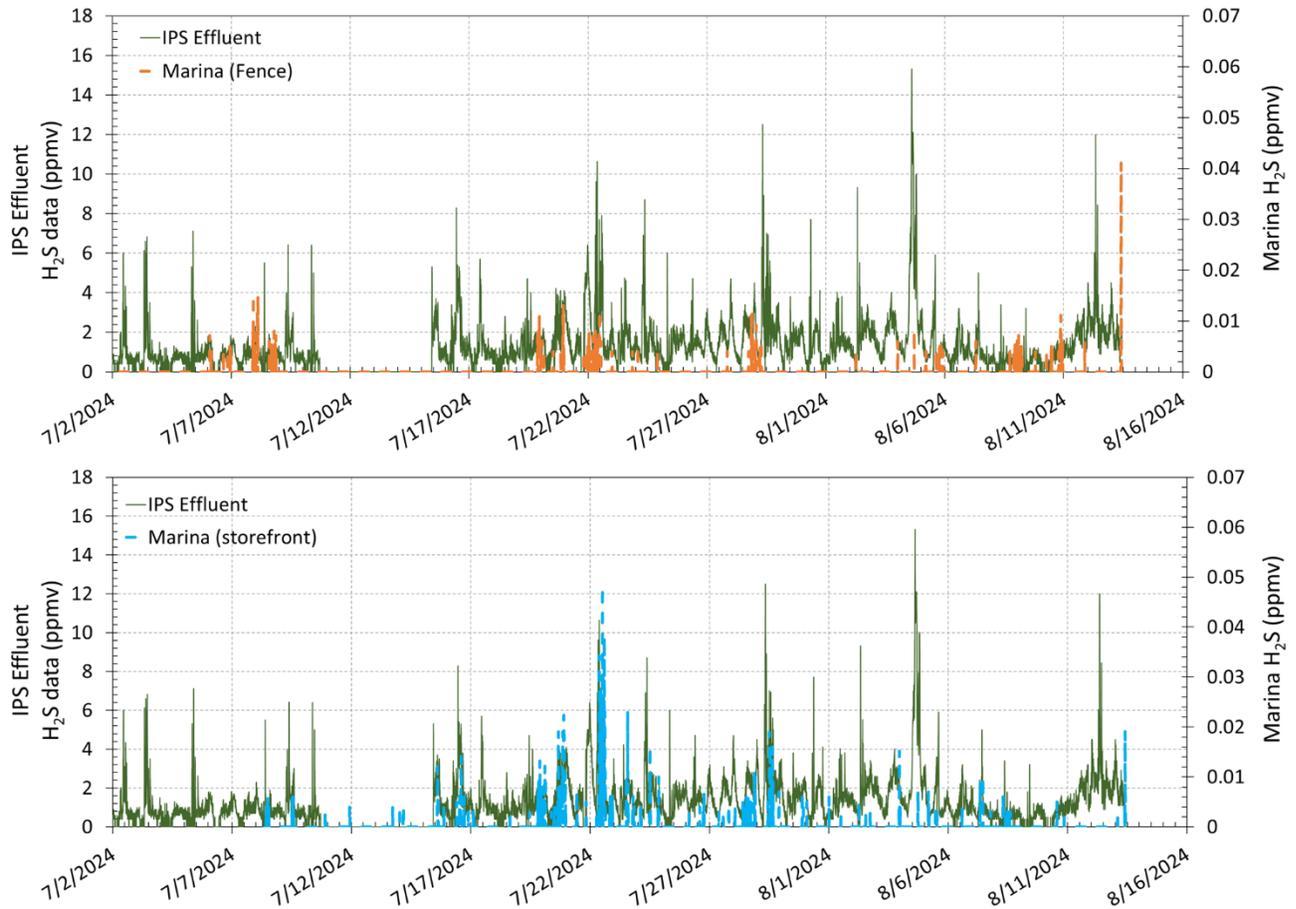
Figure 3-16: Continuous Monitoring Data from Influent Pump Station Effluent Plotted against the Data measured at the Marina

As the Influent Pump Station is closest to the marina, a comparison was made between Influent Pump Station effluent H₂S and the monitors at the marina, as shown in Figure 3-16 below.

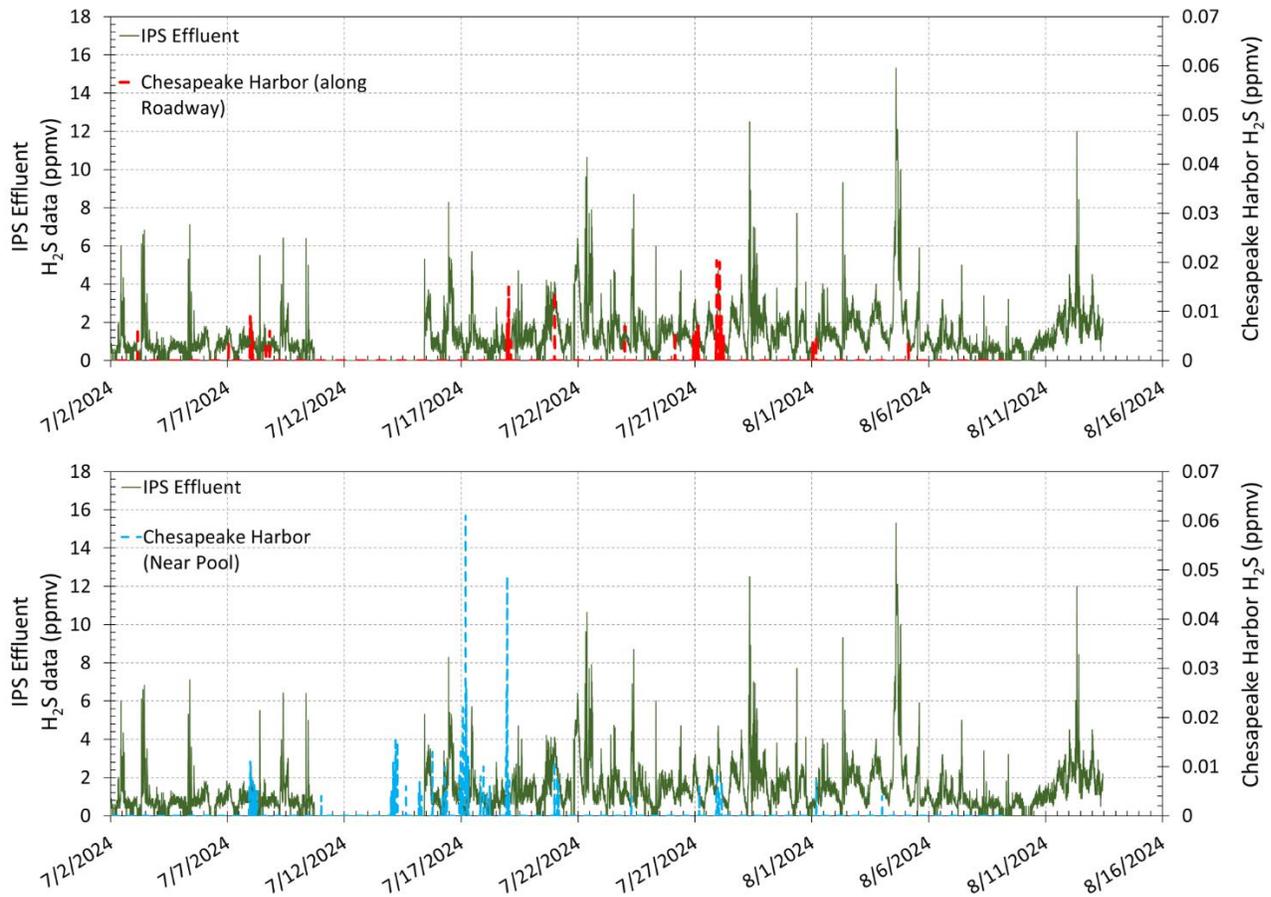
Figure 3-17: Continuous Monitoring Data from Influent Pump Station Effluent Plotted against the Data measured at the Chesapeake Harbor Community

Given the frequency of emissions, comparisons were also made between the Influent Pump Station effluent H₂S and the monitors at Chesapeake Harbor, as shown in Figure 3-17 below.

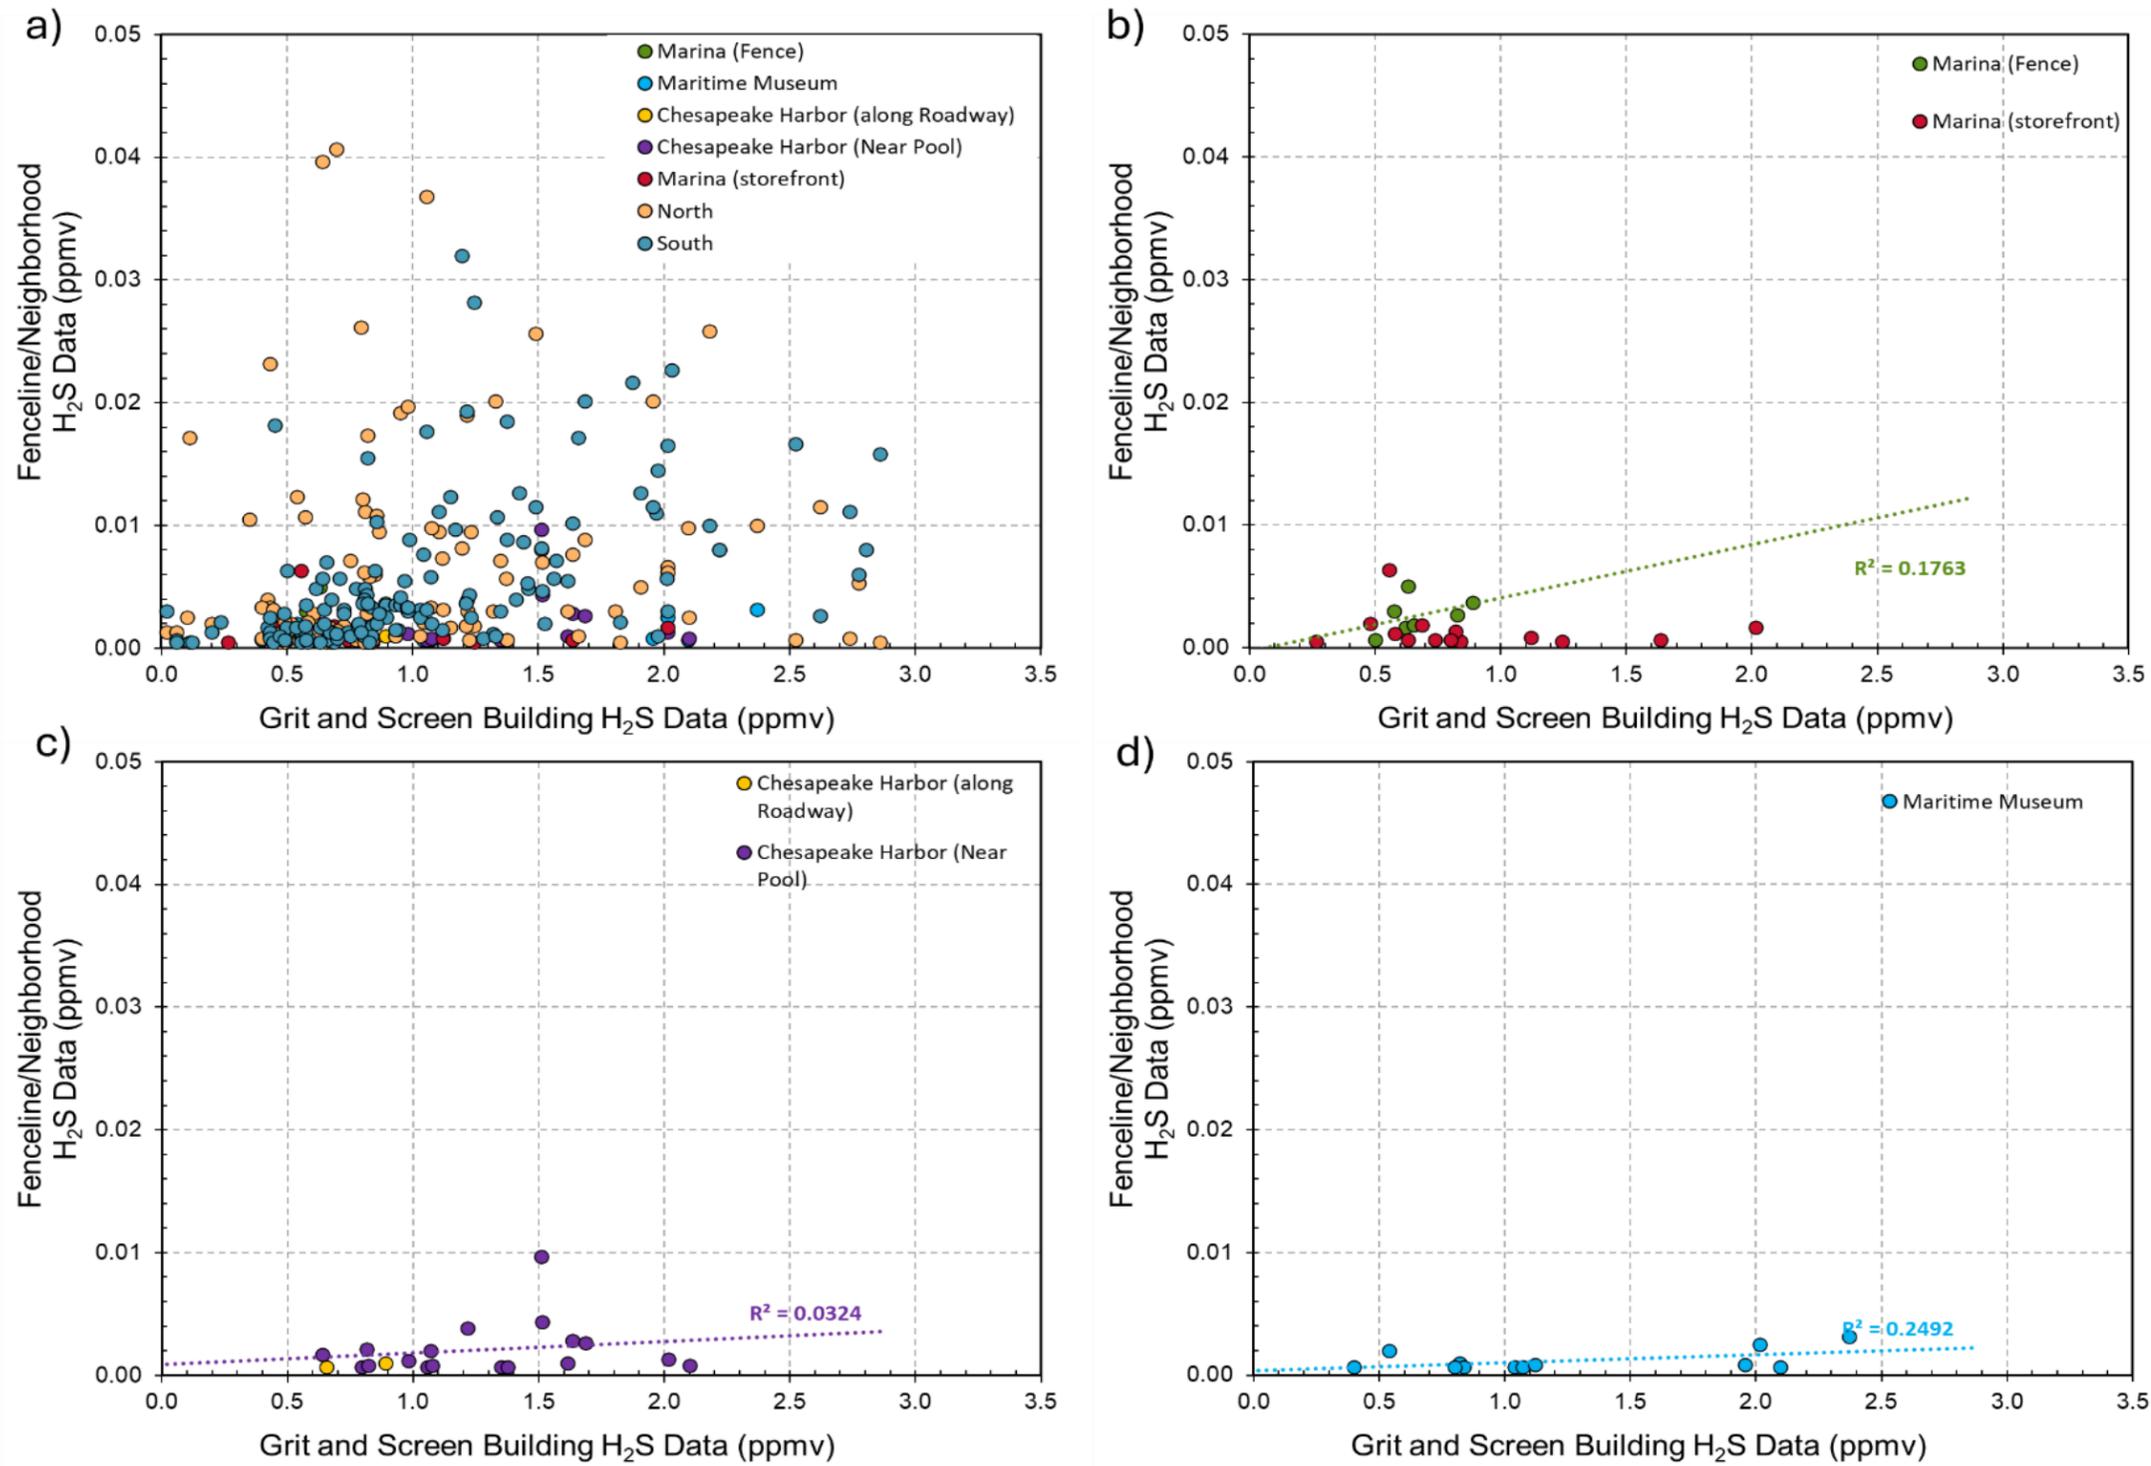
Figure 3-18 shows the correlation plot for the grit and screen building effluent data with the other PPB loggers' data. No strong correlation was observed between the odor emissions from the IPS effluent and any of the fenceline or neighborhood locations during this round of odor monitoring. Even though the marina fenceline and the maritime museum are slightly farther from the grit and screen building, a slight correlation was found between the data from these locations and the grit and screen building effluent data. Therefore, meteorological data should be examined in conjunction with the H₂S logger data to better understand the dispersion of odorous air into the neighboring areas.
