Odor Control Summer Monitoring Data

Annapolis Water Reclamation Facility
Odor Control Evaluations

December 10, 2024

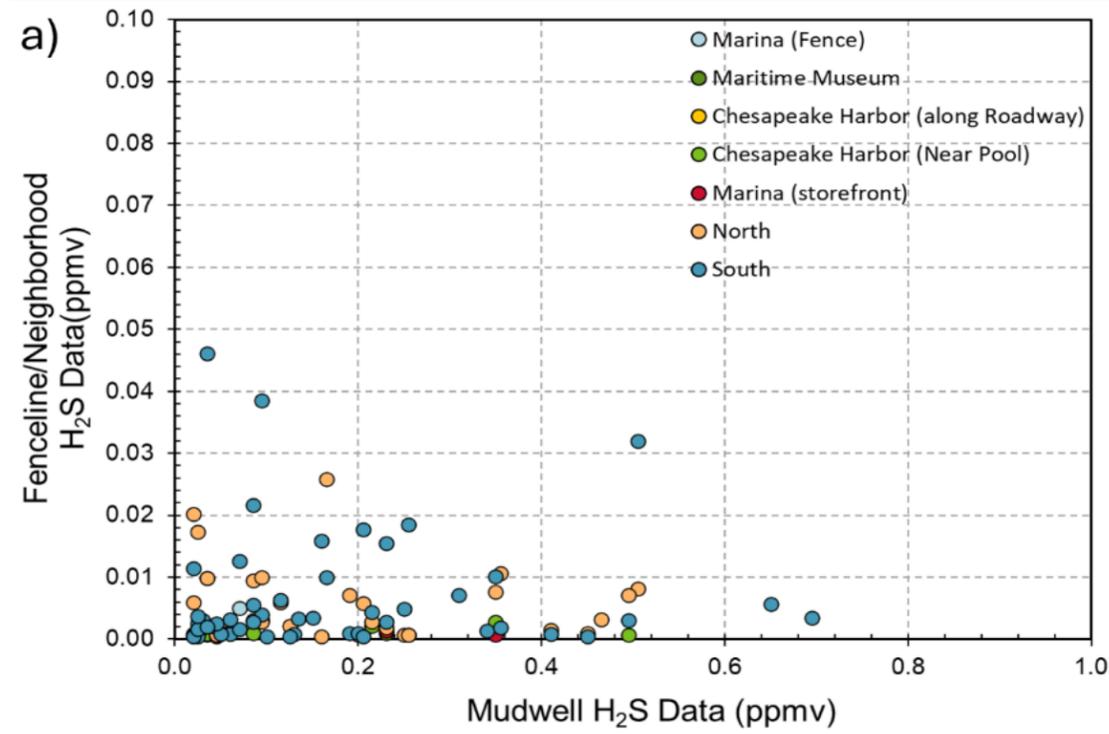
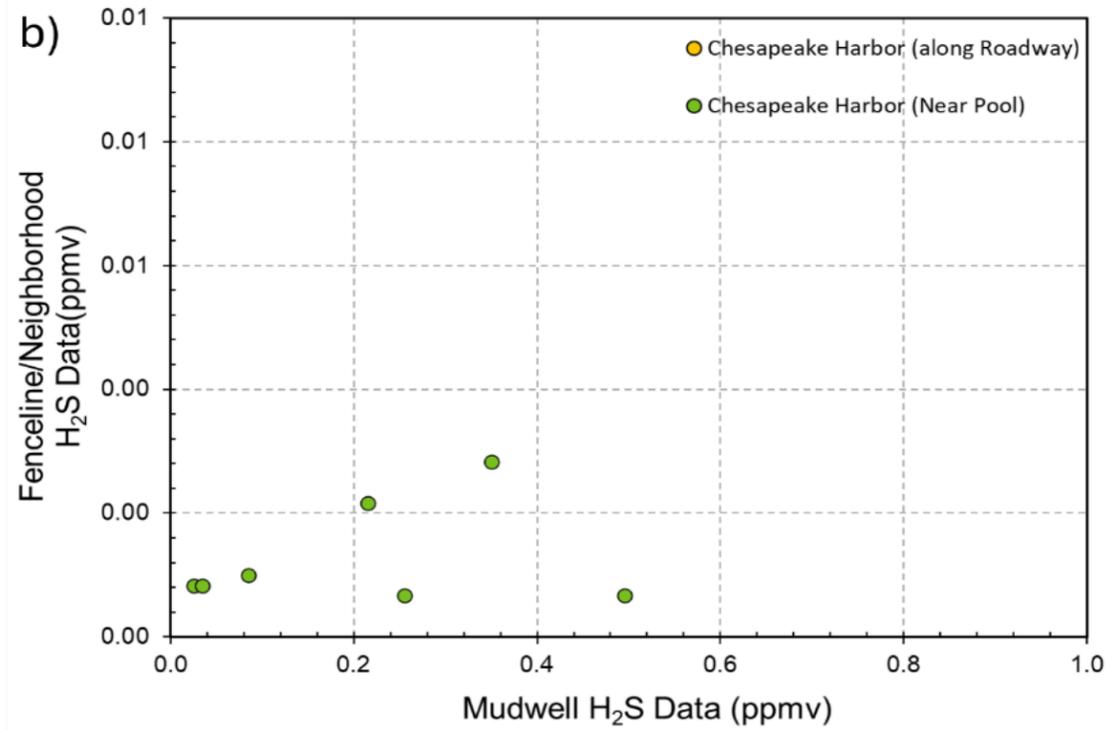
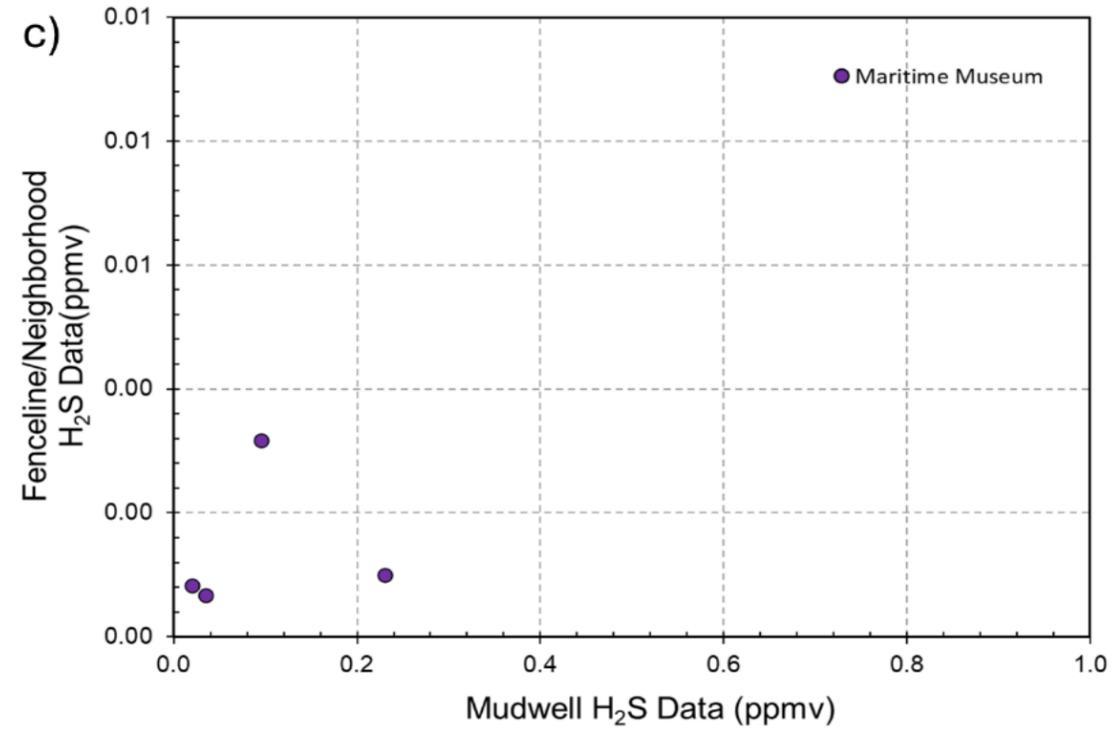
Figure 3-20: Hourly Time-Averaged Concentrations: Fenceline and Neighborhood Data Plotted against Mudwell Data

Figure 3-20 shows the correlation plot for the mudwell data with the other PPB loggers' data. Similar to the above findings, no direct correlation was observed between the odor emissions from the mudwell and any of the fence line or neighborhood locations during this round of odor monitoring.

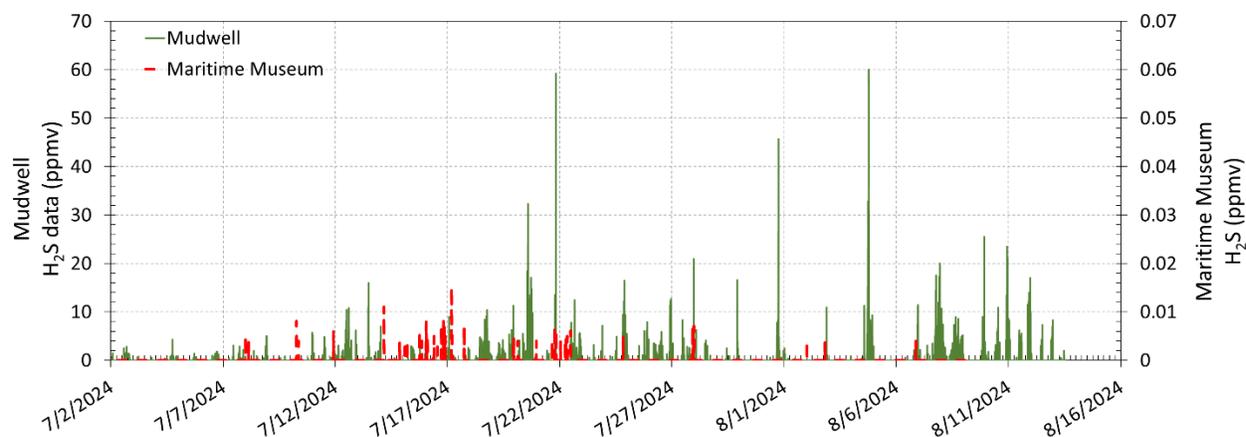
Figure 3-21: Continuous Monitoring Data from Mudwell Compared with Data from the Maritime Museum

Comparisons were also made between the mudwell and the monitor at the Maritime Museum, as shown in Figure 3-21 below.

As with above, no direct correlation is evident. There are times when concentrations are observed at the Maritime Museum but not at the mudwell location.

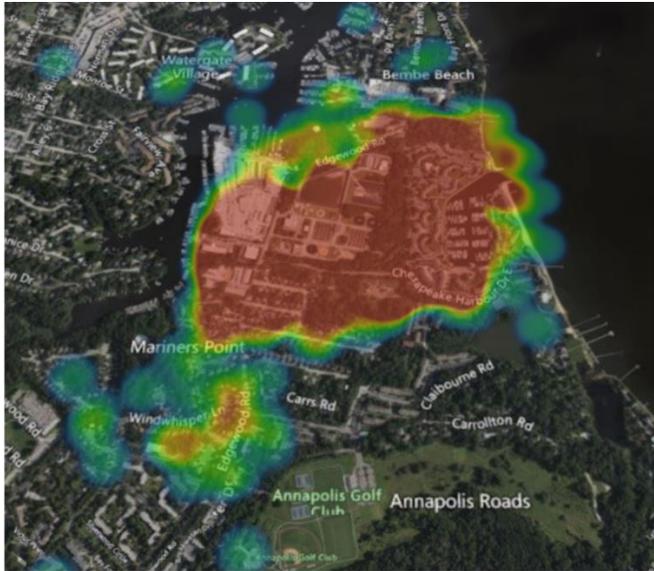
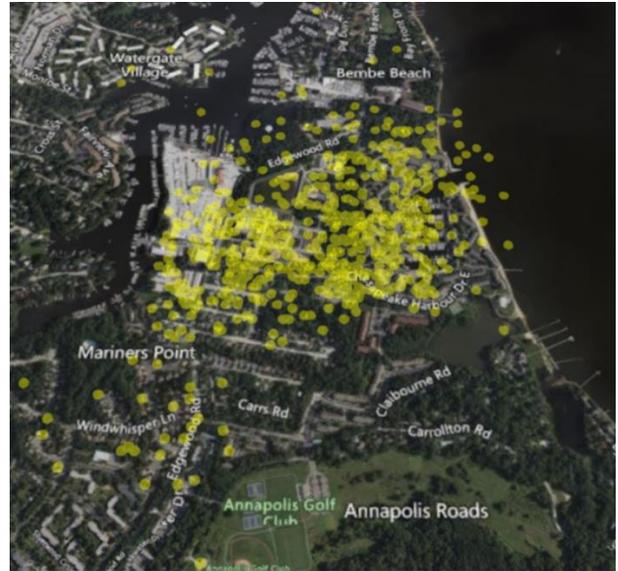
Figure 3-22 Odor Complaints Logged on Smell My City App During July 1 to August 16.

Local residents have been using the “Smell MyCity” app to document odor nuisance complaints. The team gathered information from the Smell MyCity app to evaluate and correlate the odor nuisance complaints with the data recorded by the loggers. Figure 3-22 presents a heat map and a scatterplot showing where the majority of complaints were reported during the sampling period from July 1 to August 16. During the summer monitoring period, the complaints were concentrated around the WRF, while in the winter monitoring period, most complaints originated from the east of the WRF. Figure 3-23 shows the number of odor complaints per day for the sampling duration (July 1 - August 16) overlaid on H₂S data recorded from the neighborhood monitors. Although it appears that complaints were logged when the monitors recorded H₂S spikes, a clear correlation was not observed between the two, as a considerable number of complaints were logged even when the loggers recorded negligible levels of H₂S.

Heat map showing where most of the complaints are coming from.

Scatter plot showing the locations of individual complaints (same data shown differently)

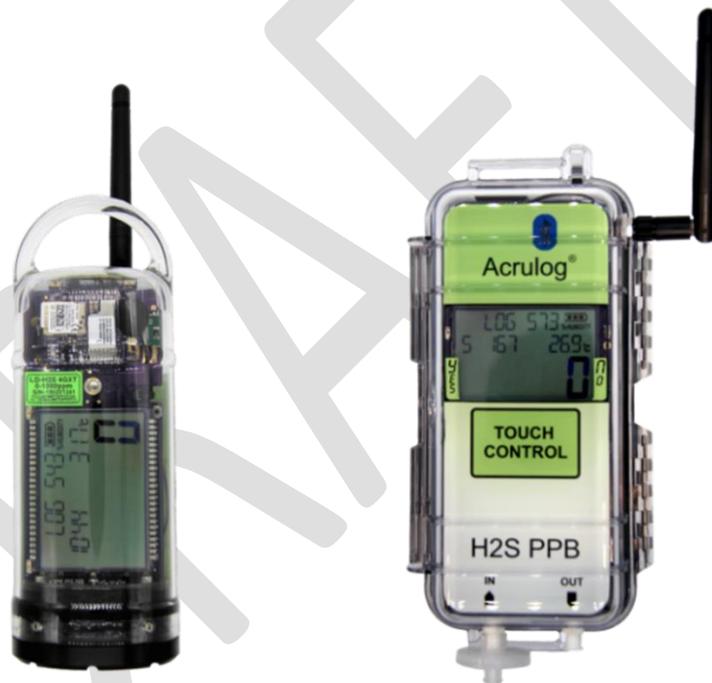
Figure 2-1 Photos of Acrulog H₂S Gas Monitors: Parts Per Million (left) and Part Per Billion (right)

The County will purchase (through HDR) ten H₂S data loggers for this odor evaluation study. Six of the loggers are Parts Per Million (PPM) monitors, preferred for source locations within the plant, while the remaining four are Parts Per Billion (PPB) monitors, preferred for fence line locations where the concentrations are lower than those at source locations. An example of Acrulog™ H₂S PPM and PPB monitors are shown in Figure 2-1.

These H₂S gas monitors are portable data-loggers, designed to track continuous data for extended periods of time and to withstand the harsh environments typically found within the wastewater industry. These monitors can be attached directly to the fence or structure with zip ties or other forms of connection. The collected data is easily downloadable via Bluetooth wireless technology. HDR, in collaboration with County staff, will install the data logging monitors. Additionally, HDR will be responsible for the weekly tasks of data collection and battery replacement.

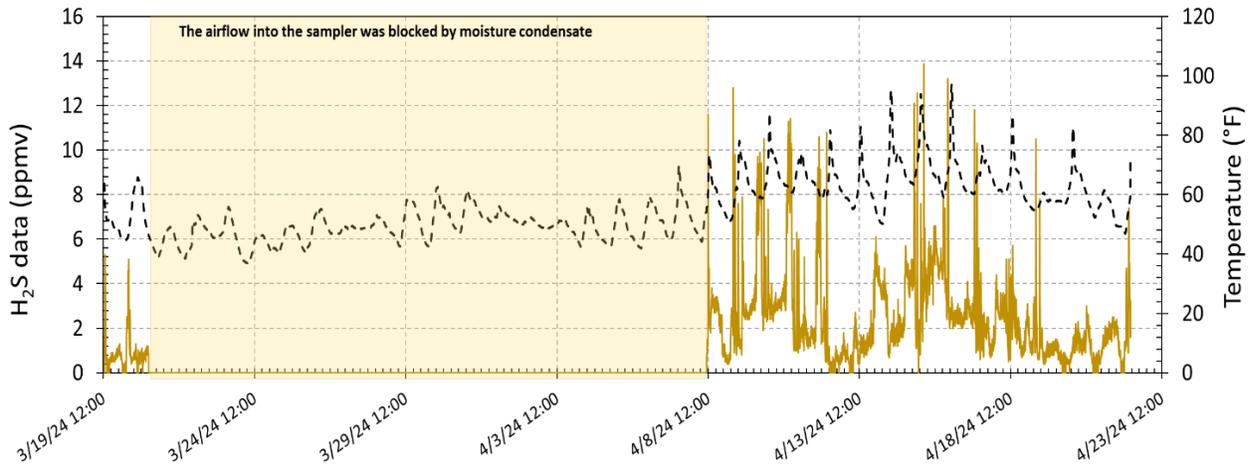
Figure 3-2 Results of Continuous Monitoring at Influent Pump Station (3/19/2024-4/22/2024)

Subsequently, it was discovered that moisture in the sampled air had condensed in the sampling tube, obstructing airflow into the logger. Therefore, the zero results from these two weeks do not indicate the absence of H₂S in the sampled air, but rather a sampling error. The sampling error will be mitigated in the next round of sampling by frequently inspecting and clearing the sampling tube of any condensation.

In comparison, both the frequency and magnitude of measurable H₂S levels were higher during the weeks of 4/8 – 4/22. With two weeks of data missing, it is difficult to pinpoint a single cause that could have resulted in this observation. However, a probable cause could be the increase in temperature during these last two weeks. Higher ambient and wastewater temperatures could lead to higher measured concentrations of H₂S. The time-averaged temperatures, recorded by the logger are presented in Table 3-2. The spikes in H₂S concentration do not exhibit a diurnal pattern that correlates with the influent flow patterns.

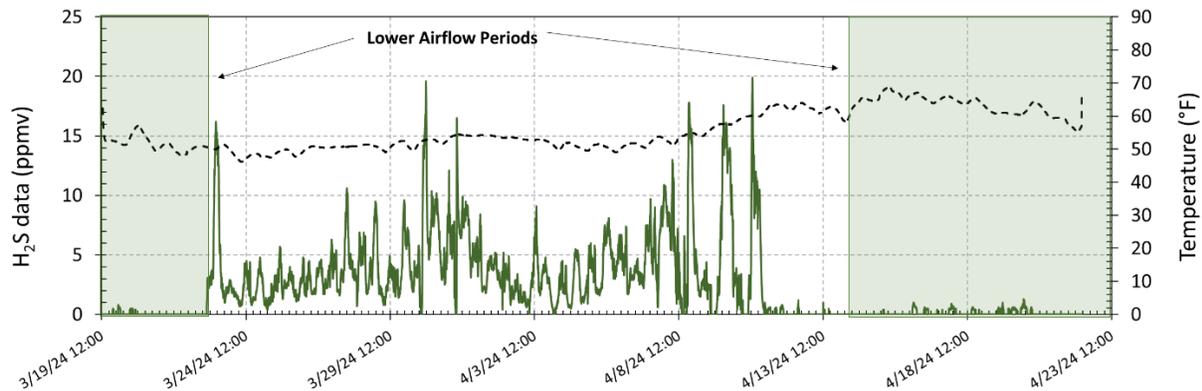
Figure 3-3 Results of Continuous Monitoring at Screen and Grit Building (3/19/2024-4/22/2024)

The space within the screen and grit building is ventilated through an inactive chemical odor scrubber. The monitoring setup involved tapping a sampling tube into a pressurized location downstream of the fan. The H₂S concentrations and ambient air temperature measured for the five-week period, spanning from March 19 to April 22, are shown in Figure 3-3. During the first monitoring week, it was observed that the airflow rate to the logger was relatively low, necessitating a direct sampler plug and tube connection to the sampling port of the logger, which was implemented from the second week onward. Consequently, the measurable H₂S concentrations

were appreciably lower during the week of 3/19 – 3/22 compared to other weeks. Additionally, during the week of 4/15 – 4/22, it was noted that the sampler plug had detached from the logger, causing the logger to measure the low-flow-rate air entering the bucket, resulting in lower magnitude H₂S levels.

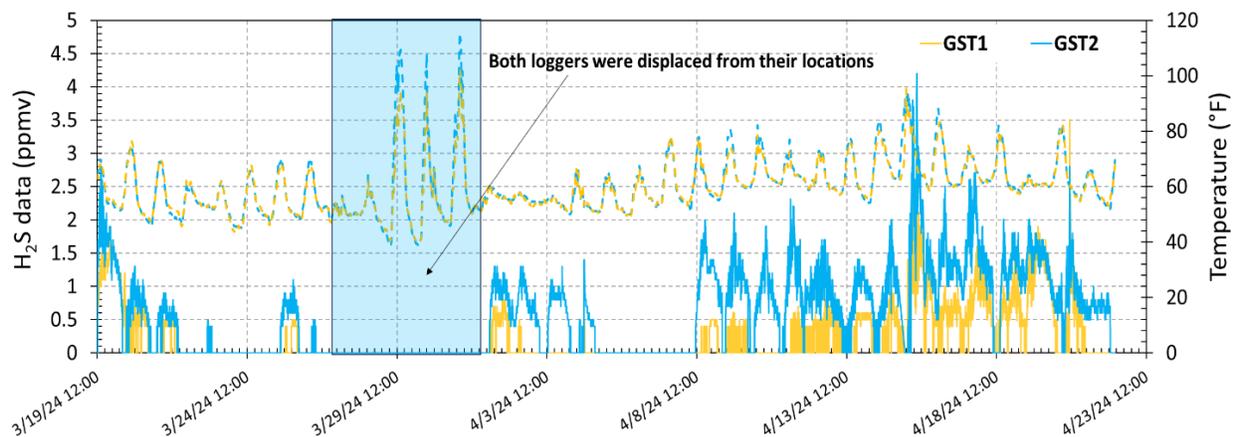
Figure 3-5 Results of Continuous Monitoring at Gravity Sludge Thickeners (3/19/2024-4/22/2024).

During this monitoring period, two H₂S PPM monitors were installed beneath the covers of gravity sludge thickeners (GSTs). The H₂S concentrations and ambient air temperature measured for the five-week period, spanning from March 19 to April 22, are shown in Figure 3-5. The presented data shows the continuous generation of H₂S in the GSTs (except for the weeks of 3/22 – 4/1 and 4/1 – 4/8), with detected levels comparable at both locations except for the last two weeks. During data collection on 4/1, it was noticed that both loggers, GST1 and GST2, were displaced from their locations (cause unknown), which explains the missing data observed in Figure 3-5.

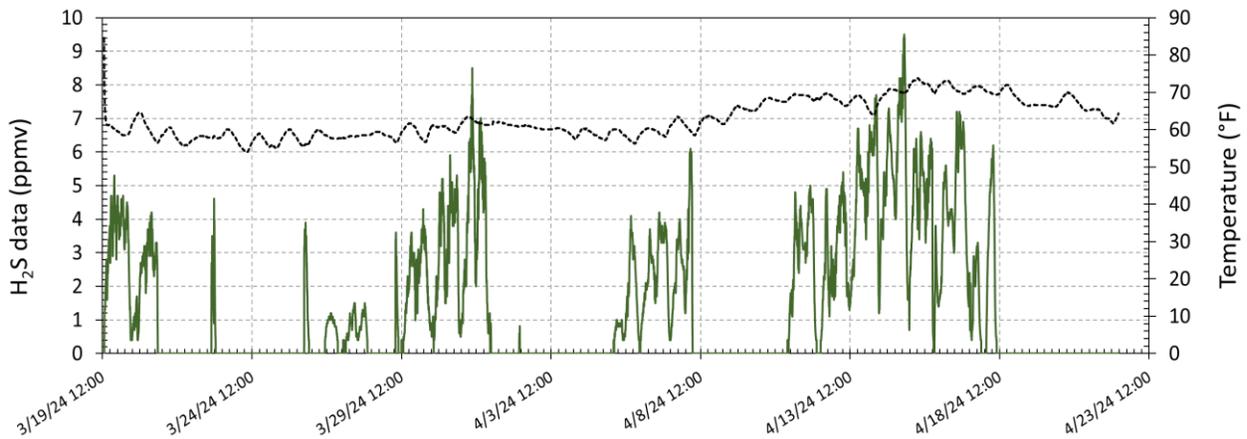
Figure 3-6 Results of Continuous Monitoring at Odor Control Blowers (3/19/2024-4/22/2024).

Air supply for the existing aeration blowers currently is provided by the odorous air ventilated from the primary clarifiers and GSTs. A PPM logger was employed to tap into the pressurized location downstream of the fan to collect H₂S sample measurements. The H₂S concentrations and ambient air temperature measured for the five-week period, spanning from March 19 to April 22, are shown in Figure 3-6. The recorded H₂S levels were not continuous, and periodic peaks were observed. No clear trend can be discerned between the temperature and the H₂S concentration or among the sampled weeks.

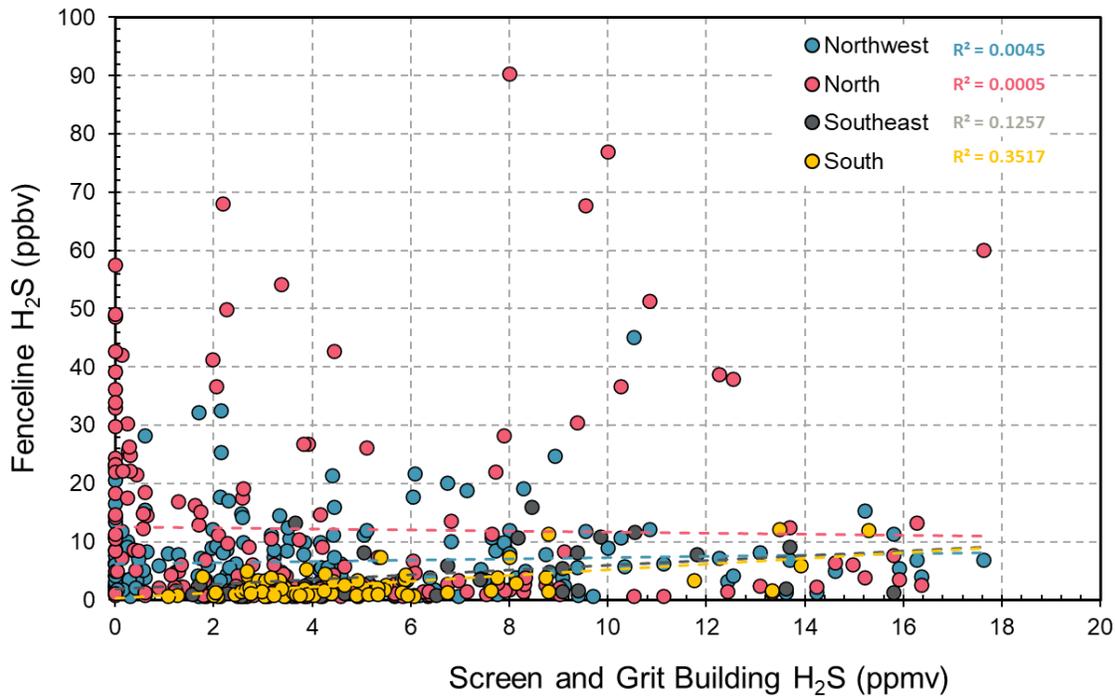
Figure 3-10 Hourly Time-Averaged Concentrations: Fenceline Data Plotted against Screen and Grit Building Air Data

Time-averaged hourly concentrations for the fenceline monitors were plotted against time-averaged hourly concentrations for the grit and screen building to see if there was a correlation between odorous emissions at the grit and screen building and observed H₂S concentrations at the fenceline. This correlation plot is shown in Figure 3-10 below. The south and southeast monitors showed the strongest correlation, while the north and northeast monitors showed weak correlation.

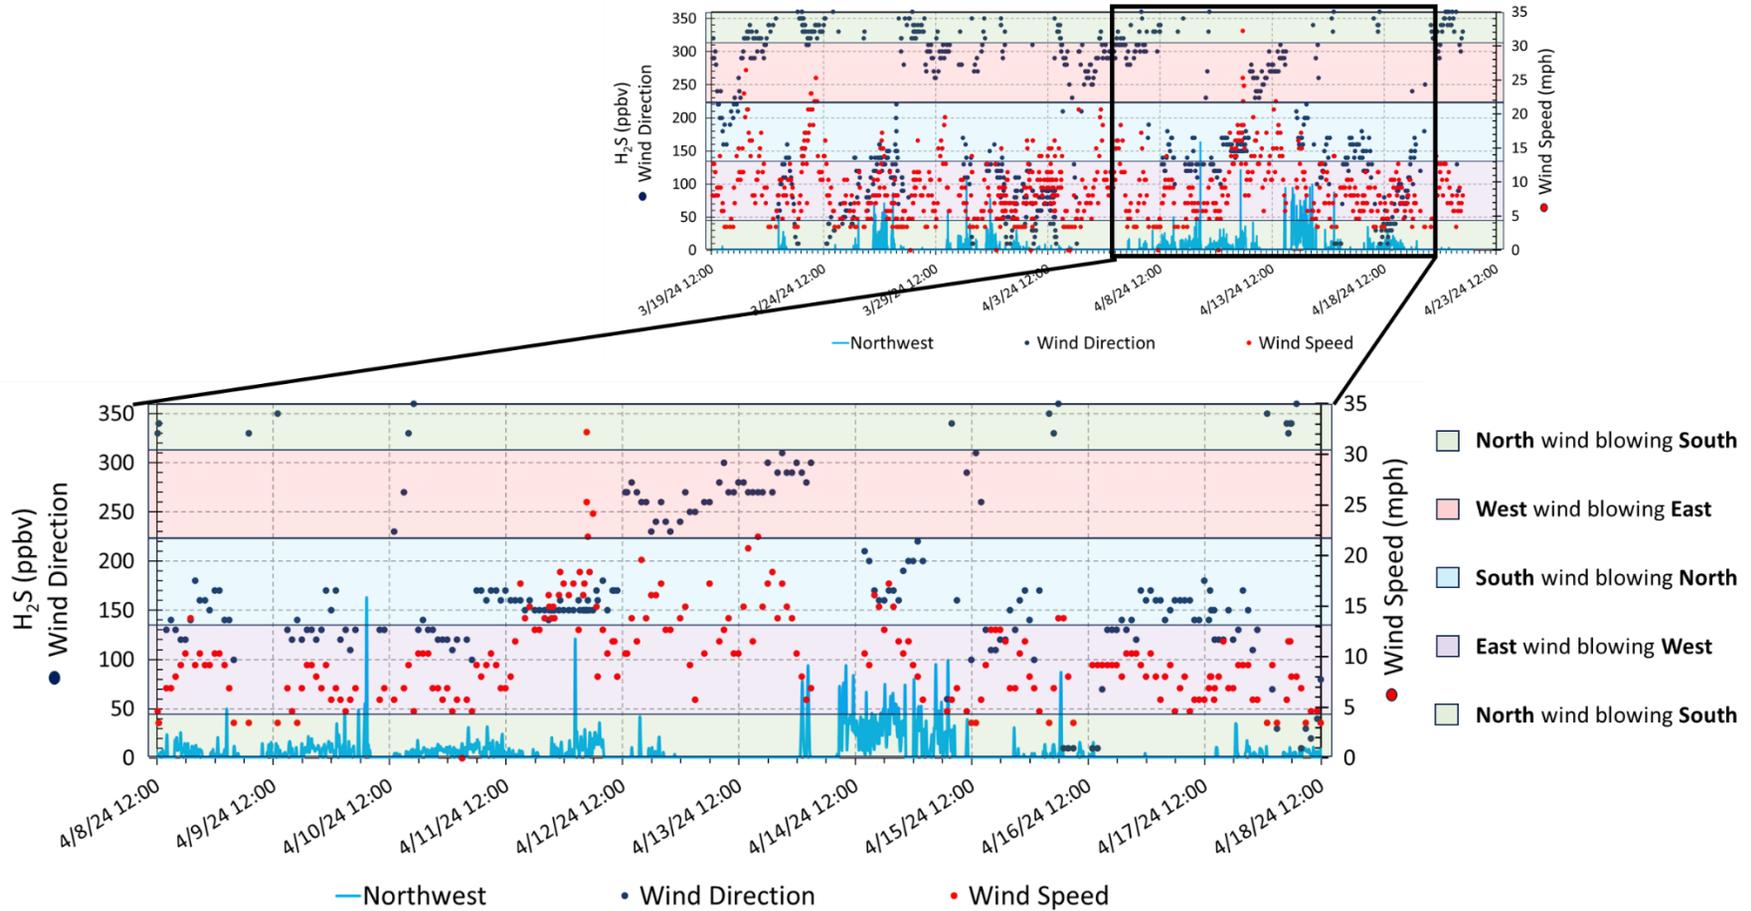
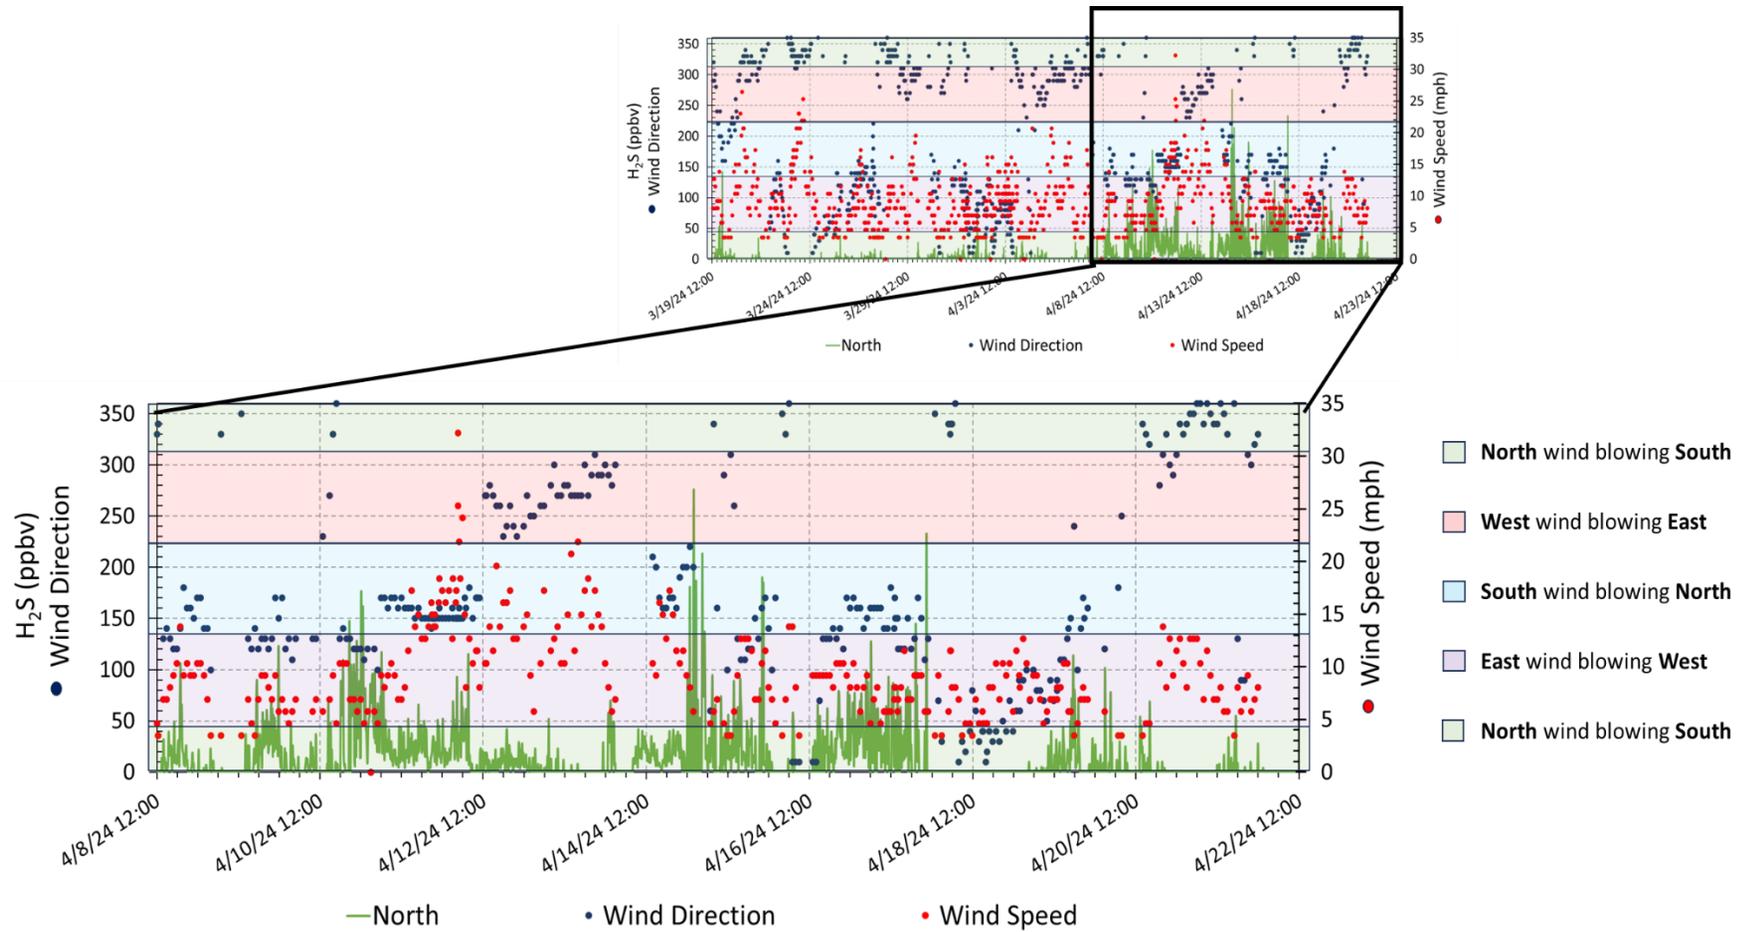
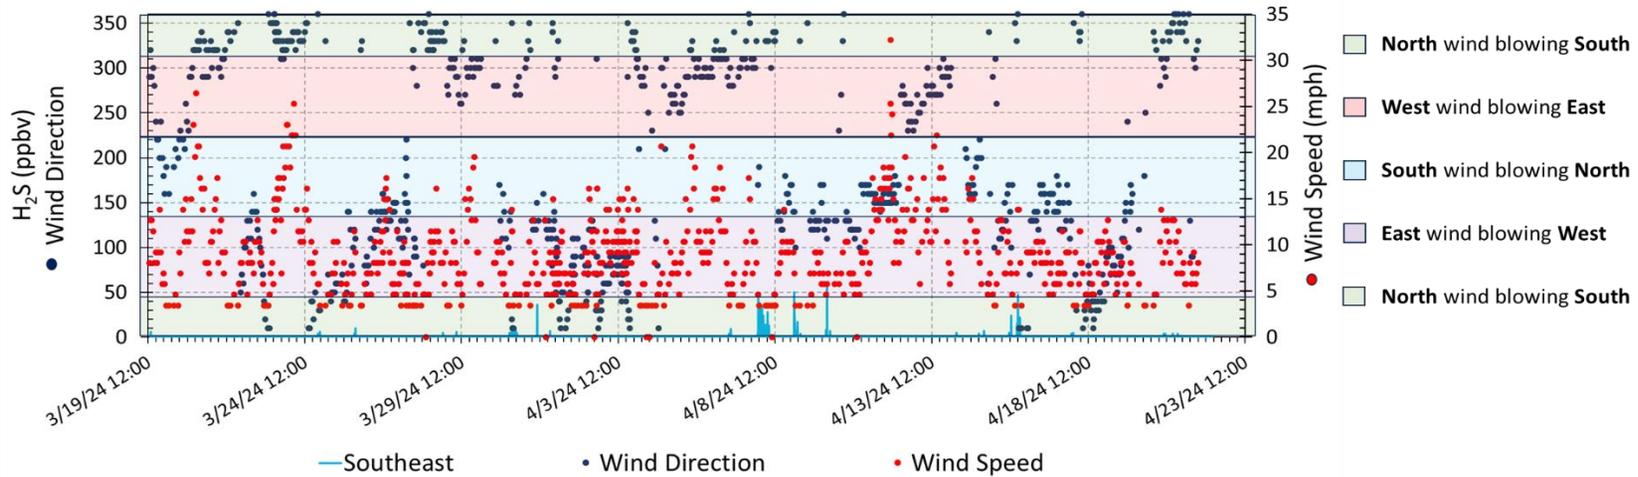
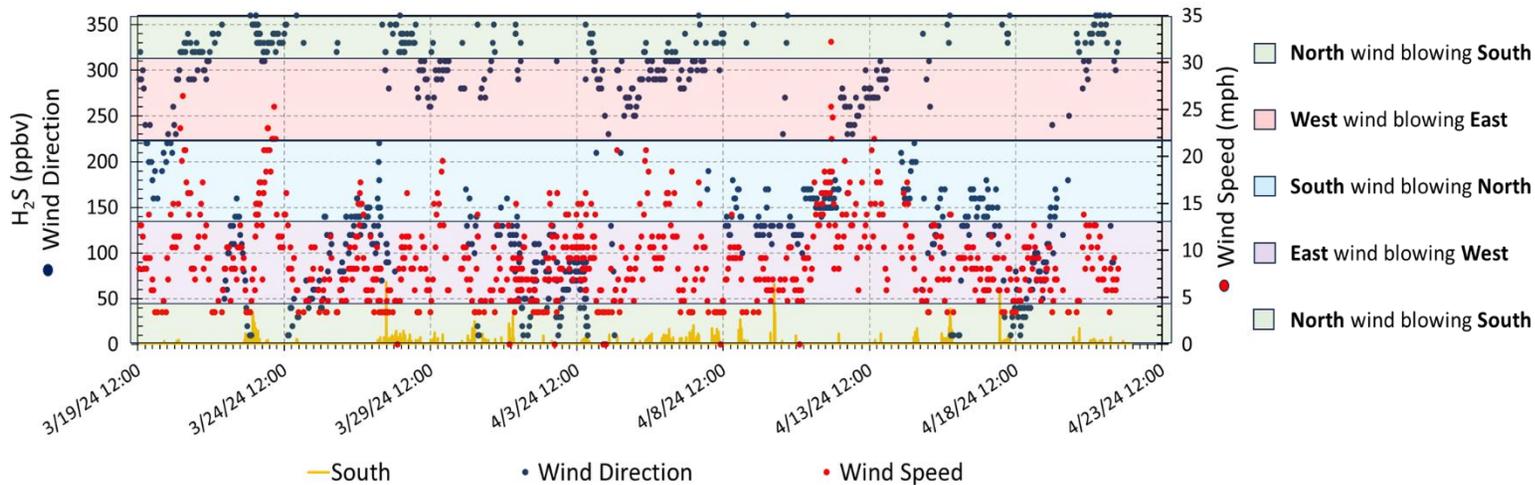
The wind speed and wind direction data were collected from the United States Naval Academy Weather Station in Annapolis for the H₂S sampling duration from March 19 to April 22. These data were plotted alongside the H₂S monitoring data to identify which sources within the WRF are generating odors that are carried by the prevailing wind and affecting neighboring communities. The H₂S data overlaid with the wind data for Northwest and North fenceline locations, with high-magnitude regions highlighted to understand the influence of local meteorological conditions on the odor issue, is shown in Figure 3-13 and Figure 3-14. The Southeast and South fenceline data with the wind data are presented in Figure 3-15 and Figure 3-16. During the sampling event, the wind speed ranged between 5-20 mph, and most of the time, the wind was blowing from north to south or east to west of the WRF. However, a clear correlation cannot be drawn between the wind data and the fenceline detections or the odor complaints. Wind data and source odor emission impacts on fenceline concentrations will be evaluated further with air dispersion modeling to understand the correlation between these factors in the next phase of the project.

Figure 3-13 Wind Direction and Speed Data for the Days the Odor Data Was Collected, along with the H₂S Data from the Northwest Fenceline Monitor.

Figure 3-14 Wind Direction and Speed Data for the Days the Odor Data Was Collected, along with the H₂S Data from the North Fenceline Monitor.

Figure 3-15 Wind Direction and Speed Data for the Days the Odor Data was Collected, along with the H₂S Data from the Southeast Fenceline Monitor.

Figure 3-16 Wind Direction and Speed Data for the Days the Odor Data was Collected, along with the H₂S Data from the South Fenceline Monitor.
