**ANNE ARUNDEL COUNTY  
ILLICIT DISCHARGE DETECTION  
AND ELIMINATION PROGRAM REPORT:  
July 2024 – June 2025 (Fiscal Year 2025)**

Anne Arundel County  
Department of Public Works  
Bureau of Watershed Protection and Restoration  
2662 Riva Road  
Annapolis, MD 21401

KCI Technologies, Inc.  
936 Ridgebrook Road  
Sparks, MD 21152

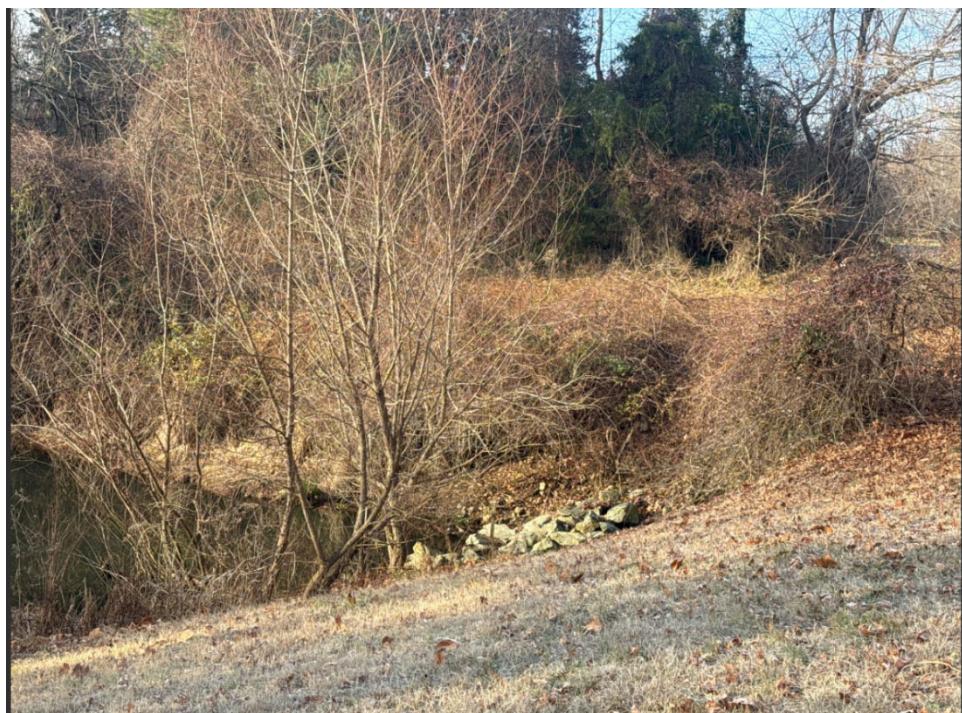
Overview of Outfall O22E8000001

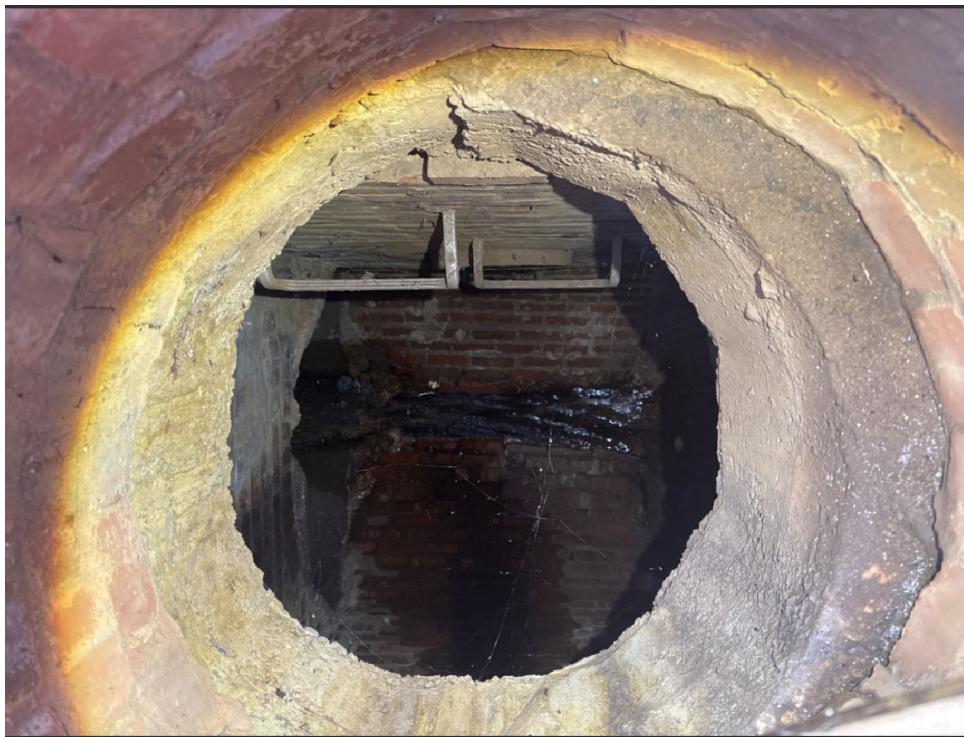
Interior of first upstream structure

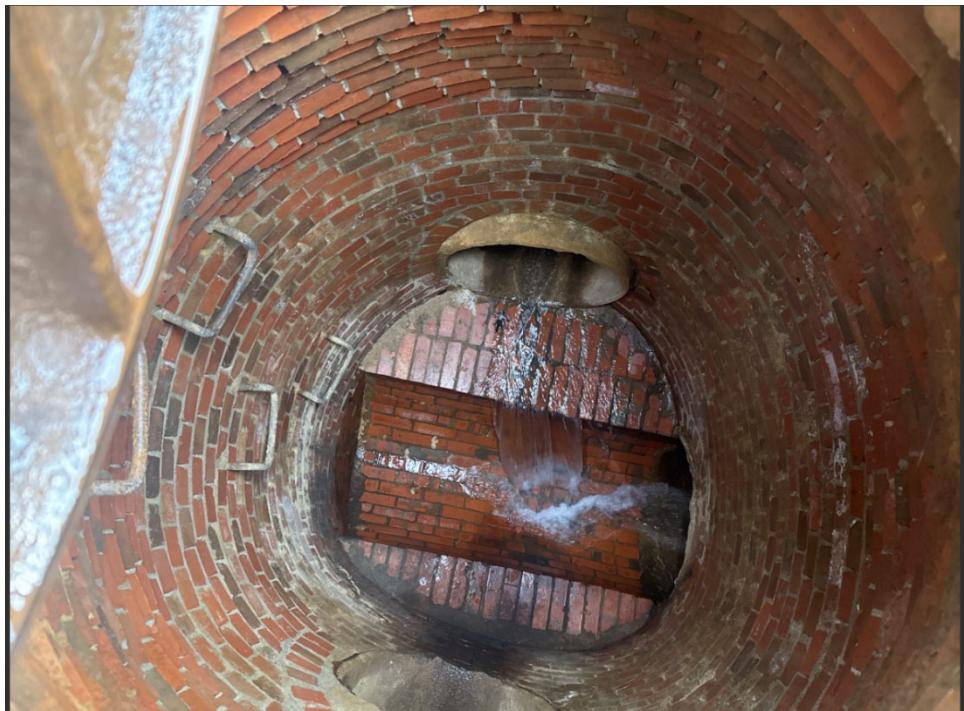
Interior of sixth upstream structure

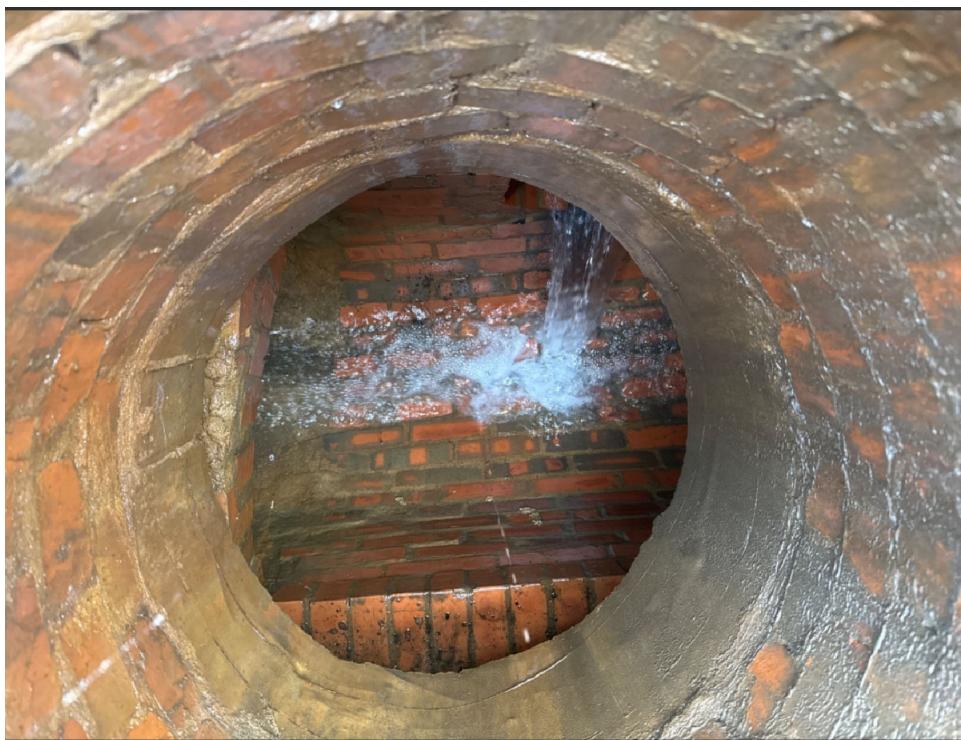
On January 3, 2025, while performing IDDE outfall inspections for Anne Arundel County, KCI Technologies, Inc. discovered a potential illicit discharge with high chlorine results discharging from Outfall O22E8O00001. The outfall was inspected and tested from the first upstream structure due to the outfall location being in a locked BMP. There was steady flow out of the upstream structures to the outfall. An IDDE test was conducted. Chlorine (1.0 mg/L) was found to be above the screening thresholds. A small amount of ammonia (0.14mg/L) and fluoride (0.29mg/L) were detected along with a strong chlorine odor. The discharge was traced upstream to a manhole along Westbury Drive. The inlet connected to the manhole was dry, but running water could be heard. It is believed that the water is discharging from a point in the pipe connection between the manhole and inlet. All the other upstream structures were dry.

A reinspection of this outfall was performed four hours later. The flow remained the same with no change in chlorine (1.0mg/L) and only minor fluctuations in ammonia (0.18mg/L) and fluoride (0.24mg/L). The source of the discharge is believed to be a water line break leaking into the storm drain. Recent pavement work could be seen near the manhole and the inlet that may have contributed to the leak. The Utilities Emergency Line was called, notifying them of the discharge.

Interior of eighth upstream structure, source of discharge

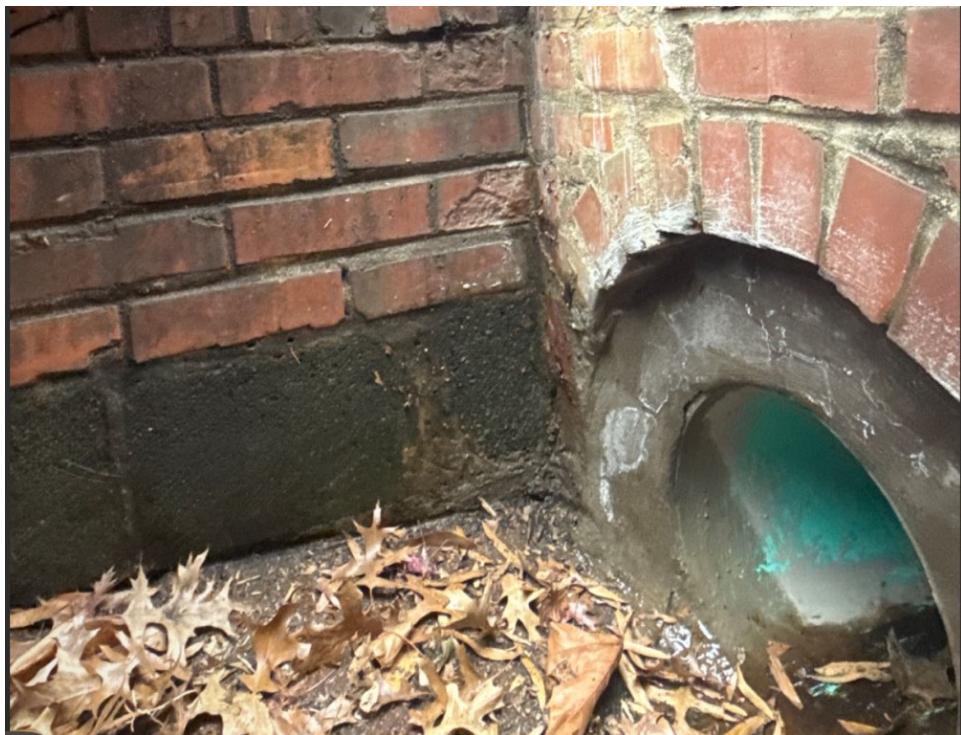
Interior of inlet connected to manhole with discharge source

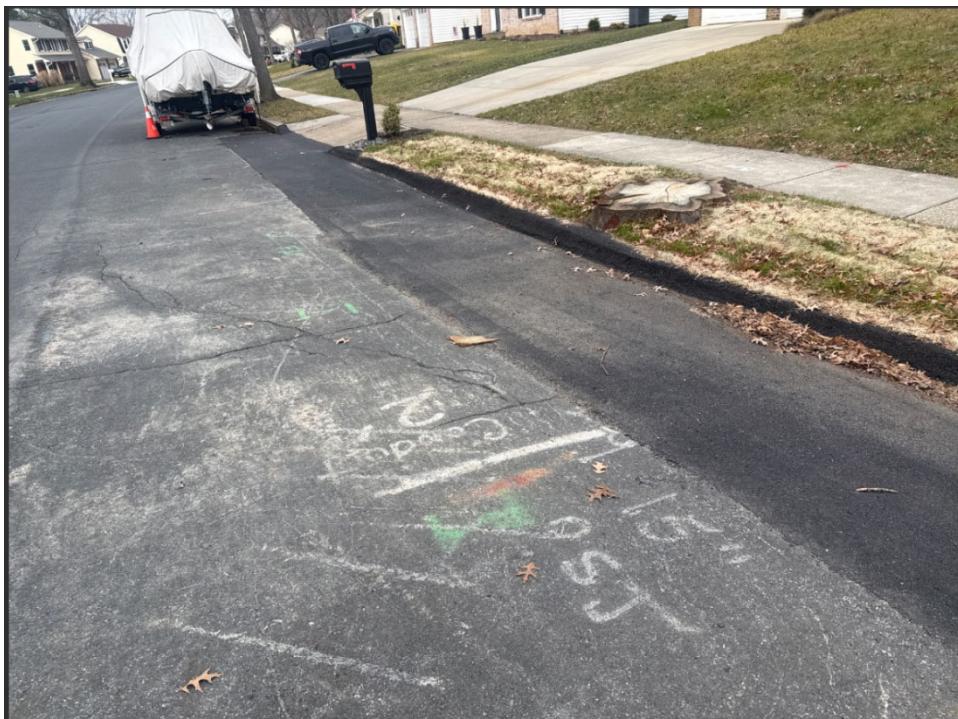
Recent pavement near discharge source

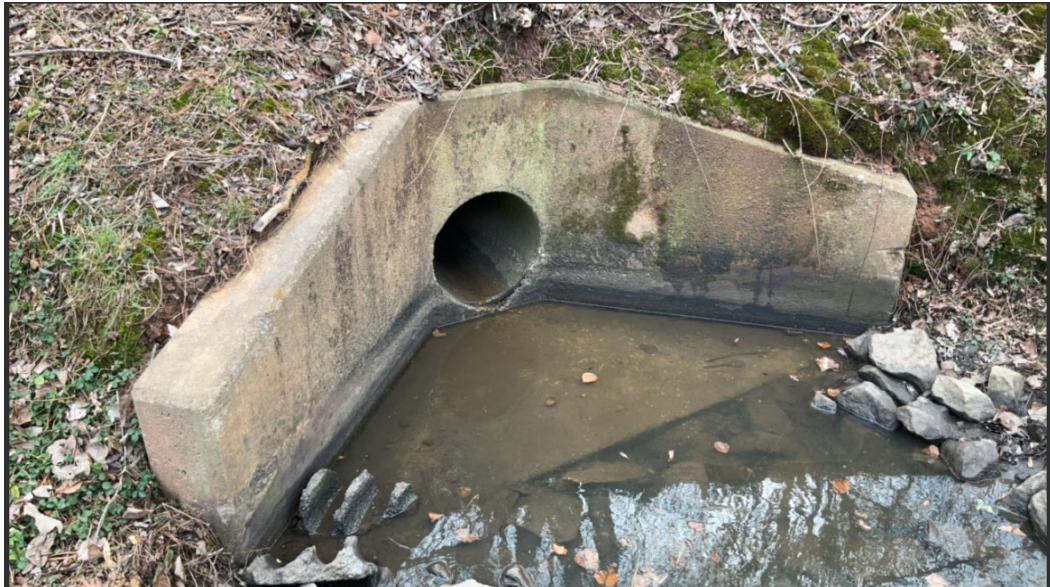
On February 4<sup>th</sup>, 2025, while performing a follow up inspection for previous years' potential illicit discharge areas, KCI Technologies, Inc. discovered flowing water from outfall B11G7000012. After testing the sample, KCI found ammonia to exceed the allowed limit at 1.41 mg/L. A small amount of detergent (0.1mg/L) and fluoride (0.27 mg/L) were also detected but were under the screening thresholds. No odor could be detected from the sample, but a grey sheen was seen on the surface of the pooling water around the outfall.

Outfall B11G7000012 overview.

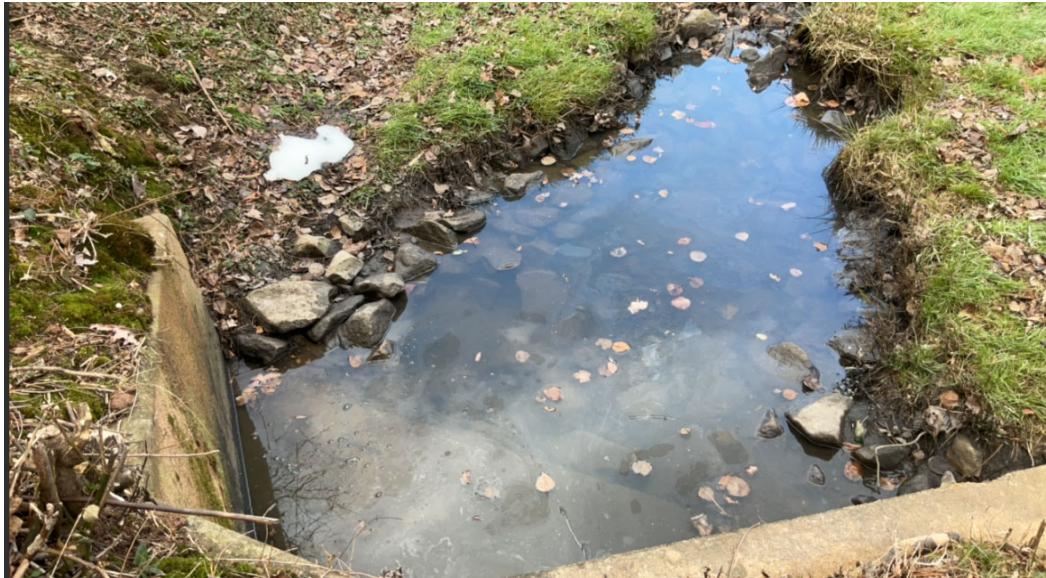
Outfall B11G7000012 downstream.

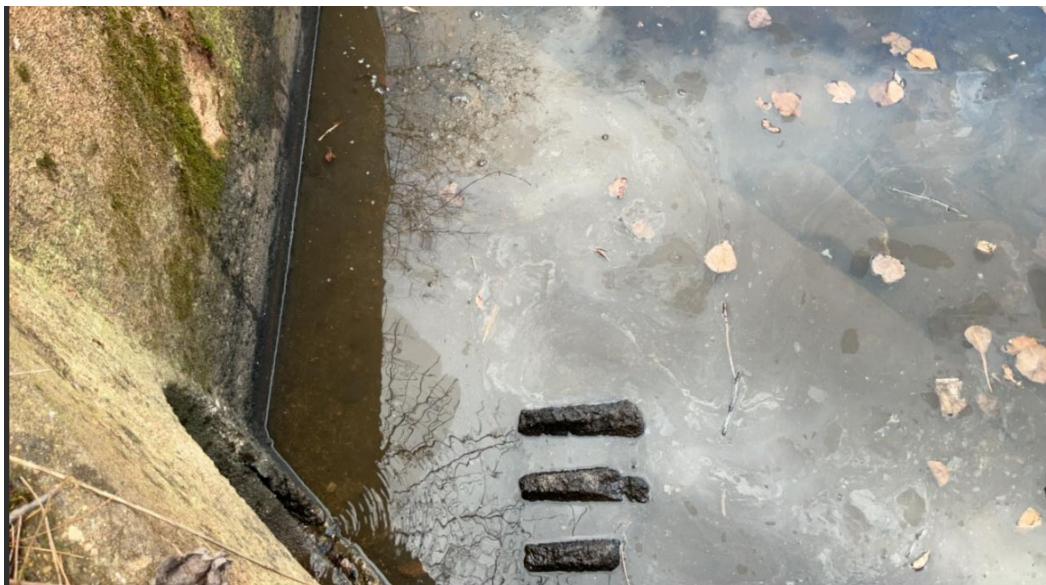
Outfall B11G7000012 pooling water with sheen during 1<sup>st</sup> Test.

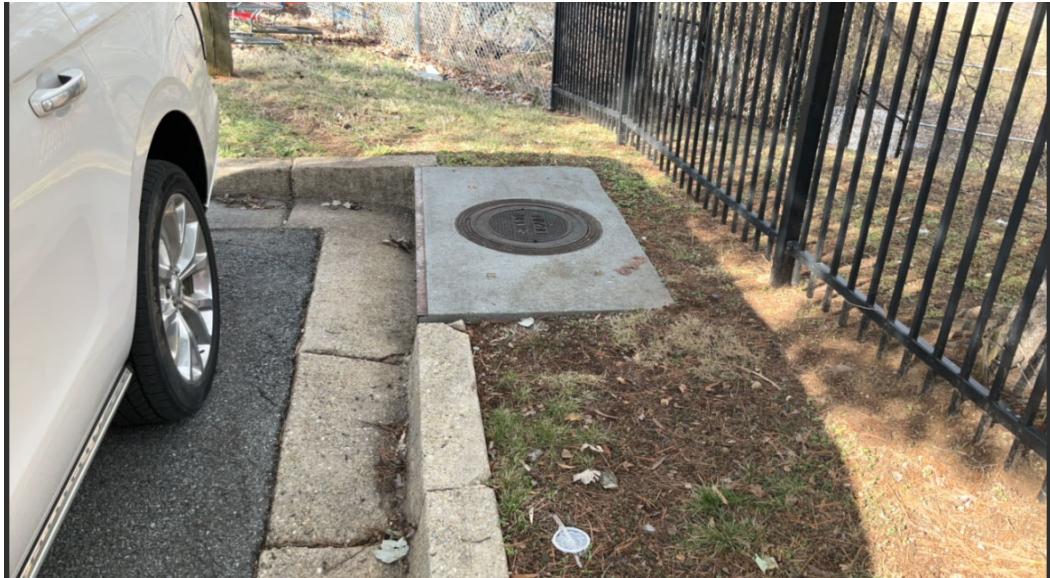
Upstream curb inlet.

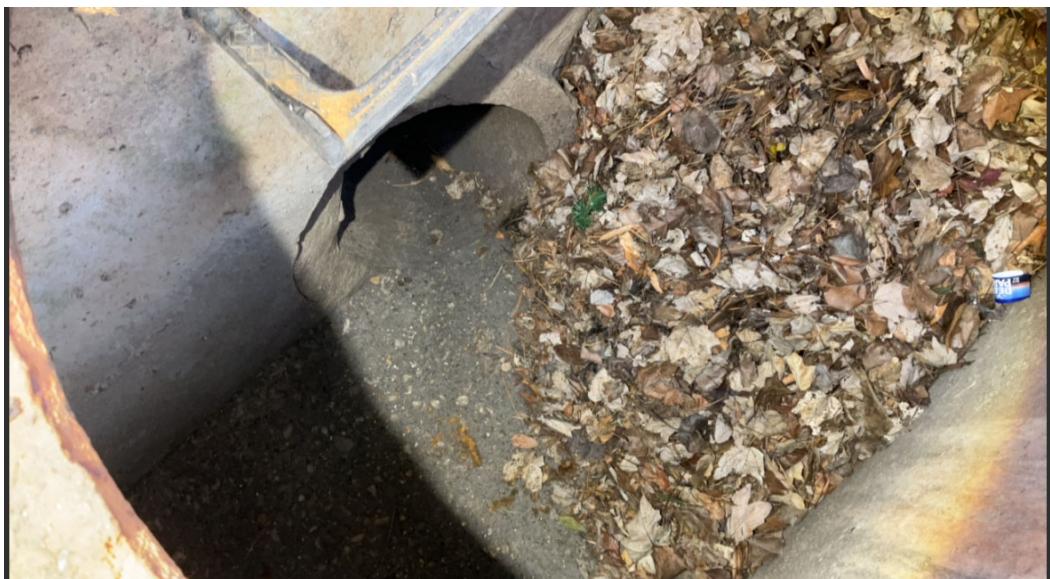
Upstream curb inlet interior.

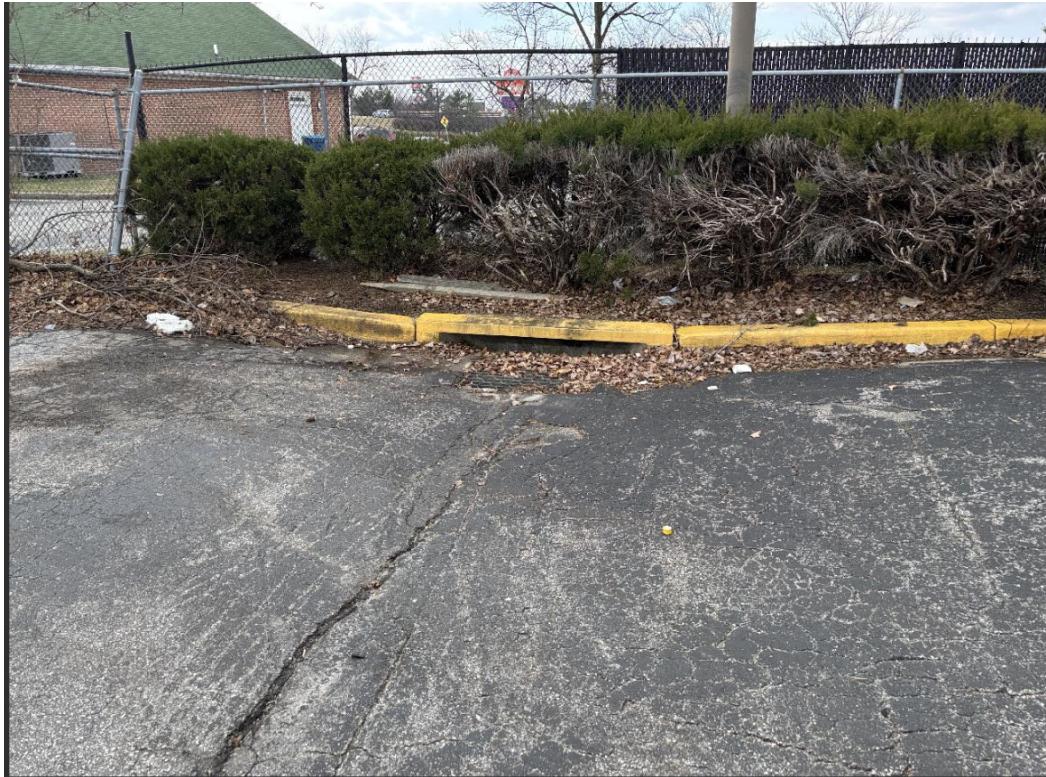
Upstream grate inlet.

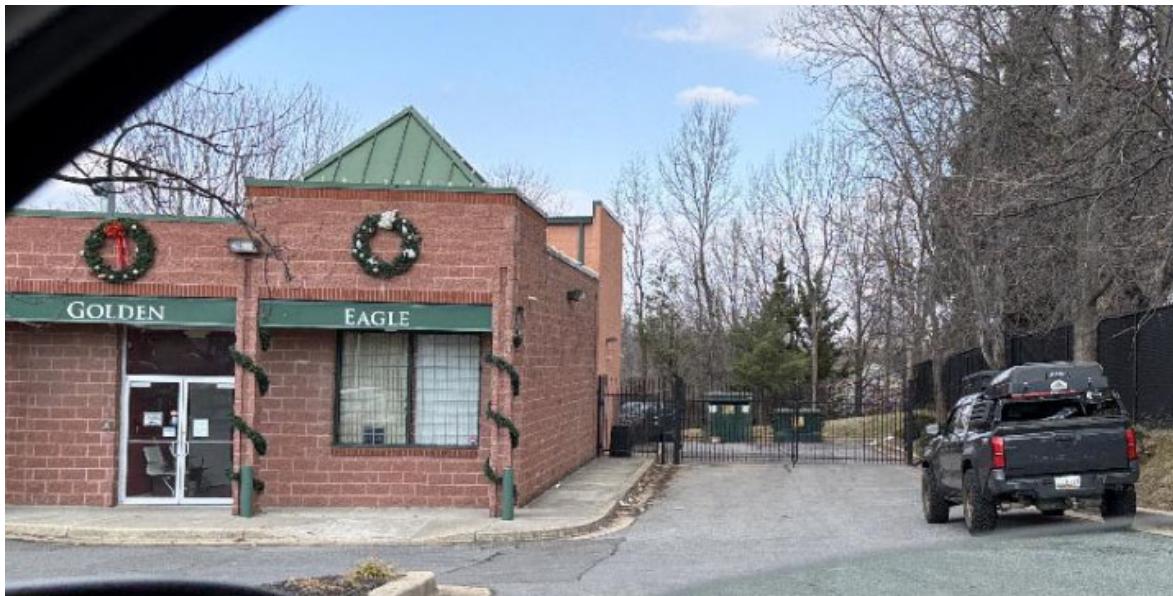
Fencing around upstream structures.

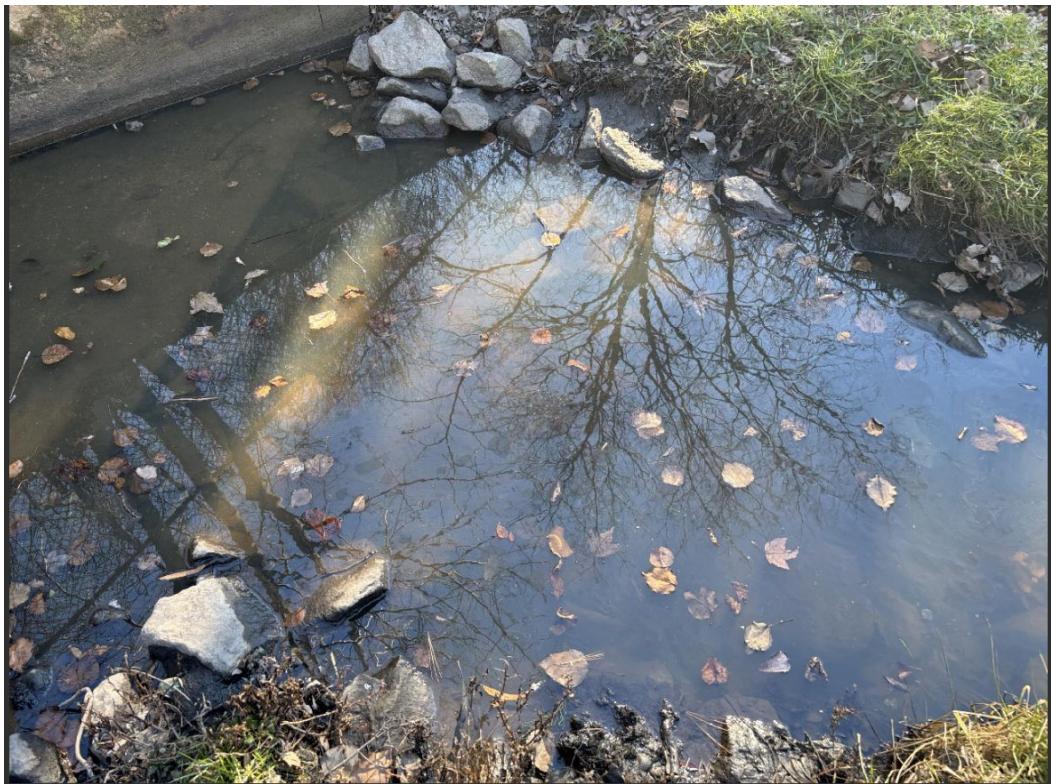
Fencing around upstream structures.

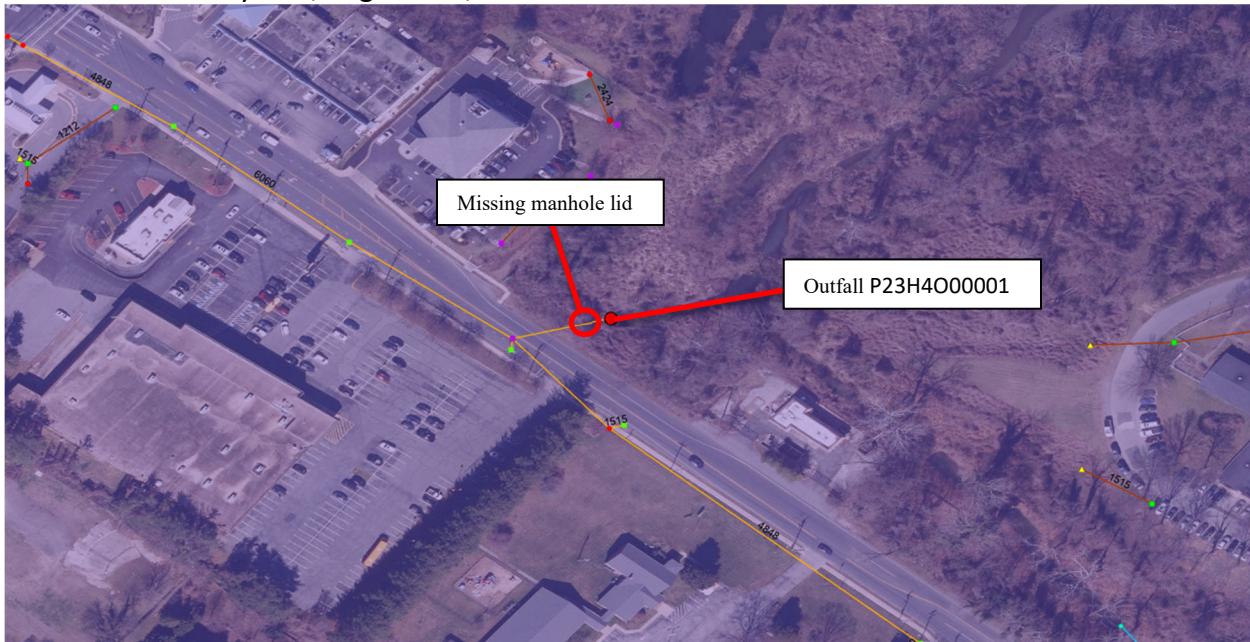
On December 2<sup>nd</sup>, 2024, while performing illicit discharge inspections for Anne Arundel County, KCI Technologies, Inc. discovered a missing manhole lid at an upstream structure of Outfall P23H4O00001. The missing manhole lid is half covered with old wood planks and leaf debris posing a safety issue.

12/2/2024 Inspection- Overview of P23H4O00001.

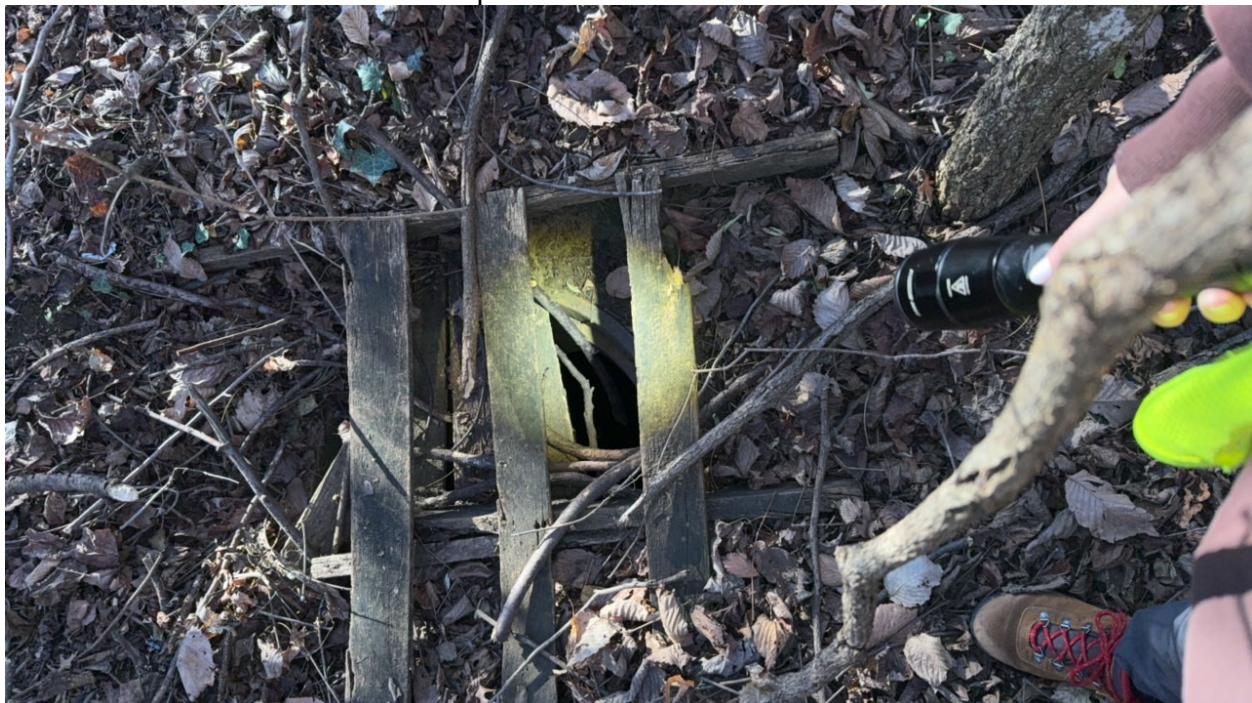
12/2/2024 Inspection- Upstream manhole, missing lid.

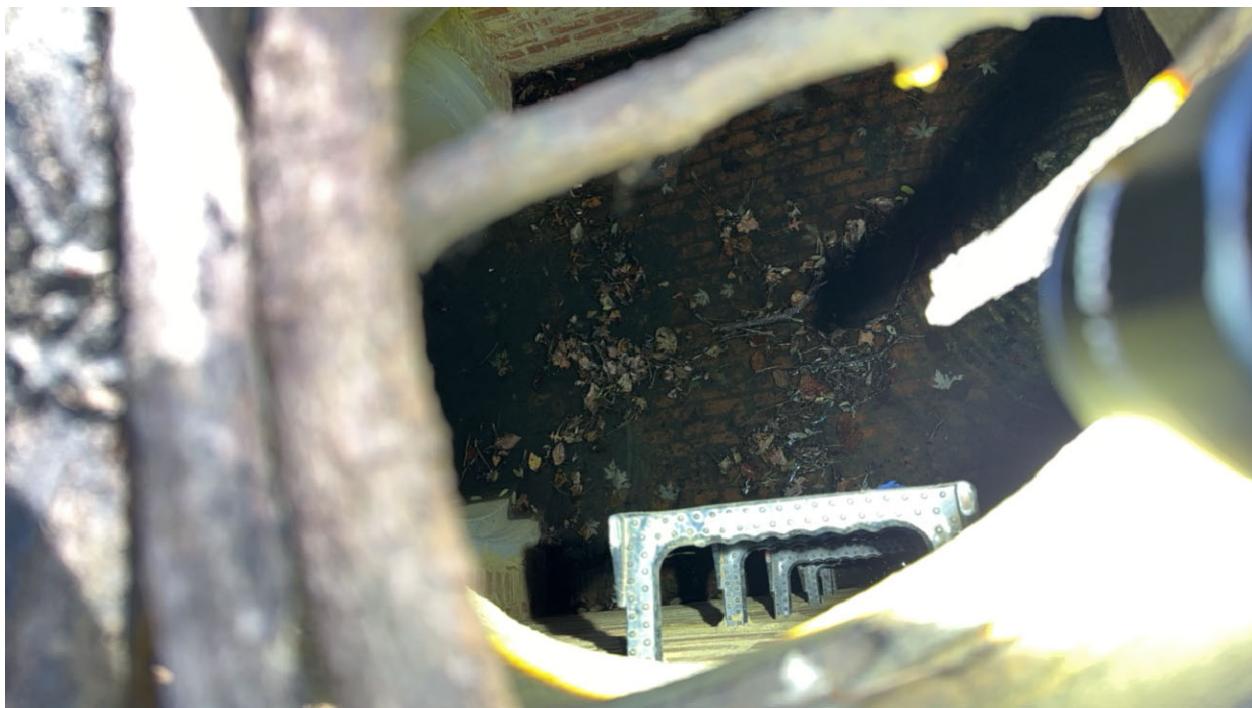
12/2/2024 Inspection- Upstream manhole, interior.

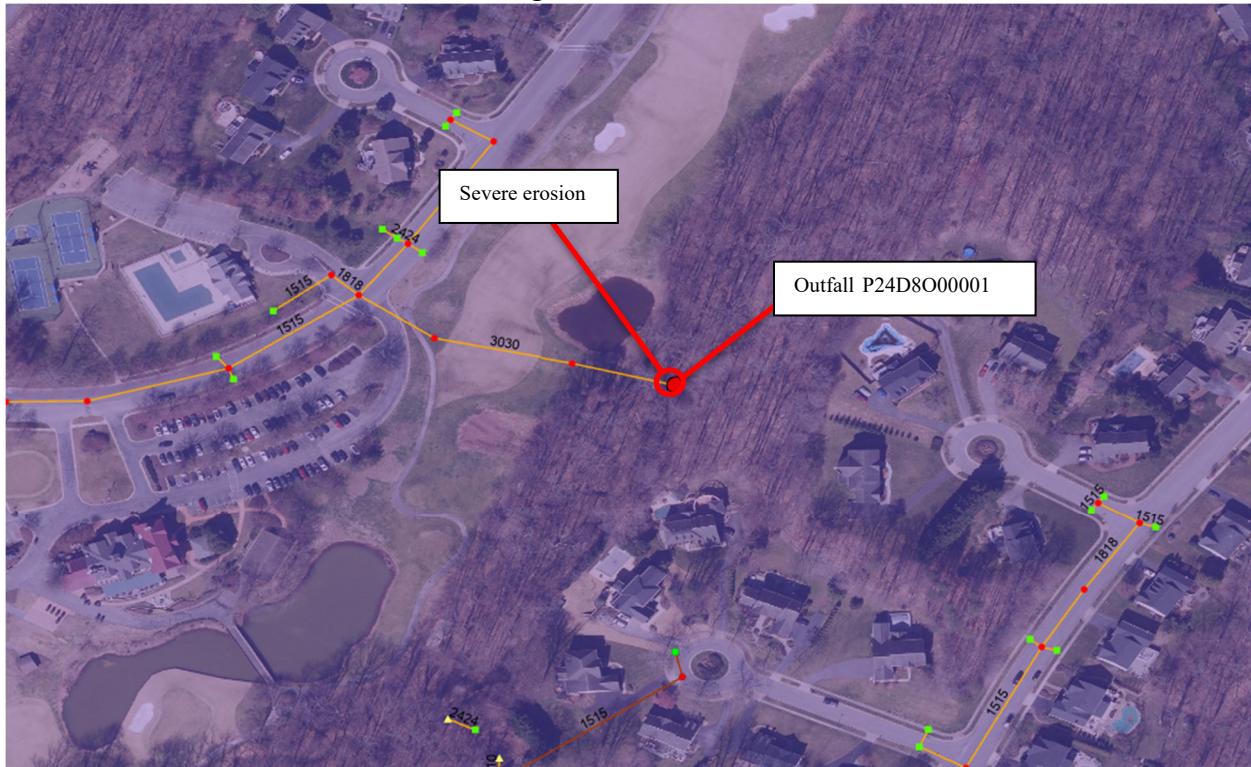
On December 5<sup>th</sup>, 2024, while performing illicit discharge inspections for Anne Arundel County, KCI Technologies, Inc. discovered severe erosion around Outfall P24D8O00001. The embankment erosion occurring downstream of the outfall is causing trees to uproot and deep channels to form. The erosion upstream is causing severe undermining and separation of the outfall structure from the surrounding hillside.

12/5/2024 Inspection- Overview of P24D8000001.

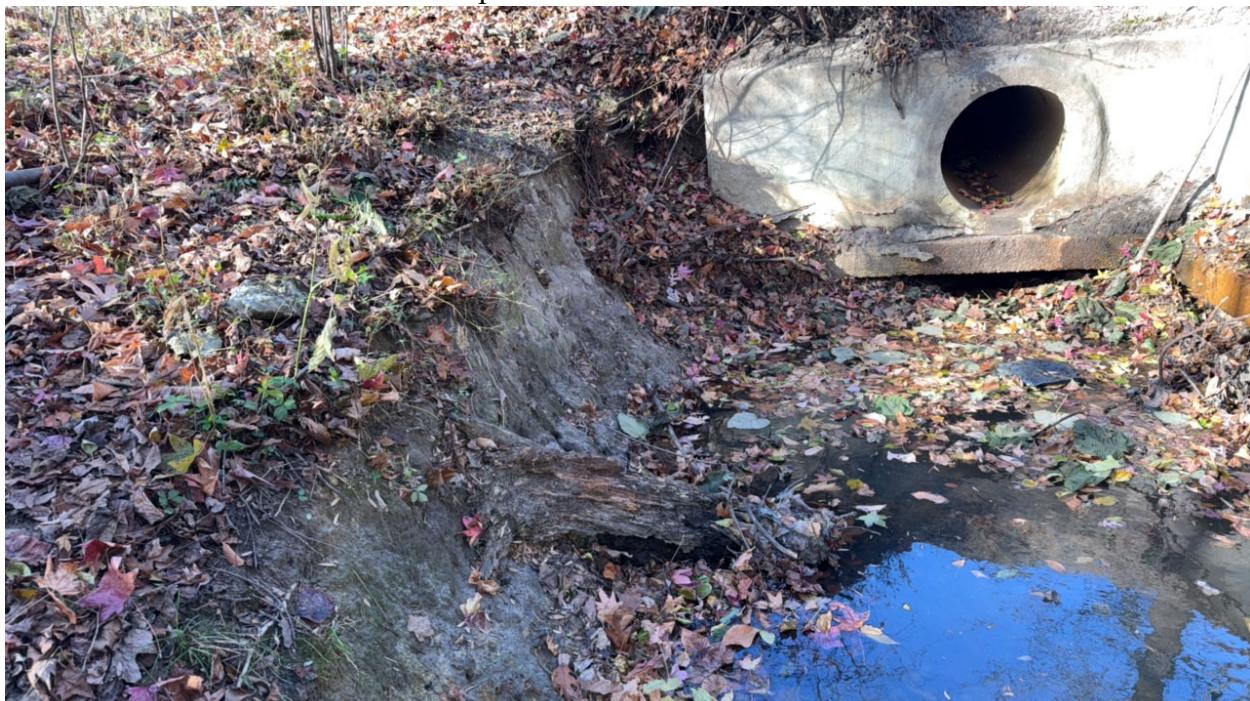
12/5/2024 Inspection- Downstream side slope erosion.

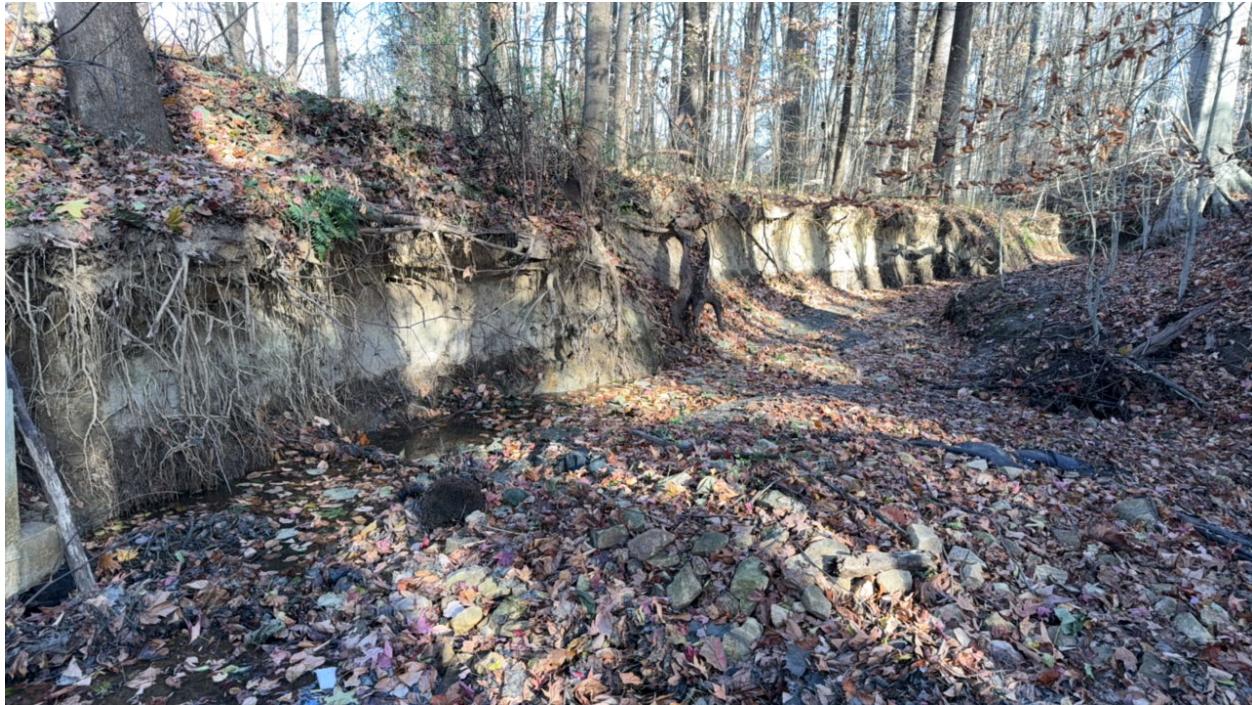
12/5/2024 Inspection- Severe downstream embankment erosion.

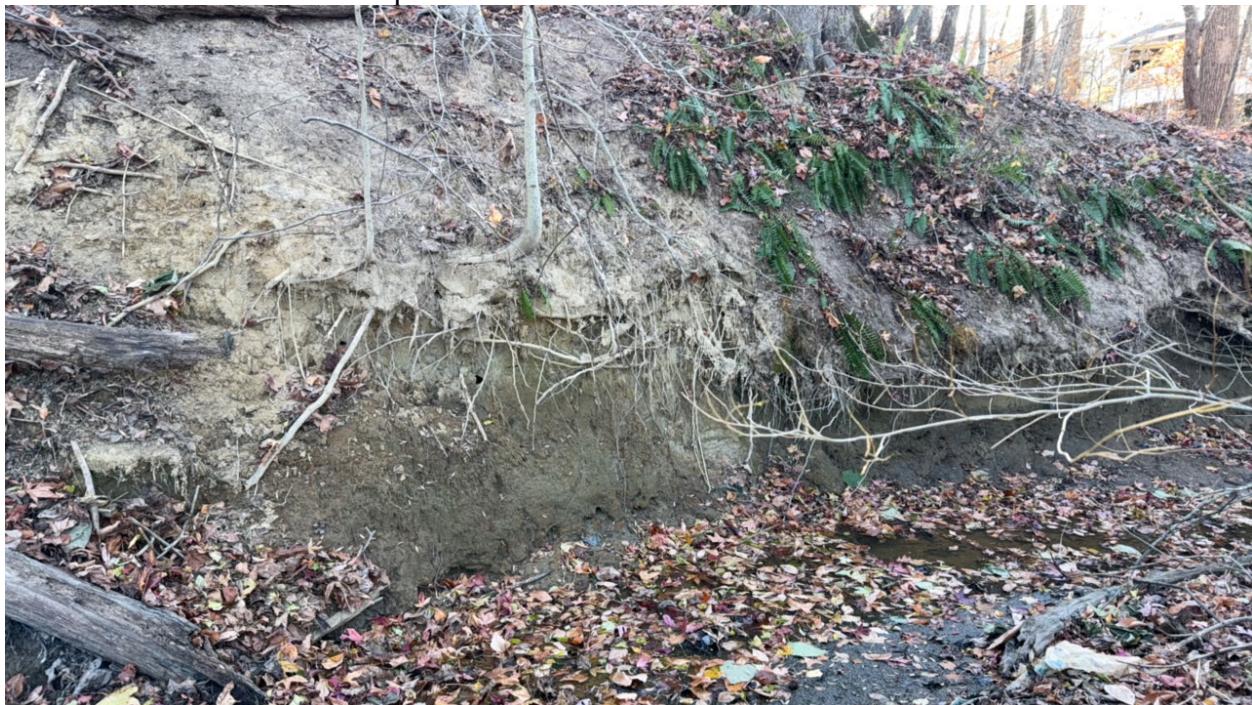
12/5/2024 Inspection- Severe downstream embankment erosion causing uprooting of trees.

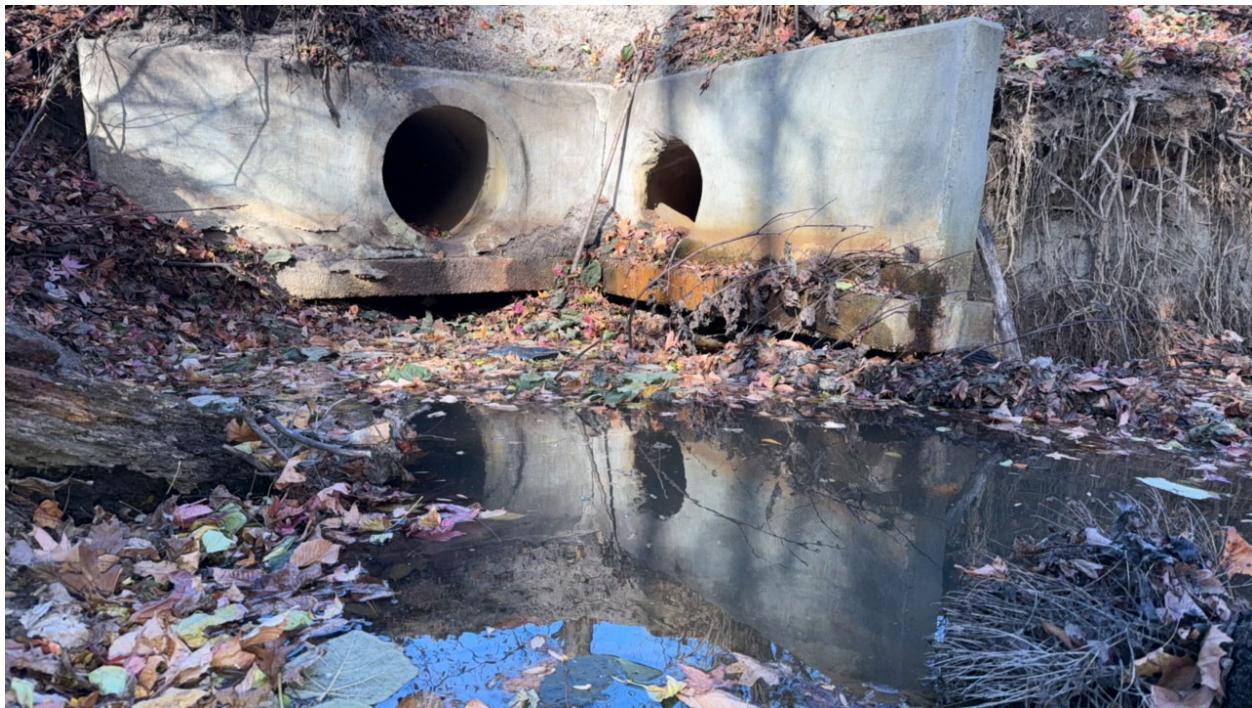
12/5/2024 Inspection- Upstream erosion is causing severe undermining and separation of the outfall structure from the surrounding hillside.

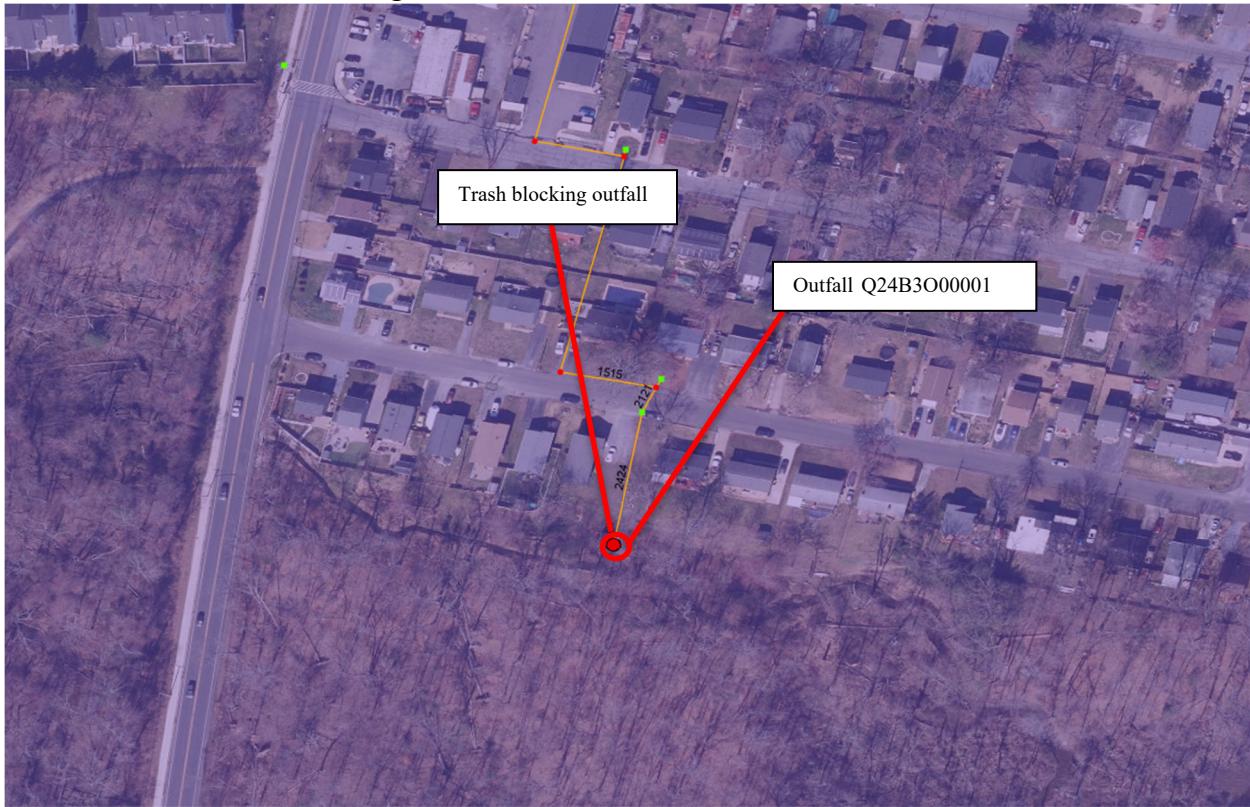
On December 2<sup>nd</sup>, 2024, while performing illicit discharge inspections for Anne Arundel County, KCI Technologies, Inc. discovered a significant amount of trash and debris at Outfall Q24B3O00001. Multiple downed trees and a basketball hoop stand, as well as other trash and debris, are blocking the outfall pipe. The outfall and downstream channel need to be cleared to allow discharge from the pipe to freely flow.

12/2/2024 Inspection- Overview of Q24B3000001.

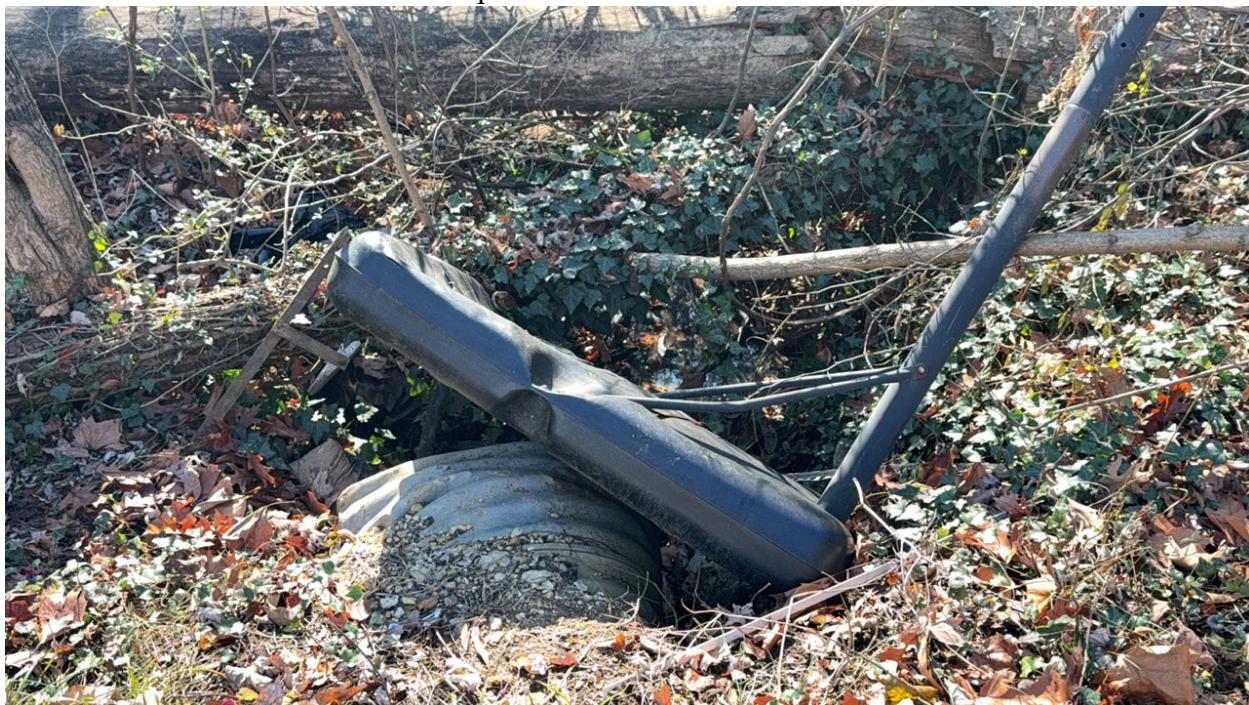
12/2/2024 Inspection- Downstream overview. Basketball hoop and debris blocking outfall channel.

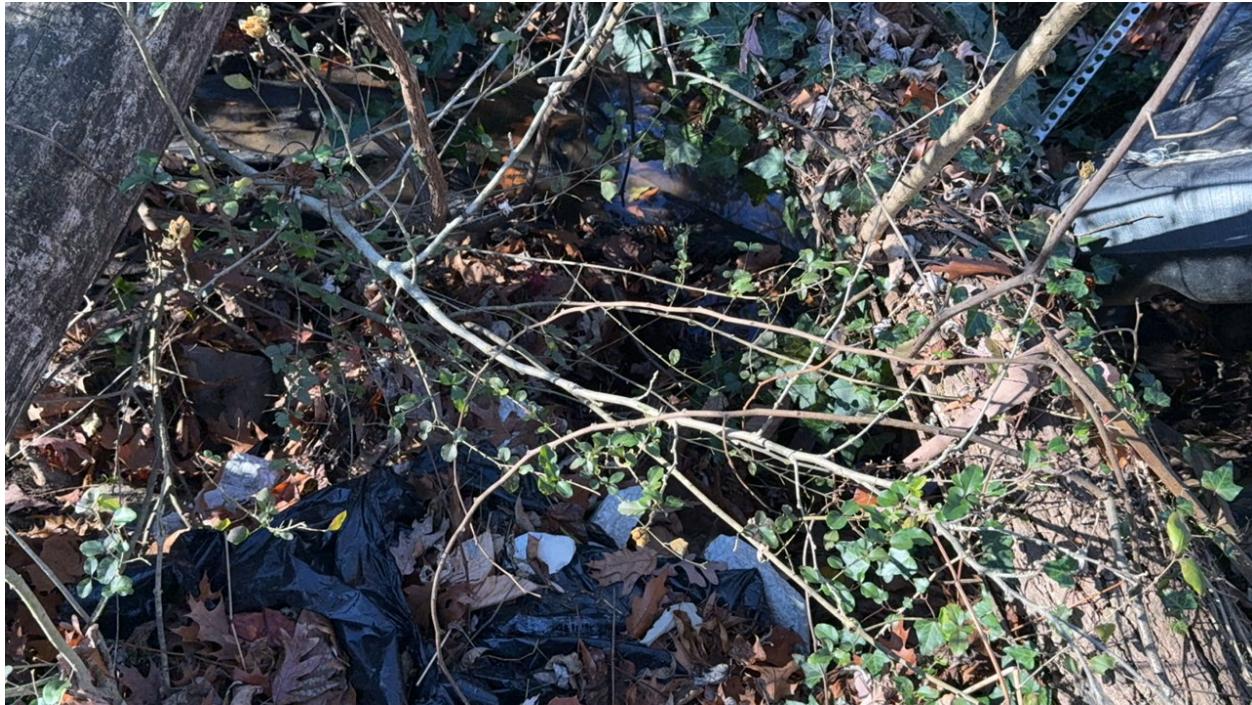
12/2/2024 Inspection- Trash blocking downstream channel.

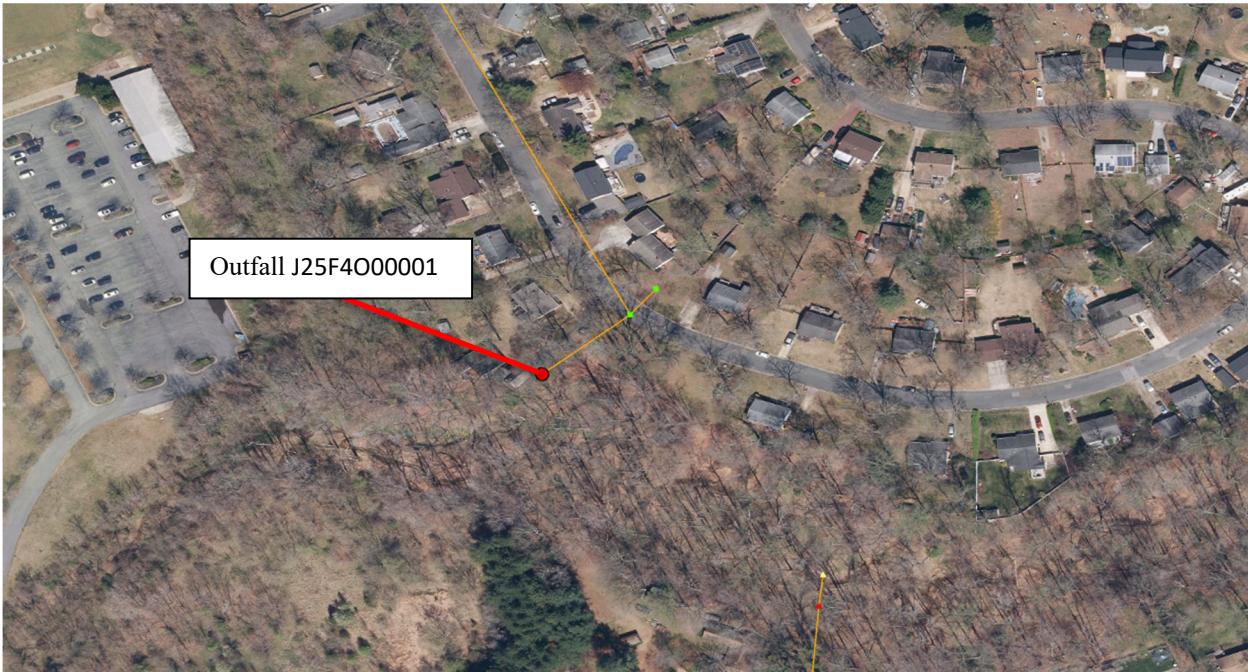
On November 18th, 2024, while performing illicit discharge inspections for Anne Arundel County, KCI Technologies, Inc. discovered moderate downstream erosion and a hole forming above Outfall J25F4O00001 indicating a joint separation is occurring.

11/18/2024 Inspection- Overview of J25F4O00001.

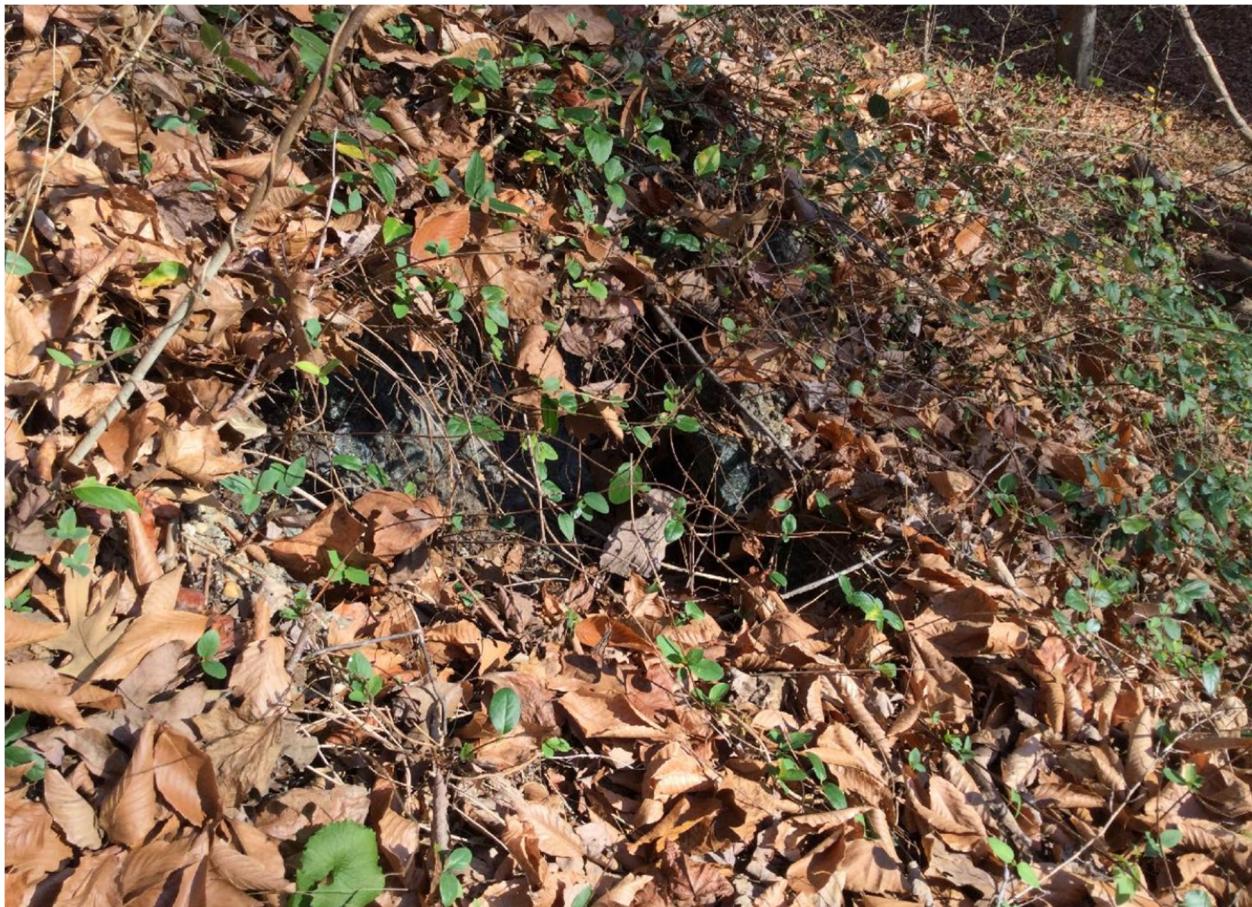
11/18/2024 Inspection- Hole forming on top of pipe.
