**ANNE ARUNDEL COUNTY  
ILLICIT DISCHARGE DETECTION  
AND ELIMINATION PROGRAM REPORT:  
July 2024 – June 2025 (Fiscal Year 2025)**

Anne Arundel County  
Department of Public Works  
Bureau of Watershed Protection and Restoration  
2662 Riva Road  
Annapolis, MD 21401

KCI Technologies, Inc.  
936 Ridgebrook Road  
Sparks, MD 21152

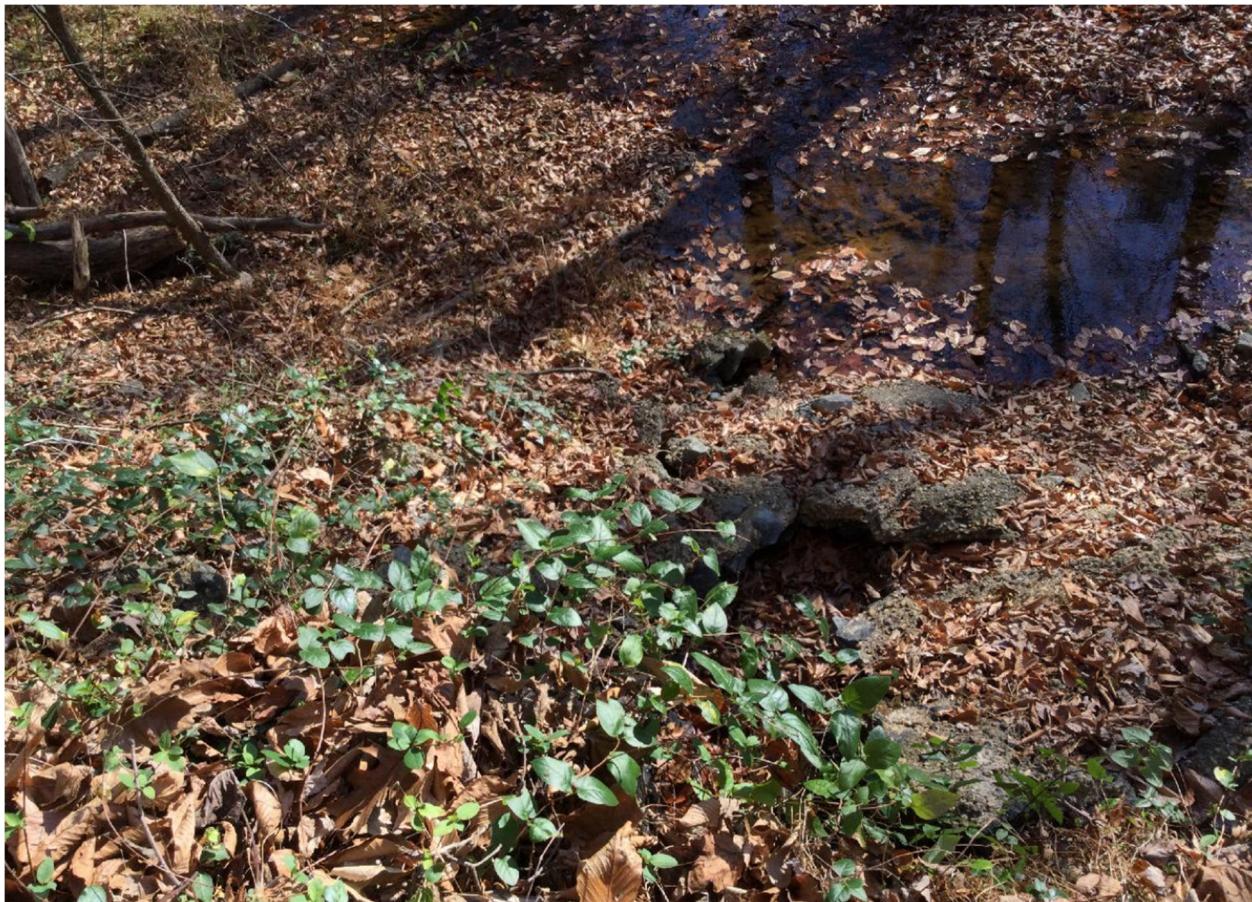
11/18/2024 Inspection- Severe erosion downstream of Outfall J25F4O0000.

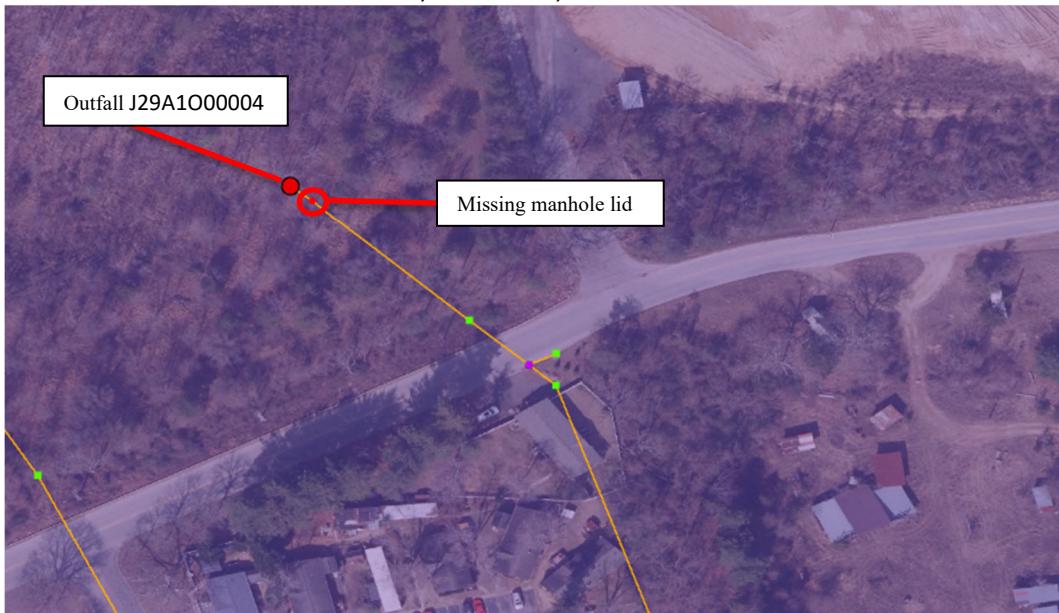
11/18/2024 Inspection- Overview of J29A1O00004.

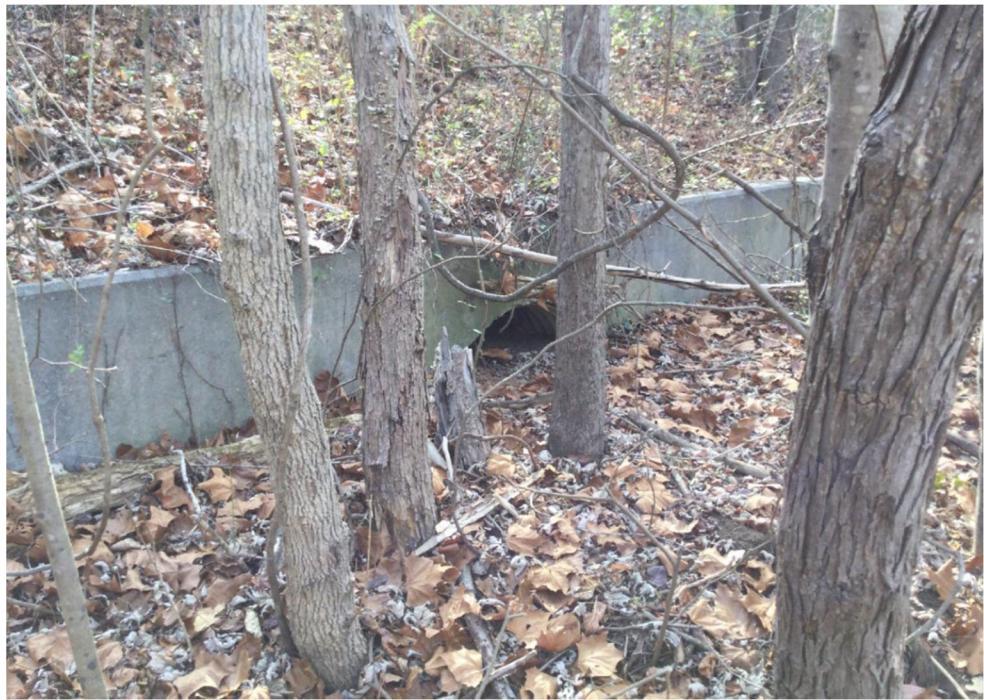
On November 18th, 2024, while performing illicit discharge inspections for Anne Arundel County, KCI Technologies, Inc. discovered a missing manhole lid at Outfall J29A1O00004. The missing manhole lid is posing a safety issue.

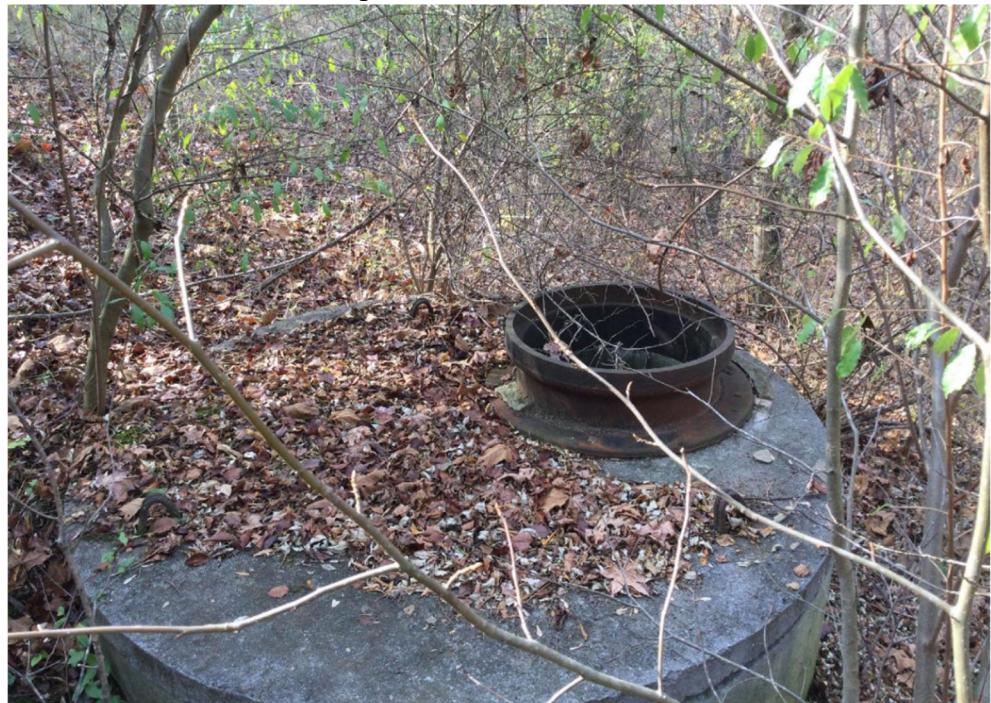
11/18/2024 Inspection- Upstream manhole, missing lid.

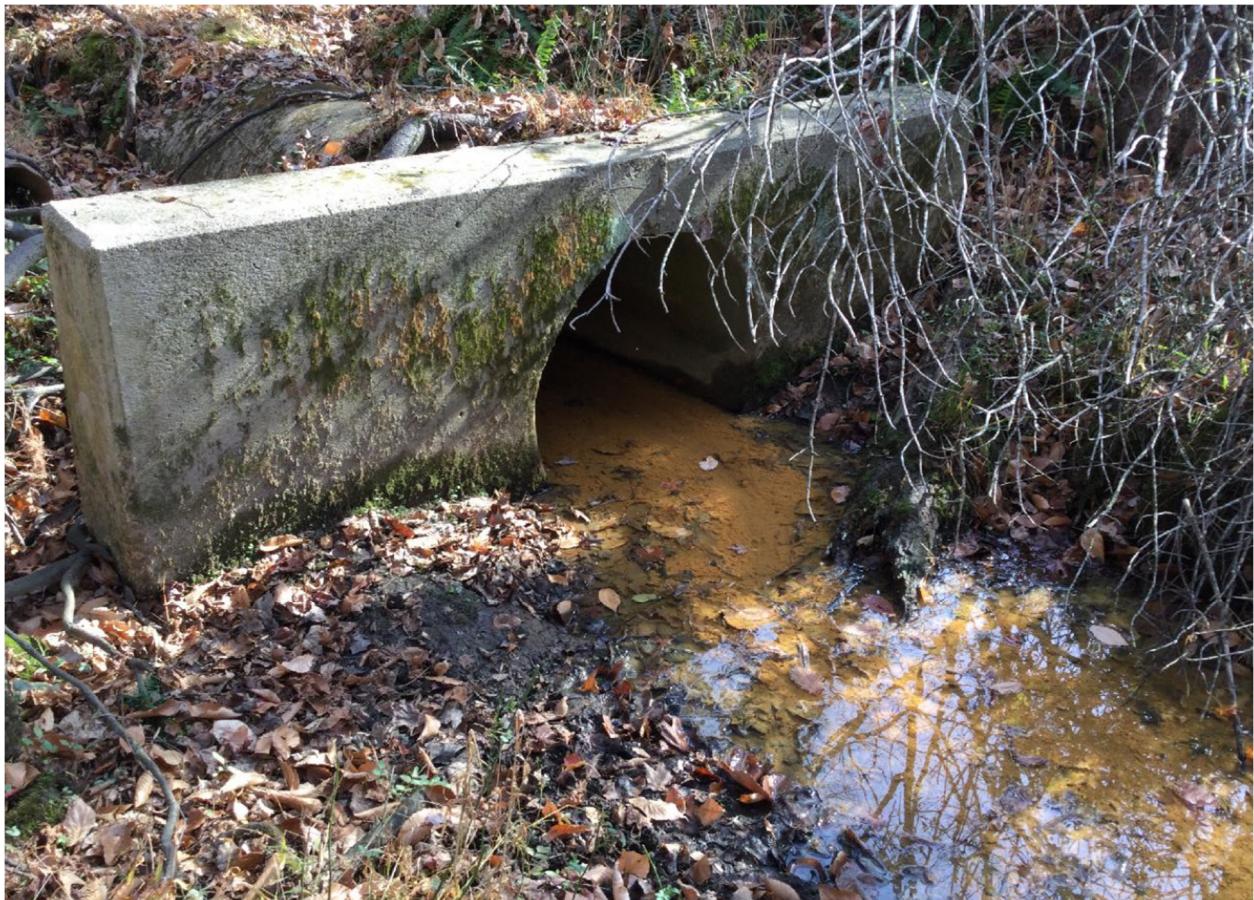
11/18/2024 Inspection- Overview of L26F4O00001.

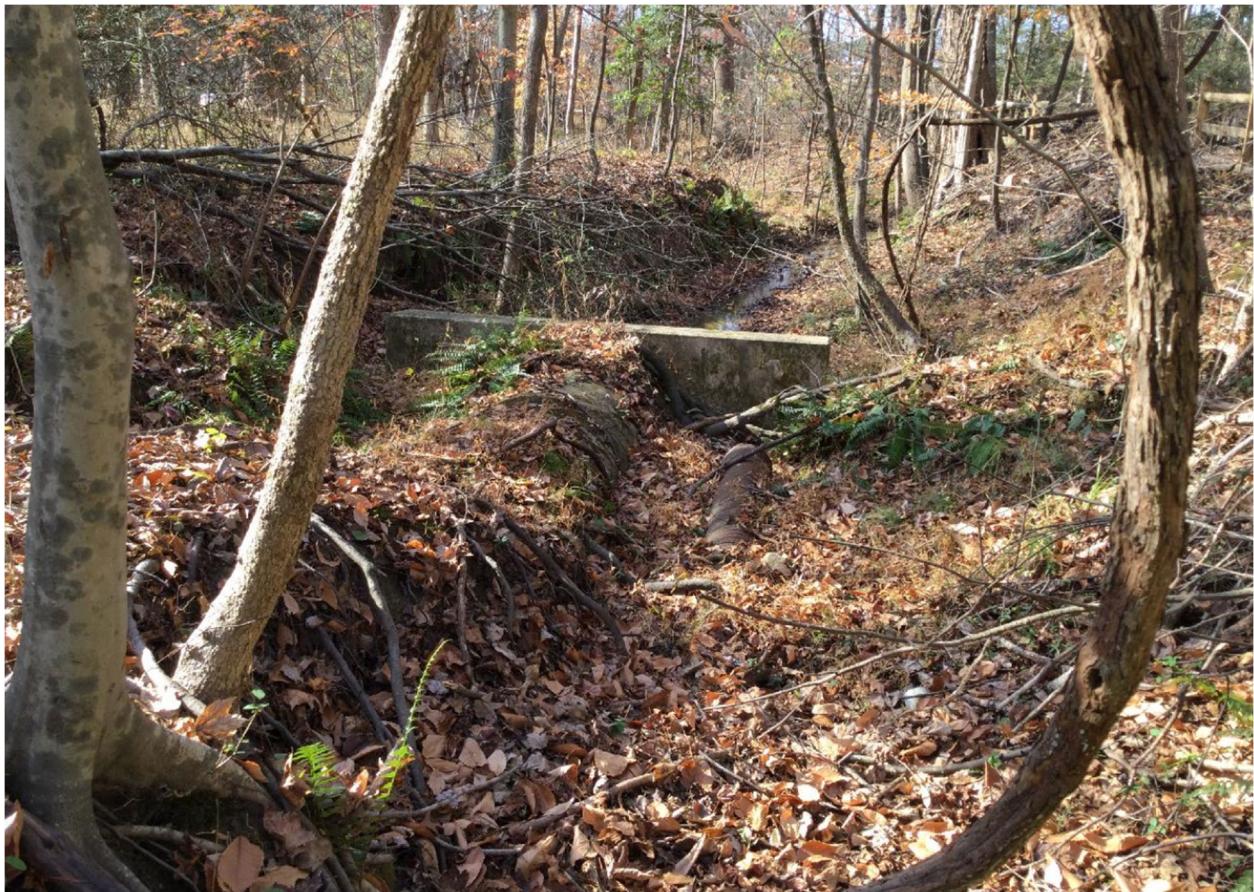
On November 18th, 2024, while performing illicit discharge inspections for Anne Arundel County, KCI Technologies, Inc. discovered moderate to severe upstream erosion exposing Outfall L26F4O00001. Moderate downstream erosion is also present. Two secondary corrugated metal pipes were found upstream and are in bad condition, but these are assumed to be abandoned.

11/18/2024 Inspection - Erosion upstream of pipe causing pipe exposure.

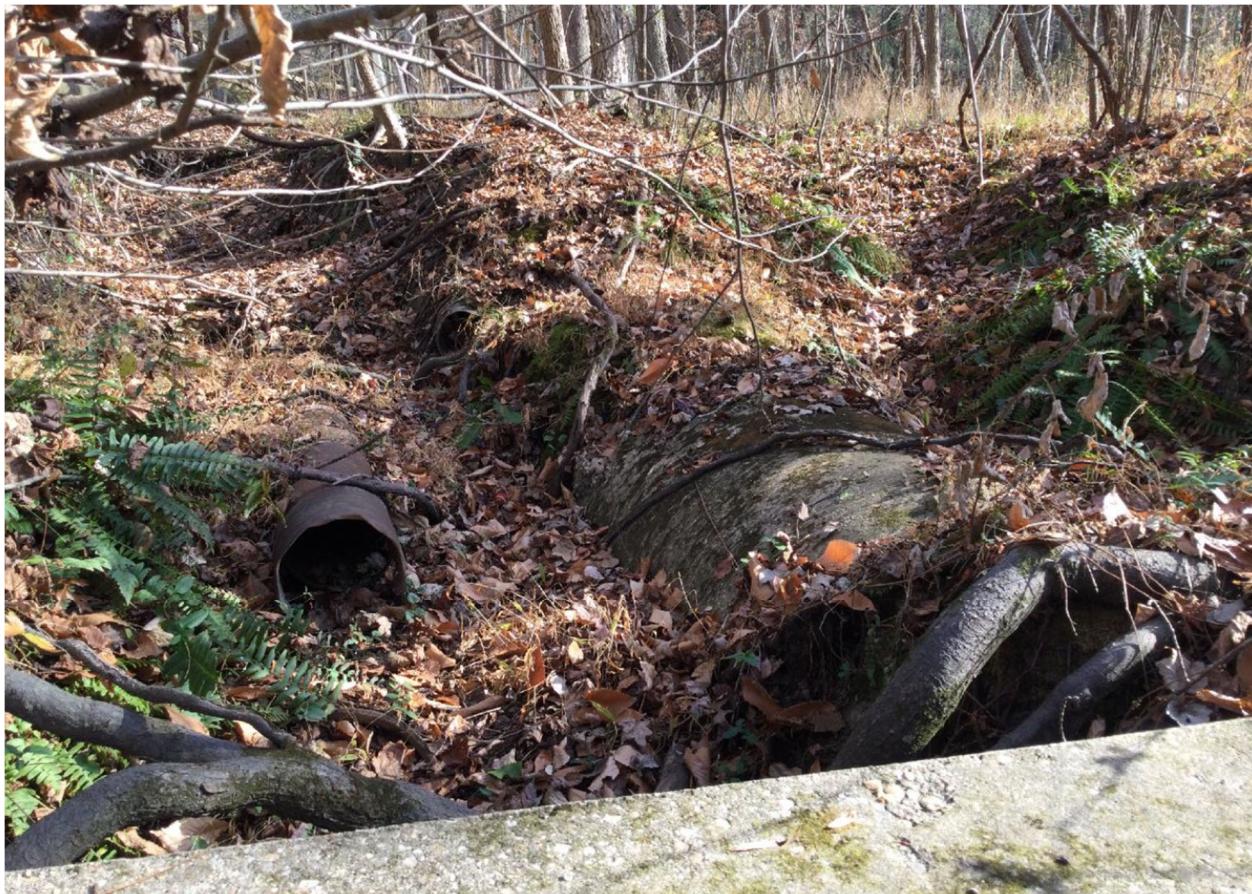
11/18/2024 Inspection - Erosion upstream of pipe causing pipe exposure. Secondary pipe is exposed and severely corroded but may be abandoned.

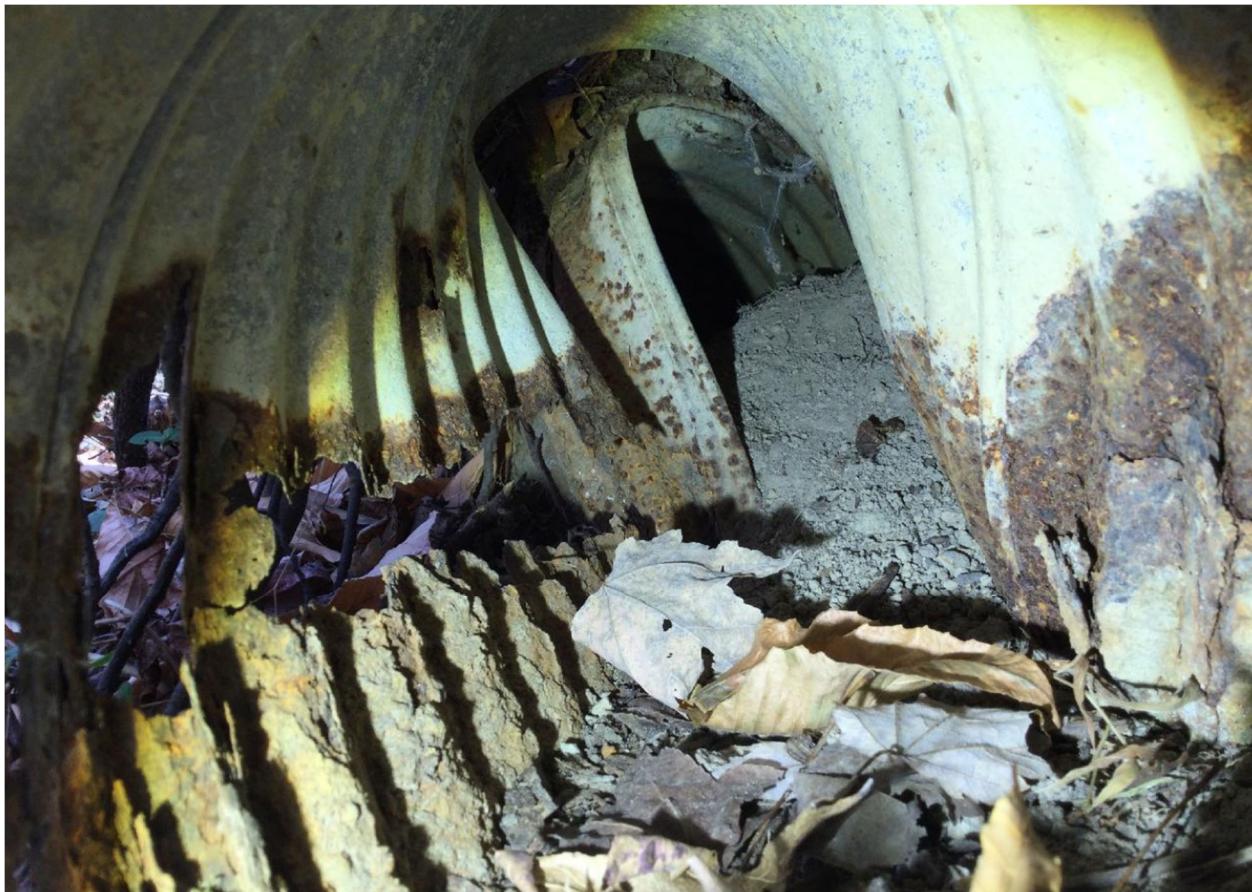
11/18/2024 Inspection - Secondary pipe is 25% filled with sediment and debris. Pipe is corroded and folding in on itself but may be abandoned.

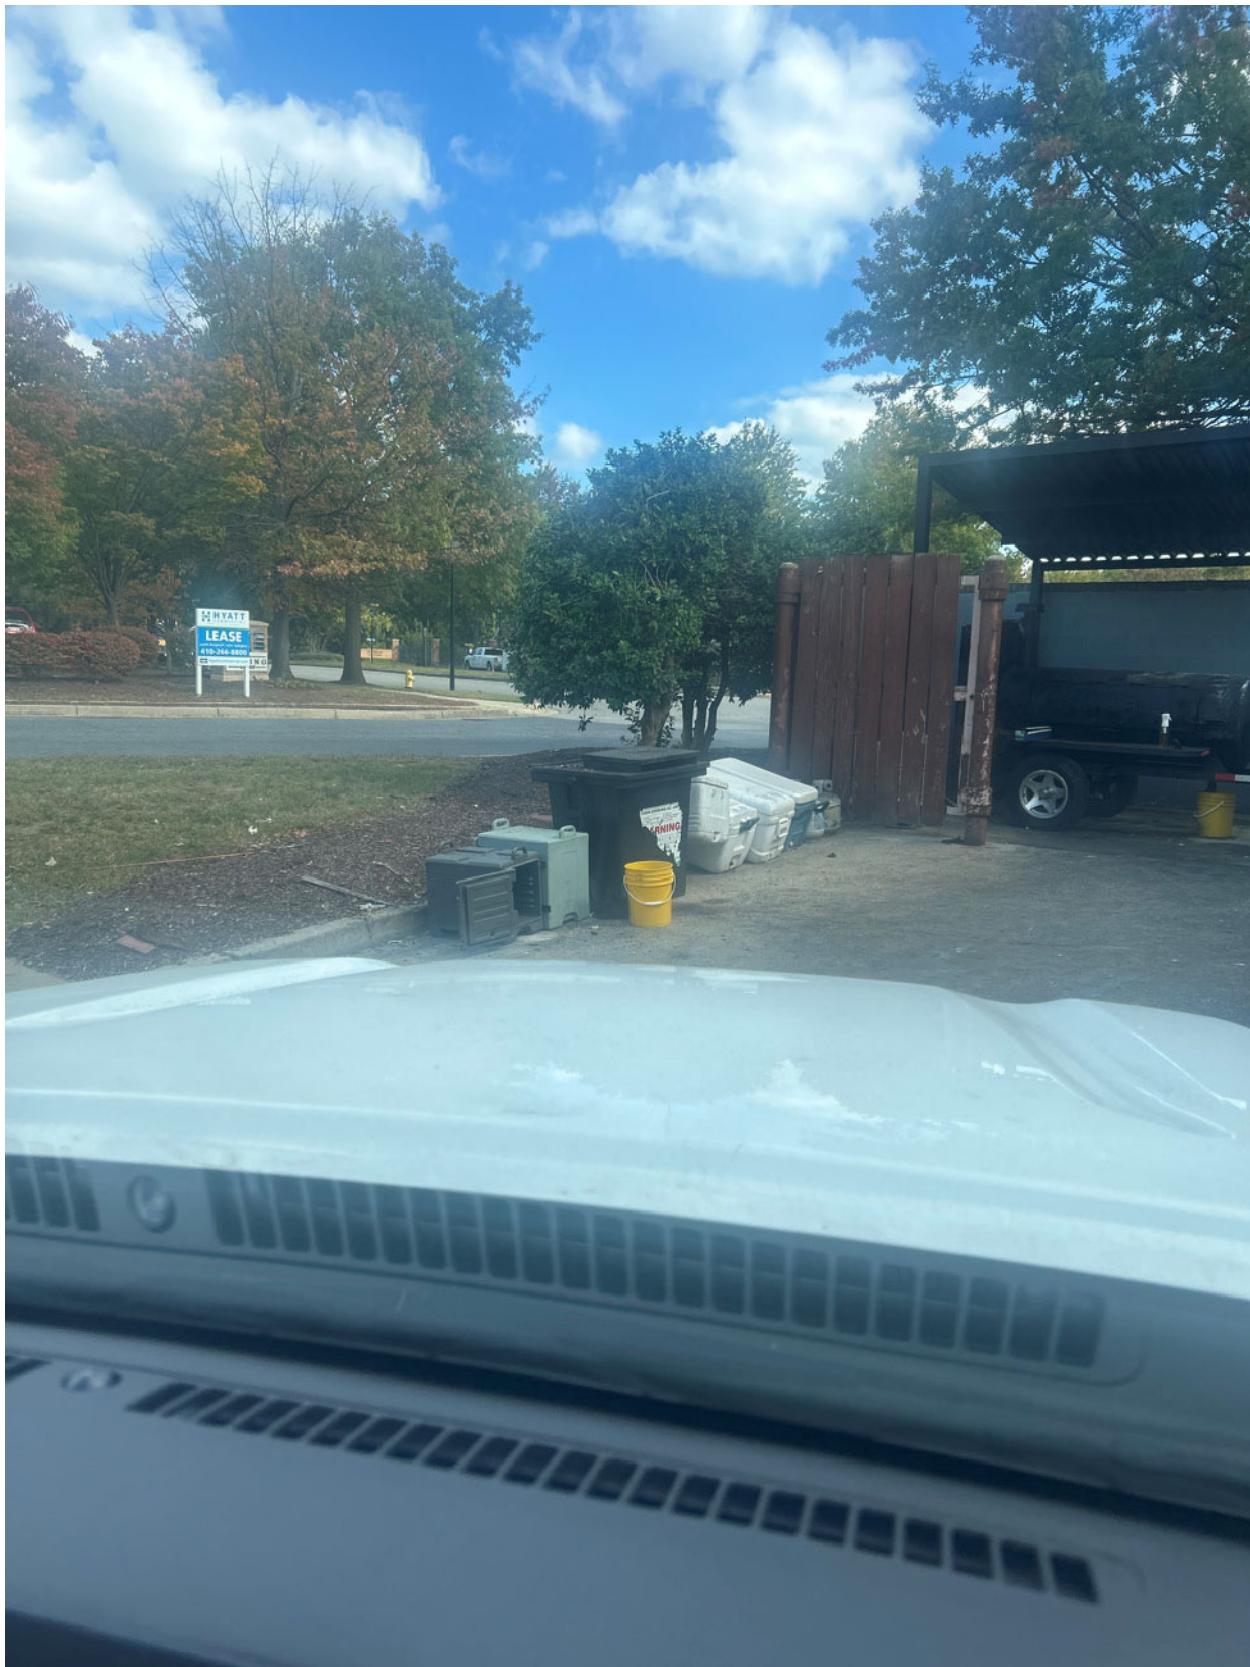
On October 16, 2024, while performing commercial industrial inspections for Anne Arundel County, KCI Technologies, Inc. discovered a grease bin with moderate staining on the pavement alongside URBurger.

10/16/2024 Inspection – stained oil bin

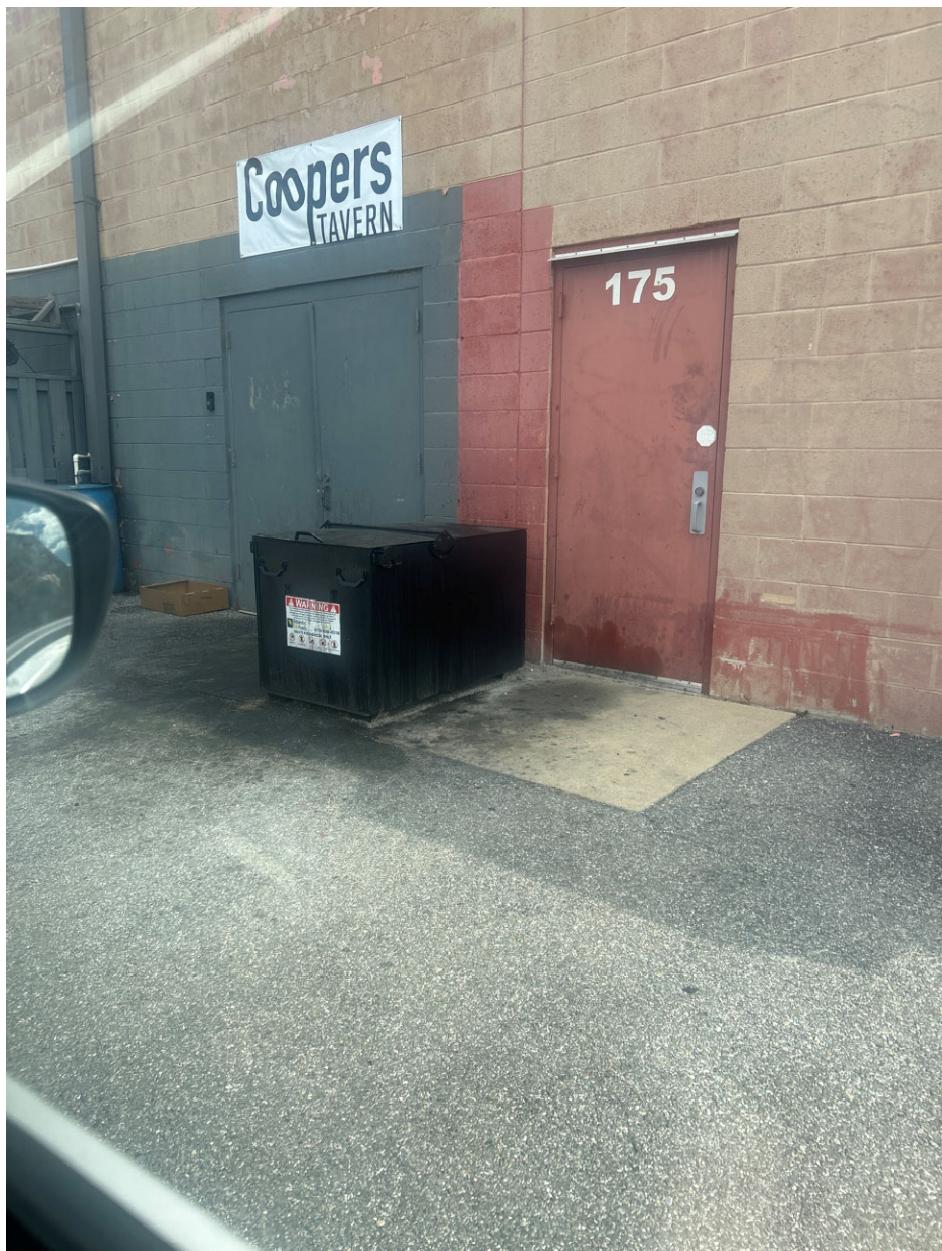
On October 16, 2024, while performing commercial industrial inspections for Anne Arundel County, KCI Technologies, Inc. discovered a grease bin with heavy staining on the pavement behind Coopers Tavern.

10/16/2024 Inspection – Grease Trap with staining surrounding it.

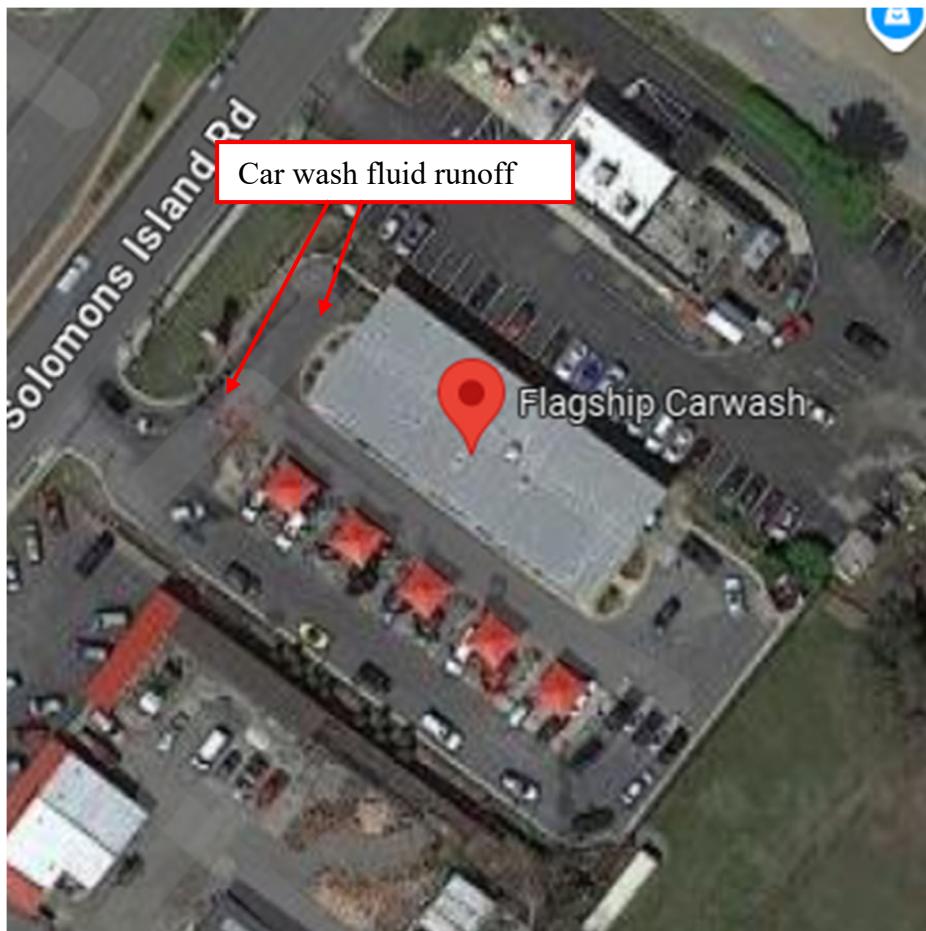
On October 16, 2024, while performing commercial industrial inspections for Anne Arundel County, KCI Technologies, Inc. discovered car wash fluid runoff going into the storm drain on the property of Flagship Carwash.

10/16/2024 Inspection – Runoff coming from car wash.

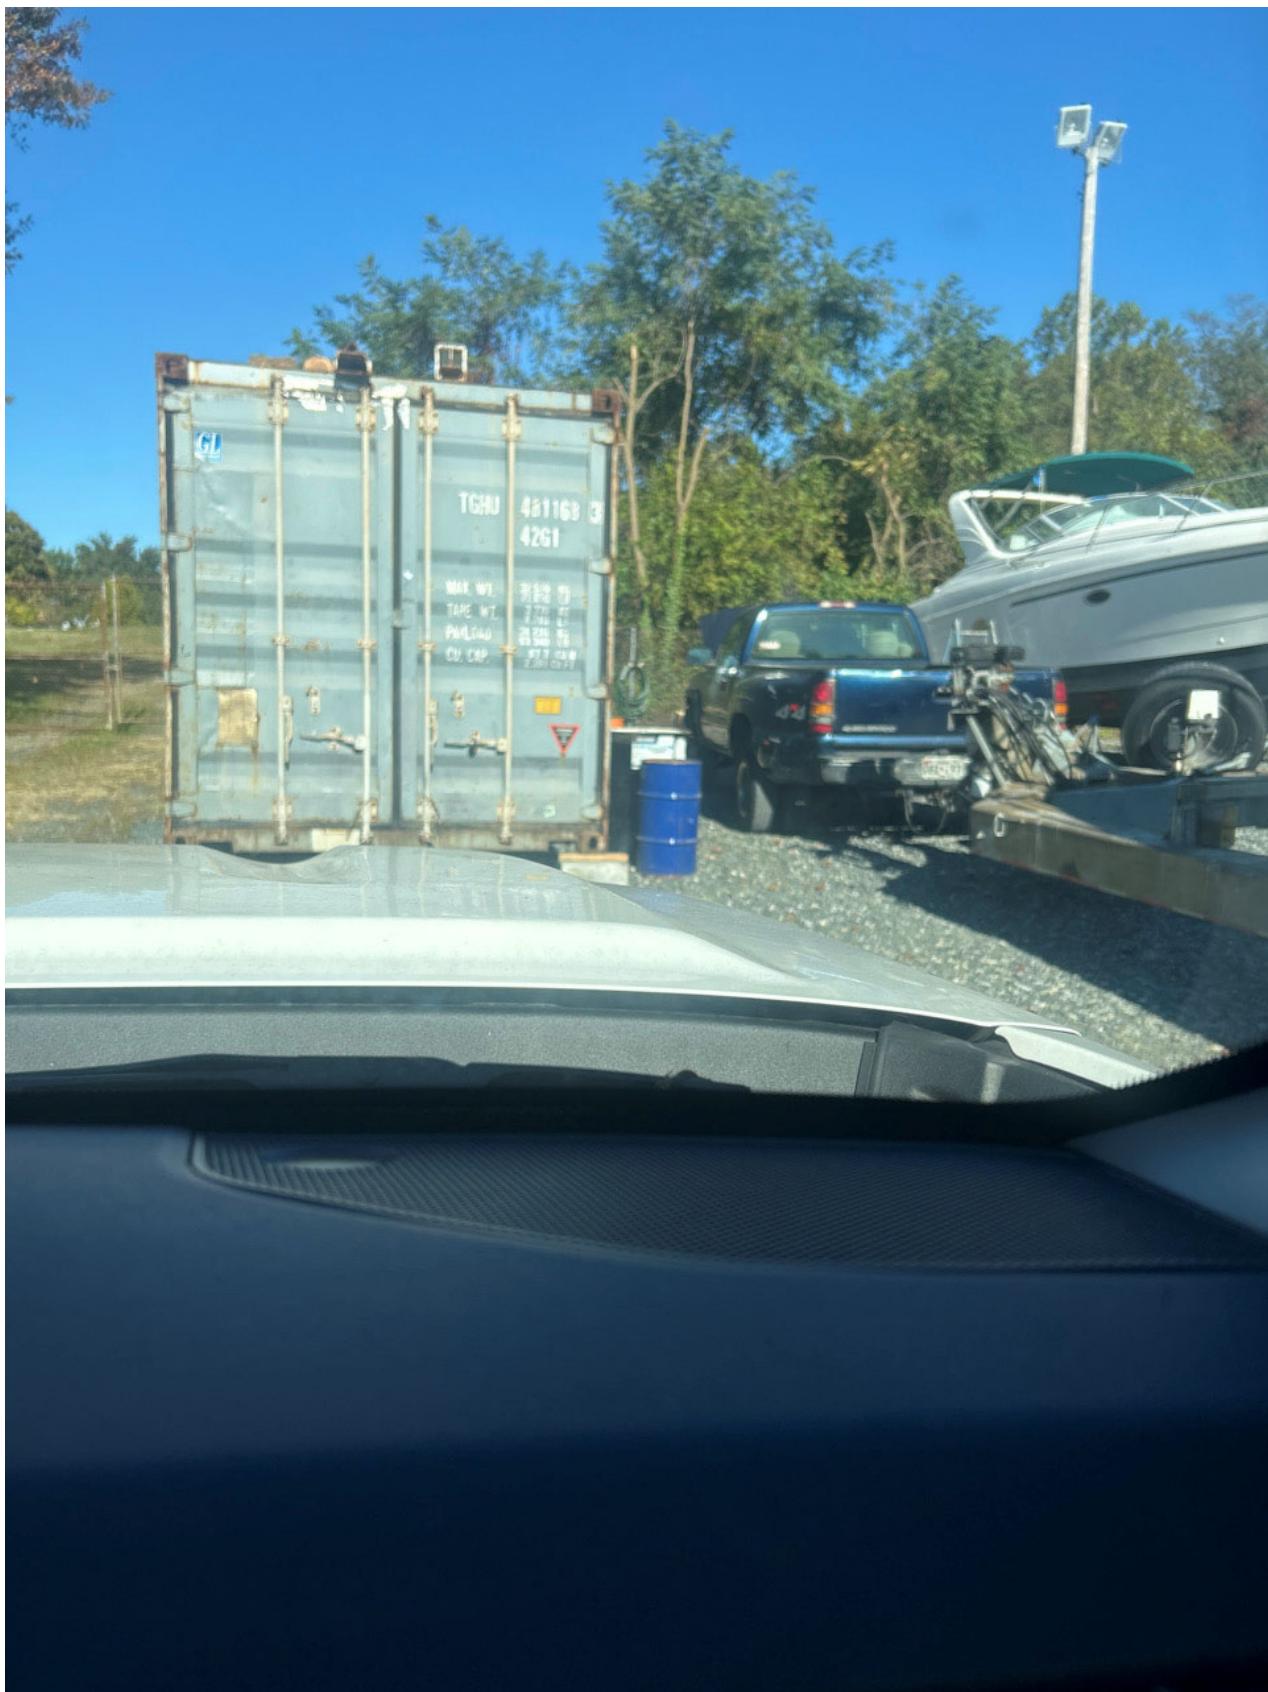
On October 16, 2024, while performing commercial industrial inspections for Anne Arundel County, KCI Technologies, Inc. discovered improperly stored chemical materials on the property of Londontowne Marina. Staff observed several 55-gallon drums left exposed and without secondary containment but it's unclear if they contain product.

10/16/2024 Inspection – Exposed 55-gallon drums.

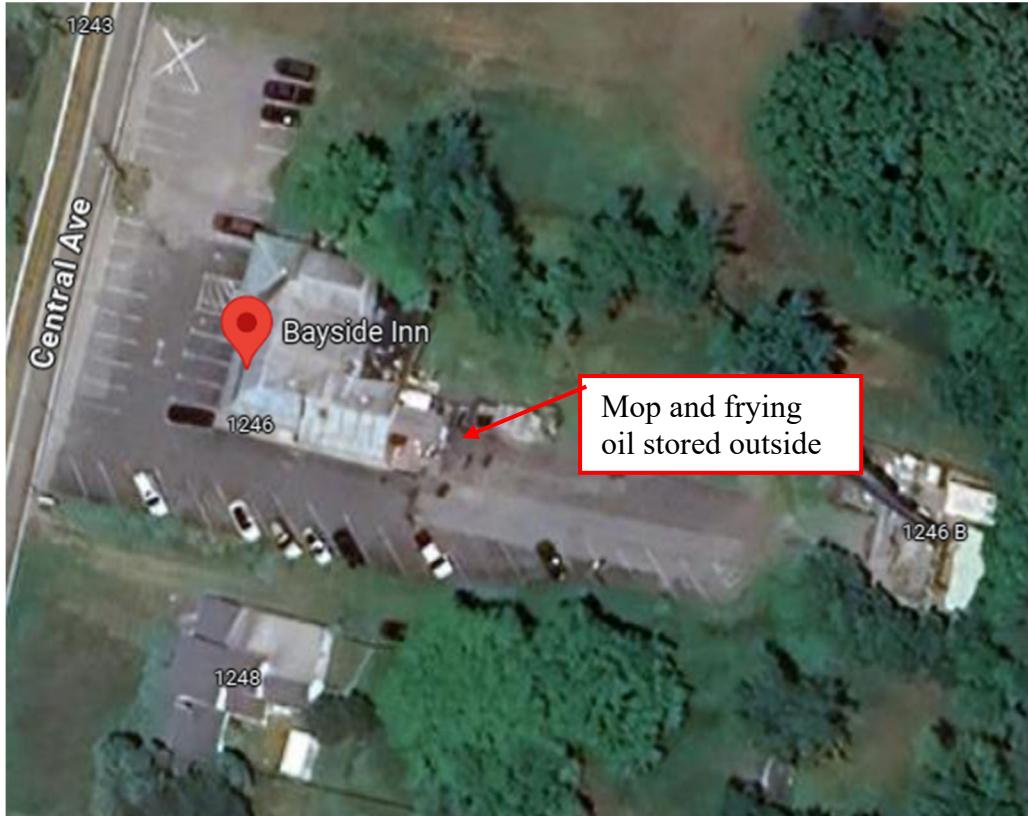
On October 17<sup>th</sup>, 2024, while performing commercial industrial inspections for Anne Arundel County, KCI Technologies, Inc. discovered improperly stored chemical materials on the property of Bayside Inn. Frying oil was found to be improperly stored outside. Mop with bucket being improperly stored outside.

10/17/2024 Inspection – Cleaning supplies improperly stored outside.

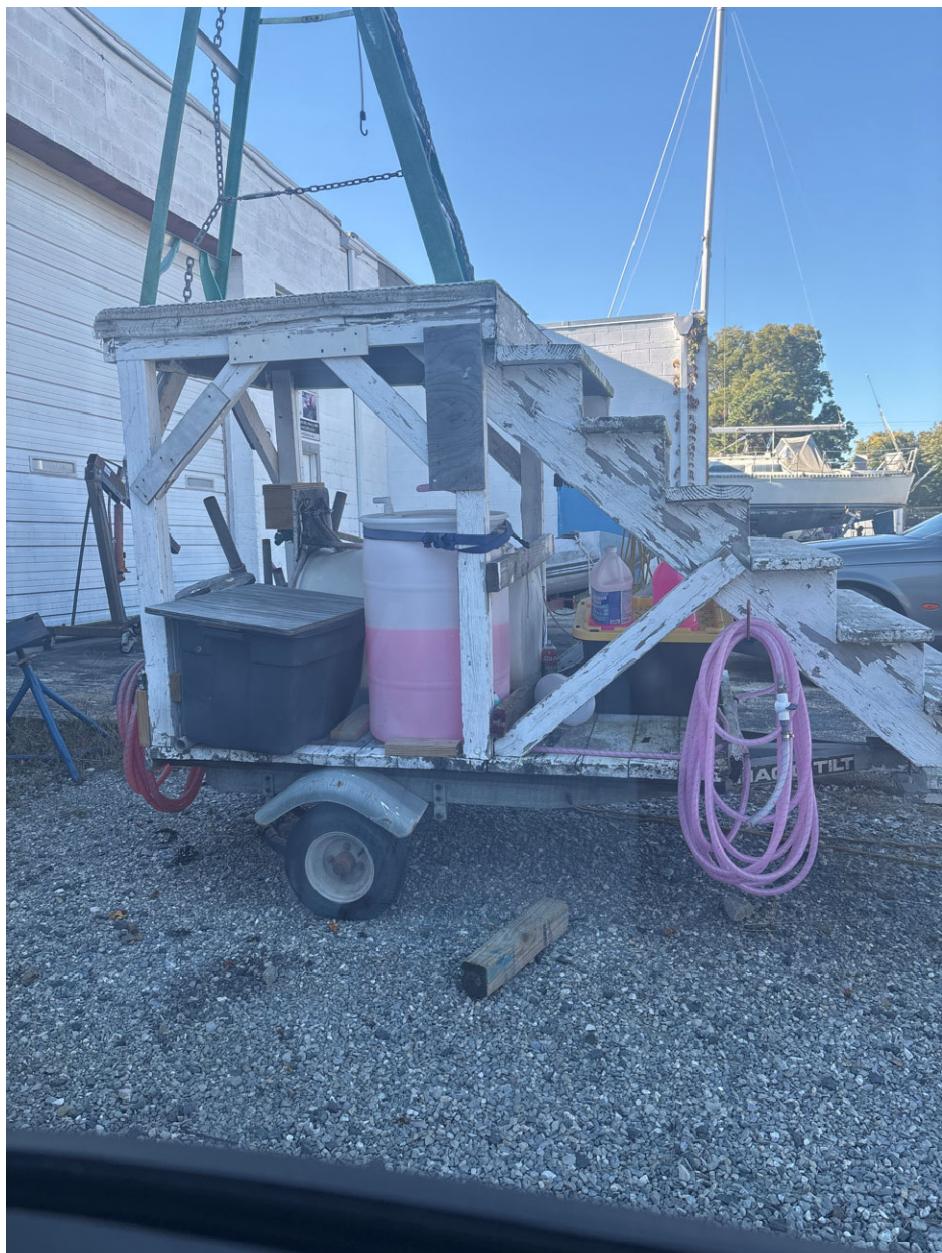
On October 17<sup>th</sup>, 2024, while performing commercial industrial inspections for Anne Arundel County, KCI Technologies, Inc. discovered improperly stored chemical materials on the property of Casa Rio Marina. Barrels of antifreeze stored outside. A stone/gravel stockpile was also located on the Casa Rio Marina property.

10/17/2024 Inspection – Antifreeze improperly stored outside.

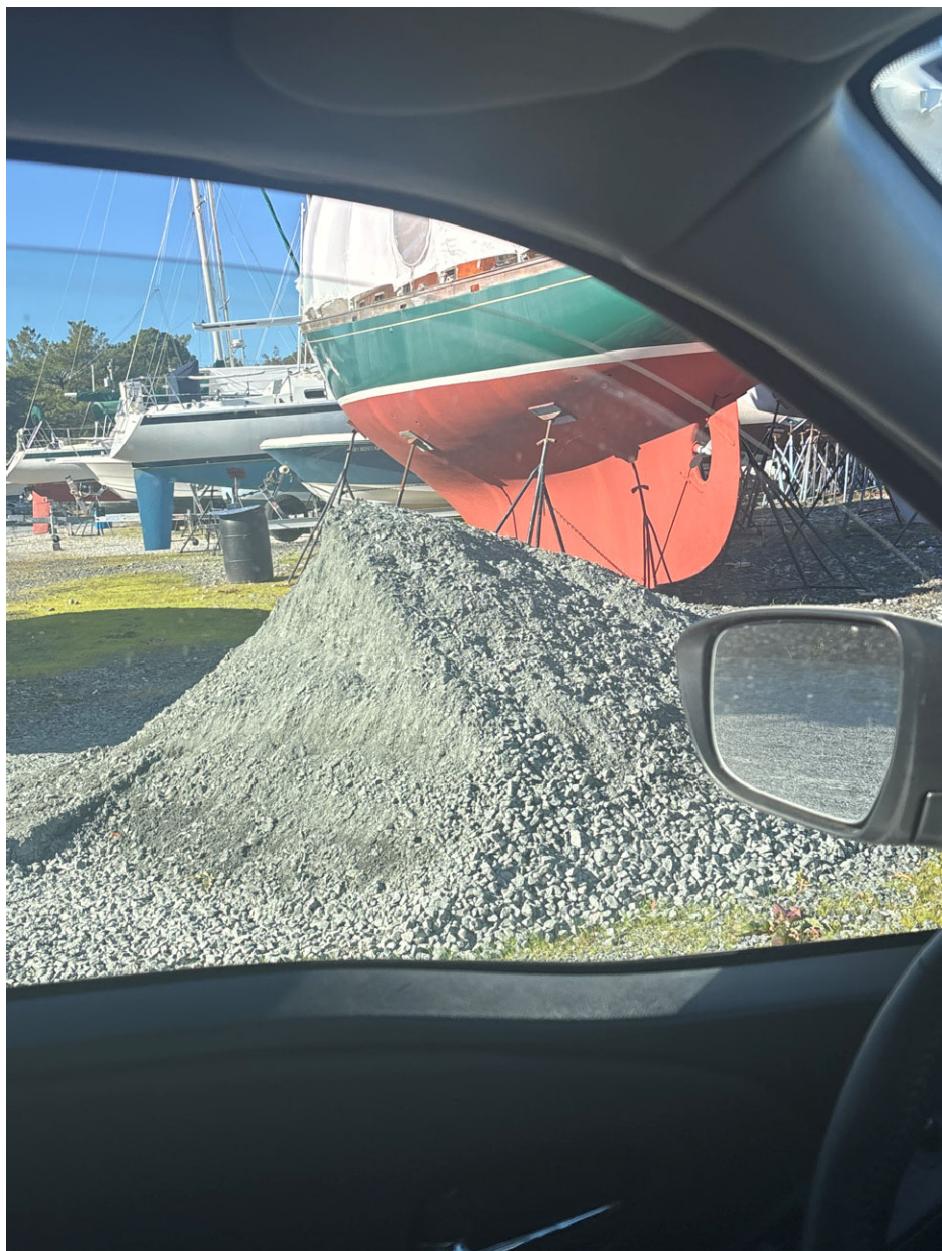
10/17/2024 Inspection – Stone/gravel stockpile.

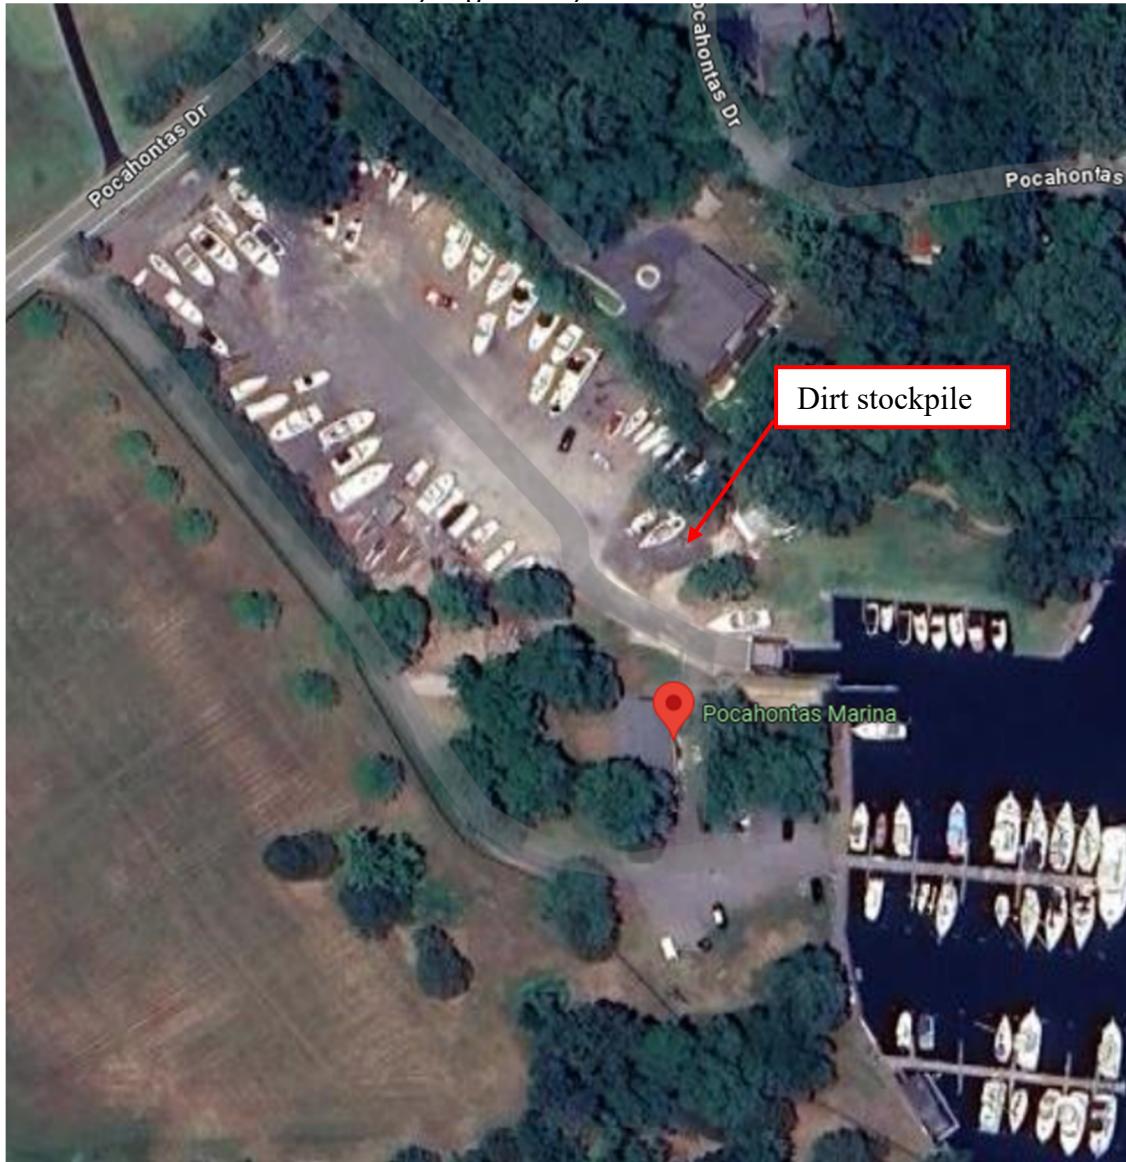
On October 17<sup>th</sup>, 2024, while performing commercial industrial inspections for Anne Arundel County, KCI Technologies, Inc. discovered a dirt/mulch stockpile being improperly stored on the property of Pocahontas Marina.

10/17/2024 Inspection – Dirt/Mulch stockpile.

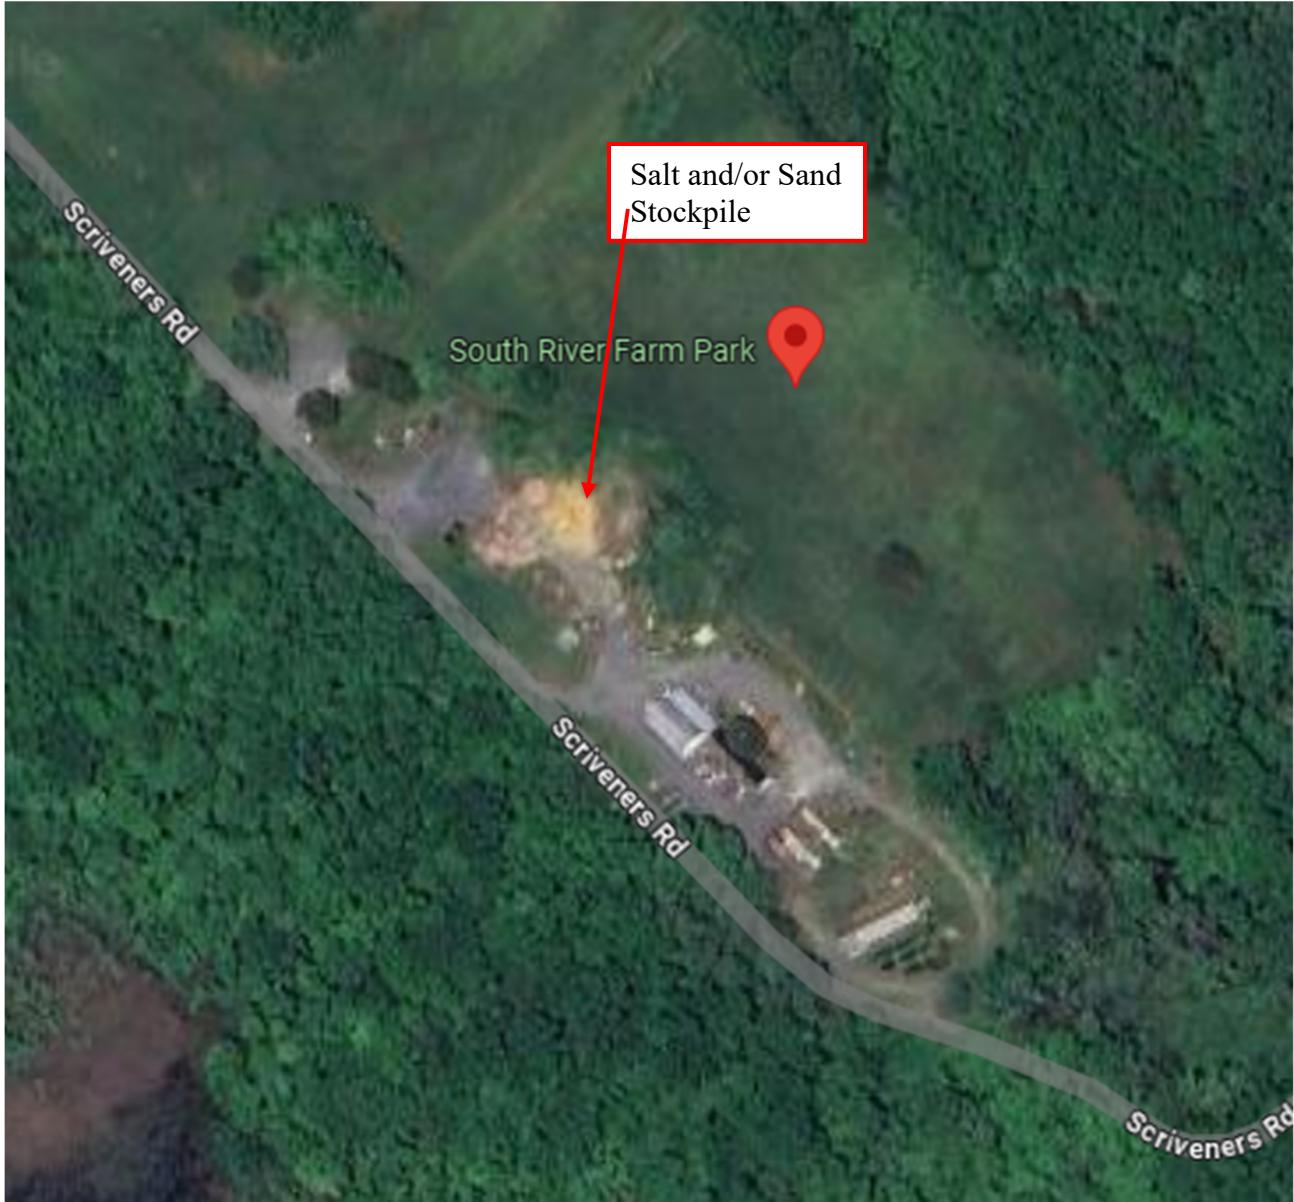
On October 17<sup>th</sup>, 2024, while performing commercial industrial inspections for Anne Arundel County, KCI Technologies, Inc. discovered a salt and/or sand stockpile being improperly stored on the property of South River Farm Park.

10/17/2024 Inspection – Salt and/or sand stockpile

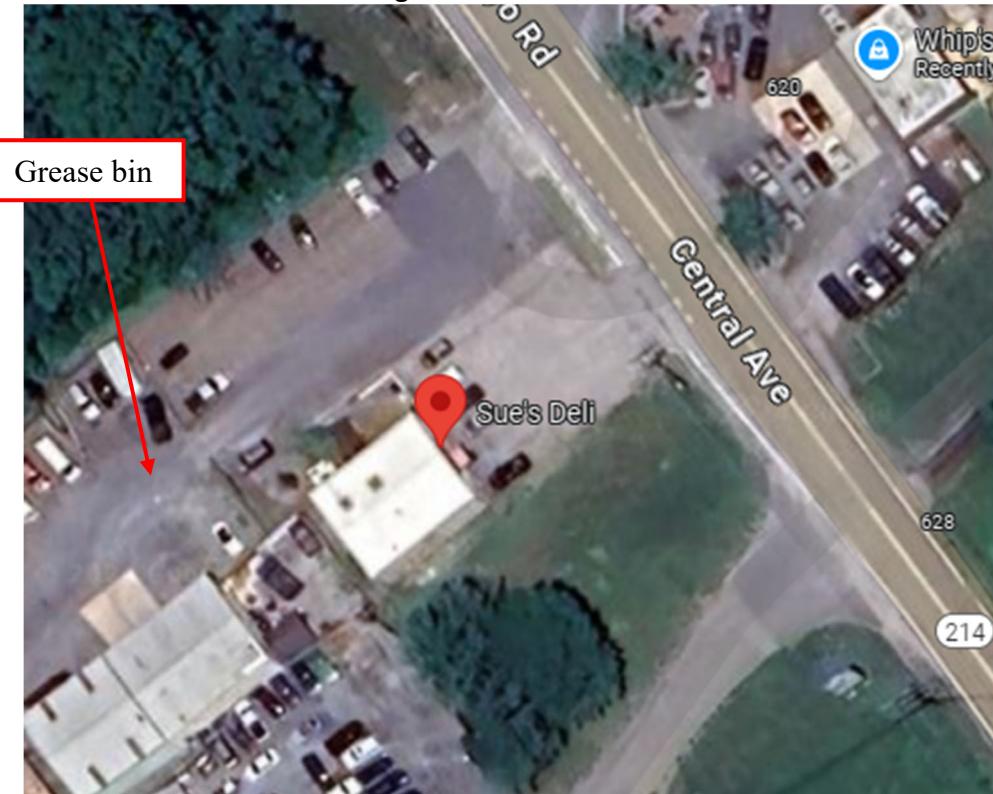
On October 17<sup>th</sup>, 2024, while performing commercial industrial inspections for Anne Arundel County, KCI Technologies, Inc. discovered a grease bin with heavy staining on the pavement behind Sue's Deli. Staff observed an excessive amount of grease accumulating on the top of the bin.

10/17/2024 Inspection – Oil container with heavy staining and residue.
