**ANNE ARUNDEL COUNTY  
ILLICIT DISCHARGE DETECTION  
AND ELIMINATION PROGRAM REPORT:  
July 2024 – June 2025 (Fiscal Year 2025)**

Anne Arundel County  
Department of Public Works  
Bureau of Watershed Protection and Restoration  
2662 Riva Road  
Annapolis, MD 21401

KCI Technologies, Inc.  
936 Ridgebrook Road  
Sparks, MD 21152

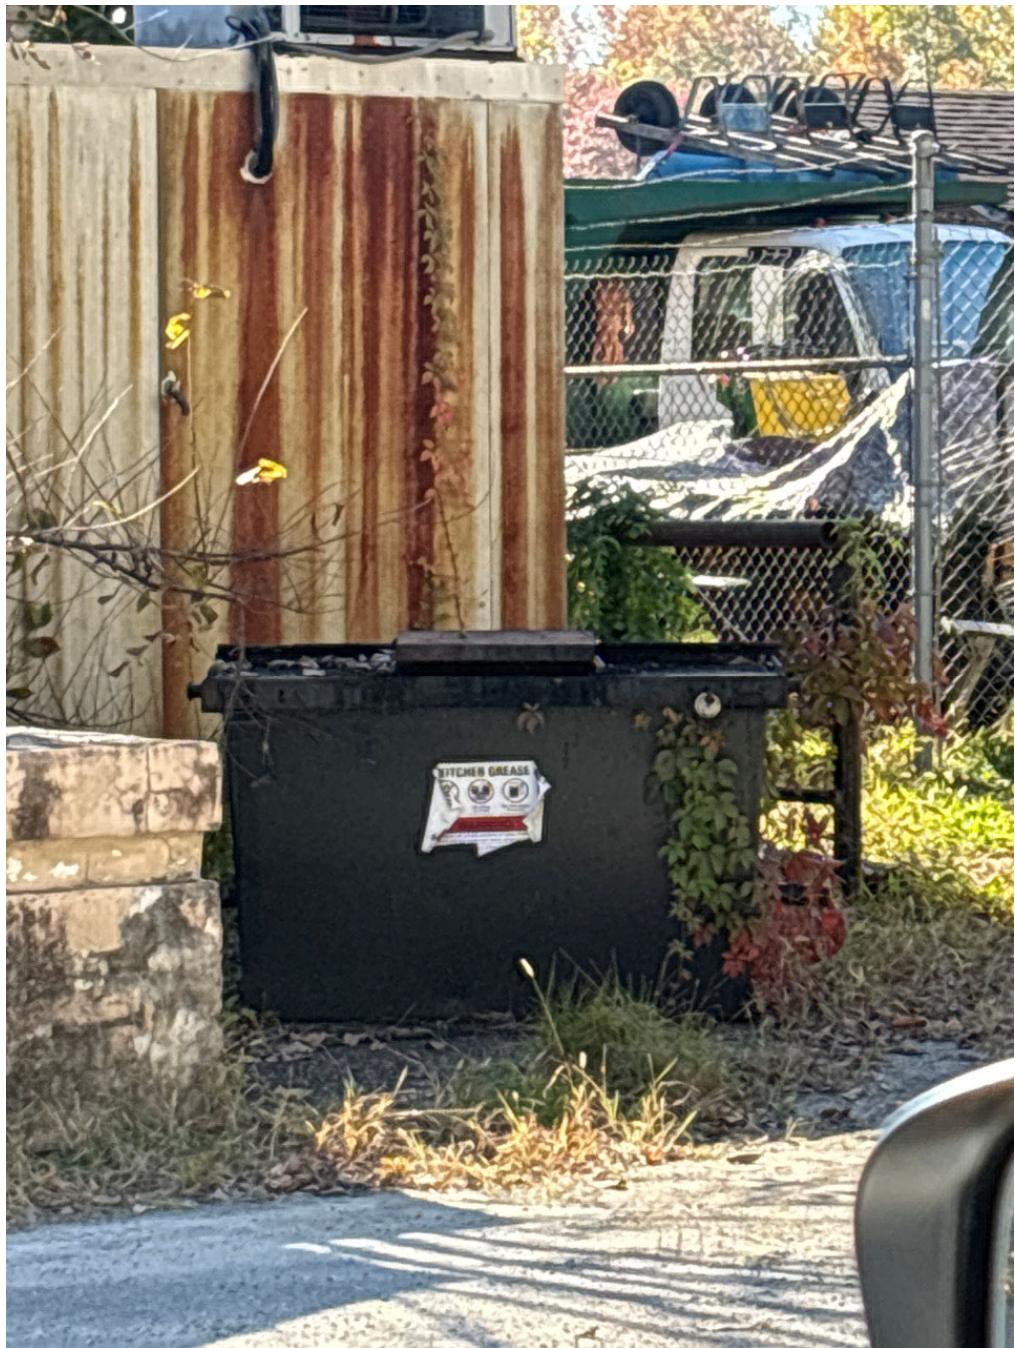
On October 17<sup>th</sup>, 2024, while performing commercial industrial inspections for Anne Arundel County, KCI Technologies, Inc. discovered a grease bin with heavy staining on the pavement behind Sue's Deli. Staff observed an excessive amount of grease accumulating on the top of the bin.

10/17/2024 Inspection – Oil container with heavy staining and residue.

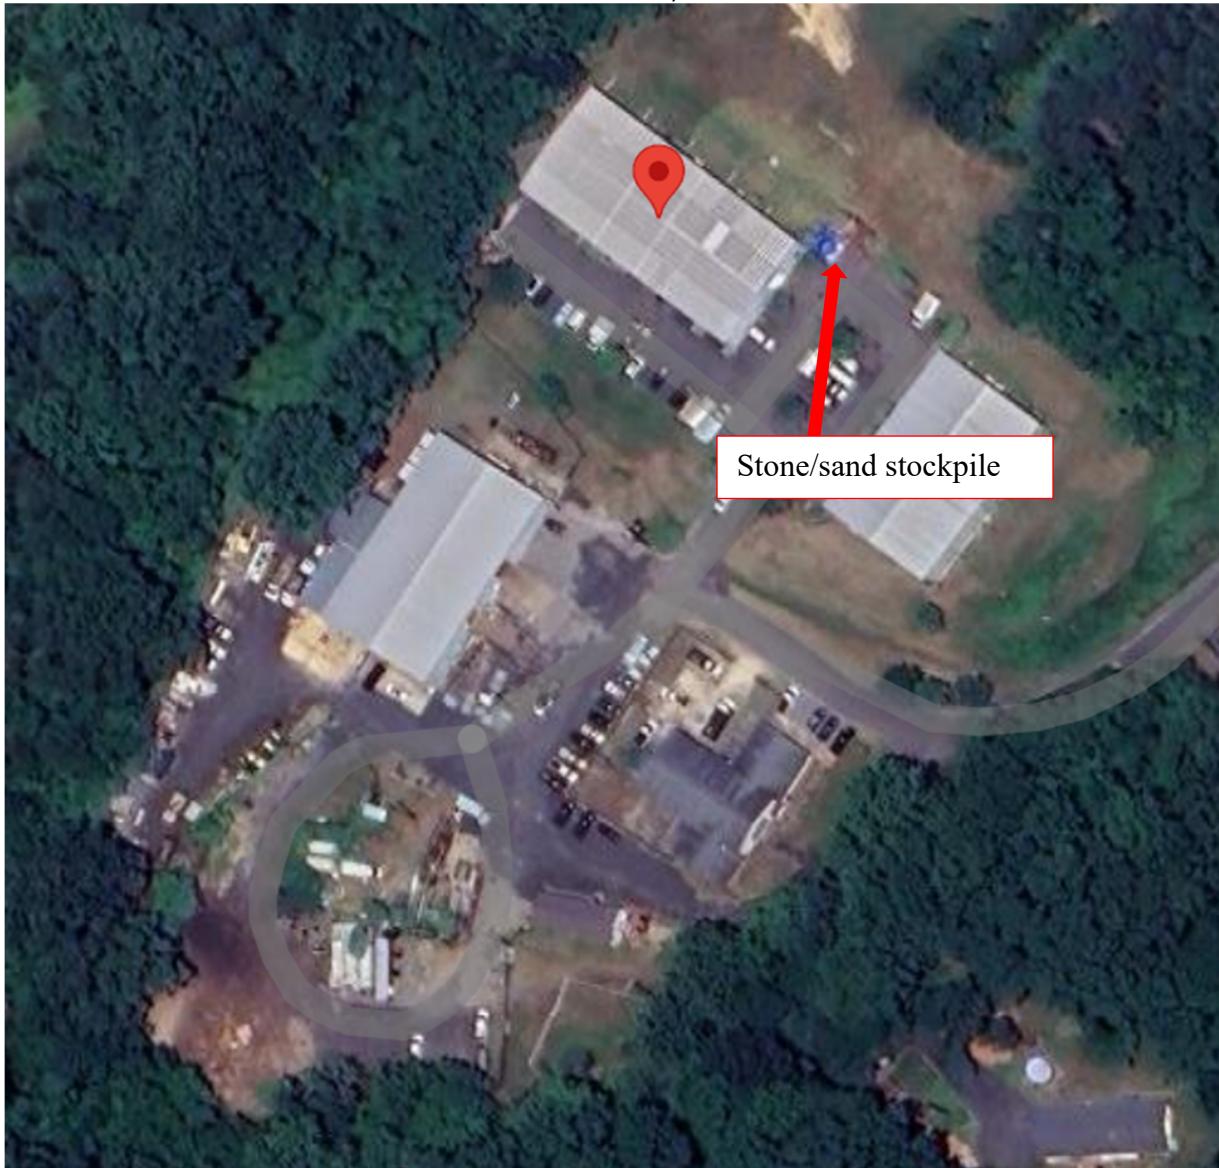
On October 18th, 2024, while performing commercial industrial inspections for Anne Arundel County, KCI Technologies, Inc. discovered a Dirt/Sand/Stone stockpile being improperly stored on the property of Amazon Construction inc.

10/18/2024 Inspection – Stockpile of Gravel/Dirt on site.

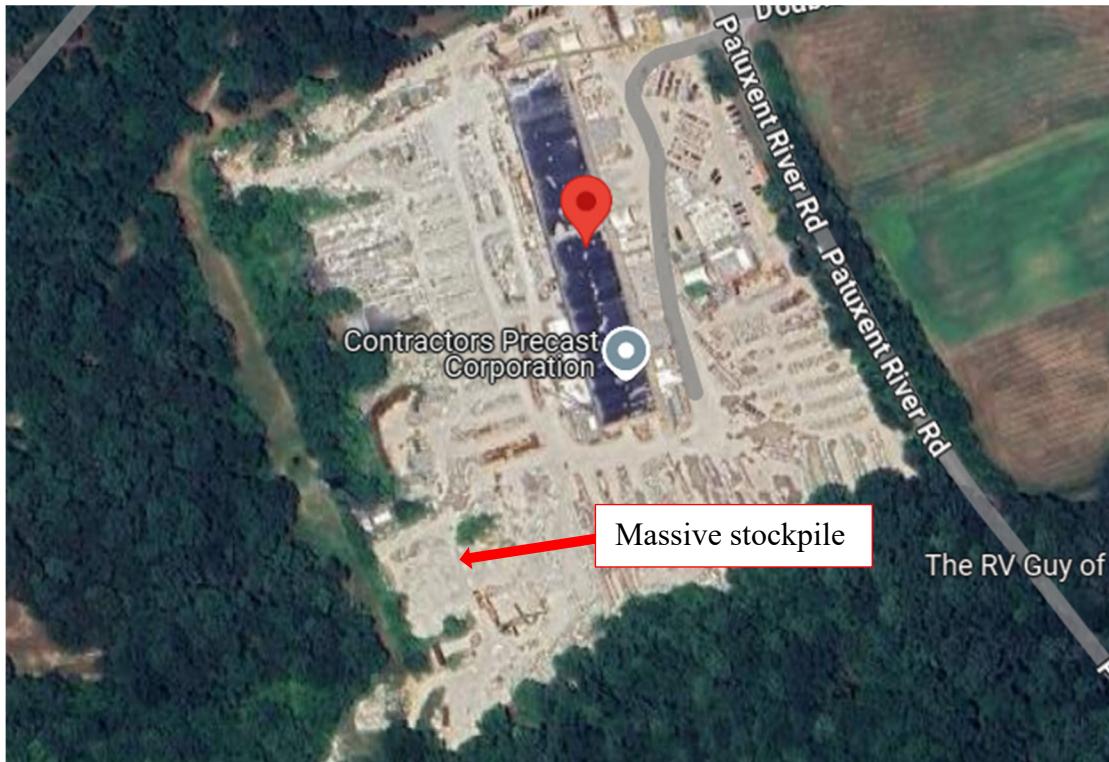
On October 18<sup>th</sup>, 2024, while performing commercial industrial inspections for Anne Arundel County, KCI Technologies, Inc. discovered a sand/stone stockpile being properly stored on the property of Contractors Precast Corporation.

10/18/2024 Inspection – One of many large sand/stone stockpiles on this site being improperly stored.

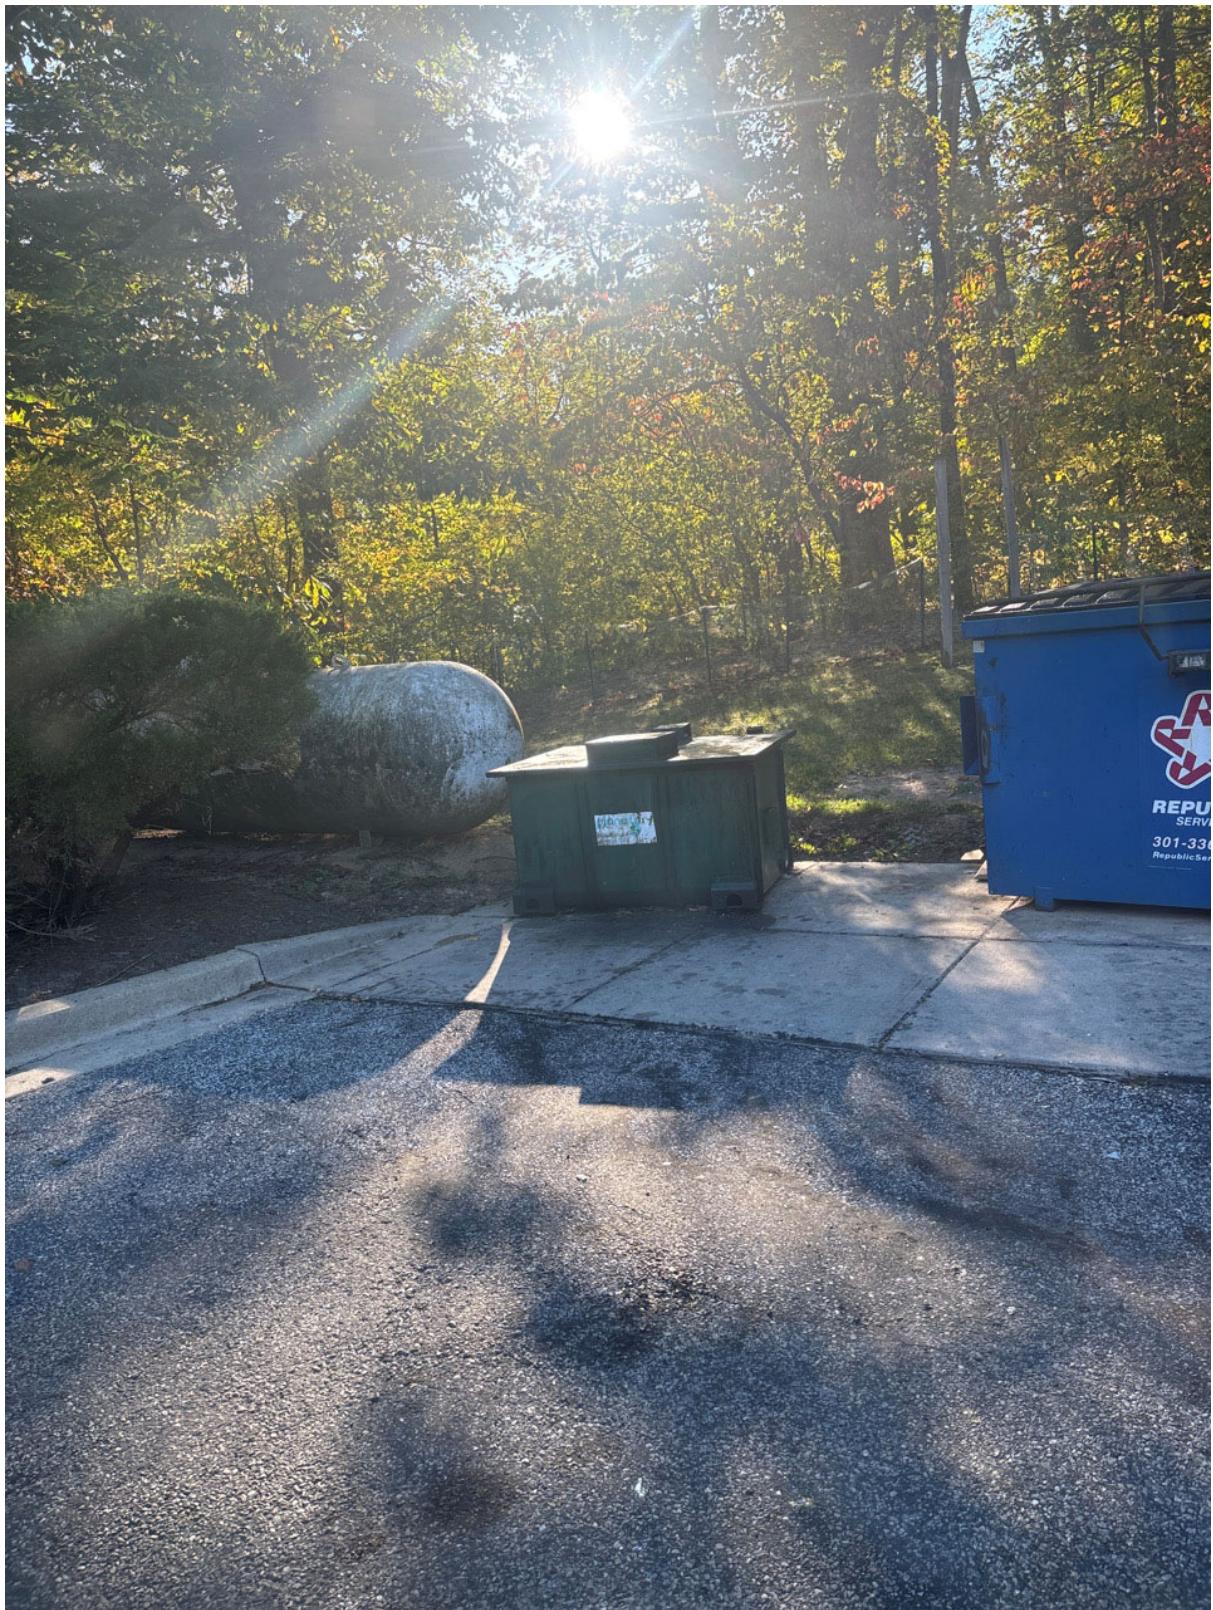
On October 18<sup>th</sup>, 2024, while performing commercial industrial inspections for Anne Arundel County, KCI Technologies, Inc. discovered a grease bin with moderate staining on the pavement behind Harvest Thyme Tavern.

10/18/2024 Inspection – Grease bin with staining on asphalt surrounding it.

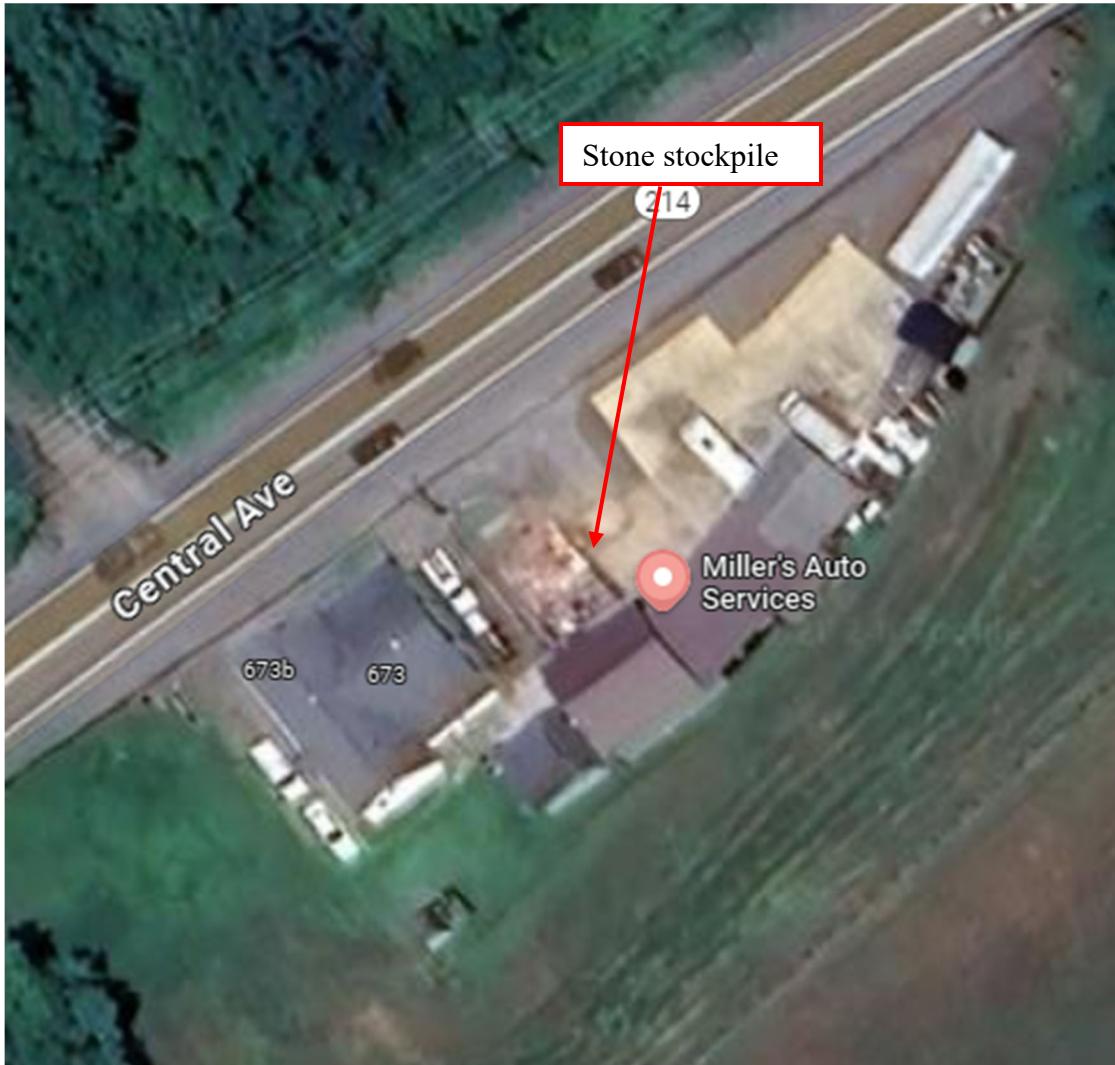
On October 18<sup>th</sup>, 2024, while performing commercial industrial inspections for Anne Arundel County, KCI Technologies, Inc. discovered a stone stockpile being improperly stored on the property of Miller's Auto Services.

10/18/2024 Inspection – Stone stockpile being improperly stored.

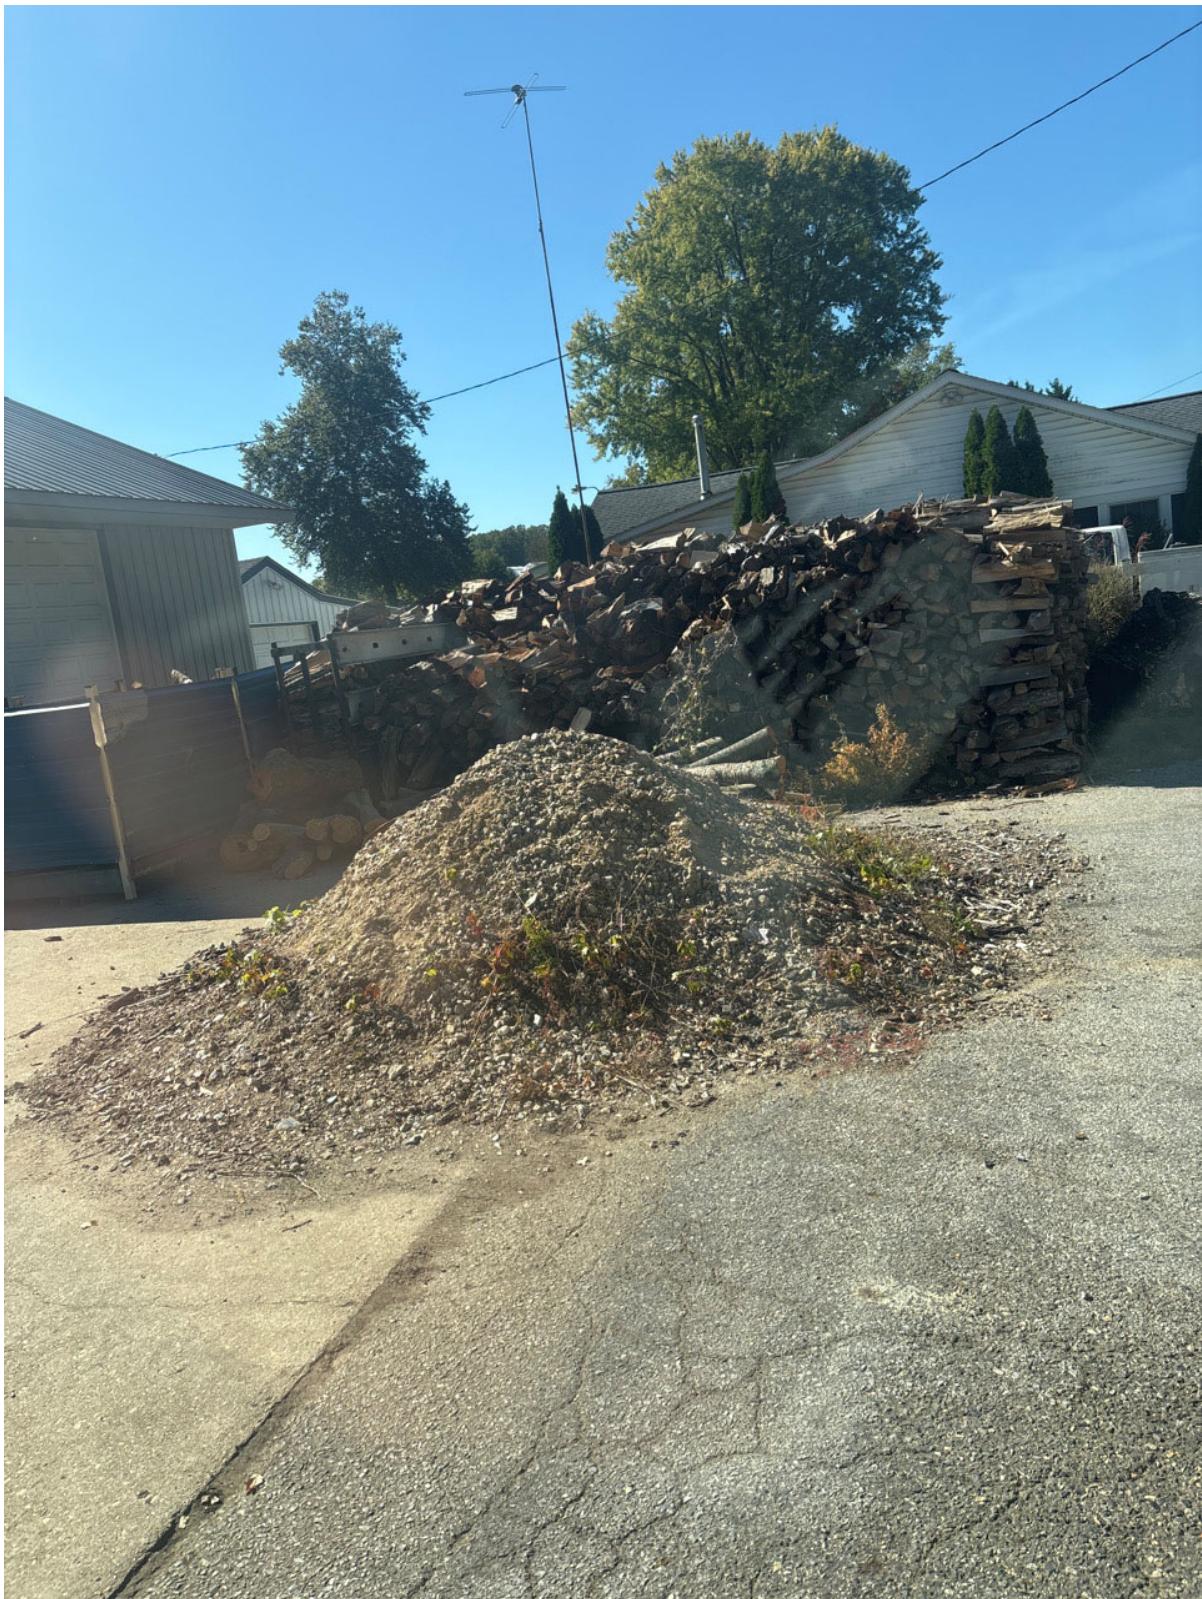
The KCI inspectors discovered a stone stockpile being improperly stored on the property of Miller's Auto Services located at 669 W Central Avenue.

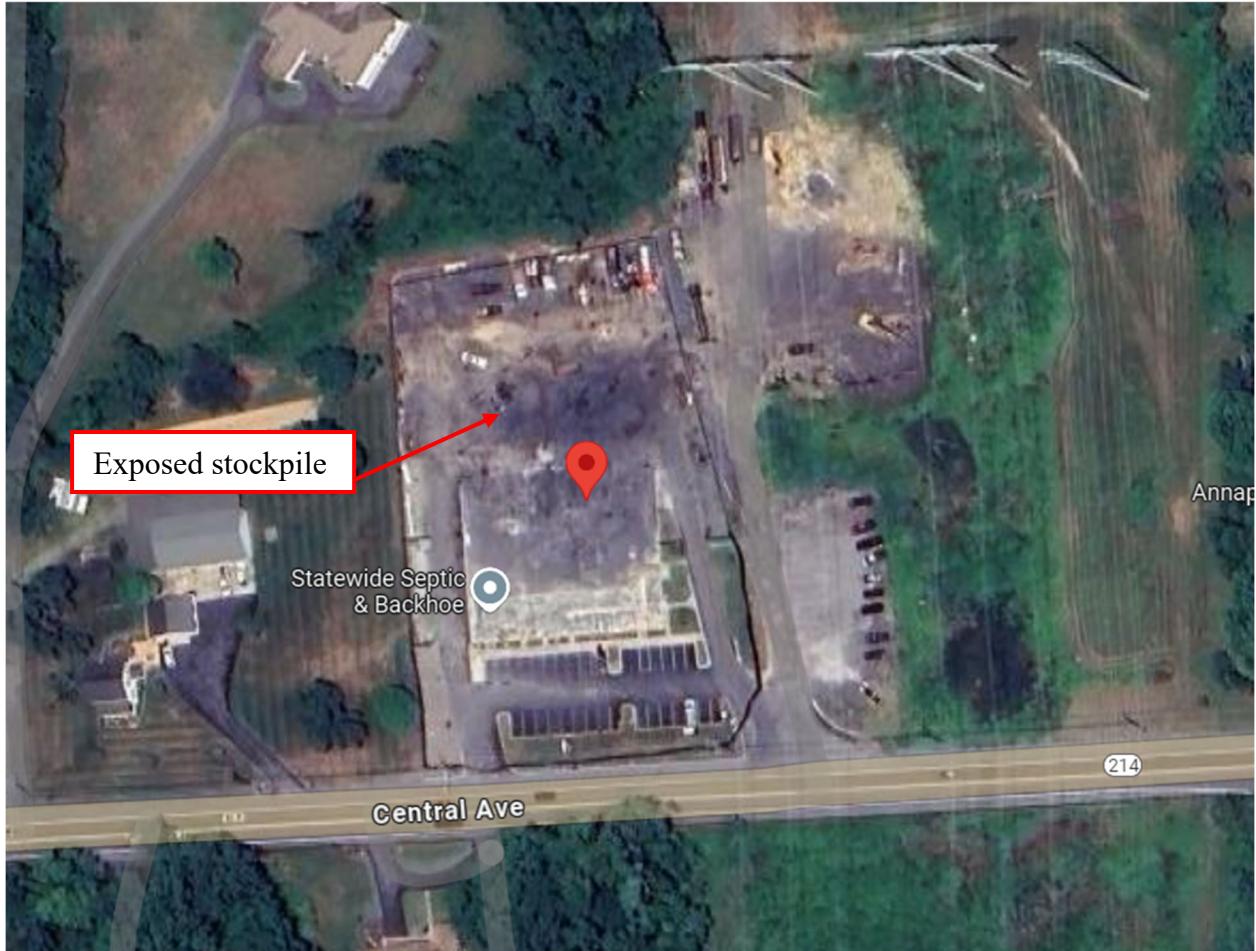
On October 18<sup>th</sup>, 2024, while performing commercial industrial inspections for Anne Arundel County, KCI Technologies, Inc. discovered a stockpile of varying materials including dirt, trash and gravel being improperly stored on the property of Statewide Septic and Backhoe.

10/18/2024 Inspection – Stockpile of various debris types being improperly stored.

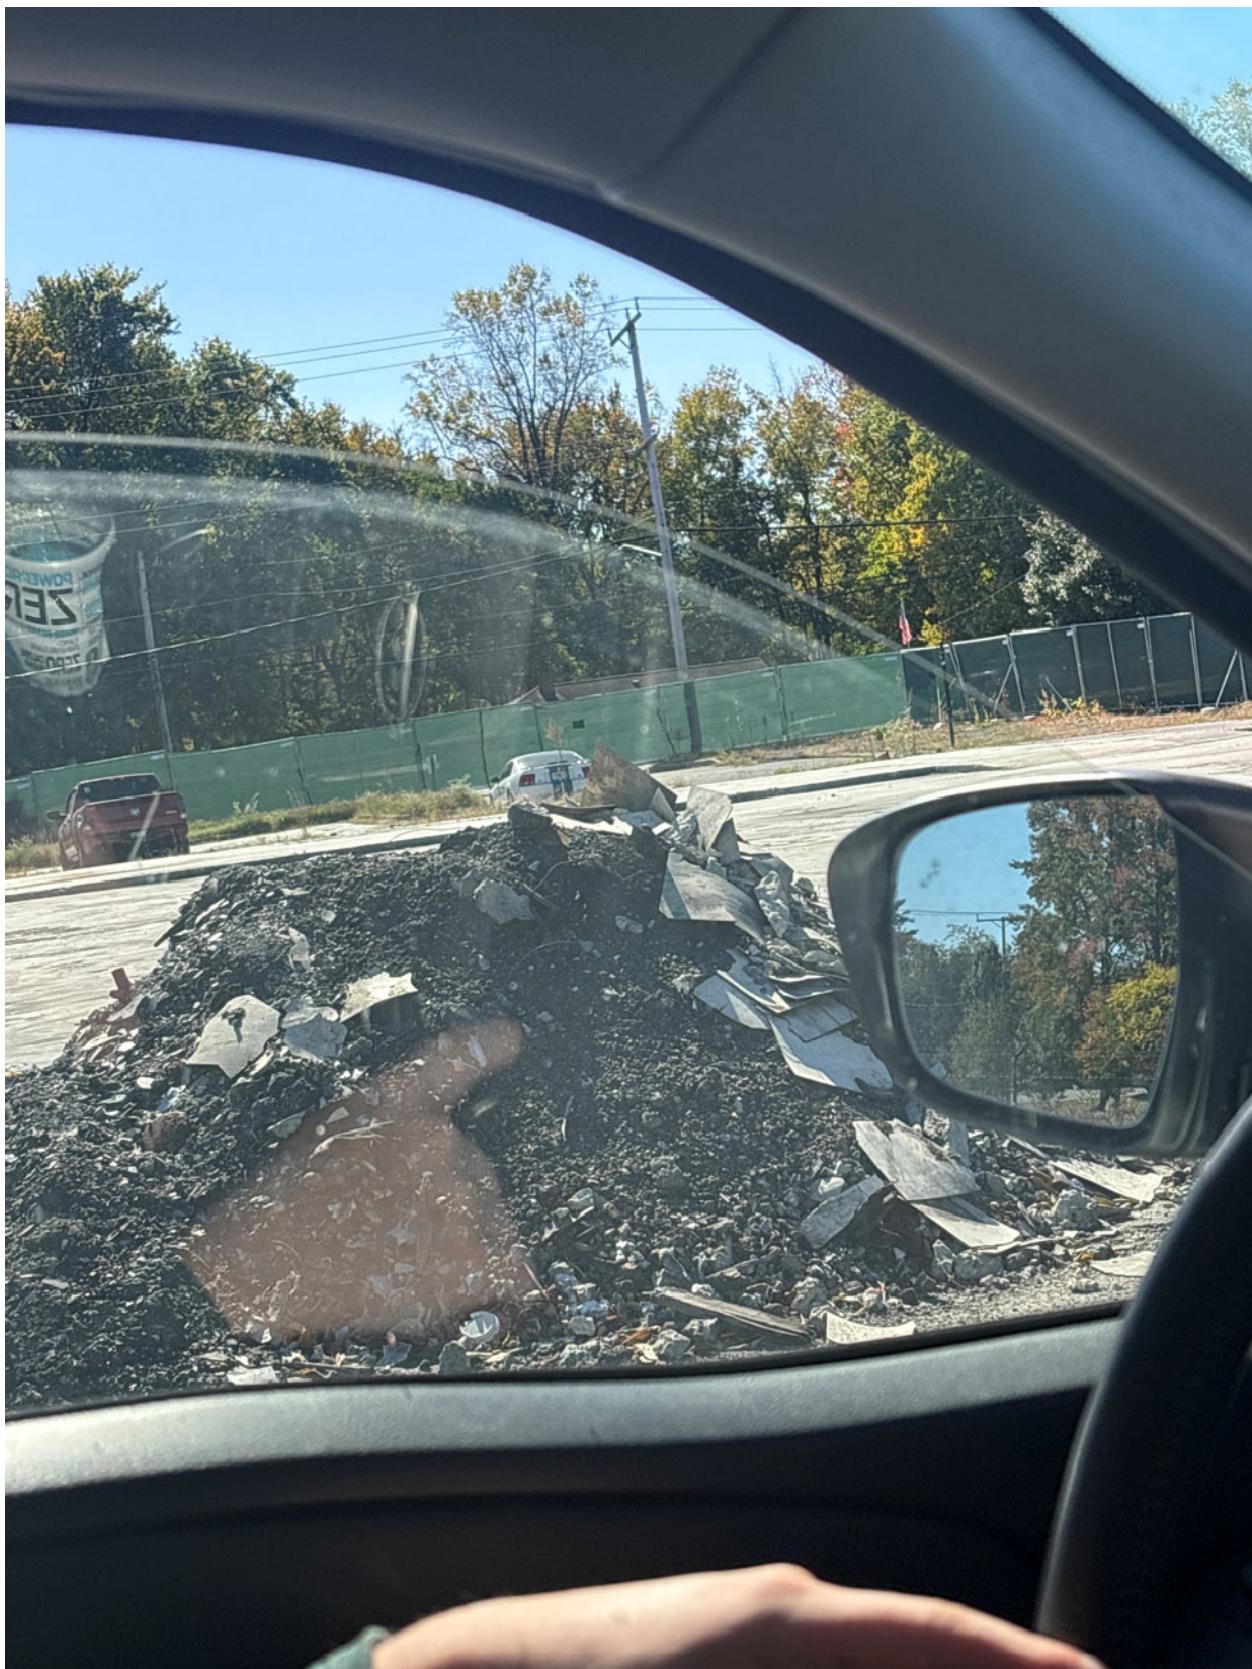
KCI discovered a stockpile of varying materials including dirt, trash and gravel being improperly stored on the property of Statewide Septic and Backhoe located at 436 W Central Avenue.

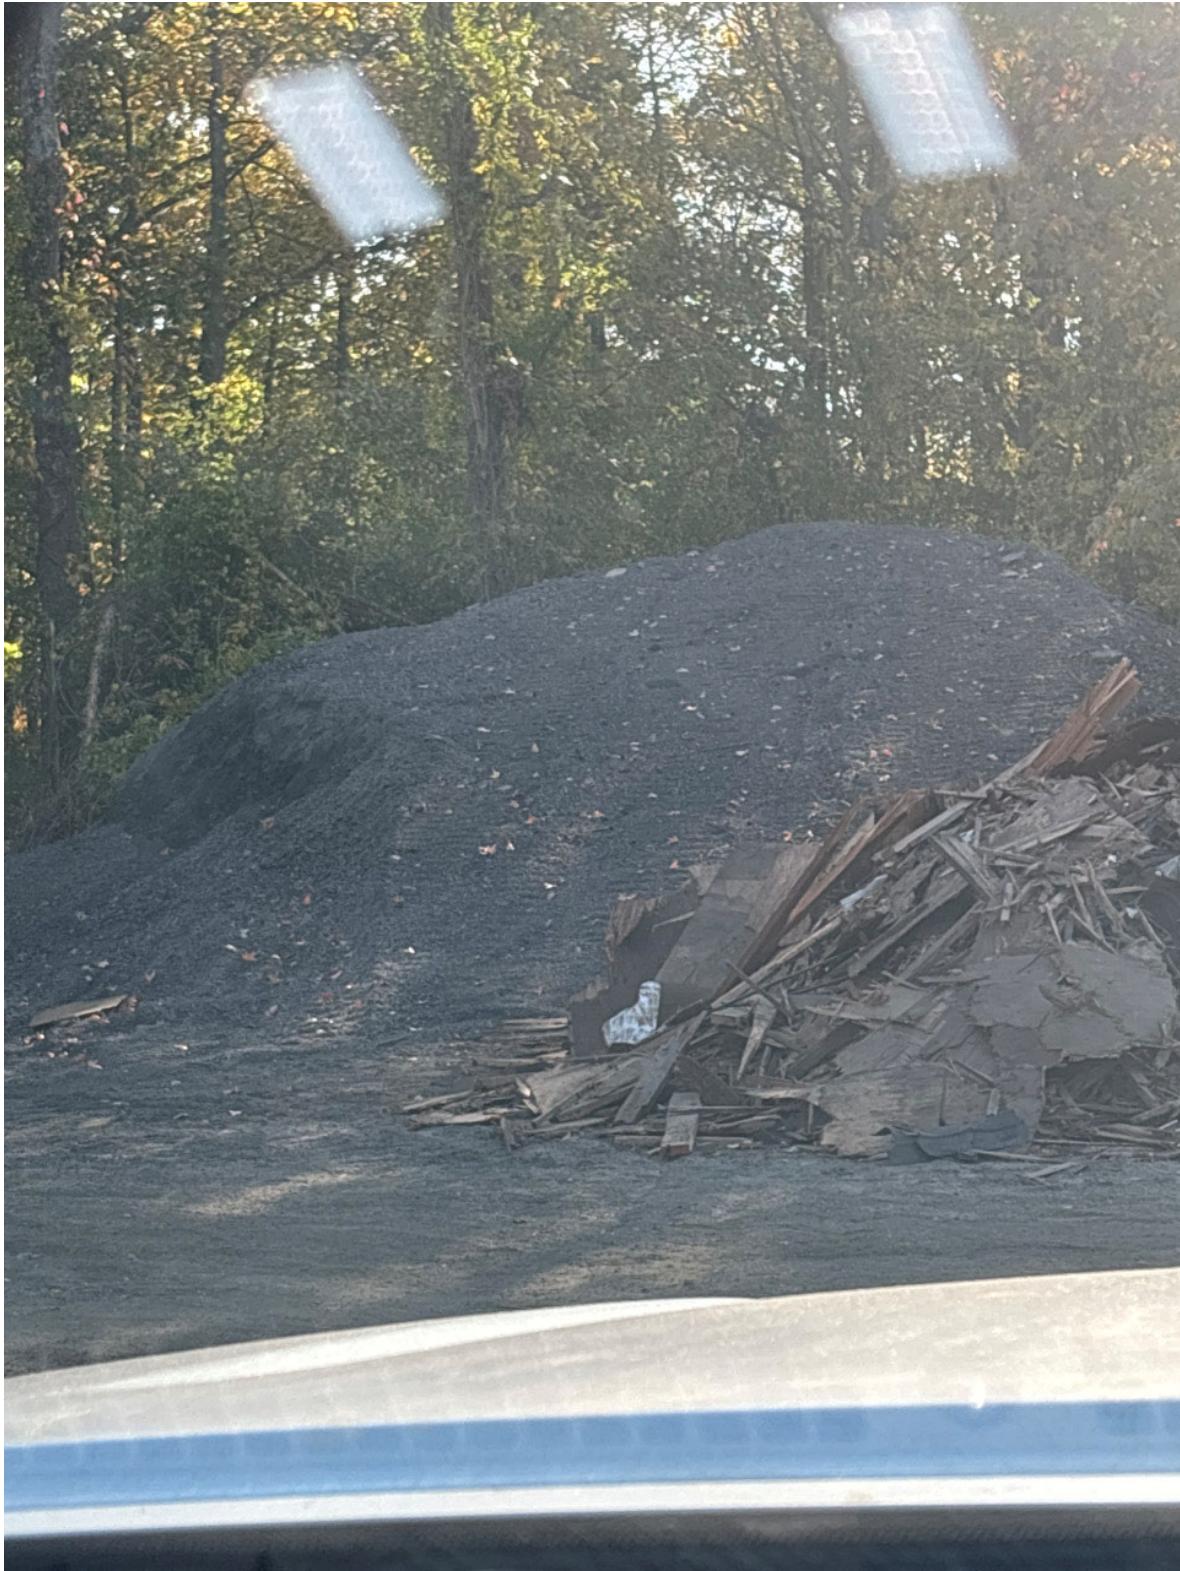
KCI discovered a gravel stockpile and a debris stockpile being improperly stored on the property of Statewide Septic & Backhoe located at 3259 Beards Point Rd.

10/22/2024 Inspection – Massive gravel stockpile and debris pile.

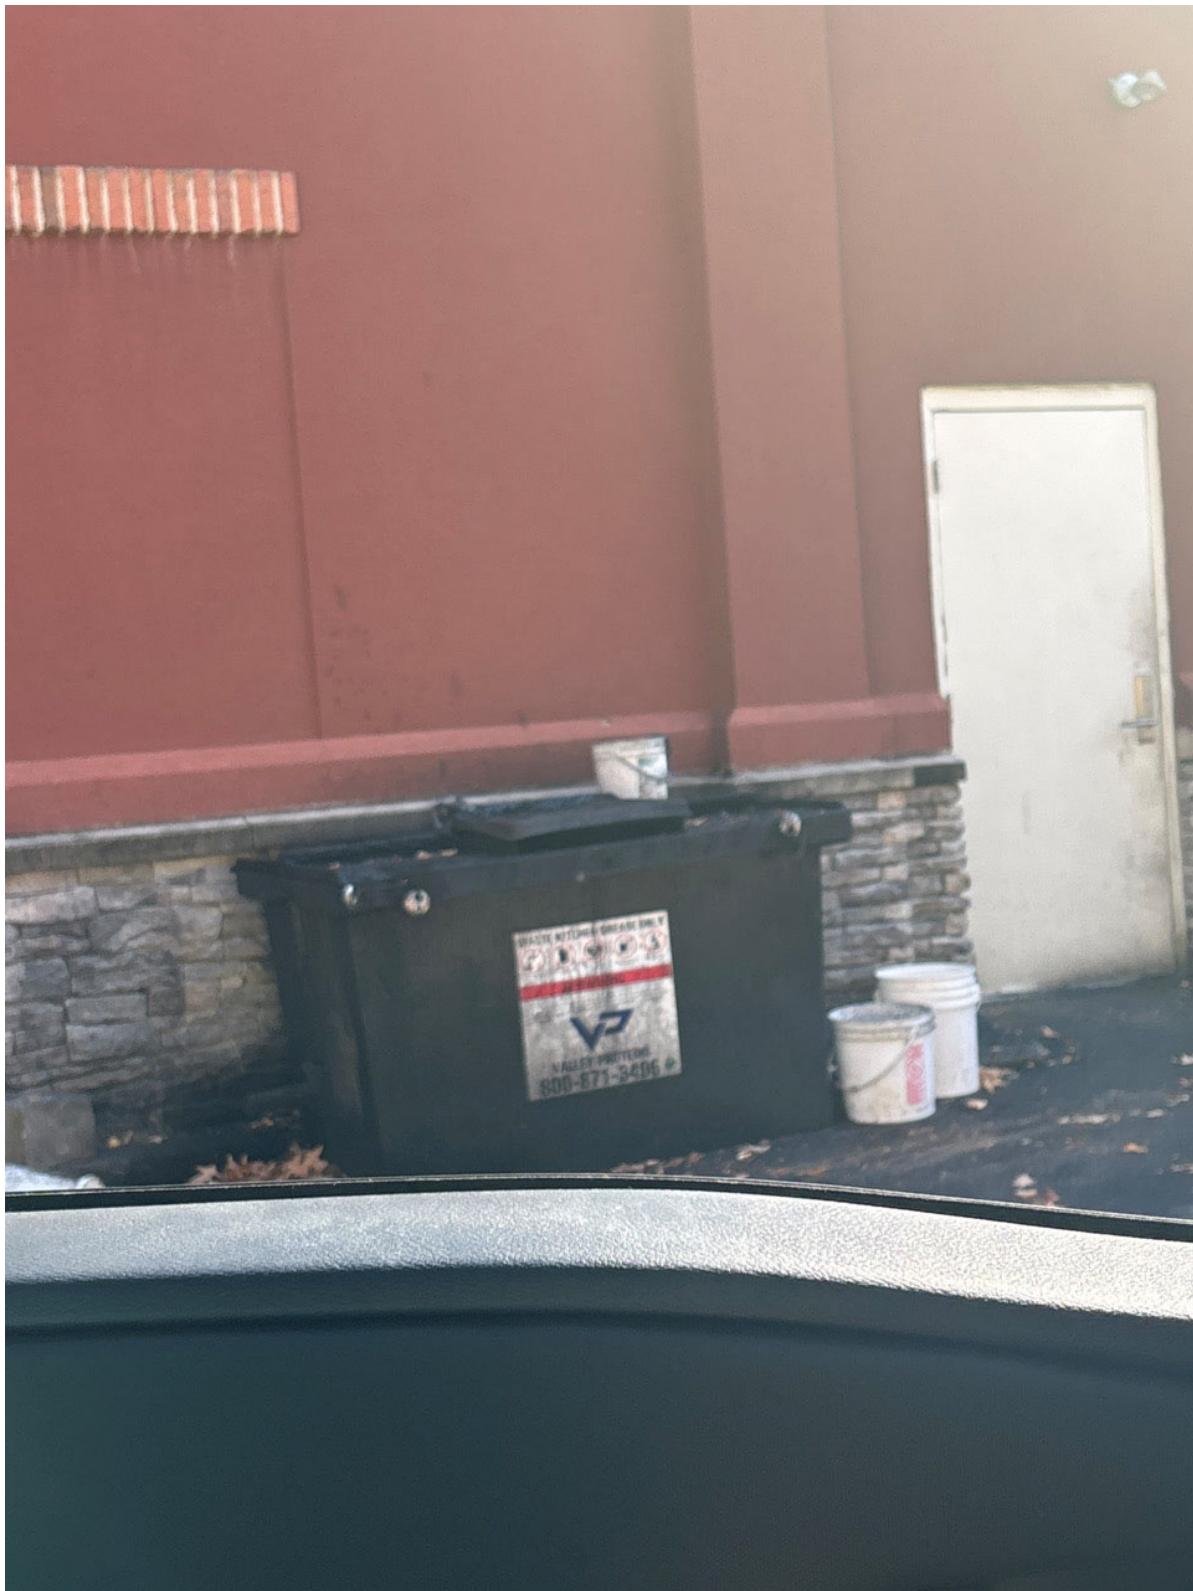
KCI discovered a grease bin with heavy staining on the pavement behind Christopher's Fine Foods located at 5570 Shady Side Road.

10/30/2024 Inspection – Grease bin with heavy staining on the surrounding asphalt and concrete.

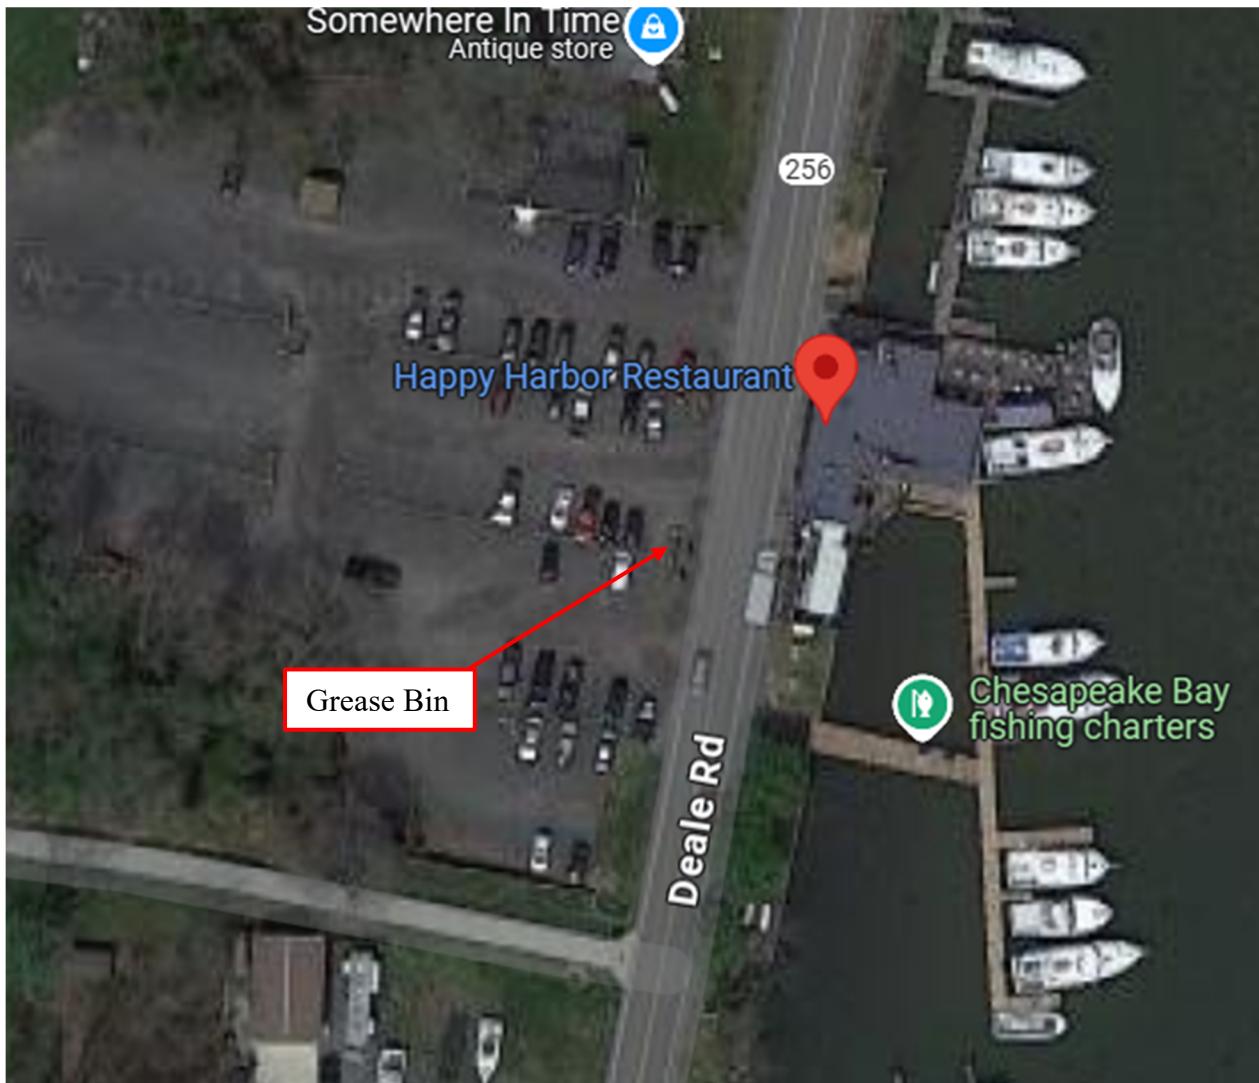
On October 30, 2024, while performing commercial industrial inspections for Anne Arundel County, KCI Technologies, Inc. discovered a grease bin with staining on and around itself at Happy Harbor Restaurant.

10/30/2024 Inspection – Grease bin with staining on and around it.

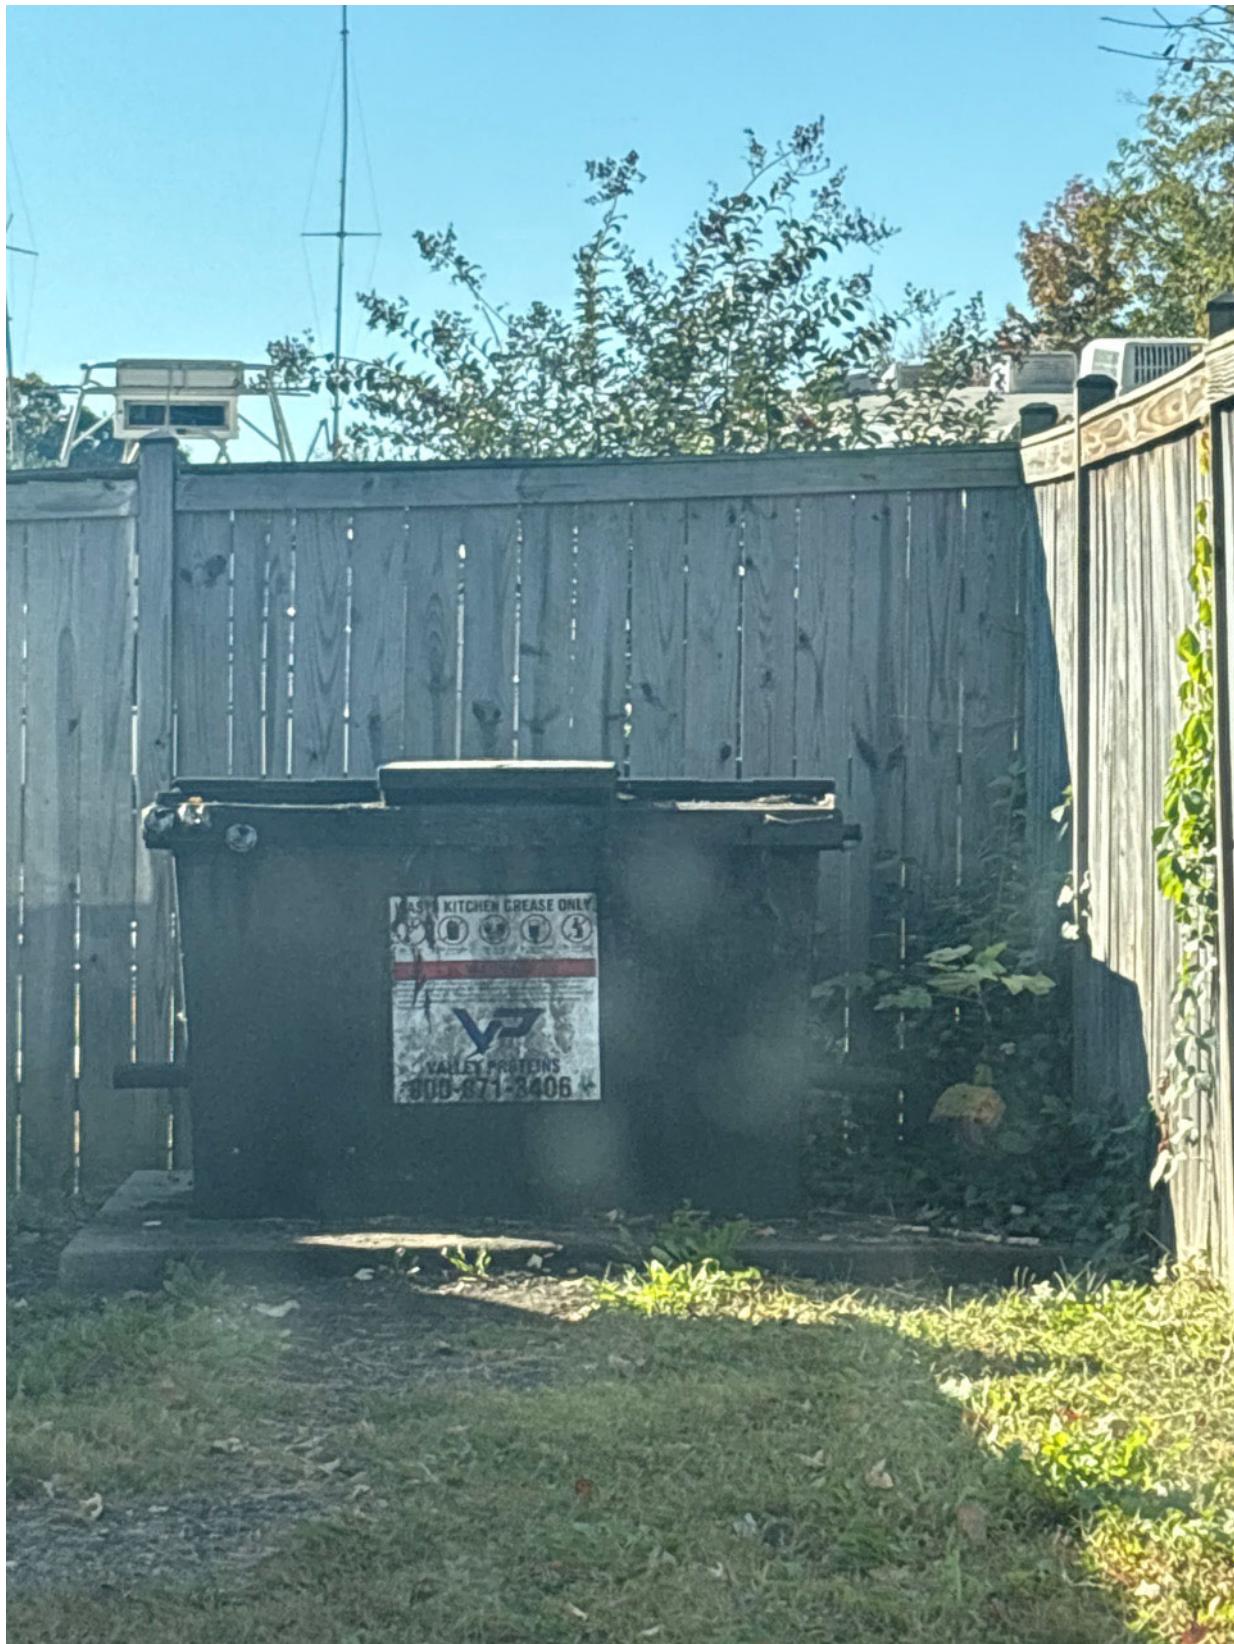
KCI discovered a grease bin with staining on and around itself at Happy Harbor

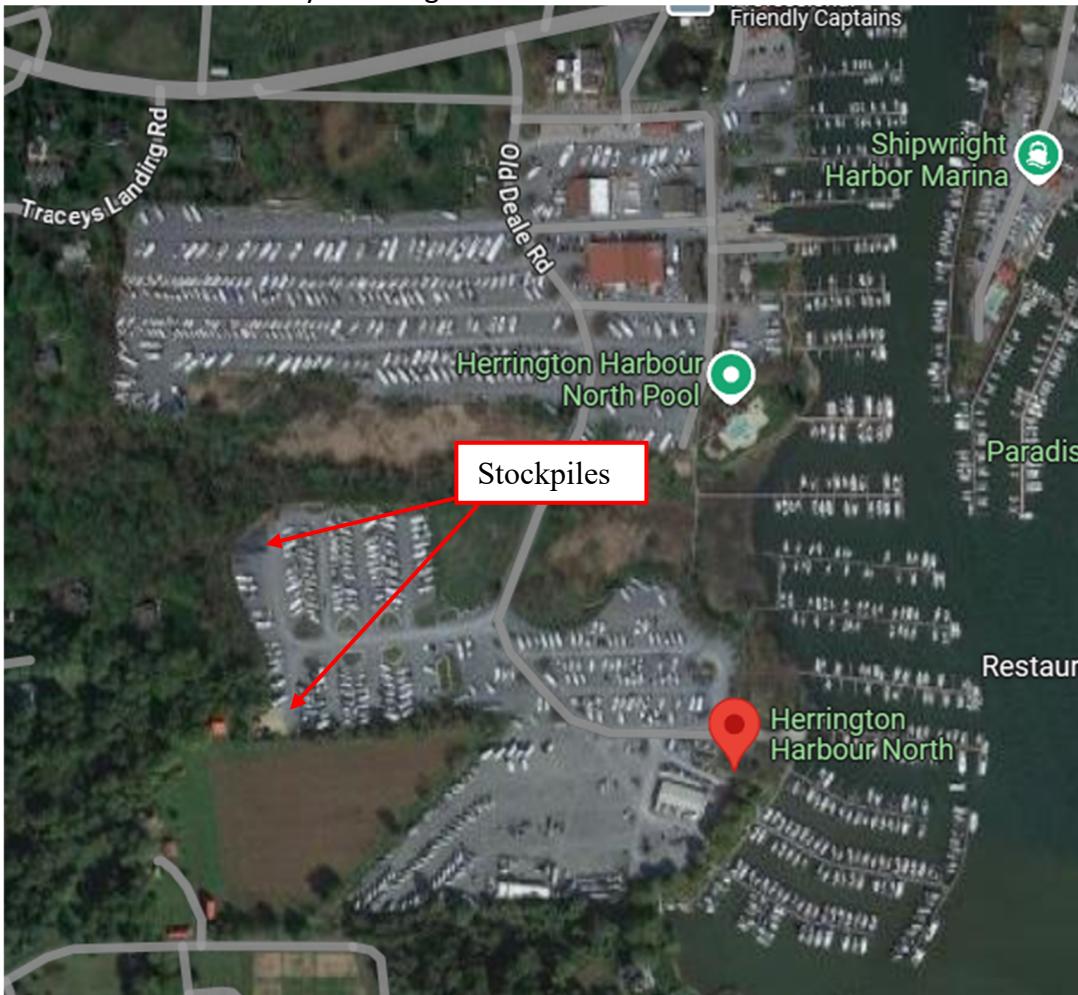
On October 30, 2024, while performing commercial industrial inspections for Anne Arundel County, KCI Technologies, Inc. discovered multiple dirt/sand/stone stockpiles on the property of Herrington Harbour North.

10/30/2024 Inspection – Multiple large stockpiles of gravel, sand, and dirt.
