**ANNE ARUNDEL COUNTY  
ILLICIT DISCHARGE DETECTION  
AND ELIMINATION PROGRAM REPORT:  
July 2024 – June 2025 (Fiscal Year 2025)**

Anne Arundel County  
Department of Public Works  
Bureau of Watershed Protection and Restoration  
2662 Riva Road  
Annapolis, MD 21401

KCI Technologies, Inc.  
936 Ridgebrook Road  
Sparks, MD 21152

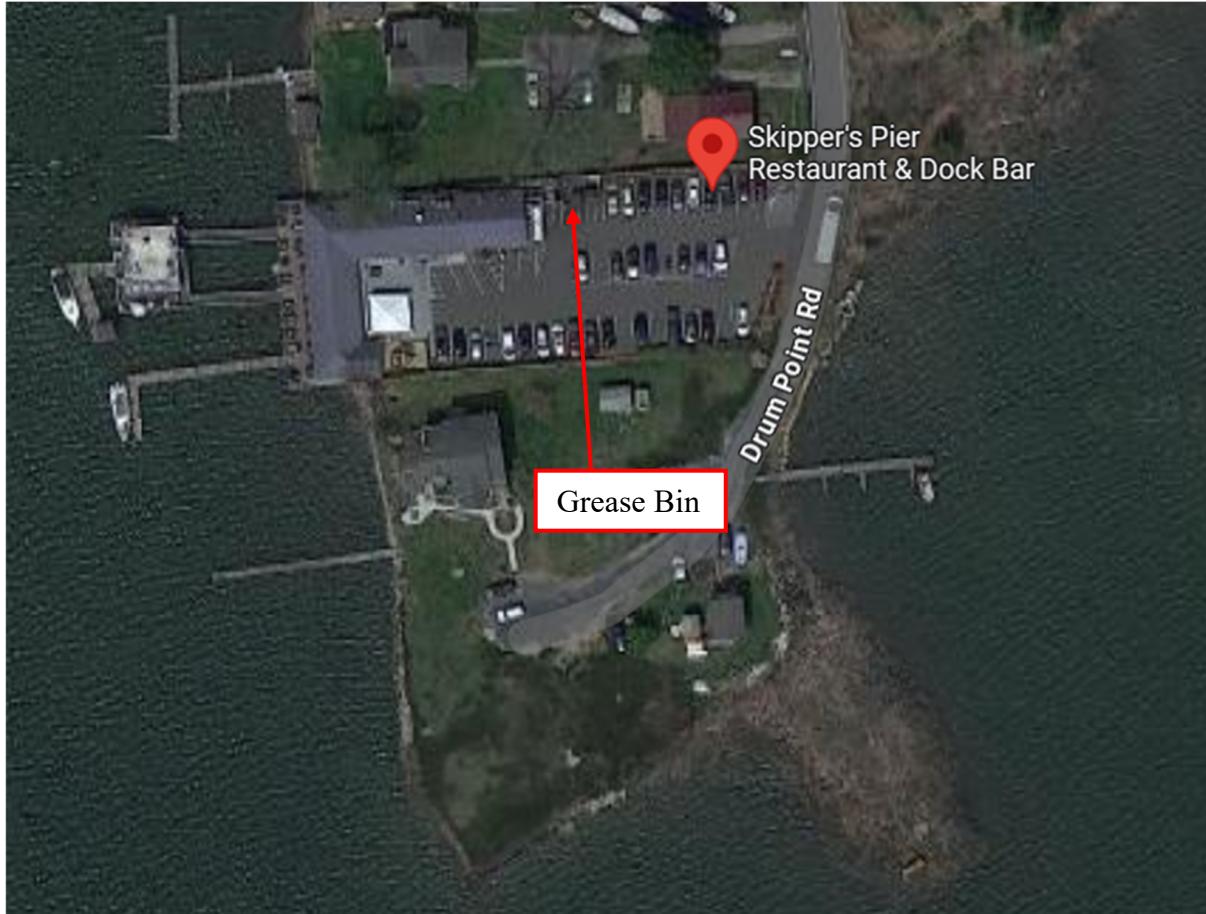
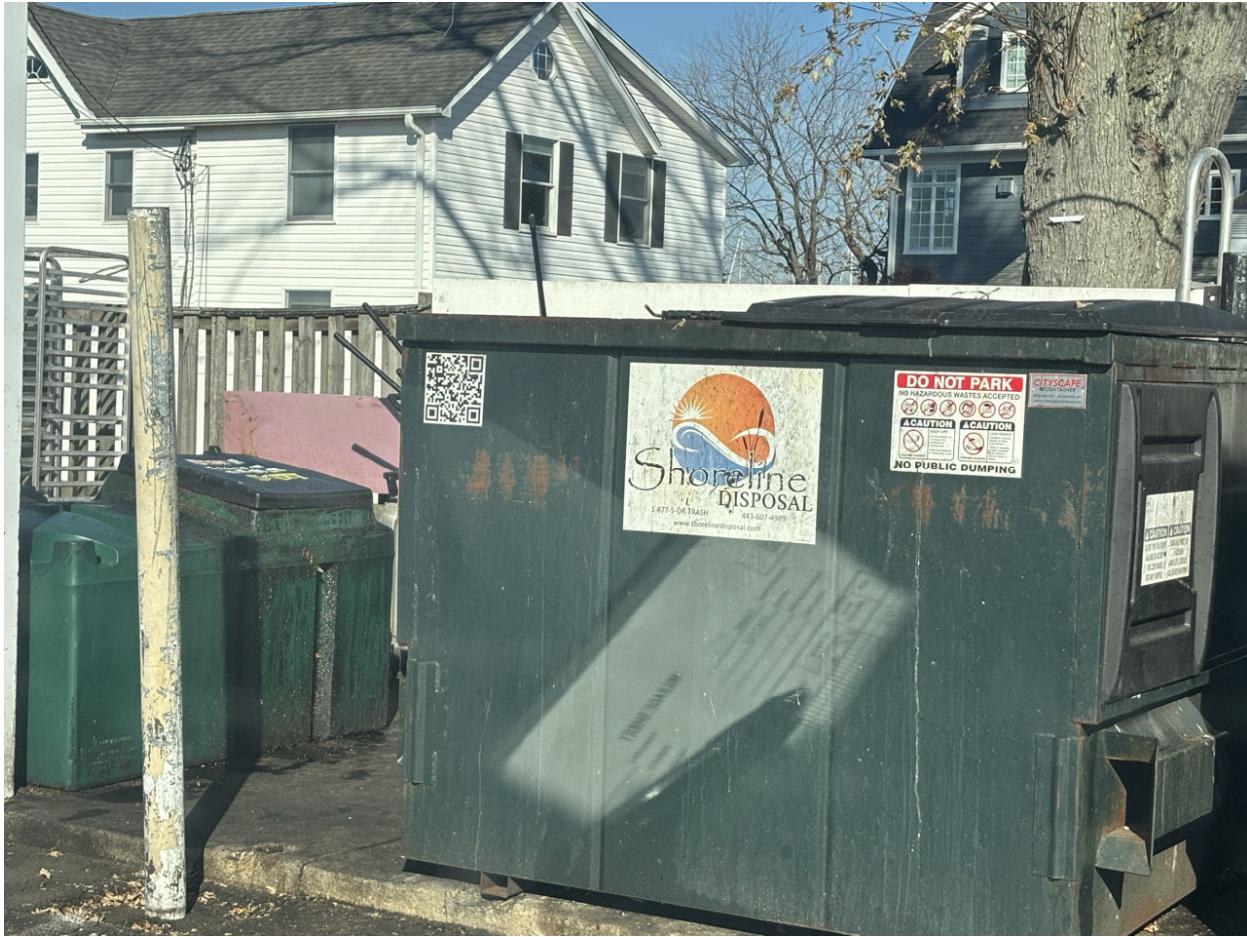
KCI discovered a grease bin with heavy staining on the pavement and on itself behind Skipper's Pier Restaurant & Dock Bar located at 6158 Drum Point Road.

10/30/2024 Inspection – Grease bin with heavy staining on itself and surrounding concrete.
