# Crofton Meadows Elementary School Safe Routes to School Accessibility Study: Existing Conditions and Recommendations

# Anne Arundel Safe Routes to School Accessibility Study

# Crofton Meadows Elementary Accessibility Study

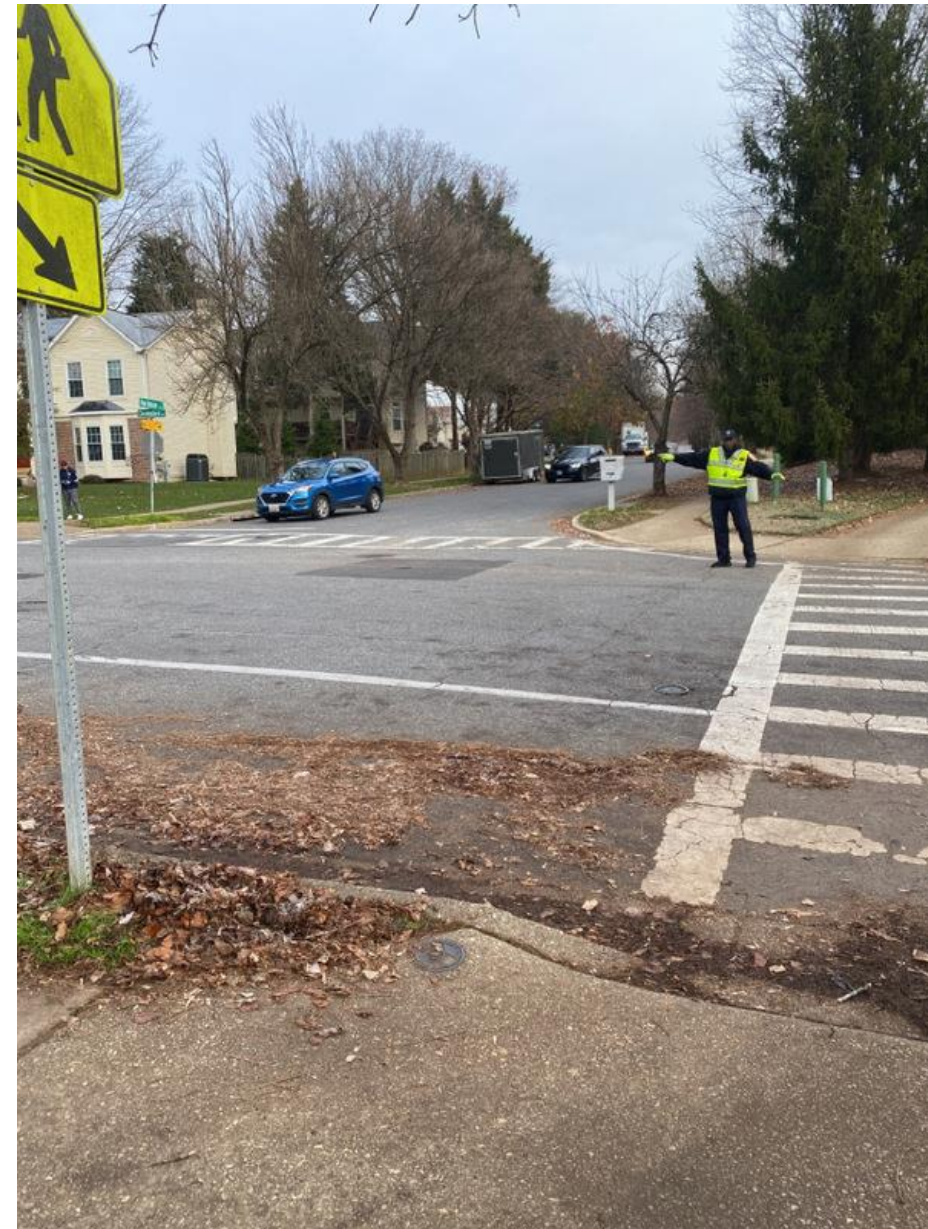
One of the crossing guards is stationed at the intersection of Chelmsford Drive and Hornbeam Drive

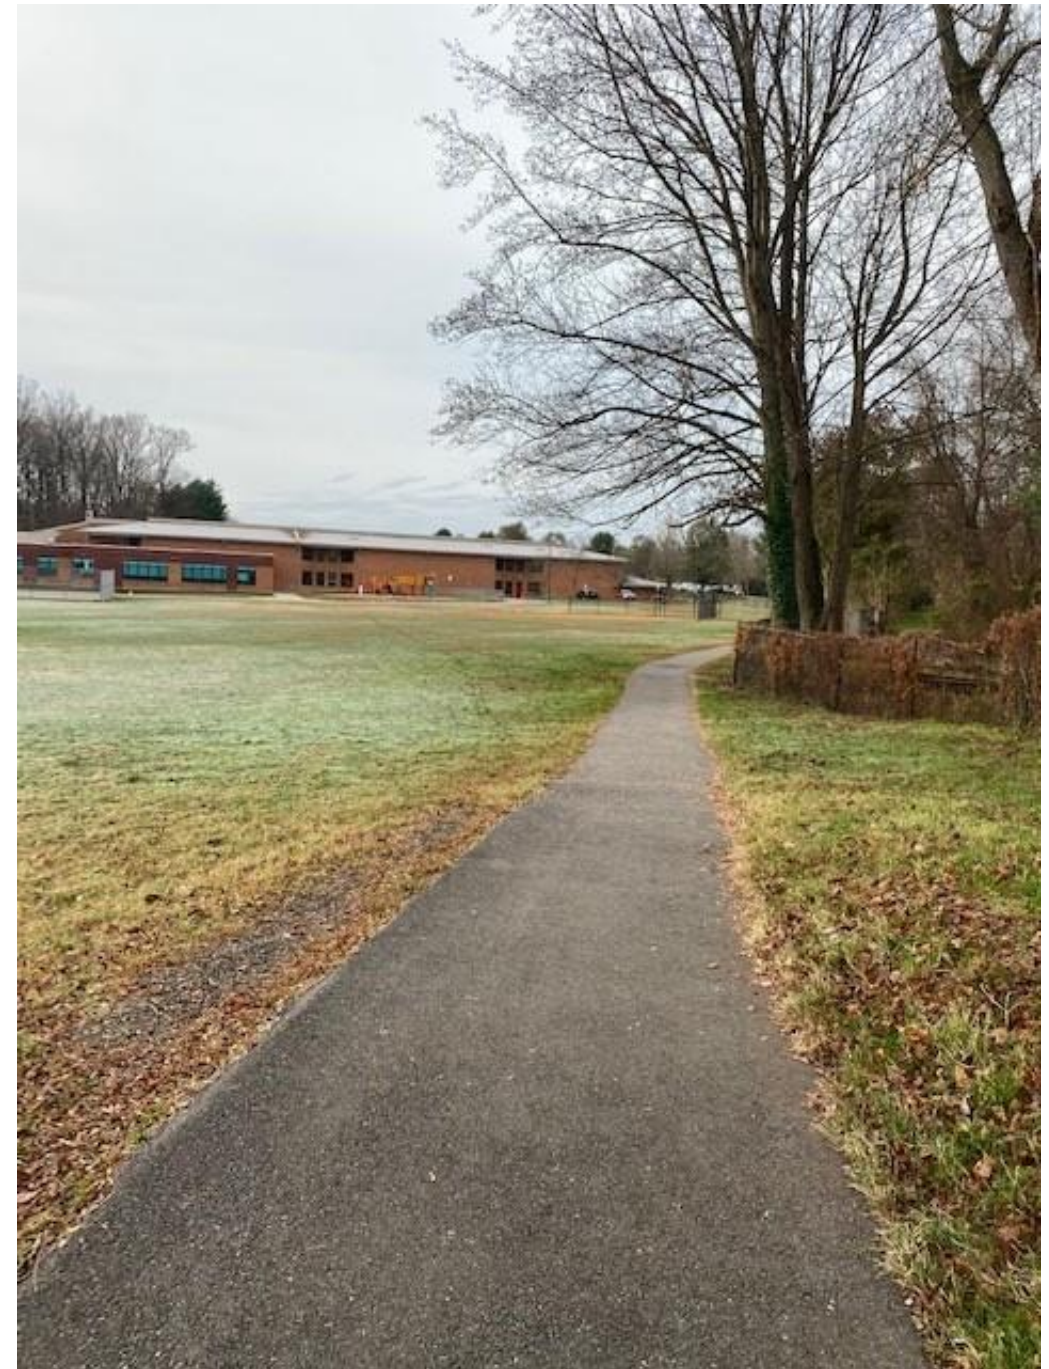
Many walkers at arrival were seen using this path to the school.

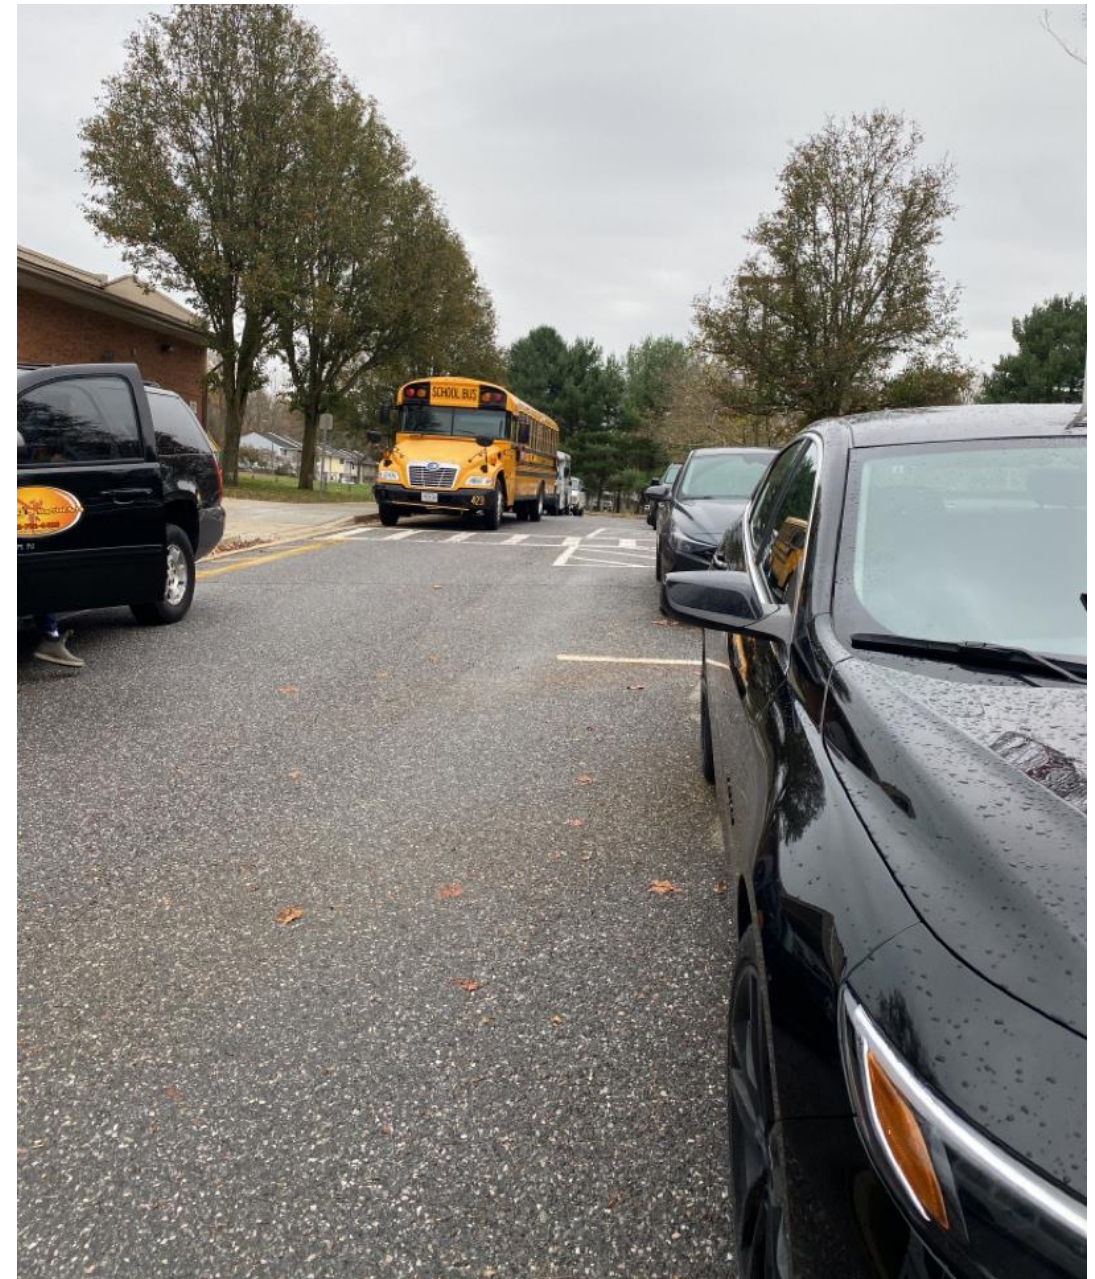
Bus drop off at the main entrance of the school (note cars are parked in marked parking spaces).

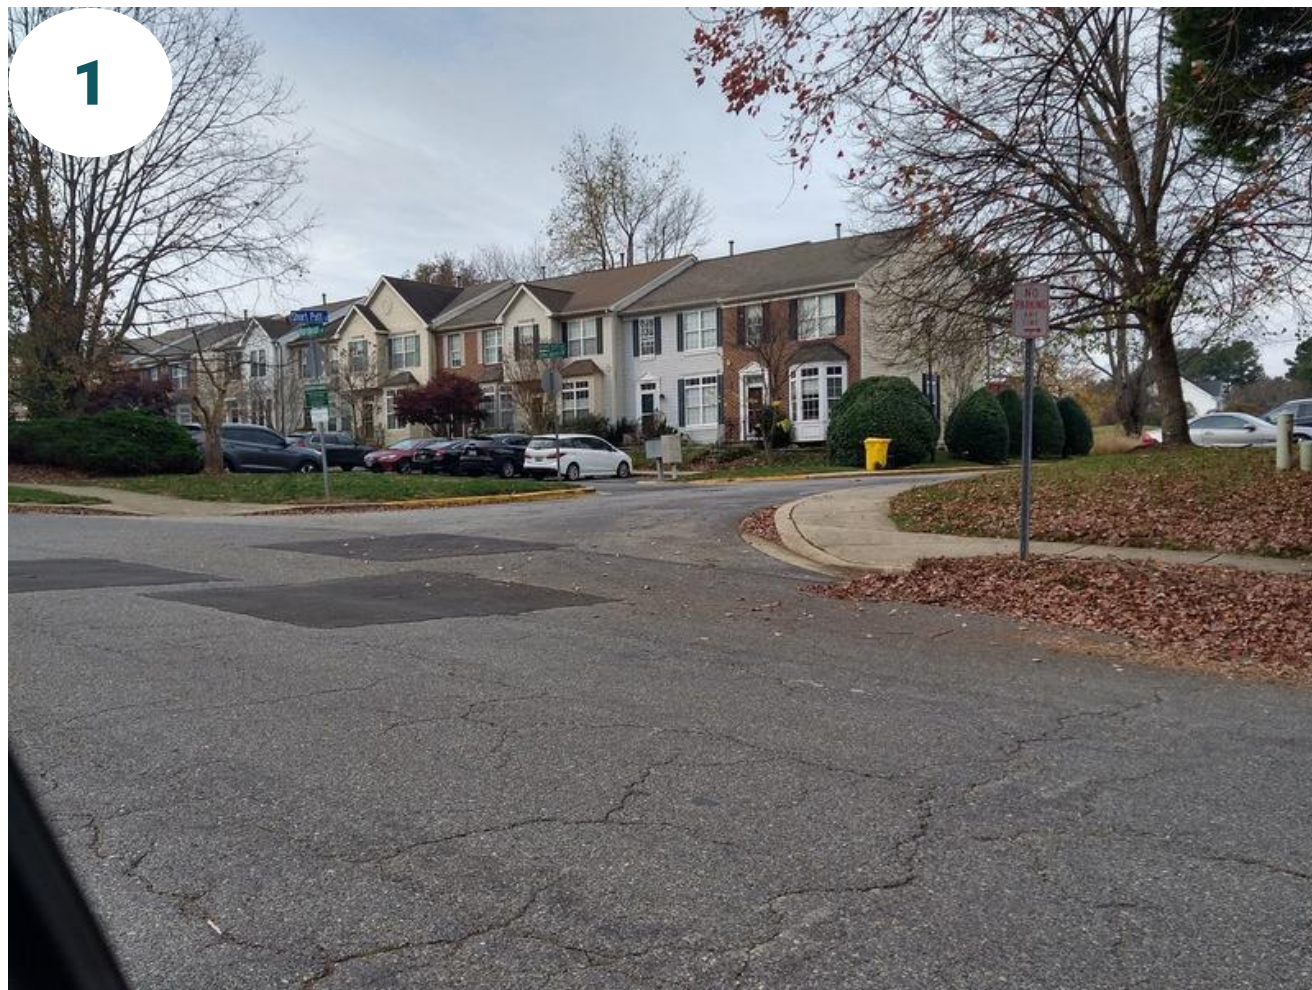
The intersection of Hornbeam Drive and Hightee Court – part of recommendation corridor.

| Map ID | Location | Facility Type | Issue | Recommendation | Potential Cost | Timeframe* |
|---|---|---|---|---|---|---|
| 1 | Hornbeam Dr (Hightee Ct to Chelmsford Dr) (Along key student walking route) | 1a. Curb Ramp | All curb ramps lack detectable warning surfaces | Reconstruct or repair existing ramps for the side street crossings of Hightee Ct/Short Putt Ct, Kemper Rd, Dog Leg Ct | \$40,000 | Medium |
| | | 1b. Crosswalk | Crossings of side streets are unmarked<br>No stop bars across side streets | Install new standard crosswalks for the side street crossings of Hightee Ct/Short Putt Ct, Kemper Rd, and Dog Leg Ct, Mark new stop bars | \$2,000 | Short |

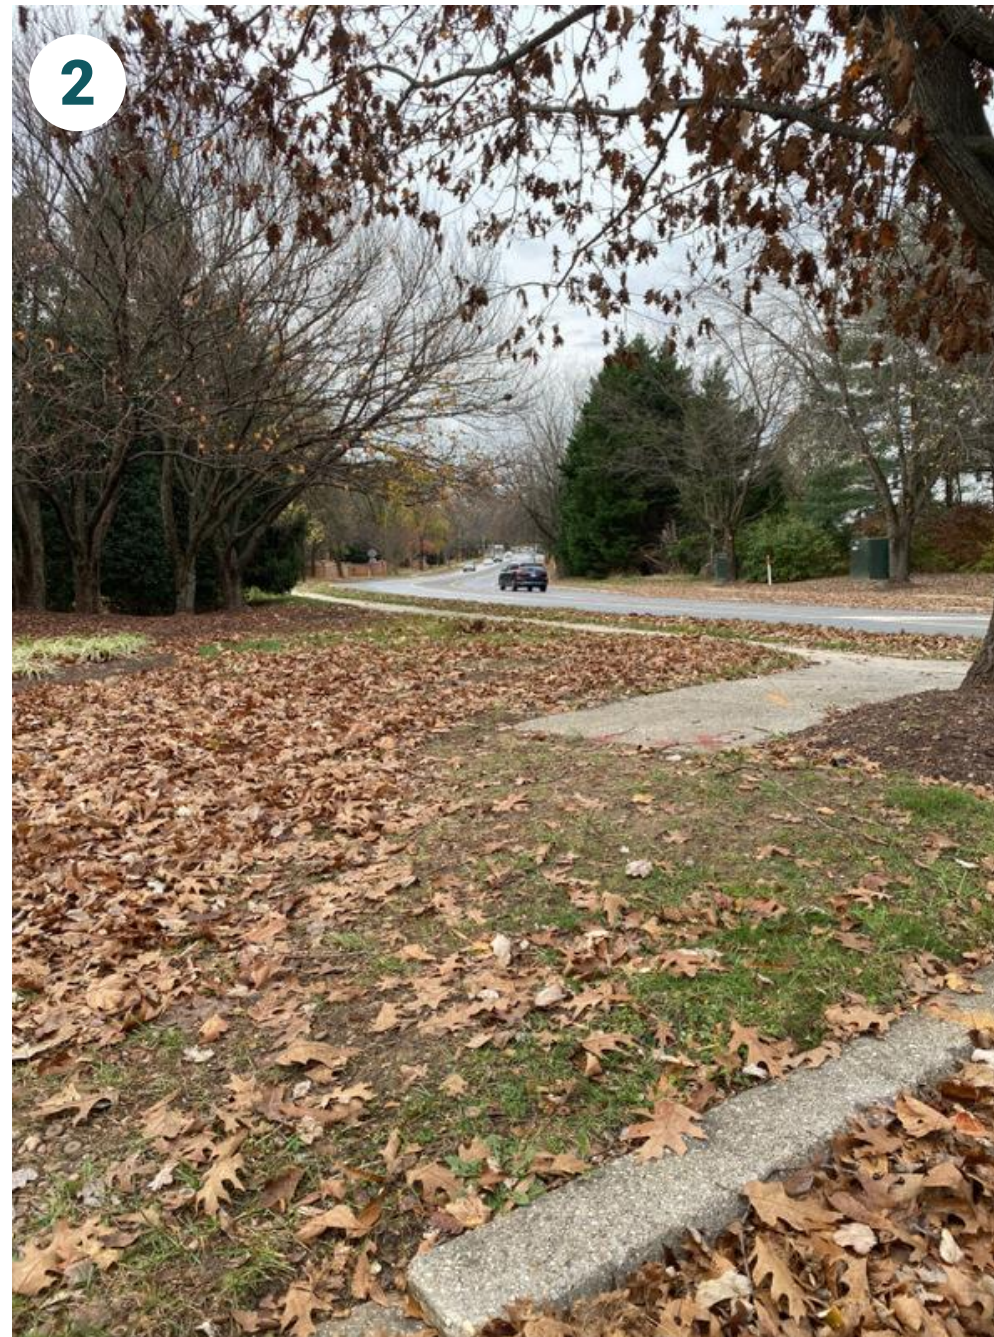
A gap in the sidewalk on Chelmsford Drive near Riedel Road.

| Map ID | Location | Facility Type | Issue | Recommendation | Potential Cost | Timeframe* |
|---|---|---|---|---|---|---|
| 2 | Chelmsford Dr (near Riedel Rd) (Along key student walking route) | Sidewalk | Gap in sidewalk network on south side of Chelmsford Dr | Install new sidewalk** | \$28,585 | Long |

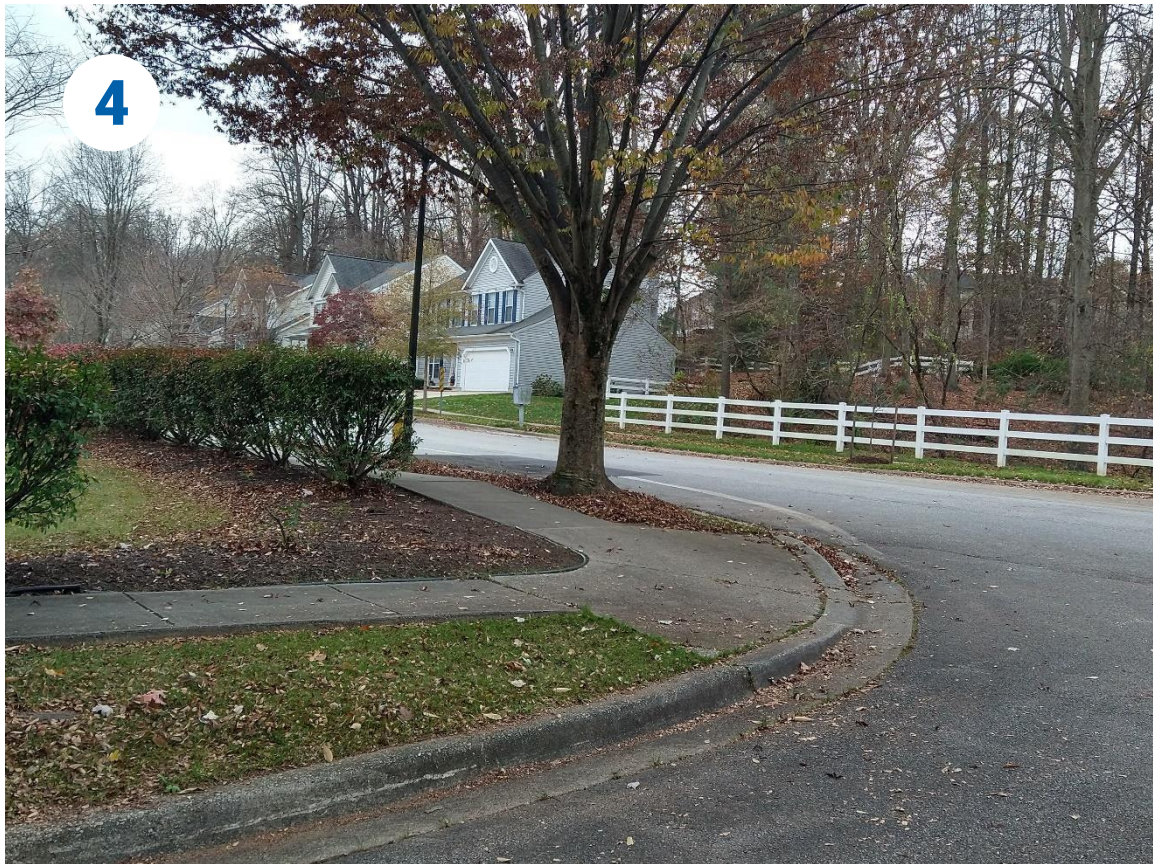
Many of the side streets intersecting with Chelmsford Drive lack marked crosswalks and detectable warning surfaces on the curb ramps.

| Map ID | Location | Facility Type | Issue | Recommendation | Potential Cost | Timeframe* |
|---|---|---|---|---|---|---|
| 4 | Chelmsford Dr (Hornbeam Dr to Thistle Brooke Ct) (Along key student walking route, Inside school zone) | 4a. Crosswalk | Crossings of side streets are unmarked or faded<br><br>No stop bars across side streets | Install new standard crosswalks for the side street crossings of Tuffed Moss Ct, Christa Ln, and Thistle Brooke Ct/Houndhill Ct), Mark new stop bars | \$2,000 | Short |
| | | 4b. Curb ramp | All curb ramps lack detectable warning surfaces | Reconstruct or repair existing ramps at location of new crosswalks and at northeast corner of Chelmsford Dr | \$3,200 | Medium |

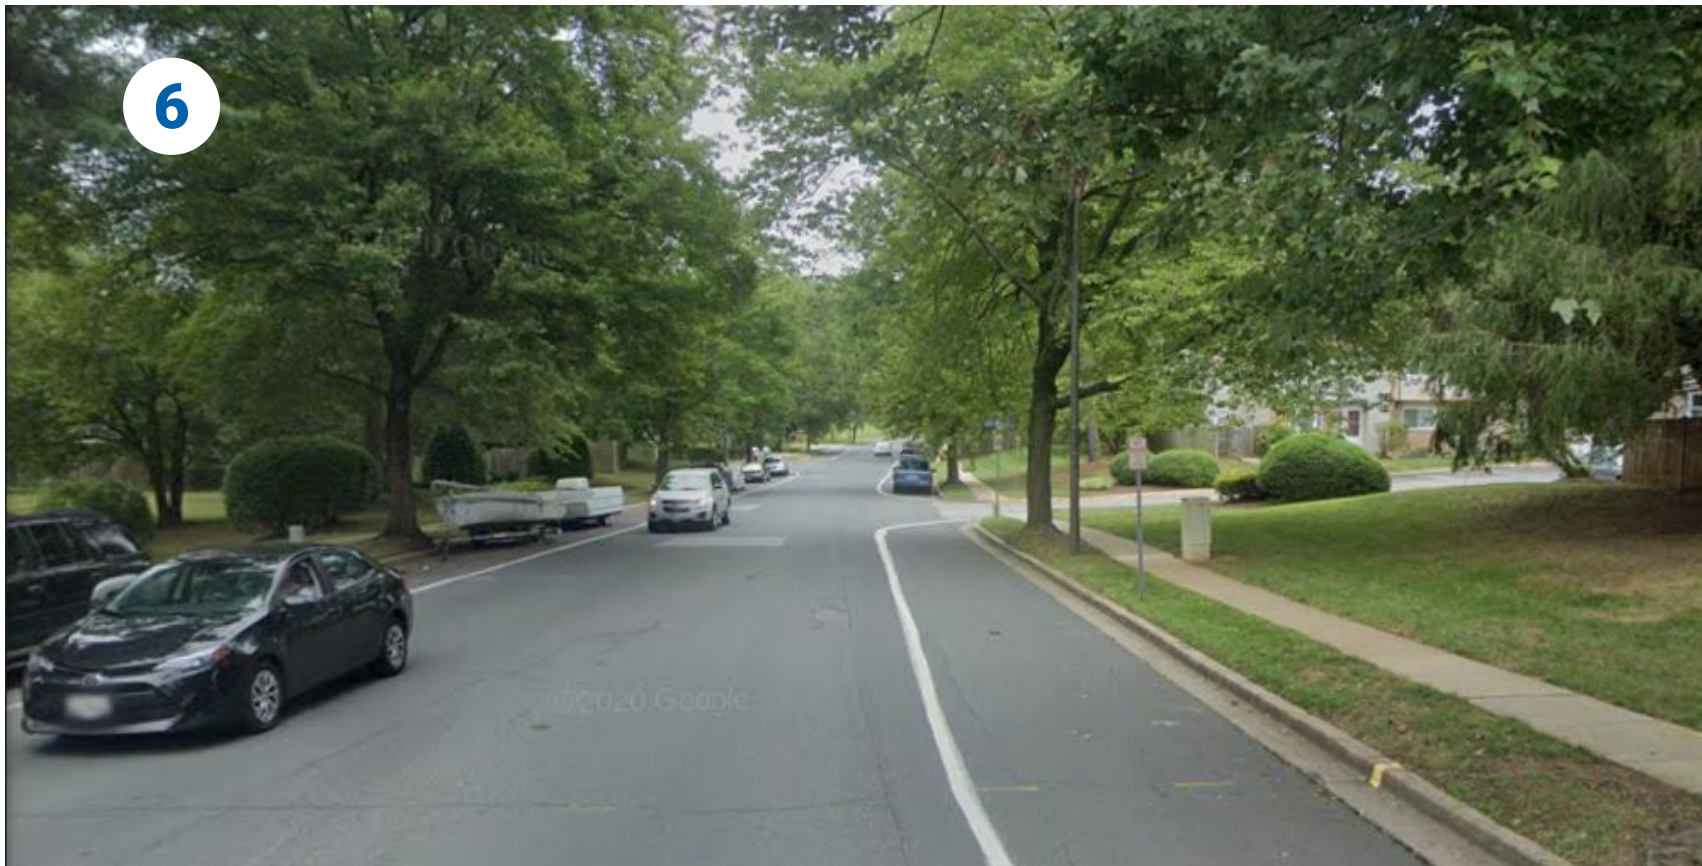
Tilghman Drive approaching Crofton Meadows Elementary School.

| Map ID | Location | Facility Type | Issue | Recommendation | Potential Cost | Timeframe* |
|---|---|---|---|---|---|---|
| 6 | Tilghman Dr (Kent Fort Ln to Yorktown Ct) (Along key student walking route, Inside school zone) | 6a. Speed Management | Observed motor vehicles appear to exceed speed limit | Conduct a speed study to consider speed management measures or other modifications. | N/A | Long |
| | | 6b. School Zone Signs and Pavement Markings | SCHOOL pavement marking, school zone sign, and school zone speed limit sign missing | Enhance existing school zone signage per MdMUTCD part 7.<br>- Install new SCHOOL pavement marking<br>- Install new school zone sign (begin/end)<br>- Install new school zone speed limit sign. | \$1,000<br><br>\$1,000<br><br>\$500 | Short |

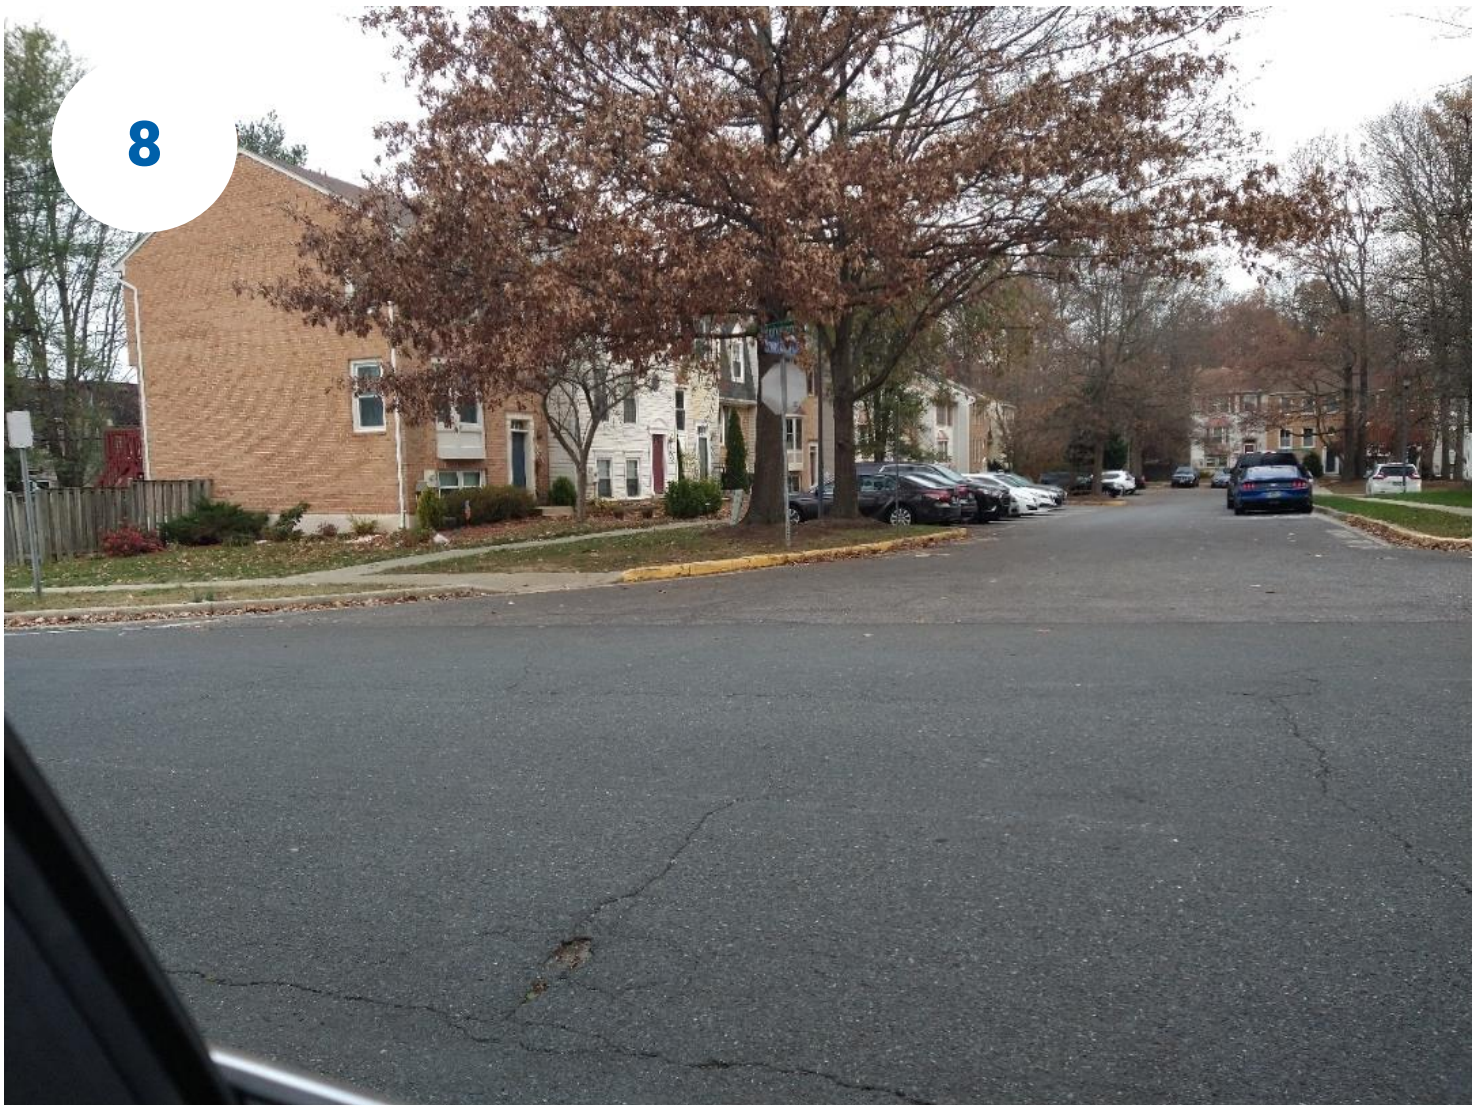
Tilghman Drive at Howard Chapel Court – part of recommendation corridor.

| Map ID | Location | Facility Type | Issue | Recommendation | Potential Cost | Timeframe* |
|---|---|---|---|---|---|---|
| 8 | Tilghman Dr (Grason Ln to Howard Chapel Ct) (Along key student walking route, Inside school zone) | 8a. Crosswalk | Crossings at side streets are unmarked<br><br>No stop bars across side streets. | Install new standard crosswalks for the side street crossings of Grason Ln, Fendall Ct/Kent Fort Ln, Mt Airy Ct/Holly Hilly Ln, Mt. Airy Ct, New Windsor Ct (east and west), Fallsway Dr/Yorktown Ct, Forest Hill Ct/Lake Grove Ln, Forest Hill Ln/Remington Dr, Howard Chapel Turn, Remington Dr/Howard Chapel Ct<br>Mark new stop bars | \$8,500 | Short |
| | | 8b. Curb Ramp | Ramps at side streets lack detectable warning surfaces (also at crossing of Tilghman Dr at Riedel Rd)<br><br>Note that County GIS data shows most curb ramps are ADA compliant. | Reconstruct or repair existing ramps at location of new crosswalks | \$144,000 | Medium |

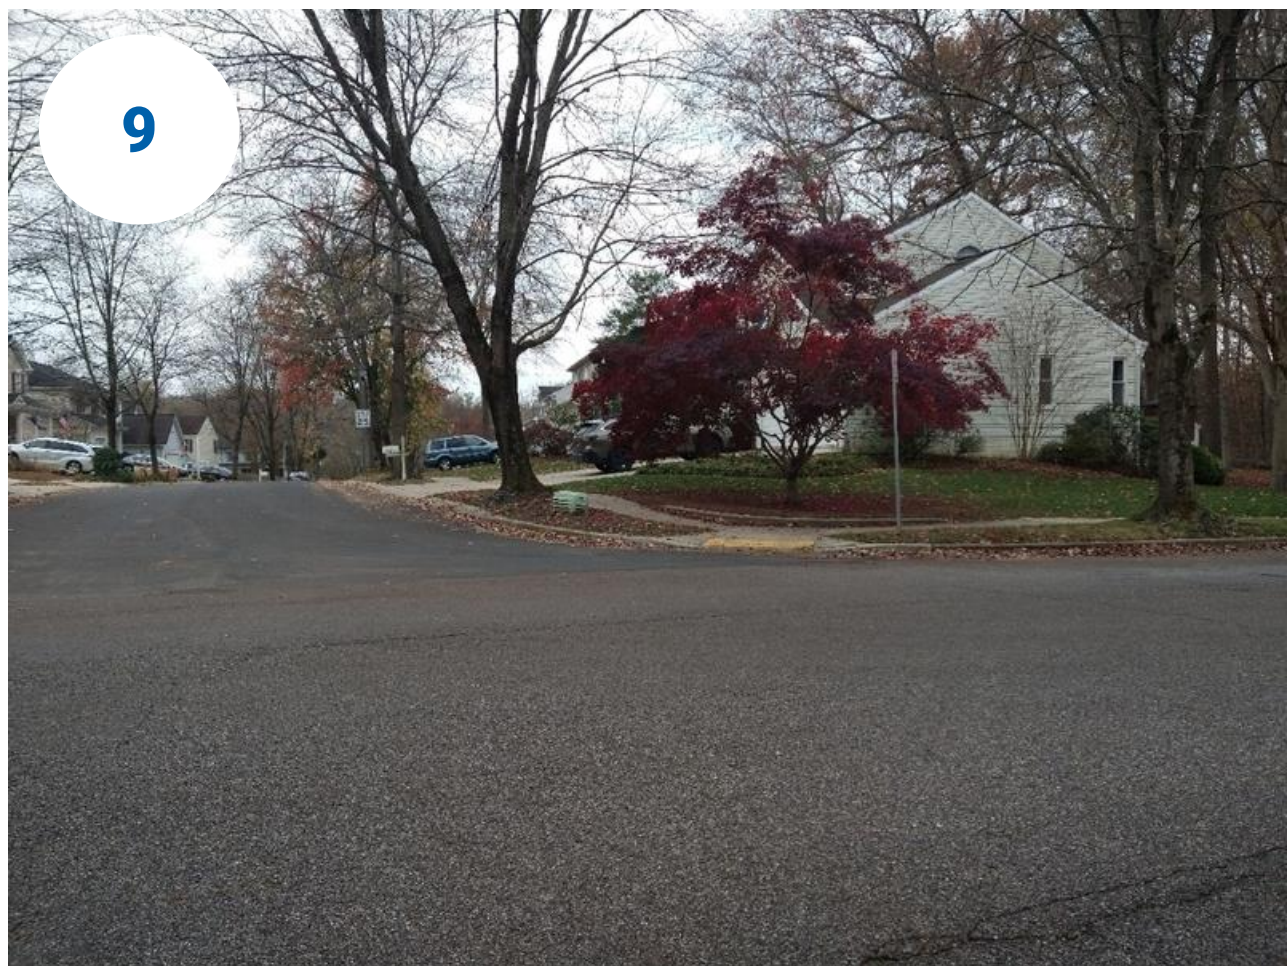
Fallsway Drive at Harewood Lane – part of recommendation corridor.

| Map ID | Location | Facility Type | Issue | Recommendation | Potential Cost | Timeframe* |
|---|---|---|---|---|---|---|
| 9 | Fallsway Dr (Whites Fetty Pl to Lake Grove Ln) (Along key student walking route) | 9a. Crosswalk | Crossings of side streets are unmarked<br><br>No stop bar | Install new standard crosswalk, Mark new stop bars for the side street crossings of Whites Ferry Pl, Log Mill Pl, Ingleside Ct/Log Ln, Harewood Ln, Jones Fall Ct, Linkwood Ln (east/west), Aberdeen Dr, Cambridge Dr, Jason Ct, Lake Grove Ln | \$5,000 | Short |
| | | 9b. Curb ramp | Ramps lack detectable warning surface | Reconstruct or repair existing ramps at Whites Ferry Pl, Log Mill Pl, Log Ln, Jones Fall Ct, Cambridge Dr, Jason Ct, Lake Grove L | \$56,000 | Medium |

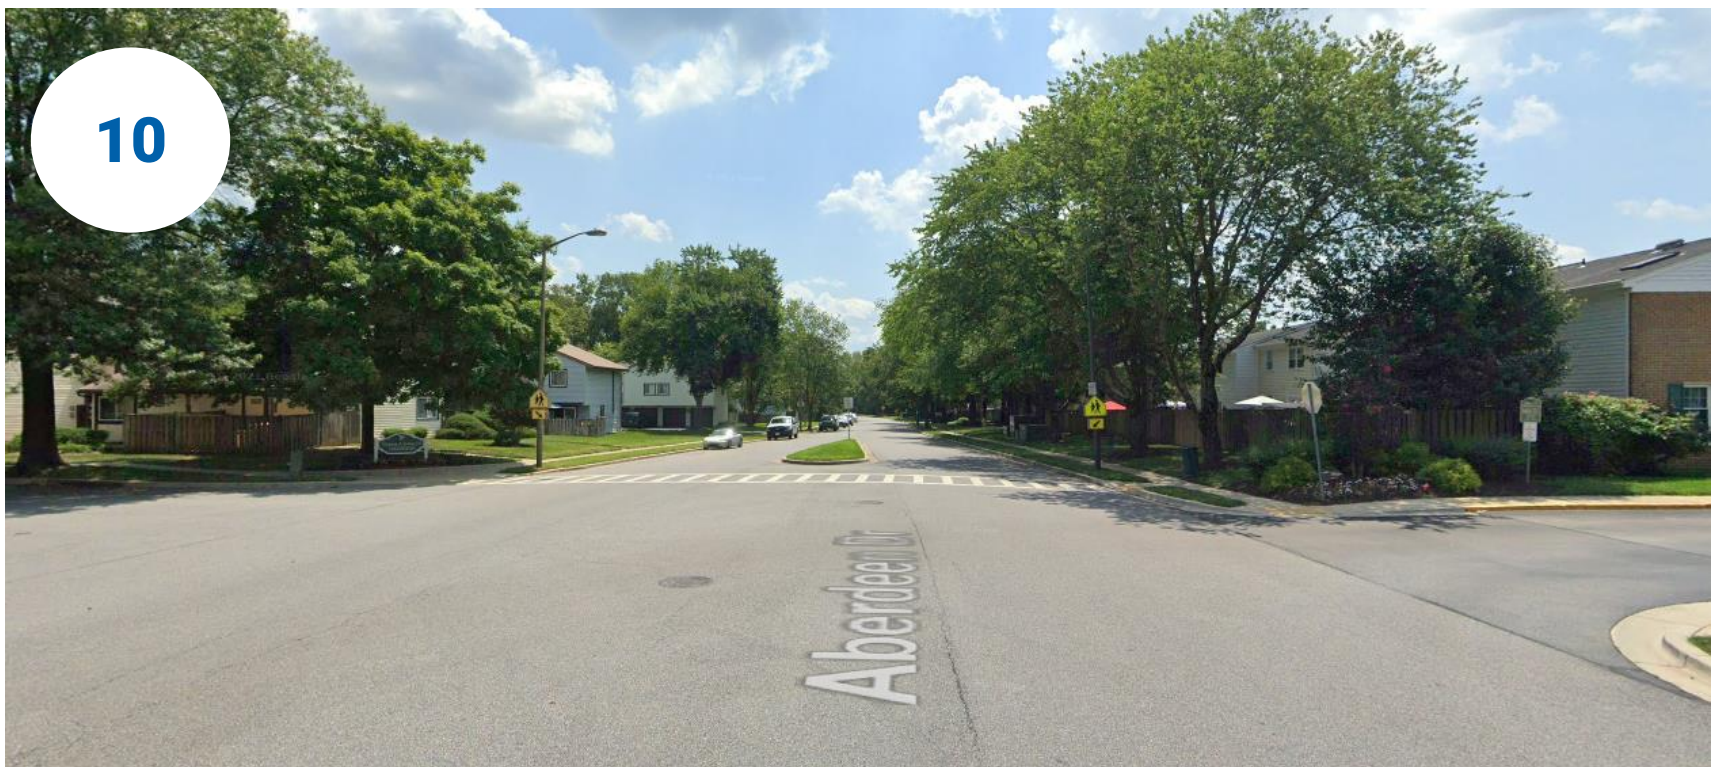
The intersection of Aberdeen Drive and Aberdeen Court, where the existing crosswalk can be seen.

| Map ID | Location | Facility Type | Issue | Recommendation | Potential Cost | Timeframe* |
|---|---|---|---|---|---|---|
| 10 | Aberdeen Dr & Aberdeen Ct (Crash hotspot) | Other intersection or crossing issues | Crossing of Aberdeen Dr long | Install median crossing island | \$3,000 | Long |

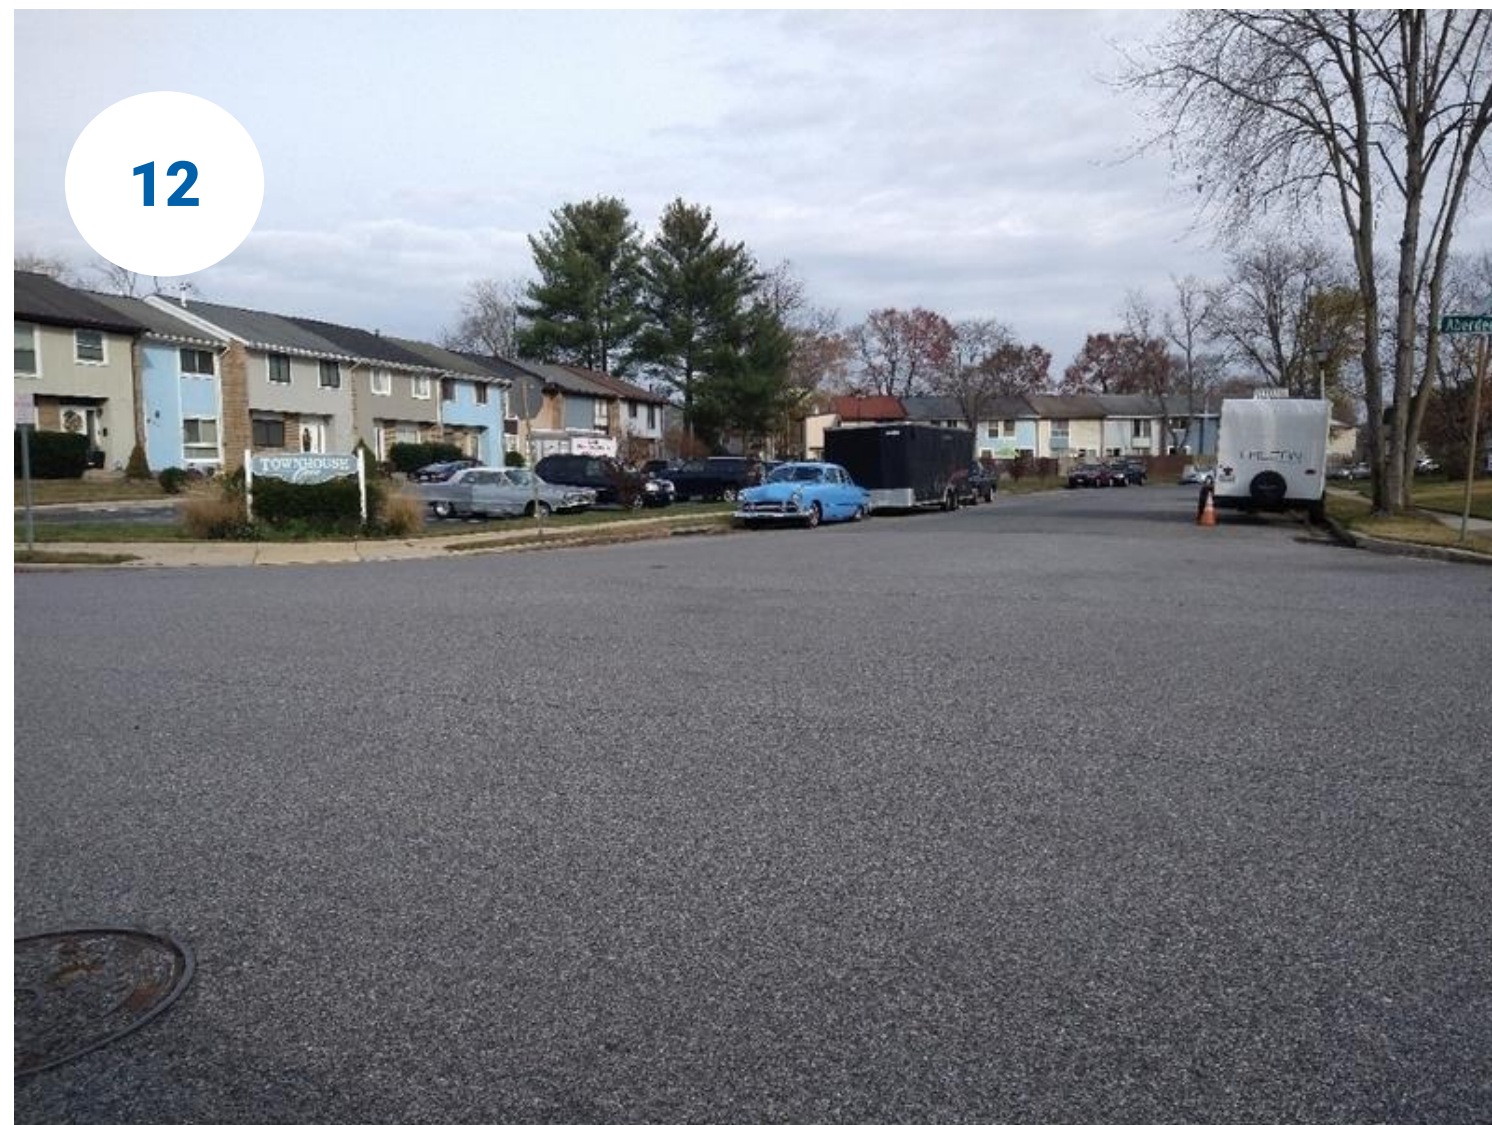
Aberdeen Drive at Cambridge Drive– part of recommendation corridor.

| Map ID | Location | Facility Type | Issue | Recommendation | Potential Cost | Timeframe* |
|---|---|---|---|---|---|---|
| 12 | Aberdeen Dr<br>(Fallsway Dr to<br>County library<br>driveway) (Along key<br>student walking route) | Crosswalk | Crossings of side streets are<br>unmarked<br><br>No stop bar | Install new standard crosswalks<br>and Mark new stop bars at the<br>library driveway, the E Bancroft Ln<br>driveway, and the side streets of:<br>Aberdeen Ct/Aberdeen Cir,<br>Aberdeen Cir, Leisure Way,<br>Kingsgate Dr, Cambridge Dr, Brian<br>Ct, Denton Ct, Elkridge<br>Ct/Chamberlain Ct for the side<br>street crossings of Aberdeen<br>Ct/Aberdeen Cir, Leisure Way,<br>Kingsgate Dr, Cambridge Dr,<br>Denton Ct, Elkridge Ct | \$6,000 | Short |
