# Four Seasons Elementary School Safe Routes to School Accessibility Study: Existing Conditions and Recommendations

August 17, 2023

# Anne Arundel Safe Routes to School Accessibility Study

# Four Seasons Elementary Accessibility Study

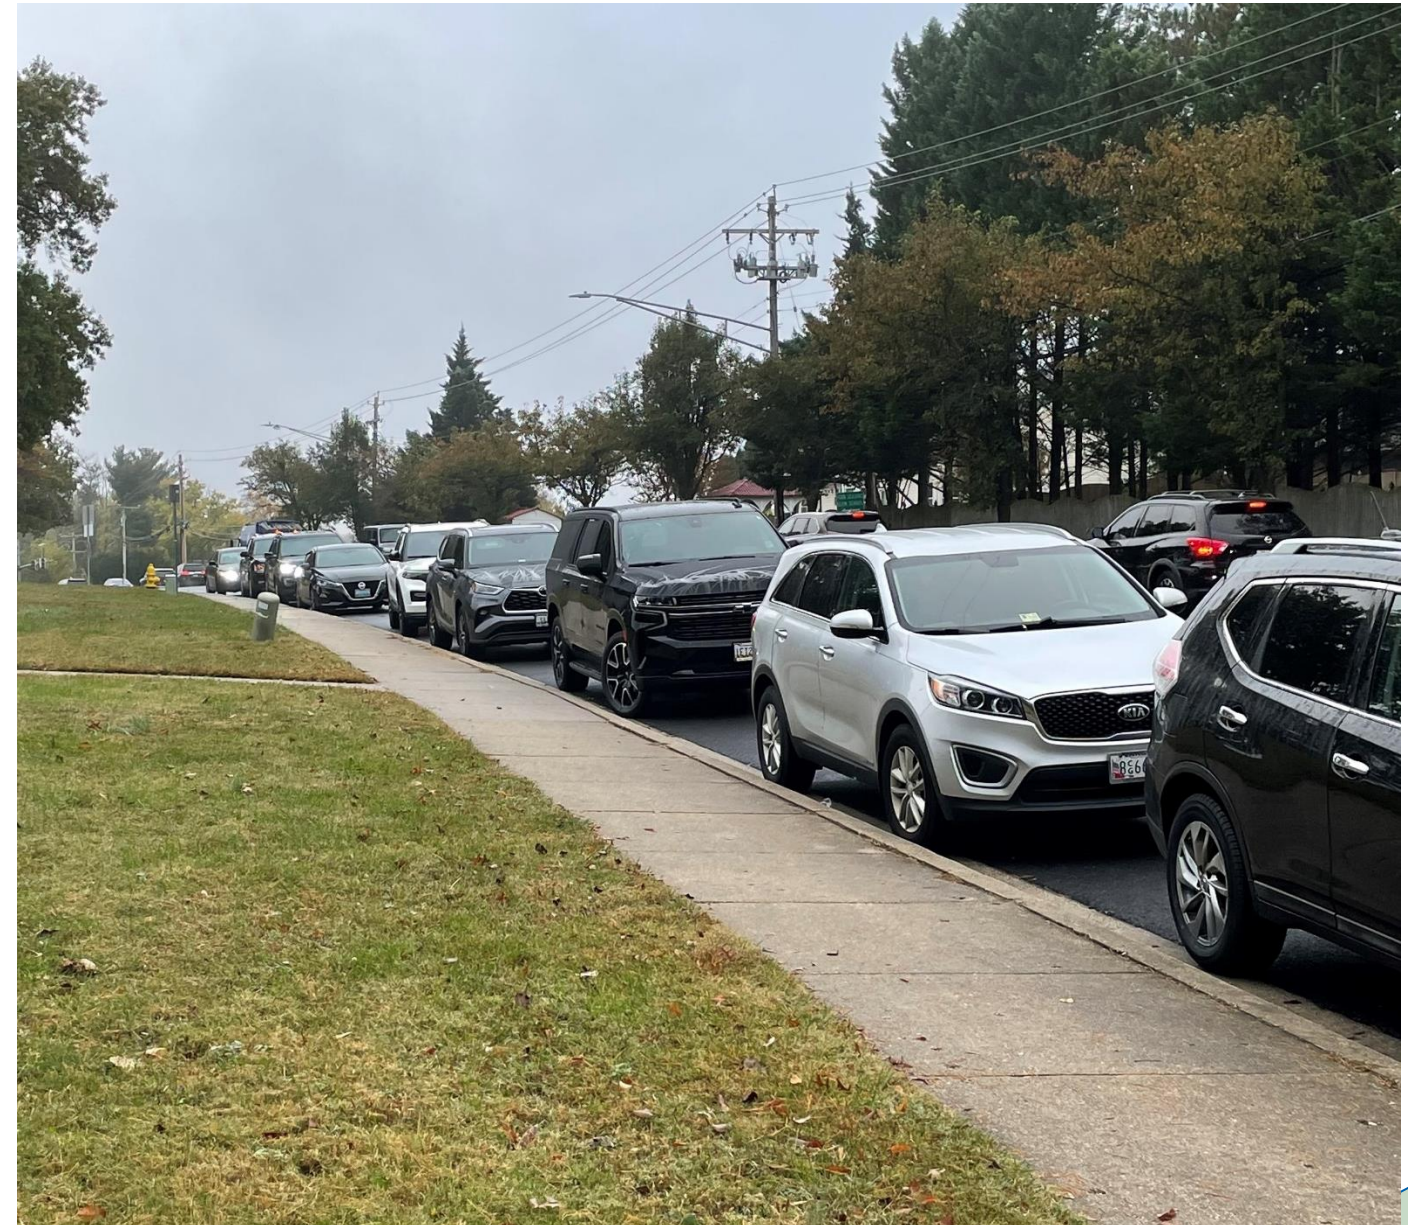
- Teachers and teacher assistants help students exit cars in the drop-off loop.
- Car loop remained relatively steady until 8:00.
- Many parents were seen dropping their students off along Waugh Chapel Road in front of the school; some made U-turns to park on the east side of Waugh Chapel Road, some parked on the west side and crossed the road with their child mid-block.
- Observed vehicle volumes on Waugh Chapel Road were heavy and constant during peak arrival.

Vehicle drop-off of students occurring along Waugh Chapel Road at school arrival.

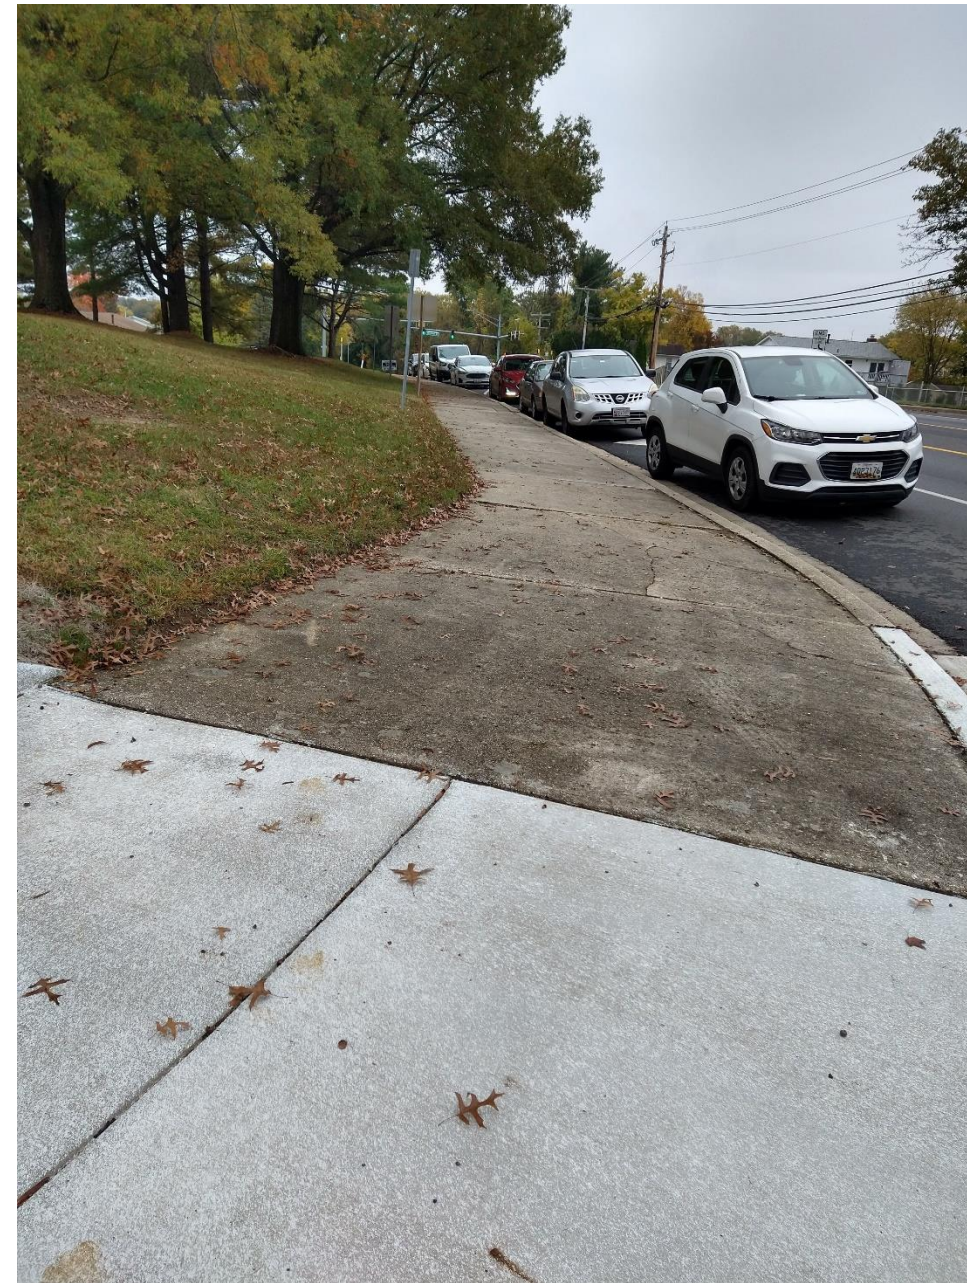
Cars are seen parked along Waugh Chapel Road at dismissal time.

- By 2:05, about 20 cars were lined up in the loop and two dozen cars were parked along Waugh Chapel Road.
- Pick-up loop was busiest from 2:25-2:35
- Staff manage pick up by having students line up when their name is called.

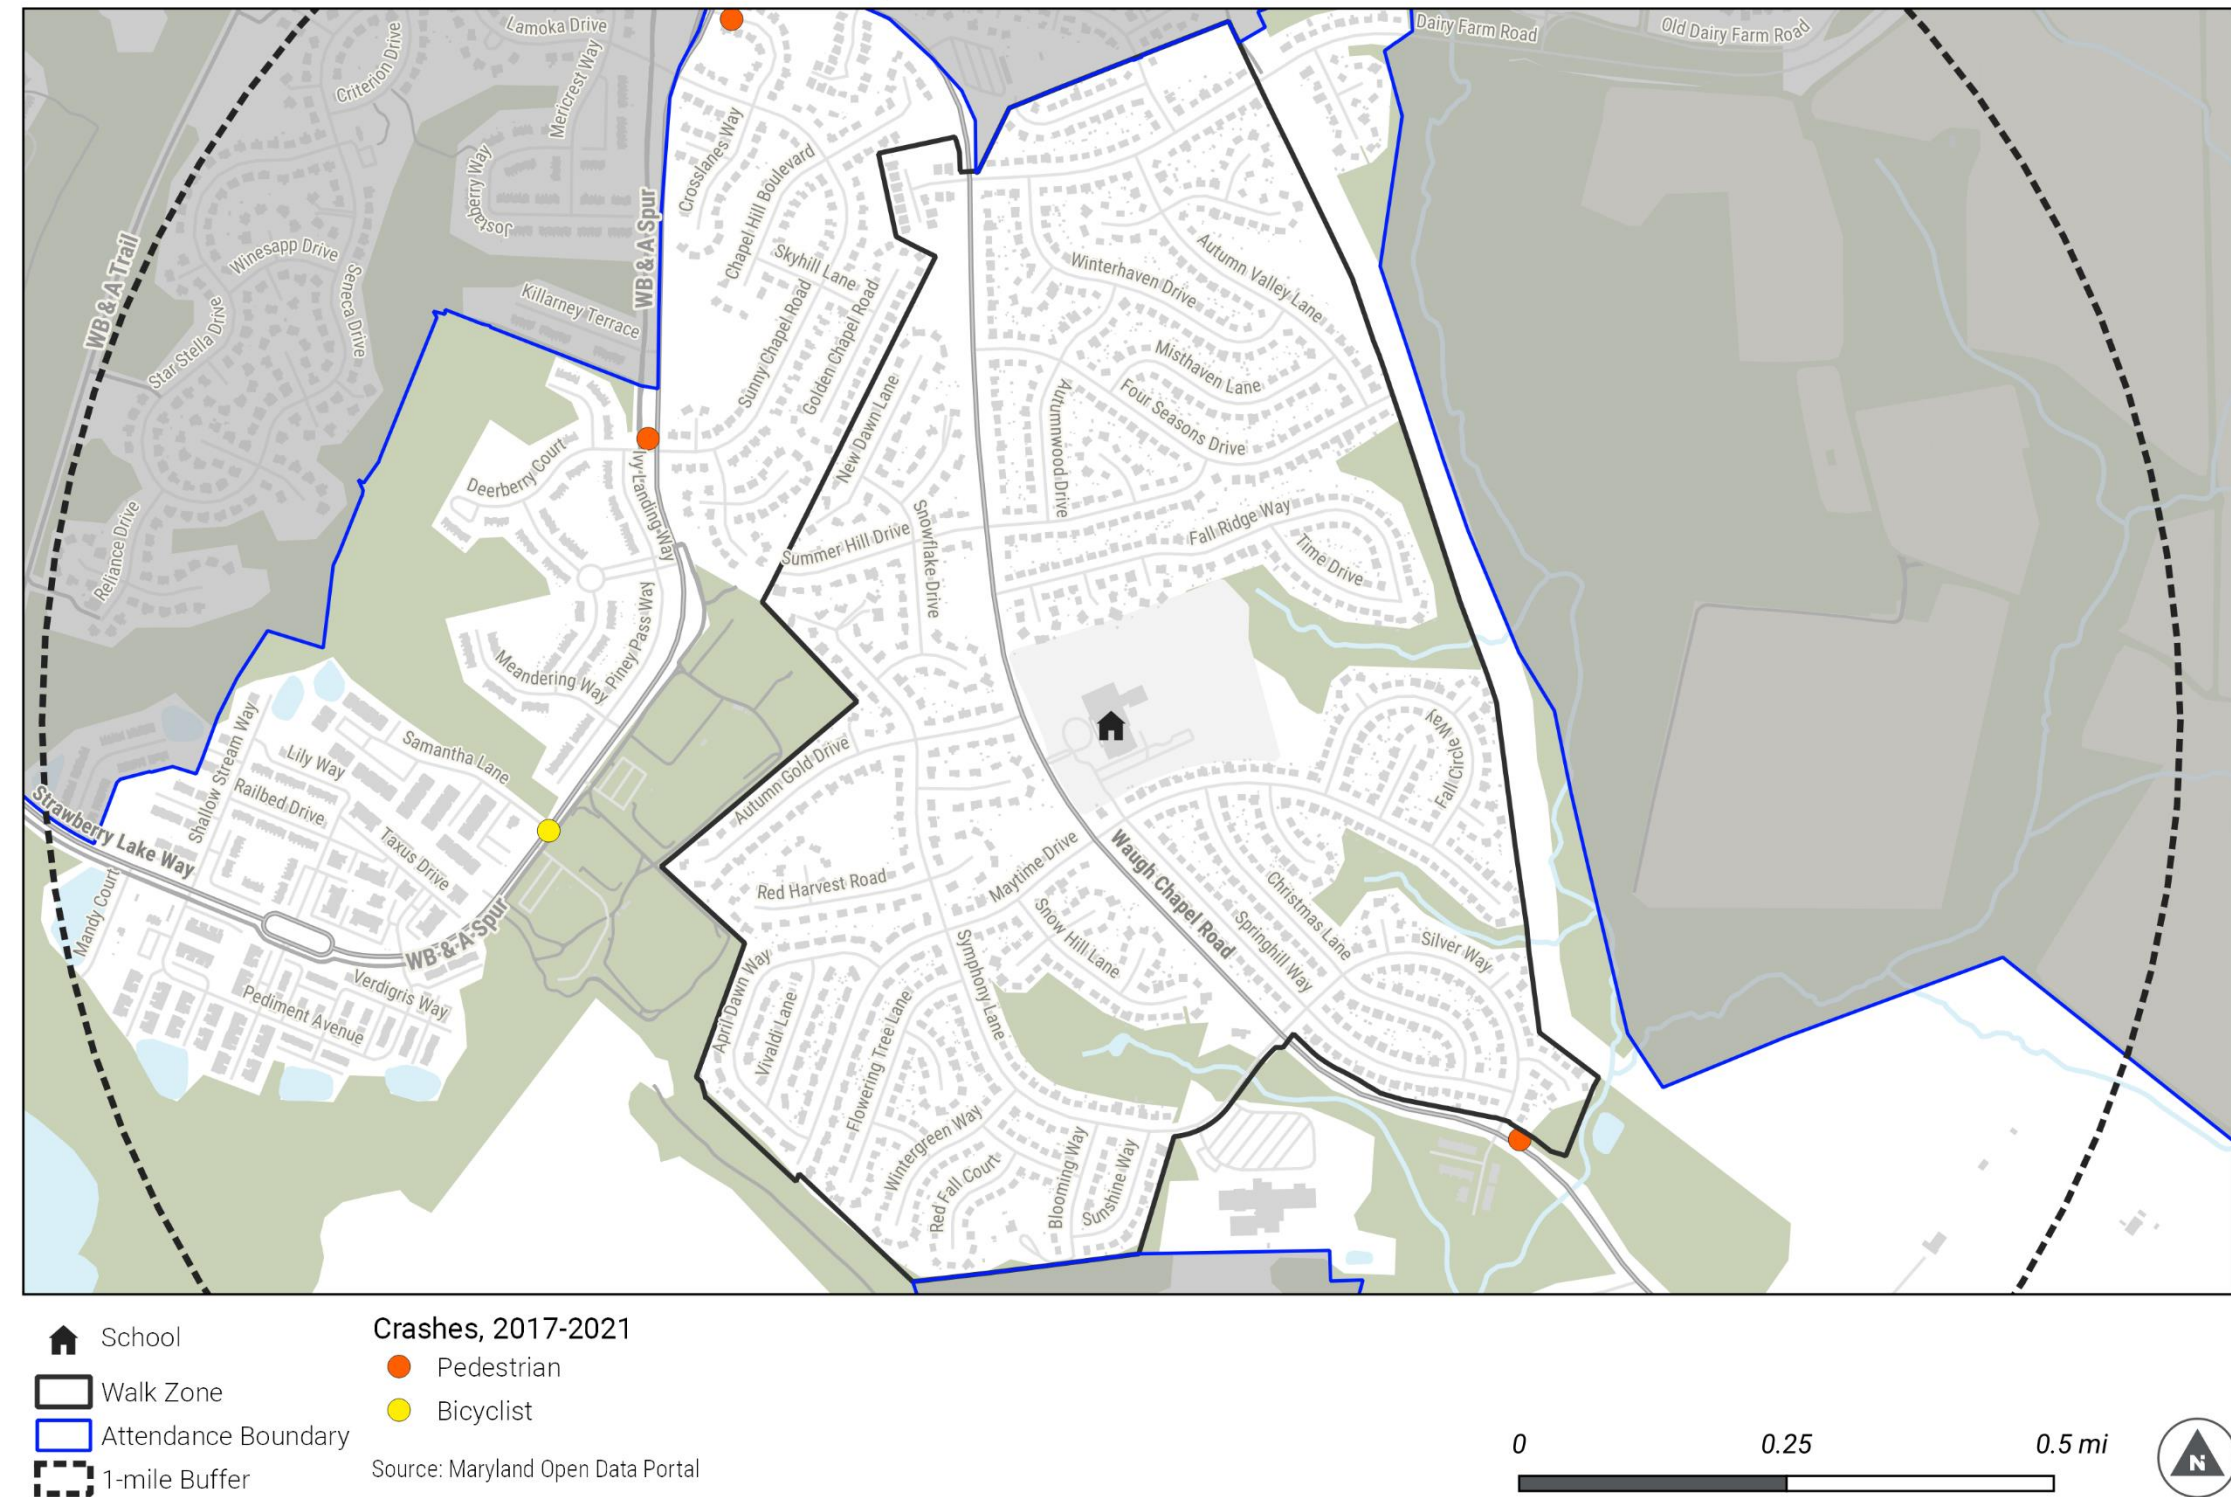
Four Seasons Elementary School - Pedestrian and Bicycle Crashes

- None within the walk zone, but one pedestrian crash just outside the southeast boundary

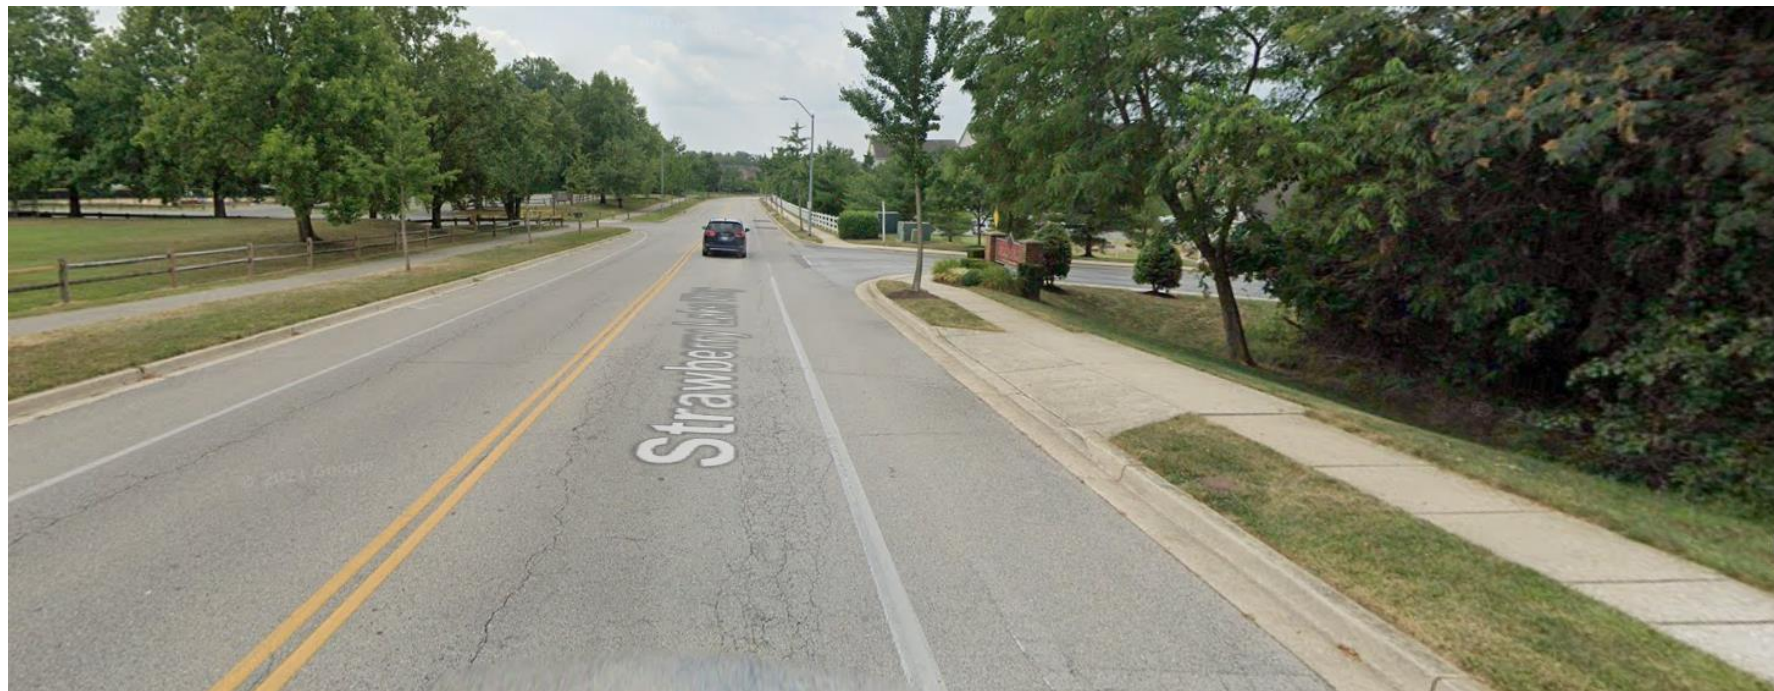
Residential areas west of GORC Park fall within what may be a realistic bicycling distance from the school using trails within the park, but Strawberry Lake Way lacks marked and controlled pedestrian crossing facilities. For long-term planning, the County could explore adding a rectangular rapid flashing beacon at a key crossing location for access to GORC park.

View of Strawberry Lake Way near GORC Park via Google Maps

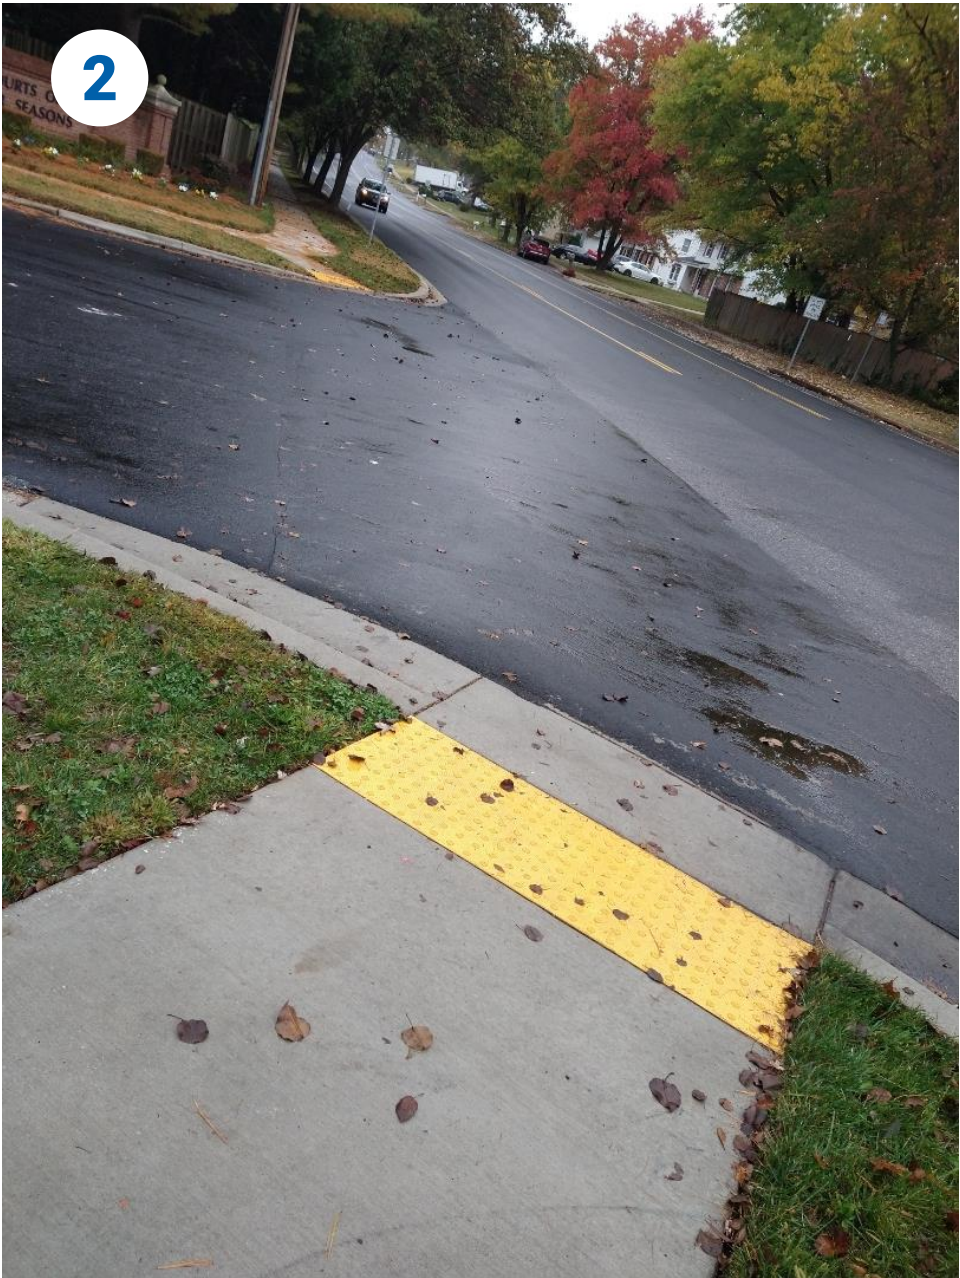
Crossing of Summer Hill Drive.

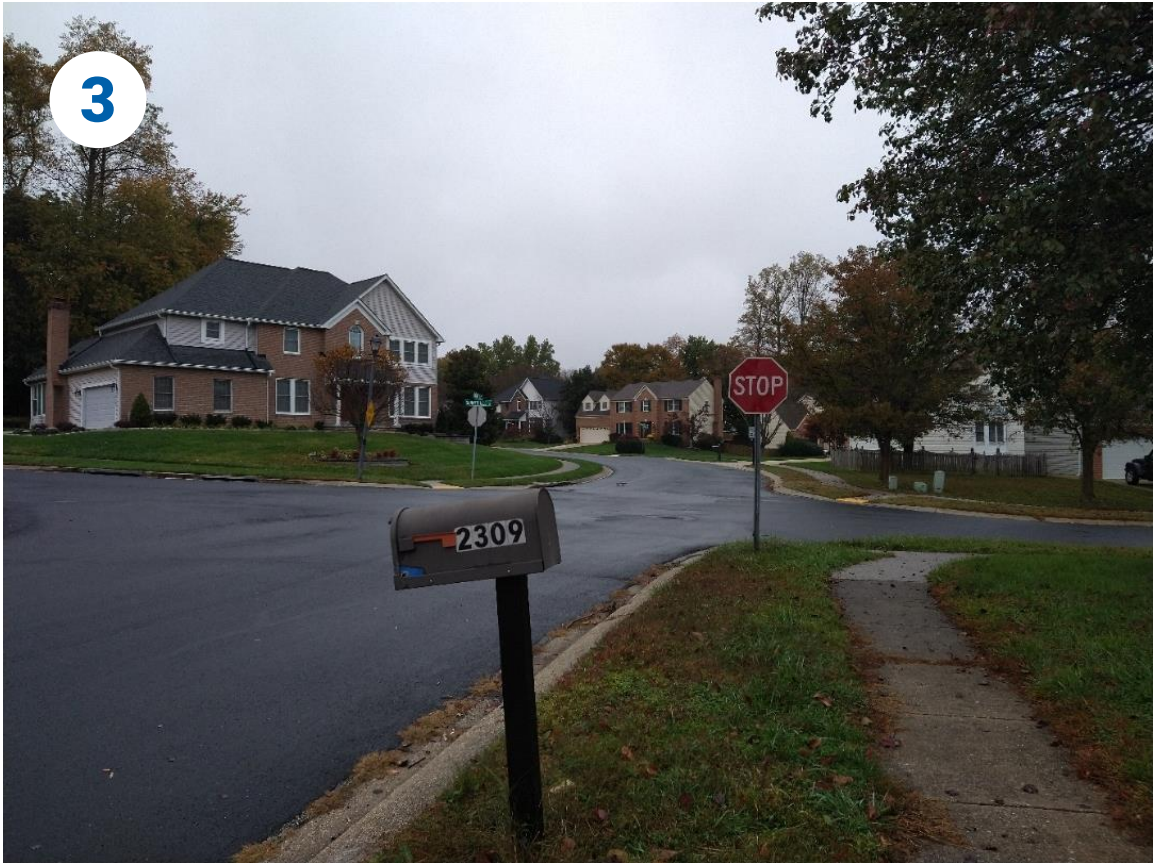
| Map ID | Location | Facility Type | Issue | Recommendation | Potential Cost | Timeframe* |
|---|---|---|---|---|---|---|
| 3 | Summer Hill Dr & Snowflake Dr | 3a. Curb Ramp | Ramps lacks detectable warning surface, Ramps not aligned with crossing | Reconstruct or repair existing ramps | \$16,000 | Medium |

Stop sign and crossing on Snowflake Drive.

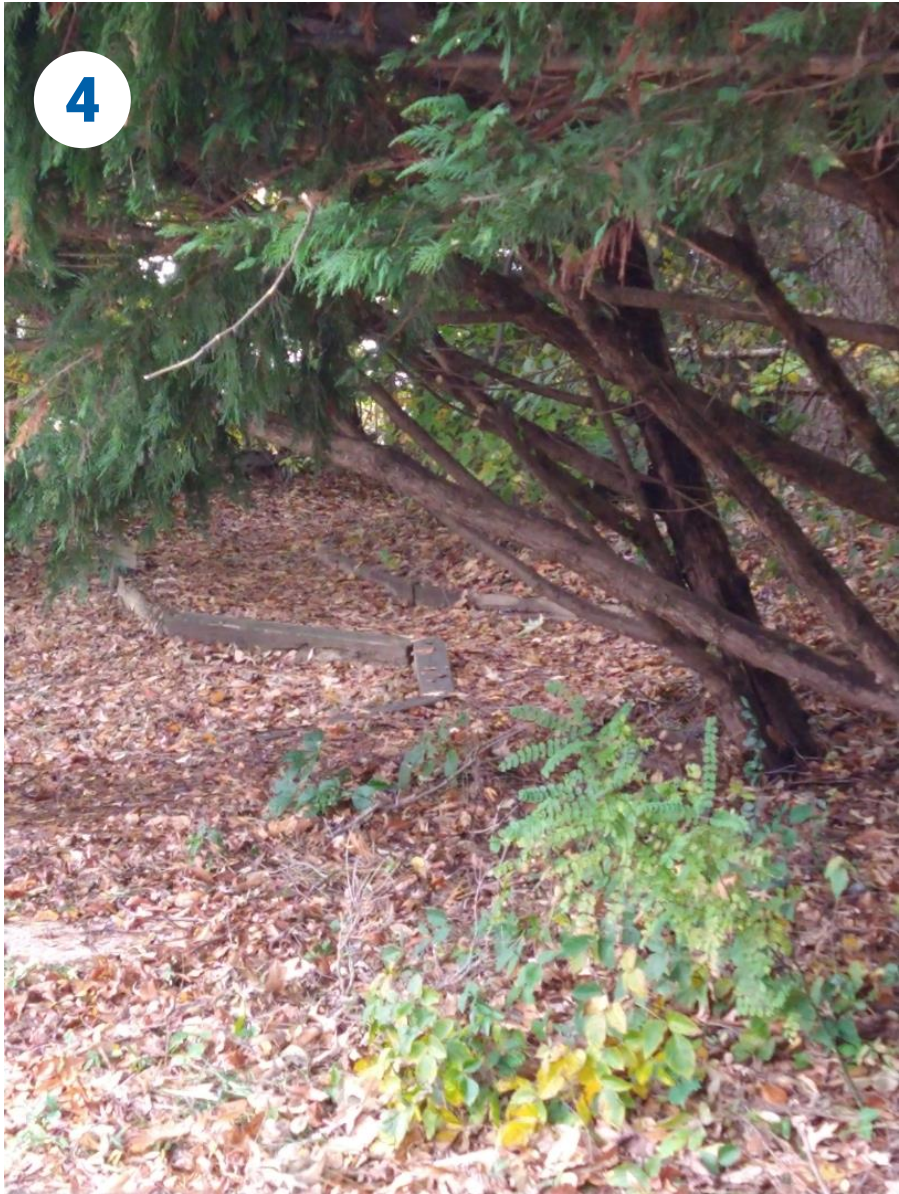
| Map ID | Location | Facility Type | Issue | Recommendation | Potential Cost | Timeframe* |
|---|---|---|---|---|---|---|
| 4 | End of Summer Hill Dr | Sidewalk | Missing sidewalk/path connection | Explore potential for new path connection (length depends on geography and ROW). A sidewalk connection to the path between GORC Park Station House Ln may allow for expansion of the school walk zone. | N/A | Long |

Missing sidewalk connecting Summer Hill Drive to GORC Park.

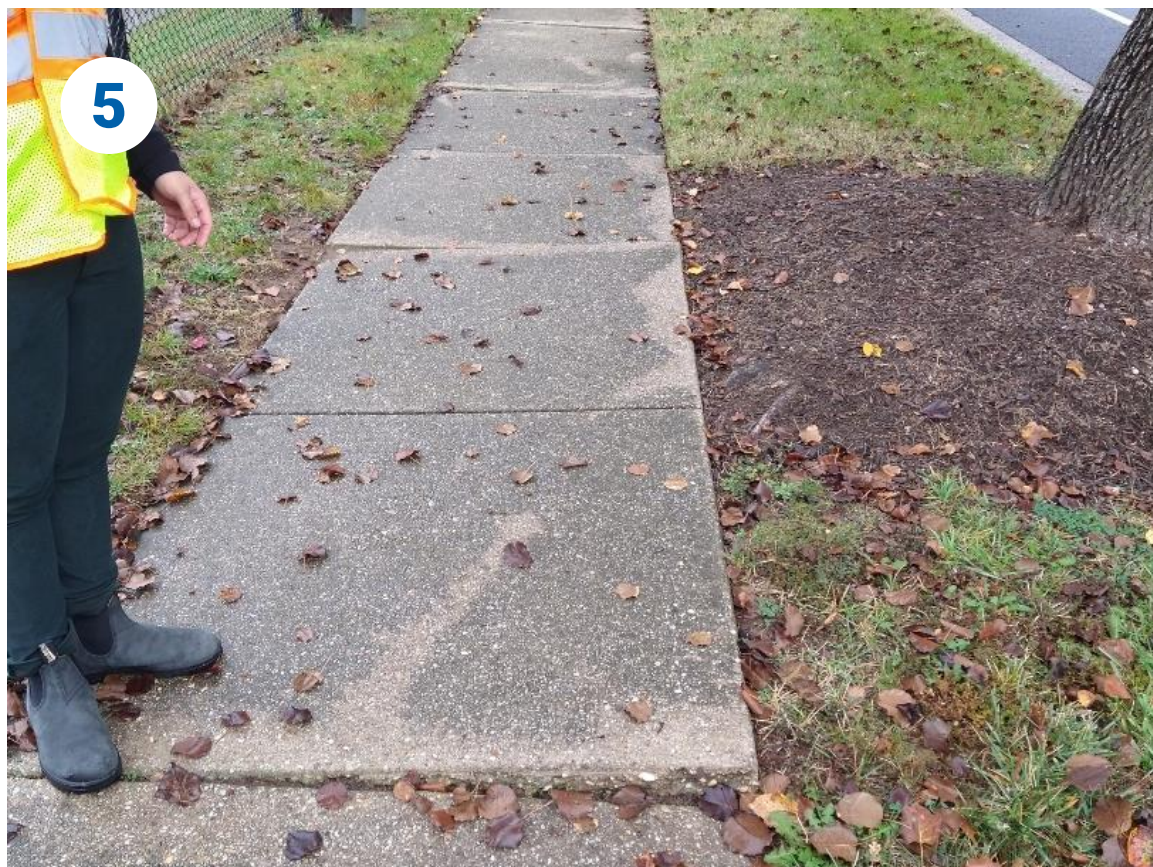
| Map ID | Location | Facility Type | Issue | Recommendation | Potential Cost | Timeframe* |
|---|---|---|---|---|---|---|
| 5 | Waugh Chapel Rd (Fall Ridge Way to Summer Hill Dr) (Along key student walking route, Inside school zone) | Sidewalk | Sidewalk uplifted on west side of Waugh Chapel Rd | Reconstruct or repair sidewalk | \$13.440 | Long |

Sidewalk along west side of Waugh Chapel Road.

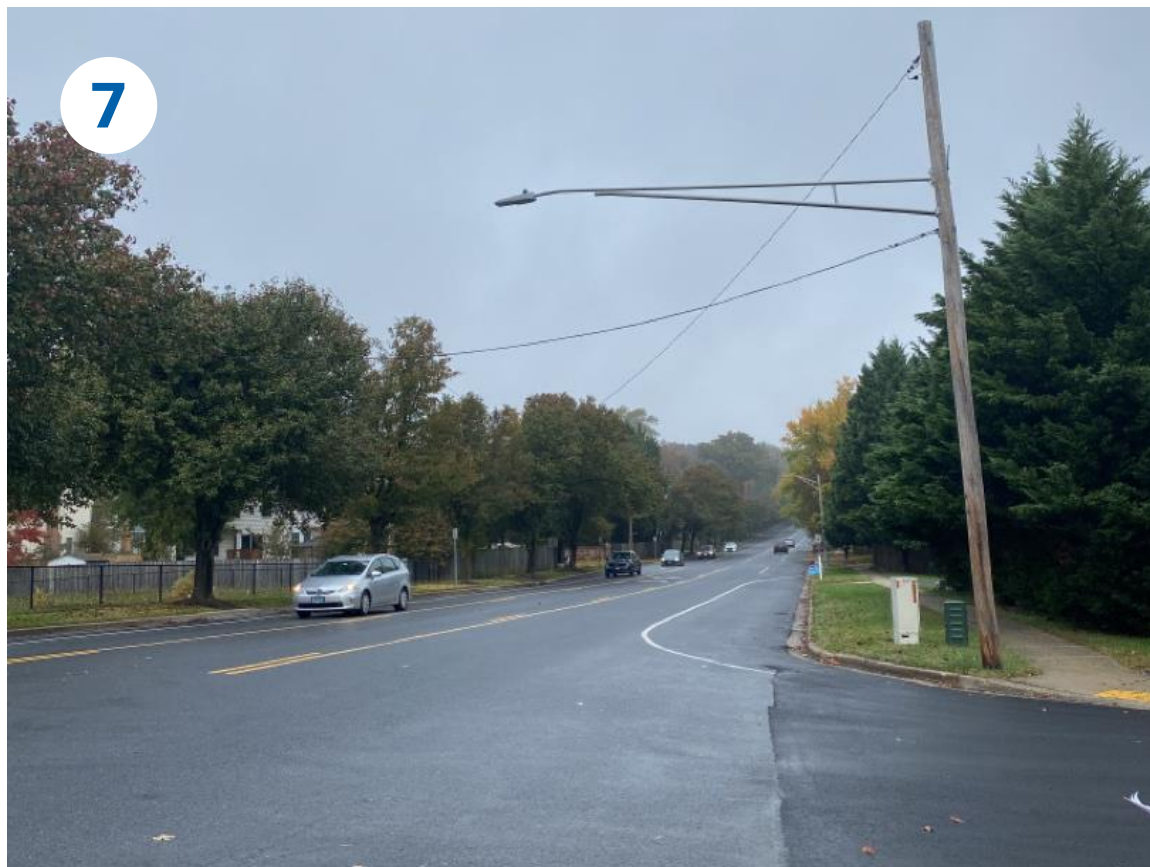
| Map ID | Location | Facility Type | Issue | Recommendation | Potential Cost | Timeframe* |
|---|---|---|---|---|---|---|
| 7 | Waugh Chapel Rd (Summer Hill Dr to Symphony Ln) (Along key student walking route, Inside school zone) | 7a. Speed Management | Observed motor vehicle speeds appear to exceed speed limit | Conduct a speed study to consider speed management measures or other modifications | N/A | Long |
| | | 7b. School Zone Signs and Pavement Markings | SCHOOL pavement marking missing | Enhance existing school zone signage per MdMUTCD part 7:<br>- Install new SCHOOL pavement marking | \$1,000 | Short |
| | | | School zone sign missing | - Install new school zone signs (begin/end) | \$1,000 | |
| | | | School zone speed limit sign missing | - Install new school zone speed limit sign | \$500 | |

View of Waugh Chapel Road within the school zone.

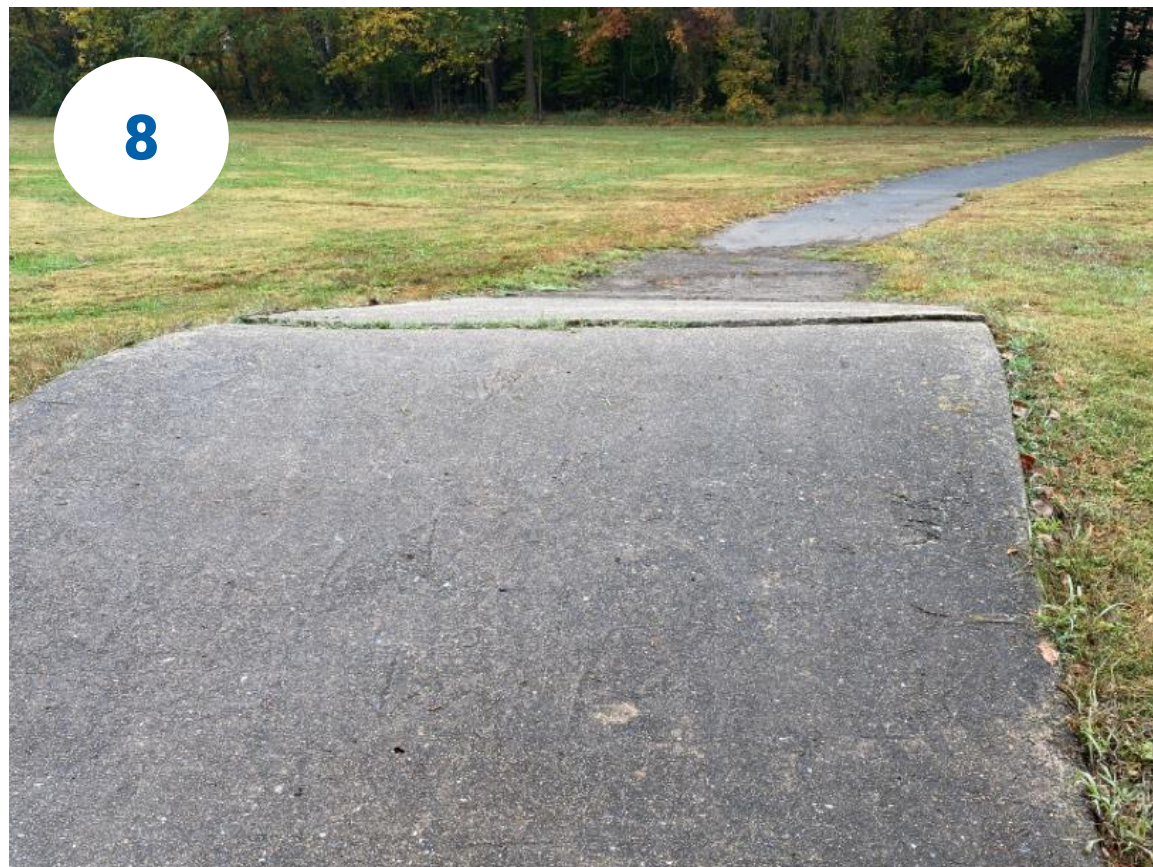
| Map ID | Location | Facility Type | Issue | Recommendation | Potential Cost | Timeframe* |
|---|---|---|---|---|---|---|
| 8 | School path to Christmas Ct | Sidewalk | Sidewalk cracked and uplifted at various points along the path | Reconstruct or repair sidewalk | \$27,200 | Long |

Path between Christmas Court and the school.

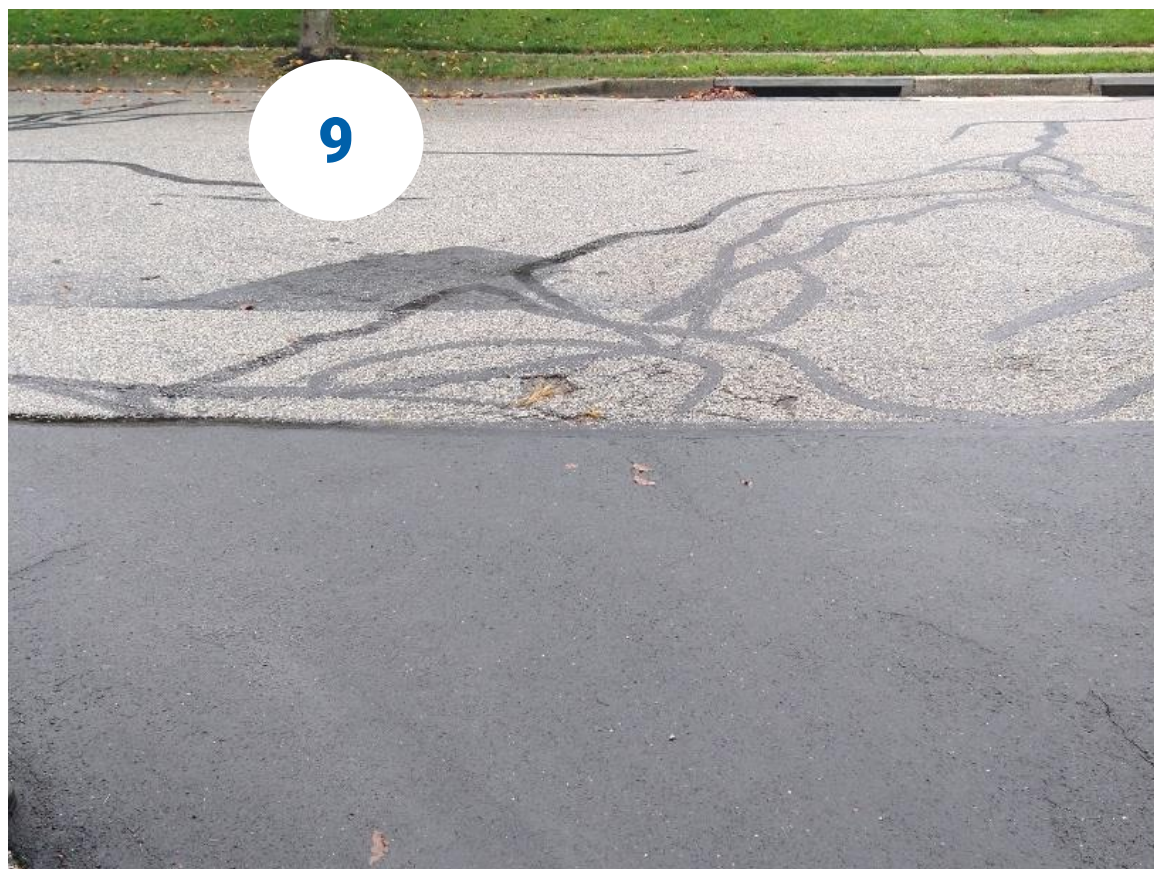
| Map ID | Location | Facility Type | Issue | Recommendation | Potential Cost | Timeframe* |
|---|---|---|---|---|---|---|
| 9 | Ice Crystal Ct & Symphony Ln | Curb ramp | Ramps not aligned with crossing | Reconstruct or repair existing ramps | \$8,000 | Medium |

Crossing of Ice Crystal Court.

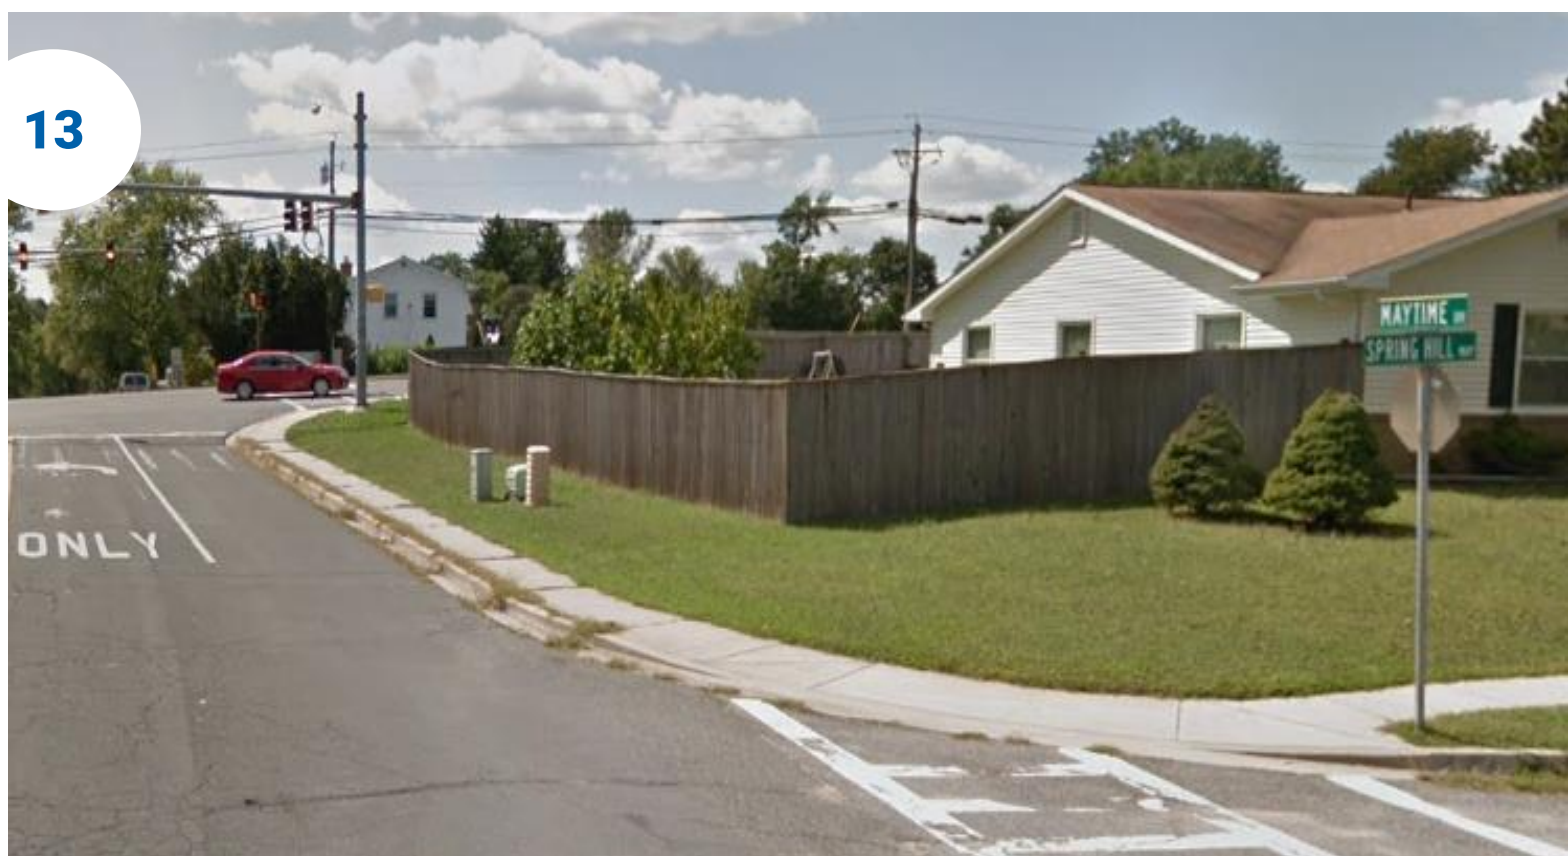
| Map ID | Location | Facility Type | Issue | Recommendation | Potential Cost | Timeframe* |
|---|---|---|---|---|---|---|
| 13 | Maytime Dr (Waugh Chapel Rd to Springhill Way)<br>(Along key student walking route, Inside school zone) | Sidewalk | Sidewalk narrow on north side of Maytime Dr and has no buffer from the road. | Reconstruct or repair sidewalk | \$7,200 | Long |

Sidewalk on the north side of Maytime Drive.

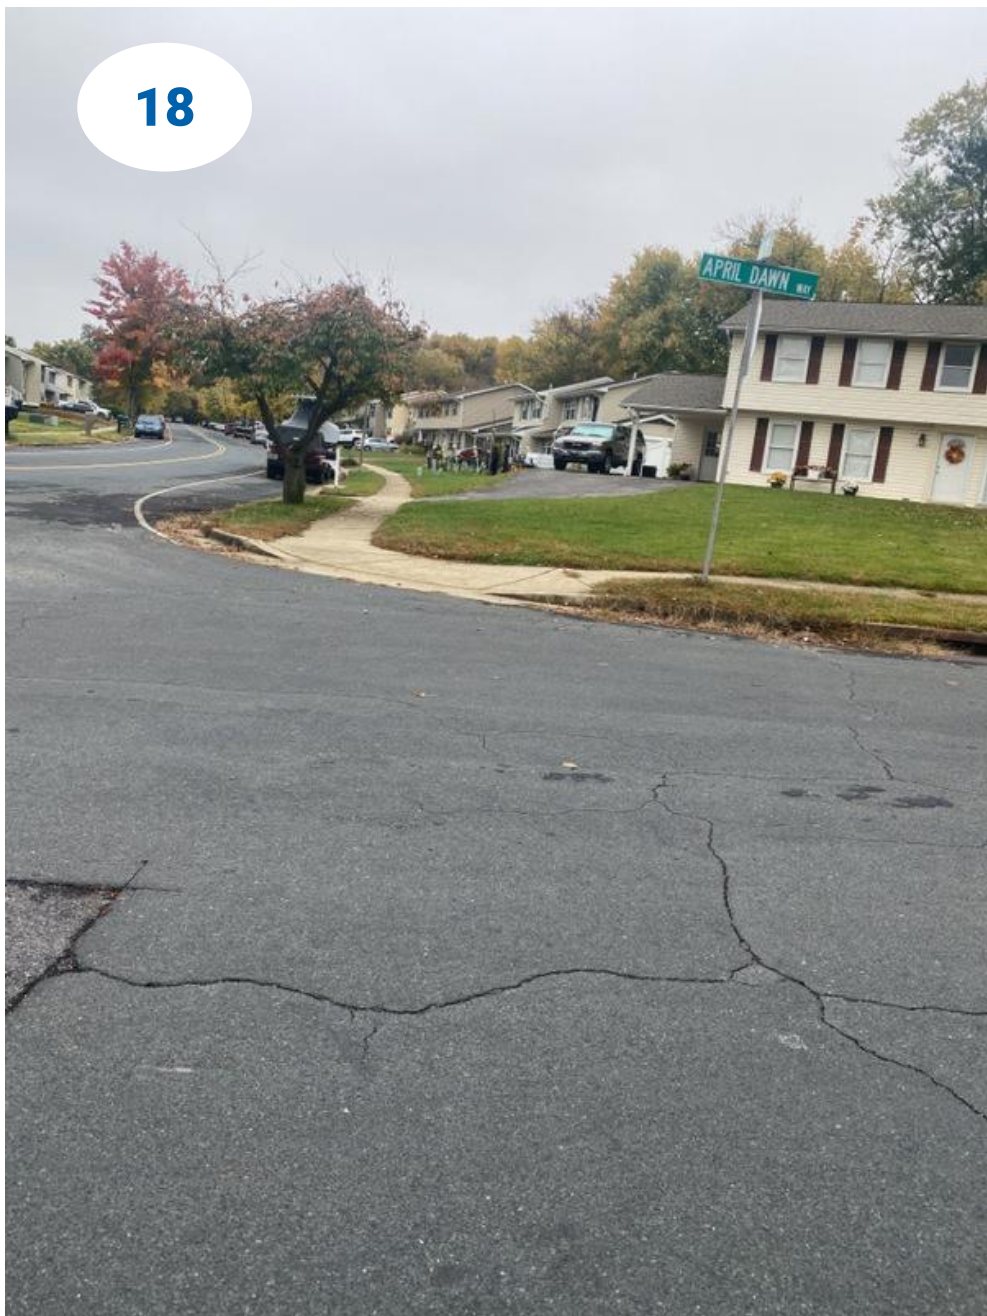
| Map ID | Location | Facility Type | Issue | Recommendation | Potential Cost | Timeframe* |
|---|---|---|---|---|---|---|
| 18 | April Dawn Way (northeast) & Maytime Dr | Curb Ramp | Ramps lack detectable warning surface | Reconstruct or repair existing ramps for crossing of April Dawn Way | \$8,000 | Medium |

Crossing of April Dawn Way (northeast intersection with Maytime Drive).

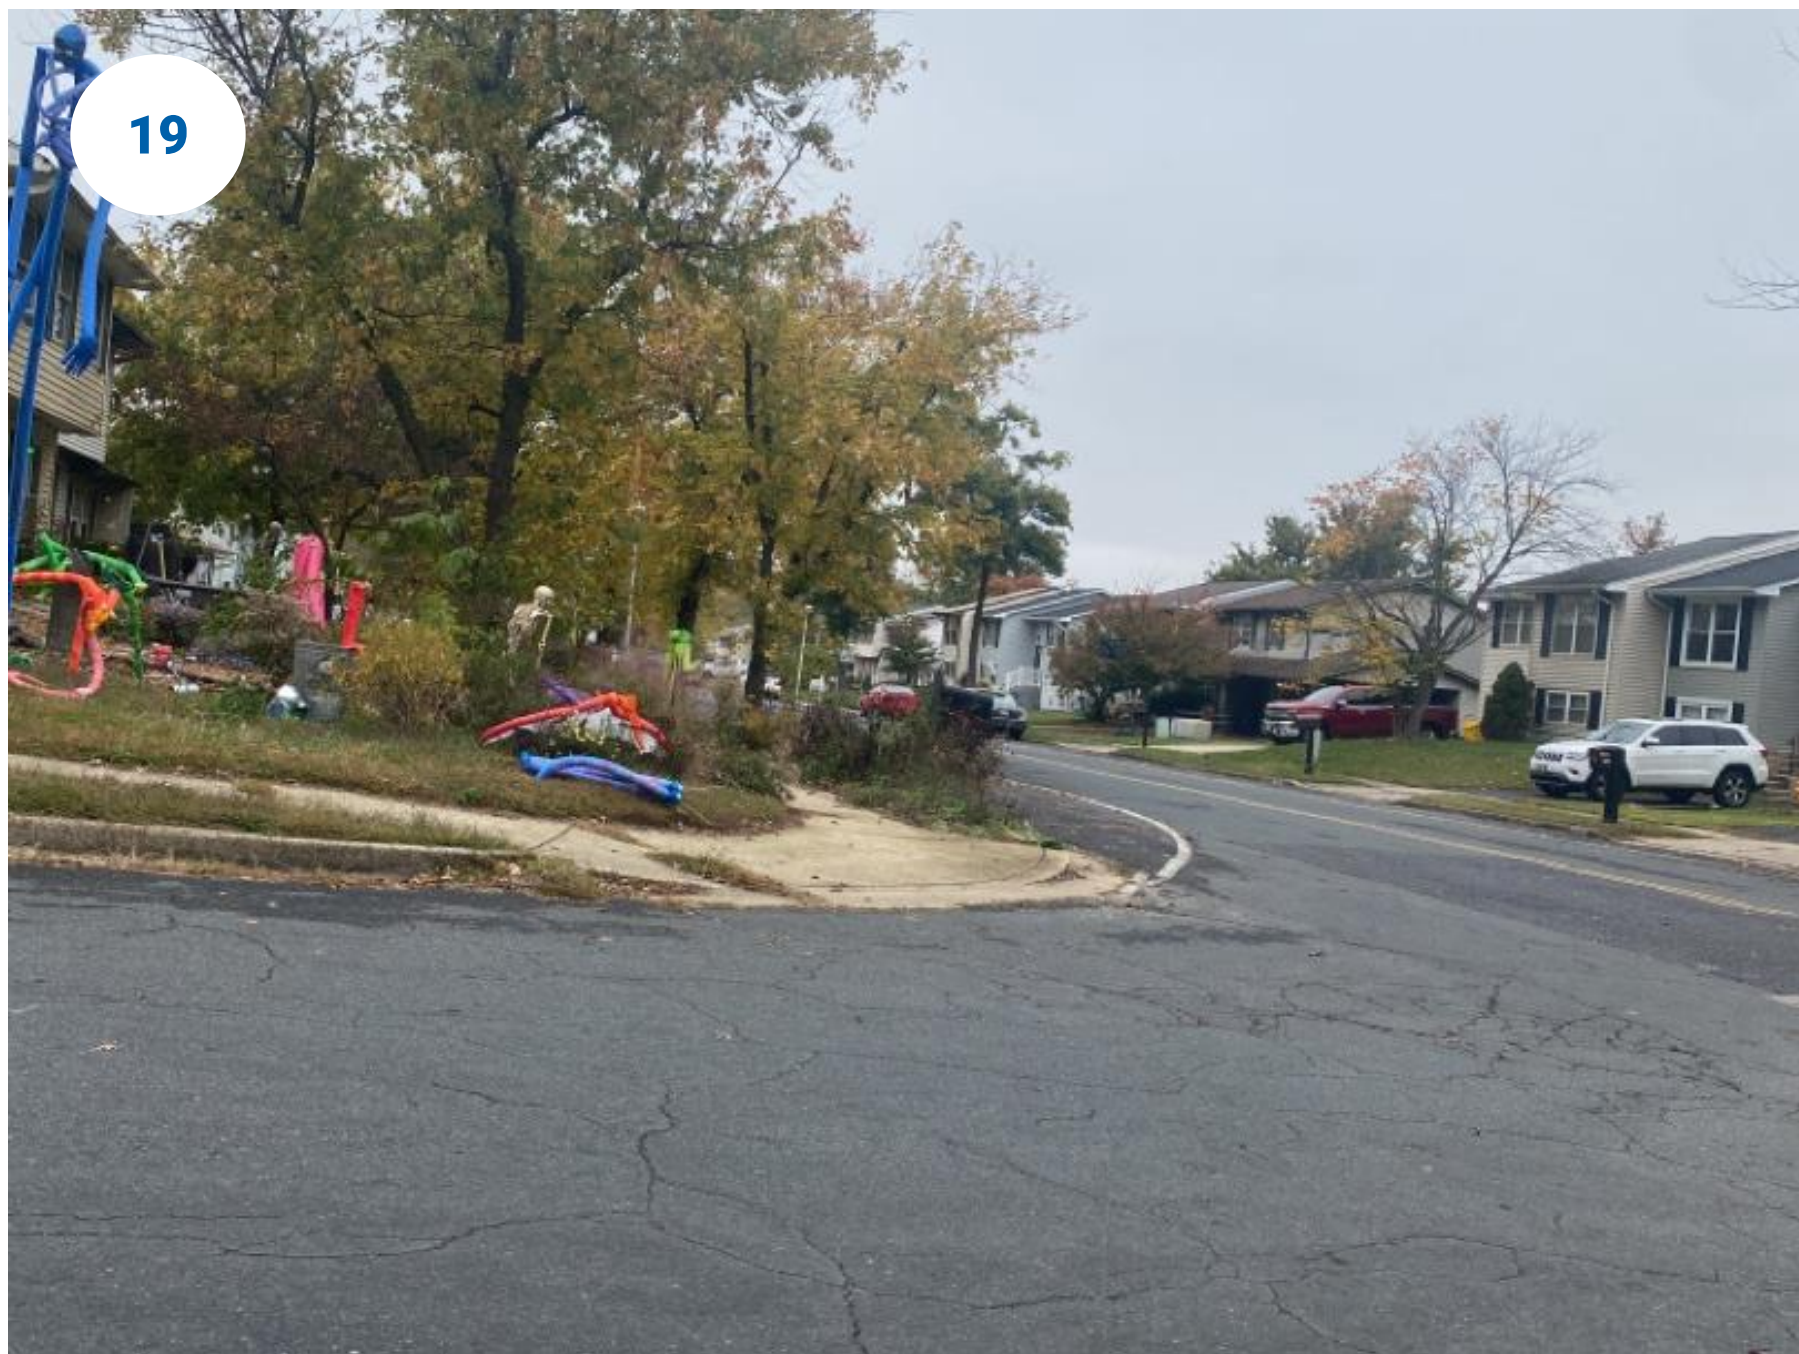
| Map ID | Location | Facility Type | Issue | Recommendation | Potential Cost | Timeframe* |
|---|---|---|---|---|---|---|
| 19 | April Dawn Way (west) & Maytime Dr | Curb Ramp | Ramp lack detectable warning surface | Reconstruct or repair existing ramps for crossing of April Dawn Way | \$8,000 | Medium |

Crossing of April Dawn Way (western intersection with Maytime Drive)
