# Georgetown East Elementary School Safe Routes to School Accessibility Study: Existing Conditions and Recommendations

August 17, 2023

# Anne Arundel Safe Routes to School Accessibility Study

# Georgetown East Elementary Accessibility Study

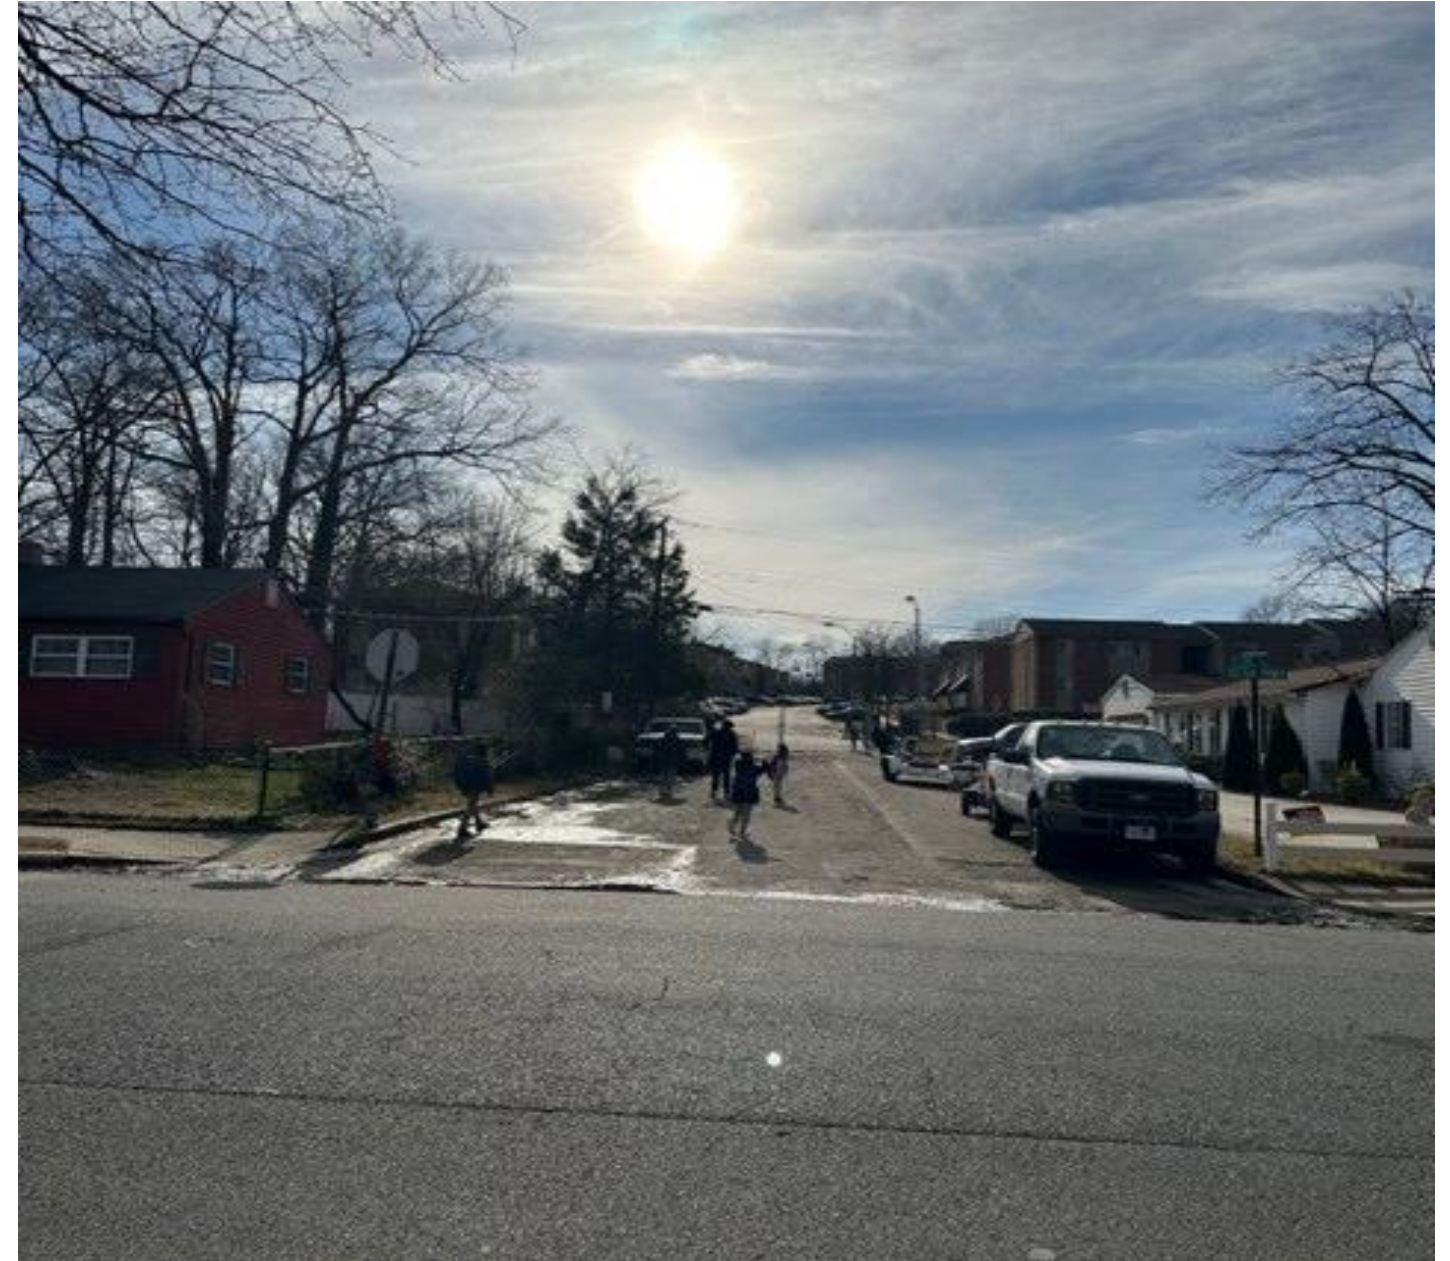
Students walking home through a gate to the apartments adjacent to the school.

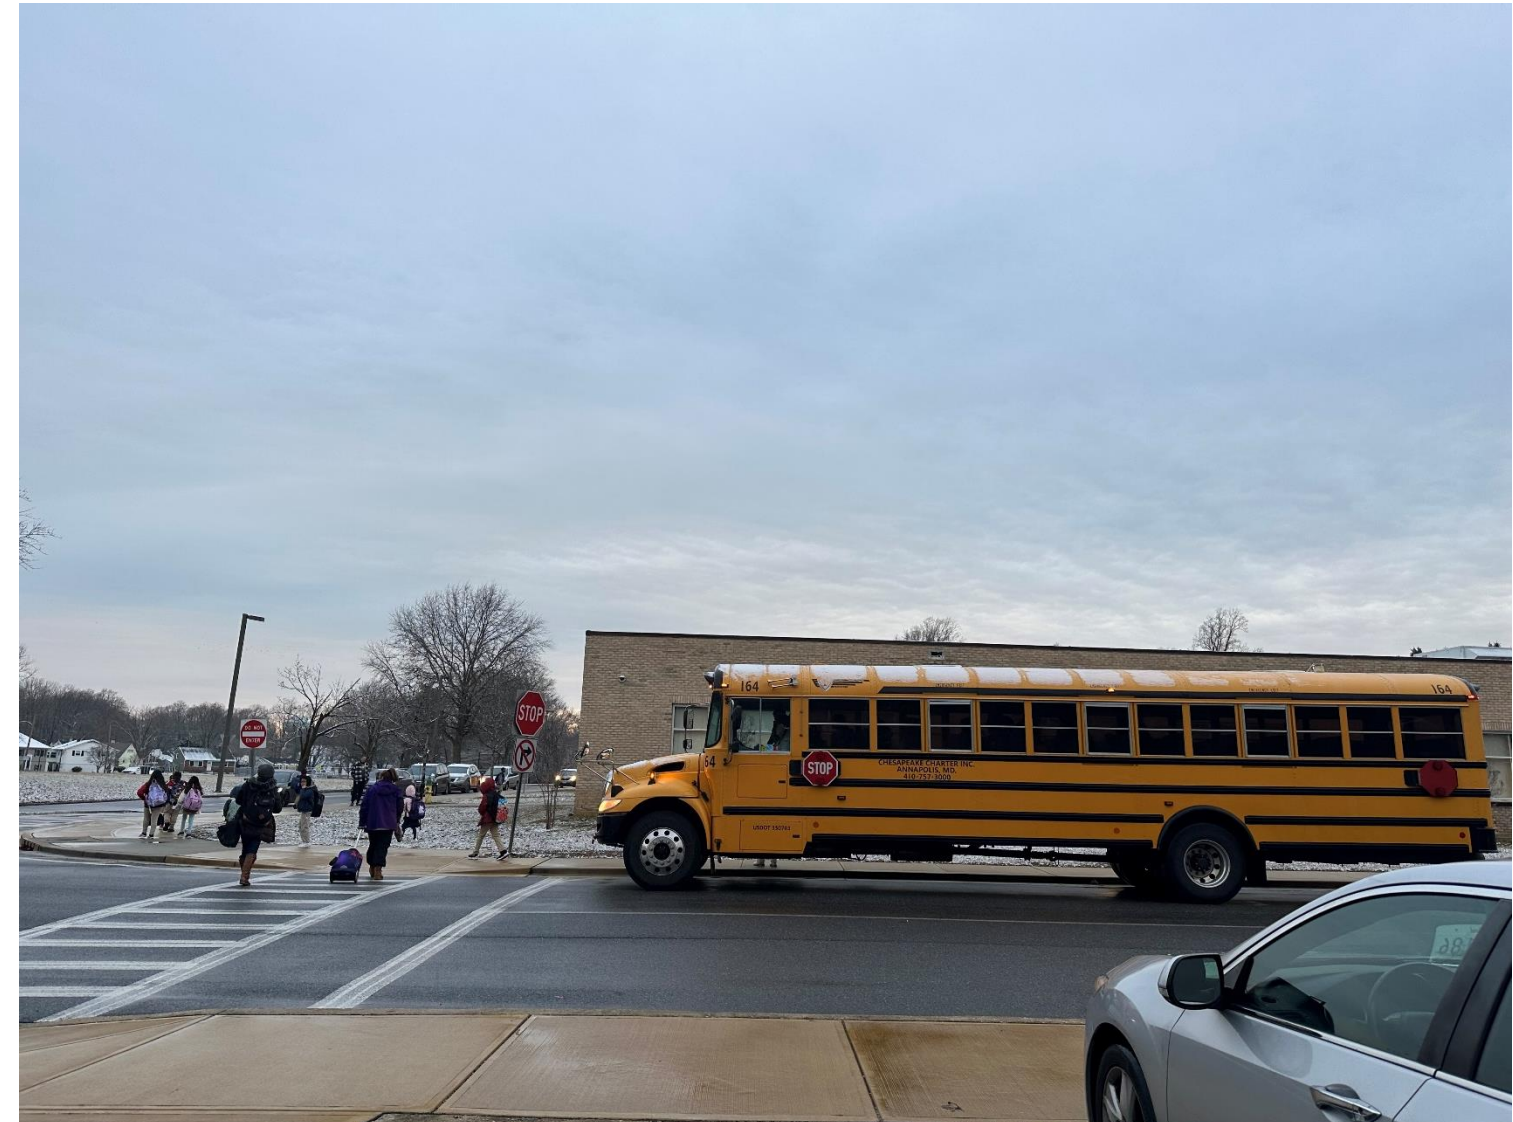
Students and staff arrive as the school bus unloads at the east side of the building

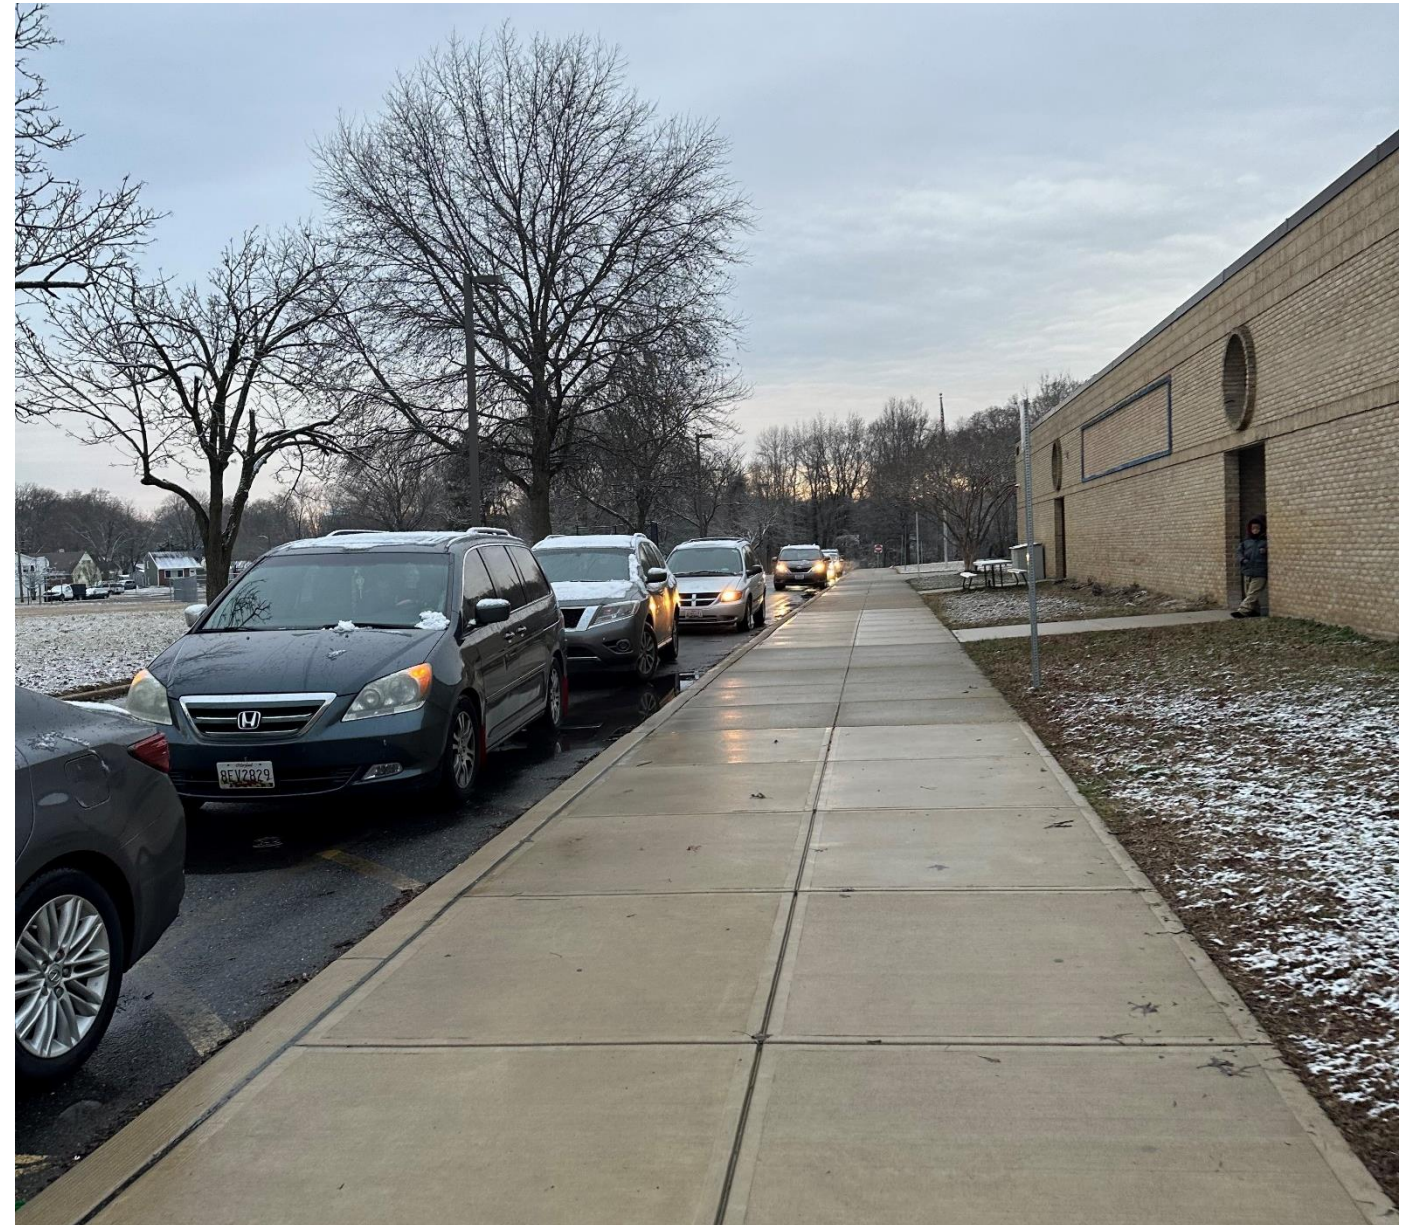
Vehicle drop-off loop during school arrival.

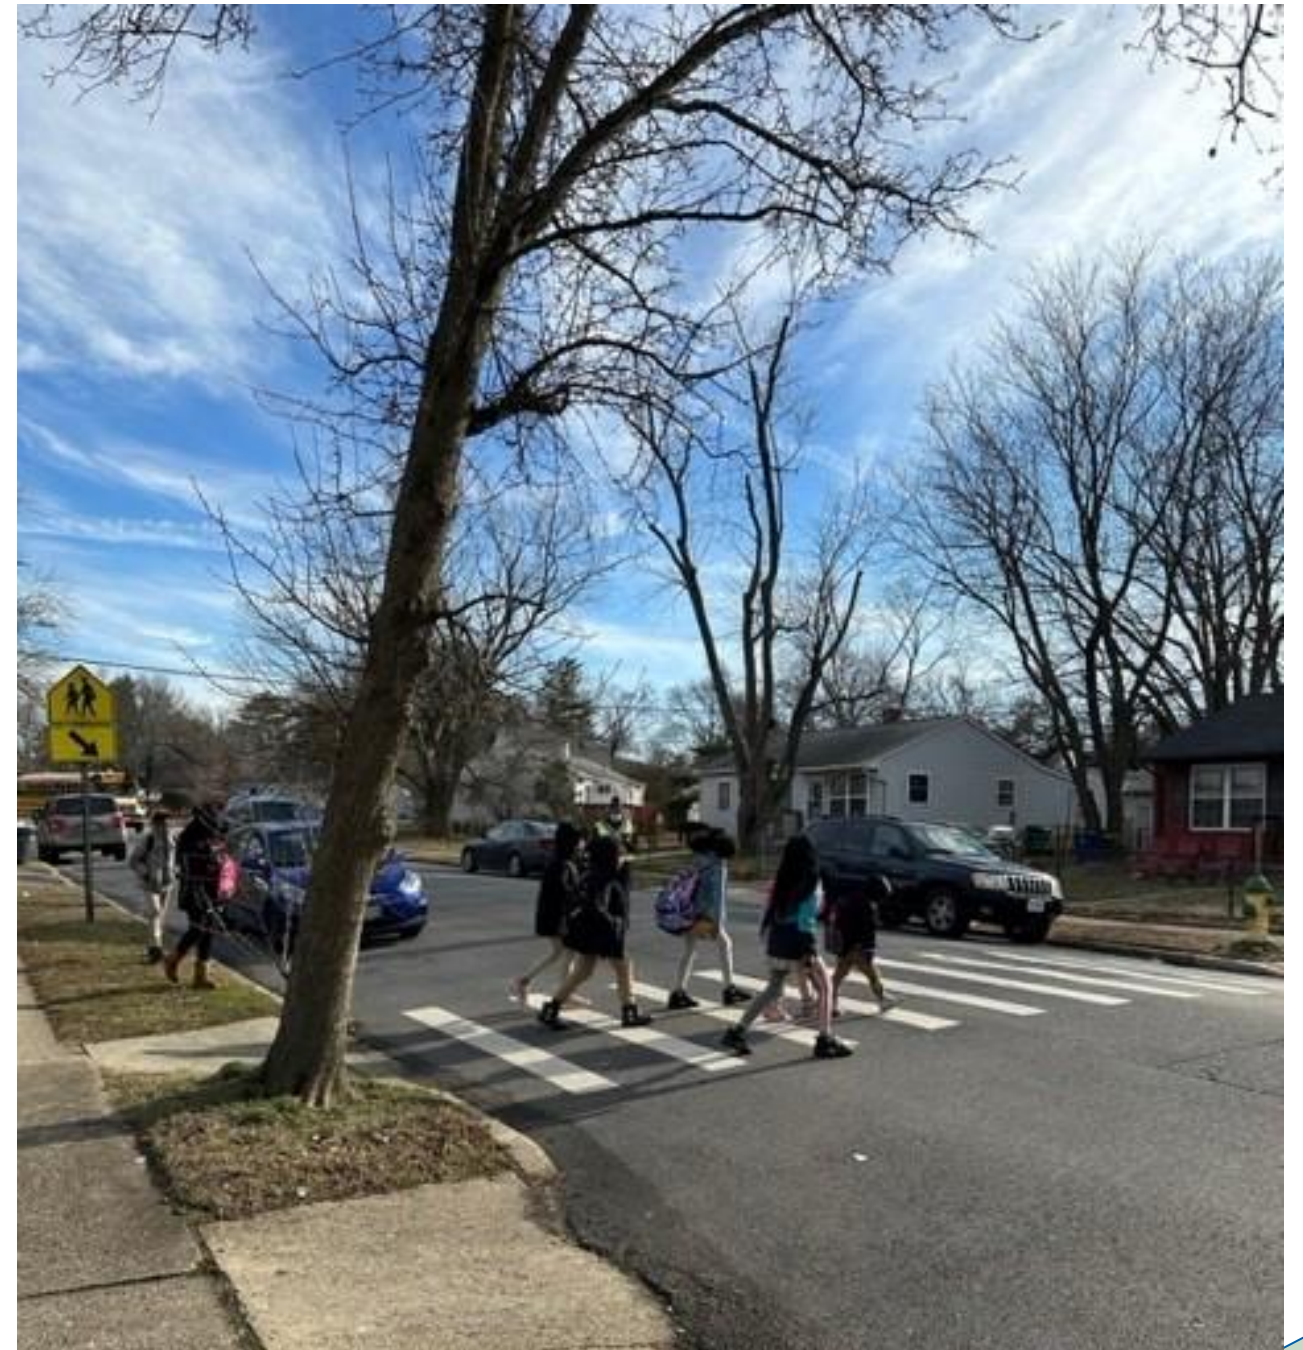
After-school walkers arrive at Bay Ridge Gardens apartments on Victor Parkway

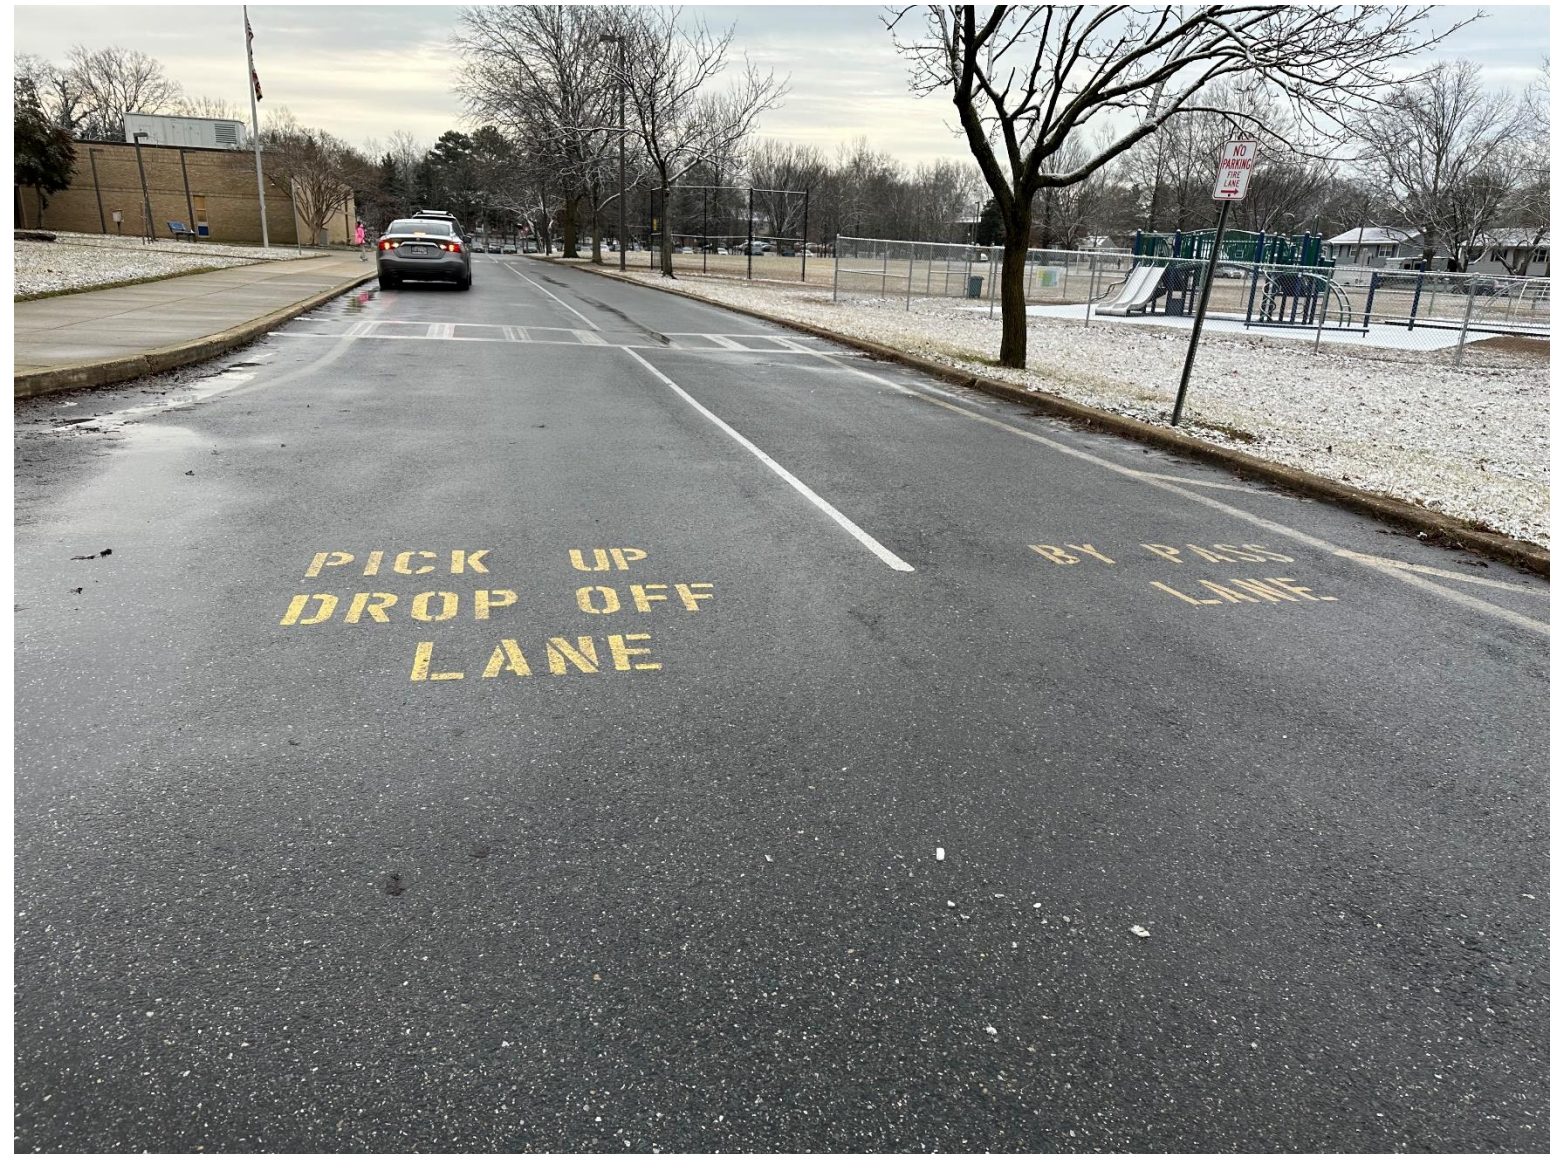
Pavement markings on the school driveway for parent drop off and pick up.

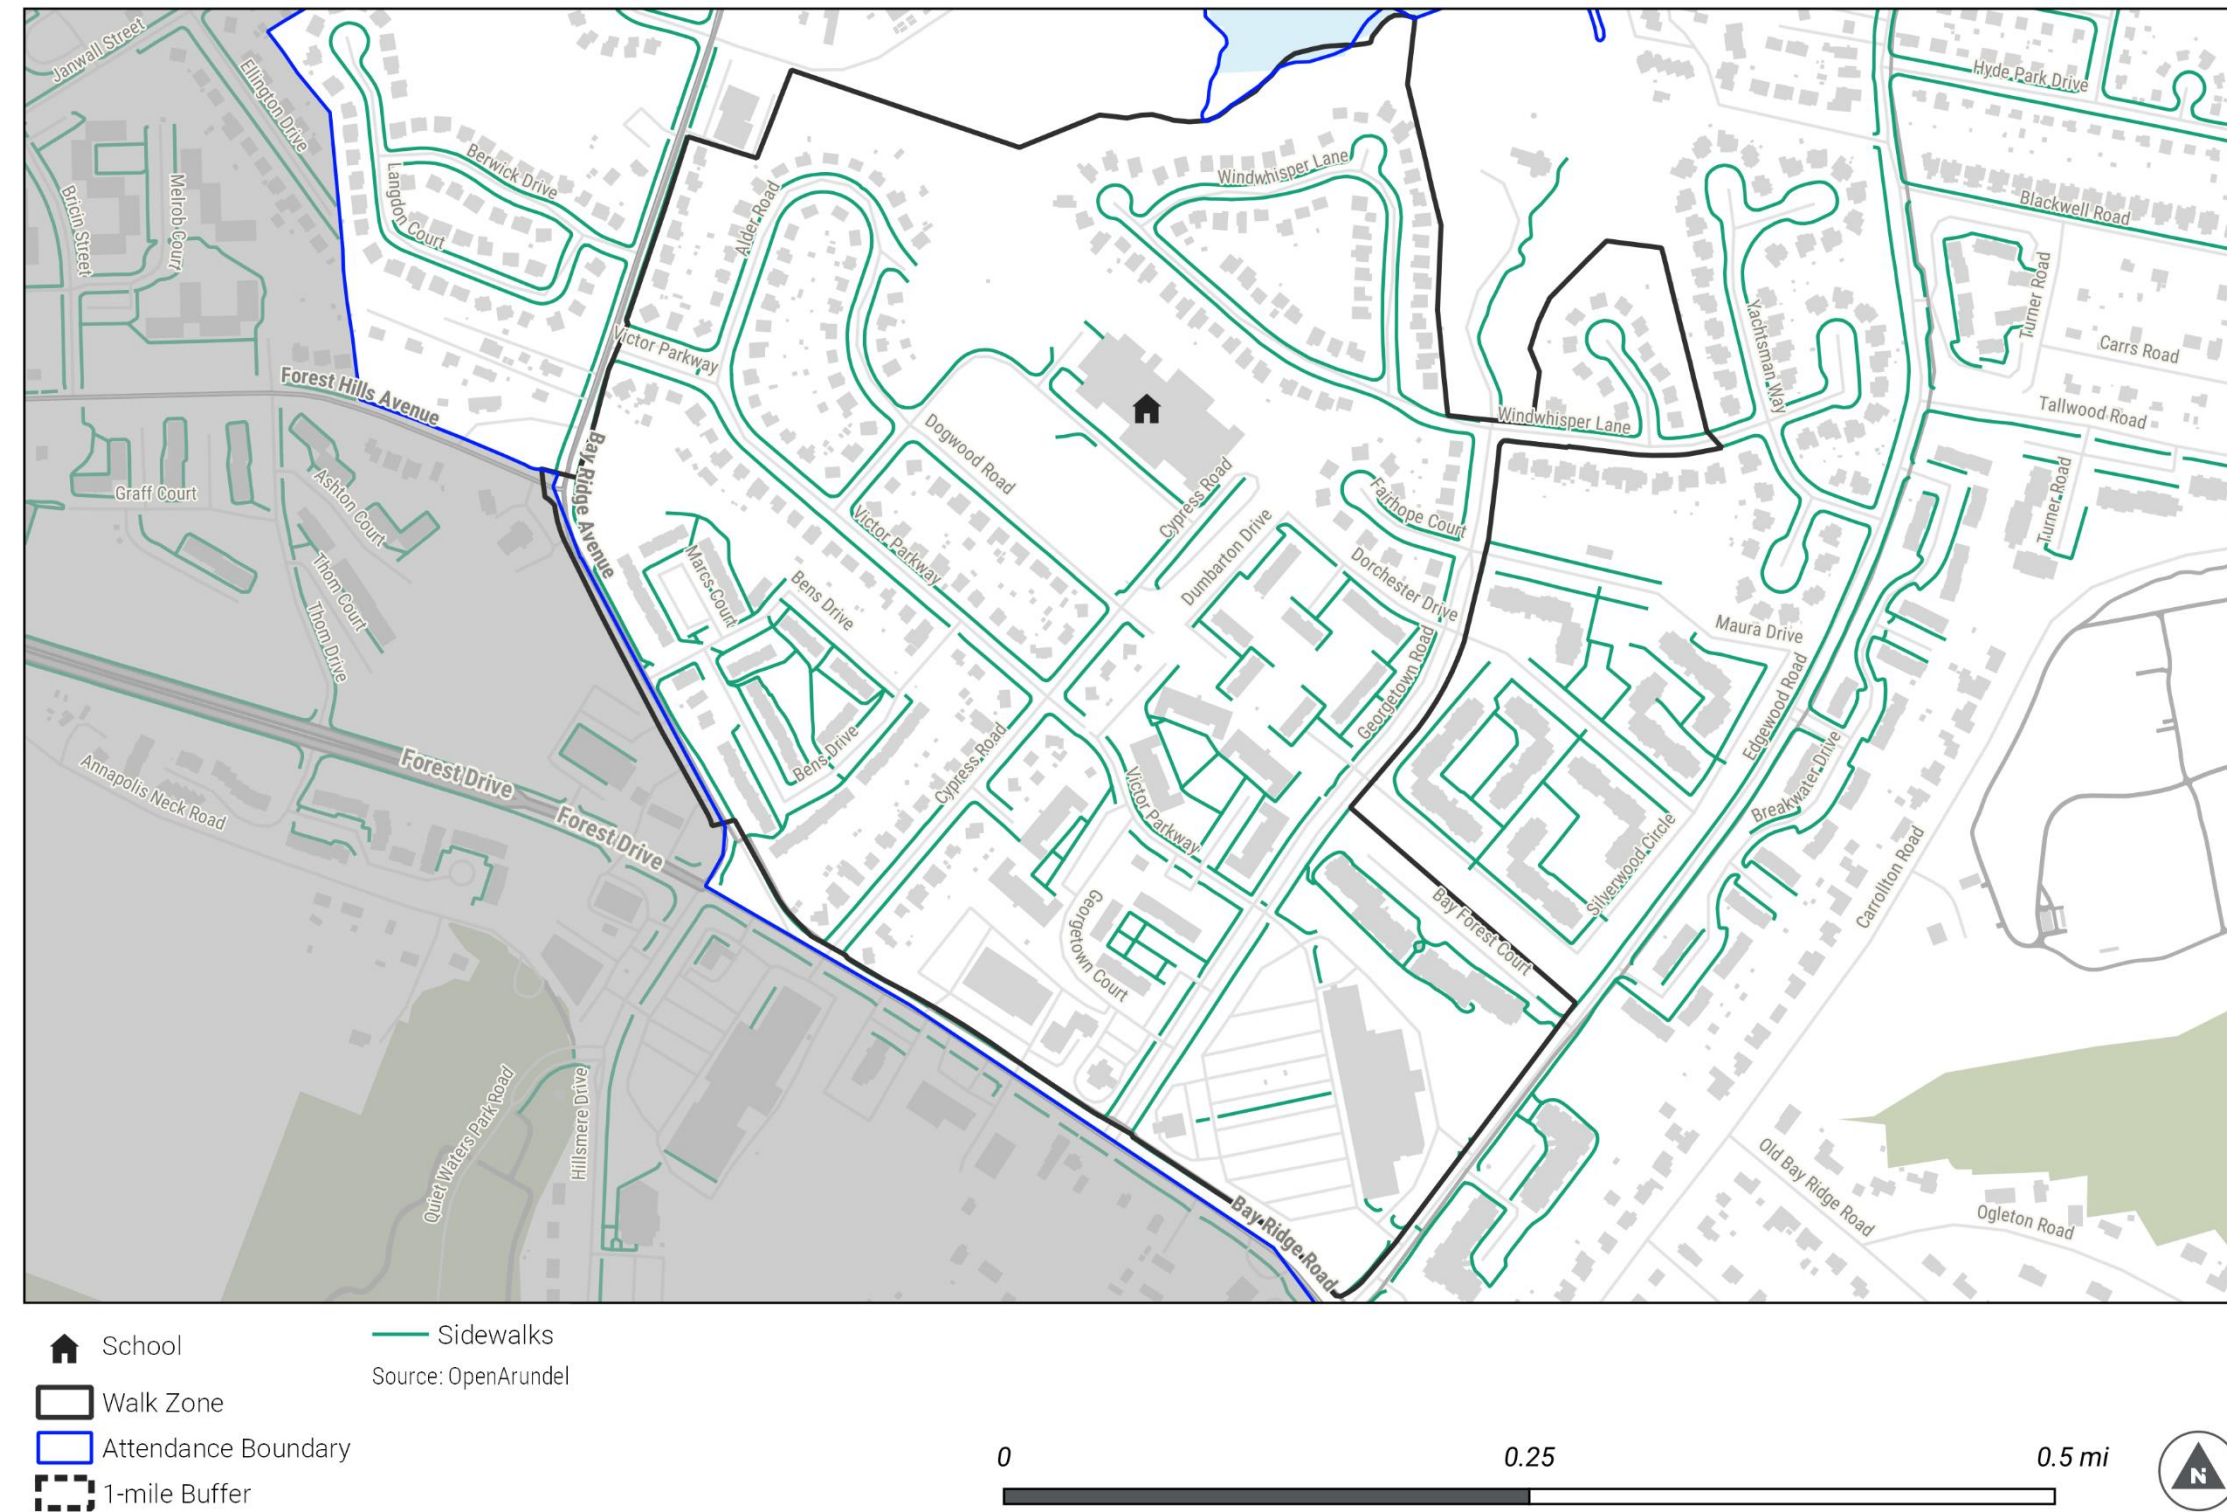
Georgetown East Elementary School - Existing Sidewalk Network

There are sidewalks present on all roads within the walk zone except along Dogwood Road directly in front of the school; no sidewalk exists on the north side.

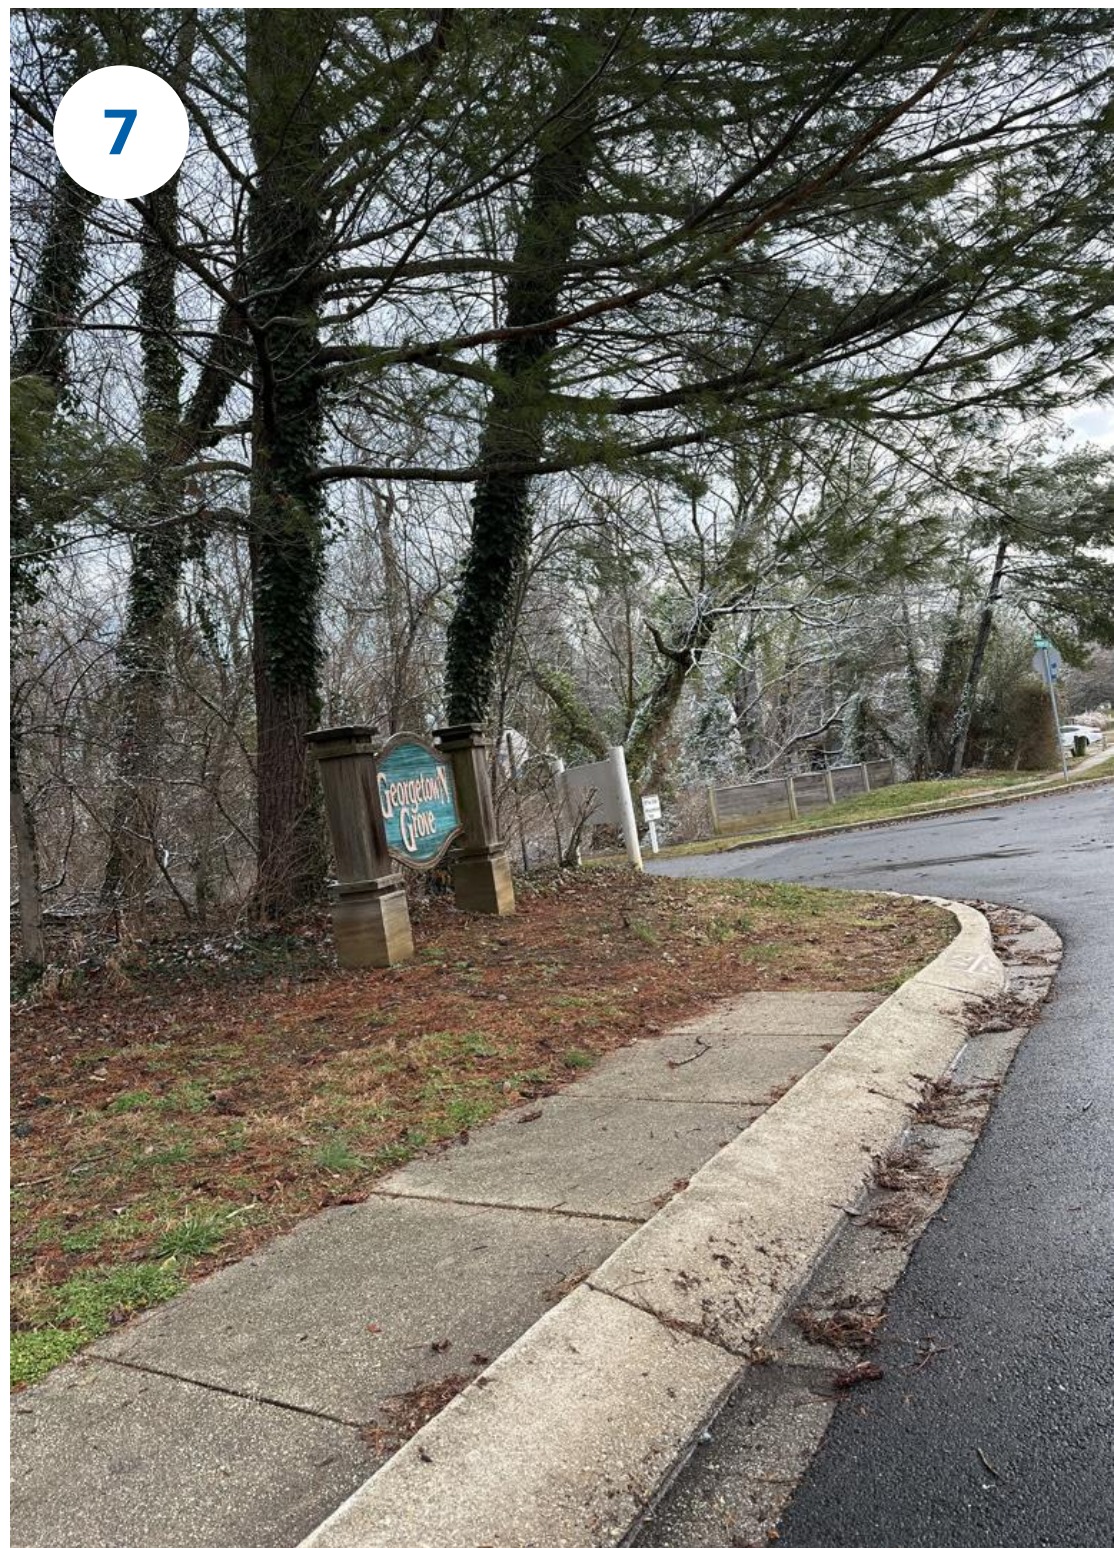
Windwhisper Lane & Georgetown Road

| Map ID | Location | Facility Type | Issue | Recommendation | Potential Cost | Timeframe* |
|---|---|---|---|---|---|---|
| 7 | Windwhisper Ln & Georgetown Rd | 7a. Curb ramp | Missing ramp (all) | Install new ramps | \$16,000 | Medium |

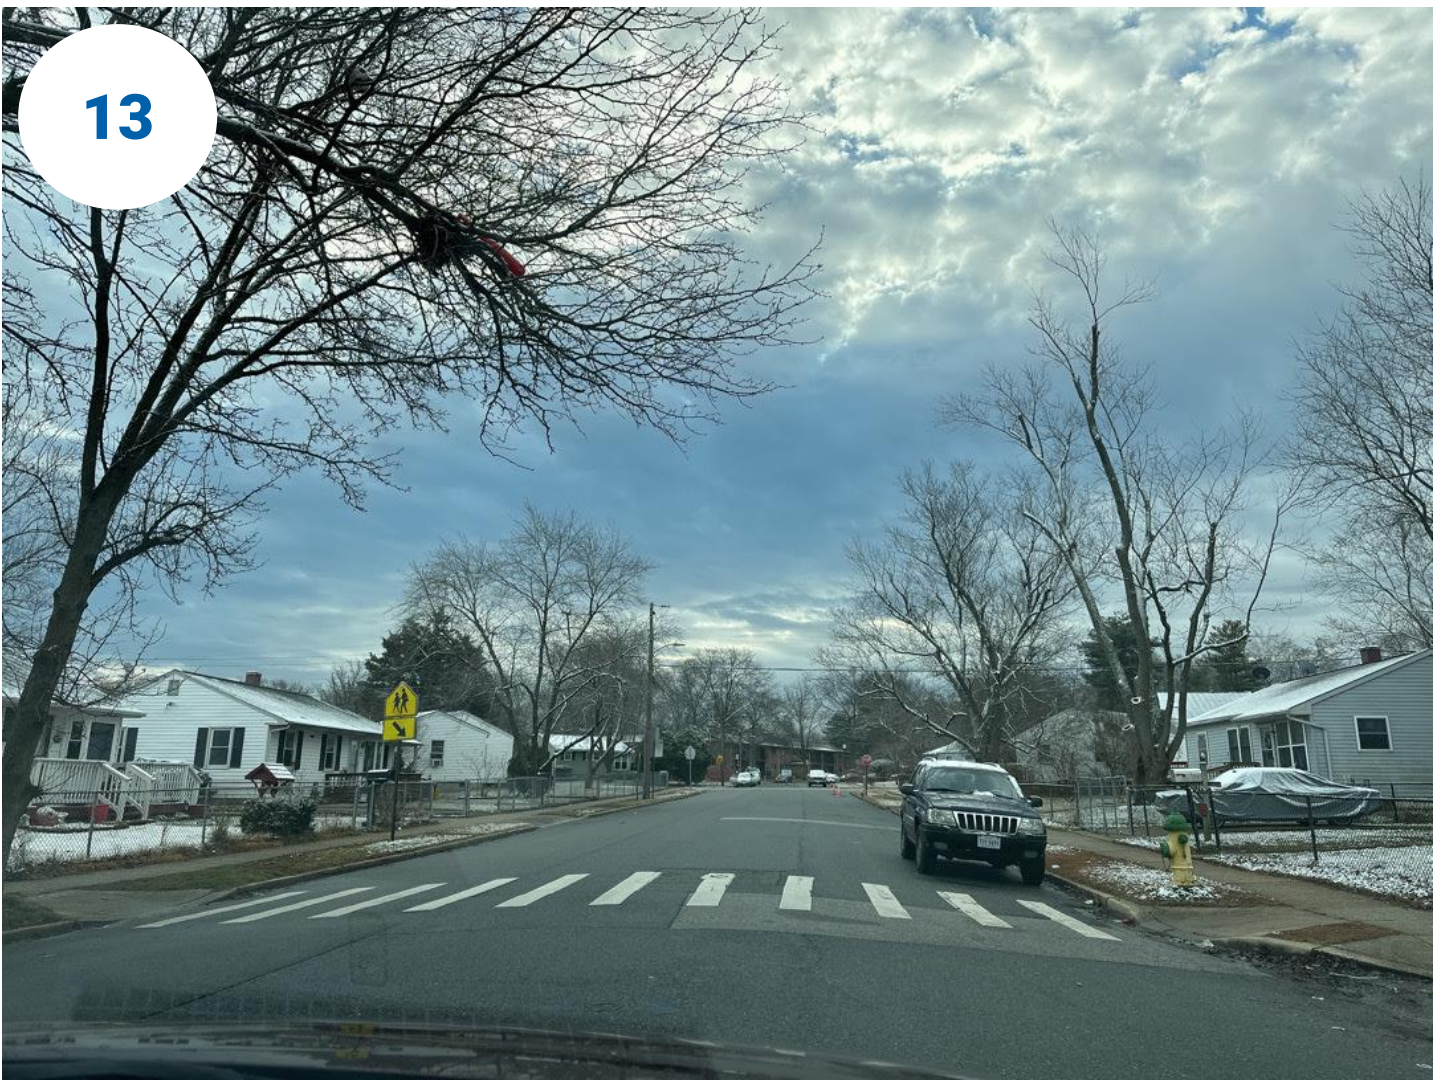
Victor Parkway & Bens Drive

| Map ID | Location | Facility Type | Issue | Recommendation | Potential Cost | Timeframe* |
|---|---|---|---|---|---|---|
| 13 | Victory Pkwy & Bens Dr (Along key student walking route) | 13a. Curb ramp | Ramp lacks detectable warning surface (all) | Reconstruct or repair existing ramp | \$16,000 | Medium |

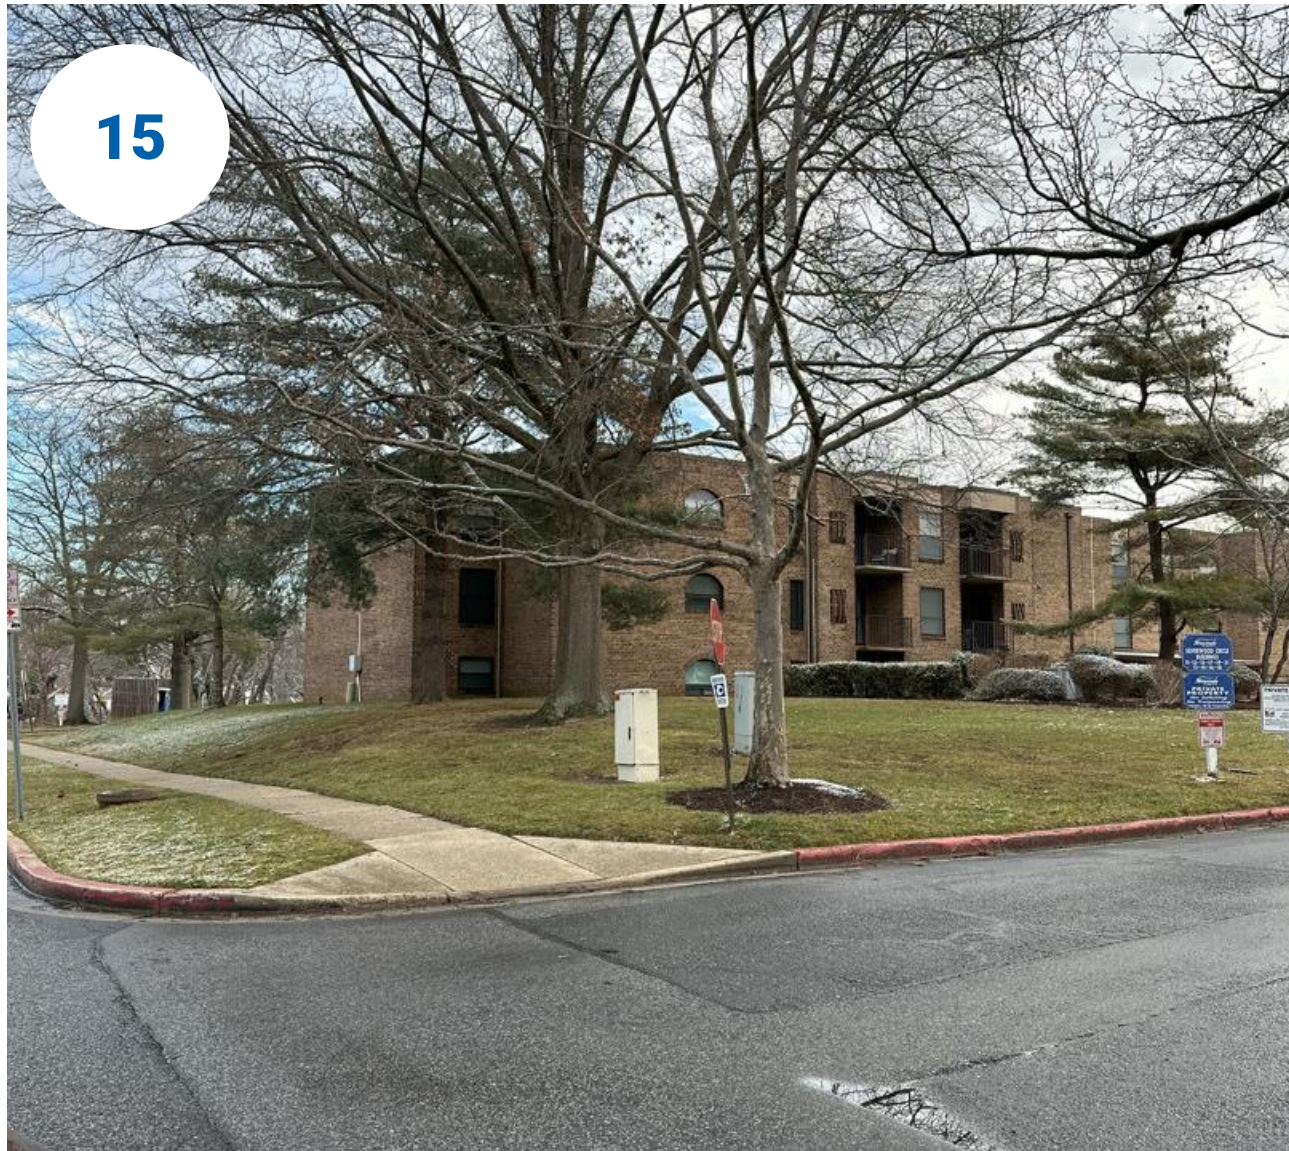
Dorchester Drive & Georgetown Road

| Map ID | Location | Facility Type | Issue | Recommendation | Potential Cost | Timeframe* |
|---|---|---|---|---|---|---|
| 15 | Dorchester Dr/Silverwood Cir & Georgetown Rd | 15a. Curb ramp | East, west ramp lack detectable warning surfaces | Reconstruct or repair existing ramps | \$16,000 | Medium |

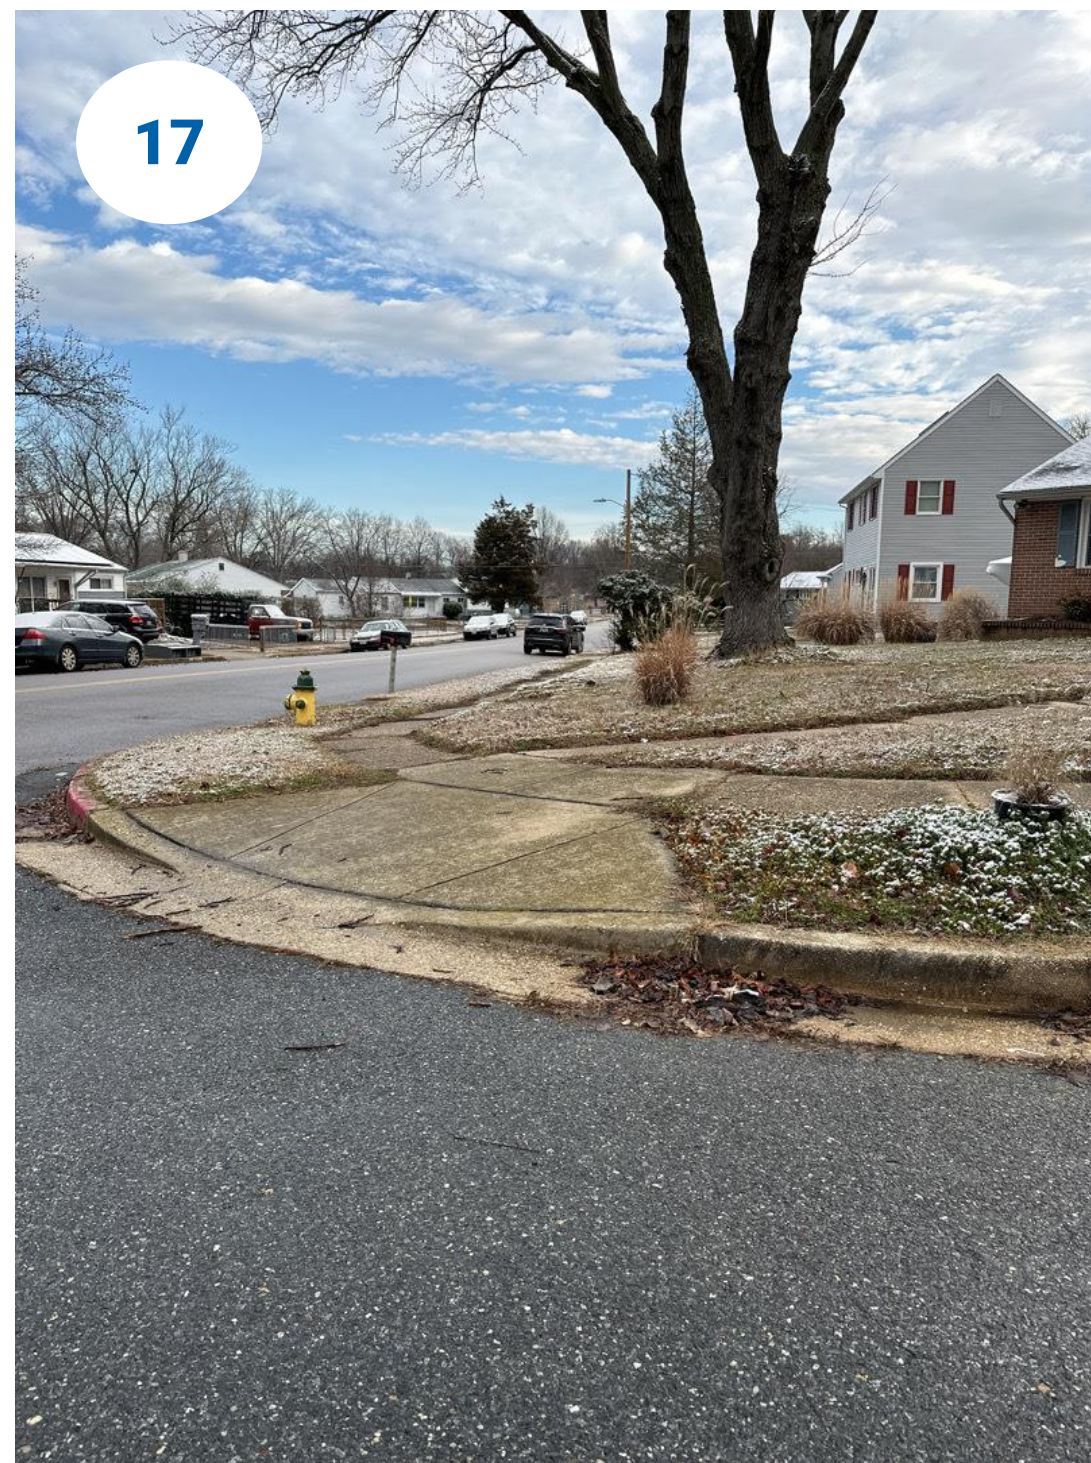
Cypress Road & Cul-de-sac

| Map ID | Location | Facility Type | Issue | Recommendation | Potential Cost | Timeframe* |
|---|---|---|---|---|---|---|
| 17 | Cypress Rd & Cul-de-sac (Along key student walking route) | 17a. Curb ramp | East ramp lacks detectable waring surface | Reconstruct or repair existing ramp | \$4,000 | Medium |
